58th HIGHWAY GEOLOGY SYMPOSIUM

POCONO MANOR, PENNSYLVANIA, OCTOBER 16-18, 2007

PROCEEDINGS

HOSTED BY
THE PENNSYLVANIA DEPARTMENT OF TRANSPORTATION AND
THE PENNSYLVANIA GEOLOGIC SURVEY

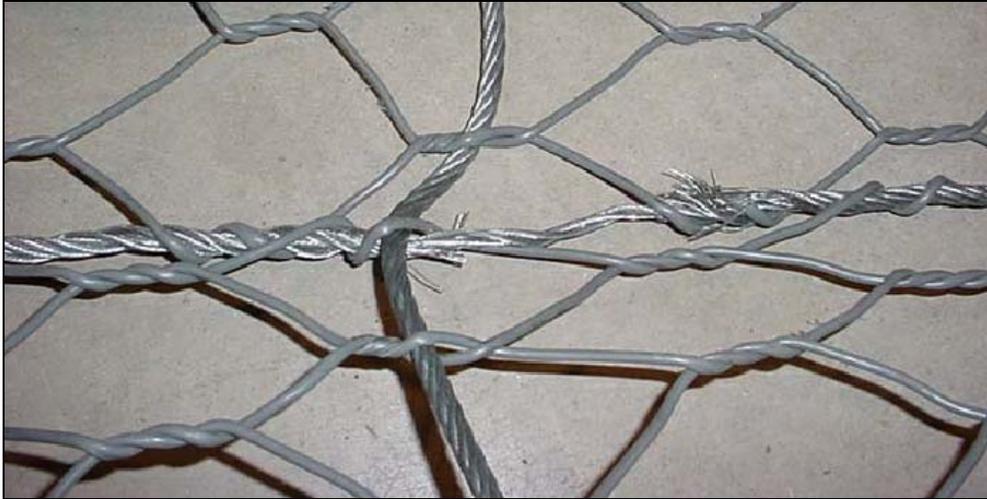
Figure 4 – Rock Mesh test at Bathurst (1), Clarabut Geotechnical Testing, Inc.

Other tests were performed to demonstrate that the mesh would not break before the cable got in tension. The test was carried out by Bathurst (1), Clarabut Geotechnical Testing, Inc. in 2005. With 2 cables inserted at 2 feet (0.6 m) spacing, both vertically and horizontally, in all the tests the cable was breaking before the mesh.

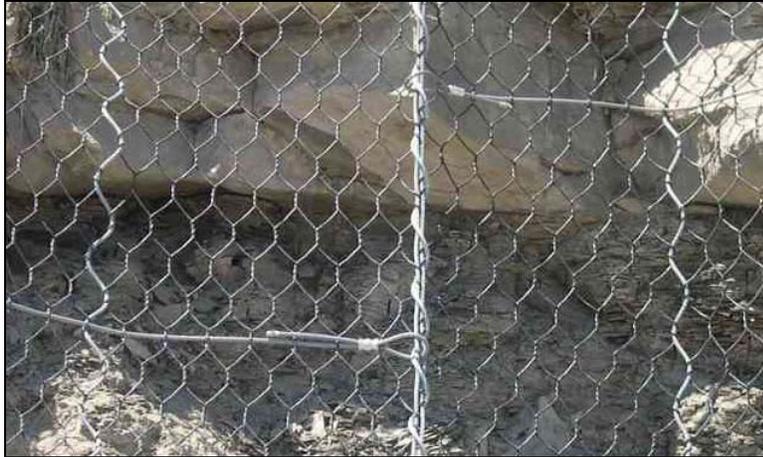
Figure 5 - Lacing cable at every mesh opening.

- Each panel was connected using 5/16 in (8 mm) steel cable in every mesh opening and secured at the end.
- No cables were installed at the toe to capture the rock; the debris is caught by the catchment area.
- The cable panels were designed to be 20 to 30 feet (6.1 to 9.15 m) shorter than the catchment area.

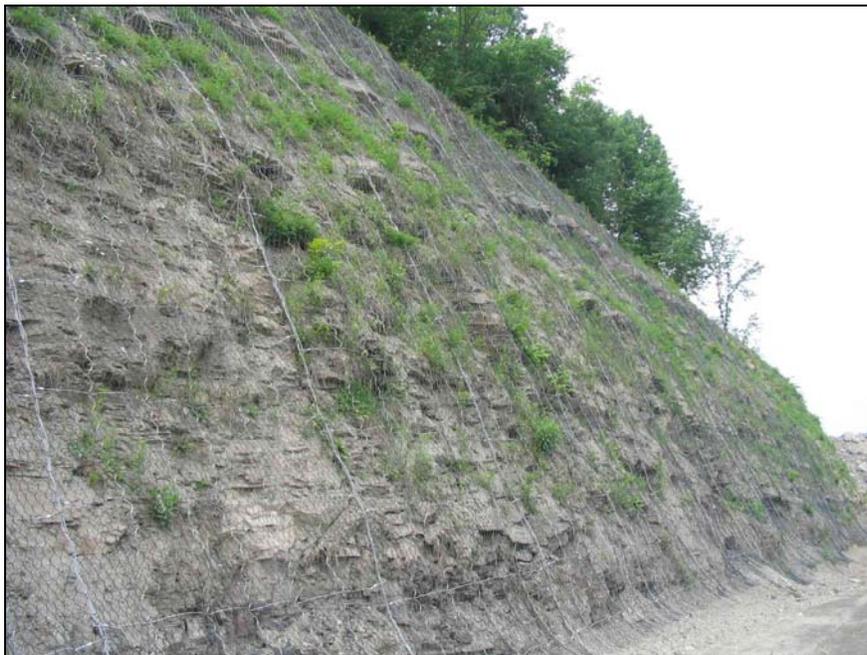
Figure 6 - Installed Rock Mesh B900 on the southbound area.

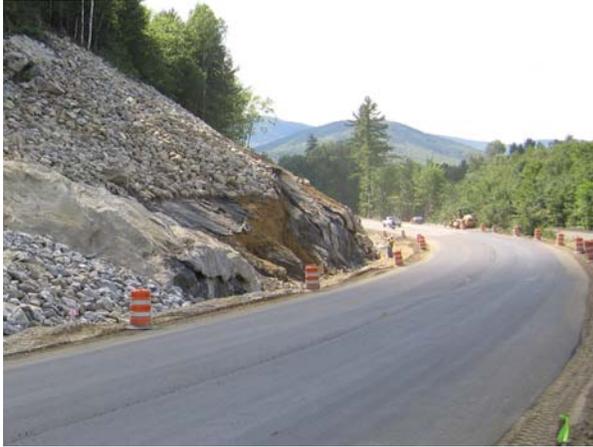
Figure 2 – Project View from East

During blasting operations in August 2005 for the 4V:1H rock cut, unstable rock and soil slope conditions were encountered along the cut slope section from Sta 2+060 to 2+120 as shown on Figures 2 through 5. Adversely oriented joints and fractures in the bedrock mass were dilated from explosive gas travel, and allowed some large bedrock blocks to be displaced. These joints and fractures dip towards the roadway, i.e., to the north. Near vertical soil slopes were

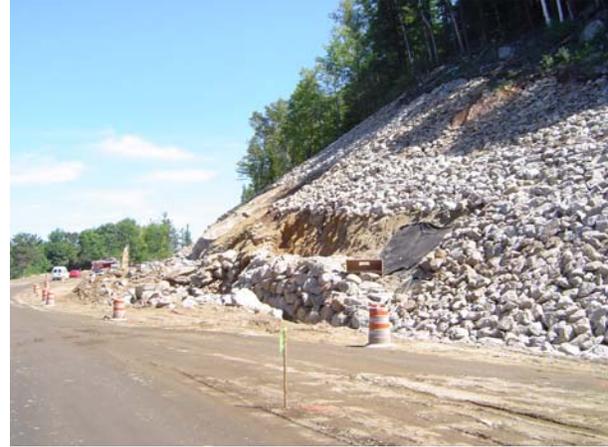
Figure 3 – Project View from West

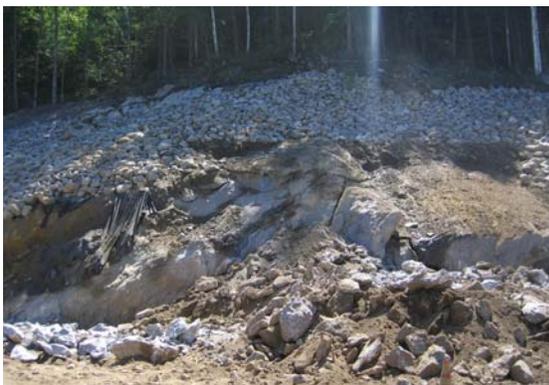
**Figure 4 – Vertical Soil Slope Section
8/26/05**

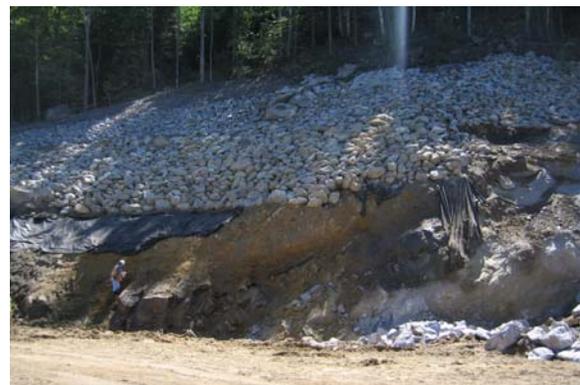
**Figure 5 – Unstable Rock Mass Section
8/26/05**

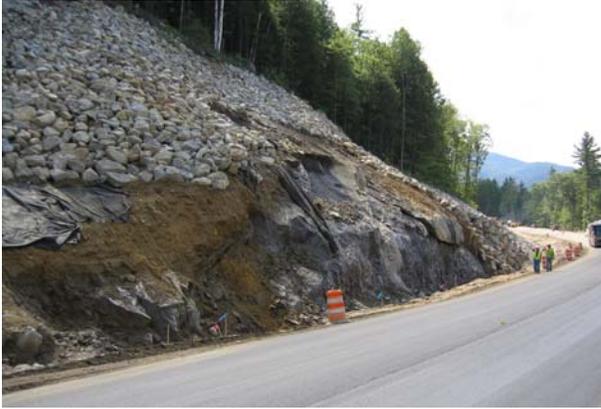
Figure 6 – Eastern Slope Section
9/2/05

Pursuant to Golder's initial site visit in late August, the project contractor (H.E. Sargent, Inc.) scaled loose surficial rock from the slope area and cleaned up the soil and rock materials at the base of the slope to allow two lanes of travel on Route 2. Conditions present in early September 2005 are shown on Figures 6 and 7 and included the following conditions requiring stabilization:

- Nearly vertical glacial till soil and completely weathered bedrock slope, with overlying riprap armor
- Dilated bedrock blocks on adverse joints and fractures dipping towards the roadway
- Soil and riprap overlying bedrock surfaces dipping toward the roadway
- The presence of large rock blocks on the slope, generally above the blasted rock zone, that were suspected to be talus blocks and not bedrock.
- Persistent groundwater seepage at the base of the overburden soils exposed above the rock cut.

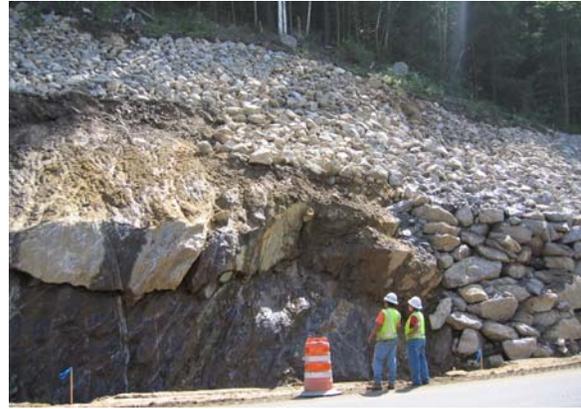
Figure 7 – Dilated Rock Block
9/2/05

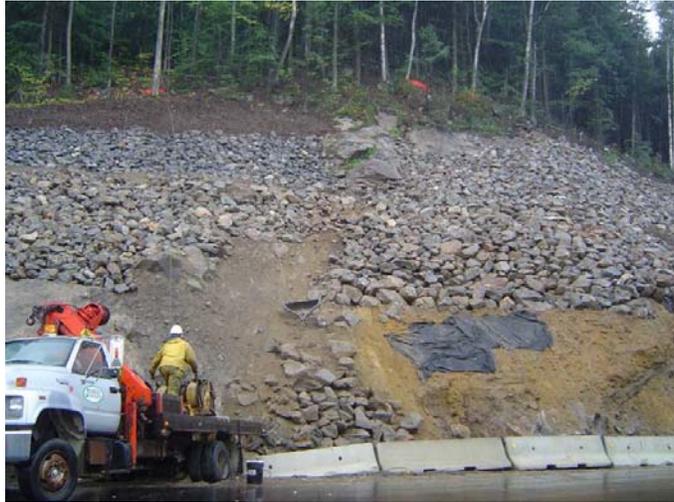
Figure 10 – Slusher in Operation 9/29/05

Janod completed soil excavation to layback oversteepened soil slopes covered with riprap to 1.5H:1V in Area A using a slope scaling “slusher” machine. The slusher consists of a compressed air powered, three-drum winch motor that uses a specialized excavation bucket to scrape loose material from soil and rock slopes. The drums contain steel wire rope, and are operated using separate clutches to engage the winches. The two outer cables are thread through pulleys mounted on trees or other anchors at the upper right and left sides of the slope to be excavated, and are attached to the upper side of the bucket.

lower side of the bucket. The slusher operator can move the bucket up and down the slope, as well as left and right, to access the area requiring excavation. Excavated and scraped materials were piled at the base of the slope and removed with an excavator. Figure 10 shows the slusher in operation. Slushing operations were halted when the excavation encountered talus rock blocks too large to be removed (on the order of 3+ m diameter).

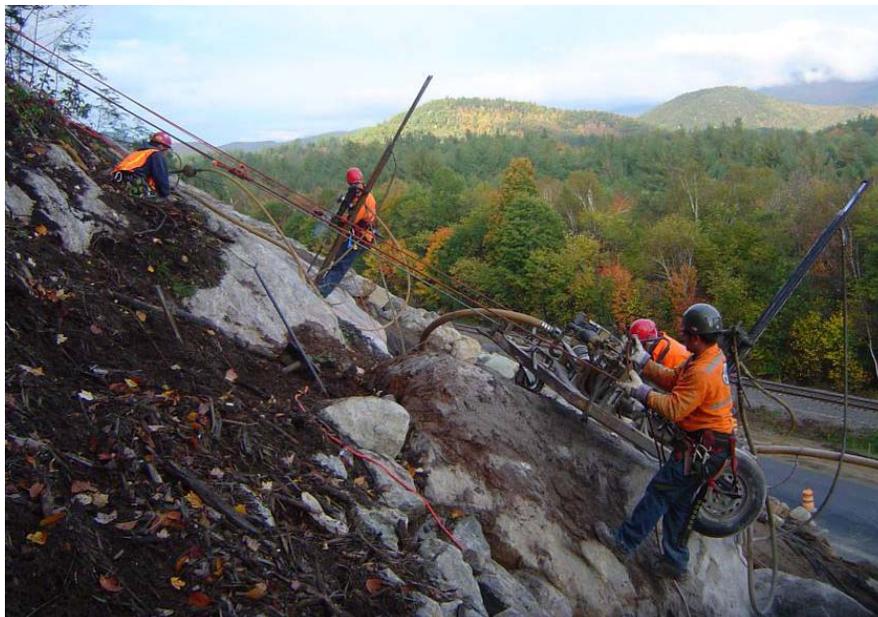
Figure 11 – Top hammer drills mounted on bencher (left) and wagon frame (right) 10/12/05

In general, the hand-operated “plugger” drills were used to install dowels in exposed bedrock and for shallow (3 m or less) rock dowels. The bencher-mounted and wagon frame-mounted drills were used to drill dowels for the talus blocks and the Tecco system dowels extending through soil materials (see Figure 11). The DTH drill (Figure 12) was used to drill holes for the wire rope anchors.

The drills mounted on the wagon frames were suspended by steel cables attached to trees above the slope. The drills were maneuvered on the riprap surfaced slope using the self-propelled air winches at the front of the wagon drills. Drill hole diameters were 51, 64 and 89 mm. Drilling for the Tecco and ring net anchors placed within overburden materials required use of casing to prevent collapsing conditions. As the minimum diameter of the DTH wagon drills is about 89 mm, this allowed for drilling a pilot hole within the overburden, followed by drilling in bedrock.

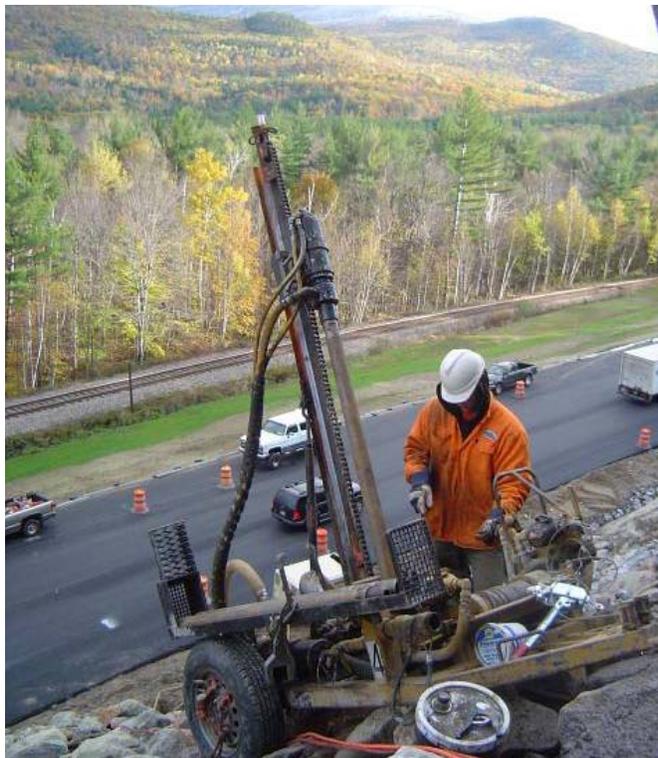
Figure 12 – DTH hammer drill on wagon frame used to drill holes for wire rope anchors

The ring net anchor holes were drilled using the DTH wagon drill (Figure 12) with a 89 mm diameter bit, and were inclined at about 45 degrees from horizontal. Anchor drilling depths were terminated after penetrating at least 1.8 m of bedrock. Drilled anchor lengths ranged from 1.8 to 4.3 m.

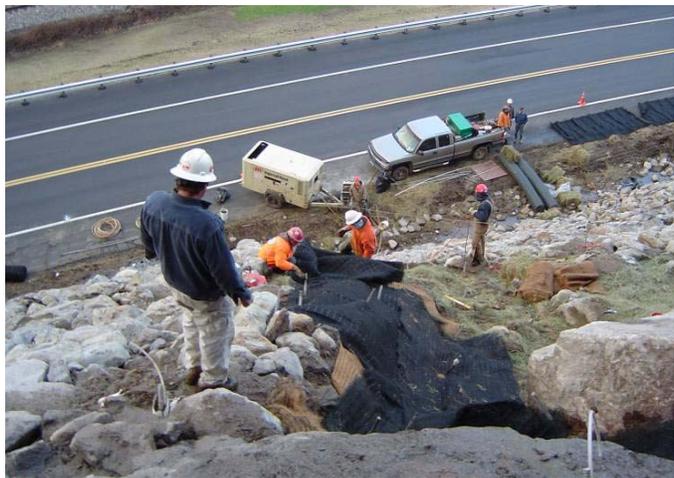
Figure 14 – Placement of turf reinforcement mat on soil prior to wire mesh

2. Spread seed mix over soil areas and cover with hay.
3. Place a coconut fiber erosion control blanket (ECC-2) over two soil “gully” areas where groundwater seepage was observed during the stabilization construction.
4. Place Landlock TRM 1060 turf reinforcement mat over all soil areas (Figure 14).

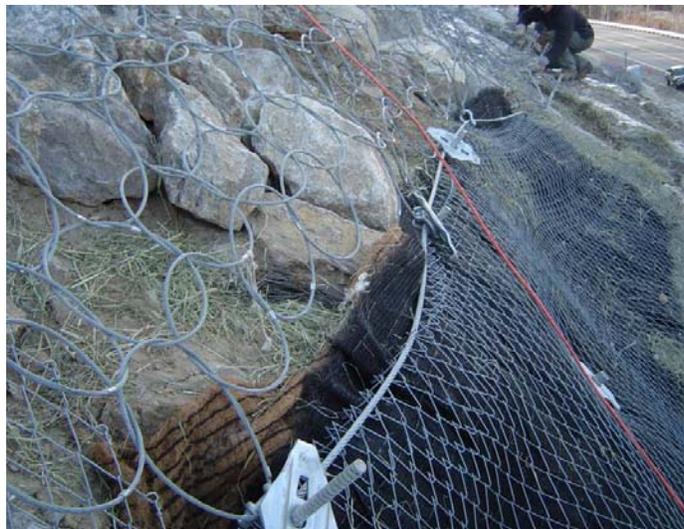
Figure 15 – Tecco mesh / ring net connection prior to tightening seaming cable

6. Place and tension a 16 mm wire rope seaming cable around the perimeter of the Tecco mesh panels. The seaming rope was also integrated with the seaming rope of the ring nets (Figures 15 and 16).

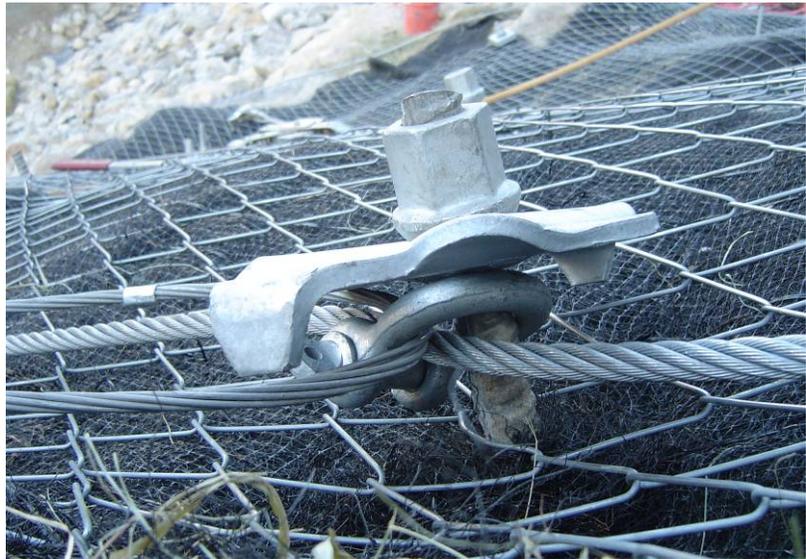
Figure 16 – Close-up view of Tecco anchor (prior to tightening), with in order from top to bottom: nut, spike plate, shackle, 16 mm wire seaming rope (right), ring net cable (left), Tecco wire mesh

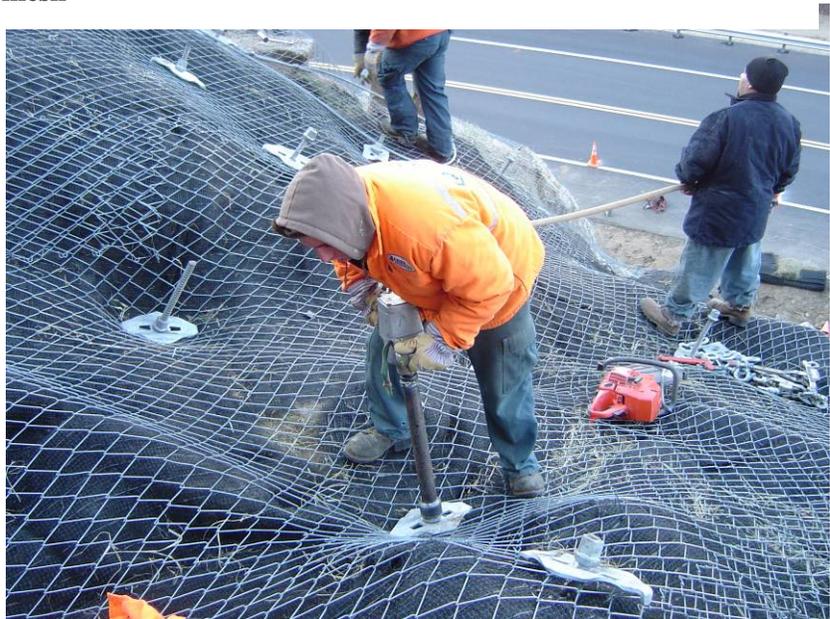
Figure 17 – Using air-operated impact wrench to tighten nuts onto Tecco anchor spike

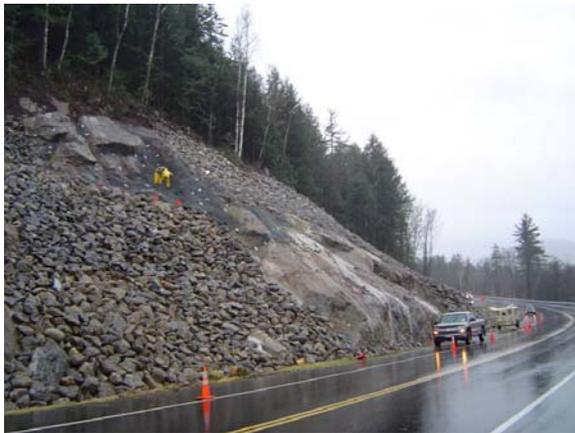
Figure 18 – Stabilization work nearing completion 11/22/05

Near completion conditions at the onset of winter precipitation in November 2005 are shown in Figure 18, and recent conditions in the summer of 2007 are shown in Figure 19. While the stabilized slope faces the north and receives little direct sunlight, the vegetative species planted as part of the stabilization, as well as native wild-growing species have already taken root and are supplementing the mechanical stabilization construction. No slippage, sloughing or other evidence of slope movement in the stabilization area were noted in the summer of 2007, about 1½ years after construction was completed.

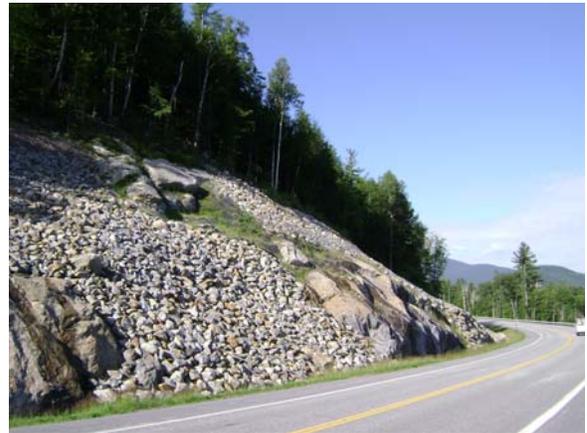
Figure 19 – Slope conditions 1½ years post construction – 7/17/07

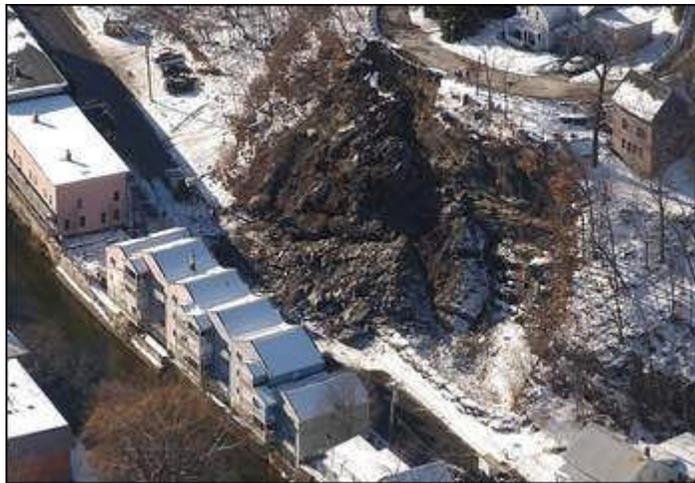
Figure 1 – Aerial view of rock slide on December 26, 2005, one day following the slide event

On December 26, 2005 a rock slide occurred in Montpelier, Vermont (see Figure 1). The rock slide was located northwest of Elm Street, between School Street on the southwest end and Spring Street on the northeast end. Cliff Street is located adjacent to the crest of the slope, approximately 85 to 100 feet (ft) above and roughly parallel to Elm Street in the slide area. The rock slide occurred during a heavy warm rain which followed a period of intense freezing. Rocks, soil and debris toppled and slid to the southeast down the slope, across the pedestrian walkway located northwest of Elm Street. Several large rocks struck planters in front of the apartment building located on the southeast side of Elm Street. Two utility poles on Elm Street were broken by falling debris, and the lines attached to them were cut or damaged. Cliff Street lost about 5 ft of street width (pavement) and approximately 70 ft of guardrail. The City temporarily closed Elm Street and Cliff Street to traffic in the area of the slide¹.

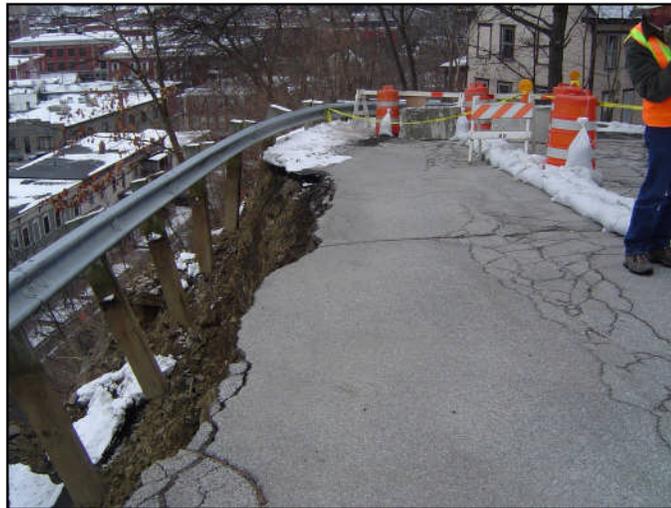
Figure 2 – Damage at the head of the slide on Cliff Street, December 27, 2005

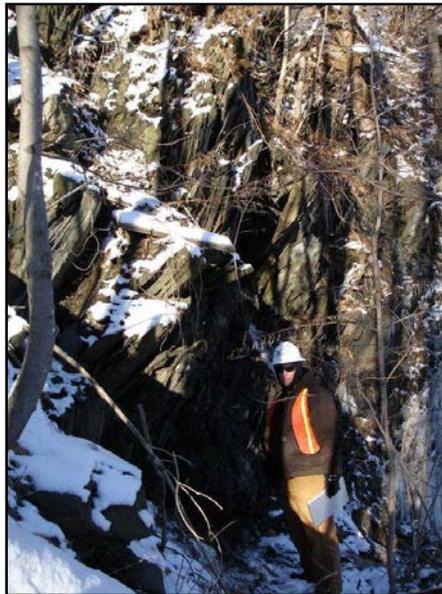
Figure 3 – Chevron toppling within phyllite dipping steeply into the slope

Subsequent field work conducted on rock outcrops located near the slide area, and consultation with the VGS indicate the failure mechanism consisted of chevron toppling³ within the middle part of the slope, followed by rotational slumping within the overlying overburden materials (see Figure 3). We suspect that the extended sub-freezing weather in December 2005 caused ice jacking to occur behind the metasandstone layer, pushing the blocks out from the slope. When the sudden thaw occurred, accompanied by heavy rain, the ice that had held the blocks to the slope melted, eliminating the remaining support for the blocks, and the blocks toppled.

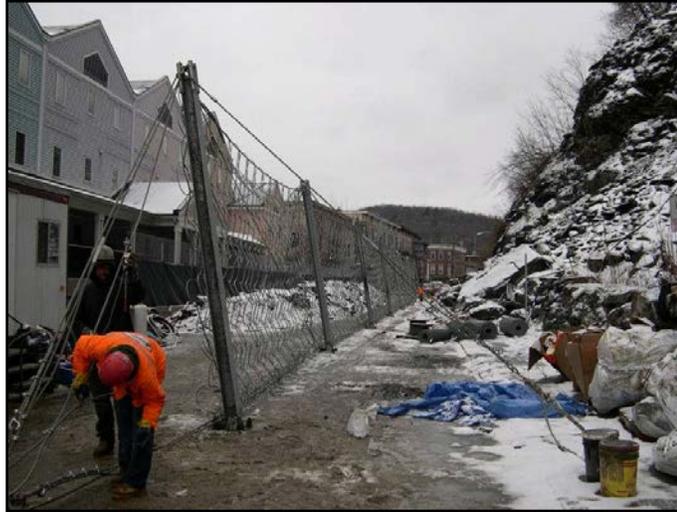
Figure 5 – Installation of temporary rockfall barrier on Elm Street

In mid-January 2006, Janod installed a 2,000 kilojoule rockfall barrier in the middle of Elm Street. The 260-ft long barrier employed interweaved ring nets, tieback cables with braking elements, and pivoting fence posts (see Figure 5). The temporary rockfall barrier served two purposes: to stop rockfalls and falling debris, and to catch rocks removed during scaling. Scaling of the slope was done using hand scaling bars, air bags, boulder busters and a mechanical slusher.

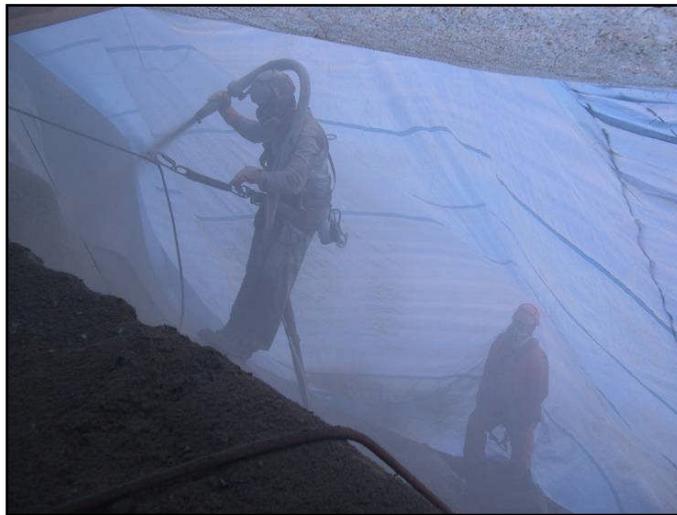
Figure 6 – Application of shotcrete under hoarding during winter conditions

Temporary stabilization construction of the top of the slide area was completed concurrent with installation of the rockfall barrier on Elm Street. This stabilization consisted of installation of geotextile drainage strips and shotcrete facing installation, followed by relocation of utilities and drilling and installation of rock nails anchored within bedrock. As the nightly temperatures in January commonly dipped to below 0 degrees Fahrenheit (°F), hoarding, consisting of tarps and propane heaters, was needed to keep the ground and shotcrete above 40°F so it could properly cure (see Figure 6). The south facing slope, coupled with the heaters, kept the work area as warm as 70°F. One lane of Cliff Street was reopened for service vehicles following the temporary stabilization construction.

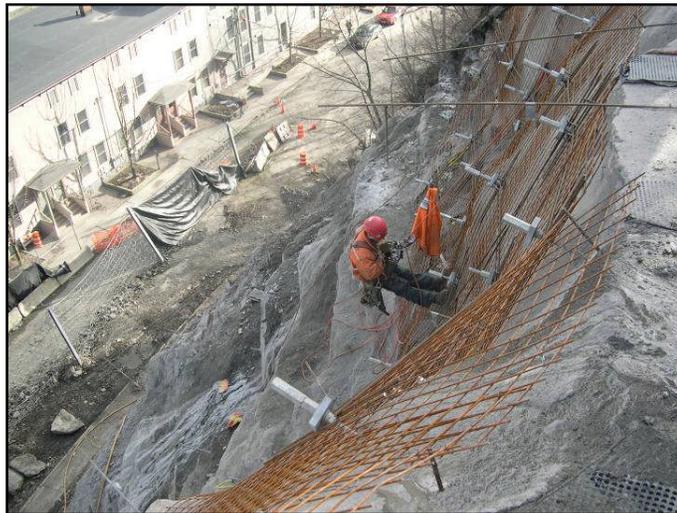
Figure 7 – Construction of permanent shotcrete wall

The thickened permanent rock nail/shotcrete wall installed below Cliff Street was designed with three layers of steel reinforcement (rebar and welded wire fabric), installed between layers of fill shotcrete (see Figure 7). The shotcrete included steel fibers for further reinforcement. Due to the cold weather installation, hoarding was used to keep the curing temperatures above 40°F. The rock nails were extended into the shotcrete as the wall was built out. The wall was founded on a hand-excavated bedrock bench, reinforced with rock dowels. The permanent shotcrete wall was built out to a maximum thickness of 5 ft.

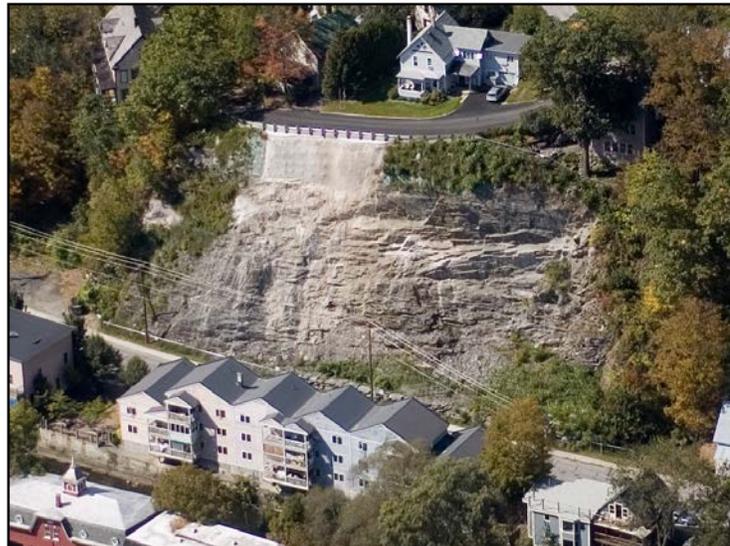
Figure 8 – Final repairs of slide area

All of the rock slope remediation construction was completed by mid-May 2006, well within the six-month FHWA funding window, and therefore the City was fully reimbursed for these costs. Elm Street was opened to traffic in mid-May as well. Following moment slab construction and final paving, Cliff Street was opened to two lanes of traffic by July (see Figure 8).

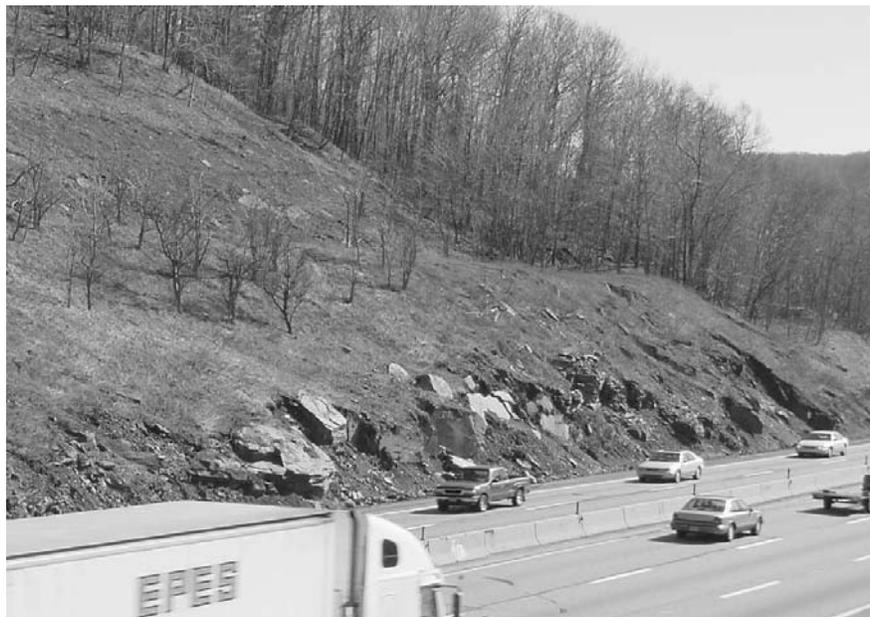
Figure 4 – Toe area of the New Baltimore Landslide along I-76.

The New Baltimore Landslide has been studied since the Pennsylvania turnpike was constructed in 1939. The construction of the Pennsylvania turnpike reactivated an ancient landslide and in the 1940's a new slide occurred which blocked an area of the turnpike. This slide prompted immediate attention and studies have been ongoing since then. The PTC has sketched and mapped the landslide to show the extent of the movement along the slide. A 40-foot (12 m) wide bench with drainage was constructed on the landslide by the PTC in the 1950's to try to stabilize the slide. This attempt at stabilization has not worked very well because the landslide is still creeping a rate of 5 to 10 inches (13 to 25 cm) per year. In 1972, PTC hired Geomechanics, Inc. to perform a subsurface investigation to find the failure plane of the landslide and they drilled three borings. In 1999, the PTC was concerned about the stability of the New Baltimore Landslide and hired American Geotechnical and Environmental Services (AGES) to perform a more detailed investigation. The purpose of their investigation was to find the rate of movement, location of the failure plane, and remedial measure need to stabilize the slope. They drilled 18 borings, installed 15 vibrating wire piezometers, 11 Time Domain Reflectometry cables, and three slope inclinometers (Henderson, 2000). Ryan Tinsley, a previous graduate student at Kent State University, worked along with AGES to research the slide. He mapped the landslide and reported his results in his master thesis which was completed in 2004. In 2006, the PTC hired AGES again to perform geotechnical investigations and to determine the stability of the slopes along the stretch of the Turnpike between mile markers 128 and 129. This company has drilled 10 borings on the south side of the turnpike (Figure 2). The area of these 10 borings is also shown as the "upper section" of the landslide in Figure 3. Additionally, two borings were also drilled on the north side of the turnpike to investigate the toe area of the New Baltimore Landslide (Figure 2). Slope inclinometers have been installed in 5 of the 10 borings on the southern side as well as in the 2 borings on the northern side of the turnpike. A nested vibrating wire piezometer has also been installed to measure hydrostatic pressure. The slope inclinometers have been monitored by AGES and the senior author of this research. Figures 4, 5, and 6 show examples of unstable rock at the toe of the New Baltimore Landslide.

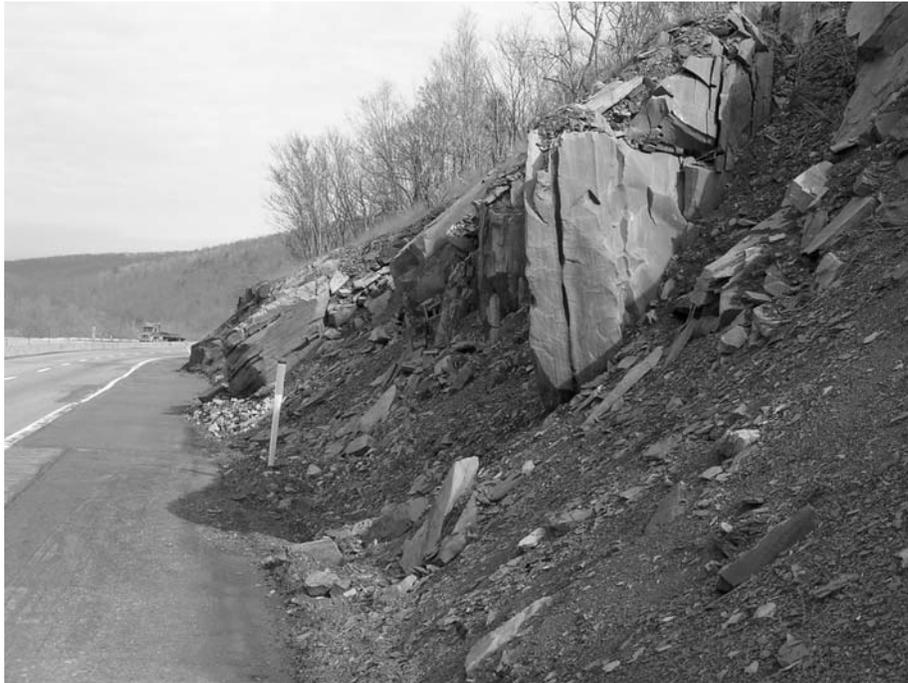
Figure 5 – Unstable rock mass at the toe of the landslide along I-76.

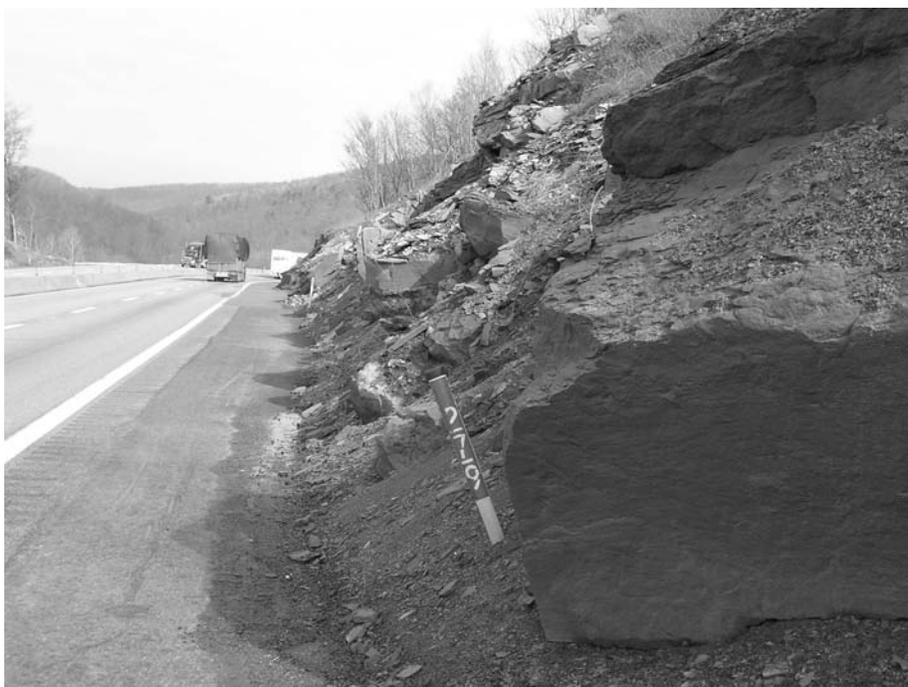
Figure 6 – Toe of the New Baltimore Landslide.

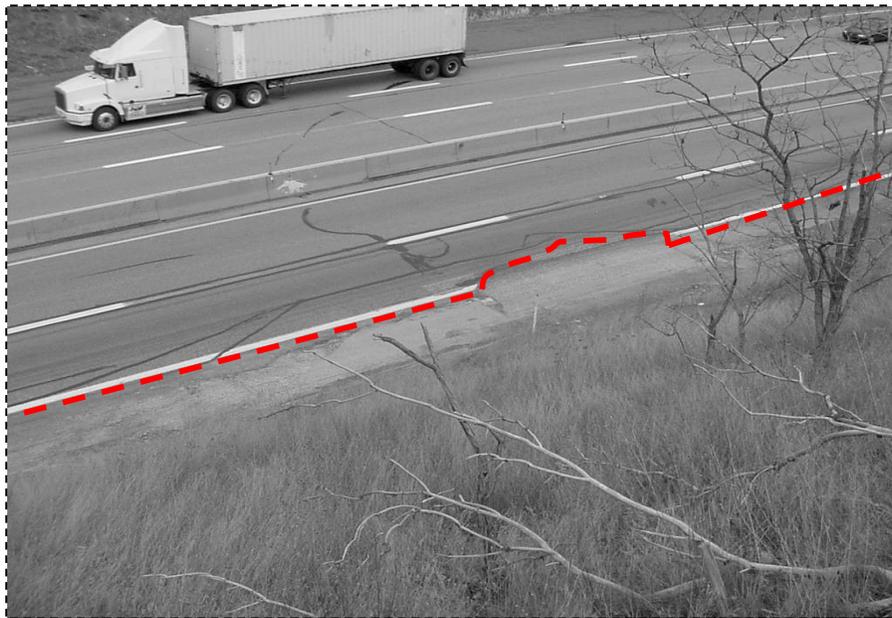
Figure 7 – Pavement heaving of the eastbound lane of I-76.

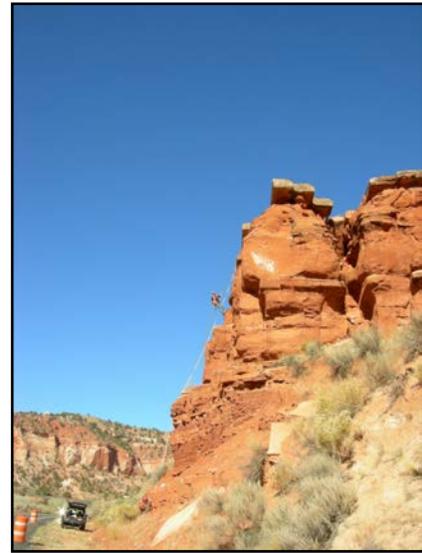
Figure 2: Mountaineering Techniques for mapping near MP 68.1

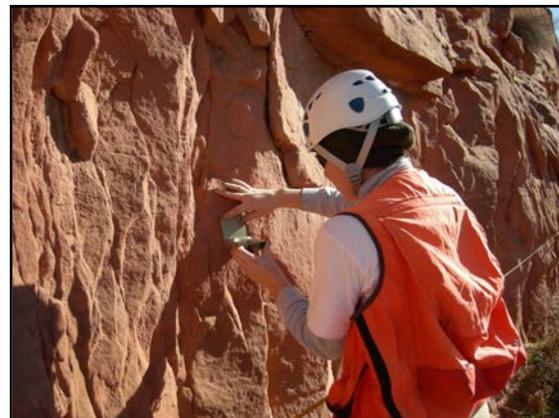
Figure 3: Kami collecting discontinuity orientations

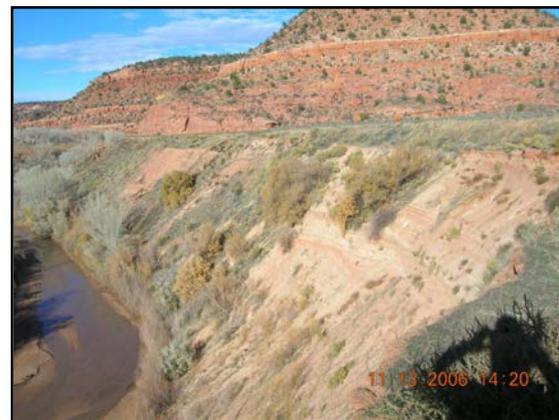
Figure 4: Kanab Creek cutbank evaluation

Kanab Creek parallels the western aspect of US-89 along this stretch of the project between mile post (MP) 65.0 and MP 68.3 at the bridge crossing. Kanab Creek is a mature meandering stream with classic point bars and cutbanks. The cutbanks have formed as a result of headward erosion of the stream at the head of the meander loop into older terrace deposits. Typically during flood stage, the stream erodes the toe of the slope on the outside of the stream meander thus steeping the slope, removing lateral support and creating unstable conditions; sloughing and larger landslides towards the creek then ensue (Figures 6 and 7). Near MP 65.5 the team observed a small landslide (about 10,000 cy) in the terrace deposits. The headscarp of the slide was within five feet of the southbound shoulder of US-89. The landslide demonstrated typical morphology of landslide such as a bulbous toe, hummocky terrain, and a steep headscarp. Relief between the shoulder of the highway and the creek ranges between 100 and 200 feet.

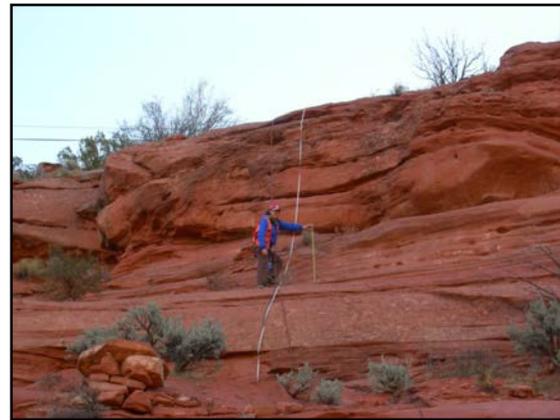
Figure 5: Chad estimating RQD

In boreholes, RQD is a directionally dependent parameter and its value may change systematically depending upon borehole orientation. Therefore, using the volumetric joint count by Planström is useful in reducing this directional dependence. To evaluate J_v in the field one must select an open cleft in the rock which displays x, y and z dimensions. One then sums all the fractures along a 1-meter length in each of the 3-dimensions to obtain a volumetric joint count. The RQD is used in estimating the RMR values.

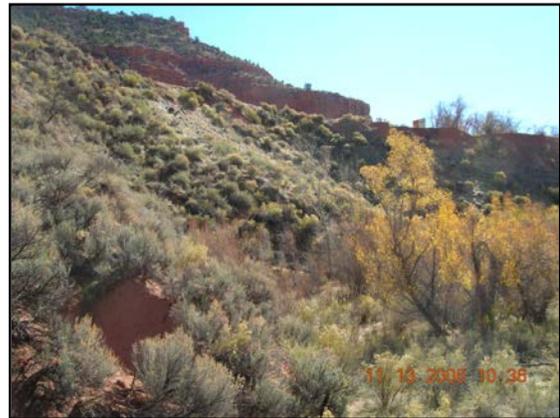
Figure 6: Landslide present near MP 65.5

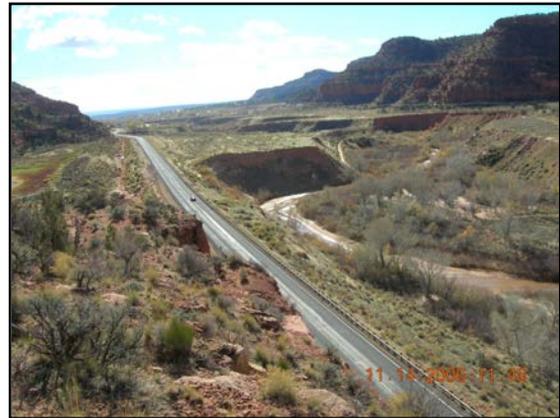
Figure 7: Cutbank near MP 66

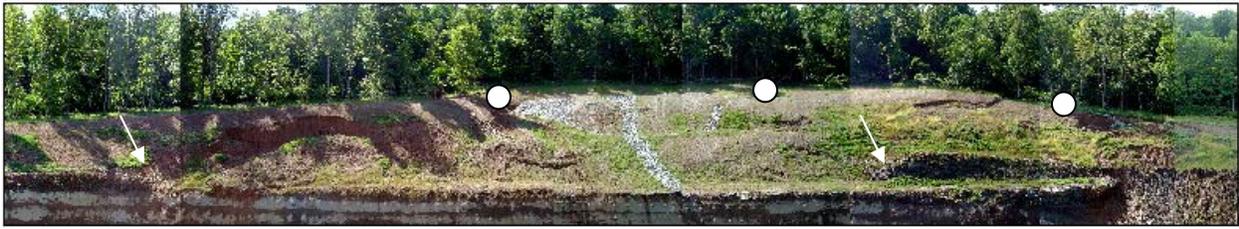
Figure 3 – Panorama of SW Cut Area
(Circles represent inclinometer locations and arrows mark edges of discontinuous bed)

Although the creep at elevation 950 feet appears to have almost completely ceased, Inclinometers I-1 through I-3 have continued to show cycles of minor creep movement and subsequent stabilization at relatively shallow depths within the soil overburden. These periods of movement are believed to be related to the buildup of perched water following precipitation events. Following the completion of construction, soil slides occurred in the southwestern cut area in May 2006 and June 2007, and these features can be seen in the panoramic photograph in

Figure 3. Each of these slides involved the movement of roughly 5,000 to 10,000 cubic yards of material, consisting mostly of gravelly to clayey silt (colluvium and residual claystone).

During the excavation of the southwestern cut, laterally discontinuous beds of sandstone and sandy siltstone were exhumed. Most notably, an approximate 500-foot-wide gap was discovered where a 6-foot-thick layer of sandy shale is laterally discontinuous. This sandy shale bed, which is present on either side of the gap, sits directly above the top of the claystone beds. The edges of this bed are visible at the lower left and right portions of Figure 3 (see arrows), and it can be seen that the recent landslides generally coincide with the gap. Also note that Inclinometers I-1, I-2, and I-3, which are spaced at 200 feet, are roughly centered about the slide area (inclinometers are numbered from right to left in photo).

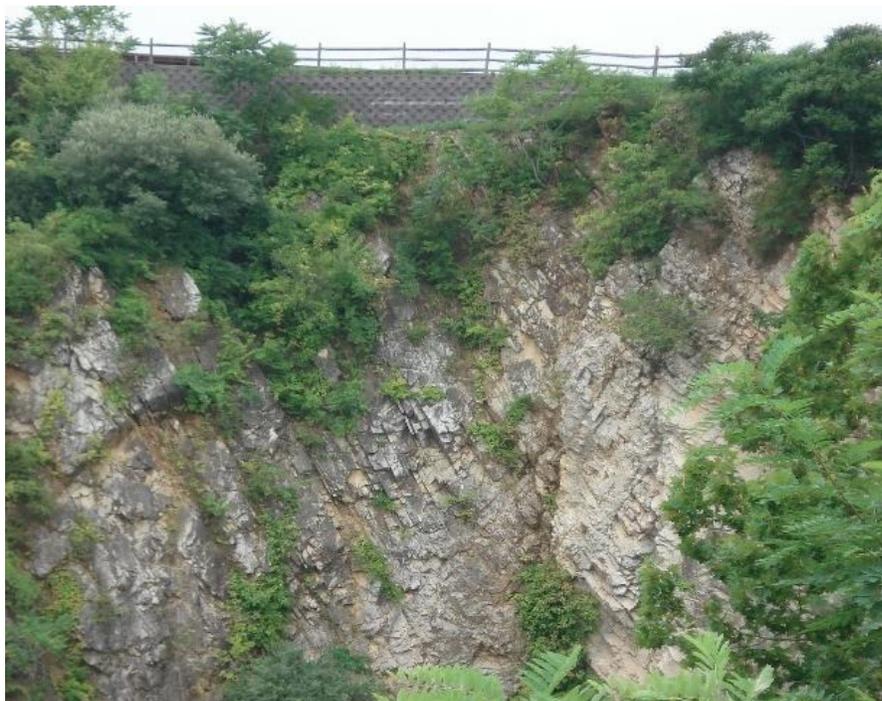
Figure 2. Steeply Dipping Elbrook Formation Limestone at an Abandoned Quarry near the Project Site (August, 2007)

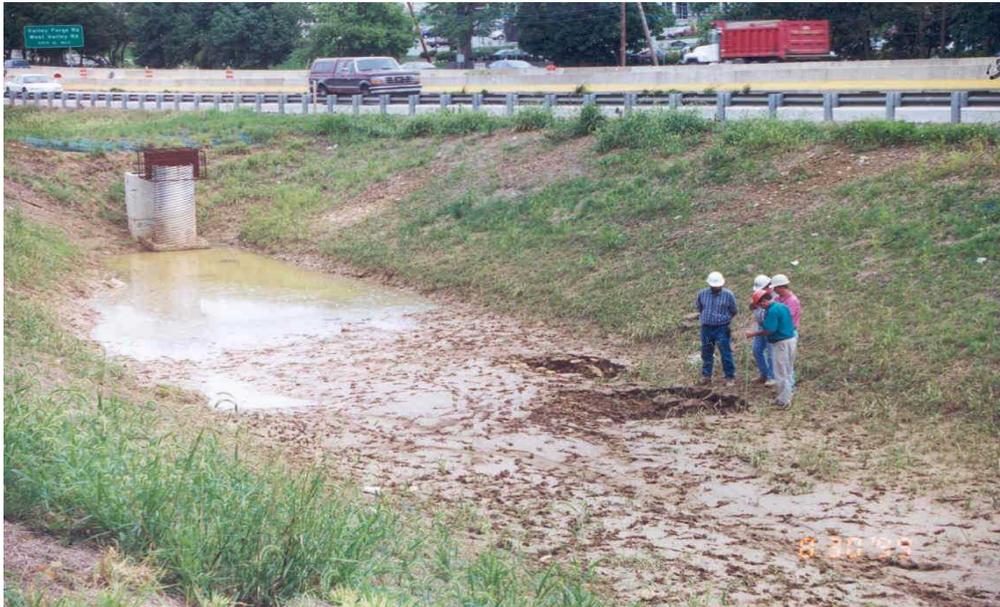
Figure 6. Small Scale Sinkhole Collapse at a Storm-Water Management Pond after Hurricane Floyd (S.R. 202, Section 400) August, 1999)

During the construction of the adjacent S.R. 202, Section 400, which is at the north of the project limits, a significant number of sinkhole events were observed. The relatively smaller sinkhole collapses were concentrated in drainage swales alongside of 202. Figure 6 illustrates a sinkhole collapse at a newly constructed storm-water management pond. The pond was lined with a geomembrane. Usually, these small size collapses indicate relatively shallow bedrock depths. At a new ramp (Ramp L) at the S.R. 422, 202, and I-76 interchange, where a significant soil cut (between 15 ft to 20 ft) was anticipated, larger sinkholes were encountered during construction. Figure 7 presents a large sinkhole collapse at a bridge pier during construction. These large collapses usually correlate with deep bedrock and often occur during construction and after unusual heavy rains following a prolonged draught. Peterson (2003) reported that the bedrock at Ramp L is greater than 100 ft within 202, Section 300. A sinkhole approximately 25ft x 20ft was identified (April, 2001) at a basin located within the Penn State University campus. The basin is located adjacent to 0202 southbound between 29 and Ramp B of 202. The geomembrane-lined basin was excavated from the original ground. The sinkhole developed near the stormwater pipe discharging water into the basin (Figure 9). Stiff sandy silt soil was found at

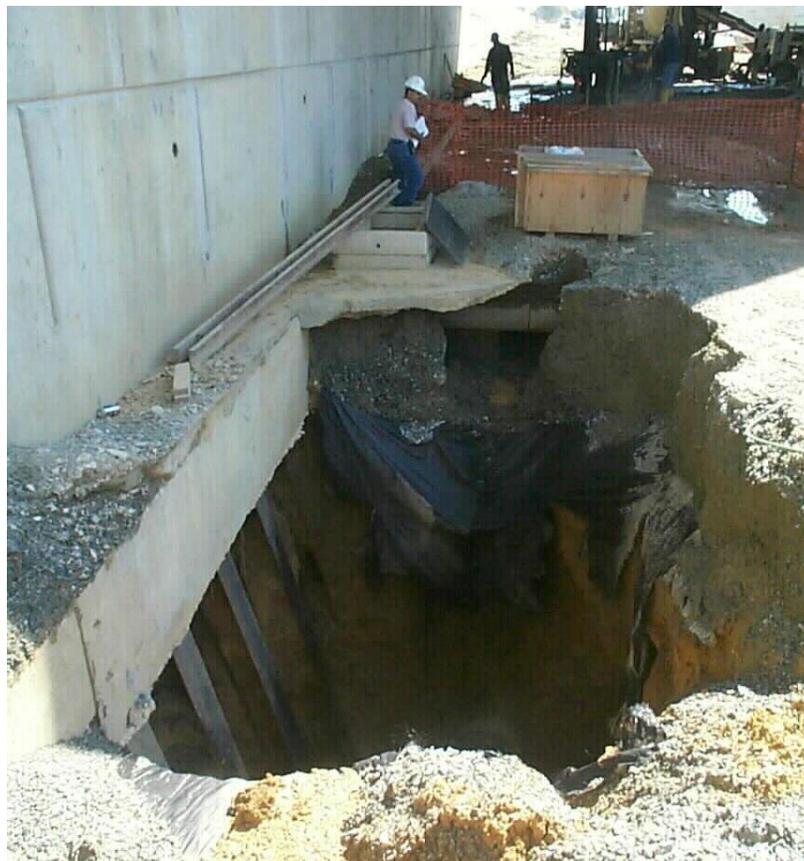
Figure 7. Sinkhole Collapse at a Bridge Abutment during Construction (S. R. 202, Section 400, June 2001)

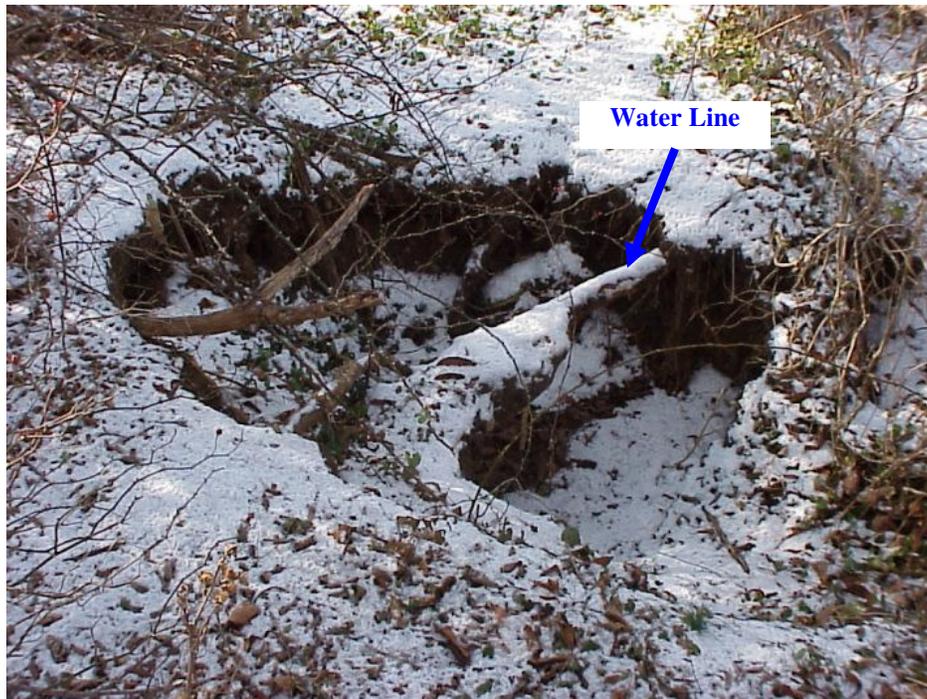
**Figure 8. Sinkhole Induced by the Water Leakage from the Utility Line
(Station 265+00, Zone A in Figure 4, April, 2001)**

The infiltration of water increases the unit weight of the soil and induces seepage forces within the soft soil zone. In addition, the rise in saturation reduces existing suction in the unsaturated surrounding soils, which decreases the effective strength in the soil. If the strength of soft soil at the rock crevice could not support the weight of soil above, a “local failure” zone is developed and the seepage water in the crevice washes these softened soils away. Finally, a small soil void is created above the rock crevice and gradually enlarges when the hydrological conditions are favorable. The stability of this soil-void system is maintained by soils above the void through a mechanism called the “arch effect”. When the soil above the void does not have enough thickness due to construction or soil erosion, or infiltrated water reduces the strength of the above soil, the “arch effect” in the soil-void system could not be maintained; therefore, a collapse will occur and will result in an open sinkhole or depression at the ground surface. A field investigation in East Tennessee (Newton and Turner, 1986) indicated that rainfall triggered 85% of the approximately 300 sinkhole events surveyed. 70% of the sinkholes identified within the 202, Section 300 project limits were associated with surface drainage paths while some others were associated with the breakage of water mains or sewer lines. Figure 8 indicates a good example of a sinkhole collapse caused by the water leakage from a utility line at the station 265 in zone A area (Figure 4).

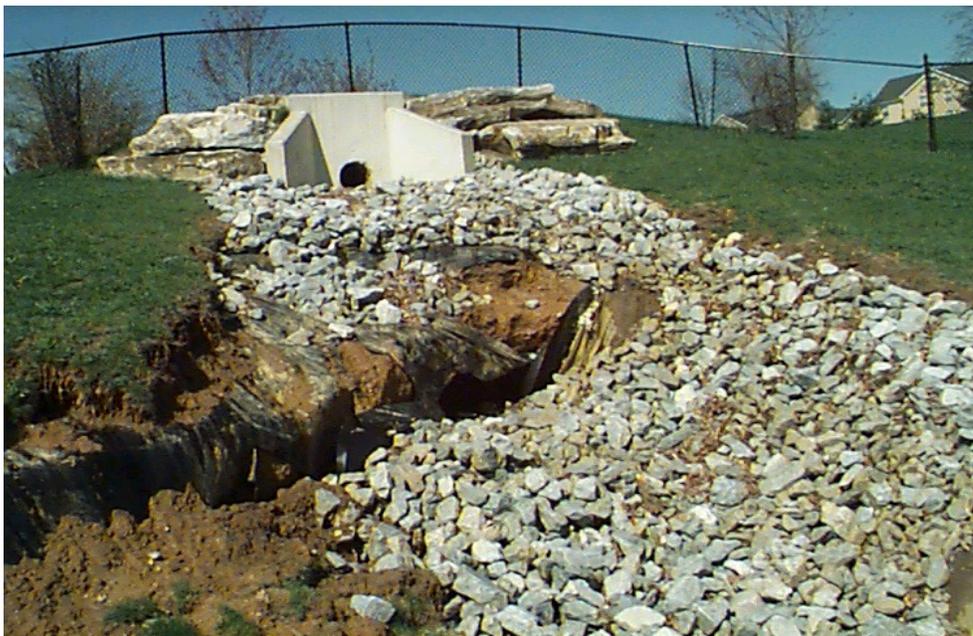
**Figure 9. Sinkhole Collapse at a Newly Constructed Storm Water Management Pond
(S.R. 202, Section 300, Station 436+50, 160 ft Left April, 2001)**

As shown in Figure 4, several open sinkholes have been field verified in this area (Zone B) and major sinkhole repairs were also observed (Figures 9 and 13). From the rock outcrops

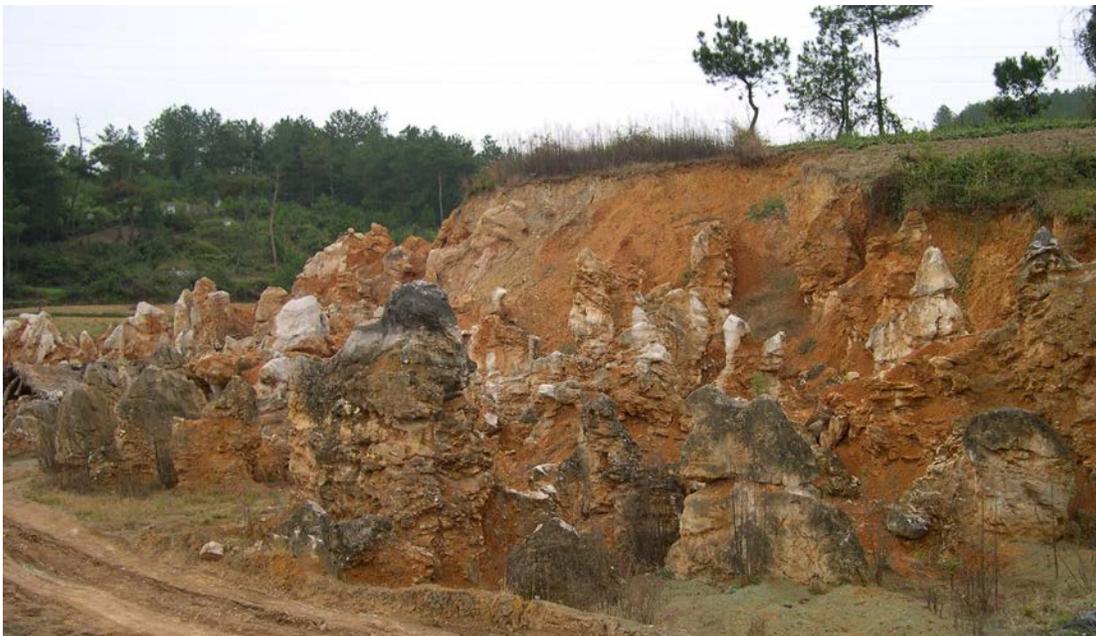
Figure 10. Example of a Well Developed Karst Rock Pinnacle System
