58th HIGHWAY GEOLOGY SYMPOSIUM

POCONO MANOR, PENNSYLVANIA, OCTOBER 16-18, 2007

PROCEEDINGS

HOSTED BY
THE PENNSYLVANIA DEPARTMENT OF TRANSPORTATION AND
THE PENNSYLVANIA GEOLOGIC SURVEY

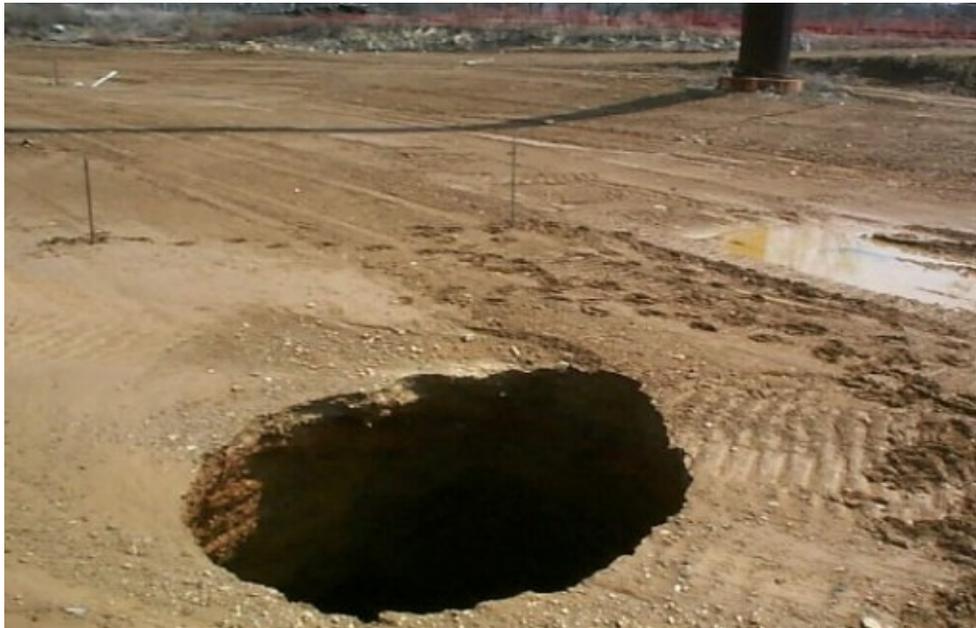
**Figure 11. Sinkhole Collapse at S.R. 422/I-76 Interchange
(S.R. 202, Section 400, June, 2001)**

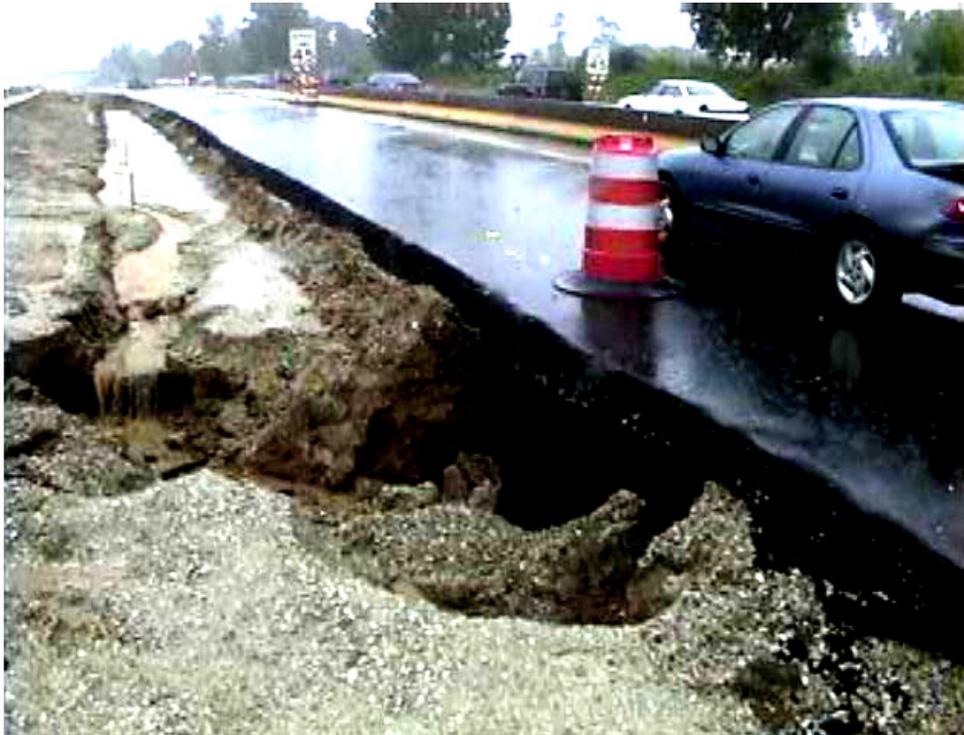
Figure 12. Road Side Sinkholes Created by Heavy Rain at S.R. 202, Section 400 (During Hurricane Floyd, September 1999)

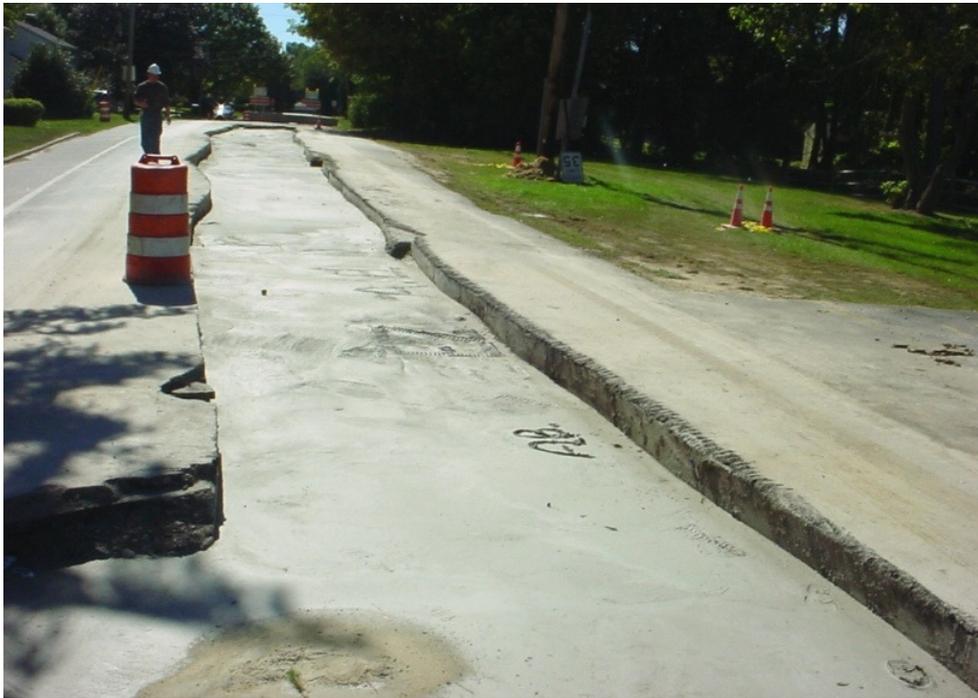
Figure 13 Repair of Sinkholes underneath Swedesford Road (S.R. 202, Section 300, September 2002)

As shown in Figure 4, several open sinkholes have been field verified in this area (Zone B) and major sinkhole repairs were also observed (Figures 9 and 13). From the rock outcrops

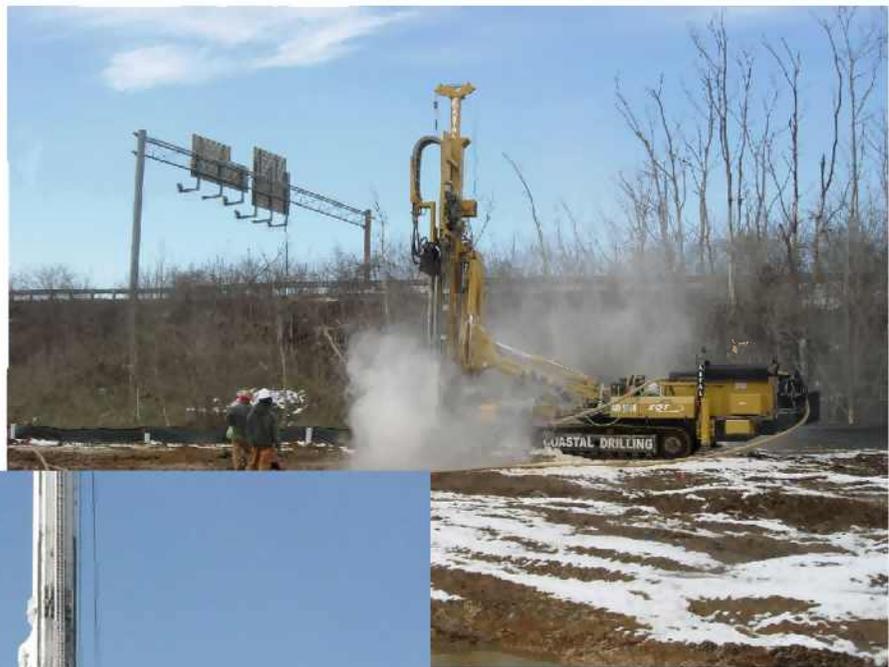
Figure 16 – Photo of EGT MD 5000 air-rotary track rig drilling primary grout holes

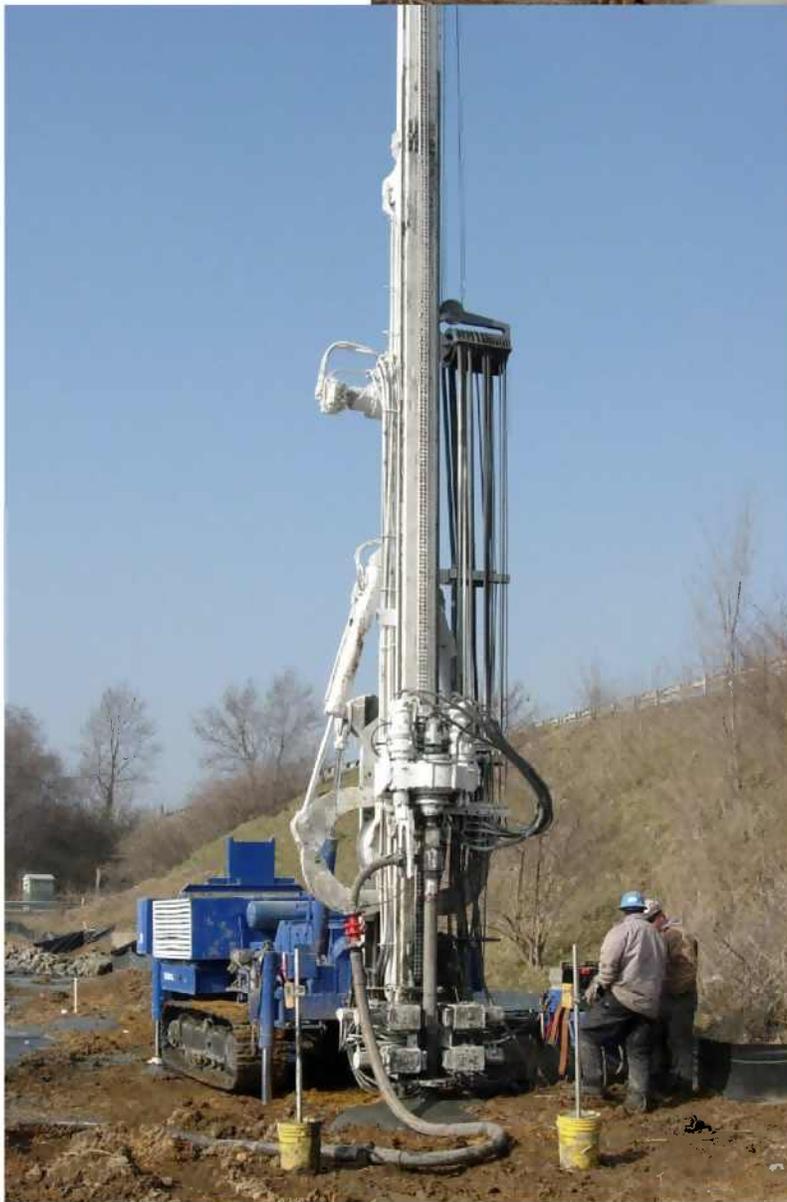
Figure 17 – Photo of Casagrande C-8 rotary track-rig with a lowered steel mandrel (casing) used for grouting of primary hole.

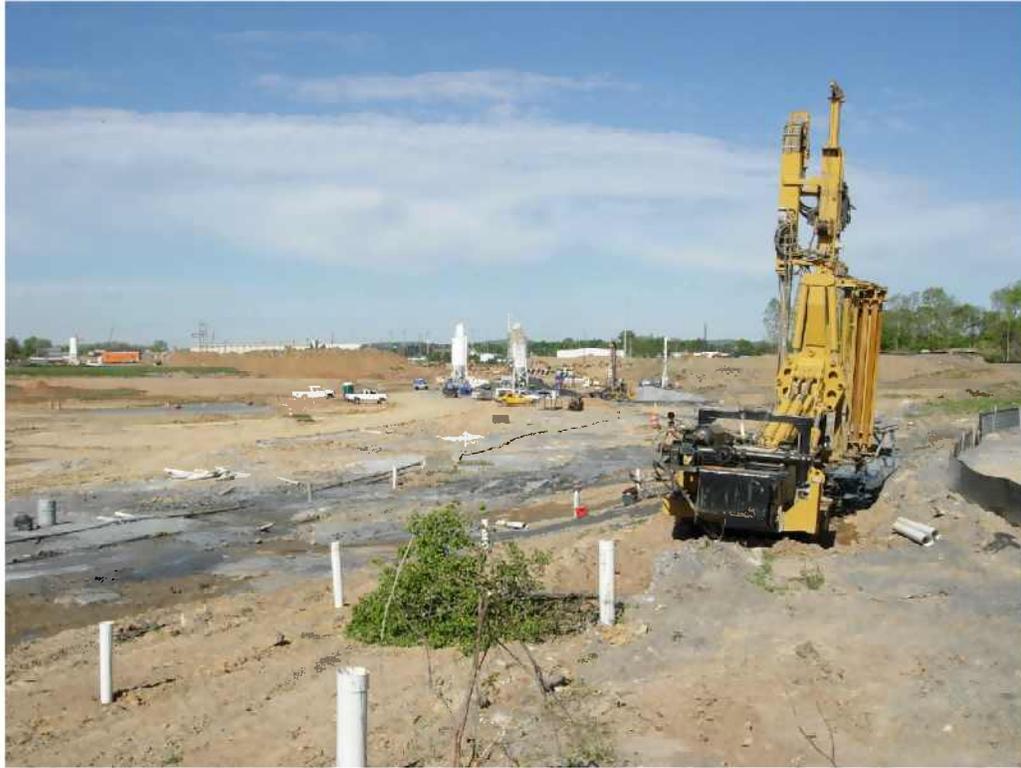
Figure 18 – Photo of Grout Zone 10 Where Grout was Pumped over 1000 lineal ft, note the use of PVC casing to prevent caving of hole.

A second air-rotary track rig with a continuous grout mandrel (casing), was used for grouting the primary grout holes (Figure 18). This mandrel was used as the injection pipe during the grouting process and primarily consisted of five-foot threaded steel casings having a nominal three-inch inside diameter. Generally, the casing was lowered to within five feet of top

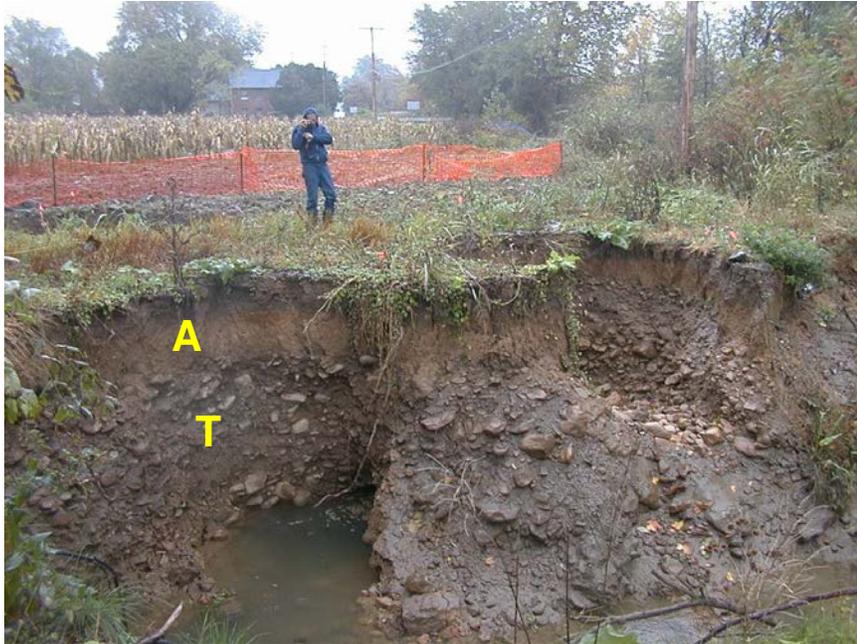
Figure 3. Sinkhole along the north bank of the Bushkill Creek showing coarse glacial till (T) overlain by finer alluvial sediment (A).

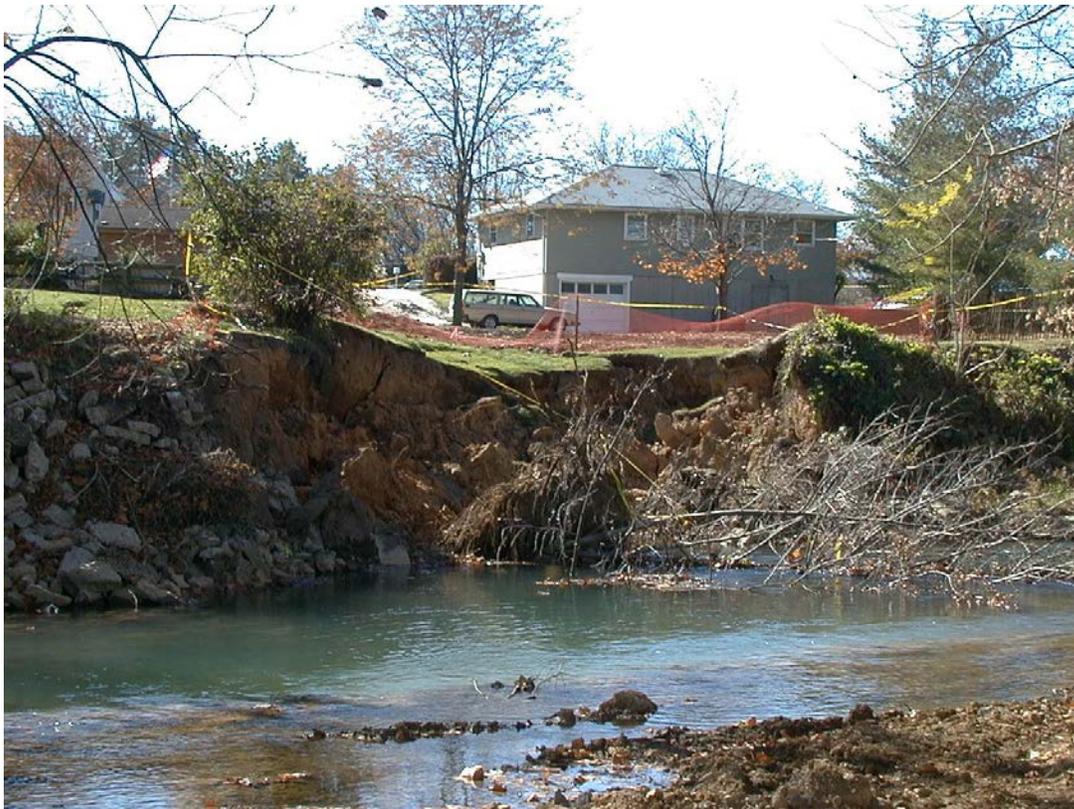
Figure 4. A large sinkhole on the south bank of the Bushkill Creek in 2001.

In April 2001, large sinkholes opened along the south bank of the Bushkill with a portion of the Norfolk Southern railroad bridge being damaged.

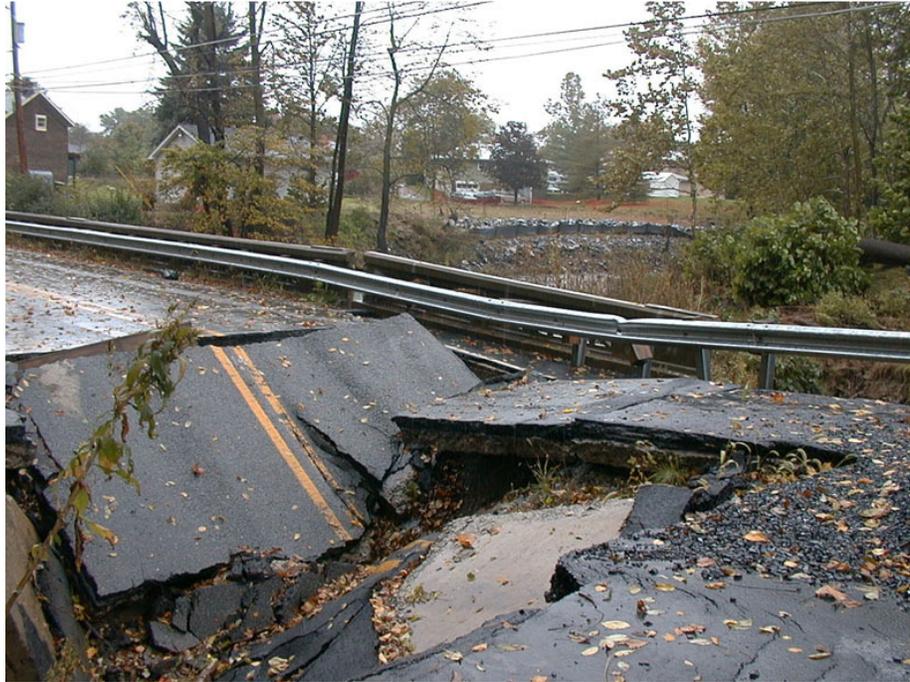
Figure 5. The SR 2017 bridge in October 2002.

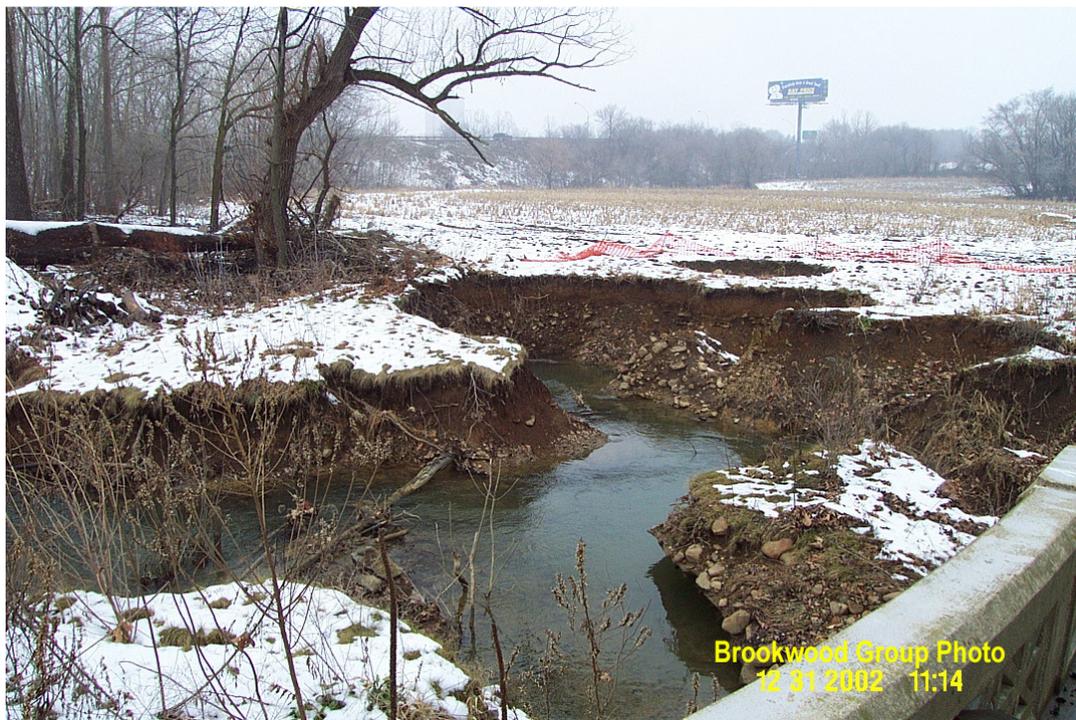
Figure 6. Coalescing sinkholes along the SR 2017 bridge in 2002. Photo courtesy of the Brookwood Group.

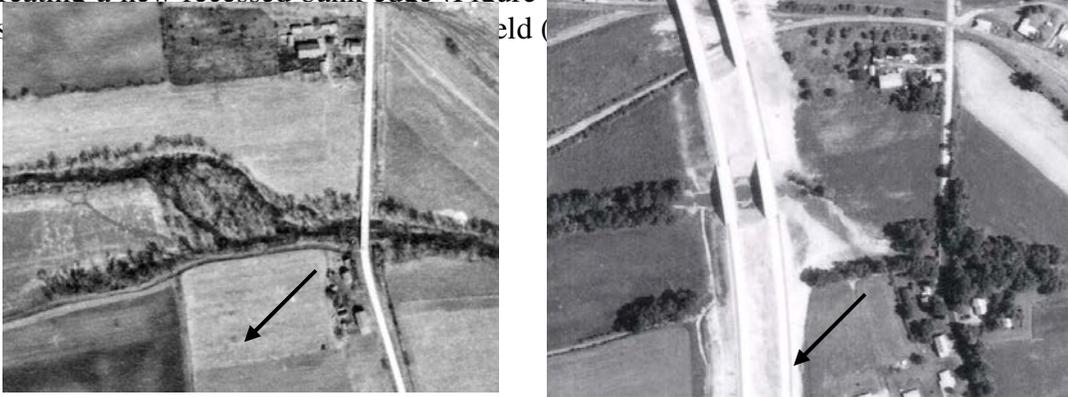
Figure 8. a.) Aerial photograph from 1939 on the left shows the island bar on the Bushkill Creek (arrow) with the channel split circumventing the island. b.) The 1971 photo on the right shows the location of SR 33 and the modified channel of the Bushkill Creek. Flow of the Bushkill is from left to right, north is up.

the 1980s, well after the construction of SR 33 and its realignment of the Bushkill Creek. (see previous section and Figure 8).

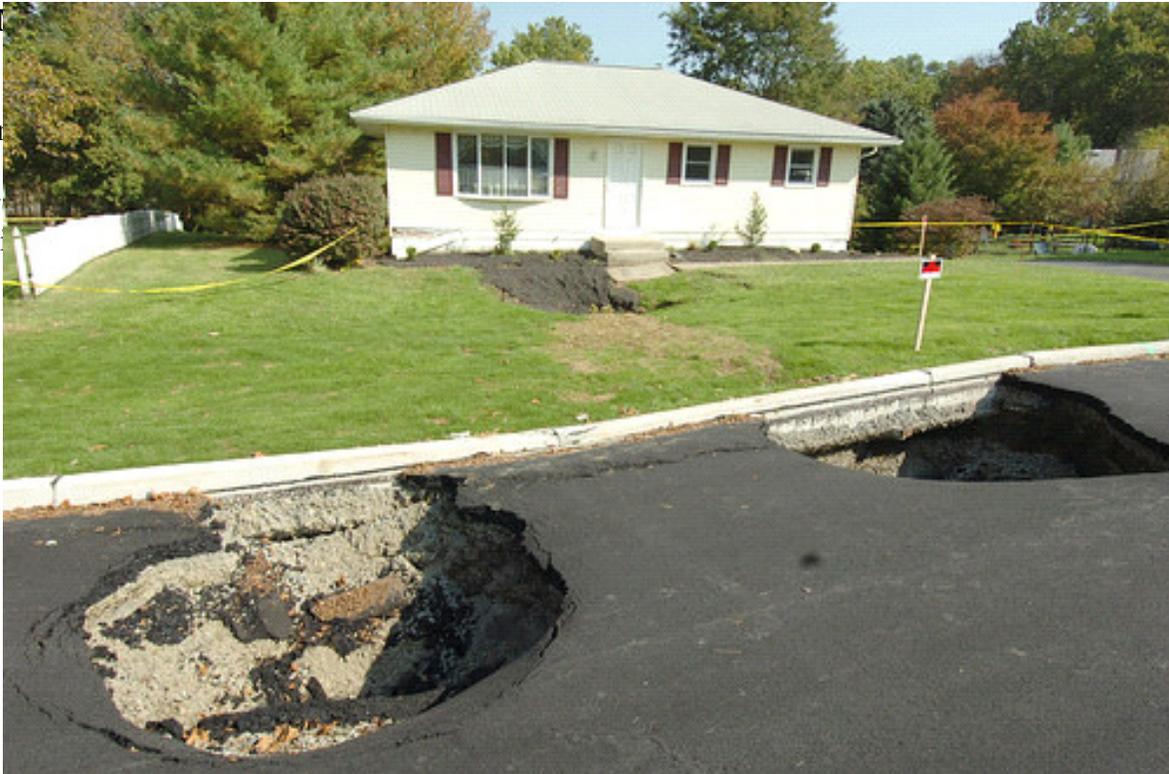
Figure 11. Sinkholes along water and sewer lines in the Brookwood community.

Sinkholes can be exacerbated by the failure of water-bearing utility lines. As a matter of record, water and sewer lines in the Brookwood community were compromised during June and October of 2006 (Figure 11). It was not determined whether these lines failed by some flaw in the composition or installation of the pipes or if they were affected by a longer ranging and more complex subsidence process. The occurrence of sinkholes within the stream channel and along the banks of the stream suggest that the stream was one major source of water to flush out the karstic drains and create sinkholes.

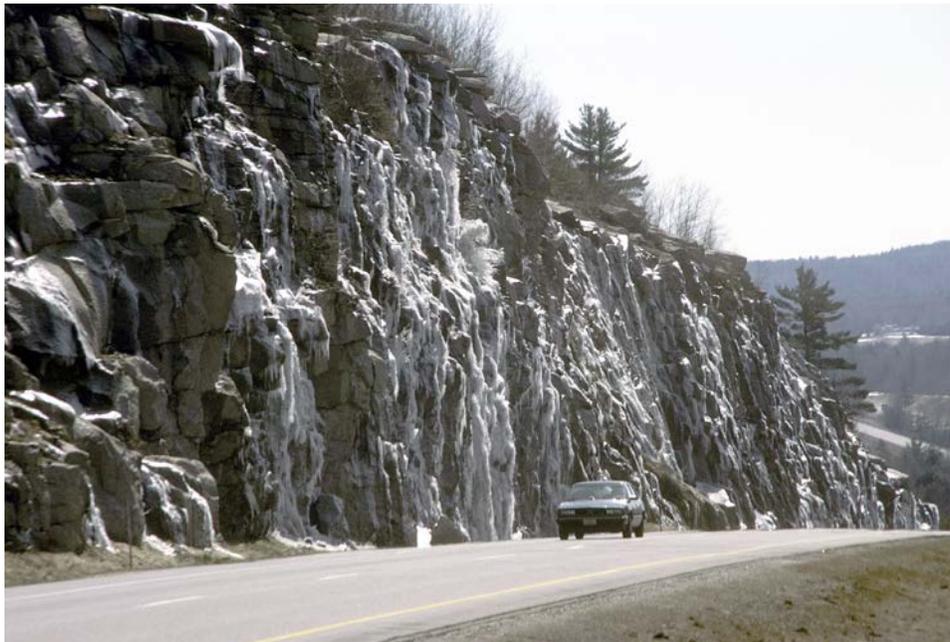
Figure 2 – Irregular Rock Slope with Jointing, Blocky Structure and Heavy Seepage of Water

This rock cut was constructed in 1968-69 using production blasting techniques. The rock slope was ragged in appearance and had a blocky structure caused by numerous sets of intersecting joints. There was heavy seepage of water from the rock slope and surface water flowed continuously over the rock face in several areas (Figure 2). During the winter, much of the exposed rock slope along the east side of the northbound barrel was covered with a layer of ice. There were overhangs and unstable blocks throughout the rock cut. Rapid deterioration of the rock in some sections had resulted in weathered zones, which were undermining large blocks. Extensive over blasting during the original construction had shattered the rock face and opened existing planes of weakness (fractures, joints, etc.). This made the rock slope more susceptible to the infiltration of water, causing increased weathering and freeze-thaw action. This site had a history of rock fall, particularly along the northbound barrel.

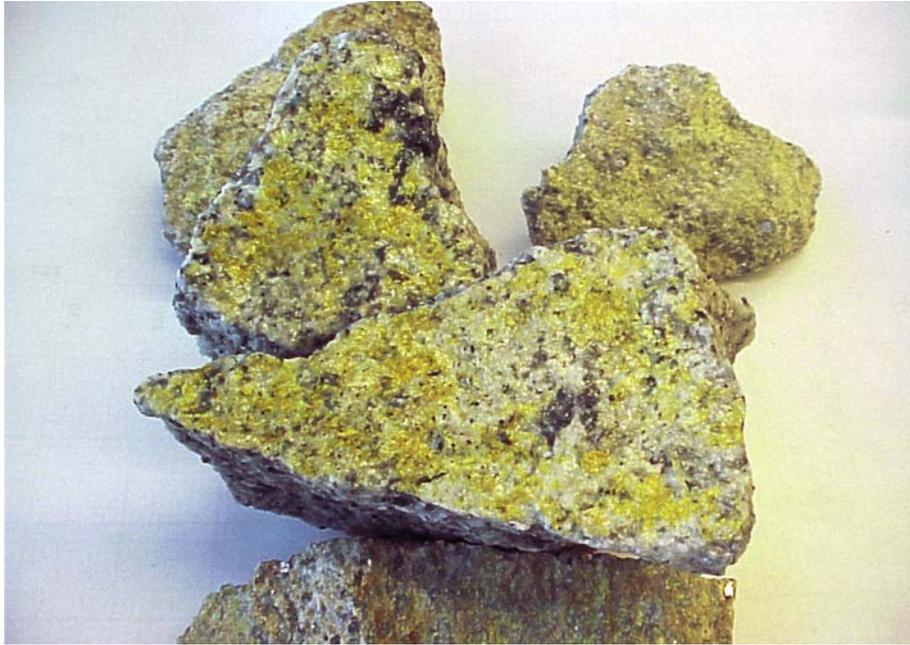
Figure 3 – Lemon-yellow Uranium Mineralization

Uranium ore was identified at this site in 1969, during the initial excavation of the rock cut. A rock with a lemon-yellow and grass green mineralization was found at the rock cut by a mineral collector who took the sample to the Geology Department at Dartmouth College for identification (Figure 3). A visit to the construction site by Dartmouth Professors Dr. Lyons and Dr. Boudette, confirmed that the granite contained

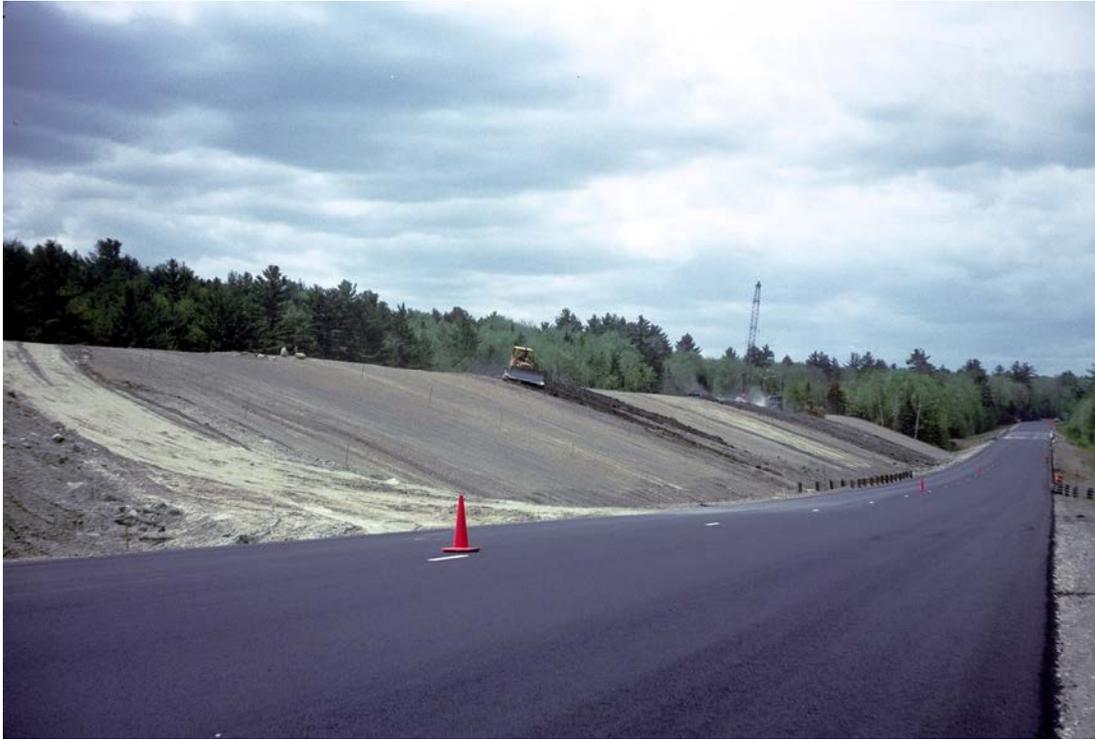
Figure 8 – Completed Disposal Site

All vegetation to include stumps and topsoil were removed in the disposal area. Fill was placed over the disposal site to an elevation of at least five feet above the seasonal high water table. The rock excavation was placed in four foot thick layers and chinked with smaller rock sizes to eliminate large voids. The area was capped with an impervious soil to keep surface water from contacting the buried rock fill. A 12-inch thick drainage layer of sand was placed between the imperious cap and a layer of topsoil to expedite lateral movement of the surface water (Figures 6, 7 & 8). Only grass was allowed to grow at the disposal site to eliminate potential roots from bushes or trees penetrating the imperious soil cap.

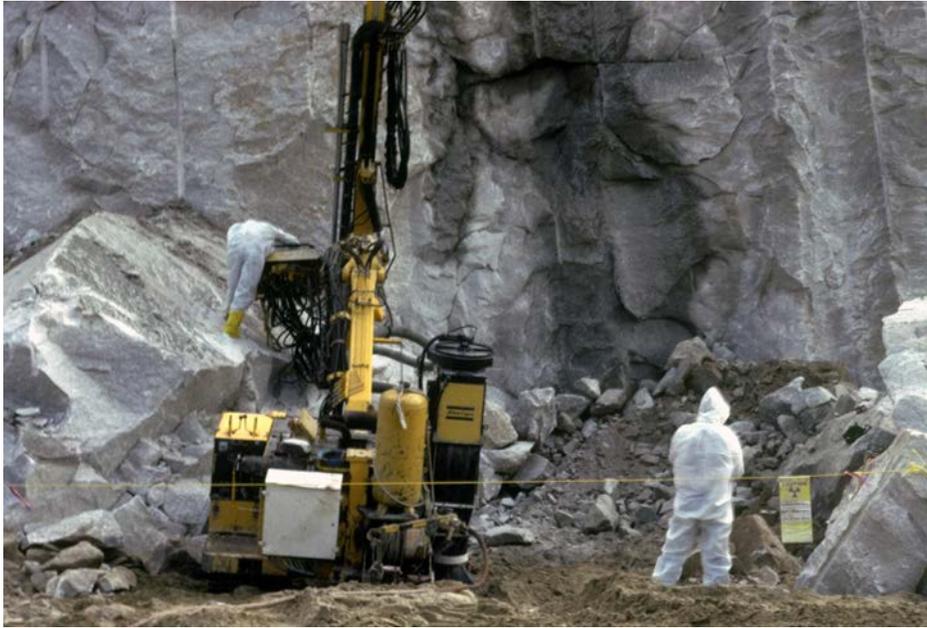
Figure 9 – Drillers Wearing Protective Clothing

- Protective clothing and respirators would be available (Figure 9).
- The radiation exposure of workers was monitored and tracked with individual monitoring devices (Thermal luminescent dosimeter badges and pocket dosimeters) to be worn on the person at all times while in a radiologically controlled area. The individual sampling devices were worn by the loader operators and the drillers. An exposure history file was maintained on all workers. The workers would be periodically frisked with a probe to detect contamination on clothing.

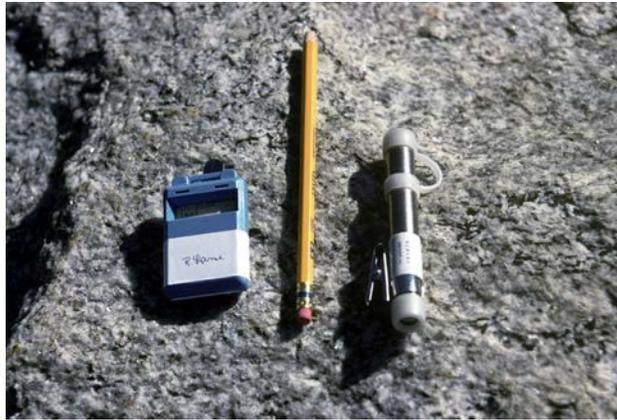
Figure 10 – Individual Monitoring Devices

- Thermal luminescent dosimeter badges and pocket dosimeters (Figure 10)
- Loose and fixed contaminants – Ludlum 177 with thin window gm pancake probe (Figure 11)

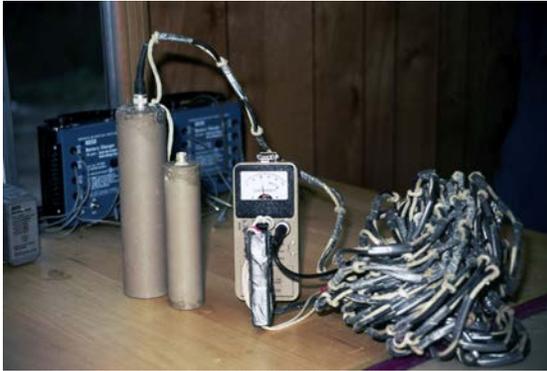
Figure 12 - Well Logging Scintillator

- Loose and fixed alpha contamination – Ludlum 177 with 59 cm² ZnS scintillation probe
- Drill hole monitoring – NMC GA-6 well logging scintillator (Figure 12)

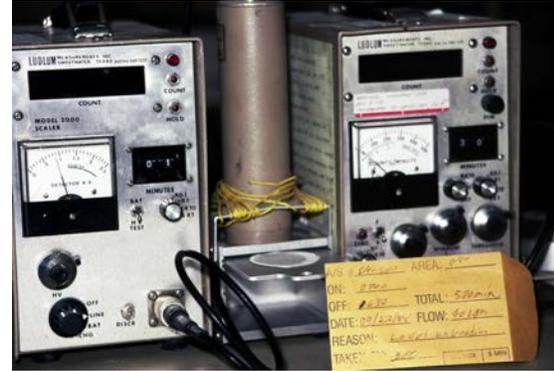
Figure 13 - Ludlum 2000 scales with ZnS Scintillator and ThinWindow Pancake gm Detector

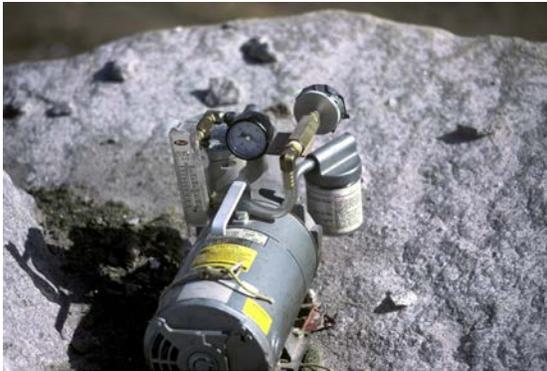
Figure 14 – Air Sampler

- High volume air sampling (within one foot of the drill rig) – Radeco/Staplex air sampler (Figure 14)
- Beta exposure – Eberline RO-3C air ionization chamber (Figure 15)

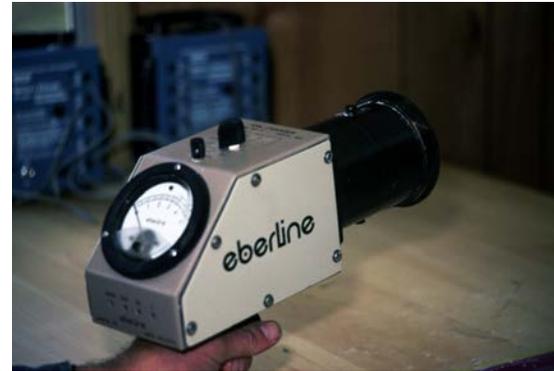
Figure 15 - Eberline RO-3C Air Ionization Chamber

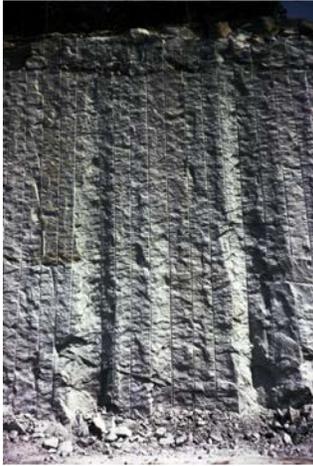
Figure 16 – Stable Slope

The newly constructed rock slope along the east side of the northbound barrel was uniform, stable and without overhangs (Figures 16 and 17). The half casts from the

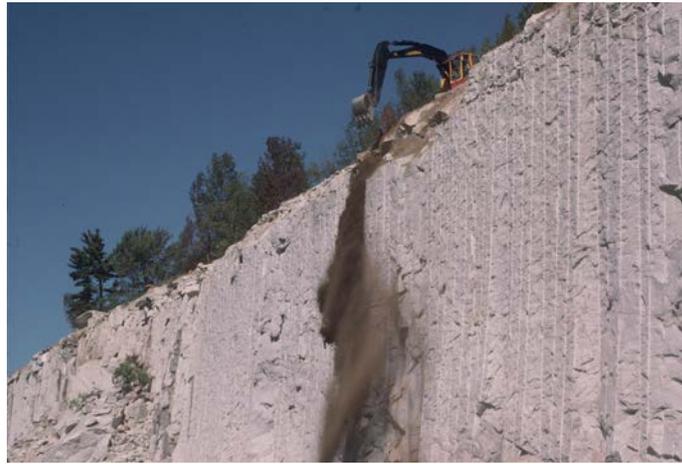
Figure 17 – Presplit Holes Evenly Spaced with Less than 2 Percent Deviation

presplit drill holes were evenly spaced throughout the rock slope with the deviation in the holes

maintained at less than two percent of the total drill hole length. The new widened ditch along the toe of the eastern rock face on the northbound barrel provided a sufficient catchment area for future rock fall. The overall condition of the stabilized northbound rock slope was excellent.

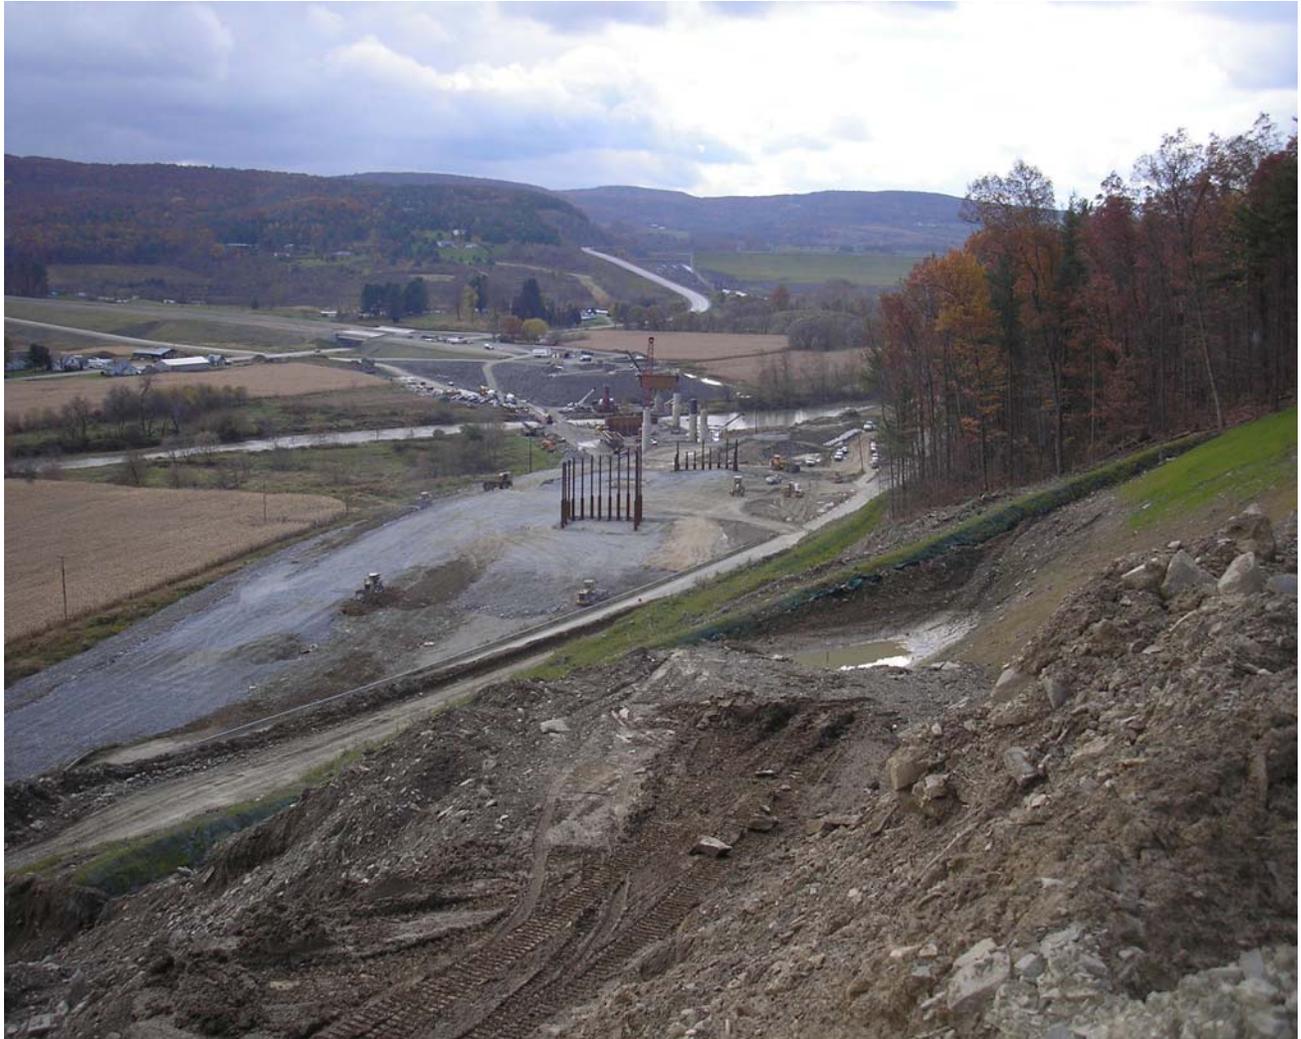
Figure 3 - View from the south end of the southbound rock cut looking toward Pennsylvania. The new Cowanesque River Bridge is being built with fill from the rockcut.

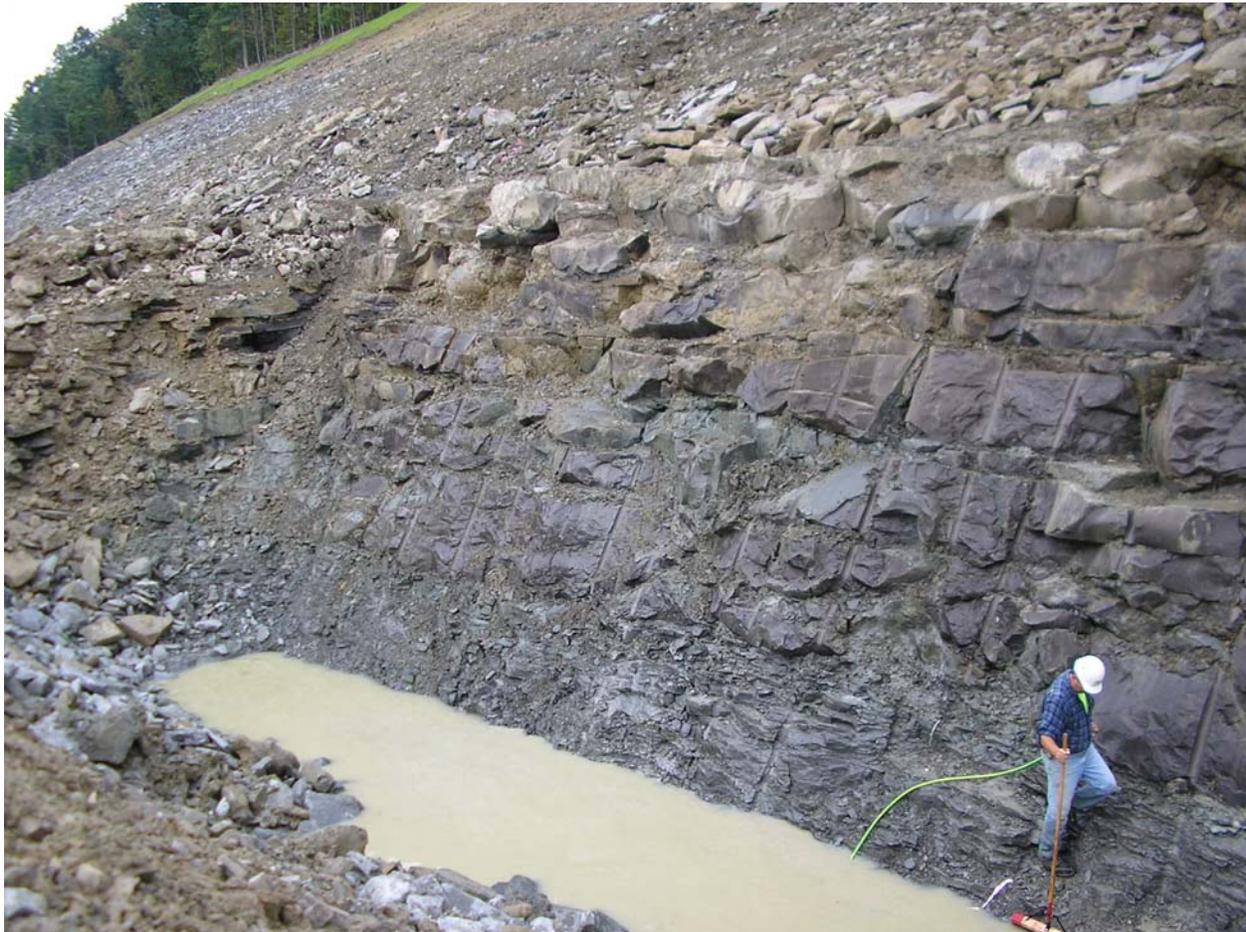
Figure 4 - Cleaning of the test section.

The test blast was on September 8, 2006. A total of 27 presplit holes were shot to a depth of 60 feet. Production blasting and cleaning of the slope took an additional two days. The presplit

drill traces measured ranged from 55 to 59 degrees varying slightly from the designed 56.3 degrees (3V:2H). Approval was given to proceed with the presplitting. The contractor drilled and blasted presplit and production holes on the top lift. The blaster shot the presplit days ahead of the production holes in front of it. Production holes were 6 inches in diameter and the depths were only 25 feet long. Bulk loading trucks were used to load a maximum of 50 pounds of ANFO into each hole.

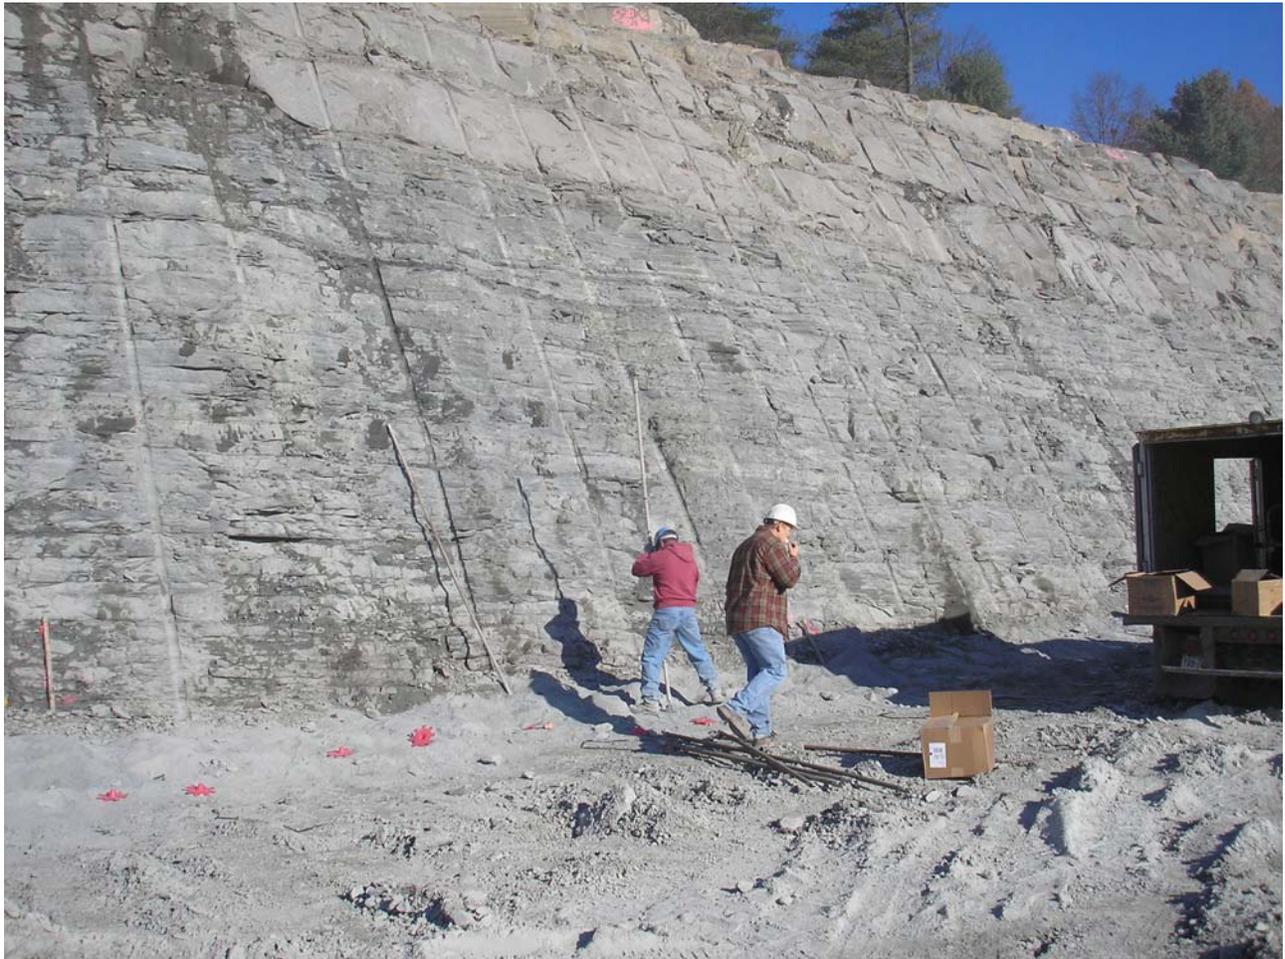
Figure 5 – Loading of the second lift

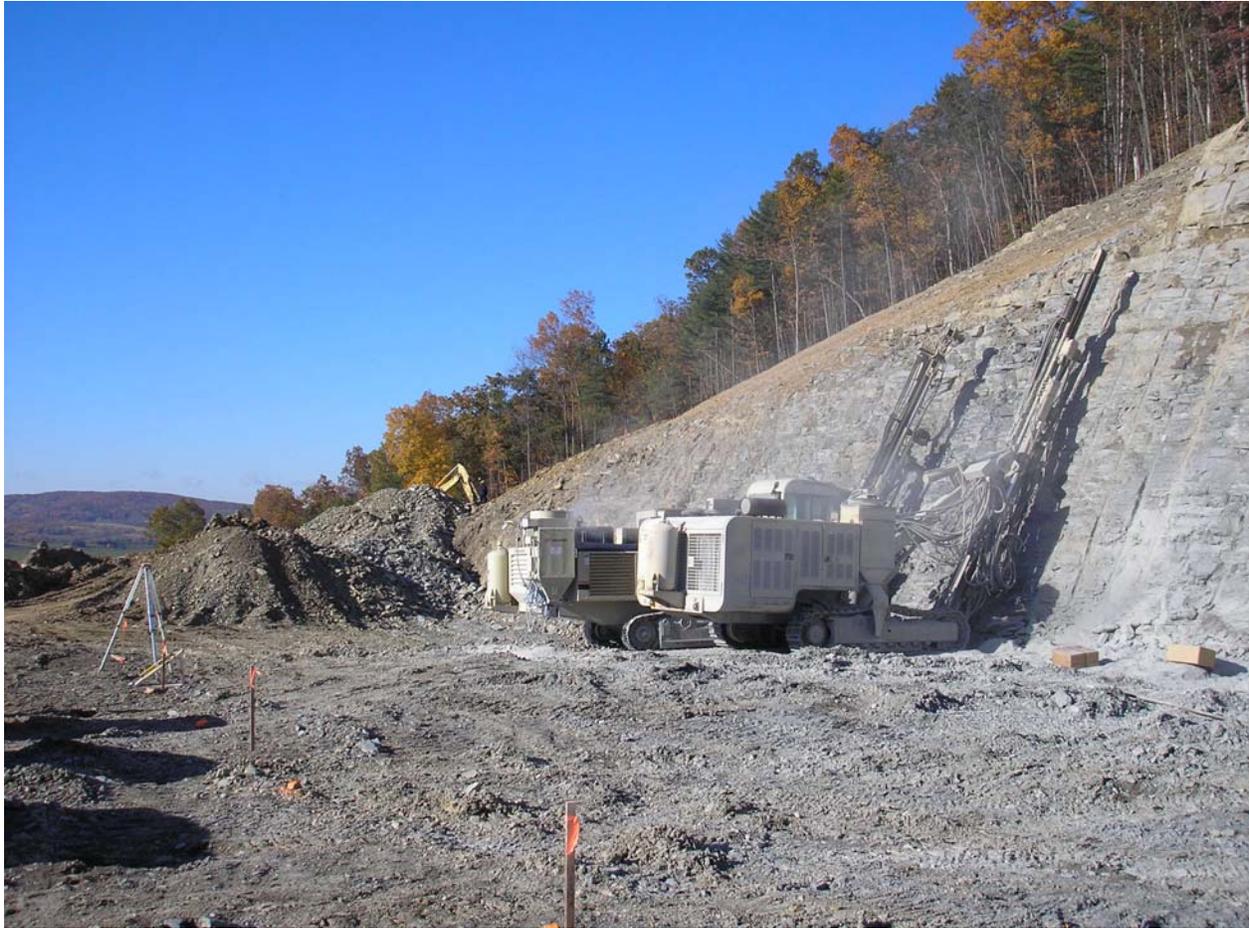
Figure 6 - Drilling the second lift

The contractor began the second bench by drilling the presplit holes to a depth of 60 feet and the production holes to a depth of 25 feet. The drillers attempted to lay the drill rigs up tight against the rock face and were able to achieve a working bench that varied from one to two feet in width. This was acceptable to NYSDOT as every effort was made to minimize the bench width. During excavation of the middle lift the backhoe operator was able to effectively remove this bench.

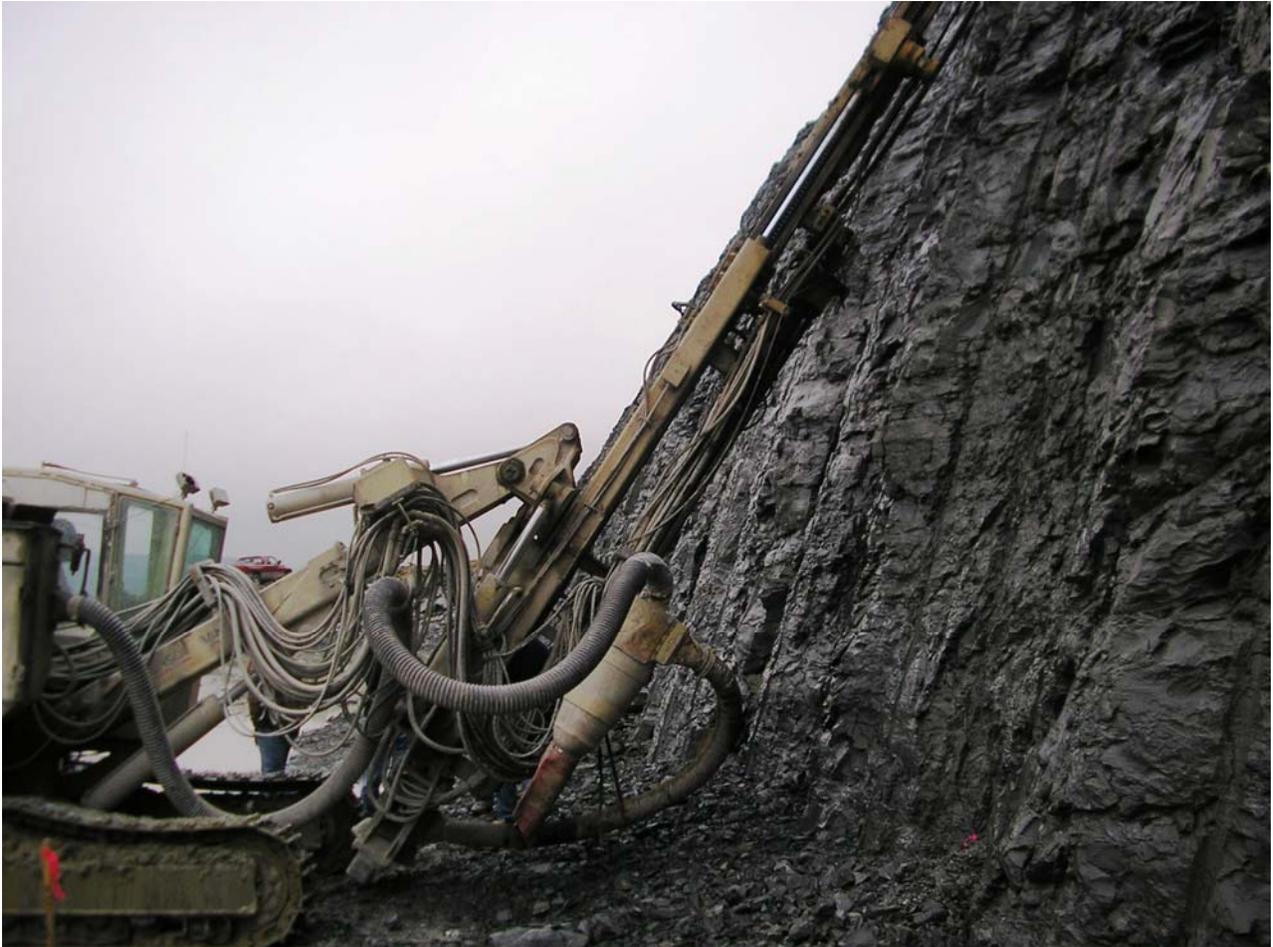
Figure 7 - Drill set up on third lift. Notice how the rig cannot be laid up against the slope and drill at the design slope angle.

This steepening of the drill traces set the bottom of the second bench back eight to ten feet behind the design slope location in places. A meeting was held on the slope to discuss possible design changes. The rockslope was looking very clean and stable even at this steeper slope angle. At the NYSDOT Geologist's request, the driller set up his drill rig against the rockslope. To continue on the same slope angle, the drillholes would have to be collared eight feet in front of the toe of slope. One option discussed was to steepen the bottom lift to a four vertical on one horizontal slope which would keep the bench width smaller, but greatly increase the excavation quantities and ditch width. The decision was made to start the third lift at the original design

location, based upon practical drilling considerations, slope stability concerns, and the necessary transition to the adjacent New York State contract that will complete the construction of the rockslope.

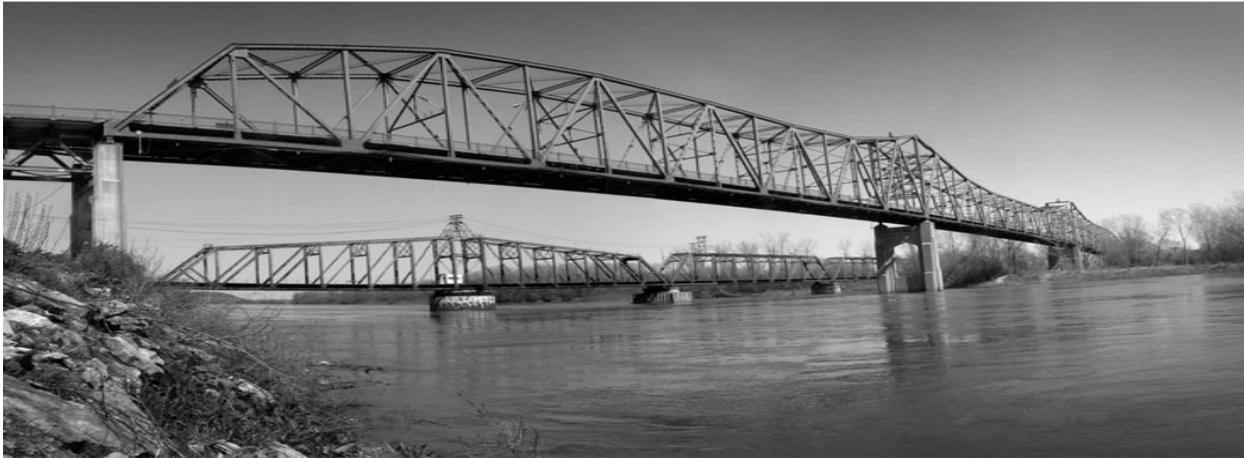
Photo #1 Looking North at the Overhead Truss Section and UPRR Bridge

The existing Amelia Earhart Memorial Bridge was constructed in 1938 and carries US-59 across the Missouri River. This bridge serves as a major arterial for Missouri and Kansas as the next closest river crossings are approximately 30 miles north and/or south of this location. The memorial bridge is a very unique structure utilizing 4 span types in 6 separate segments. The span types are: Steel Beam, Steel Girder, Steel Deck Truss, and Steel Overhead Truss. (See Photos)

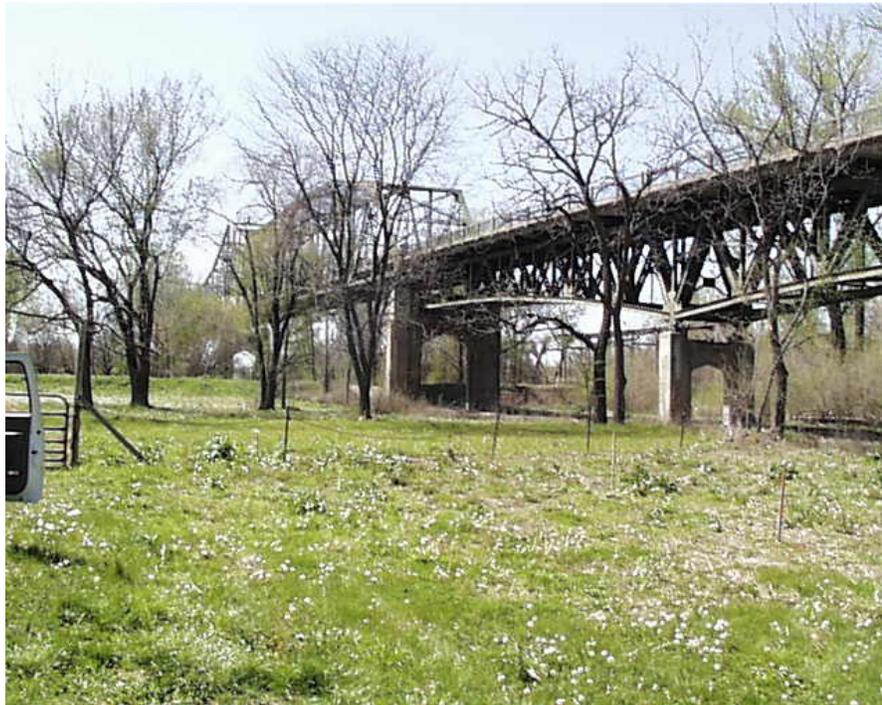
Photo #2, Looking west, Steel Deck Truss and Overhead Truss Sections
