58th HIGHWAY GEOLOGY SYMPOSIUM

POCONO MANOR, PENNSYLVANIA, OCTOBER 16-18, 2007

PROCEEDINGS

HOSTED BY
THE PENNSYLVANIA DEPARTMENT OF TRANSPORTATION AND
THE PENNSYLVANIA GEOLOGIC SURVEY

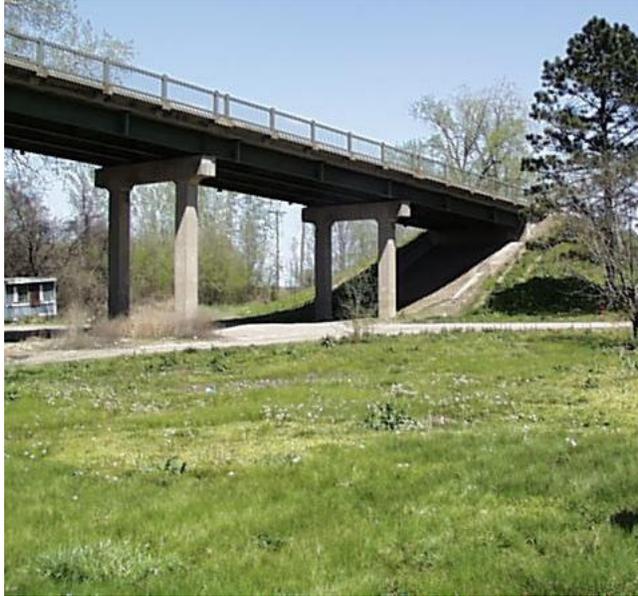
Photo #3 Looking east at the Steel Beam Section

The existing Amelia Earhart Memorial Bridge was constructed in 1938 and carries US-59 across the Missouri River. This bridge serves as a major arterial for Missouri and Kansas as the next closest river crossings are approximately 30 miles north and/or south of this location. The memorial bridge is a very unique structure utilizing 4 span types in 6 separate segments. The span types are: Steel Beam, Steel Girder, Steel Deck Truss, and Steel Overhead Truss. (See Photos)

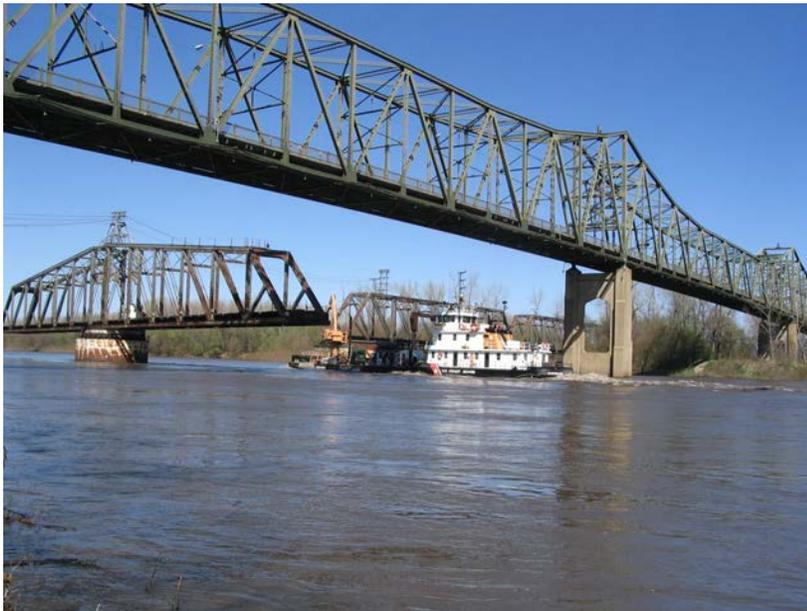
Photo #4, Railroad Bridge in Operation

The railroad structure to the north of the US-59 Bridge is an electric turnstile bridge. As barge traffic approaches the bridge an operator rotates the bridge to parallel the river channel. This structure was built in the 1860's and originally was operated by man-power.

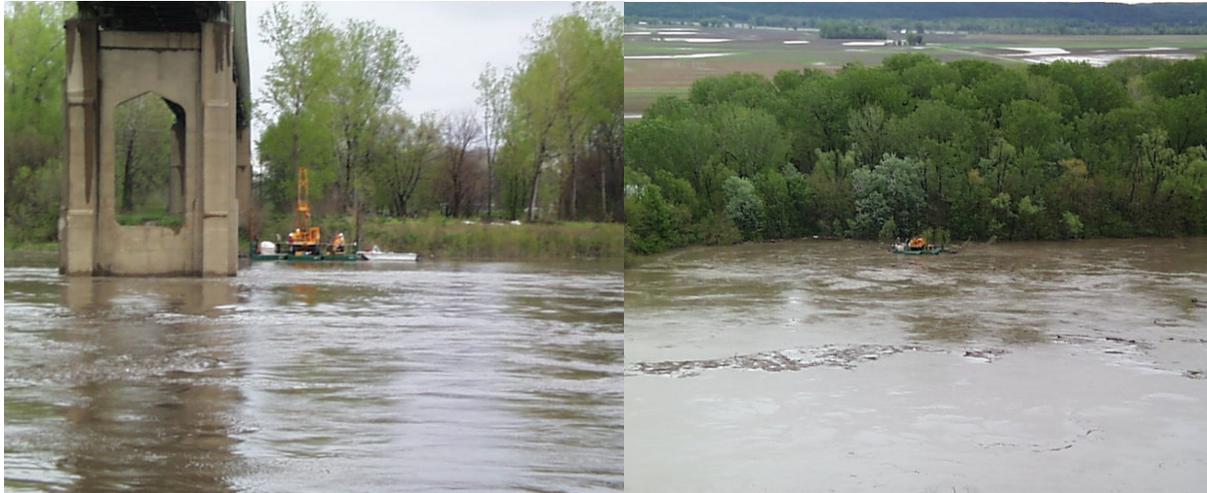
Photo #5 Core Drilling at High Flow!

Photo #6 Barge and Rig are Found!

The coring on the river proved to be extremely difficult, mainly do to the extended periods of rain. The drilling operations were conducted at flows 10 feet higher than normal and over 8 mph. Removing debris from around the barge was a constant battle. Spuds on the barge were design with normal flows depths in mind, thereafter several holes had to be abandoned due to the depth of water. At one point the river was so high it spilled out over the levee's The barge was tied off but the river eventually won and the barge with the drill rig still aboard floated over a mile south of the project.

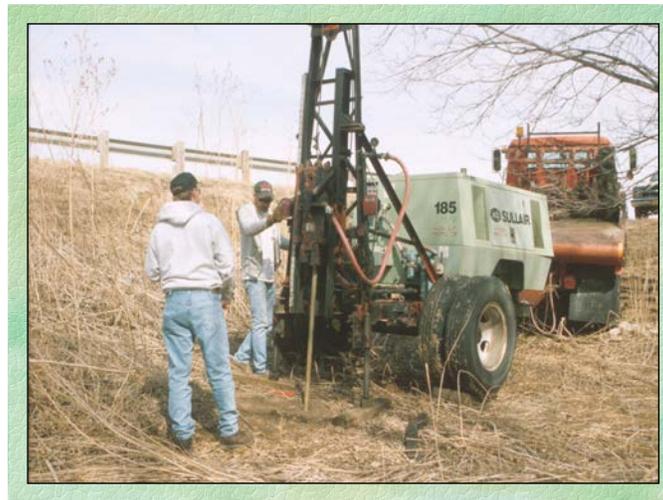
Photo #7 Air Hammer

The Kansas Dept of Transportation has developed an investigative tool for deep sediment situations. This tool is an Air Hammer. The Air Hammer drives a 2 inch washer into the soil at a known pressure. Much like a pile drive the blows and depths are recorded as well as the time. These are plotted and the depth of penetration and resistance give a very good indication as to the final depth of the pile.

Air Hammer drives were conducted on Piers 8-14. All drives penetrated into the Weston Shale. The penetration was from 1.4 feet to just over 6 feet.

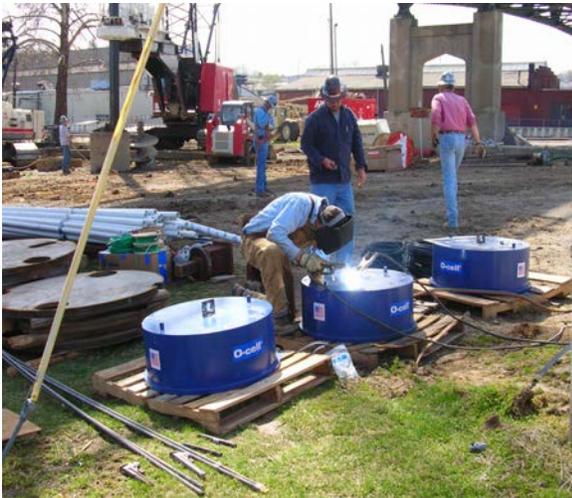
Picture #8 O-cells

Due to the variable nature of the shale and Drilled Shafts being the preferred foundation element in the river a Loadtest (Osterberg Cell Test) was performed. We had originally planned on conducting 2 tests, one either side of the river to check the allowable skin friction for multiple layers of shale. However, this plan was changed when we could not get the equipment into the eastern site. We then changed to conducting one very deep test with 3 O-cells installed into the shaft.

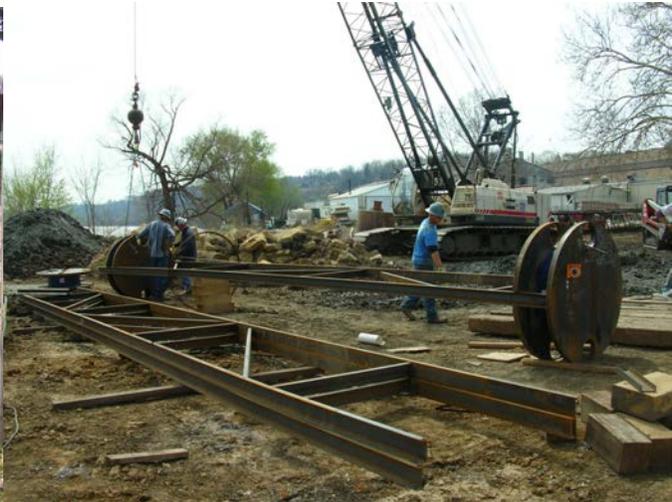
Picture # 9 Load Frame with 2 cells installed.

To closely mimic the proposed drilled shafts a 60 inch test shaft was constructed. The test shaft was drilled through 61 feet of fill and alluvium then advanced 100 feet into the Weston Shale. To a model a worst case scenario, the shaft was flooded and left standing for 4 days. After 4 days the load frame was placed into the shaft as it was being adjusted the middle O-cell broke free from the welds and causing it and everything else to fall to the bottom of the shaft! The O-cells and frame were removed from the shaft and reconstruction of the load frame and replacement of all hydraulic lines was required. Concrete was placed into the shaft to the top of the bedrock, representing a 100 foot rock socket.

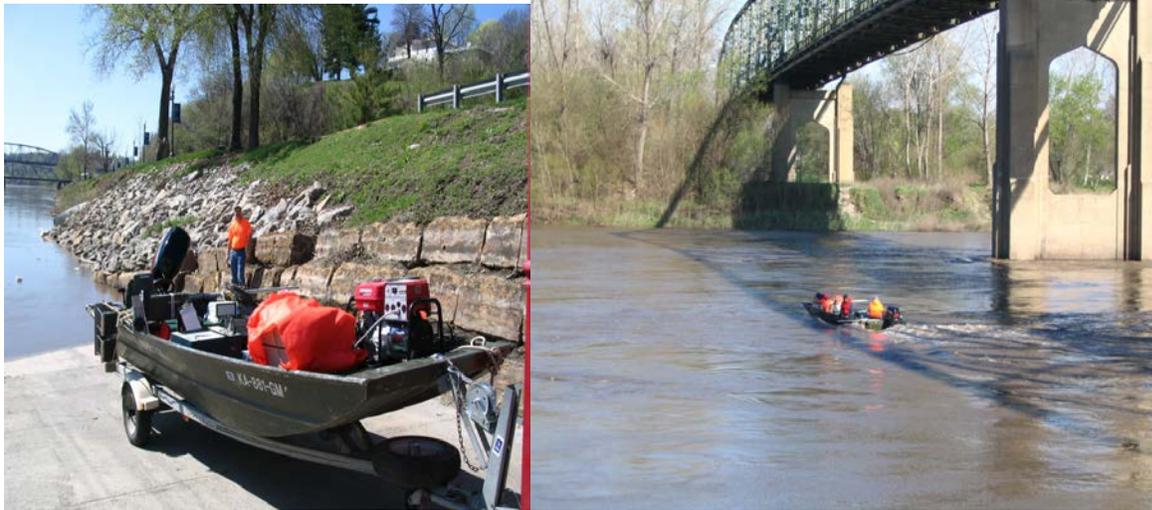
Picture #11 Boat Loaded with equipment. Photo #12 Still surveying after a 12 foot raise!

of Transportation contracted with Golder Associates to perform this survey. They utilized seismic reflection, sub-bottom profiling, side scan sonar and a single beam echo-sounder.

Once again the river was not cooperating; it rose over 12 feet in just over 14 hours. This made the boat travel extremely treacherous especially around the piers. KDOT's bridge inspection team operating the boat did an outstanding job of not losing Golder's 30,000 dollars worth of equipment!

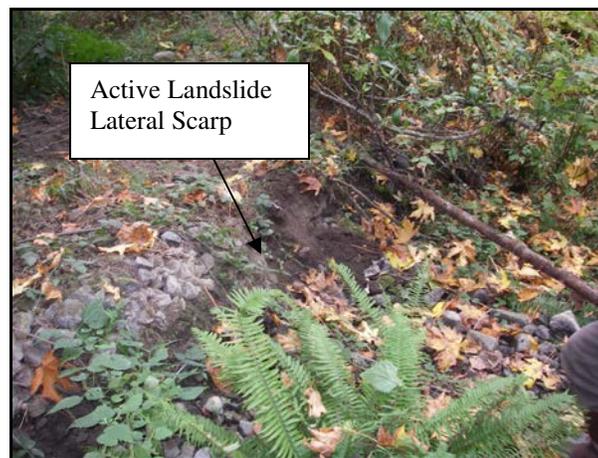
Figure 4: Landslide lateral scarp against southern bridge pier.

This landslide is located immediately adjacent to the southeastern side of the Green River Bridge. Landslide scarps (Figure 4), bent Douglas fir and Cedar trees, and a landslide toe (Figure 5) wasting over the cliff down to the Green River below were observed during the initial site reconnaissance.

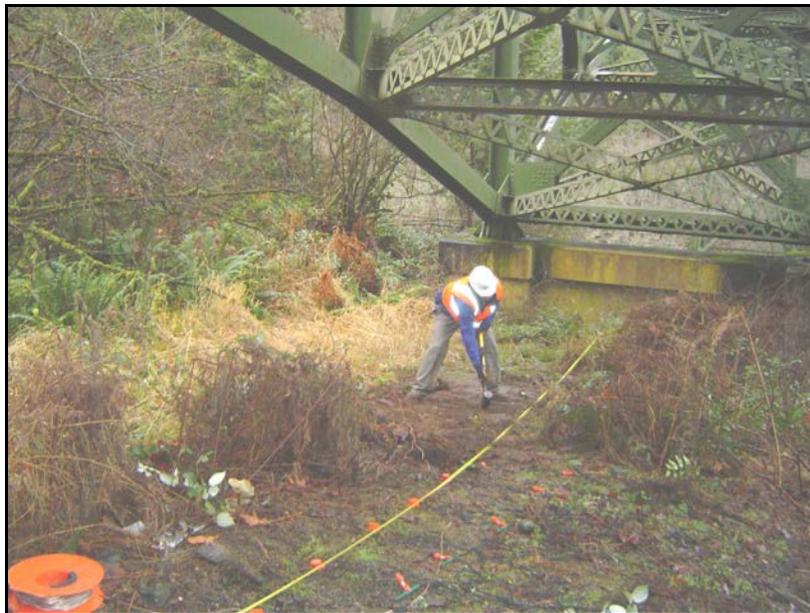
Figure 11: Seismic refraction layout - Line 1

High resolution seismic refraction data were acquired with one line parallel to the bridge immediately below the roadway between pier 1 and pier 2 (Figure 11) and another line perpendicular to the bridge, 6 feet north of pier 1. The line between the piers was 80 feet long and the line perpendicular to the road was 94 feet long, both with 5 foot geophone spacing.

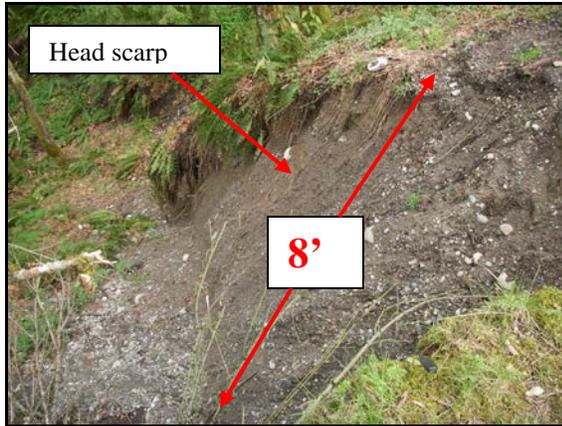
Figure 18: Head scarp with eight feet of displacement, April, 2007.

In April of 2007, the head scarp was measured to be approximately 8 feet in height. The head scarp had encroached further up towards the bridge abutment. The active western lateral scarp of this slide was further pronounced and runs adjacent to the eastern side of pier. At this time, the ground surface was 4 feet 2 inches lower than the original ground surface (Figure 21). Based upon the as-built plans, approximately 4 feet 3 inches of soil remain above the top of the spread footing at pier 1.

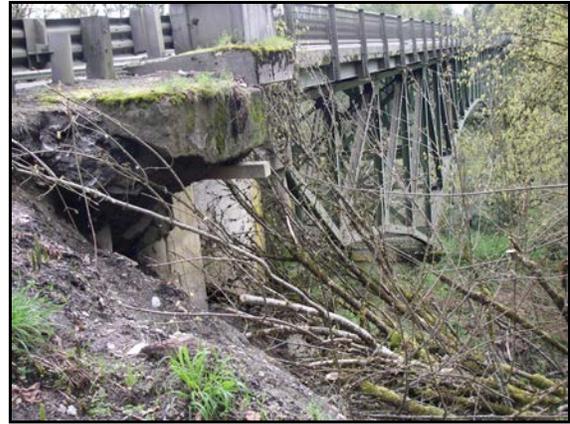
Figure 19: The head scarp encroaching upon bridge abutment, April, 2007.

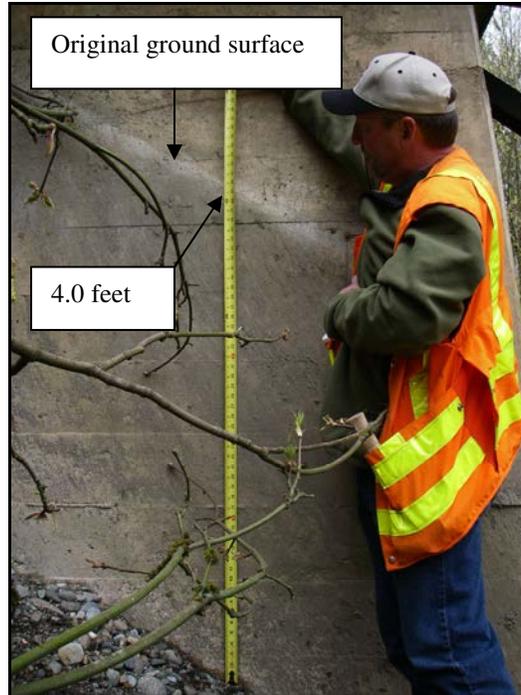
Figure 21: Ground surface on eastern side of pier 1 in April 2007. Original ground surface was 4.0 feet higher.

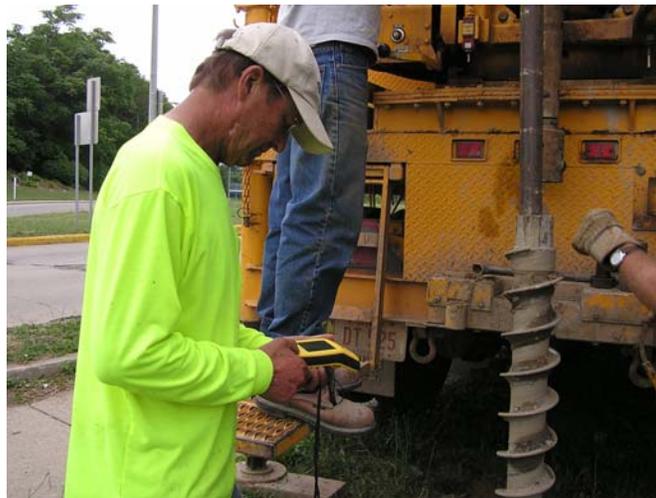
Figure 3 – With a data interchange standard, data entered in the field can be sent, used with various software programs, stored, and reused.

An example of data interchange using a data standard is the use of a PDA in the field. The subsurface exploration data can be entered at the drill rig as the boring is being conducted. The data can then be sent electronically through the web via the data standard to the DOT office where it is electronically checked and validated with software, entered into a database along with pertinent project information, and used for boring log generation and/or modeling applications. The data can be maintained electronically in the database and retrieved when needed for future use.

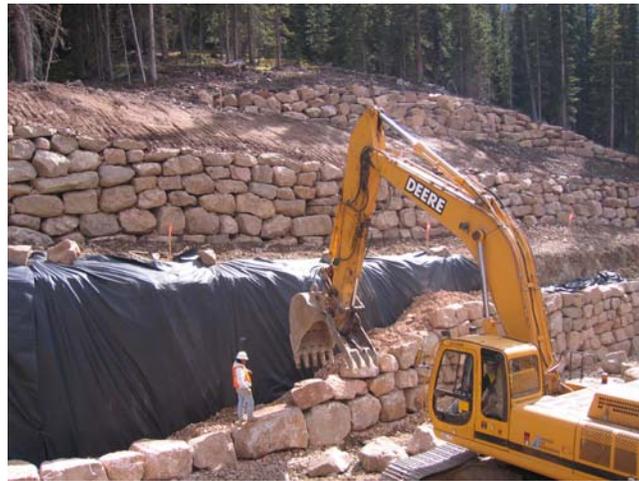
Figure 1. Typical rockery construction.

As defined herein, rockeries should not be confused with rock buttresses, rock inlays or slope armoring, each of which can have the appearance of a rockery once constructed. Rock buttresses are more massive and generally have dumped stone rather than individually placed stone. Buttresses are usually used to improve global stability of a marginally stable slope that extends far above the buttress by adding mass to the toe. Internal stability of the buttress is maintained by its thickness and a 1:1 or flatter slope angle at its face. Rock inlays are similar except they are thinner and used to control seepage and maintain face stability, primarily, and only secondarily add mass to the toe. They are used where near-surface water needs to be controlled. Slope armoring consists of individually placed stones, often only one stone thick, covering cut or fill slopes. Armoring does not provide significant improvement with respect to global stability or drainage of near surface water. Armoring provides resistance to surface erosion and vegetation. Figure 1 shows typical rockery construction.

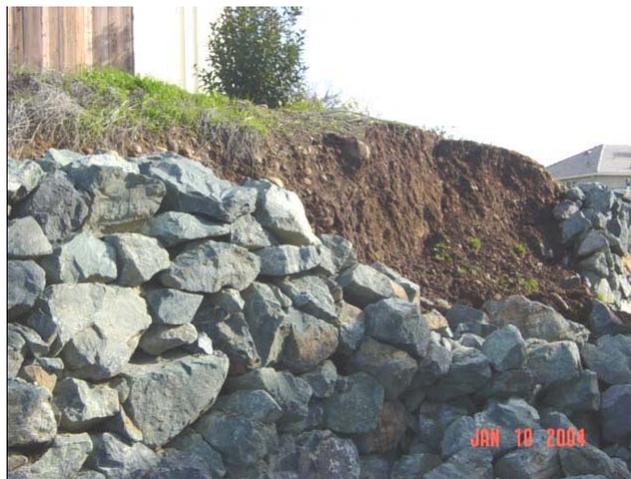
Figure 2. Rockery failure.

The lack of statewide or national design standards and construction guidelines has sometimes resulted in permitting and performance problems. Many municipal agencies are slow to accept rockery plans because they are unfamiliar with the design concept and/or do not have accepted guidelines to use as a basis for review. In the absence of standard guidelines, some municipal agencies require conservative designs and rockeries become prohibitively expensive. In other cases, poor rockery design and construction procedures, as well as a lack of understanding of the nature of rockeries during the review process, have resulted in poor performance, including failures during or after construction. In many cases, the lack of quality assurance or construction oversight guidelines exacerbates problems related to poor design or construction practices. For example, the failed rockery shown in Figure 2 generally has rocks of inadequate size which are poorly stacked. In addition, drainage features do not appear to have been installed.

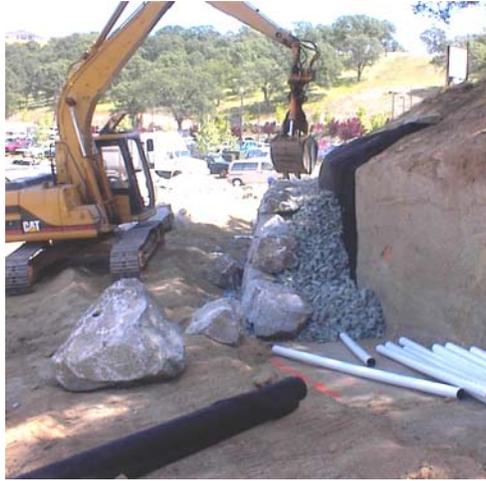
Figure 6. Hydraulic excavator with a clamshell constructing a rockery.

Because the rocks must be “finessed” into proper interlocking positions, the use of proper equipment for rock placement can be the difference between a successful and unsuccessful project. An excavator with a rotating clamshell attachment are useful for properly placing rocks, as shown in Figure 6. The clamshell allows the rock to be grasped uniformly on two sides, and the powered rotation capability allows the operator to quickly make adjustments to the rock orientation and alignment. In addition, a clamshell with rotation capability also allows one rock to be placed and replaced at multiple locations to determine the best fit without the need to move the excavator or regrasp the rock. An excavator with a rotating clamshell should be specified in the plans, as it improves rockery construction and reduces time of installation.

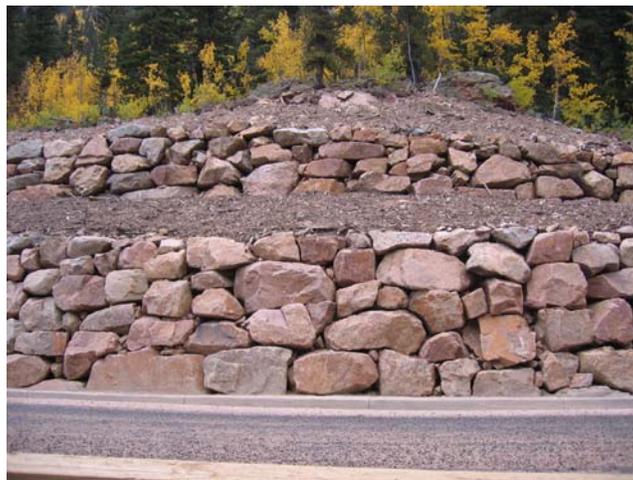
Figure 7. Example of a well constructed rockery.

An example of a relatively well constructed rockery is shown in Figure 7. Although a few vertical seams can be located, the rocks are generally bearing at the proper locations and stacking in an approximate running bond pattern.

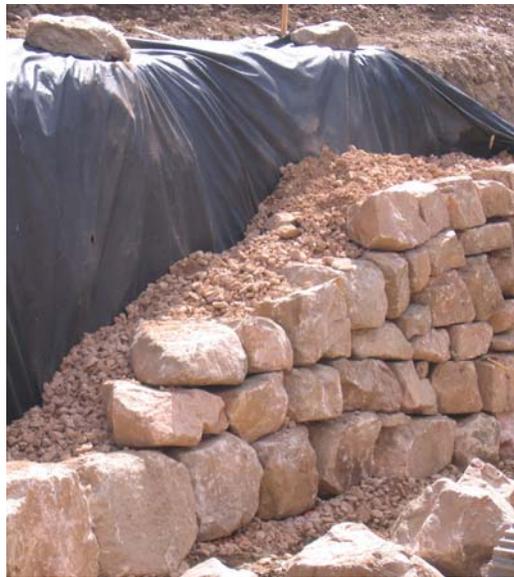
Figure 9. Placement of drain blanket and non-woven geotextile behind rockery.

As the base and facing rocks are placed, it is generally most convenient to construct the rockery drain and crushed rock zone concurrently. The drain pipe should generally consist of a 4 in (100 mm) diameter perforated drain pipe surrounded on all sides by at least 4 in (100 mm) of screened, 4- to 6-in (100 to 150 mm), angular crushed rock unless unusual conditions exist as determined by the Geotechnical Engineer. The drain pipe should consist of either corrugated high-density polyethylene (HDPE) pipe or smooth polyvinyl chloride (PVC) pipe. The pipe should be placed with the perforations down. A diagram of the drain components is presented in Figure 8 and photographs of installed crushed rock backdrains are presented in Figure 9.

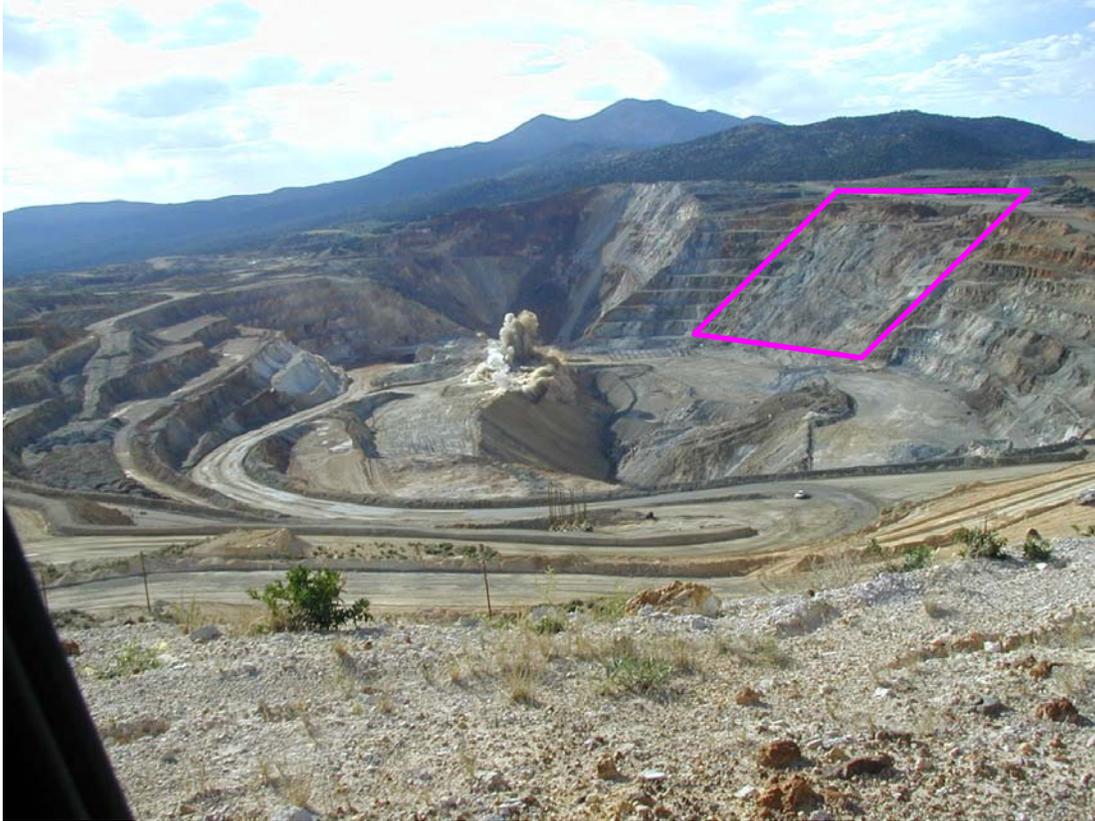
Photo 1 – Open pit copper mine with failing pit slope (purple box)

The author spent approximately two months at a historic open pit porphyry copper mine in central-eastern Nevada in 2004. Although the mine will remain confidential, it had the notoriety of being one of the most geotechnically “active” in North America, if not the world. Upwards of 10 individual open pits existed on the site, with two being actively mined. The entire project had recently been purchased by a “junior” mining company, well aware of the complex geotechnical conditions that existed at the site. The intent was to expand the existing open pit mining operation, as the price of copper had recently spiked. One of the pits slated for expansion was unique in that any rock slope engineering considerations had to be based not only on risks to mining operations, life, and equipment, but also on the process of production itself. One of the very ore blocks comprising the primary deposit was part of a large creeping slide mass, measuring some 600-ft in height by 300-ft in slope-parallel width (Photos 1 and 2).

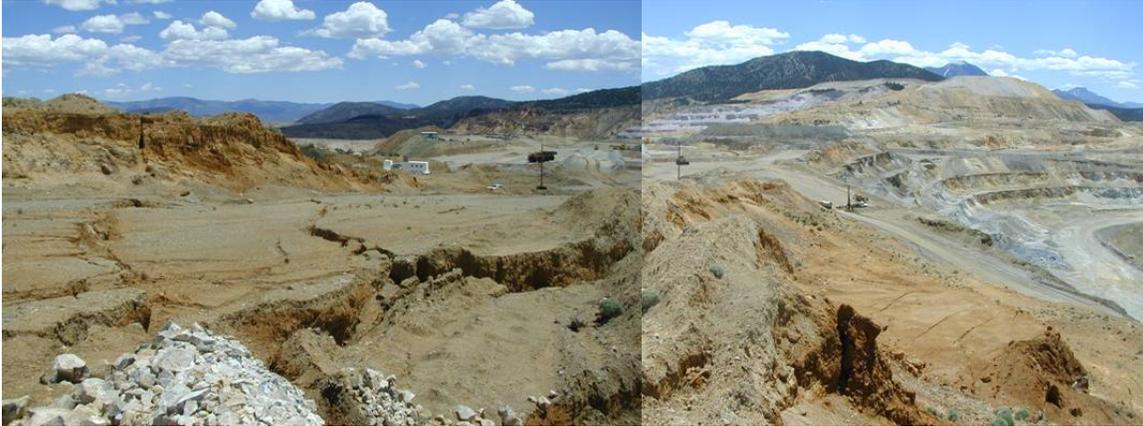
Photo 2 –Failing slope at open pit copper mine. Note tension cracks.

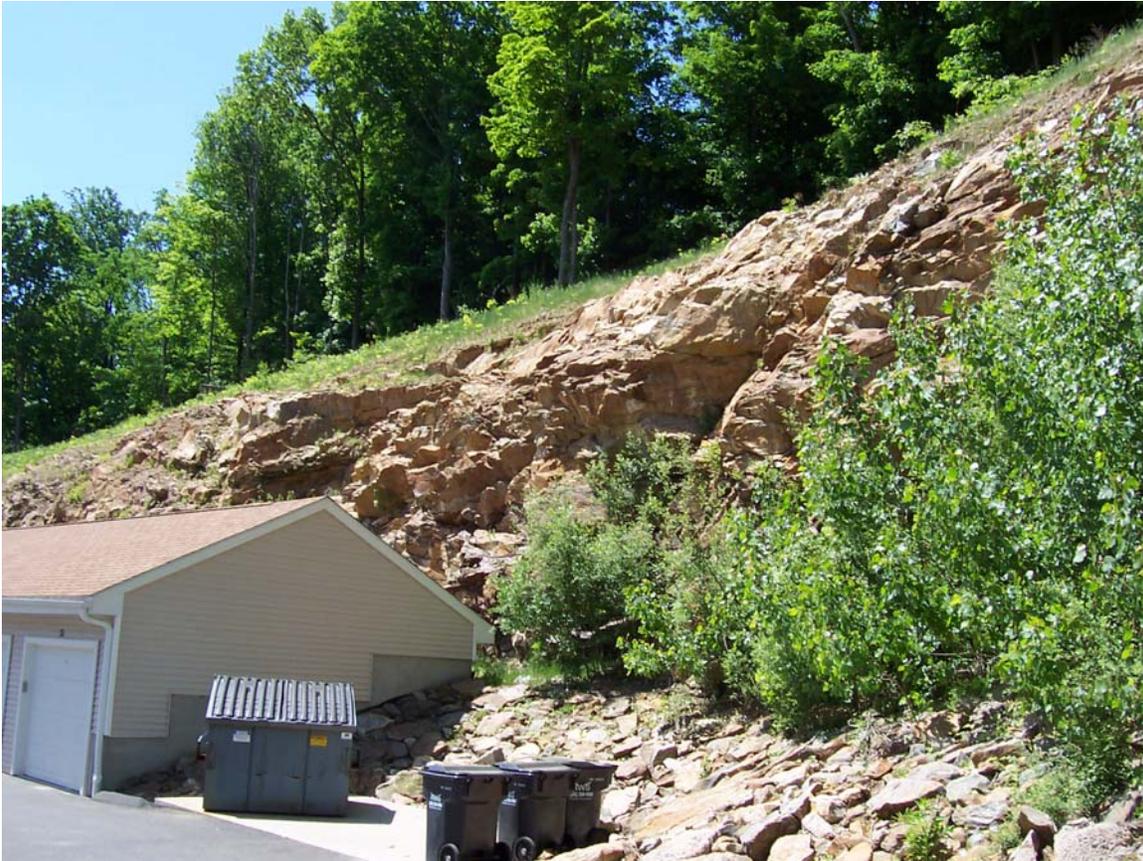
Photo 3 – Development rock slope in close proximity to existing structures

The author was recently involved in litigation support for a condominium rock slope in southwestern Connecticut (to once again remain unnamed). The rock slope was the end result of mass rock excavation activities for construction of a condominium complex. A local excavation contractor was hired for rock excavation and removal, with minimal input from rock slope engineering professionals. Three separate geotechnical reports were created, each with differing recommendations with regard to rock slope design. The geotechnical information provided for rock slope design was scant. The case developed as a result of recent rockfall events and the close proximity of the slope to existing structures (Photo 3).

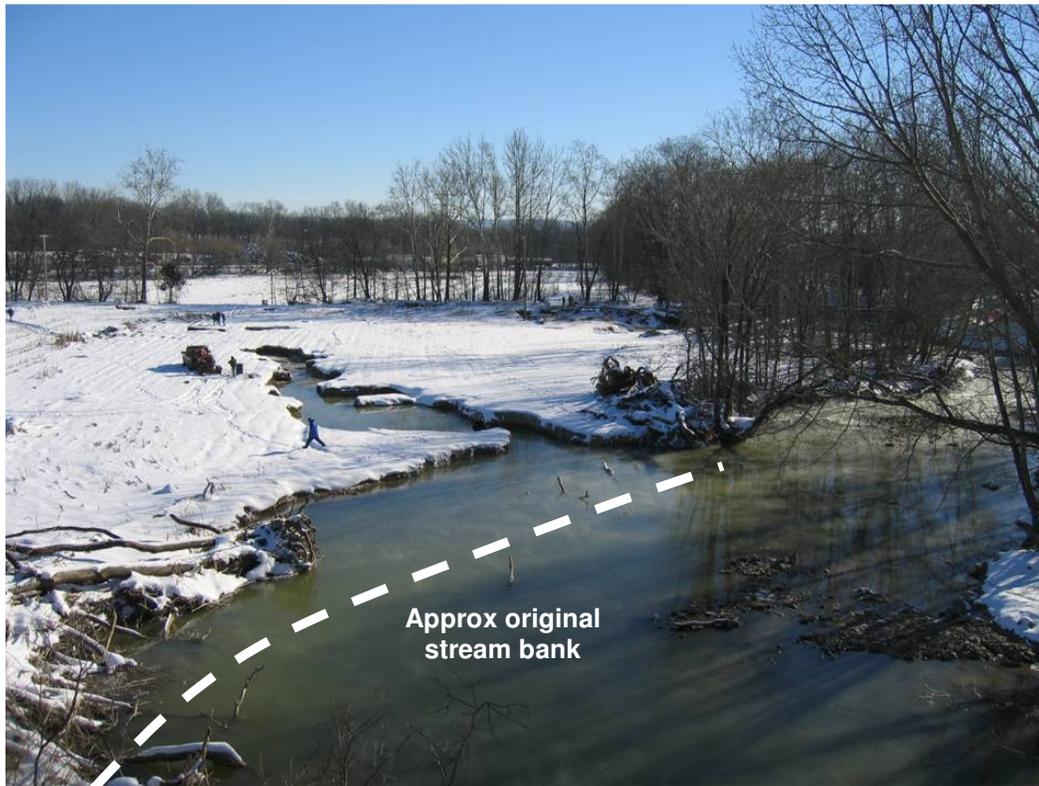
Figure #10 – January 2004 Accelerated Sinkhole Activity

In late January 2005, sinkhole activity increased dramatically just downstream (east) of SR33. A sinkhole area just beyond SR33 on the north side of the stream channel that had sporadic activity through 2004 became extremely active. A zone in the adjacent field, which had been experiencing reoccurring sinkholes for some years, developed a series of large sinkholes that coalesced and connected to the creek. The resulting channel that developed on the north side of the creek extended from just west of SR33, approximately two thirds of the distance to SR2017 (see Figure #10).
