66TH HIGHWAY GEOLOGY SYMPOSIUM SEPTEMBER 14-17, 2015

2015 Proceedings

*Massachusetts Department of Transportation
and
University of Massachusetts Amherst*

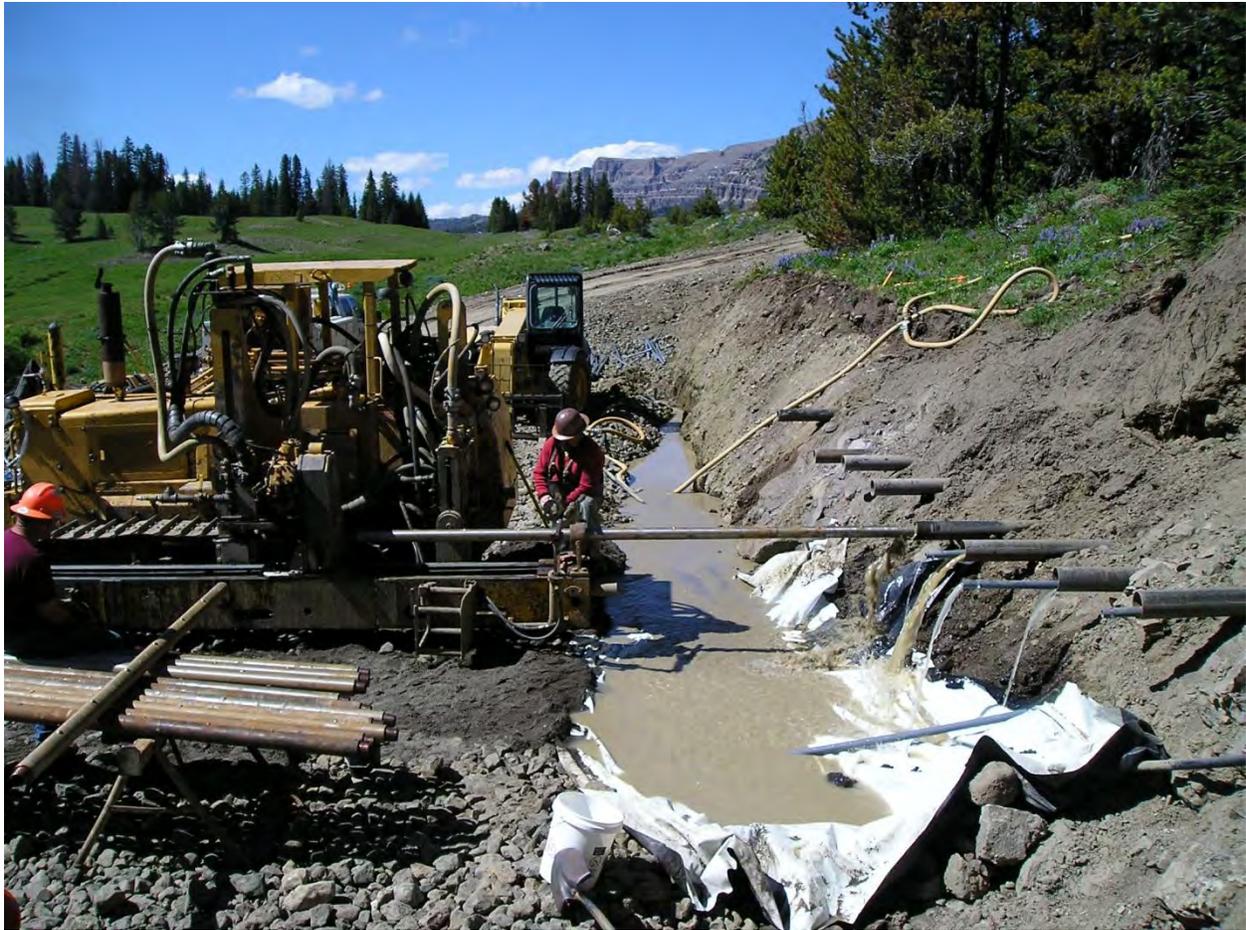
Figure 1 - Construction of horizontal drain pad on Continental Divide Landslide, Togwotee Pass, June 2010.

The utilization of horizontal drains (HD's), Figure 1, is just one of many methods that can be considered by designers in the geotechnical field for landslide remediation. Horizontal drains have the potential to completely stop a landslide or more commonly can be incorporated with other landslide remediation methods to raise the Factor of Safety (FOS) to an acceptable value. Thousands of horizontal drains have been installed and used as a method for landslide remediation around the world, yet many organizations and the professionals within have little to no experience with this concept for landslide remediation. This was the case for WYDOT Geology in 2009 when they were tasked with fixing 13 known landslides for complete reconstruction of the Togwotee Pass Corridor leading to Yellowstone National Park. Several key factors during construction of the project limited the ability to utilize other more accepted practices for landslide remediation and left little choice but to consider the use of horizontal drains on some of the landslides. This can also be said for fixing the Caribou Landslide on Powder River Pass in 2012, west of Buffalo, Wyoming.

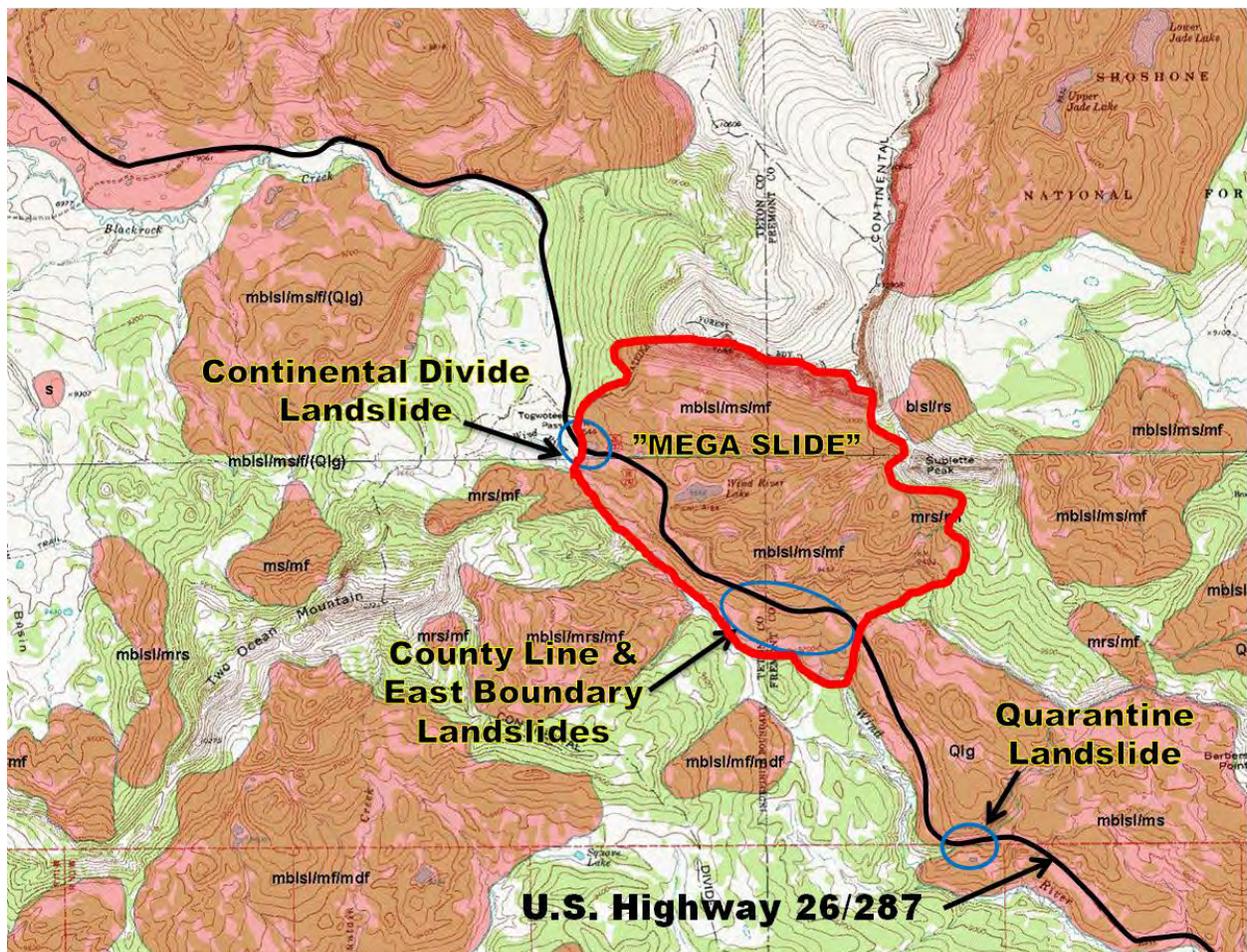
Figure 2 - WSGS Landslide Hazard Map depicting known landslide hazards affecting the Togwotee Pass Corridor.

The addition of the new East Boundary Landslide was of great concern especially given that the Togwotee/Four-Mile Section was under contract. Further research showed that survey points taken in 1999 on both the Continental Divide Landslide and County Line landslide had moved up to two feet, yet survey points outside of those slide masses showed no movement. Surveyed information and a look at the WSGS landslide hazard map led all parties to the acceptable conclusion that all three landslides were a part of one massive landslide approximately 1.5 miles long and a mile wide later named the Mega Slide, Figure 2.

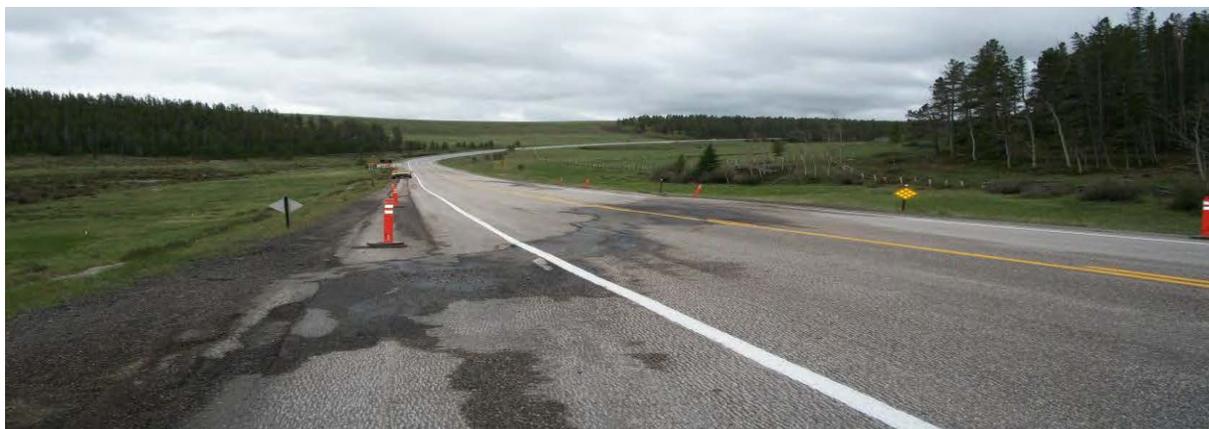
Figure 3 - Damage to US 16 on Powder River Pass by the Caribou Landslide. Excessive moisture due to winter snowpack accelerated slide movement. A horizontal drain pad was constructed near Crazy Woman Creek to the left of the photo.

The Caribou Landslide is located on Powder River Pass, between Buffalo and Ten Sleep, Wyoming on US 16. Over the winter of 2010-2011, many of the mountain ranges of Wyoming were at record levels for snow pack, up to 150 percent+ of normal. Furthermore, the spring of 2011 experienced very warm temperatures and numerous rainfall events at high elevations. This combination created excessive amounts of spring runoff water spilling to lower elevations in a very short time period. Hundreds of bridges, box culverts and other structures were severely damaged and over 30 landslides or major failures affected the highways. Many of these areas qualified for Federal Emergency Damage Funding. The Caribou landslide had a long history within the Department and qualified for Federal Emergency Damage Funding. Although the slide had never catastrophically failed, it was a constant mover requiring local maintenance crews to patch and repair the road surface annually. Caribou Landslide was no exception to the high water events in the spring of 2011 and the roadway had dropped significantly that spring. Topography was steep and there was an abundance of groundwater within the slide mass, artesian at times, recorded from a nearby abandoned water well. To satisfy deadlines for Federal Emergency Funding, WYDOT was on an accelerated schedule to let a contract for remediation. The intent for remediation was proposed in two phases, first dewater with horizontal drains and monitor effects of dewatering. If dewatering by horizontal drains did not have the desired effect, an additional remediation concept would be designed in the second phase and constructed in the future. Geotechnical drill investigations were conducted in April and May of 2012 and a horizontal drain contract was granted three months later in September 2012. A horizontal drain gallery consisting of 40 horizontal drains ranging from 400 to 600 feet in length was completed in January 2013, Figure 3.

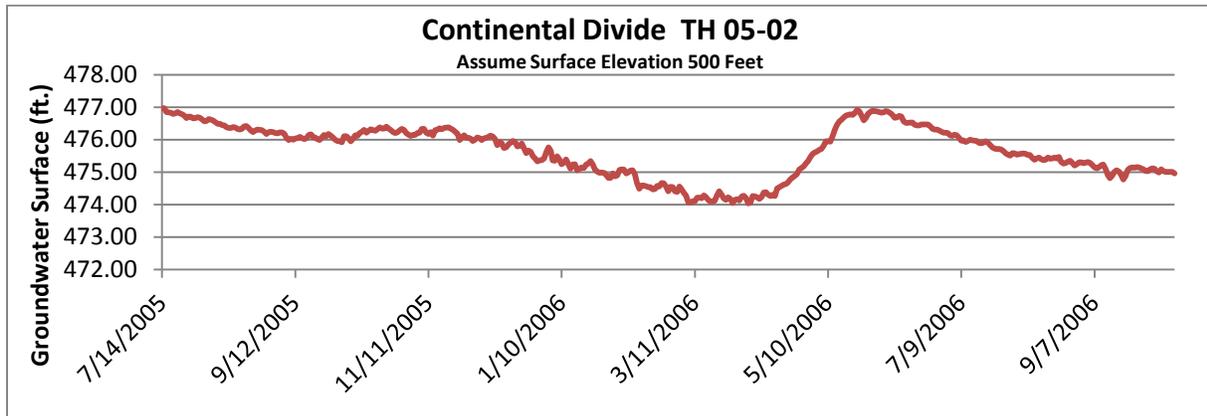
Figure 4 - Single channel piezometer data for Continental Divide Landslide depicting rapid increase in groundwater elevation during spring runoff.

during the dry portions of the year and accelerated movement in the spring months from May to July, Figure 4 and 5. The intent for horizontal drains in these areas was to lower groundwater elevations as much as possible within the slide mass, provide drainage for any perched water and maintain a consistent lowered groundwater elevation by providing an outlet for the rapid groundwater fluctuations seen in the spring runoff months.

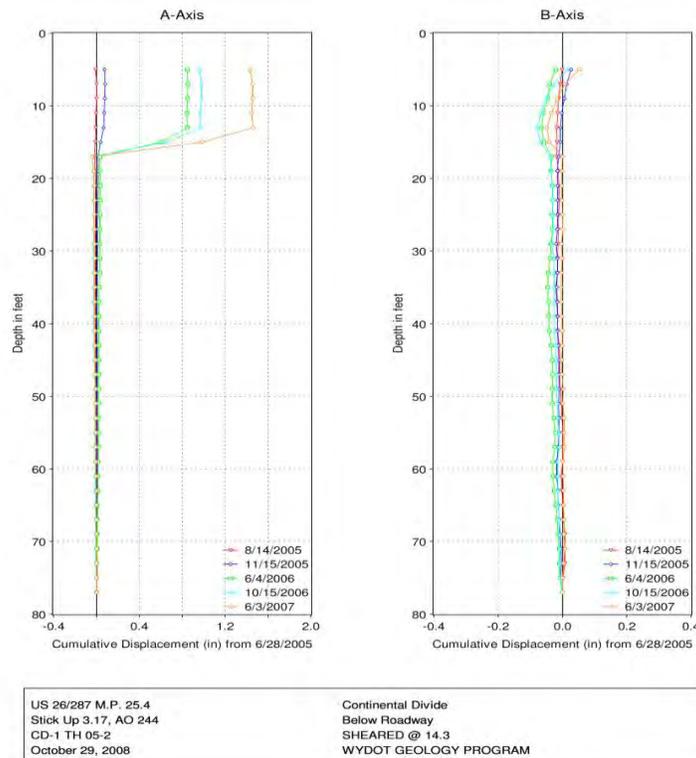
Figure 5 - Inclinometer Plot for Continental Divide Landslide. Bulk of slide movement is occurring during the months of May-July during spring runoff.

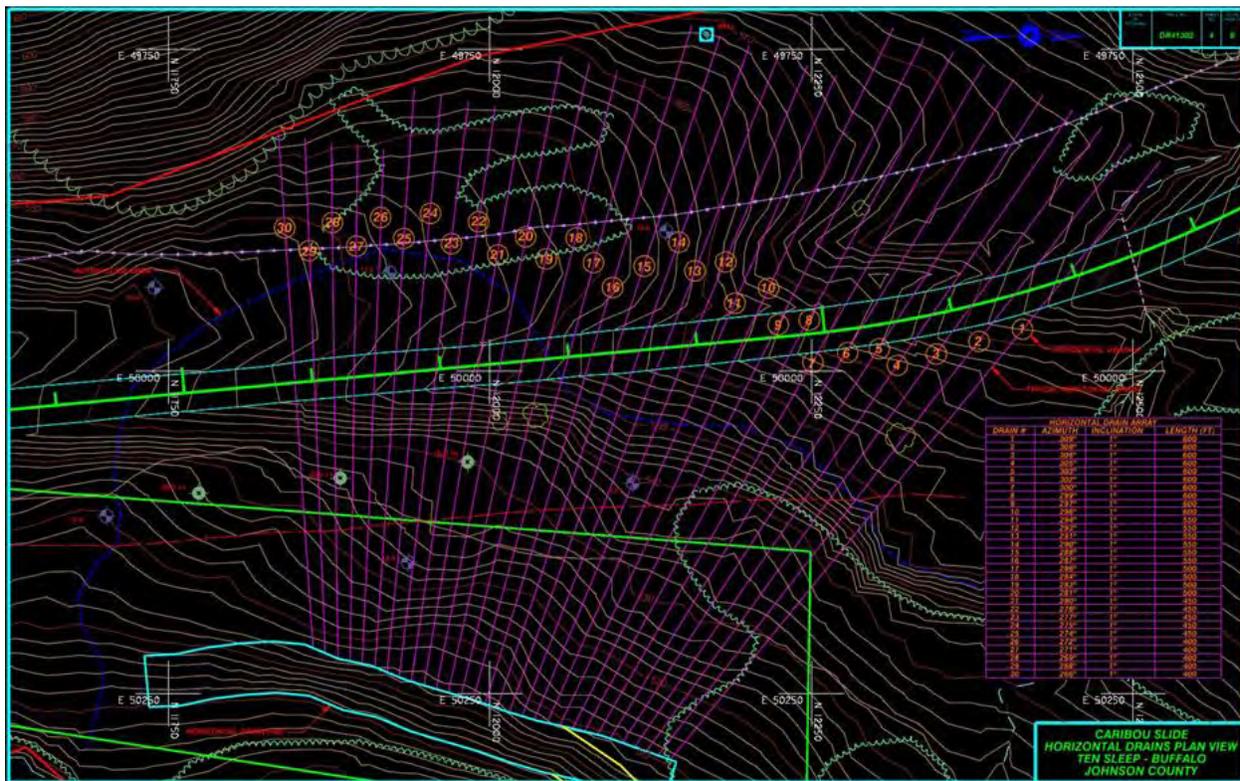
Figure 6 - Design Plan View of North drainage gallery for Caribou Landslide on Powder River Pass.

Subsurface conditions attained from drill data along with groundwater conditions were then modeled in cross section. Drain pads were then placed where topography would allow for an ample vertical temporary excavation for horizontal drilling and enough horizontal area for a drill rig, circulation/settlement pond, placement of a rock buttress and access space for future drain maintenance. This was typically defined by a 10 to 12 foot near vertical temporary excavation and approximately 40 feet of pad width sloped at a 1 to 2 percent grade away from the pad face to ensure optimum drainage. Lengths of drain pads were typically determined by topography of the area and graded at 1 to 2 percent parallel to the pad face for optimal drainage. Pads were oriented so that the vertical pad face was as close to perpendicular to the planned drain azimuth as possible to accommodate drilling and drain installation. If the site topography would allow and additional drains were desired, a second drain pad was designed under the same criteria. Number of drains for each specific pad were then limited to the maximum number of drains that could fit in each pad area at an 8 to 10 foot spacing, which equated to no more than 40 drains per pad. Up to five contingency drains were added to pad sites in the contract to allow for additional footage for areas of high production during drilling. Once location and number of pads were determined, drain arrays were placed at each pad. Drains were placed at the aforementioned 8 to 10 foot spacing to allow rig access and drains were given an azimuth that would accommodate maximum "fanning" of the slide mass for dewatering purposes. Angle of drains were generally low angle between 1 to 7 percent. Elevation, angle and length of drains were positioned to allow the maximum anticipated potential for a drop in groundwater elevation with respect to site topography, slide mass and geological constraints, Figure 6.

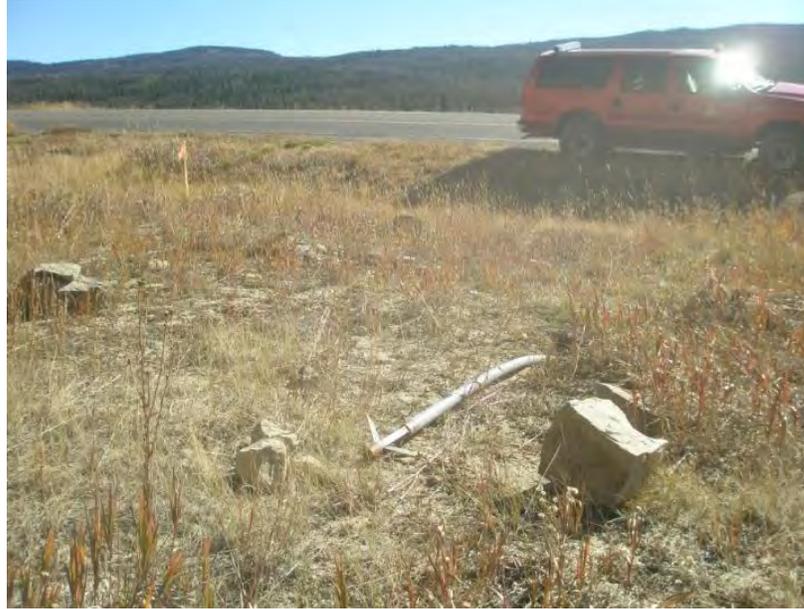
Figure 7 - Care should be taken for correct azimuth and angle of a drain. However, the photo above proves when horizontal drilling, bits tend to have a mind of their own.

Once pads were constructed to planned specifications, drilling was set in motion. Drilling began by marking 6 to 8 planned drain locations on the pad face followed by installation of 20 feet of steel surface casing. Prior to surface case installation the inspector on site would align the drill rig at the planned azimuth and inclination of the drain. Once surface casing was set, drilling commenced to planned length of each drain. During drilling, drain angles could be checked by using a monometer and calculating hydraulic water pressures recorded at a known depth. This was a very crude way to determine drain inclination and many times pressures were assumed inaccurate. Generally, once surface casing was set to the planned azimuth and inclination, gravity and geology determined the path of the drilling especially at depth, Figure 7.

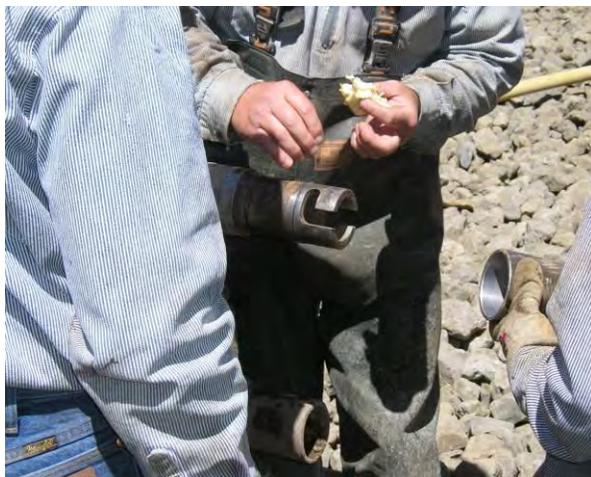
Figure 8 - View of "knock off" bit assembly.

The stereotypical path seen during horizontal drilling is for the bit to start at the set inclination, then raise, and go to the right with depth until gravity takes over and the bit begins to fall. Completed drilling orientation of the horizontal drain typically rested in a concave manner when viewed in cross section and many times was confirmed through Pajari testing discussed below. In many cases, although a significant portion of the completed drain was drilled at a negative angle, it was assumed pore water pressures were high enough to promote enough head to allow good flowing drains seen at the pad face. Once final planned depth was achieved, the bit was removed from the drill stem using a very unique method in horizontal drilling through the use of a "knock off bit", Figure 8. This is achieved by backing the bit and turning the drill stem counter clockwise Figure 9.

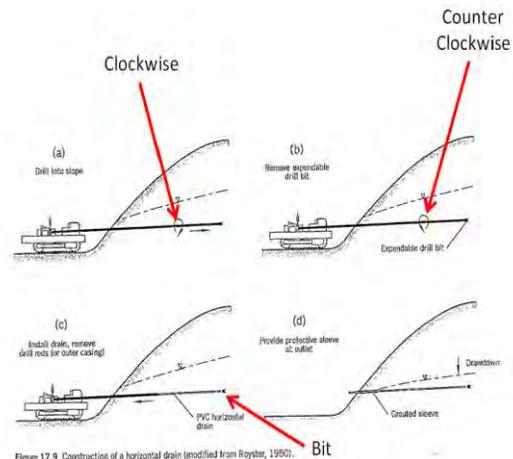
Figure 17.9 Construction of a horizontal drain (modified from Royster, 1980).

Figure 9 - Schematic of HD drilling and drain installation procedure.

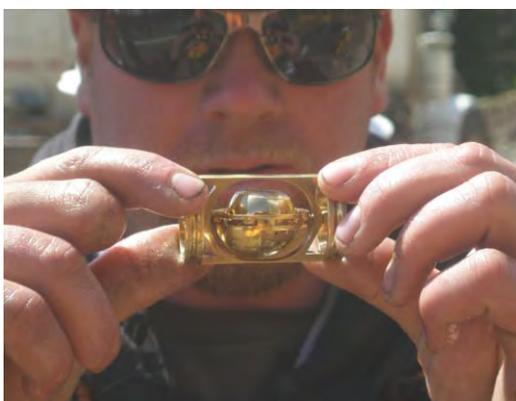
Figure 10 - View of Pajari borehole survey instrument.

Once the bit was removed, the drill head was detached from the drill steel and 1½ inch ID, schedule 80, perforated PVC drain pipe was installed to full drilled depth. A secondary method for determining orientation of drains was by the use of a Pajari borehole survey instrument, which operates through the use of a clockwork mechanism which simultaneously locks a plumb device and a magnetic compass to give the inclination and azimuth of the borehole. This device worked quite well, but was rather tedious and time consuming because it required several measurements to be taken under a set amount of time to be able to plot the entire borehole orientation, Figure 10. Due to reasons discussed above and the cost required to conduct the testing, only a handful of these tests were conducted per drain pad. It is also important to note that Pajari testing could only be conducted through an installed horizontal drain, Figure 11. Therefore, the orientation of that drain was permanent, but it would allow for adjustments to drilling of the remaining drains. Drilling and installation continued in this fashion until drain pads were completed.

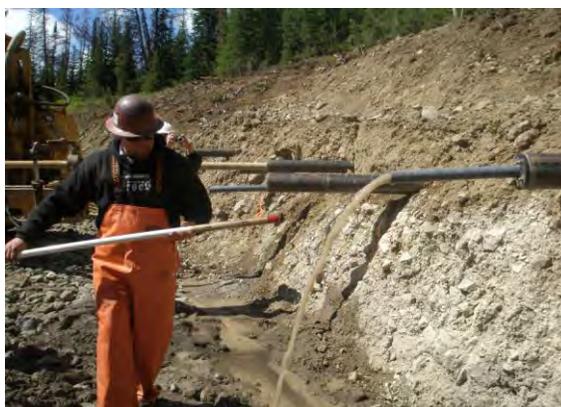
Figure 11 - Pajari assembled in protective casing for preparation to survey HD.

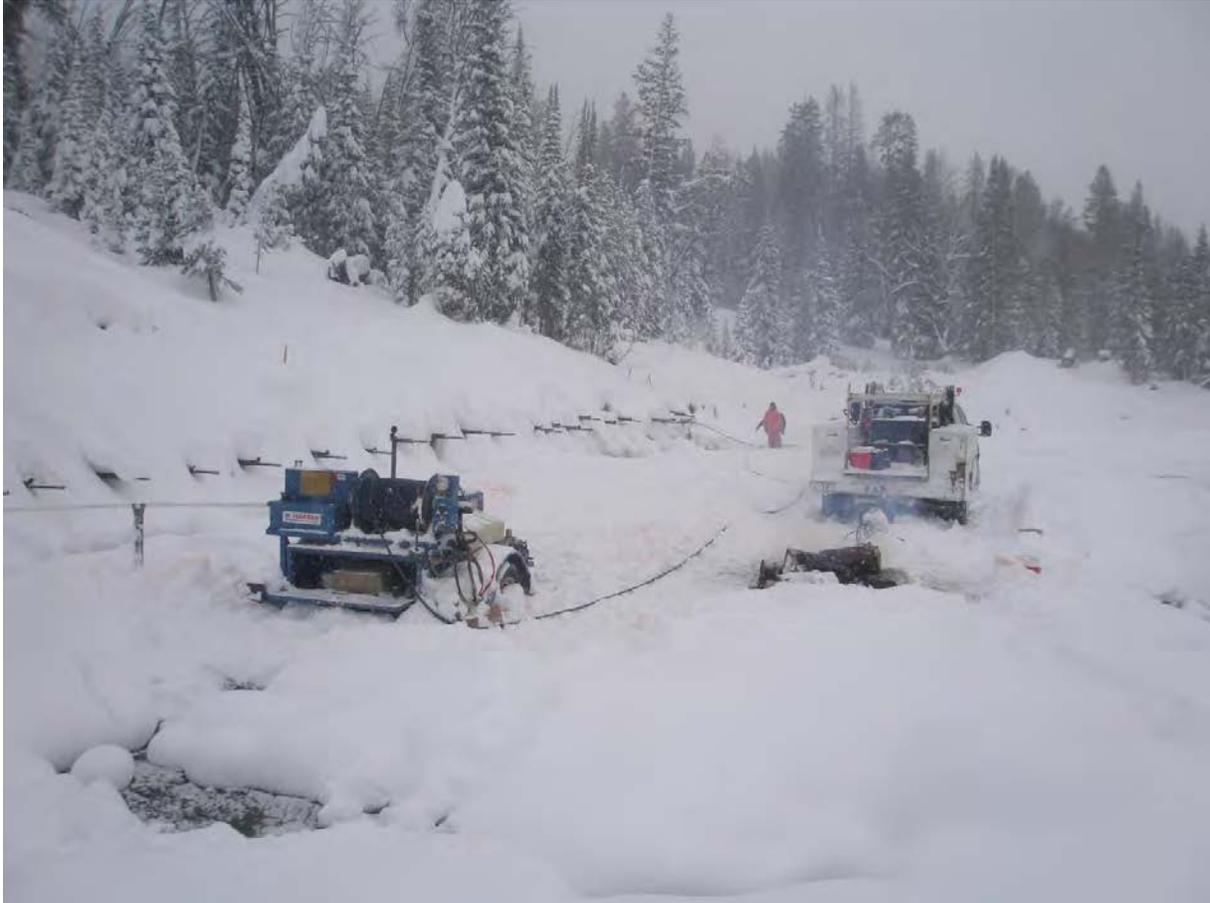
Figure 12 - Jetting of HD's on County Line Landslide, Togwotee Pass, November 2010. Preliminary jetting was conducted prior to placement of rock buttress. Drains were producing enough water to supply jetting device with clean water indicated by PVC pipe supplying storage tank to the left of the frame.

The final step for drain pad installation involved a rock buttress being placed around the outlet of all drains and adjacent to the temporary vertical excavation. This required a minimum of four feet of rock cover above the drain outlets and matching the grade of the existing slope. Rock was extended the full length of the drain extensions, 20 feet nominal, and tapered at a 1.5H:1V slope to the base of the pad. This required rock to be placed to the bottom elevation of all drains, and then drains were extended to daylight at the proposed rock buttress slope and encased in 4 inch perforated polyurethane pipe at which time the remaining rock was placed to planned specifications outlined above. The rock buttress served many purposes in that it retained the temporary vertical excavation at the pad face, protected and insulated the drain outlets from damage and freezing temperatures and the buttress provided a free draining outlet source for production water to satisfy environmental concerns. Lastly, all drains were cleaned the full length with a high-pressure jetting device to flush of any debris and clear perforations, Figure 12.

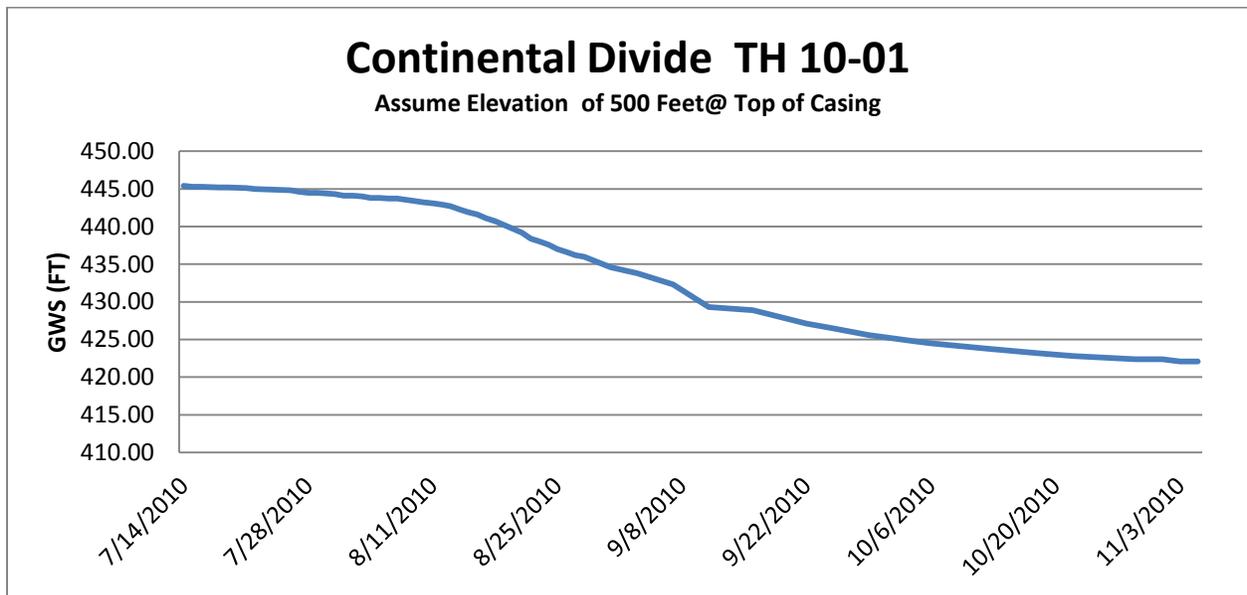
Figure 13 - Gradual drops were seen in some areas of Continental Divide during installation, yet the overall drop in groundwater elevation was impressive.

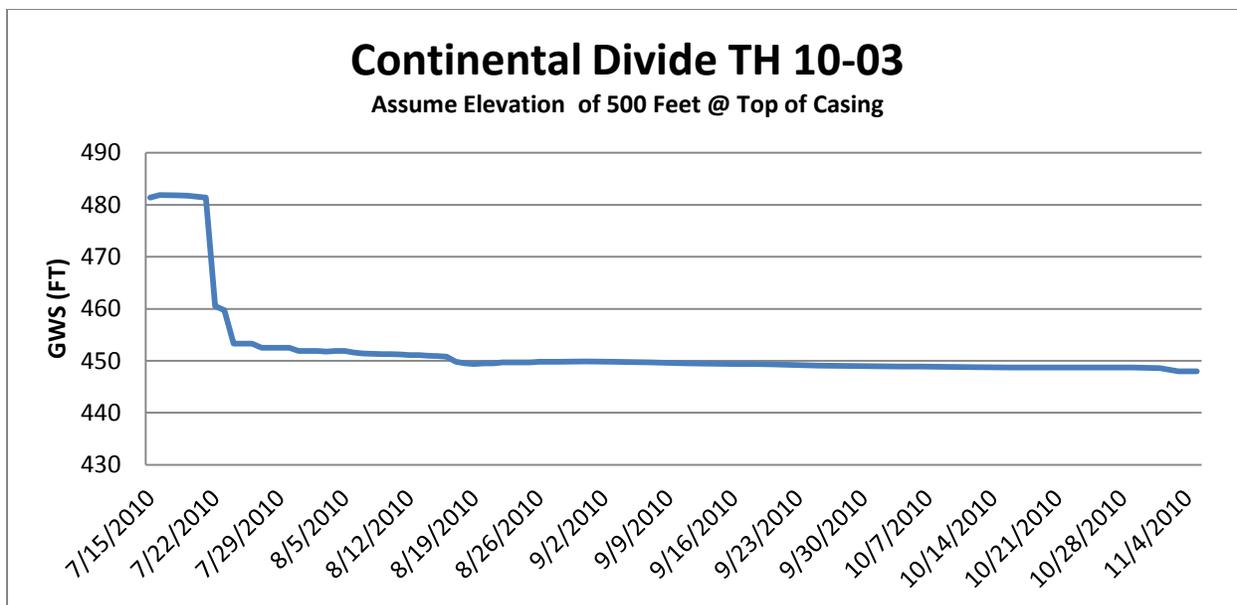
Figure 14 - Significant, nearly instantaneous drops were seen in most areas of Continental Divide.

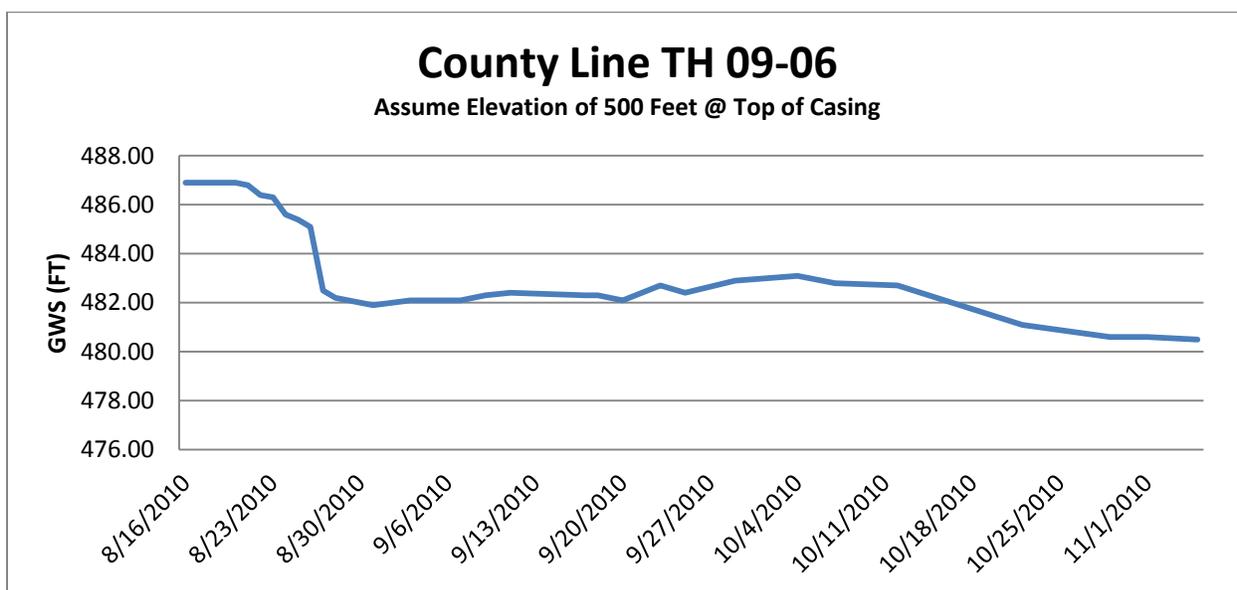
Figure 15 - County Line showed positive signs of drainage to the slide mass, but not nearly to the extent seen at the other slides. County Line groundwater elevations in response to HD installation were much more sporadic than the other slides. This may be attributed to the fractured volcanic breccia bedrock.

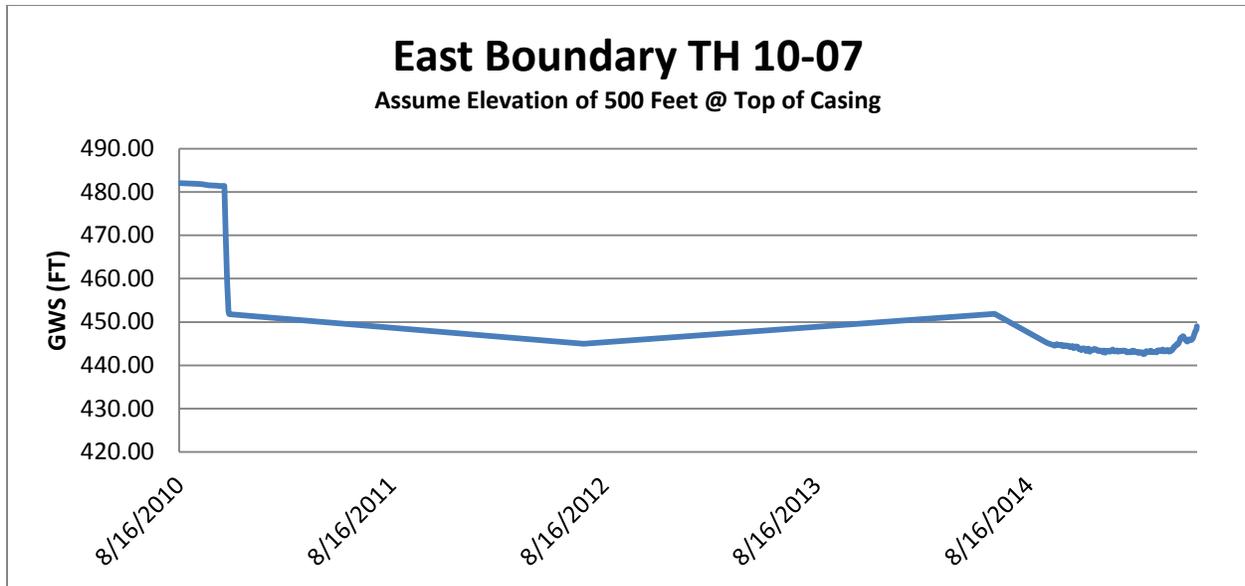
Figure 16 - Initial drop in groundwater elevation seen to the left during HD construction. Piezometer data to the right indicates water elevations are at or below post construction levels even after drains were sheared near the pad face.

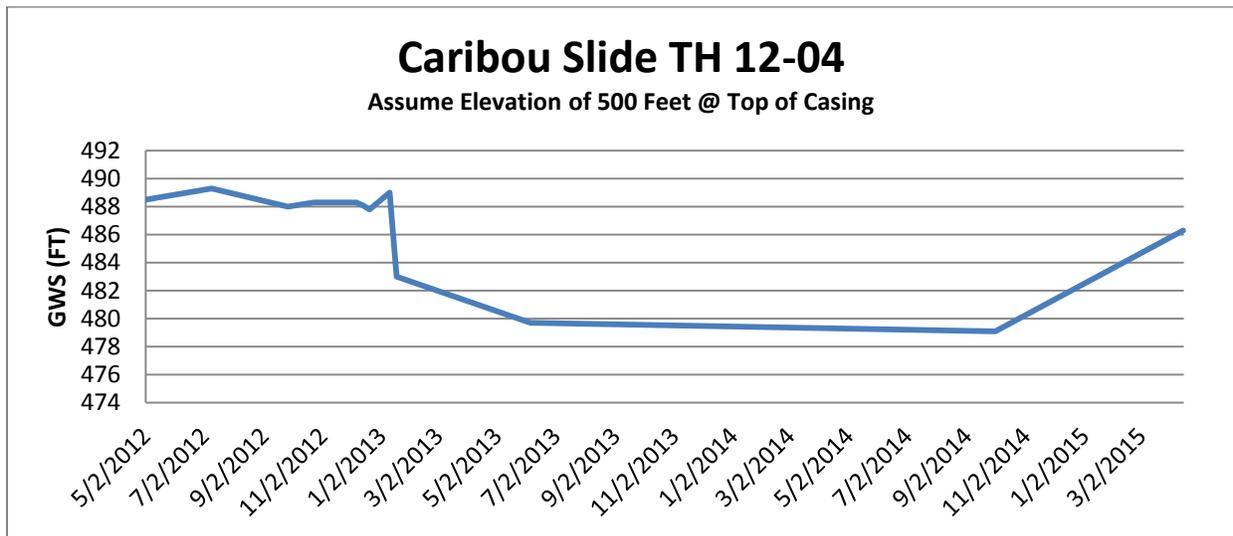
Figure 17 - Initial drop in groundwater elevation seen to the left during HD construction. Raise in groundwater elevation in recent months may indicate a dirty drain or high spring runoff in 2015.

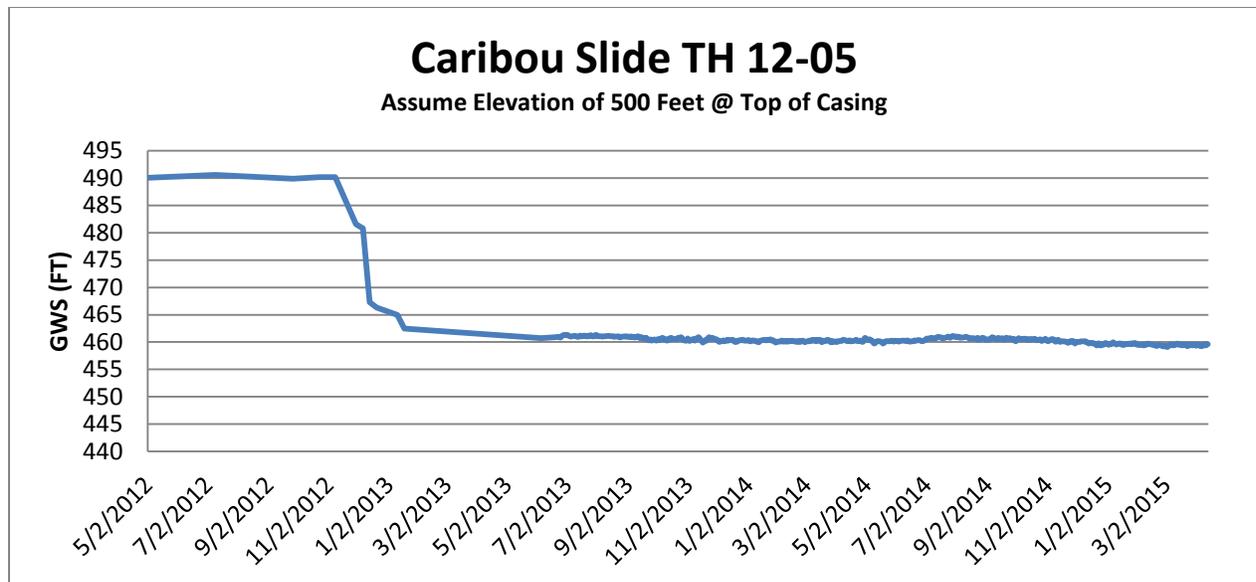
Figure 18 - This graph is indicative of the performance seen at Caribou landslide. Piezometer data post construction indicates drains are continuing to maintain lower elevations.

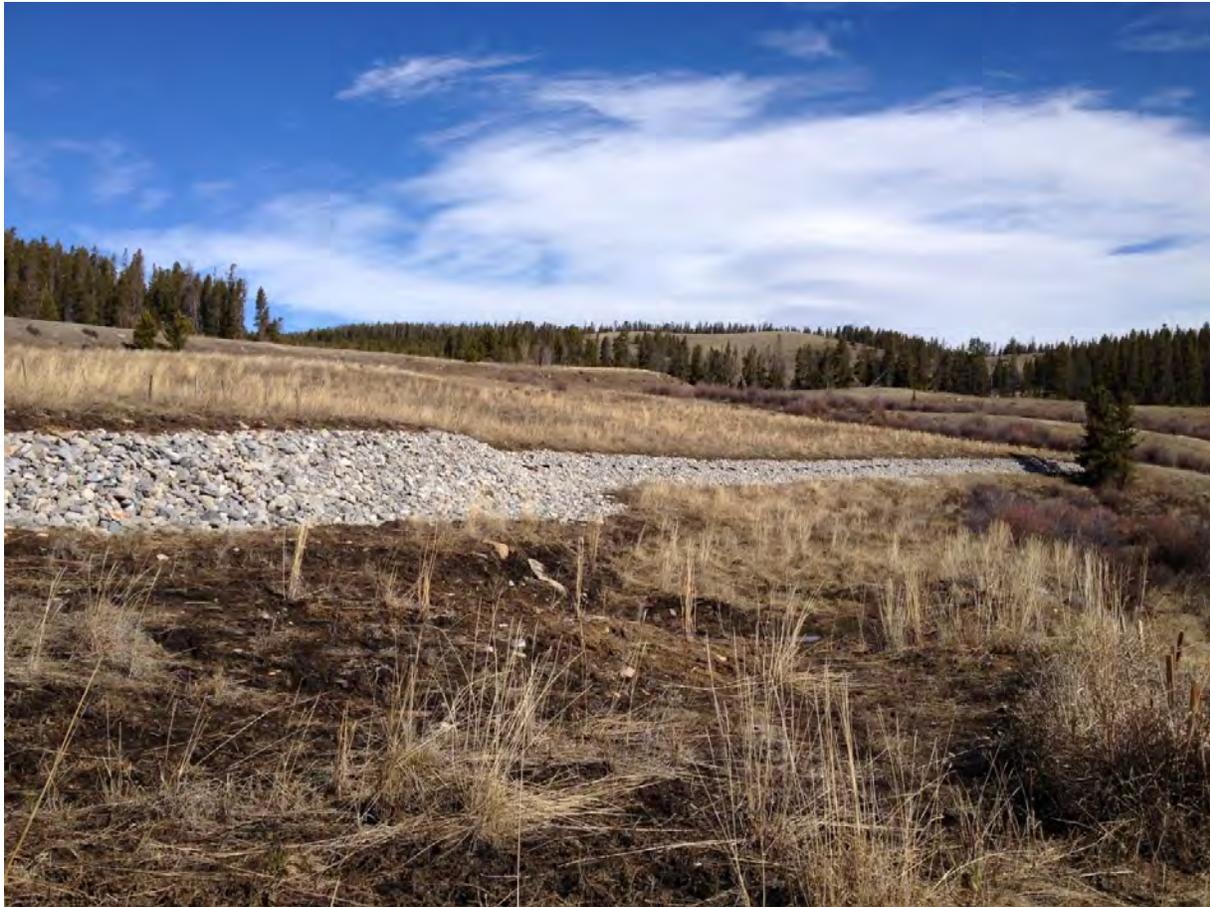
Figure 19 - Completed drainage gallery at Caribou Landslide, Powder River Pass. Drain pipes are exposed at face of rock buttress for future maintenance.

Worth noting is that the experience gained with horizontal drains on the previous Togwotee Pass Corridor played an integral part in the design and successful implementation of the Caribou HD contract. This was all encompassing from field resonance and instrumentation to final placement of the rock buttress, Figure 19. In the summer of 2013, to maintain the integrity of the drainage galleries on Togwotee Pass, maintenance personnel flushed the drains and the Caribou Landslide is planned to be flushed in the summer of 2015.

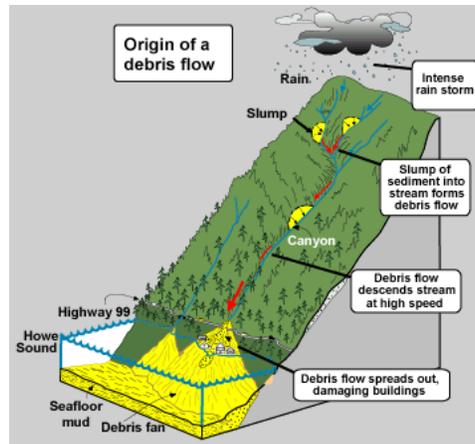
Figure 1 – Origin and evolution of a debris flow (Source: natural Resource Canada)

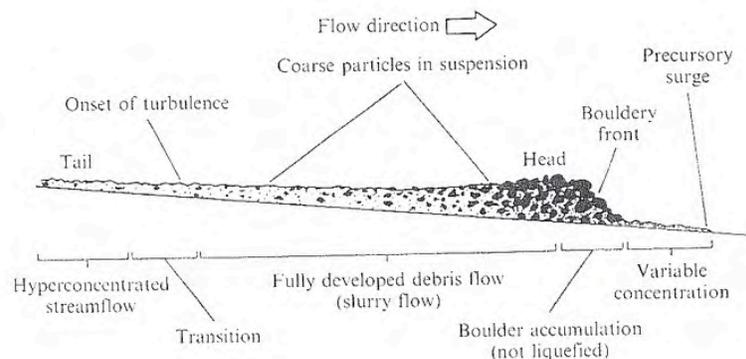
Figure 2 – Evolution of the debris flow (Source: Pierson, 1986)

The rheology of the debris flow varies with the time. When the amount of debris is increasing on the front of the flow, the discharge that drives the flow downstream is also increasing. Thus, the peak discharge rises as well. Generally the biggest particles constitute the forward-face of the debris flow, whereas the small ones create the central core. The tail of the flow is basically composed of water and very small material (Figure 2).

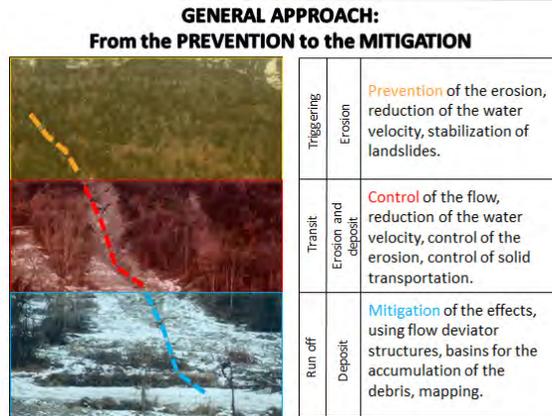
Figure 3 – Areas characterizing a debris flow. Example of a channelized flow. 3-areas can be identified: starting zone (orange), transit zone (red), and deposition zone (blue)

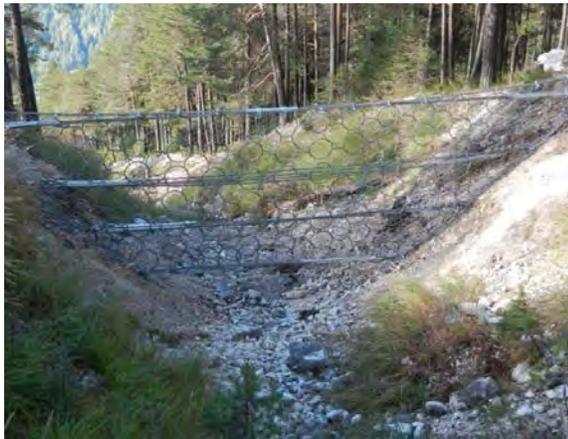
Figure 4 – Channel debris flow barrier with no posts (Italy)

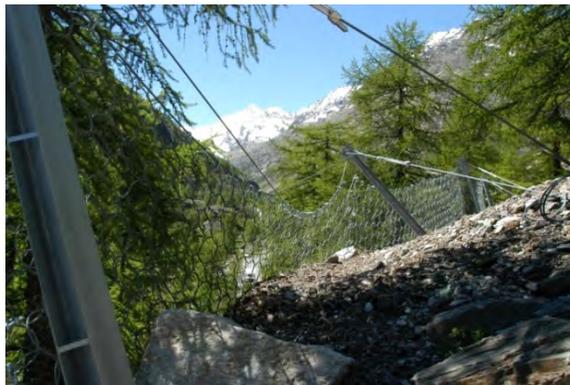
Figure 6 – Impacted open slope debris flow barrier (Italy)

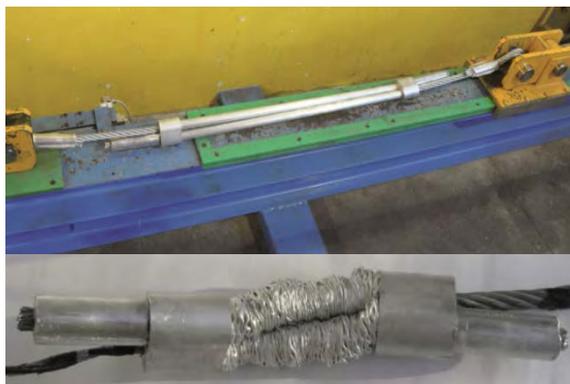
Figure 7 – Example of Maccaferri energy dissipater device (brake). Before the test (top) and after the test (bottom). The deformation of the device allows absorbing the impact energy of the debris flow.

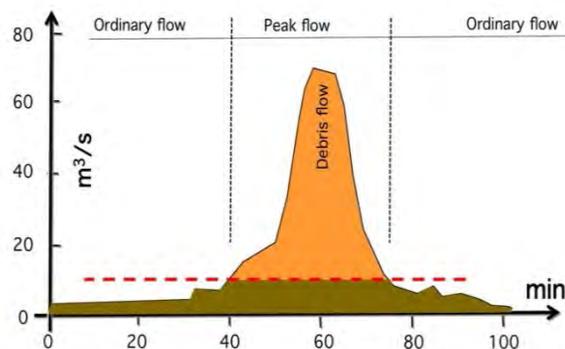
Figure 8 – Correlation between the flow-discharge vs. the duration of the debris flow event. Debris flow barriers should mainly cut the peak of the solid transportation

- Debris flow barrier should always be intended as emergency remedial solutions, aimed to reduce the peak of the sediments carried by the flow (Figure 8). The followings implications come out accordingly:

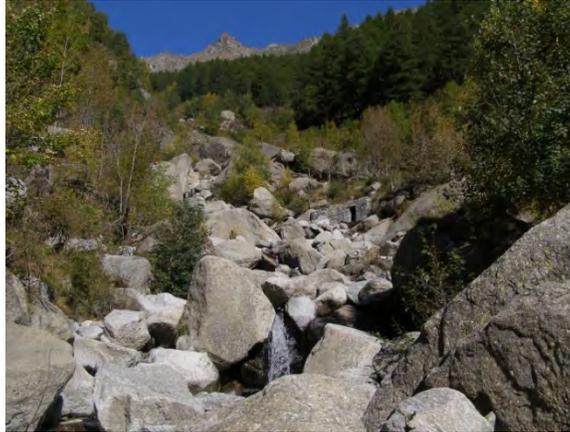
Figure 9 – Example of a creek subjected to debris flow composed of big boulders (Ciamosseretto torrent, Italy)

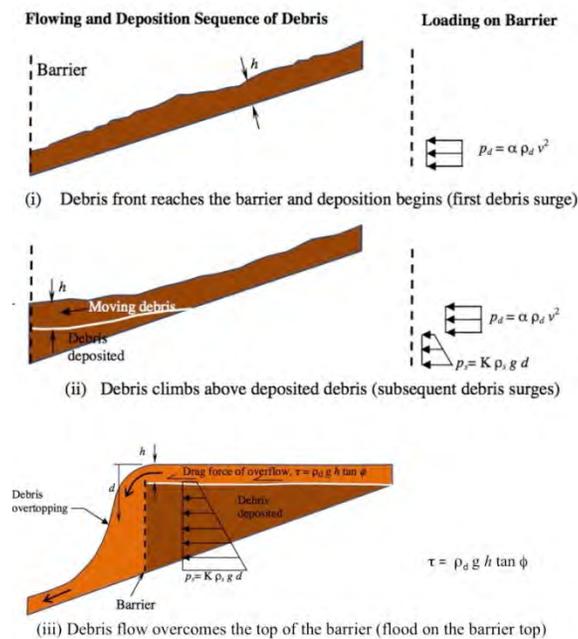
Figure 10 – Flowing and deposition sequence of debris and loads acting on the debris flow barrier (after Sun et al., 2011). The symbols have the following: d = distance between the top surface of the accumulated material against the barrier and the analyzed point; v = velocity of the debris flow at the impact; h = constant height of the debris flow surge; k = coefficient of earth pressure (typical range 0.5 to 1.0); g = gravity acceleration; α = empirical coefficient of dynamic load (according to GEO, 2011: $\alpha = 2$); ρ_d = density of the debris flow; ϕ : friction angle of the debris flow surge.

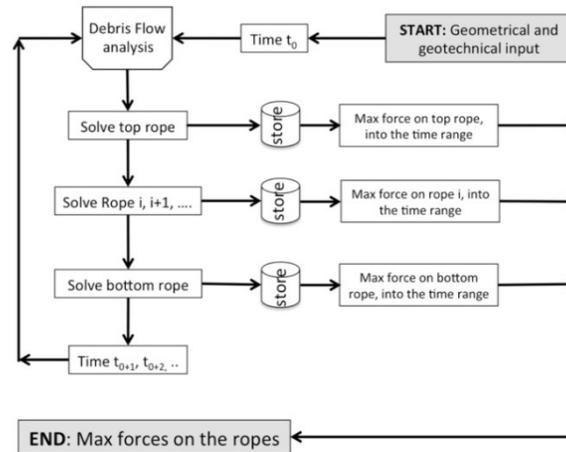
Figure 11 – Conceptual solution to calculate the forces acting on the transversal ropes

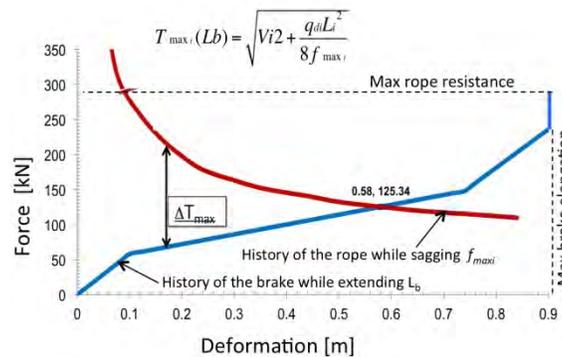
Figure 12 – Load VS deformation on the transversal rope. The calculation has to minimize force-gap ΔT_{\max} , between the dissipater (blu line) and the rope (red line). The value of T_{\max} depends on f_{\max} , which is a function of T_{\max} . Therefore an iterative process is needed to solve the problem. When the elongation of the brake reaches the maximum elongation, the force grows vertically up to the max rope resistance.

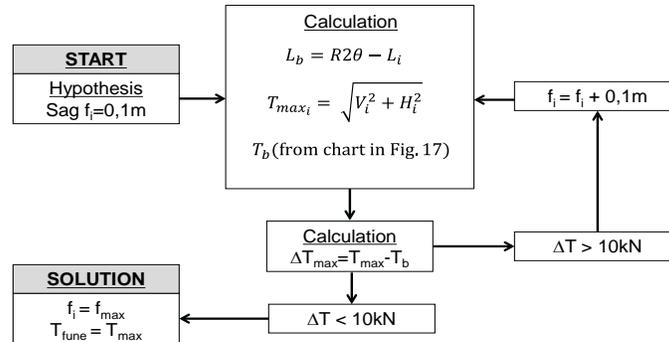
Figure 14 – Conceptual solution solving the non-linear problem of the equilibrium between forces of rope and energy dissipater. R is the curvature radius of the sag (see also figure 13). symbols: $\theta = \arcsin(L_i/2R)$, L_b = brake elongation (see also figure 17).

At each stage of the run-up mechanism, an interactive model evaluates the axial force acting on the rope-brake system (Figure 14). The process ends when the force acting in the rope reaches the equilibrium with the deformation of the energy dissipater.

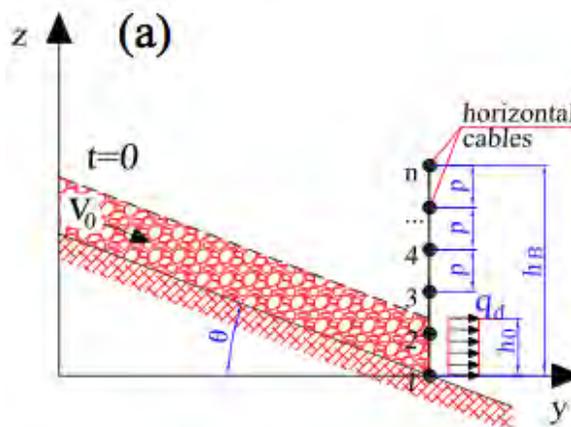
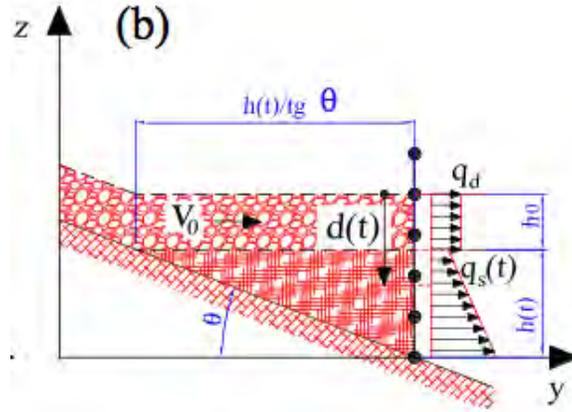
Figure 15 – Debris accumulation against the debris flow barrier and corresponding loads at the generic instant time (Segalini et al., 2012; Canelli et al., 2012)

At any time of the event (t), the static pressure acting at the depth d , measured from to the top free surface of the debris flow, can be assessed through the following relation (Figure 15) (Segalini et al., 2013; Canelli et al., 2012):

Where p = vertical distance between the horizontal cables according to figure 15 (a). Once the distributed load (q_d) for each rope (i) has been calculated, the resulting maximum tensile load (T_{max}) has to be assessed for each rope level. This value strictly depends on the length of the longitudinal rope (L_i) and its maximum displacement (f_{max}) (Figures 13 and 15).

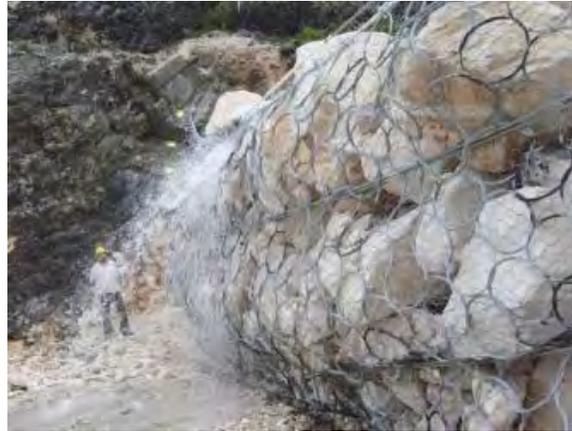
Figure 16 – Lateral view of the flexible debris flow barrier impacted during the full scale test carried out by the University of Parma in cooperation with Maccaferri

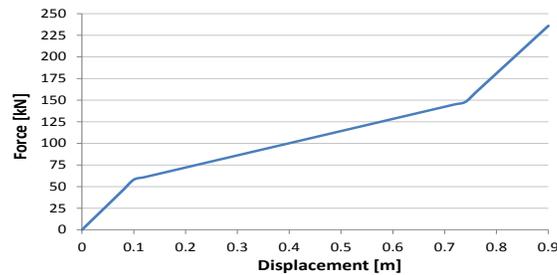
Figure 17 – Example of a typical diagram force – displacement of an energy dissipater device. The elongation of the brake L_b represents the elongation of the rope

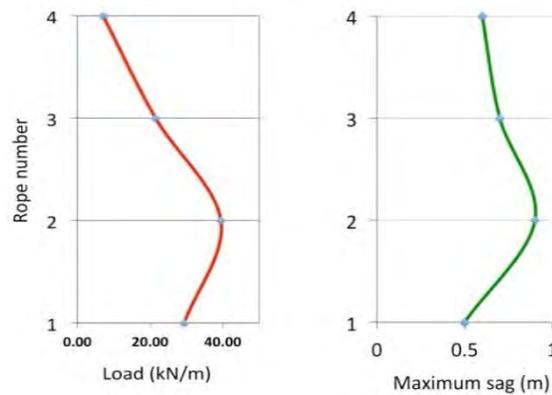
Figure 18 – Results of an impact analysis. Left: maximum load acting on the longitudinal transversal ropes, in terms of kN/m. Right: maximum sag (displacement) of the screen, in terms of m

- According to the previous point, it is not possible to define a direct proportion between the load acting on the barrier and its deformation (Figure 18).
- The dynamic load is almost always greater than the static one (Figure 20). A small increasing of the debris flow velocity gives large increasing of the load on the ropes.

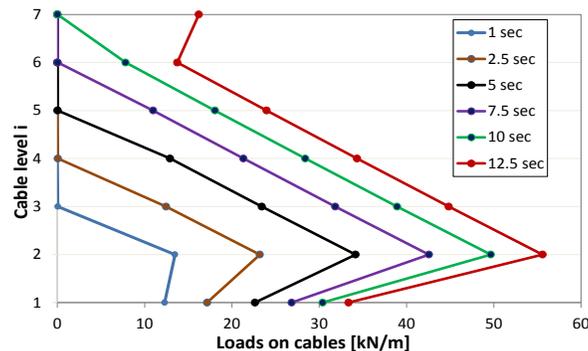
Figure 19 – Maximum distributed load (kN/m) acting on different levels of the transversal ropes while the debris flow is rising up, from the first impact (left line) to the filling of the barrier (right line)

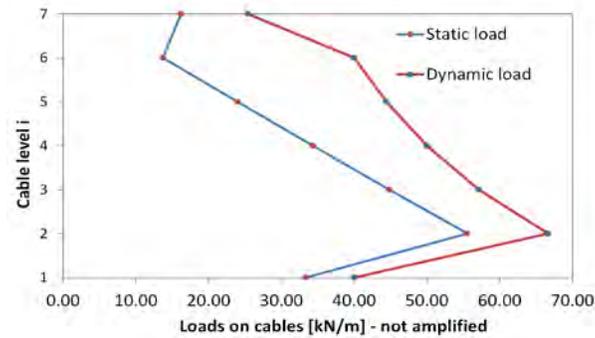
Figure 20 – Maximum distributed load (kN/m) acting on different levels of the transversal ropes related to the static load (left - blue line) and the dynamic (right - red line)

- The dynamic load is almost always greater than the static one (Figure 20). A small increasing of the debris flow velocity gives a large increase of the load on the ropes.
