66TH HIGHWAY GEOLOGY SYMPOSIUM SEPTEMBER 14-17, 2015

2015 Proceedings

*Massachusetts Department of Transportation
and
University of Massachusetts Amherst*

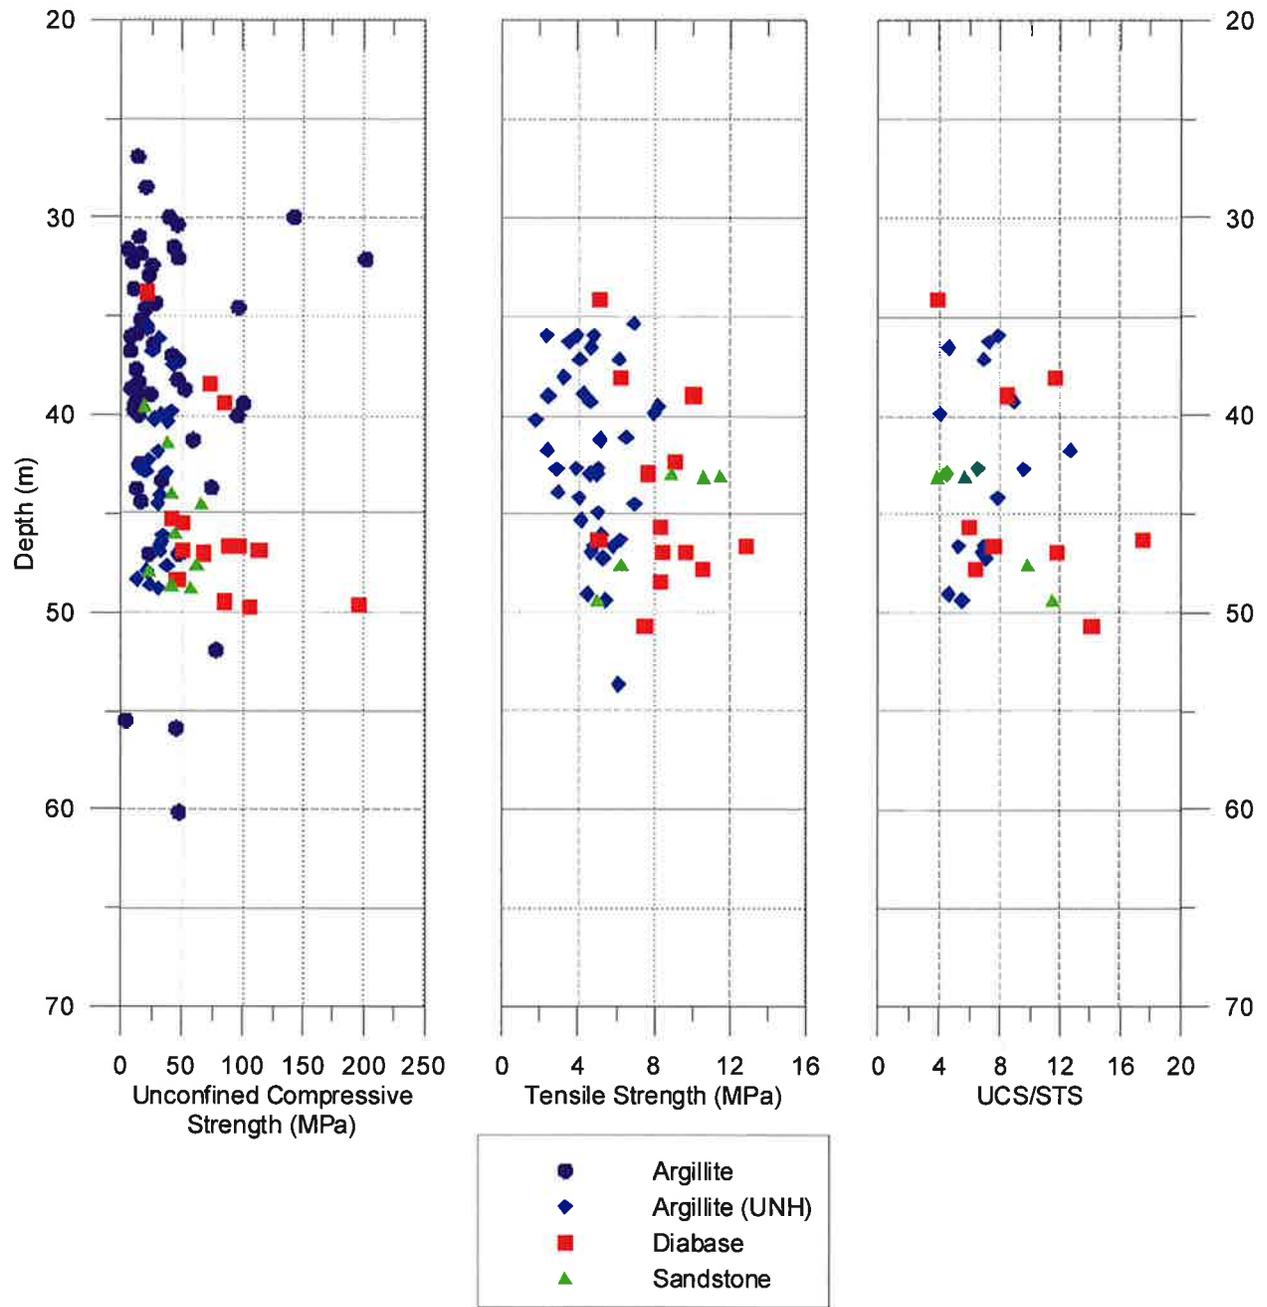
Figure 1: Unconfined Compressive Strengths (UCS), Splitting Tensile Strengths (STS), and UCS/STS Ratios for Cambridge Argillite, Diabase, and Sandstone for the Boston Area

A total of 56 specimens were tested using the Splitting Tensile or Brazilian test to determine the tensile strength. Figure 1 also compares the tensile strength with depth where an increasing trend is observed for the argillite and the diabase. However, from the limited number of tests on the sandstone, a reverse trend is shown with the deepest rock having lower strength.

Figure 1 presents the ratio of compressive to tensile strength with depth for the UNH tests. The compressive strength to tensile strength ratio ranged from 4.1 to 12.7. There seems to be an overall increasing trend even for the sandstone.

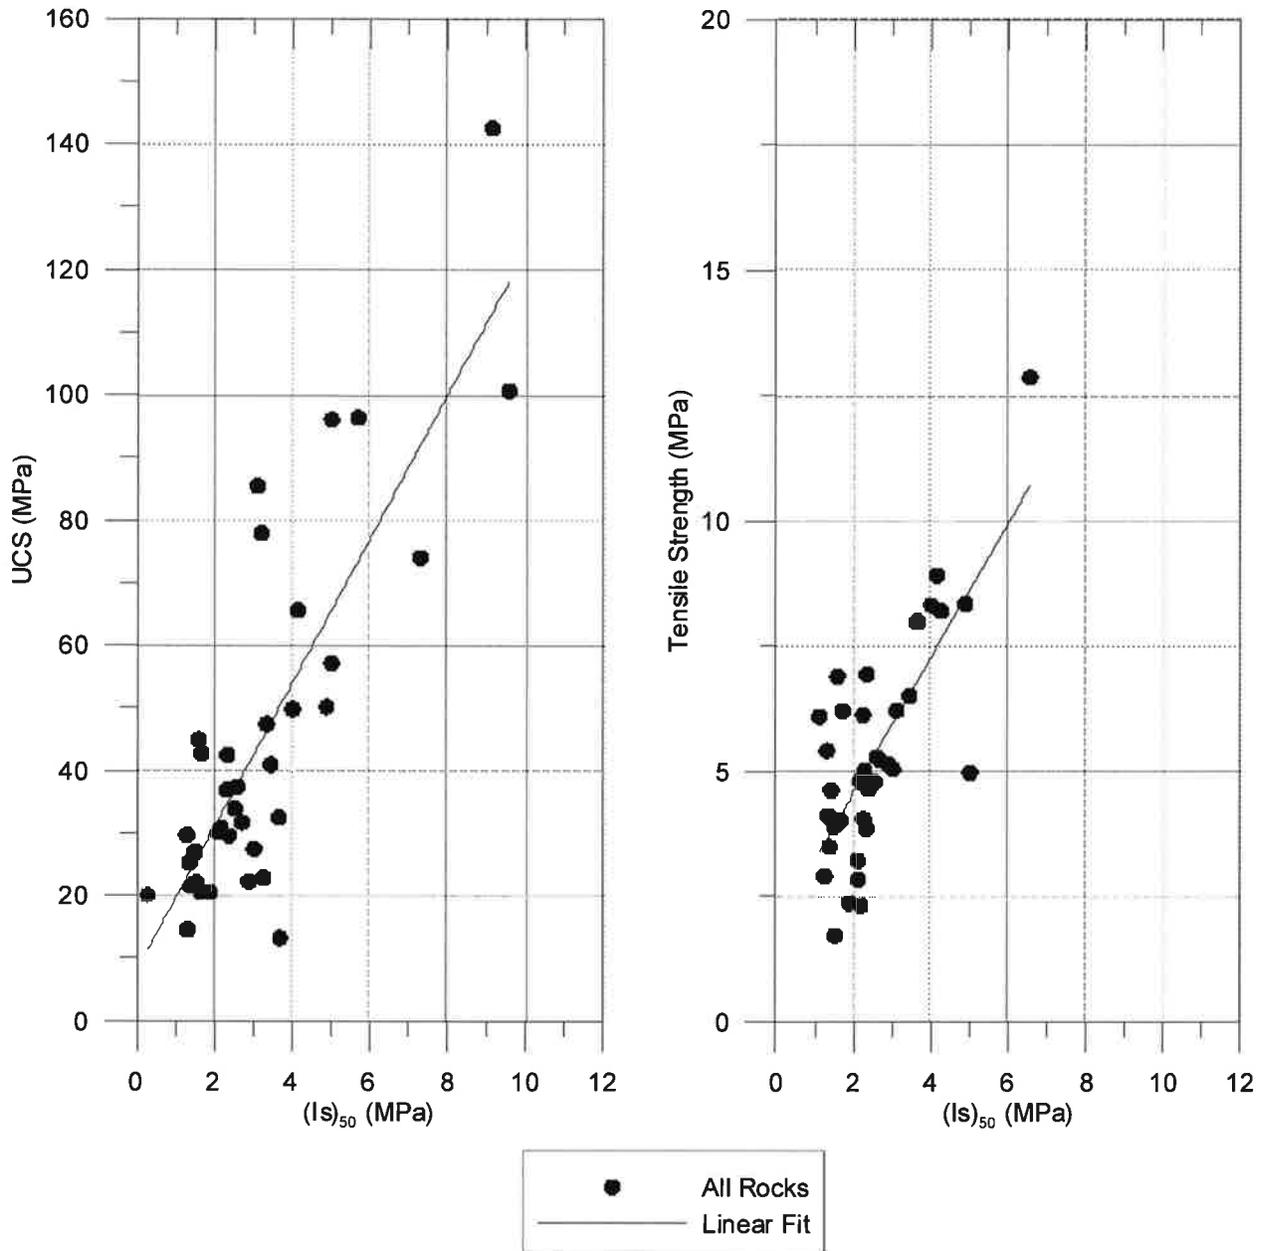
Figure 2: Unconfined Compressive Strengths (UCS) and Splitting Tensile Strengths (STS) versus the Point Load Index for All Rocks Tested from the Boston Area

Using the results from this testing program, site specific point load test correlations for three of the rocks (argillite, diabase and sandstone) were developed for both UCS and tensile strength as shown in Table 5. The results from the tests done on the Central Artery/Tunnel Project are also included in the Table. These correlations were developed using unconfined and tensile strength values from the same borehole, the same rock type, and at similar depths for the point load tests and are shown as site specific. The coefficients found for the argillite on this project significantly differ from values in the literature, reinforcing the observation made by Woodhouse and Barosh (2011/2012) about the variability of this rock within the Boston area. It

clearly highlights the need to develop more site-specific correlations for various rock types. In addition, in this case the accepted published coefficients significantly overestimate the strengths and thus are not conservative.

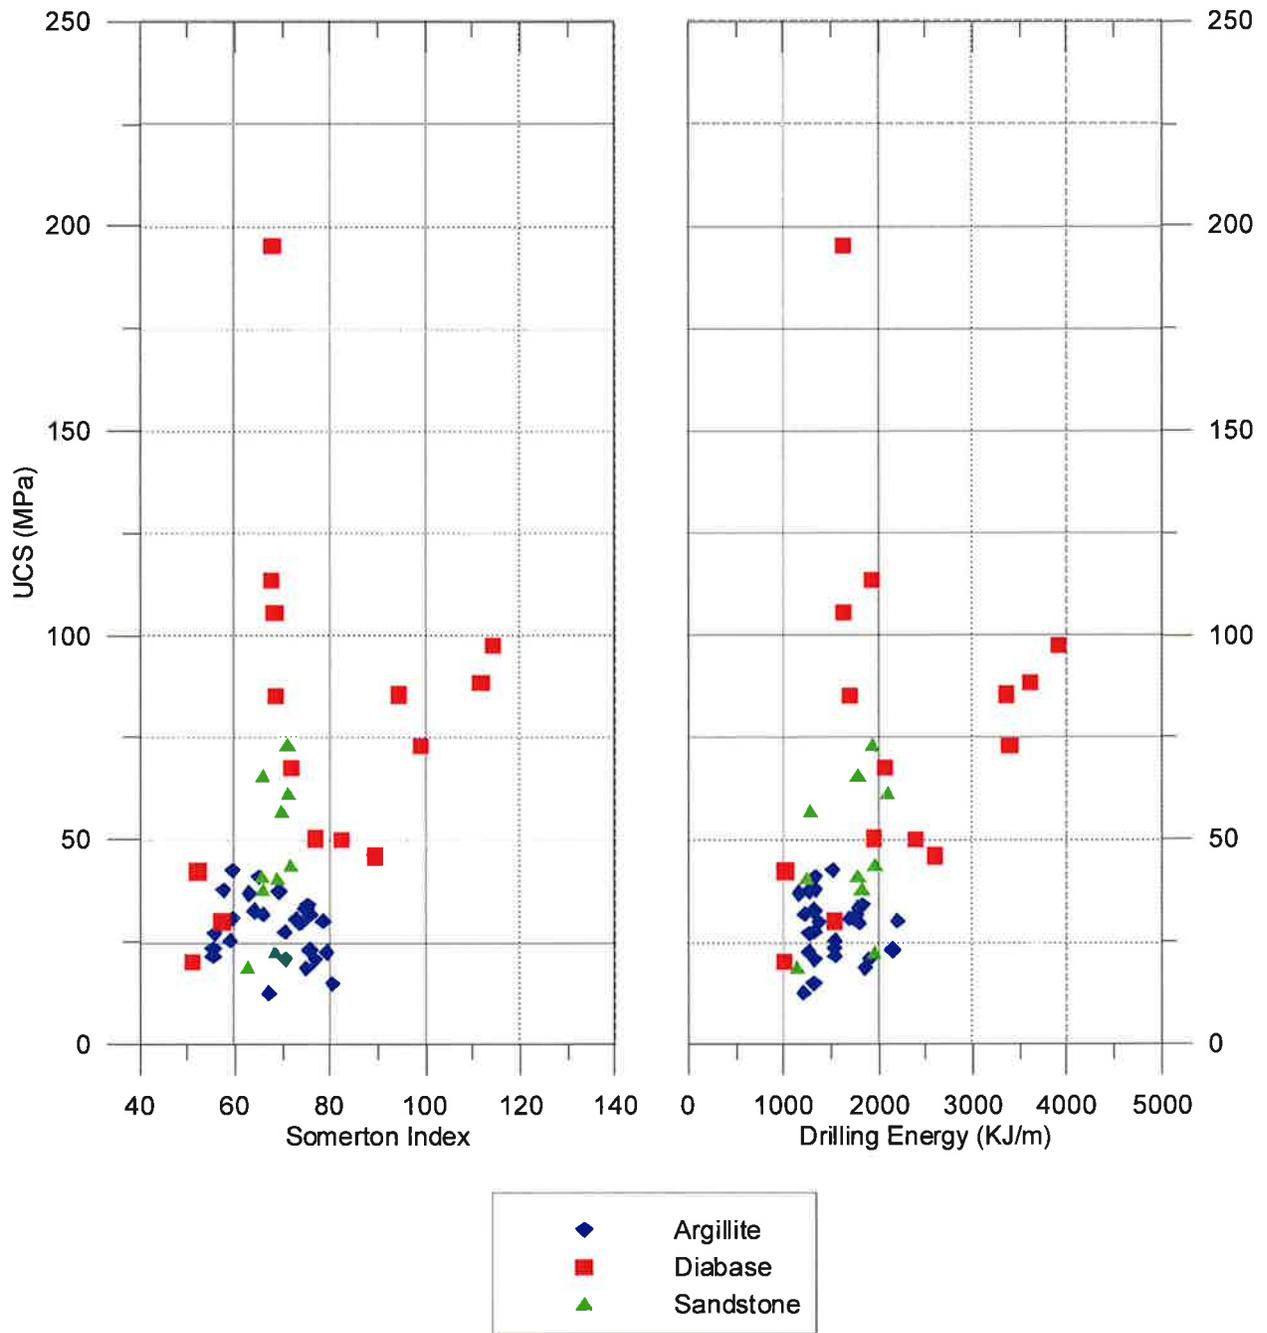
Figure 3: Unconfined Compressive Strengths (UCS) as a function of Drilling Parameters in the Boston Area

In Figure 3, the diabase has a noticeably large range of Somerton Index values, varying from 51 to 112 with an average value of about 80. Diabase intrusions often have variable structures including vesicles, phenocrysts and segregation of grain sizes. The graph reflects the

variability of the composition of the diabase. For the sandstone the range is 63 to 72 with an average of 68. The argillite varies from 55 to 79 with an average value of 69. Overall, it can be seen that based on Somerton alone, it is not possible to identify the material type.

The figure also shows the Drilling Energy in relation to the UCS. For the argillite the range is from 1168 to 2200 kJ/m with an average of approximately 1540. For the diabase the values range from about 1015 to 3900 with an average of 2300 while the sandstone ranges from 1140 to 2100 with an average of 1675. The results show less scatter than with the Somerton Index, indicating that torque maybe a better indicator of strength than down pressure on the coring bit. Figure 4 shows the tensile strength test results with respect to the Somerton Index and the Drilling Energy. The results show an overall increasing trend but with significantly less scatter in tension than in compression, even for the diabase. Figure 5 shows graphs of unconfined compressive strengths using the point load test site specific correlations as a function of the Somerton Index and the Drilling Energy, respectively. As with the previous laboratory test results, the trends and values are similar but in this case with less scatter. Overall the results seem to suggest that tensile resistance may be a better indicator of energy required to core in these types of rocks.

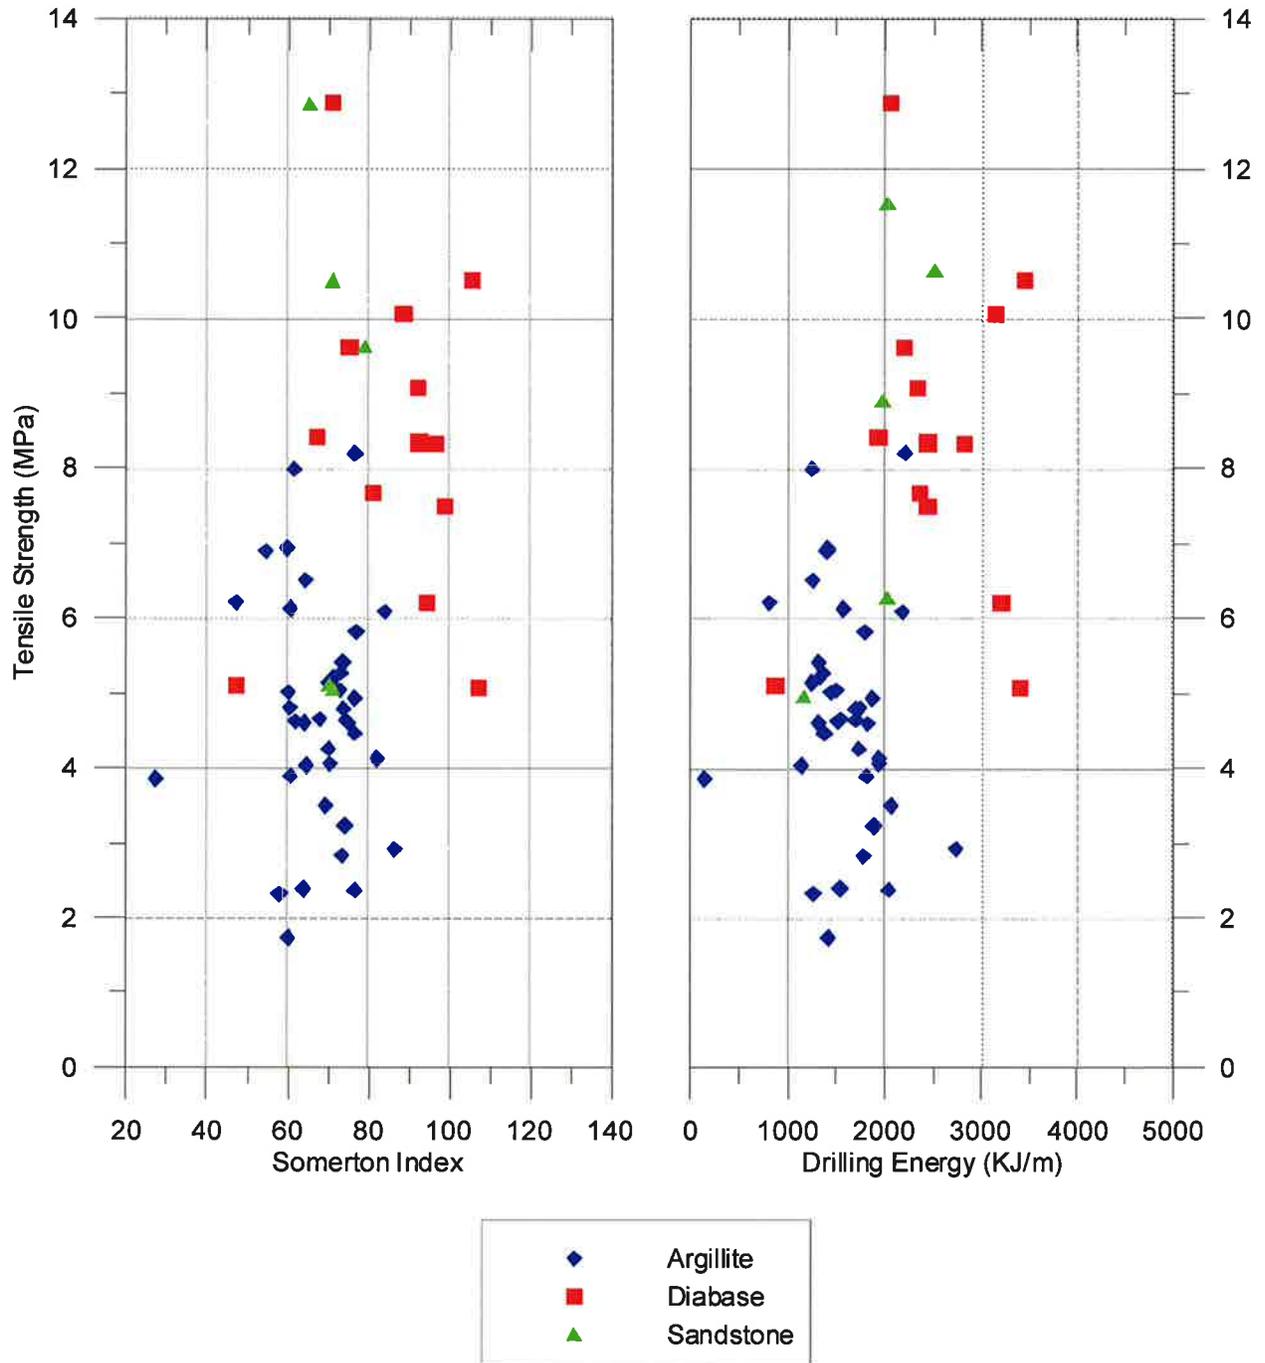
Figure 4: Splitting Tensile Strengths (STS) as a function of Drilling Parameters in the Boston Area

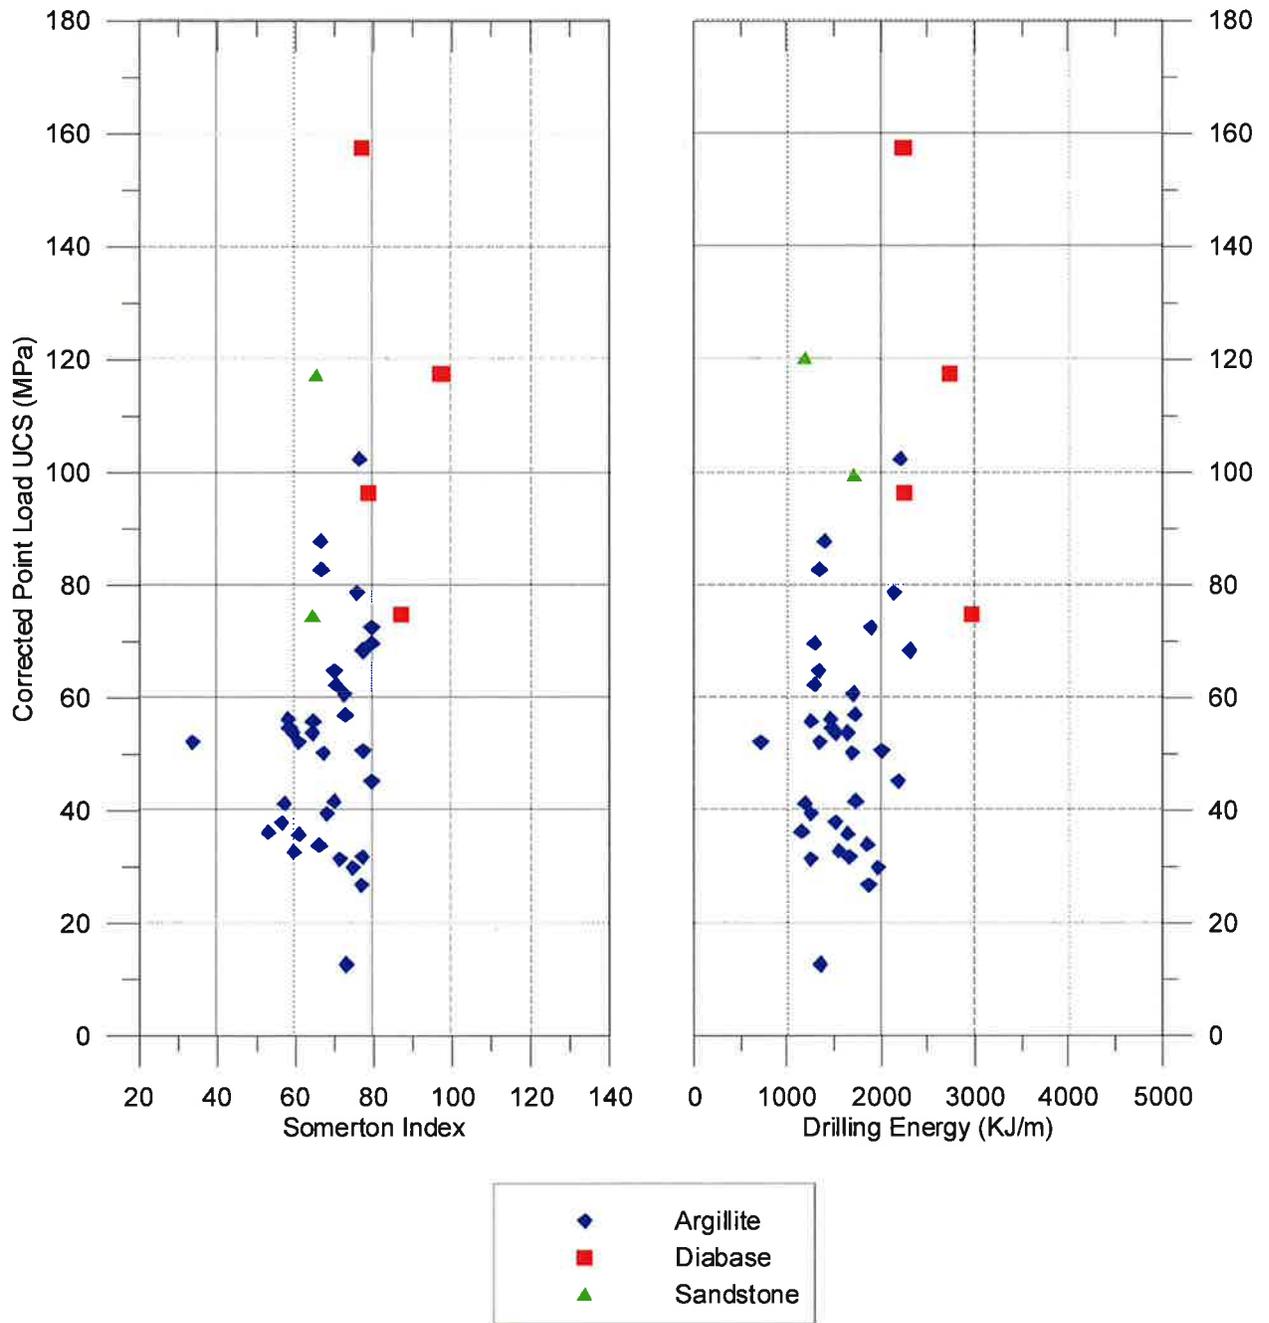
Figure 5: Corrected Point Load Strength Index as a function of Drilling Parameters in the Boston Area

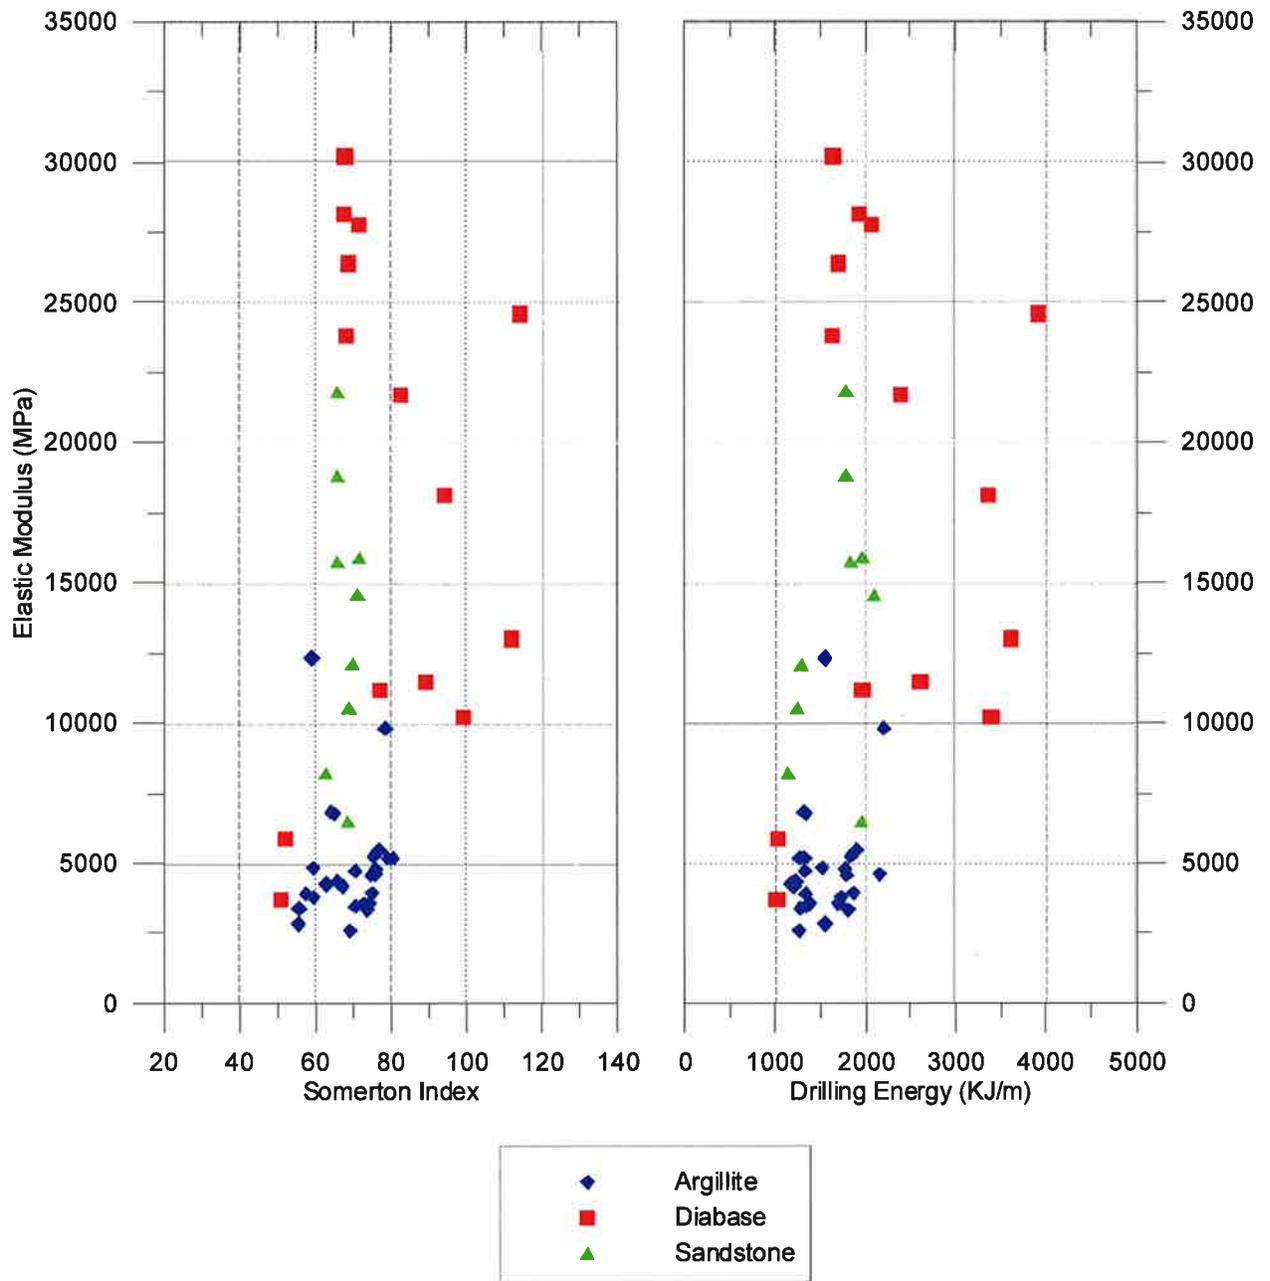
Figure 6: Elastic Modulus as a function of Drilling Parameters in the Boston Area

Using the load-displacement curves from the unconfined compressive strength tests, static elastic modulus values were calculated and compared to the MWD compound parameters. Figure 6 shows the correlations between elastic modulus and the compound parameters. Although a significant amount of scatter is shown in the data, an increasing trend can be observed with the Somerton Index and the Drilling Energy values.

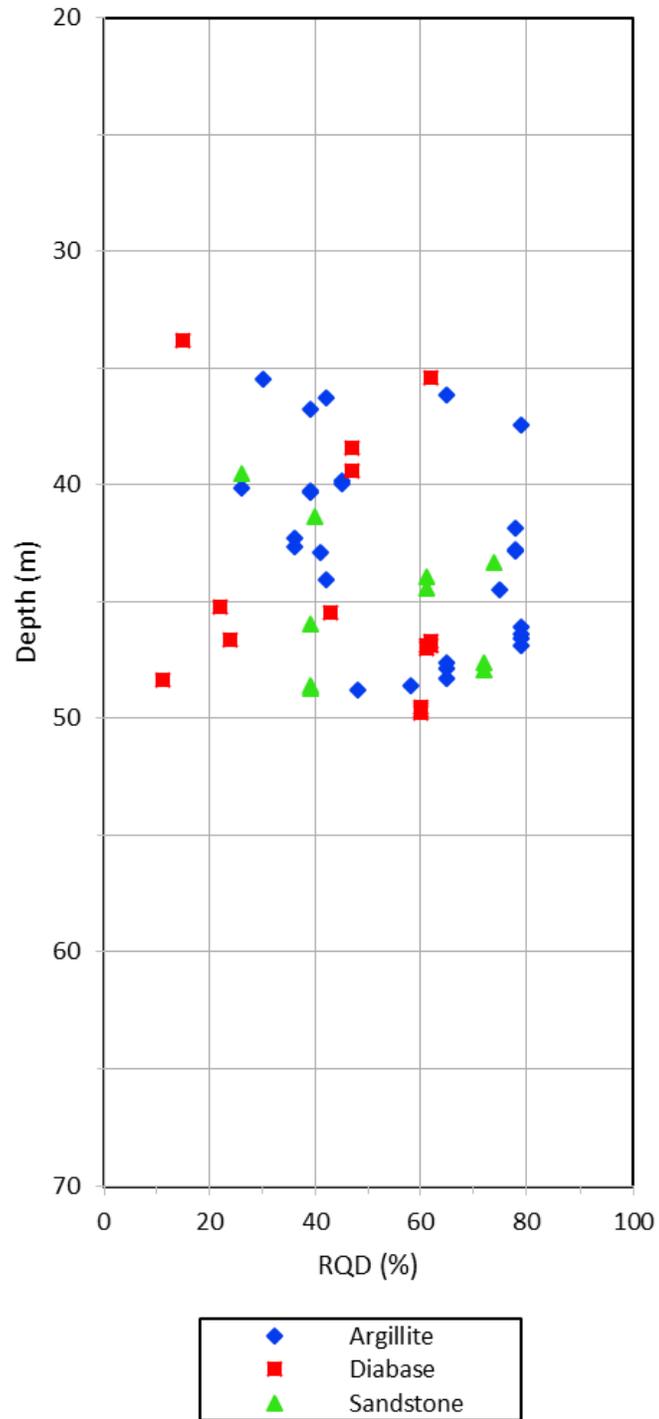
Figure 7: Rock Quality Designation (RQD) for Cambridge Argillite, Diabase, and Sandstone for the Boston Area

The rock quality designation (RQD) was determined on site for each core run using conventional logging techniques. Figure 7 shows the RQD with respect to depth depicting

significant scatter without any clear trend. Because of the fragility of the argillite and its well defined bedding planes, samples obtained from the coring were thought to have numerous fractures from drilling breaks and possibly during core extraction as opposed to natural breaks. Consequently, relationships between the Somerton Index and the Drilling Energy as shown in Figure 8 provides better insight into the rock quality in situ. It can be seen that for the argillite and the sandstone there exists a linear relationship indicating a proportional increase in RQD with increases in the Somerton Index and the Drilling Energy. The results with the diabase do not show a clear trend. The sandstone also appears to be less influenced by the drilling action. It was clearly documented on this project (Sadkowski et al., 2008) that drilling parameters significantly enhanced the quality of the information which led to a more economical design based on shortened caissons. The parameters allowed differentiation between natural breaks and those induced by drilling. This is substantiated by the splitting tensile testing results and correlations with drilling parameters, which show less scatter than with the compression testing results thus suggesting rock coring in the argillite is predominantly a tensile process.

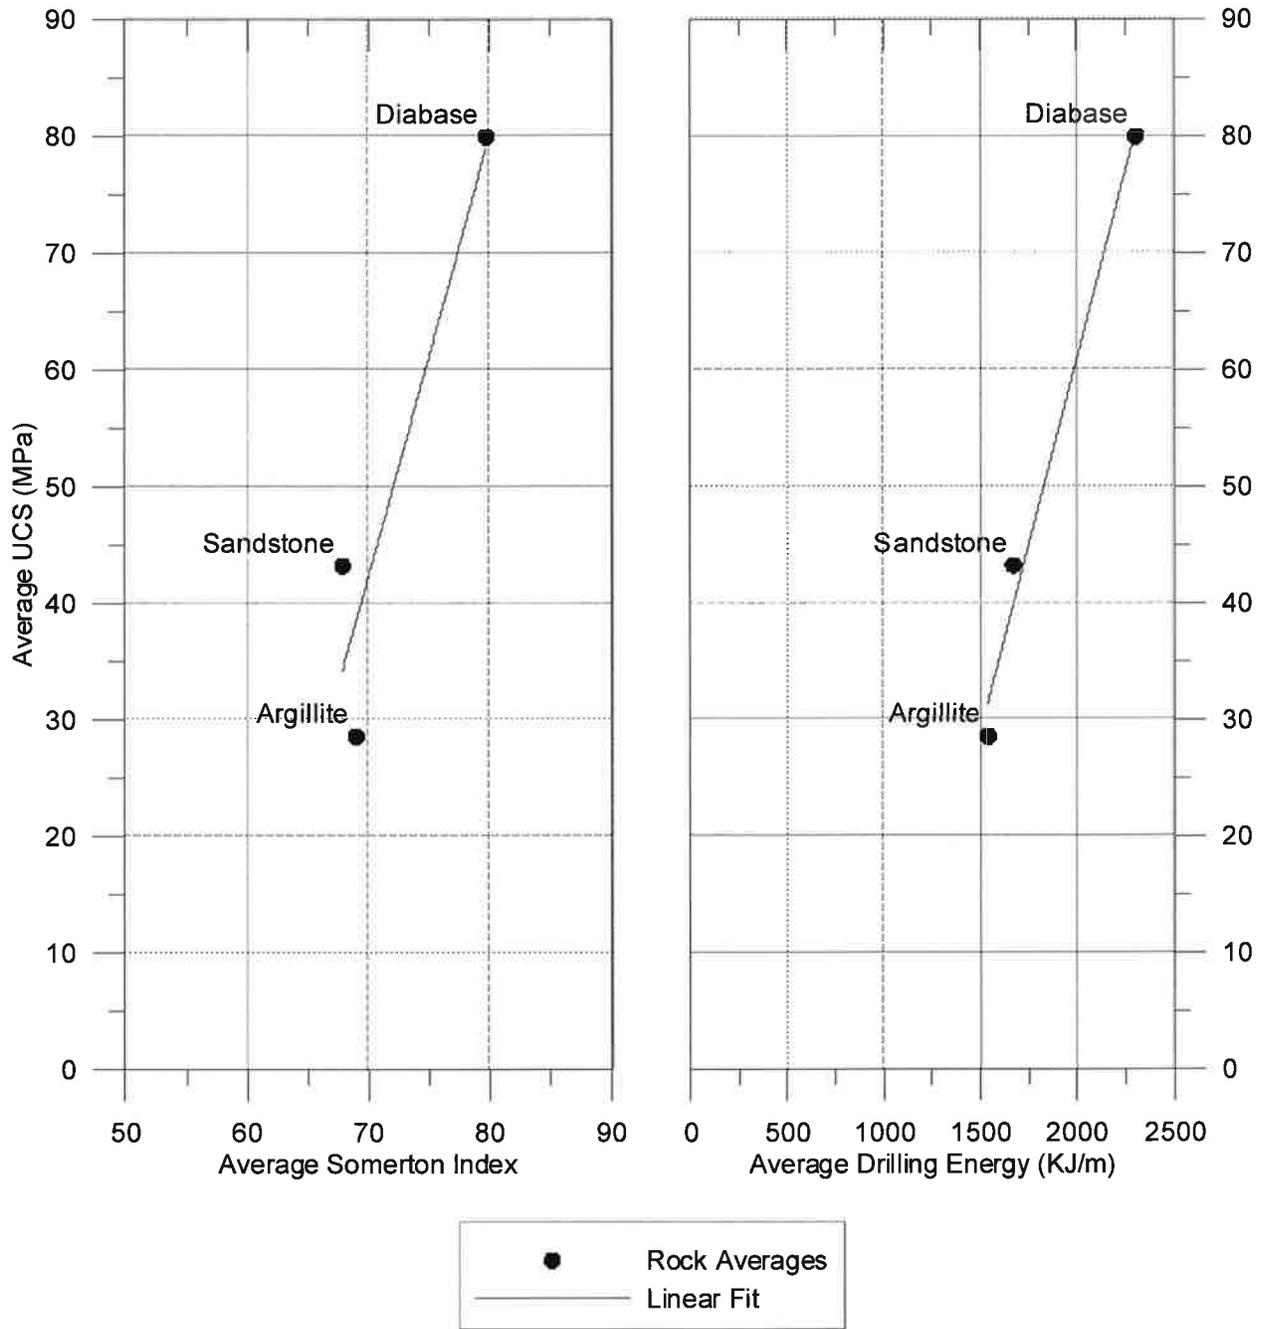
Figure 9: Average Unconfined Compressive Strength as a function of Average Drilling Parameters in the Boston Area

Energy with the UCS shows an increasing trend. A more robust relationship was found using a linear trend analysis. The R-squared values for the linear trend of the UCS vs. Somerton Index and the UCS vs. Drilling Energy on Figure 9 are 0.87 and 0.99, respectively.

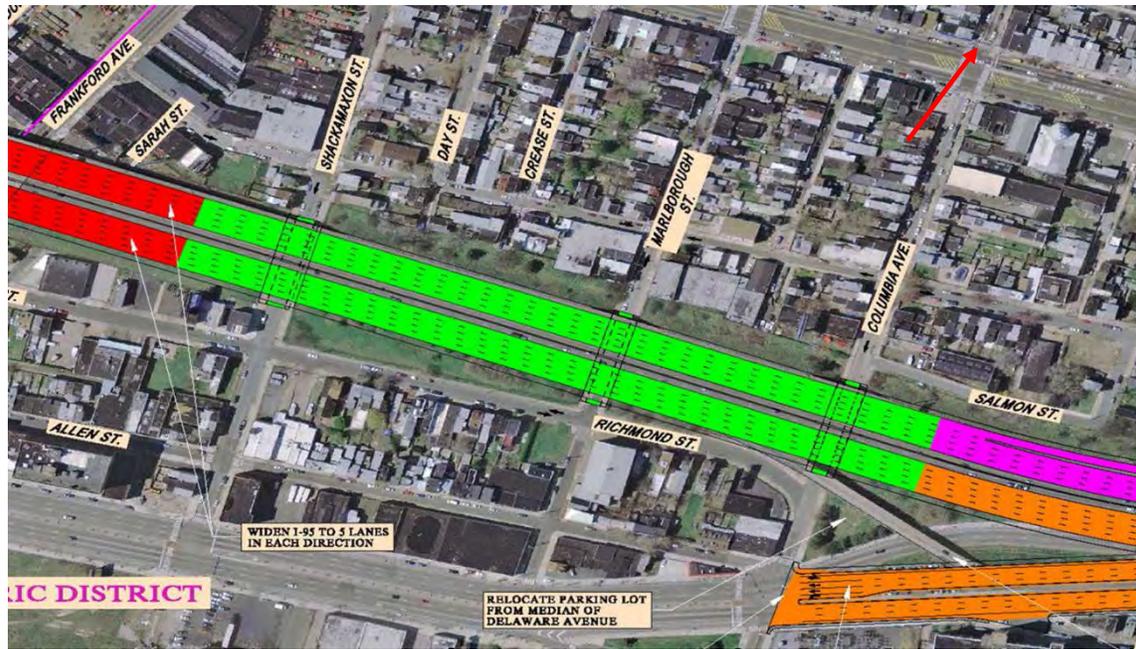
Figure 1: Bridge Locations

newly constructed outside lanes while the central portion of the bridges are reconstructed. Figure 1 illustrates the proposed widening of 95 and the location of the three bridges. I-95 trends to the northeast in this area and the Delaware River is located east of the highway.

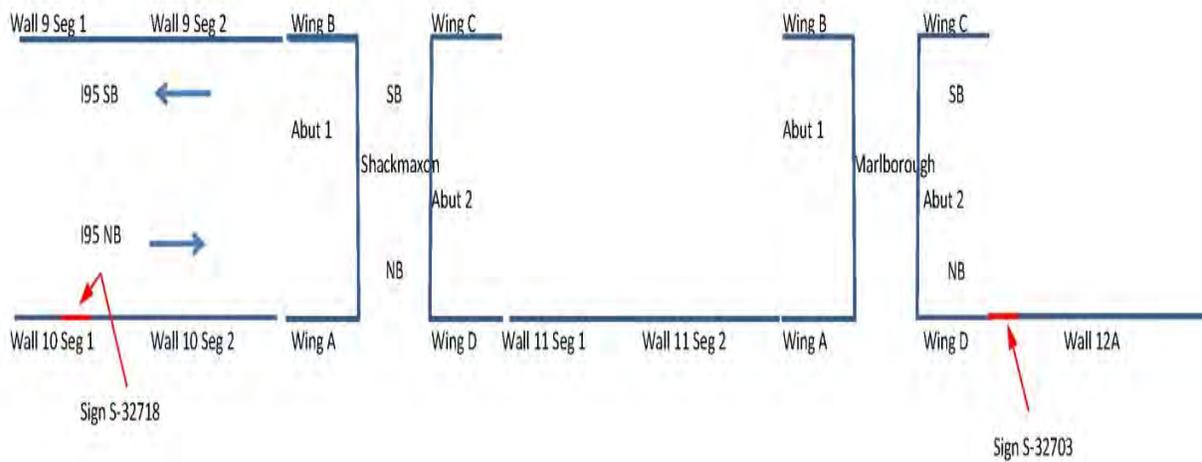
Figure 2: Structure Locations

The retaining walls support 95 adjacent to Shackamaxon St. and Marlborough St. and the sign structures are adjacent to the walls.

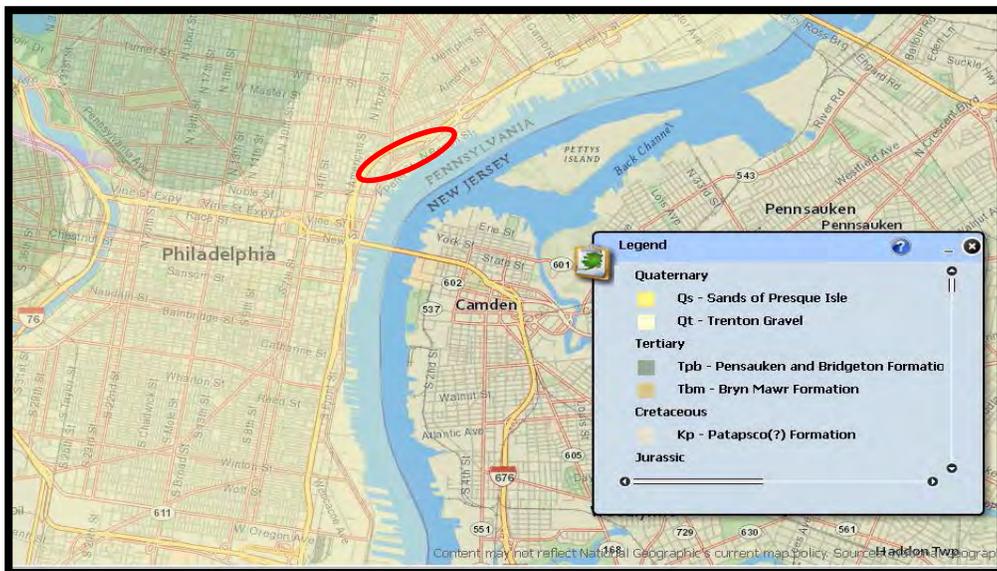
Figure 3: Geology Map

Figure 3 presents a portion of the Pennsylvania Geological Map (Philadelphia and Camden Quadrangles) with the project location indicated. As shown, the project site is mapped as being underlain by the Quaternary-aged Trenton Gravel (Qt). The Trenton Gravel formation consists of gray to pale reddish-brown, very gravelly sand with interbedded, cross-bedded sand and clay-silt layers. These interbedded layers form a wedge that begins at the Fall Line and thickens toward the southeast.

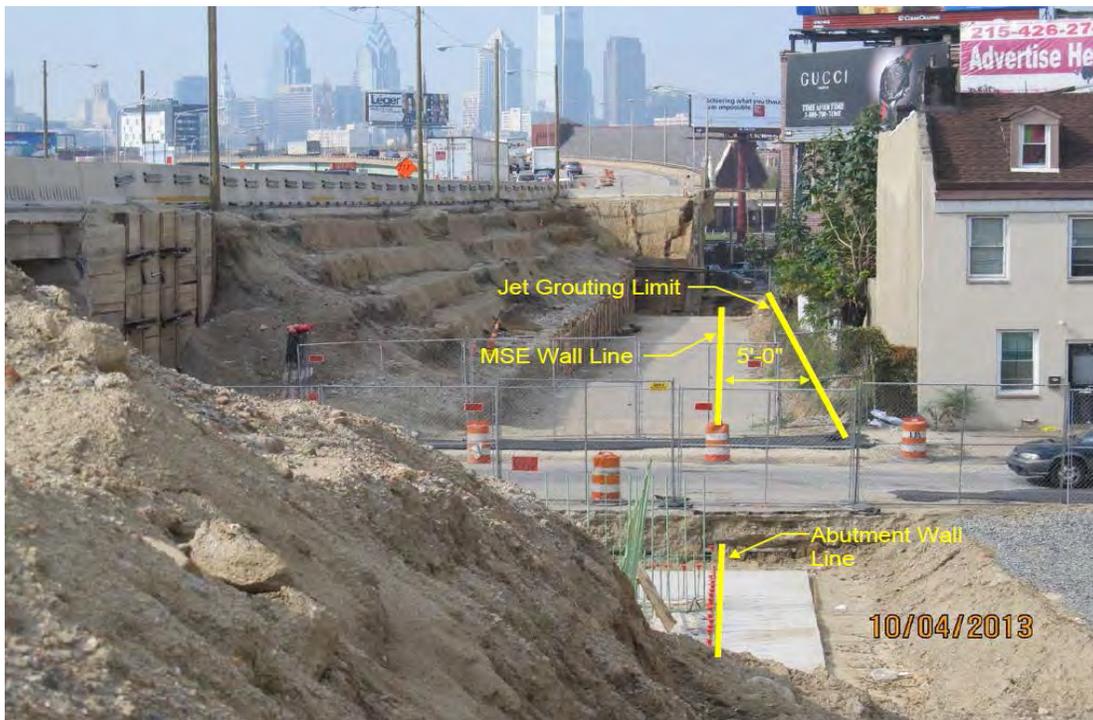
Figure 4: Proximity Proposed Jet Grouting Treatment Limits To Buildings

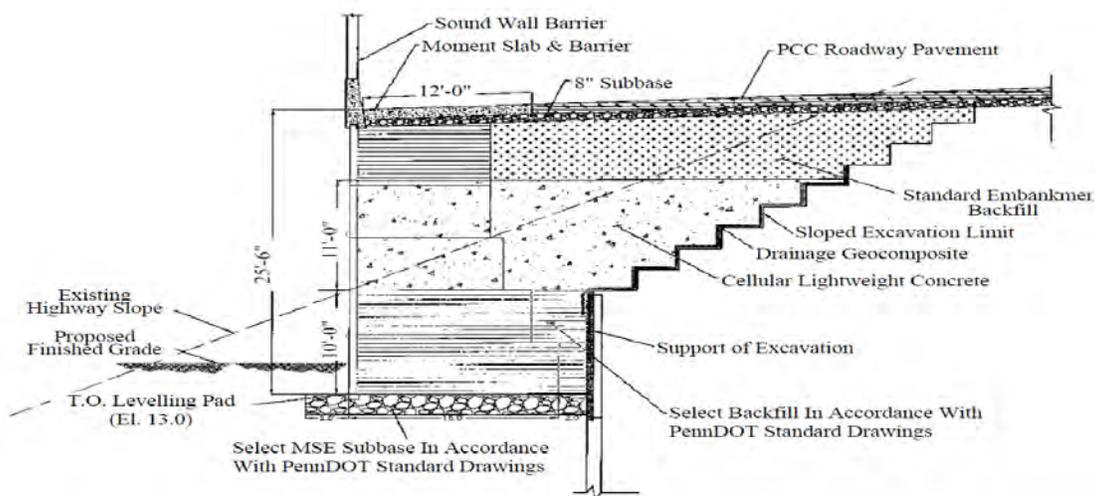
Figure 5: Typical Section of MSE Wall With Lightweight Cellular Concrete Backfill

The lightweight cellular concrete value engineering submission was based on conventional LRF design and elastic settlement analysis utilizing the bearing soil properties and design parameters taken from the original PennDOT design. The physical properties for the lightweight cellular concrete were derived from an industry standard supplier, The Elastizell Corporation of Ann Arbor, Michigan, and incorporated. Those properties used were; 30 p.c.f in-place unit weight, 40 p.s.i. unconfined compressive strength, and a 35 degree angle of internal friction. Proceeding with the design supposition that settlement would control, the various structures were load balanced to meet the design criteria of 0.5 inches maximum settlement for abutments and 1.0 inches maximum settlement for the MSE walls and sign structure foundations. Typical sections of the load balanced structures and backfills were then analyzed for PennDOT/AASHTO mandated design loads to ensure the minimum performance ratios for overturning, sliding and global stability were met or exceeded. Concurrently, the load balanced preliminary design sections were sent to and reviewed by the MSE wall supplier, The Neel Company of Springfield, Virginia, for internal stability within their MSE T Wall components.

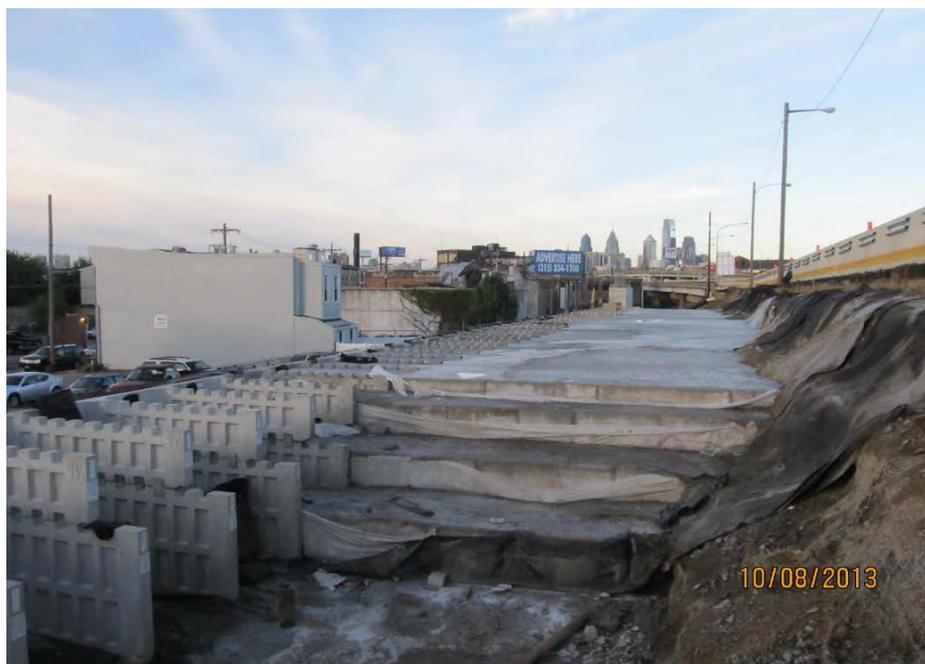
Figure 6: Lightweight Cellular Concrete Sloped at Transition Zone

Upon completion of the regular weight backfill at the T Walls, installation of lightweight cellular concrete proceeded again leaving the abutments and wing walls un-backfilled. Lifts for the T Wall were chosen at 2.5 feet, half of the height of a T Wall unit, and maintained the one to one gradient as the backfill approached the wing wall “transition” zones. In conjunction with the lightweight cellular concrete placement, a drainage geocomposite was placed against the excavated surface at the rear of the T Wall stems, between the virgin earth surface and the impervious lightweight cellular concrete, to alleviate any buildup of excess hydrostatic pressure. This drainage geocomposite layer extended the full height of lightweight cellular concrete placement, except the undercut areas.

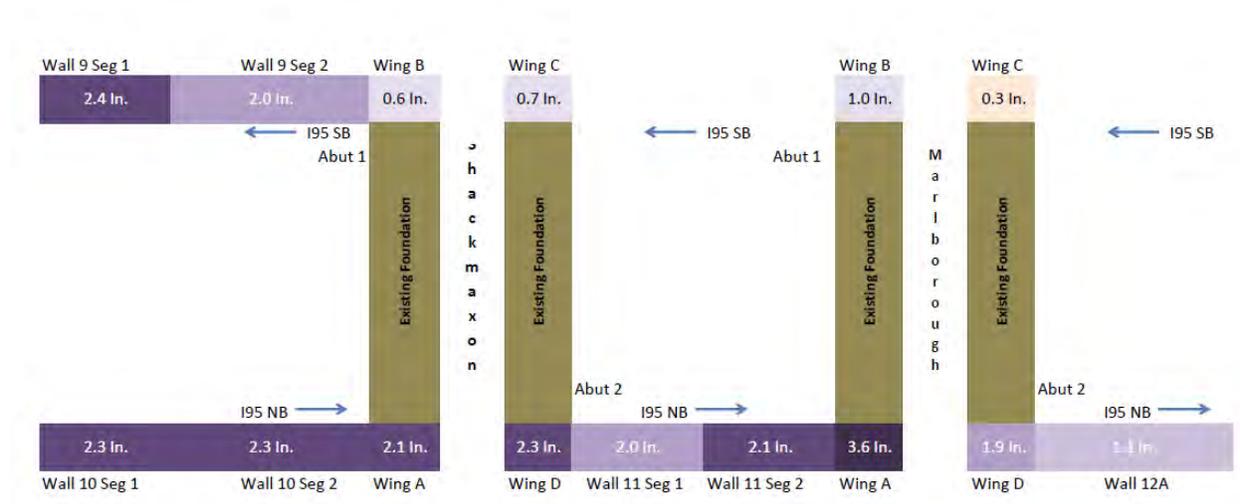
Figure 7: GR2 Predicted Settlements Without Load Balancing Or Ground Modification

Figure 7 presents the predicted settlements for the I95 GR2 structures without load balancing or treatment of the underlying soil.

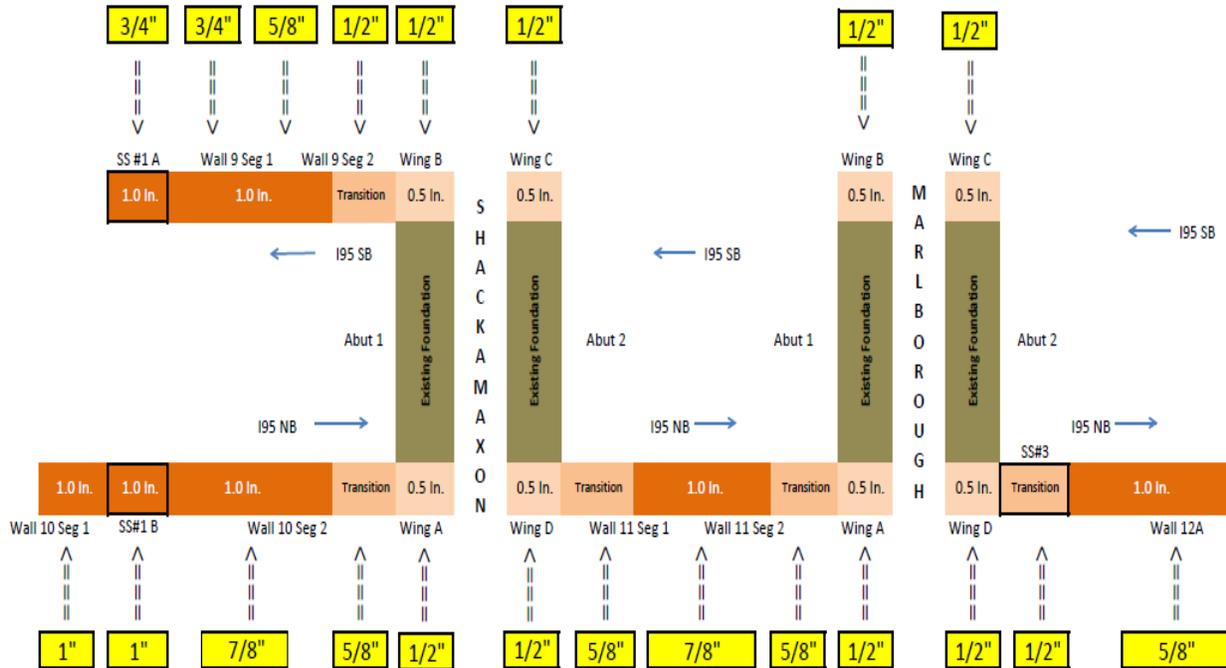
Figure 8: GR2 Allowable Settlements And Measured Settlements (Yellow) From Load Balancing Using Lightweight Cellular Concrete Backfill

Figure 8 shows the maximum allowable predicted settlement by structure as required by PennDOT. Also in Figure 8, the total measured settlement with load balancing from field monitoring is shown by structure in yellow outside the diagrammatical representation.

As discussed, settlements at the abutments and wing walls, specifically across the “hard edge” regions where the new foundations extended past the existing foundations were the areas of greatest concern. Maximum allowable settlement for these regions was limited to ½”. In these areas, near full height lightweight cellular concrete backfill was supplemented by additional load compensation via undercutting and replacement with lightweight cellular concrete to meet the more stringent settlement limit. Measured settlements in these areas confirmed this additional load balancing was needed.

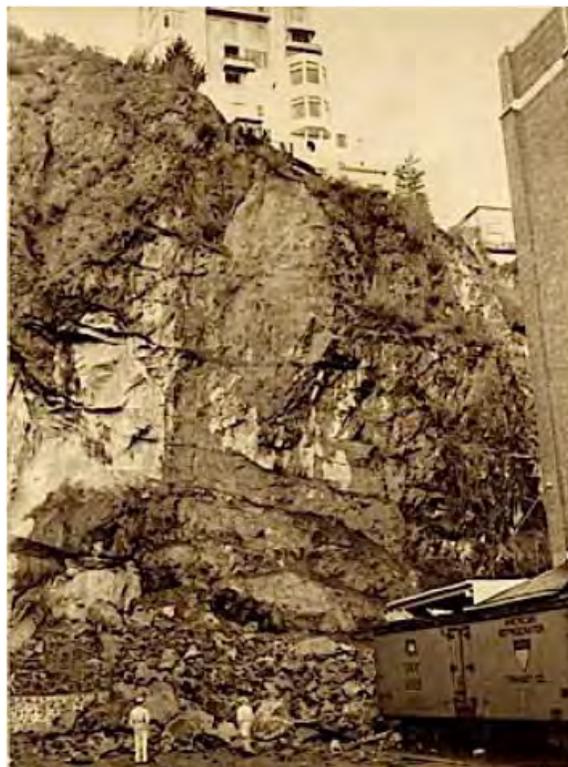
Figure 2 – Rockslide event circa 1949.

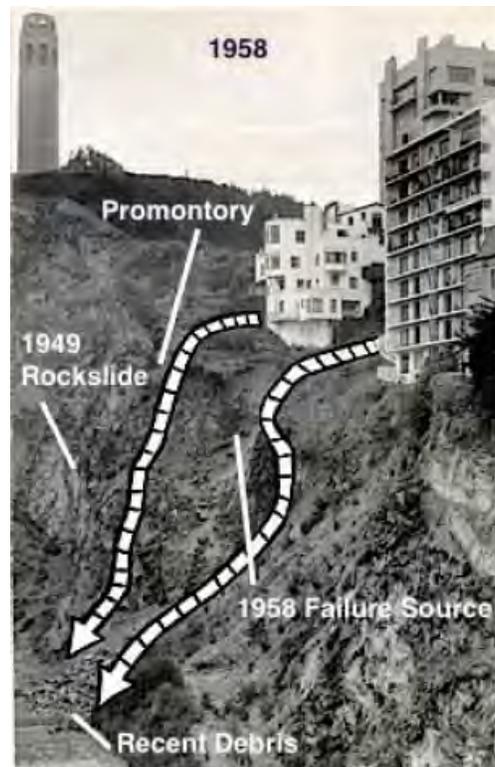
Figure 3 – Rock slide event circa 1958, also showing the location of the 1949 rock slide.

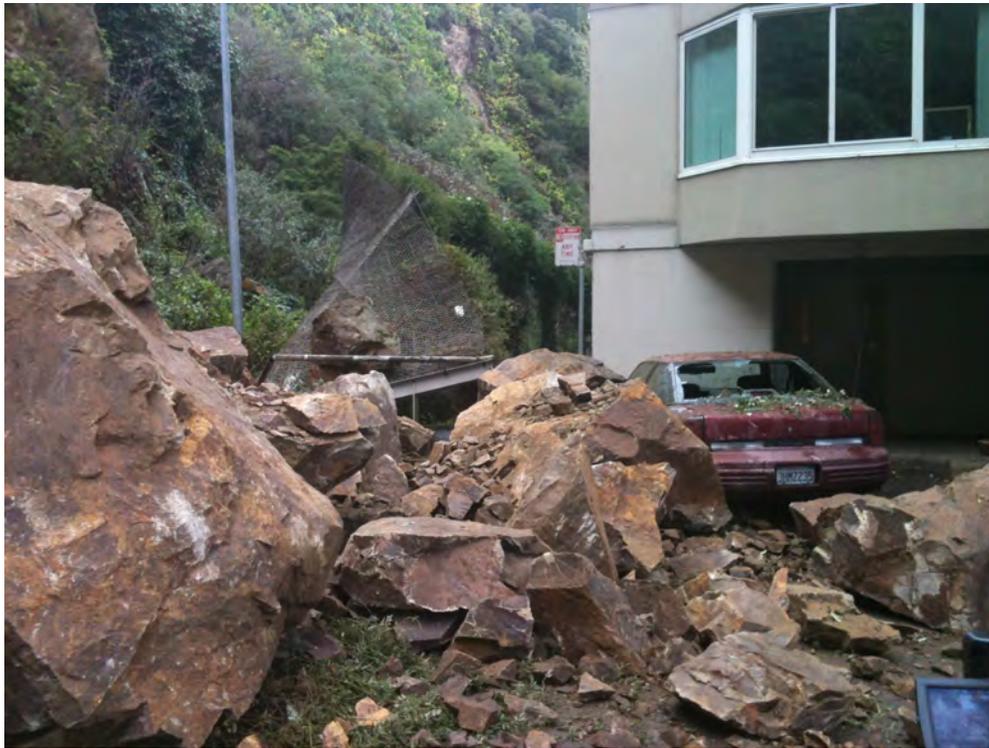
Figure 4 – Results of the January 2012 Rock Slide onto Winthrop Street.

In January 2012 a 60-foot tall near vertical section of the rock slope released as a rockslide. The day of the rockslide a "light" rainfall occurred, but was preceded by several days of moderate rainfall in the area. The rockslide debris fell from the steep slope and onto the adjacent Winthrop Street destroying a catchment fence and a car parked on Winthrop Street and rocks came to rest against the foundation of the nearby residential structure.
