66TH HIGHWAY GEOLOGY SYMPOSIUM SEPTEMBER 14-17, 2015

2015 Proceedings

*Massachusetts Department of Transportation
and
University of Massachusetts Amherst*

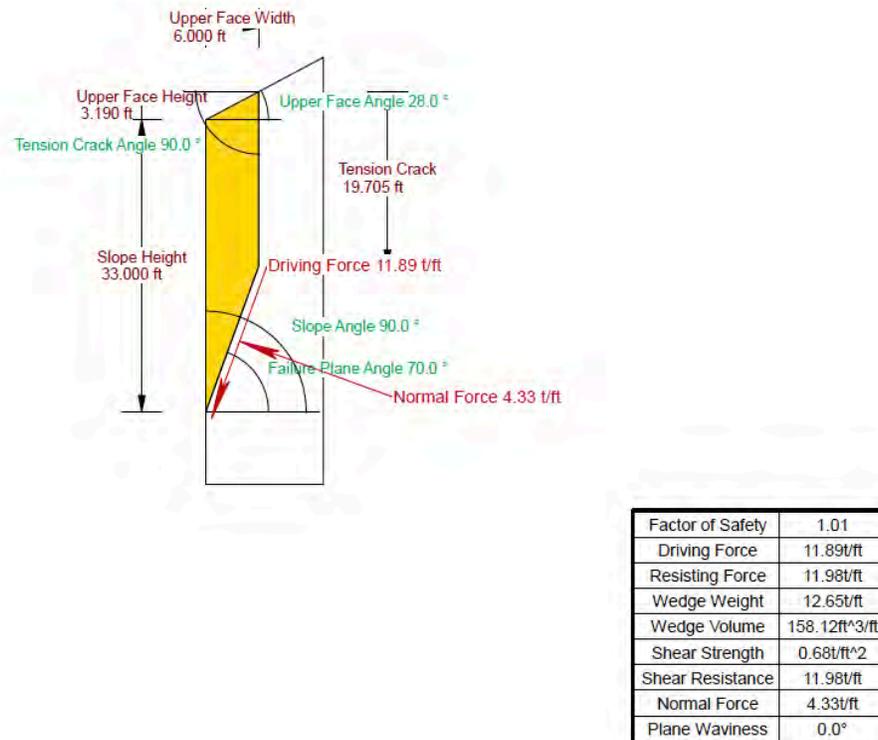
Figure 5 – Example of the back analysis method used on isolated blocks. This analysis was done by the author and matches the reported analysis of the contracting documents.

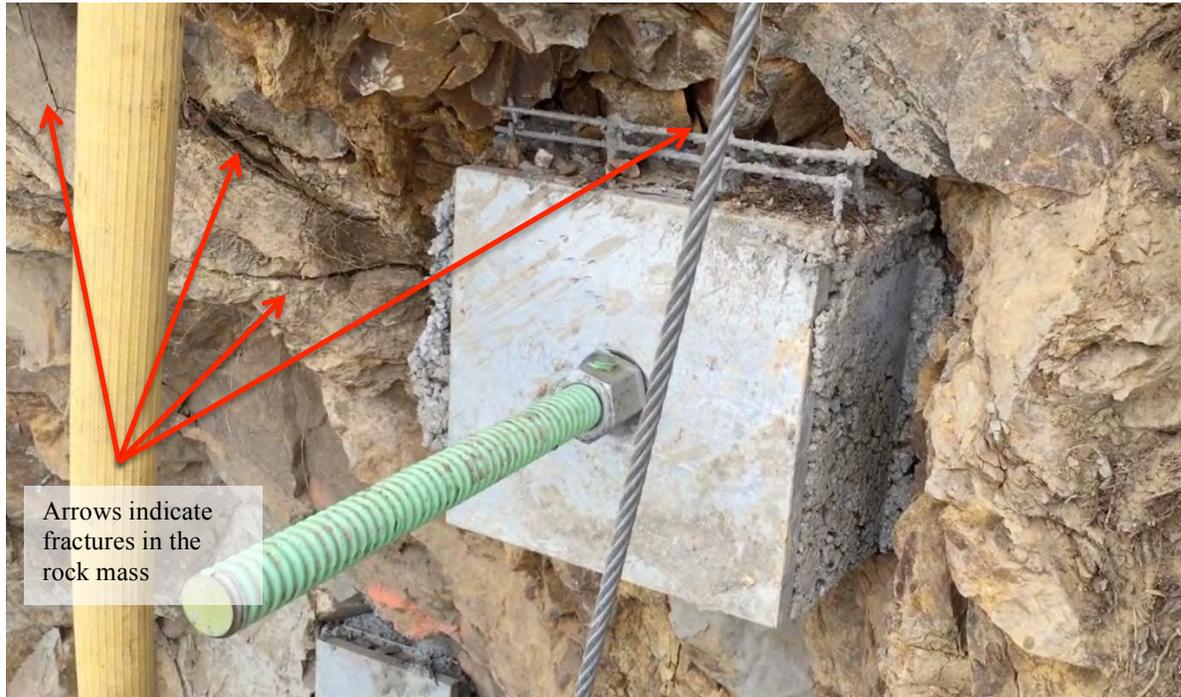
Figure 6 – Image of a rock anchor and surrounding rock mass after testing. Application of the test load fractured the rock mass and caused the rock anchor incapable of carrying the designed load.

During construction a major concern surfaced in the ability of the rock mass to support the 50 kip loads placed on it from the installation of anchors. In several locations the rock mass could be considered weathered and broken. During one specific anchor loading the force placed on the rock mass broke the rock mass rendering that anchor unsatisfactory. Figure 6 shows the rock mass around an anchor test in which the rock mass was broken by the application of the load.

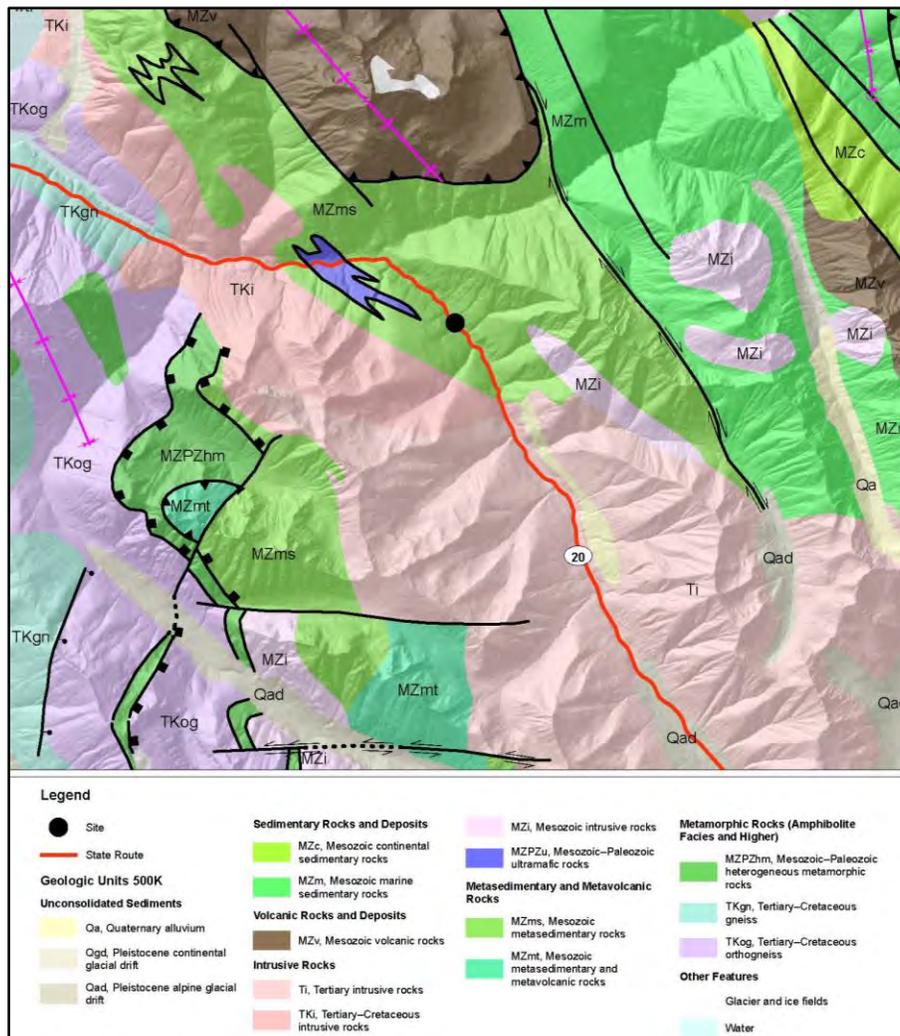
Figure 2: Geology map of the project area.

This rock cut is approximately 105 feet high and 350 feet long. It is composed of moderately weathered, blocky, strong, low-to-high grade phyllite of Tertiary age (Figure 2). The slope was constructed utilizing uncontrolled blasting techniques nearly 50 years ago. Three major discontinuities exposed in the slope create the potential for large planar and toppling type failures. The natural slope above the cut is oriented around 45 degrees and is mantled with less than 5 feet of colluvium.

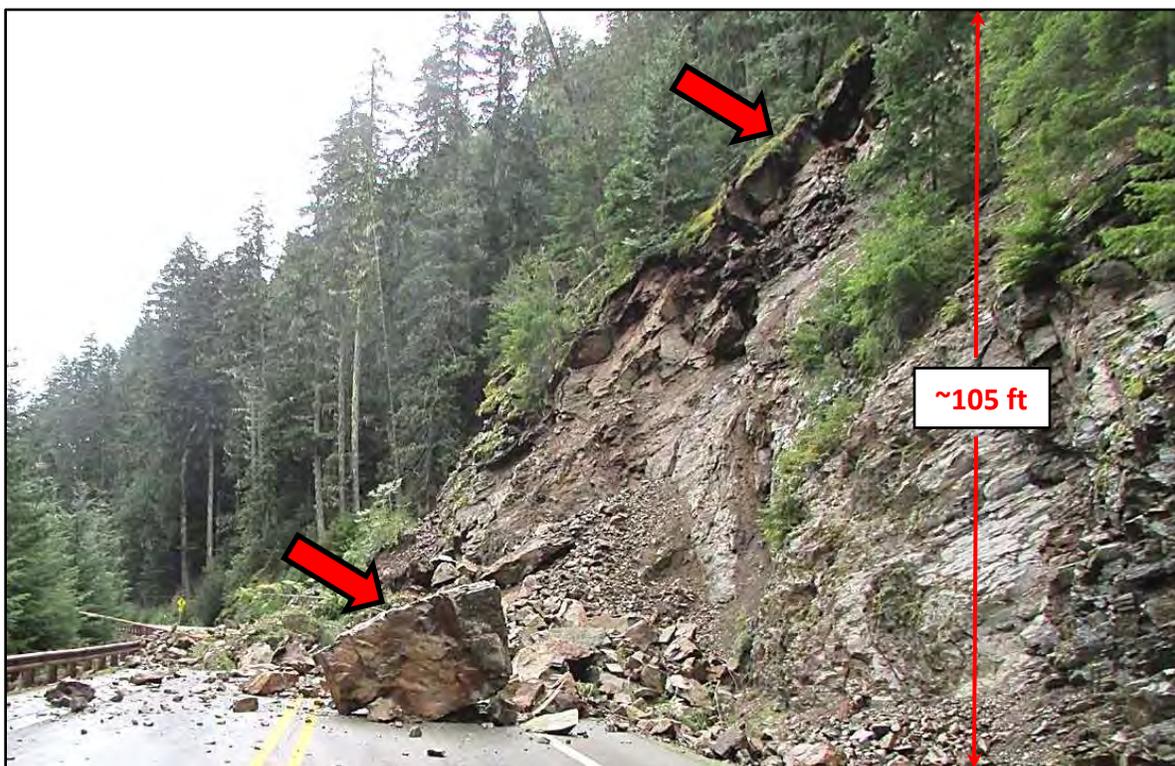
Figure 3: Western view of debris on the slope and scattered over both lanes of the highway.

Our initial site visit revealed many large boulders, trees, and rock debris scattered beneath the slope covering both travel lanes of the highway (Figures 3 & 4). We estimated the debris to be up to 10 feet deep along the eastbound travel lane. We observed numerous large detached blocks and leaning trees remaining on the slope. While we were conducting our highway-level slope inspection, minor rockfall continued to originate from several different locations on the slope. Using a laser range finder we measured slope heights and distances, collected field developed cross sections, and determined the slope distance to the top-of-cut from highway level (~135 ft). We also traversed the area above the top-of-cut to look for ground fractures or other evidence that would suggest the failure is progressing further upslope (Figure 5).

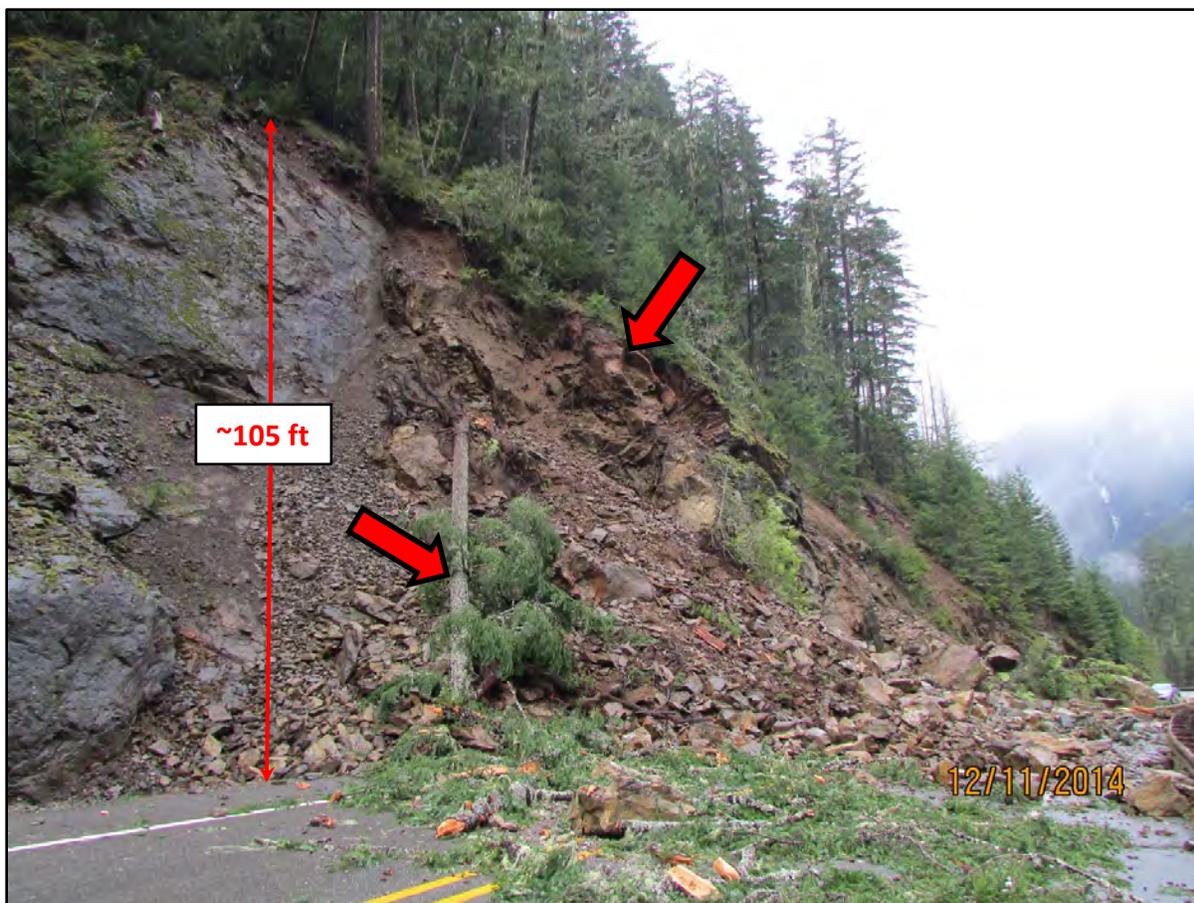
Figure 4: Eastern view of debris on the slope and scattered over both lanes of the highway.

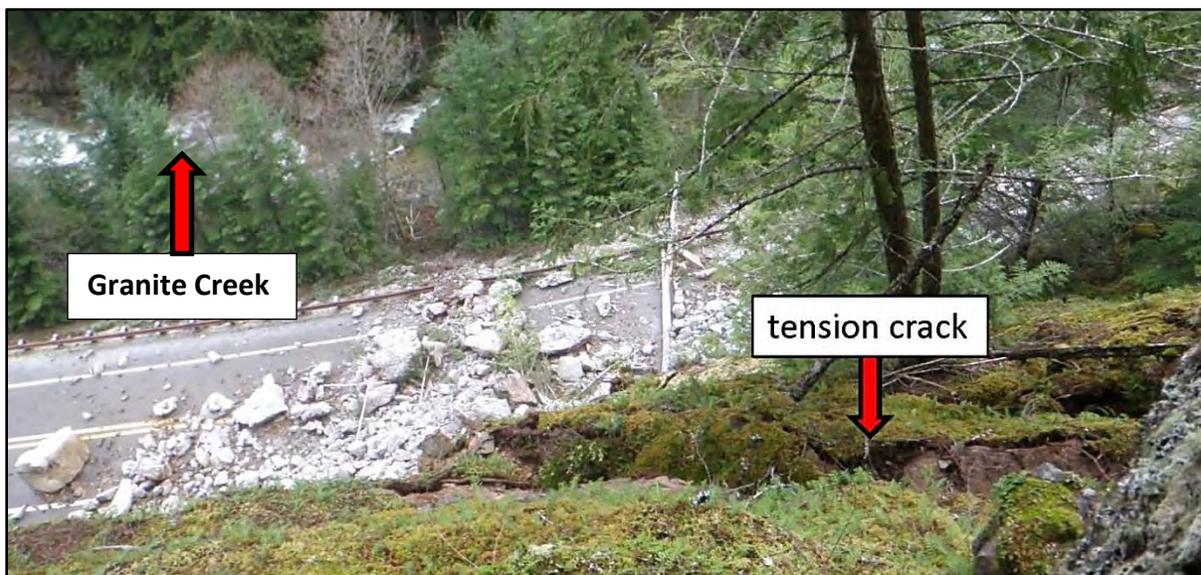
Figure 5: Looking down from the top-of-cut at a large tension crack, debris, and Granite Creek.

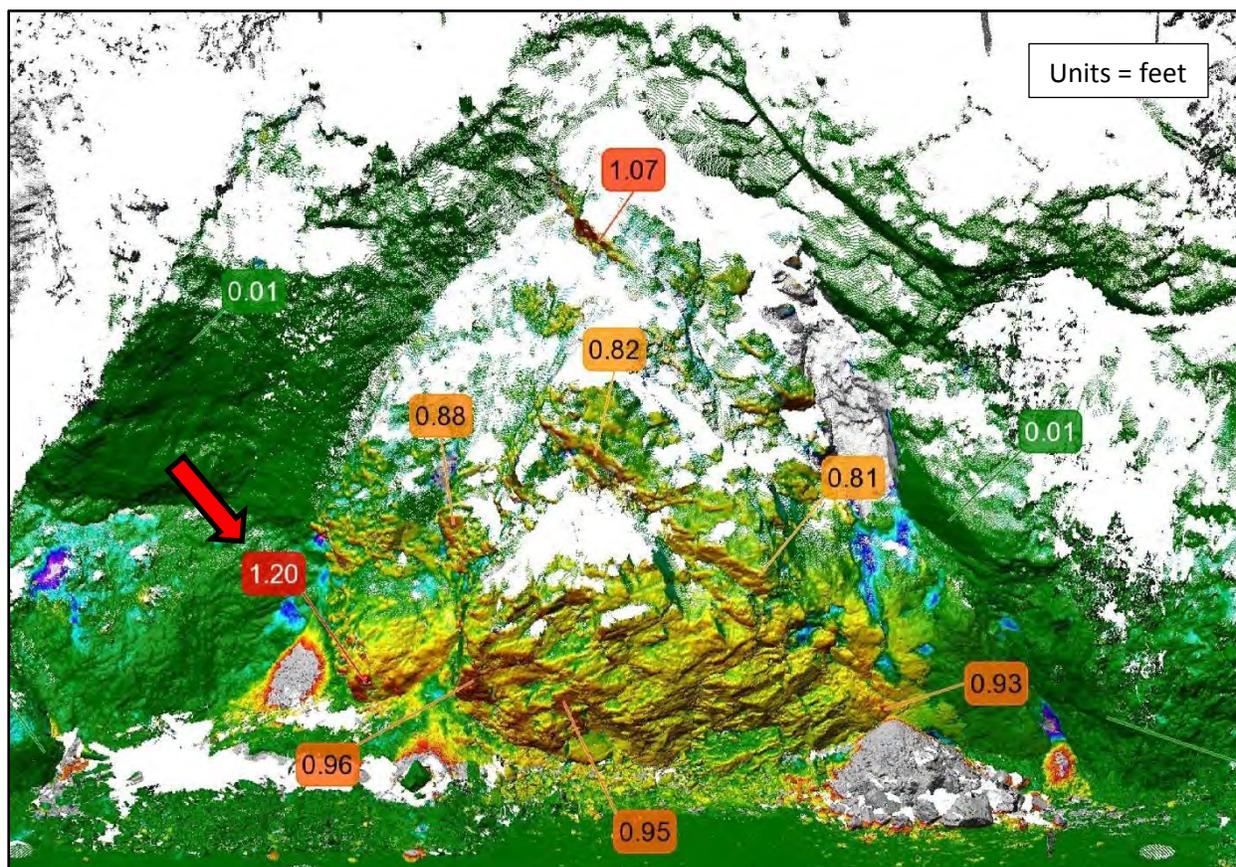
Figure 6: LiDAR change analysis showing slope movement in feet between days 22 and 41.

Our change-based LiDAR analyses (Figure 6) indicated that several feet of differential slope movement has occurred over a period of a couple of months and that the rate of movement is accelerating (Figure 13). Consideration was given to constructing a buttress in front of the distressed rock mass. Our limit-equilibrium analyses indicated that a buttress would be marginally effective at mitigating the slope movement, but it would not provide adequate protection from falling rocks above (Figure 14). Also, a buttress could only be considered a temporary solution, because its width would take the entire eastbound lane of the highway.

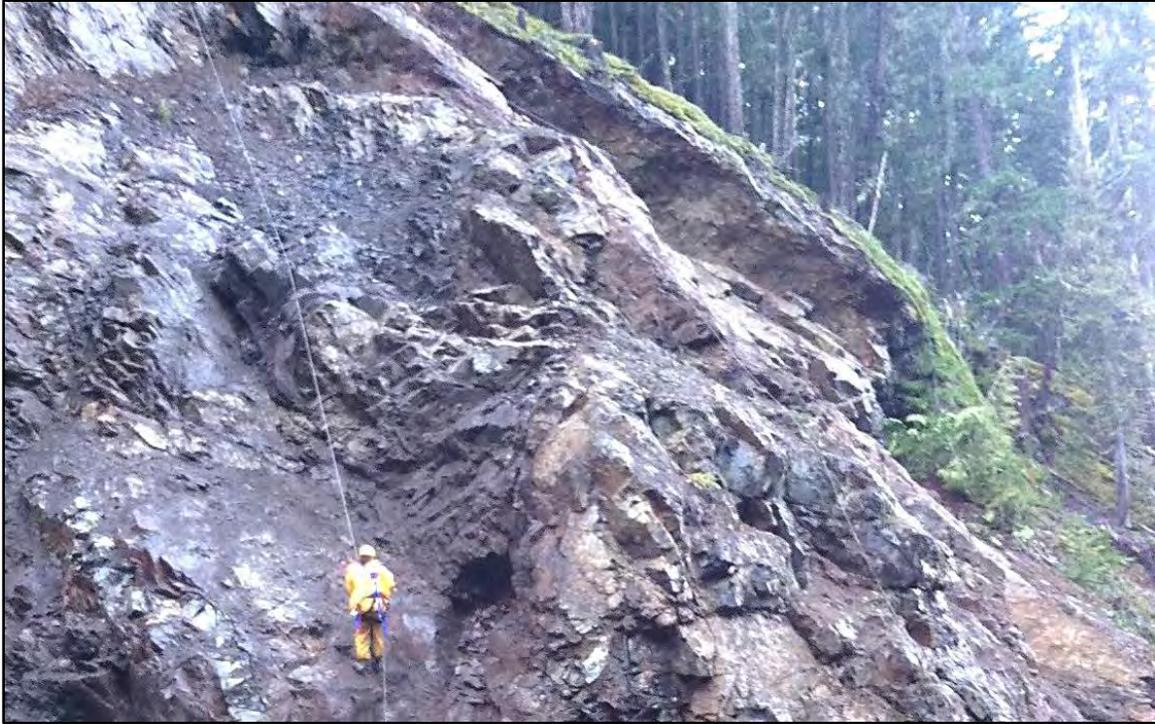
Figure 7: Collecting discontinuity measurements while rappelling on the slope.

We also conducted an on-slope inspection while rappelling from ropes in order to get an up-close view of the numerous detached blocks, to acquire manual compass readings of discontinuities, and to evaluate other areas of weathered or potentially unstable sections of the slope (Figure 7). We observed large open fractures up to 10 feet in width, large detached blocks the size of a small car, and highly unstable sections of the slope (Figure 8). At the completion of our field inspections, we conducted a literature review and looked at recent geologic maps of the area, unstable slopes data, and digital photo logs of the state highway system. Our review revealed that this rock slope is located in an area of highly distressed bedrock of the Ross Lake Fault Zone, has occasional rockfall, and that a highly persistent roadway dipping discontinuity near the toe-of-slope existed prior to the slope failure (Figure 9).

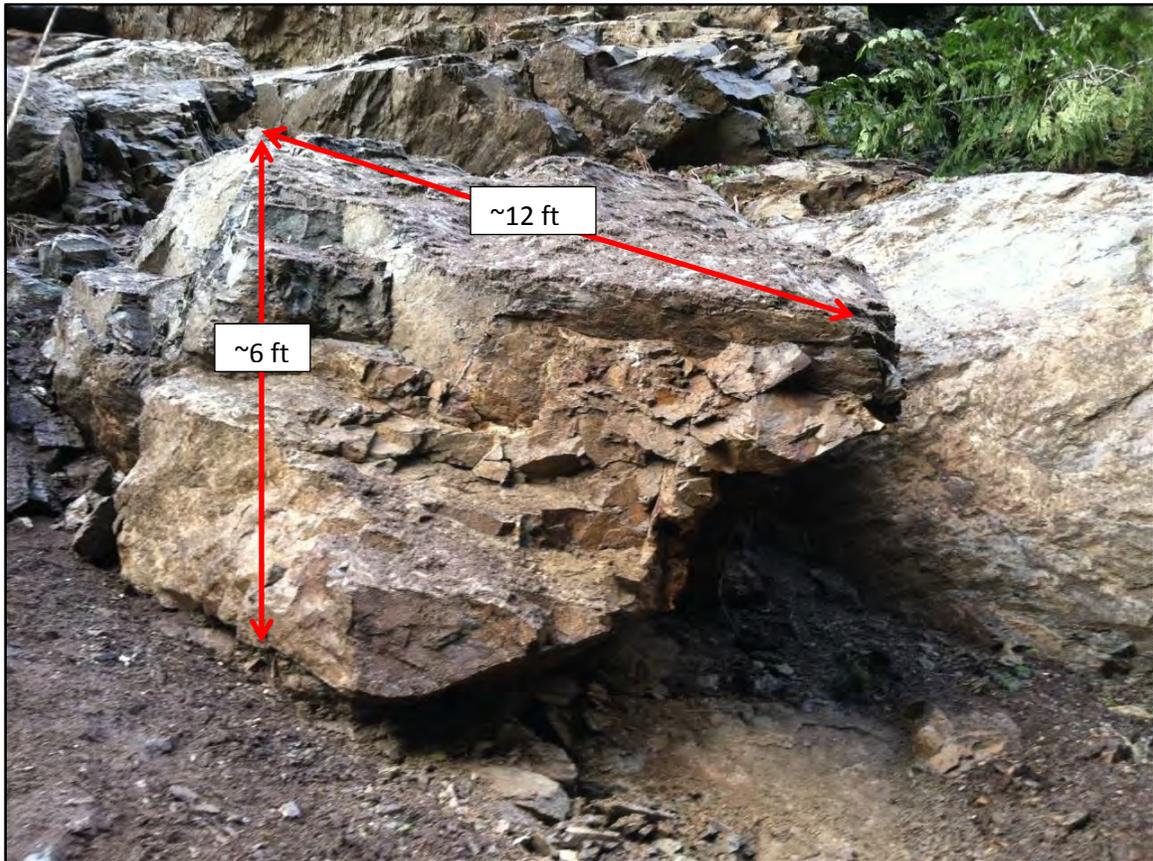
Figure 8: A large detached block on the slope.

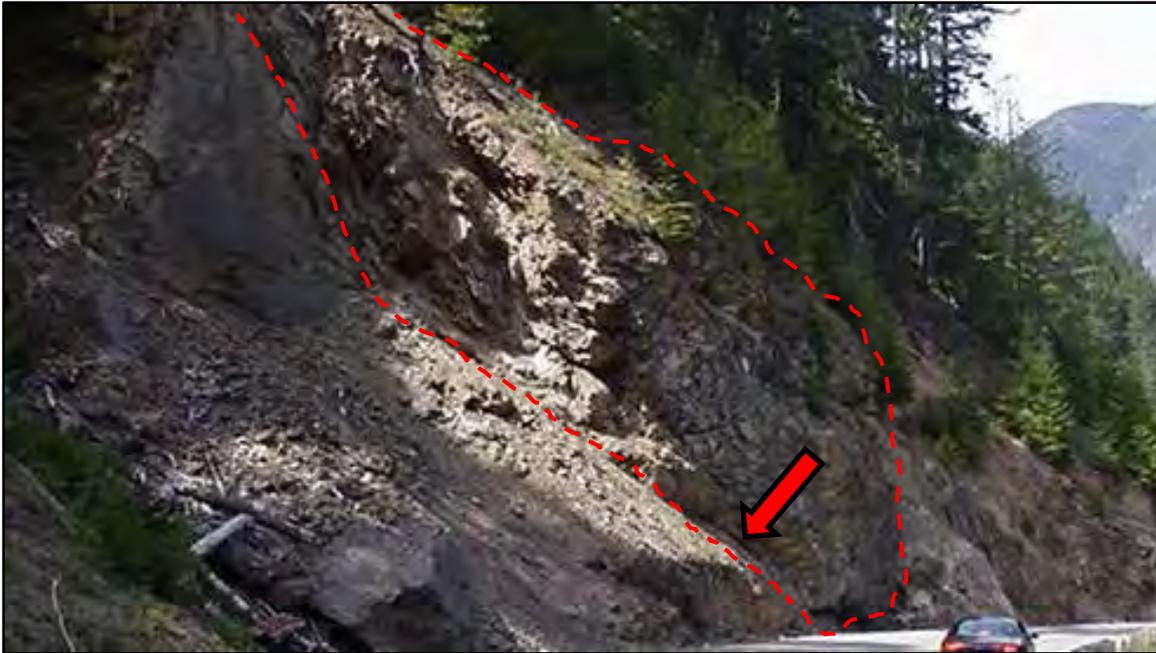
Figure 9: The slope before the failure with a roadway-dipping discontinuity near the toe-of-slope.

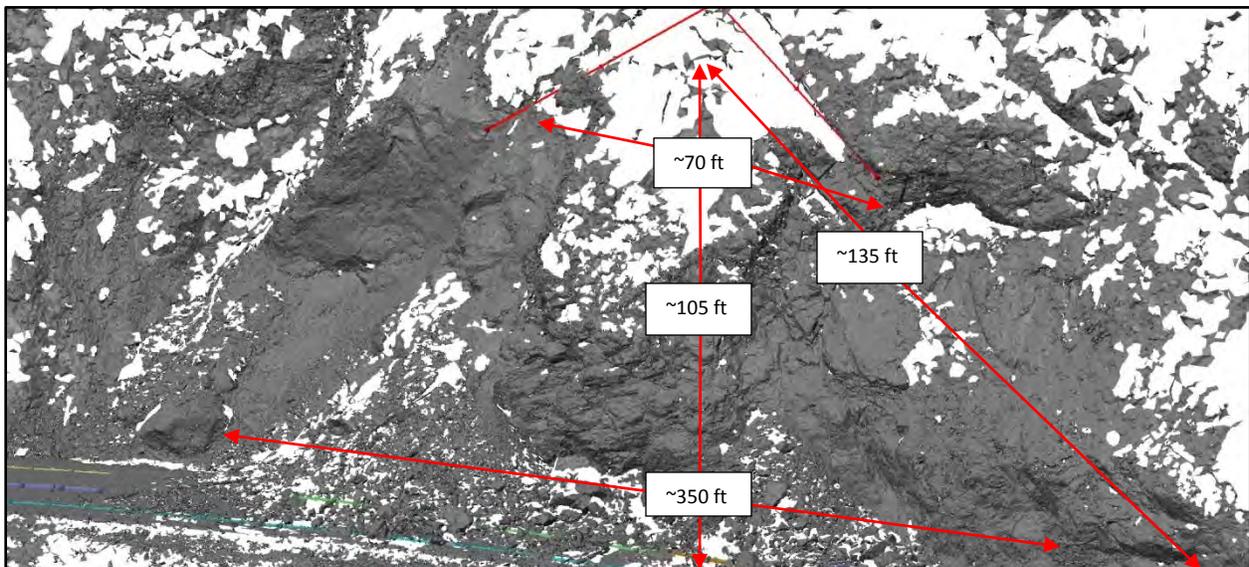
Figure 10: A DTM developed from the ground-based LiDAR scan after the initial slide.

Using the DTM developed from the first ground-based LiDAR scan, we calculated the slope height to be ~105 feet, the slope width to be ~350 feet, and the slope distance from the slope crest to the highway to be ~135 feet (Figure 10). We also used this data and the DTM to construct a subsurface model of the distressed rock mass remaining on the slope (~11,000 yds³) (Figure 11) and calculated the amount of debris that originally fell from the slope (~7,500 yds³).

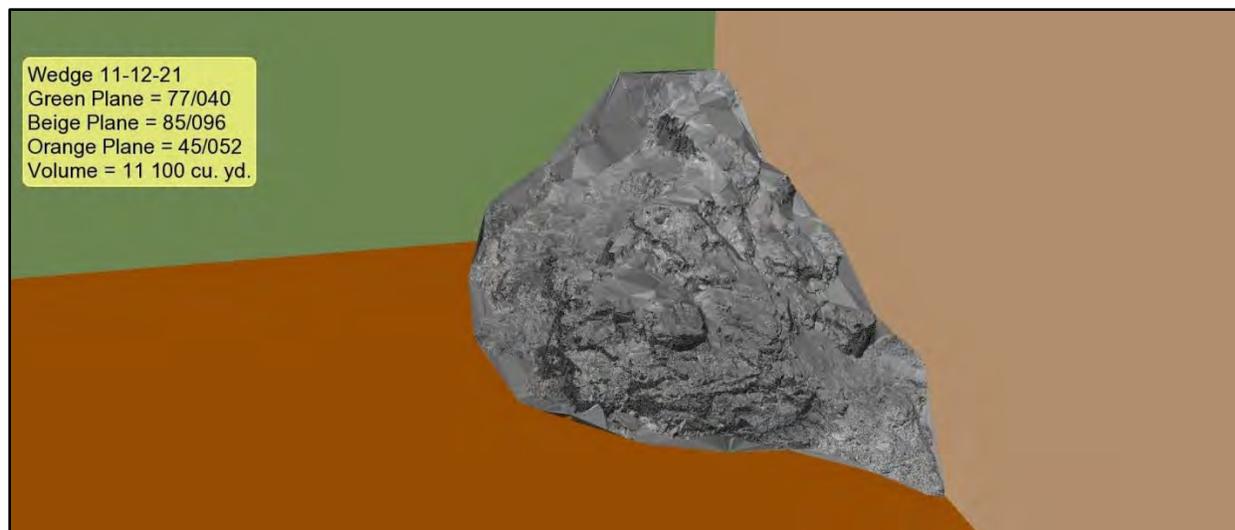
Figure 11: A subsurface model of the distressed rock mass (~11,000 yds³).

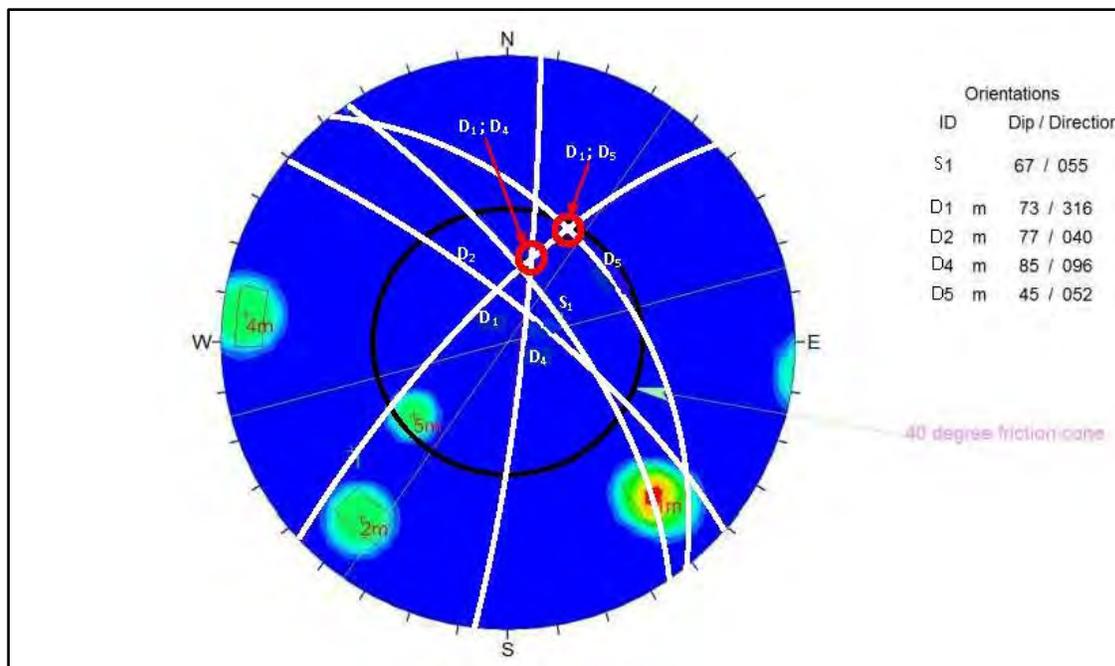
Figure 12: Stereographic projection of the discontinuity data.

In conjunction with the discontinuity measurements that we manually collected while rappelling from ropes, discontinuity measurements acquired through the ground-based LiDAR scans were also used to measure the geologic structure within the slope for areas inaccessible to safely map. The major joint sets we identified were D_1 : $73^\circ/316^\circ$, D_2 : $77^\circ/040^\circ$, D_4 : $85^\circ/096^\circ$, and D_5 : $45^\circ/052^\circ$ and the slope (S_1) is oriented at about $67^\circ/055^\circ$. Using stereographic projection, these joint sets were analyzed for potential planar, wedge, and toppling-type failures (Figure 12). To evaluate the geometry and stability of surface wedges and sliding blocks, we conducted a deterministic analysis on intersecting ($D_1:D_5$ and $D_1:D_4$) and the near parallel (D_2 and D_5) joint sets to the slope. Using conservative friction angles and no cohesion, we conducted back-analyses on several rock blocks and wedges that were adjacent to the failing rock mass. These rock blocks and wedges were identified as being potentially unstable, or that would be left unsupported after the distressed rock mass was removed. We then calculated the amount of reinforcement that would be required for each rock block or wedge to achieve a factor-of-safety of at least 1.25. We assumed the presence of tension cracks partially filled (10%) with water behind the rock mass, although these were not observed for the majority of the blocks we analyzed. To reinforce these rock blocks and wedges we used a combination of 25 kip and 100 kip passive rock dowels. Our analyses also assumed that the existing rock joint patterns in conjunction with horizontal drains could effectively limit the buildup of water pressures in the slope.

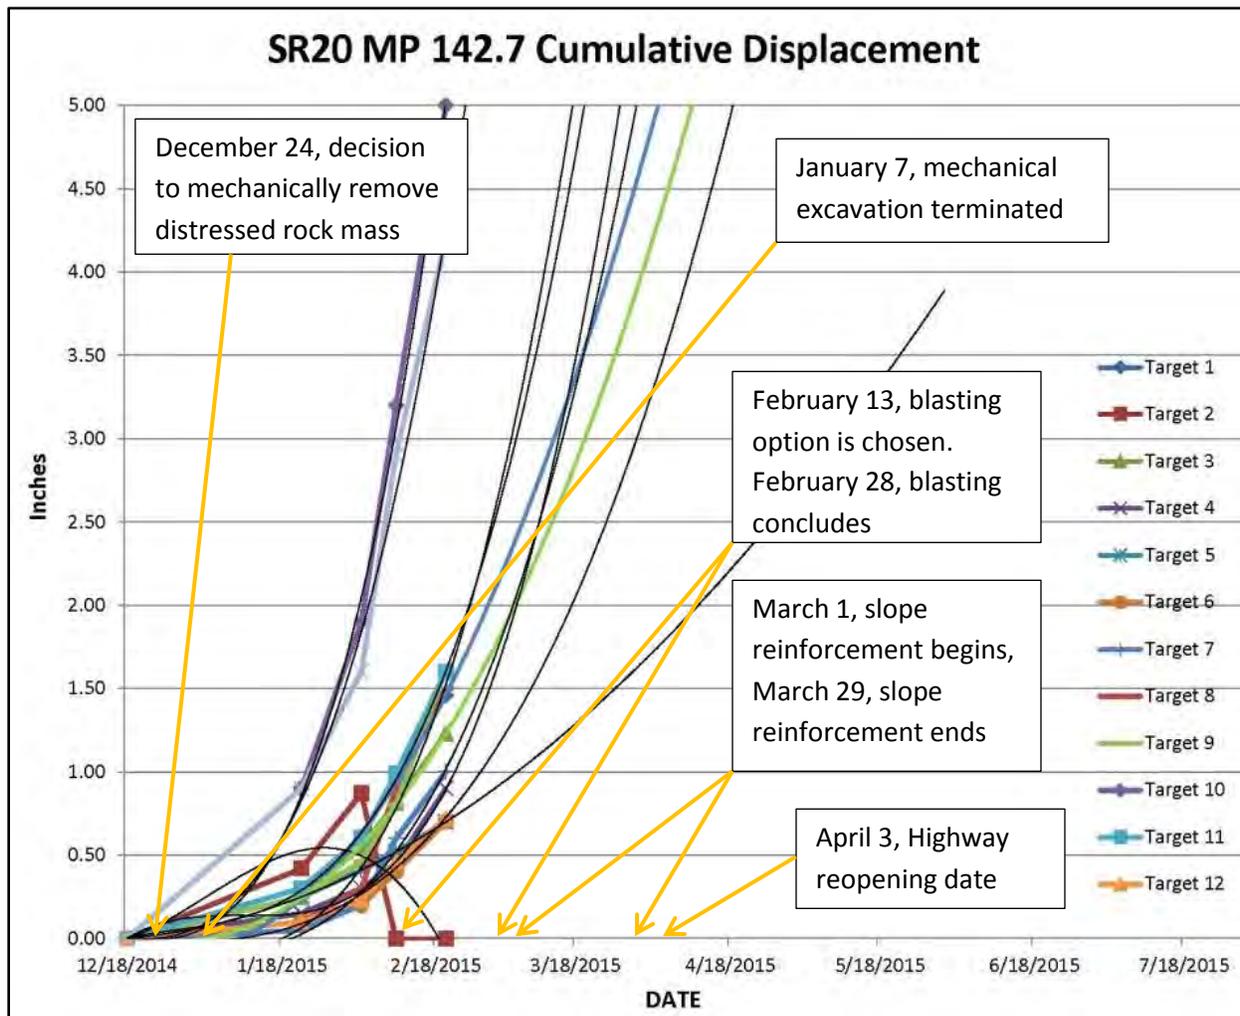
Figure 13: Graphed cumulative displacement of slope targets showing accelerated movement and the steepening of the curves towards failure.

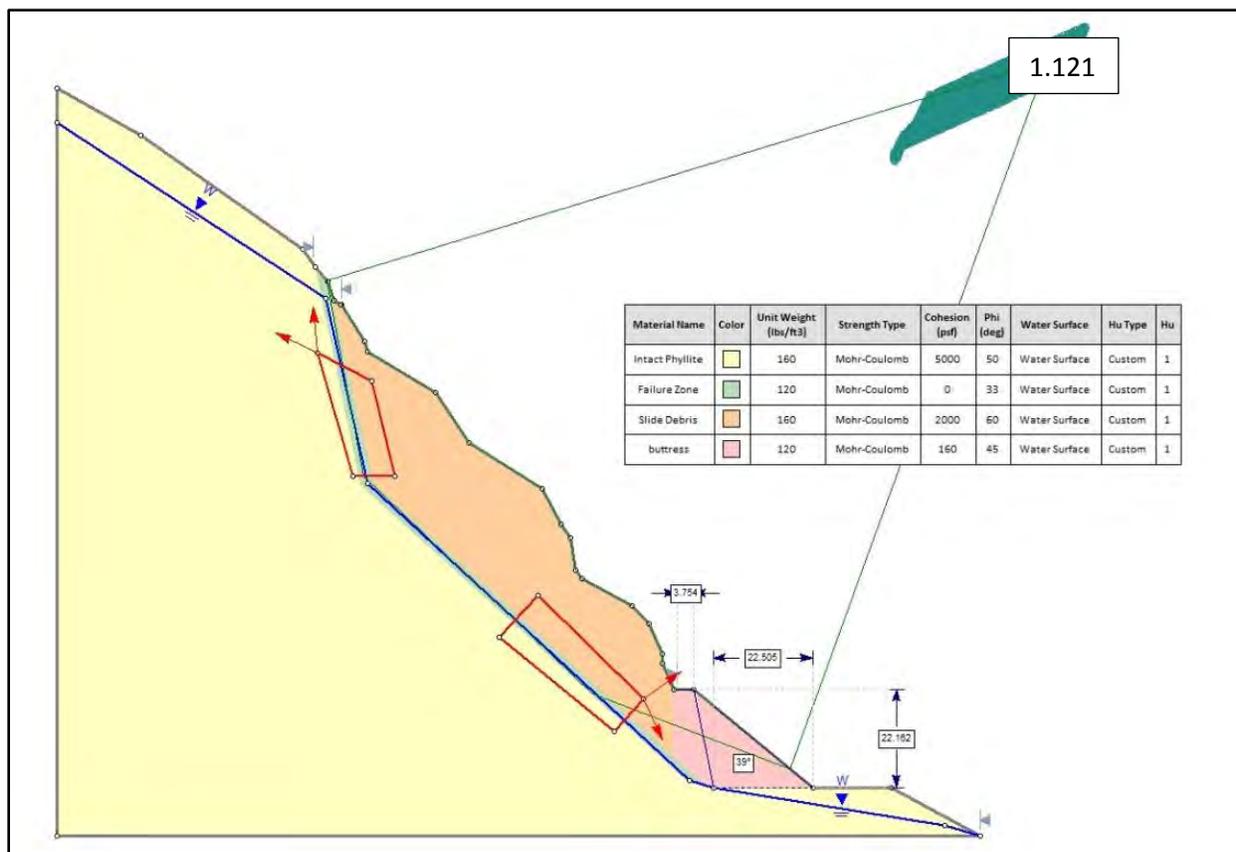
Figure 14: Limit-equilibrium analysis for a potential buttress constructed in front of the detached rock mass.

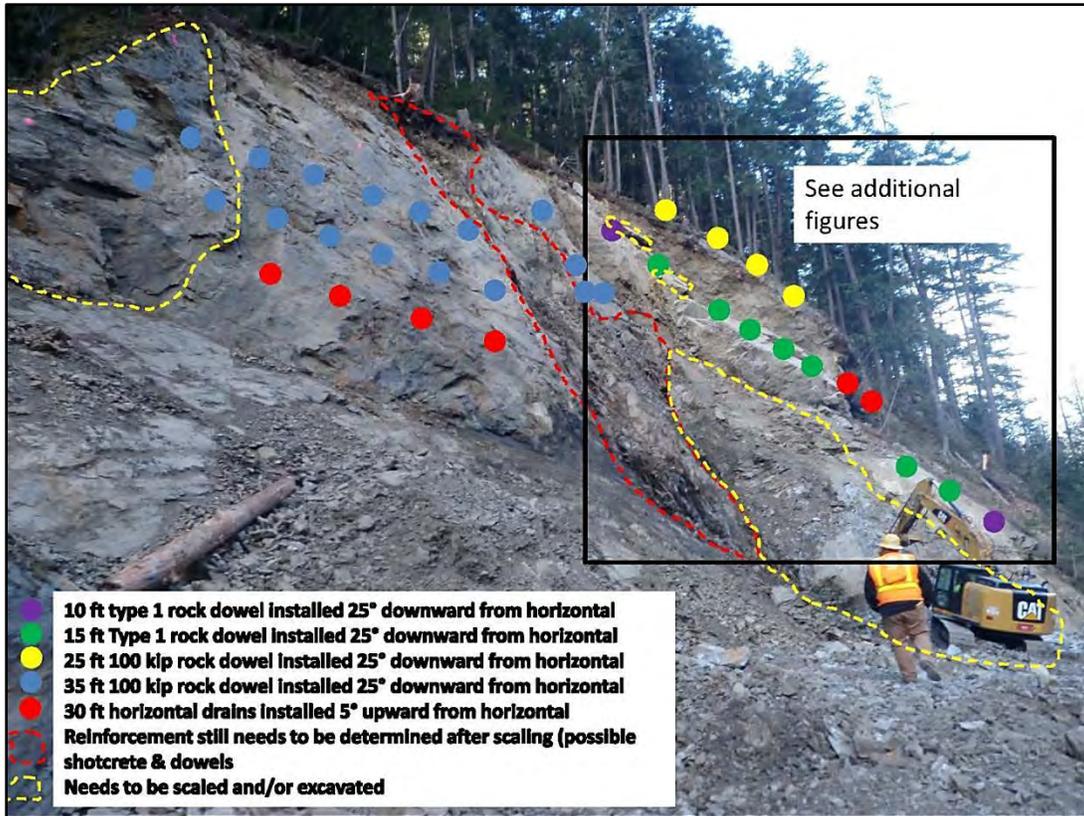
Figure 15: Recommended slope reinforcement in the eastern, middle, and western sections.

Based upon our initial site reconnaissance and our data collection and analysis, we developed recommendations that included tree cutting near the brow of the slope, brow rounding, mechanical excavation of the detached rock mass with a long-reach excavator, limited on-slope safety scaling, and at the completion of the excavation, the installation of horizontal drains and rock dowels along the back wall of the slope and within several potentially unstable blocks that remained on the slope (Figure 15). We recommended for the excavation to proceed from the top-of-slope downward and for a ramp to be constructed to maximize the 154-foot

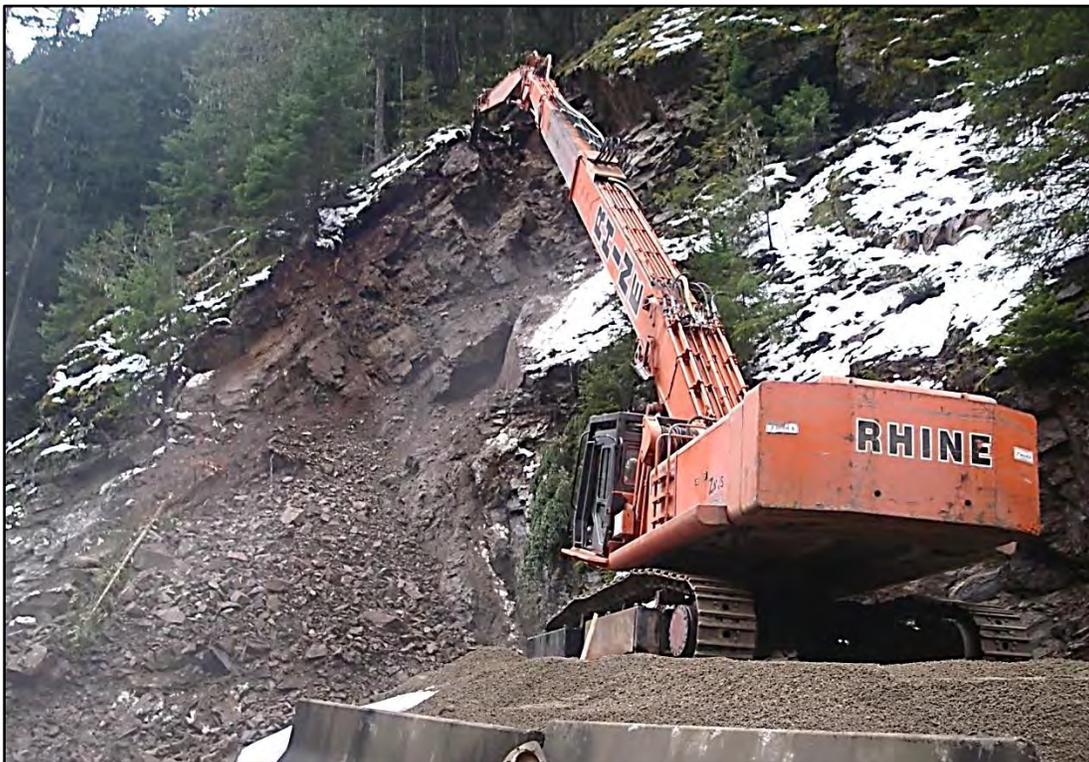
Figure 16: A long-reach excavator removing debris from the slope while on a ramp.

reach of the excavator. The ramp would also serve as a protective berm to stop falling rock from impacting the excavator (Figure 16).

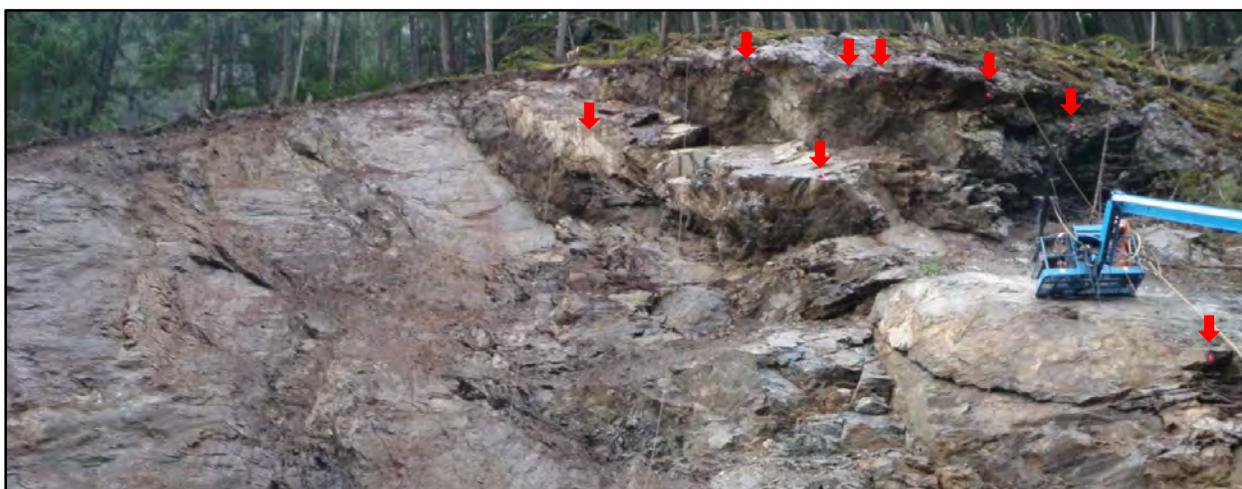
Figure 17: The red dots were monitored for movement every 15 minutes with a total station.

Because the slope was actively moving, debris was left near the base of the slope to buttress the main area of active movement and to help prevent a catastrophic slope failure. WSDOT survey also monitored specific points on the slope for movement every 15 minutes with a total station and conducted ground-based LiDAR scans on an every other week basis to help ensure worker safety on the project (Figure 17).

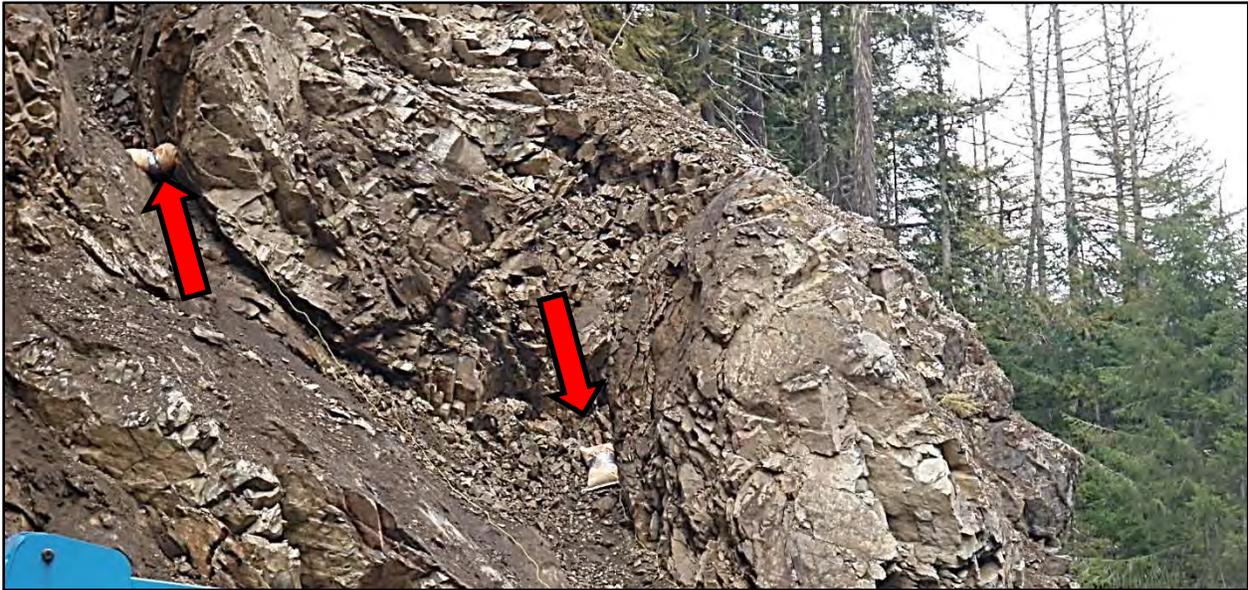
Figure 18: Surface charges placed on the slope.

were able to drill were ≤ 10 feet in length. Because the horizontal drilling was less effective, the contractor had to rely on the surface charges to remove most of the dangerous blocks on the upper portion of the slope (Figure 18). Also, the surface charges were loud, removed only limited amounts of debris from the slope, and contributed to some minor damage to the back wall of the slope (Figure 19). After several horizontal drill-hole blasts and multiple surface charge blasts, most of the middle-to-upper portions of the detached rock mass had been removed. The remainder of the rock mass in the middle-to-lower portion of the slope was then removed utilizing a combination of a hoe-ram and an excavator (Figure 20).

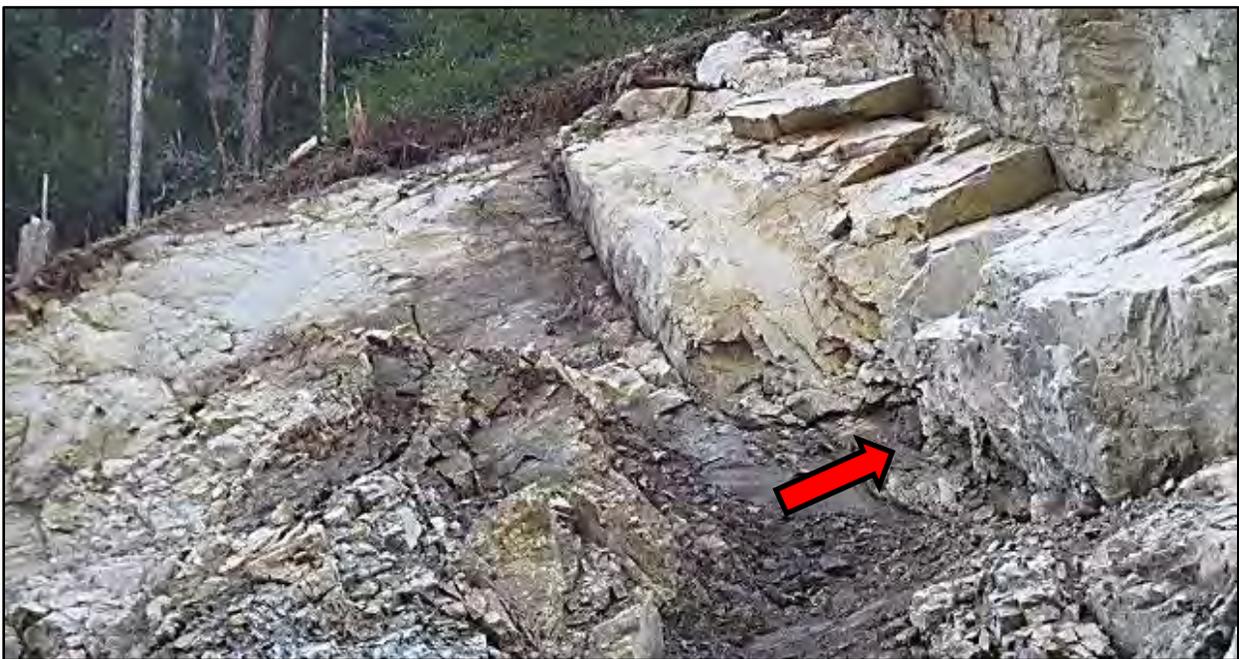
Figure 19: Minor blast damage to the back slope from the surface charges.

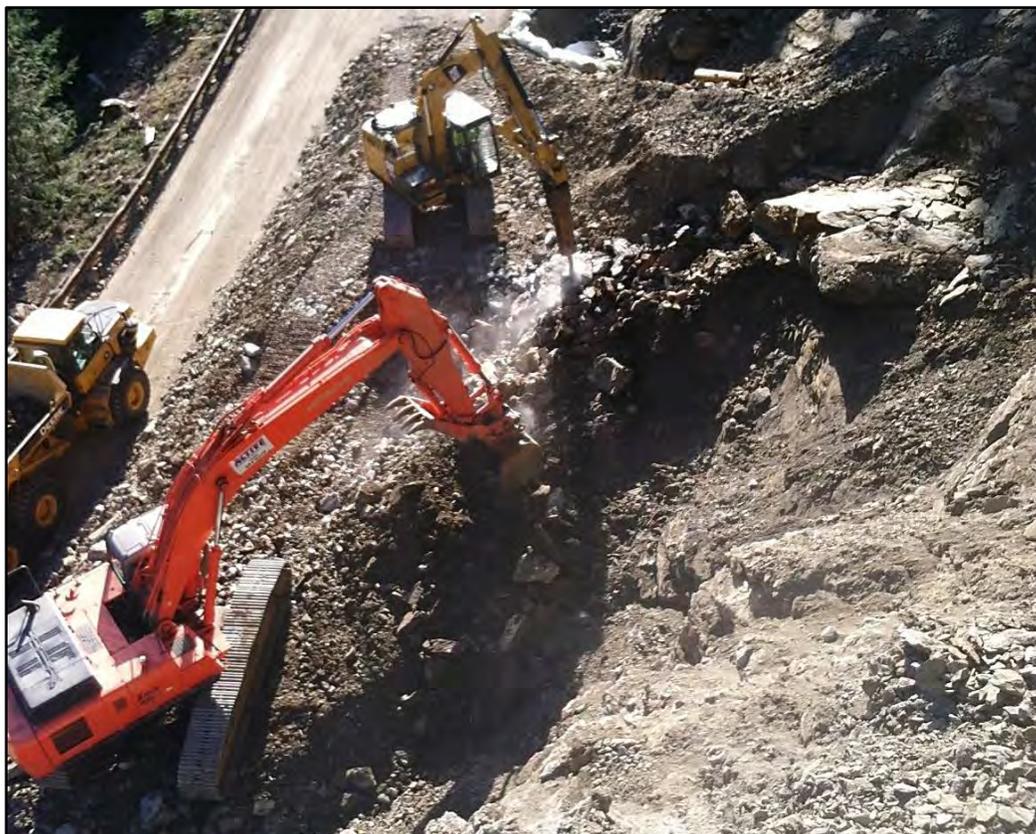
Figure 20: A hoe-ram and an excavator removing material from the lower portion of the slope.

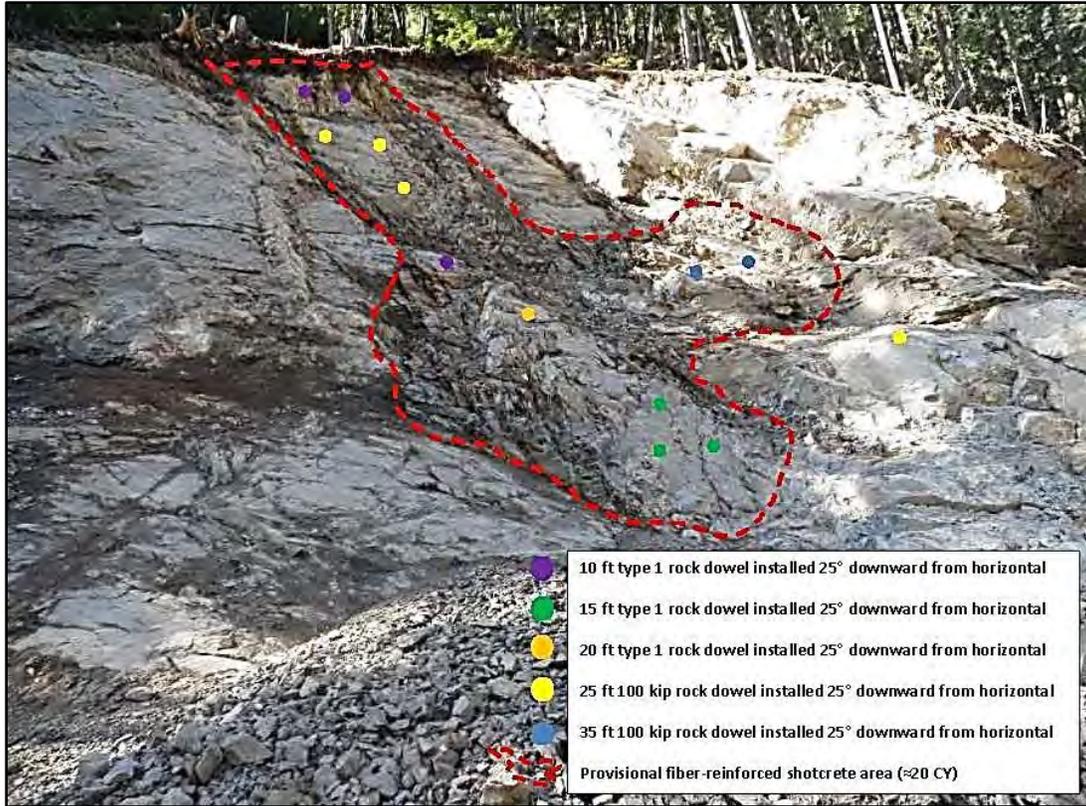
Figure 21: Additional recommended slope reinforcement in the middle section.

After the completion of blasting, another subcontractor conducted slope scaling to remove the remainder of the loose material on the slope. Based upon further analyses, additional recommendations were then developed that included more rock dowels and horizontal drains (Figures 21 & 22). Once the slope was safe to install the reinforcement, the subcontractor mobilized a crane-supported drill rig and a bencher drill to the project site. These drills were then used to drill the recommended rock dowel and horizontal drain holes (Figure 23).

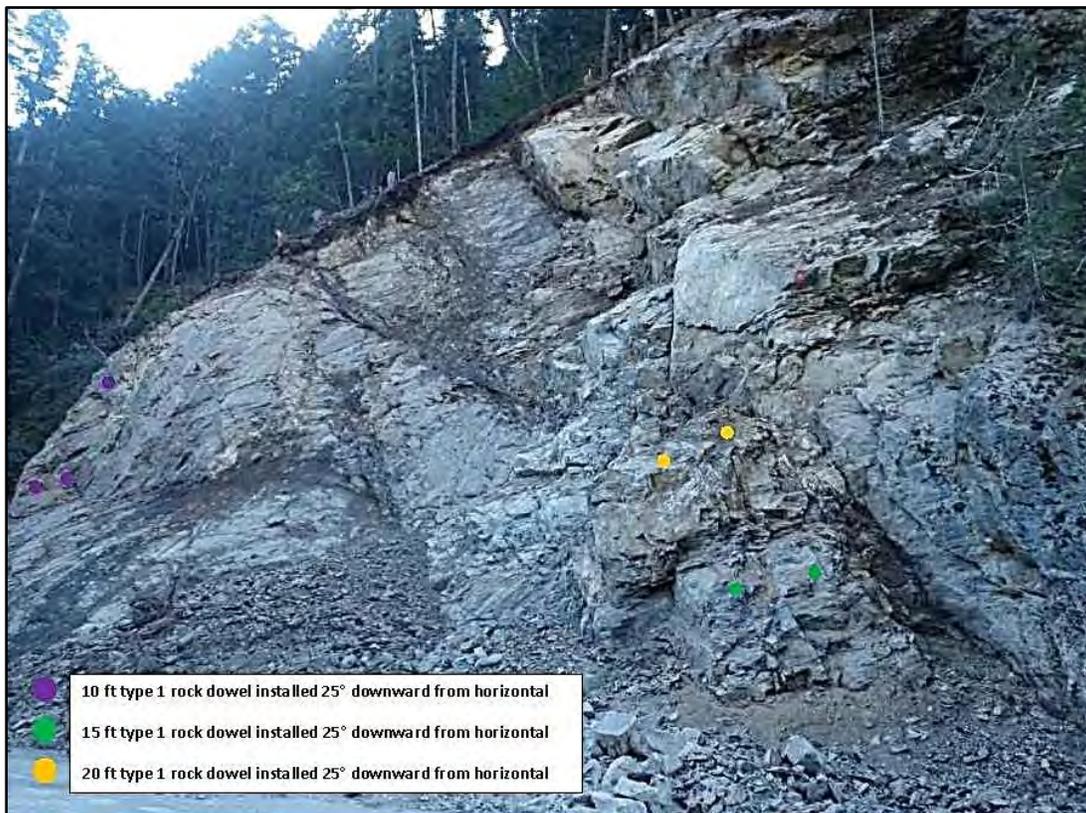
Figure 22: Additional recommended slope reinforcement in the eastern & western sections.
