66TH HIGHWAY GEOLOGY SYMPOSIUM SEPTEMBER 14-17, 2015

2015 Proceedings

*Massachusetts Department of Transportation
and
University of Massachusetts Amherst*

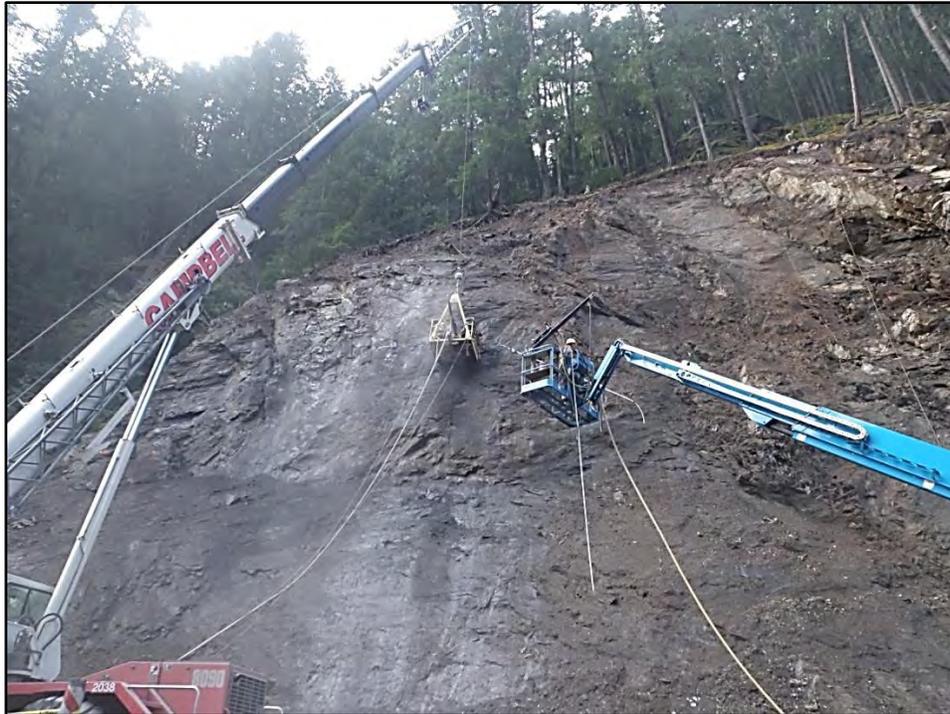
Figure 23: Drilling the dowel locations from a crane and a man-lift.

After the completion of blasting, another subcontractor conducted slope scaling to remove the remainder of the loose material on the slope. Based upon further analyses, additional recommendations were then developed that included more rock dowels and horizontal drains (Figures 21 & 22). Once the slope was safe to install the reinforcement, the subcontractor mobilized a crane-supported drill rig and a bencher drill to the project site. These drills were then used to drill the recommended rock dowel and horizontal drain holes (Figure 23).

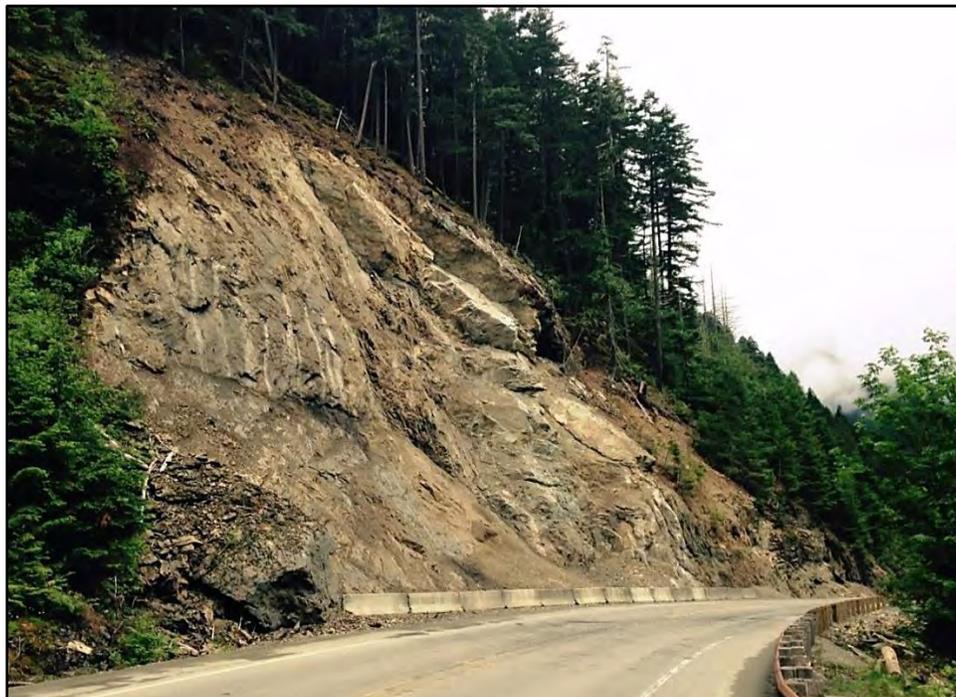
Figure 24: View of the completed project from the east.

This mid-December 2014 rock slide that completely covered State Highway 20 was fully mitigated within the 30-working day project window, for a total cost of about 1.2 million dollars. The project was completed prior to April 3, 2015, which was the earliest highway reopening date on record. Debris was kept out of Granite Creek, blasting was completed prior to March 1, and approximately 7,500 yds³ of displaced material was removed from the highway and another 11,000 yds³ of highly distressed material was safely removed from the slope, while it was still moving. To stabilize the freshly exposed back wall of the slope, the contractor installed 870 linear feet of 100 kip rock dowels, 350 linear feet of 25 kip rock dowels, and drilled another 162 linear feet of horizontal drains to help keep water pressures from building-up within the slope. Damaged guardrail was also replaced and barrier was sited beneath the slope to control minor rockfall from reaching the travel lanes (Figure 24).

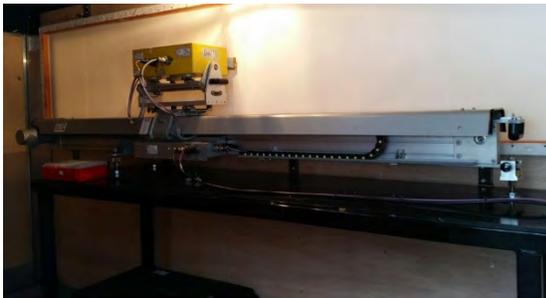
Figure 1: IBIS Radar Interferometer - Scanning Through Raydel Window at Jackson, WY.

Would we see regular, consistent movement? Movement across the Andesite feature at mid-slide that had exhibited activity in different vectors? Would velocities increase during periods of precipitation and temperature fluctuation? Would the point and extensometer data support similar results, or differences? This investigation outlines the opportunity for fulltime monitoring and presents radar data and information from an extensometer. Efforts to access point data acquired during 2014 were unsuccessful. Our own initiative to integrate corner reflector references stalled due to insufficient funding. Figures 1 and 2 present the Interferometer (IBIS) and a time series of selected data-points (Area 1).

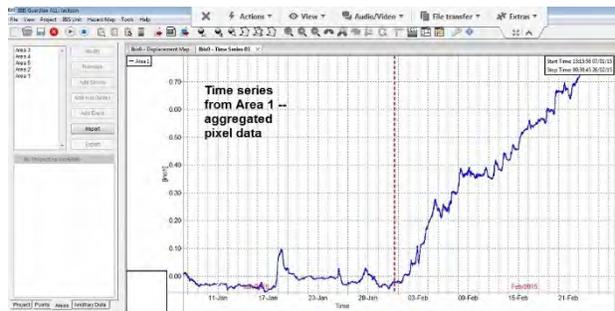
Figure 2: Time Series Data 1/11 to 2/26, 2015 – Area 1.

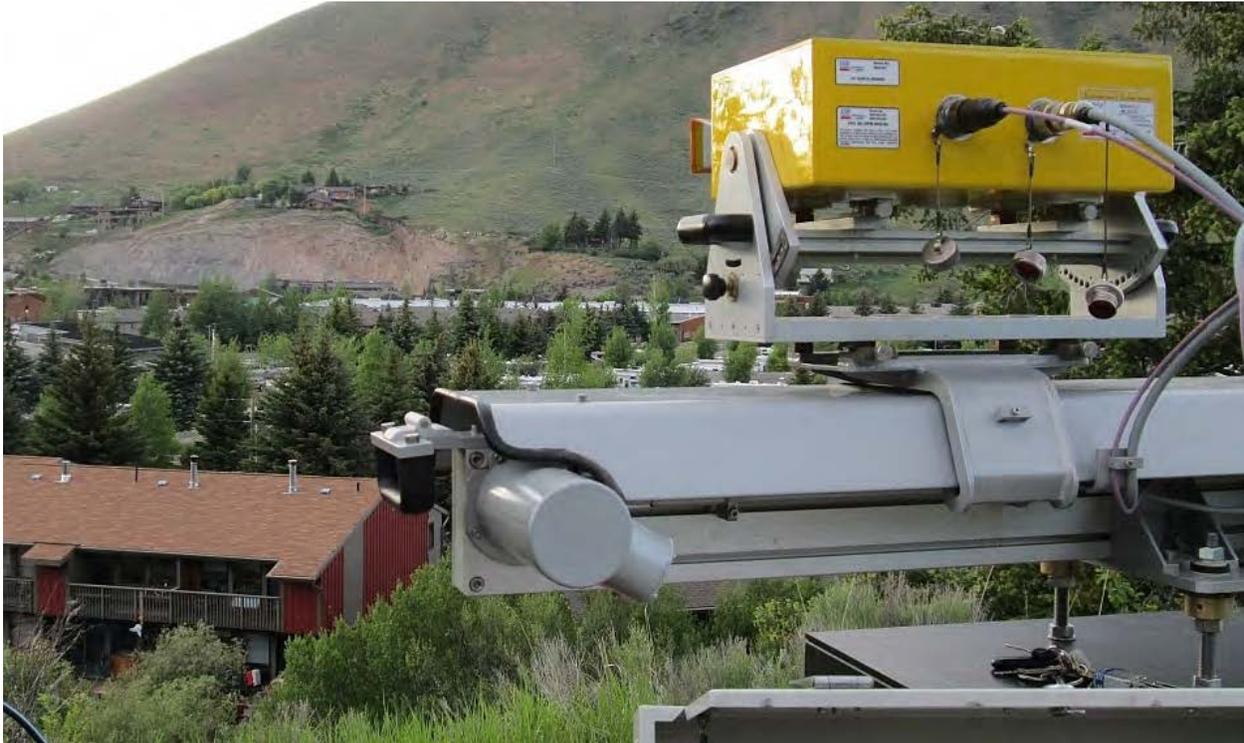
Figure 1: IBIS Interferometric Radar at the Karns Residence Facing the Budge Slide, May, 2014.

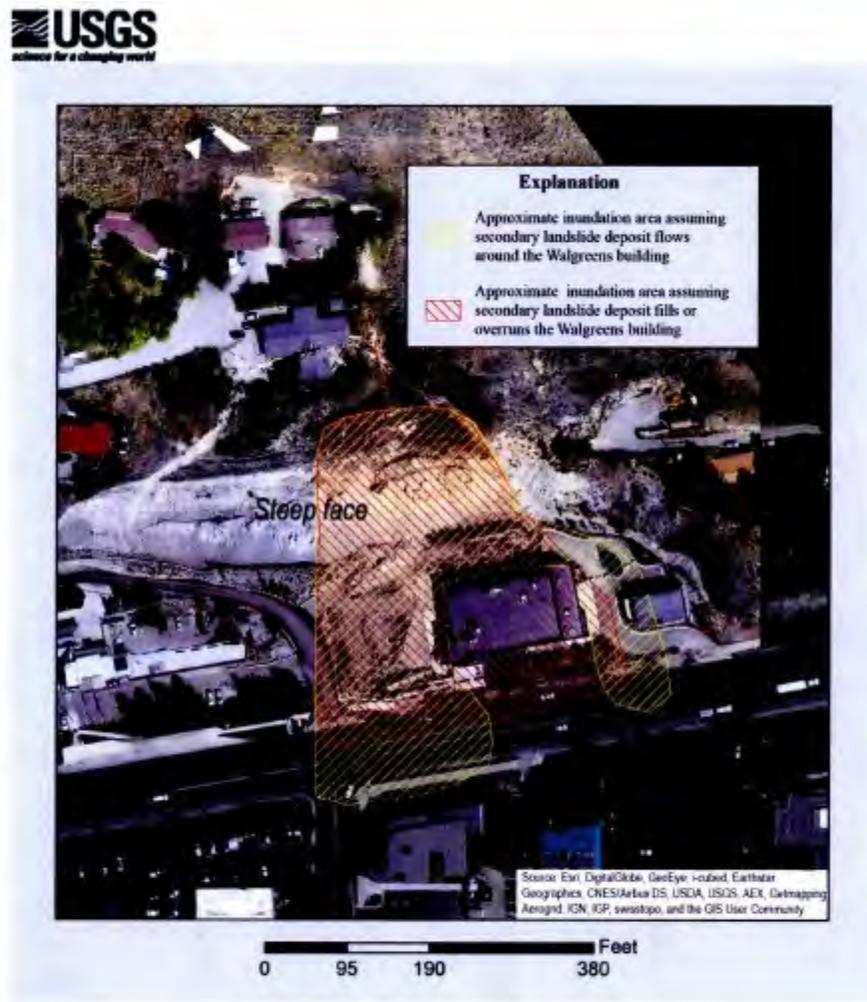
Figure 1. Map showing approximate extent of deposits from potential secondary landslide. (Orthophoto image of active landslide area courtesy of Jason Rolfe, of Tributary Environmental, Jackson, Wyoming)

Figure 4: USGS Overlay image of Runout – Potential.

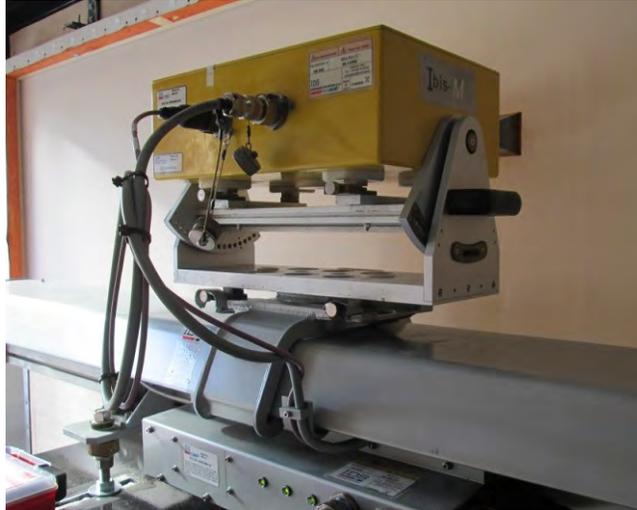
Figure 5: IBIS Unit Scanning Through Raydel Window.

Considering a redeployment in the winter season of 2014/15, a trailered enclosure was chosen to better protect the IBIS unit. IDSNA staff deployed the unit, and started the Guardian (data processing and analysis software) Project. The dataset for this presentation is comprised of scans that began on January 11th, 2015.

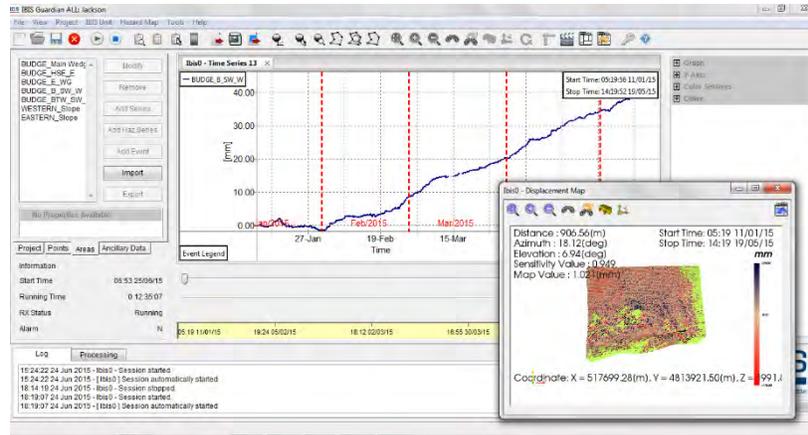
Figure 6: IDS Guardian Software Interface.

The Project folder contains the acquisition area information, acquired data, system details, georeferenced data, user defined scan area, scenario analysis information, and alerts.

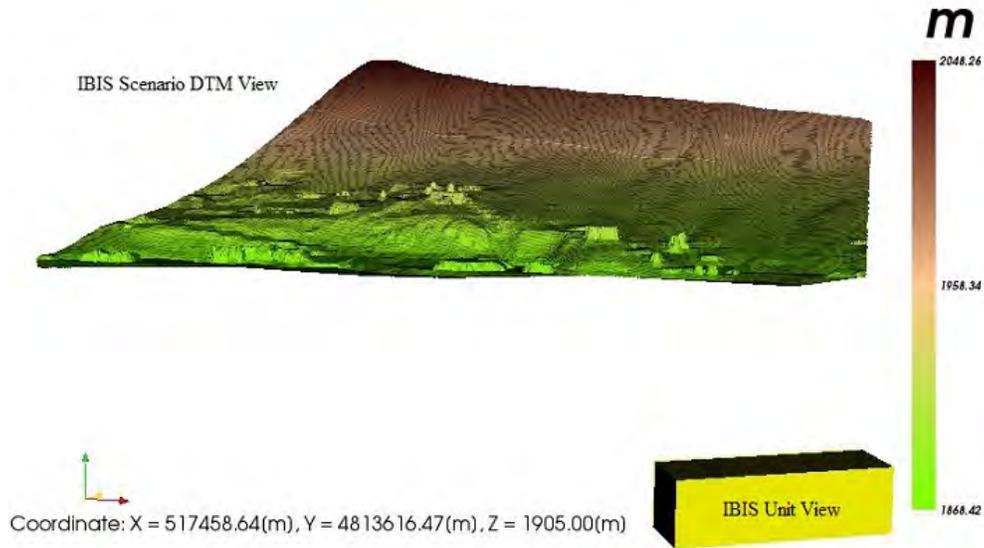
Figure 8: DTM Imported into the Guardian Analysis Software - Note Range Values in Meters (user configurable).

The radar data were georeferenced to the DTM below. A GPS (with RTK differential correction) was used to collect points across the scenario as well as from each side of the IBIS linear scanner.** The project mask was selected to include areas to the north, west, and east of the “main” area of visible instability at the intersection of Budge Drive and West Broadway.

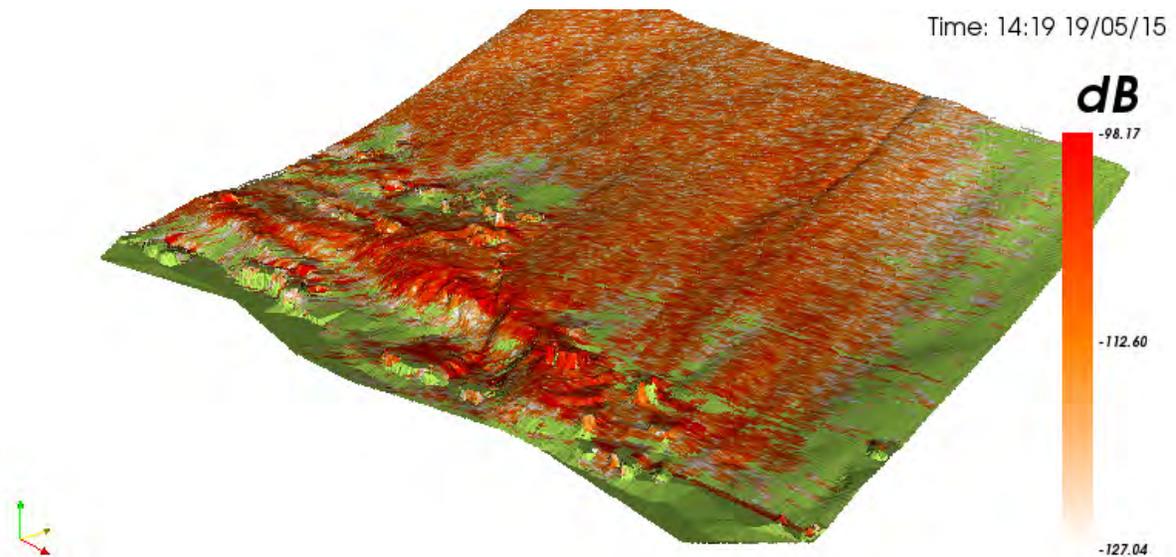
Figure 9: Project Scenario Amplitude Map and DTM.

Data are acquired through a series of scans along a 6.56 foot (2 meter) linear rail. This process – of moving the sensor array along the rail, results in the synthetic aperture technique. This creates the equivalent of a 6.56 foot (2 meter) array, with a very high cross range resolution. The SAR images are used to compare differences in phase and to generate maps of deformation. Displacements are measured in a line-of-sight vector toward the radar. During every acquisition, a radar “echo” is collected from each pixel. This echo brings back to the instrument, information

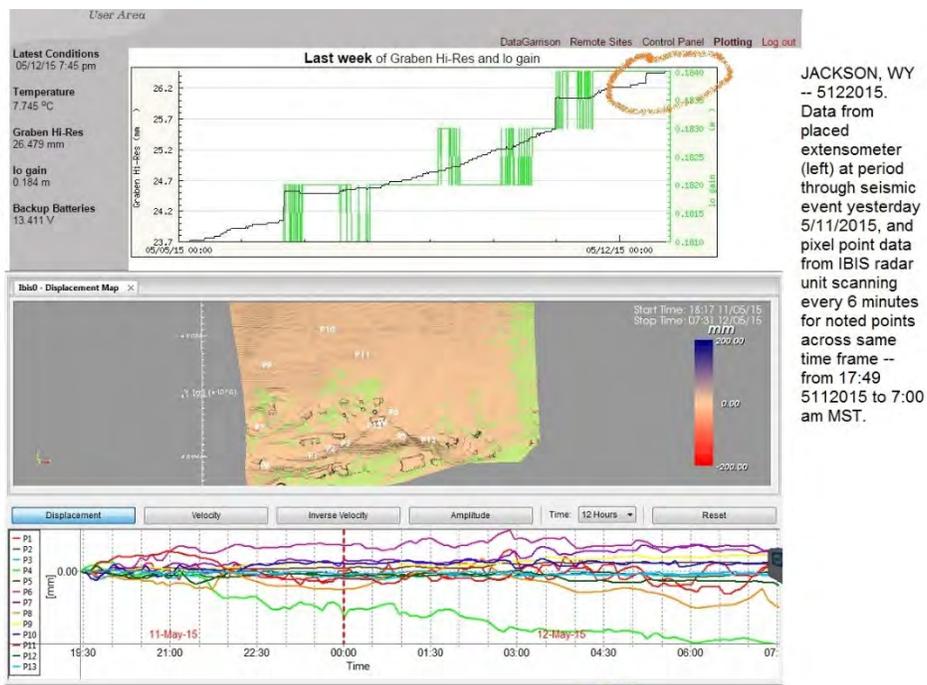
Figure 10: Local (Teton, Cty.) Seismic event of 5/11/2015 extensometer and selected points (radar) data time series.

We had access to and were monitoring the extensometer data (Ulrich/Bilham), while also observing returns from the areas where it was sited within the radar data. Also, we looked at precipitation events – snow and later rain, and how the data indicated activity that aligned with the specific events, and the aftermath.(14)

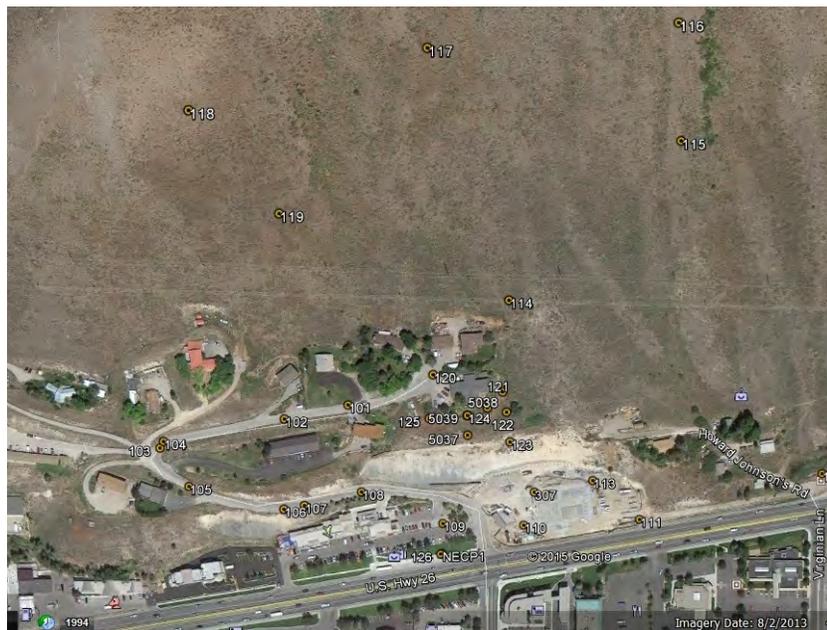
Figure 11: 30+ Points Available for Corner Reflector Placement.

Considering the Budge Slide area contained both natural structures, and items (trees) as well as poles, buildings, and power cables there was an awareness to address the mix of reflectors in the scenario with corner reflectors at known points. We prepared for a campaign of selected points by including these in our GPS data acquisition. Ground-truthing is an ageless part of geological mapping, and our colleagues were keen to complete a related and specific review of data from the selected points. Investigators supported the questions that were raised, however clarification remains incomplete at this time.

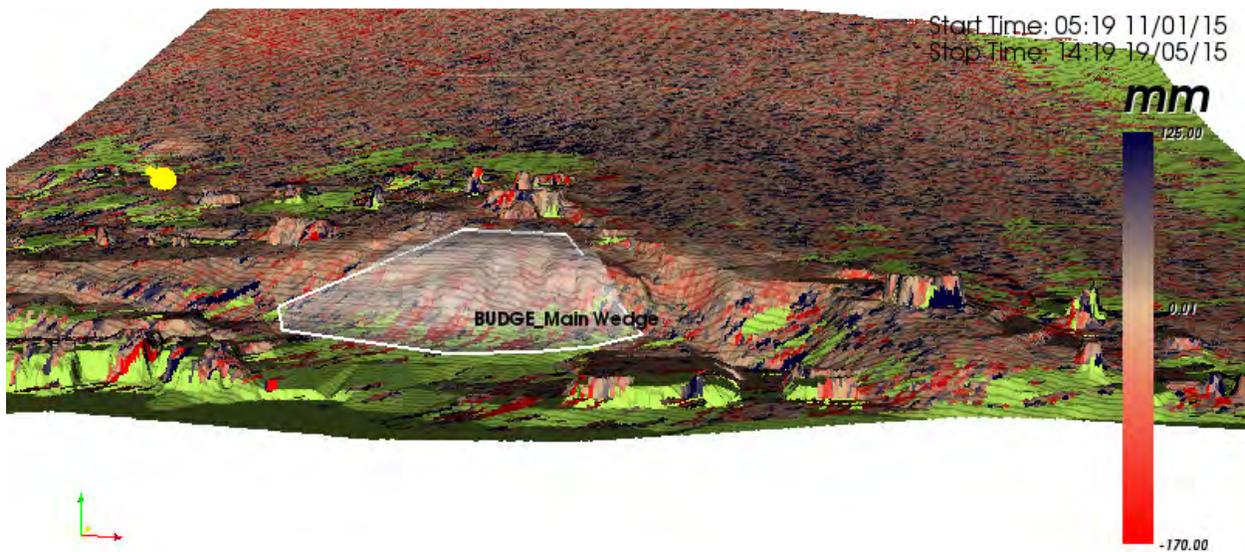
Figure 12: Budge Slide Data (all) and DTM. Yellow Arrow Is Line of Site To IBIS. Area Shown Is BUDGE_Main Wedge.

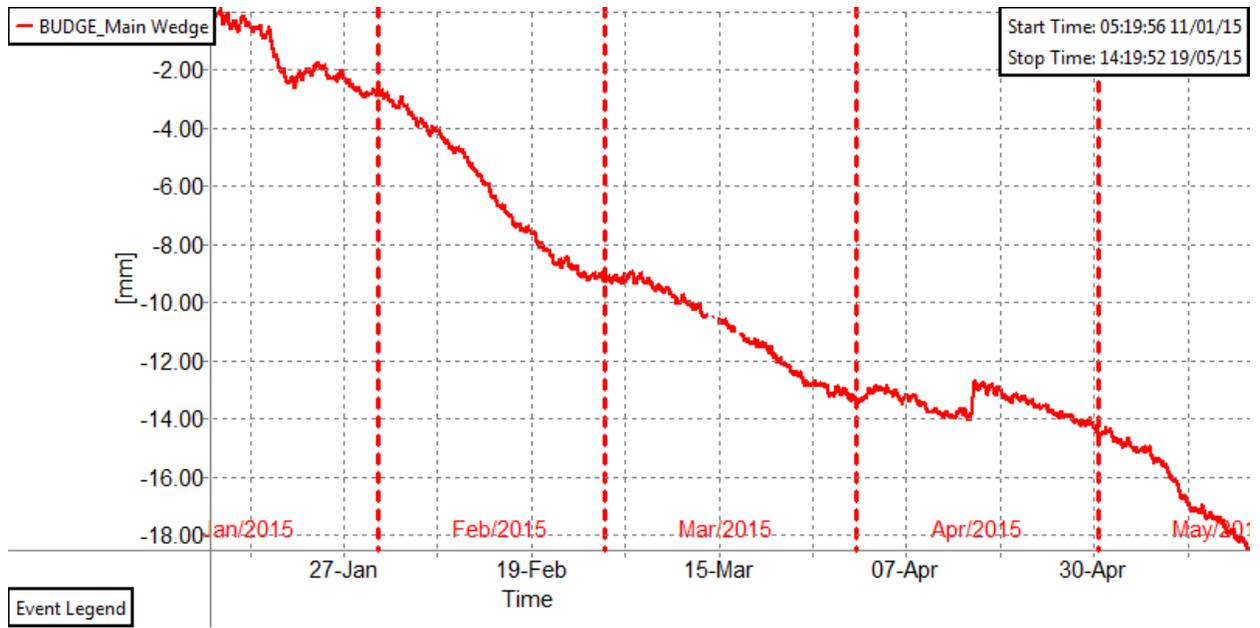
Figure 13: BUDGE_Main Wedge Time Series Data.

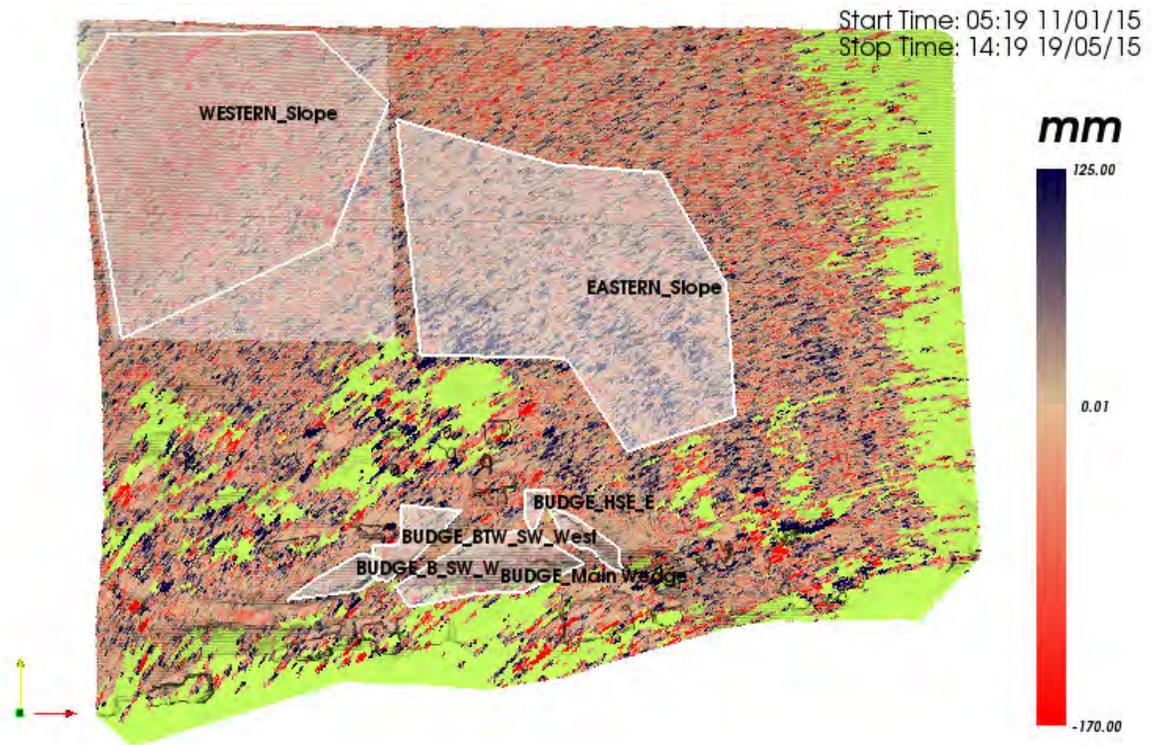
Figure 14: BUDGE_Areas – Top View - Time Series = Aggregated Displacement of Each Scan for All Cells.

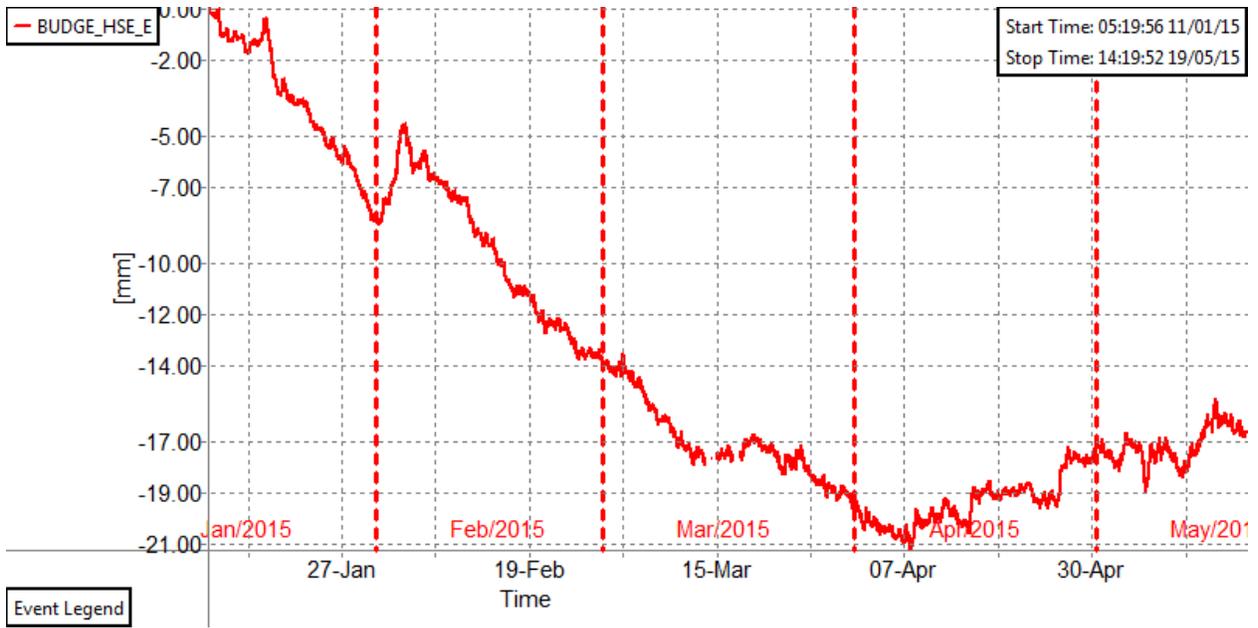
Figure 15: BUDGE_HSE_E -- Area on East Side of House. See Figure 14.

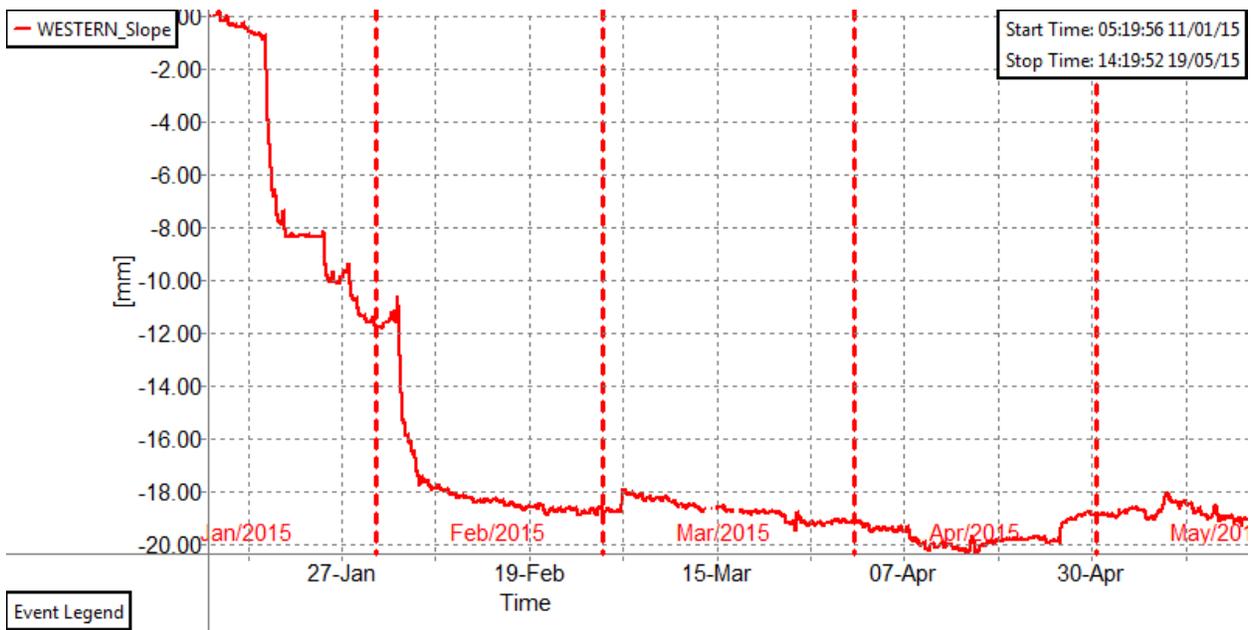
Figure 16: BUDGE_Areas -- Western Slope. See Figure 14.

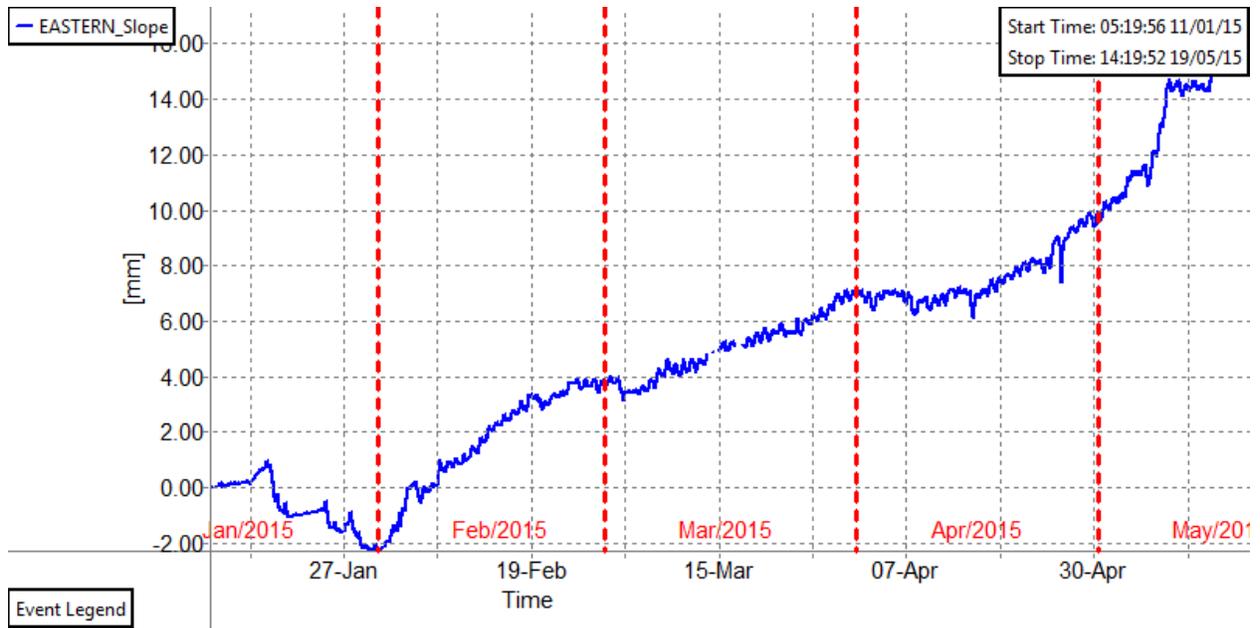
Figure 17: BUDGE_Areas - Eastern Slope - See Figure 14.

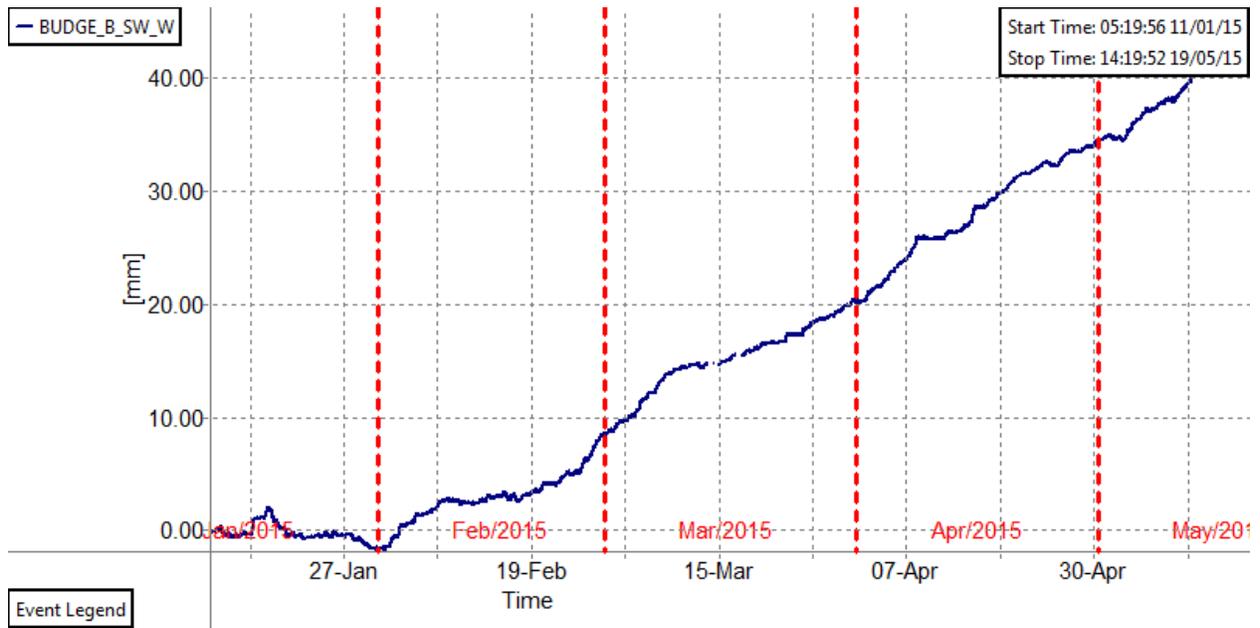
Figure 18: BUDGE_Areas - Behind Sidewinders - See Figure 14.

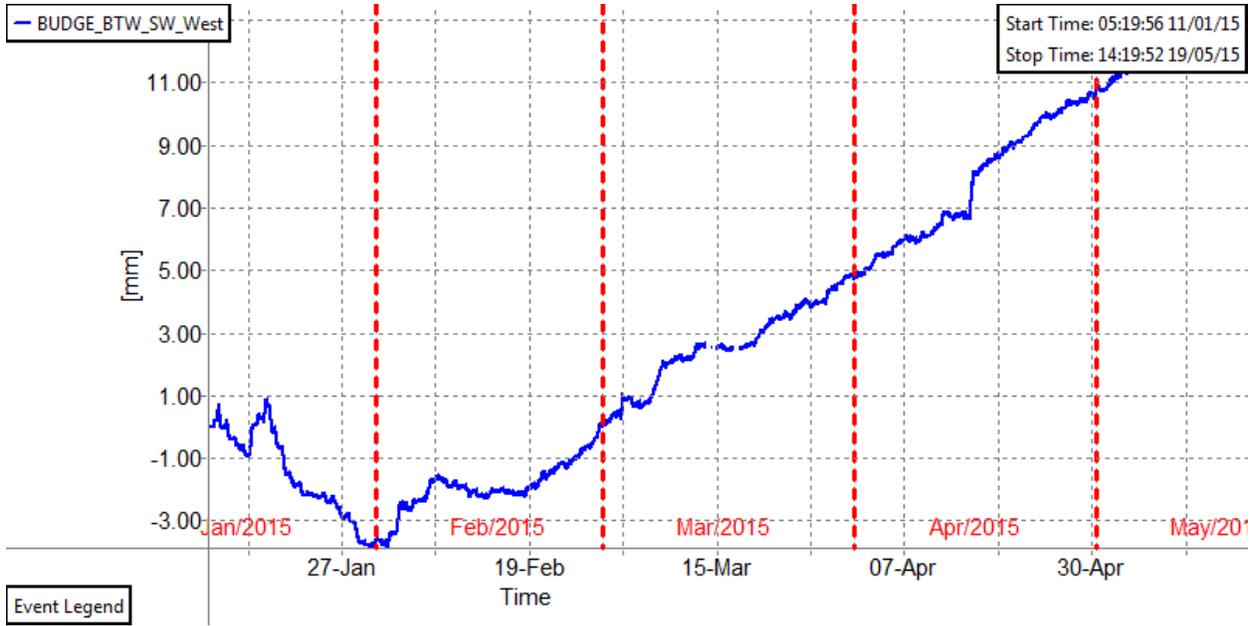
Figure 19: BUDGE_Areas - Between Main Wedge and Behind Sidewinders (area). See Figure 14.

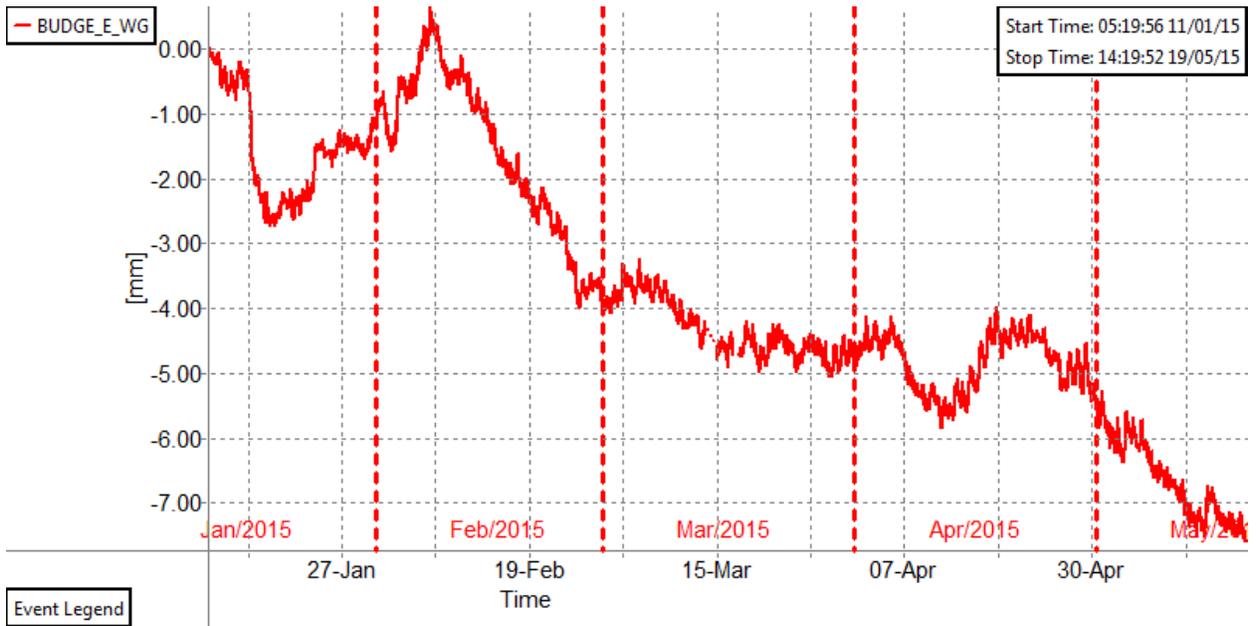
Figure 20: BUDGE_Areas - Behind Walgreens East. See Figure 14.

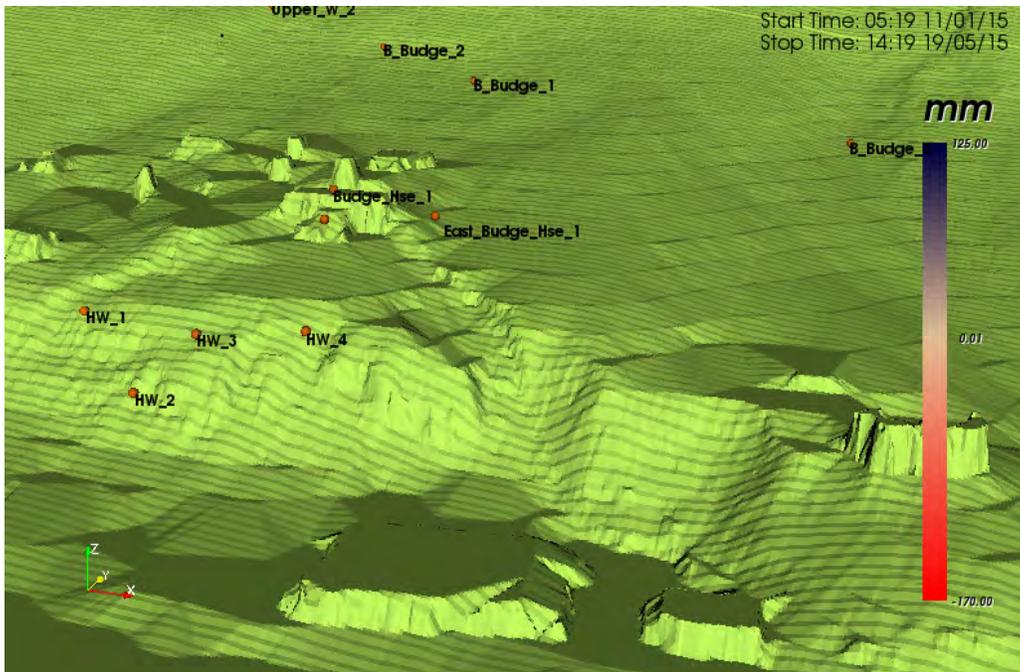
Figure 21: BUDGE_DTM - With Points at Budge House, behind Budge House and Across Slide Headwall.

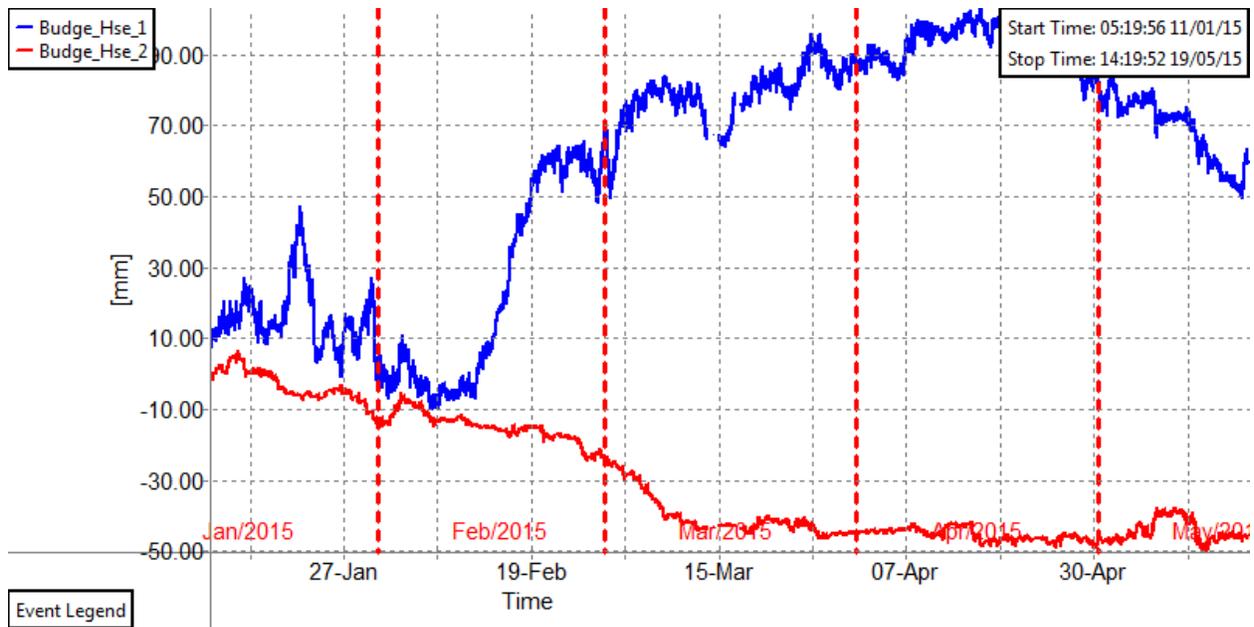
Figure 22: BUDGE_Points - Budge House Points - Upper (1) and Sheared (2) sections. See Figure 21.

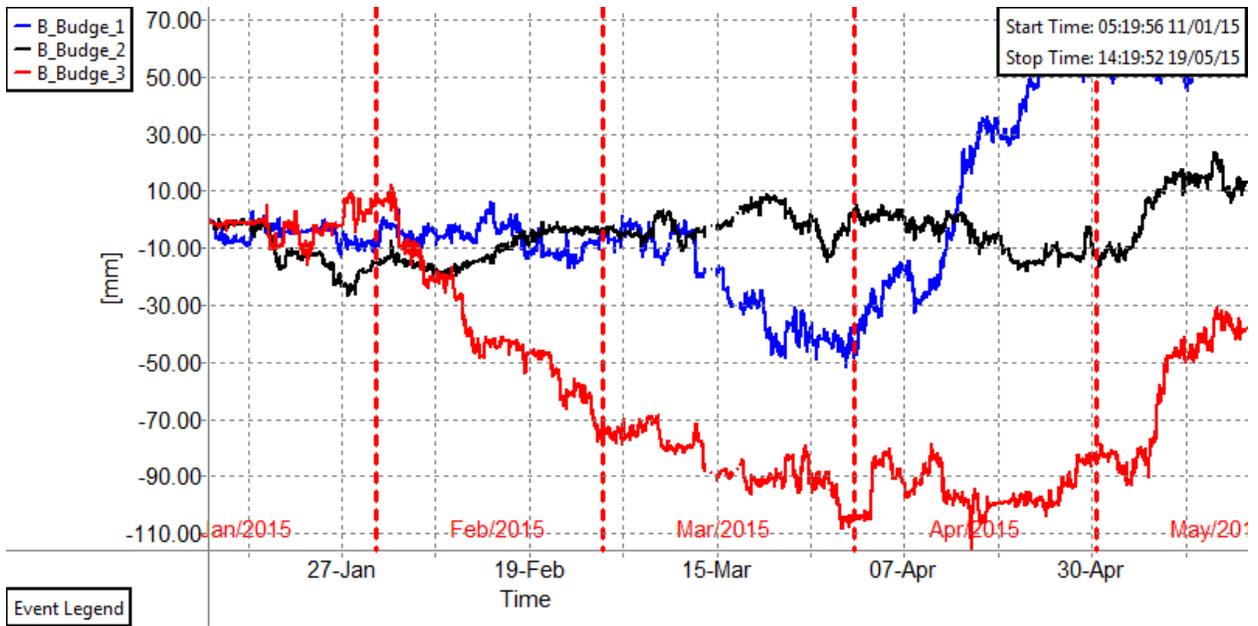
Figure 23: BUDGE_Points - Behind the Budge Home - See Figure 21.

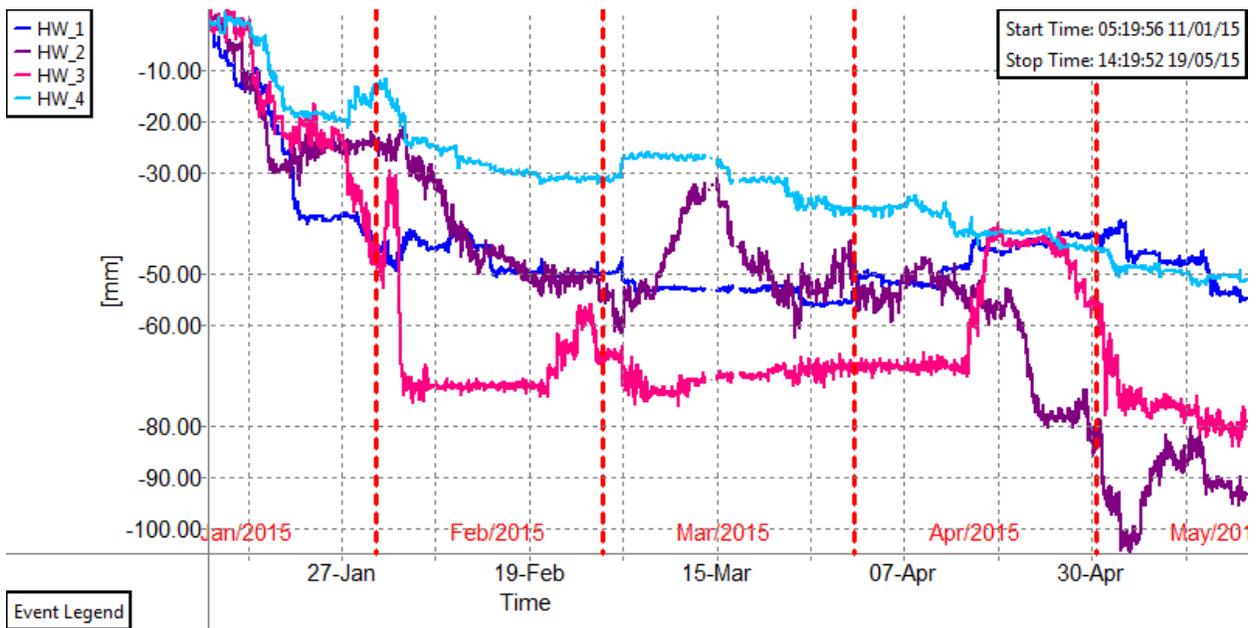
Figure 24: BUDGE_Points - Four Points Selected Across Slide Headwall.

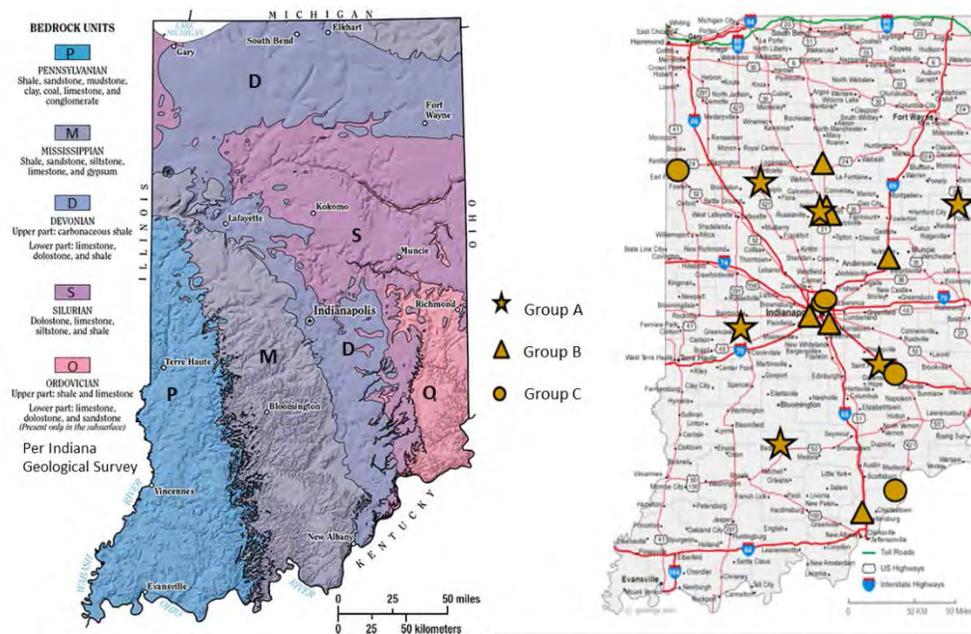
Figure 1: Bedrock map of Indiana and location of aggregate quarries selected for testing [1].

A total of eighteen carbonate aggregate samples were selected from fourteen Indiana quarries to represent statewide variation in geology and D-cracking performance. The aggregate samples were grouped into three D-cracking performance groups: Group A -aggregates known to be durable, Group B – aggregates known to be non-durable aggregates, and Group C - aggregates with variable or unknown performance. Each group consisted of six aggregate sources. Table 1 provides a list of the rock formations and geologic age of the eight aggregate sources. Table 2 gives the megascopic description of the aggregates. Figure 1 shows bedrock geology of Indiana and location of aggregate quarries sampled for testing in the course of this study.

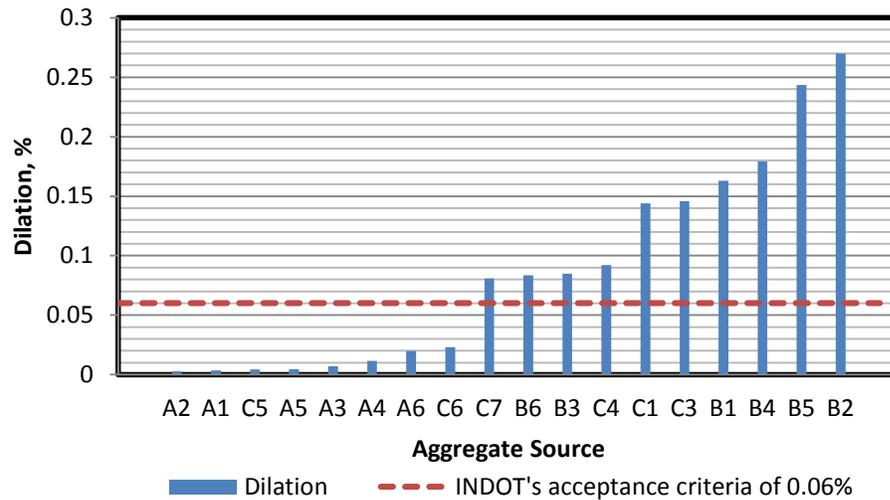
Figure 2: Percent dilation compared against INDOT's acceptance criteria.

Based on INDOT's 0.060% expansion acceptance criteria, all aggregate sources in Group A and two sources in Group C (C5 and C6) passed the freeze-thaw test while all sources in Group B and four sources in Group C tested as non-durable with dilation exceeding 0.060% expansion (as shown in Figure 2 and in Table 3). All the durable aggregates had dilations equal to or less than 0.023% and DF equal to or greater than 94, and all the non-durable aggregates had dilations equal to or greater than 0.081% and DF equal to or less than 86. The range of both the dilations and the DF for the non-durable sources are ten times wider than those of the durable sources. There was excellent correlation between percent dilation and durability factor which yielded an R-squared value of 0.91 [1].

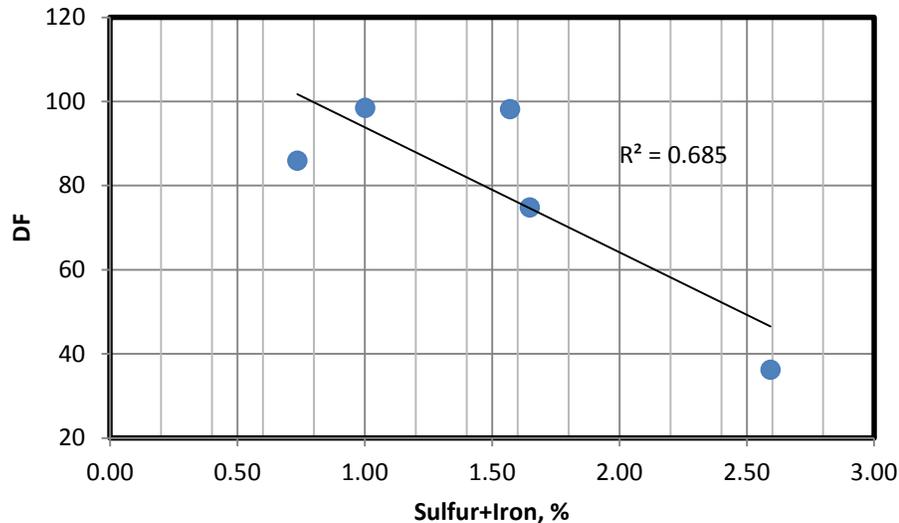
Figure 3: Relationship between DF and Sulfur+ Iron content

Sulfur and iron contents combined correlated with DF yielded an R-squared value of 0.685. As shown in Figure 3, as the combined content of sulfur and iron increased, the durability factor (DF) decreased.

The significant effect of iron content on the aggregate durability properties is seen in aggregate source B2 that had twice as much iron as any other sample tested. This might be the reason that this aggregate source is the least durable. This perhaps should not be surprising as some DOTs consider pyrite (FeS_2) a spalling material susceptible to pop-outs from freezing and thawing and restrict the amount allowed in concrete gravel sources [4]. If the correlation shown in Figure 3 holds true for other aggregate sources, it would imply that identifying the amount of iron and sulfur may provide a quick indication of the freeze-thaw performance.

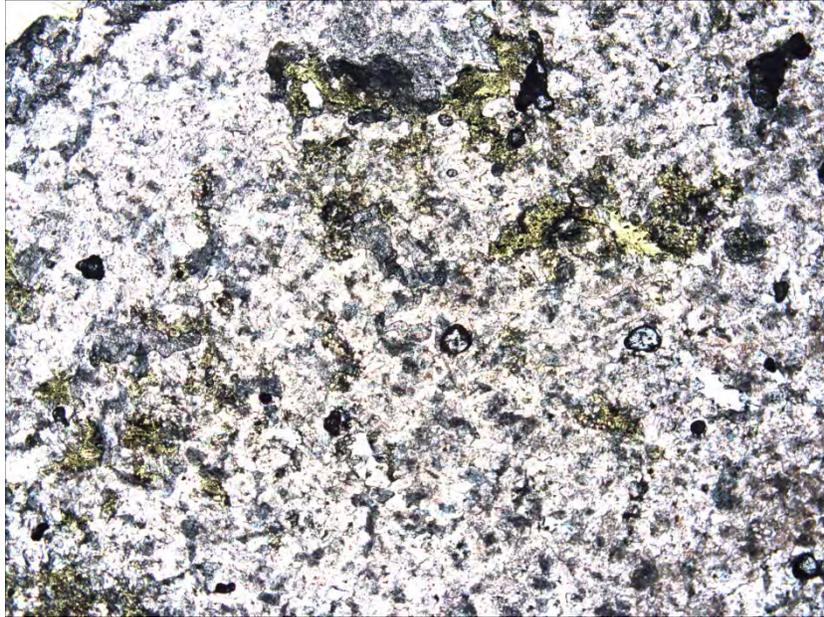
Figure 4: Photomicrograph of aggregate source A1 (field width 4mm)

The thin section analyses revealed that both samples from St. Genevieve Formation, A2 and A4, were fossiliferous limestone from Mississippian period. Almost half of the aggregate sources sampled from the Silurian period are durable and the remaining being non-durable. Of the dolomitic limestone sources, 70% of them were non-durable; the durable ones being A6, C5, and C6. Fine-grained dolomite sources (A3 and A5) appeared to be durable. All pure dolomite sources (A1, A3, and A5) were durable with the exception of C1. Aggregate sources containing large pores (ie: vuggy = pores larger than grains or crystals) (A1, A3, A5, and C5) were found to be durable. Figure 4 shows micrograph of aggregate from source A1 showing large pores (some of them highlighted by the presence of yellow epoxy in the voids).

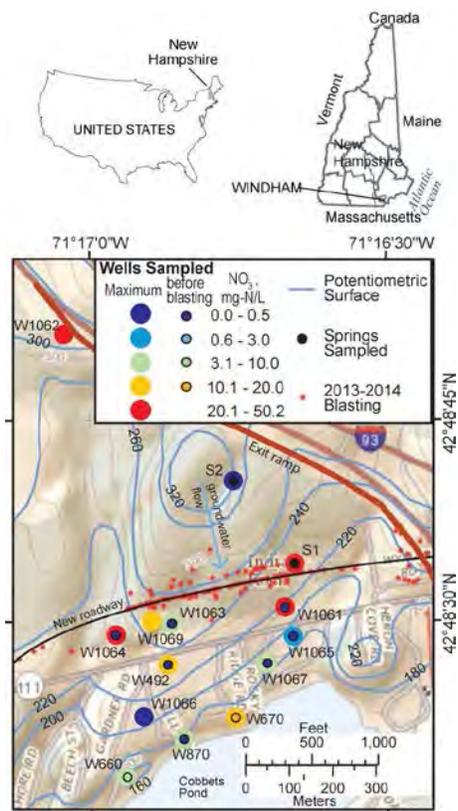
Figure 2. Potentiometric surface map, sample locations, blasting locations

The study area is covered by thin (<3m) layer of glacial till overlain by metamorphic bedrock. A potentiometric surface map from existing water level data was generated with available information (figure 2). In general groundwater flow was southward toward Cobbetts Pond with local various relative to topography. Developed areas have bedrock aquifer water-supply wells and septic systems for residential and commercial wastewater disposal.

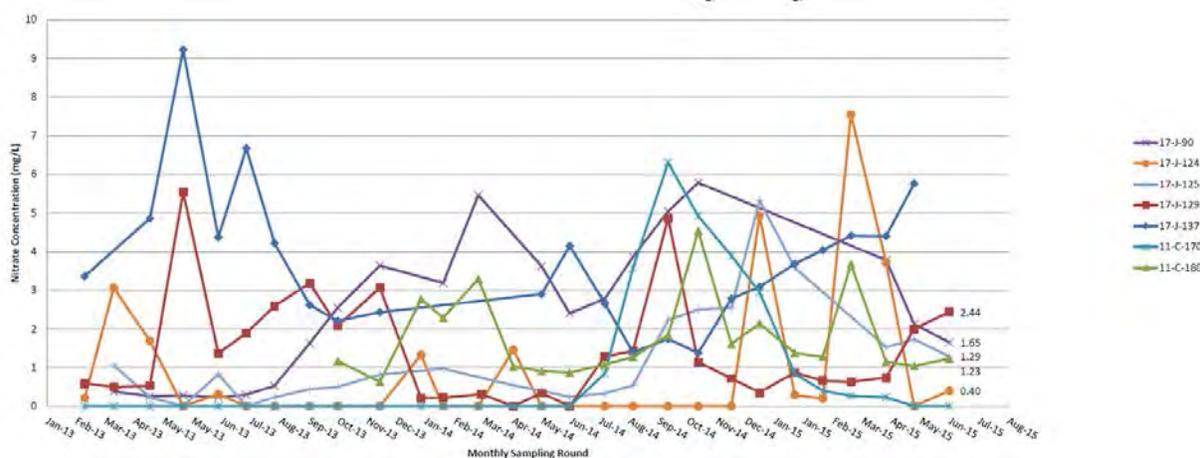
Figure 3. Nitrate contamination over time

As additional locations of blasting became more scattered as the work progressed based on construction scheduling and operations trends became less predictable. Overlap of impacts between contracts became a consideration. Figure 3 shows the trends in nitrate concentration alone which exhibited substantial variability with nitrate over time. In addition due to the densely populated nature of the study area and the numerous septic systems and other potential sources of nitrate the need to be evaluated. As a result the study was developed to evaluate the use of nitrogen and oxygen isotope ratios to assess if the attributing factors could be determined.
