66TH HIGHWAY GEOLOGY SYMPOSIUM SEPTEMBER 14-17, 2015

2015 Proceedings

*Massachusetts Department of Transportation
and
University of Massachusetts Amherst*

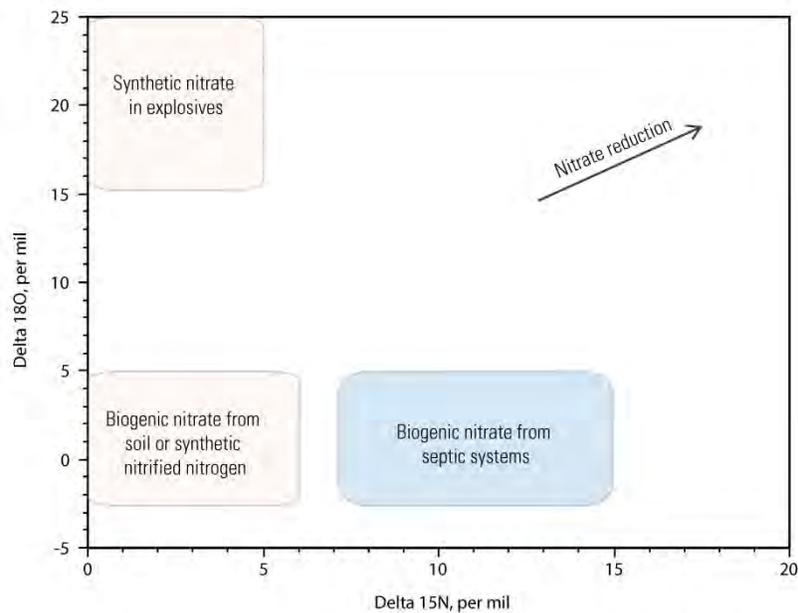
Figure 3. Graphs showing relation between delta15N and delta18O of nitrate.

Blasting related nitrate peaks were characterized by low d15N and high d18O which is indicative of synthetic nitrate used in explosives. Additionally, the nitrate concentrations were unusually high in select wells near the blasting activities for short periods of time. Groundwater with blasting-related nitrate moved rapidly from the construction site to downgradient wells in the time frame of months and decreased to below regulatory standard over the time of year(s). In wells located in developed land use settings such as adjacent to Cobbetts pond with septic systems, located the furthest downgradient of the site, had relatively stable nitrate concentrations. Septic effects were identified with moderately high nitrate levels with elevated Mn, CL, and Ca. These locations also had higher d15N and lower d18O falling in the range of biogenic nitrate (Figure 3).

Figure 3: Graph showing D15N and D18O of nitrate sources

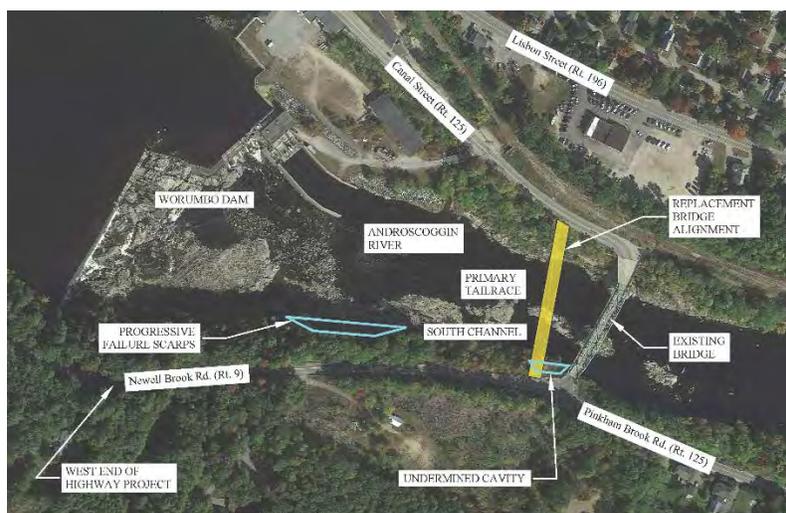
Figure 1 – Project Site

The existing bridge carries Route 9/125 (Canal Street) over the Androscoggin River in Durham and Lisbon as shown on the annotated aerial photograph, **Figure 1**.

The replacement bridge is planned to consist of a 340-foot-long, two-span bridge with a steel plate girder and cast-in-place concrete deck, the approximate location of which is shown on **Figure 1**. The bridge will be supported on full-height cantilever abutments with wingwalls and a concrete pier, each supported by a spread footing bearing on bedrock. A single pier (Pier 1) is proposed to be located on the northern portion of the same bedrock pinnacle that provides footing support for existing South Pier.

The highway reconstruction project extends approximately one-half mile along Route 9 westward from the Route 125 bridge, as shown in **Figure 1**. The roadway is perched toward the top of a steep slope that extends down to the south bank of the Androscoggin River. Progressive failures have occurred along the riverbank slope below the roadway 500 to 700 feet west of the existing bridge. Bedrock outcrops are present at the bottom of the scarps. Representative photographs of the scarps taken during our work at the site are shown on **Figure 4**.

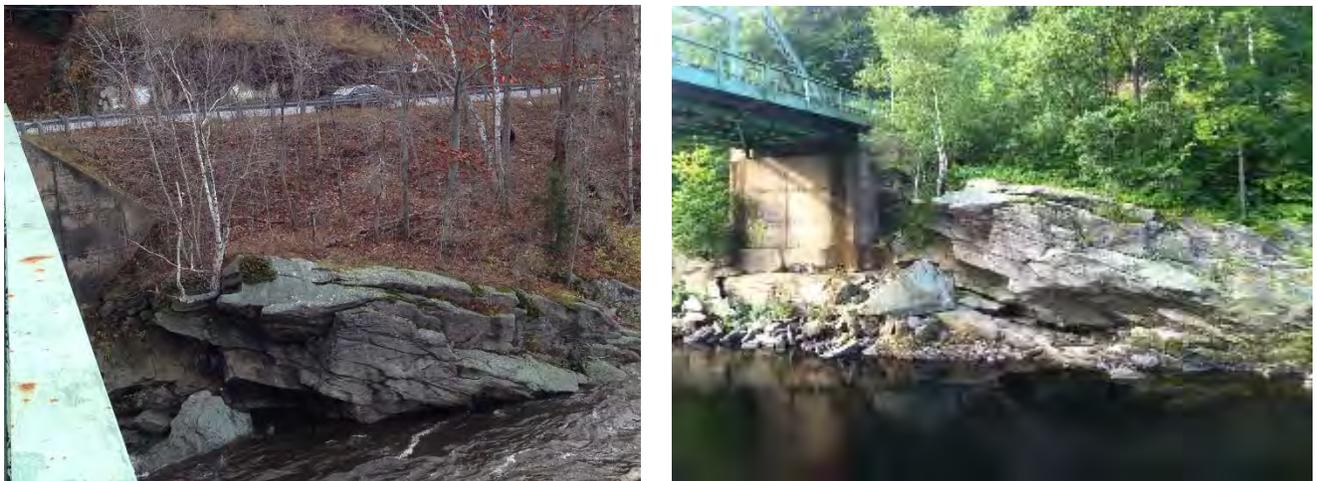
Figure 2 – Undermined Area, Durham Abutment

The most significant undermining occurred between the existing and proposed Durham abutments, where the height of the undermined area was approximately 20 feet and the depth extended approximately 10 feet behind the face of the slope. Large rock blocks were present at the base of the largest undermined area (approximately 40 feet Rt. of proposed baseline), assumed to have fallen out from the undermined area. The rock slope above and upstream of the undermined area is near vertical. The base of the near vertical/undermined portion of the rock slope was between El. 67 and El. 75. The approximate plan limits of the undermined area are shown on **Figure 1** and representative photographs are shown on **Figure 2**.

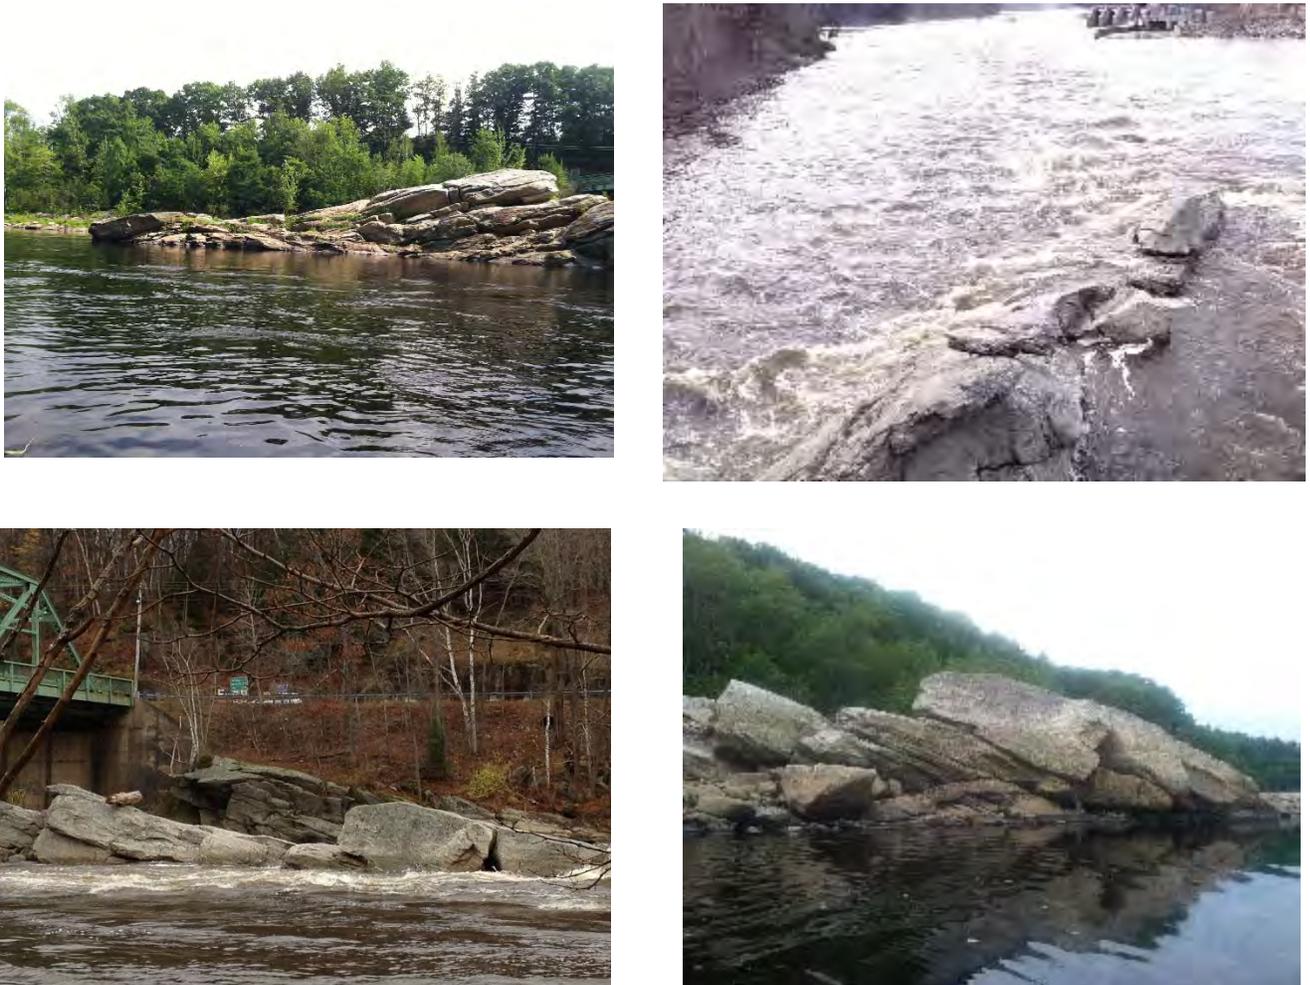
Figure 3 – Bedrock Pinnacle, Center Pier

The bedrock pinnacle that supports the existing South Pier and is proposed to support Pier 1 is oriented nearly parallel to the run of the river. The top of the pinnacle varies between approximately El. 75 and El. 85. The pinnacle extends down to the river bed in the south channel between about El. 60 and El. 65 and in the lower tailrace at approximately El. 50 to El. 54. Representative photographs are shown on **Figure 3**.

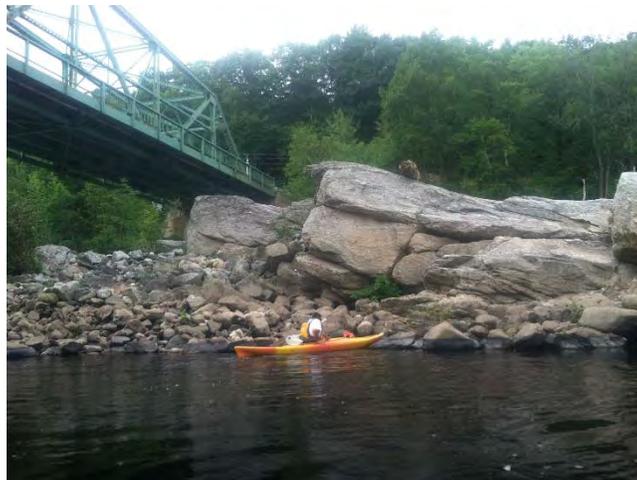
Figure 5 – Bedrock Field Mapping by Kayak

Geologic field mapping was undertaken on the exposed outcrops within, along and adjacent to the river to provide data for evaluating the stability of the rock mass in the area of proposed foundations. A GZA engineer made direct measurements of bedrock joints and features on existing exposures. A Brunton compass was used to collect strike and dip measurements on 53 features. Outcrops within and along the riverbank were accessed using kayaks, as shown on **Figure 5**.

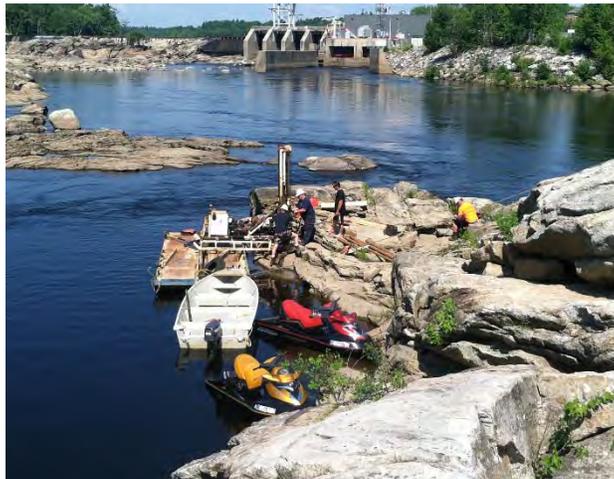
Figure 6 – Test Boring at Bedrock Pinnacle

Each boring was cored to an elevation corresponding roughly to the bottom of the adjacent riverbank or tailrace/channel. ATV and OTV borehole viewer surveys were conducted in each boring. The test borings were completed using a skid-mounted drill rig, which was placed over the Route 9 guardrail using a crane for the Durham abutment borings and transported up river on a pontoon barge and skidded partially off of the barge for drilling the pier boring. The skid drill rig configuration for the pier boring is shown in **Figure 6**.

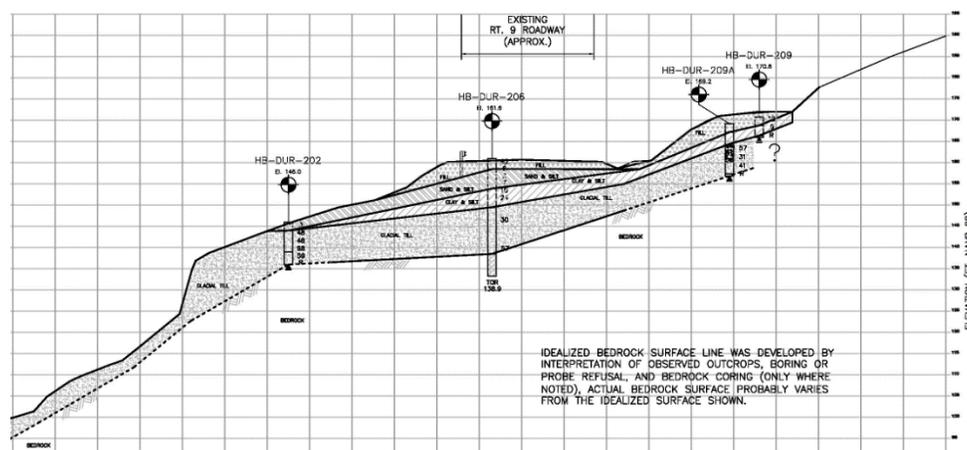
Figure 7 – Idealized Subsurface Profile through Failure Scarp

Subsurface stratification was evaluated at three cross sections based primarily on straight-line interpolation of the strata between adjacent borings located on the same section. The idealized subsurface profile developed to analyze one of the progressive failure areas is shown in **Figure 7**.

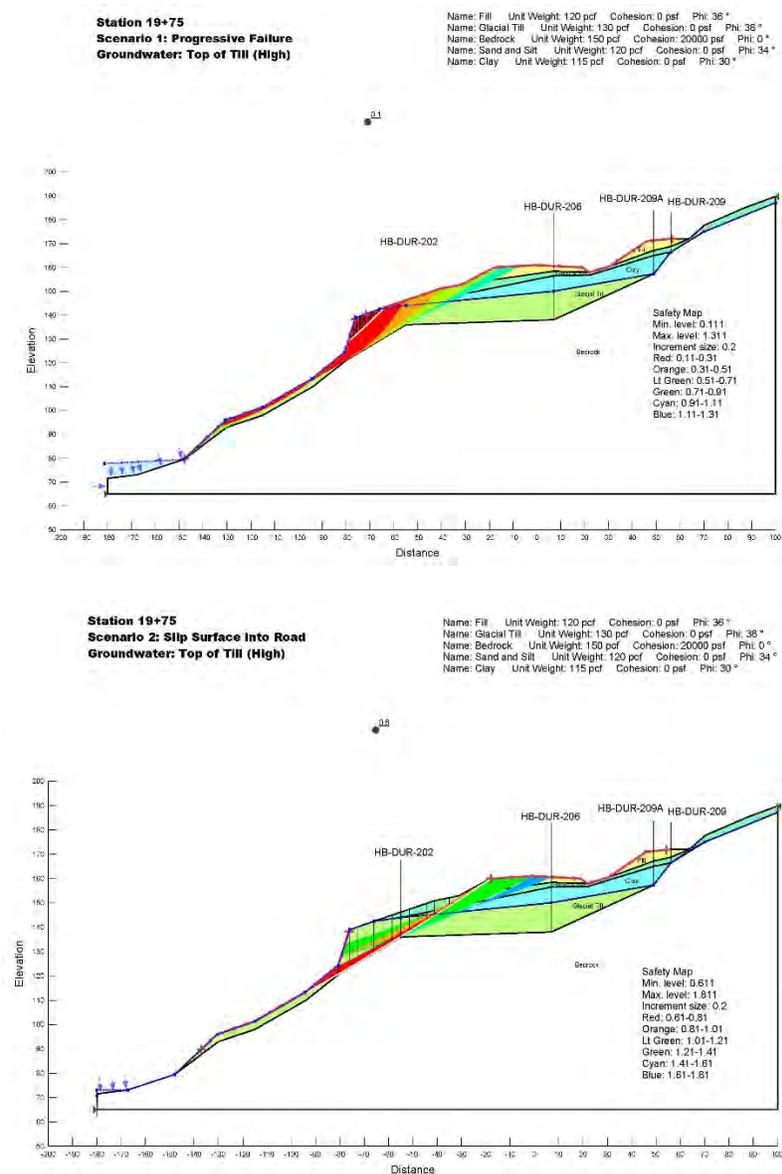
Figure 8 – Representative Slope Stability Output

Figure 8 shows representative results of GZA’s Slope/W analyses for Scenario 2. These results indicate that the calculated minimum factor of safety against rotational failure is less than 1 and is therefore unacceptable. AASHTO LRFD guidelines consider a minimum factor of safety of 1.3 acceptable for a slope that does not support or contain structural elements. Although a failure of the existing slope that extends into the roadway is considered unlikely in

the short-term, it was considered necessary to stop the migration of the progressive failures to protect the road over the longer term.

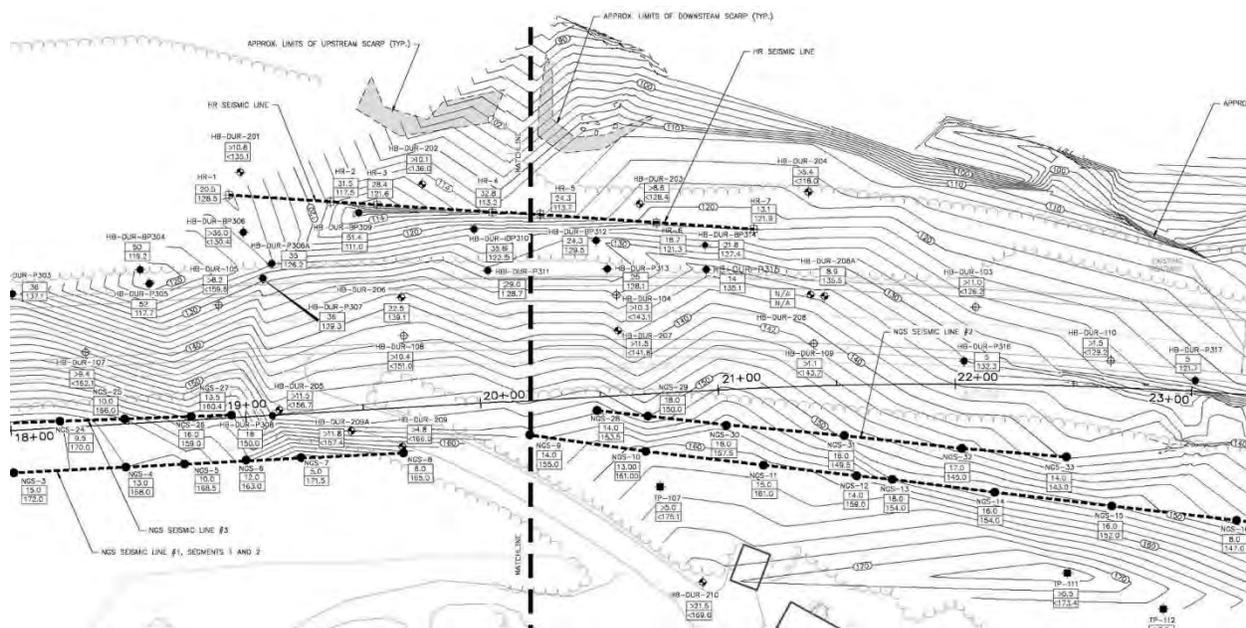
Figure 9 – Bedrock Elevation Contour Plan

GZA plotted the observed and interpreted bedrock elevation data from all available subsurface investigations, surface geophysical data and bedrock exposures in the Route 9 slope area. Initially, a top of rock elevation contour plan was developed that linearly interpolated between all of the points with no manual adjustments. Detailed review was required to assess locations where bedrock was shown to daylight above the existing ground surface and where it didn't match well with the bedrock exposures. Through this process, additional "dummy" bedrock elevation points were added to the model using engineering judgment in an effort to provide more realistic output. GZA developed a bedrock elevation contour plan and provided it to Stantec as an electronic document, which was then used to create ledge lines by cutting sections through the contours. An excerpt from the plan is shown in **Figure 9**.

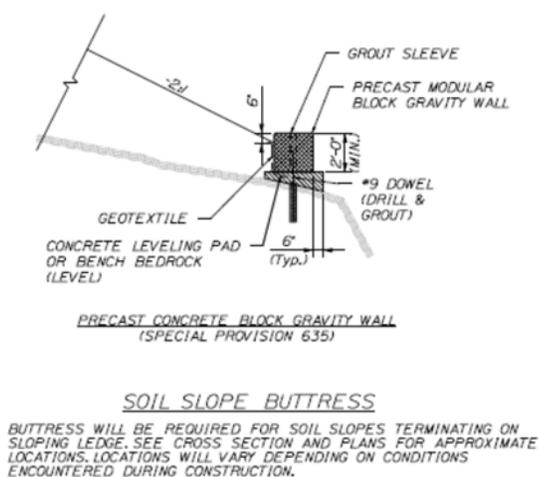
Figure 10 – Slope Buttress Detail

The design team identified a potential stability concern for the cut slope toe terminating on rock. Seepage along the bedrock surface that daylighted at the toe of the soil slope could destabilize the toe of the slope, especially if it occurred before the slope was well vegetated. GZA and Stantec considered several options to promote stability at the toe of slope, including a bedrock key, and gabions and precast concrete blocks to act as a toe buttress. The preferred solution was a precast concrete slope buttress detail, which included regularly spaced rock dowels extending through the blocks, to allow them to be constructed on a sloping bedrock surface. The final slope buttress design detail is shown on **Figure 10**.

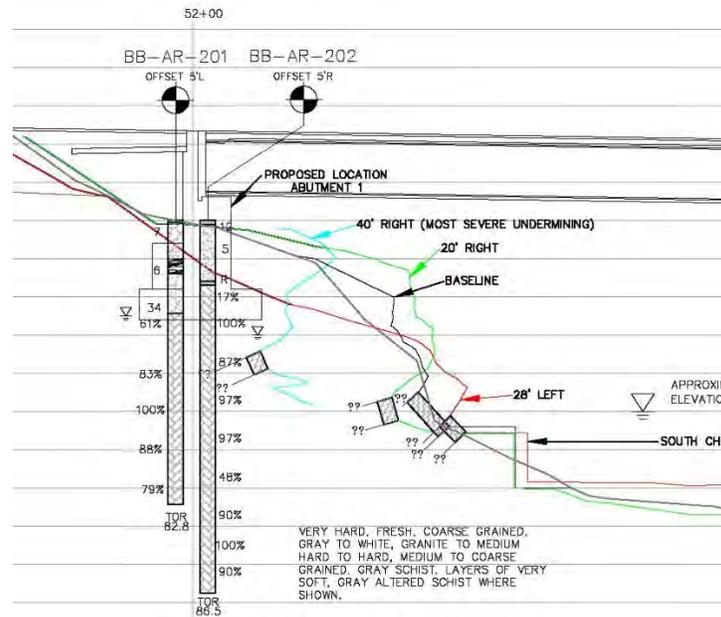
Figure 11 – Cross Sections through Undermined Rock

GZA developed a three-dimensional surface of the rock slope in AutoCAD using the MaineDOT Microstation files from their scanning survey and tied that data to known survey points at the boundaries of the MaineDOT survey. GZA interpreted the survey data provided by MaineDOT to develop two-dimensional cross sections of the undermined areas at the selected locations (28 feet Lt., Baseline, 20 feet Rt., and 40 feet Rt.) near the proposed Abutment 1, which are presented on **Figure 11**.

Based on the sections through the undermined cavity, it was found to be outside of the zone of influence of the proposed Durham abutment footing. However, the configuration did not appear stable, and additional loss of rock from the top of the undermined cavity could eventually threaten the rock supporting the footing.

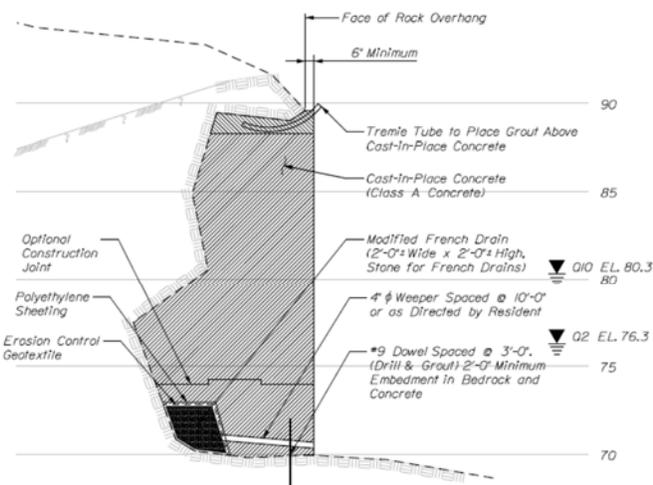
Figure 13 – Stabilization Buttress Design Detail

SECTION - ROCK OVERHANG STABILIZATION
(SECTION TAKEN DOWNSTREAM OF PROPOSED DURHAM ABUTMENT)

To protect the new Durham abutment from undermining, a concrete buttress was designed to fill the undermined cavity, thereby retaining and protecting the exposed weak rock at the back of the undermined zone and supporting the overhanging rock mass to prevent additional loss of the rock face. The buttress was recommended to be supported on a clean, sound bedrock surface and to consist of structural concrete. Vertical dowels were recommended for lateral base resistance, and a French drain with weep holes through the buttress was recommended to prevent buildup of hydrostatic pressure. The buttress length was estimated to be 50 feet, but the limits couldn't be accurately determined on paper because of the highly variable conditions, so it was recommended that GZA assess the limits during construction. The design detail for the buttress is shown below in **Figure 13**.

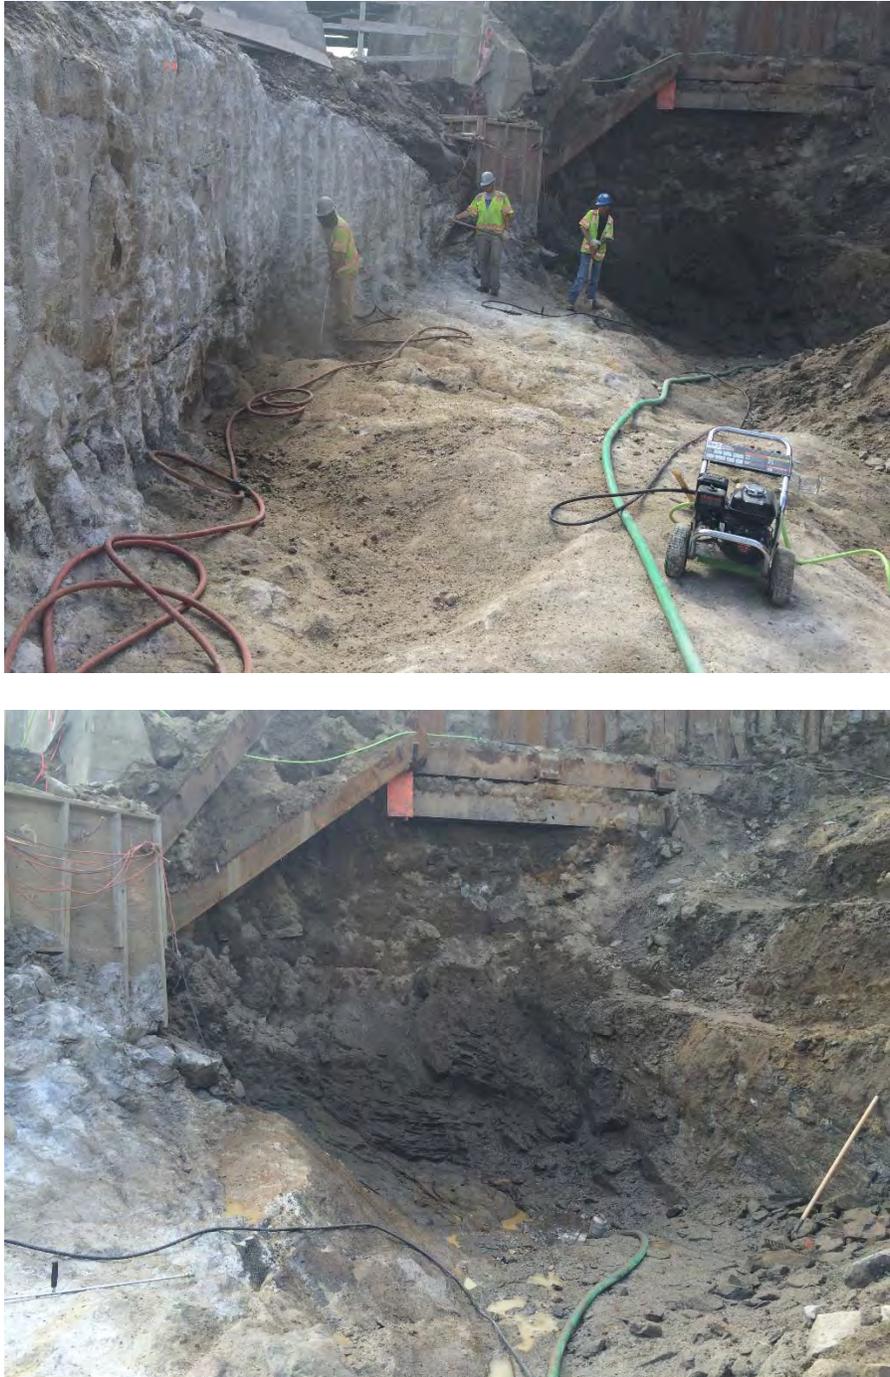
Figure 19 – Line Drilling to Excavate Granite Intrusion (top) and Contact Zone between Granite and Altered Schist (bottom)

Foundation excavation activities at the Durham abutment exposed bedrock geology that was remarkably similar to the profile shown above in **Figure 18**, and also highly unusual in Maine. The very hard granite was encountered at the river side of the abutment footing, as high as approximately El. 89, or 7 feet above design bearing level. Due to blasting restrictions near the river, the contractor line drilled the excavation perimeter and hoe rammed to remove the granite, as shown below on **Figure 19**. The top of the granite dipped down at an angle of roughly 30 degrees towards the south, across the width of the footing and away from the river. Within the width of the abutment and wingwall footings, the granite surface dipped down below the design bearing level (El. 82), where variably altered schist was exposed at the contact. The contact zone between the schist and the underlying granite intrusion is shown in **Figure 19**, which is looking east at the east end of the wing wall foundation. Significant portions of the wingwalls and the back of the abutment footings were supported on moderately hard schist, but GZA observed the conditions to ensure that the softer altered schist was completely removed where exposed below the foundation bearing level to provide bearing support consistent with the design recommendations.

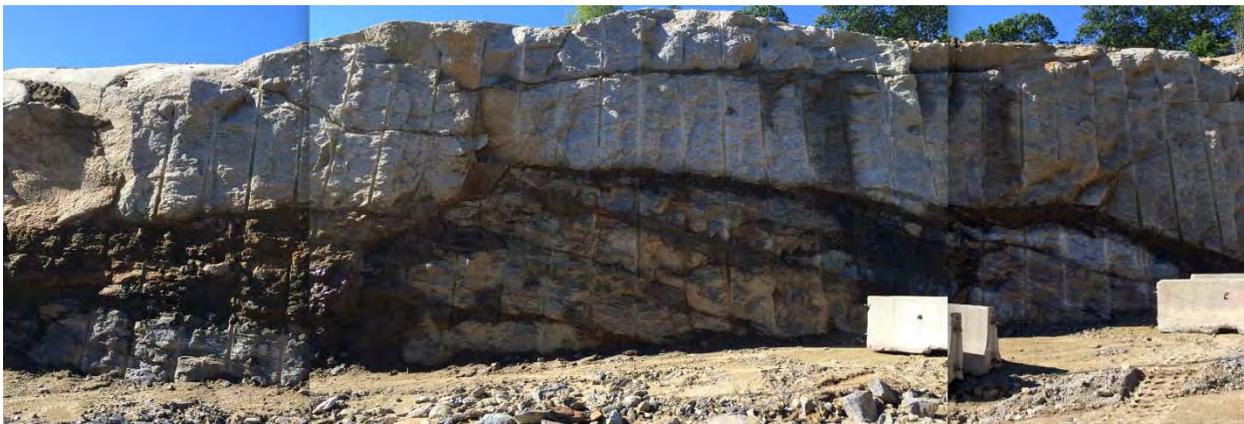
Figure 20 – Granite Intrusion over Altered Schist in Roadway Cut

The roadway construction required blasting to the south of the realigned Route 9, south of the river. The completed rock slope also shows a contact between schist below, and granite above, and again, a variably altered schist layer is present near the contact, as shown in **Figure 20**. We observed seepage of water from the altered schist during a site visit in August 2015, despite a fairly dry period before. The sequence shown in **Figure 20** is indicative of another granite intrusion above the schist well above the Durham abutment area.

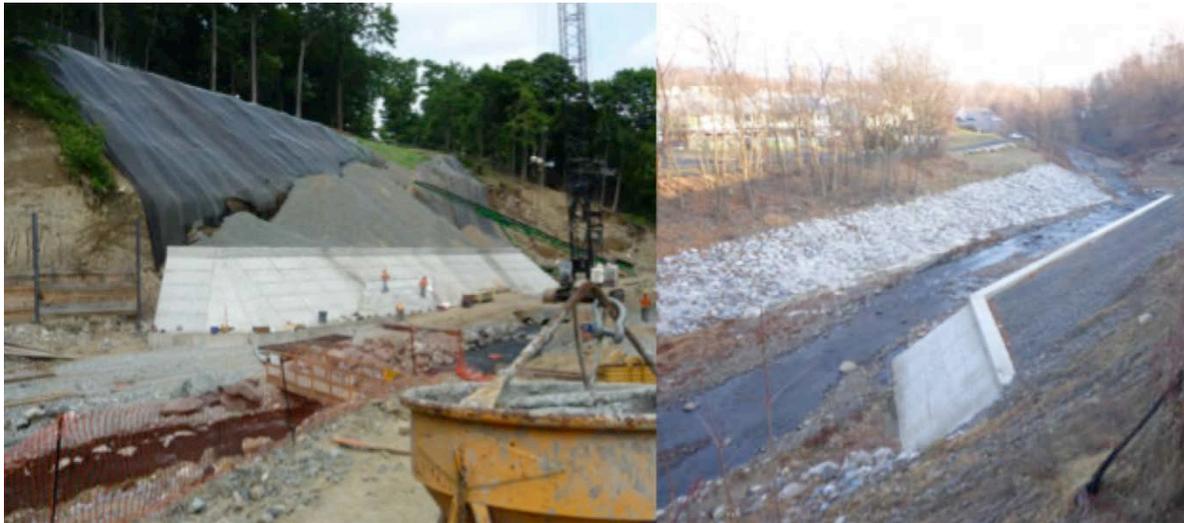
Figure 2 – Phase 1 Utility Crossing Stabilization

A subsurface investigation was completed to determine the engineering properties of the soil to complete stability analysis to design the stabilization system to protect the utilities. The investigation included borings, inclinometers, and piezometers. The first phase of design and construction was to stabilize the stream crossing within the limits of the Orange & Rockland Utilities Right of Way. This phase included a concrete buttress founded on micropiles along the south embankment and grouted riprap on both sides of the creek for a length of approximately 300 feet.

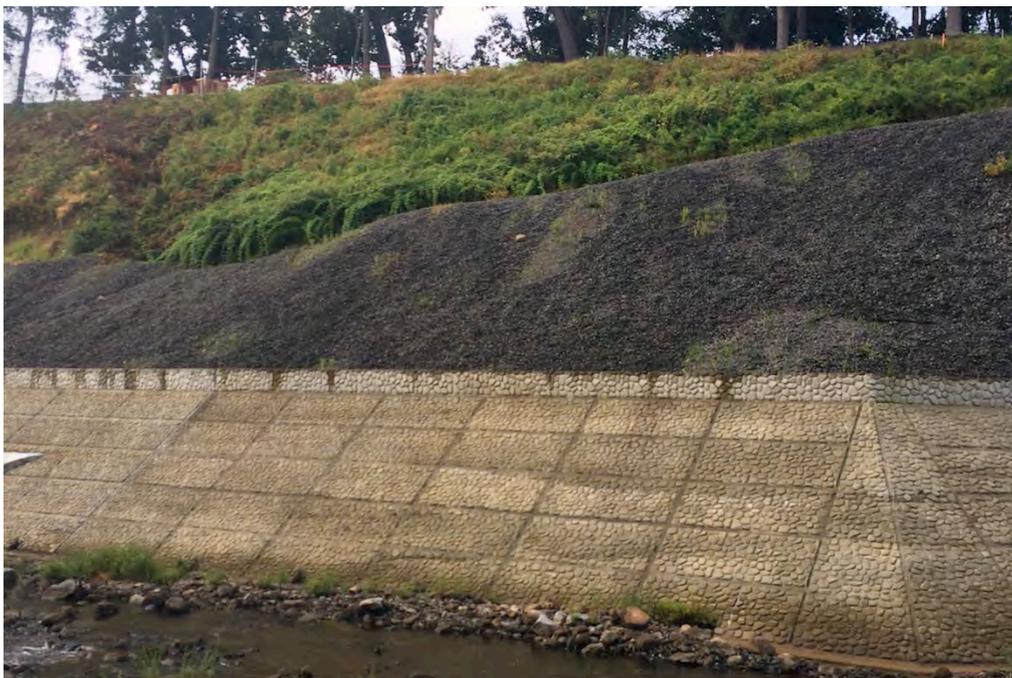
Figure 3 – Phase 1 Concrete Buttress at South Embankment

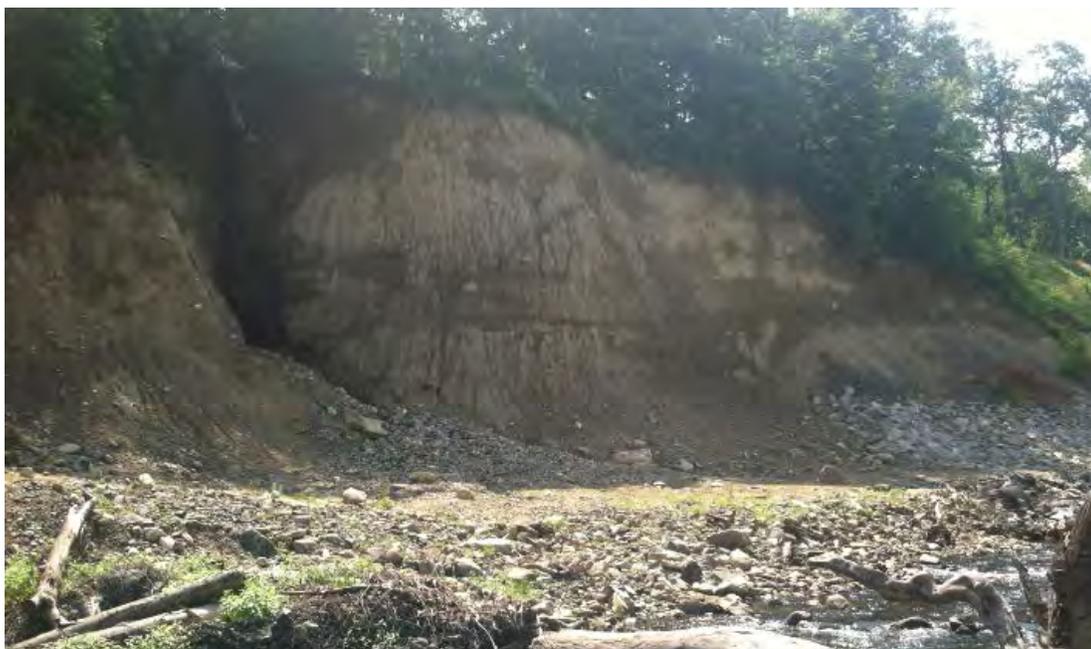
Figure 4 – South Embankment Downstream

At about 8 p.m. on Monday, October 29, 2012, approximately 14 months after Tropical Storm Irene and just months after the completion of Phase 1, Hurricane Sandy made landfall along the New Jersey shore. Storm surge, heavy rain, and high winds began causing significant damage to the entire region many hours before Sandy made landfall. Sandy left Rockland County with more than two times the power outages of Irene and a similar increase in the amount of damage caused. Damage included severe scour along Minisceongo Creek on both ends of the work completed during Phase 1. The south embankment downstream of the concrete buttress scoured 60 feet into the slope for a length of 337 feet, coming within feet of undermining the private property above. The south embankment upstream of the concrete buttress scoured for a length of 140 feet with near vertical slopes heights greater than 40 feet.

The near vertical slopes were temporarily protected by vegetation at the crest of the slope. The root masses temporarily confined the soil, allowing the slope to stand at a near-vertical angle in many locations. As the material eroded, the vegetation and roots became exposed and the trees and shrubs inevitably fell causing more of the slope to slough.

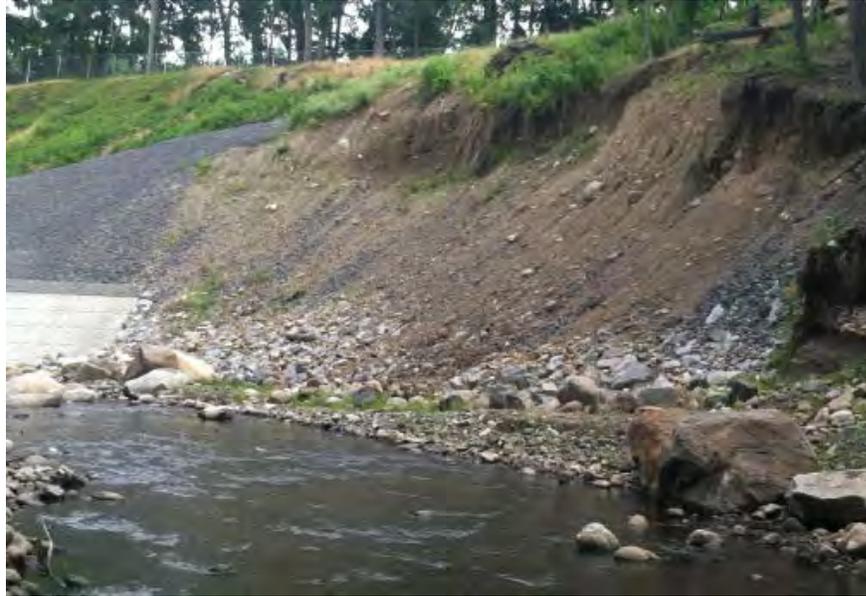
Figure 5 – South Embankment Upstream

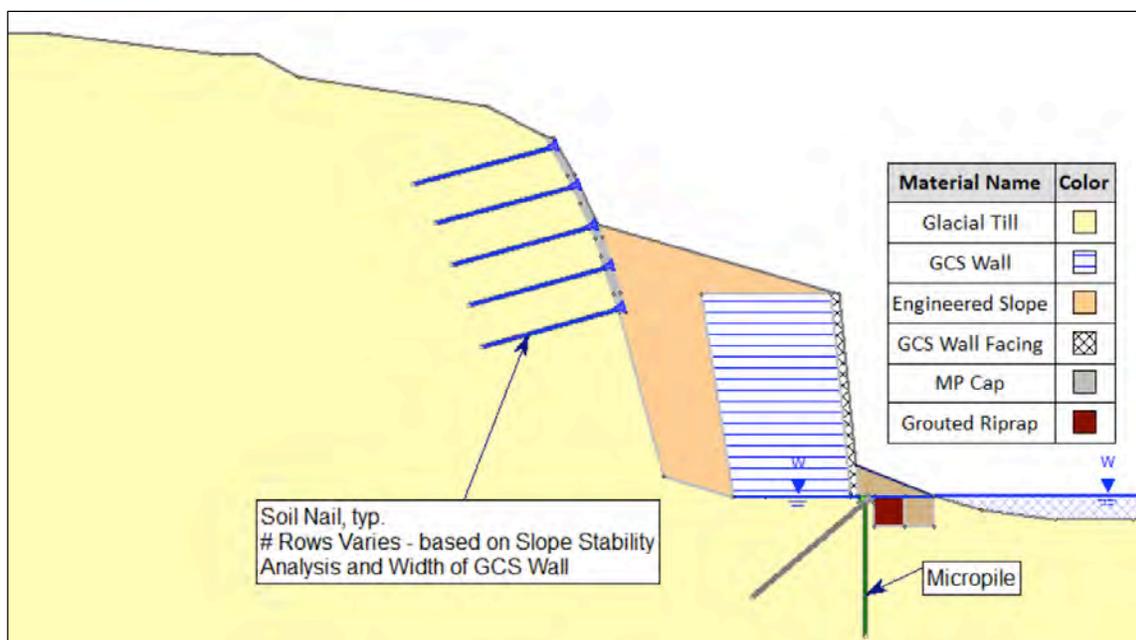
Figure 6 – Typical Downstream Cross-Section

Number 8, Grade 75 bar was used for the modeling due to its lower yield strength. The tensile capacity of the soil nails used within the model was 32,944 lbs. The soil nail pullout design strength was 6 psi (ultimate strength of 12 psi). This was verified in the field during soil nail verification testing. The pullout input used within the model was 904 lbs/ft (based on a 4 inch diameter drill hole). The maximum nail loading experienced in any of the modes was 2,862 lbs/LF of repair system. The nails were spaced at 6-feet on center and therefore the design facing load (T_{\max_s}) of 17,172 lbs.

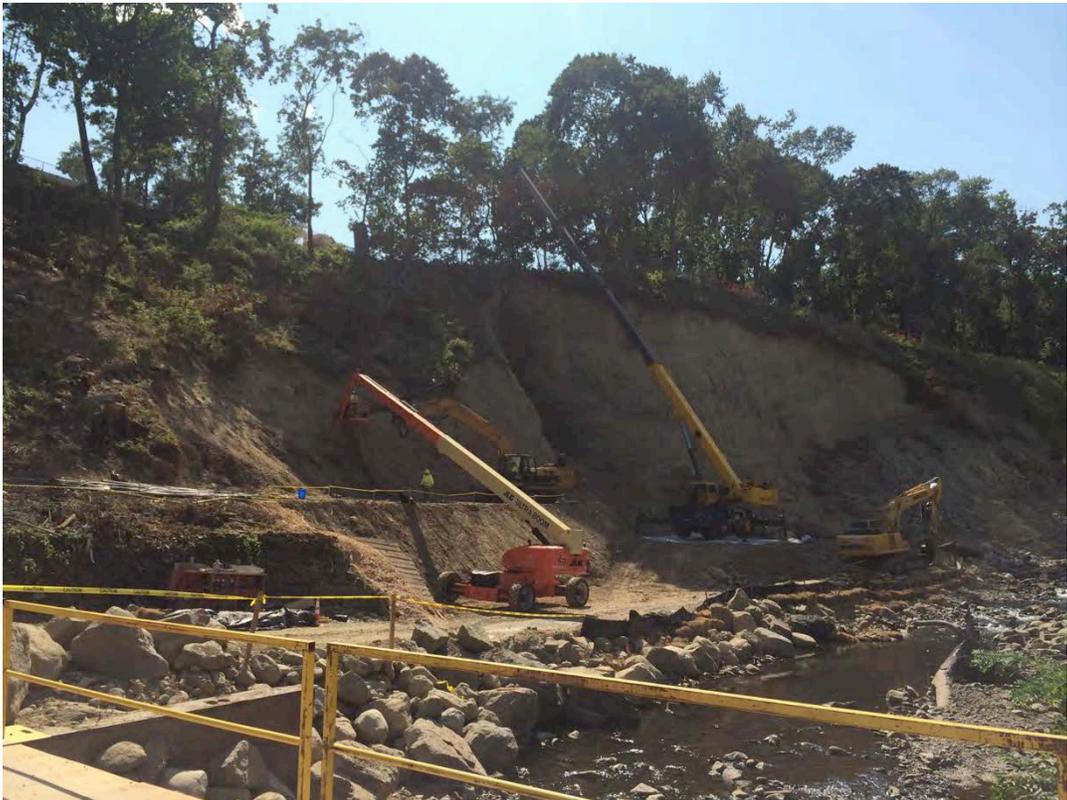
Figure 7 – Downstream Stabilization

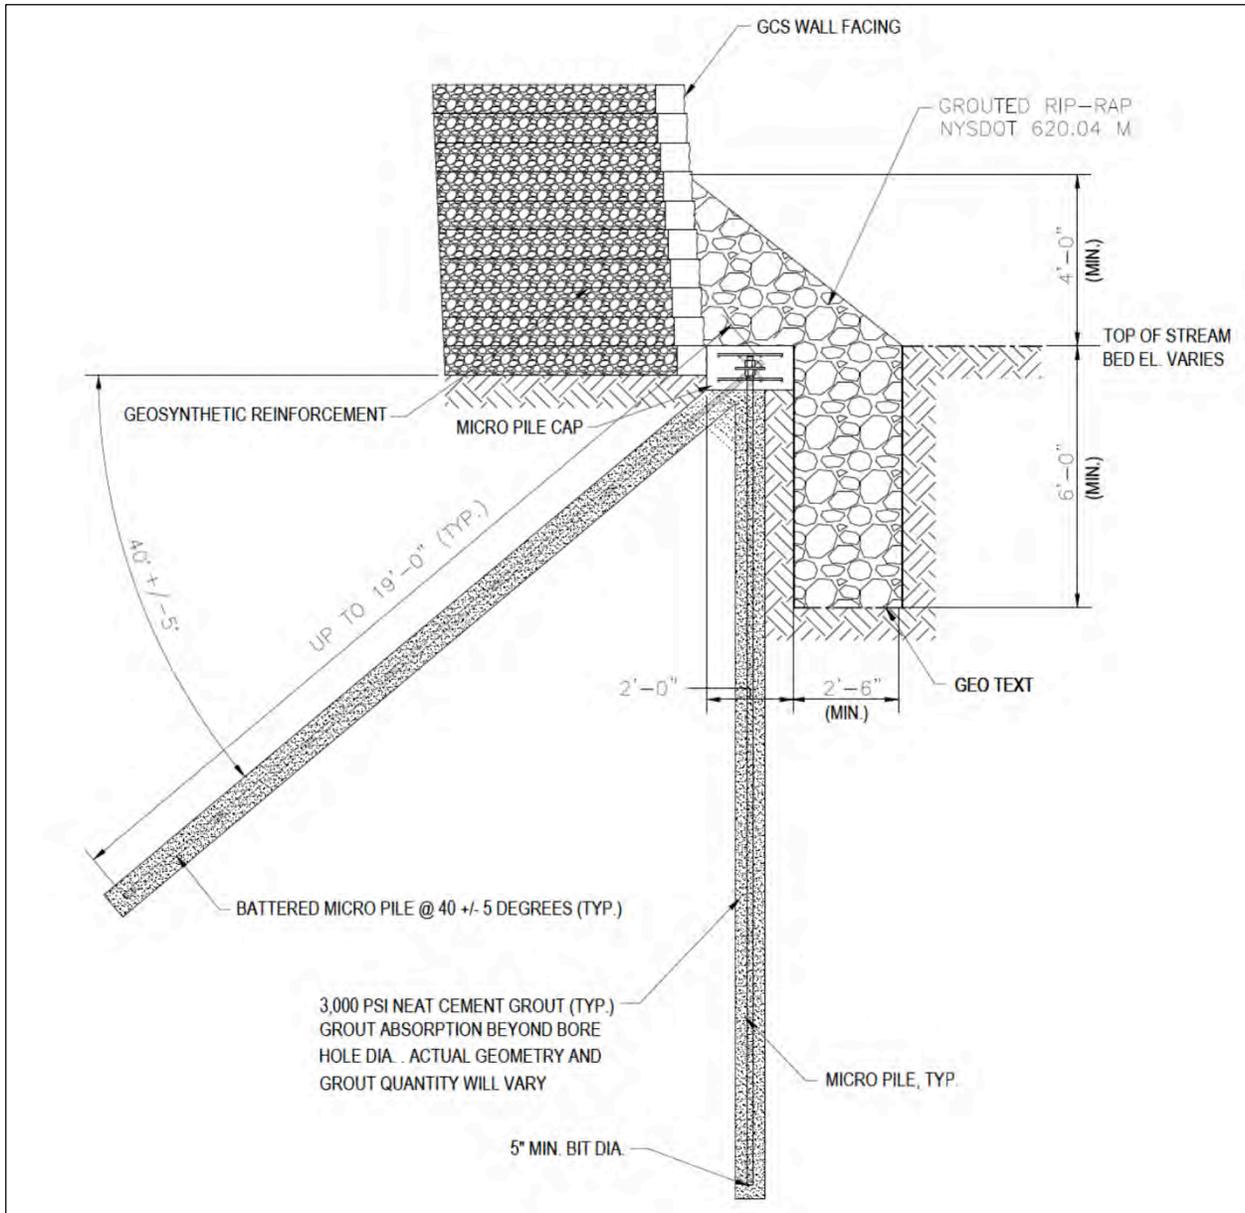
Figure 8 – Scour Resistant Micropile Cross-Section

Micropiles were installed within the system to resist scour and increase lateral capacity of the system. The micropiles were spaced every 18 inches along the base of the system for the entire length. Every third micropile was battered as shown in Figure 8 to resist buckling that may result from the GCS surcharge load in the event that scour occurs at a depth greater than four feet. The micropiles were pinned at the top and the tight spacing provided a subsurface “grout curtain” at depths of up to 19 feet.

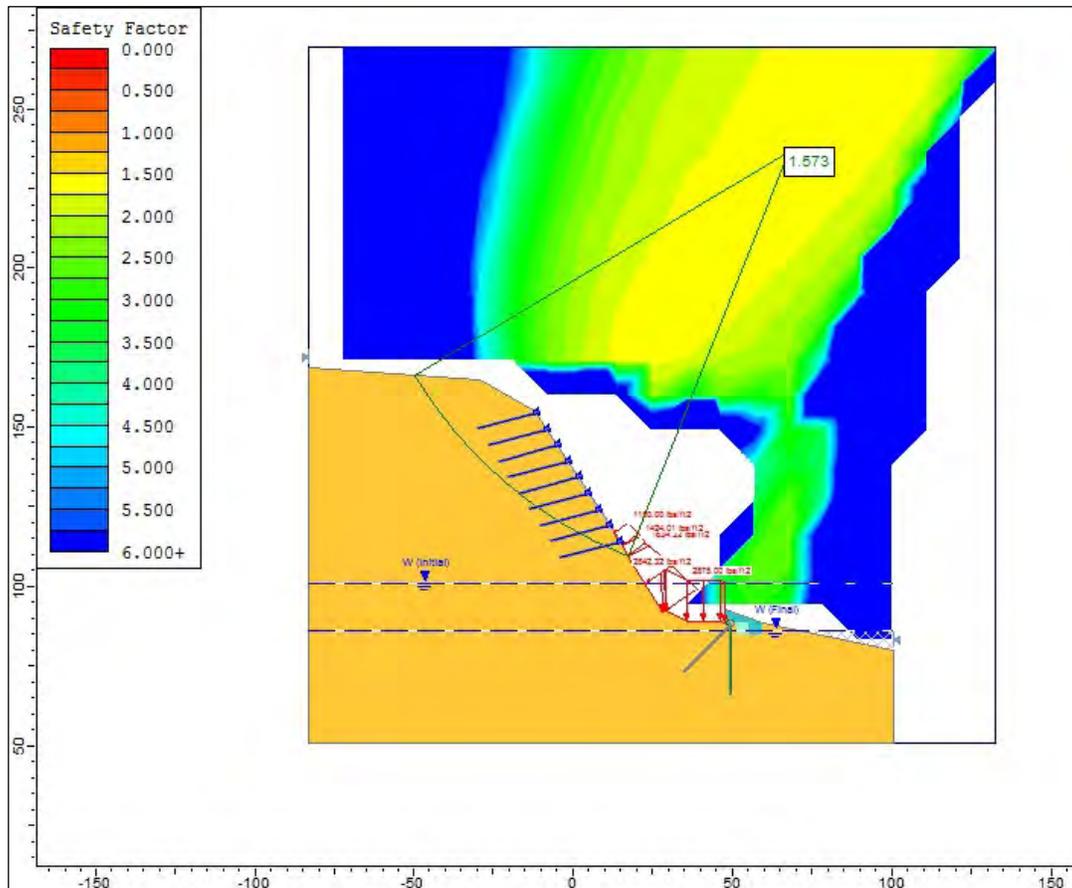
Figure 9 – Rapid Drawdown Modeling

All limit-equilibrium modeling included a storm event water elevation increase of 15 feet followed by a rapid drawdown event. Due to the permeability of the GCS wall and the weight of the system there was only minimal decrease in overall FS (>0.01).

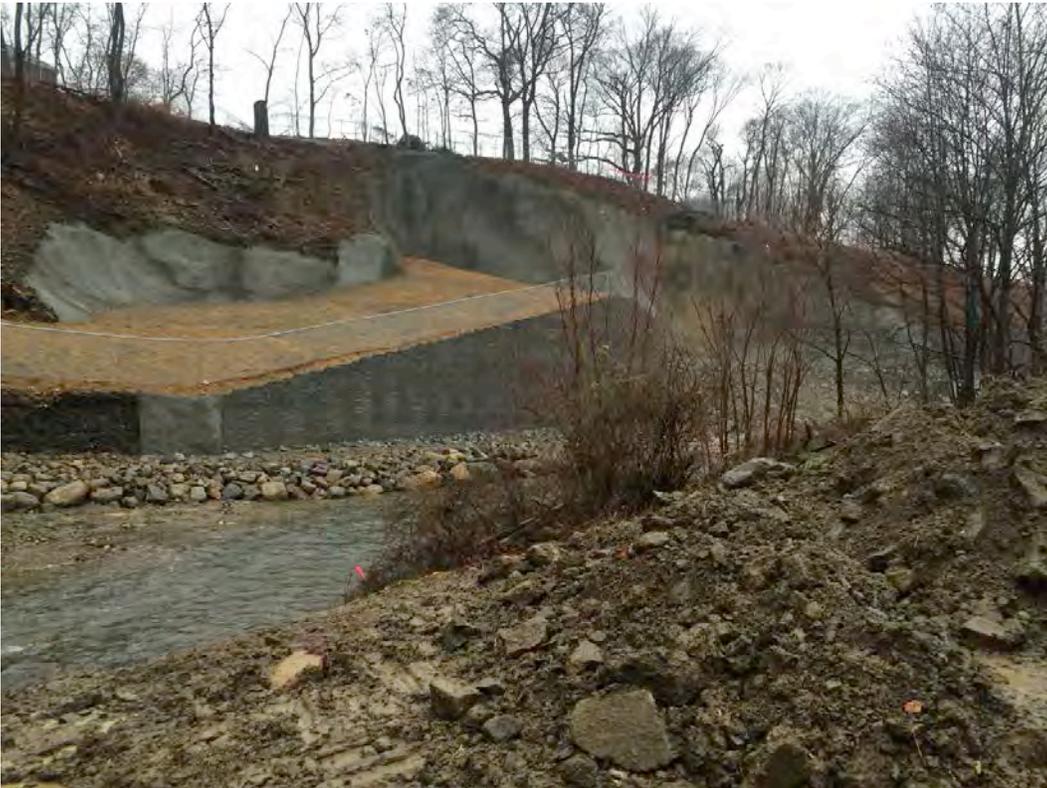
Figure 10 – Completed Project Upstream Section

The final project included over 18,000 linear feet of soil nailing which was completed with both track mounted and crane basket mounted drills, 17,800 SF of shotcrete, and over 5,000 SF of GCS wall. The project was completed in less than four months and on budget.

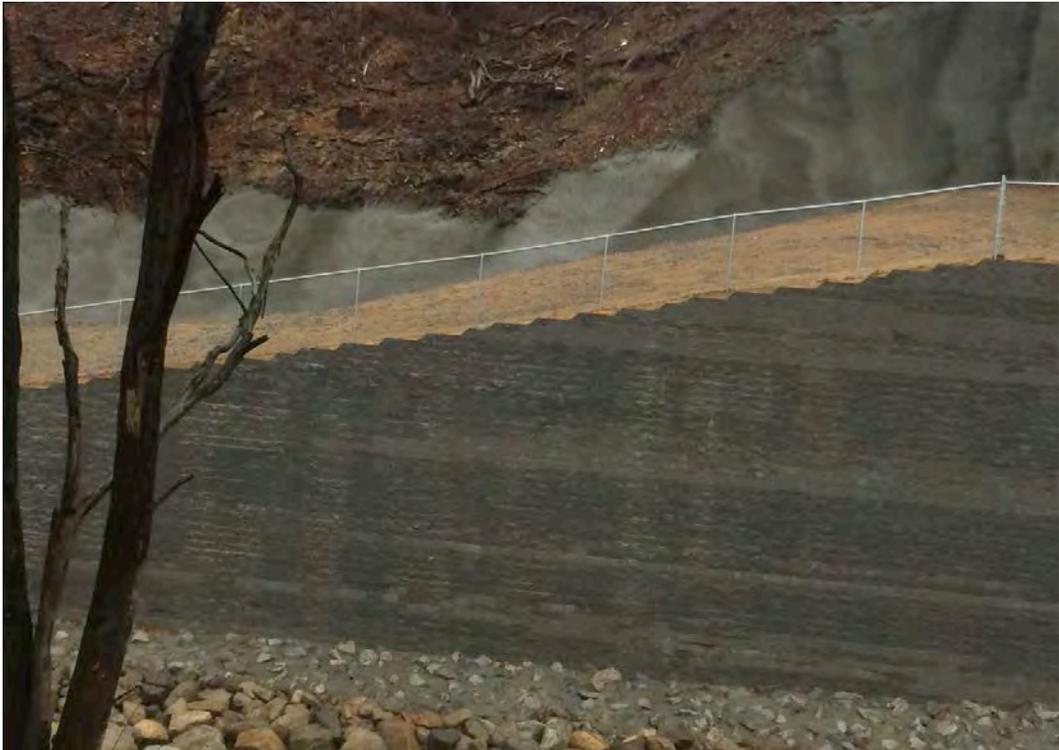
Figure 11 – Completed Project GCS Wall

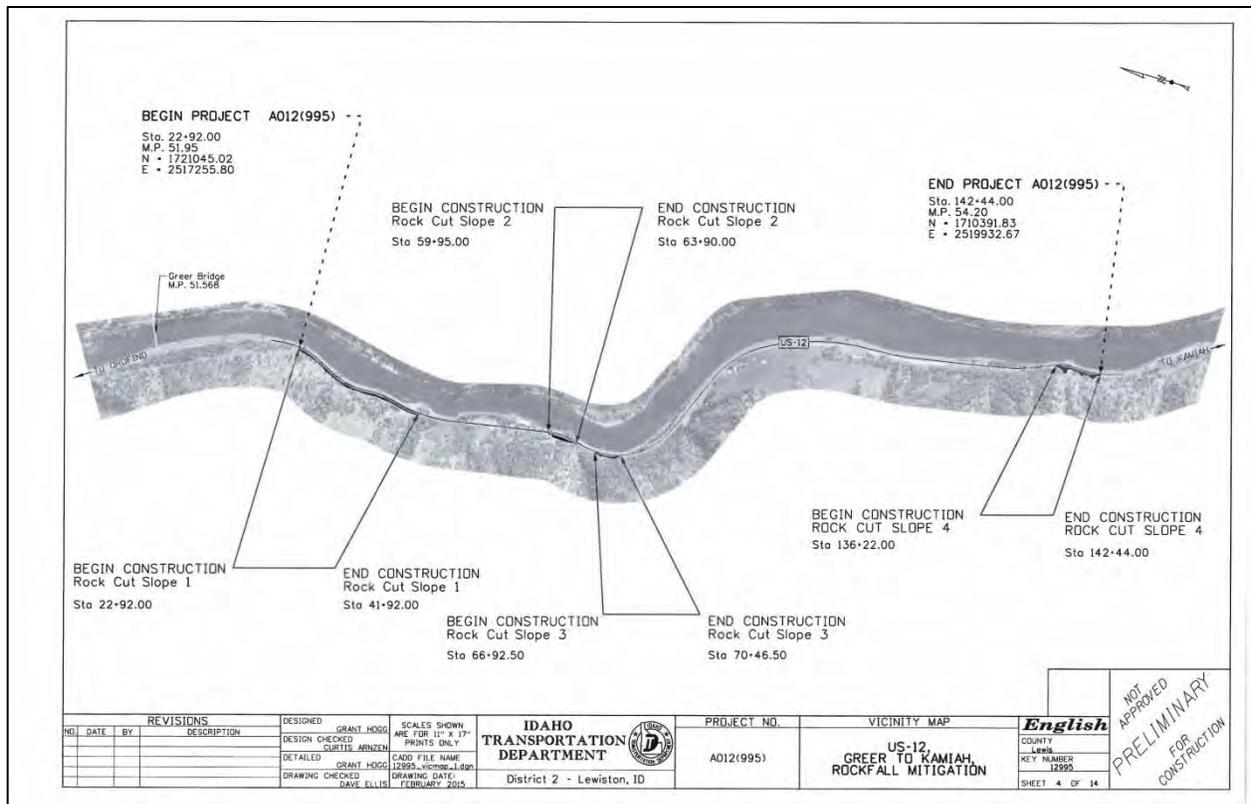
Figure 2: Preliminary construction map displaying locations of rock cut slopes 1 through 4.

Once station limits were established for the four sections (Figure 2), the rock mass was characterized along horizontal and vertical scan lines and discontinuities (fractures, joints, beds, etc.) were measured. Over 300 discontinuity measurements were used in the kinematic analysis to identify potential planar, wedge and toppling failures. Measurements were limited to existing cut slopes within the four areas.

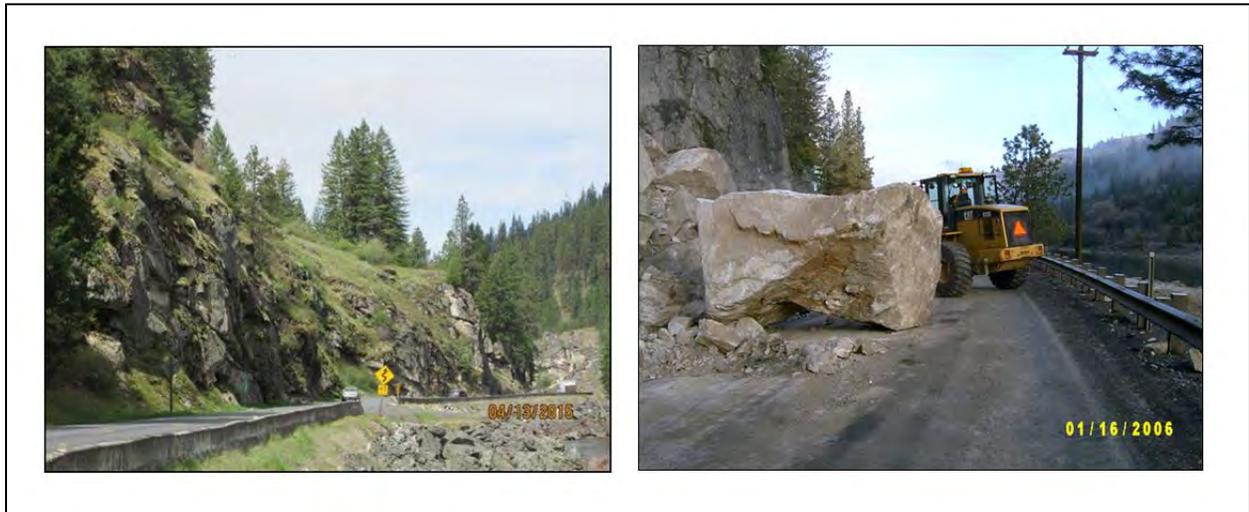
Figure 4: Left photo; typical blind corners with inadequate site distance near MP-56. Right photo; displays inadequate rockfall catchment ditch problems near MP-54.
