66TH HIGHWAY GEOLOGY SYMPOSIUM SEPTEMBER 14-17, 2015

2015 Proceedings

*Massachusetts Department of Transportation
and
University of Massachusetts Amherst*

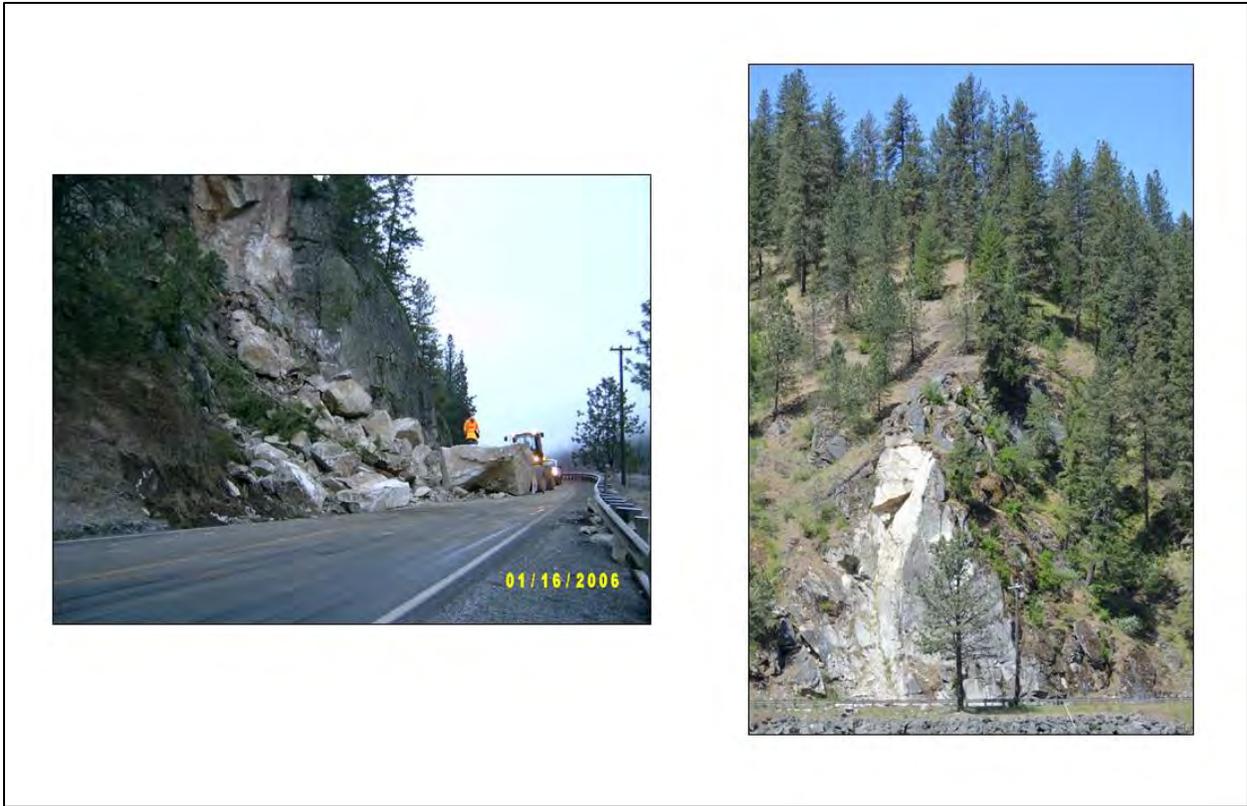
Figure 5: Rockfall problem area near MP-54, rock cut 4. Rock slope failed by wedge sliding on January 16, 2006.

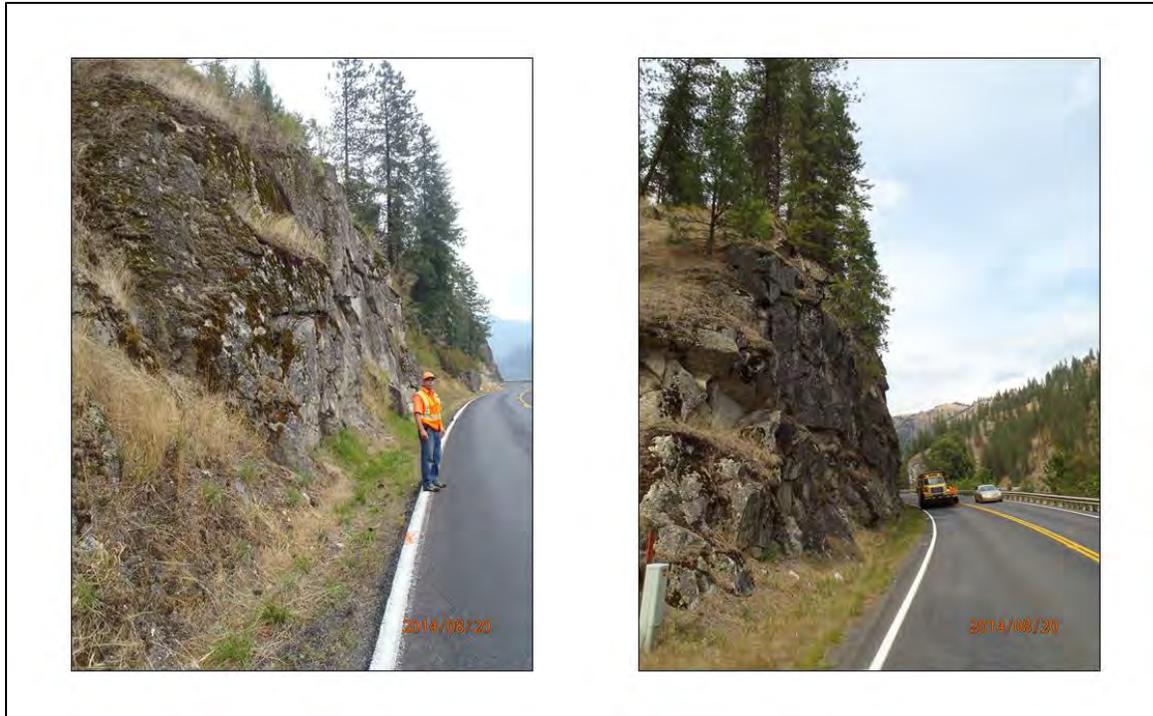
Figure 6: Rockfall catchment zones typically are inadequate (less 90% catchment) to arrest the rockfall. Note blind corners.

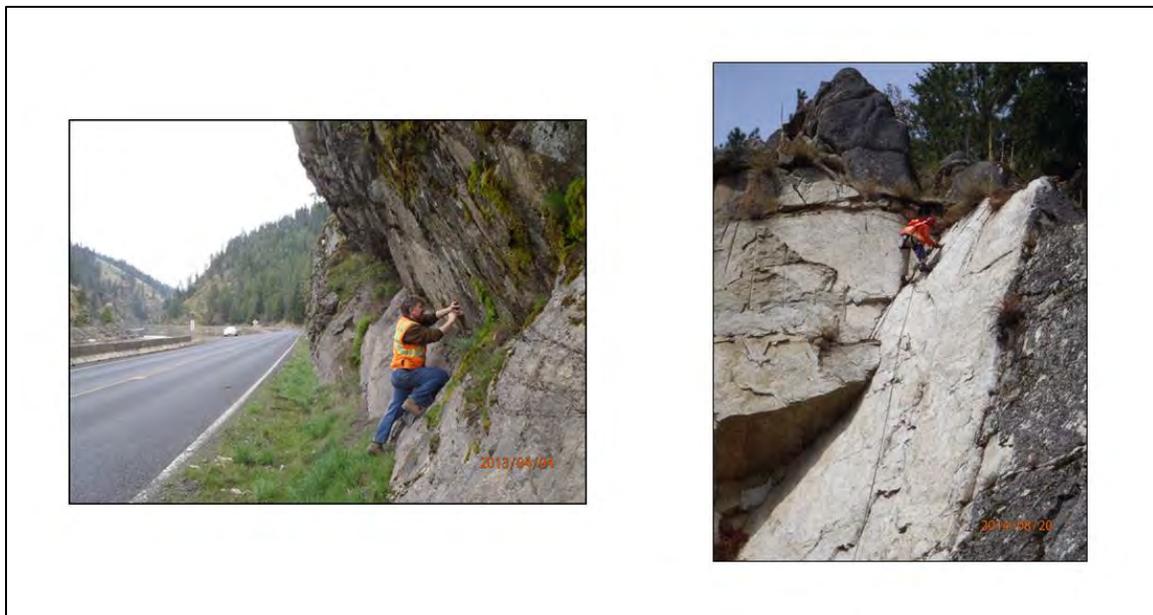
Figure 7: Horizontal and vertical scan line mapping.

The rock cut slopes were subdivided into four manageable windows for geologic characterization. A window was typically length of the slope or 50 feet wide by the height of the rock cut. To characterize the geology, the teams conducted horizontal scan lines along the toe of the slope (Figure 7). In addition, vertical scanlines were completed using rappelling limited rope access techniques (Figure 7). Rock mass characteristics (RMRs, Bieniawski, 1989), geologic strength index (GSI) by Hoek and Brown (1997) and attitudes of the discontinuities were collected at each rock window sufficient to characterize the rock mass, assess the rock cut stability and develop reinforcement contingencies, including:

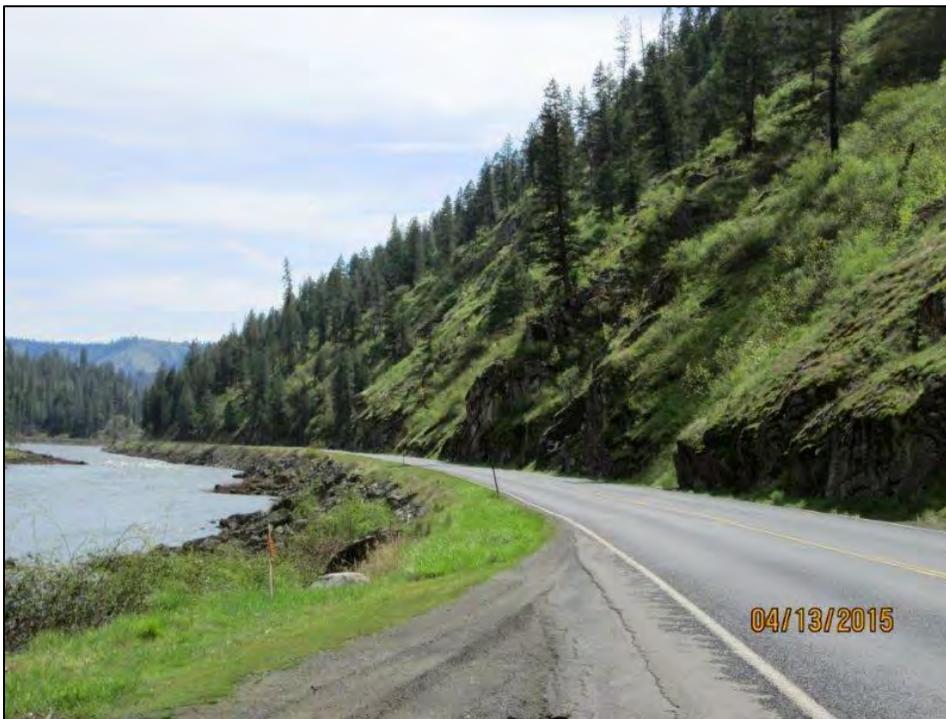
Figure 8: Most of the cut slopes have been stable with some raveling and minor rockfall since the slopes were constructed in 1935.

There is little to no rockfall from most of the rock slopes and most the slopes have stabilized since the original construction of the highway (Figure 8). In all areas, we noted some mode of potential kinematic instability to include minor rockfall and raveling, planar sliding, wedge sliding and toppling (flexural and direct). Interestingly, each rock cut slope area exhibited a unique primary mode of potential instability or failure mechanism based on our field observation and the results of our kinematic analysis. The following is a summary for each rock cut slope.

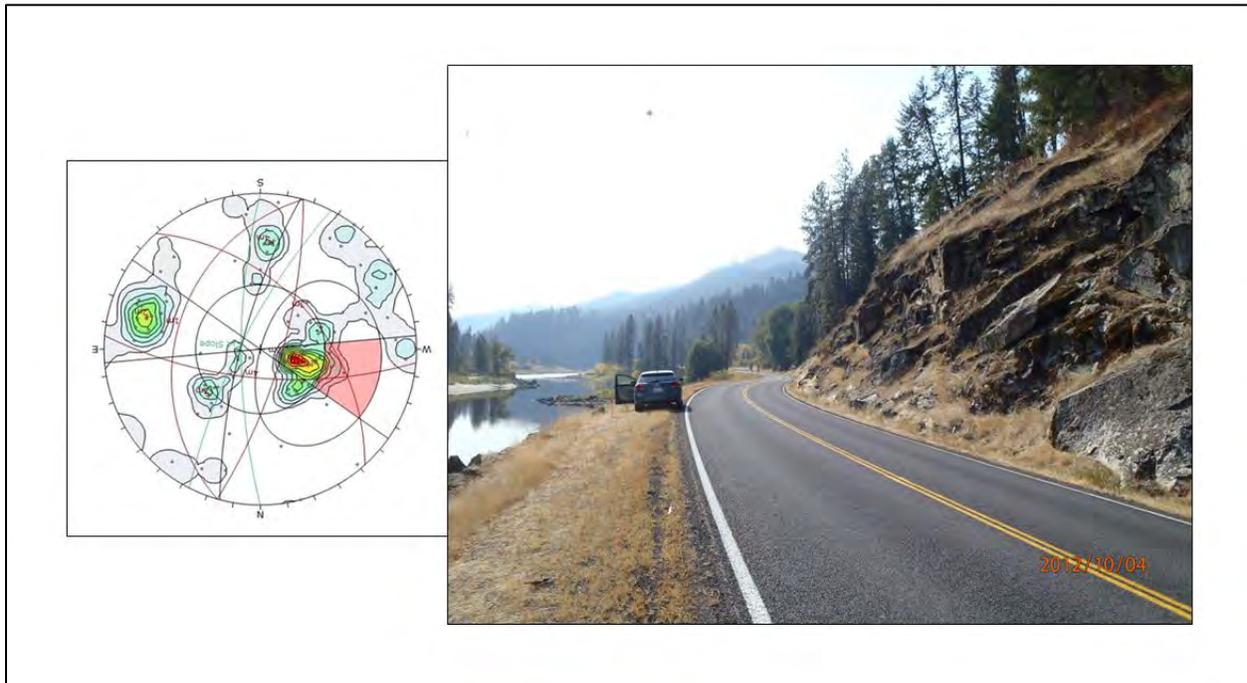
Figure 9: Rock cut slope 1, potential mode of failure is planar, sliding east into the road. Stereonet is oriented parallel to the cut slope face. North is to the bottom of the photo. Note toppling is kinematically possible but the geometry of the blocks did not support toppling.

Rock Cut Slope 1 (Figure 9) starts at MP-52.0 and stretches for about 2200 feet. Height of the rock cut face ranges upward to about 55 feet. At the top of the rock cut, the back slope rises for several hundred feet at about 36 degrees and mirrors the primary discontinuities dipping out of slope. Ditch width is about 11 feet and theoretically will retain 75% or more of the rockfall based on a 55 foot high, 0.25H: 1V slope (Pierson, et al, 2001). This is not an active rockfall area. Based on our field observation and kinematic analysis, the blocks may potentially fail by planar sliding into the highway, however, the rock slope appeared stable kinematically and key blocks exhibited a factor of safety around 2.57. Even though the faces of the slopes overhang in places, toppling was not an issue, because the bases of the blocks are wider than their height. Based on our analysis and observation, regrading to a flatter slope would not improve the factor of safety and patterned bolts would not be required. Recommendations to ITD included: trim blast the face of the slope to 0.25H: 1V, plan for a contingency of 200 LF of 25 kip rock bolts during construction should conditions change.

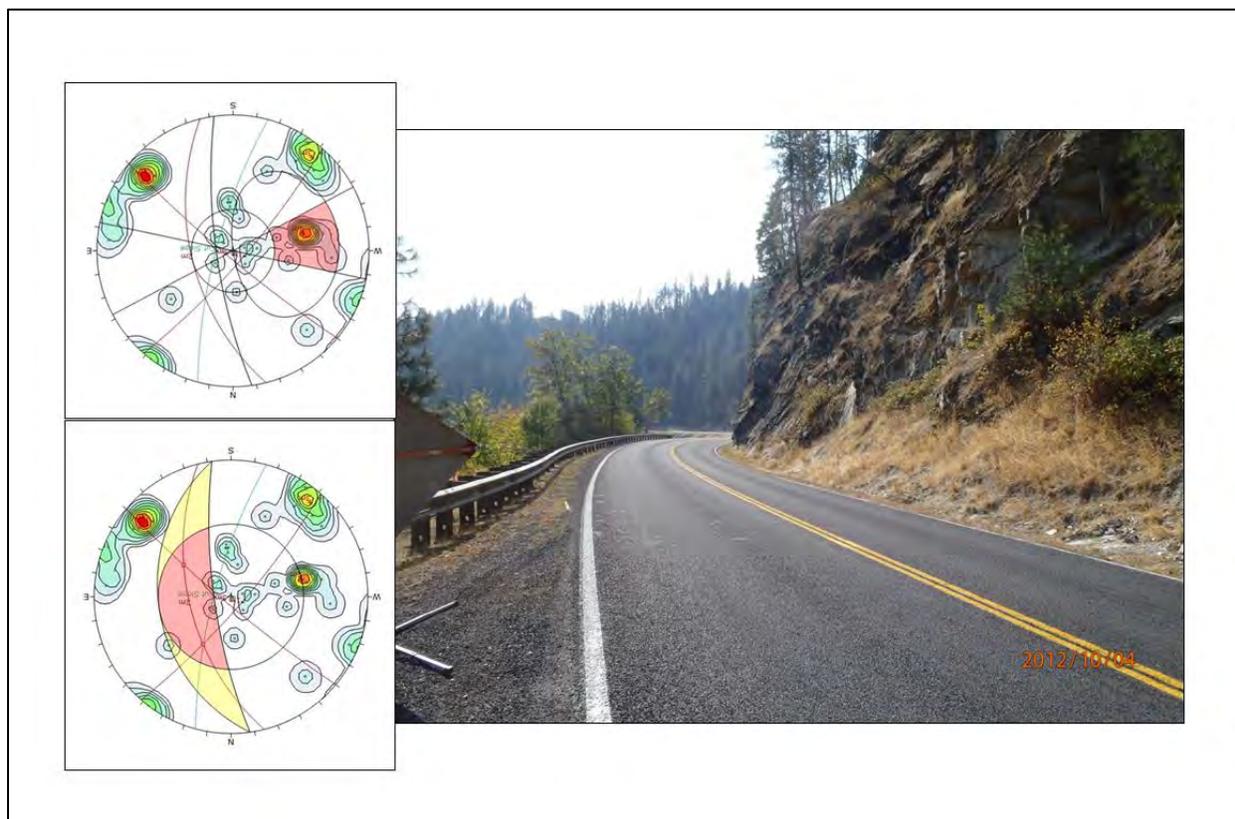
Figure 10: Rock cut slope 2, primary modes of failure may include planar and wedge sliding to the east into the road. Note the blind corner. The stereonet are oriented parallel to the cut slope face. North is to the bottom of the photo. Note potential for planar sliding in top stereonet. In the lower stereonet, two major wedges daylight the critical zone and are potentially kinematically unstable.

Rock Cut Slope 2 (Figure 10) forms a blind corner near MP-52.7. The slope is about 400 feet long and over 200 feet high. Ditch width is about 11 feet and theoretically will retain 50% of the rockfall based on an 80 foot high, 0.25H: 1V slope (Pierson, et al, 2001). The back of the slope is bounded by a county road. Planar and wedge sliding are primary modes of failure in this area as displayed in the stereonet. However the wedges appear to have steep subvertical limbs and the blocks will probably fail primarily by planar sliding. Toppling was not a kinematic issue. Grading the slope to 0.75H: 1V will remove the critical failure planes. However, regrading would require additional right-of-way to include possible modification of the county road above the brow of the slope. Whereas steeping the slope to 0.25H: 1V requires rock bolts and there are no right-of-way issues. Recommendations to ITD included: stabilize slope by regrading and trim blasting to 0.25H: 1V and install 720 LF of 25 kip patterned rock bolts.

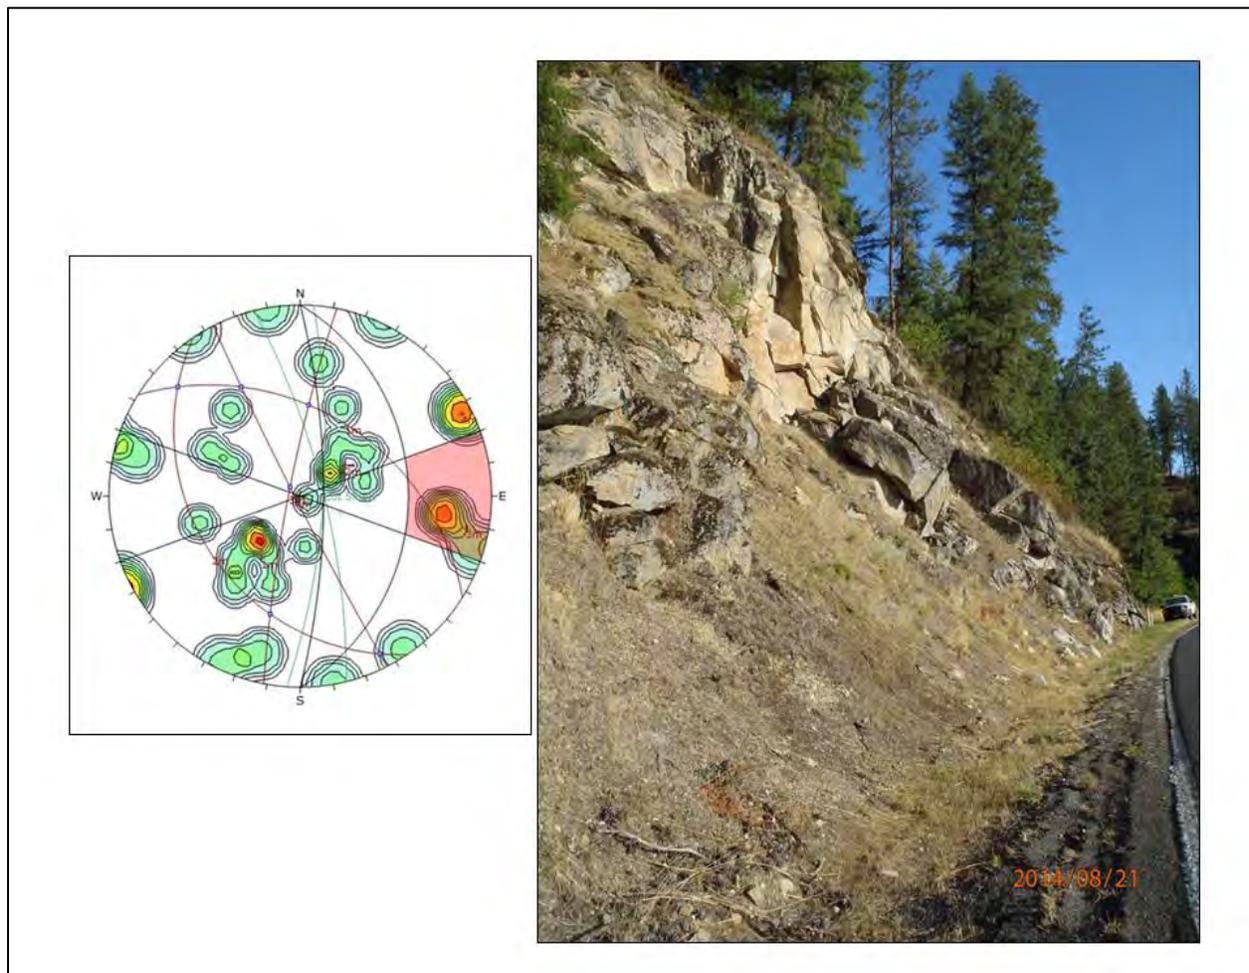
Figure 11: Rock cut slope 3, potential mode of failure is toppling to the east into the road. Stereonet is oriented parallel to the cut slope face. North is to the top of the photo. Note blocks at toe of slope that have failed by apparent toppling.

Rock Cut Slope 3 (Figure 11) is near MP-52.8 and is about 125 feet long and the rock face is over 30 feet high. Ditch width is about 11 feet and theoretically will retain 95% of the rockfall based on a 30 foot high, 0.25H: 1V slope (Pierson, et al, 2001). At this location, kinematic analysis indicates that toppling is the potential mode of failure. The probability for planar and wedge sliding appeared low based on the kinematic analysis. Regrading to a flatter slope will not improve the stability for this slope. Recommendations to ITD included: trim blast slope to 0.25H: 1V, plan for a contingency of 150 LF of 25 kip rock bolts during construction should conditions change or merit it.

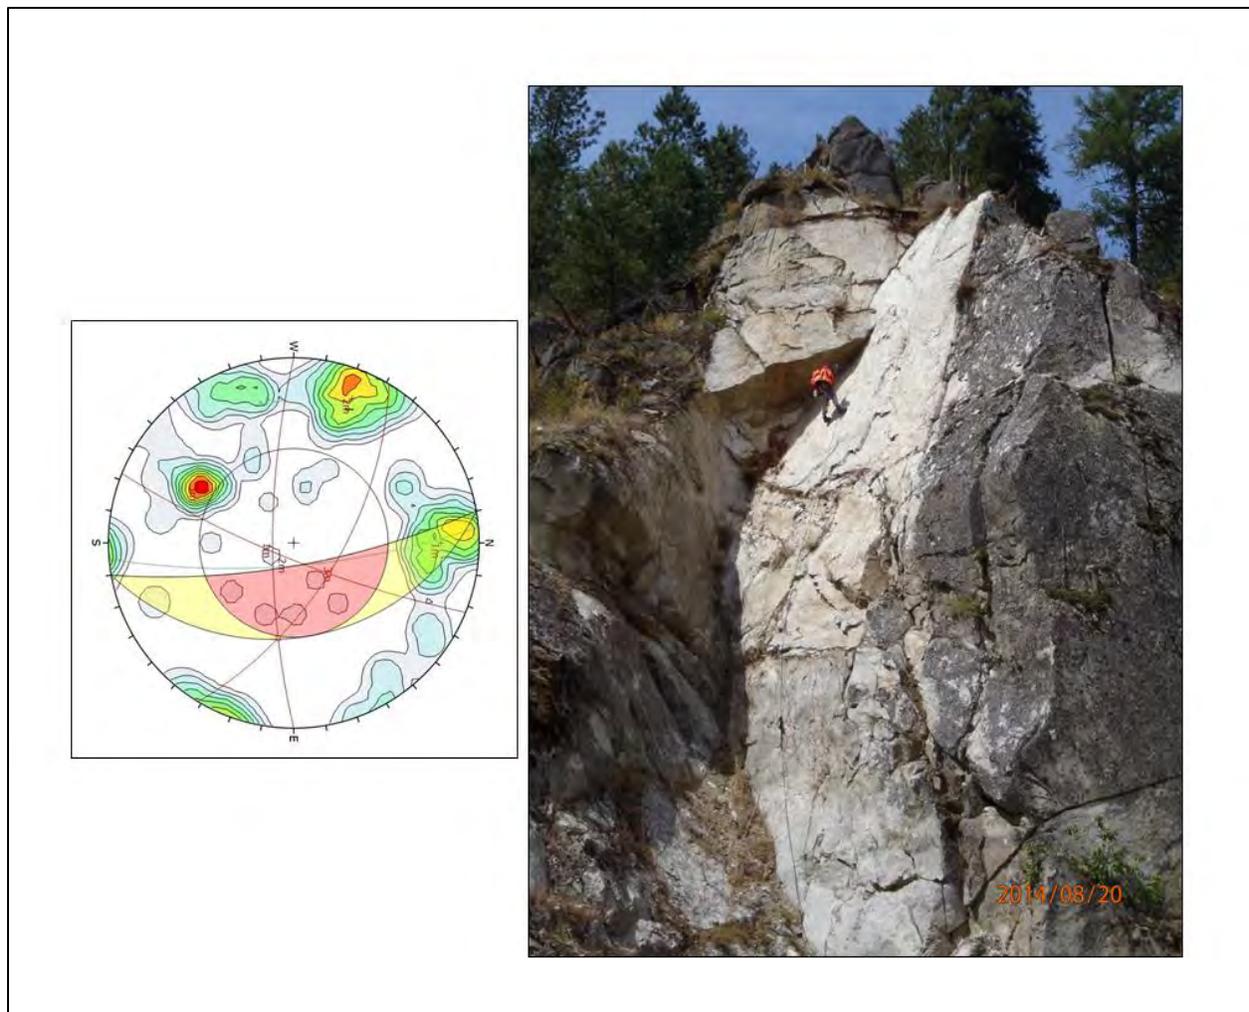
Figure 12: Rock cut slope 4, primary mode of failure is wedge sliding east into the road. Stereonet is oriented parallel to the cut slope face. North is to the right of the photo. Block above the geologist on rappel is kinematically unstable and should be removed.

Rock Cut Slope 4 (Figure 12) is around MP-54.1. The slope is about 1125 feet long and about 75 feet high. Ditch width is about 11 feet and theoretically will retain 55% of the rockfall based on a 75 foot high, 0.5H: 1V slope (Pierson, et al, 2001). This area has a history of rockfall and rockslides as wedge failures (Figures 4 and 5). The kinematic analysis demonstrated that wedge sliding will occur for slopes steeper than 0.5H: 1V when the cohesive strength on both joint planes dropped to zero. Based on the kinematic analysis, the probability for planar sliding and toppling is low. Grading the slope to 0.5H: 1V will remove the wedge shaped blocks and improve the stability of the slope. Recommendations to ITD included: stabilize slope by regrading and trim blasting to lay slope back to 0.5H: 1V. Install 225 LF of patterned 25 kip rock bolts on selected blocks.

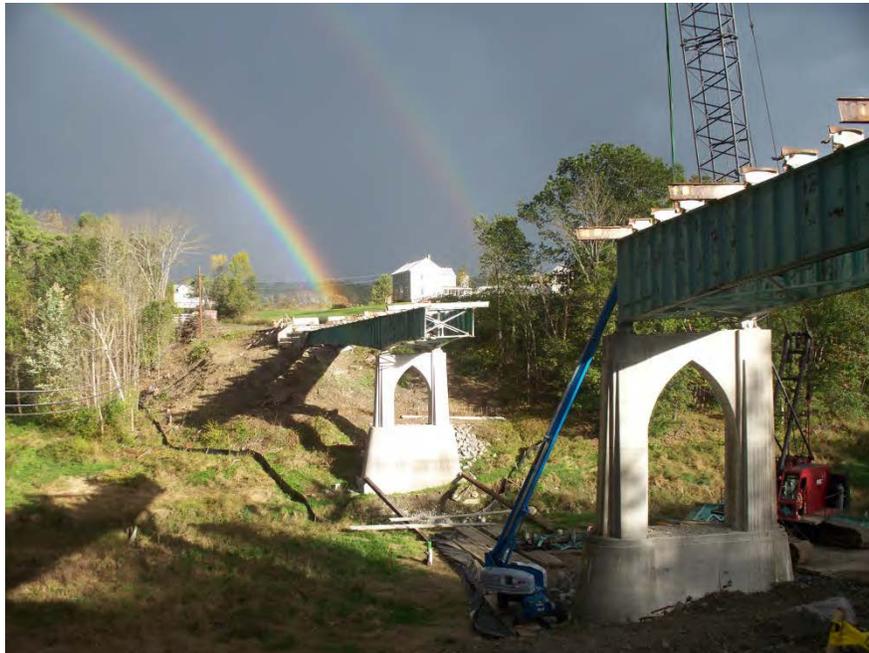
Figure 1 - Original Mile Brook Bridge during demolition. East approach embankment in the background and Outlet Stream in the foreground. (courtesy of Bryan Steinert)

The original Mile Brook Bridge, constructed in 1947, was a 350-ft long, three-span structure that carried Garland Road across the Outlet Stream in Winslow, Maine (see Figure 1). As part of their annual bridge rating program, the Maine Department of Transportation (MaineDOT) determined that the bridge was structurally deficient and required replacement. The scope of the replacement project included a 325-ft long, two-span replacement bridge along with modifications to the approach embankments, including changes in vertical roadway profile necessitating raises-in-grade of 2 to 4 ft.

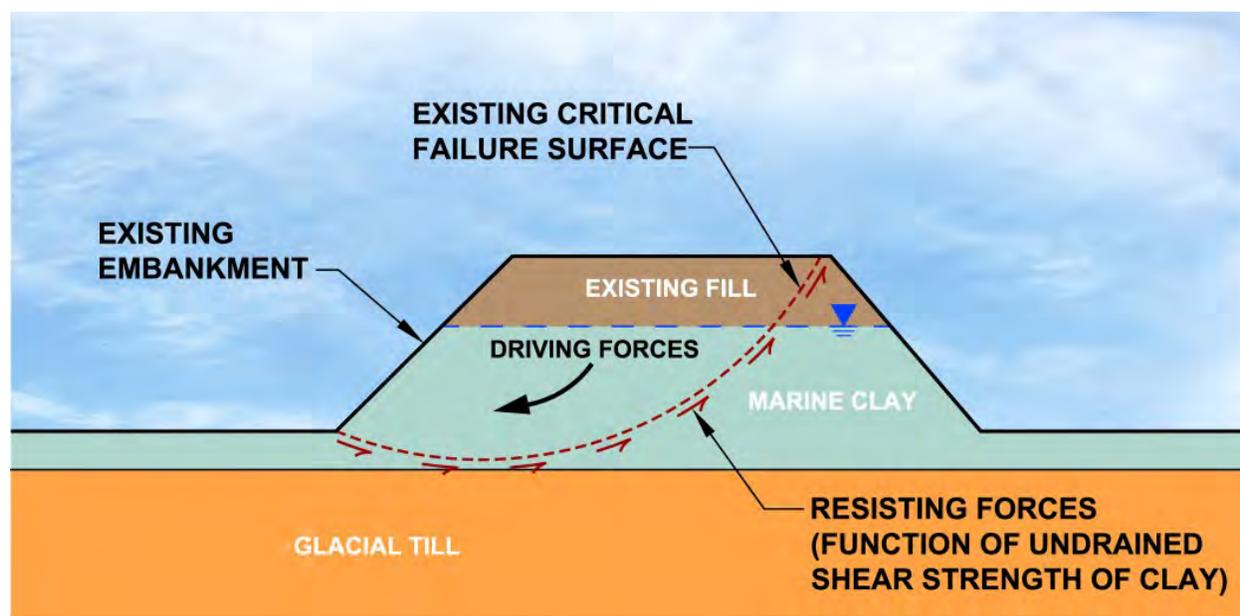
$$\text{Factor of safety} = \frac{\text{sum of resisting forces}}{\text{sum of driving forces}}$$

$$\text{Factor of safety for existing conditions} \approx \text{Minimum required factor of safety (FS min. required)}$$

$$\text{FS min. required} = 1.3 \text{ (slopes) to } 1.5 \text{ (slopes supporting structural elements)}$$

Figure 2 – Existing west approach embankment was marginally stable prior to construction.

A series of computer-assisted, two-dimensional global stability evaluations were performed to evaluate the west embankment. Both static and pseudo-static (seismic) evaluations were conducted through the abutment, wingwalls and at 50-ft intervals along the approach embankment, transverse to the roadway alignment. The results of global stability evaluations showed that an approximately 100-ft long portion of the northern side of the west approach embankment (see Figure 6) had a lower factor of safety than was required by the AASHTO LRFD Bridge Design Specifications (see Figure 2 and 3).

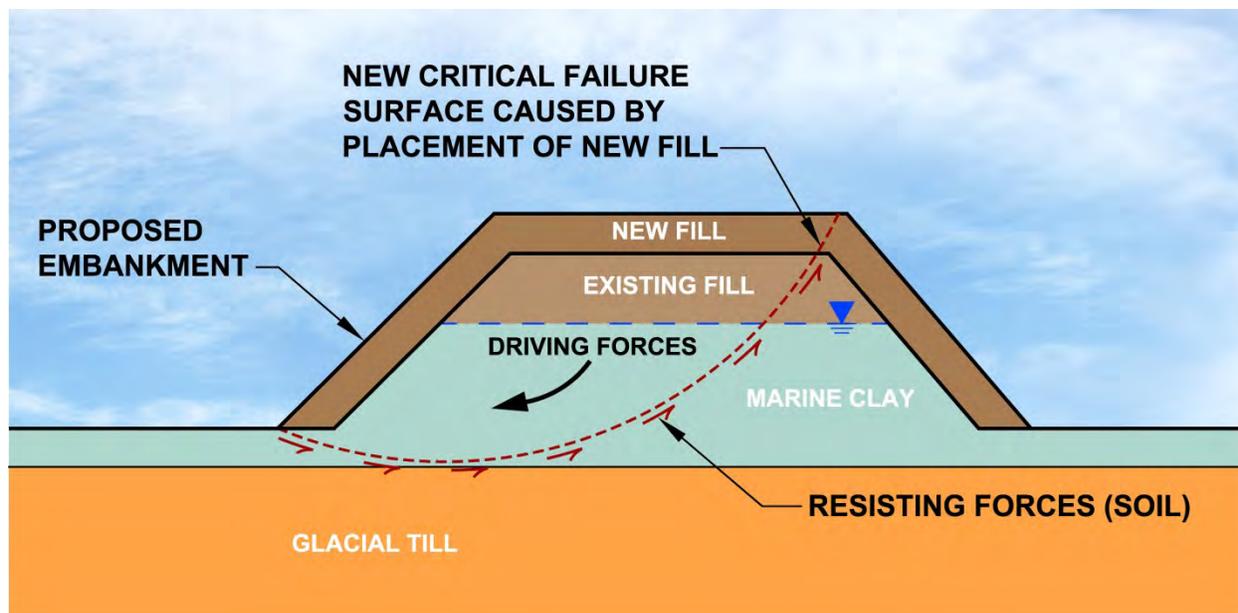
Factor of safety for proposed conditions < FS min. required

Therefore the resisting forces need to be increased
to achieve FS min. requirements

Figure 3 – Fill placement needed for new vertical road profile would have caused an unstable condition. (courtesy of Terri McEleney)

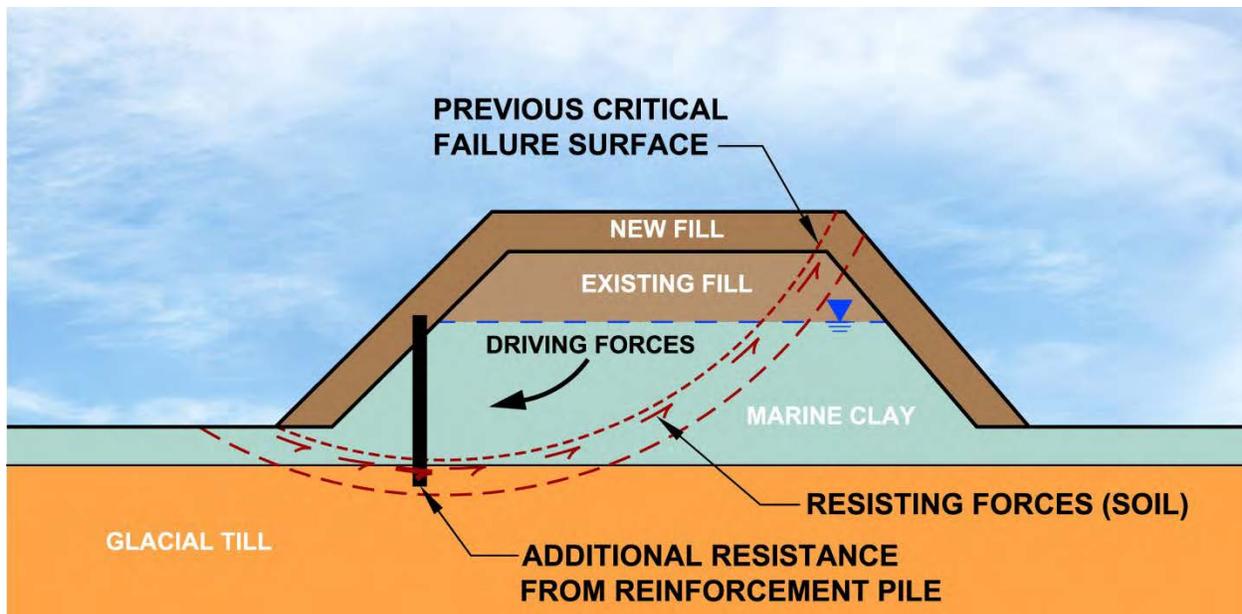
Figure 4 – Stabilization piles advanced to depth so that failure surface shifts down below the bottom of the piles, into dense glacial till. New deeper critical failure surface has acceptable factor of safety. (courtesy of Terri McEleney)

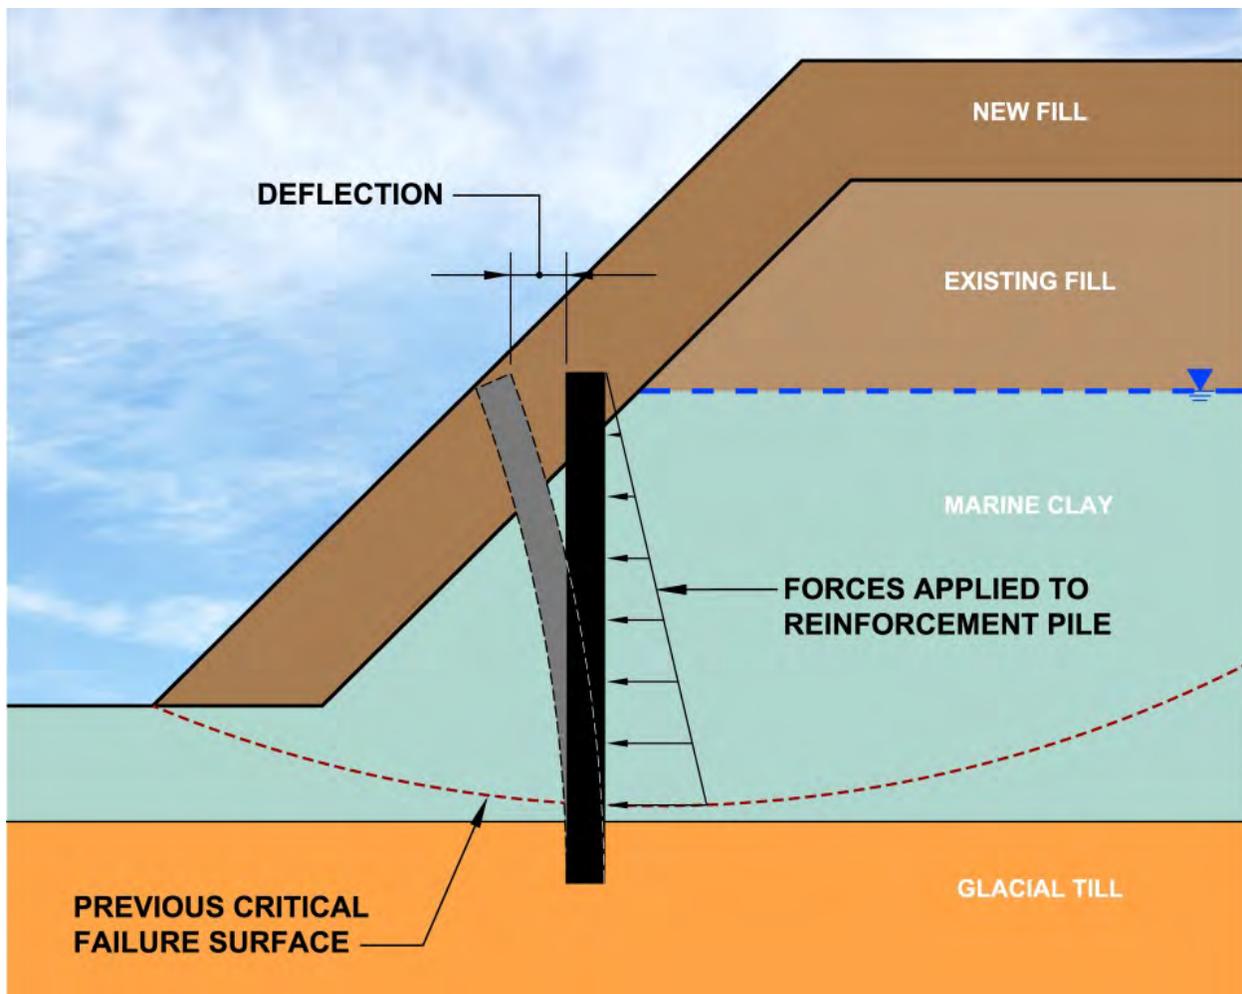
Figure 5 – Lateral pile evaluations were used to determine spacing and sizing requirements of stabilization piles such that deflections are limited to maintain pile stability (i.e., fixity at bottom of pile). (courtesy of Terri McEleney)

3. Conduct lateral pile evaluations to determine the loads and moments in the stabilization piles when the minimum stabilizing force calculated in Step 2 is applied to the piles (see Figure 5). This was completed using the computer software LPILE Plus Version 5.0 by Ensoft, Inc (4). Sheetpiles were also considered and analyzed using WALLAP Version 5.04 by Geosolv.

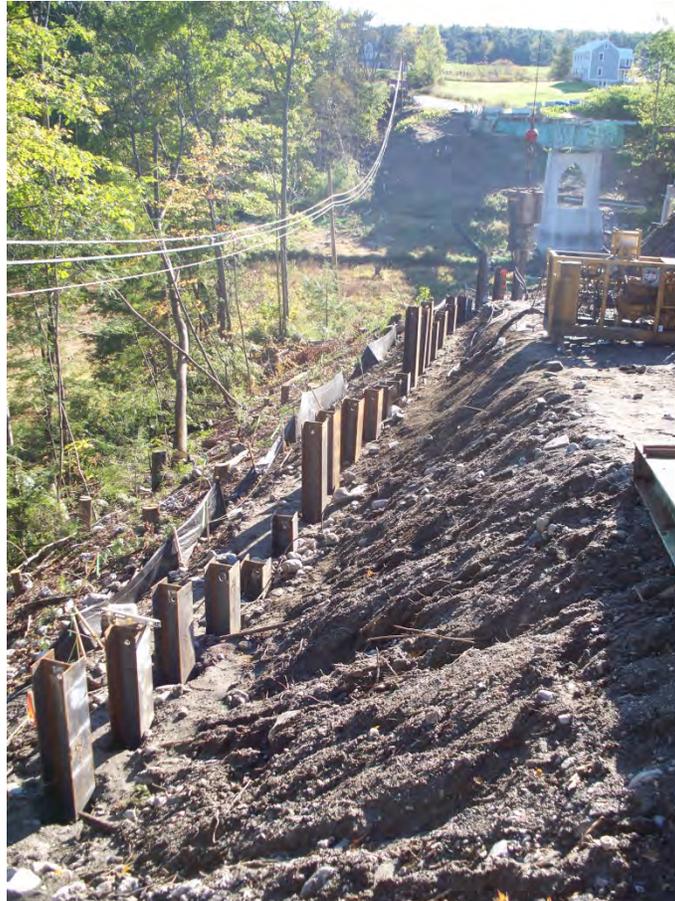
Figure 7 – Installed HP12x53 stabilization piles along the north side of the west approach embankment. (courtesy of Bryan Steinert)

approach, 26 piles along the north side of the west embankment and 6 piles behind the west abutment and wingwalls. The piles were spaced 4 ft center-to-center, driven through the Presumpscot marine clay and into glacial till. The reinforcing elements were installed near the mid-point of the slope (see Figure 7) and behind the proposed west abutment.

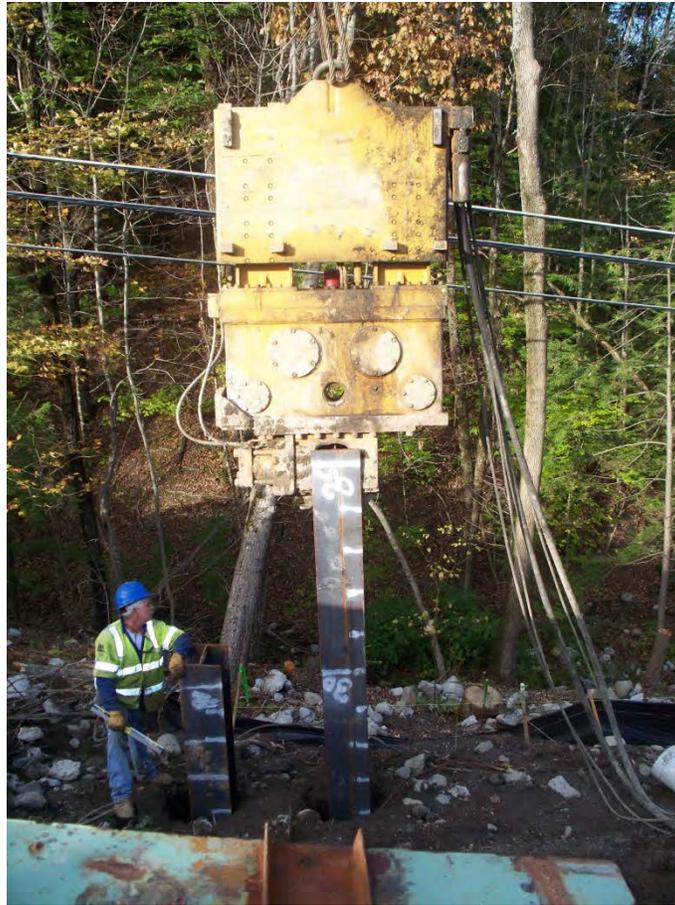
Figure 8 – Installation of HP12x53 stabilization pile by CPM Constructors using an H&M 1700 vibratory hammer supported by a Link Belt LS-318 Crawler Crane. (courtesy of Bryan Steinert)

Prior to installation, CPM Constructor's earthwork crew constructed a bench along the embankment slope to provide a level work area to install the piles. The piles were installed using an H&M 1700 vibratory hammer supported by a Link Belt LS-318 Crawler Crane (see Figure 8). Minimum installation depths of reinforcing piles were determined prior to installation based on the supplemental test boring obtained after project award and prior to final design. Determination of whether piles had achieved the required installation depth was based on observations made by Haley & Aldrich during construction. The piles were cut off at least 2 ft below finished embankment grades.

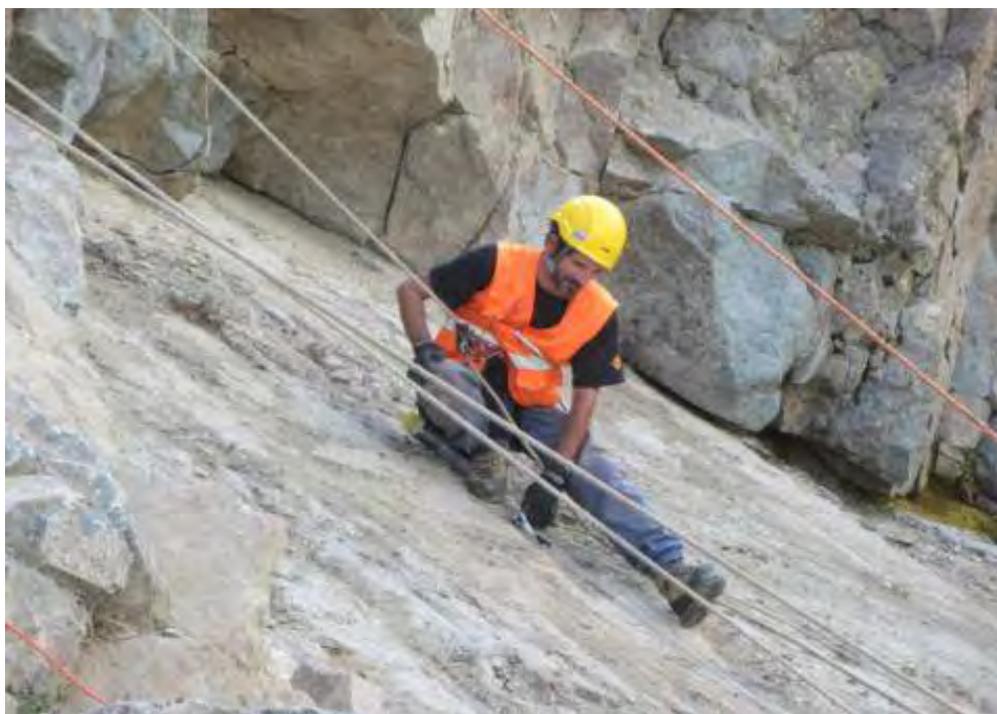
Figure 2. Dr. Castaldini laying out steep smooth surface

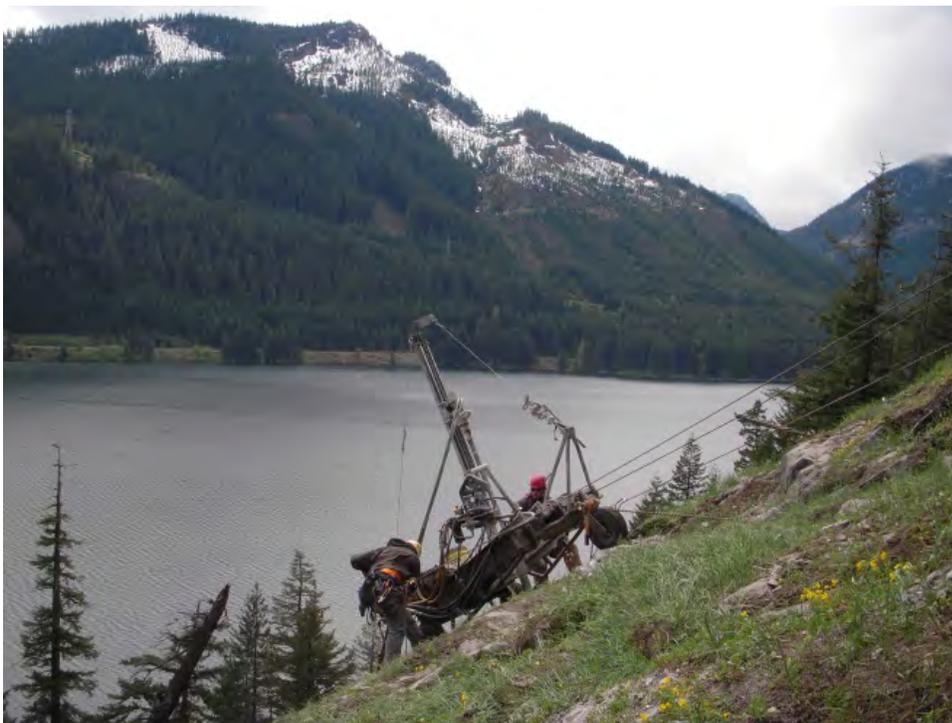
Figure 3. Wagon Drill

The anchors for the project required HI-TECH to contract with a U.S. based geotech engineer to determine drilling depths and hole diameters to achieve the required pull-out strength. The project specifications called out sacrificial anchors to be installed in all the different ground conditions that would be encountered to prove the bond strength of the anchor design. Kane Geo-Tech of Stockton, CA, U.S.A. was selected based on their vast experience in designing and testing of ground anchors for rockfall mitigation and debris flow practices. With the different capacities and sizes of the flexible structures on the project there were 18 different anchor capacities overall. Some of the challenges of the design were the fact that WSDOT was requiring all the anchors to be tested to 2 times the design load to assure that the anchors would not fail. It was determined that the materials supplied for the flexible structures could not withstand that type of testing and failure of the wire rope cables would occur as the loads needed to be pulled during the testing far exceeded the breaking strength of the material. After many meetings and discussions it was determined that HI-TECH could upsize the material for the sacrificial tests to prove the bond strength between the grout and ground conditions, however the testing criteria would remain at 2 times the design load. More meetings and discussions were required for the production anchors and the testing criteria got reduced from 2 times to 1.6 times and then finally to 1.35 times design load. The Owner required 100% of all the anchors installed to be tested. This included every production anchor. Having to deal with the very steep and uneven terrain required specialized drilling equipment. The hole diameters ranged from 50mm to 100mm and the depths from 1.7 meters to 4.5 meters into solid rock. HI-TECH brought in wagon drills and Spyder backhoes with specialized drills mounted on the arm to drill all of the holes. These machines have the capability to be winched and crawl around in steep and uneven terrain while still having the ability to level themselves and productively drill in those conditions.

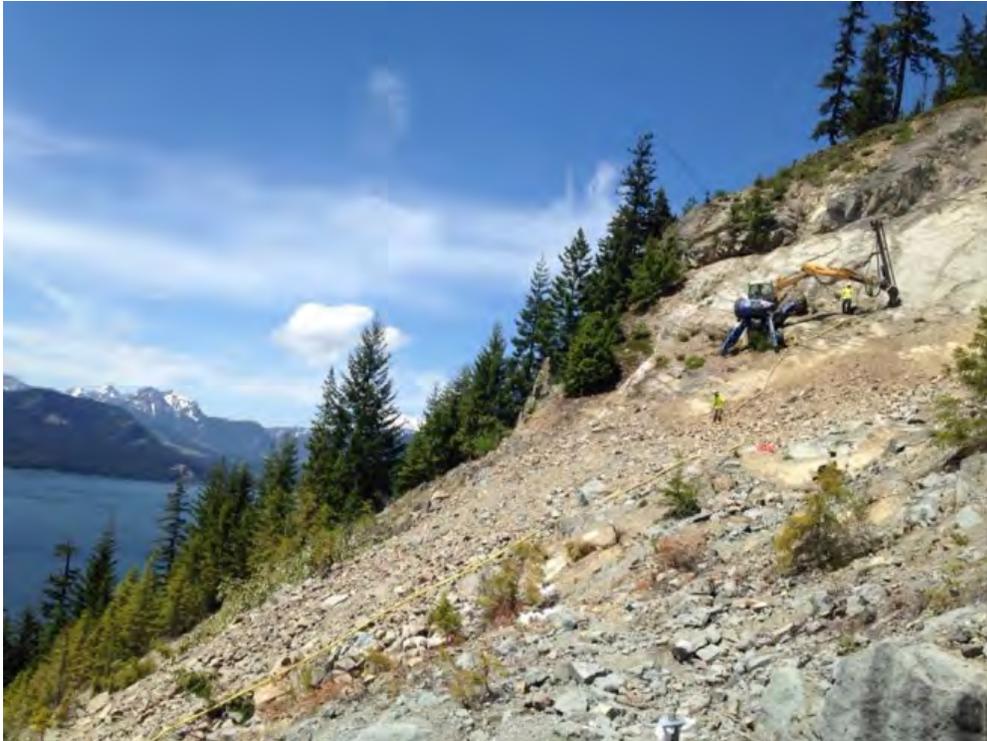
Figure 4. Spyder Drill

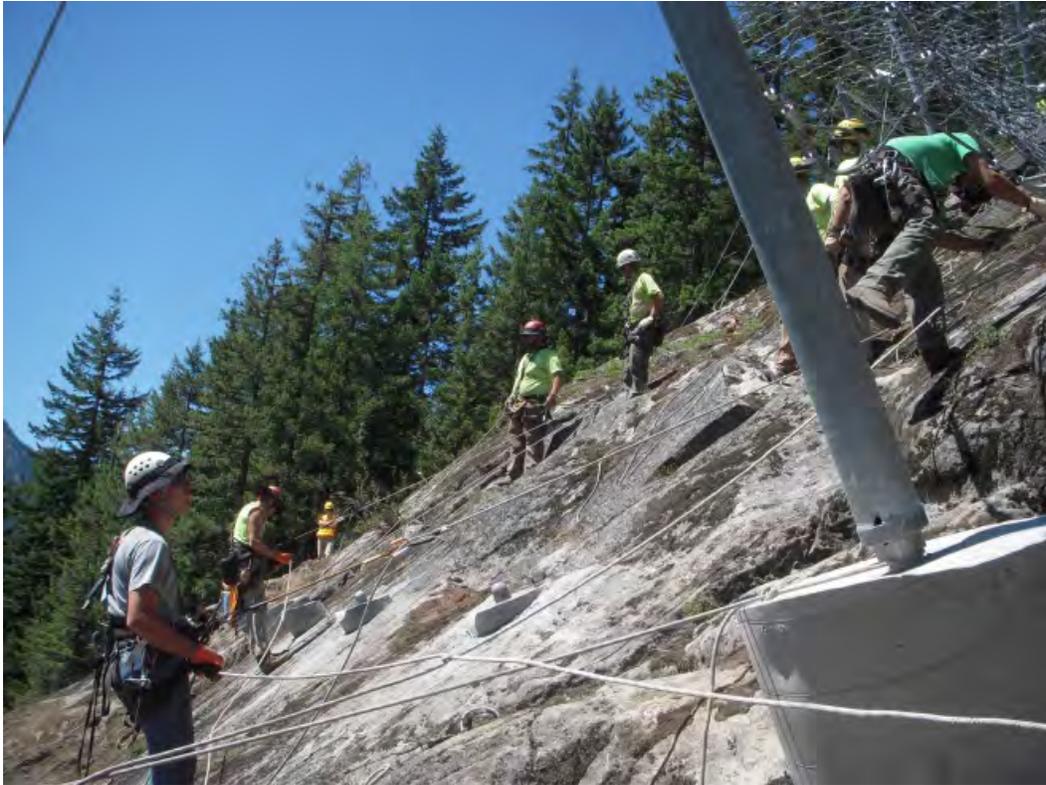
Figure 6. Completed pier footing

The uneven ground conditions required that many of the foundations were above ground piers. These foundations required engineering by a structural engineer to assure that they would allow for the snow nets to function properly. These piers ranged from 30cm to 120cm above existing ground. The use of a helicopter was required to fly all the required materials for the foundations to specific points on the slope.

The concrete was mixed on the slope and poured into the forms. Water for mixing had to be pumped up the slope from as far away as 200 meters to temporary storage containers that were placed on the slope. Once the foundations were constructed, the installation of the post and nets was the next step.

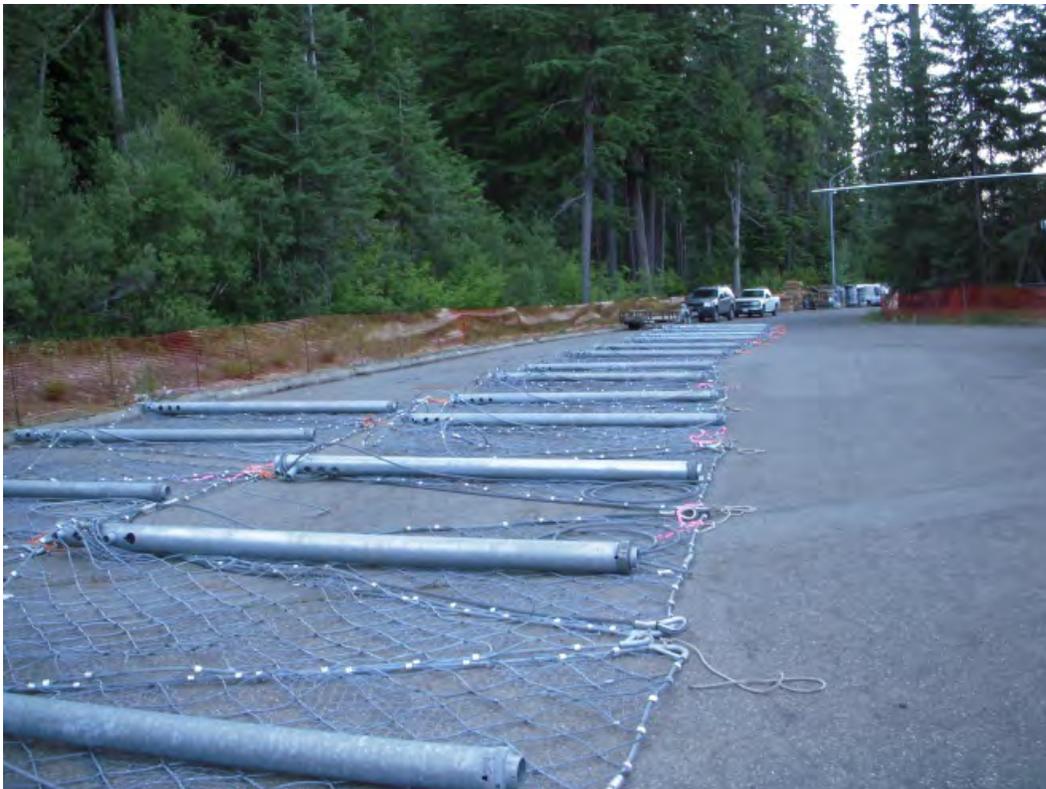
Figure 7. Materials ready for fly

The snow net lines were laid in a level area approximately 11Km from the slope as this was the only area large enough to accommodate our needs. The lines were laid out in 2 and 3 post setups to be prepared to be lifted by the helicopter and placed up on the slope.

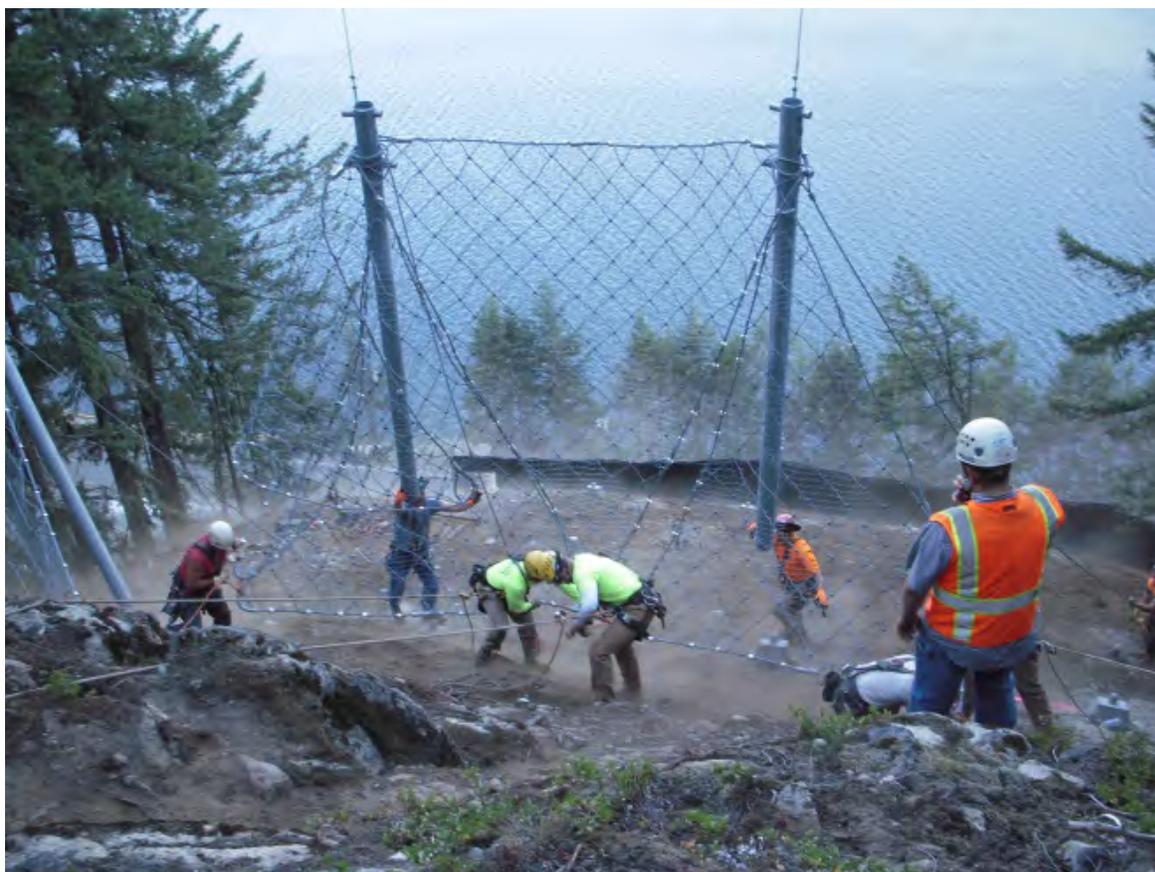
Figure 8 Helicopter installing post & nets

Alberto Grimaldi from Maccaferri was onsite during this time to ensure that the system was being properly installed. HI-TECH had previously used helicopters to install rockfall draperies on over 100 projects in the past but had never installed flexible snow nets before. The installation went very smooth as we averaged 110 meters per day in place. This operation required 4 men at the yard area and 10 men up on the slope.

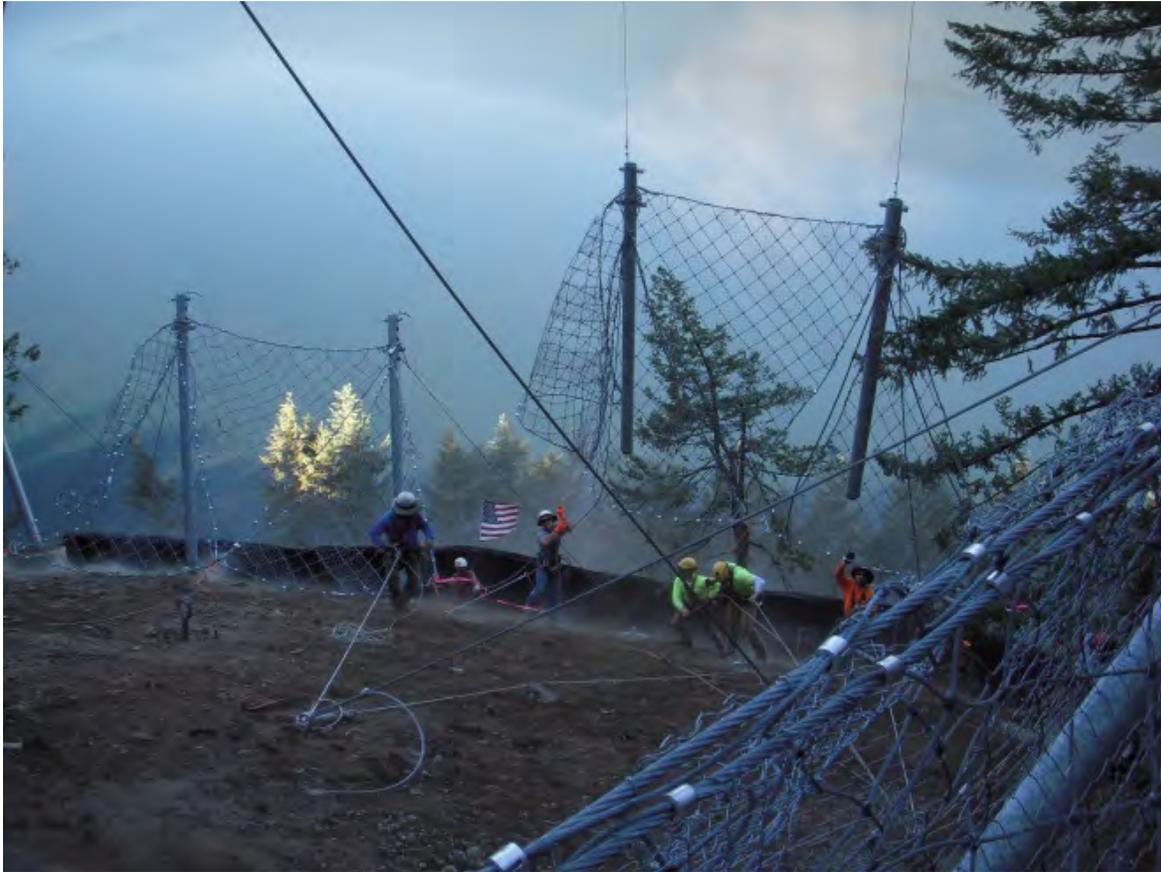
Figure 9. Helicopter installing post & nets
