66TH HIGHWAY GEOLOGY SYMPOSIUM SEPTEMBER 14-17, 2015

2015 Proceedings

*Massachusetts Department of Transportation
and
University of Massachusetts Amherst*

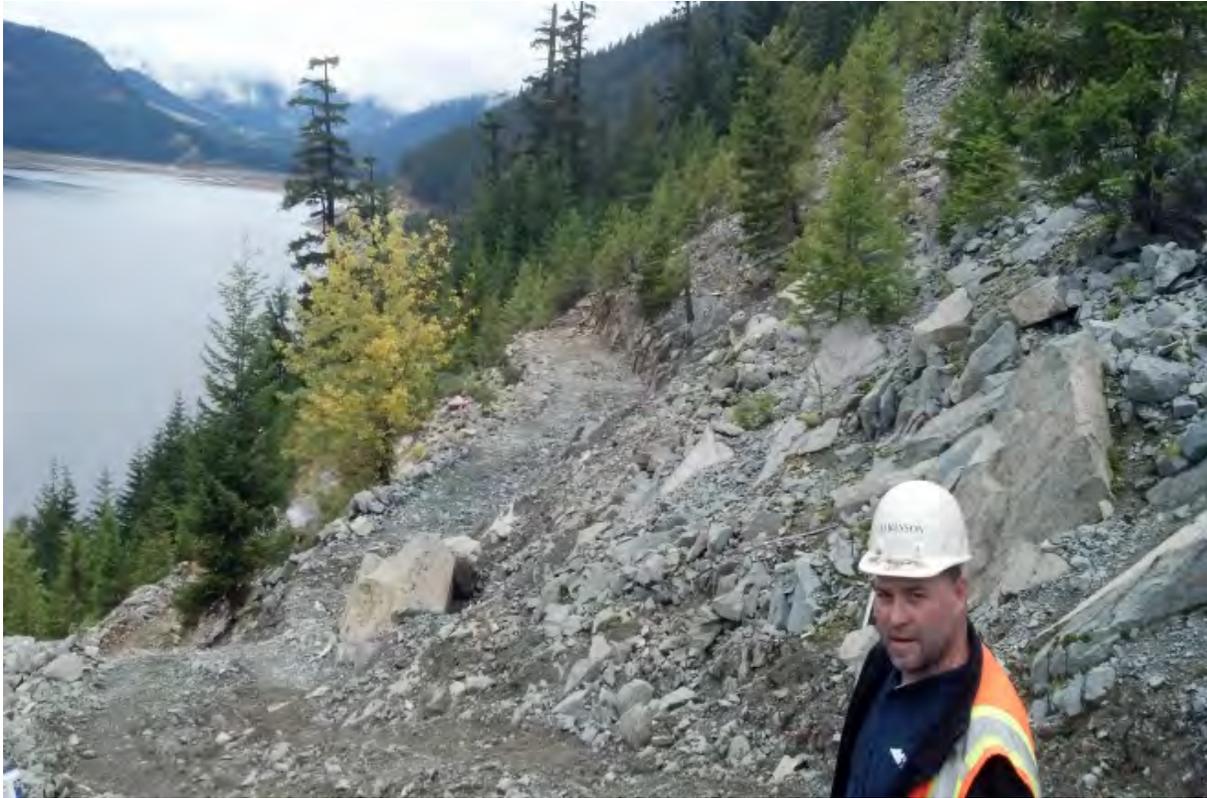
Figure 10. Initial grading of lower slide curve

To date approximately 20% of the flexible structures are in place and complete and the remaining 80% will be complete by October 2015. HI-TECH is continuing construction of anchors and foundations at upper slide curve and should be complete with that portion this year. Lower slide curve is still awaiting final approval from the changes recommended by Dr. Castaldini in his site visit this year. This area had the most uneven terrain and loose rock on the slope and required grading to be done prior to lay-out. The initial grading is complete and we are beginning final grading for the lay-out this year.

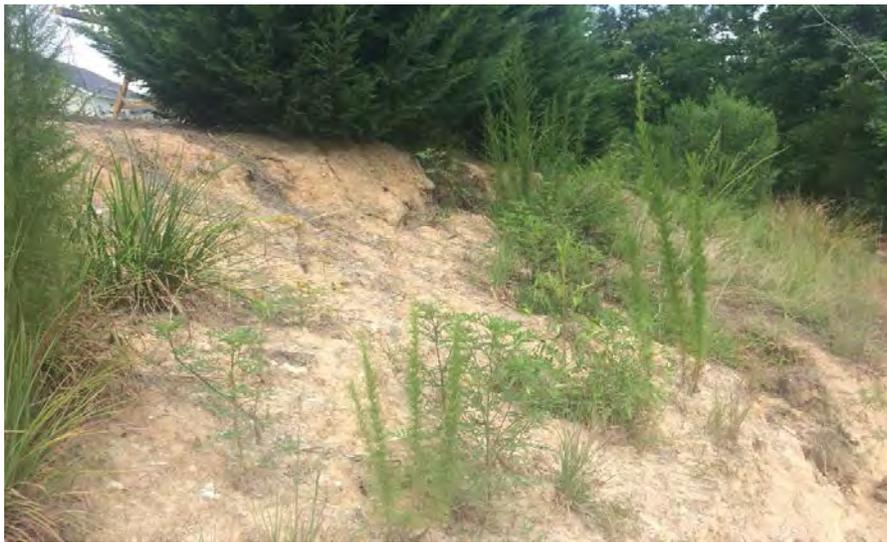
Figure 1. Observed slope failure (2014)

The failure of the side slopes (figure 1) along a detention pond in the Weldon Ridge Subdivision, located in Cary, NC, required a significant amount of repair in 2014. The original design plans included removing the spoils that had sloughed into the detention pond and installing a typical gravity gabion basket retaining wall (figure 2). During construction it was determined that access into the site was restricted which made getting stone to fill the baskets an extremely expensive option, therefore alternative solutions were investigated.

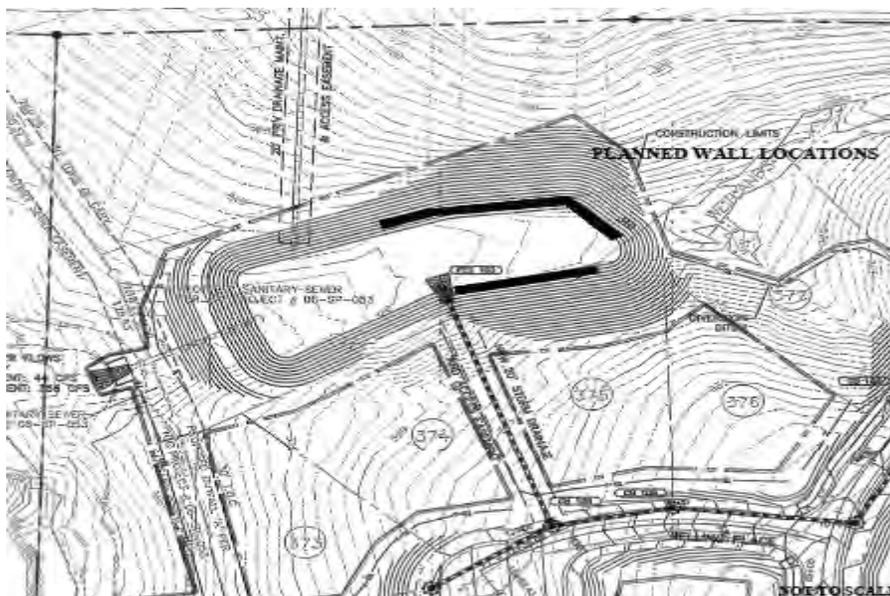
Figure 2. Proposed wall and slope area to be reconstructed

The original design called for the soils within the failed zones to be removed and replaced with a conventional stone filled wire basket retaining structure. The plans called for the placement of stone filled wire baskets to a height that would reduce the side slopes to a stable angle of repose. During construction, it was apparent that access to the site was limited, making the project more expensive than originally proposed.

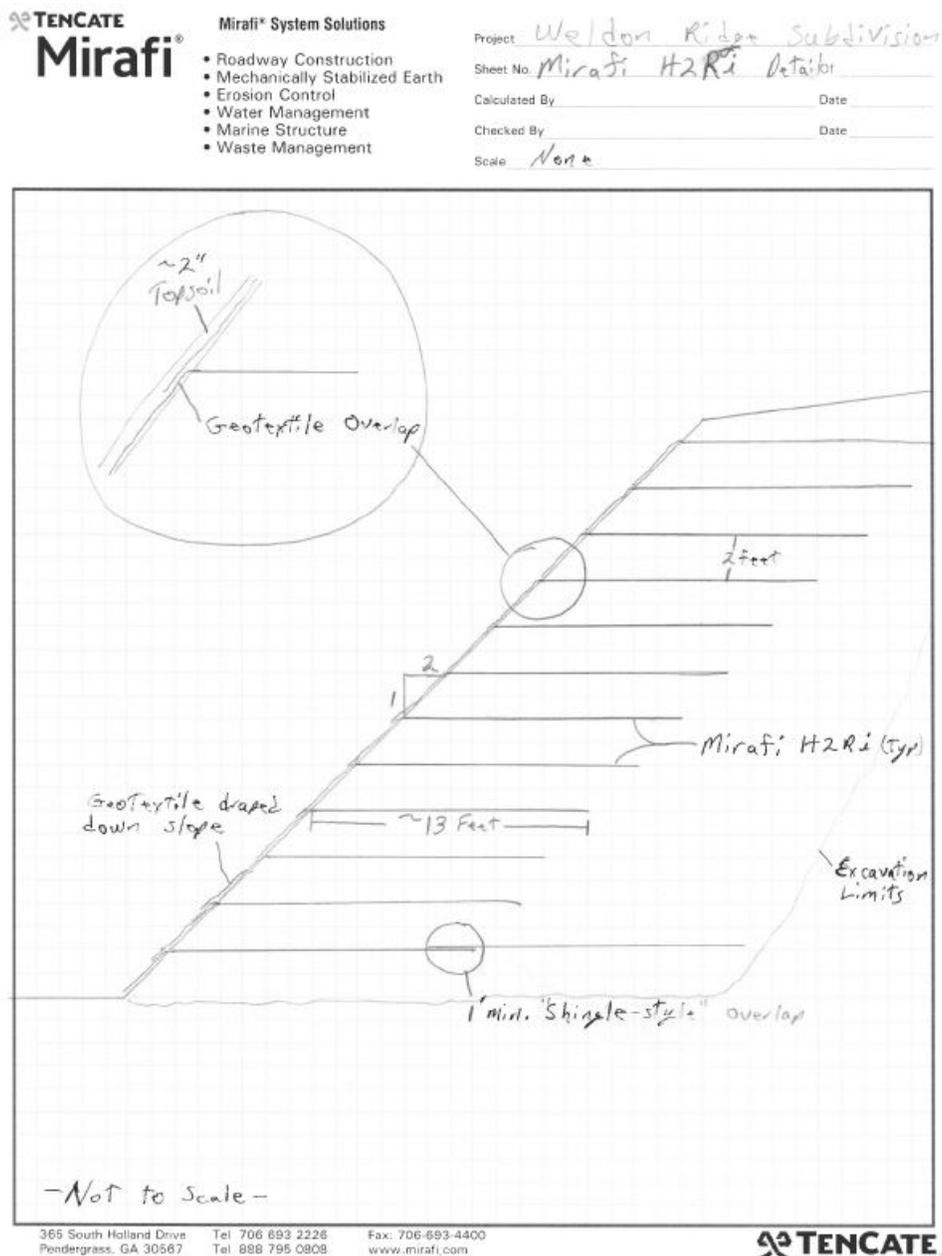
Figure 3. Final grading of the high strength wicking geotextile reinforced slope.

The local geosynthetic distributor contacted the geosynthetic manufacturer's Engineers to help with the product selection. The revised design incorporated the use of multiple layers of the high strength wicking geotextile for both its reinforcing strength and drainage ability. The design called for the high strength wicking geotextile to be placed horizontally in layers spaced 2 feet apart and extending into the embankment approximately 13 feet, longer with an overlap, if water was encountered (figure 3).

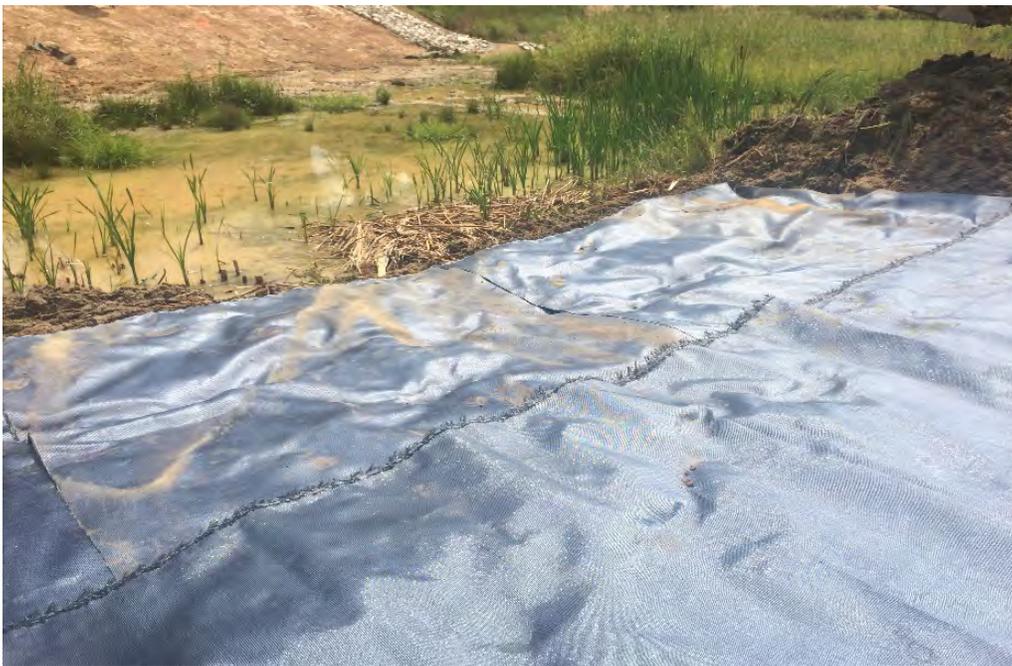
Figure 4. Horizontal installation of high strength wicking geotextile.

Construction was performed in relatively short sections (less than 50 feet along the slope) to allow for the reuse of the on-site soils. The high strength wicking geotextile was placed so it would drain in the direction of the detention pond. The geotextile was installed “shingle style” (figure 4) when it needed to be extended beyond the 15 foot roll size so it would optimize the water flow.

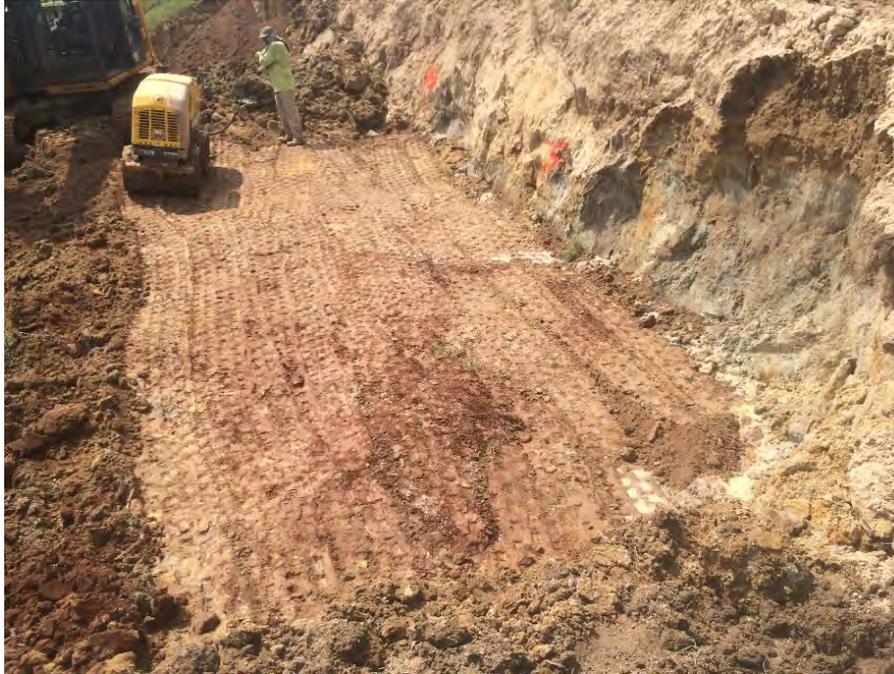
Figure 5. On-site soil placement in compacted lifts.

The on-site highly plastic clay soils (classified as CH) were allowed to be used for backfill and were placed in lifts of 12 inches or less and compacted using a walk behind vibratory sheepsfoot roller (figure 5).

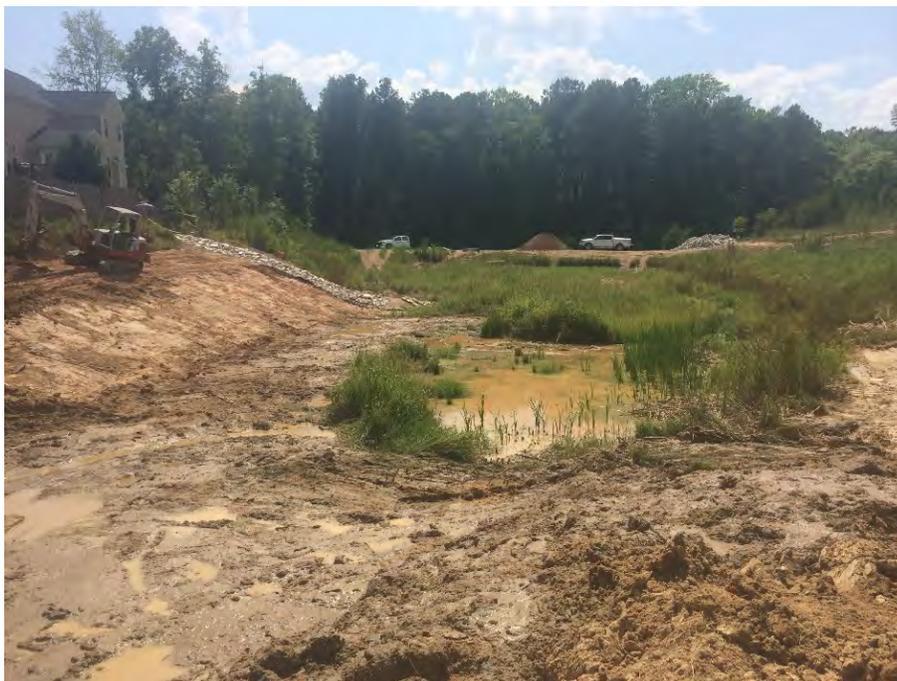
Figure 6. Final grading of the high strength wicking geotextile reinforced slope.

The geotextile extended to the face of the slope and then down the slope approximately 2 feet and was covered with a few inches of soil. The idea was to allow for the vegetation to grow into the end of the geotextile and help remove the water. The final grade along the slope face was smoothed over with the excavator (figure 6).

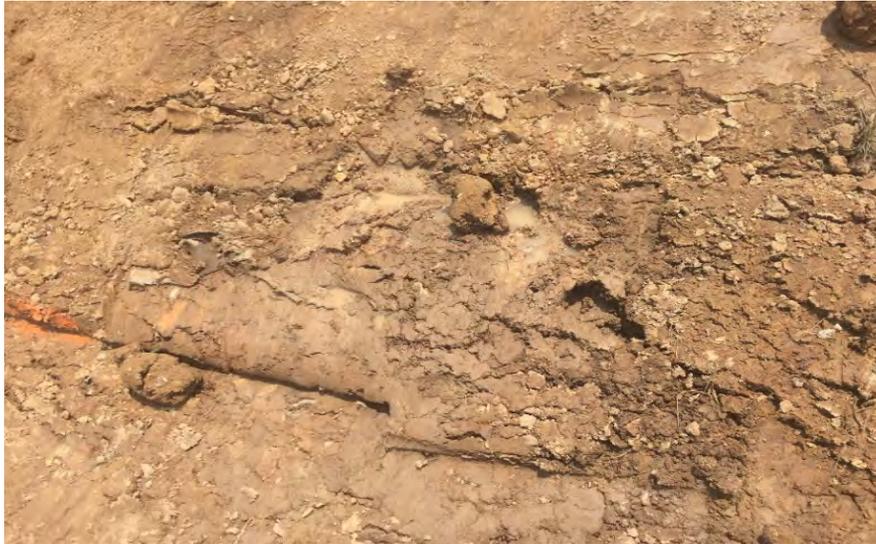
Figure 7. Water observed at face of slope during construction.

During construction, bedrock was encountered in one area and water was observed seeping into the excavation. The geotextile was extended approximately 22 feet into the slope to capture the water. The next day water was observed coming out of the slope face in that area (figure 7). This was proof that the wicking of the water was already occurring.

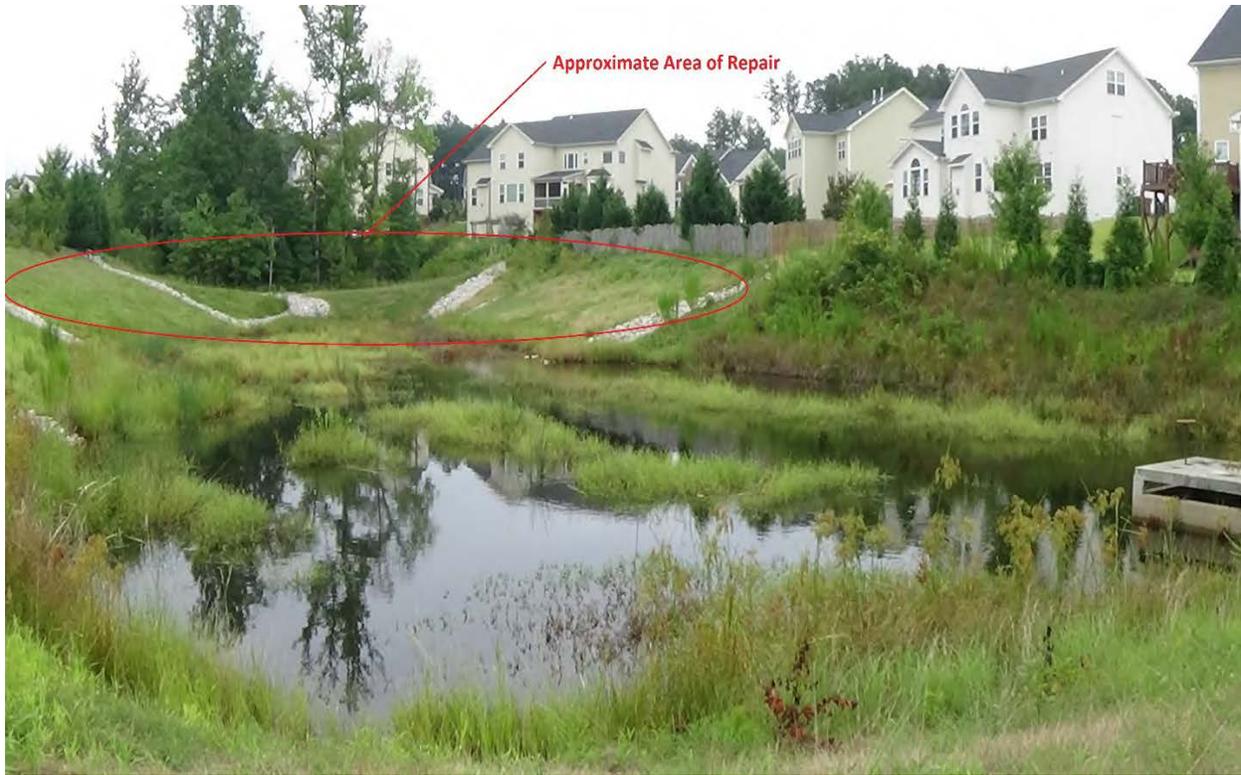
Figure 8. Completed detention pond after 1 year (2015).

A site visit was made in August 2015 to observe the vegetative growth and to visually inspect the slopes. Vegetation had been established and no visible signs of slope movement within the reinforced areas could be seen (figure 8).

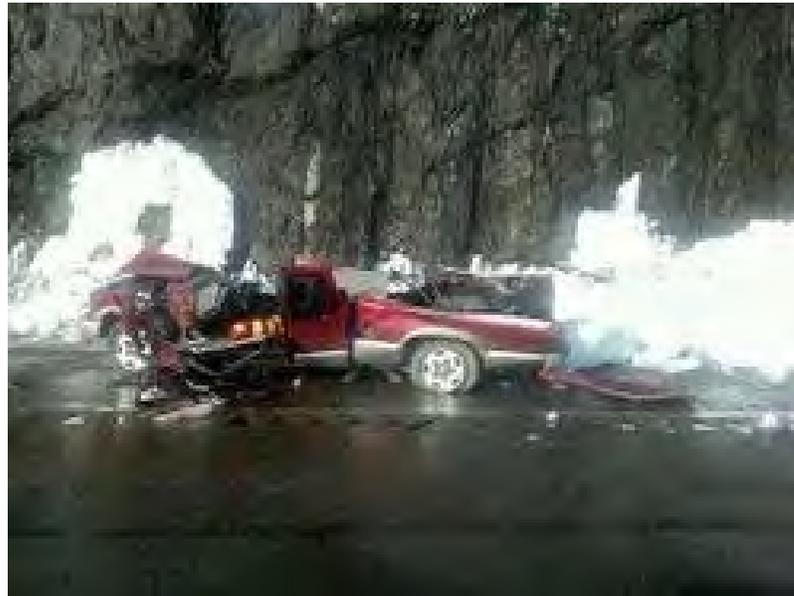
Figure 1 – Direct icefall impact damage to small pick-up truck along Seward Highway near Anchorage, Alaska. Photo courtesy of Anchorage Daily News, 6 April, 2012.

Direct icefall impact hazards can be most significant, and result from point-to-point contact with pavement, pipelines, utilities, or vehicles (Figure 1). Direct impact hazards for icefall can be similar to direct impact from rockfall with respect to energy and collision damage.

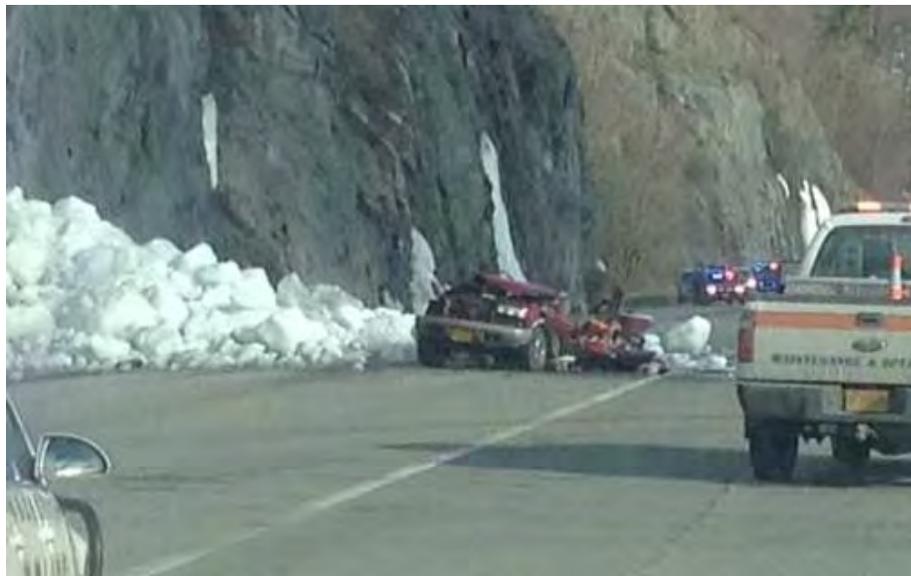
Figure 2 – Direct icefall impact damage to small pick-up truck along Seward Highway near Anchorage, Alaska. Photo courtesy of Anchorage Daily News, 6 April, 2012.

During spring melting, a very large slab (approx. 60 ft. in height) of ice fell and struck a small pick-up truck just south of the Anchorage city limits on 6 April 2012, seriously injuring the driver. It is the author's opinion that the slab became partially detached from the rock slope surface due to loss of adhesion, and that the bottom of the slab became fractured due to progressive increases in loading. Upon loss of strength at the base of the ice slab, failure likely commenced as a combination of near-vertical slab fall and subsequent crushing. This resulted in the generation of a large ice debris pile that developed outward and into the roadway. There was likely a minor rotational component of the failure as internal slabs fell, rotated, shattered, and entered the roadway. Note that the author was retained as an expert consultant relative to the event.

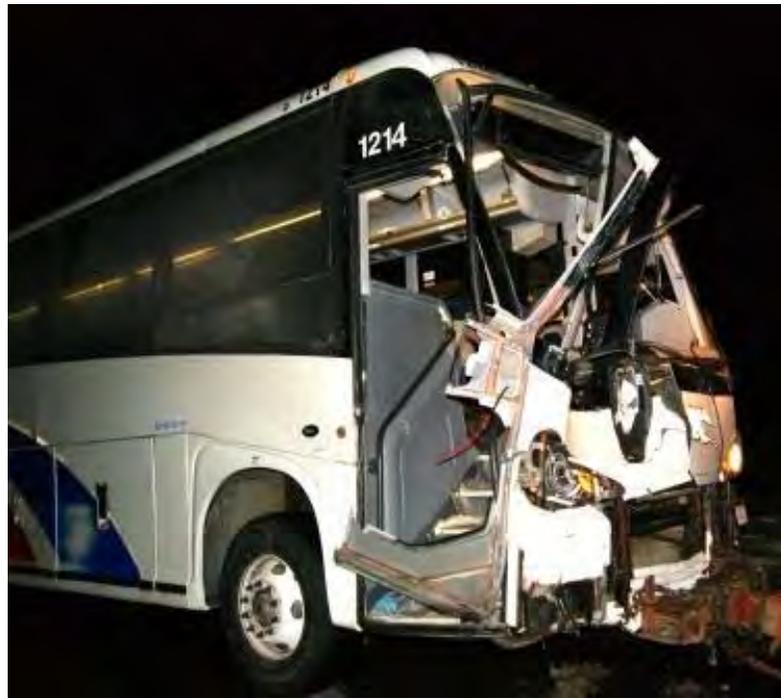
Figure 3 – Icefall impact to tour bus outside Terrace, British Columbia. Photo from Terrace Standard, 15 February 2011.

A falling piece of ice near Terrace, British Columbia hit a Greyhound bus on February 4, 2011, resulting in an injury to the bus driver and the local highway and railway being temporarily shut-down (Figure 3 below).

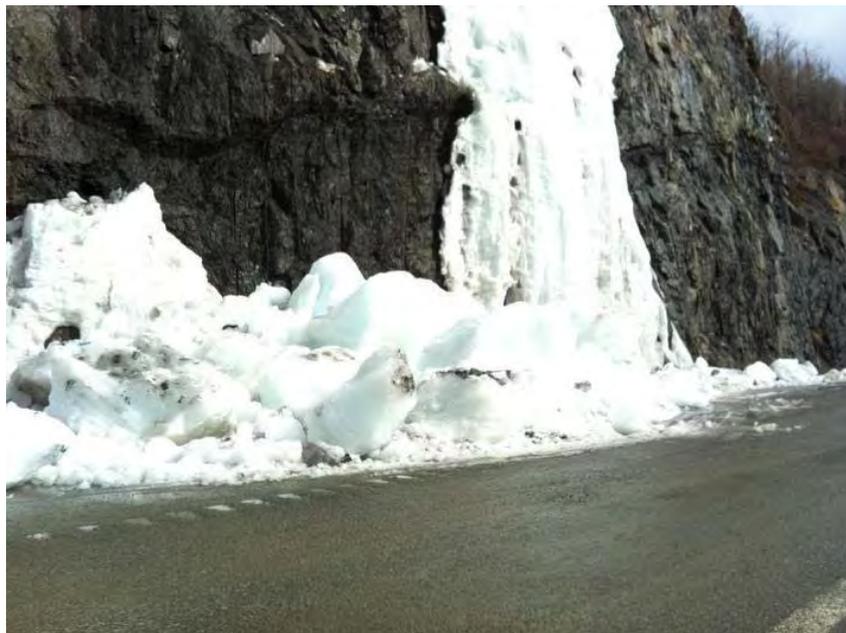
Large or global ice block failures are subject to the same mechanics as rock block failures (e.g. sliding, toppling, and falling). Ice block sliding for example can be assessed, at least preliminarily, with limit equilibrium slope stability analyses. Ice adhesion can be considered as an equivalent cohesion component of the stabilizing force, until melting commences at which point adhesion to the host rock surface is significantly reduced. These types of failure mechanisms in the source zone can be assumed at the moment of incipient failure; however, a block of ice observed at the side of a road may be perceived as an “icefall” event. Management controls dictate how such a failure is perceived and recognized. Source zone controls make use of design elements that are intended to manage the block in the source zone. Conversely, impact area controls are intended to allow for block failure and subsequent fall, but limit the horizontal distance that the block can travel. Understanding how large slabs of ice may fail can be helpful in estimating the impact area and risk to the traveling public (Figure 4).

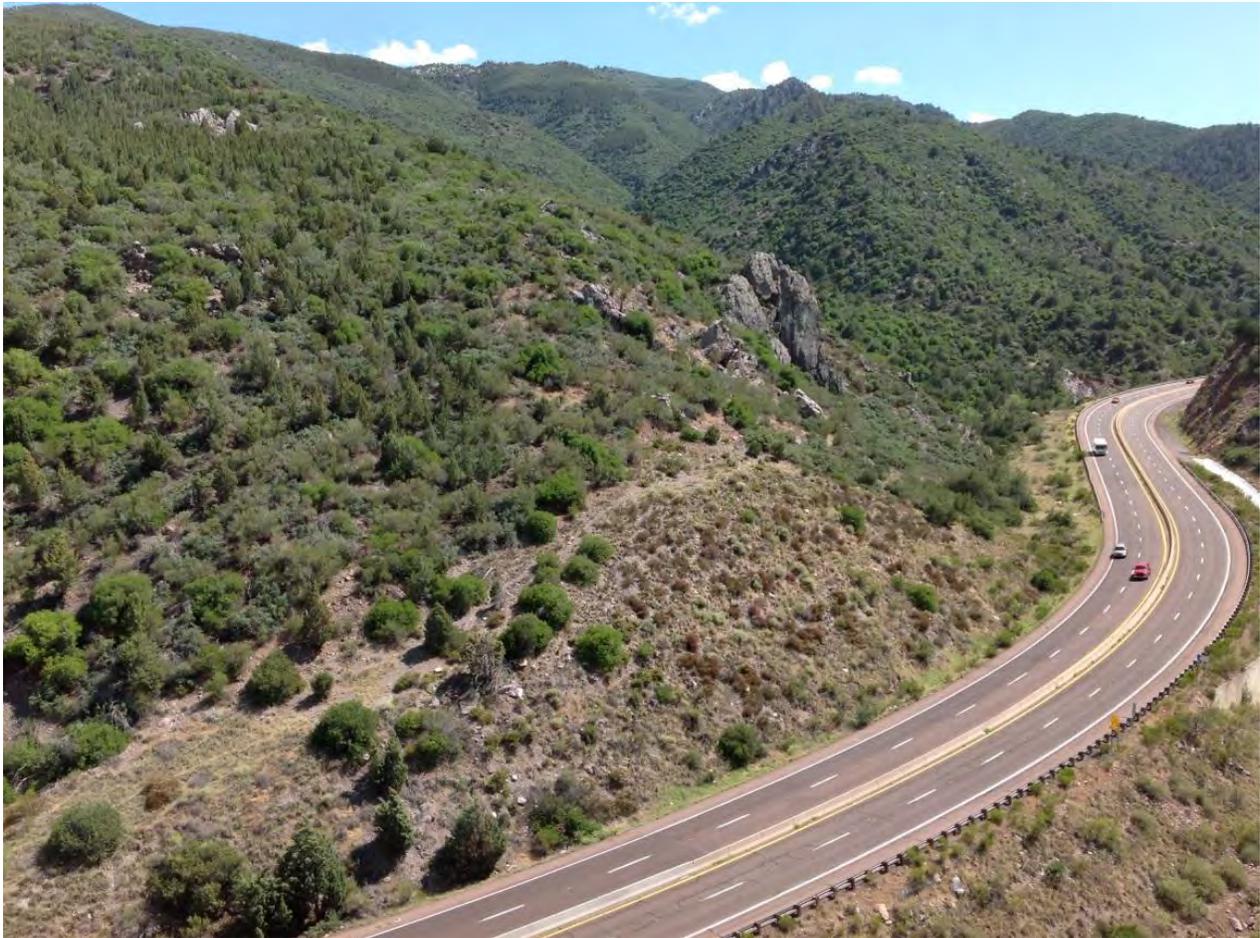
Figure 2 – Photograph of the Curve Realignment looking north.

In Figure 2, the photograph shows the highway previous to this project had both directions of traffic at the same elevation and the super was below current standards. This project flattened the curve (increased the radius of curvature), created grade separation between the north and south bound lanes, increased the ditch width to 15 feet, and required the stabilization of the slope south of the roadway.

Typically, materials having a p-wave velocity less than 5,000 feet per second are considered to be soil and those materials with a p-wave velocity above 5,000 feet per second are considered intact bedrock. The results of the seismic refraction surveys indicated p-wave velocities typical of soil extending to depths of 30 to more than 60 feet at the location of the surveys. However, using the depth to bedrock as determined in the borings and plotting this depth on the corresponding seismic survey, the upper bedrock materials fall within the soil like p-wave velocity range. Based on the p-wave velocity of the bedrock materials encountered throughout the entire project site, the completely weathered phyllite and quartzite have engineering characteristics more characteristic of dense soil rather than weak bedrock. As observed on the site, the quartzite has highly variable weathering, with some of the quartzite characteristic of a dense soil and other portions of the bedrock standing vertical above surrounding grades for approximately 20 feet (See Figure 2).

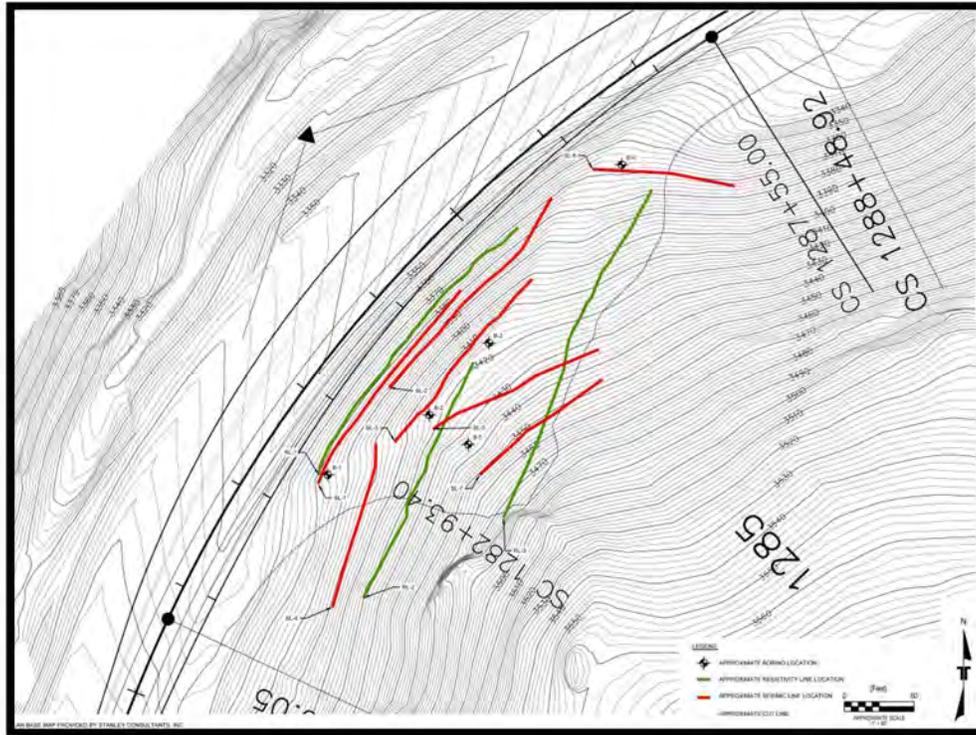
Figure 3 – Site Plan of Boring and Geophysical Locations

Terracon's field exploration program was performed in two phases, with the first phase comprised of five borings advanced by coring methods and three hollow stem auger (HSA) borings. To increase our coverage of the site at a relatively low cost, 13 geophysical surveys were performed to better assess the subsurface conditions across a larger portion of the site. The borings located on the side of the hill were advanced using helicopter mobilized drill rigs using HQ3 coring methods. The hollow stem augers were advanced in the existing roadway with a truck-mounted CME-75 drill rig utilizing 4¼-inch inside diameter hollow-stem augers.

Terracon completed seven seismic refraction traverses (SL-1 thru SL-7) and three multi-electrode resistivity (MER) lines (RL-1 thru RL-3) within the proposed slope cut area of the project. The seismic refraction lines used a DAQLink III seismograph with 24 geophones to derive the subsurface seismic velocity information. The MER lines used an Advanced Geosciences Inc. (AGI) SuperSting and 112 electrodes. The dipole-dipole method of collection was used, to derive subsurface resistivity information.

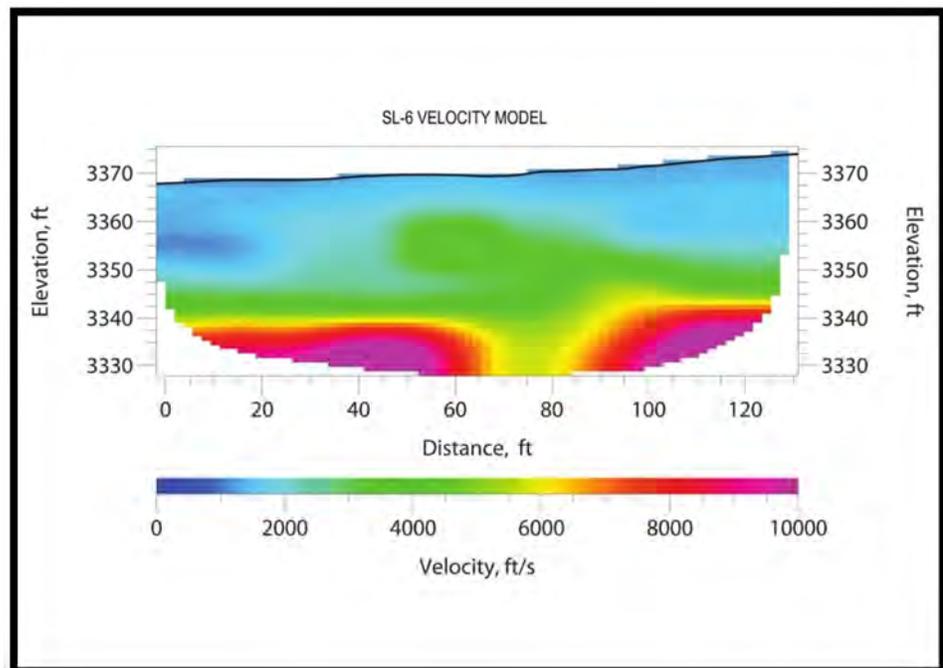
Figure 4 – Typical Plot of Seismic Refraction Line Survey

The purpose of the seismic refraction and MER surveys was to determine the boundary between the paleo-stream deposits and the underlying phyllite bedrock materials. The presumption in the seismic refraction analyses, was that the paleo-stream deposits would have a slower p-wave velocity than the underlying phyllite bedrock materials. The presumption in the MER analyses, was that the paleo-stream deposits would have lower resistivity due to the infiltration of surface water. The analysis for either method therefore involved determining the location of the bottom of the paleo-stream deposits and the top of the undisturbed phyllite bedrock by interpreting the change in p-wave velocity or resistivity with depth.

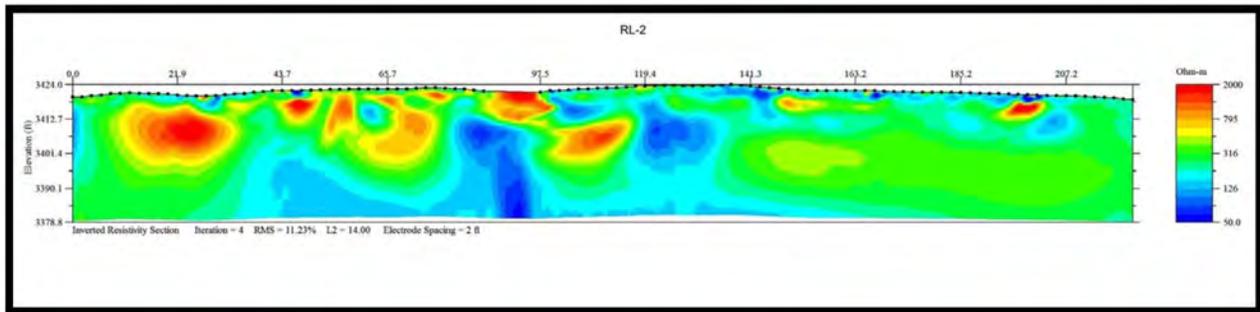
Figure 5 – Typical Plot of MER Line Survey

The actual field conditions as encountered during the drilling of the anchors generally supported the exploration results though the stream deposits were 0% to 20% thicker than indicated by our exploration. The MER survey results were too ambiguous to be of any use, and therefore were not considered in the final analyses of the subsurface conditions.

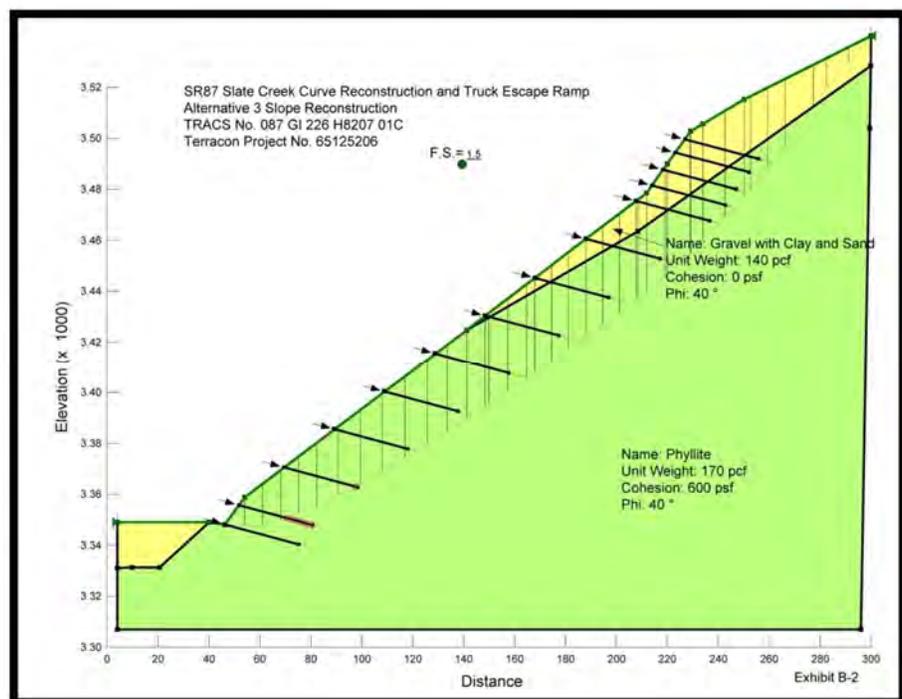
Figure 6 – Cross Section of Alternative 3 showing the potential failure plane.

At the completion of a design team meeting it was decided that Alternative 2 was the preferred alternative. However, after further exploration and analyses, Alternative 2 was not considered feasible and the recommended alternative for slope reconstruction became Alternative 3. Due to the amount of “sliver” cuts that would have been created near the top of the cut slope with a 1.3H:1V slope ratio, it was decided to increase the slope to 1.2H:1V and thus reduce

the “sliver” cuts that would have been required. A gabion basket slope ditch was added at the top of the cut slope to reduce the erosion potential of surface water from above the slope causing significant soil movement. A cross section of this alternative without the gabion basket slope ditch is shown as Figure 6.

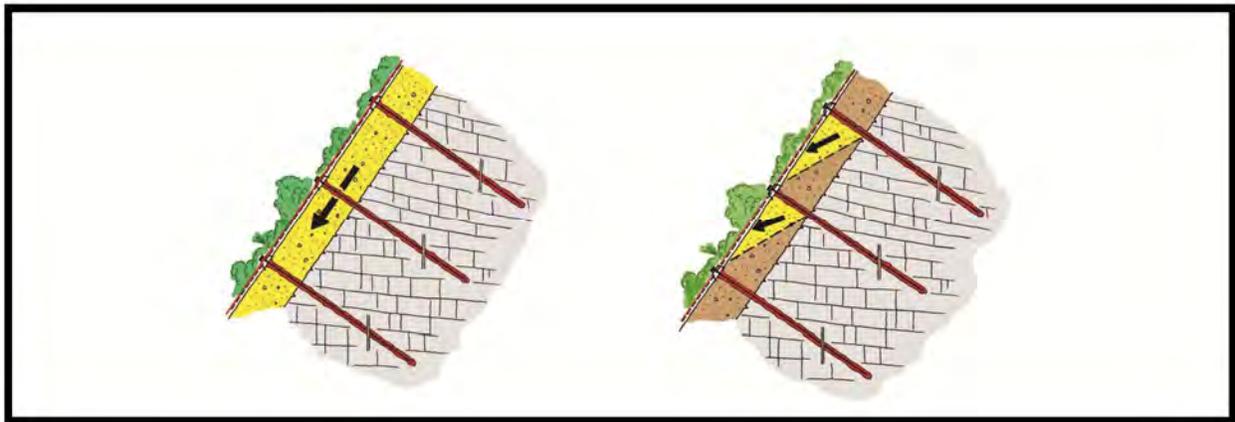
Figure 7 – Cross Section of Slopes with Potential Failure Parallel to the Slope Face and Potential Failure Between Rows of Anchors

The program RUVOLUM performs analyses of the entire system including the grouted bar anchors, high tensile steel mesh, steel plates, subsurface conditions, and geometry of the slope. The program considers sliding of the entire soil mass parallel to the slope at a specified depth, soil wedges moving out from between rows of grouted bar anchors, shear of the grouted bar anchors, and punching shear of the high tensile strength mesh. Schematic cross sections of these potential failure modes are shown in Figure 7.

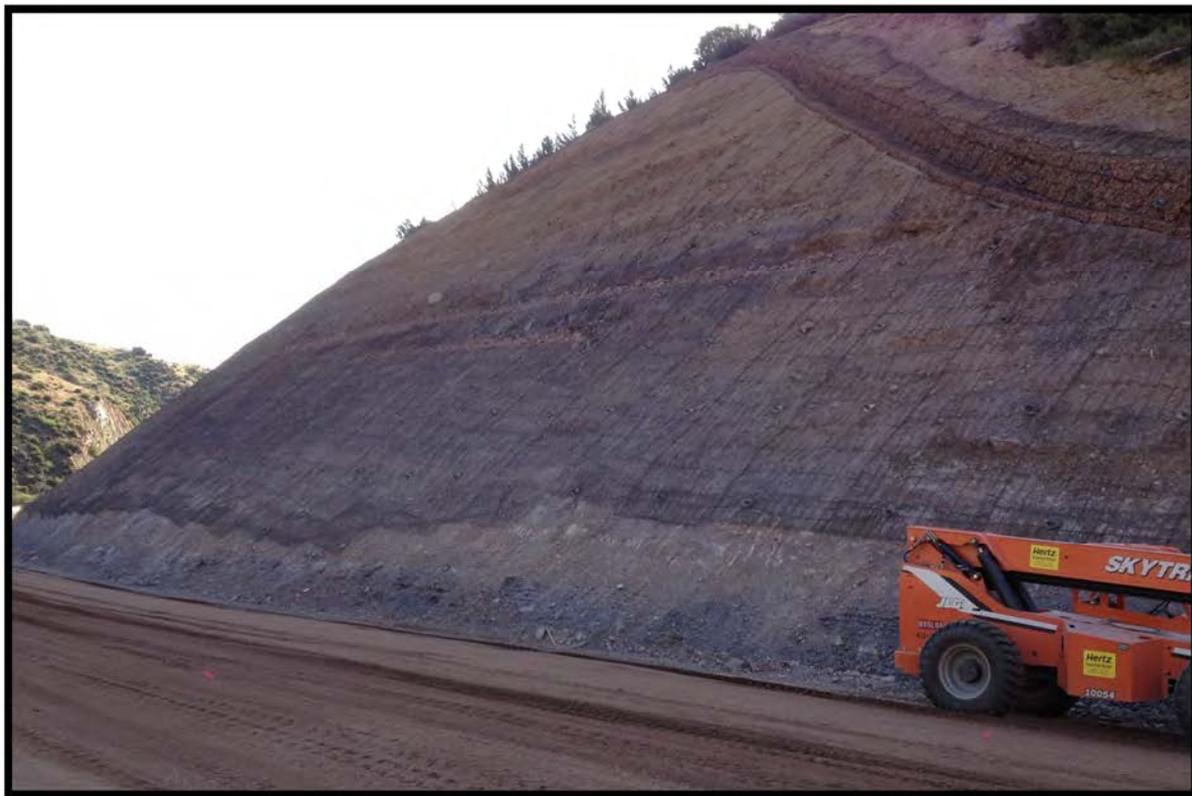
Figure 8 – Photograph of the finished cut slope with the mesh fully installed and the seeding effort half completed.

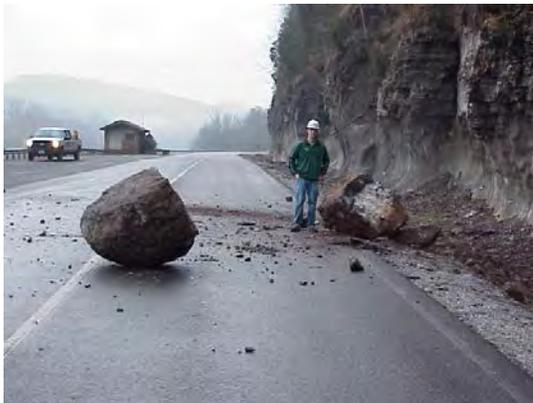
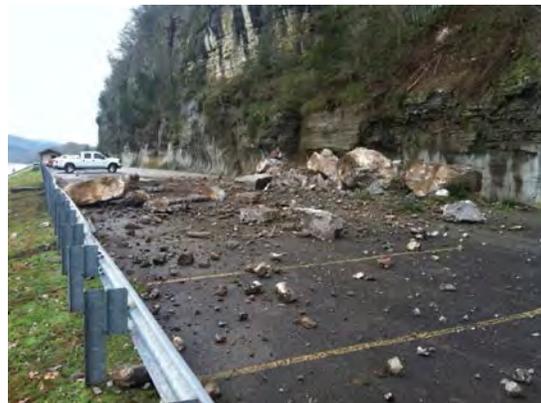
A: Photo taken 16 January, 2010

B: Photo taken 30 November, 2011

Figure 2. Photos of Rockfall along Cordell Hull Dam Access Road from 2010 and 2011

The access road to Cordell Hull Dam in Carthage, TN illustrates the problems that can develop over time in a natural rock cut in karst terrain. This access road had experienced numerous small rockfalls over the years, but the number and size started accelerating in 2011. This rock cut, was made by the river with some small scale blasting used to widen the cut at the base to widen the road and provide parking for fishing access. Differential weathering of some of the Hermitage shaley layers at the base was mitigated by a shotcrete finish, but overall most of the cut was left in its original condition. A scaling contract was let in 2012 to address these problems and remove the large unstable columns and boulders on the face.

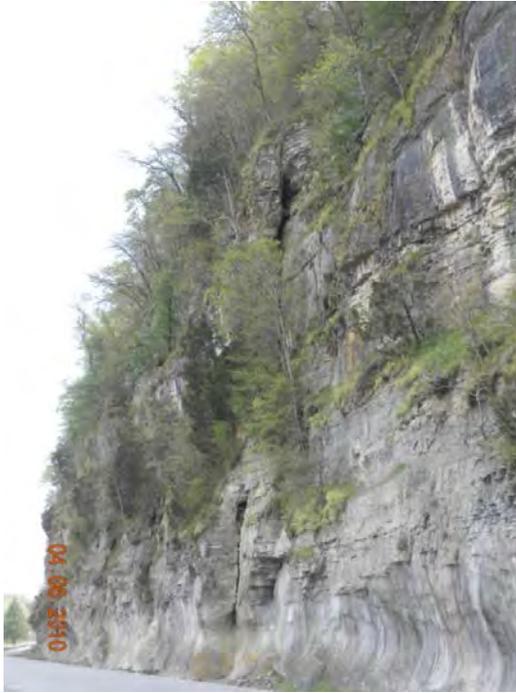
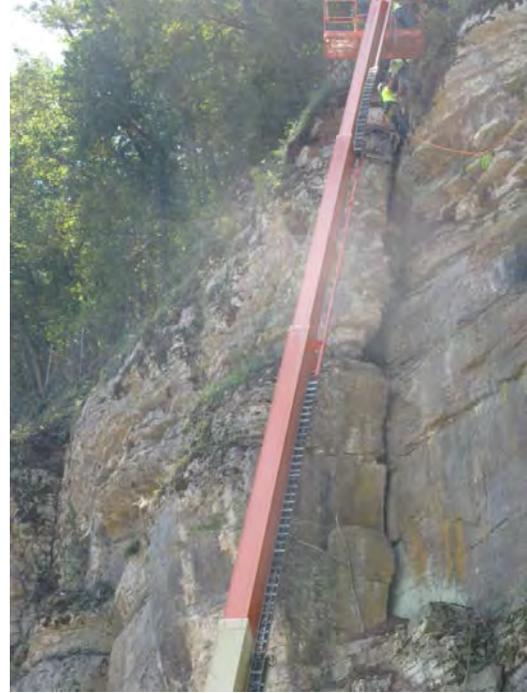
A: Column Above Comfort Station

B: Close up taken in 2012

Figure 3. Two Photos of a Typical Rock Joint Exiting the face at Moore's Bluff causing stability problems at the site. Note shotcrete at the bottom of the slope placed to protect the lower shaley layers from differential weathering.

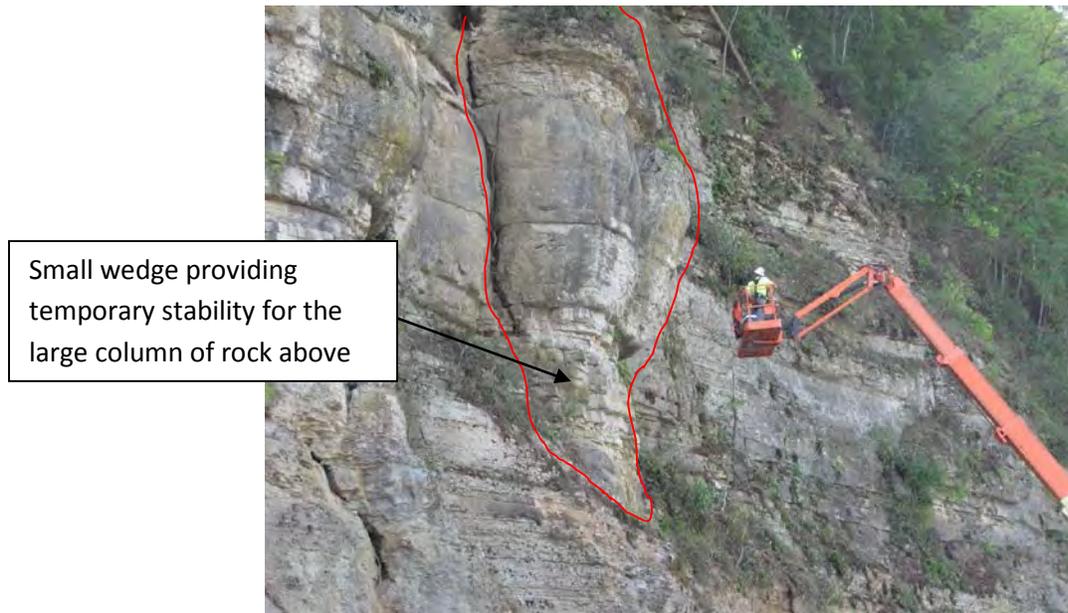
Figure 4. Large Column at Station 20+50

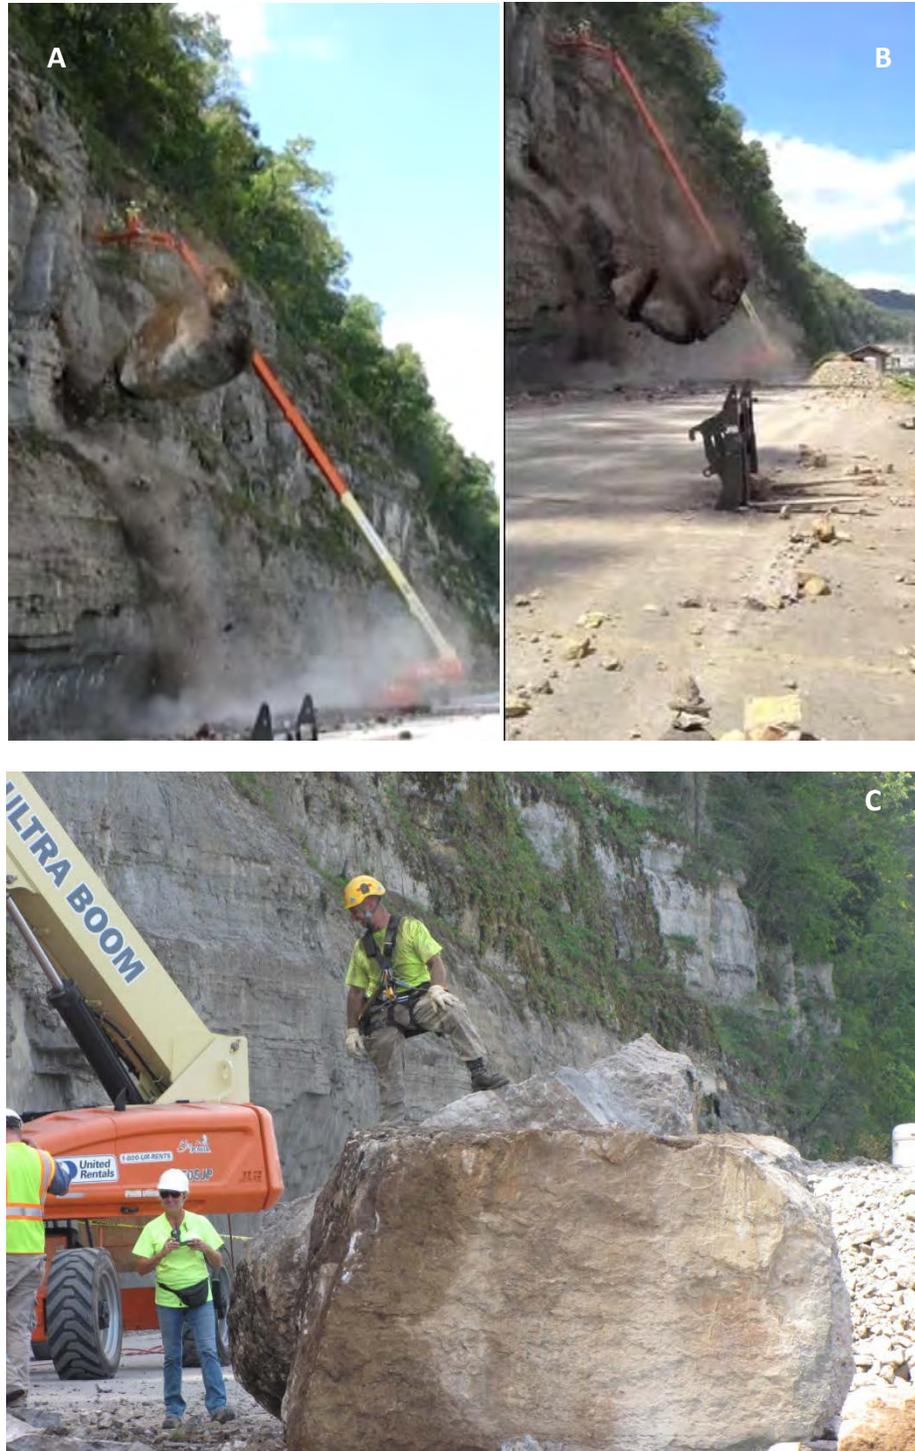
Figure 5. Removal of Large Boulder on Slope by Air-bagging in Joint (2012)

Many of these large columns on-site were removed by using air-bags placed in the opened joints behind them. These large boulders were actually already completely detached from the surrounding rock fabric, and were being held in place by a center of gravity located just behind their existing footing which was continuing to weather. Figure 5 shows the removal of one of these large columns by use of an airbag.

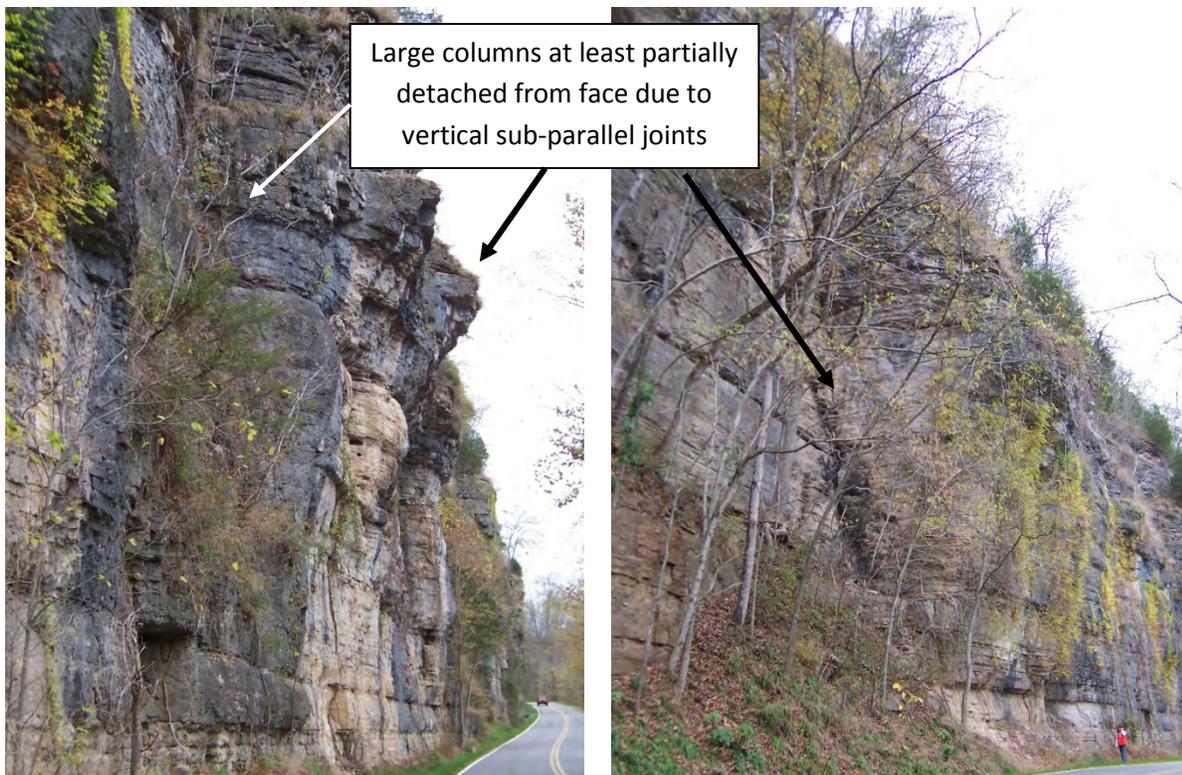
Photo A: Multiple Columns in Slope

Photo B: Large Open Joint behind Rock Face

Figure 6. Natural Rock Slope on SR-141 in Trousdale County, TN

Figure 6 below contains two photographs of similar geological problems on two existing Tennessee Highway rock slopes that are natural cuts. SR 141 located less than 50 miles from Cordell Hull along the Caney Fork River in Dekalb County shows a similar pattern to what is seen at the Cordell Hull Dam Access Road Site. Again, there is more massive rock located on top of limestone that is more weathered, producing large overhangs and columns of rock. As with the Access Road, this bluff on SR 141 at LM 0.6 is located along a river, this time the Caney Fork. Numerous rockfalls have occurred at the site, but with its very low ADT and high expense, this segment has not yet been repaired. Figure 6 Photo A shows rock columns that look almost identical to what was removed at Cordell Hull. Small karst features can be seen in some of the rock columns. Figure 6 Photo B shows a large open vertical joint that extends behind the rock face.
