66TH HIGHWAY GEOLOGY SYMPOSIUM SEPTEMBER 14-17, 2015

2015 Proceedings

*Massachusetts Department of Transportation
and
University of Massachusetts Amherst*

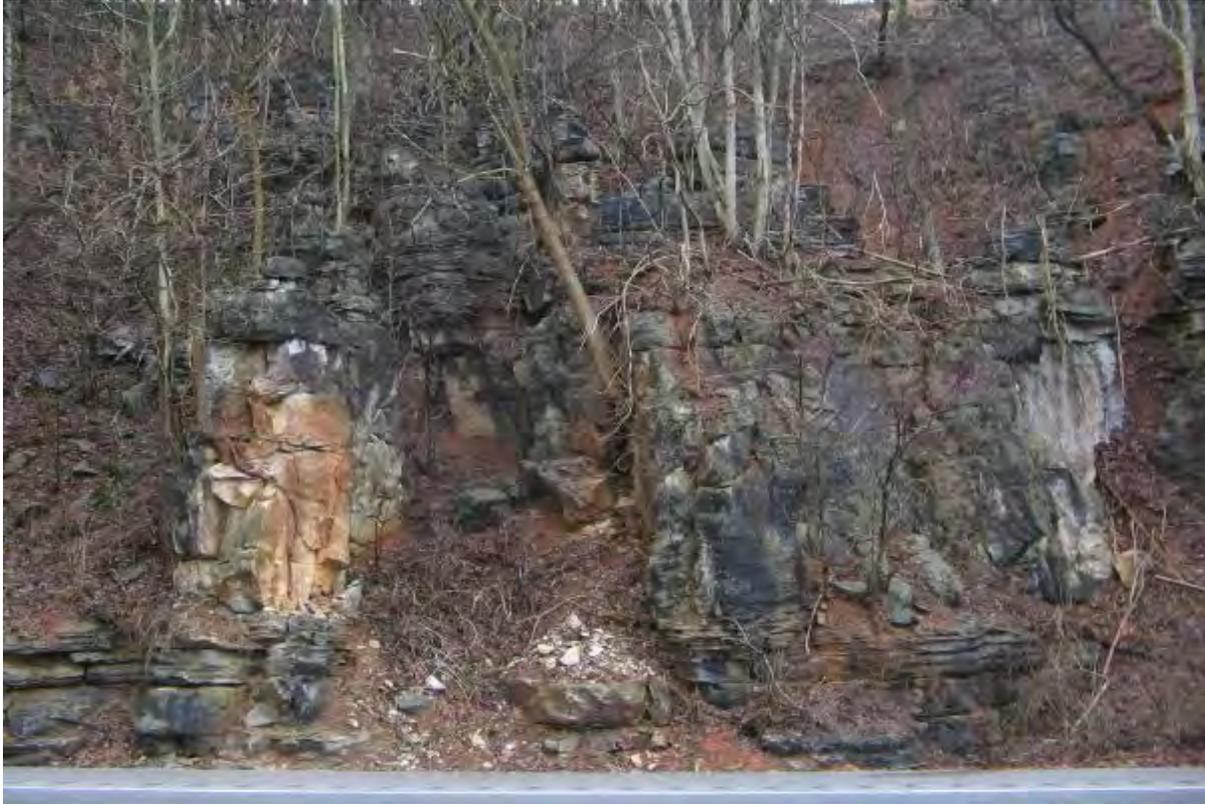
Figure 7. Solutioning in Limestone along Natural Rock Slope Face on I-40 in Putnam County, TN located at margin of Highland Rim and Cumberland Plateau

A slightly different situation exists in the photograph in Figure 7 below, which shows solutioning directly leaving unstable columns and boulders on a natural rock cut face along I-40 in Putnam County in the Highland Rim. There are also solution widened joints here, but no valley stress relief jointing is present.

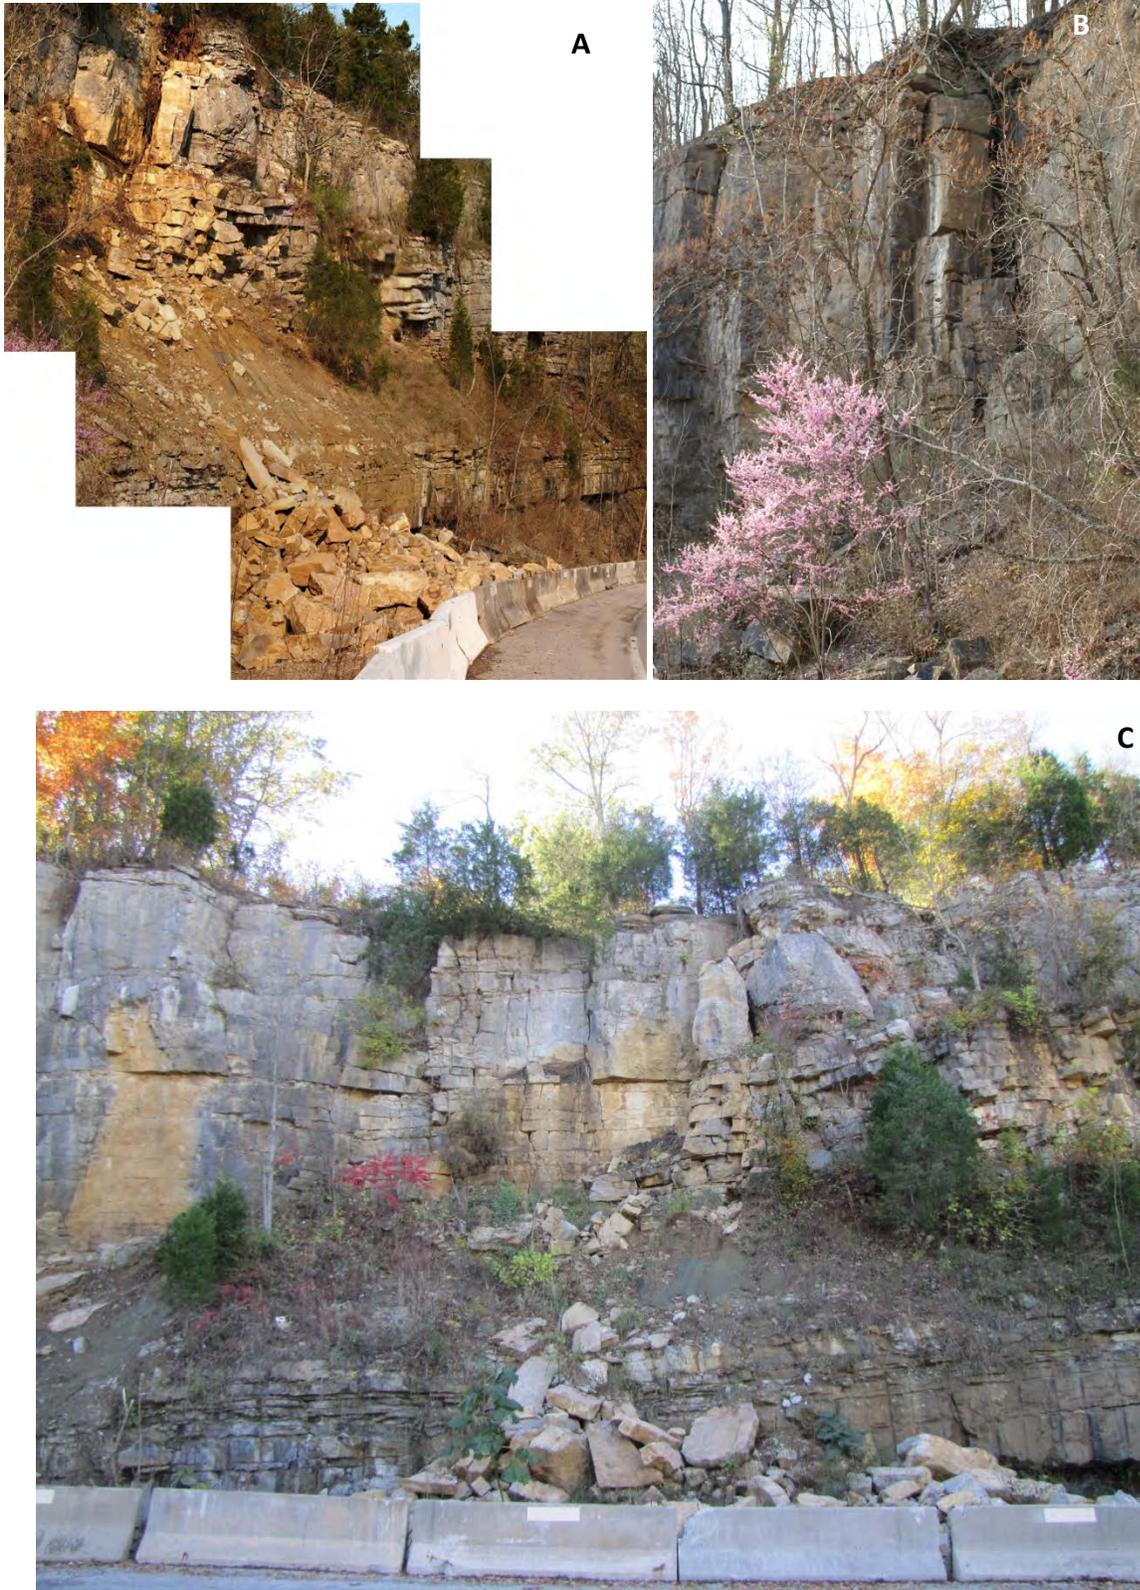
Figure 8. SR-16, Franklin County, TN – Shale layers undermine overlying larger limestone boulders with vertical joints leading to secondary toppling failure of the rock

Many of these same issues can also be seen in constructed slopes across the state. A good example of this is SR-16 in Franklin County, TN located at the edge of the Highland Rim and Cumberland Plateau. This rock cut contained numerous problems which led to several large scale rockfalls. Shale layers, located at the base and in the middle of this rock cut, were weathering quickly and undermining the limestone blocks above. These blocks were cut by solution widened joints and also by sub-parallel valley stress relief features. Figure 8 photo A shows the secondary toppling failure mode with rock at the base of the cut successively failing. The underlying shale formation at this cut is undermining the overlying rock which is releasing along the vertical joints in the face. Figure 8 Photo B shows a large open vertical joint. Figure 8, Photo C is another view of the same section of the cut as shown in Photo A.

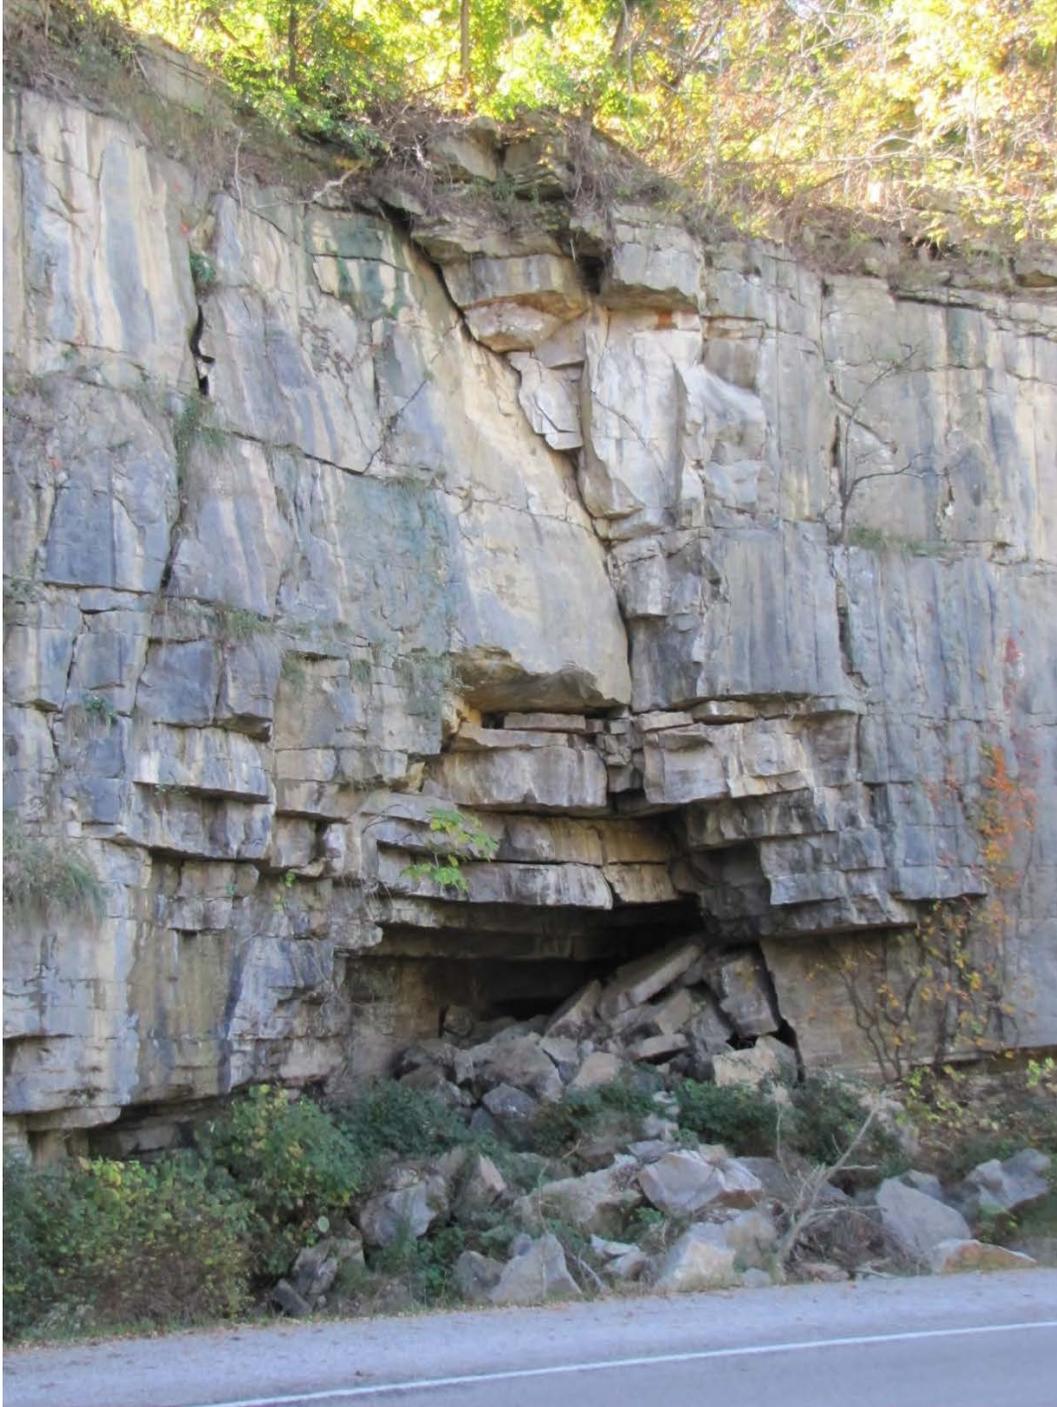
Figure 9. Cavity Located in base of rock cut undermining rock above along vertical joint face

This cut, as can be seen in Figure 9, also contains a large cavity which is interacting with the vertical joints in the face to undermine stability of the cut. Here we can see the brown weathered face of the remaining rock where a boulder has already fallen from the slope and existing vertical joints and tension cracks developing in the limestone beds just above the cave. Half-casts can be seen in the face from original construction. Several large rockfalls prompted the Tennessee Department of Transportation to recommend a repair in 2010.⁴ A project was let to contract to repair this section of rock cut in 2012.⁵

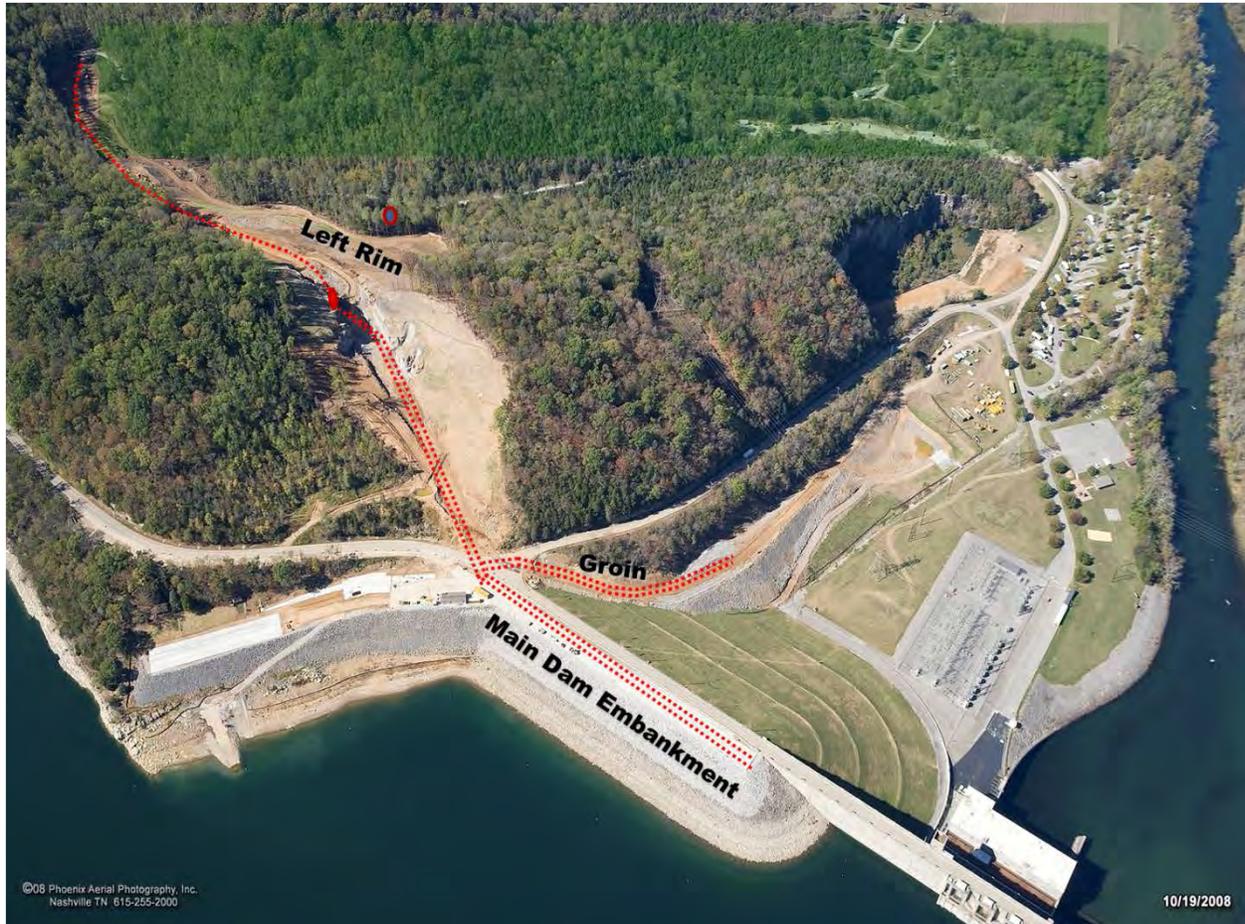
Figure 10. Aerial Photograph of Center Hill Site illustrating Grout Curtain Installation from 2009-2010.

extreme epikarst than is usual in Tennessee was encountered on the flanks of the large hill to the left of the main dam embankment where a rock cut was used to construct a grouting platform. Figure 10 below shows the locations of the grout lines installed at the site to deal with a karst driven potential failure mode at the dam.

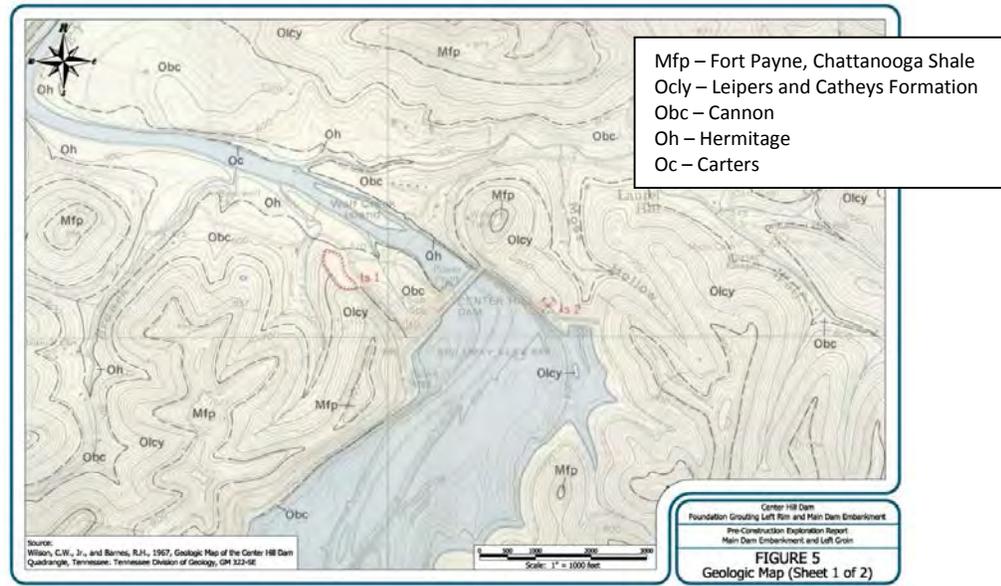
Figure 11. General Geology Map in the Vicinity of Center Hill Dam⁷

Center Hill Dam, as shown in Figures 1 and 10 above, is located on the dissected outer edges of the Central Basin and the Highland Rim. Figure 11 below shows the general geology map of the site with the Ordovician Aged limestones typical of the Central Basin and Devonian Chattanooga Shale and overlying Mississippian Fort Payne formation of the Highland Rim. The geology of this area interacted to produce a highly developed vertical karst system that solutioned along existing structural joints and valley stress relief joints that developed due to the uplift of the Nashville Dome and along the flanks of an anticline located very near Center Hill Dam.⁶

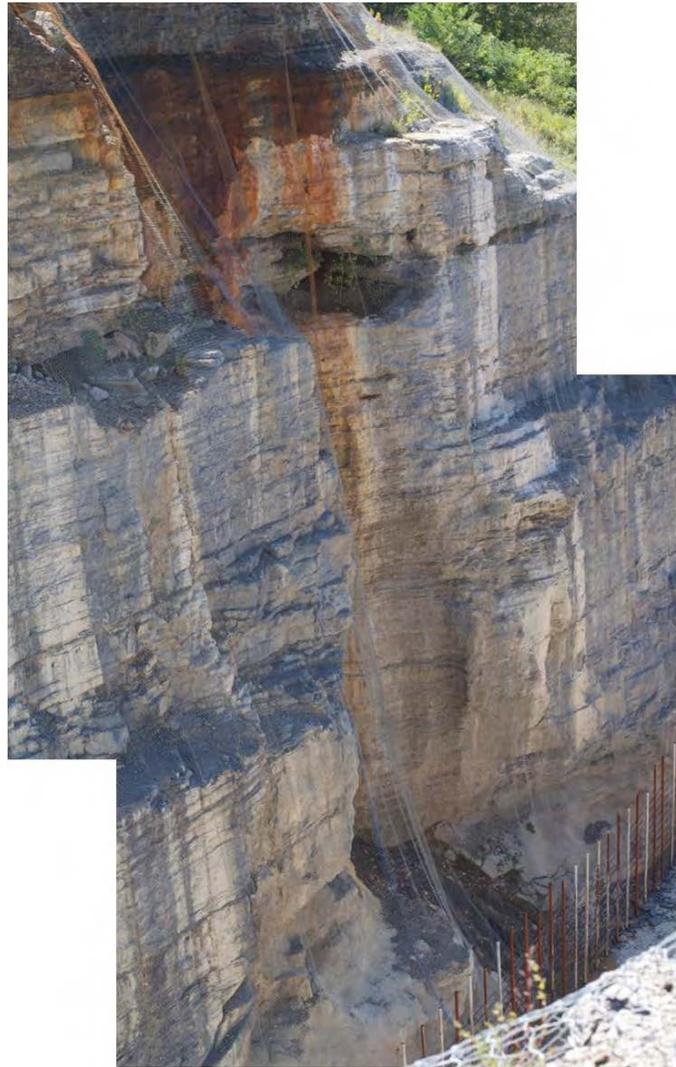
Figure 12. Acid Drainage Staining vertical karst feature in left Rim cut – Center Hill Dam ¹⁴

situation and likely contributing to the more extreme epikarst at the site is the presence of pyrite in the overlying Chattanooga Shale.¹² Waltham and Fooks note that karst development tends to concentrate close to boundaries “...where allogenic drainage is supplied from impermeable rock outcrops.”¹³ The acidic drainage at this allogenic margin may have further accelerated the development at the site. Figure 12 below shows a karst shaft with strong iron staining from the water seeping out of the Chattanooga shale bedding interface with the underlying limestone, an indicator of acidic drainage.

These pictures, taken of the same karst shaft shown in Figure 12, illustrate the stability concerns from a rock slope that was not designed to incorporate these features. The Center Hill Left Rim Grouting Platform was not designed with any of the standard rockfall catchment guidance that would typically be used on projects today.¹⁵ However, even if a design guidance document had been used, the catchment guideline may only have been sufficient for the type of rockfall seen in Figure 19. Such design tables were not meant to be used for large scale structural failure of rock. Where additional problems exist in the rock face, further design time is needed to ensure that the rock cut is stable and the rockfall catchment zone is sufficiently wide.

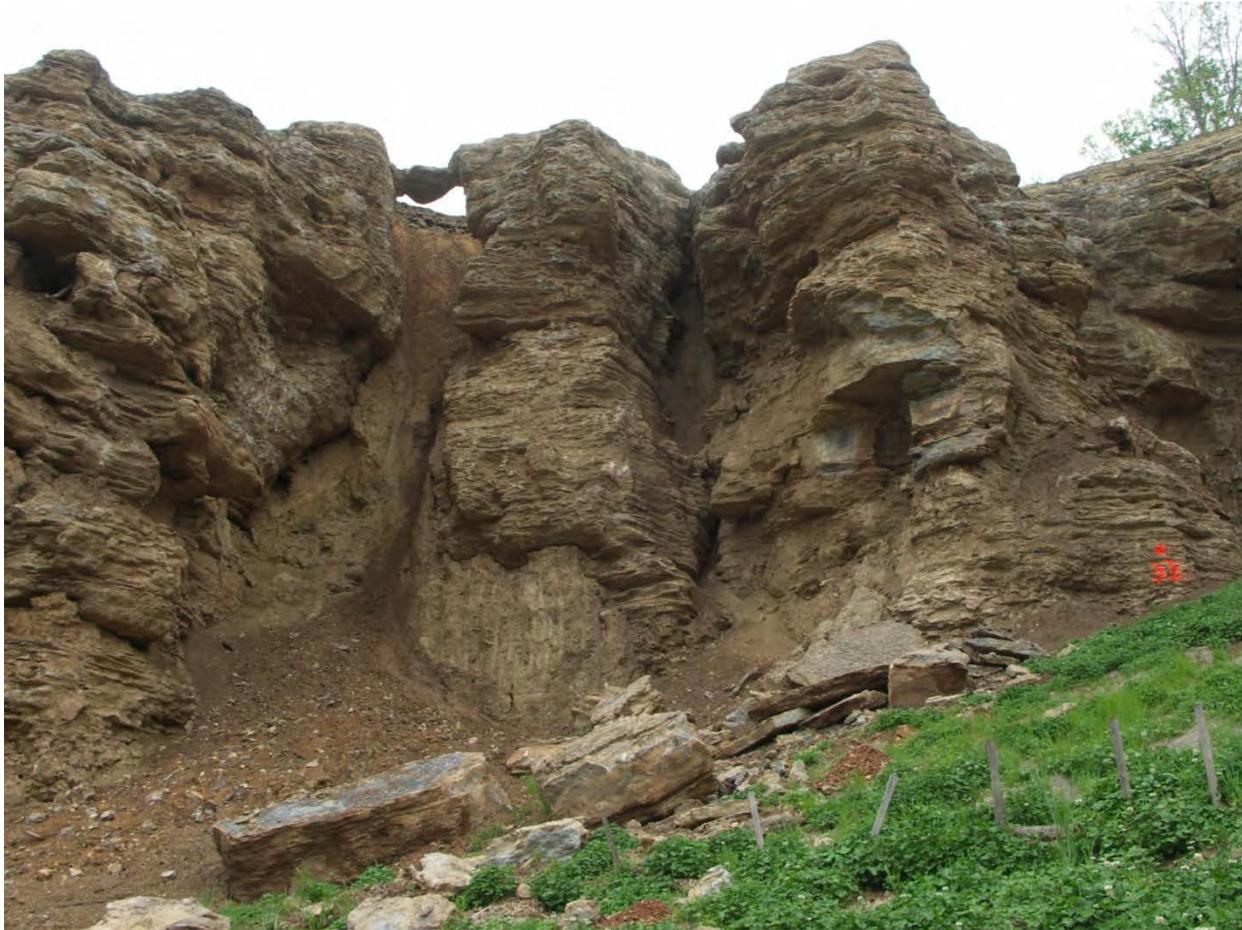
Figure 13. View of “Adobe Village” on the flanks of the left rim cut. Figure 14 below shows a wider angle view

Numerous karst features are present in the two rock cuts that were constructed in order to build the left rim grouting platform. However, what appeared to be the most unexpected problem was the significant epikarst zone located on the flanks of the left rim cuts. This weathered limestone, was excavated after a slide began in the overlying soil. This area, featuring deep vertical mudcutters and isolated boulders was named “Adobe Village” by the local USACE personnel. Figures 13 and 14 show views of this area.

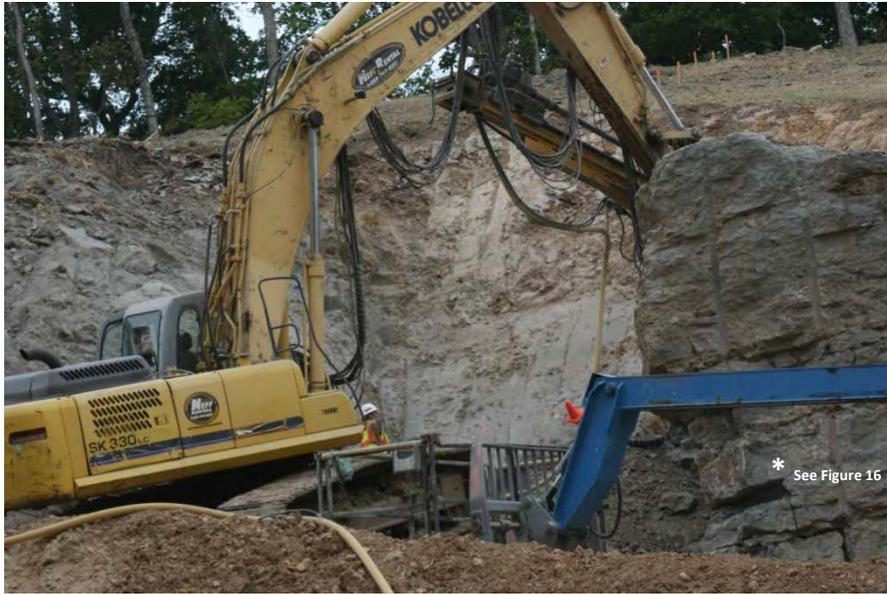
Figure 15. Excavation of mudcutter at the top of the left rim excavation - 2008

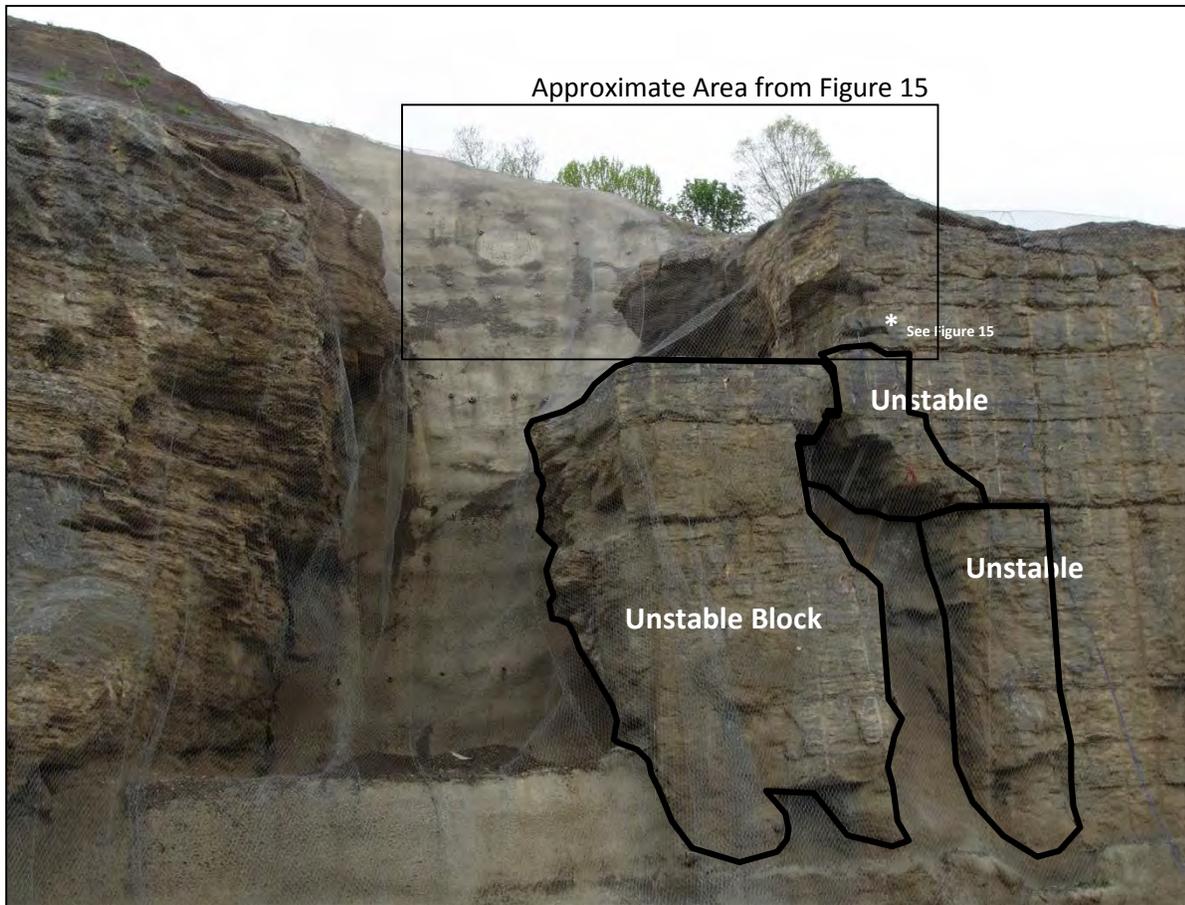
Figure 16. Unstable Blocks incorporated into Left Rim Cut. Largest block appears to be nearly fully detached from the surrounding rock by the vertical features. Photo 2010.

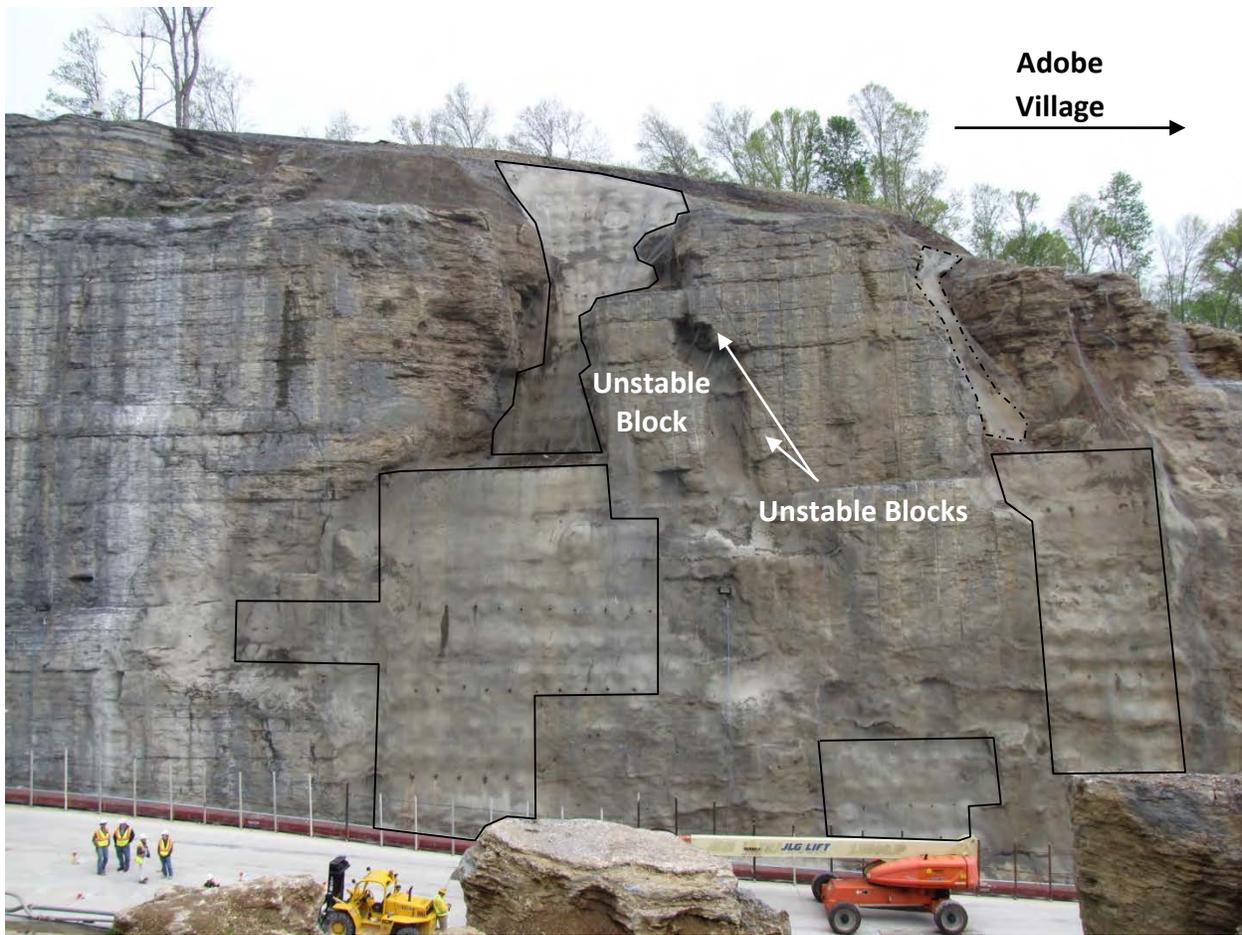
Figure 17 Unstable Blocks incorporated into Left Rim Cut view from the work platform, Jan 2014. Soil nails and shotcrete face areas are outlined in black.

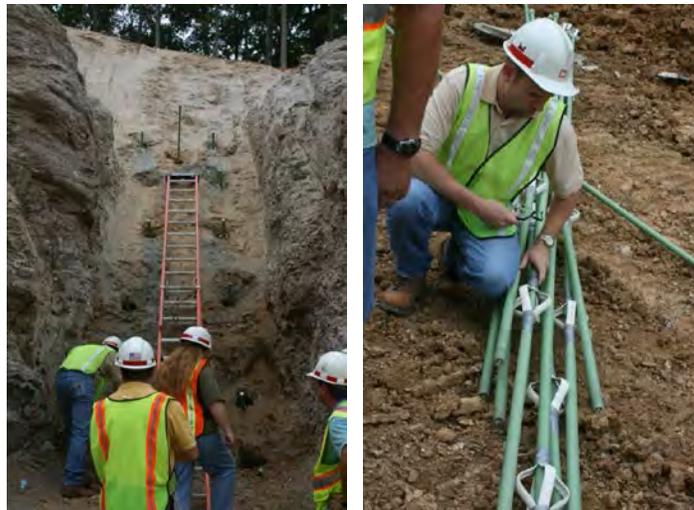
Figure 18. View of Vertical Clay Seams and Soil Nail Installation, September 2008

Even where the surrounding rock mass was more competent, towards the center of the hill, there were still numerous large vertical mudcutters, karst features filled with soil that “cut” the rock. These were covered by shotcrete as the excavation proceeded. Unfortunately, the depth of these features was poorly understood prior to their excavation. Figure 15 shows the excavation of one of these mudcutters when the excavation was still near the top of the constructed slope. Figures 16 and 17 show the entire cut as constructed, with several unstable blocks left near the top of the slope. Soil nails with a shotcrete face were installed in order to stabilize the face as the excavation proceeded. Figure 18 shows the excavation of one of the mudcutters and installation of the soil nails.

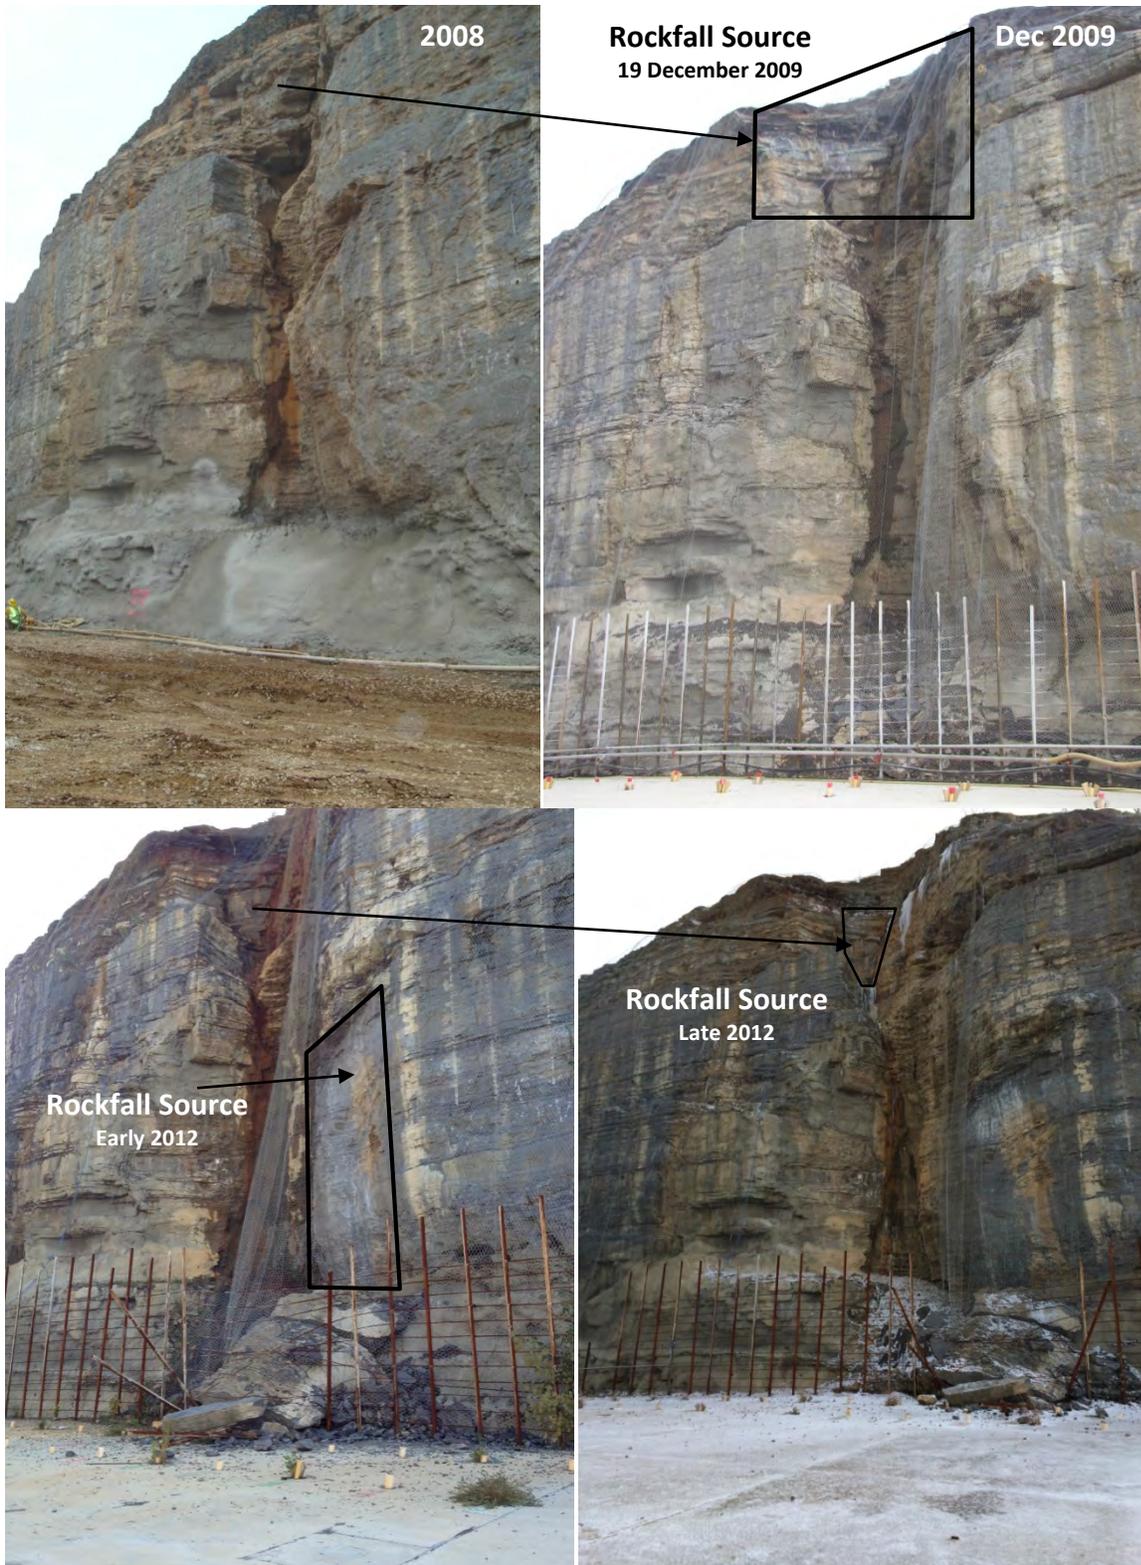
Figure 19. South Side Left Rim Cut Vertical Feature illustrating rockfall since excavation.

Even where the mudcutters were less extreme, rockfall developed along the open karst shafts exposed in the face. Figure 19 shows the development of rockfall down a karst shaft in the face from 2008-2012.

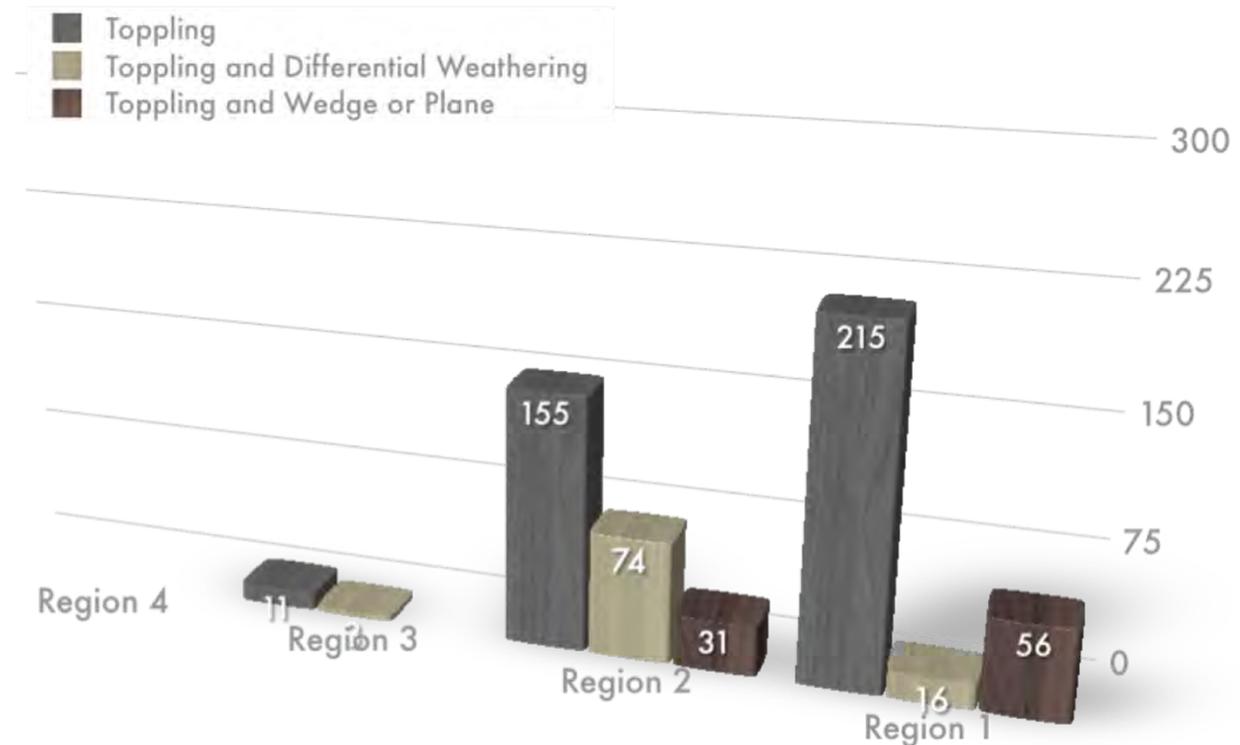
TDOT’s Rockfall Hazard Rating Program identified 166 sites along Interstates and State Routes in the two regions (2 and 3) that are located in Central Basin, Highland Rim and margin of the Cumberland Plateau discussed in this paper that had a toppling failure mode¹⁶. This toppling failure mode is most often secondary toppling, and as can be seen from the graph below, often occurs with differential weathering.

A view of the rockfall data from TDOT's rockfall program shows that far from being an unlikely failure mode, secondary toppling is significant rock failure mode present across the state.

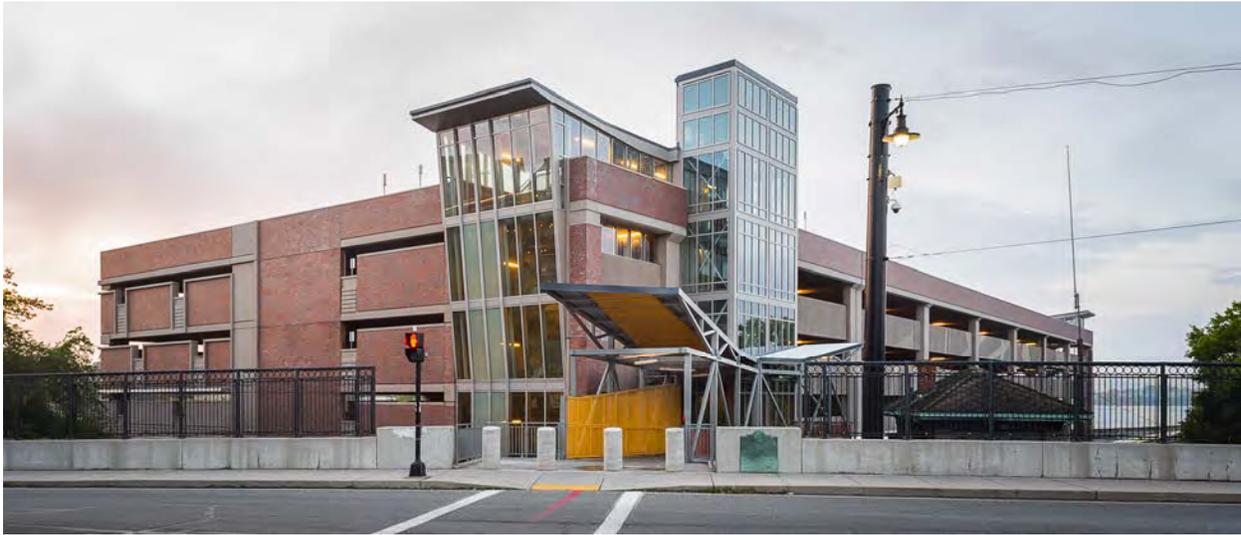
Figure 1- New Parking Garage and Pedestrian Bridge at the MBTA Commuter Rail Station in Salem, Massachusetts (Looking North from Bridge Street)

The improvements at the Salem station consist of a new five-level parking garage (shown in Figure 1) to provide additional parking capacity at the station, two accessible elevators, a full-length high-level (“full-high”) commuter rail platform, and a pedestrian bridge that enhances accessibility from downtown Salem to the station (see Figure 2). Site improvements also include a passenger drop-off/pick-up area, secure bicycle parking, and improved traffic flow patterns for buses and taxis. The new garage increases parking capacity from the previous 340 parking spaces to about 700 spaces. An enclosed waiting area in the garage and platform canopies offer shelter for passengers accessing the train along the new platform.

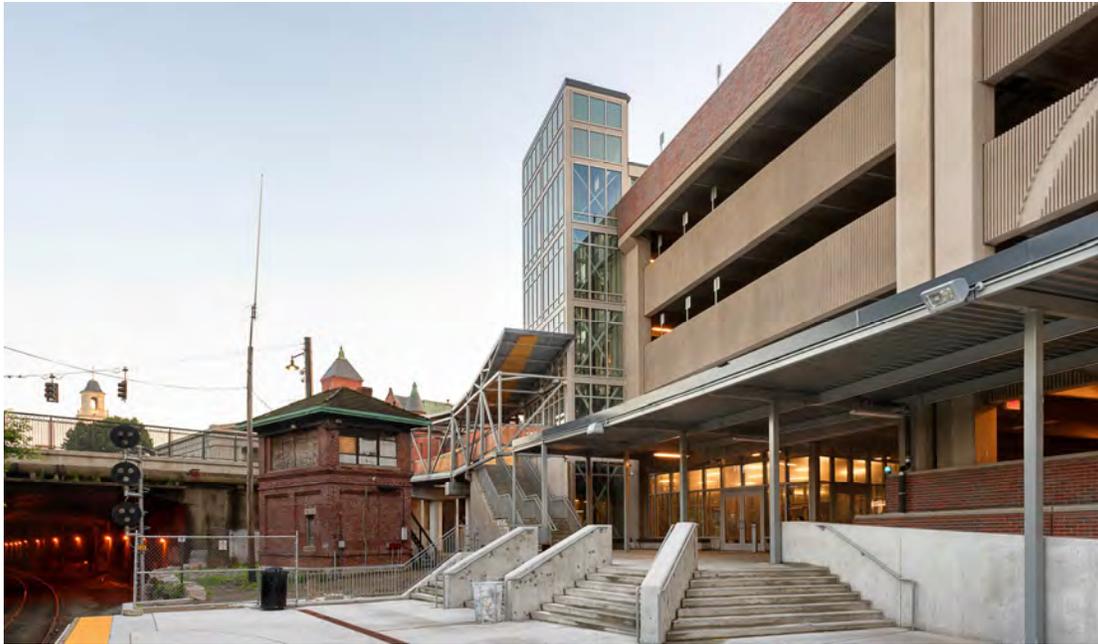
Figure 2 - New Pedestrian Bridge and Stairs Connecting Bridge Street to the New Train Platform (Looking South towards Bridge Street)

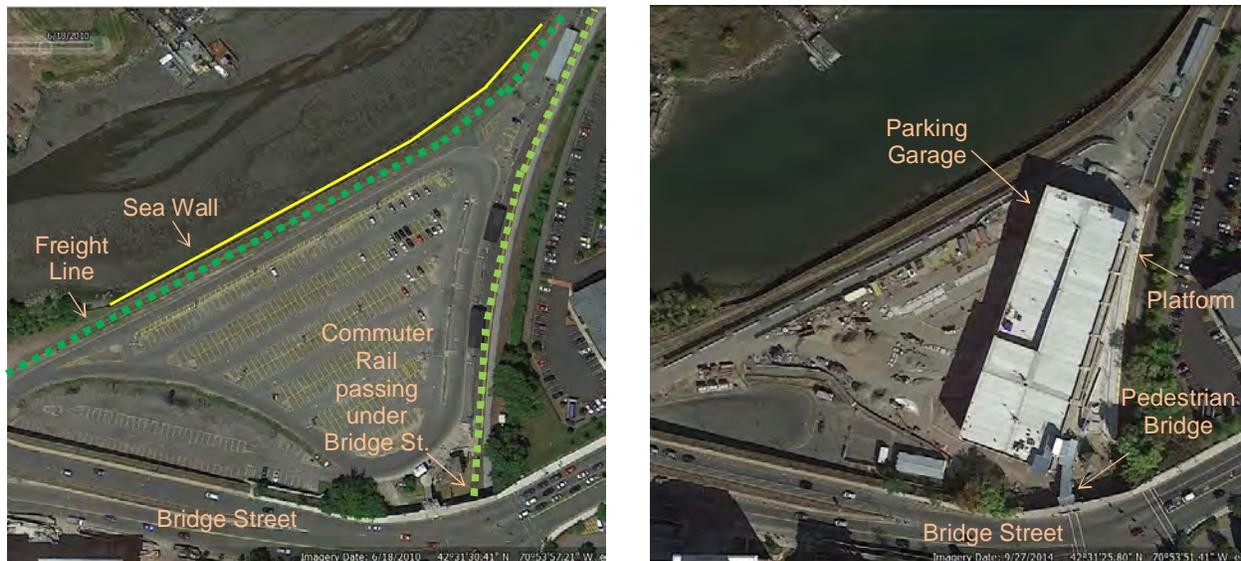
(a) Pre-Construction (June 18, 2010)

(b) During-Construction (September 27, 2014)

Figure 3 - Pre-Construction and Construction Conditions at the Site

The new parking garage was constructed along the eastern side of the site. Figure 3 shows the pre-construction and construction conditions at the site. The new garage building is a pre-cast concrete building with no below grade space except for the elevator pits. The building column loads are up to 2200 kips, and the fundamental period in one direction is 0.56 seconds. The ground floor of the building is 3 to 6 feet above pre-construction grades and set above the newly established flood level for the area.

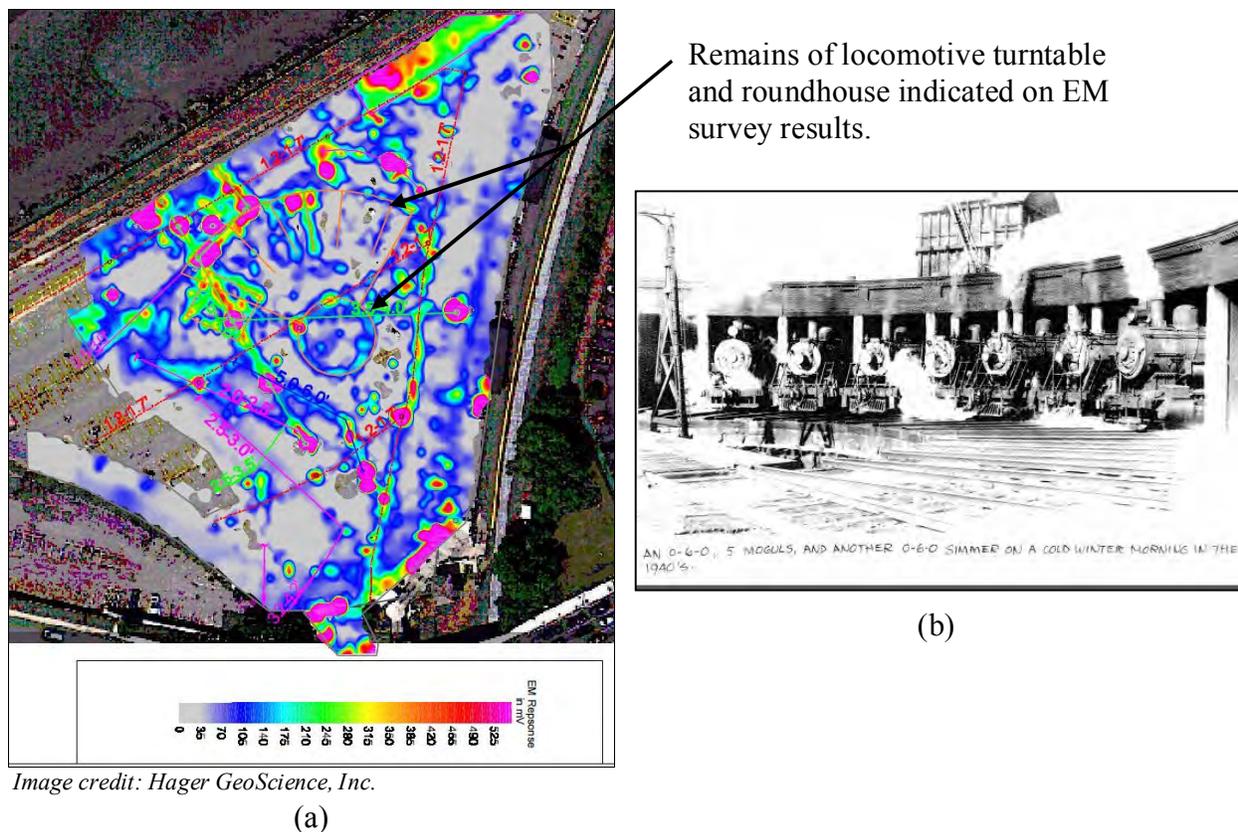
**Figure 4 - (a) EM Survey Results Indicating Remains of Turntable and Roundhouse
(b) A 1940's Photograph of Locomotive Turntable and Roundhouse.**

A 1940's photograph of the site showing a locomotive turntable, tracks, and roundhouse is shown in Figure 4. Figure 4(a) shows the results of the EM survey. The survey results strongly suggest the presence of subsurface structures resembling the historical turntable and roundhouse structures as indicated on the Sanborn maps and old site photographs.

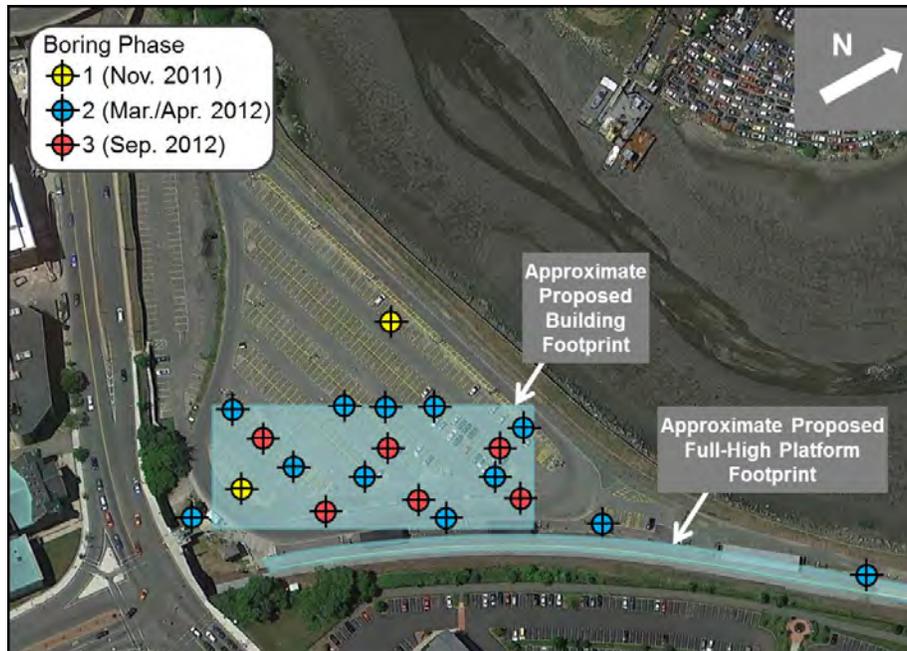
Figure 5 - Subsurface Exploration Location Plan

Kleinfelder performed a total of 21 test borings in three phases. The test borings extended to depths up to 100 feet below ground surface. Some of the boring locations were selected specifically at building column locations intersecting the buried structures identified in the geophysical exploration to get an indication of the thickness and depth of the buried structures. The buried structures were not encountered in any of the 21 borings drilled at the site. The approximate test boring locations are shown in Figure 5. The third phase of borings was performed specifically to assess the extent of potentially liquefiable soils on site.

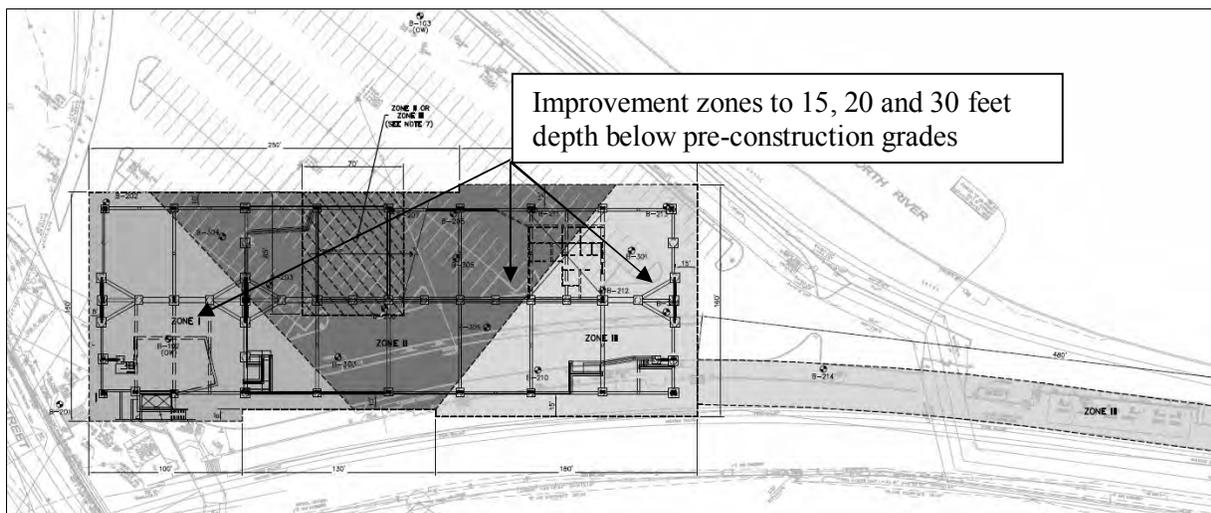
Figure 6 - Ground Improvement Zones Defined in Contract Drawings

Kleinfelder based the required depth of ground improvement on the pre-construction boring data. Three improvement zones were defined as shown in Figure 6. The 15 and 20-foot in length VSCs were installed using an excavator-mounted VSC rig, while the 30-foot in length VSCs needed to be installed using a crane assembly (Figure 7).

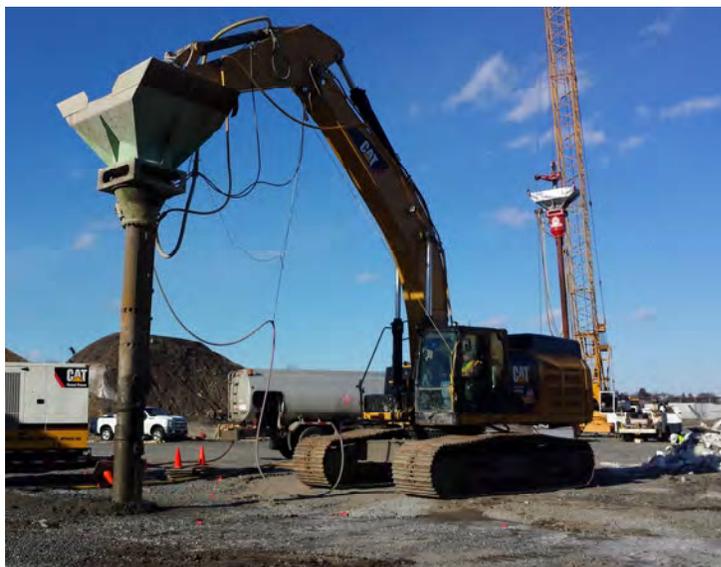
Figure 7 - VSC Attachments

VSC attachment on an excavator in the foreground and hanging from a crane in the background.

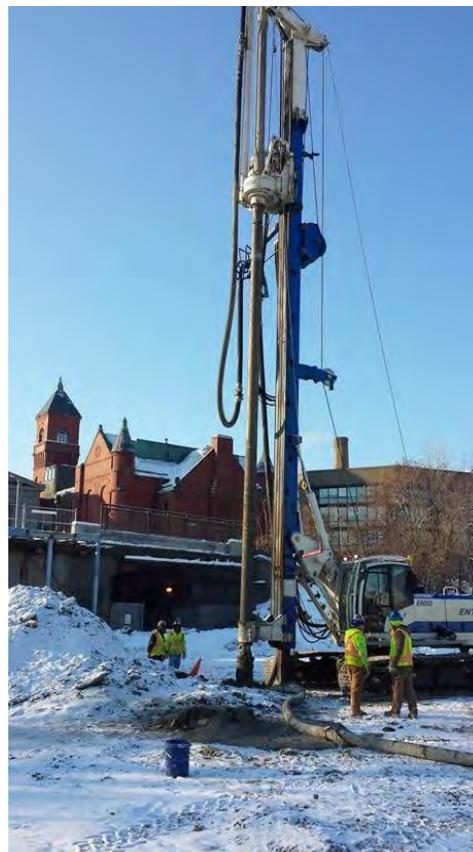
Figure 8 – CMC™ Installation

Nearly 470, 15.5-inch diameter, 150-kip capacity CMCs™ were installed extending to bedrock or into the thin till layer. The installation of the CMCs™ resulted in minimal spoils from the site as part of the foundation construction, resulting in savings for the project as compared to traditional deep foundations.

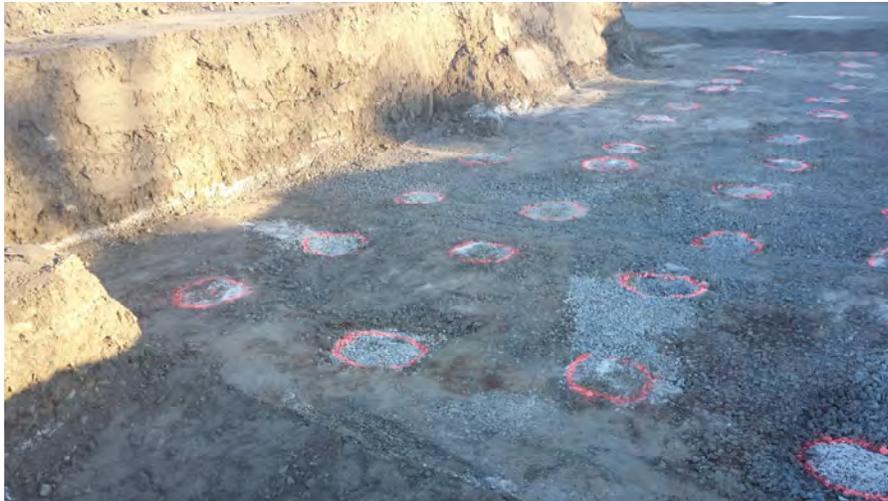
Figure 9 - Garage Footing Subgrade with Exposed CMCs™

Transfer of the column loads from the spread footing into the CMC™ elements requires placement of at least 6-inches of structural fill between the top of the CMC™ elements and the bottom of the footings. Placement of the structural fill required careful excavation to expose the top of the CMC™ element below each footing. Figure 9 shows the in-place CMCs™ below a footing.
