66TH HIGHWAY GEOLOGY SYMPOSIUM SEPTEMBER 14-17, 2015

2015 Proceedings

*Massachusetts Department of Transportation
and
University of Massachusetts Amherst*

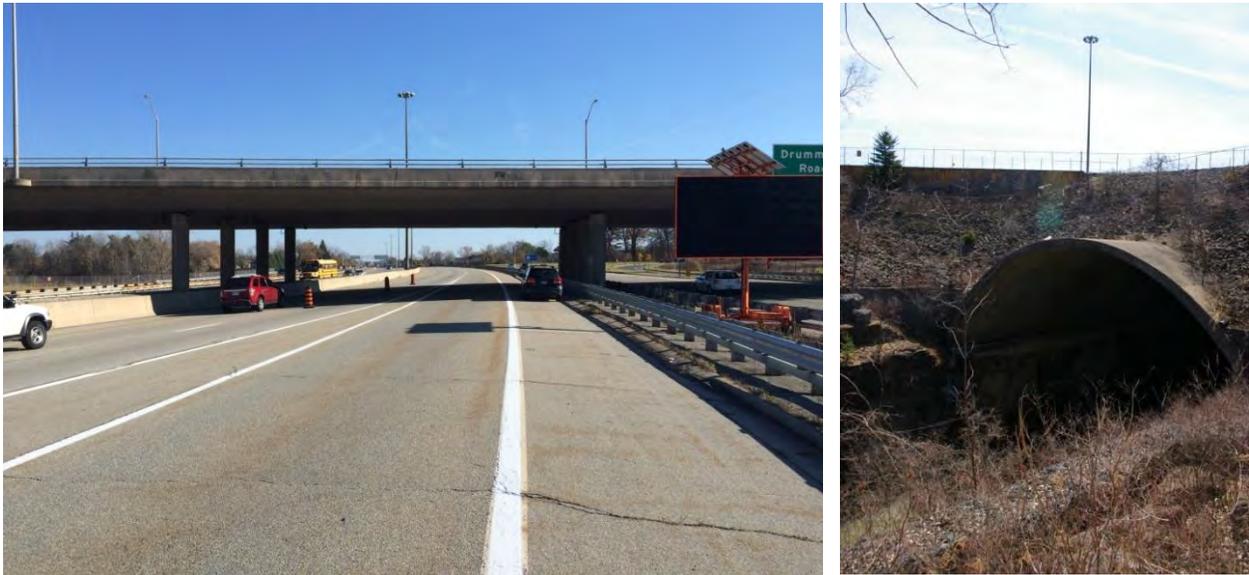
Figure 1: Highway 420 and Dorchester Road underpass (left) crossing over the Chippawa Power Canal on a large concrete arch culvert (right)

Highway 420 in Niagara Falls, Ontario crosses over the Chippawa Power Canal on a large cast-in-place concrete arch culvert structure which is founded on bedrock along the canal walls. **Figure 1** shows Highway 420 and the Dorchester Road underpass at the location of the canal crossing. Over the years, displacements of some of the culvert's concrete segments were observed together with significant deterioration of the canal walls above the water level in the canal. No information was available for the underwater wall sections but deteriorations were expected as well. The Ontario Ministry of Transportation (MTO), owners of the bridge and culvert, awarded a Consultant Assignment to Morrison Hershfield (MH) to investigate the cause of the culvert movement, evaluate the stability of the rock canal face, assess the risk of culvert failure and provide remedial measures. MH retained Golder Associates Ltd. (Golder) to undertake a geotechnical investigation to determine the causes of the displacements and the canal wall deterioration and to assist in the risk assessment.

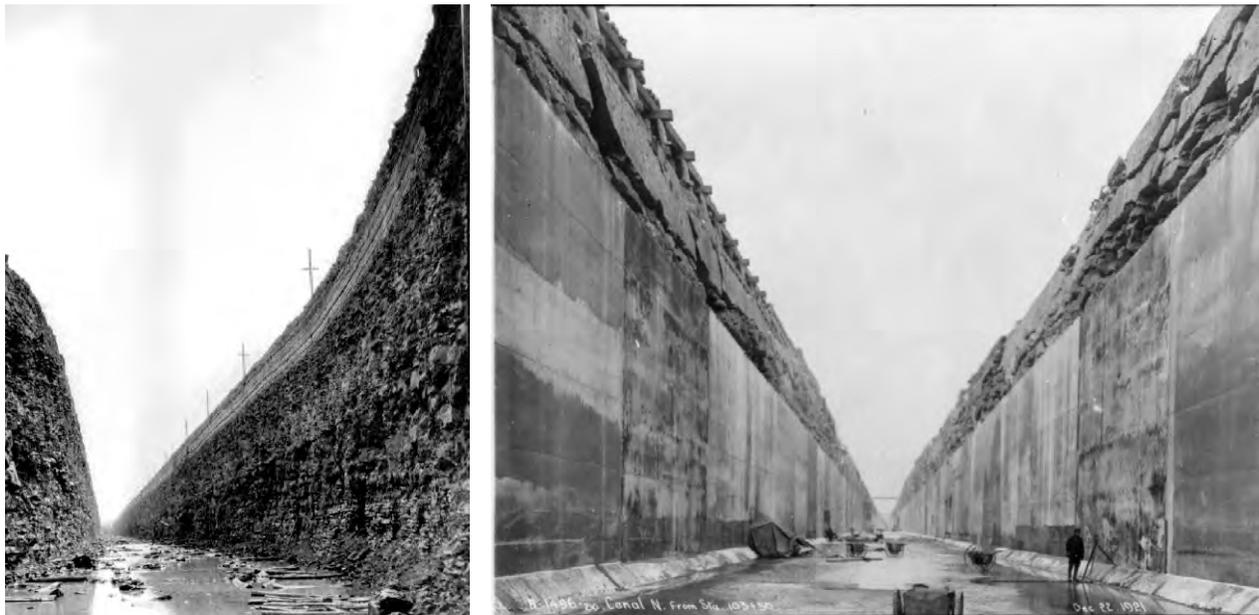
Figure 2: Chippawa Power Canal during construction (left: canal excavation in rock, 1920 (photo: www.nflibrary.ca); right: concrete lining on canal walls and bottom, 1921 (photo: www.collectionscanada.gc.ca))

The approximately 13 km long Chippawa Power Canal in Niagara Falls, Ontario was built to divert water from the Welland River to the Sir Adam Beck power station located at the bank of the Niagara River. The canal was constructed between 1917 and 1921 and the walls and bottom of the canal were lined with shotcrete and concrete respectively (**Figure 2**).

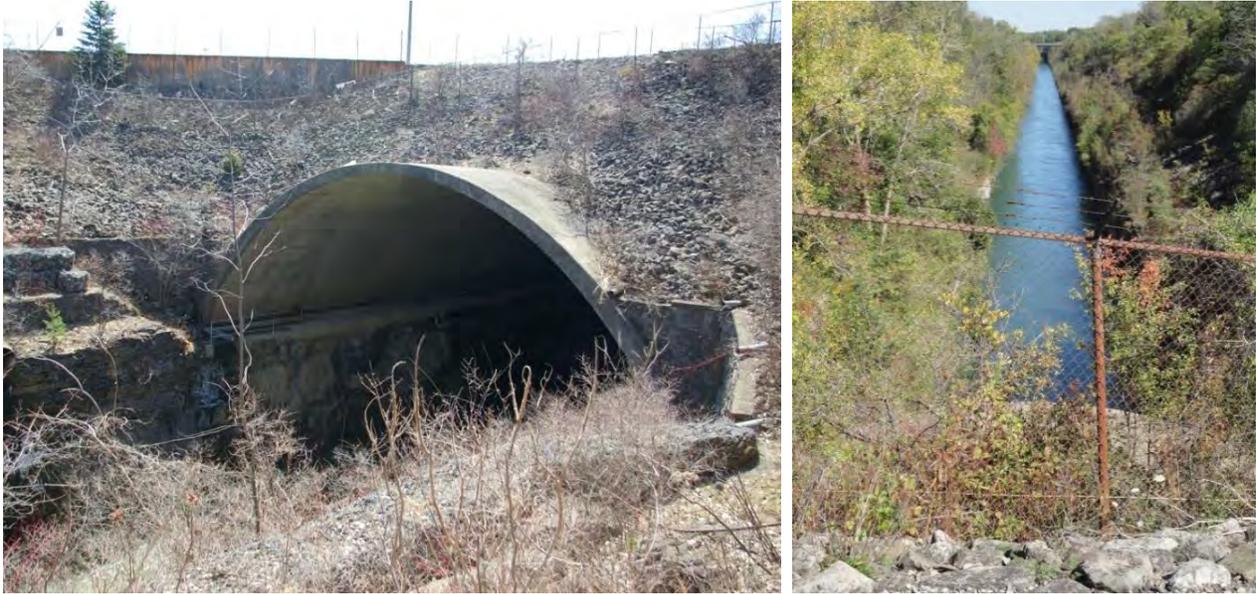
Figure 3: Concrete arch culvert (left) spanning over the Chippawa Power Canal (right)

of eight cast-in-place concrete arches (segments), each of which is 25.9 metres long. The east entrance of the culvert is shown in **Figure 3**. The culvert has a span of 22.7 metres, a rise of about 7.6 metres, and is supported on strip footings parallel to the canal walls that are founded on dolostone bedrock. Highway 420 and the Dorchester Road underpass were constructed above the culvert in 1972.

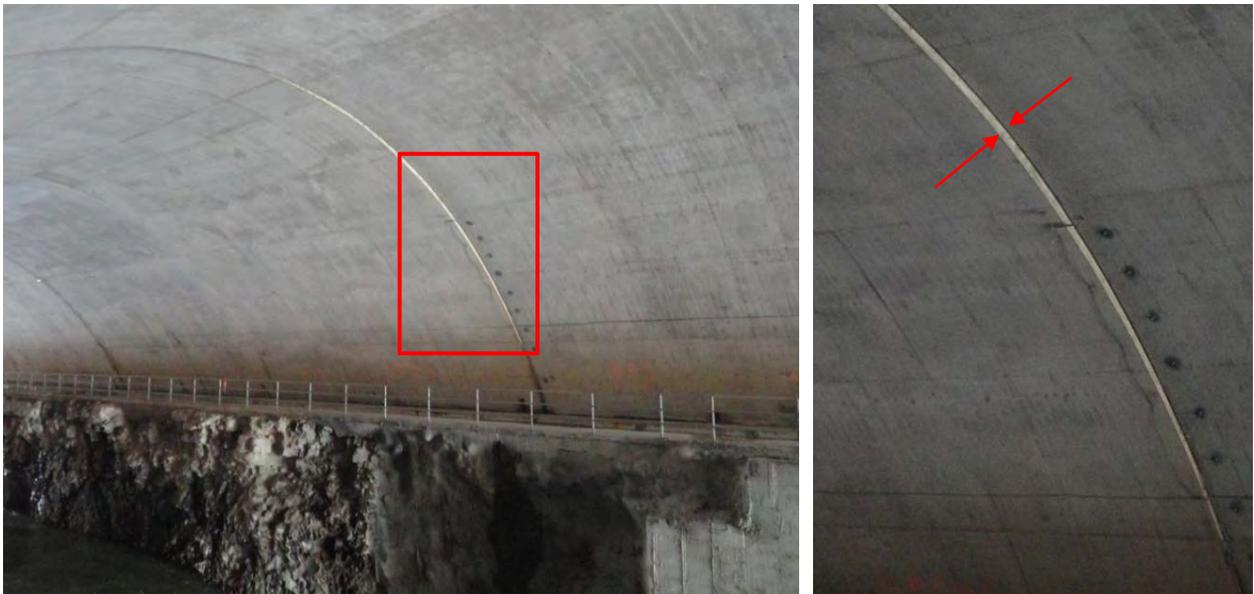
Figure 4: Displacements of culvert segments (right: detail of displacements)

Over the years, differential displacements of approximately 100 mm have been noted at the joint between two culvert segments (**Figure 4**), in particular in the haunches of the concrete arches.

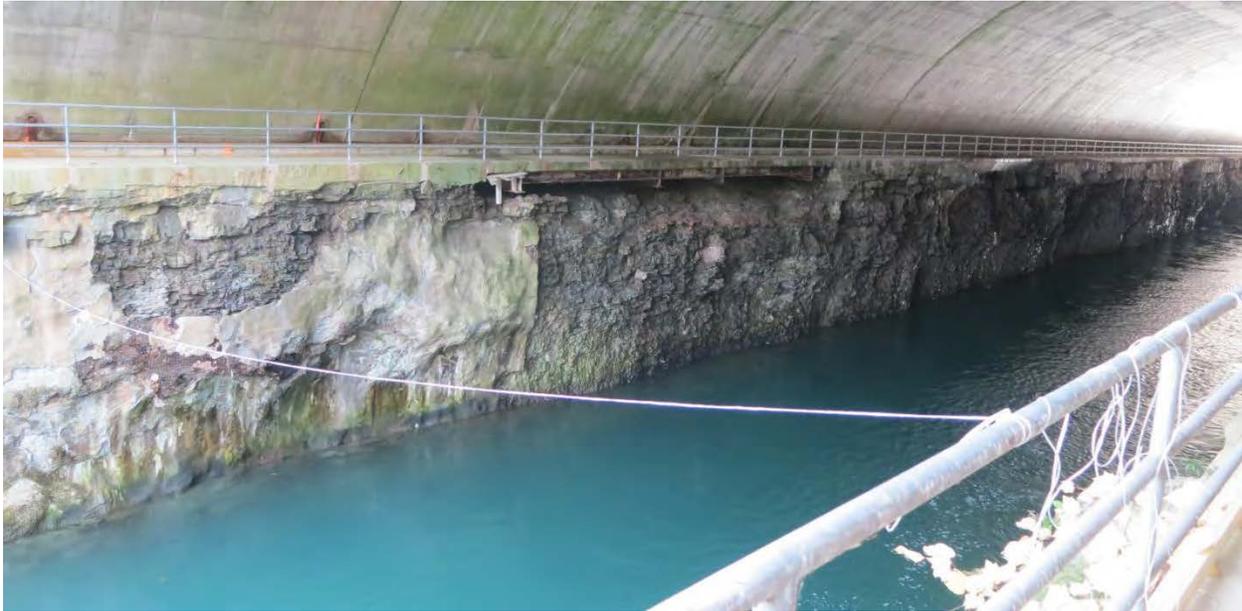
Figure 5: Deterioration of shotcrete lining and rock faces along canal walls

In addition to the culvert distortion, the shotcrete and concrete liner on the canal walls exhibit severe deterioration and spalling. The exposed rock face itself has undergone major degradation, slaking and undermining underneath the concrete sidewalks, adjacent to the culvert foundations. **Figure 5** shows the south side wall of the canal with areas of failed shotcrete and a section of undermined sidewalk.

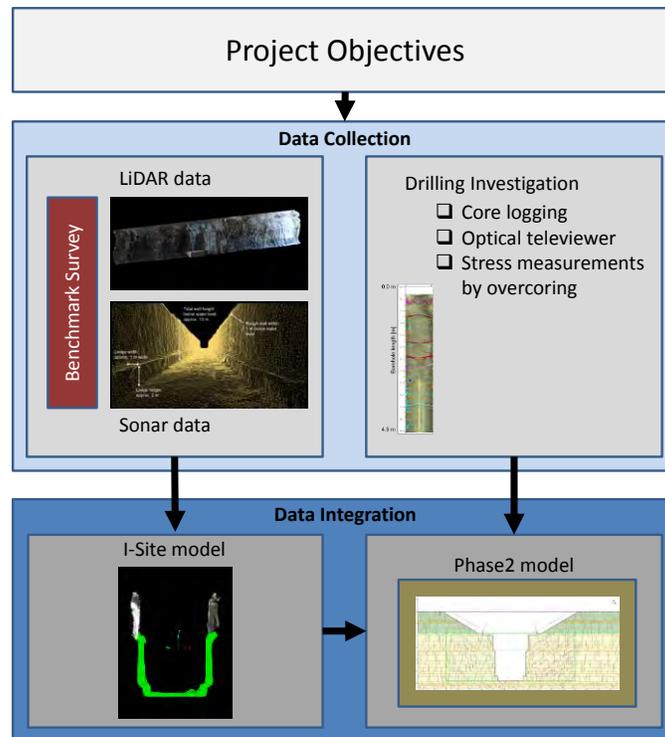
Figure 6: Applied Methodology

A combination of standard investigation methods and innovative surface mapping technologies was finally chosen to allow an assessment of the canal wall conditions and the culvert foundations. **Figure 6** illustrates the applied methodology to collect and integrate the required data.

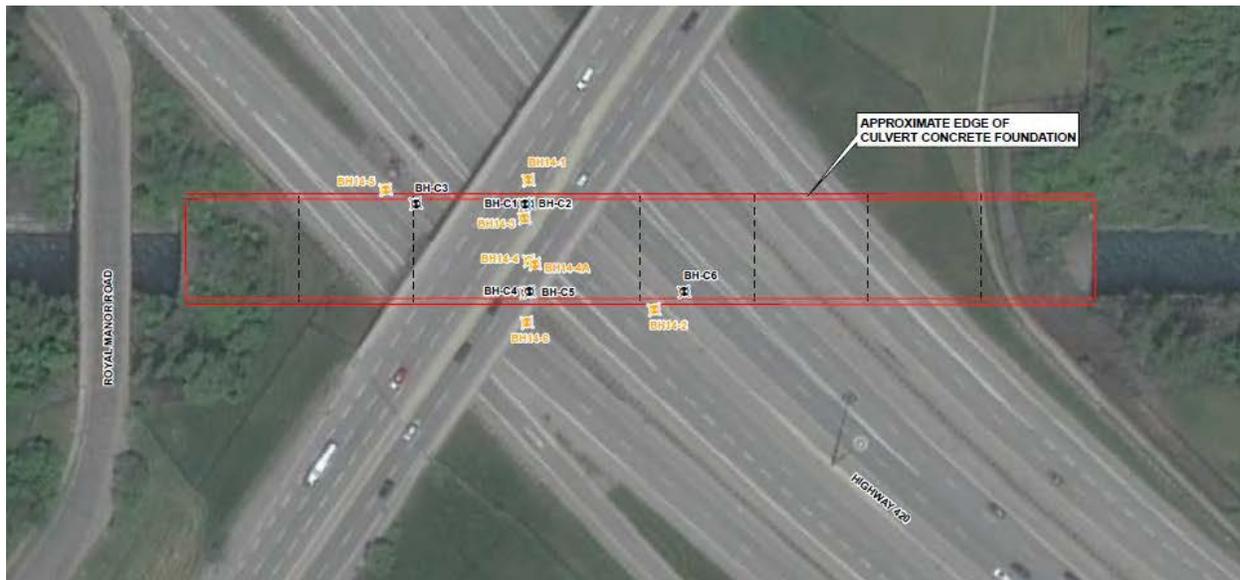
Figure 7: Location of power canal below Highway 420 and Dorchester Road underpass

The culvert alignment was surveyed and the surveyed layout transferred to highway grade to accurately determine the borehole locations above the culvert. The culvert layout below Highway 420 is shown in **Figure 7**. In order to reference both the LiDAR and the Sonar data to a global coordinates system, common reference points had to be established in the field that could be used for both surveys. This was important as the goal was to combine both data sets and allow a comprehensive assessment of the condition of the wall surfaces.

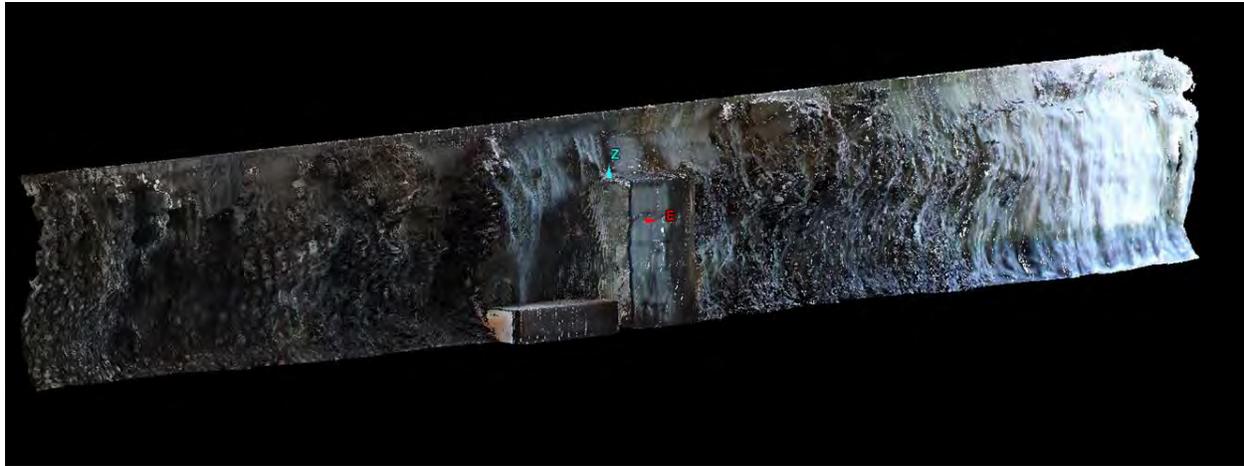
Figure 8: Example of LiDAR survey results showing the canal walls above water level

LiDAR survey results provided in **Figure 8** shows the rough wall surface that is largely covered with shotcrete or concrete structures.

It was evident that many areas of the canal walls have undergone significant deterioration and the dimensions of these areas were measured from the LiDAR data in order to determine the extent of remediation required. The data also showed that large areas of the canal walls are still covered with shotcrete or concrete and have, therefore, not changed significantly since the rehabilitation of the canal in 1965.

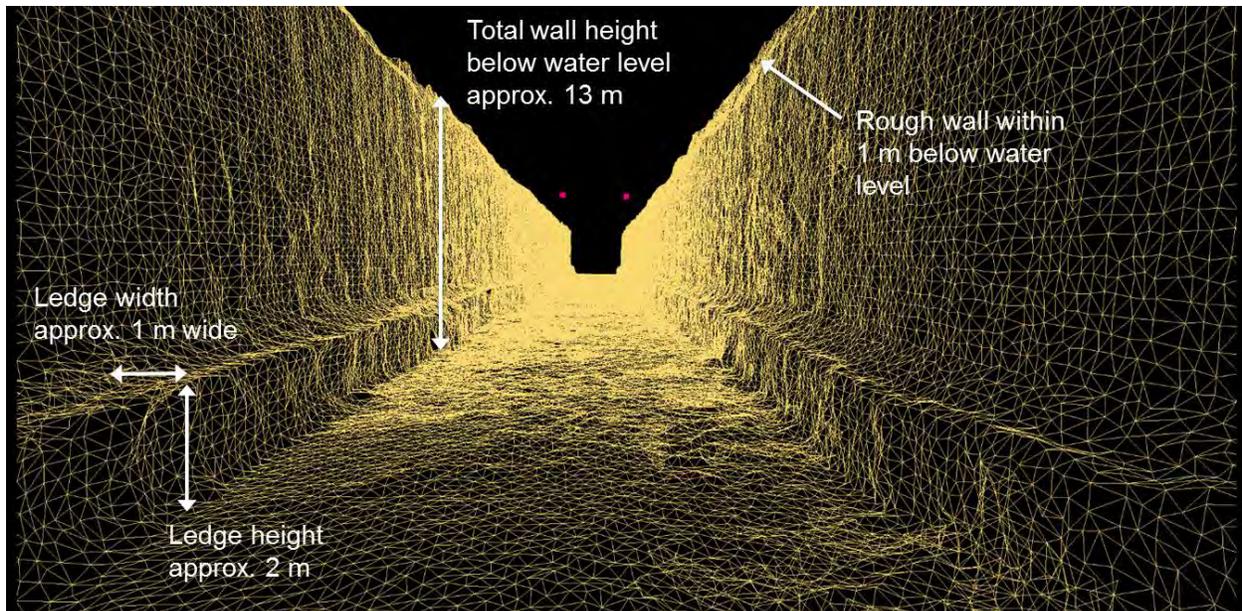
Figure 9: Example of 3D acoustic Sonar profiling results showing the canal walls and bottom below water level

The 3D point cloud data resulting from the acoustic Sonar profiling was processed with I-Site Studio 5.0 software (*I*) and the surface model was used to assess the condition of the canal walls below water level and identify areas where the walls have deteriorated. It was noted that the walls are generally intact and no areas of significant deterioration were identified except from the upper approximately 1 m of wall below the water level. The data also gave information about the dimensions of the canal and revealed small ledges at the toe of the walls. Some accumulations of debris were noted on the bottom of the canal as well as on the ledges. **Figure 9** shows an example of the collected acoustic Sonar data.

Due to the water flow in the canal, movements of the scanning equipment could not be entirely avoided and affected the data quality. The accuracy of the data was estimated to be +/- 150 mm.

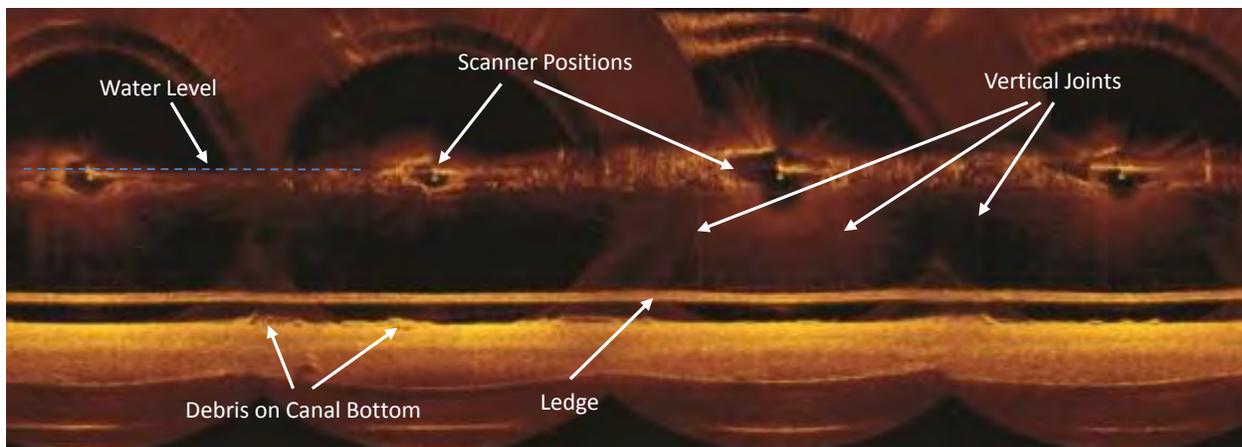
The two-dimensional image scans of the vertical canal walls resulting from the Sonar imaging results in a two-dimensional image of a three-dimensional surface and provides information about the texture of the wall surfaces (like joints, scour, overhangs, ledges etc.). **Figure 10** provides an example of the collected imaging Sonar results. The image shows the canal walls and the bottom of the canal as well as the ledges along the wall toe. Some debris was identified on the canal floor; however, no significant accumulations of debris were observed. Vertical and horizontal joints were observed on the walls, indicating that the walls are covered with concrete.

Figure 10: Example of 2D Sonar imaging results showing the canal walls below water level

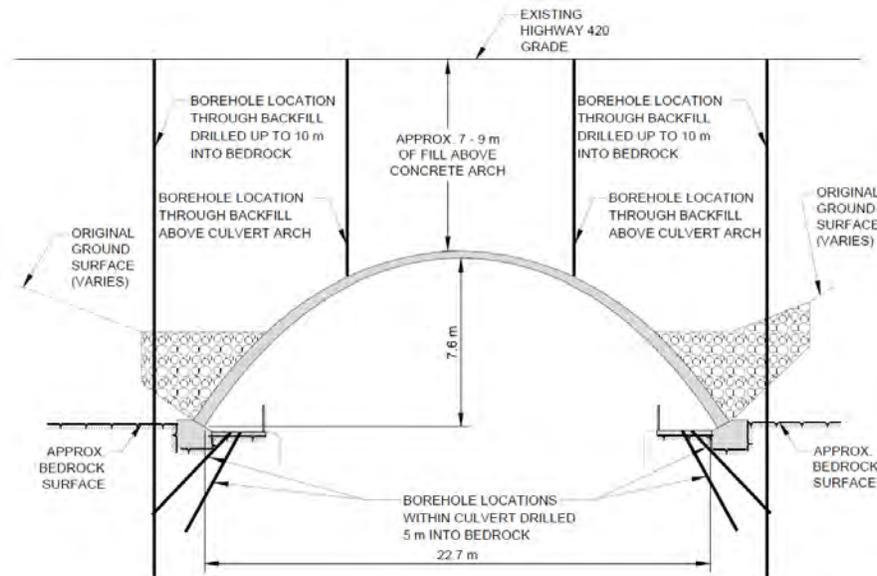
The approximate locations of the boreholes inside and above the culvert are shown in **Figure 11**. The borehole investigation carried out from inside the culvert focused on the bedrock foundation below the arch culvert footings. The information gathered from the rock core indicates a fresh to slightly weathered, strong to medium strong dolostone with thin shale interbeds belonging to the Lockport Formation.

Figure 11: Cross section through Chippawa Power Canal Culvert with drilling locations inside the culvert

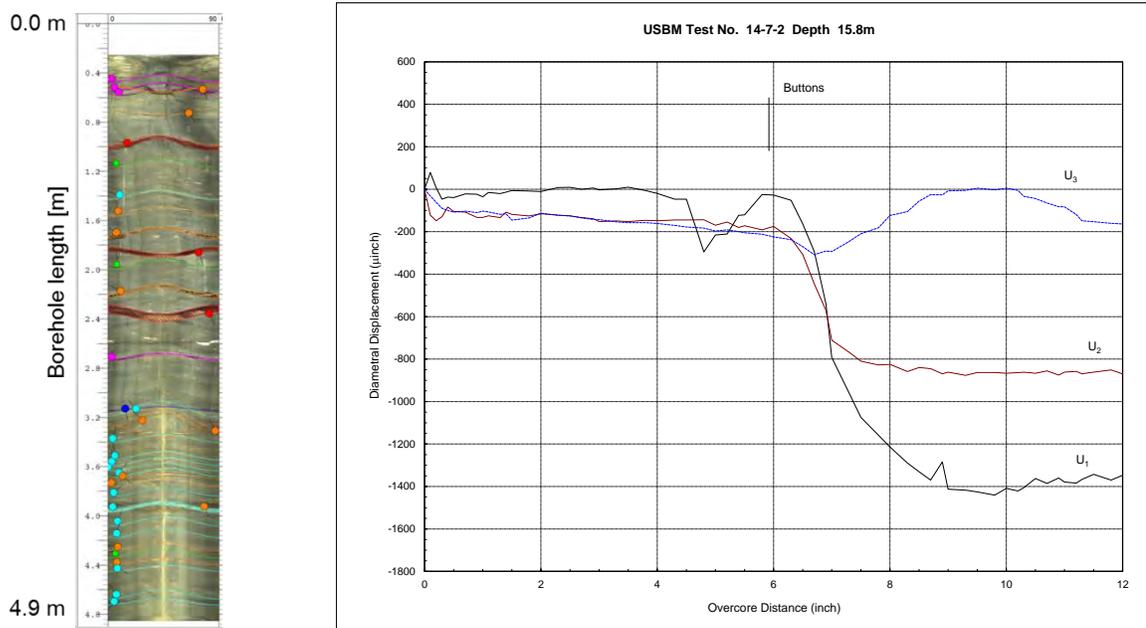
The borehole images and structural data gathered with the televiewer survey indicated horizontal bedding planes and several open discontinuities on both sides of the canal that were dipping towards the canal walls. **Figure 12** (left side) provides an example of the borehole images showing several open and inclined structural features. This observation was consistent with observations that were made by Golder at the time of the culvert construction (2). The oriented structural data was used to prepare stereoplots using the DIPS 6.0 software from Rocscience (3) and to perform a kinematic analysis of potential failure modes along the canal walls. The results indicate slight chances of planar and toppling failures.

the canal. A typical stress measurement result is shown in **Figure 12** (right side). A piezometer installed in this borehole indicated a water level approximately 3.5 m below the bedrock surface.

Figure 12: Results of optical televiewer survey (left) and overcoring (right)

The stress measurements in the vicinity of the culvert were carried out to investigate the potential impact of the stresses in the rock mass on the canal walls. The results indicate that in the investigated area the major principal stress is oriented approximately parallel to the canal and that the major stress is significantly higher than the minor principal stress. This result is in accordance with historical measurements in the general project area (4). It is expected that the minor principal stress has relaxed since the excavation of the canal. This is supported by the Sonar investigation results that show no significant movements along the walls or the bottom of

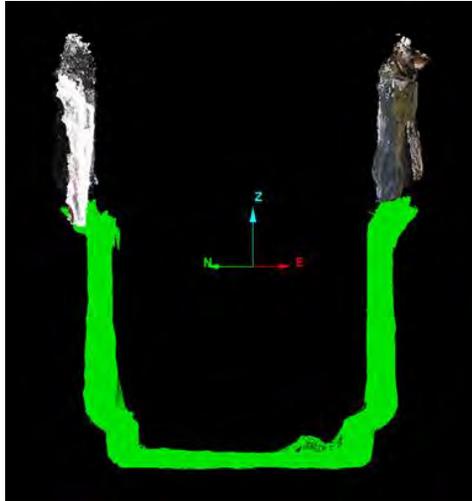
In a first data integration step, both the LiDAR and the Sonar data sets were processed using the I-Site Studio 5.0 software (*I*) to develop a three-dimensional surface model of the canal walls. This model allowed an assessment of the wall conditions and determination and measurements of wall features of interest including size and depth of deteriorated and eroded wall sections. In addition, the LiDAR data allowed structural mapping of the rock along the wall areas where the shotcrete lining had fallen off the walls. **Figure 13** shows the integrated 3D surface model of the canal walls.

The two data sets matched up well when combined; however, some small data gaps occurred along the water level elevation. The reason for these gaps could be that some areas at the transition zone between upper and lower walls were not reached by the laser or sonar beams. Some gaps were probably caused by fluctuating water levels occurring between the execution of the LiDAR survey and the Sonar survey. The overall assessment of the walls was not affected by the data gaps.

Figure 13: 3D surface model of the canal walls

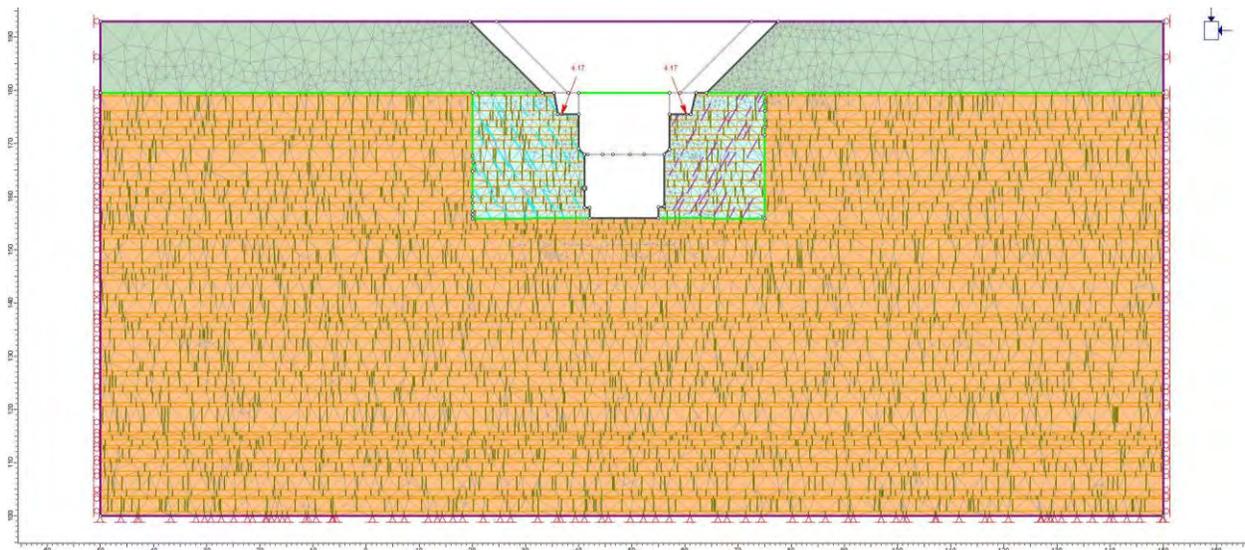
In a second data integration step, the information from the surface model was combined with the data collected during the subsurface investigation and integrated in a 2D model of the canal and the bedrock using RS2 (Phase2 9.0) (5), a 2D elasto-plastic finite element stress analysis program, in order to perform a stability analysis of the canal walls and culvert foundation. Bedrock information including unconfined compressive strength, elastic modulus, rock mass characterization and in-situ stress was included in the model as was information regarding the discontinuities in the rock, including orientation of joints and bedding. **Figure 14** shows the 2D model of bedrock and canal walls. The bedrock was modelled with a discrete joint network and several stages were used to model the excavation of the canal.

Figure 14: 2D model of canal and surrounding bedrock (RS2 (Phase2 9.0))

This model is to be used for a stability analysis of the canal and the bedrock foundation below the culvert footings.

The 2D model is to be used to perform stability analyses of the canal walls and the bedrock foundation underneath the culvert foundation. The model will be used to investigate the required bedrock thickness between the culvert footings and the face of the canal walls. The analysis will also focus on the potential for wedge failures along the canal walls that might impact the culvert foundations.

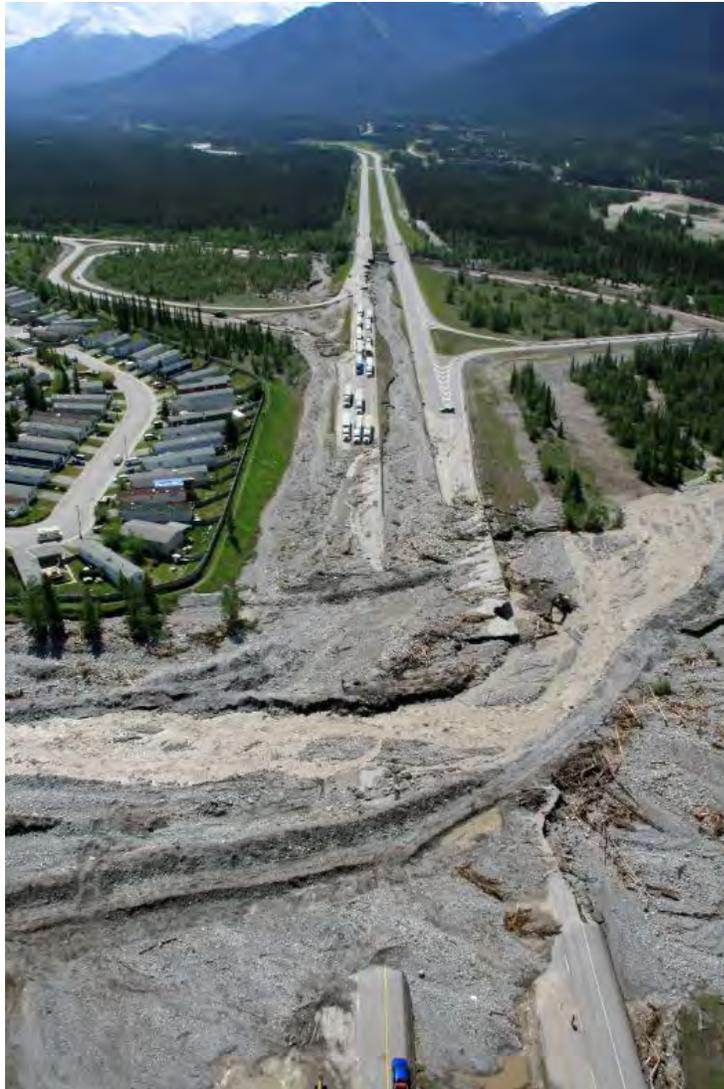
Figure 1. Trans-Canada Highway overwhelmed by the June 2013 debris flood at Cougar Creek in Canmore, Alberta. Town of Canmore.

Sediment and debris blocked numerous culverts and bridge underpasses, and choked channels, which led to flow avulsions, bank erosion, and flooded communities and roadways. The Trans-Canada Highway was closed for seven days (Figure 1). Highways, roads, communities, railways and critical infrastructure were all severely affected. In some locations highway and roadway embankments caused ponded floodwaters and, in other locations, fast flowing water undermined house foundations. Following the initial emergency response and recovery efforts, the province of Alberta, including Alberta Transportation and individual municipalities, commissioned studies to quantify damages and design measures to reduce the likelihood and severity of such damages in future events (2-26). Along the Trans-Canada Highway, these studies included work by BGC Engineering Inc. (BGC) to systematically identify, prioritize, and assess flood and debris-flood hazards and risks, and to design and implement risk reduction measures that improve resiliency and reduce consequences of future floods.

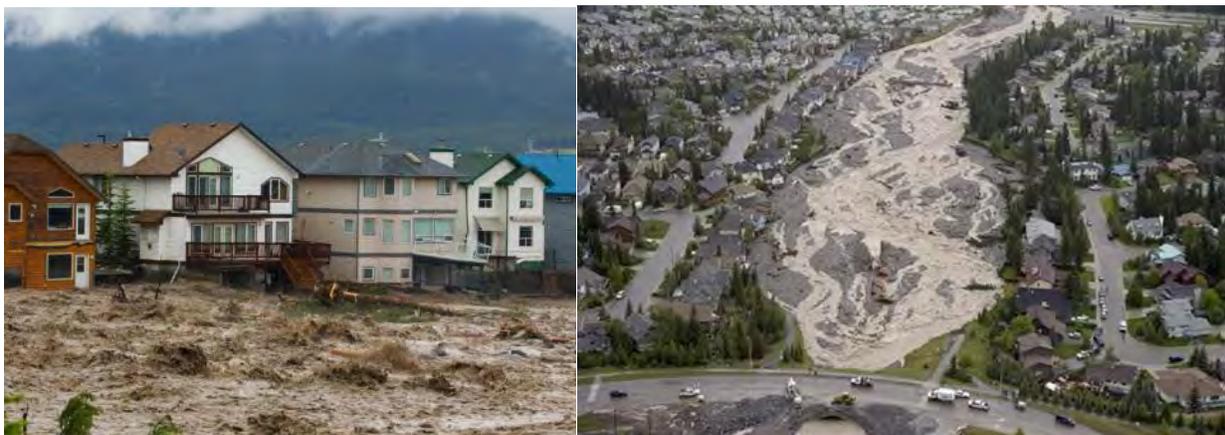
Figure 2 - Flooding on Cougar Creek threatened many residences (left) and channel aggradation lead to a braided river that caused significant bank erosion near Elk Run Boulevard (right). Town of Canmore.

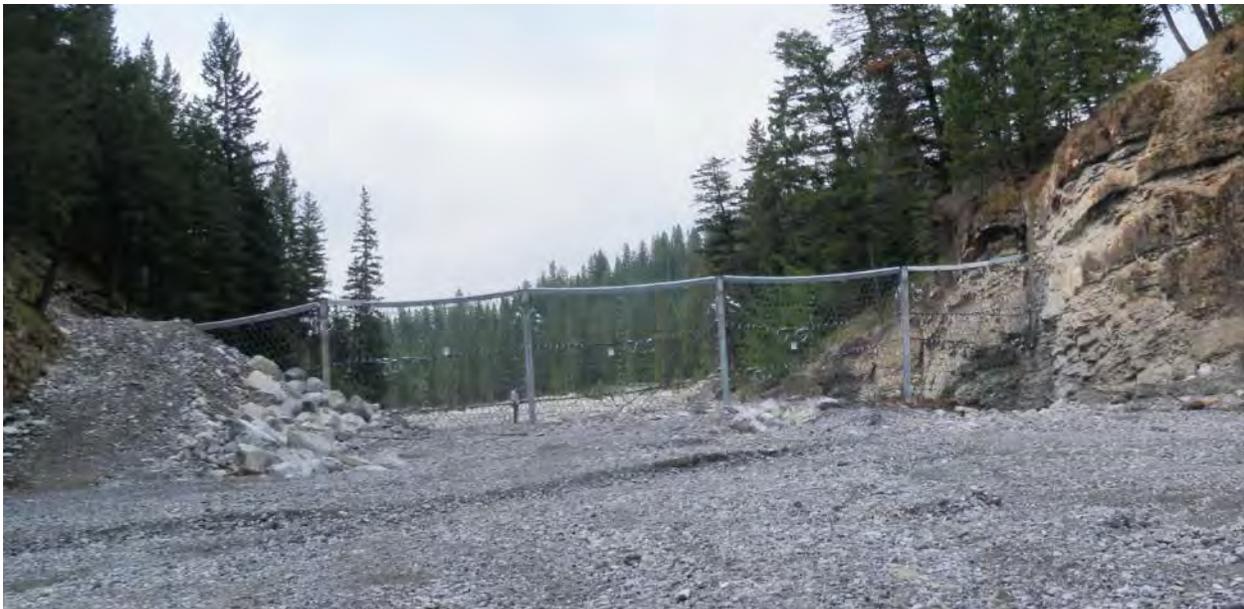
Figure 3 - Flexible debris net located at the head of the Cougar Creek fan is 40 m wide by 6 m tall and is designed to trap coarse sediment, while allowing fine grained sediment and water to pass. BGC Engineering.

The short-term risk reduction elements were constructed in 2014 and consisted of a flexible ring net barrier to capture sediment near the fan apex (Figure 3), an excavated channel, and articulated concrete mats lining the channel to prevent re-mobilization of sediment (Figure 4). Long-term risk reduction elements are currently being designed and include a barrier at the fan apex to retain sediment and, and attenuate peak discharge; and downstream grade control structures to reduce fan sediment re-mobilization, improve conveyance of flows, and protect the banks. The long-term design may also include increasing the conveyance capacity of local roads, railroad, and the Trans-Canada Highway crossing of Cougar Creek.

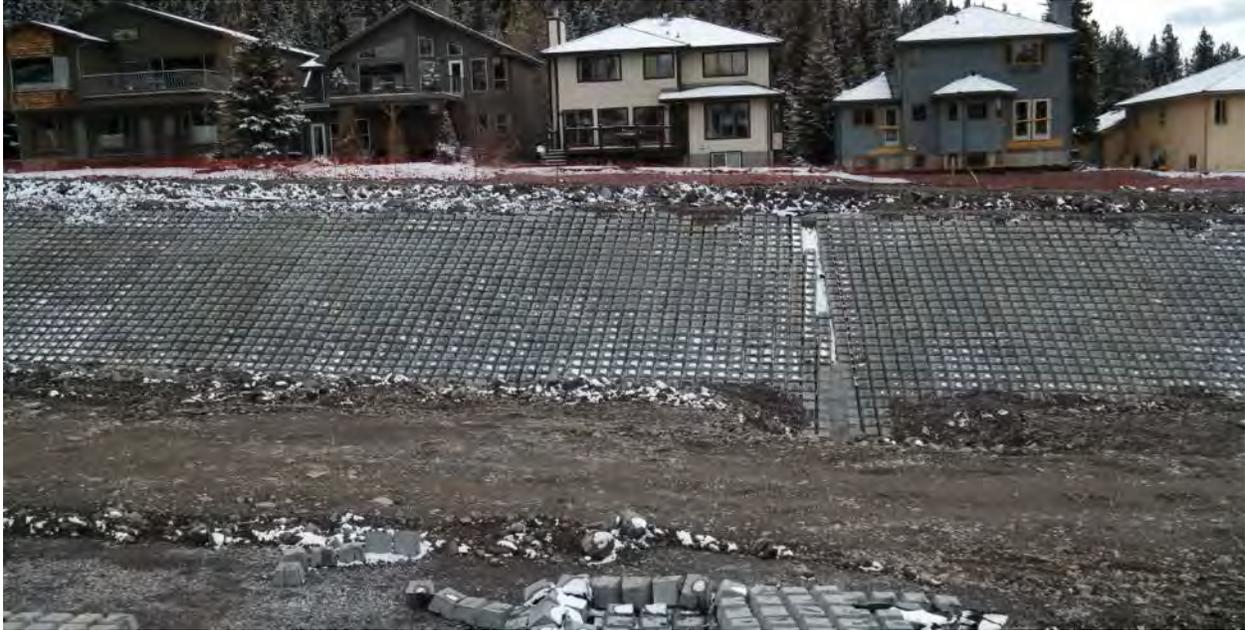
Figure 4 - Excavated channel with articulated concrete mats to prevent mobilization of sediment along the active channel of the Cougar Creek alluvial fan. Photographed during construction. BGC Engineering.

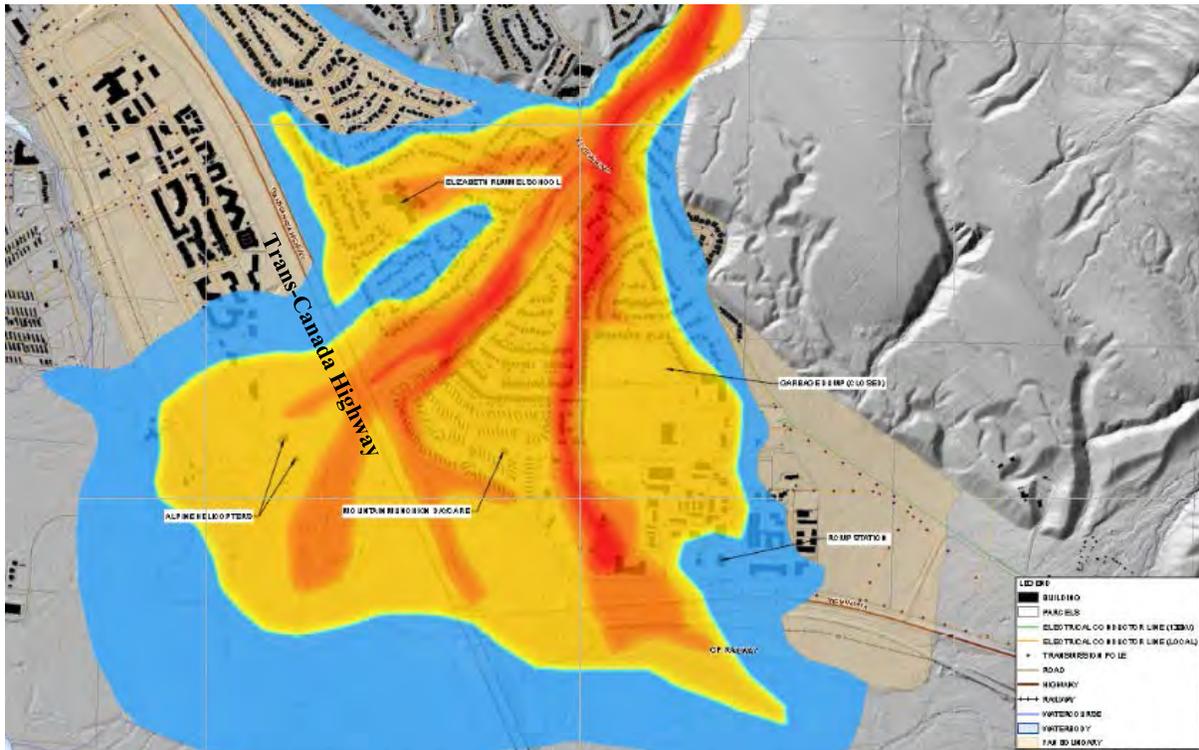
Figure 5 - Composite debris-flood hazard intensity map at Cougar Creek, considering multiple flood magnitudes. Hazard intensity ranges from very fast flowing and deep water (red) to slow flowing shallow and deep water with little or no debris (blue).

Design of the long-term risk reduction elements was based on quantitative hazard and risk assessments. The hazard assessment focused on estimating the frequency and magnitude (e.g. discharge, sediment volume) of debris-flood events and modelling the intensity of flows (e.g. depth, velocity) for representative debris-flood scenarios considered in the risk assessment. (Figure 5). The risk assessment focused on safety risks (i.e. loss of life) for persons occupying buildings on the fan, and economic risks (i.e. annualized direct damage costs). Risk reduction designs were optimized by identifying the minimum debris barrier height that would reduce both individual and group safety risks to tolerable levels. The cost of mitigation was justified based on comparison to the economic risk associated with leaving the hazard unmitigated. Further risk reduction will be achieved according to the ALARP (“as low as reasonably practicable”) principle, for example through improved emergency response measures. The ALARP principle recognizes that it is impracticable to completely eliminate risk, but risks should be reduced when it reasonable to do so.

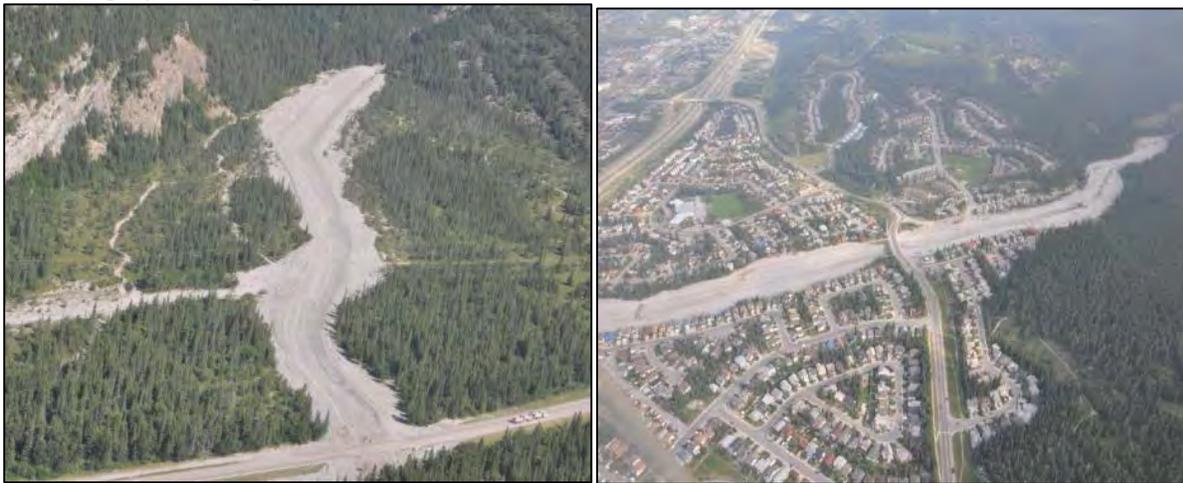
Figure 6. Comparison of roads crossing an undeveloped fan (left) and the highly-developed Cougar Creek fan (right) in Bow River Valley. Current practice would call for the same conveyance capacity design at each fan. BGC Engineering.

Alberta's current flood management approach focuses on the flood hazard without explicit consideration of flood consequences. Flood hazard mapping has been produced by the Government of Alberta since the 1970s. Floods only relate to inundation by rivers or creeks of their surrounding terrain, and they do not explicitly include debris floods or debris flows, although these processes have not been purposely excluded. For flood hazards, standard practice has been to estimate the discharge and flood stage of a 100-year return period flood using hydrological methods, and use this as the basis for design of flood protection measures. This hazard-based method, while based on sound assumptions, does not specifically address debris-flow and debris-flood hazards, and does not account for consequences to elements at risk. This method is less useful for prioritizing funds, and can lead to unacceptable damages to critical infrastructure or communities when the flood protection works are overwhelmed. A hazard-based design method for highways would lead to similar culvert or bridge conveyance capacity designs at each fan shown in Figure 6, despite the extremely high consequences of flow avulsion at the highly developed fan.

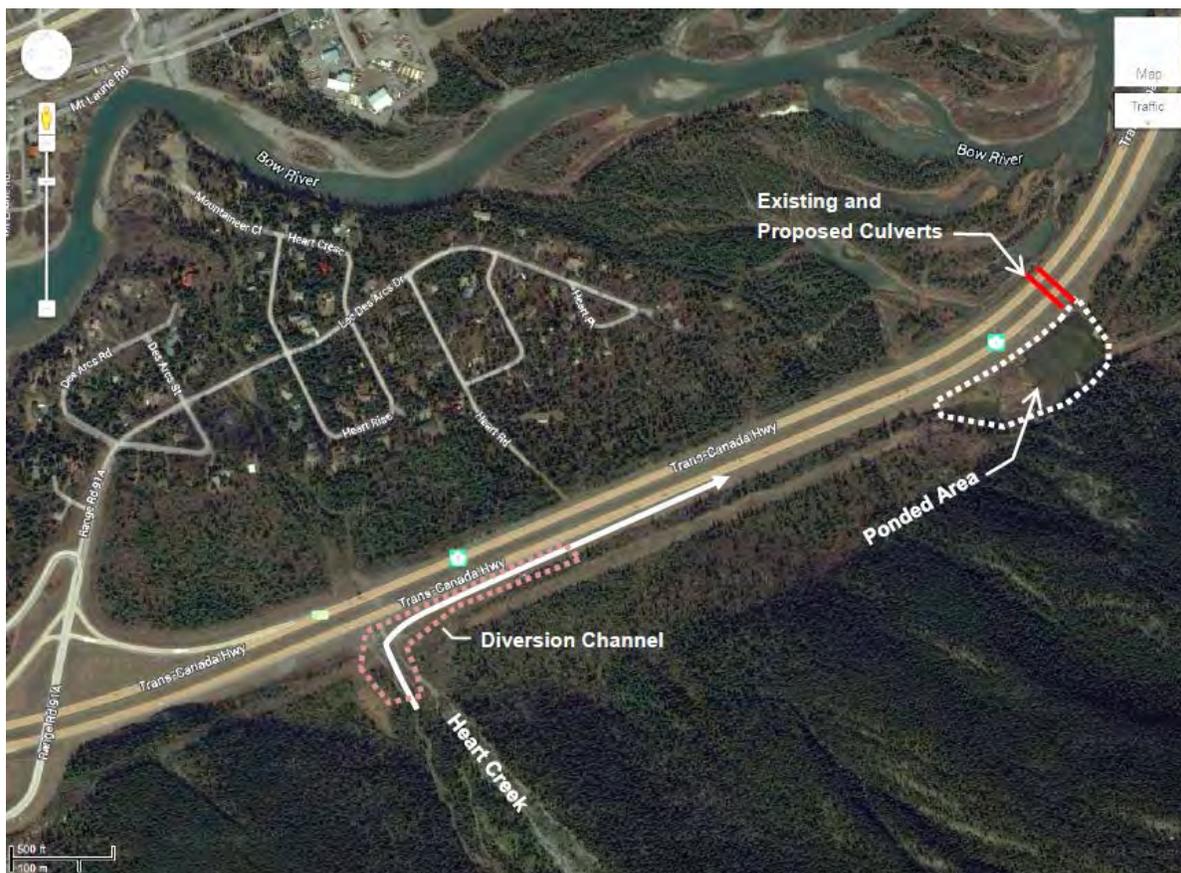
conceptual mitigation design study concluded that it was not feasible, or desirable, to increase the channel to the needed size because it would impinge on residential properties along the channel (15). Instead, the conceptual design proposed to use the highway embankment to reduce risks to residential development. The design called for covering the existing box culvert with a grizzly rack that encourages the culvert to become blocked when the downstream channel capacity is reached. A flood diversion berm constructed along the highway embankment would then direct flood flow to an adjacent undeveloped area and on to the Bow River (Figure 8).

Figure 8 - Proposed Heart Creek debris-flood mitigation design. Google Earth.

Debris-flood hazard and risk were assessed for the community following the June 2013 event, and it was determined that the channel capacity within the community, downstream of the highway, was too small to convey the design peak debris-flood flow of 50 m³/s (18,19). A

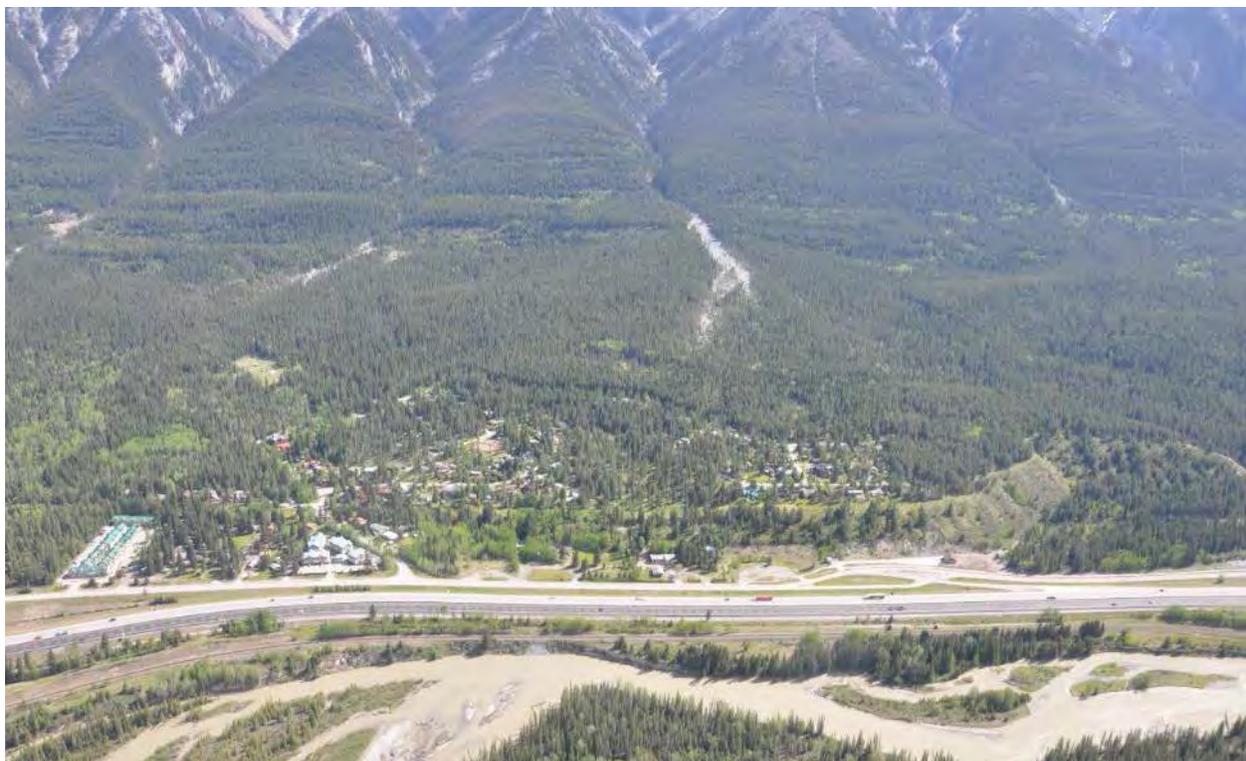
**Figure 9 - Harvie Heights creek fan, during typical summer season (without flooding).
BGC Engineering.**

The Trans-Canada Highway crosses Harvie Heights Creek fan near the toe of the fan, adjacent to Bow River (Figure 9). During the June 2013 debris floods, sediment from Harvie Heights Creek clogged a culvert under the Trans-Canada Highway. Water was trapped by the highway embankment, and a water treatment plant located adjacent to the highway was flooded to its eaves with standing water, along with flooding of roads, businesses, and other infrastructure (Figure 10). Flood water eventually overtopped the highway, which blocked the single access point to the community and closed all west-bound traffic on the highway (16, 17).

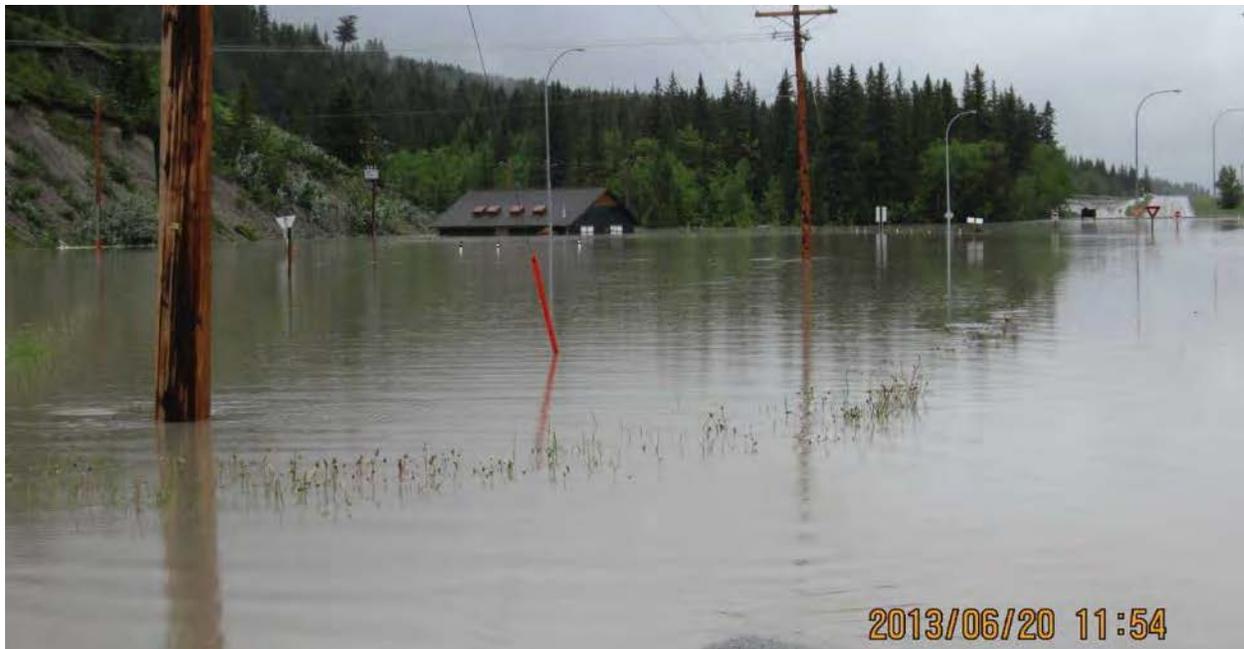
Figure 10 - Flooding of water treatment plant at Harvie Heights Creek fan. Jackie Latvala.

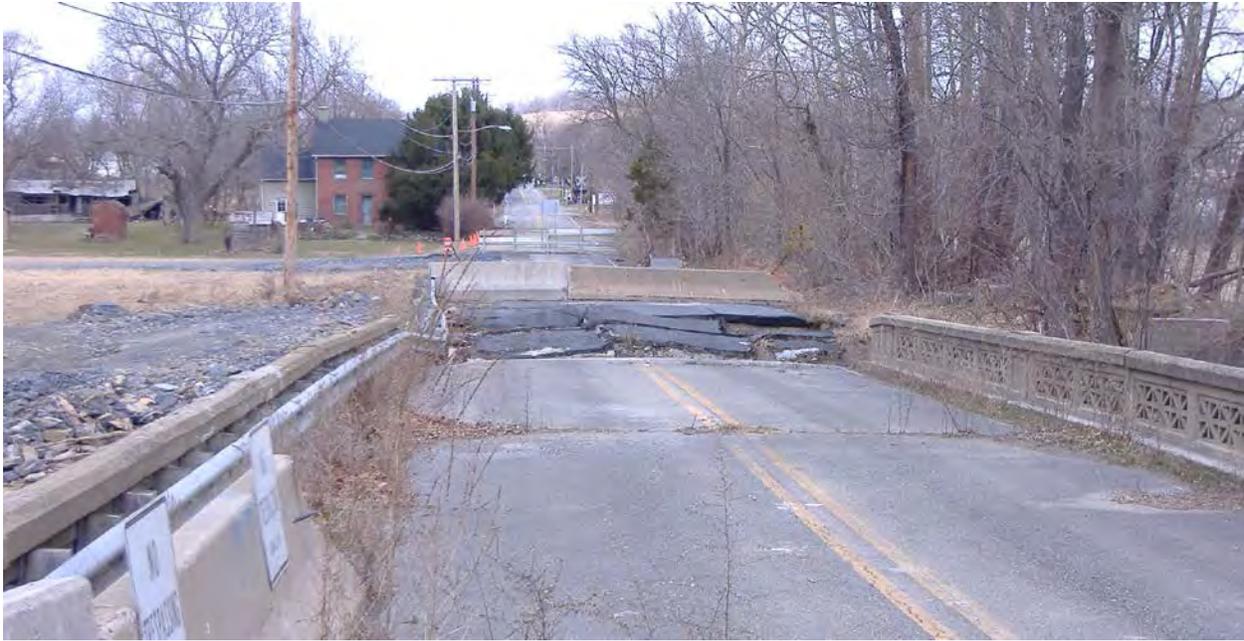
Figure 3 – North Abutment of SR 2017 Bridge over the Bushkill Creek after October 2000 sinkhole.

In October of 2000, the SR 2017 bridge was damaged and closed. In 2001, a railroad bridge crossing the creek (see yellow X on Figure 2) about a half mile downstream from the quarry was damaged by a sinkhole. The northbound SR33 span was lost in January 2004. Figure 2 shows the SR33 and SR 2017 bridge locations and the quarry to the west. The missing section of the SR 2017 bridge after the formation of sinkhole along the edge of the Bushkill Creek, adjacent to the north abutment is shown as Figure 3.
