66TH HIGHWAY GEOLOGY SYMPOSIUM SEPTEMBER 14-17, 2015

2015 Proceedings

*Massachusetts Department of Transportation
and
University of Massachusetts Amherst*

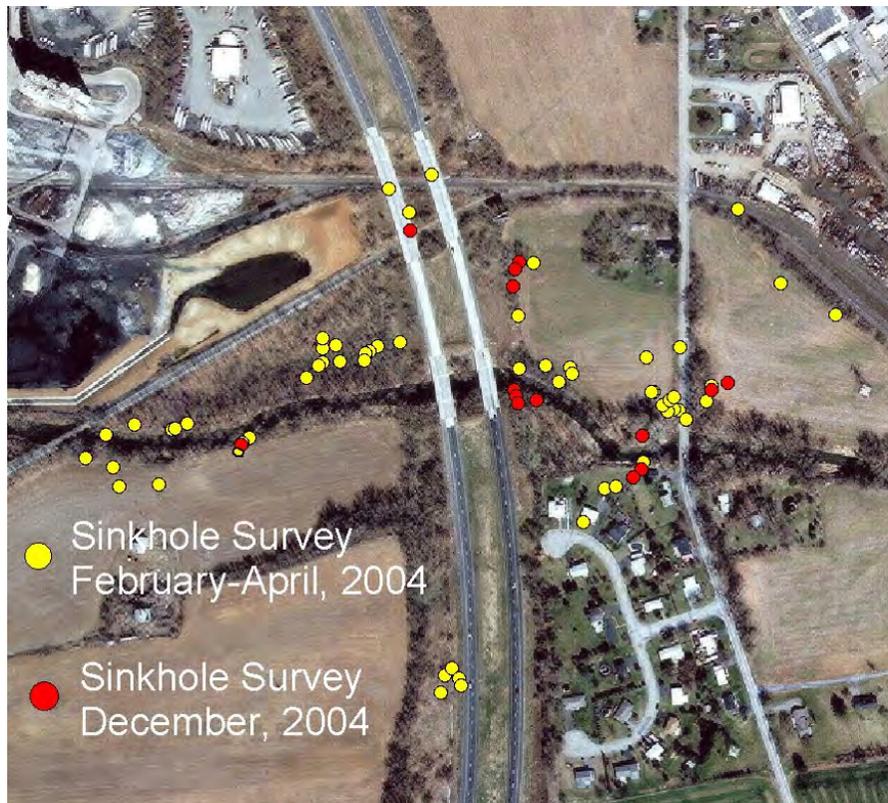
Figure 4 – Area showing sinkholes identified in 2004. New sinkholes occurring in December are in the general area as those inventoried earlier that year.

PA Dept. of Transportation and Dept. of Environmental Protection. A site geologic reconnaissance was performed by State geological survey personnel and one result of that reconnaissance is provided as Figure 4.

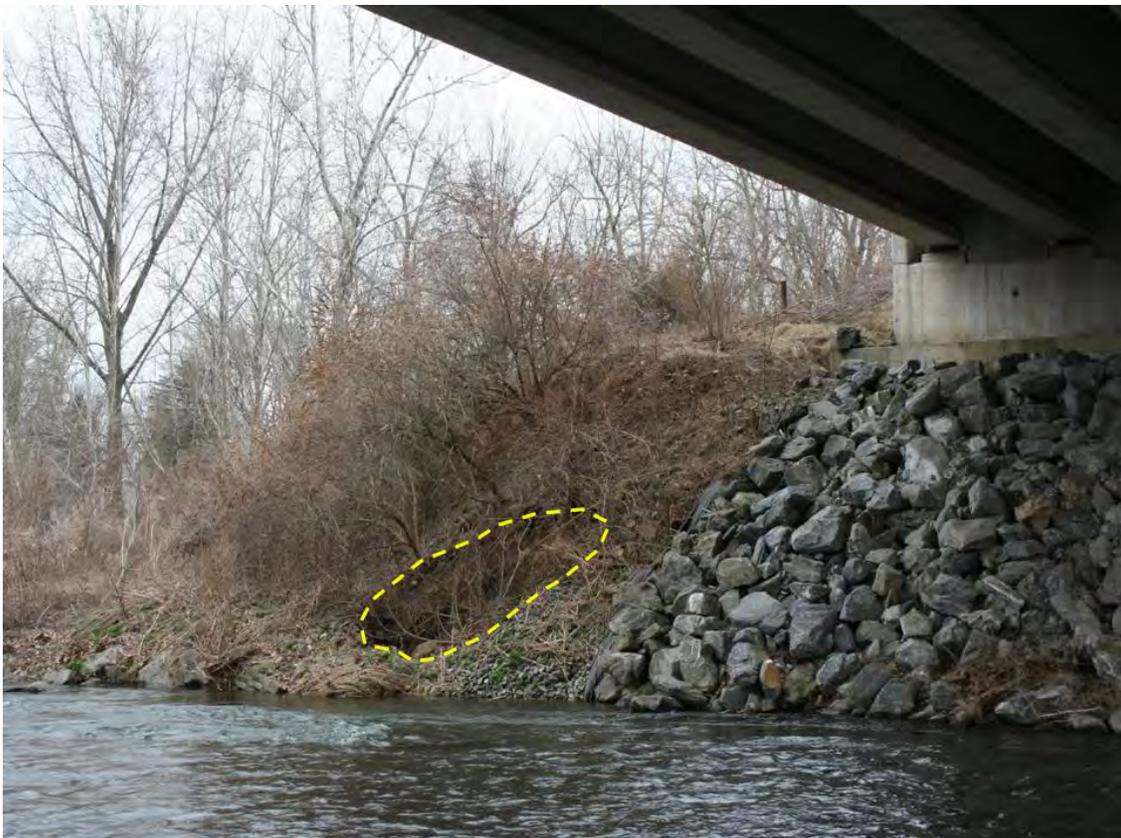
Figure 5 – Recurring sinkhole adjacent to SR33 bridging crossing the Bushkill Creek. Taken in April of 2015.

Despite the best efforts for investigation and design, the new spans have started to move. Sinkhole occurrence continues (Figure 5). The erosion and enlargement of the sinkholes has not stopped with one exposing the pile foundation of the south abutment of the northbound lanes of the replacement SR33 bridge.

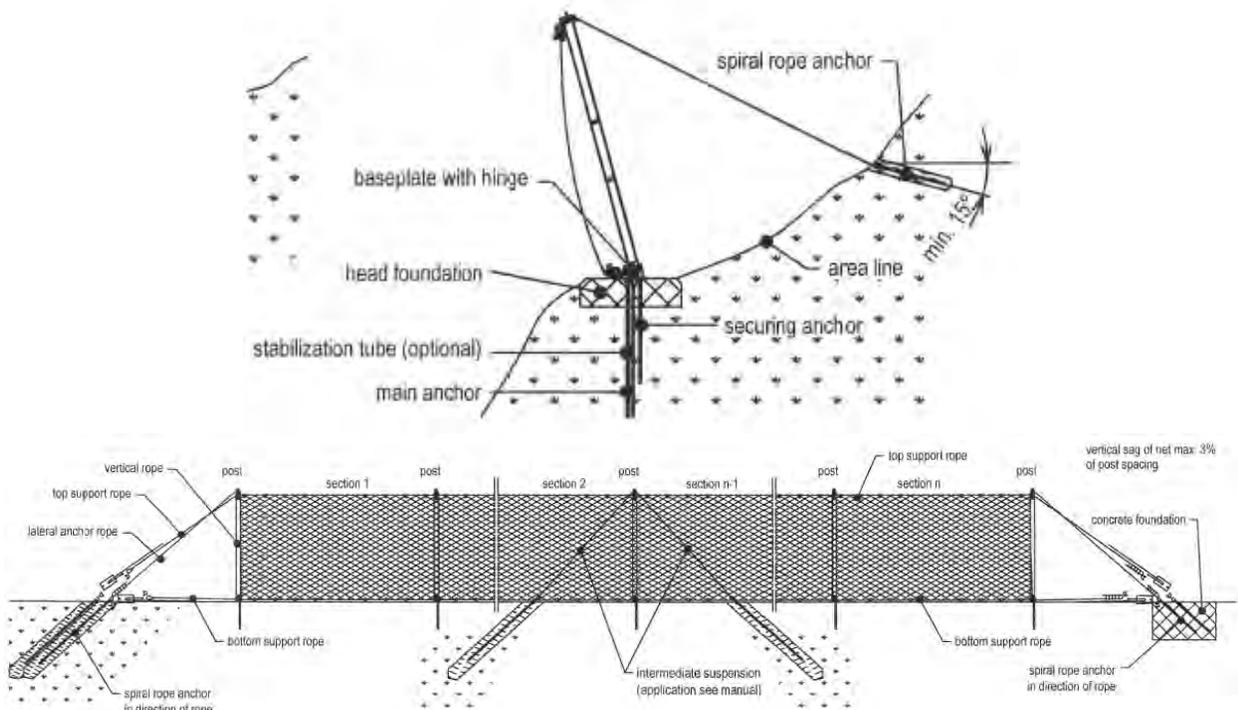
Figure 1 Schematic of a Rock fall Barrier GBE-1000A System

Flexible rock fall barrier systems are a protection measure that intercept falling rocks and catches the rock, dissipating the rock fall impact energy through total system deflection. In general rock fall barriers consist of a structural net supported by steel posts and wire ropes often containing energy absorbing brakes (Figure 1; Badger and Duffy, 2012; Andrew, et al., 2011).

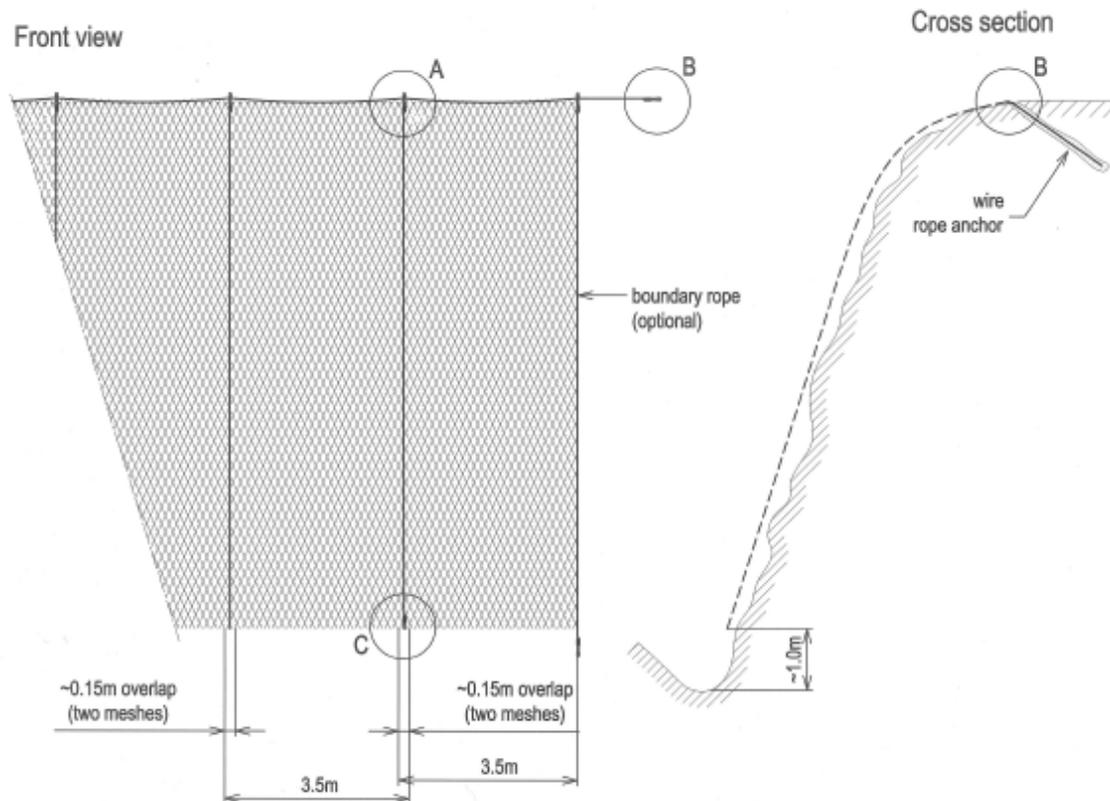
Figure 2: Schematic of a standard rock fall drapery system.

Another very common rock fall mitigation measure is a rock fall drapery system that has been employed since at least the 1950s in North America (Badger and Duffy, 2012). Rock fall draperies are passive mesh systems placed over the entire area where rock fall is anticipated to control the descent of falling rocks directing them to a planned catchment area at the base of the slope or mesh terminus (Figure 2; Badger and Duffy, 2012; Muhunthan et al., 2006; Wyllie and Norrish, 1996; Bertolo et al., 2007; Andrew, et al., 2011). A detailed analysis of draped mesh design, title *Design Guidelines for Wire Mesh/Cable Net Slope Protection*, was completed in 2005 by Washington State University (Muhunthan, et al., 2005).

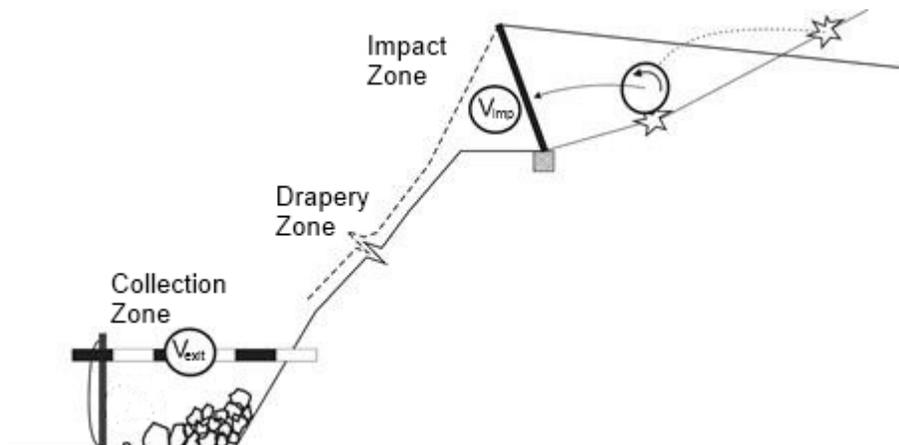
Figure 3: Sketch of typical post supported attenuator system
 V_{imp} = impact velocity; V_{exit} = exit velocity from Mumma, 2012.

Attenuators are a combination of traditional rock fall barriers and drapery systems. These systems hybridize the best features of both a rock fall barrier and a slope drapery (Figures 3 and 4). Hybrid drapery addresses rock fall source areas, both underneath and upslope of the installation, and controls the rock's descent under the mesh, combining the performance of standard unsecured draperies and flexible rock fall fences. (Fish et al., 2012; Eliassen, 2011; Badger et al., 2008). No internal, side or bottom anchoring of the fabric is generally included, allowing for controlled deformation of the fabric and attenuation of the rock fall trajectory to the base of the installation (Fish et al., 2012). Similar to drapes, the tail of the netting is open, allowing the rocks to pass through the system while reducing their velocity and controlling their trajectory (Mumma, 2012). They are intended as low maintenance passive barrier systems (Glover et al., 2010; Badger et al., 2008).

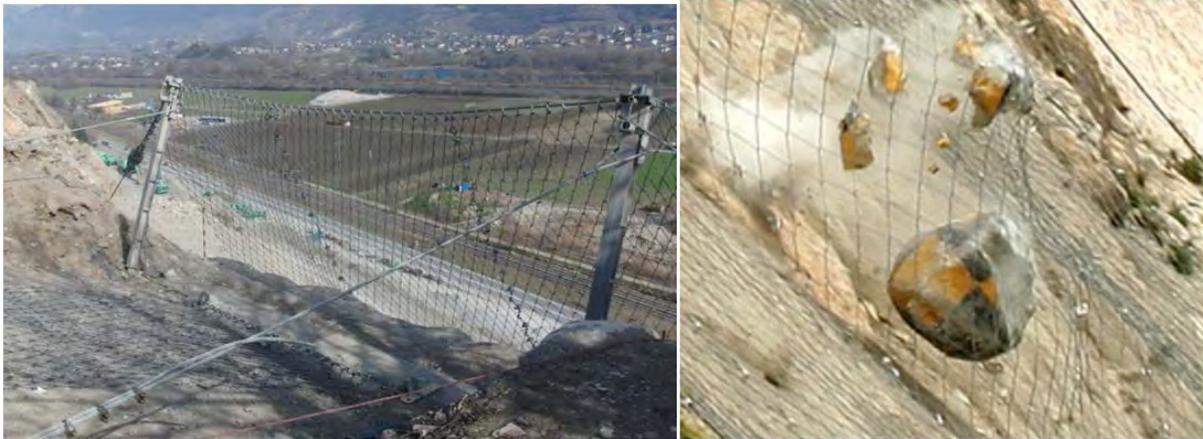
Figure 4: Catchment area of attenuating structure (left) and guided boulder along rock face (right) from Glover et al., 2012.

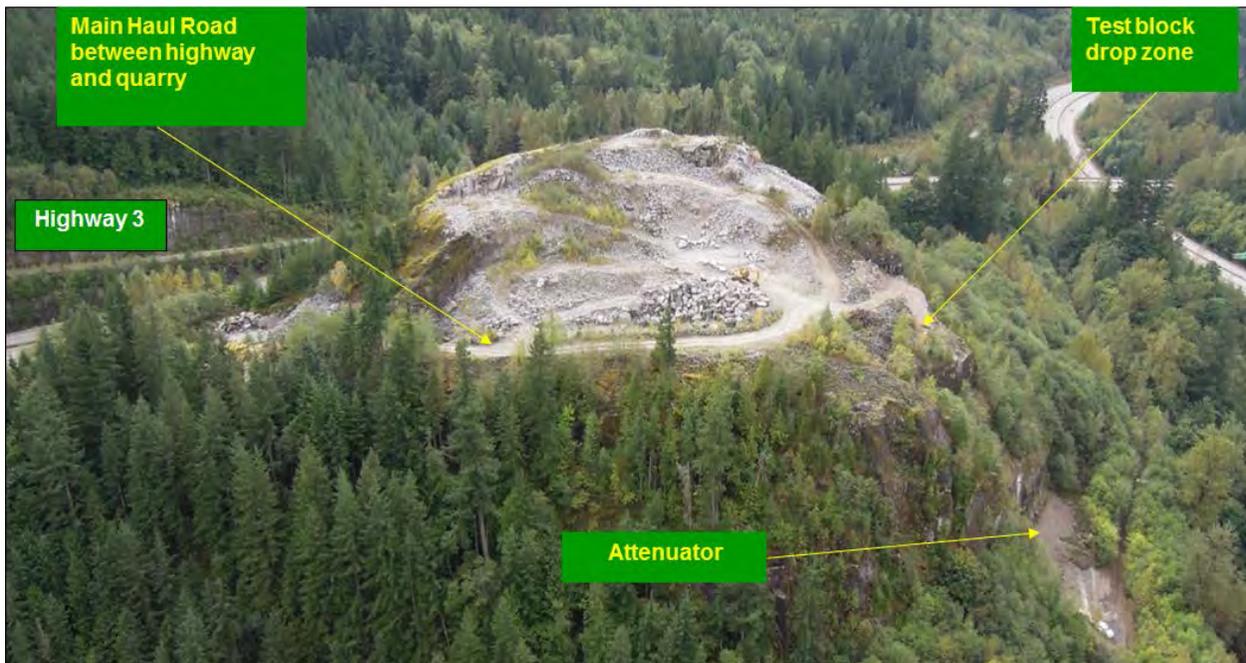
Figure 5b: Nicolum Quarry Test Site

This paper summarizes the preliminary results of the rock fall attenuator testing program carried out during January and February of 2015 at Nicolum Quarry near Hope, British Columbia, Canada (Figure 5a and 5b). The tests were documented with instrumentation and camera systems. A total of 26 tests, comprising both blocks of rock and reinforced concrete cubes, were carried out. These preliminary tests of the attenuator system were “proof of concept” tests to evaluate all components of the system and test site to determine how future tests may be conducted.

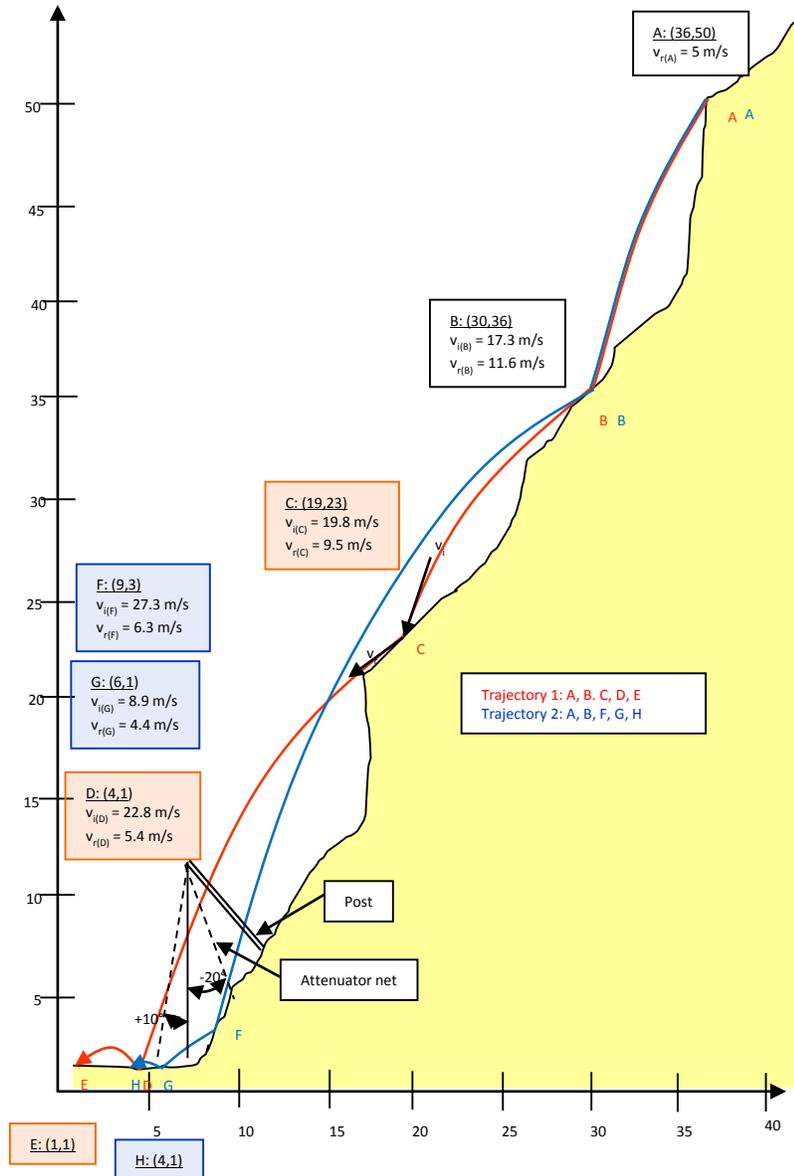
Figure 6:

Quarry Test Site Profile.

The total fall height from the crest of the rock face to ground level was 180 ft. (55 m), although an additional fall height of about 16.5 ft. (5 m) could be achieved by extending the boom of the excavator to drop the blocks. The overall angle of the rock face was 60 degrees comprising two benches and near vertical rock faces (Figure 6).

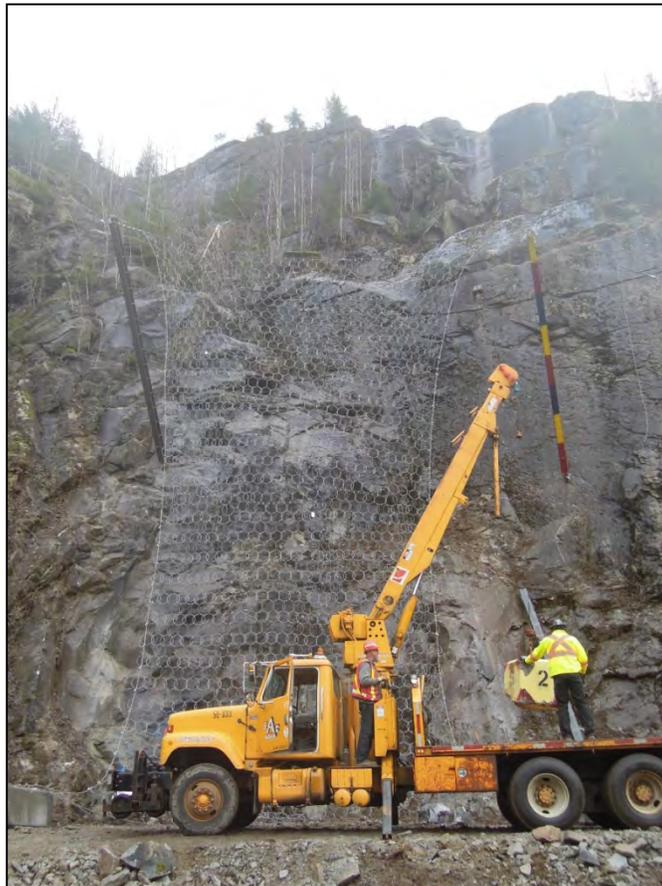
Figure 7: RXE-1000 Attenuator Net System from Geobrugg Protection Systems

The attenuator system was a Geobrugg's RXE-1000A Attenuator System consisting of a ROCCO ring net (7/3/300) approximately 30 ft. (9 m) wide by 36 ft. (11 m) tall, supported by 26.25 ft. (8 m) long steel posts attached to a hinged base plate, and support cables running from the top of the posts to anchors in the rock face (Figure 7). The steel posts supporting the ROCCO ring nets were spaced at 34.5 foot (10.5 m) and installed at an angle of 45 degrees. The support ropes were attached to the granite rock face with 6.5 ft. (2 m) long wire rope cable anchors. Additionally, vertical cables were attached to the sides of the ring nets and secured to concrete blocks at the toe of the slope.

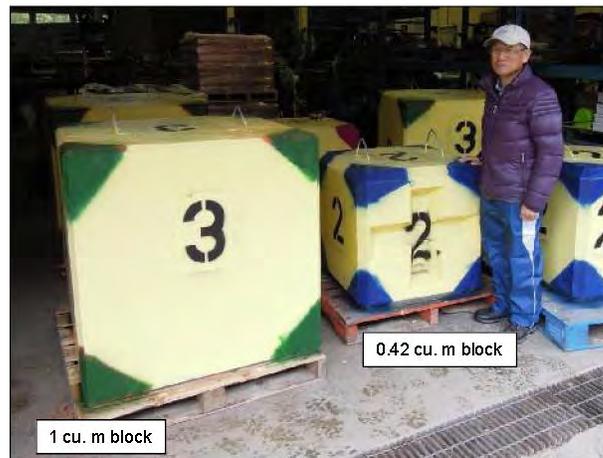
Figure 8: Concrete Test Blocks before testing.

Natural granitic blocks approximately 1.5 foot ft. (0.45 m) in diameter and cubic reinforced concrete blocks were used for testing. The dimensions of the two concrete blocks were 14.88 ft³ (0.42 m³) and 35.28 ft³ (1 m³) cubes. The concrete blocks incorporated lifting eyes on two faces and were painted yellow with emphasis on the corners, and each face numbered to maximize their visibility in the videos (Figure 8).

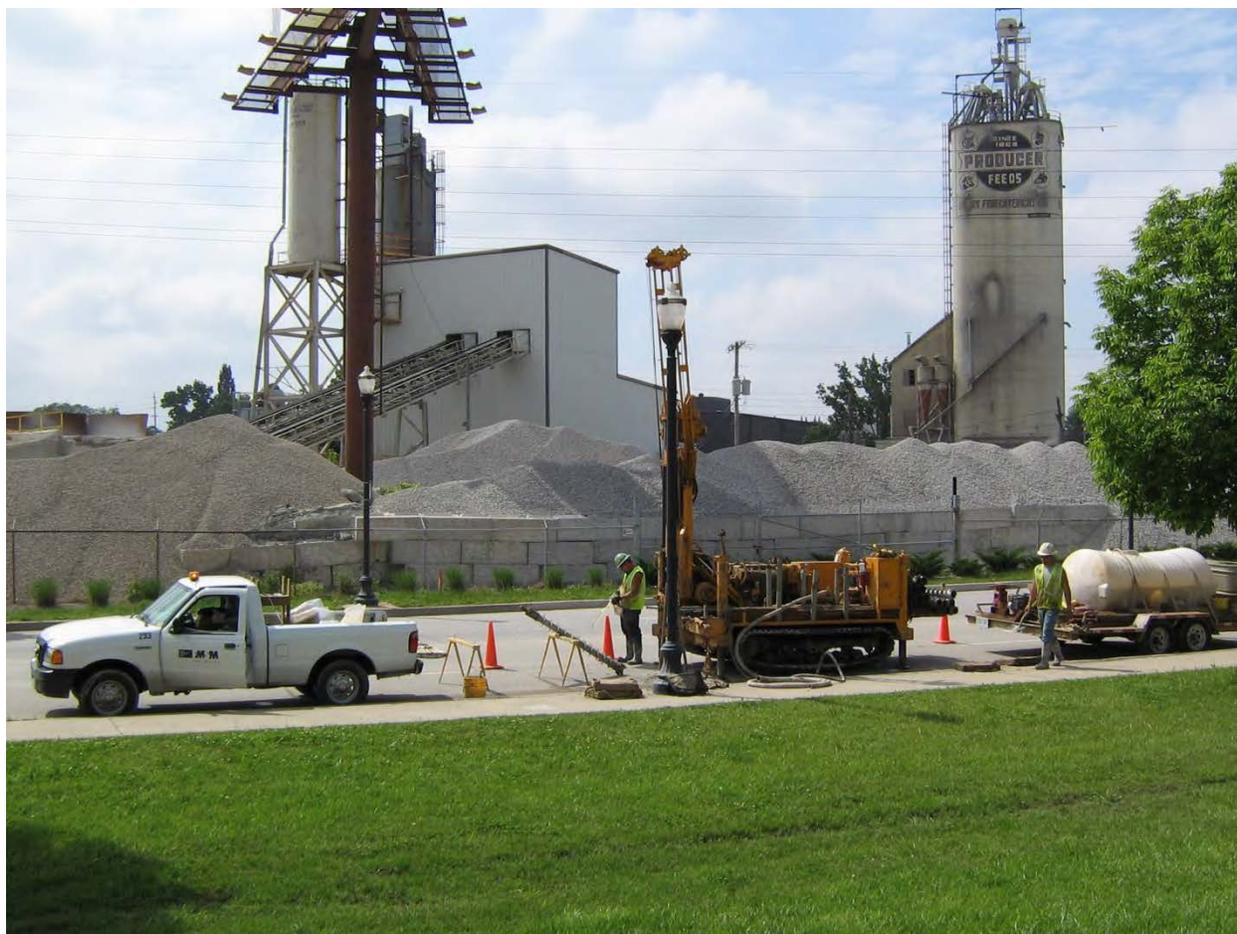
Figure 2. Drilling along an existing side street.

For the sake of this paper, the focus will be on Sections 1 and 2 of the Downtown portion, the Kennedy Interchange and the I-65 Bridge over the Ohio River. Geotechnical explorations were performed between 2005 and 2008 on approximately 80 bridges and 20 retaining walls. The roadway alignment at that time was a completely new alignment south of the current interstate. Over 363 borings were advanced to encompass over 24,000 feet of drilling. A large portion of this drilling was performed in areas considered to be environmentally sensitive. Keep in mind that we are in an old community with years of industrial growth and change. Figure 2 is an example of the industrial setting.

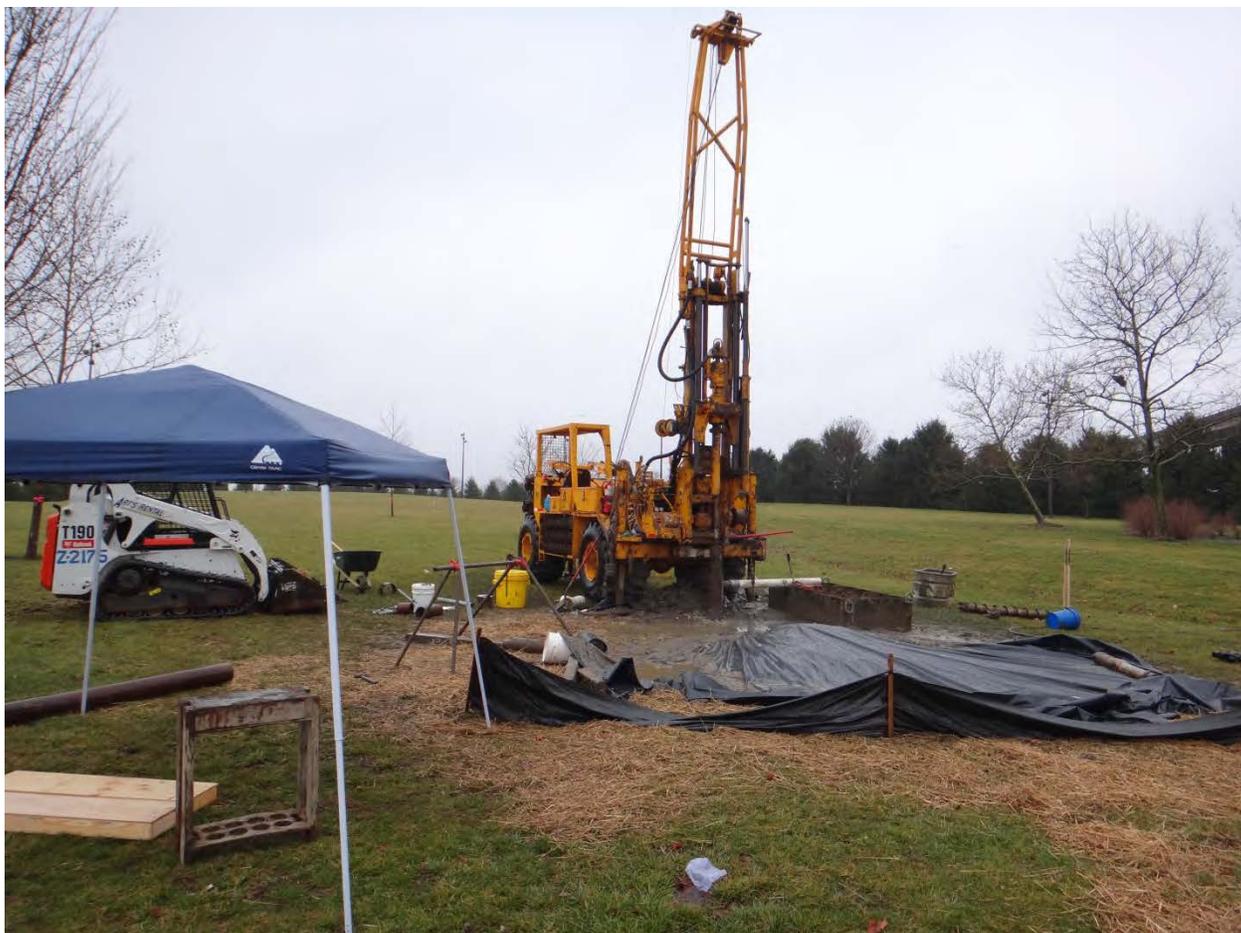
Figure 3. Drilling within the Great Lawn area.

Walsh was awarded the project in January 2013. With the alignment being moved back within the existing interstate corridor, new geotechnical explorations were required for the new bridges and walls. This effort could not be performed during the proposal pursuit, therefore when the contract was awarded; the geotechnical work was already behind. An additional 175 borings and over 50 CPT holes were performed for the 40 new bridges and 21 retaining walls planned. We also performed 9 additional borings and PS suspension logging for the new bridge over the Ohio River. Figure 3 shows drilling for the Ohio River Bridge within the Great Lawn area.

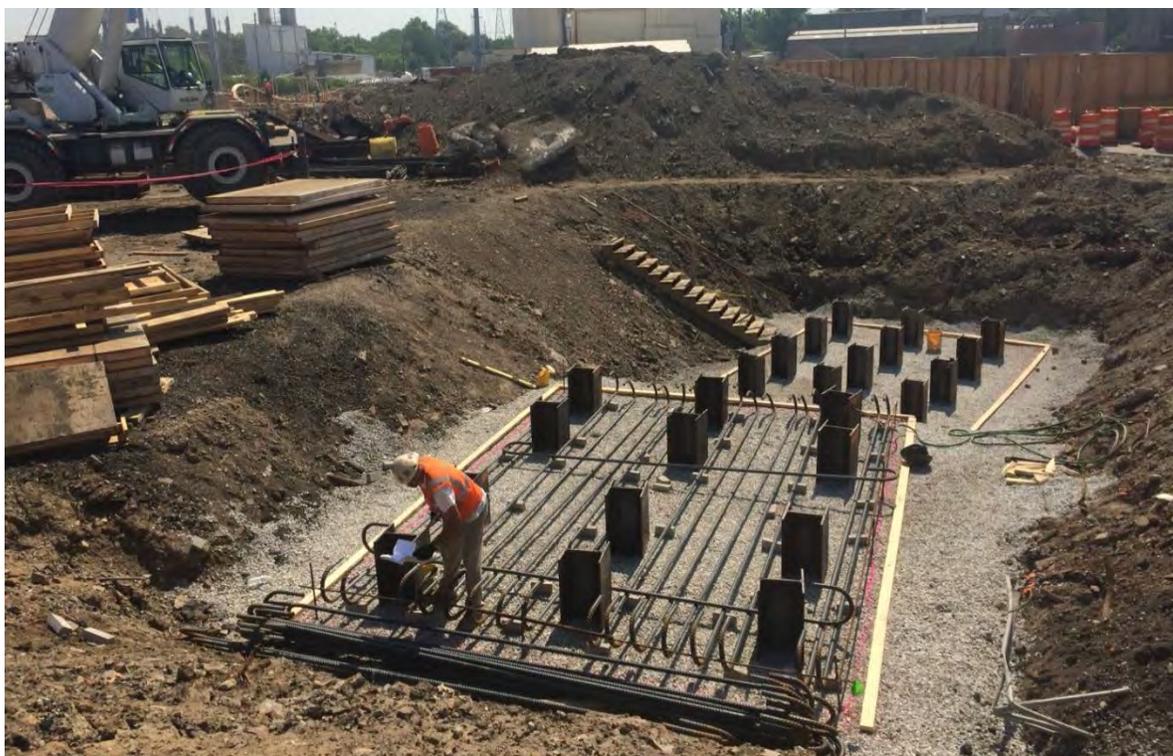
Figure 4. Typical H-pile foundation.

With the field testing complete, we were able to change most of the larger pile sections to smaller sections. Many of the deeper/longer piles had been increased in size to handle the predicted difficult driving. This decrease in pile size helped offset the change to longer piles for bridges originally designed with friction piles. Figure 4 shows a H-pile foundation.

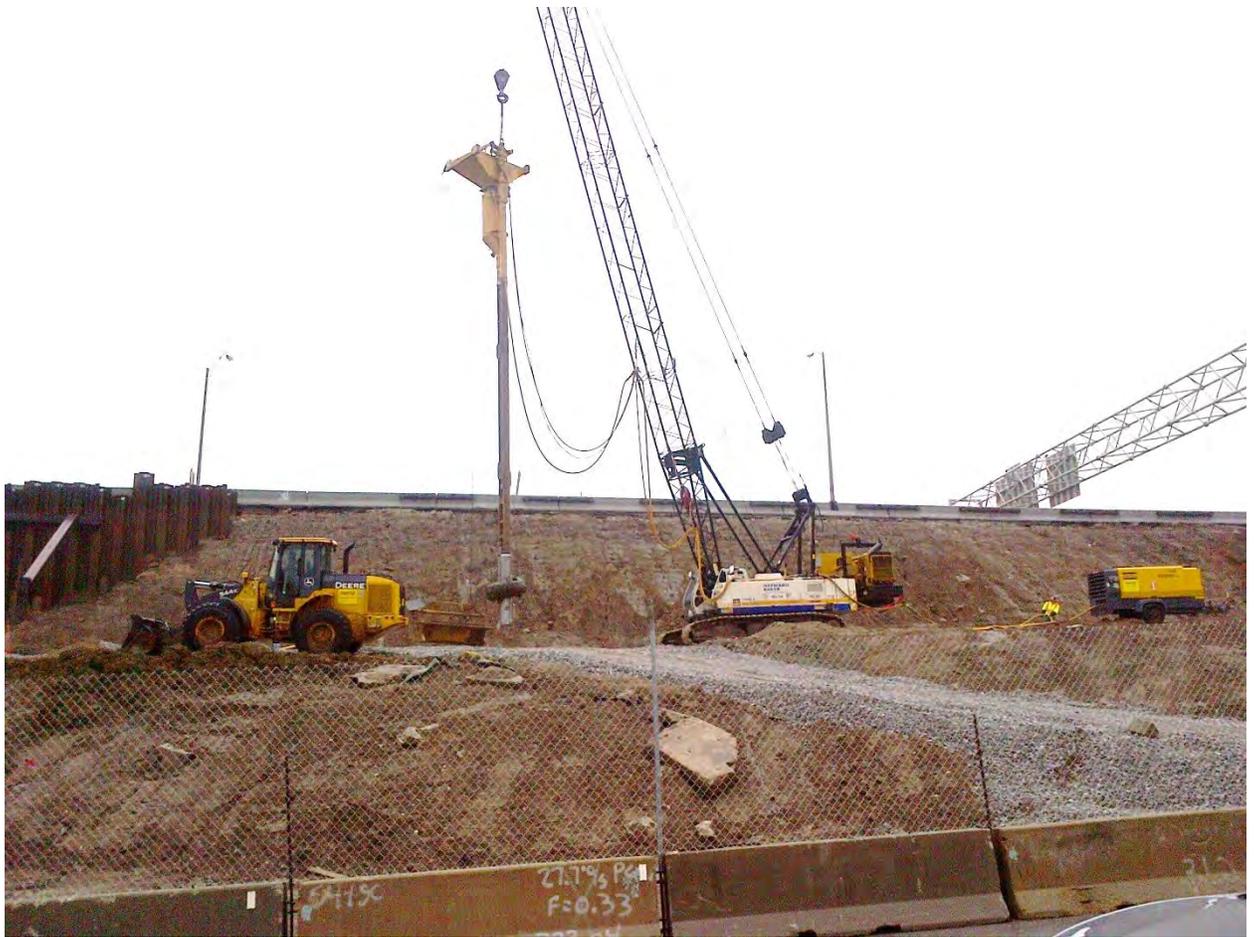
Figure 5. Stone column installation.

Jacobs provided the geotechnical engineering related to the retaining walls. The main concerns the project team and KYTC had with the retaining walls were settlement and poor bearing conditions. With the assistance of Hayward Baker, many wall foundations included stone columns. Test embankments were constructed early, that included instrumentation, to confirm designs and predicted settlements. Stantec assisted with the installation of the instrumentation. Figure 5 includes some of the equipment used for stone column installation.

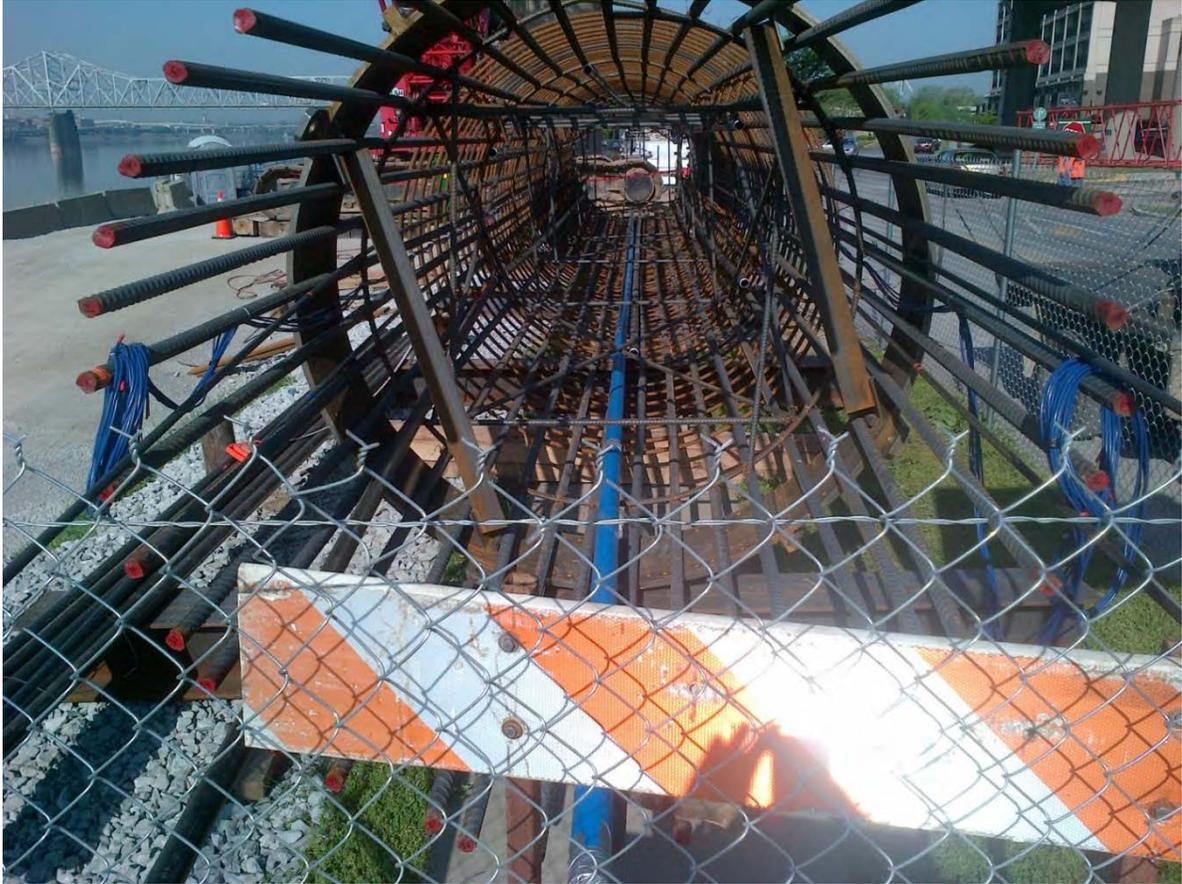
Figure 6. Rebar cage and initial O-cell installation.

The Ohio River Bridge foundations were primarily constructed on drilled shafts varying from 8 feet to 12 feet in diameter. A technique shaft was constructed that included four Osterberg cells to verify parameters used for end bearing and side friction. The shaft included a nominal 90 inch diameter rock socket approximately 30 feet into rock. In addition, the team performed static testing to evaluate lateral loading. The testing resulted in values that were similar to predicted values used for preliminary sizing of the shafts. Figure 6 shows initial wiring and preparation for the O-cells.

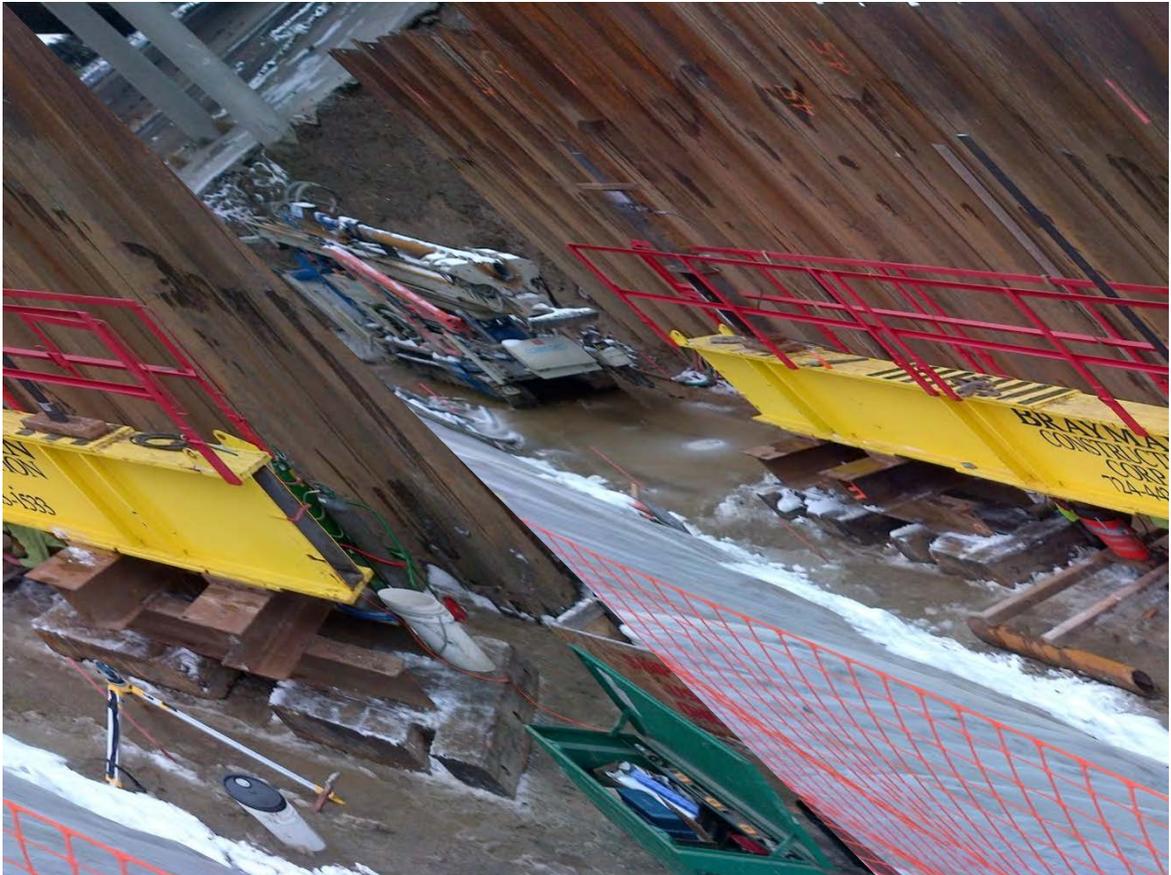
Figure 7. Micropile proof testing.

Micropile foundations were used on a few select footings because of utility restraints and the need for a small footing footprint. The micropile size that was used was 9-5/8". A load/verification test was performed at each foundation as well as proof testing one micropile per foundation. Micropiles were typically extended into bedrock 10 to 15 feet. Figure 7 depicts a micropile test setup.

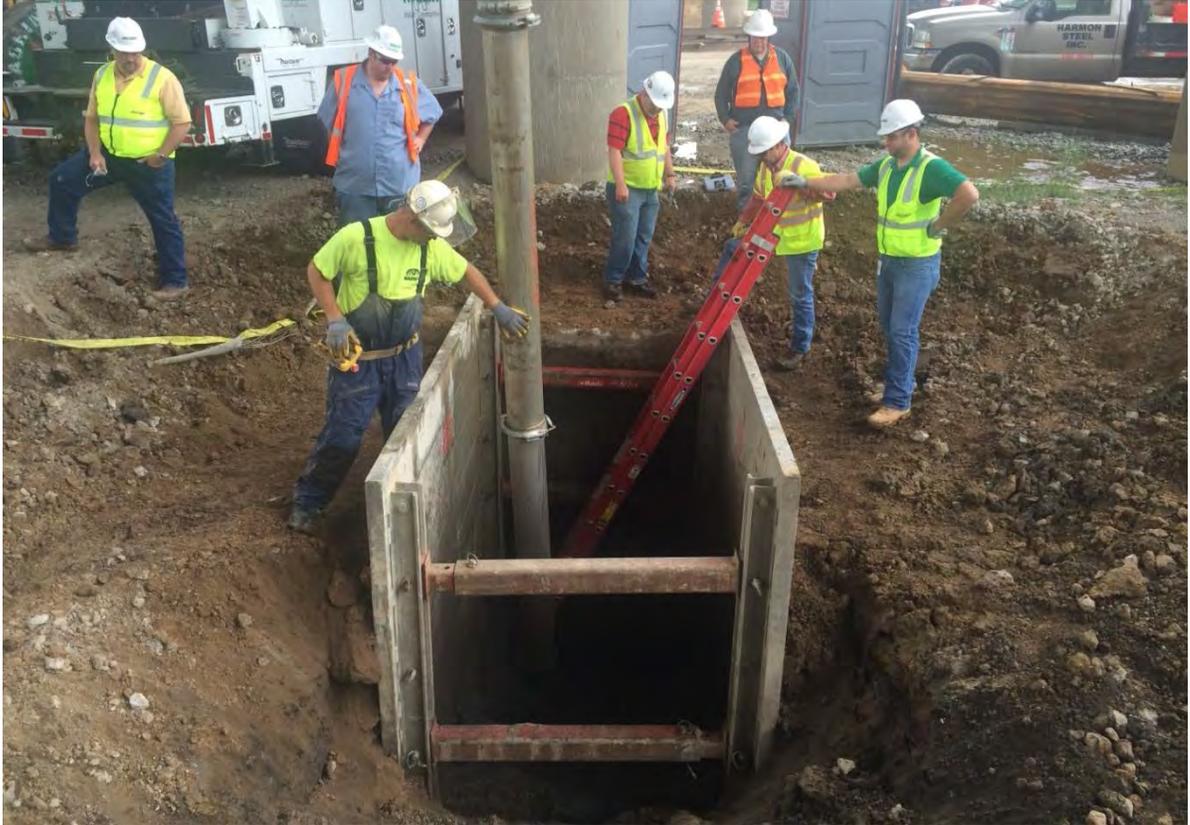
Figure 8. Inspection of existing foundation.

The team was allowed to reuse a foundation that is currently a part of the existing Kennedy Bridge. However, in order to reuse the footing, the Team needed to understand what the footing consisted of and its current condition. The original design drawings identified multiple options, but no one knew which option was chosen. Walsh exposed the footing for the Team to visually inspect. The foundation consisted of spiral welded pipe piles filled with concrete and appeared to be in very good condition. Figure 8 demonstrates the efforts utilized to expose the footing for inspection.

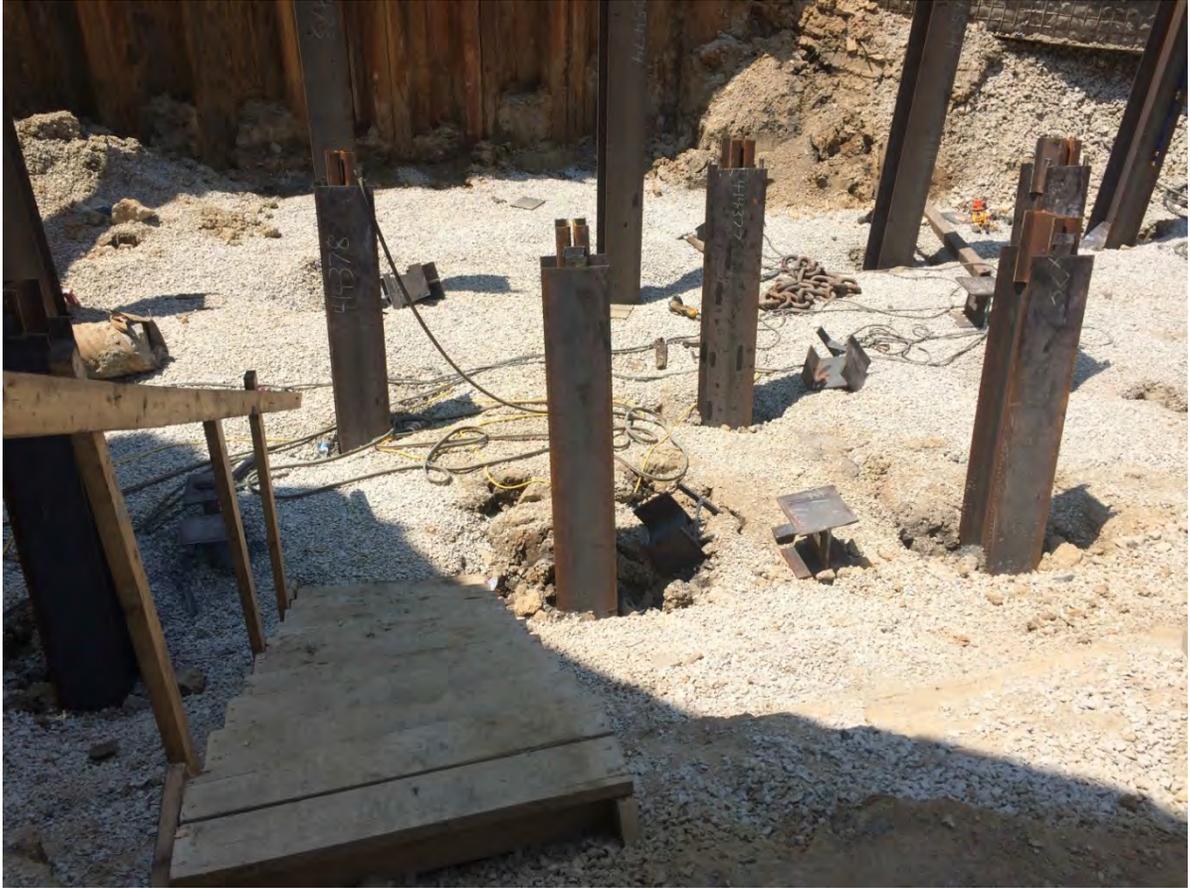
Figure 9. Cavitation after pile driving.

During the driving of H-piles, the contractor dealt with a lot of cavitation around the piles. The amount of cavitation varied at different bridge sites and at times made worse due to wet weather conditions. These depressions were backfilled with flowable fill prior to pouring the footing.

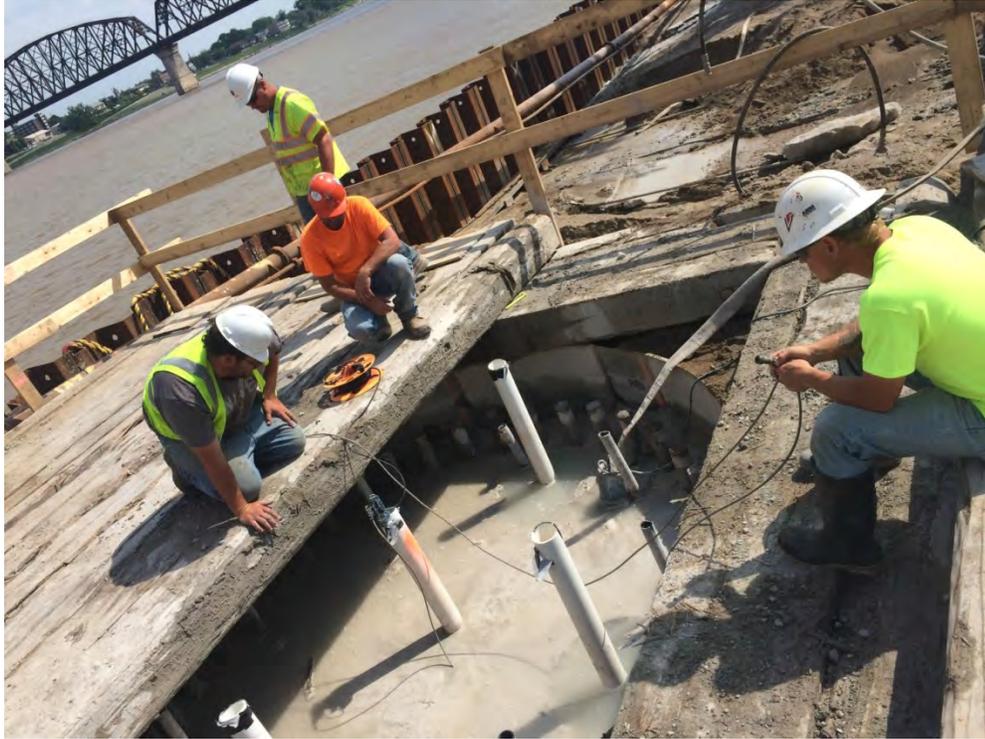
Figure 10. Cross hole sonic logging of drilled shaft.

The I-65 Bridge over the Ohio River experienced problems during a concrete pour of a drilled shaft. The shaft was 12-foot in diameter and had basically lost its tremmie seal under 130 feet of water. The issue was not realized until after about the initial 60 feet had been poured. Cross hole sonic logging was performed with little to no reading between tubes. Stantec was called out to perform coring of the shaft from top to bottom around the perimeter, and perform unconfined rock testing. Figures 10 and 11 show some of this work.

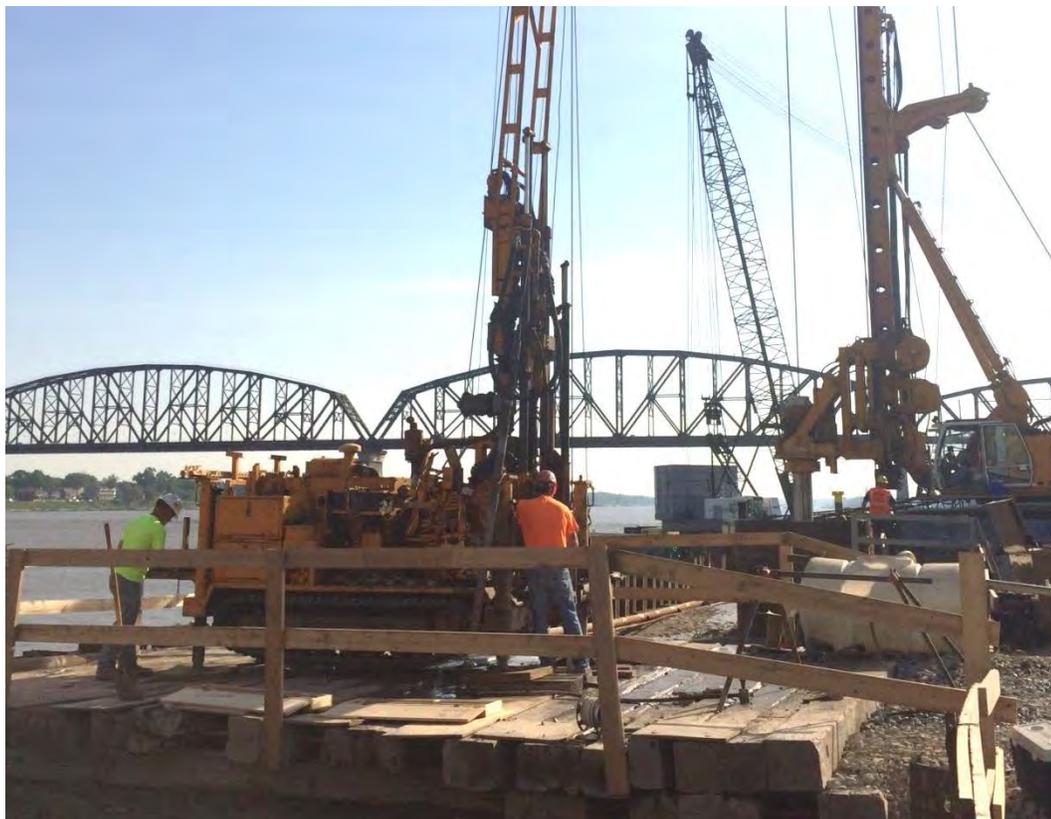
Figure 11. Concrete coring around perimeter of drilled shaft.

The results indicated that the bottom 60 feet of the 120 foot long shaft contained concrete of varying strength and quality that did not meet the design criteria. Therefore, the design team redesigned a new shaft that basically incorporated a smaller shaft (7.5 foot diameter) within the original shaft and extended it deeper into the bedrock. Walsh drilled out the center of the 12-foot shaft with great care so that the hole was maintained straight. Figure 12 is one of the drills utilized by Walsh to construct the drilled shafts.

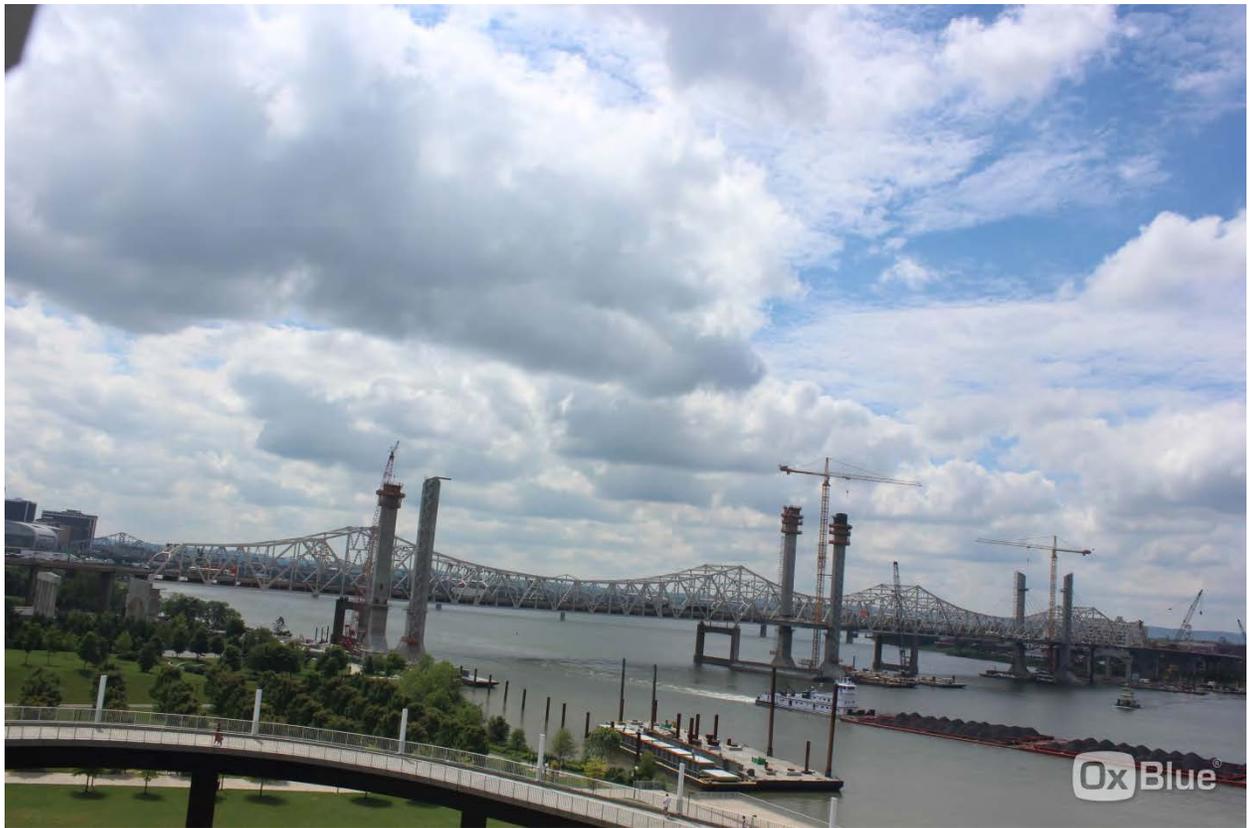
Figure 13. Progress as of May 29, 2015.

The current construction is progressing on time. There has been discussions about an early bridge opening over the Ohio River. Late winter snows and early Spring floods have made those opportunities tough.

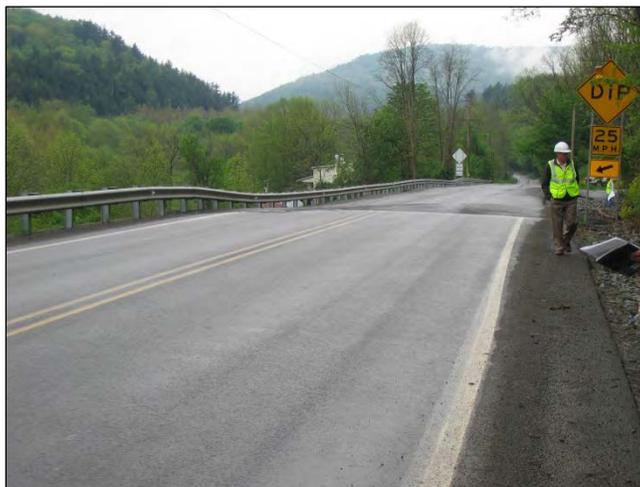
Photo 1: Dip/Rough Roadway Conditions Through Landslide Area

S.R. 0029 in this area parallels Snake Creek which flows northward into New York where it empties into the North Branch of the Susquehanna River. S.R. 0029 is a major north/south roadway in this area of the county and experiences considerable use by trucks due to Marcellus shale drilling activities, logging, and bluestone quarrying operations in the region. The landslide damaged the S.R. 0029 roadway, as large bumps, tension cracks, and rough

roadway conditions were evident through the landslide area (Photo 1). Periodic maintenance consisting of filling tension cracks with cold patch and milling/overlay of the pavement was performed in an effort to restore rideability. S.R. 0029 remained open to traffic and warning signs were installed to caution oncoming motorists of the bump and rough roadway conditions at the project site.

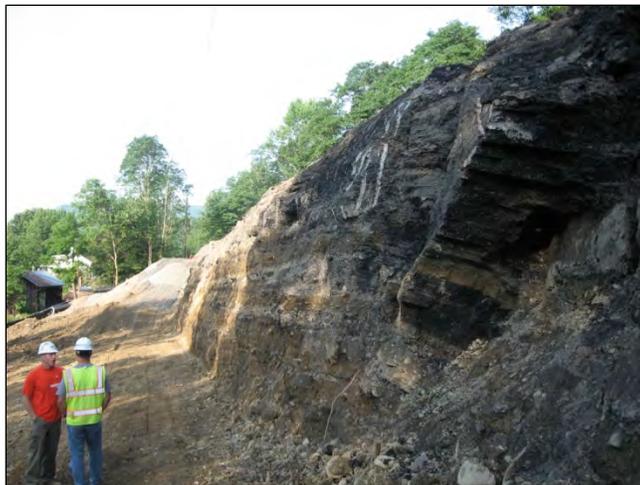
Photo 2: 2010 Excavation of Roadway Exposing 13 to 14 feet of Pavement

Subsequent to the 2006 GER, an embankment excavation and replacement with a rock buttress was designed and constructed during the summer of 2010. The intent of the rock buttress was to provide load reduction at the top of the slope and to keep the repair area within the existing right-of-way. During construction of the rock buttress, 13 to 14 feet of pavement was exposed and confirmed the boring data collected by PENNDOT and the local resident's claims of a long history of slope movement (Photo 2).
