66TH HIGHWAY GEOLOGY SYMPOSIUM SEPTEMBER 14-17, 2015

2015 Proceedings

*Massachusetts Department of Transportation
and
University of Massachusetts Amherst*

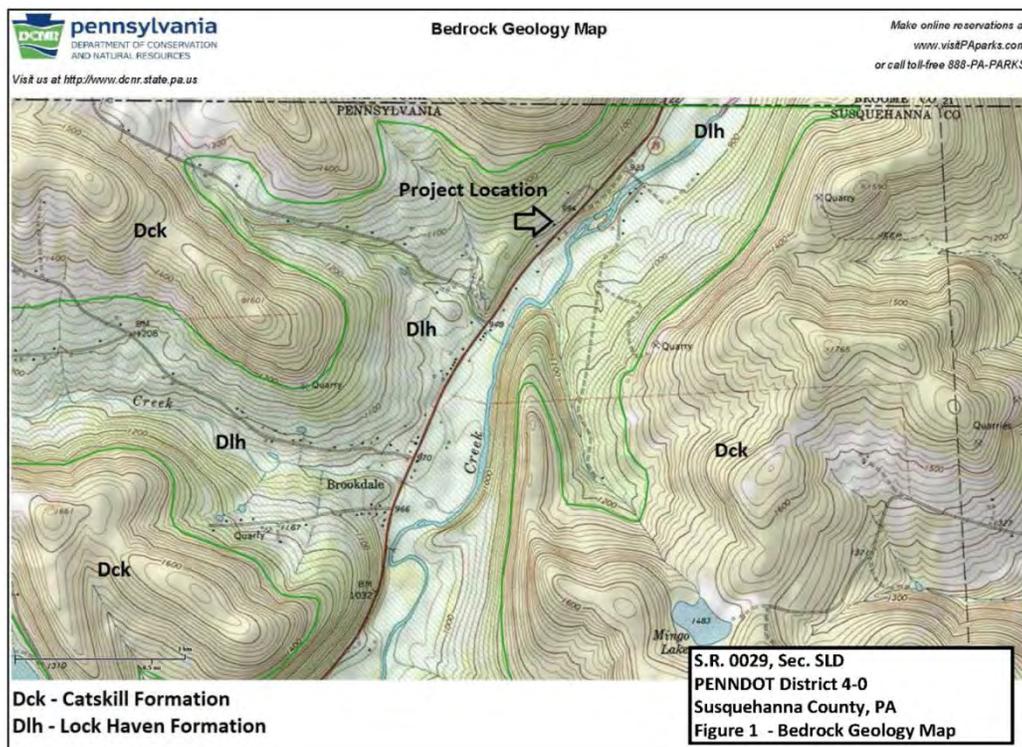
Figure 3: Bedrock Geology Map

A review of available published information, including bedrock geology and surficial geology, was performed to gain an understanding of the project subsurface conditions. Based on the Pennsylvania Bureau of Topographic and Geologic Survey, the Devonian age Lock Haven (Dlh) Formation underlies the active landslide area, and the contact between the Catskill (Dck) and the overlying Lock Haven Formation is located upslope of the active landslide area (1). The Catskill Formation is a complex unit consisting of grayish-red sandstone, siltstone, and shale generally in a fining upward sequence. Gray sandstone and conglomerate are also present. The Lock Haven Formation is composed of predominantly light olive gray interbedded sandstone, siltstone, and shale. Fine grained rocks (shale and siltstone) constitute about 70 percent of the formation. A Bedrock Geology Map is shown in Figure 3.

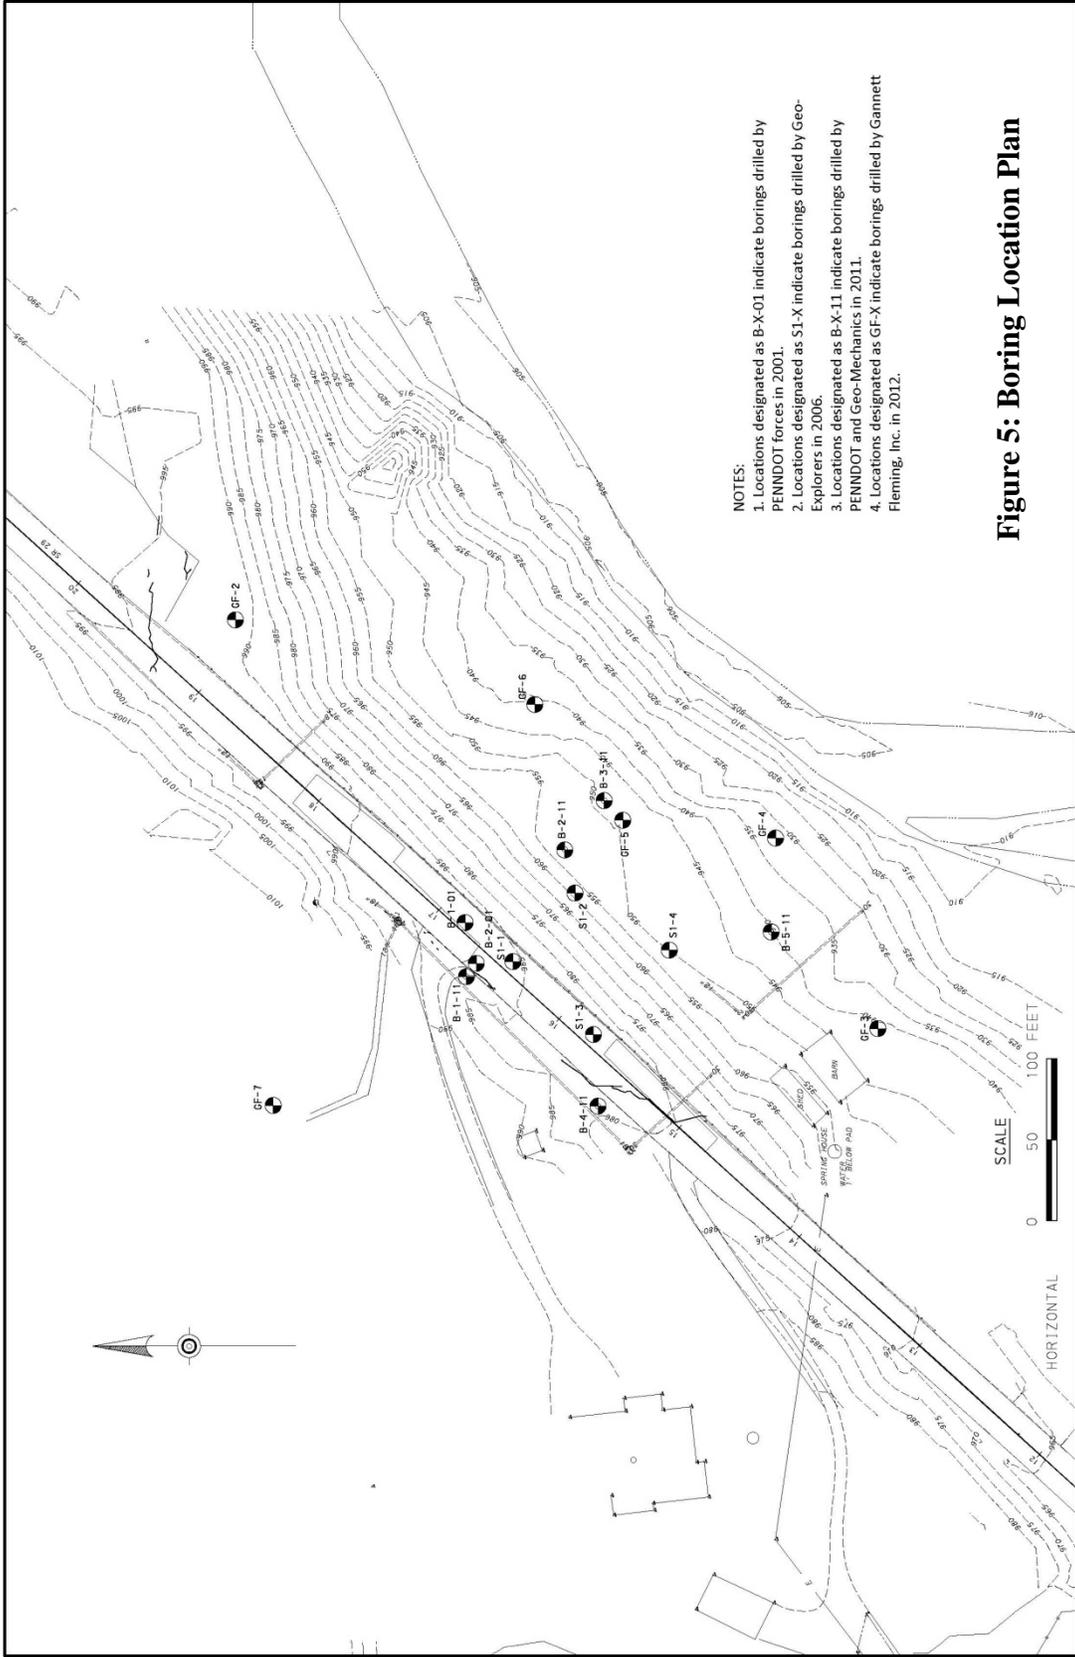
Figure 5: Boring Location Plan

- NOTES:
1. Locations designated as B-X-01 indicate borings drilled by PENNDOT forces in 2001.
 2. Locations designated as S1-X indicate borings drilled by Geo-Explorers in 2006.
 3. Locations designated as B-X-11 indicate borings drilled by PENNDOT and Geo-Mechanics in 2011.
 4. Locations designated as GF-X indicate borings drilled by Gannett Fleming, Inc. in 2012.

Gannett Fleming, Inc. initiated a subsurface exploration program for PENNDOT in 2012 to gain additional information at the site. A total of ten (10) geotechnical borings were drilled at the project site to better define the subsurface conditions, collect soil samples for laboratory testing, and for installation of inclinometer casing and piezometers in the area of the landslide between September and November of 2012. A boring location plan showing all borings drilled at the site since 2001 is shown in Figure 5 and a typical subsurface cross section, developed at Station 16+68 (Section A-A) from historical and recent borings is shown in Figure 6.

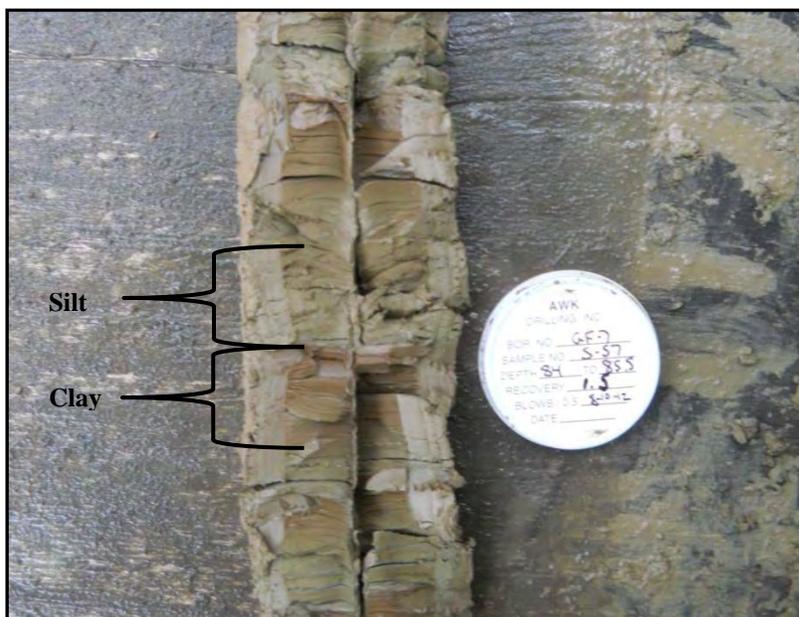
Photo 3: Varved Lake Clay Sample Encountered in GF-7

Overlying the lower till is a gray to grayish brown lacustrine or glacial lake clay deposit. The borings confirmed the presence of alternating intervals or couplets of silt and clay sized particles, often termed varves, as shown in Photo 3. The glacial lake clay was typically moist and ranged from stiff to very hard. Localized rounded to subrounded gravel fragments were also identified.

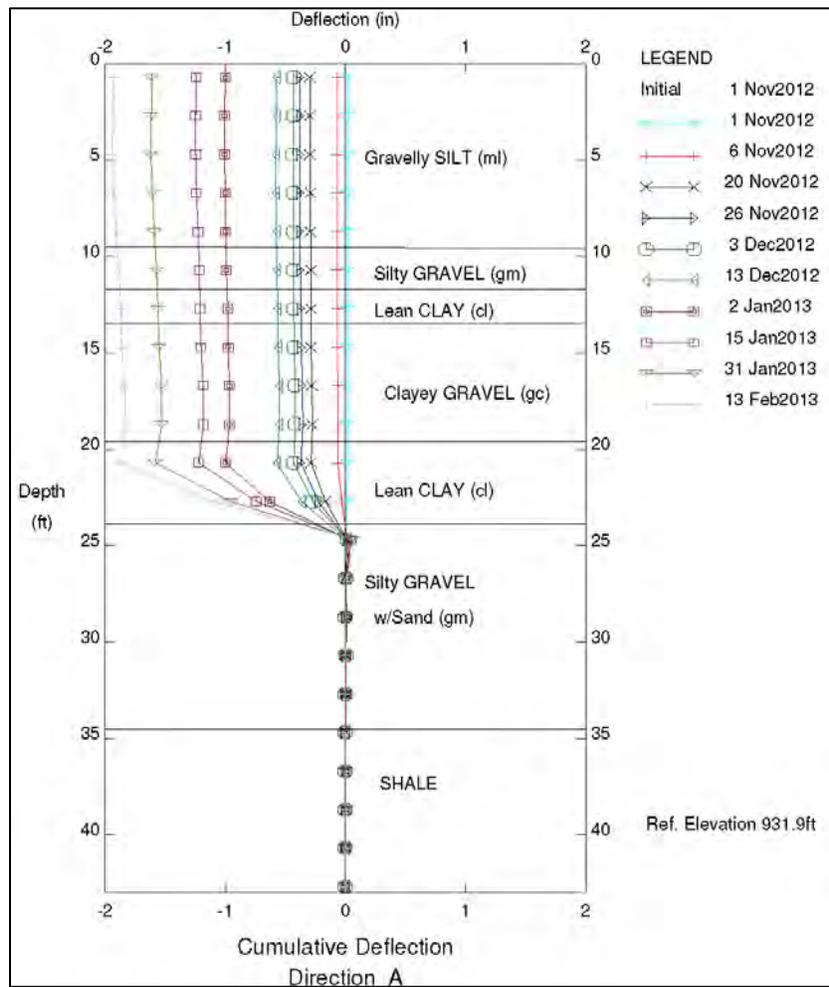
Figure 7: Typical Inclinometer Plot

During the 2012 subsurface investigation inclinometer casing was installed in 5 borings. Three of the inclinometers were installed within the active landslide and the remaining two located outside the active landslide. These inclinometers, together with the inclinometers installed by PENNDOT in 2001, 2011, and a previous consultant in 2006, were very successful in identifying the location of the failure plane. The inclinometer readings consistently showed that the movement of the slide mass was within the glacial lake clay layer, just above the lower glacial till. Table 2 below lists the inclinometers and the elevation of the failure plane at each instrument. Figure 7 presents a typical plot of the inclinometer readings taken over a four month time period in a direction perpendicular to the head scarp of the landslide.

Boring/Inclinometer ID	Installation Date	Approximate Failure Plane Elevation (ft)	Material Description (USCS)
B-1	2001	962.6	ml
S1-1	2006	960	cl-ml
S1-3	2006	952	cl-ml
B-2	2011	910	cl-ml
B-3	2011	910.2	cl-ml
B-5	2011	909	cl-ml
GF-2	2012	946	cl
GF-4	2012	909	cl
GF-6	2012	925.2 (Upper) 912.0 (Lower)	cl

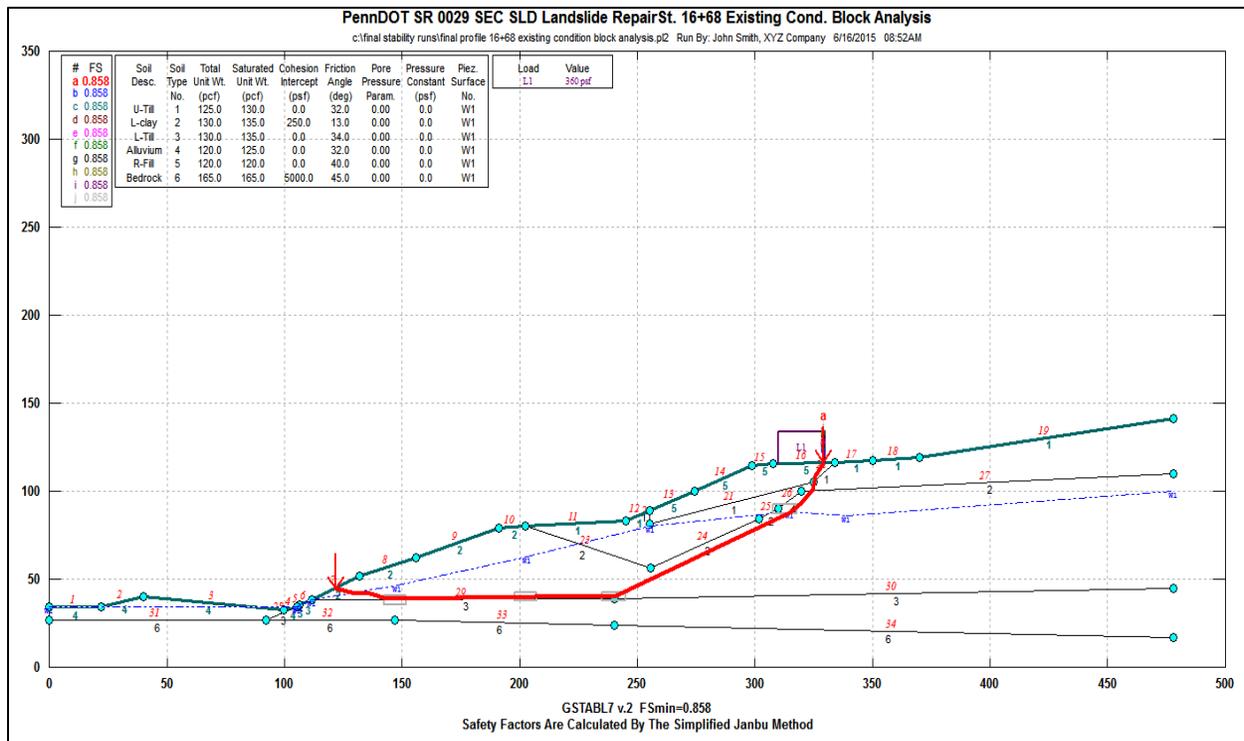
Figure 8: GSTABL7 Plot of Existing Conditions Analysis

Multiple iterations for both sliding block and circular types of failures were evaluated to find a failure plane that closely matched the depth of the failure plane identified by the inclinometers. Various initiation and termination points were evaluated to determine the most critical factor of safety of each run. The GSTABL7 model and the results of the existing slope analysis are shown in Figure 8.

Data obtained from the borings and inclinometers confirmed the failure plane of the landslide was located in the glacial lake clay deposit. The residual strength of this material was used in the slope stability analyses due to the significant past activity of the landslide and the ongoing movement. The laboratory test results for residual shear strength of the silt stratum varied from 10.8 to 17.5 degrees with an average value of 14.2 degrees, not considering the test result from sample GF-5 (ST-6). The test result from this sample was not considered representative due to a piece of gravel in the sample, which adversely affected the test. The residual shear strength values were considerably lower than the peak shear strength values for the glacial lake clay. Since the landslide had a long history of movement, the residual shear strength was considered more appropriate for use in determining the existing factor of safety of the slope and for designing the remediation. Peak shear strength values would have produced higher factors of safety in the stability analyses and lead to an under-designed remediation.

order to create a more reasonable model, 250 pounds per square foot (psf) of cohesion was included in the shear strength of the glacial lake clay deposit. The addition of cohesion to the model was justifiable because the varved clay and silt was overconsolidated due to past glacial loading. The over consolidation ratio (OCR) of 2.4 determined by consolidation testing verified that the material was overconsolidated. The shear strength of overconsolidated clay typically includes some cohesion. Results of the existing condition analysis stability run utilizing 250 psf of cohesion resulted in a F.S. of 0.9, which was assumed to be a realistic factor of safety for the moving slope condition.

The top of bedrock was used in the existing conditions analysis as a limiting boundary so that failure surfaces did not extend below the top of bedrock. The soil parameters for the upper and lower glacial till units and alluvium were determined based on laboratory test results, in-situ SPT results, and published empirical data. Groundwater levels obtained from the piezometers installed at the site were used to model the groundwater table. The soil and bedrock rock parameters, presented in Table 4, were used in the stability analyses.

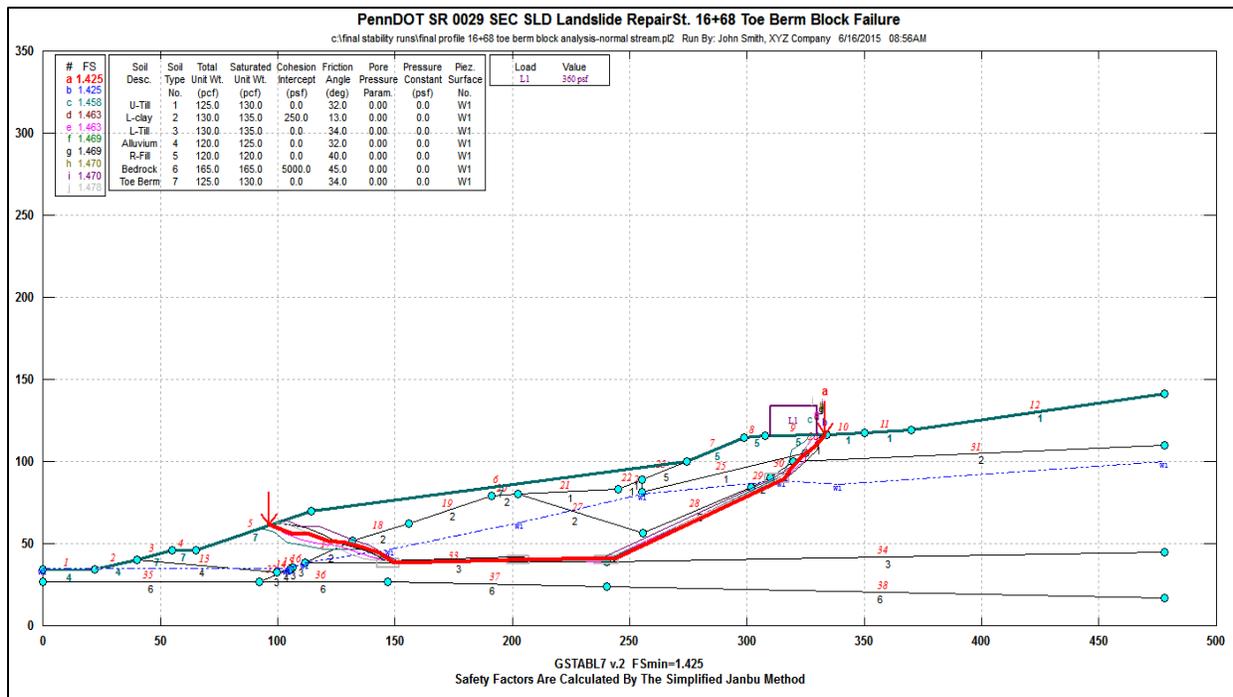
Figure 9: GSTABL7 Plot of Critical Toe Berm Analysis

The subsurface profile, failure plane and groundwater levels used in the earth berm analyses were consistent with the models used for the existing conditions analyses and were based on boring information and instrumentation data obtained from the inclinometers and piezometers installed at the site. A summary of the results of the slope stability analyses performed for the representative cross section at Station 16+68.11 is presented in Table 5, and the GSTABL7 plot for the critical analysis is shown in Figure 9.

The results of the stability analyses were presented to PENNDOT during a progress meeting in January of 2013 and it was determined that the earth berm in conjunction with the relocation of Snake Creek was the preferred remedial design because it provided an acceptable factor of safety and was a more reliable solution than other alternatives considered. The stability of the earth berm was assessed and the results indicated the factor of safety was greater than the required factor of safety of 1.3. The GSTABL7 analysis modeling the normal water surface elevation in Snake Creek resulted in the lowest factor of safety.

Station	Analysis Condition	Factor of Safety
16+68.11 (Section A-A)	Existing Condition – No cohesion – Block analysis	0.63
	Existing Condition – 250 psf cohesion – Block analysis	0.86
	Existing Condition – 250 psf cohesion – Circular analysis	1.13
	Pile Alternate – 250 psf cohesion – Circular analysis	0.94
	Toe Berm – 250 psf cohesion – Normal Water - Block analysis	1.43
	Toe Berm – 250 psf cohesion – Normal Water - Circular analysis	1.56
	Toe Berm – 250 psf cohesion – 100-year flood - Block analysis	1.43
	Toe Berm – 250 psf cohesion – 100-year flood - Circular analysis	1.56

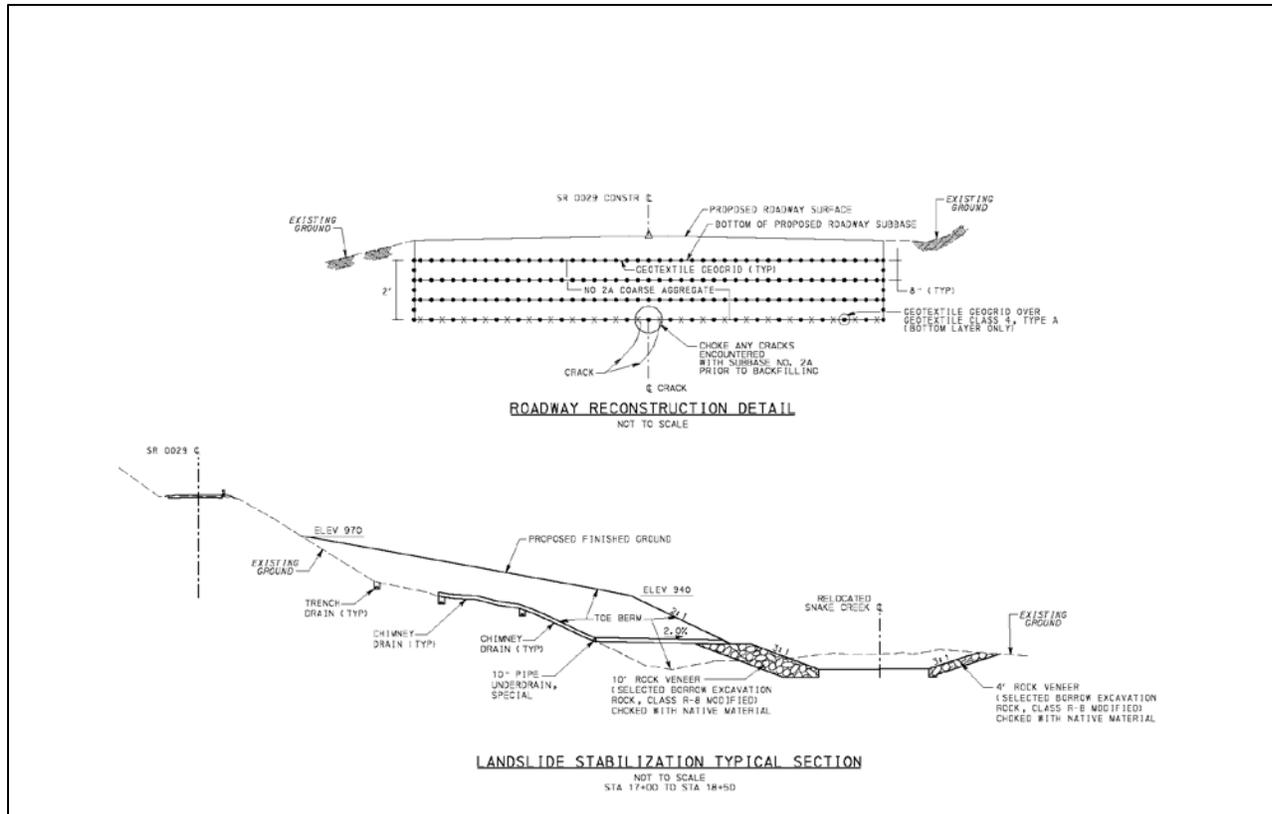
Figure 10: Landslide Stabilization Typical Section and Roadway Reconstruction Detail

The remediation includes reconstruction of the S.R. 0029 roadway through the landslide area. Tension cracks were documented in many locations within the roadway throughout the landslide area and the head scarp is located just off the shoulder of the roadway. To mitigate the potential for reflective cracking in the reconstructed roadway, overexcavation below the pavement subgrade and placement of alternating layers of biaxial geogrid and coarse aggregate subbase will be provided. A roadway reconstruction detail is included as Figure 10.

Based on the amount of seeps that were observed within the project limits during site reconnaissance, and the nearly continuous wet soil conditions in localized areas of the landslide, seeps during construction of the earth berm were a concern. Aggregate chimney drains and underdrain pipes are provided to collect and control water from the seeps and direct it to exit points lower on the slope, where it will be outlet onto the rock veneer. Additionally, considering that the existing roadway embankment in the vicinity of the slide is constructed of rock, a trench drain along the toe of the existing embankment is provided. The trench drain will collect any water that travels through the rock embankment from the upslope side of the S.R. 0029 roadway. Lateral outlet pipes are provided at minimum 100-foot intervals along the trench drain, and extend to the berm slope to outlet.

Surface drainage along the S.R. 0029 roadway will be enhanced by relocating two drainage pipes that outlet in the vicinity of the landslide on the downslope side of S.R. 0029. Roadway drainage and water from an intermittent stream located on the upslope side of S.R. 0029 will be collected in pipes and removed from the landslide area to prevent it from saturating the slope. The water will be outlet to the south of the landslide area. Additionally, a concrete curb and inlets will be provided along the edge of the S.R. 0029 roadway to prevent water from flowing downslope.

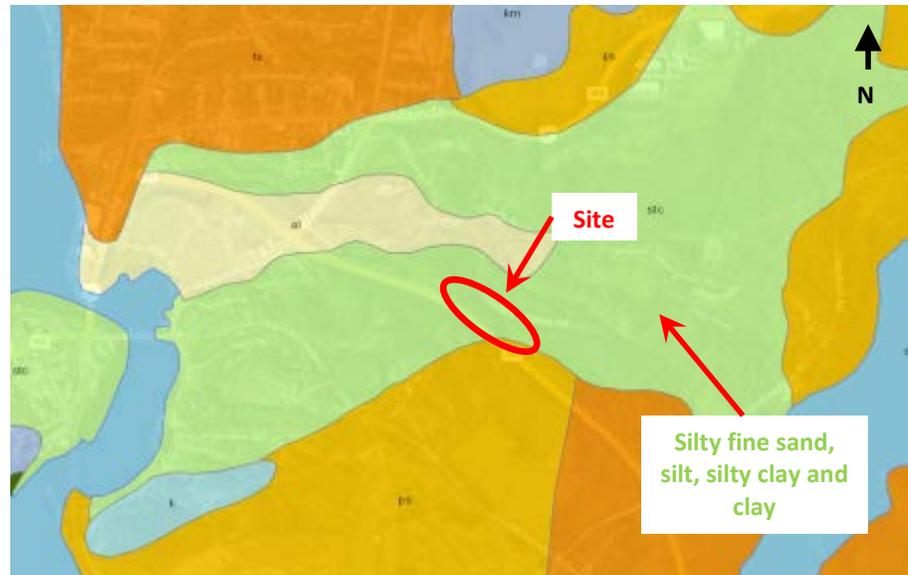
Figure 2 - Surficial geologic map.

In areas such as northeast Vermont, glacial lakes dammed by ice-contact deposits formed in some topographically low areas, including the Lake Memphremagog basin. These lakes deposited sediments consisting of clays, silts, and fine sands on the slopes of submerged regional hillsides (Figure 2). In some areas, the till materials may have been eroded during glacial retreat and prior to glaciolacustrine sedimentation, especially in topographically steep areas. As floating ice melted in the lakes, cobbles and boulders contained in the ice were also deposited within these fine-grained sediments as dropstones. Regional mapping indicates the project area is covered by silt, silty clay and clay from glacial Lake Memphremagog, deposited during a late stage of the lake when the lake shore was just above the site elevation (Stewart and MacClintock, 1969; Doll, Stewart and MacClintock, 1970).

Late Pleistocene (Wisconsin) glaciation (14 to 24 thousand years ago) modified all of New England. The continental glaciation formed north of New England and advanced to the south. As the glaciers advanced, some of the material picked up by the glaciers was deposited directly on bedrock surfaces at the base of the glacier as dense, relatively fine-grained glacial till (lodgement till). In most areas, when the glacial front retreated to the north, the soil and boulder-sized particles carried in the body and on the surface of the glacier formed a new mantle of less

dense glacial till (ablation till) deposited directly on the lodgement till or exposed bedrock surfaces. Meltwater streams removed the glacial till and further modified the landscape, forming well sorted (poorly graded) deposits of silts, sands and gravels in the river valleys and other fluvial environments.

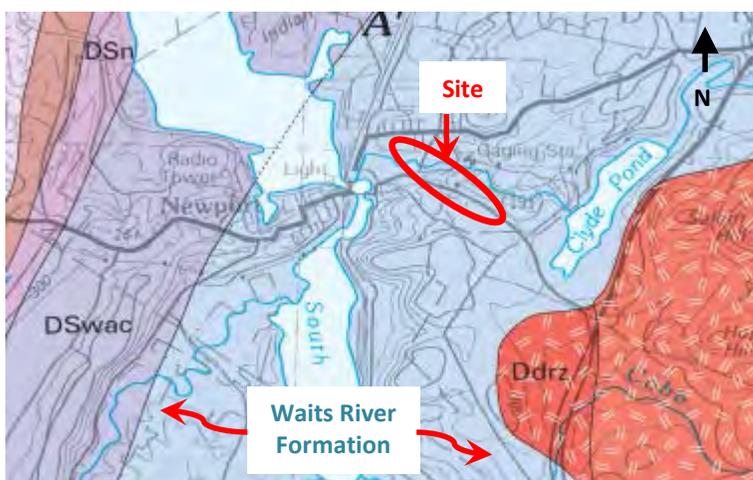
Figure 3 - Bedrock geologic map.

The project area lies within the Carbonaceous Phyllite and Limestone member of the Lower Devonian and Upper Silurian Waits River Formation (Ratcliffe et al., 2011), previously mapped as the Silurian-aged Barton River Formation (Doll, 1951) (Figure 3). The lithology of this member consists of a dark-gray to silvery-gray, lustrous, carbonaceous muscovite-biotite-quartz (\pm garnet) phyllite containing abundant beds of punky-brown-weathering, dark-bluish-gray micaceous quartz-rich limestone in beds ranging from about 1 ft to 30 ft thick.

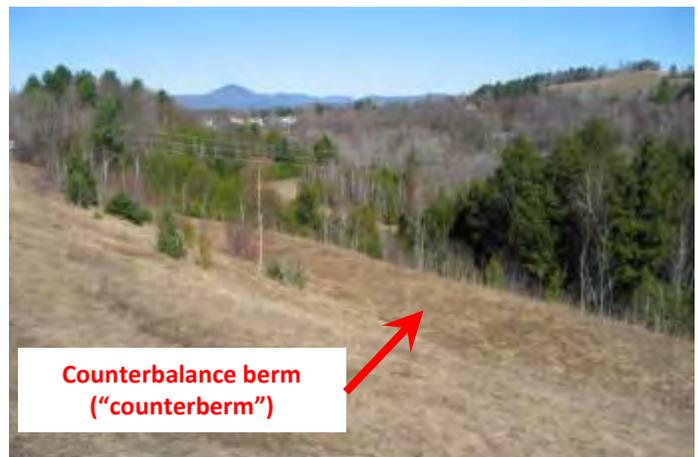
Figure 4 - Counterbalance berm (“counterberm”) installed in 1991 (March 23, 2012).

Shortly after construction was completed in 1971, embankment settlement was observed, and an underdrain was placed along the uphill side of the fill to collect and discharge surface water. Continued road settlements led to the installation of horizontal drains at the toe of a portion the embankment fill in 1973. From 1973 to 1989 road settlements (and pavement shimming) continued at an average rate of about 3 to 4 inches per year. Based on further VTrans investigations and evaluations, a stabilizing berm (i.e., a “counterberm”; Figure 4) and additional horizontal drains were constructed in 1991 at the toe of the embankment fill slope to stabilize slope movements and reduce or stop road settlements.

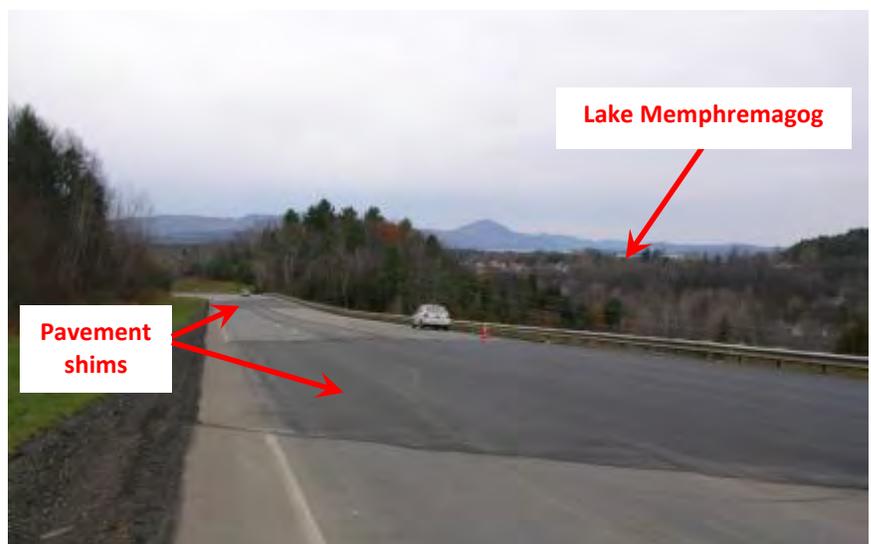
Figure 5 - View to northwest showing pavement shims at headscarp crossing of roadway. Note depression in roadway and stressed guardrail (October 31, 2006).

Over the subsequent 15 year period (1991 to 2006) road settlements (and pavement shimming) continued to occur (Figure 5). VTrans estimated that by 2006 the aggregate road settlement since original construction was about 8 ft. From 2006 to 2009 VTrans conducted further site investigations and installed instrumentation to monitor and assess the movements of a larger potential slide mass than had previously been considered. Inclinometer data from this period indicated the base of the slide mass was located up to

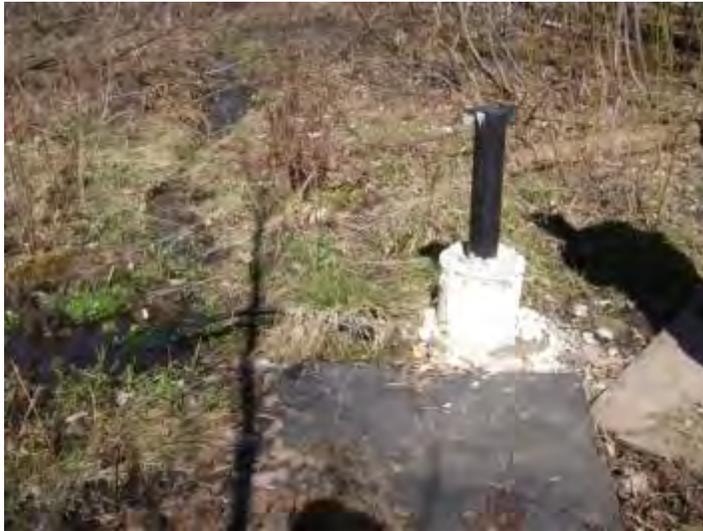
Figure 6 - Inclinometer near landslide toe installed in 1989 with artesian groundwater flow through pressure relief tube (~800 mL/min) (March 22, 2012).

about 120 ft below ground surface and possibly extended laterally to the Clyde River at the base of the valley roughly 600 ft north of Route 191. During the installation of two inclinometers adjacent to the Clyde River in late 2009, significant artesian water pressures were encountered in confined sand layers underlying the site producing heads above ground surface of at least 11 ft as measured during drilling (Figure 6). The reduction of artesian pressures at the inclinometer boreholes resulted in lower hydraulic heads in monitoring wells near the roadway indicating hydraulic connectivity across the site. Deep seated slope movements have slowed since 2009 when the artesian pressures were relieved at the two inclinometer boreholes.

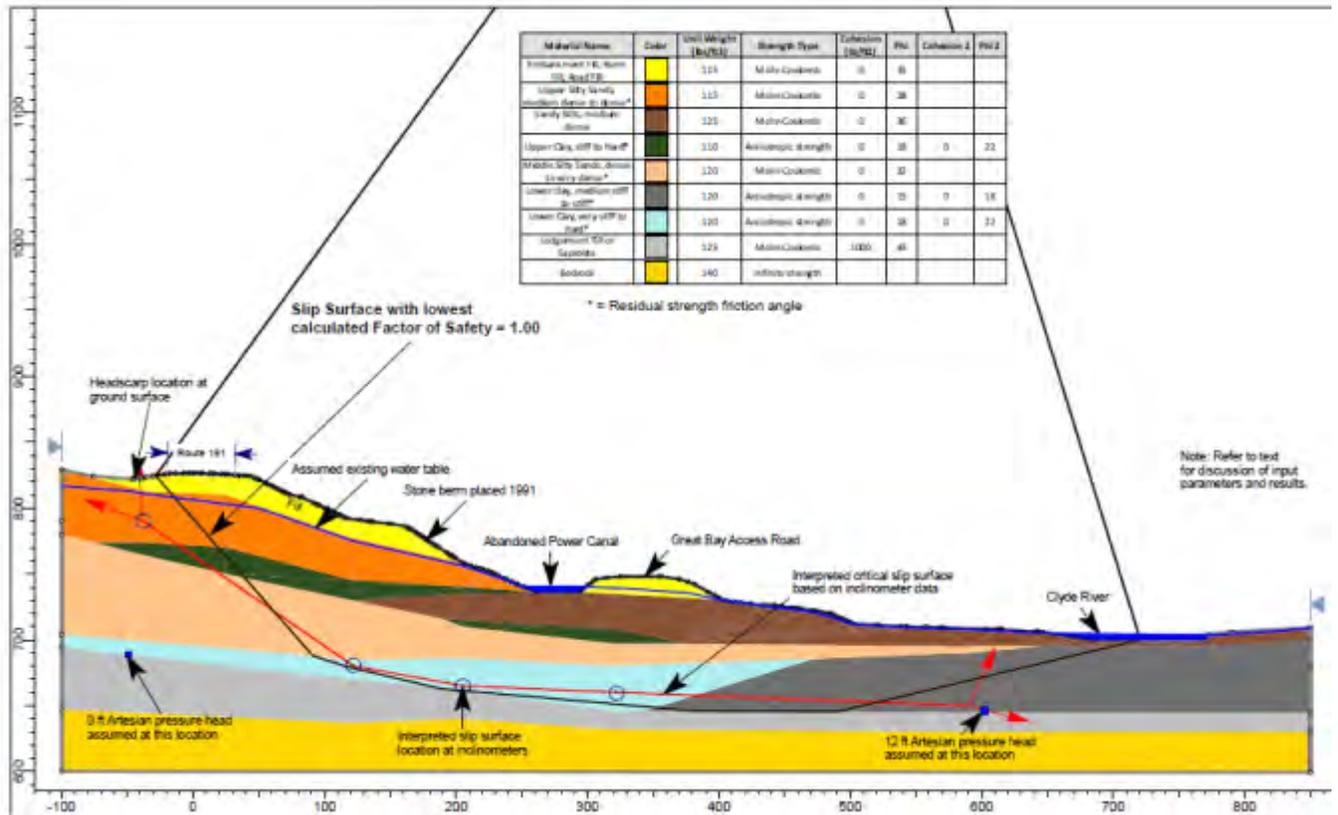
Figure 7 – 2012 stability analysis of ambient groundwater conditions.

The 2012 analysis was similar to previous analyses in that a back-analysis was conducted to develop a model simulating soil strength parameters that result in a FS of 1.0 (Figure 7). The model was then used to evaluate remedial measures to improve the FS for long term stability, including lowering the groundwater elevation (Figure 8). The analysis varied from the initial studies due to differences in the orientation, interpreted soil profile, soil strengths and groundwater pressures. Review of inclinometer data indicated that the slide is moving in a north-northeasterly direction towards the bend in the river, possibly following the trough of a bedrock surface depression. Due to the long term nature of the movements this subsequent analysis concluded that drained residual strength parameters were appropriate to assess existing conditions. Analyses were conducted using the 2-dimensional Slide software package (RocScience Inc., 2015).

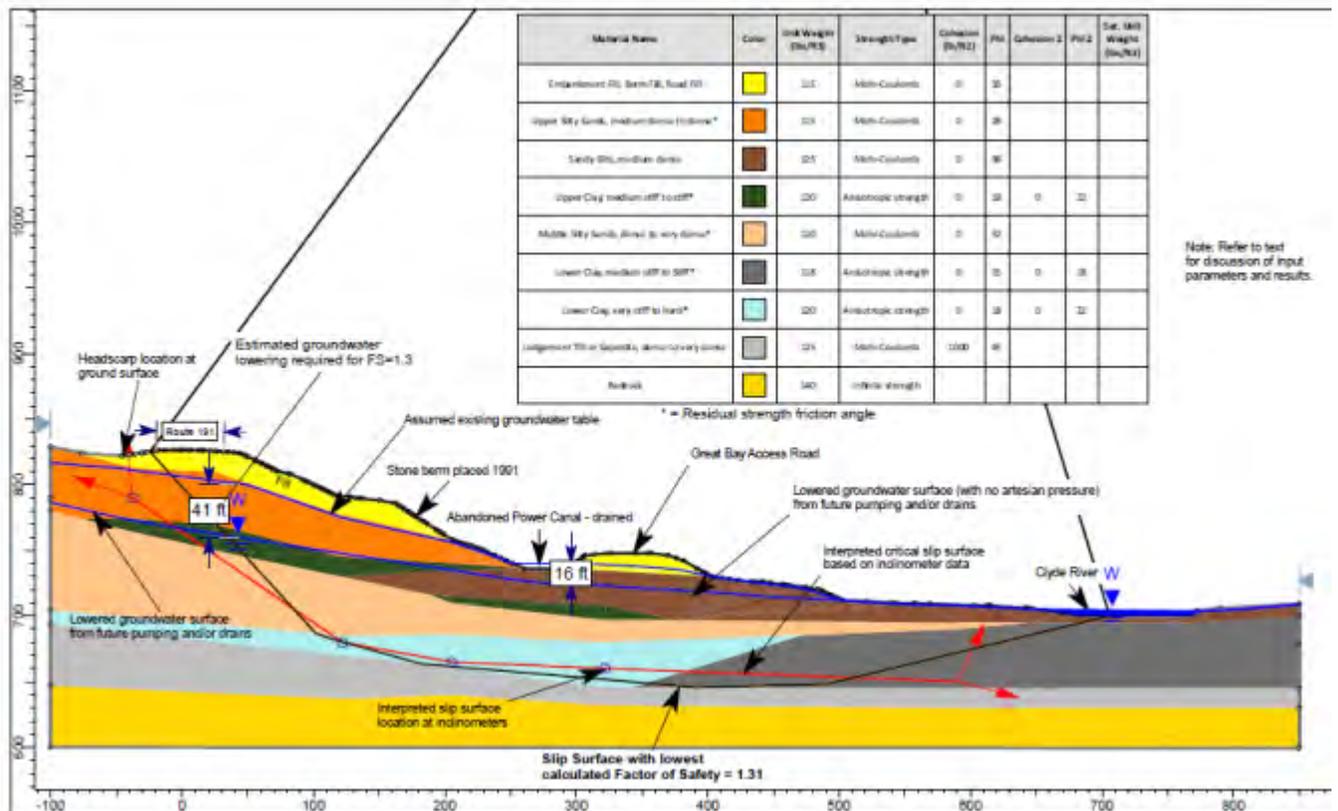
Figure 8 – 2012 stability analysis of lowered groundwater levels.

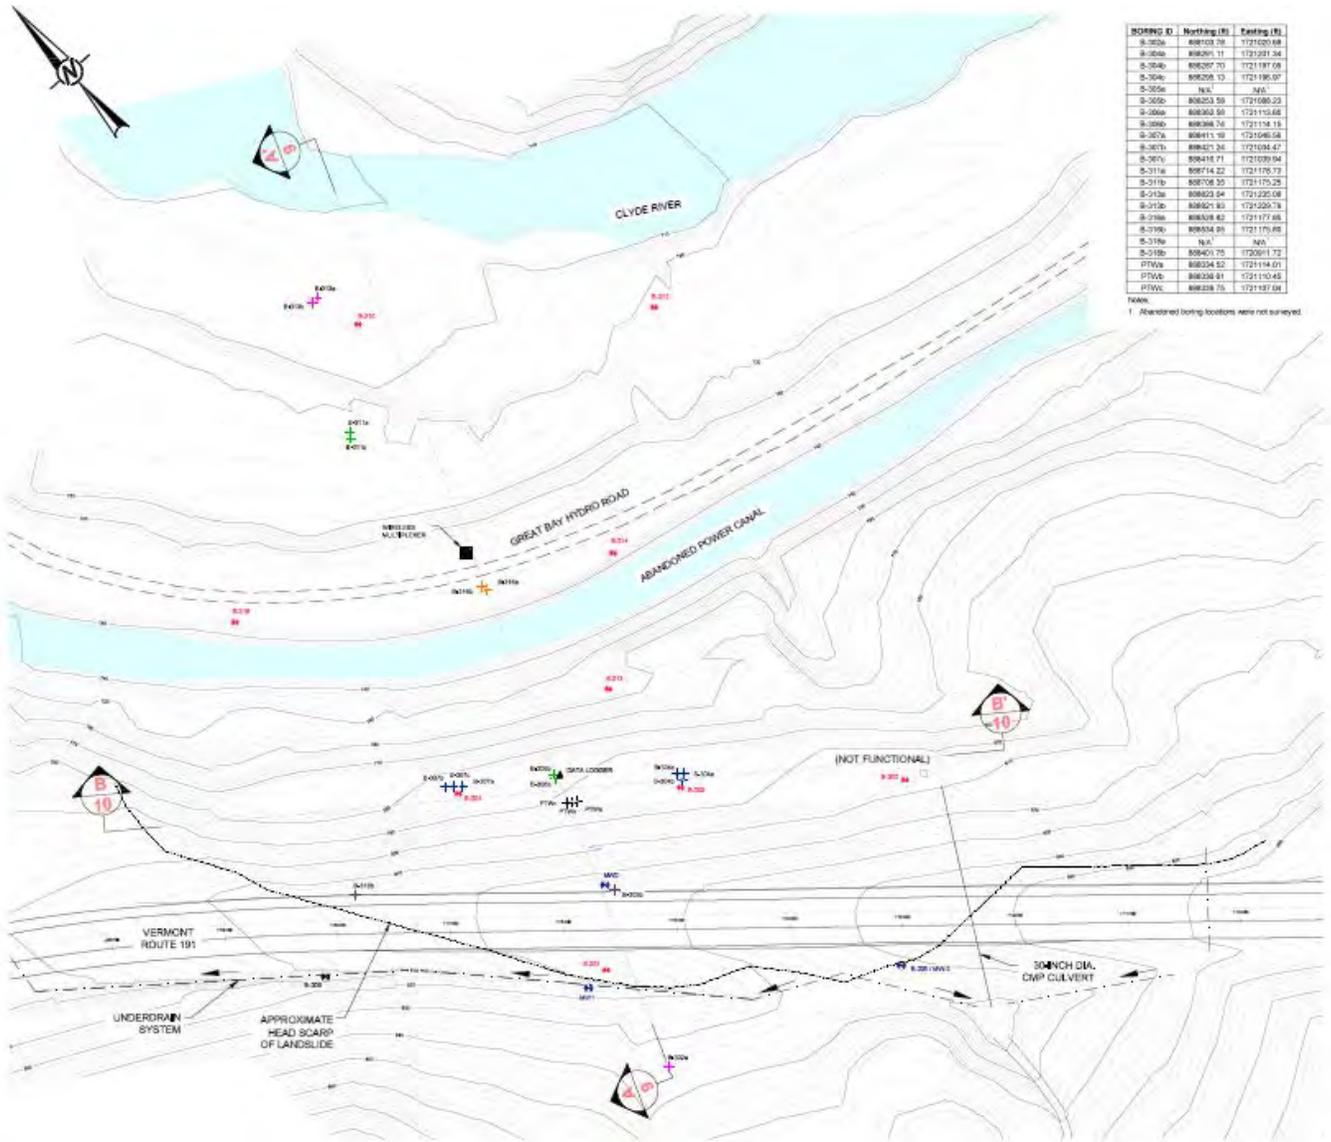
Figure 9 – Site investigation map.

In summer 2013 VTrans completed a site investigation program using both sonic and drive and wash drilling methods. The program included soil and rock sampling, in-situ testing, installation of an automated instrumentation system, and a field pumping test. A site investigation location map, including the cross section parallel to inferred slide movement is presented in Figure 9.

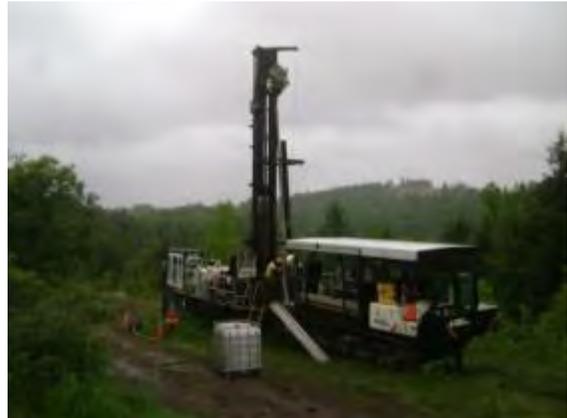
Figure 10 - Drilling test borings on the counter berm using a track-mounted sonic drilling rig (June 2013).

Between June 3 and June 21, 2013 Boart Longyear Environmental and Infrastructure of Little Falls, Minnesota (now Cascade Drilling L.P.), completed 12 borings to depths ranging from 36 to 176 ft below ground surface (bgs) using a Boart Longyear 600T track mounted sonic drill rig (Figure 10). Eight of the borings were advanced to bedrock and included 5 ft of advancement into bedrock and recovery of disturbed rock core. The remaining four borings were advanced to a predetermined depth solely to install monitoring wells. All boreholes were advanced with a 4-inch diameter core barrel and a 6-inch diameter override casing using sonic methods. In general, the core barrel was advanced

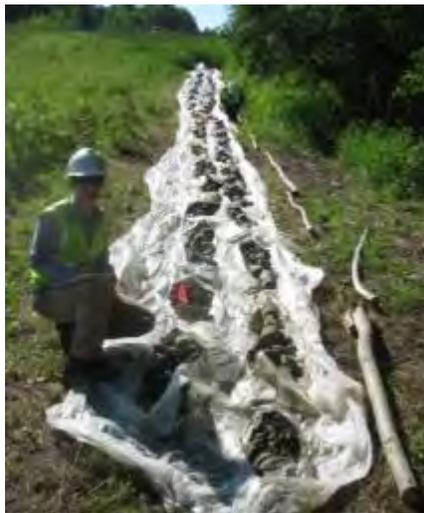
Figure 11 - Logging sonic drill continuous core samples of the overburden (June 2013).

dry to a depth of 5 to 20 ft below the bottom of the hole, and then the 6-inch override casing was advanced to the bottom of the core barrel using water to flush the annulus between the casing and core barrel. The core barrel was then withdrawn and the soil core vibrated out using the sonic head into roughly 5 foot lengths of soil bagged in a plastic sleeve (Figure 11). The core barrel was then advanced further into the hole. The core barrel was typically advanced dry to preserve the structure of the soil, however water was used in some boreholes to preserve bedrock core that generally disintegrates into a powder when drilling without water. Continuous disturbed soil samples were logged for the entire depth of each borehole and representative samples were collected from each borehole for index testing. Standard Penetration Test (SPT) using standard tooling was employed for the conventionally drilled borings.

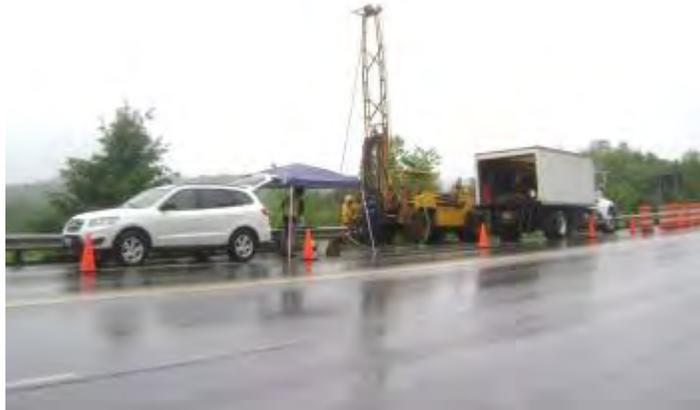
Figure 12 - Drilling conventional geotechnical borings on shoulder of roadway (June 2013).

Between June 10 and July 25, 2013, New Hampshire Boring of Londonderry, New Hampshire completed 10 borings to depths ranging from 40 to 183 ft bgs using rubber-tired ATV and track mounted drill rigs (Figure 12). Most of the borings were started with 4-inch diameter (HW) casing, generally driven to 10 to 60 ft bgs into very dense soil and then completed with an open hole below using drilling mud when advancing below the bottom of the casing. SPT sampling was generally conducted at 5-foot intervals except when targeting specific layers, where the sample interval was decreased at the discretion of the field engineer/geologist. Samples were generally collected using a 2 inch diameter split spoon sampler with a rope and cathead pulley system in accordance with ASTM D1586. For encountered conditions where the 2 inch split spoon had low recovery, a 3 inch diameter split spoon sampler was used to improve sample recovery. Twelve undisturbed Shelby tube samples were collected following ASTM D1587 methods.

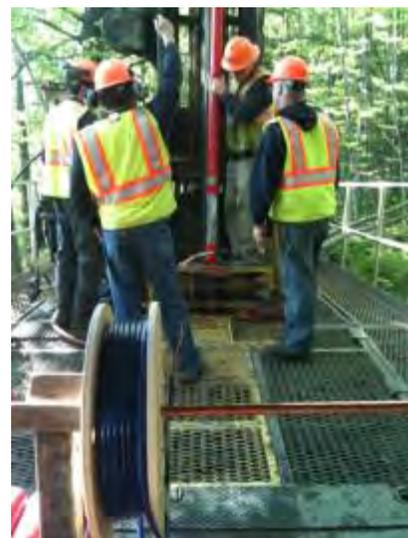
Figure 13 - Installation of inclinometer casing with sonic rig (June 2013).

- Two ShapeAccelArray inclinometer arrays (SAAs) manufactured by Measurand, Inc. of Fredericton, New Brunswick, Canada;
- Two In-Place-Inclinometer (IPI) arrays;
- Seventeen Vibrating-Wire (VW) piezometers;
- One VW barometer;
- A tipping bucket rain gauge; and
- Two CR1000-based dataloggers manufactured by Campbell Scientific Inc. of Logan Utah.

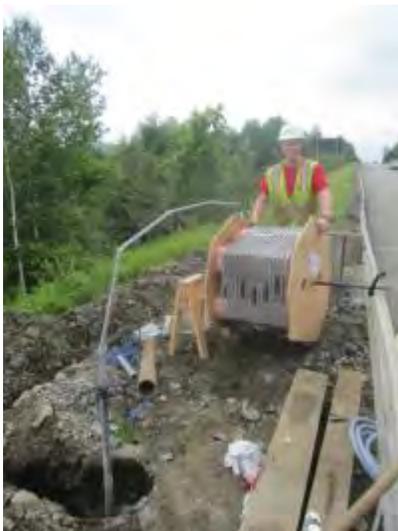
Figure 14 - Installation of SSA inclinometer (June 2013).

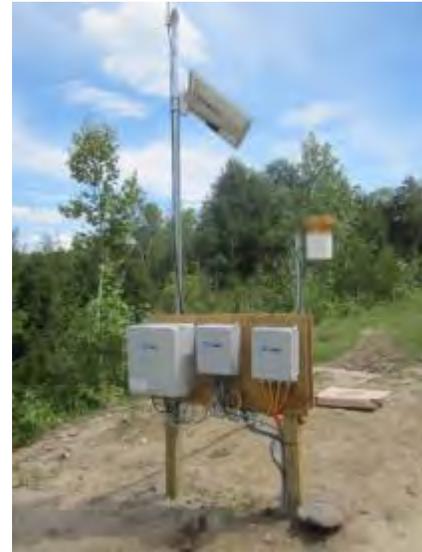
Figure 15 - Remote data collection and cellular communication system with solar panel power source.

To provide remote monitoring capability the 2013 site investigation included installation of a solar powered remote monitoring system, utilizing cellular communication (Figure 15). Shallow cable trenches were excavated between the boring locations and a datalogger for locations south of the abandoned power canal and between the borings and a wireless multiplexer on the north side of the canal. Communication cables for the instruments were directly buried in the trenches and backfilled. To cross Route 191 with a communication cable, VTrans cut into the asphalt and installed a 1.5 inch electrical conduit across the road prior to the start of the field program. The top of each instrumented boring was fitted with a lightning protection board or terminal board in a weatherproof enclosure that allows the various separate instrument cables to be combined into a larger multipair cable that is run to the datalogger or wireless multiplexer. This also allowed the trenching and installation of the communication cables to be performed prior to completion of the borings and before the removable instruments (SAAs and IPIs) were installed.

The datalogger and the wireless multiplexer were mounted to plywood panels supported by pressure-treated wood posts set into the ground. After installing the plywood panels, 2-inch galvanized steel pipe was attached to one of the posts at the main datalogger and at the wireless multiplexer to support radio modem antennas and solar panels. A copper-clad grounding rod was installed at all boring locations and at the main datalogger and wireless multiplexer for grounding the installed lightning protection.

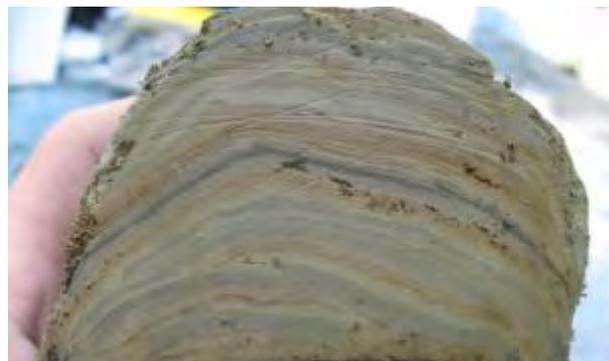
Figure 16 - Clay and silt varves exposed in sonic core sample.

properties for design (Figure 16). The testing was conducted by VTrans at their Materials and Research Laboratory in Berlin, Vermont, and by Dr. Don J. DeGroot, Sc.D, P.E., at his soil testing laboratory at the University of Massachusetts Amherst. Shelby tubes were also X-Rayed by GeoTesting Express of Acton, Massachusetts prior to being testing by Dr. DeGroot or VTrans. Laboratory work was generally performed in accordance with applicable American Association of State Highway and Transportation Officials (AASHTO) and American Society for Testing Materials (ASTM) testing procedures. The testing performed for the investigation is summarized in Table 1 below.

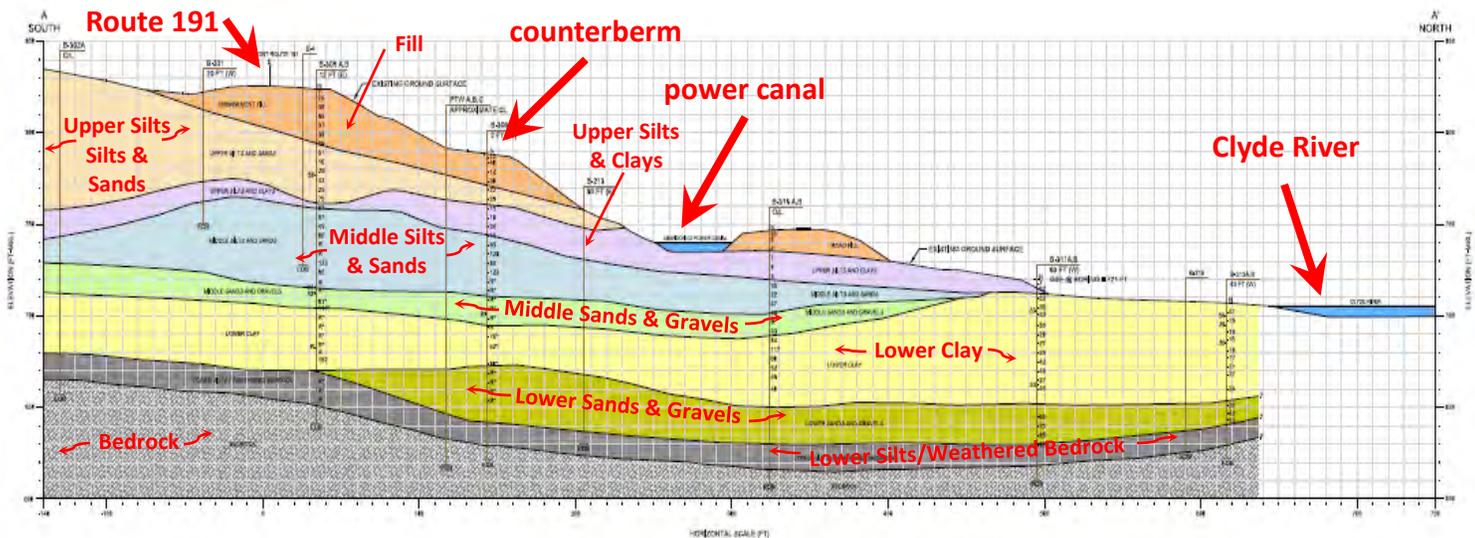
Figure 17 - Cross section parallel to landslide movement showing complex glacial geology.

Figure 17 presents our interpreted soil profile along a southwest to northeast section through the axis of the interpreted slide mass, parallel to our estimated direction of slide movement based on inclinometer data. The 2013 site investigation provided refinement to the site geologic/geotechnical model, including more layers and different orientations and thicknesses of major soil units.

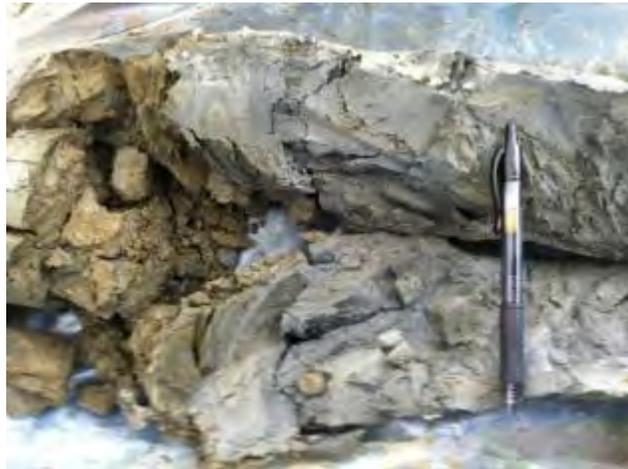
Figure 17 - Folded varves exposed in sonic core.

- **Lower Clay:** Underlying the middle silts, sands, and gravels a continuous layer of layered, dry to moist, very stiff to hard, generally high plasticity varved clayey silt and silty clay exists (AASHTO: A-6 to A-7-5 to A-7-6, USCS: MH, CH, and MH-CH). The orange brown and gray color of the layer changes to brown and gray towards the river. This lower clay layer was observed in all of the borings, ranging in thickness from 20 to over 60 ft. Zones of disturbance and slickensides were noted throughout (Figure 17). Folded varves and reworked zones were

observed in the sonic borings at the approximate depth of the failure surface identified in the historic inclinometers. In some borings, seams containing sand and gravel were encountered within the deposit. Varve thickness ranges from 0.1 to 2 inches. Zones of non-varved clay up to 5 ft thick were also encountered.
