66TH HIGHWAY GEOLOGY SYMPOSIUM SEPTEMBER 14-17, 2015

2015 Proceedings

*Massachusetts Department of Transportation
and
University of Massachusetts Amherst*

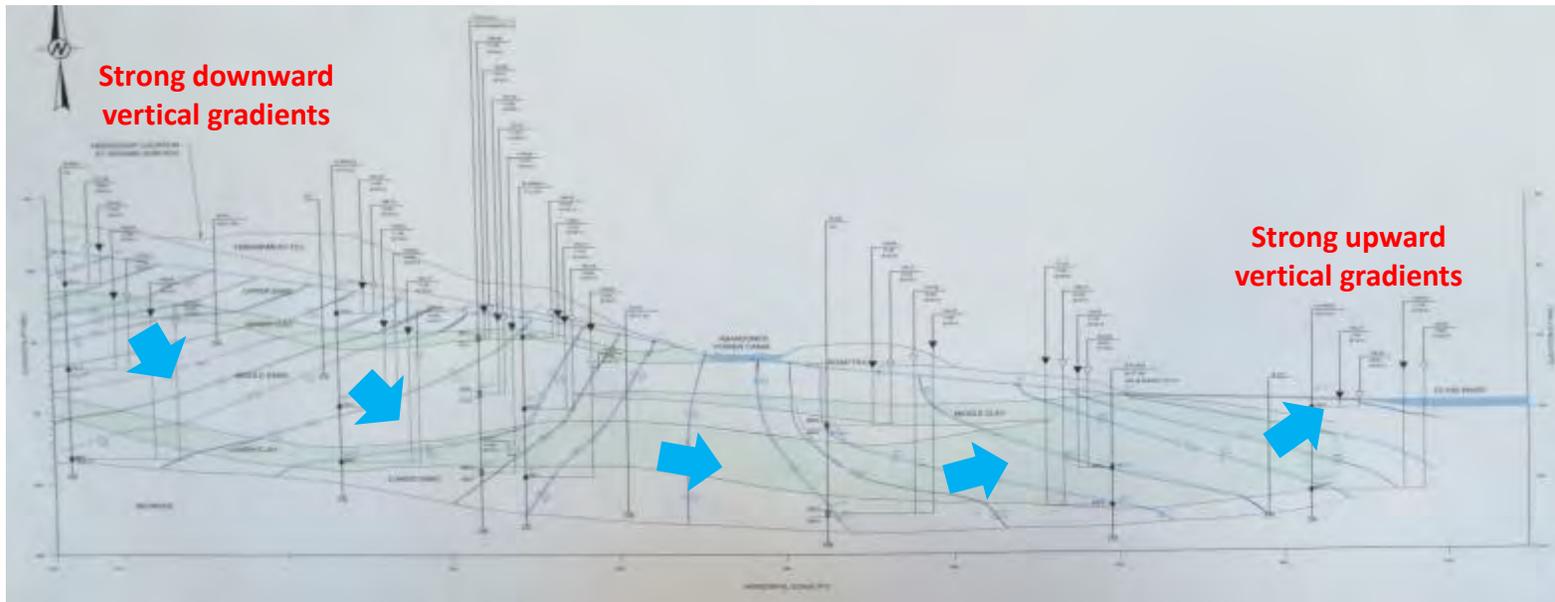
Figure 19 - Conceptual groundwater flownet along site cross section.

The Lower and Upper Clay units play an important role in groundwater flow. While these units appear to be discontinuous in some portions of the site, their thickness provides confining pressures beneath and downgradient of Route 191. Groundwater, originating as precipitation recharge southwest of Route 191, flows downward to the northeast, across the site, discharging to the Clyde River. The pressures within the Middle and Lower Silty Sands are higher than within the Upper Silty Sand, as measured by artesian conditions observed during installation of the inclinometers near the toe of the slide in 1989. This indicates an upward vertical gradient exists between the counterberm and the Clyde River. The 2013 piezometers in this area indicate artesian heads as much as 24.4 ft above the ground surface exist in this area (Figure 20). Shallower surface water, originating as precipitation, is trapped as perched groundwater on low hydraulic conductivity soils (clays and silts) within the upper soils, and is discharged as springs feeding small unnamed streams.

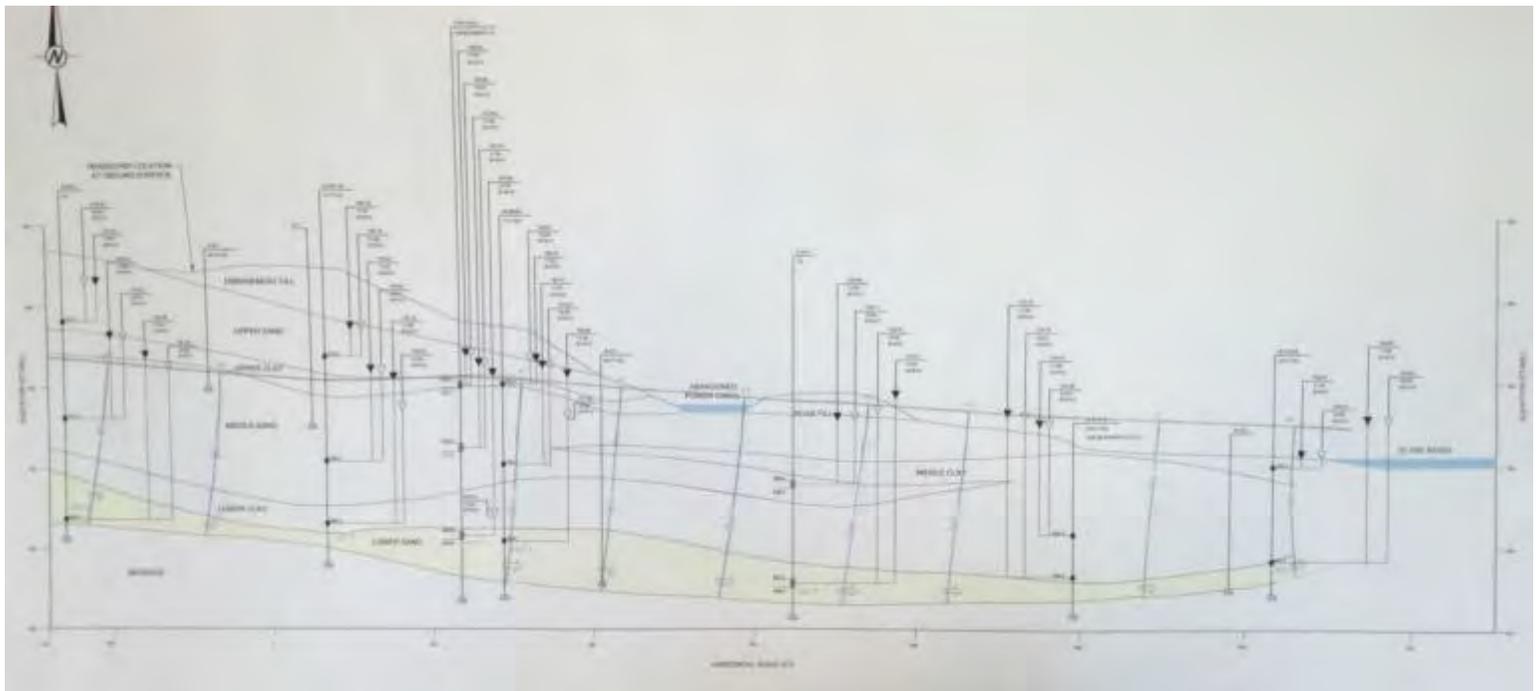
Figure 20 – Piezometric surface and groundwater flow net of Lower Sands and Gravels (yellow) under ambient conditions. Note artesian conditions exceeding 24.4 ft at toe.

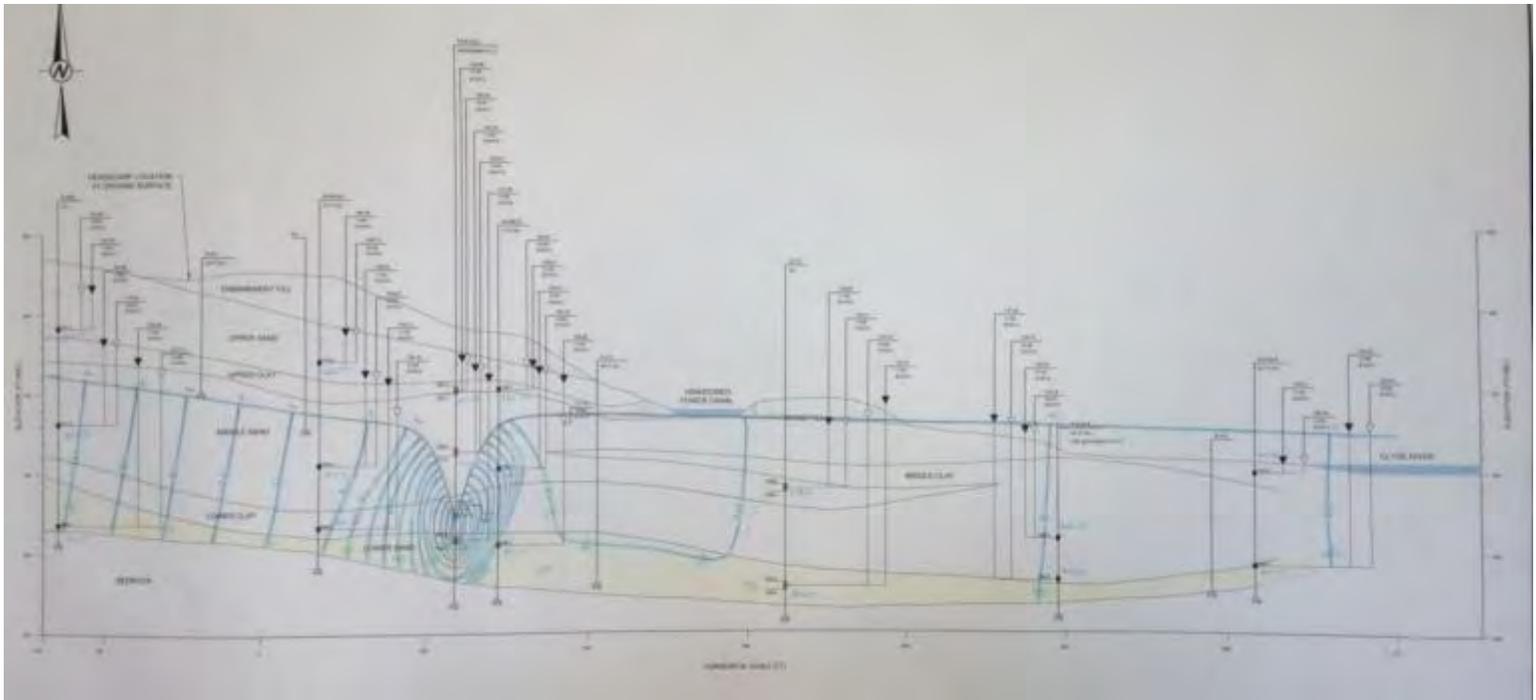
Figure 21 - Piezometric surface and flow net of lower sands and gravels unit (yellow) during pumping test showing cone of depression and reversal of local horizontal gradients.

The hydrogeologic field testing program indicated the sandy units have relatively low hydraulic conductivities, ranging from about $5E-03$ to $5E-05$ centimeters per second (cm/sec), with an average of about $5E-04$ cm/sec. The Lower Clayey Silt, which acts as a confining layer, has hydraulic conductivities ranging from $2E-05$ to $3E-09$ cm/sec. The testing also indicated the Lower Sands and Gravels are interconnected in varying degrees with the Middle Sands and Gravels, and to a lesser degree with the Upper Sands and Silts. The observations confirmed the excessive artesian head exhibited by the Lower Sands and Gravels exists in the lower/northern portion of the slide mass. The testing also indicated a reduction in vertical groundwater gradients occurs when pumping from the Lower Sands and Gravels, including a reduction in the artesian heads (Figure 21).

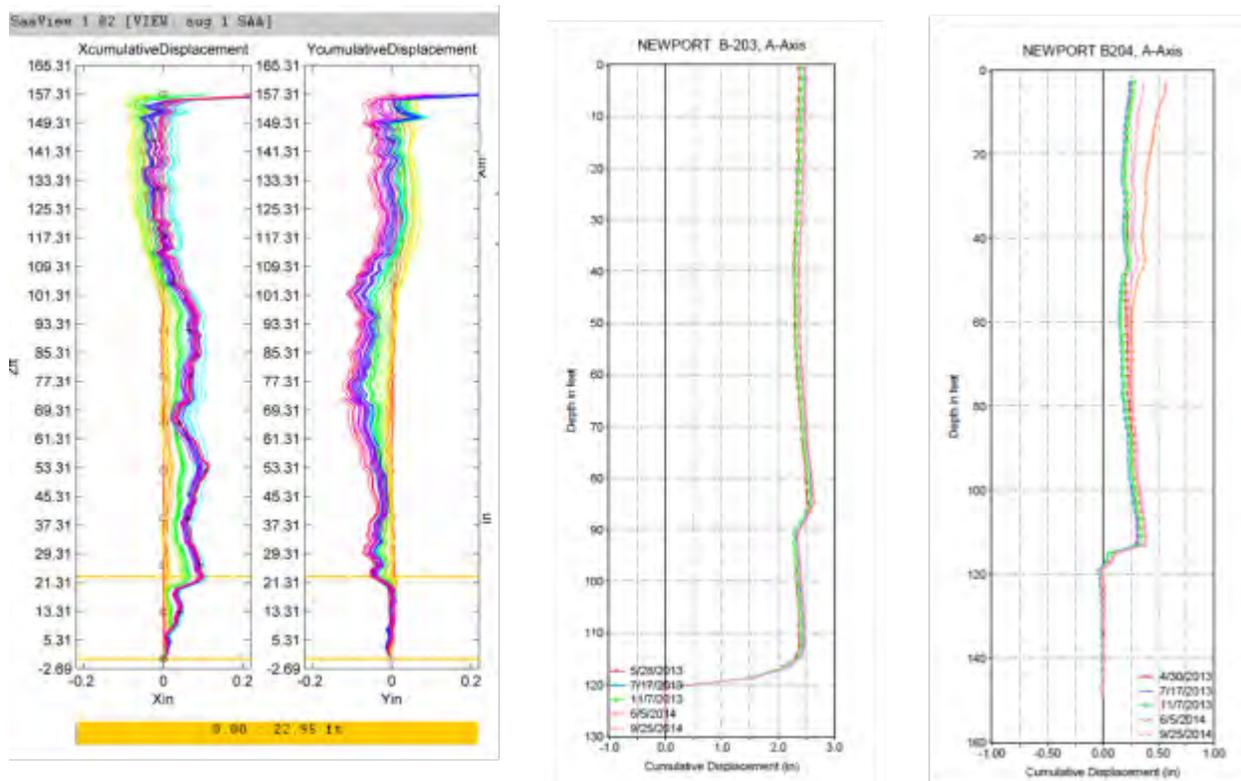
Figure 22 - SSA data (right) and manual inclinometer data (left) indicating slope movement between 0.1 and 0.2 inches/year since 2013.

Typical inclinometer data (SSA and manual) are shown in Figure 22. The data collected since 2013 indicate landslide movement continues roughly at about 0.1 to 0.2 inches/year, similar to the reduced rate observed since installation of the inclinometers at the toe of the slide in 1989 which relieve artesian pressures. The data indicate that while the rate of landslide movement has slowed, movement continues, which if not mitigated, will require continued maintenance and eventual replacement of roadway infrastructure.

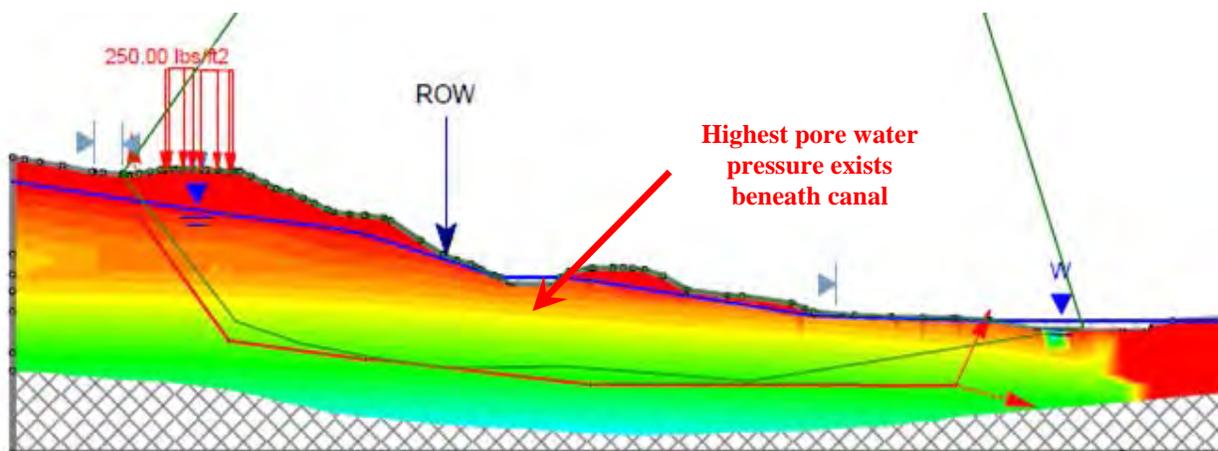
Figure 23 – Updated slope stability model of deep seated slide mass current conditions (FOS = 1.001).

the residual strength data from the extensive direct shear testing program based on the assumption that the movement of the slope to date has been sufficient to mobilize residual strengths. The lower clay layer was further divided into two units due to slightly lower strengths observed north of the abandoned power canal (the “downslope” lower clay). Granular soil layers were modeled using Mohr-Coloumb strength parameters assuming no cohesion. Once initial material properties were entered in the model, the “current” groundwater scenario was modeled and the soil properties of the lower clay unit were adjusted slightly to result in a FS of 1.001 (Figure 23). This stability model indicates the highest pore water pressure exists beneath the power canal.

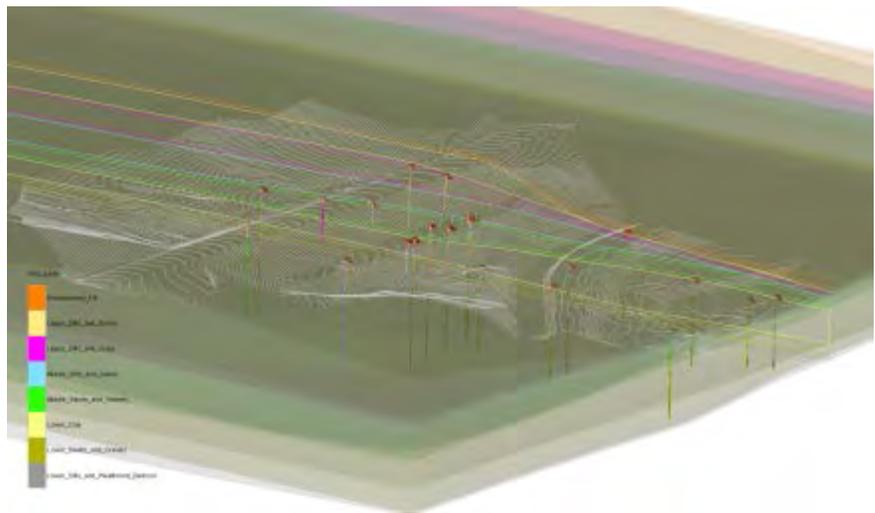
Figure 24 - Block diagram of EVS/MVS geologic model.

The numerical groundwater model was completed using MODFLOW, published by the U.S. Geological Survey (Hill et al., 2000). This is a modular 3-dimensional finite-difference groundwater flow model that utilizes a numerical solution for the equations governing groundwater flow through porous media. The model geometry is defined by external and internal boundaries

(consisting of geologic and hydrogeologic features as well as hydraulic flow) and a grid of orthogonal blocks with a central node. The input parameters include the geologic layer thicknesses and extents, the hydraulic conductivities from the pumping test performed in 2013 and the laboratory testing, storage and porosity, and precipitation recharge measured from the on-site rain gauge. The 3-dimensional geologic modeling software platform EVS/MVS (C-Tech Development Corporation, 2014) was used to compile the geologic layer geometry for the MODFLOW model (Figure 24). Once the groundwater model was assembled, with the pre/post processor Groundwater Vistas (Environmental Solutions Inc., 2015), it was refined and calibrated to predict the “current” groundwater conditions measured on site shortly before the start of the pumping test in August 2013. Since the groundwater model is 3-dimensional, output of groundwater head pressures for use in the 2-dimensional slope stability model was accomplished using Arc GIS and an Excel spreadsheet to translate x, y, z, and head pressure from the groundwater model into x, y, and pore

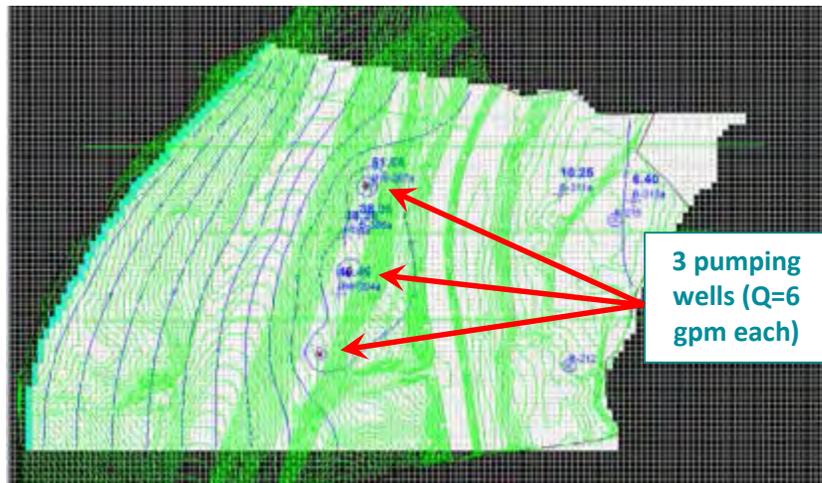
Figure 24 - Groundwater model simulating three extraction wells in lower sands and gravels on counterberm (Alternative D).

Using the groundwater model and the resulting groundwater pressures imported into the slope stability model, four stabilization alternatives that reduce groundwater levels were evaluated. Alternative A consists of twelve (12) passive artesian flowing wells near the river with an assumed groundwater flow of 1 gallon per minute (gpm) from each well. Alternative B replaced the twelve passive wells with three (3) active extraction wells near the river, with an assumed flow of 6 gpm each. The wells for Alternatives A and B are

assumed to be about 70 ft deep. Alternative C moved the three active wells up slope to the canal access road, and Alternative D further moved the three active wells up slope to the counter berm below Route 191, within the VTrans ROW. The depth of the wells for each alternative would need to be determined as part of final design for the system, but would increase from roughly 70 ft for Alternatives A and B, to roughly 105 ft for Alternative C, to roughly 130 ft for Alternative D. When evaluating these alternatives, only the groundwater pressures were adjusted; no changes to the topography or material properties were made. Stability analyses for these four scenarios indicated the FS ranged from 1.19 for Alternative A (12 passive wells at toe) to 1.37 for Alternative C (three active wells at the canal). All three of the active well alternatives have a higher FS than the passive well alternative, which is consistent with the ability of the active wells to decrease pressures below artesian pressure, as the passive wells of Alternative A can only reduce the water pressure to that equaling the local topographic head.

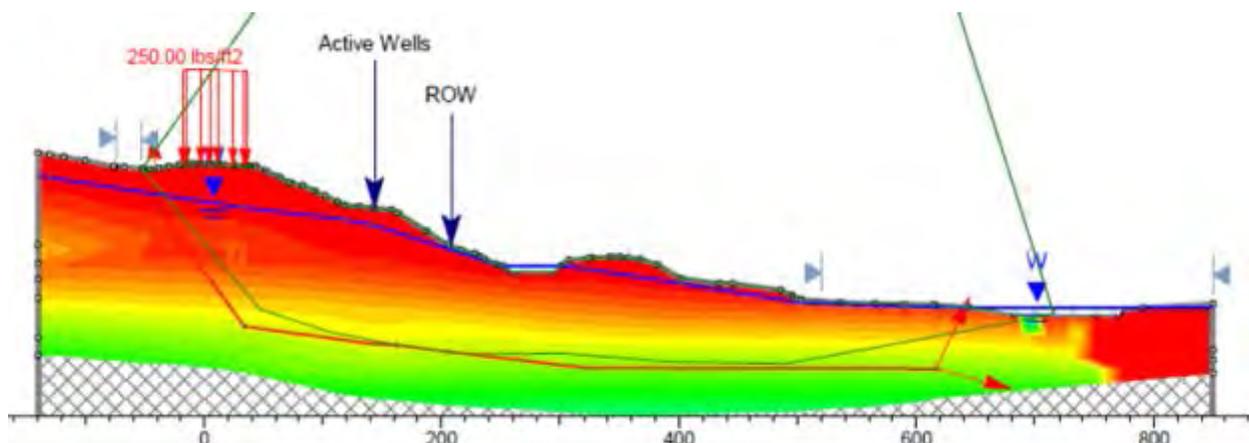
Figure 25 - Stability analysis simulating three pumping wells on the counterberm (Alternative D) (FS = 1.272).

The remedial design approach selected by VTrans involves design, installation and operation of groundwater extraction wells placed on the existing counterberm to lower the groundwater pressures affecting the stability of the deep slide mass (Alternative D; Figure 25). Issues involving property acquisition or right-of-way, wetlands, power transmission and access to the well system present unfavorable costs and challenges for either a passive or active groundwater extraction system at the power canal or toe of the landslide. Favorable access is allowed by an existing access road from Route 191 to the counterberm, and can be used for extraction system construction, operation and maintenance. The extreme winter conditions of northern Vermont, including a design frost depth of 6.5 ft, will need to be considered for the extraction system design. A self-sufficient solar power generating system with the ability to dump excess energy onto the local power grid will be considered for pump operations during final design. Groundwater chemistry data indicate post-extraction treatment is not required according to the Vermont Department of Environmental Conservation, and groundwater can be discharged into the power canal and eventually into the Clyde River. VTrans has begun the final mitigation design for the system, which may be operational by 2017 or 2018. Following successful construction of the extraction system to lower groundwater pressures, and subsequent establishment of the cessation of landslide movement, permanent roadway infrastructure repairs can then be implemented.

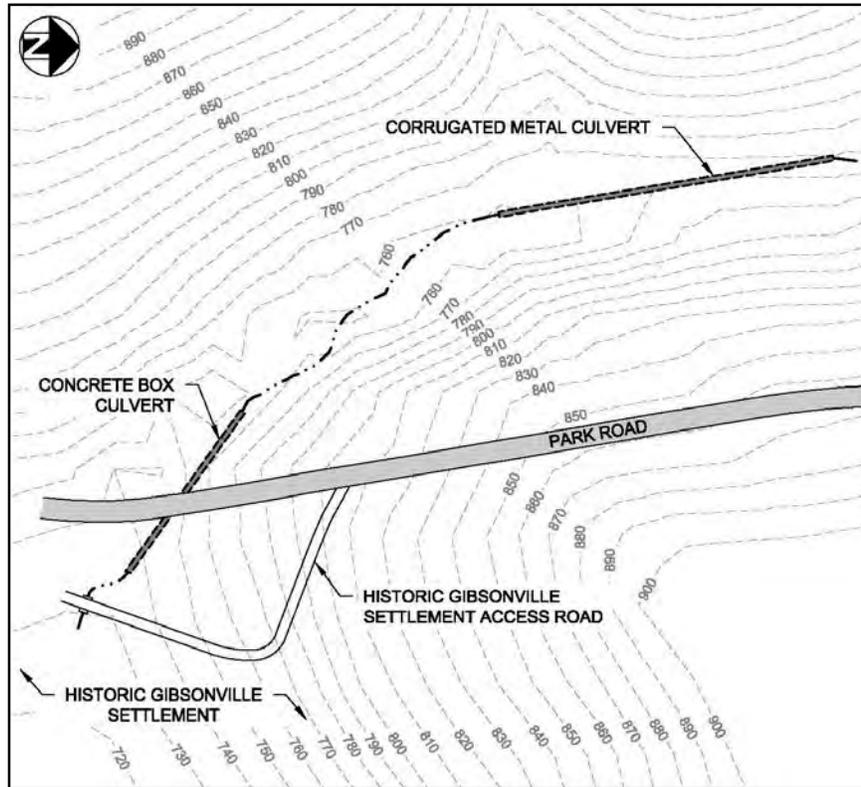
Figure 2 – Site plan view

The original road through Gibsonville traversed the steep slopes of an unnamed tributary valley (herein referred to as Gibsonville Creek) north of Silver Lake Outlet. Design plans dated 1937 show that the CCC realigned the road over the valley by constructing a concrete box culvert to convey Gibsonville Creek beneath a new embankment fill. The realigned road provided a smoother vertical profile, however the road was aligned parallel to Gibsonville Creek on a steep slope. This road, now known as Park Road, is the main north-south route through Letchworth State Park operated by the New York State Office of Parks, Recreation, and Historic Preservation (NYSOPRHP) (Figure 2).

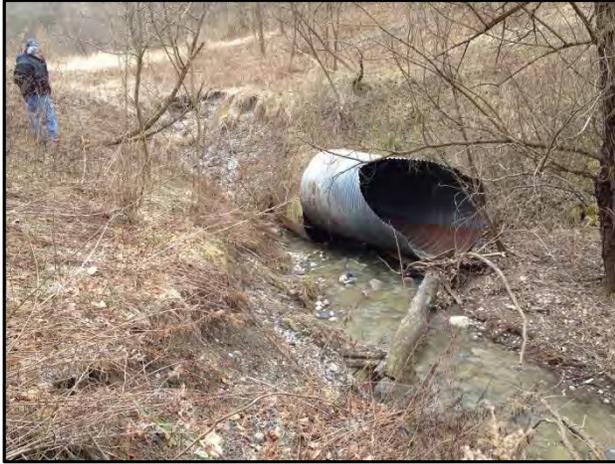
Figure 3 – Culvert: Upstream End

After 35 years in service, the corrugated metal culvert deteriorated and was approaching the end of its service life. Throughout its service life, the hydraulic conditions resulting from the culvert's installation also caused erosion and loss of pipe stability at both the inlet and outlet of the culvert (Figures 3, 4, and 5). Conversely, the slope between this culvert and Park Road did not show signs of instability, indicating that the GEB 1976 work successfully stabilized the slope following Hurricane Agnes.

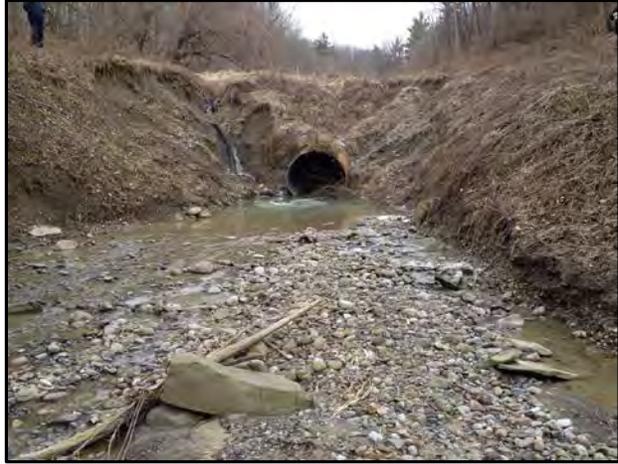
Figure 4 – Culvert: Downstream End

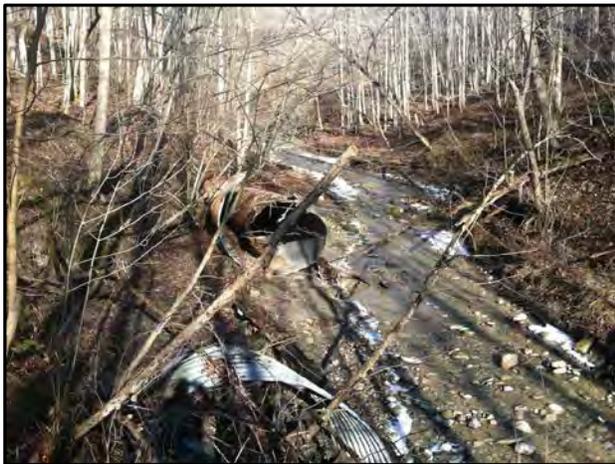
Figure 5 – Dislodged End & Pipe Sections

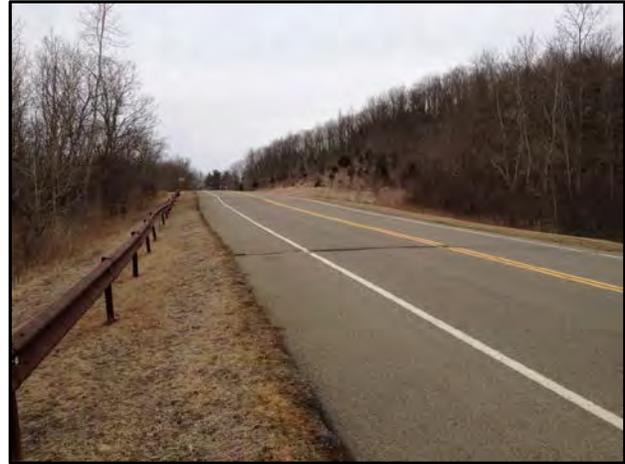
Figure 6 – Park Road Settlement

The valley slope and Park Road adjacent to the reach of Gibsonville Creek between the corrugated metal culvert and the concrete box culvert was, however, showing signs of slope instability. The integrity of Park Road was being threatened (Figure 6) here similarly to the way the upstream reach had after Hurricane Agnes. The instability was evidenced by cracked and settled roadway pavement, together with sloughs and scarps in the slope between Park Road and Gibsonville Creek.

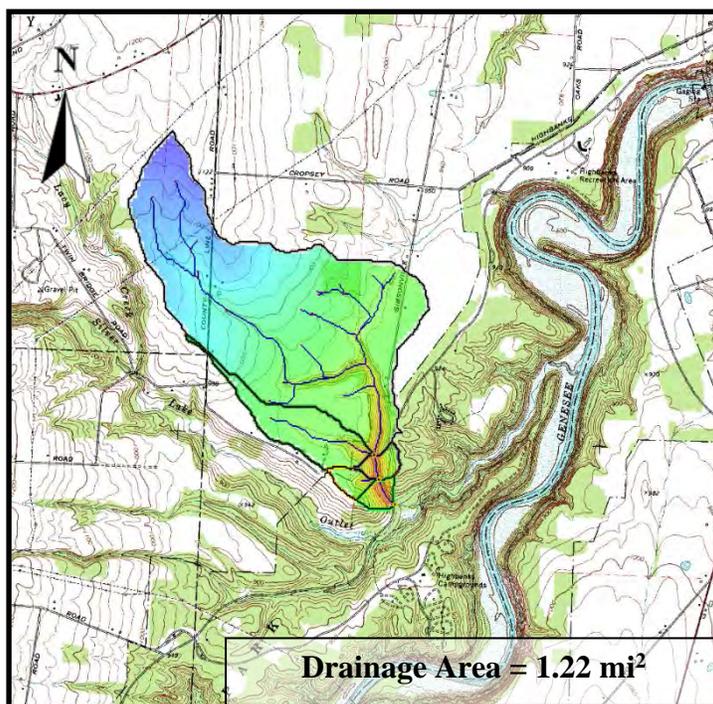
Figure 7 – Portion of the Mount Morris USGS Quadrangle showing the drainage area for Gibsonville Creek upstream of Park Road

Hydraulic modeling of Gibsonville Creek was conducted for the reach from Park Road to 200-feet upstream of the existing 90-inch culvert. The contributing drainage basin area was delineated using the *Watershed Modeling System, Version 8.4 (WMS)* and determined to be 1.22 square miles (Figure 7). The U.S. Army Corps of Engineers *Hydraulic Engineering Center's hydrology software, HEC-1*, was used to develop the hydrology for Gibsonville Creek (Table 1).

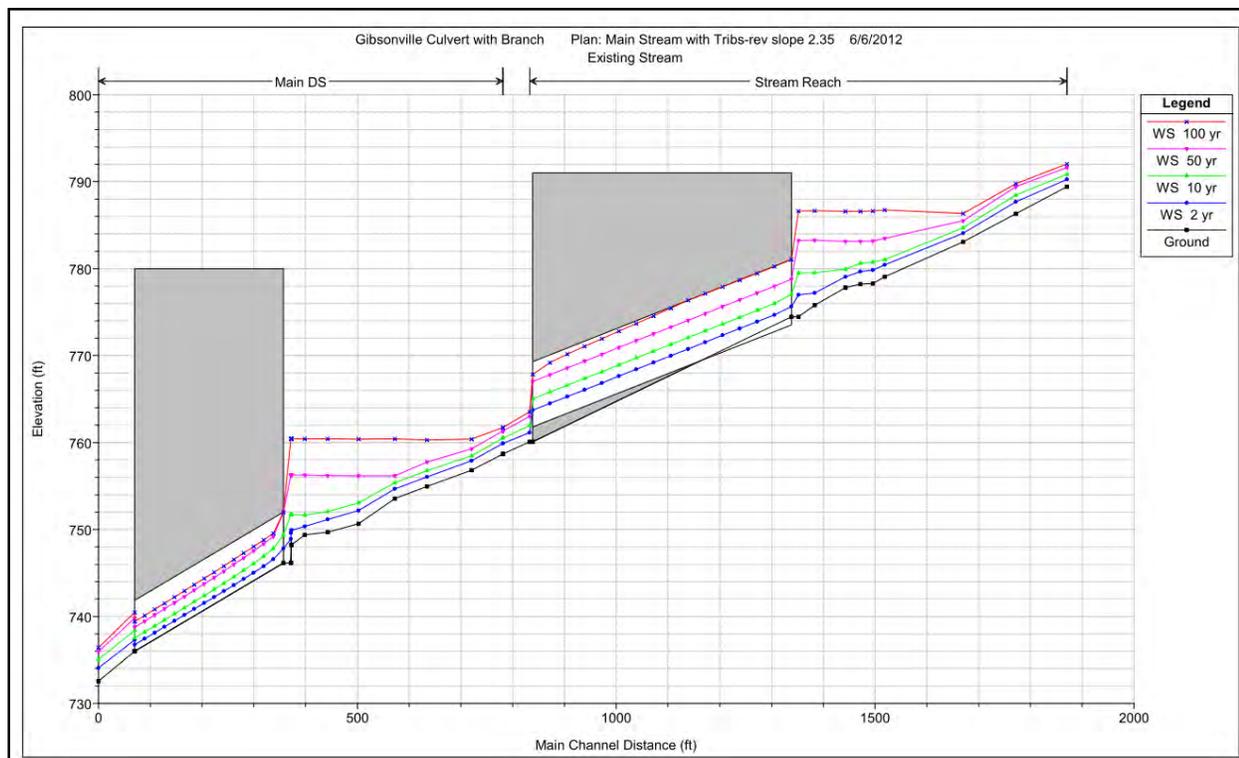
Figure 8 - HEC-RAS Water Surface Profiles – Existing Conditions

The hydraulic analysis was performed using the U.S. Army Corps of Engineers *River Analysis System* program, *HEC-RAS (Version 4.1.0)*. The results (Figure 8) confirmed that for nearly all storm events analyzed, flows through the existing 90-inch culvert were supercritical, thus confirming the severe erosion that plagued both the inlet and outlet of the culvert.

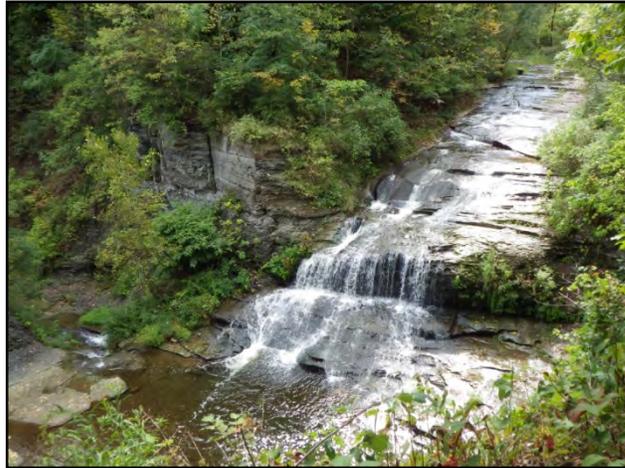
Figure 9 – View of bedrock exposed in the downstream reference reaches

The streams in the lower, or downgradient reference reaches were incised into shale and siltstone outcrops (Figure 9). The channel profiles included flat benched areas, slopes in shale up to 45 degrees, and vertical falls below siltstone beds. There were disorganized flow paths that diverged and converged along discontinuities in the bedrock, resulting in a channel section that was significantly wider than it was deep. The sinuosity of the bedrock reaches was approximately unity, meaning that the channel length was equal to the valley length. The

bedrock reaches were devoid of sediment, except where round cobbles accumulated below the shale and siltstone falls.

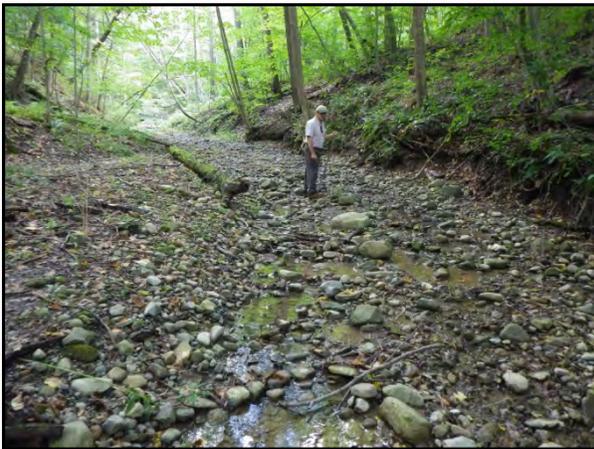
Figure 10 - View of typical bedload in upstream reference reaches

The streams in the upper reference reaches were incised into glacial till, silt, and sand. The streambed had cobbles and boulders that were eroded out of the till banks, and often formed lateral and medial bar deposits. The cobbles and boulders created an armor layer in the stream bed where fines had been winnowed out from the spaces between the coarser materials (Figure 10). The D_{50} particle size was estimated at $\frac{1}{2}$ inch. The channel slope was on average approximately 3%, however, the bed featured numerous step/pool features rendering the average slope not representative of the localized bed conditions. The step/pools often occurred near woody debris, where sediment accumulated above fallen trees and scour pools formed below as the stream cascaded over the woody debris steps (Figure 11). Several of the pools, where the stream velocity was low, were lined with sand and silt. The channel cross section was trapezoidal, and it was considerably wider than it was deep. The channel length was slightly longer than the valley length in the soil reaches, resulting in a sinuosity of 1.2 (ratio of channel length to valley length).

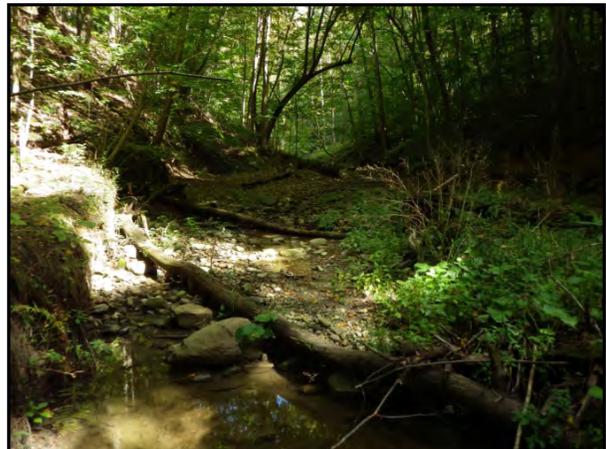
Figure 11 – View of logs forming step – pool stream structure

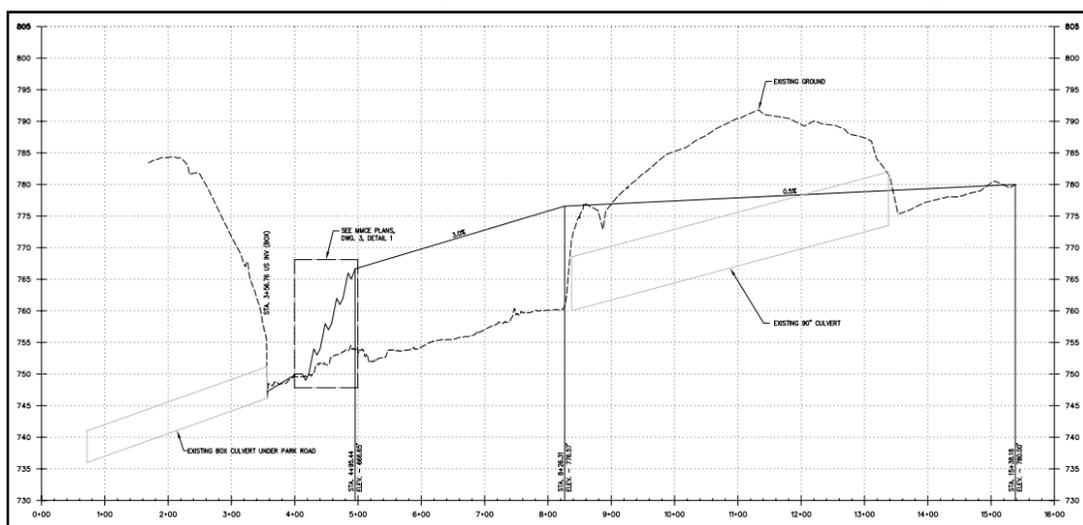
Figure 12 - Proposed Stream Profile

The stream restoration would begin approximately 200-feet upstream of the corrugated metal culvert. The stream profile (Figure 12) would carry through the valley along the culvert by cutting into the soil above the culvert, and matching the grade at the top of the culvert at its downstream end. From there, the valley would be filled with as much as 20 feet of fill, adding a buttress to the adjacent valley slope and conveying the stream on top of the fill. Beginning at a point 140 feet upstream of the concrete box culvert beneath Park Road, a grouted riprap drop structure would be constructed to bring the stream down to match the existing stream elevation.

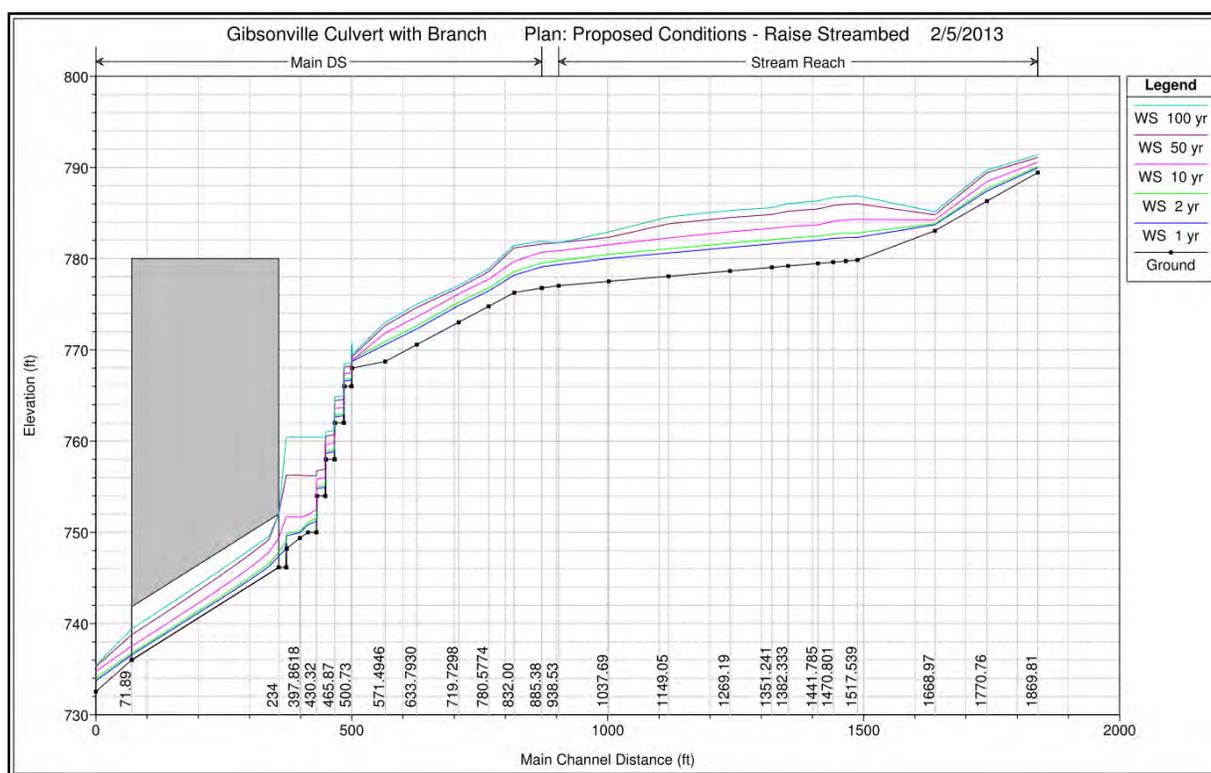
Figure 13 - HEC-RAS Water Surface Profiles – Proposed Profile

The hydraulic analysis of the proposed stream conditions demonstrated the benefits of eliminating the 90-inch culvert and the erosive conditions associated with it. Figure 13 shows the HEC-RAS water surface profiles for the proposed restored stream.

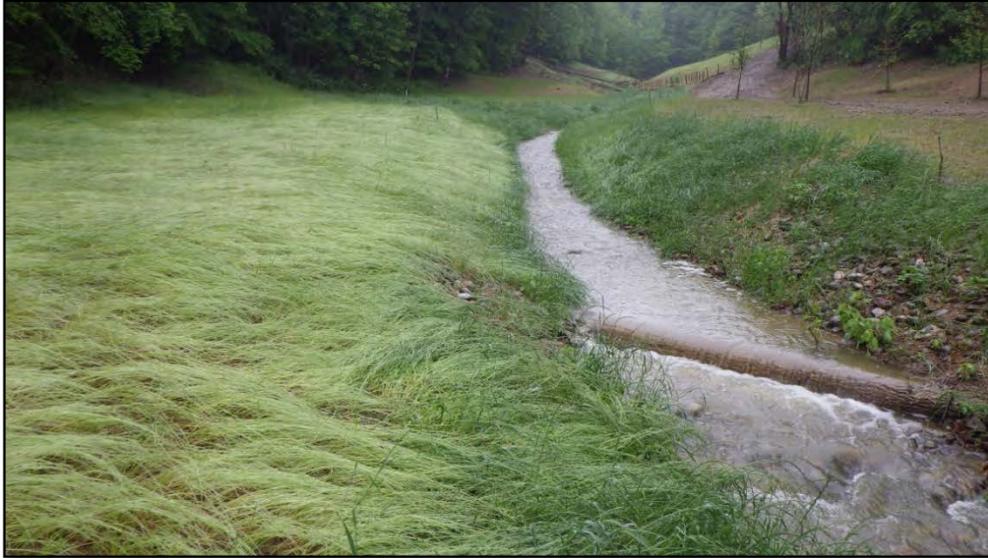
Figure 14 – View of log revetment

The woody debris features were oriented similarly to bendway weirs and bank attached vanes (Figure 14). These structures are commonly made of rock riprap, and are used to concentrate the thalweg at a point in the stream section that creates an advantageous scenario of erosion and deposition. The design used the woody debris bendway weirs and bank attached vanes to replicate the conditions of the woody debris found in the reference reaches as well as to serve as redirective structures.

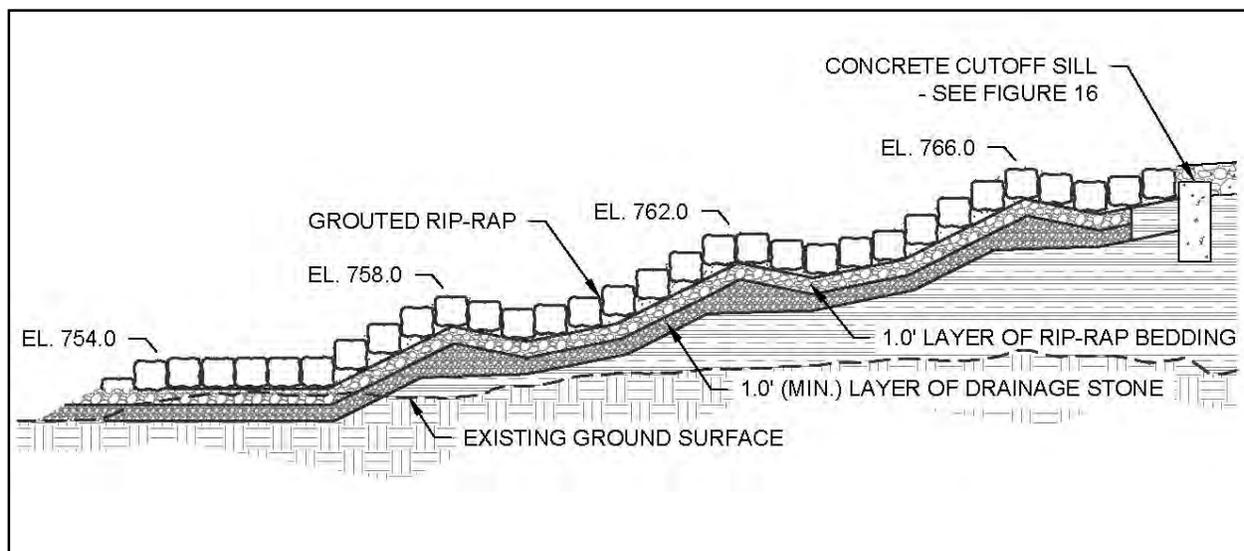
Figure 15 – Profile of the Grouted Riprap Drop Structure

The grouted riprap drop structure was designed to dissipate the erosive energy of the descending stream flows using grade drops, pools, and roughness (Figure 15). The drop structure was also meant to keep the stream flowing on the surface, rather than into the riprap subgrade, which could cause high pore-water pressure along the structure. The hydraulics mimicked the step/pool conditions found in the upstream reference reaches as well as the steep bedrock cascades found in the lower reference reaches.

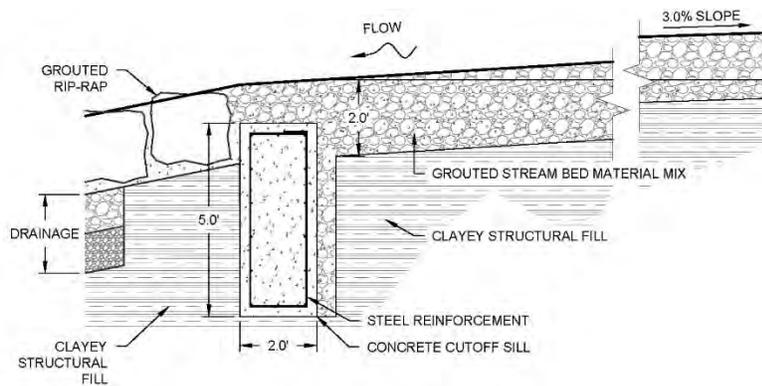
Figure 16 – Section through the concrete cutoff sill

Lateral short-circuiting of the grouted riprap drop structure was another concern that needed to be addressed by the design. One of the most common failure mechanisms of a drop structure is that they get eroded around the end, leaving the inlet to the drop higher than the eroded channel. The design team included a steel reinforced concrete cutoff sill that extended into the valley side slopes (Figures 16 and 17). The center third of the 150 foot wide cutoff sill was designed to be three feet lower than the outer flanks of the cutoff sill. This depressed section would serve to promote a centralized spillway, rather than a spillway located near the valley side slopes.

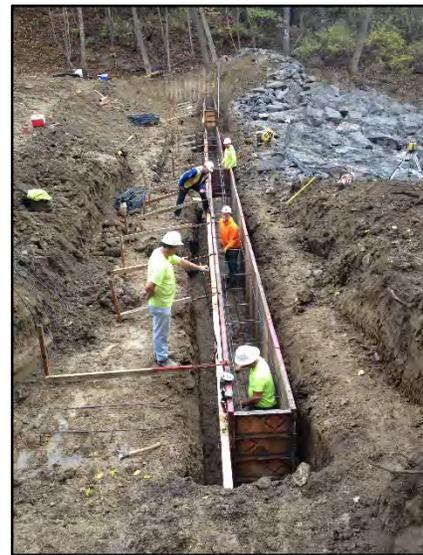
Figure 17 – Concrete cut-off sill under construction

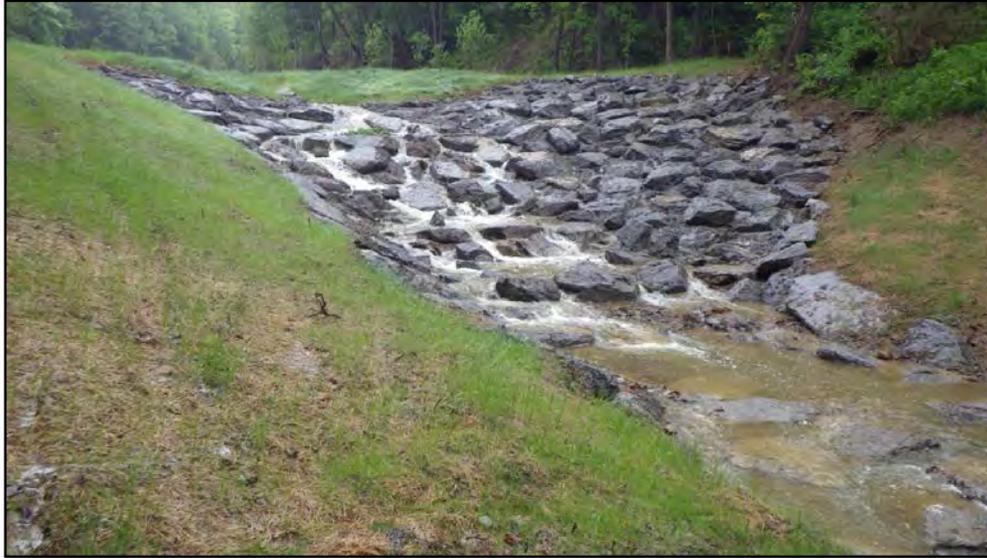
Figure 18 – View of the grouted riprap drop structure

The inlet area above the drop structure and the outlet area below the drop structure were also identified as areas of potential scour. The design team decided to include a grouted streambed revetment pad above the concrete cutoff sill to prevent a pool from forming above the drop structure, and a grouted riprap stilling basin at the toe of the drop structure to prevent the formation of a knickpoint below the drop structure.

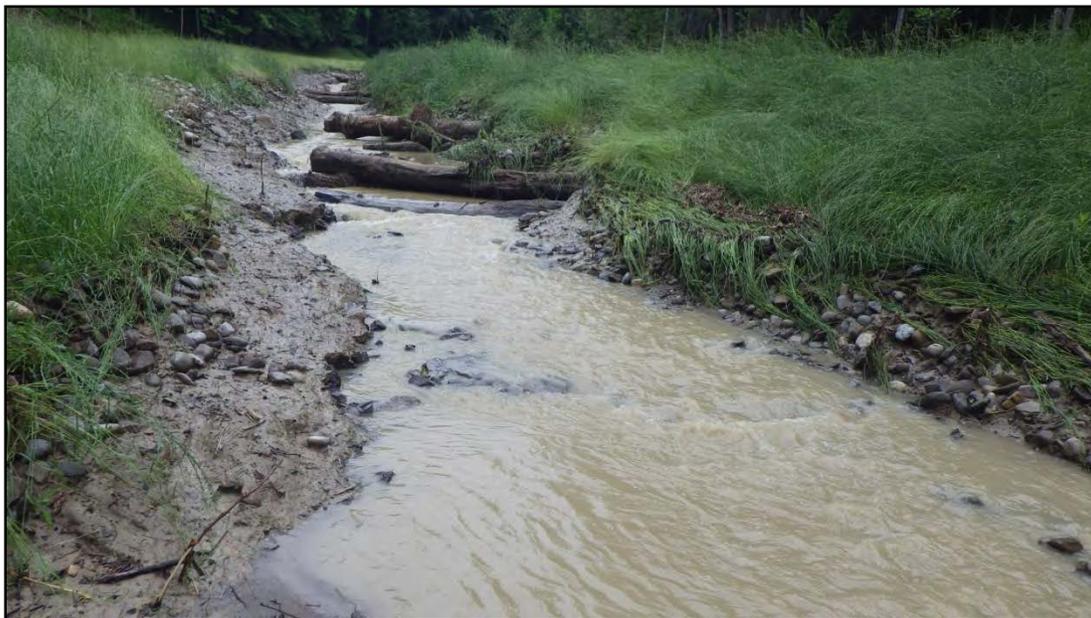
Figure 19 – View looking at erosion following the June 14, 2015 storm flow

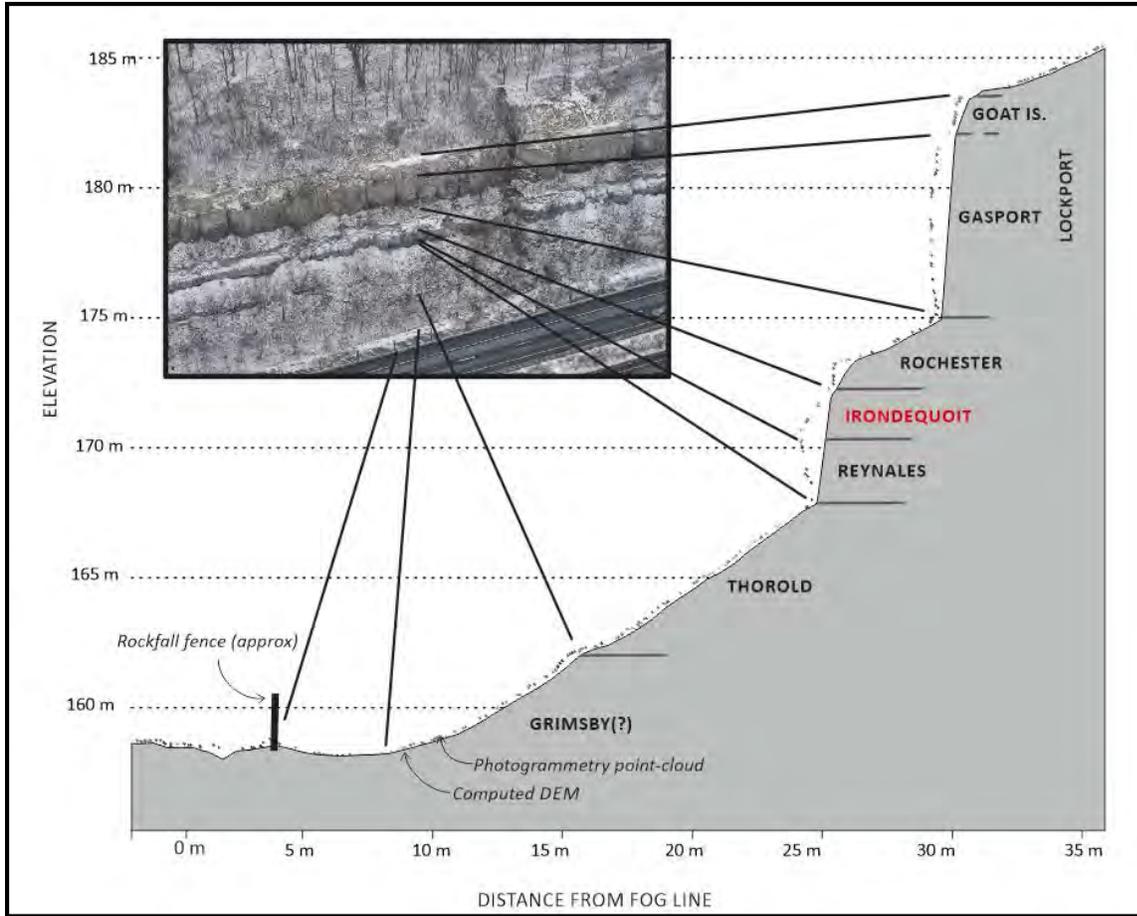
Figure 2. Idealized geological cross section showing typical geometry (DEM and point cloud) in the west section. The lower slope is mostly talus covered.

Figure 2 presents a basic stratigraphic interpretation for a typical section in the west part of the site. Formations and their characteristics were compiled from Hewitt (1971). The typical section in the east part of the site is identical, except with a longer talus-covered slope at the toe.

The idealized geological section presented in Figure 2 was partly derived based on descriptions of geological and geotechnical character of the strata, described in Hewitt (1971). With reference to observed and potential rockfall occurrence, and resulting rockfall hazard to the highway, the following is noted, working down the slope and stratigraphy from crest to highway-level:

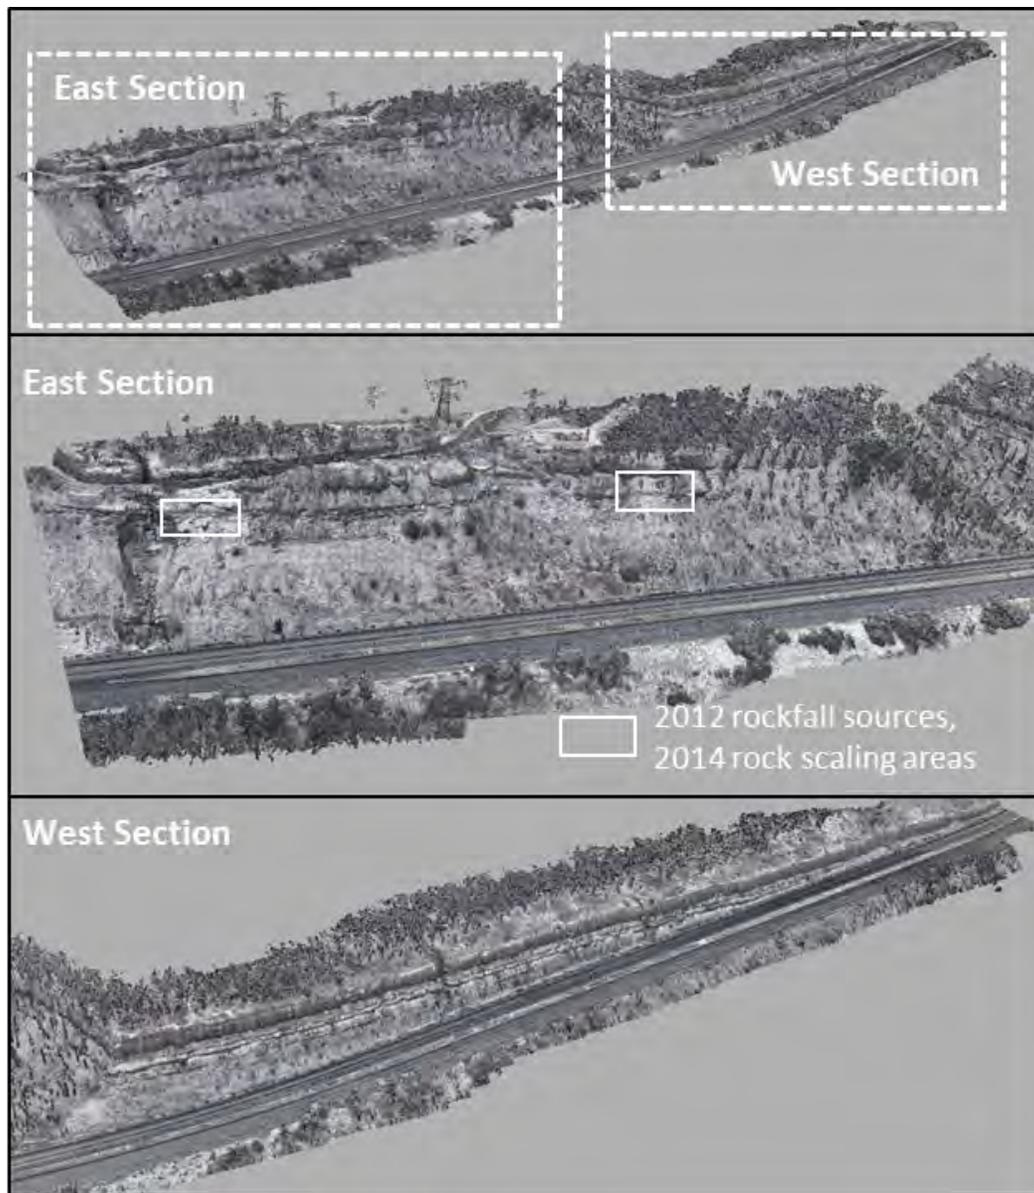
Figure 3 – Oblique view of the 3d photogrammetry model of the site, highlighting the known source areas of significant rockfalls and remediation effort.

- The general shape of the terrain, particularly in section, is bedrock-controlled (See Figures 2 and 3);
- The generalized stratigraphy identified across the site is expressed in the rock face and slope as intervals of differing colour, weathering, blockiness, and texture (See Figures 2 and 3);
- Rockfall may be sourced from many of the strata, but not equally by frequency, volume, or contribution to the hazard.
