66TH HIGHWAY GEOLOGY SYMPOSIUM SEPTEMBER 14-17, 2015

2015 Proceedings

*Massachusetts Department of Transportation
and
University of Massachusetts Amherst*

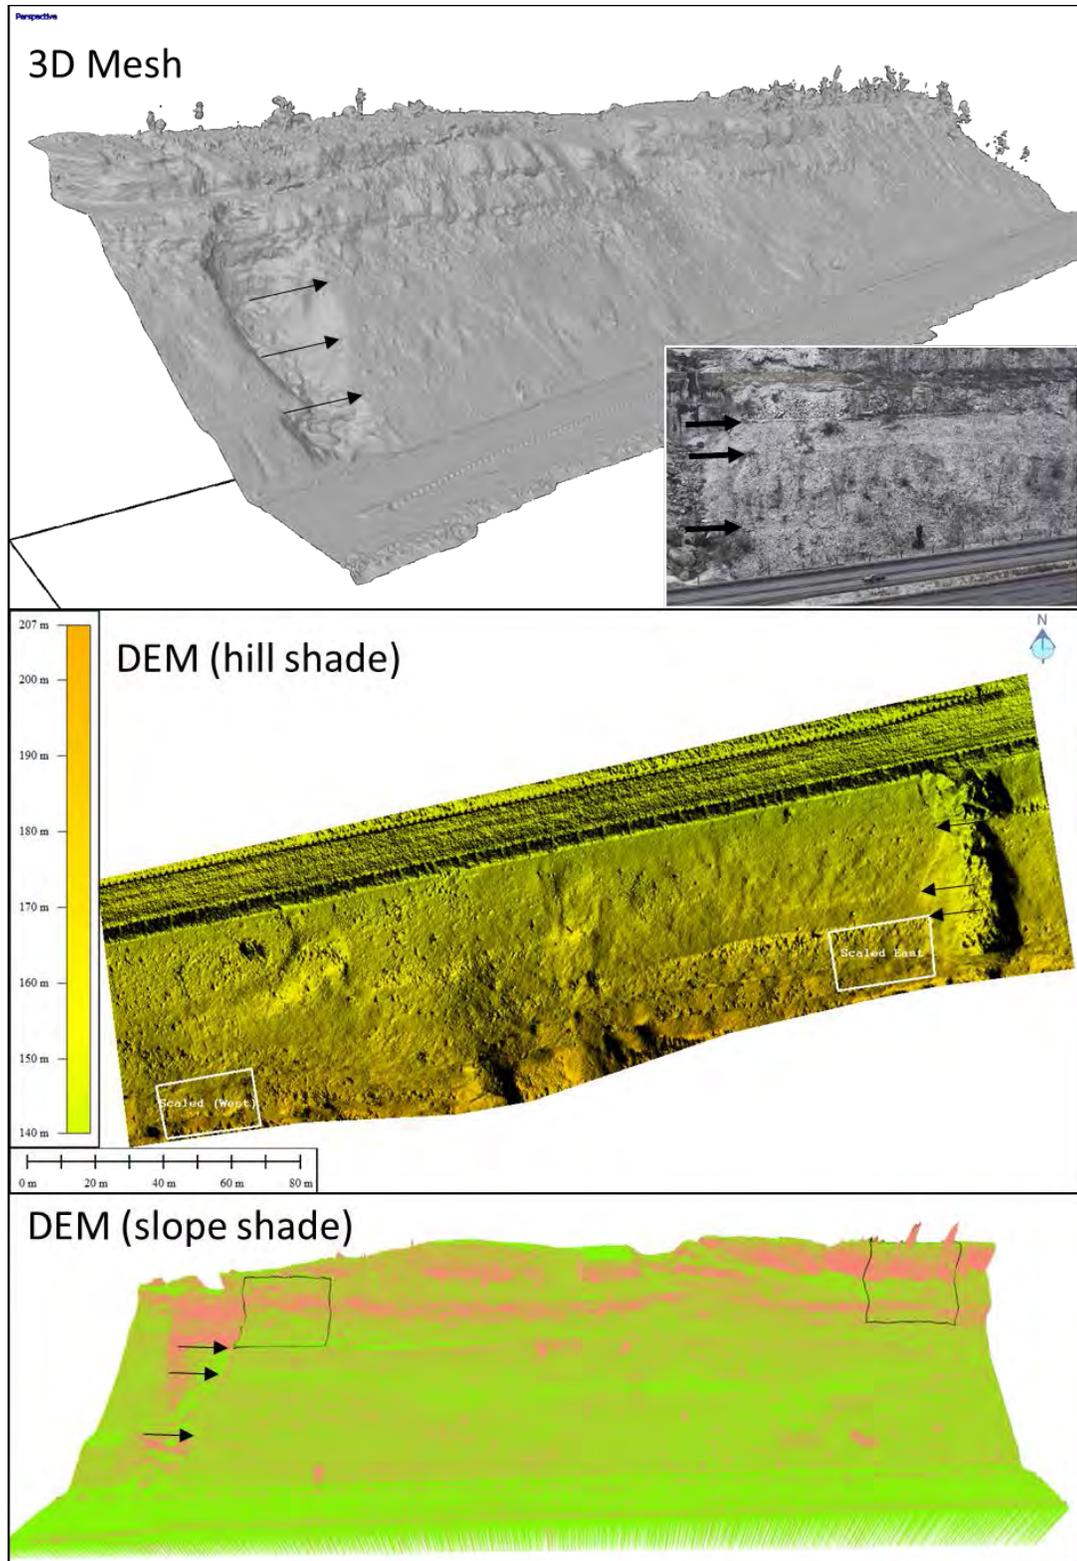
Figure 4 – Oblique view of the photogrammetry mesh surface, map-view of the hillshaded DEM, and oblique view of the slope-angle shade DEM surface, highlighting the subtle bench features in the talus slope, which are related to underlying bedrock strata and appear to arrest a certain number of falling/rolling/sliding blocks.

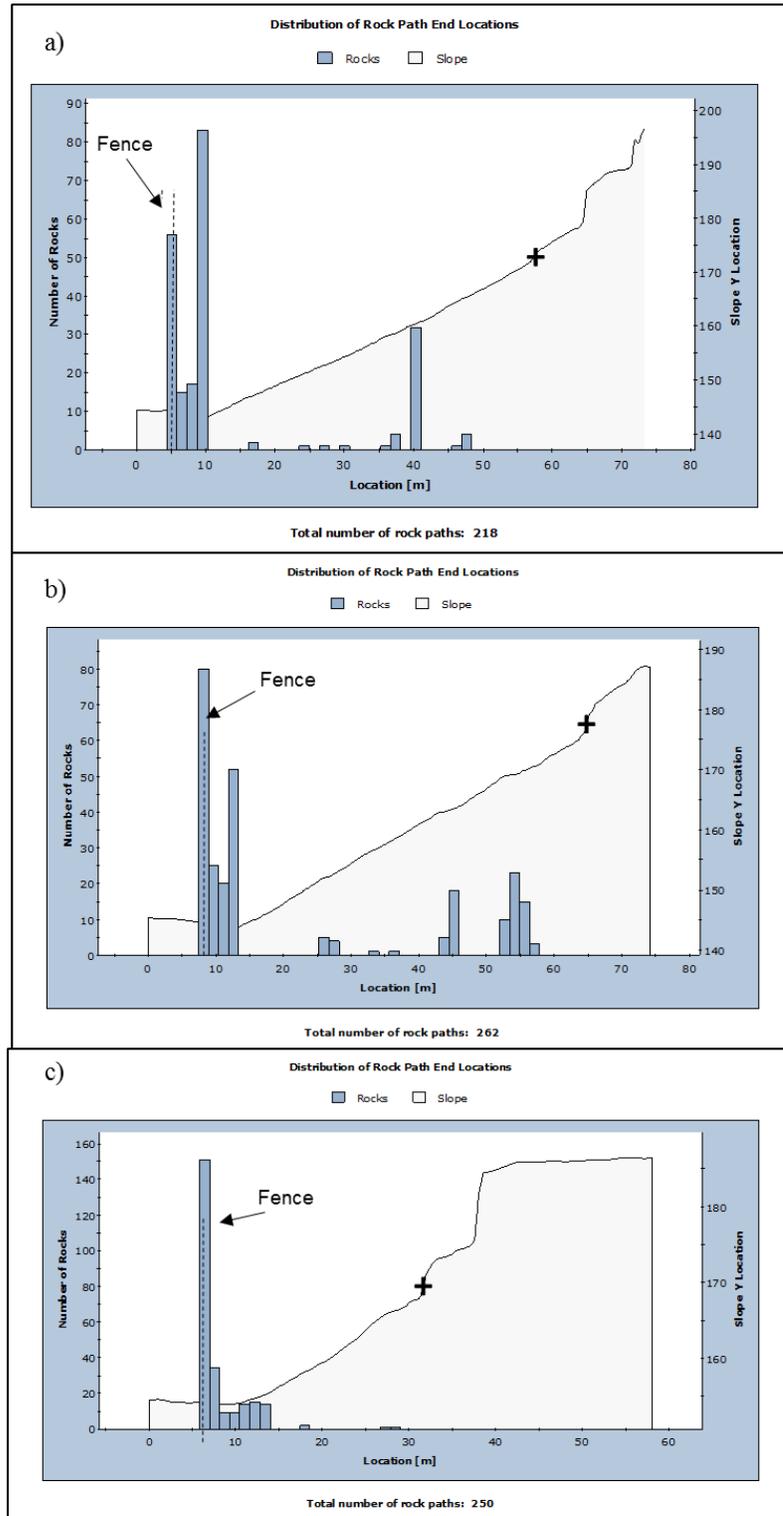
Figure 5 – Rocfall (V5) model simulation results for three sections, highlighting arrest of rolling/sliding blocks on subtle benches in talus (a, b), but not where they don't occur (c).

Using Rocscience's Rocfall (V5) program we conducted rockfall simulations at the source of the most hazardous rockfalls. The two-dimensional cross-sections were captured directly from the photogrammetry-derived DEM. We used observations of real events for calibration, with the goal of replicating the reach and approximate impact energy of those events. The design block was 4.5 m³, with an assumed density of 2500 k/m³, for a mass of 11,250 kg. The simulations were seeded at the known source location of the most hazardous falls, i.e. within the Irondequoit Fm. We selected conservative model parameters for the slope materials and initial conditions of the blocks. The results showed that blocks reached the catchment fence, stopped in the ditch or at its foreslope, and stopped on the talus-covered lower slope – typically at the subtle benches noted in the terrain model (Figure 5a).

Using these calibration parameters we conducted simulations at two other locations (Figure 5b,c). Both were chosen as potential worst-cases, since the slope is tallest, and least impeded by vegetation etc. In the case with similar benches in the talus, we found a similar distribution, i.e. blocks arresting on the benches, which are more pronounced and numerous than in the calibration set. In the other case, which was a section further west, where the highway is close in elevation to the source formation – and therefore the talus slope is less developed and not benched, showed most blocks reaching the ditch and catchment fence, rather than arresting on the slope.

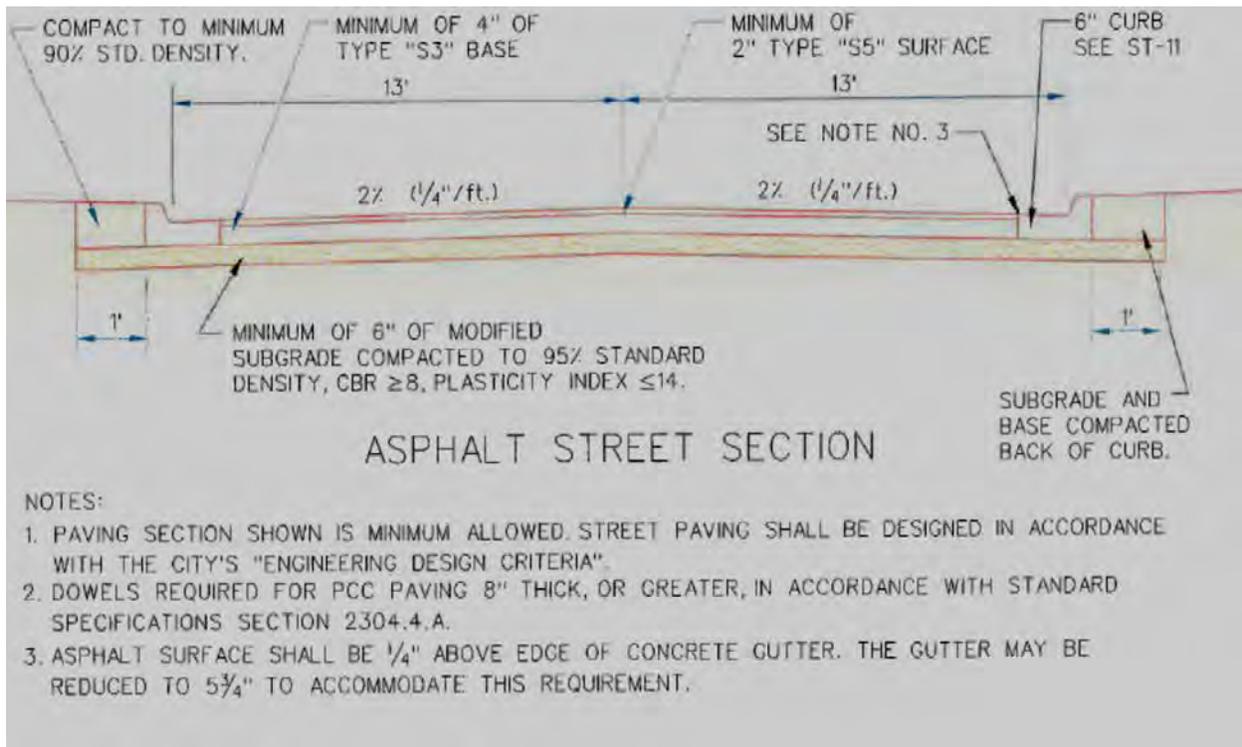
Figure 2. City of Norman Drawing No. ST 01 for asphalt pavement typical section.

The street construction required the removal of the old 6 inch concrete slab pavement installed in the early 1950's. The new pavement section consisted of 6 inch asphalt pavement placed in two lifts (bottom 4 inch layer and a top 2 inch layer) underlain by a 6 inch thick hydrated lime modified subgrade base course. A detail for the pavement section for these streets is shown in Drawing No. ST 01 taken from the City of Norman Engineering Criteria for Streets, Storm Drains, Water Lines and Sanitary Sewers, Amendment No. 8b: July 11, 2006, see Figure 2.

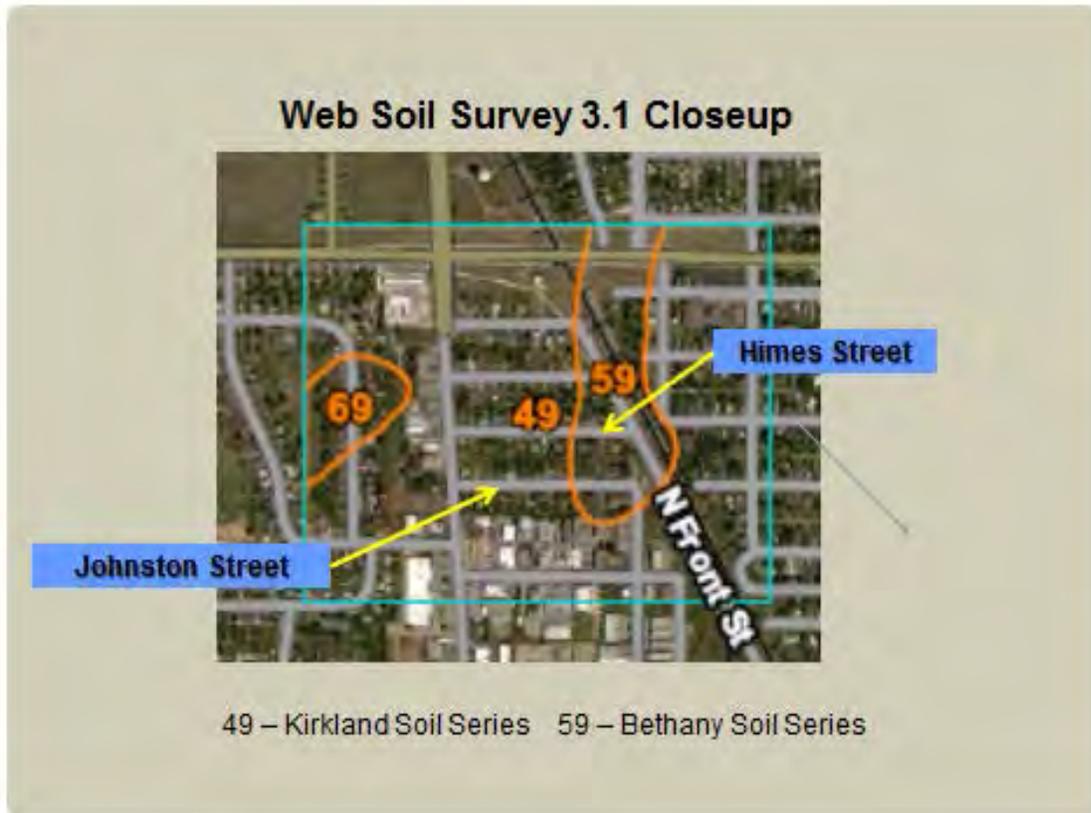
Figure 3. Web Soil Survey 3.1 for the Sooner Homes Addition.

An enlargement of soil map from the Web Soil Survey 3.1 is shown in Figure 3. Based on Figure 3 the Kirkland–Urban land–Pawhuska complex soil series is the predominately mapped soil unit along the lineal extents of both of these streets. The distribution of the Kirkland–Urban land–Pawhuska complex and Bethany–Urban land complex soil series is also seen in an enlarged soil map from the Web Soil Survey 3.1, see Figure 3. Based on Figure 3, the approximate percentages of the Kirkland–Urban land–Pawhuska complex and Bethany–Urban land complex are respectively 632 feet (72.34 percent) and 241.6 feet (27.66 percent) along the lineal extent for Himes Street and 620 feet (69.43 percent) and along the lineal extent for Johnston Street 273 feet (30.57 percent) for Johnston Street.

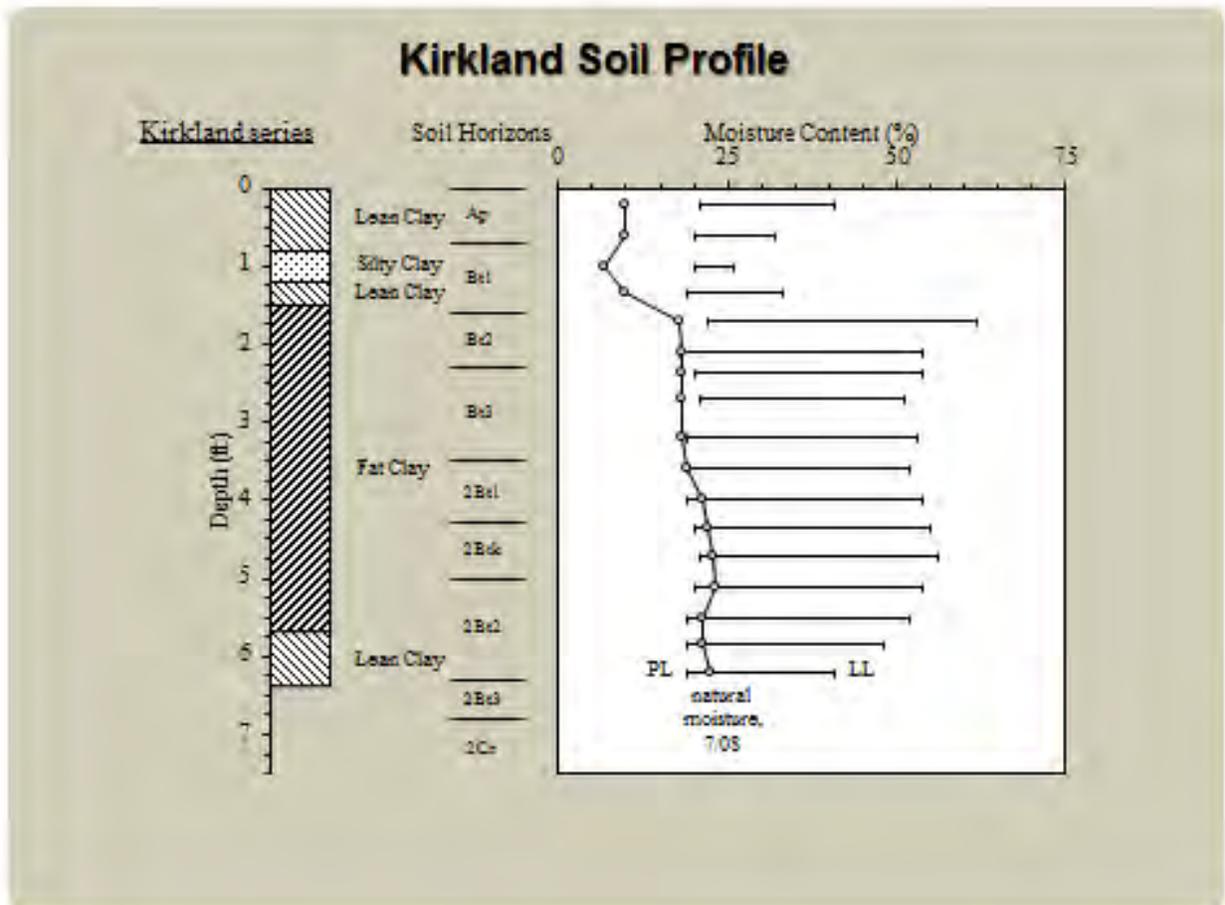
Figure 4. Kirkland soil series profile.

The Kirkland soil moisture profile in Figure 4 was adjusted to the top of the average finished subgrade depth of 1.31 feet below the natural surrounding ground line (Johnson Street) for the soil analysis, see Figure 6. As seen in Figure 6, the wet moisture profile is extended to an intersection with the in situ moisture profile to establish the active zone at approximately 3.61 foot depth below the ground surface.

Based on the moisture contents and plasticity indices shown in Figure 4 for the depth of influence of the idealized initial and final moisture profile with depth shown in Figure 6, a SWCC was estimated between 1.39 and 3.02 feet. For the moisture contents (12 and 22 percent) a depth of 1.31 feet in Figure 6 the volumetric water contents were based on a weighted unit weight average and found to be 21.9 and 40.2 percent. From Figure 11 these volumetric water contents resulted in approximate suction increase of 195 psi.

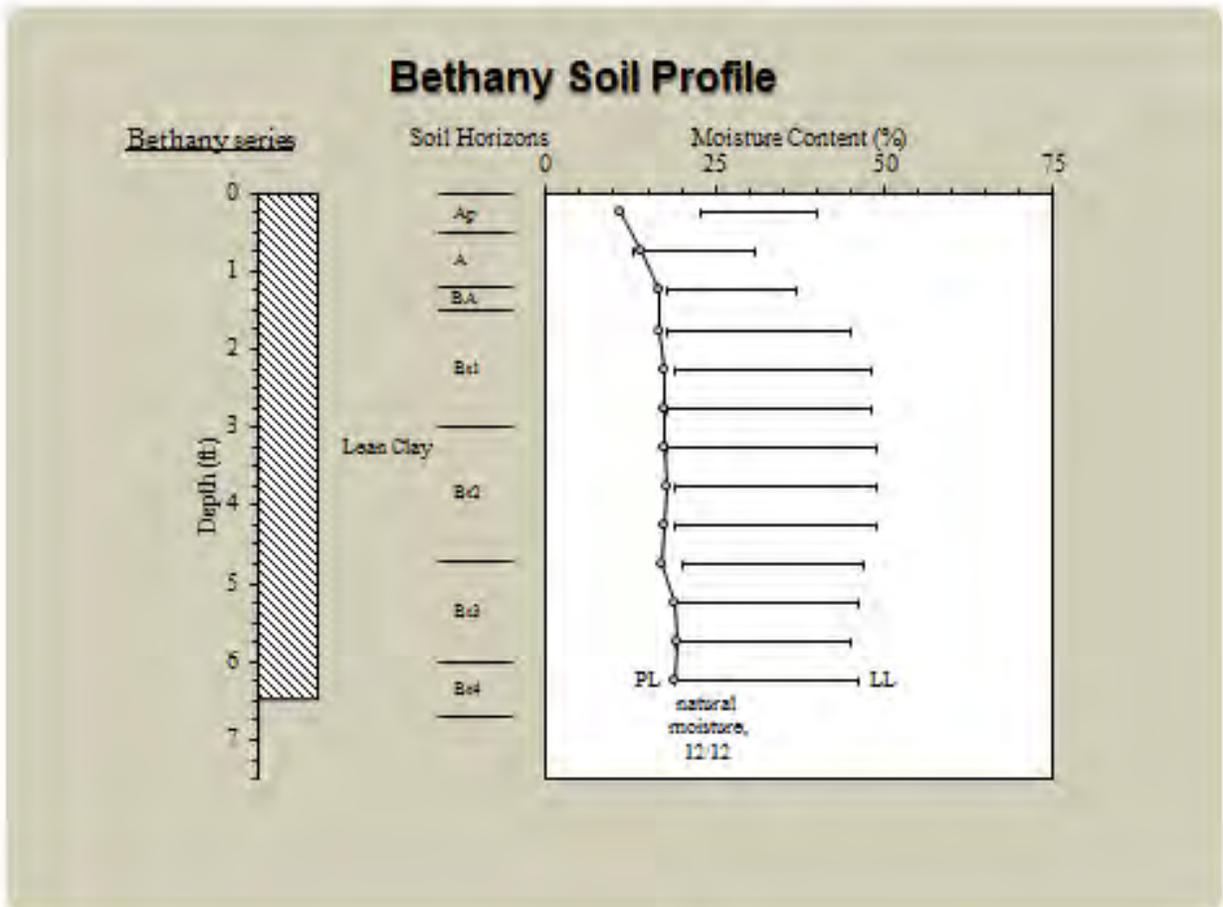
Figure 5. Bethany soil series profile.

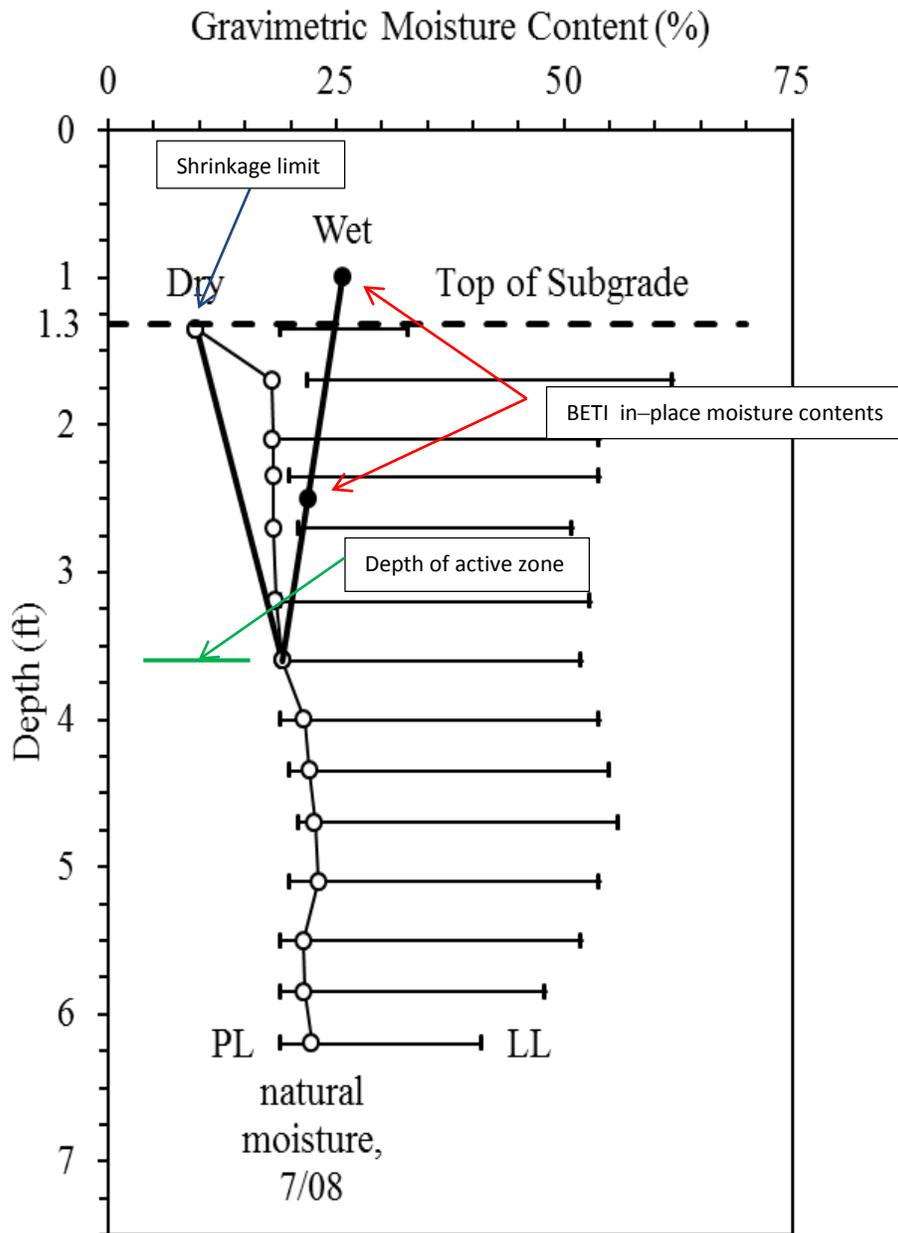
Figure 6. Estimated wet and dry moisture profiles.

Subgrade Soils. A subgrade analysis was made for both the Kirkland and Bethany soil profiles, and analysis for the Kirkland soil series is presented, see Figure 6. The in situ moisture contents from the BETI report were observed to be very wet, close to or in excess of the plastic limit. The highest in situ moisture content at 0.98 feet was 25.7 percent, and the highest moisture content at 2.49 feet was 21.9 percent, and these values were used to establish a wet moisture profile shown in Figure 6.

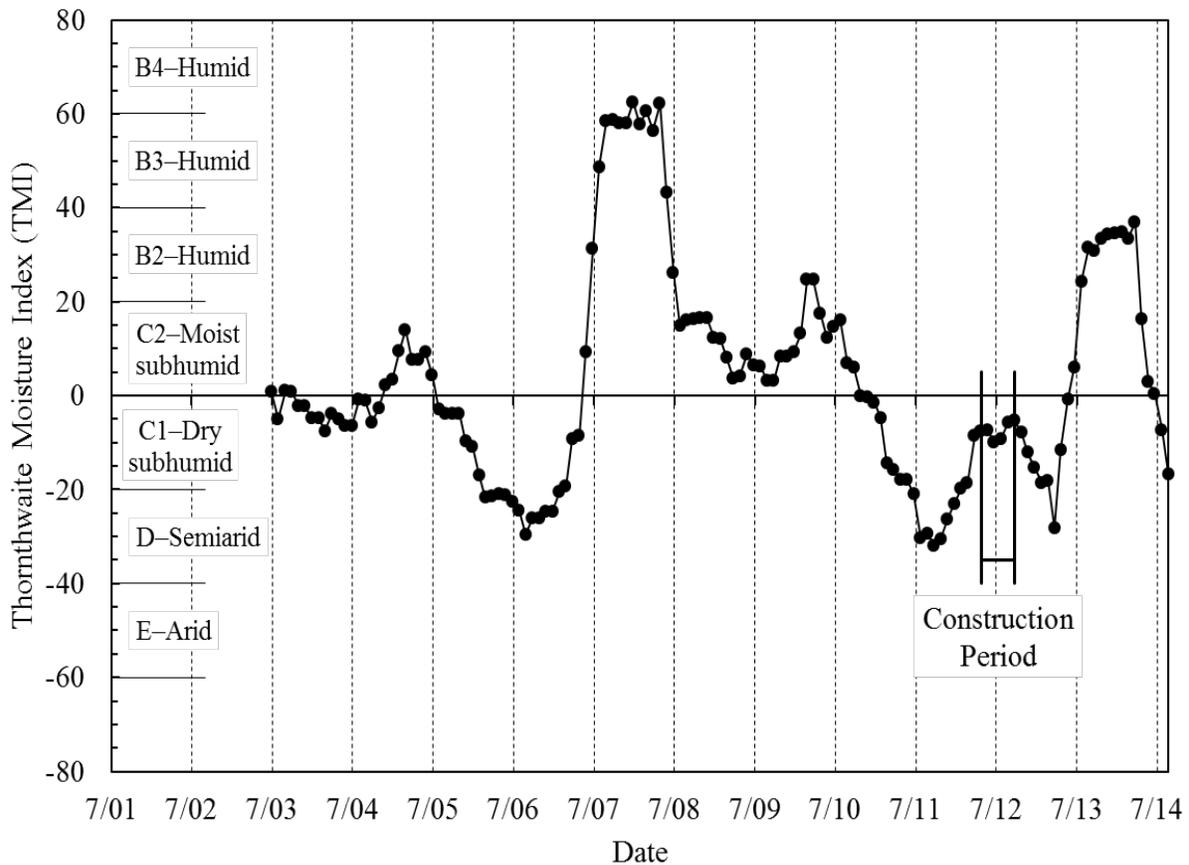
Figure 7. Thornthwaite Moisture Index (TMI) versus time at the site.

The Thornthwaite Moisture Index (TMI) (Thornthwaite 1948) and the designated time of construction are presented in Figure 7. Referring to Figure 7, the time of construction is in a negative TMI zone indicating a dry sub-humid climatic condition. During the construction time frame, the TMI indicates that the slight drying and wetting. Following the construction period, the TMI suggests that drying continues.

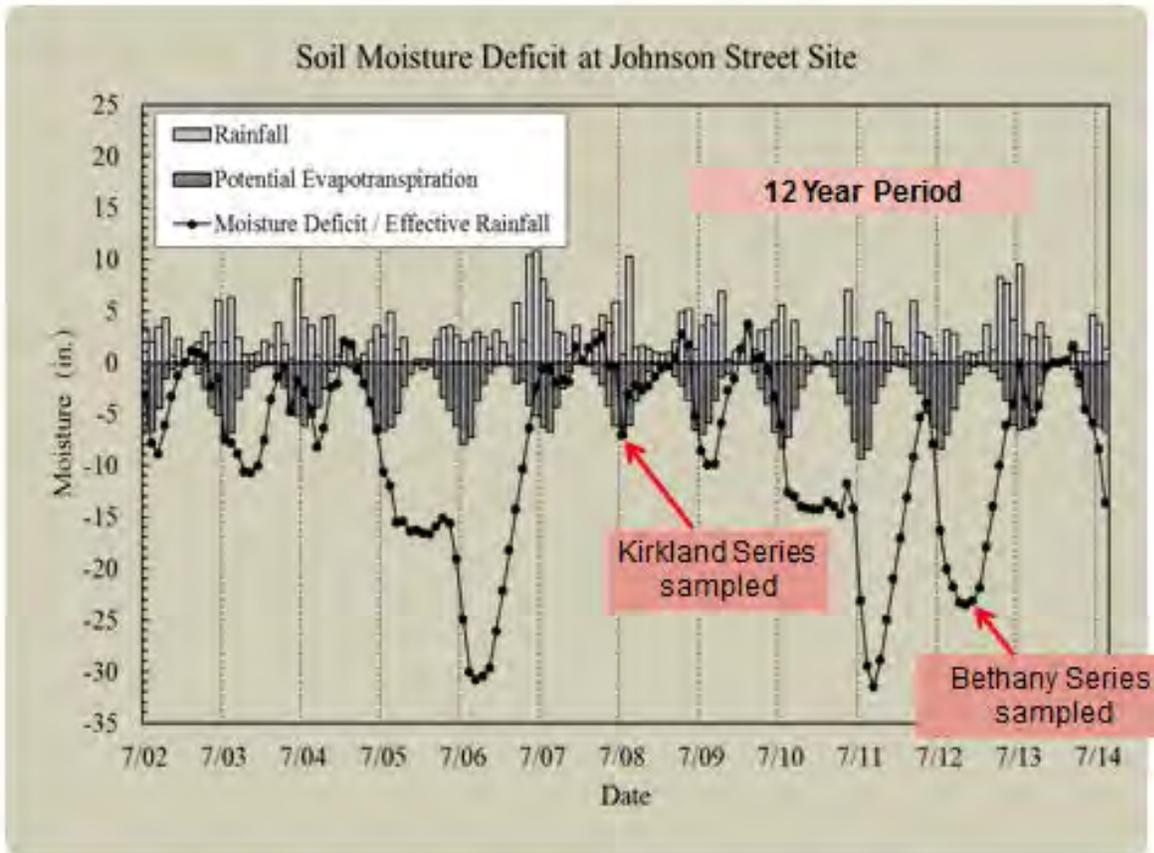
Figure 8. Soil moisture deficit versus time at site.

Soil Moisture Deficit. The climate at the time of re-construction of Himes and Johnson Streets was in a very dry condition. In order to quantify the potential shrinkage occurring in the subgrade soil once the old concrete pavement was removed, an estimate of the soil moisture deficit was utilized. The soil moisture deficit defined by Biddle (1998) refers to the amount of water which needs to be added to a soil profile to bring it to its normal moisture content or field capacity. The soil moisture deficit (SMD) calculated for the idealized initial and final moisture profile with depth is shown in Figure 8 and presented in Table 2. The SMD is shown over a twelve-year period in Figure 8. The SMD during the re-construction period is shown in Figure 9. Here the SMD is based on an estimate of the potential evapotranspiration rather than the actual evapotranspiration.

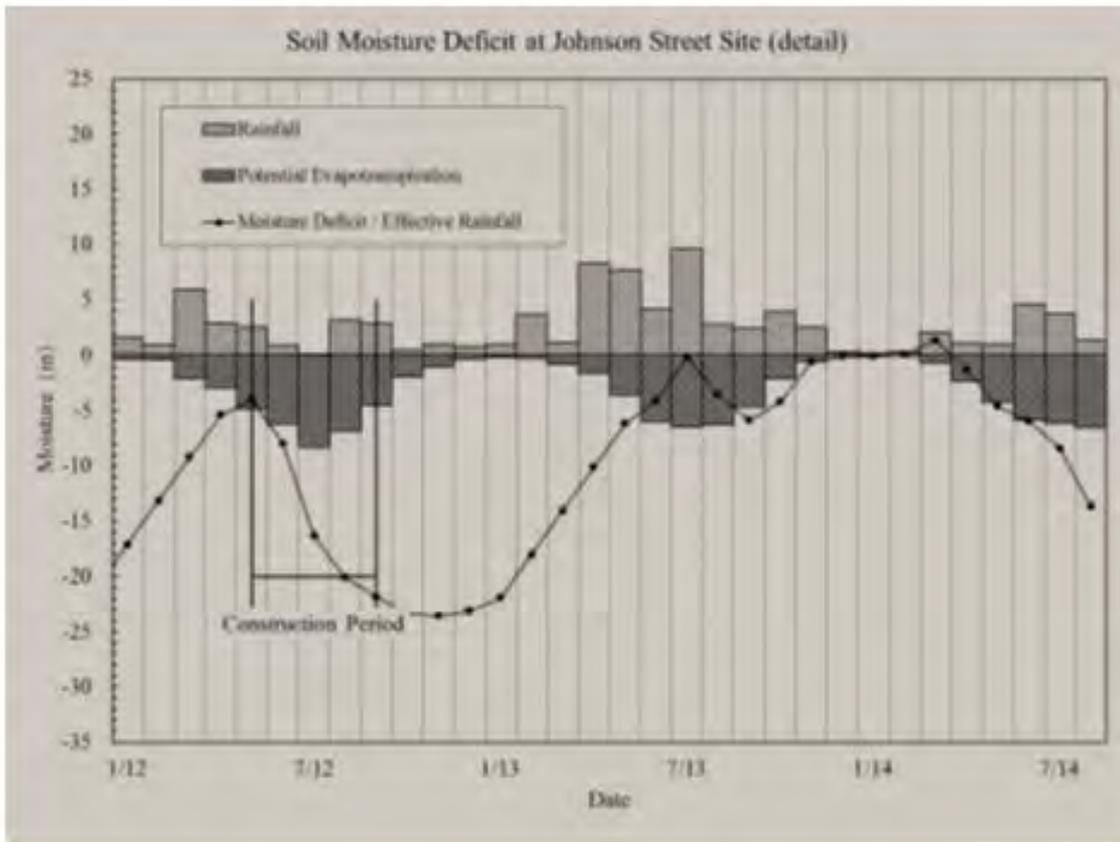
Figure 9. Soil moisture deficit during construction period.

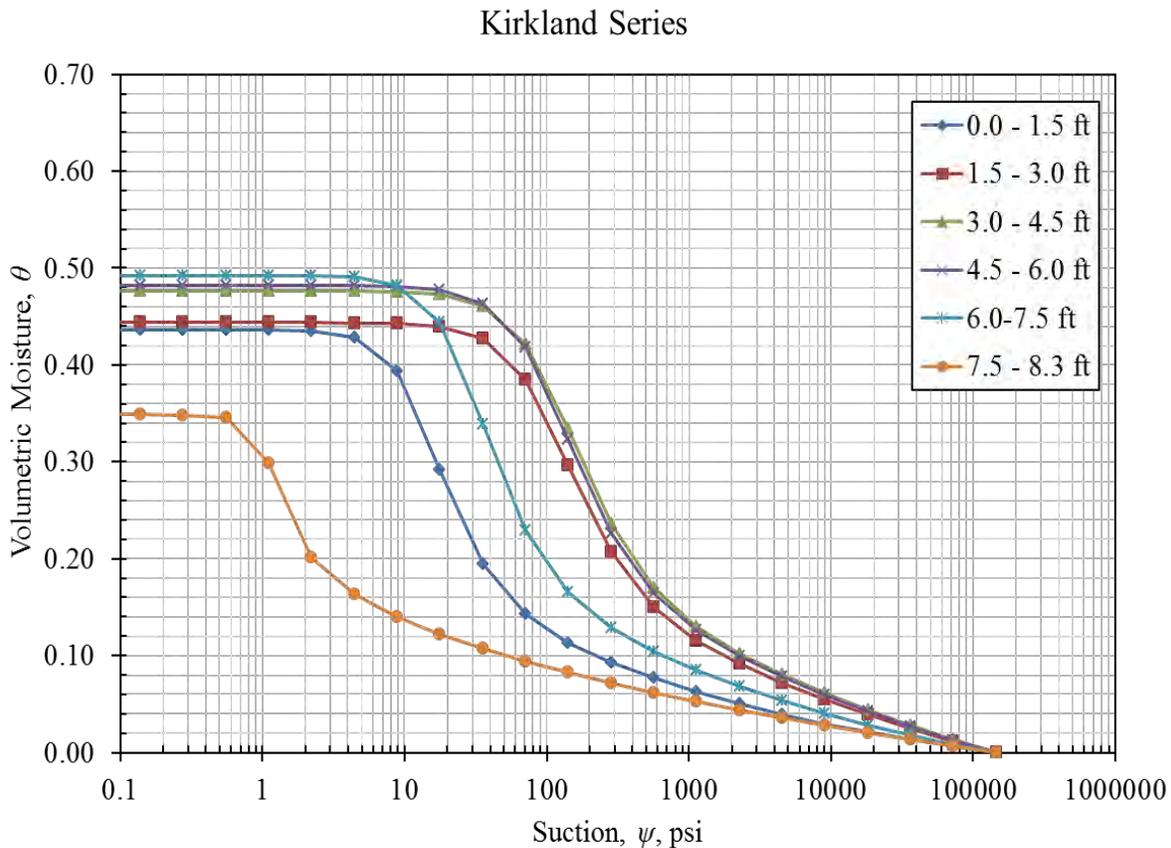
Figure 20. Soil water characteristic curves for the Kirkland soil series.

Soil Water Characteristic Curve. The soil suction change associated with the drying of the subgrade during and following the re-construction of Himes and Johnson Streets can be found from soil water characteristic curve (SWCC), see Figure 10. The SWCC used in this analysis was estimated using the Zapata fitting parameters in Fredlund and Xing equation (Fredlund et al. 2013) and is presented in metric units.

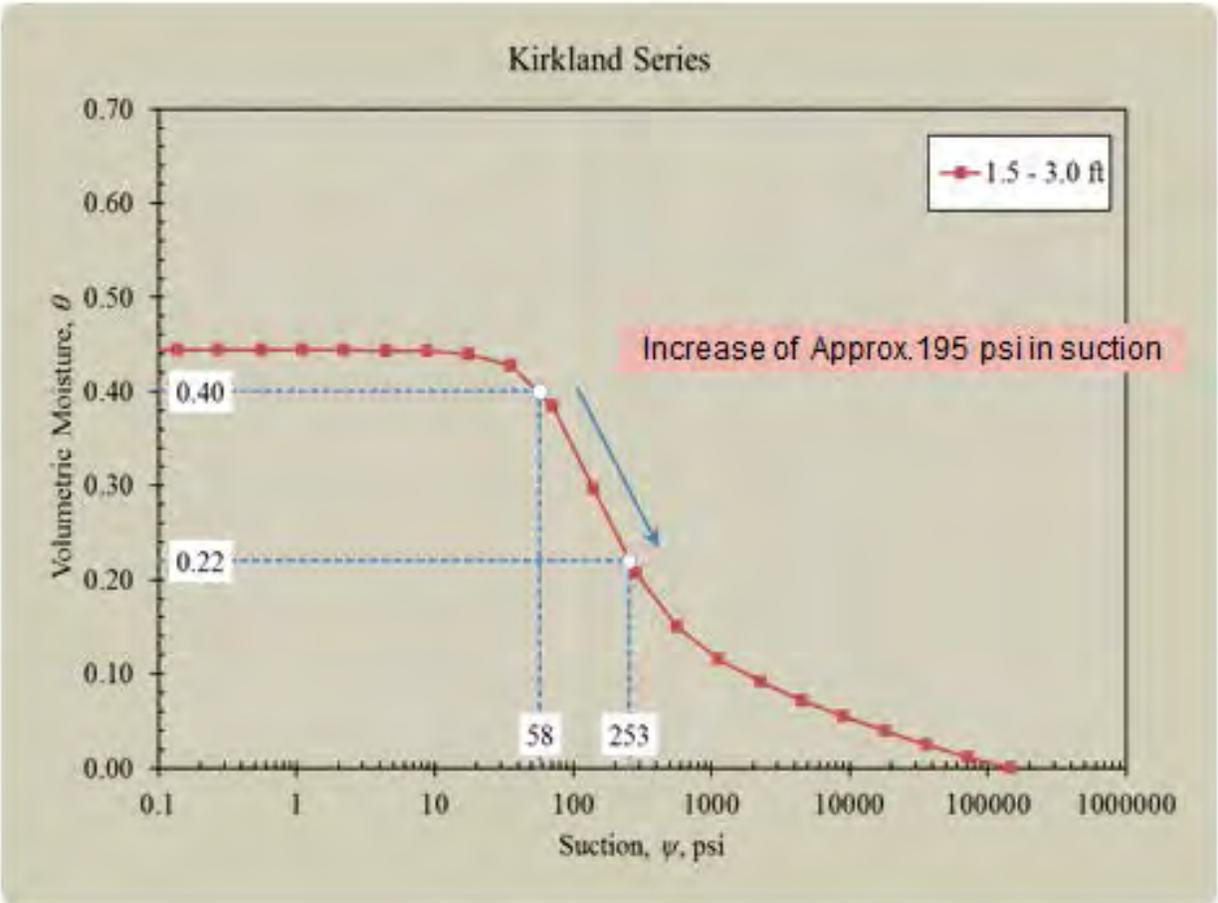
Figure 11. Soil water characteristic curves for the Kirkland soil series at 1.5 to 3.0 foot depth.

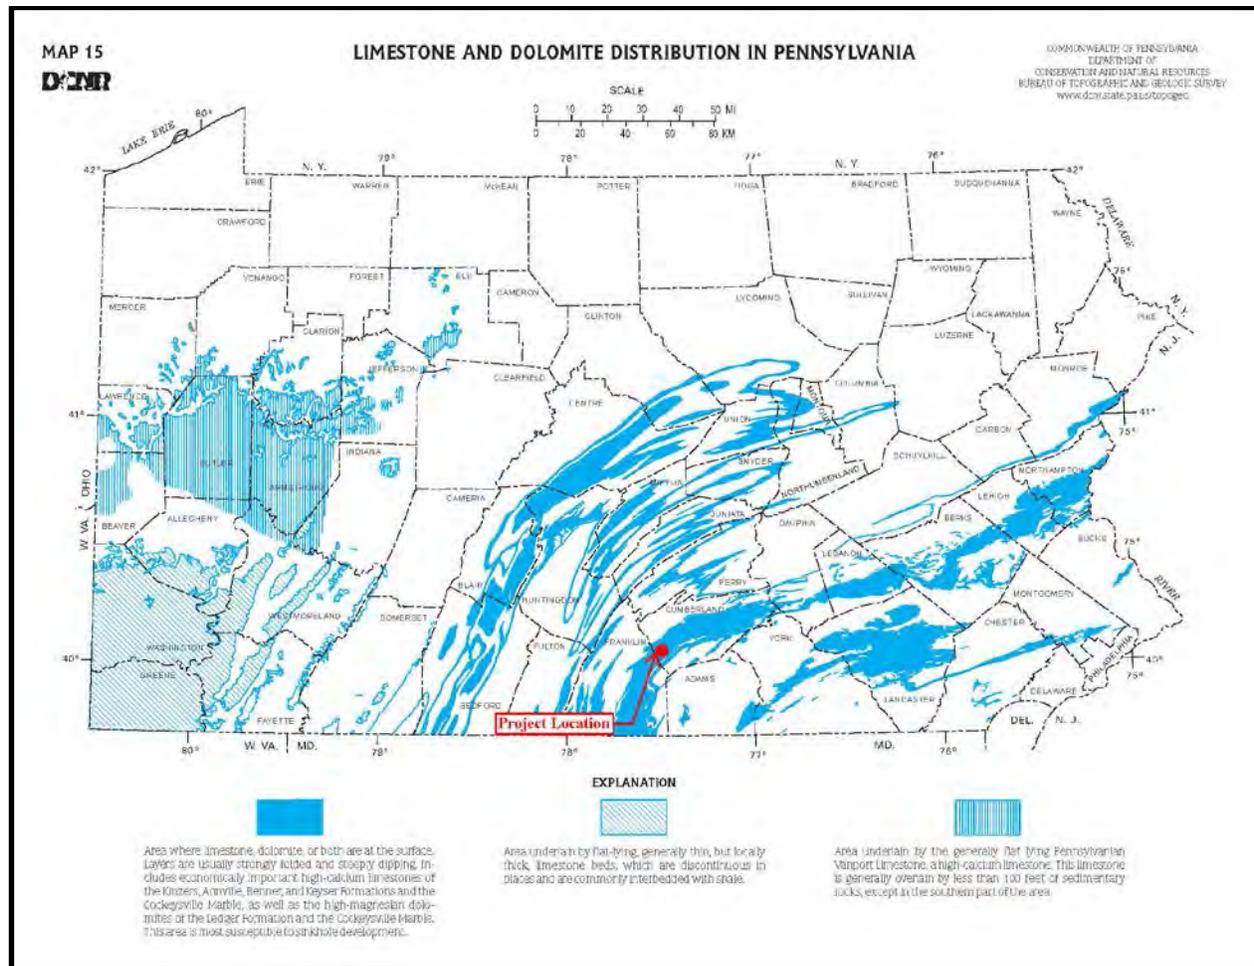
Figure 2: Limestone and Dolomite Distribution in Pennsylvania

Based on the Pennsylvania Bureau of Topographic and Geologic Survey, the project location is underlain by limestone and/or dolomite bedrock that is considered most susceptible to sinkhole development (1). A map showing the carbonate bedrock distribution in relation to the project site is provided in Figure 2.

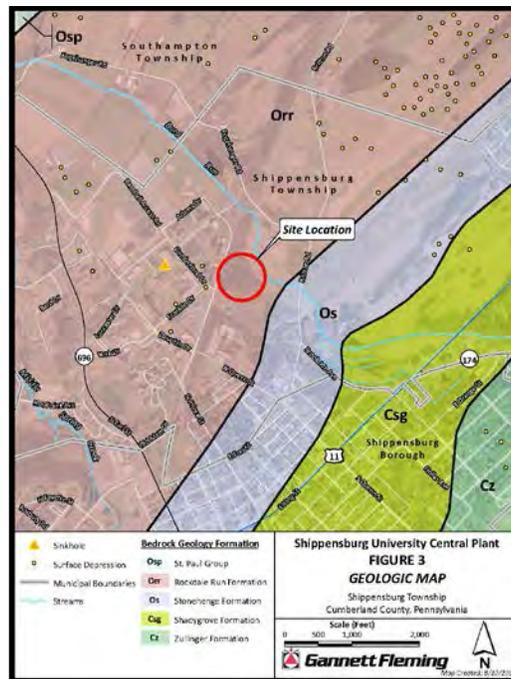
Figure 3 – Geology Map with Historical Karst Related Features

The Pennsylvania Bureau of Topographic and Geologic Survey identified historical karst related features, in particular, closed depressions and a sinkhole in the vicinity of the Central Utility Plant site (4). A Geology Map that also includes historical karst related features is shown in Figure 3.

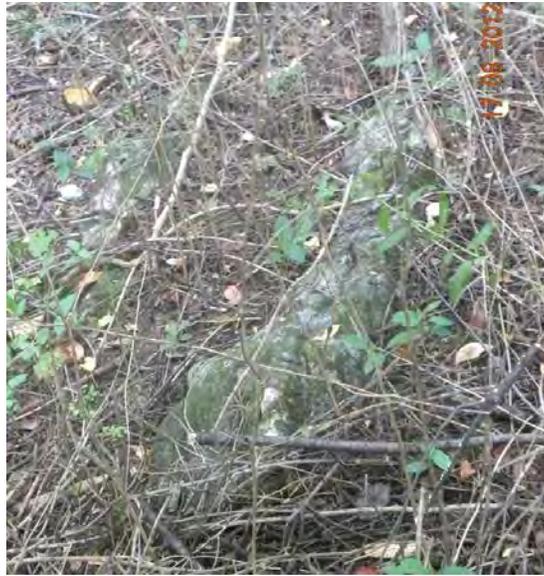
Photo 1: Exposed Bedrock at Ground Surface

Site reconnaissance of the project area was performed during the design phase of the project. The proposed Central Utility Plant site was completely wooded and covered with extremely dense vegetation. Exposed bedrock was observed at the ground surface at several locations throughout the site, which is indicative of the pinnacled top of bedrock surface that was described as a common characteristic of the Rockdale Run Formation (3). Exposed bedrock at the Central Utility Plant site is shown in Photo 1. A sinkhole was observed within a natural swale that carries stormwater runoff from the adjacent developed site. The sinkhole was located approximately 100 feet from the proposed Plant building and approximately 25 feet from a proposed stormwater detention pond. The sinkhole was approximately 5 feet in diameter and approximately 5 feet in depth when observed during site reconnaissance. The sinkhole is shown in Photo 2.

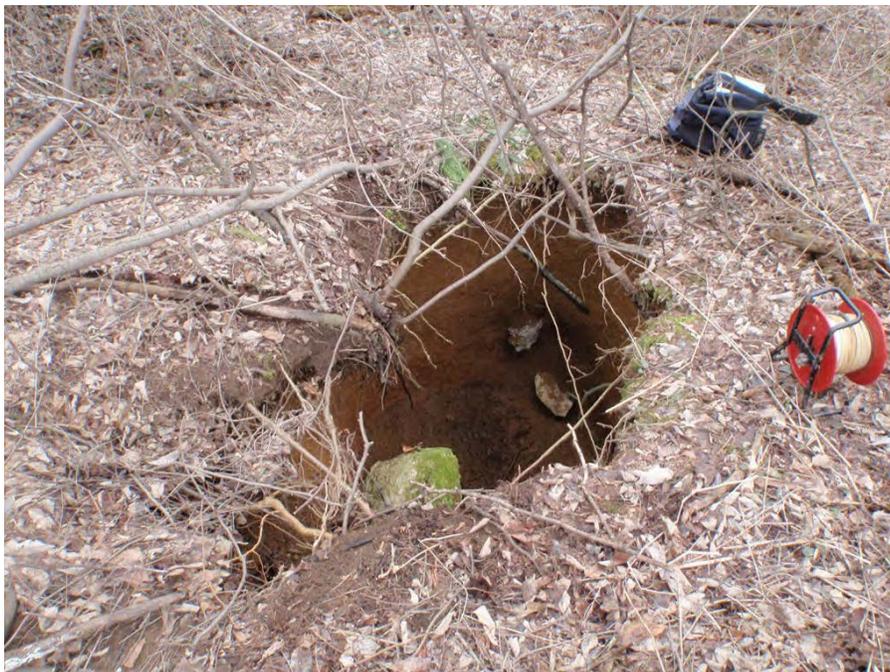
Photo 2: Sinkhole on Plant Site

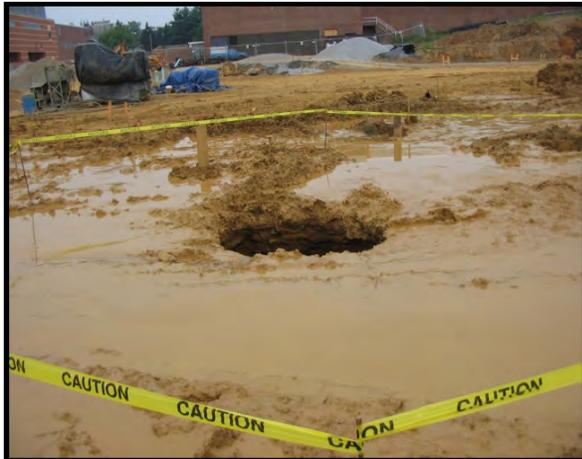
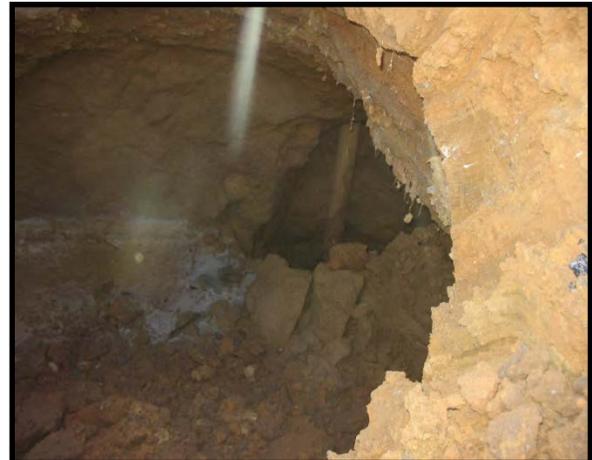
Photos 3 and 4: Sinkholes Encountered During Construction of Campus Building

one-half mile from the Central Utility Plant Site and is also underlain by the Rockdale Run Formation. Sixteen (16) borings were conducted at the building site as part of the subsurface exploration program. The borings encountered intense local pinnacle development in the form of extremely variable depths to the top of limestone bedrock within borings located as little as 3 feet apart. The borings also encountered soil seams within the bedrock, but no voids were encountered in the borings. The local intense pinnacle development and soil filled solution features discovered in the borings are consistent with the characteristics of the Rockdale Run Formation presented in published literature. Micropile foundations socketed into limestone bedrock were utilized to support the building and multiple sinkholes opened during micropile installation (6). Examples of the sinkholes encountered during construction of the micropiles are provided in Photos 3 and 4.

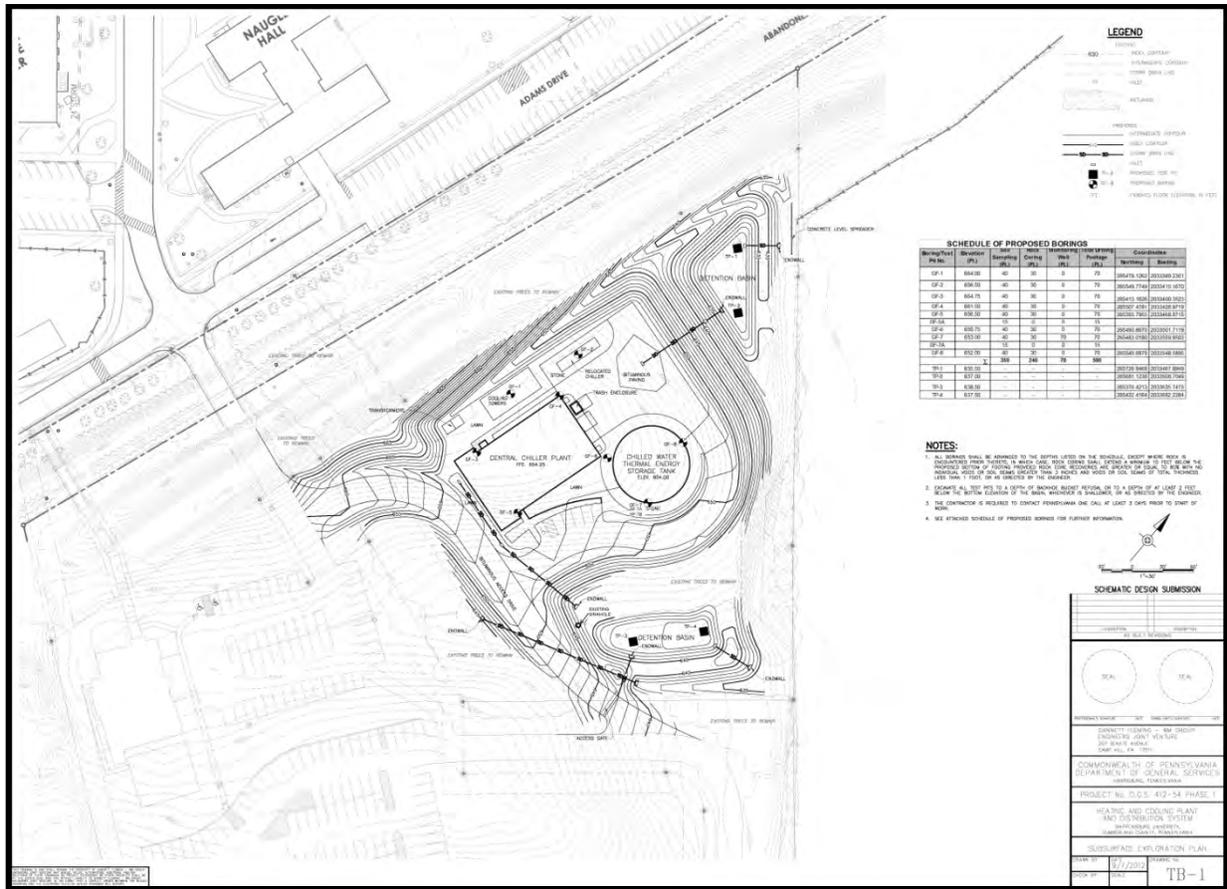
Figure 4 – Boring and Test Pit Location Plan

The subsurface exploration program conducted at the Plant Building and Water Storage Tank took place between December 2013 and March 2013 and included a total of ten (10) borings and a geophysics survey. In addition, four (4) test pits were performed to evaluate the subsurface conditions at the two stormwater detention basins and to perform infiltration testing. The boring and test pit locations are shown in Figure 4.

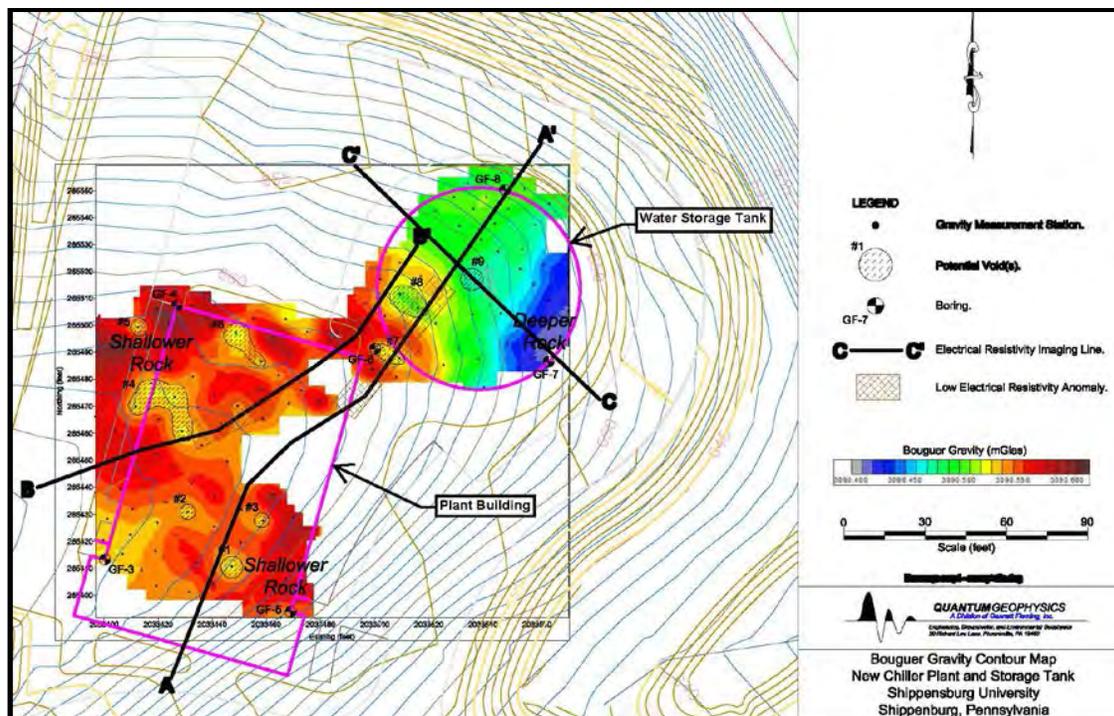
Figure 5 – Microgravity Results

The microgravity geophysics technique identified nine potential voids at the Central Utility Plant site. Five of the voids were located within the footprint of the Plant Building, three were located within the Water Storage Tank and one was located to the west of the Plant Building. The microgravity data suggested that the size of the potential voids was relatively small and are generally not expected to be more than about 10 feet in length or width, except for one larger, irregular shaped void located along the west side of the Plant Building that shows the potential void was as large as 30 feet long. The microgravity survey also noted that pinnacled bedrock was encountered in the footprint of both structures and that the depth to top of rock is greatest on the east side of the Water Storage Tank. The pinnacled top of rock and depth to top of rock correlated well when compared with the data obtained in the borings. The microgravity results, including the potential voids and relative location of the top of bedrock, are shown on Figure 5.

The electrical resistivity imaging (ERI) technique identified two low electrical resistivity anomalies within the bedrock at depths of 30 to 50 feet below ground surface. One of the anomalies is located completely within the footprint of the Plant Building, while the other anomaly underlies the north east corner of the Plant Building and continues under the west side of the Water Storage Tank. These anomalies are generally associated with the potential voids that were identified in the microgravity survey. Boring GF-6 was located in the vicinity of a low resistivity anomaly and a potential void indicated by the microgravity survey. This boring encountered more than 20 feet of continuous rock with no voids, but highly weathered zones were encountered from 19 feet to 24.5 feet and from 29.1 feet to 29.8 feet. The ERI survey interpreted the soil/rock interface and indicated that the depth to rock is generally 6 to 8 feet below ground surface at the Plant Building, and is variable at the Water Storage Tank. These findings are consistent with the depth to rock recorded in the borings. The locations of the low electrical resistivity lines and anomalies are shown on the plan view in Figure 5 and the ERI profiles are provided in Figures 6, 7 and 8.

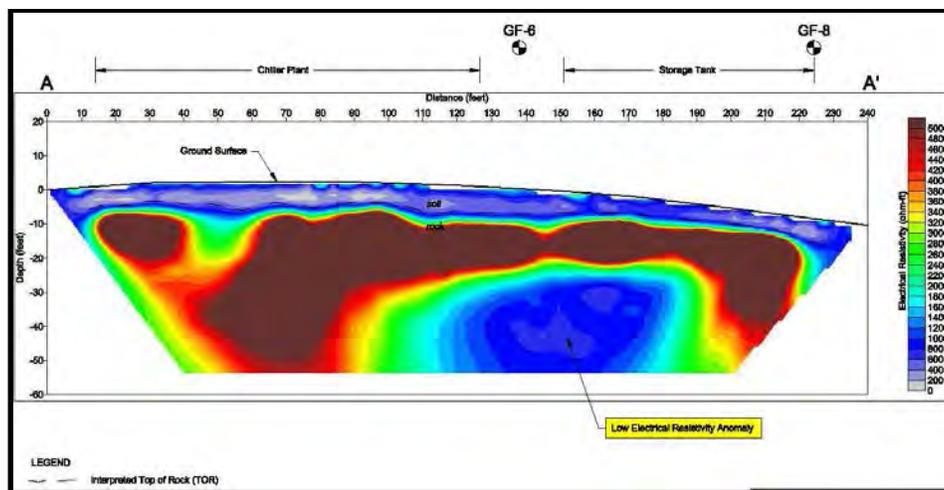
Figure 6 – ERI Line A-A' Profile

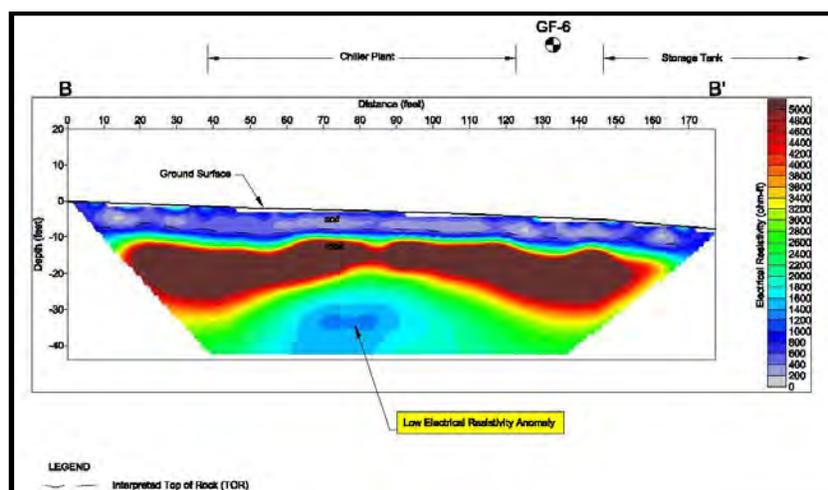
Figure 7 – ERI Line B-B' Profile
