66TH HIGHWAY GEOLOGY SYMPOSIUM SEPTEMBER 14-17, 2015

2015 Proceedings

*Massachusetts Department of Transportation
and
University of Massachusetts Amherst*

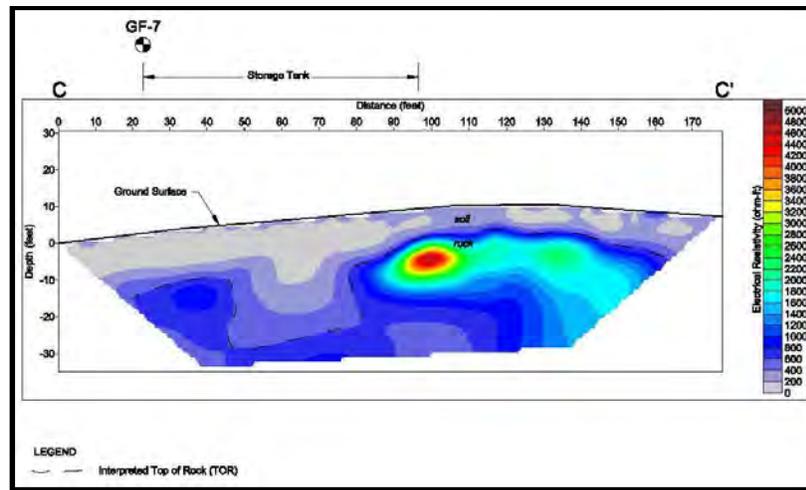
Figure 8 – ERI Line C-C' Profile

The electrical resistivity imaging (ERI) technique identified two low electrical resistivity anomalies within the bedrock at depths of 30 to 50 feet below ground surface. One of the anomalies is located completely within the footprint of the Plant Building, while the other anomaly underlies the north east corner of the Plant Building and continues under the west side of the Water Storage Tank. These anomalies are generally associated with the potential voids that were identified in the microgravity survey. Boring GF-6 was located in the vicinity of a low resistivity anomaly and a potential void indicated by the microgravity survey. This boring encountered more than 20 feet of continuous rock with no voids, but highly weathered zones were encountered from 19 feet to 24.5 feet and from 29.1 feet to 29.8 feet. The ERI survey interpreted the soil/rock interface and indicated that the depth to rock is generally 6 to 8 feet below ground surface at the Plant Building, and is variable at the Water Storage Tank. These findings are consistent with the depth to rock recorded in the borings. The locations of the low electrical resistivity lines and anomalies are shown on the plan view in Figure 5 and the ERI profiles are provided in Figures 6, 7 and 8.

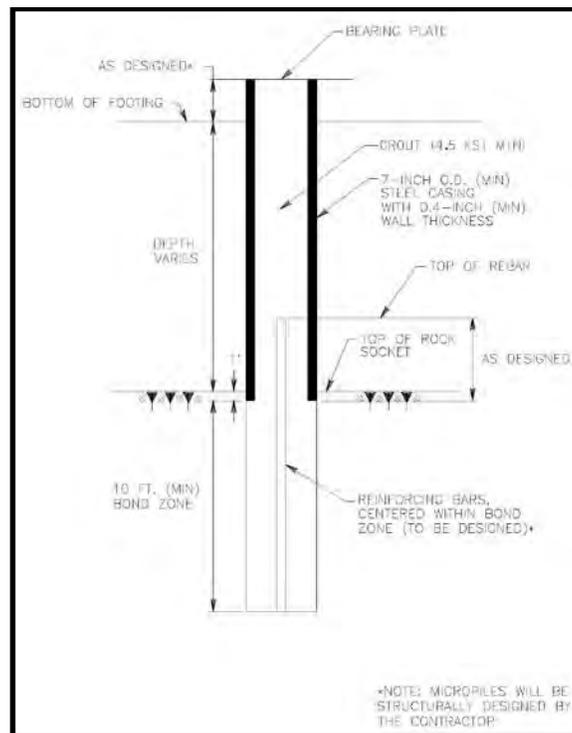
Figure 9 – Typical Micropile Detail

The structural design, including casing thickness and sizing the reinforcement bar, was performed by the Contractor in accordance with the performance specification developed for this project. The specification required the structural capacity of the micropiles to meet or exceed the geotechnical capacity. In addition, the specification required the Contractor to advance the steel casing to the bottom of the rock socket and then withdraw the casing to a minimum of 1 foot below the top of bedrock during grouting in an effort to minimize grout loss. A typical micropile detail is shown as Figure 9.

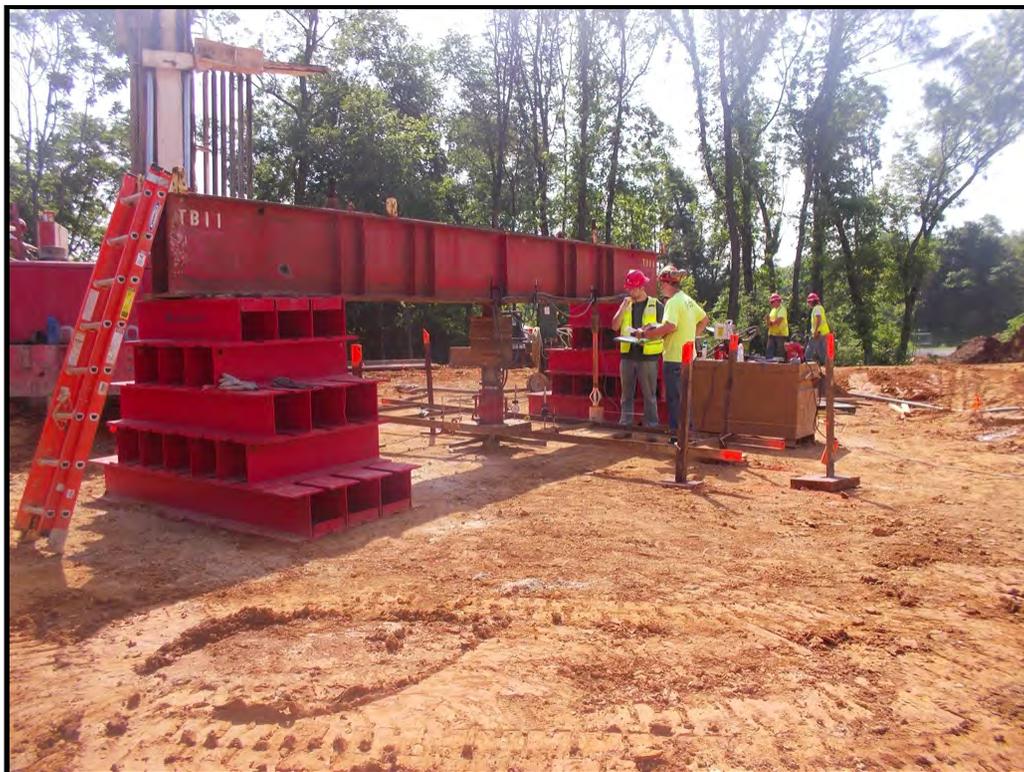
Photo 5: Micropile Load Test

A micropile compression load test was conducted in accordance with ASTM D1143 to verify that the micropile design and construction techniques were adequate to carry design loads without excessive micropile deformation (7, 8). A steel reaction beam and sacrificial reaction micropiles were utilized along with a hydraulic jack and load cell to perform the compression load test. The micropile deformations were measured using dial indicators attached to an independent reference frame. The maximum load transferred to the test pile was 250 kips, or 2.5 times the micropile design load of 100 kips. The casing movement at the maximum test load was 0.046 inches, which was less than the expected elastic deformation of the steel casing. Based on the limited micropile deformation at the maximum test load, the micropile design and construction techniques for this project were considered satisfactory. Photo 5 was taken during the load test.

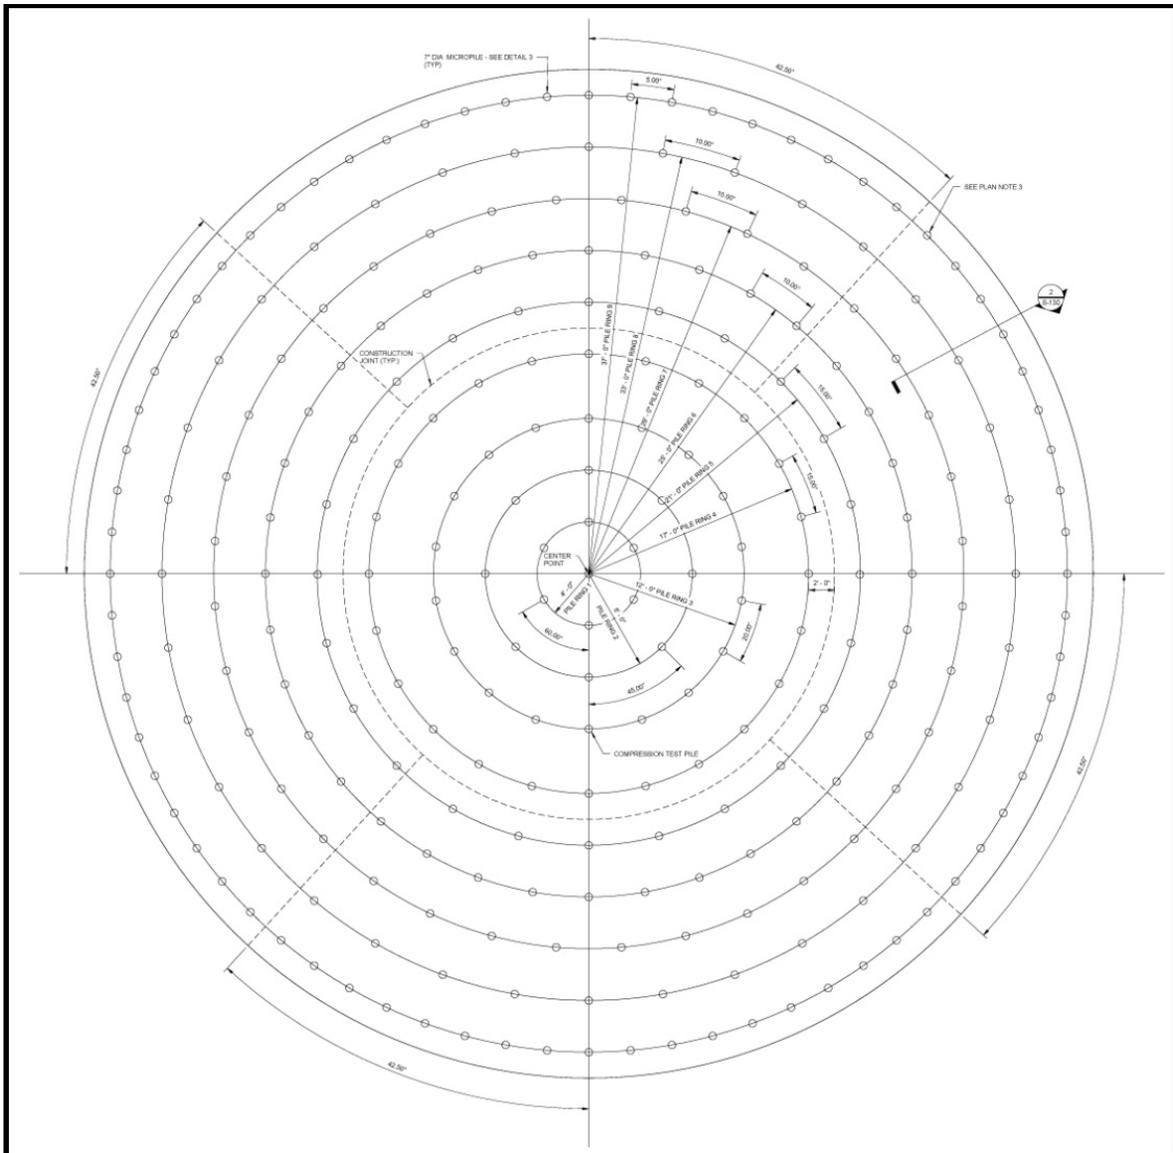
Figure 10 –Micropile Layout

Lobar, Inc. submitted the low bid to construct the structures involved with the Central Utility Plant project. Lobar, Inc. subcontracted with Nicholson Construction Company to install the 261 micropiles required to support the Water Storage Tank. Nicholson Construction Company completed micropile installation in June and July 2014. To date, the Water Storage Tank is not in service, but no foundation issues or sinkhole activity at the site have been reported. The micropile layout is shown in Figure 10.

The lengths of the installed micropiles corresponded well with the depth to rock identified in the geophysics and boring data. The longer micropiles were generally installed in the area of the Water Storage Tank that the Microgravity survey identified deeper rock. In addition, Boring GF-7 was drilled in this area and the depth to top of rock in this area was the deepest top of rock encountered in any of the borings.

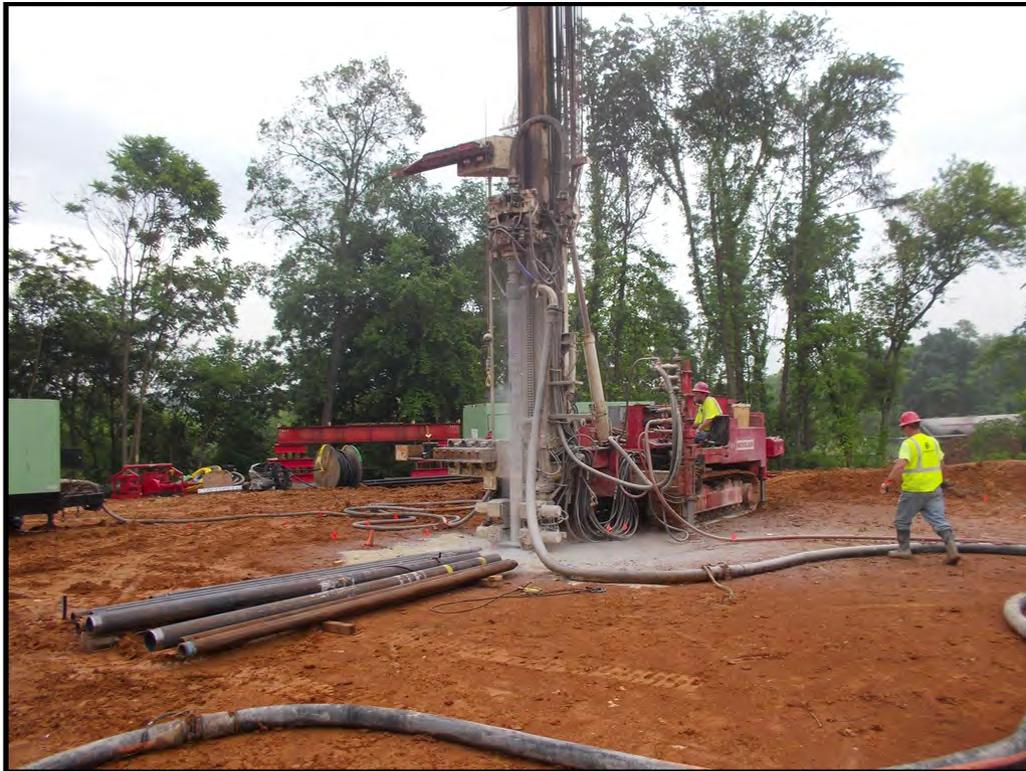
Photo 6: Micropile Installation

Photos 6, 7 and 8 were taken during micropile construction and the completed Water Storage Tank is shown on Photo 9.

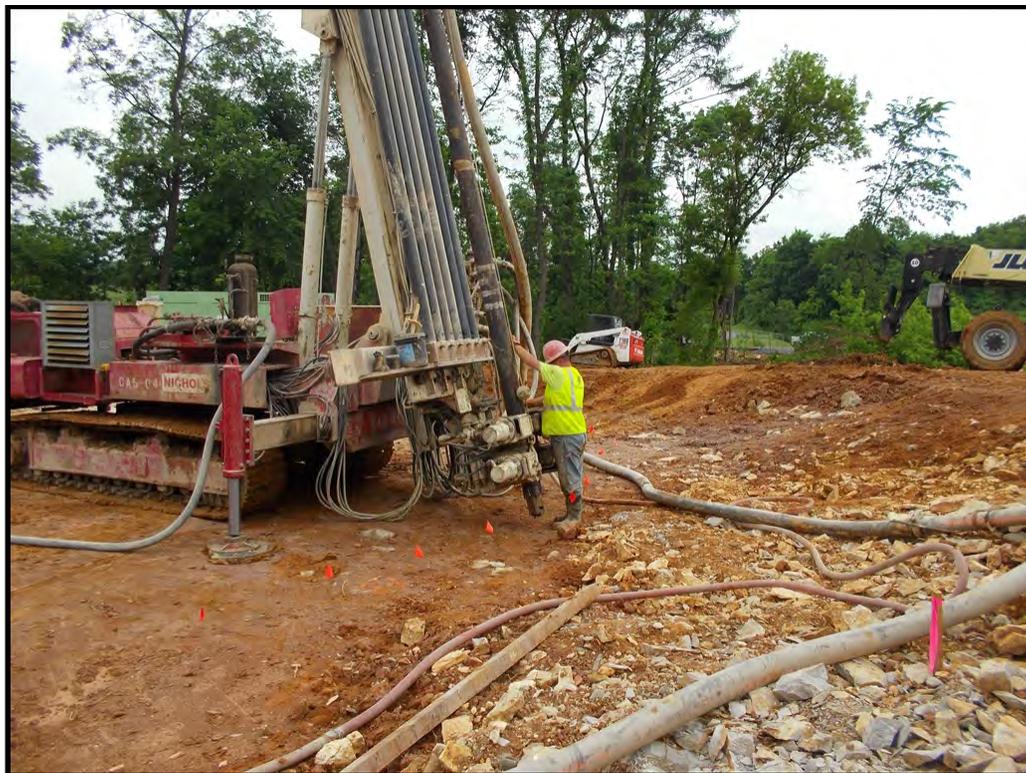
Photo 7: Battered Micropile Installation

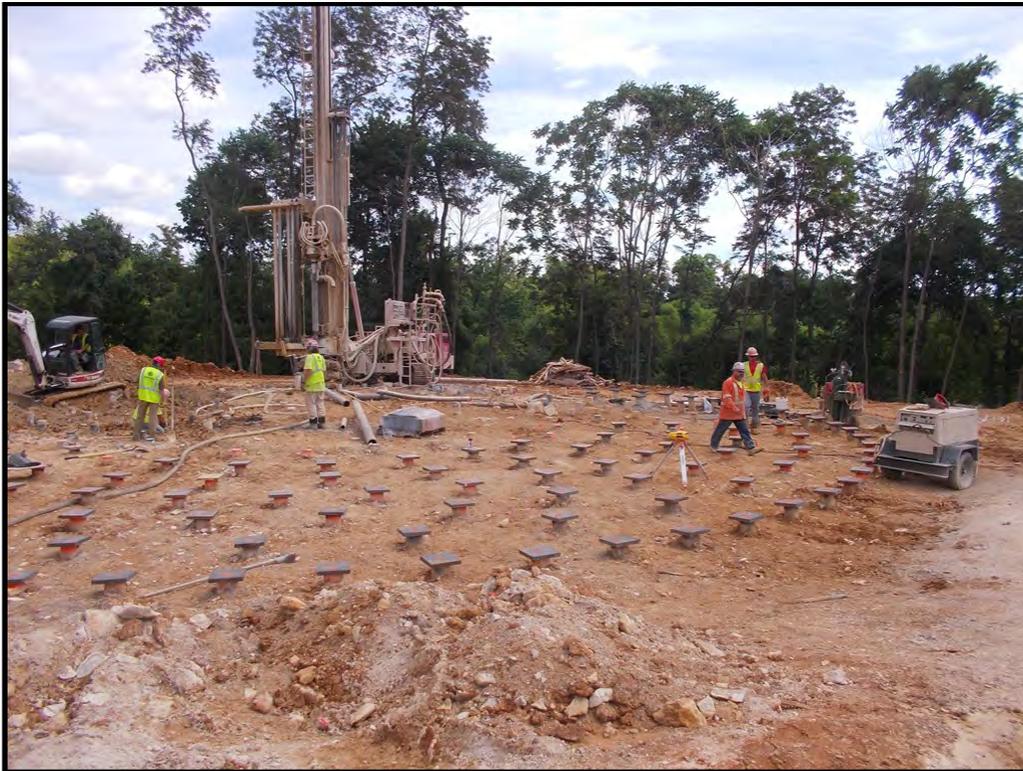
Photo 8: Completed Micropiles

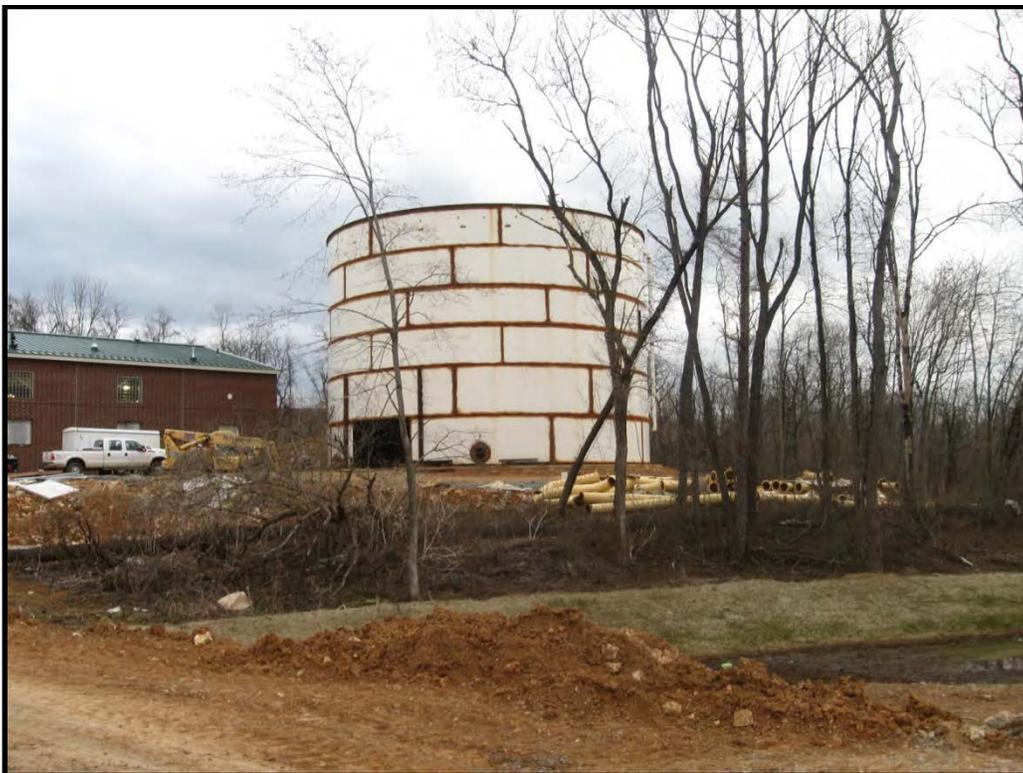
Photo 9: Water Storage Tank and Plant Building

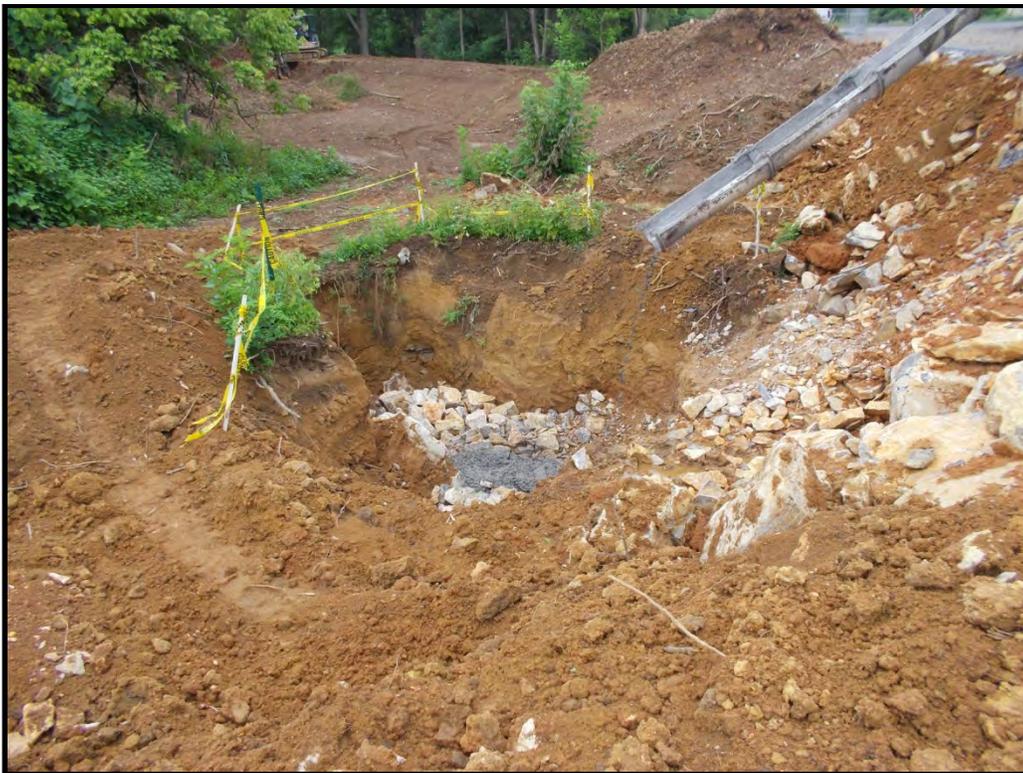
Photo 10: Sinkhole Repair

The on-site sinkhole identified within the natural swale during site reconnaissance was repaired by Lobar Inc. in July 2014. The sinkhole repair included excavation to determine the location of the sinkhole throat. The sinkhole throat was discovered and the voids in the bedrock were filled with rock fill and encapsulated with concrete. The remainder of the excavated area was backfilled with low permeability soil consisting of lean clay. A photo of the sinkhole repair is shown on Photo 10.

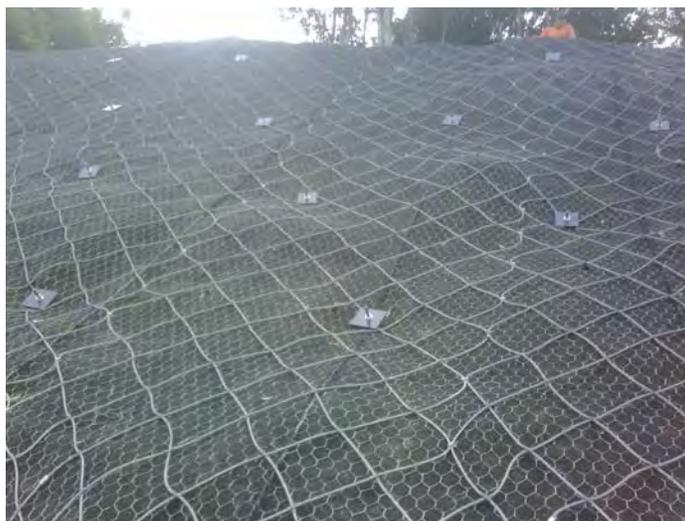
Fig. 1 - Example of soil nailing with hexagonal mesh and steel rope panel or facing.

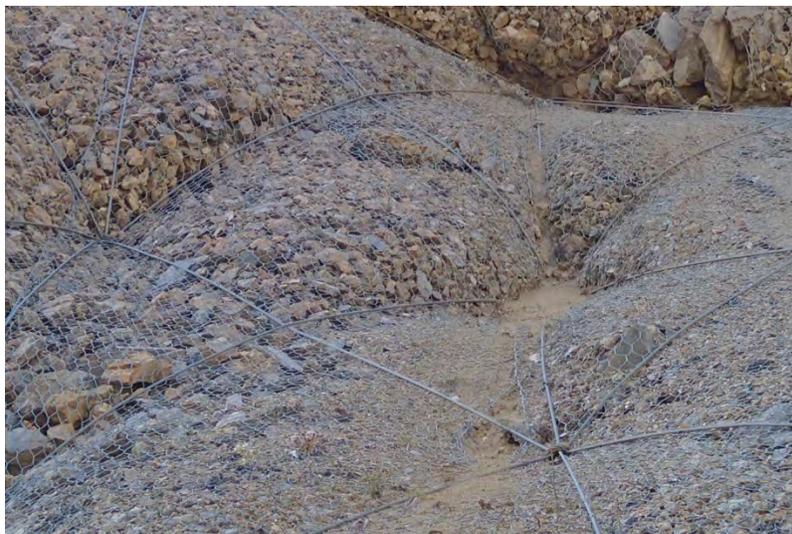
Fig. 2 - Large pockets of debris pushing on the facing and deforming the mesh.

Experience shows that the facing provides passive restraint (Turner, 2012) despite any construction effort: on one hand placing the mesh in continuous contact with the soil is not possible because of the surface morphology (Ferraiolo and Giacchetti, 2004), on the other hand pre-tensioning of the mesh by means of nail plates does not offer any advantage because the forces are short circuited just below the plate. (Giacchetti et al., 2011). For this reason, the flexible facing can never be considered as a structural fit to allow perfect cooperation between nails, especially when their spacing is wider than 1.5 m (5 ft). The flexible nature of the meshes means that the ground surface can deform and push on the facing, which will then allow formation of pockets of debris (Figure 2).

Since the test generates a typical graph load vs. deformation curve, a design approach considering Ultimate and Serviceability approaches for the structure is becoming possible. For example (Figure 2), a large deformation implicates conditions of potential stripping of the nails or an incipient rupture of the mesh (ultimate limit state). If the facing is slightly deformed, the pocket of debris should be removed before the mesh is irreversibly damaged (serviceability limit state).

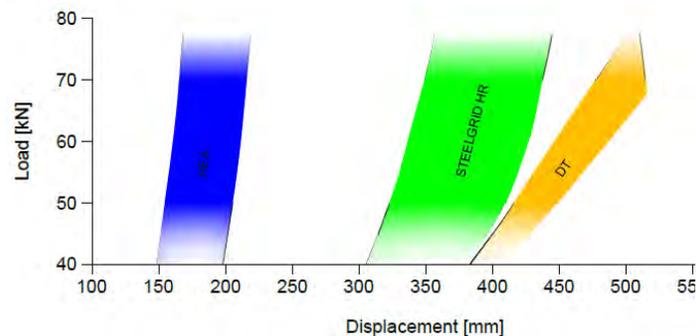
Fig. 3 Comparison between the load-displacement curves of different mesh types subject to punch tests

Based on the author's experiences and the technical literature, the main properties of the meshes are the weight per unit area, the resistance to- and related deformability under tensile and punch testing. Various studies and laboratory tests have been carried out with regard to the behavior of the meshes using various sized samples fastened to test frames with a range of constraint conditions. (Ruegger R., & Flumm D., 2000; Bonati & Galimberti 2004; Torres et al., 2000; Muhunthan B. et al., 2005, Bertolo et. al. 2007; Bertolo et. al., 2009). The results of the research highlight that the movement of meshes subject to punching ranges from several tens of centimeters (a few inches) up to one or more meters (feet), with a non-linear development of response, the trend of which depends mainly on the combination of the mesh weave, the size of

the test sample and the type of constraint with which the sample is fixed during testing. During the initial phase of loading, large displacements have been observed in all the tests. Then the mesh starts to appreciably resist the load.

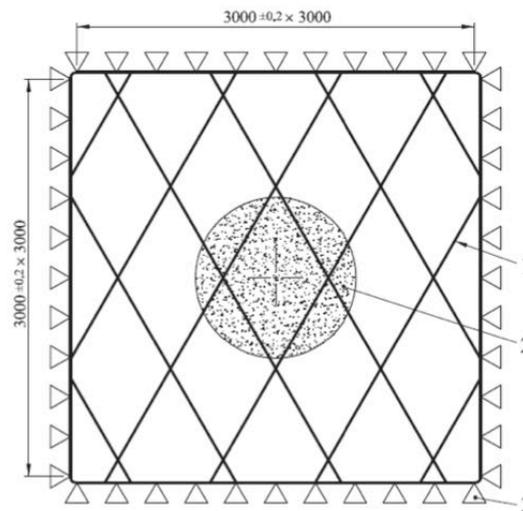
Fig. 4 Plan view of the punch test according to UNI 11437:2012. Legenda: 1 = tested mesh; 2 = punching device (1.0 m (3 ft) in diameter); 3 = perimeter constraint between the mesh and the frame.

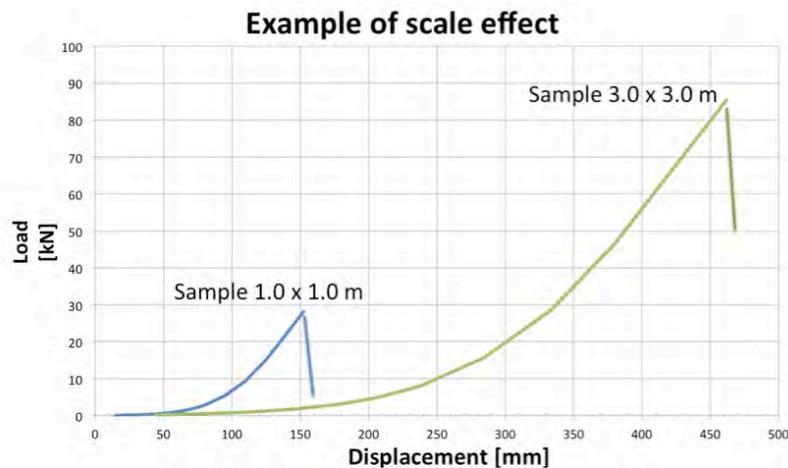
Fig. 5 Graph Displacement VS Load with the typical scale effect in the punch test

The constants (μ_x, μ_y) are scale coefficients that correlate the mechanical behaviour of the net as a function of the sample dimensions (the distance between the nails on the jobsite application). Maccaferri has been able to get reliable values because of the large amount of data they have collected during many tests.

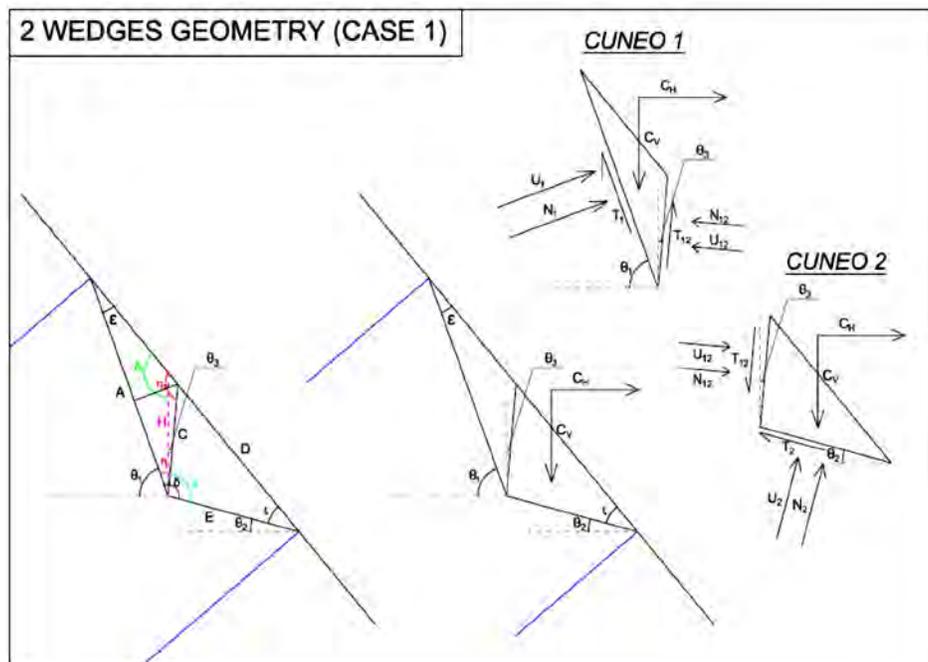
Figure 6 – Two wedges mechanism of failure

The short term solution is divided in two sub-analysis; in particular two wedges are analyzed (Figure 6) and along with a one wedge (Figure 7) mechanism of failure to consider every possible collapse. The minimum value of safety factor obtained from the two methods is compared with the limit value of 1.0:

The analysis is carried out evaluating the forces acting on the two wedges faces and the value of the safety factor (FS). You get 2 equations of equilibrium to the translation (vertical and

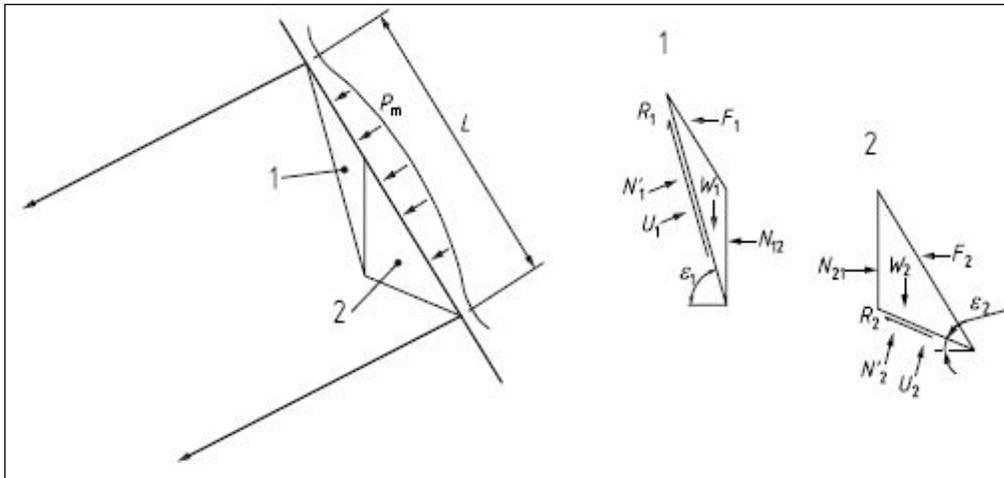
Figure 8 – BS 8006-2 Figure 32 - Calculation of design loading acting on a simple flexible facing

The calculation procedure for the load acting on the facing is conducted, according to the BS 8006-2 procedure with reiterative analysis using the method of the two wedges (with possible seismic load). This calculation method maximizes the force acting on the net analyzing every possible geometrical configuration of the two wedges (combinations of angles ε_1 and ε_2 - see Figure 32 BS 8006-2).

The analysis calculates the forces acting on structural flexible facing according to BS 8006-2.

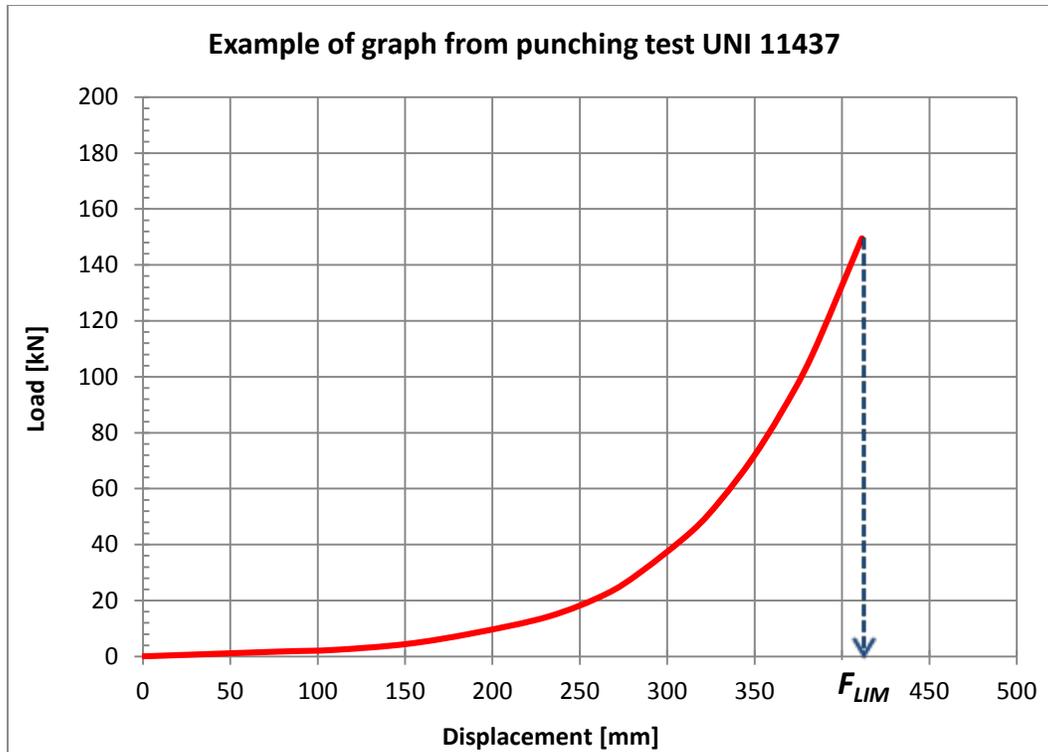
Figure 9 – Punching test graph according UNI 11437

The limit load tolerated by the net (F_{lim}) is directly estimated from the characteristic curve of the punching test.

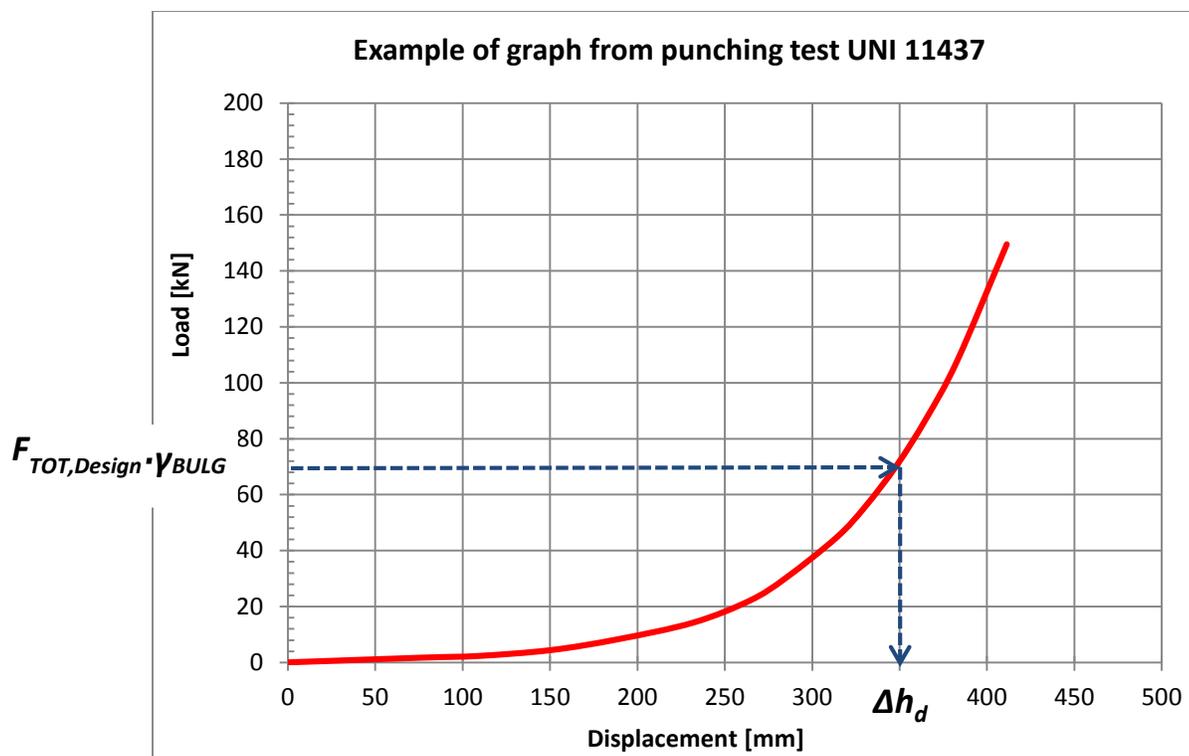
Figure 10 – Punching test graph according UNI 11437

$$F_{TOT,Design} \cdot \gamma_{BULG} \rightarrow \Delta h_d \quad [19]$$

Where γ_{BULG} is the amplifying coefficient that takes into account the slope irregularities. This value should never be less than 1.5.
