HGS 2016  
Proceedings

# 67TH HIGHWAY GEOLOGY SYMPOSIUM

## JULY 11 – 14, 2016

Cheyenne Mountain Resort  
COLORADO SPRINGS, COLORADO

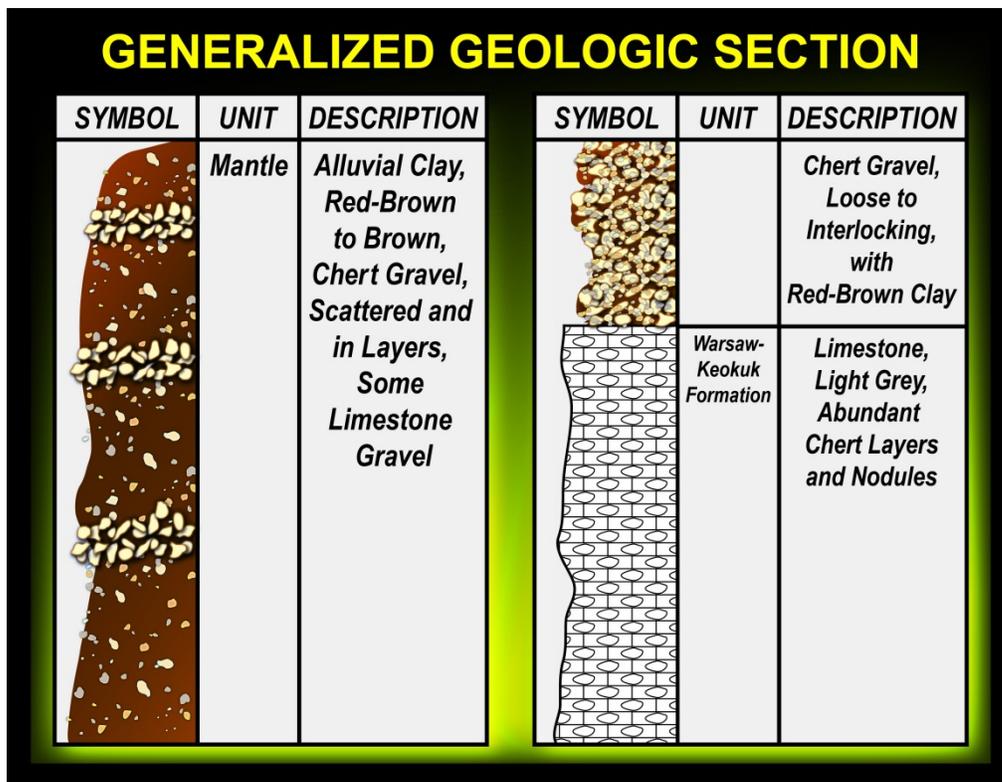
Figure 2: Simplified geologic section of the stream crossings on the project.

Seven of the proposed bridges cross a perennial stream (an unnamed tributary to the Spring River), while the other two structures carry traffic over the new 4-lane. Preliminary drilling and past projects showed us that depth to the Warsaw-Keokuk Limestone at these locations varies from 2 feet to over 30 feet, but at most foundation elements the depth is 10 to 20 feet (Figure 2). There were two concerns about the resistivity survey; the biggest uncertainty was the groundwater level. If the ground was saturated at or above the bedrock contact, it would likely be impossible to discern any useful information about the configuration of the limestone. Also, do dry chert gravel and dry limestone have such similarly high resistivities that would prevent discerning shallow interfaces in the upland locations? On the other hand, a dry bedrock contact should stand out because of the high contrast between limestone and clay, such as might be found in the valleys. With these questions in mind, we set our electrode spacing at 2 feet, to get the highest resolution in the 10 to 20 foot depth range.

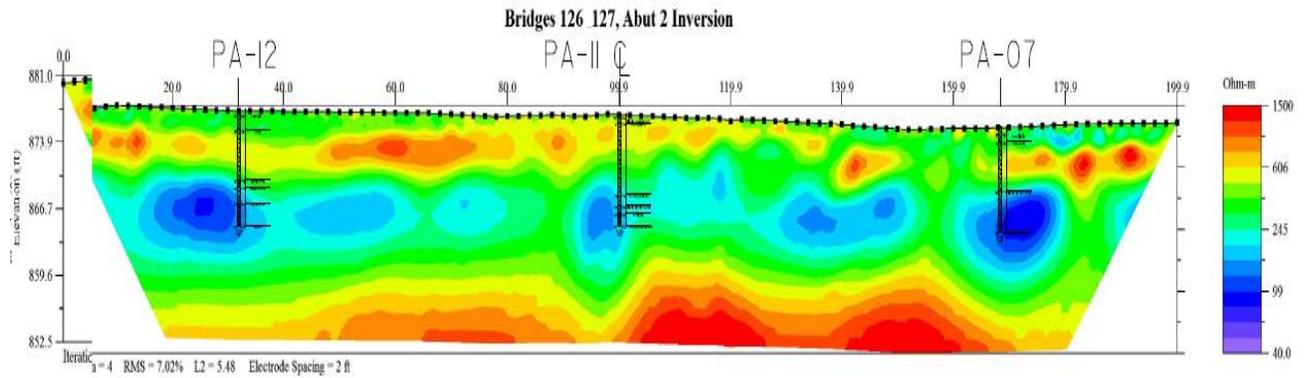
**Figure 3: Inverted section at one of the stream crossings, interpreted as a flat-lying limestone contact. The chert gravel that fills stream channels complicated data collection, and only 2 of the 4 lines at this bridge location gave useful information.**

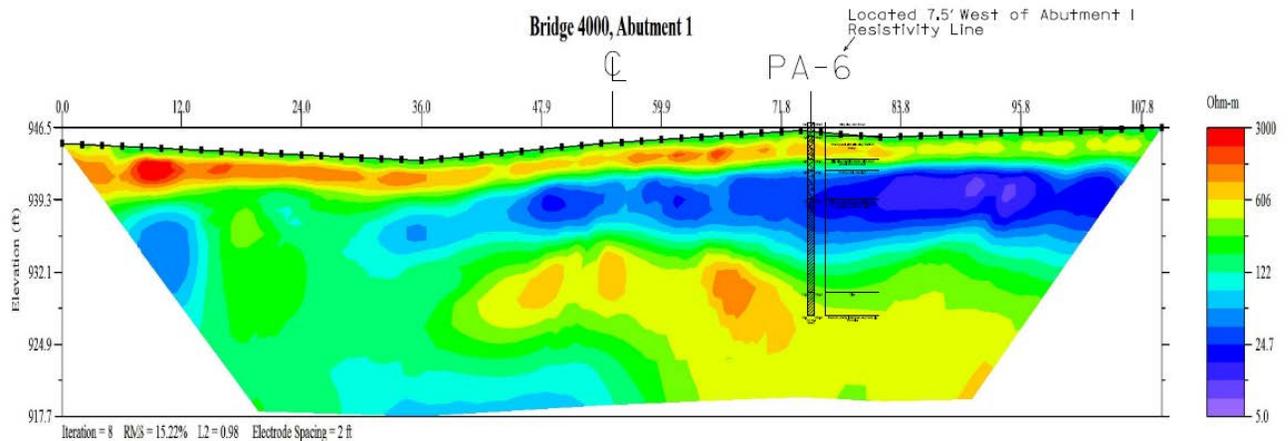
**Figure 4: Inverted section at the bridge on Star Road. Notice the higher-resistivity feature (yellow and orange) extending from right to left of centerline.**

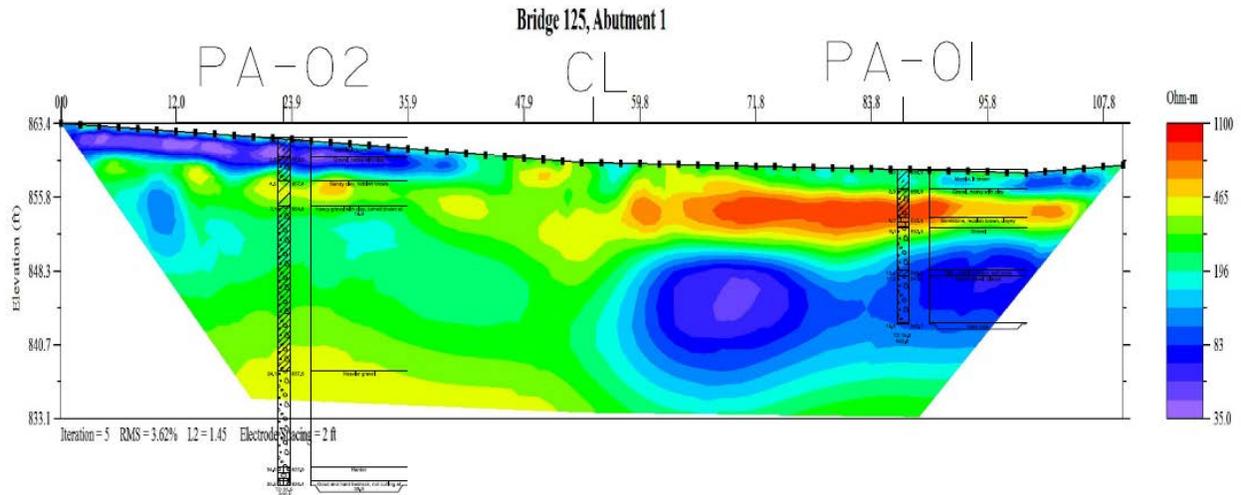
**Figure 5: Inverted section at US 400 bridge over US 166. The large bullseyes of low resistivity (blue and purple) could not be easily explained.**

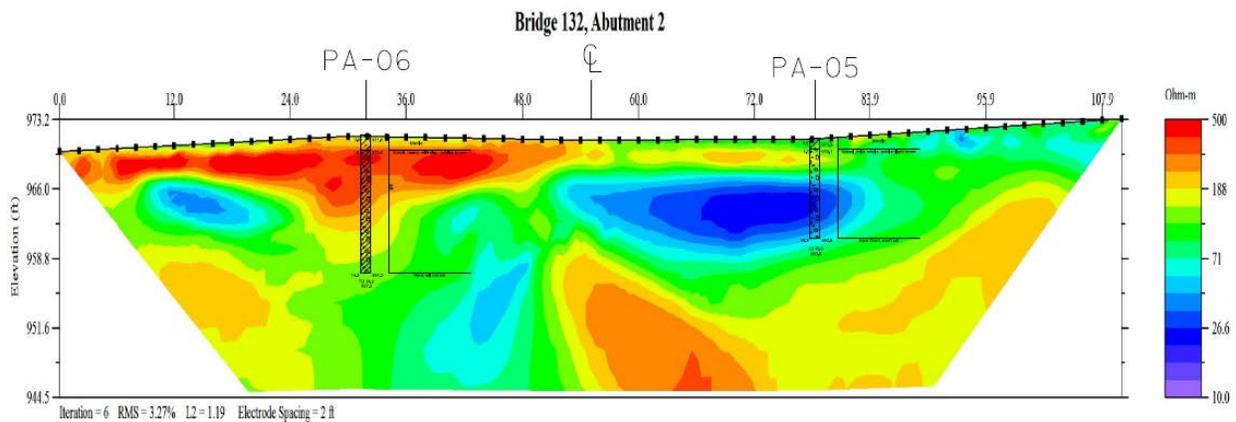
**Figure 6: Inverted section at K-26 over US 166. The high-resistance areas (red) near the surface left of centerline are buried bricks. The remainder of the interpretation eluded the author.**

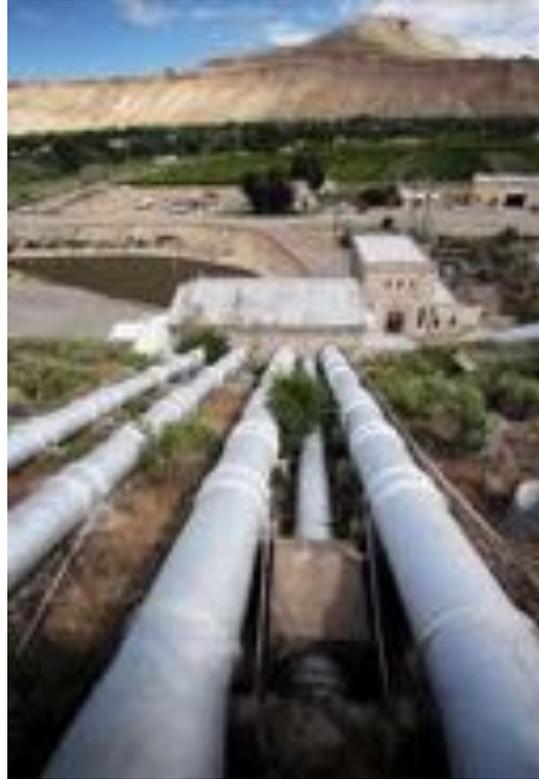
**FIG. 1. Orchard Mesa Irrigation Pump House Penstocks**

After the power station uses the required flow to operate the turbines, the remaining water flows through 4 additional penstocks that feed the pump house, shown in Figure 1. The pump house penstocks provide hydraulic energy that powers pumps that deliver water to the upper (canal 2) and lower (canal 1). Canal 1 then travels towards the 38 Road MSE Wall in a pipe system before the siphon carries the water under 38 Road. The siphon is a 54" bell and spigot pipe system, likely constructed in the 1960's, that transfers the irrigation water directly below 38 Road to the 4,300 acres of farmland that surrounds the lower canal.

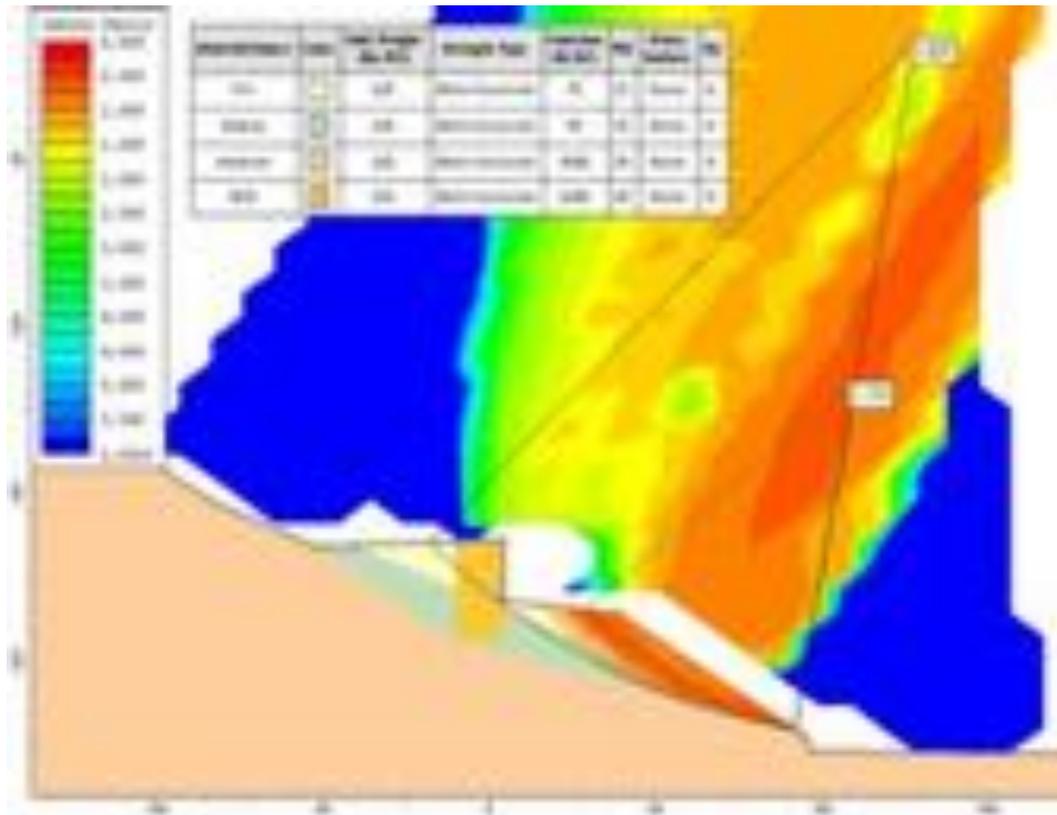
**Figure 3 - Preliminary Typical Cross-Section**

The extra width provided by the MSE wall construction required the wall to be founded on competent bearing material to support the additional surcharge applied to the system by the retaining wall facing, backfill and traffic. The typical cross-section below in Figure 3 shows the geometry of the MSE wall construction with the estimated subsurface layers. Due to the emergency nature of the repair and the possibility that the wall could experience a catastrophic failure at any moment, there was not sufficient time to provide additional subsurface borings and geotechnical data before GSI's design could be finalized and implemented. GSI design engineers provided a preliminary design for the emergency repair based from past geotechnical data and experience with the local geology, as well as a back calculation of existing conditions. The preliminary design provided a foundation for field engineering and allowed flexibility during the construction process to address changes in conditions that may occur.

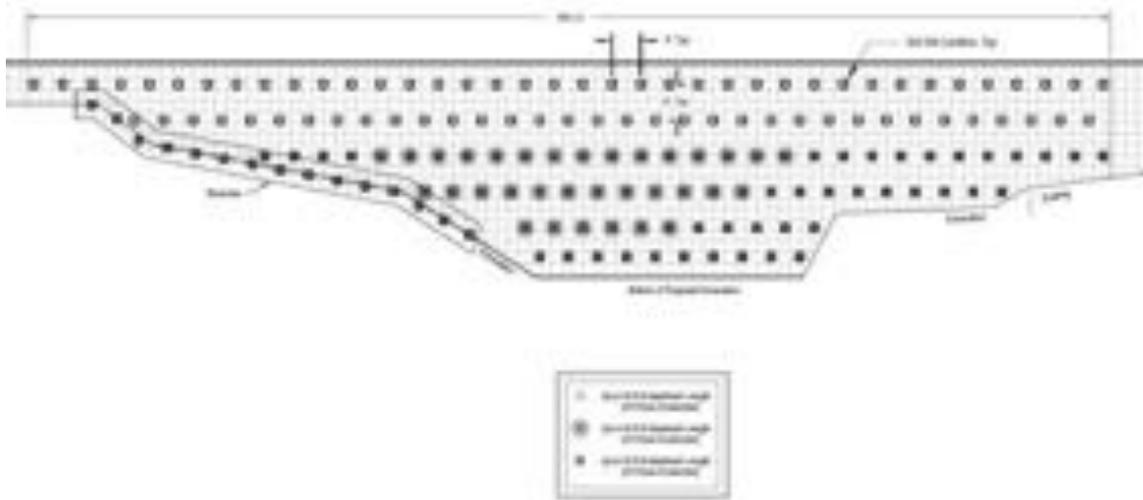
Figure 4 – As-Built Elevation View

The design for the wall failure utilized hollow bar soil nails (HBSN) that increased the resisting forces to counteract the driving forces of the failure. The HBSNs designed for the repair were installed in various lengths as shown in the elevation view in Figure 4 below. The soil nails are installed directly through the wire basket face, through the granular fill of the existing MSE wall and into the undisturbed material near the inboard edge of the roadway. The soil nails penetrated through the wall fill into the undisturbed material and were embedded past the failure zone and successfully confined the failing material wedge behind the MSE fill to stable material.

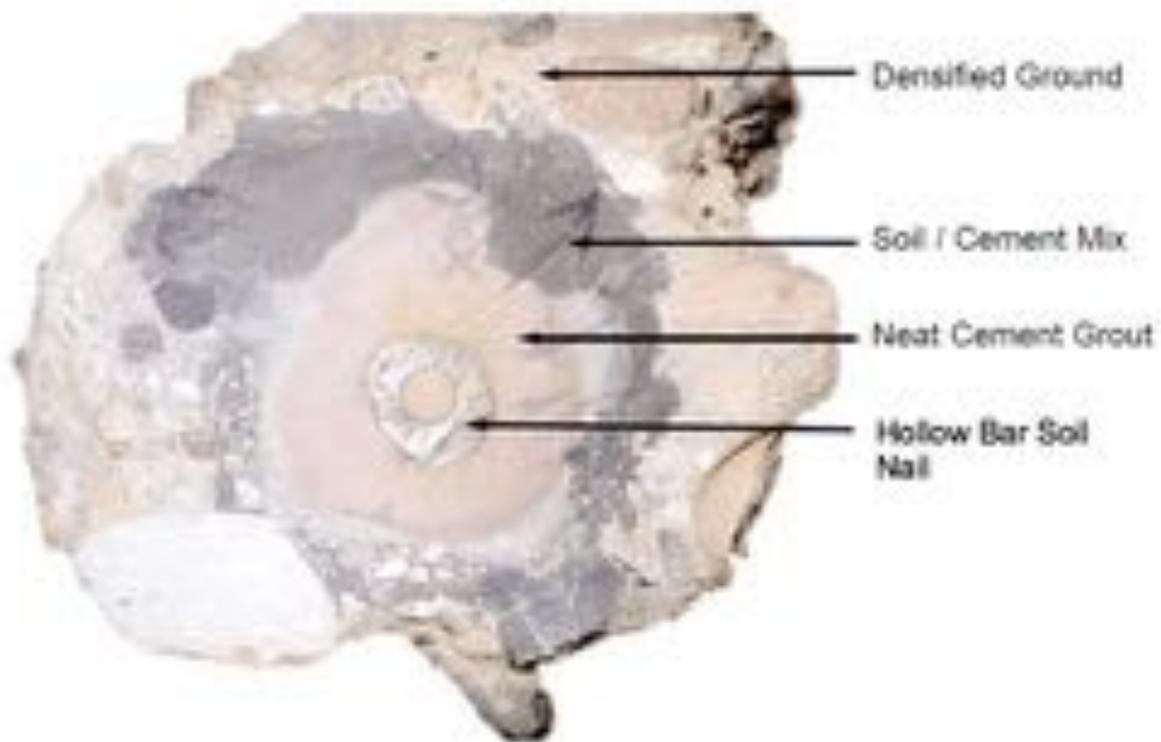
**Figure 5 – Typical Cross Section for HBSN Grout Column**

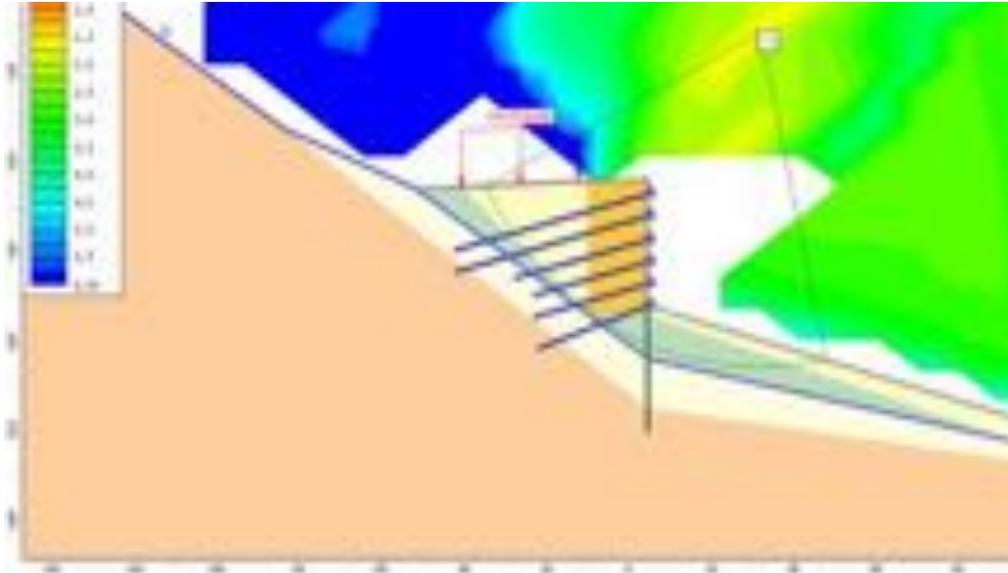
**Figure 6 - Typical Cross-Section Repaired Model w/ Micropile**

The cross section above represents a typical view of the proposed soil nail repair that was designed and installed by GSI crews. The soils nails vary in length from 30-50 feet according to the output information from the limited equilibrium modeling software. The micropiles shown in this image represent a design iteration that was field engineered once the bedrock was located. In lieu of the micropiles as shown above, compaction grouting techniques were implemented to provide the required bearing capacity needed to satisfy global stability. Figure 7 shows the Factor of Safety (FoS) of the repair solution without the micropiles for additional bearing support.

In Figure 6, the subsurface conditions were modified based on the drill logs acquired from the soil nail installation. The undisturbed shale bedrock layer was found to be located farther below the bottom of the constructed MSE wall system than initially expected. The engineering team then modified the soil nail repair system to account for the change in conditions without additional cost to Mesa County.

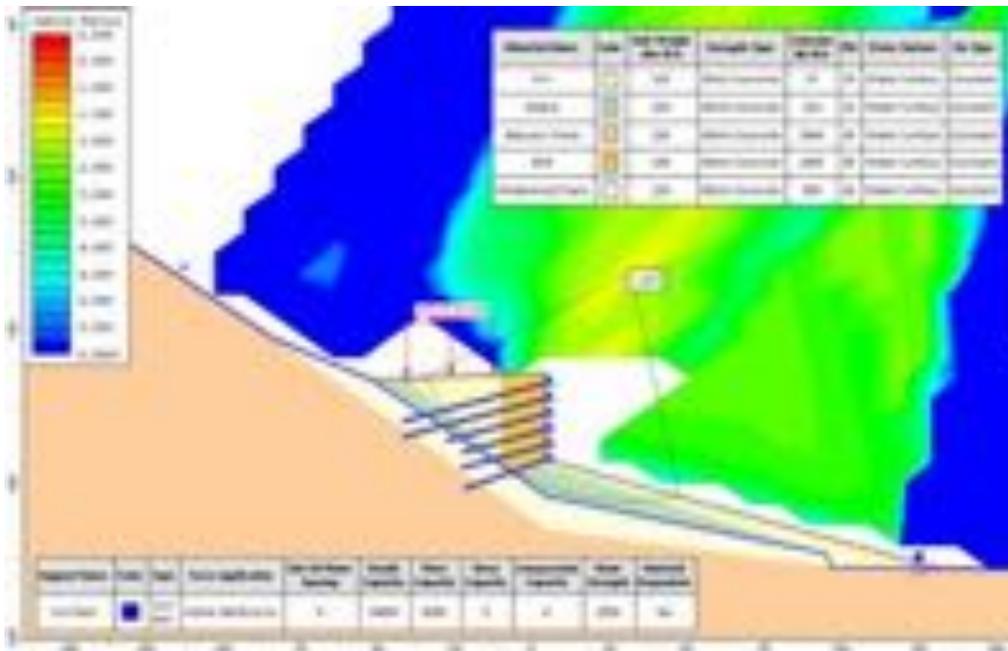
**Figure 7 - Typical Cross-Section Repaired Model**

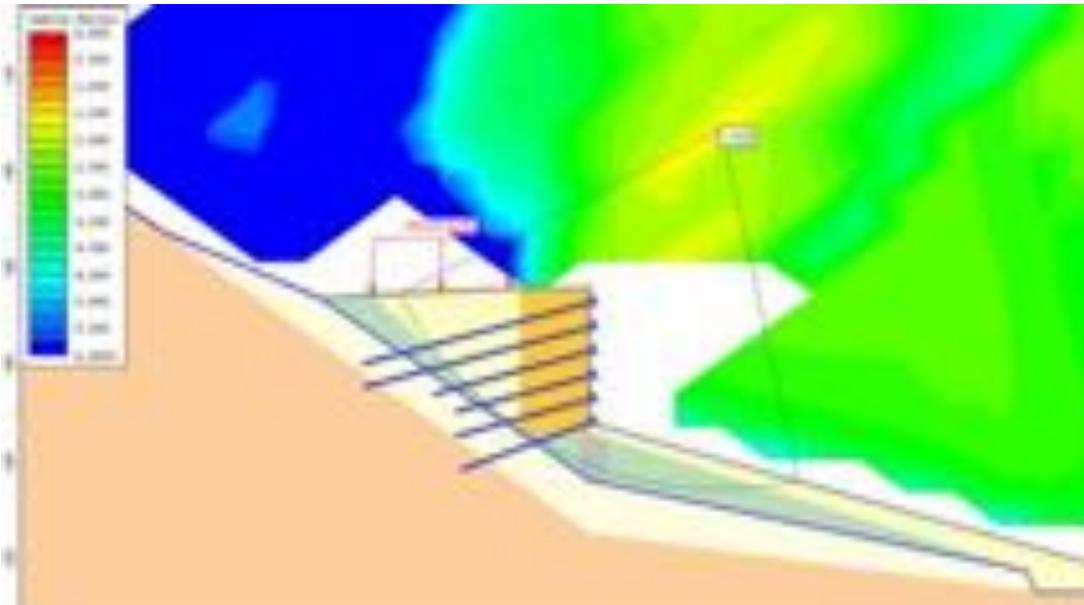
**Figure 8 - Typical Cross-Section Repaired Model**

resistance to the stability while the compaction grouting at the base provided the required bearing capacity to aid in resisting the settlement. The second location for compaction grouting was located directly below the roadway platform. During the initial wall failure, lateral and vertical movements created voids at the interface between the wall backfill and the existing roadway fill. The low slump grout material was strategically installed in the trouble areas to fill the voids and densify the soil. The grouting procedures were carefully monitored to avoid unwanted heaving or displacement of the roadway or wall. Figure 8 shows the compaction grouting zone near the base of the wall.

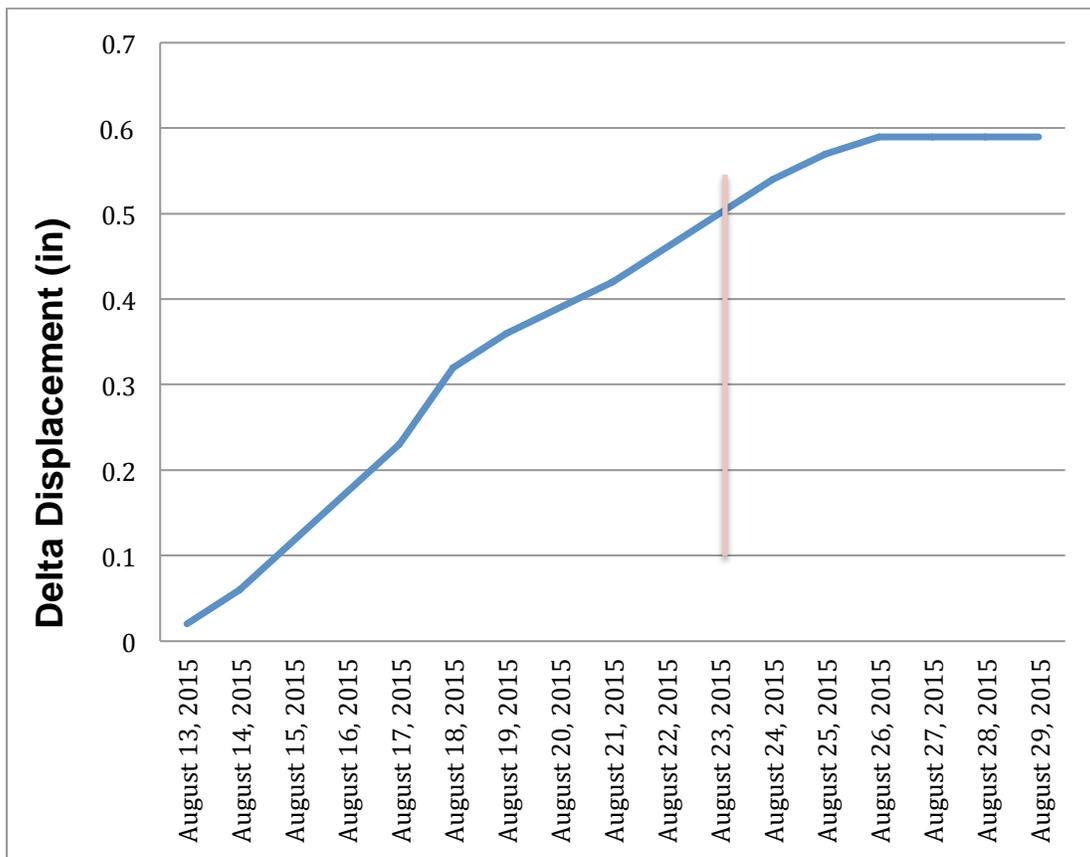
Figure 9 - Wall Face Displacements at Station 26+00

The graph below in Figure 9 represents the outside wall face displacement in relation to date of each survey. Prior to the GSI repair, survey targets were installed on August 13, 2015 once tension cracks in the new pavement began to develop. The targets were routinely surveyed to monitor the movement and eventually provide Mesa County proof that a mitigation plan was necessary. The movement increased in a linear trend until August 26<sup>th</sup> when crews installed 5,940 lineal feet of soil nails into the failing section of the MSE wall. Through decisive and quick thinking from the County, the wall could be stabilized at the current alignment and height. If the movements were allowed to continue, global failure would have resulted in a catastrophic collapse of the wall and roadway platform, as well as the Orchard Mesa Irrigation District siphon.

Due to the severity and consequence of failure and not knowing when the inevitable collapse would occur, the engineering team decided that the center and worst area of the wall should be stabilized first. That decision turned out to be correct when the siphon water line finally compromised enough by the movement to severely leak, inundating the site with irrigation water. Figure 9 shows the movement of the wall was counteracted between August 24, 2015 and August 26, 2015. That is important because August 24, 2016 was the day the fill material below

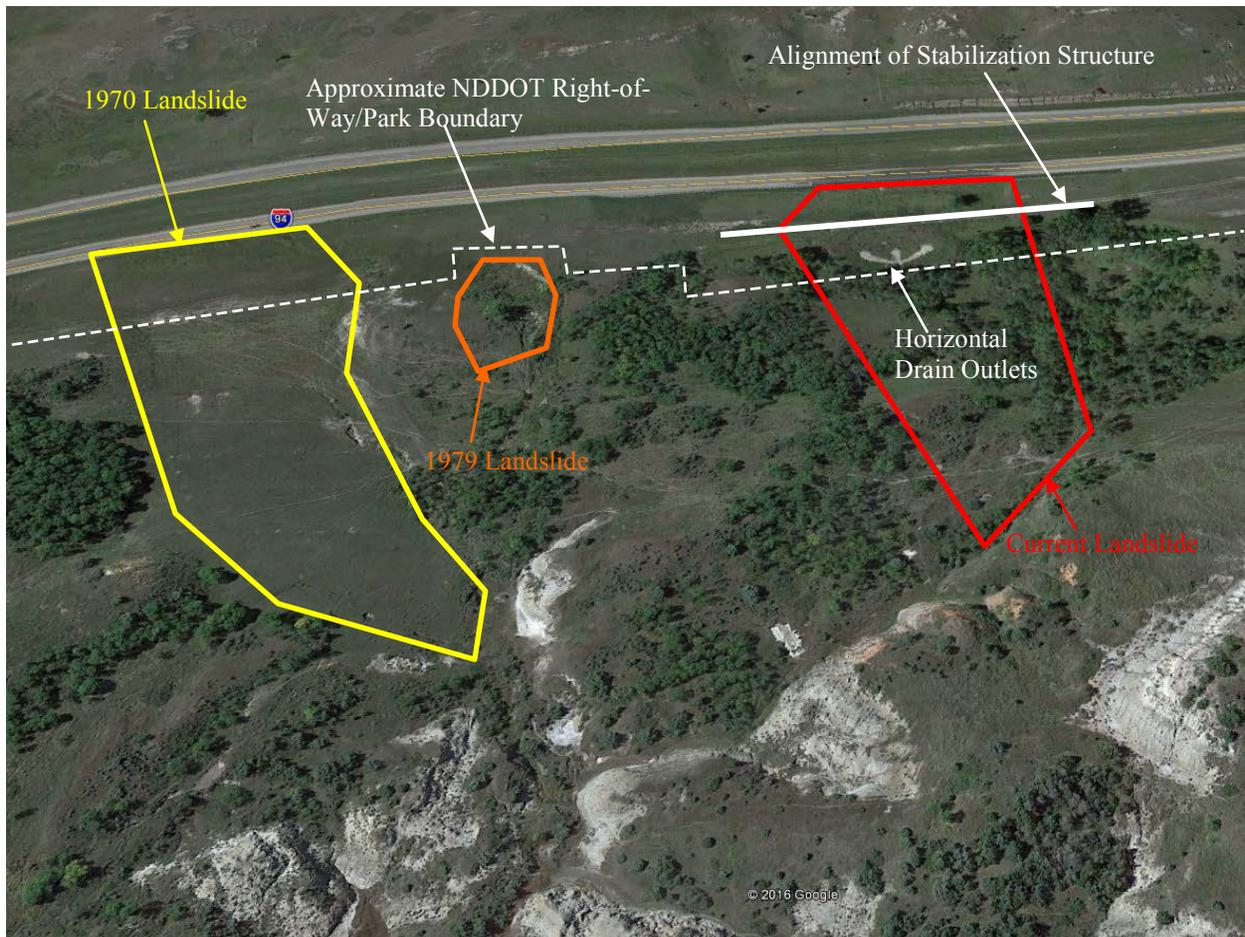
**Figure 2 – Oblique Aerial View of Site.**

The approximate location of the alignment of the structure is shown in Figure 2. A typical section showing a schematic of the repair is shown in Figure 3. A plan and elevation view of the structure are also shown in Figure 4.

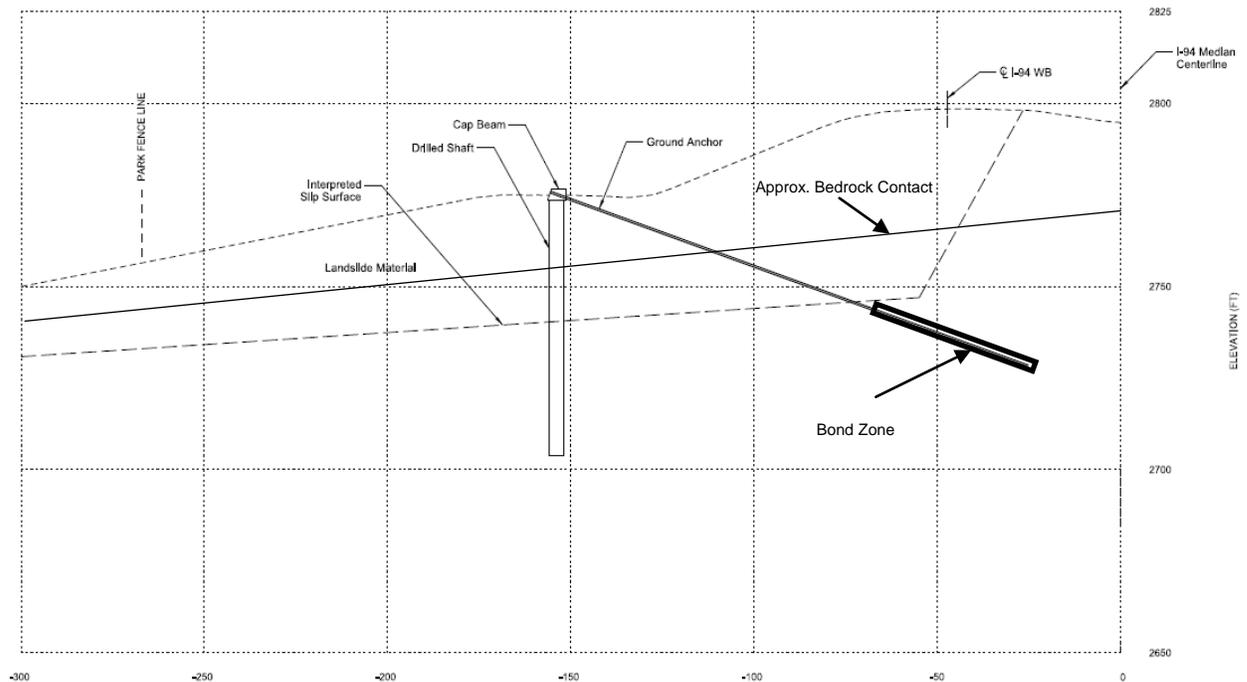
**Figure 3 – Schematic Cross-Section of Repair**

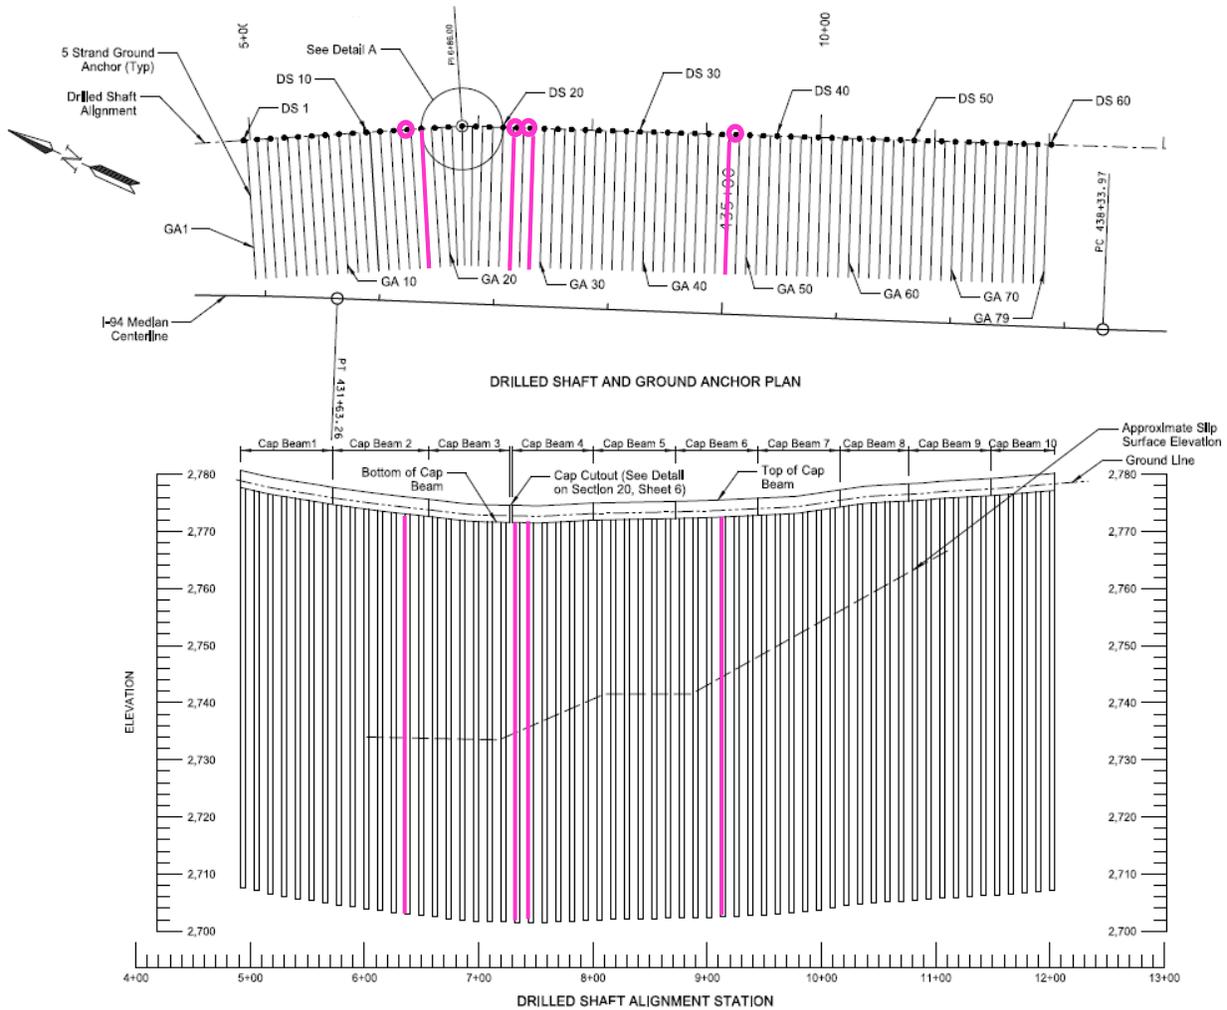
**Figure 4 – Plan and Elevation View of Landslide Stabilization Structure (instrument locations shown in pink).**

The above instruments were installed at four different instrumentation installations located along the length of the wall (see Figure 5). The load cells and elasto-magnetic sensors are currently being monitored with a data acquisition system, while the NDDOT is taking manual readings of the inclinometers.

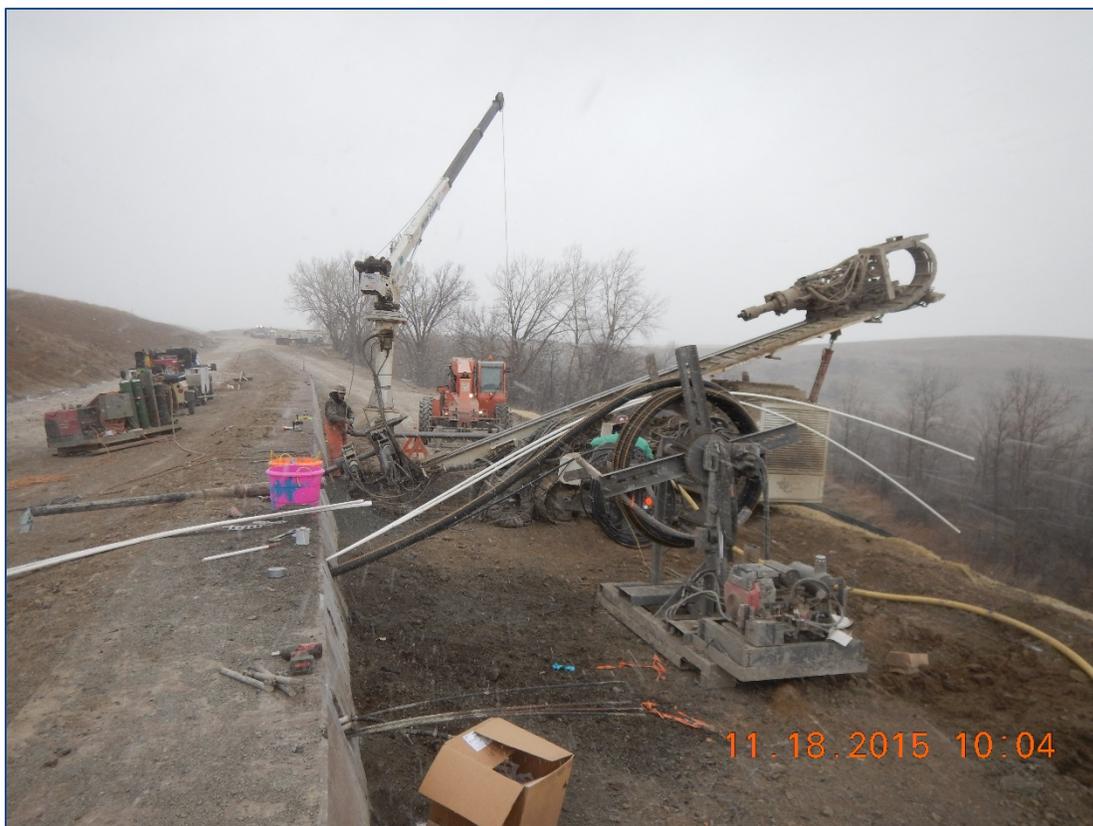
**Figure 5 – Photo Showing Installation of Production Ground Anchors through Cap Beam (Note drill rig in background and uncoiler in foreground).**

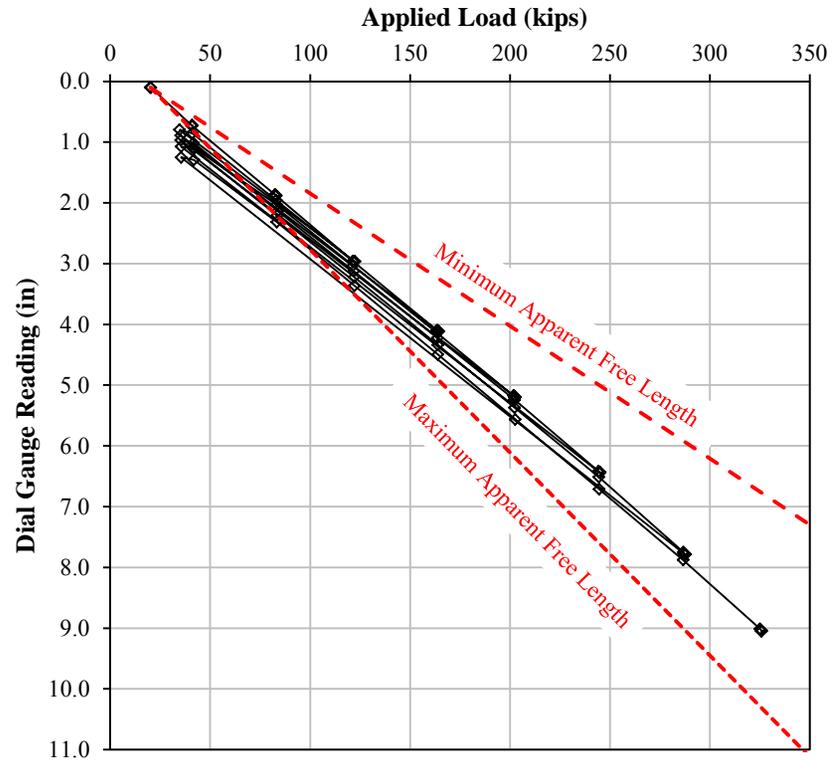
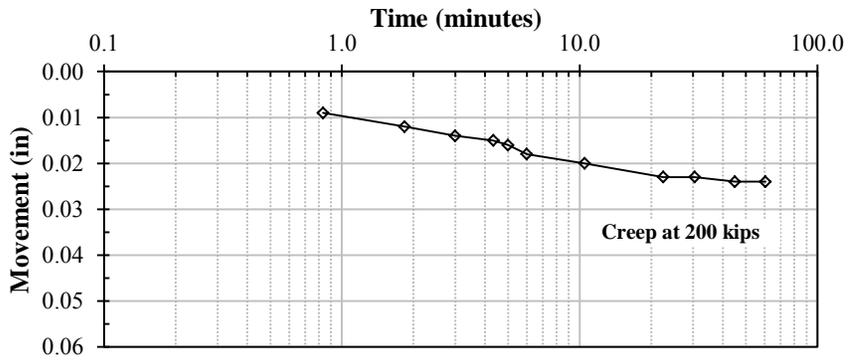
Figure 6 – Sacrificial Anchor 1 Test Results

Results for the tests are presented in Figures 6 and 7 for each anchor as plots of force versus displacement and creep displacement. The force-displacement plots also include conventional minimum and maximum apparent free length criteria, where the minimum apparent free length is assumed equal to the jack length plus 80 percent of the design free length and the maximum apparent free length is assumed equal to 100 percent of the free length plus 50 percent of the bond length plus the jack length. Creep data are provided for a load of 200 kips (the load increment closest to the factored design load of 191 kips).

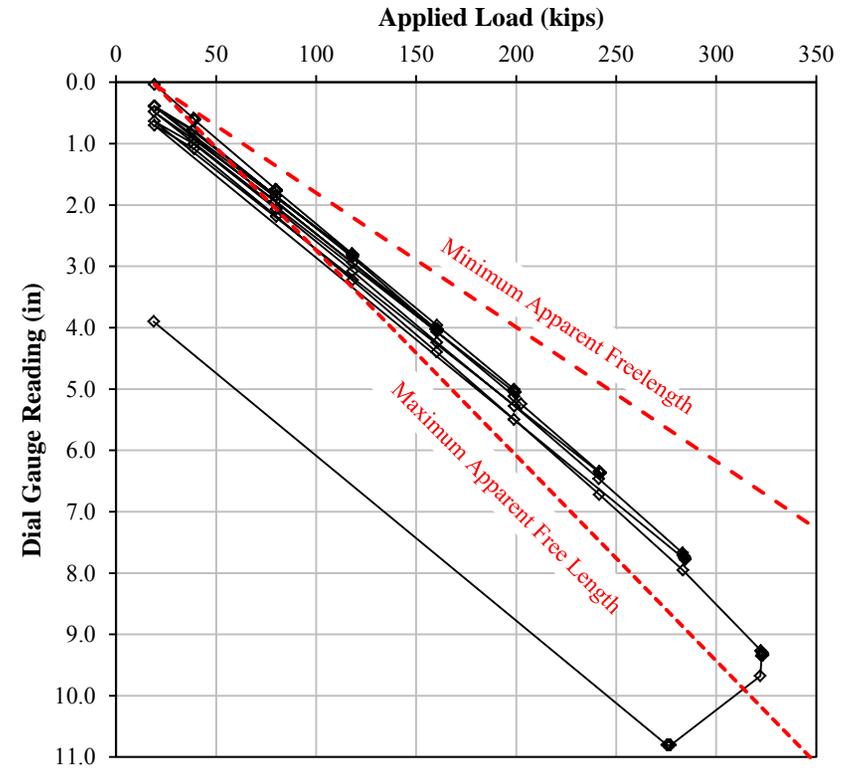
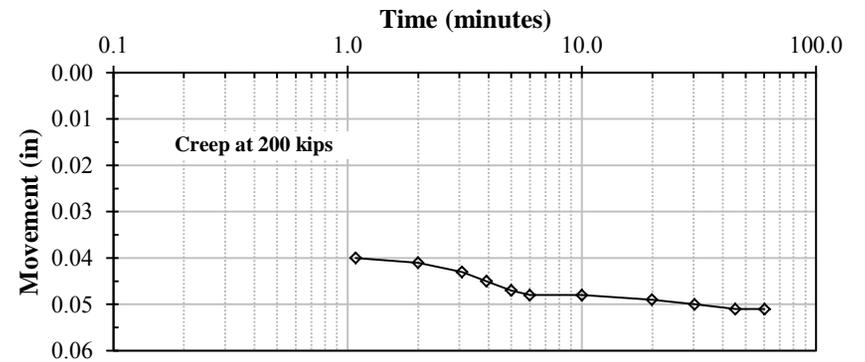
Figure 7 – Sacrificial Anchor 2 Test Results

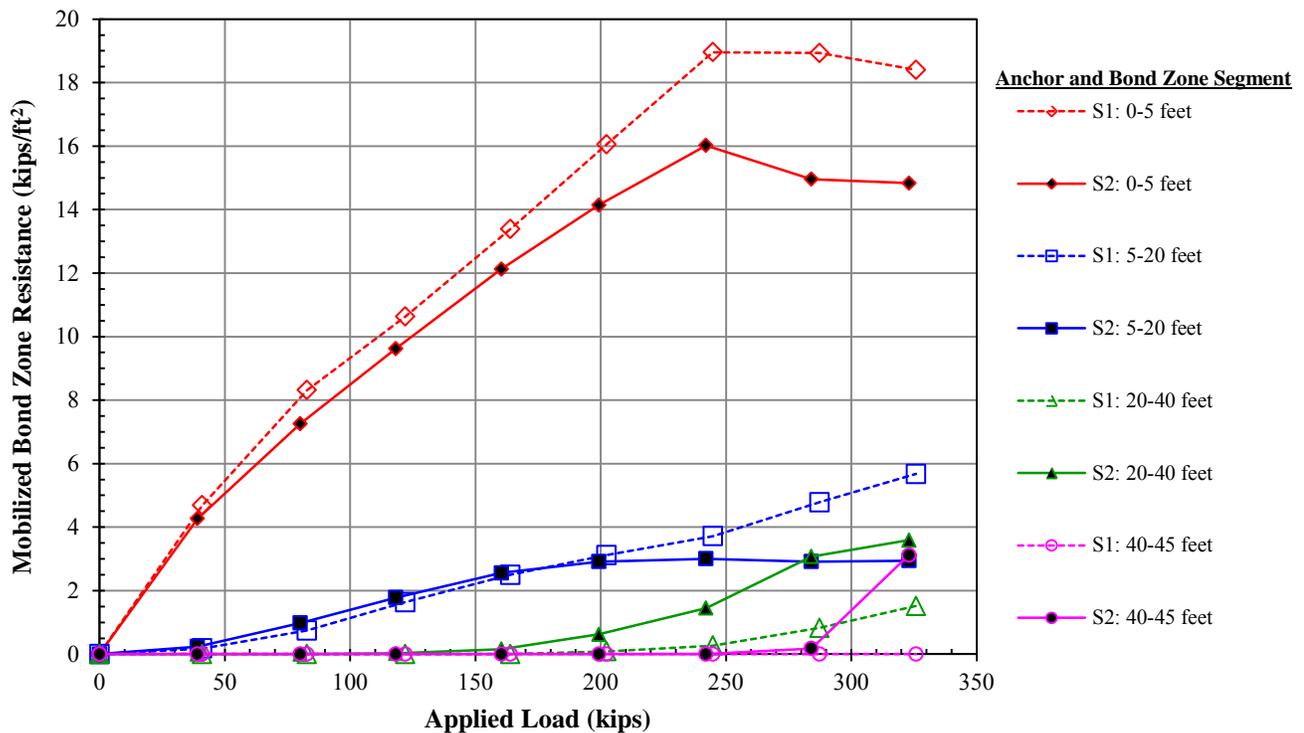
**Figure 8 – Verification Test Results, Mobilized Bond Resistance by Segment of Bond Zone**

Data obtained from the elasto-magnetic gages installed in the bond zone are presented in Figure 8 as mobilized bond resistance for four segments in the bond zone versus applied load (jacking force). The load readings obtained from the gages were converted to mobilized bond resistance assuming no load transfer in the free length, linear load transfer between adjacent gages, and a bond diameter of six inches.

As shown in Figure 8, both anchors mobilized the majority of their resistance in the front 5 feet of the bond zone, where the maximum mobilized bond strength ranged from about 16 to 19 ksf. Substantially less resistance was mobilized in the next segment of the bond zone (5 to 20 feet), where the maximum mobilized bond strength ranged from 3 to 6 ksf. Essentially no load was mobilized in the back 5 feet of the bond zone in either anchor. However, as pull out failure occurred in S2, about 3 ksf of bond strength was mobilized at the back of the bond zone.

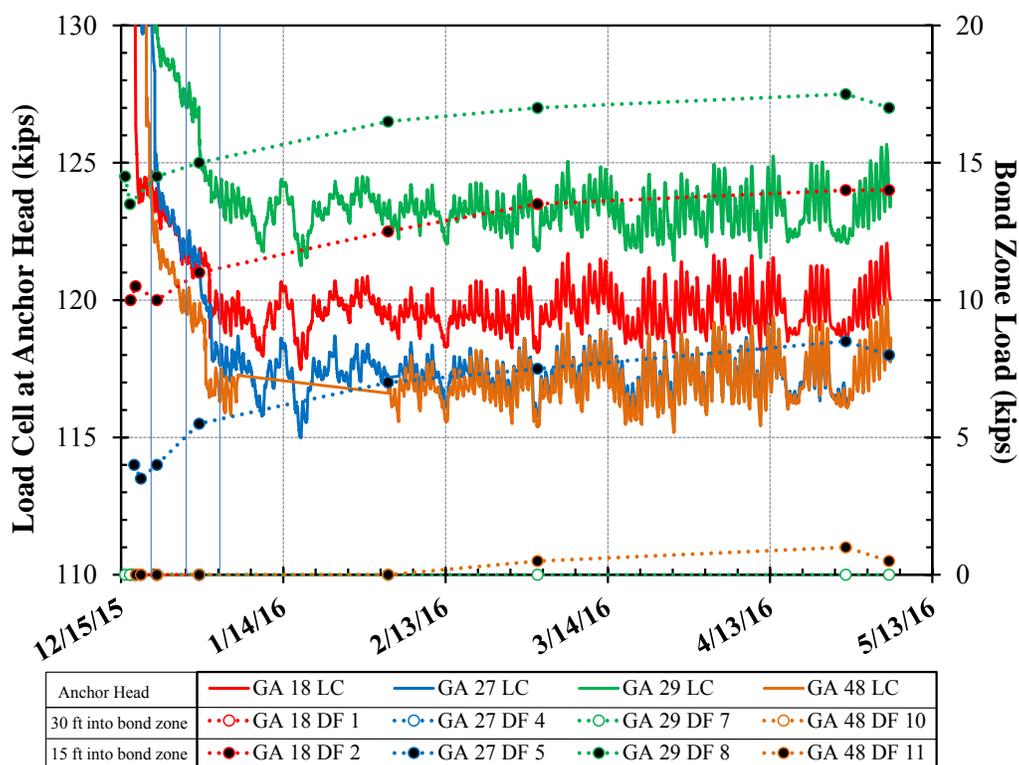
**Figure 9 – Post-construction Monitoring Data, Load Cells and Bond Zone Force Gages**

Post-construction data from the ground anchor load cells and elasto-magnetic sensors installed in the anchor bond zones are shown in Figure 9. Additionally, representative data from one of the four inclinometers installed in drilled shafts are shown in Figure 10 as a plot of cumulative displacement versus depth. In reviewing the data, it should be noted that past monitoring of the landslide indicates that the greatest slope movement typically occurs in June and July. The monitoring data is currently limited to December through May, a period where the landslide movement is comparatively less. However, NDDOT will continue to monitor the instrumentation on a quarterly basis. Indications of distress in the pavement in the landslide area have not been observed since project completion.

The four instrumented ground anchors were locked off between December 15 and December 17, 2015. Following lock off of the instrumented ground anchors, stressing of the remaining anchors continued through December 21, 2015. The data show a reduction of about

20 to 30 kips in the measured anchor load as adjacent ground anchors were tested and locked off. About one week after the anchors were all locked off, the load in the instrumented anchors had essentially stabilized. Since then, the anchor loads have held relatively steady, except for minor diurnal fluctuations that are likely temperature-related.

Similar to the sacrificial ground anchors, the monitoring data suggests that the majority of load transfer occurs near the front of the bond zone. Although only two gages were installed in each of the instrumented production anchors, at 15 and 30 feet in the bond zone, about 90 percent of the anchor load has transferred to the ground in the front 15 feet of the bond zone. Essentially no load has been mobilized in the back 15 feet of the bond zone.

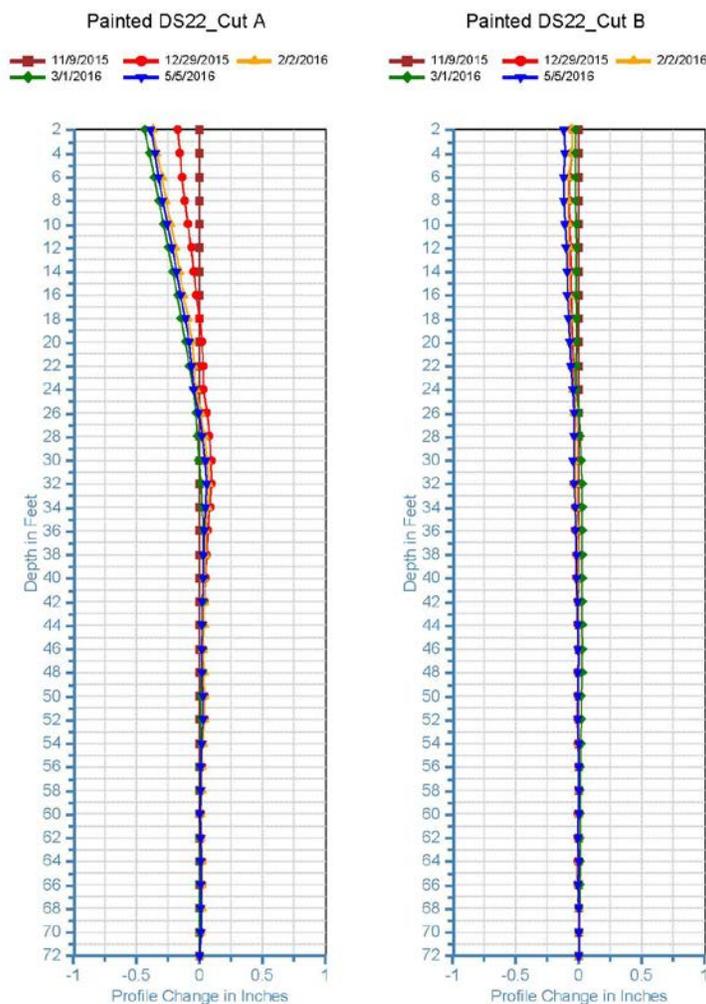
**Figure 10 – Inclinometer Installed in Drilled Shaft 22, Cumulative Displacement**

The inclinometers installed in the drilled shafts were initialized in November 2015, about 1 ½ months before the ground anchors were stressed and locked off. The data show that the drilled shafts moved about ¼ inch uphill as the anchors in the cap beam were stressed and locked off. However, subsequent readings show continued uphill movement, although at a decreasing rate, with essentially no movement after March 2016. Interestingly, the load cells did not

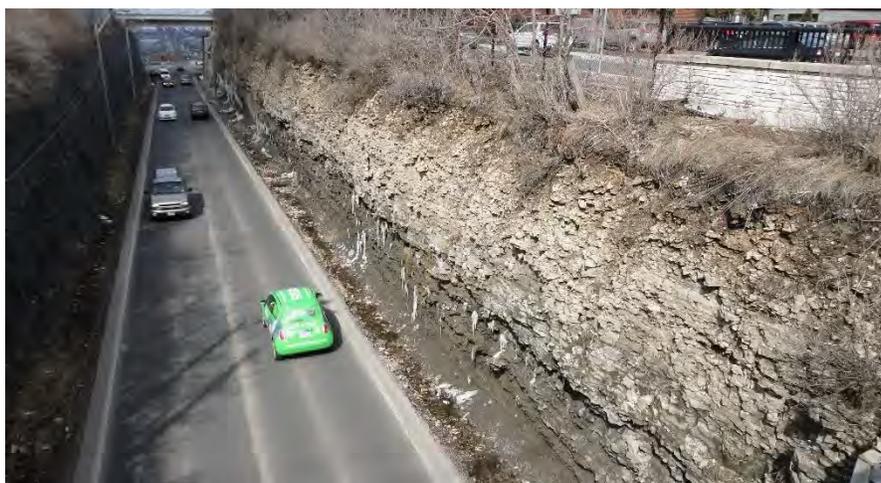
**Figure 1: Roadway crossing through the Niagara Escarpment**

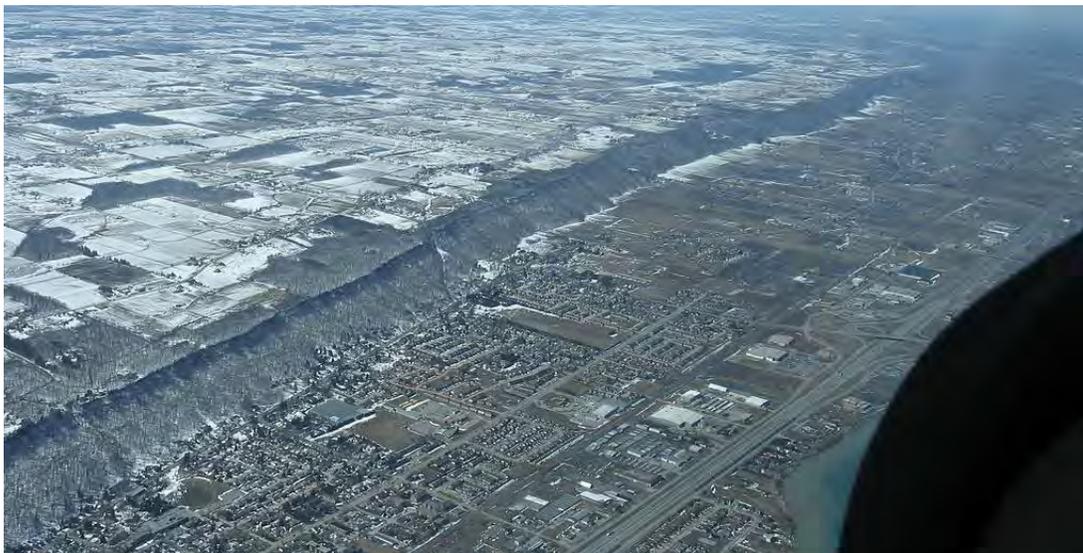
**Figure 3: Aerial View of the Niagara Escarpment in Grimsby near Hamilton [1]**

In the Hamilton area, the Niagara Escarpment rises to a maximum height of about 250 metres above sea level with rock slopes along the road within the City of up to 50 metres in height. Typically, the rock faces of the ridge are oriented towards north in the direction of Lake Ontario. Figure 3 shows an aerial view of the rock faces of the ridge in the Town of Grimsby in Ontario, just east of the City of Hamilton.

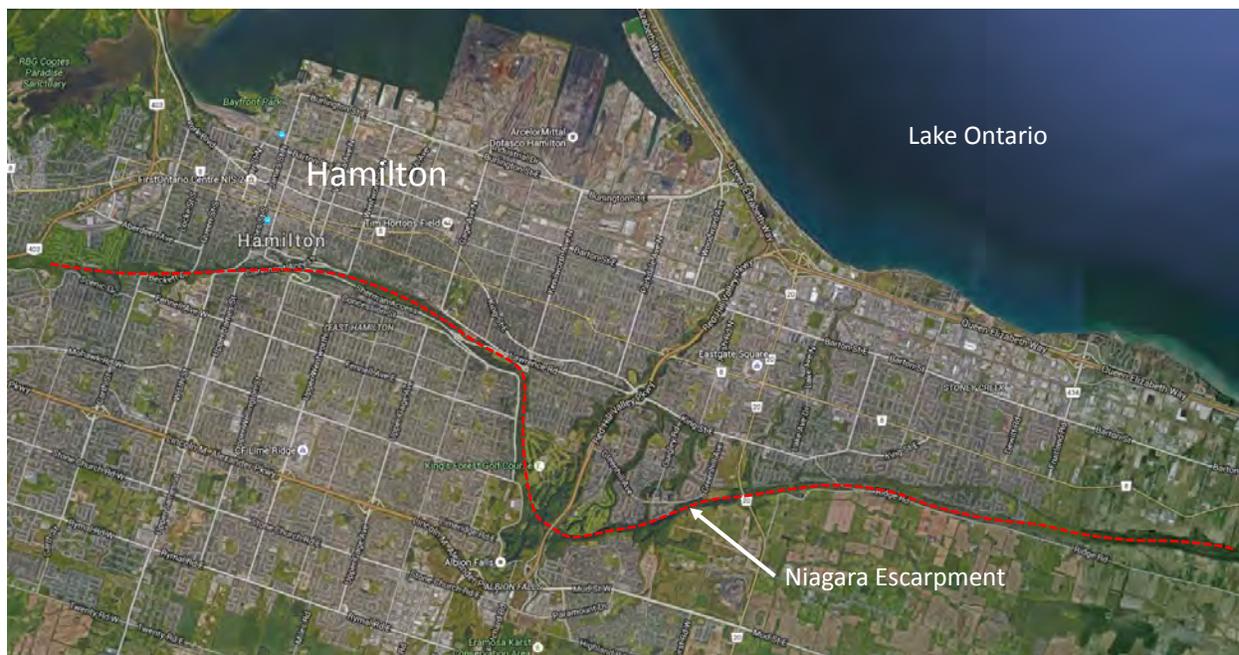
**Figure 4: Map of the City of Hamilton, showing the location of the Niagara Escarpment [2]**

lake shore, whereas the southern part of the city as well as rural neighborhoods extend on top of the escarpment. Several roadways cross through the escarpment to connect the upper city areas with the downtown area and with the major highway that runs along the shore of Lake Ontario. Figure 4 shows a map of Hamilton with the Niagara Escarpment (marked with a red line) that divides the City into a northern part and a southern part.
