HGS 2016  
Proceedings

# 67TH HIGHWAY GEOLOGY SYMPOSIUM

## JULY 11 – 14, 2016

Cheyenne Mountain Resort  
COLORADO SPRINGS, COLORADO

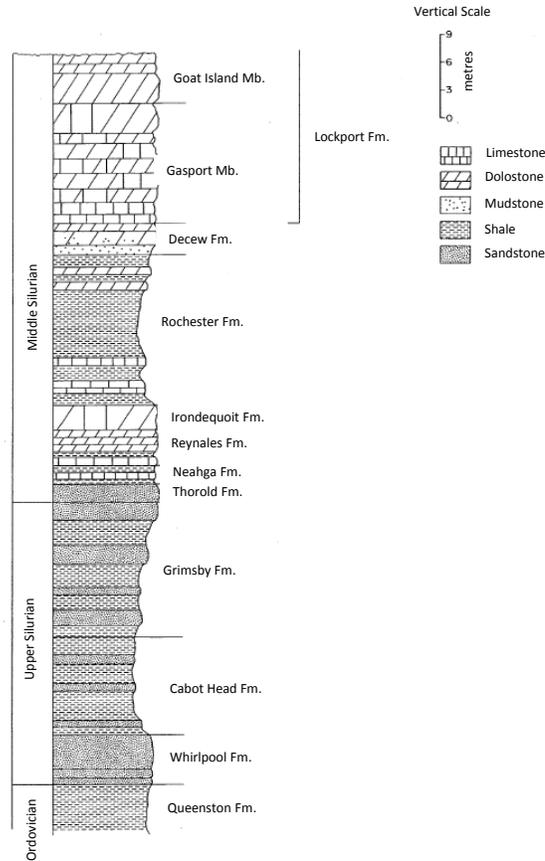
**Figure 5: Stratigraphic Section of the Niagara Gorge [3]**

The Niagara Escarpment is a massive ridge of sedimentary rock comprising of dolostone and limestone formations that were formed in turns with layers of sandstone and shale, the latter often with limestone interbeds. A typical section of the escarpment rock stratigraphy is shown in Figure 5. The exposed rock faces of the road cuts along Hamilton's escarpment crossings typically consist of dolostone and limestone layers at the top of the faces that are overlaying shale layers, often with limestone interbeds.

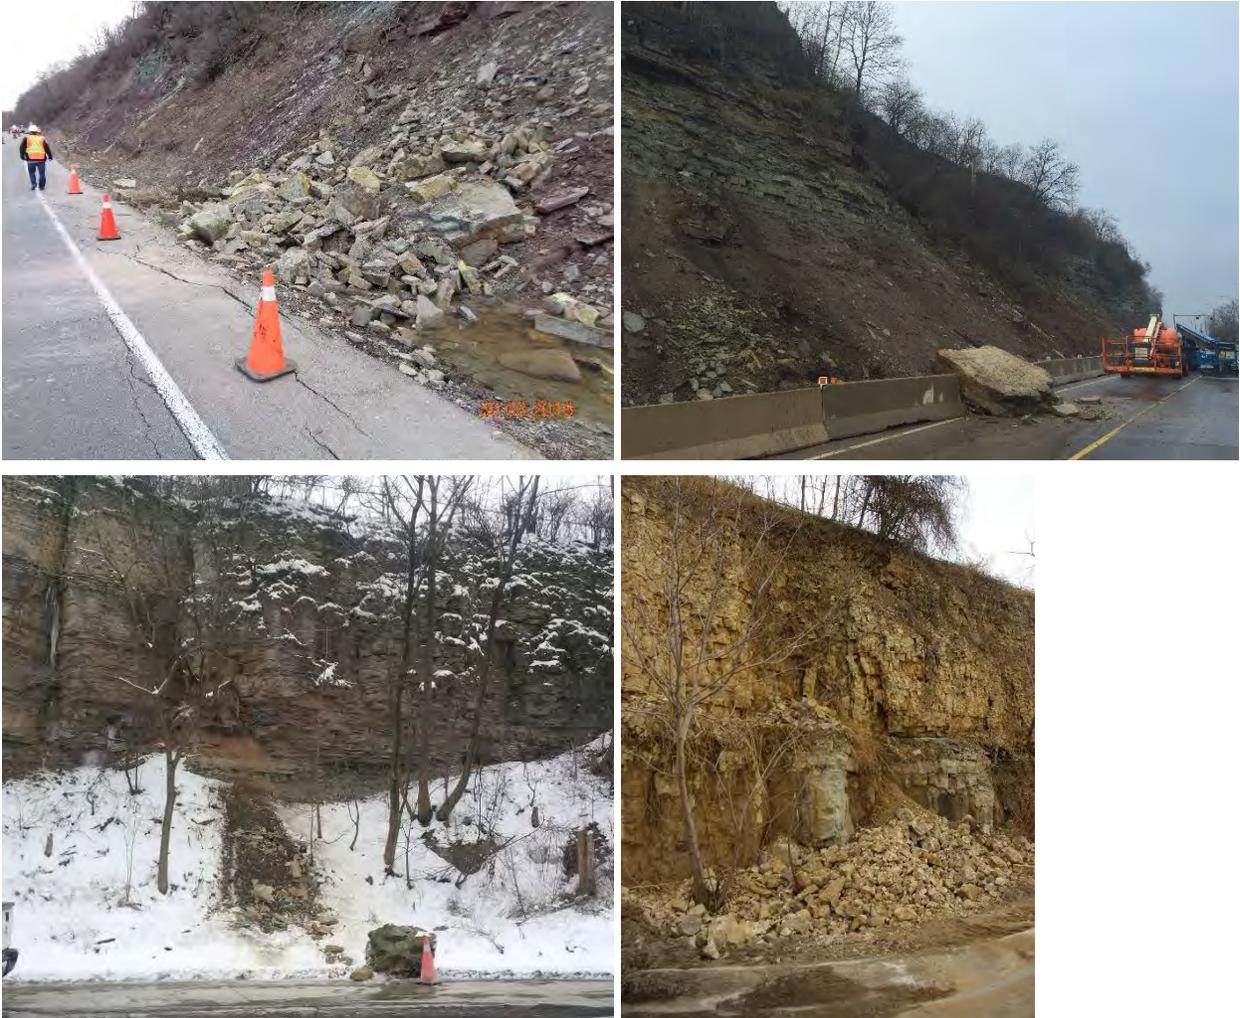
**Figure 6: Typical Rockfalls from Hamilton's Rock Slopes**

Rockfalls from the rock faces within the City of Hamilton range from individual pieces of rock that ravel from the faces, to large amounts of smaller blocks caused by a surficial failure of a section of blocky rock, to failure of large blocks from the more massive layers often present at the top of the escarpment slopes. Examples of typical failures are shown in Figure 6. Note that the photos in these Figures show the rockfall areas after the rock debris was removed from the road. In areas where retaining structures were erected to protect the roadways from rockfalls, these structures can also be affected by the failure of the rock as shown in Figure 7.

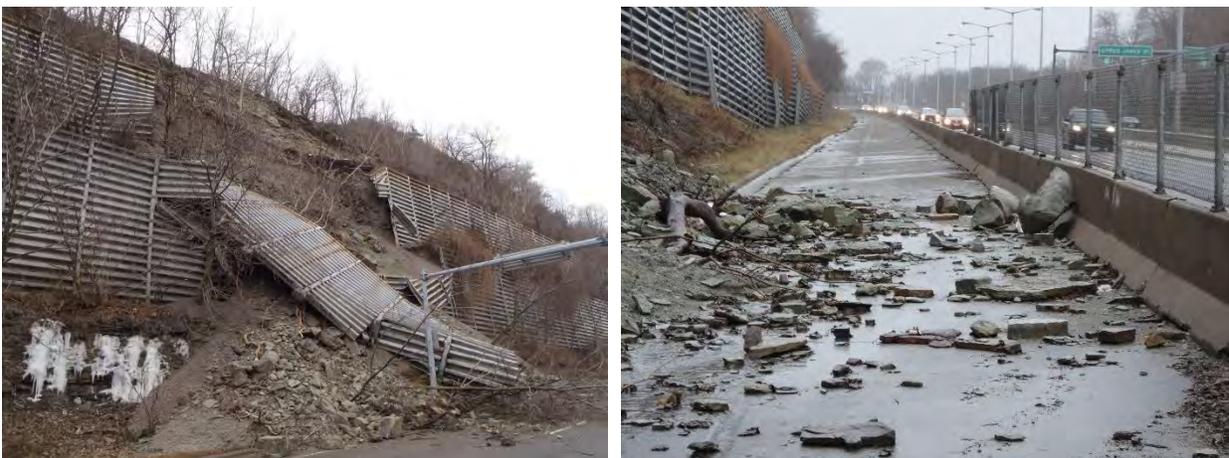
**Figure 7: Failure of Rock Slope and Retaining Wall (left) and Current Annual Amount Rockfall from the Wall Failure Area (right)**

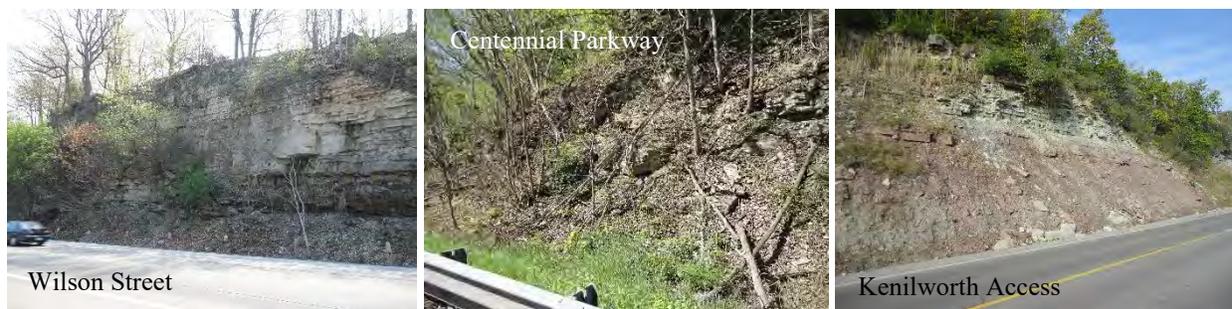
**Figure 8: Examples of Typical Rock Slopes (near-vertical rock faces, overburden slopes with rock outcrops, inclined rock slopes with rock faces at the top)**

In total, 20 different rock slope sites were inspected throughout the City of Hamilton as listed below. The sites comprised various types of rock slopes including near-vertical rock cuts comprising dolostone and limestone faces, inclined rock slopes consisting of shale and limestone interbeds often with vertical faces at the top, and forested overburden slopes with rock outcrops. Figure 8 shows examples of typical layouts of the investigated sites.

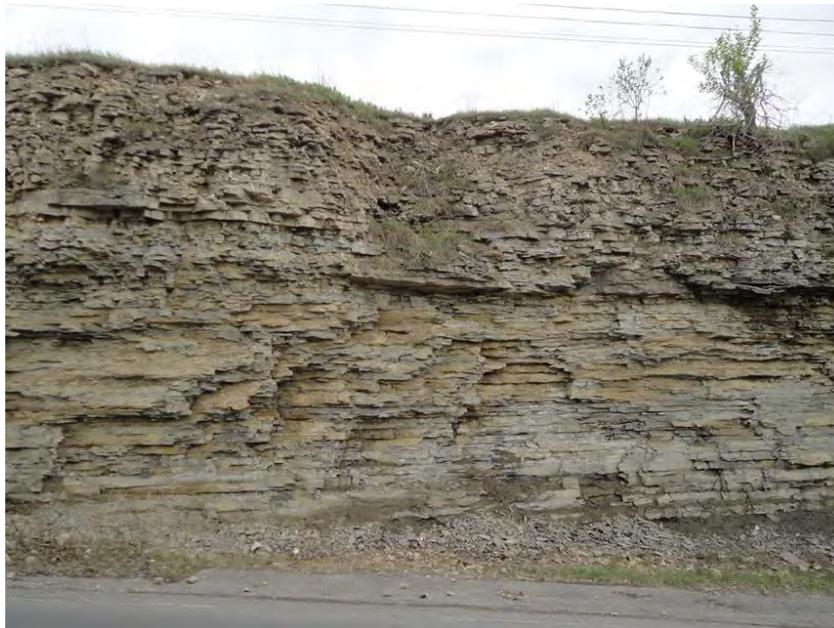
**Figure 9: Typical Blocky Rock Face Conditions**

- Near-horizontally bedded limestone and dolostone rocks with distinctive near-vertical cross jointing.
- A near-vertical joint set running near-parallel to the exposed rock faces parallel to the roadways was noted at many sites.
- Orthogonal joints at other sites results in a “saw tooth” rock face configuration
- Bedding spacing and joint spacing typically thin to thick. Wider bedding and joint spacing was noted along the crest of several slopes.
- Horizontal bedding and closely spaced near-vertical cross jointing result in very blocky, ‘brick wall type’ rock faces. Figure 9 shows the typical blocky rock faces.

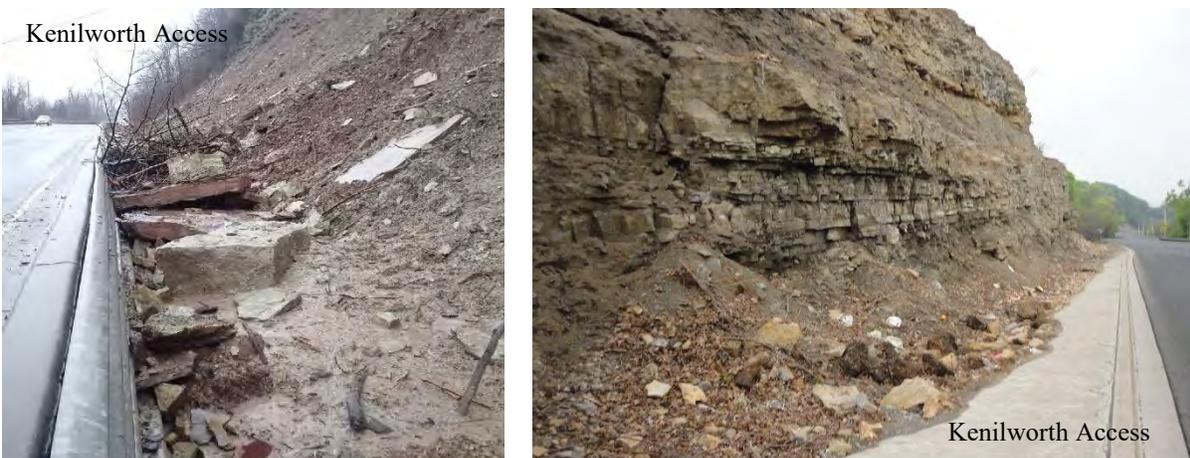
**Figure 10: Examples of Catchment Areas filled with Rockfall Debris**

- Roadways comprised one-lane to multi-lane roads, some with bike lanes along the upslope or downslope side of the road.
- Various catchment conditions, including some roads without any ditch or catchment area to roads with narrow road shoulders and roads with wide ditch and shoulder areas.
- Visibility of potential rockfall debris on the roads usually poor due to the winding nature of many of the escarpment crossings.
- Information regarding traffic volumes on the affected roadways was provided by the City of Hamilton. Traffic volume was mostly high throughout the days, except for few roadways that are connecting less densely populated areas at the outskirts of the City.
- Accumulations of rockfall debris noted in several ditch or catchment areas causing reduced catchment capacities and increased risks of rockfall overspill onto the roads (see Figure 10).

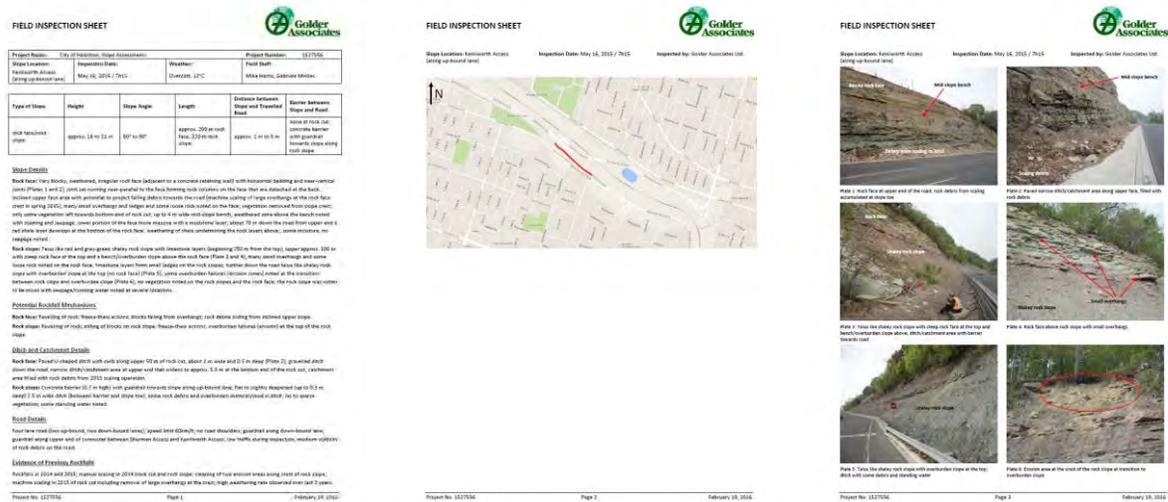
**Figure 11: Example of Field Inspection Sheet**

An individual field inspection sheet was developed for each of the 20 inspected rock slopes summarizing the site observations (see Figure 11). The same type of data was presented for each site in a systematic manner to serve as reference for future inspections and long-term monitoring of the individual sites and to facilitate the comparison of the sites.

The inspection sheet also included annotated photographic records of the slope layout and of site areas or features that were of particular interest or concern. In addition, a site map with the inspected slope area marked was provided with the field sheets for future reference.

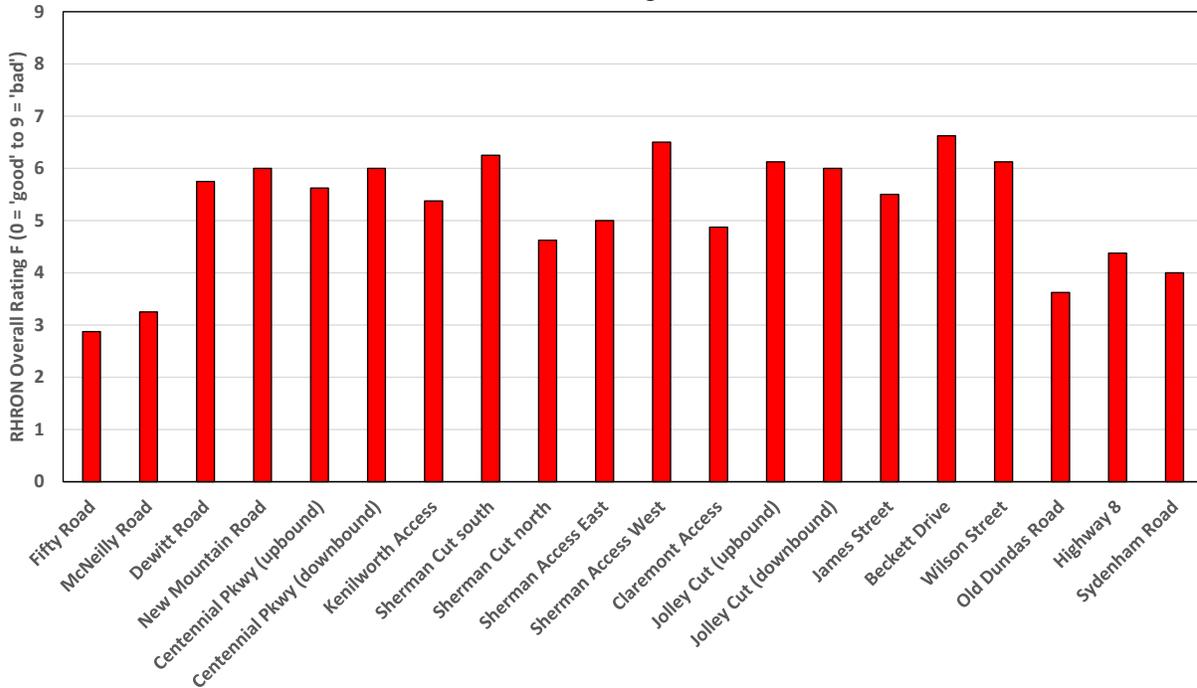
**Figure 12: Total Rating F**

The overall RHRON rating of the slopes ranged from F = 2.9 to F = 6.6 (see Figure 12), corresponding to a Slope Criticality Rating of 2 (low risk) to 4 (high risk) (Figure 13). None of the slopes were considered as very low or very high risk.

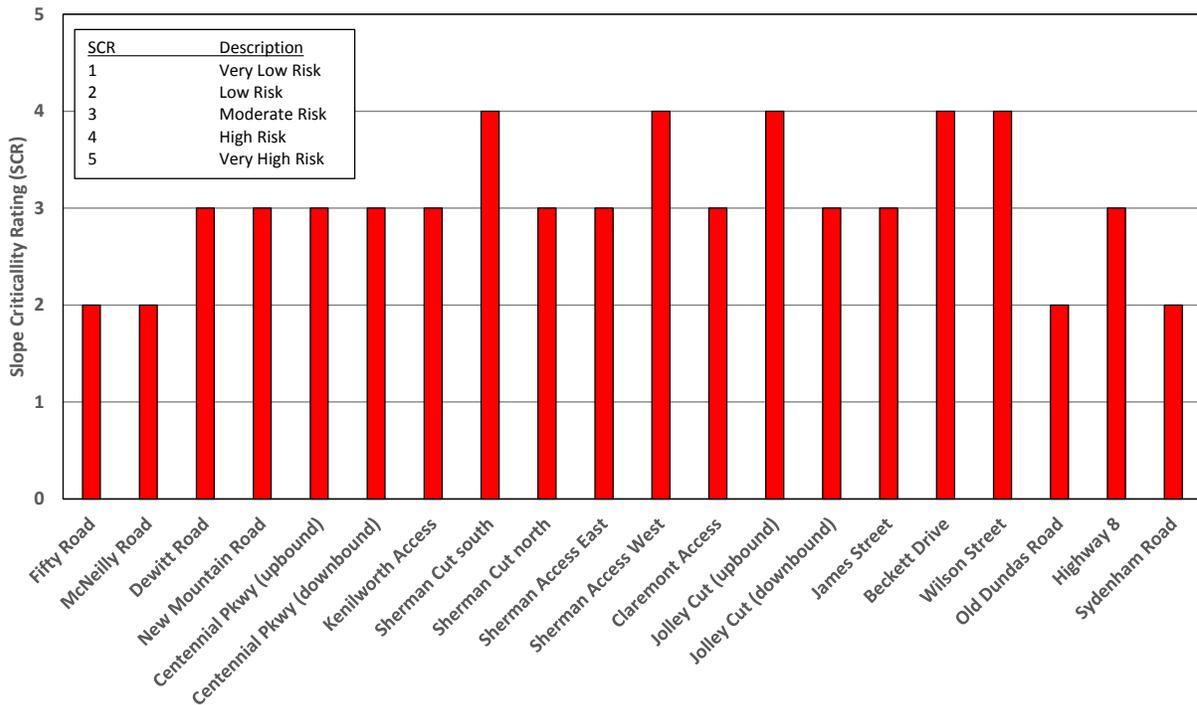
**Figure 13: Slope Criticality Rating SCR**

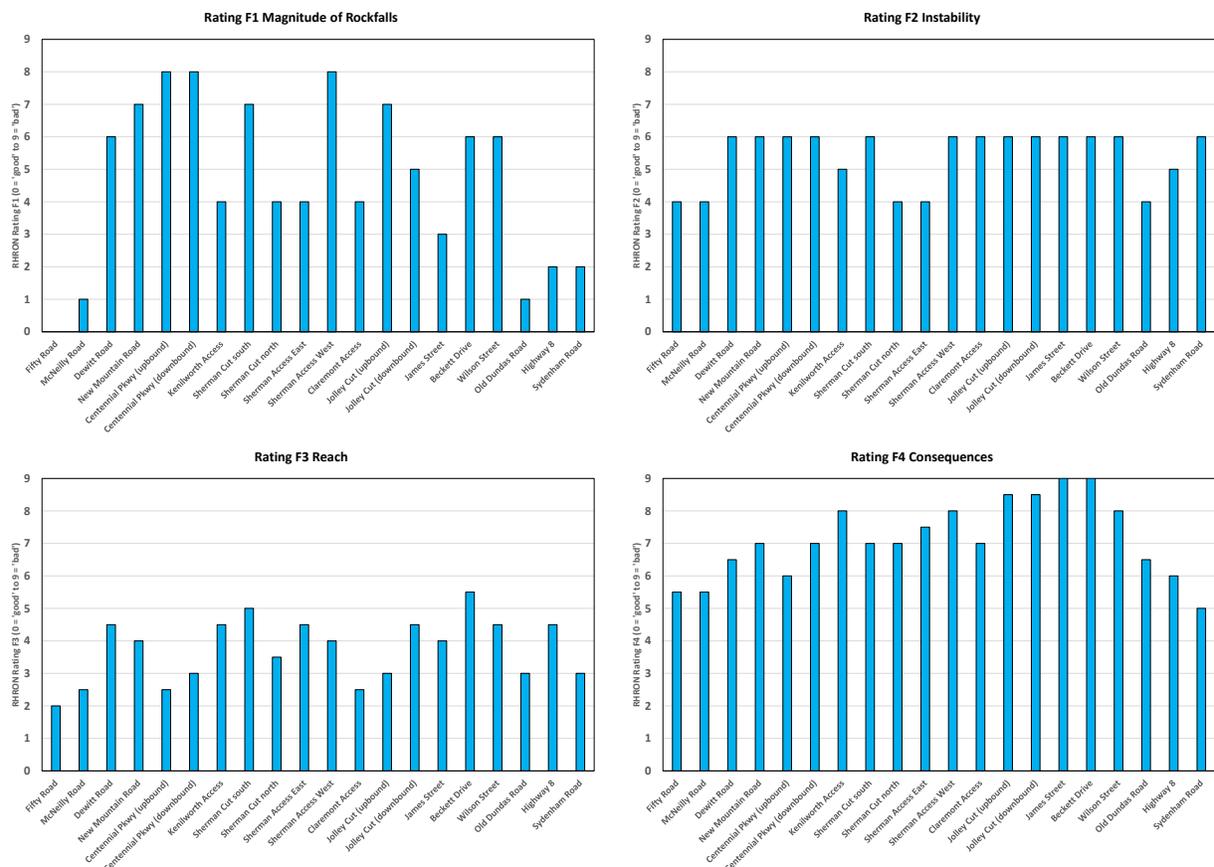
**Figure 14: Rating Criteria F1 Magnitude, F2 Instability, F3 Reach and F4 Consequences**

The individual ratings for the four criteria F1 Magnitude, F2 Instability, F3 Reach and F4 Consequences are presented in Figure 14.

As shown in the graphs, the rating for the expected magnitude of rockfalls was highly variable between 0 and 8, corresponding to rockfall amounts between 1 m<sup>3</sup> and 60 m<sup>3</sup>, whereas the instability rating was relatively consistent with ranges between 4 and 6, corresponding to an annual to monthly frequency of falls. The rating for the reach of the rockfalls, as a combination of slope angle and overspill onto the road, ranged between 2 and 5.5, indicating that rockfalls will likely block only on parts of the roadways. The rockfall consequences, as a combination of traffic density and visibility, were rated relatively high for all sites (between 5 and 9).

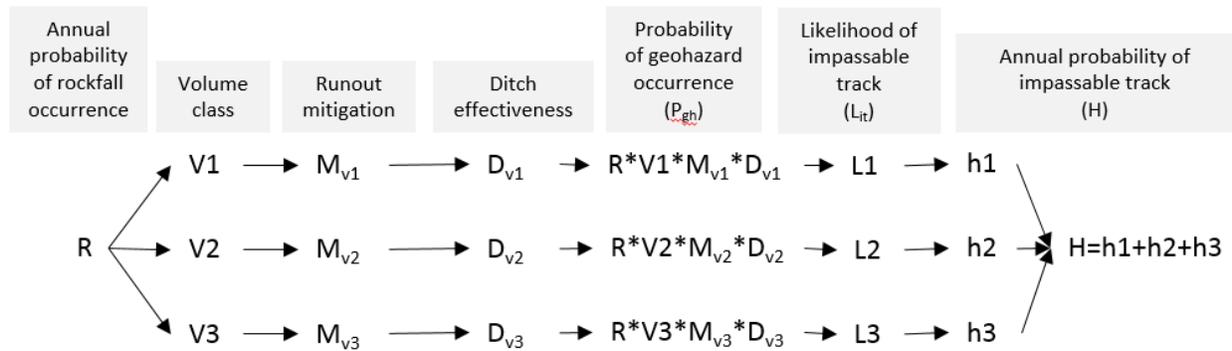
**Figure 2 –Hazard probability formulation.**

Annual probability of impassable track (H) was estimated based on an assessment of the probability of rockfall occurring, the volume distribution of rockfall events, presence of rockfall runout mitigation, and ditch effectiveness (Figure 2).

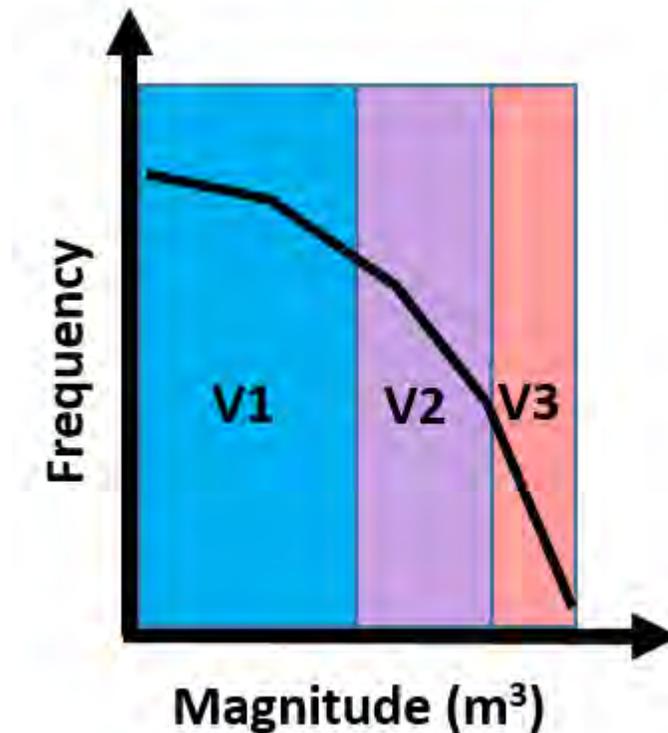
Figure 3 –Schematic rockfall frequency-magnitude relationship.

The proportion of all rockfall events that would fall within each volume class ( $V_1+V_2+V_3 = 100\%$ ) was assessed for each site, based on visual inspection of the rock slope (e.g. joint spacing, block size, volume of recorded events, volume of rockfall deposits in ditch) and on a typical rockfall frequency-magnitude relationship from literature (4). Hungr et al. (4) present a rockfall frequency-magnitude curve for transportation corridors in Western Canada that corresponds approximately to:  $V_1$  (50%),  $V_2$  (30%),  $V_3$  (20%).

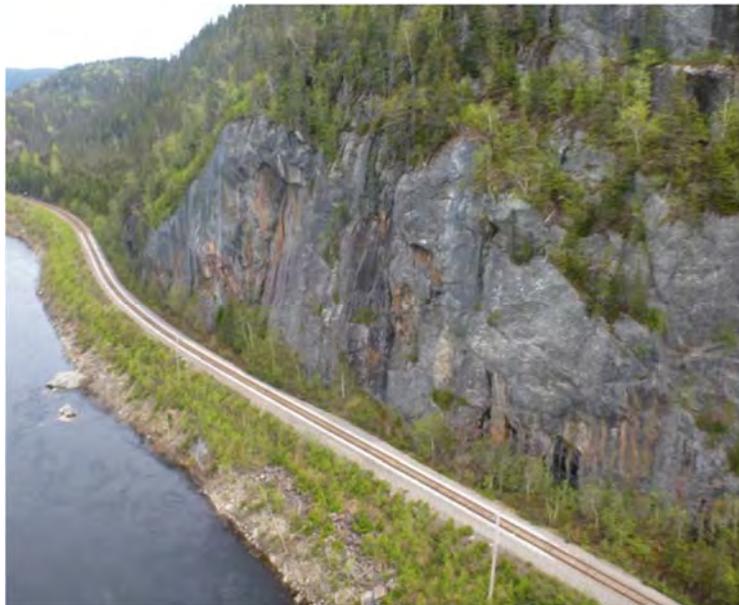
**Figure 4 –Example rock slope.**

An example calculation is presented below for the rock slope shown in Figure 4.

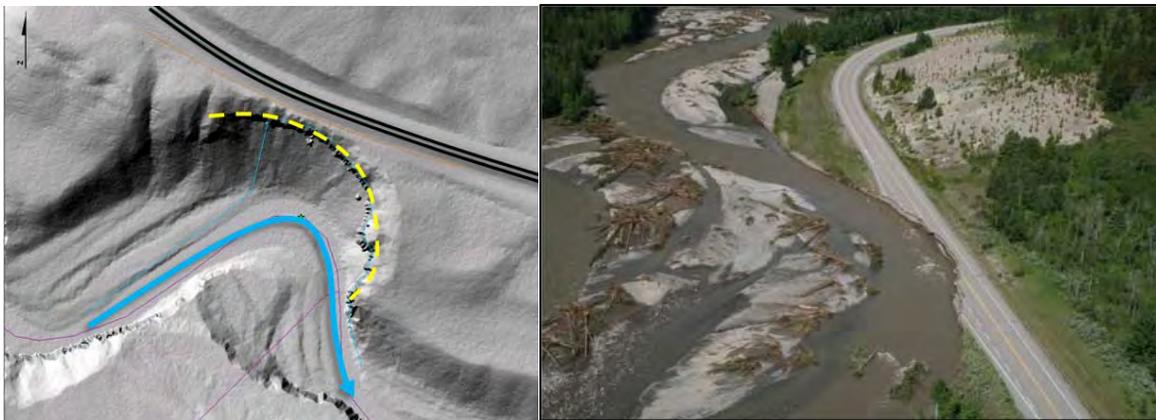
**Figure 5 –Examples of encroachment in Alberta.**

Encroachment hazards are present where highways are near the outside banks of river bends (Figure 5). The river encroachment hazard assessment method was developed as part of a semi-quantitative assessment of highway closure risk for the Alberta provincial highway network. The purpose of the project was to reduce the potential for bank erosion or bank slope failures to migrate towards a highway resulting in partial or complete road closure. The complete assessment included inventorying bank erosion sites along the road network, and prioritizing those sites for construction of bank erosion mitigation measures. Risk ratings explicitly included assessment of the presence and effectiveness of bank erosion mitigation measures. It is intended that bank erosion mitigation at individual sites will be implemented following cost-benefit analysis that compares the cost of various mitigation options with the risk reduction achieved by the mitigation measure.

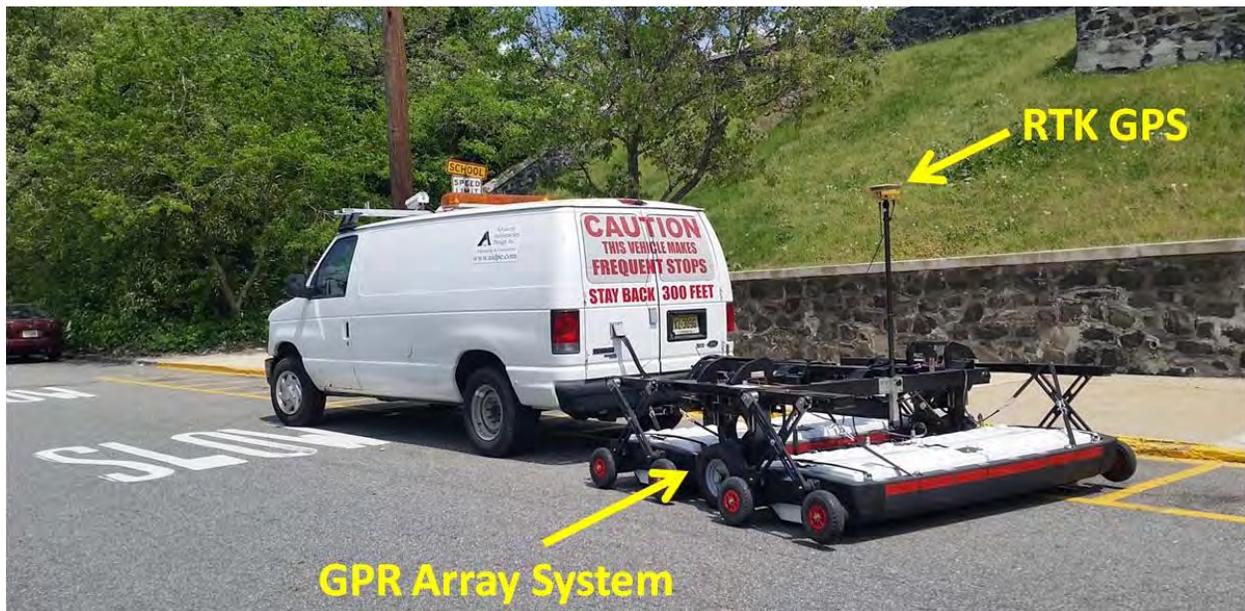
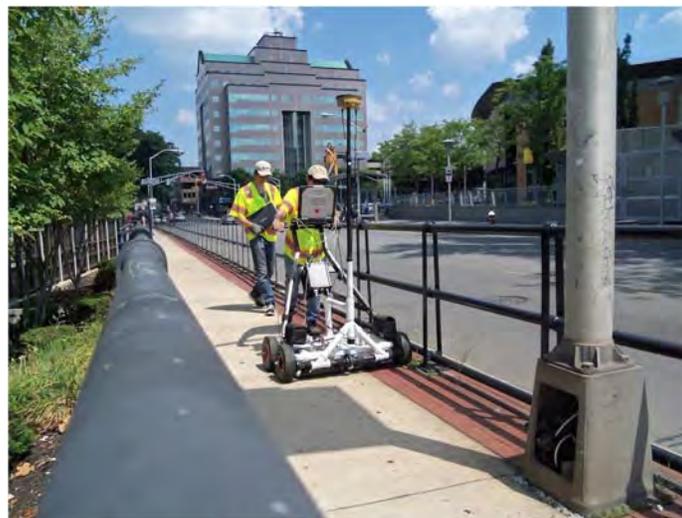
a) Multichannel GPR Array System

b) Push-cart GPR System

**Figure 1. GPR Systems Used in this Study.**

A crucial issue regarding data collection is positioning. Real-time kinematic (RTK) GPS or robotic total station systems can be interfaced with acquisition software to mark system trajectory in order to correctly position data on the XY plane during the follow-up analysis stage. Integration with Inertial Measurement Systems (IMU) platforms is probably the near future solution for urban environments. For the study presented in this paper, an RTK system with centimeter accuracy was fitted to the GPR system to provide accurate positioning (see Figure 1 for details).

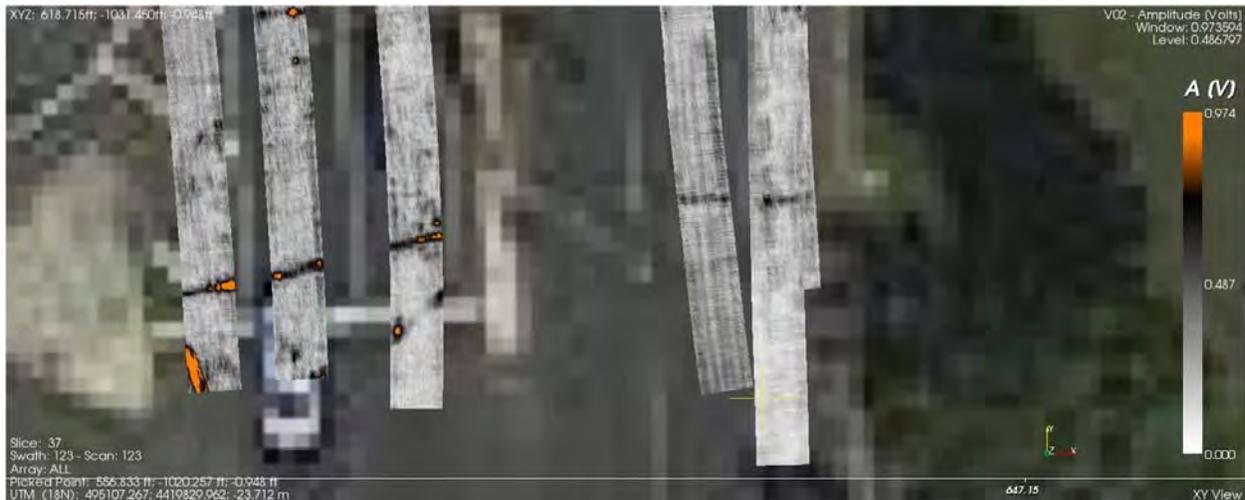
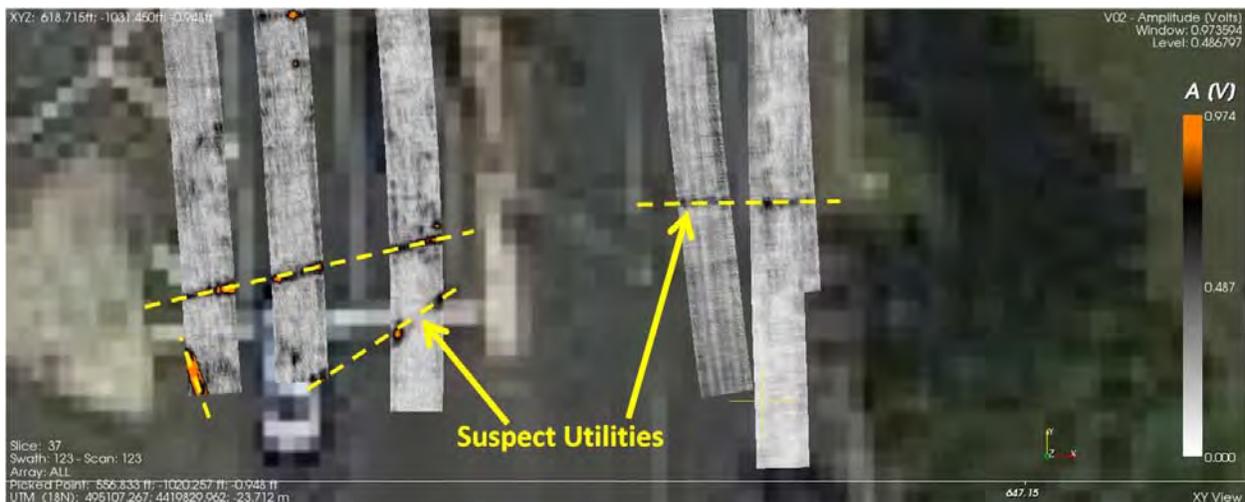
a) Raw Image

b) Identified Targets (Utilities)

**Figure 2. Sample Data with GPR Array System.**

The GPR array systems used in this study included a computer-navigation guided system to accurately follow profile direction and keep sufficient overlap among profiles without any physical marker on the ground surface, avoiding any previous stake-out or topographical survey in the field before the GPR survey. The navigation screen provides a graphic interface so the operator can see the tracks on the screen of the laptop in real time. In addition, horizontal slices can be visualized on the fly. This allows target mapping in real-time. An example of a tomographic image obtained with the GPR system used in this study is shown in Figure 2a. Up to six passes are shown. The tomographic image shows GPR results at a depth of about 1 ft. Each pass is shown as a grayscale superimposed on a georeferenced image of the area investigated. In the image four anomalies can be seen as orange lines and are suspected of being pipes (Figure 2b).

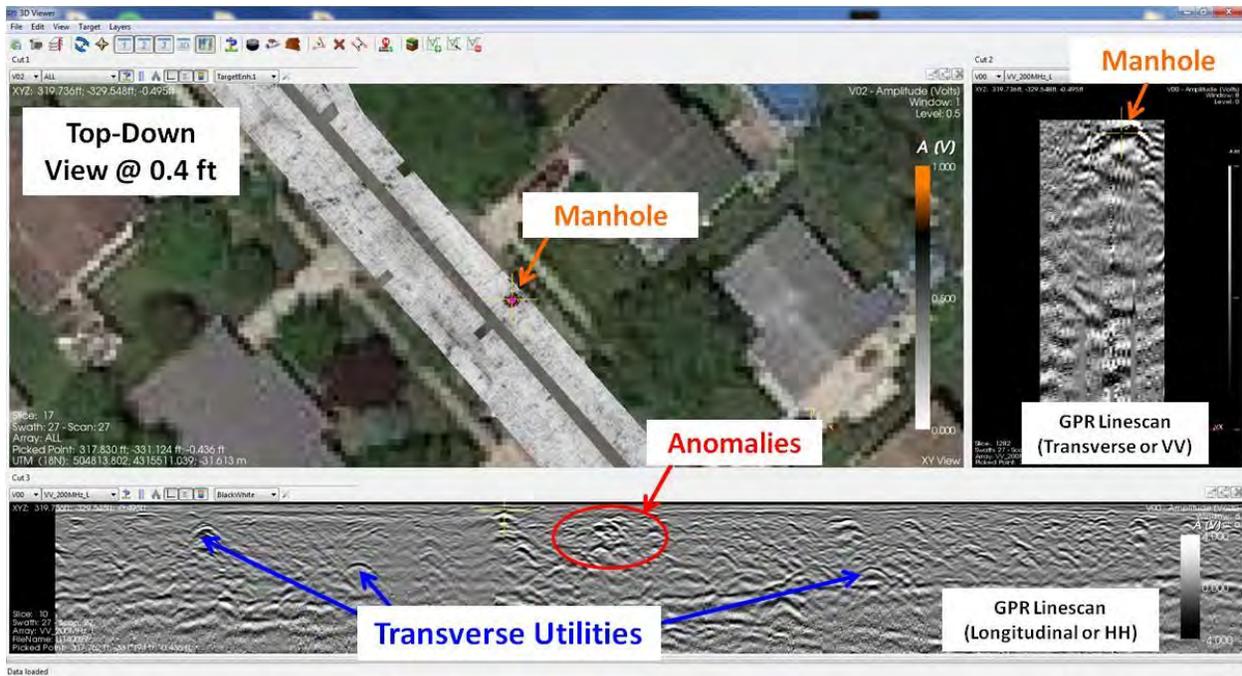
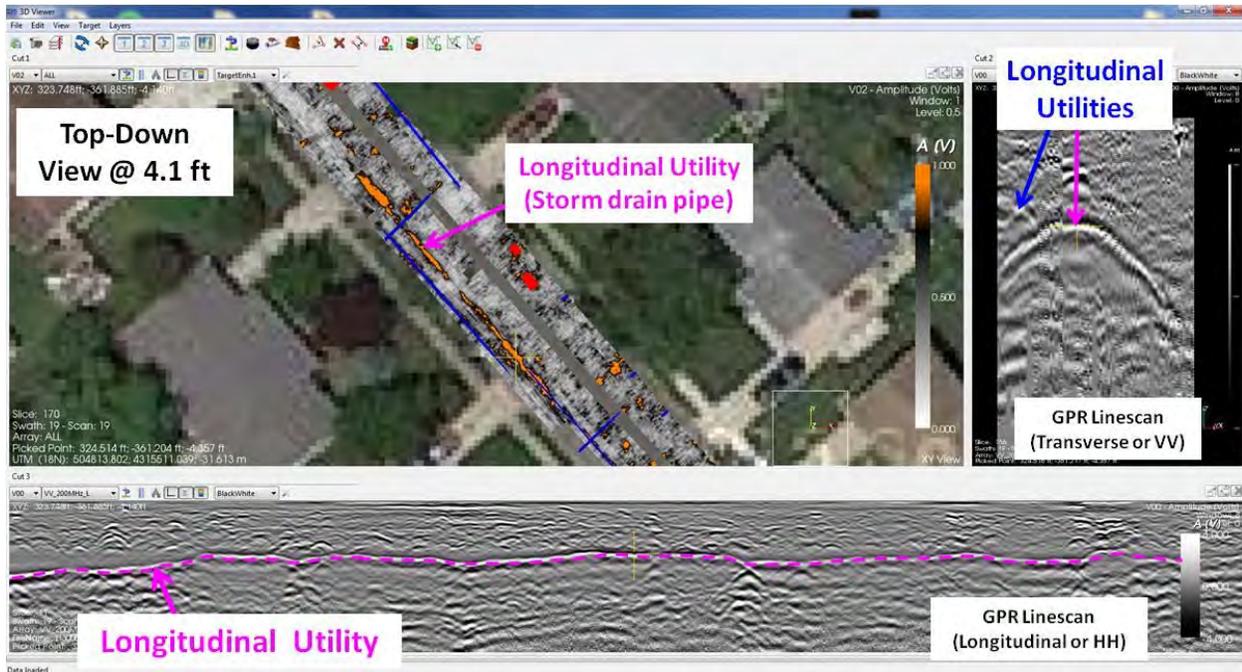
a) Tomographic, Longitudinal and Transverse GPR Views at 0.4 ft. Manhole, Anomalies and Transverse Utilities Identified

b) Tomographic, Longitudinal and Transverse GPR Views at 4.1 ft. Longitudinal Utility Identified

**Figure 5. Typical Results with the GPR Trailer Mounted System**

A view from the same location with a depth of about 4 ft. is shown in Figure 5b. In this case one longitudinal utility is clearly identified in the horizontal line scan (seen as a horizontal band). On the other hand, longitudinal utilities are seen as inverted hyperbolae on the upper right image (transverse line scan). In this case, two inverted hyperbolae are seen. After careful examination and coordination with existing base maps, it was found that the larger hyperbola corresponded to the storm drain pipe. The depth of this utility (vertex of hyperbola) at this location was about 4.1 ft. For the case of the tomographic view, the suspected storm drain pipe is seen as an orange linear feature. Previously selected utilities are also identified as blue lines (for linear utilities) or red polygons (for other anomalies). For the case of the suspected storm drain pipe, a different color (purple line) was selected to identify this utility.

The summary of findings (utilities, manholes, anomalies) for the area selected in Figure 5 is depicted in Figure 6. Four longitudinal utilities (including the storm drain pipe), six transverse utilities, one manhole, and four areas of unknown anomalies are shown.

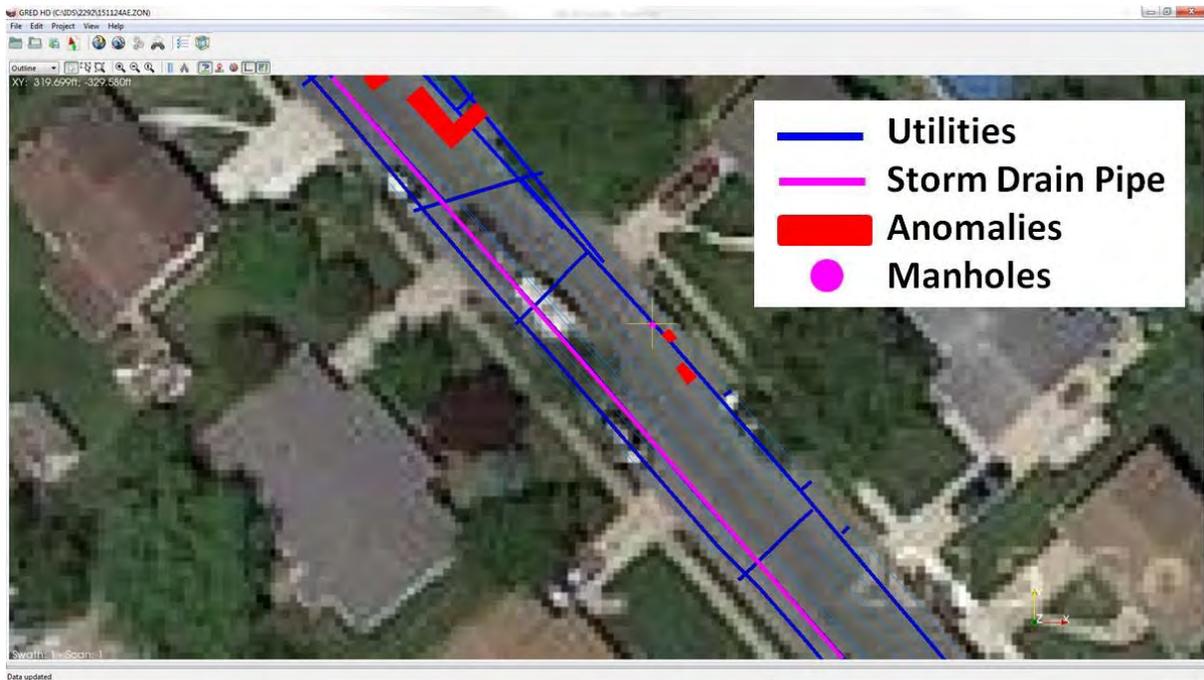
**Figure 6. Typical Summary of Findings with the GPR Trailer Mounted System**

After careful evaluation and analysis of all GPR passes conducted on the main lane and sidewalks of Roseann Avenue, results were compiled and summarized. A total of three hundred (300) targets, including suspected utilities, manholes, and other anomalies were found. All findings were combined into an AutoCAD file with the New Jersey State Plane Coordinate system of reference. As previously indicated, all data was georeferenced with centimeter accuracy.

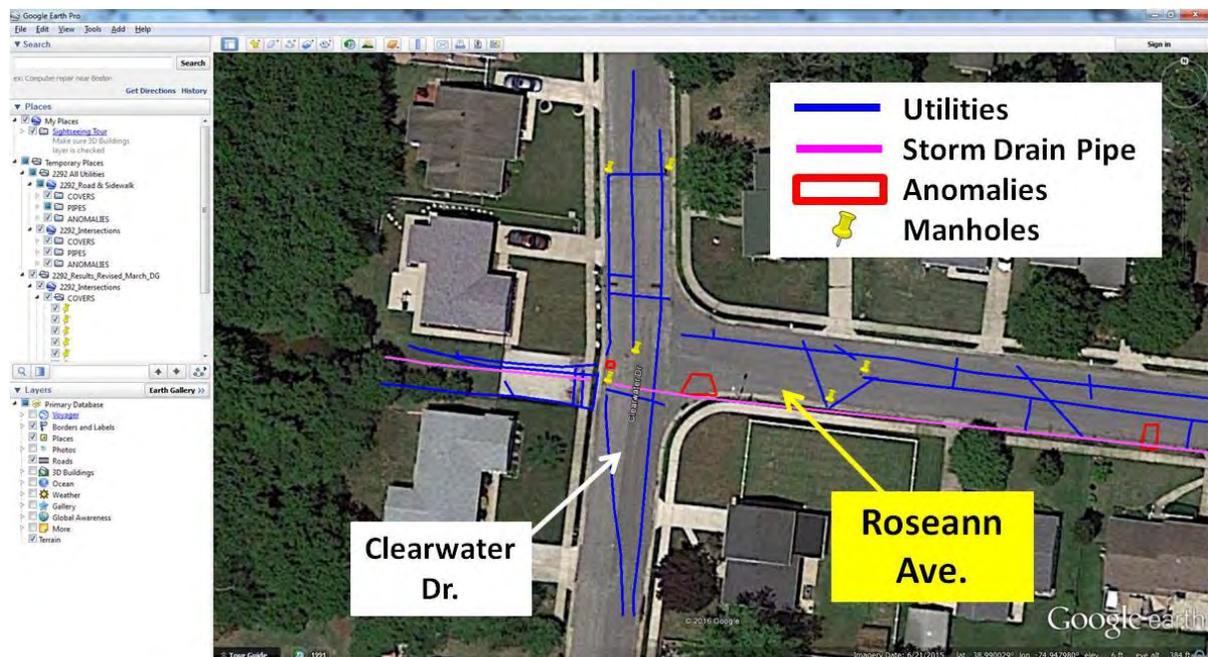
**Figure 7. Typical Summary of GPR Findings Presented as a Google Earth File**

In addition, a georeferenced Google Earth file was prepared separately for easy reference. This file was provided as a complementary way of representing the data along with the AutoCAD file and this report. In that file, the same color scheme and features used in the GPR software to identify all targets was used. For longitudinal and transverse utilities, blue lines were used, for anomalies red polygons, and for point targets (i.e. manholes, inlets), a push pin was selected. The suspected storm drain pipe was highlighted as a purple line for easy reference. A close up view of all targets found at the intersection of Clearwater Drive and Roseann Avenue (west end of the project) is shown in Figure 7.

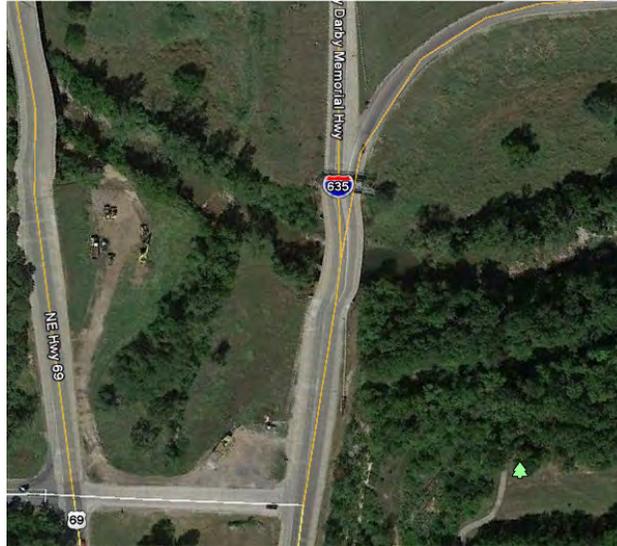
Figure 1: Image of Turkey Creek before any construction.

The US69/I635 highway in the Kansas City Metro area is the primary connection between the City of Mission and the rest of the Kansas City Metro area. About 70,000 people travel on this road every day. The bridge over Turkey Creek that connects northbound US 69 to I-635 is located over a bend in the creek that makes the south embankment highly susceptible to erosion. This problem has been known to KDOT for some time and was under observation by the KDOT Bureau of Structures and Geotechnical Services.

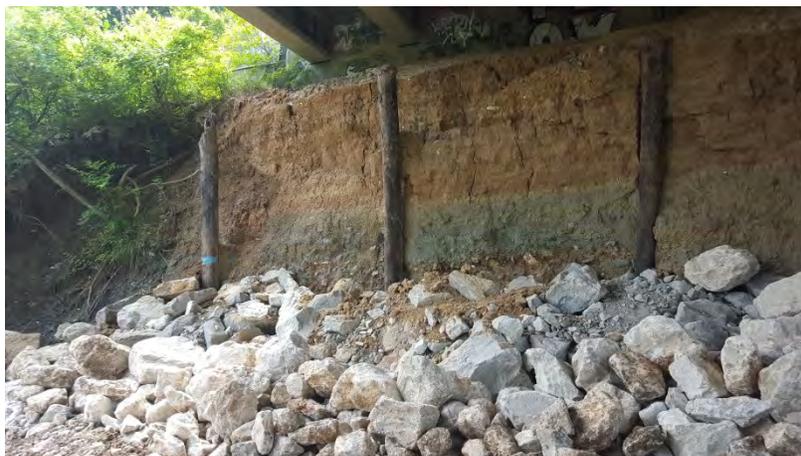
Figure 2: Emergency Repair of Embankment

In the spring of 2014 the erosion became so severe that the Bureau of Structures and Geotechnical Services decided that corrective action was needed. They suggested an emergency repair in order to stabilize the slope and prevent further erosion damage while a permanent repair design was finalized. This temporary repair consisted of a large amount of rip rap stone placed on the embankment. The emergency repair was completed less than a month after KDOT called for it, and was in place until the summer of 2015 when construction on the permanent repair started.

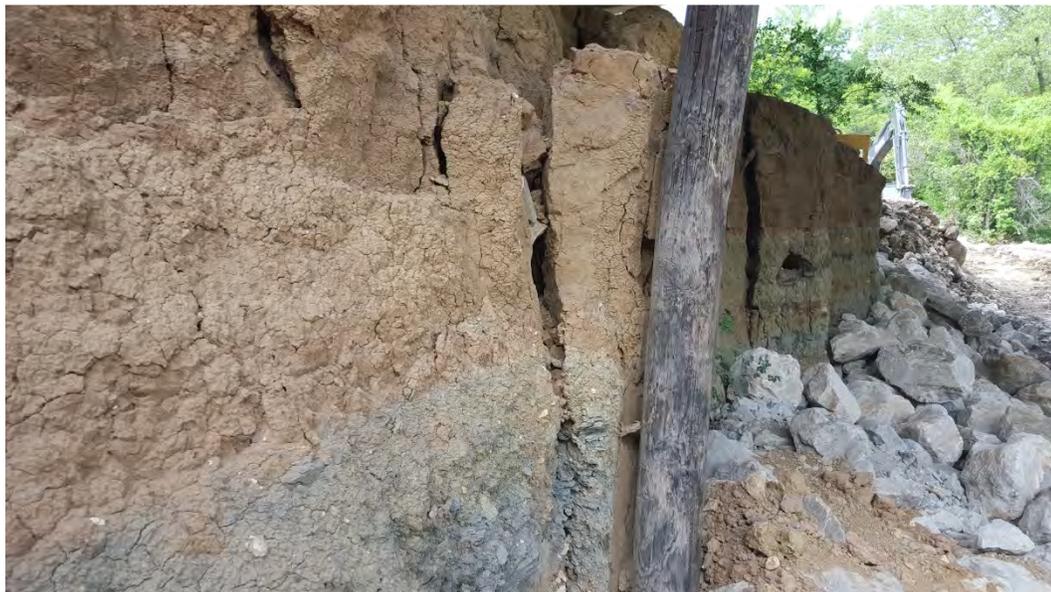
Figure 3: Embankment drop off and growing crack.

Of these, the cramped working conditions seemed like they would be the most difficult thing to deal with. The soil nail wall is located in the embankment just 9 ft in front of the abutment and only 3 ft from the bottom of the bridge girders. The embankment was too narrow and too unstable to serve as a work platform for the drill rig. Large vertical fissures in the face of the embankment made working on or around it too dangerous. Even if the embankment was stable, it was still too narrow to work on. The embankment only extended 9 feet from the front of the soil nail wall before dropping off to form a vertical face and TerraFirm needed 18 ft in order to operate their drill rig.

While the operator did a good job of avoiding the girders on the first couple rows of soil nails, he did slip up once on the 3<sup>rd</sup> row. While excavating for the 4<sup>th</sup> row, the excavator bucket caught one of the old timber piles that were left from when the bridge was built (see Figure 3 above), and when the pile snapped it knocked the excavator arm up into one of the girders. The damage to the girder was minor; no rebar was exposed, and it was repaired before the project was completed.

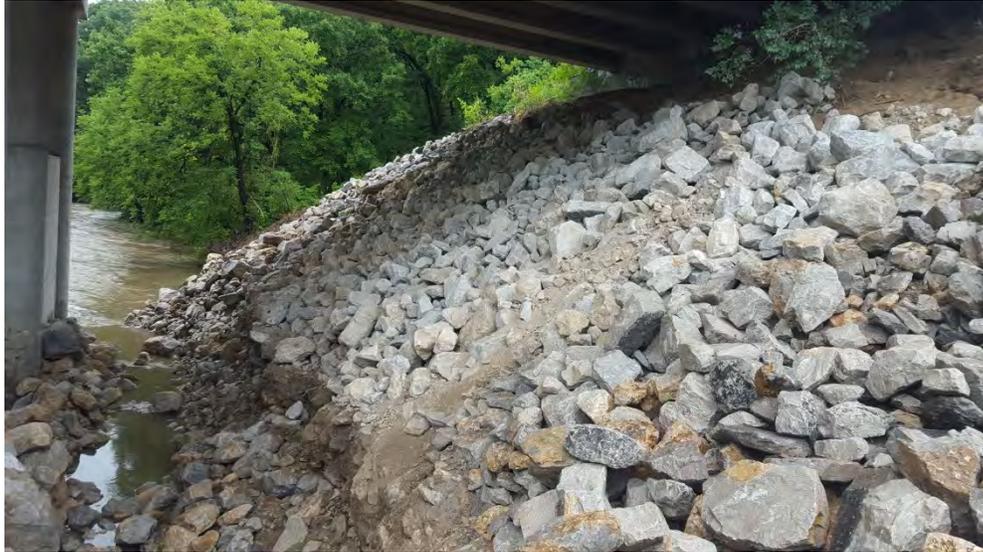
Figure 4: Rip rap placed to create a workable area.

In order to fix both of these issues, Philips Hardy placed a large amount of rip rap stone against the face of the embankment in order to prevent it from collapsing and to widen the area that TerraFirm had to work on. This rock would be later used as the rip rap surrounding the walls

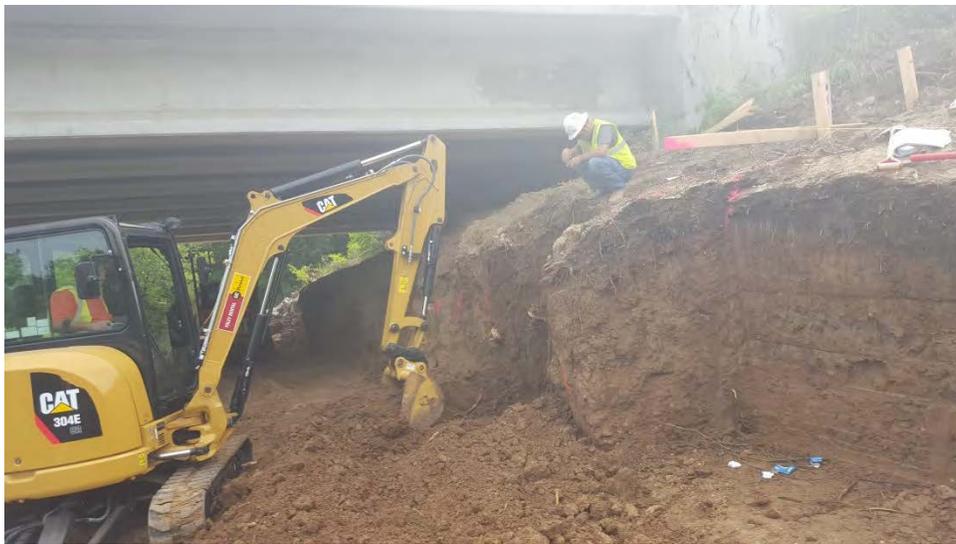
Figure 5: Work area for top row of nails.

when the project was finished, (after being cleaned). In addition to those issues, there was also a lack of vertical space when working on the first row of nails. The distance from the bottom of the bridge girders to the excavated work area was only 9 feet. The drill rig had no issues working in this space, but the excavator operators had to be very mindful of the bridge girders when they were excavating for the first couple lifts.

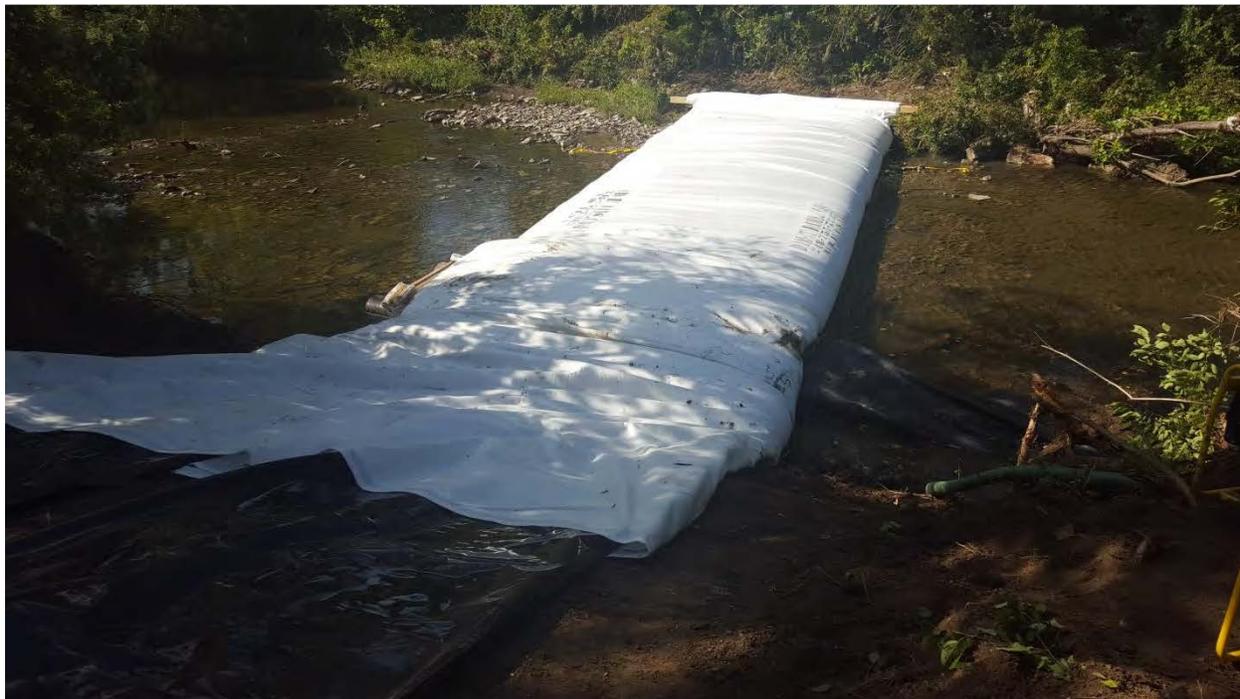
Figure 6: Dam and flume system fully installed.

The section of Turkey Creek that was adjacent to the work area has a very low flow rate when not flooding, but the water pools up to 12 feet deep right under the bridge. Most of that water just sits there like a pond and the small trickle of water flowing in flows right over the top and over the natural rock berm on the downstream side. Philips Hardy decided that they would use an inflatable damn to block the small amount of flow, the dam sat on top of three 12-inch steel pipes that connected to a flume chute that would transport the water flow past the work site, and then they would use two 6-inch water pumps to pump the standing water over the natural rock berm. This set up could only handle the normal flow of Turkey Creek; it couldn't handle the flow after even a mild rain event. If there was rain in the forecast then the system would need to be removed and reinstalled after the flood water receded.
