HGS 2016  
Proceedings

# 67TH HIGHWAY GEOLOGY SYMPOSIUM

## JULY 11 – 14, 2016

Cheyenne Mountain Resort  
COLORADO SPRINGS, COLORADO

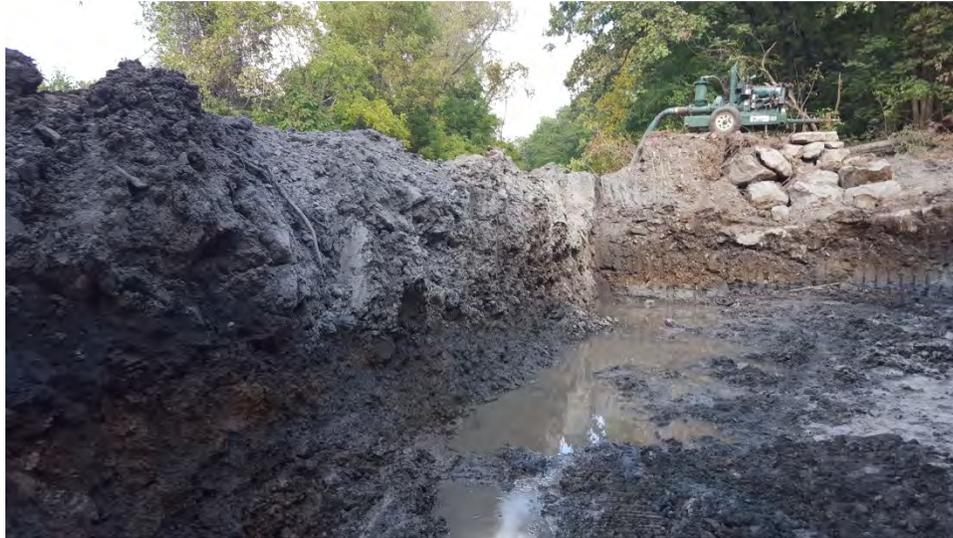
Figure 7: View of earth berm from work area.

the rock hammer drill.) This left them with a 15' wide berm made of soil, rip rap stone and solid shale standing between the work area and Turkey Creek. This berm was intended to mitigate the damage that flood waters would do when the dam and flume were removed prior to a storm event. It could also be used as a backup in case the dam and flume system failed completely.

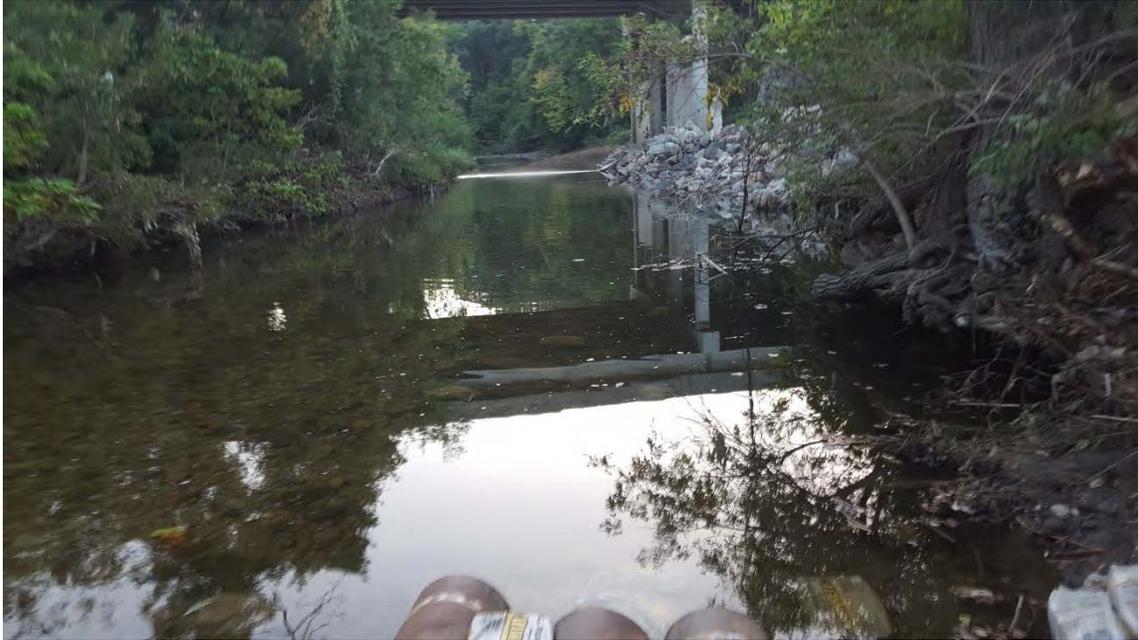
Figure 8: Aftermath of first storm. Not Pictured: Flume Chute

And it did. There were two mistakes that caused the dam and flume system to fail. The first was that the flume chute they originally purchased wasn't long enough to reach past the downstream side of the project. The second was that due to the large amount of time required to remove and reinstall the dam and flume chute, the contractor decided to only remove the dam when a storm was forecast. It just so happened that the day after the dam and flume were first installed, a storm appeared in the forecast for the next day. The contractor pulled the dam out of the creek but the flume chute would be left in the creek. They thought the weight of the metal pipes would anchor the chute enough to resist the stormwater. Turkey Creek has a rather large watershed for a creek, so even though there was only 1" of rain from the storm, the creek level still rose 10 ft and had a raging current. The pipes were able to resist the stormwaters, but the straps attaching the flume to the pipes were not. The flume chute was washed away in the storm and wasn't able to be recovered.

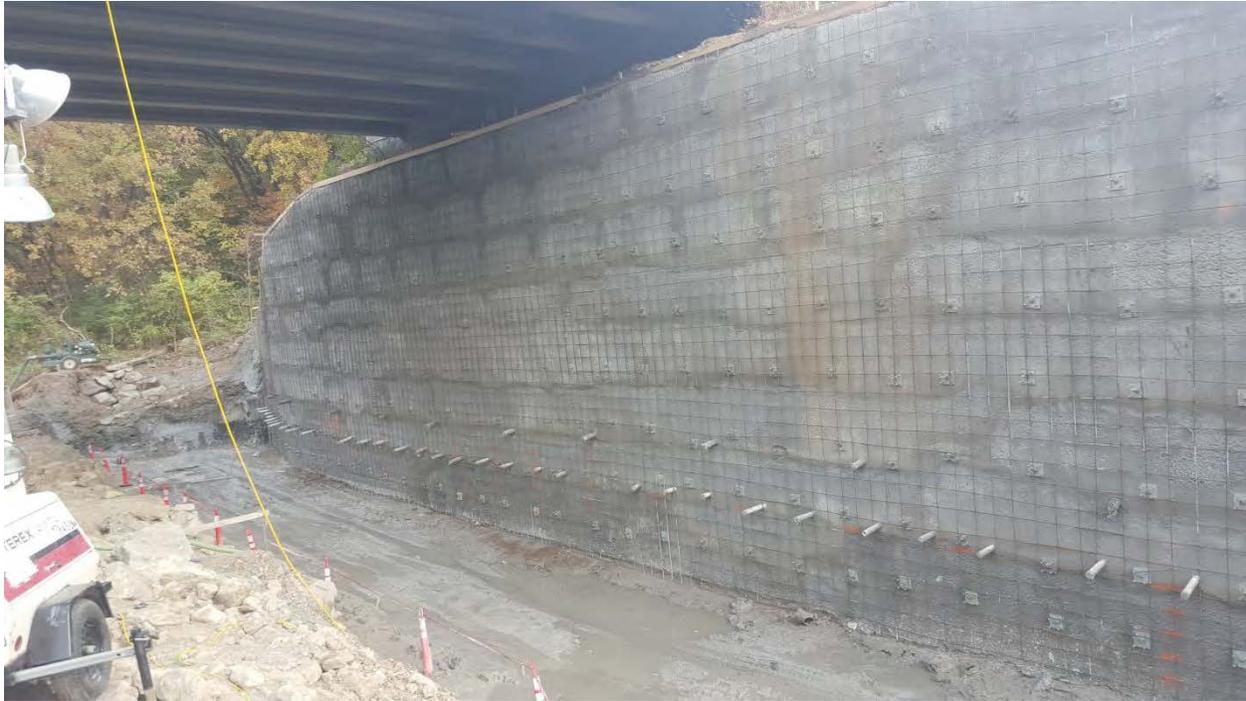
Figure 9: Work area before a rain event.

Over the course of construction, rain and weather related conditions caused 68 working days of delay. The majority of those days were spent restoring the work area after a rain event flooded it. After the contractor started to rely on the earth berm to protect against the creek, any kind of rain event would fill up the creek and water would seep through the berm and fill up the work area. The water flowing through the berm would also strip away the soil holding a section of rocks together and that section would allow water to freely flow through the remaining rocks. In order to fix this, the contractor needed to wait until the water flow in Turkey Creek returned to normal and pump out the creek until the water level was below the breach in the berm, then pump the water out of the work area before finally replacing the failed berm section with concrete. Because of this, a rain event that would normally cause 2 days of delay would end up causing at least a week long delay.

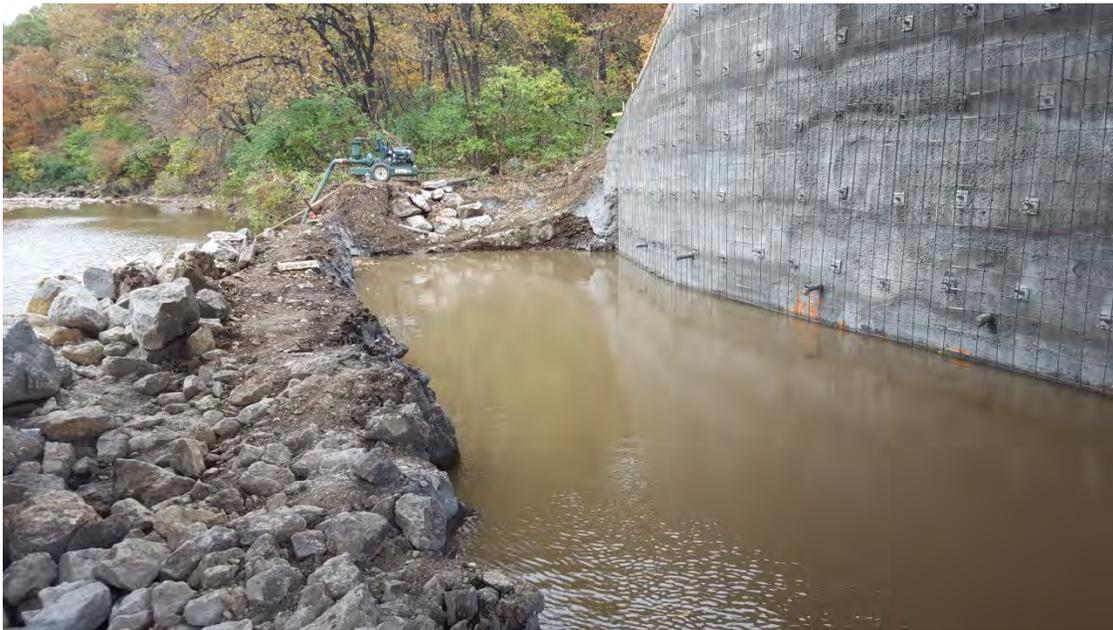
Figure 10: Work Area after a rain event.

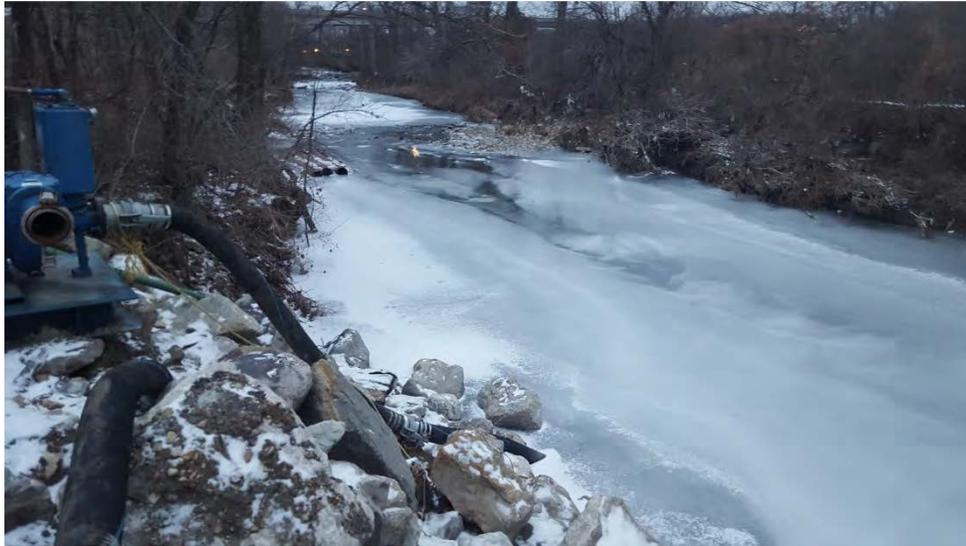
Figure 11: Turkey Creek frozen

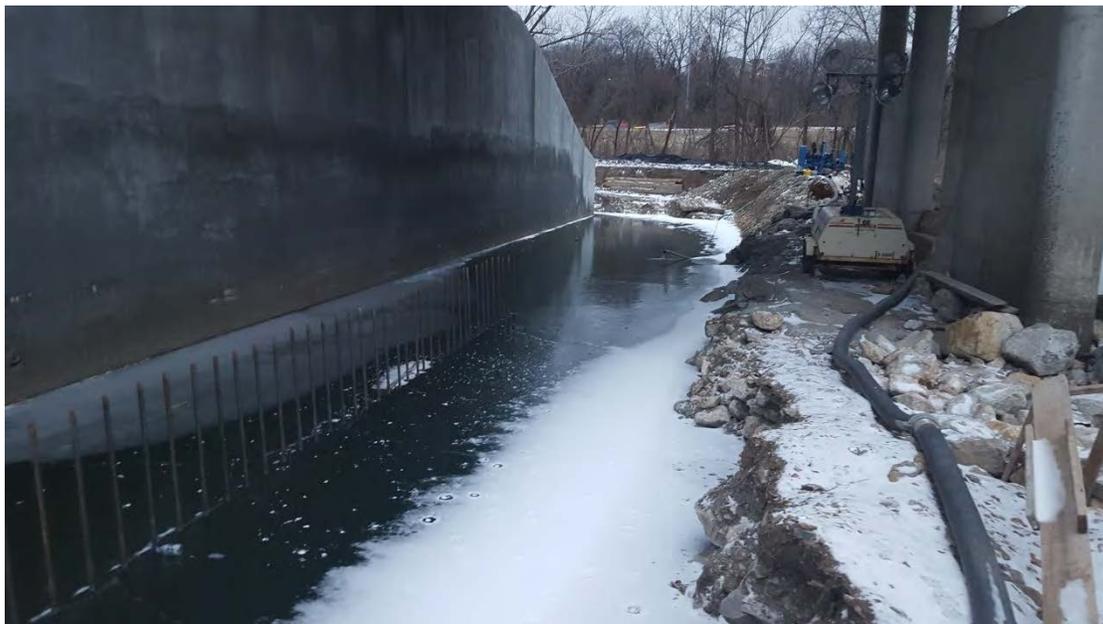
Figure 12: Work area frozen.

For the next two weeks the contractor tried their best to lower the water level of the creek, but they weren't able to make any progress. They decided to wait until after the Winter Holiday Period, December 23<sup>rd</sup> to January 3<sup>rd</sup>, to try again. They resumed pumping on January 4<sup>th</sup> and were able to make some progress, but two days later on the 6<sup>th</sup> it rained for four straight days. The Monday after the rain, Jan. 11<sup>th</sup>, everything froze. The creek, the work area, even the hoses for the pumps were all frozen solid. The contractor couldn't operate the pumps without

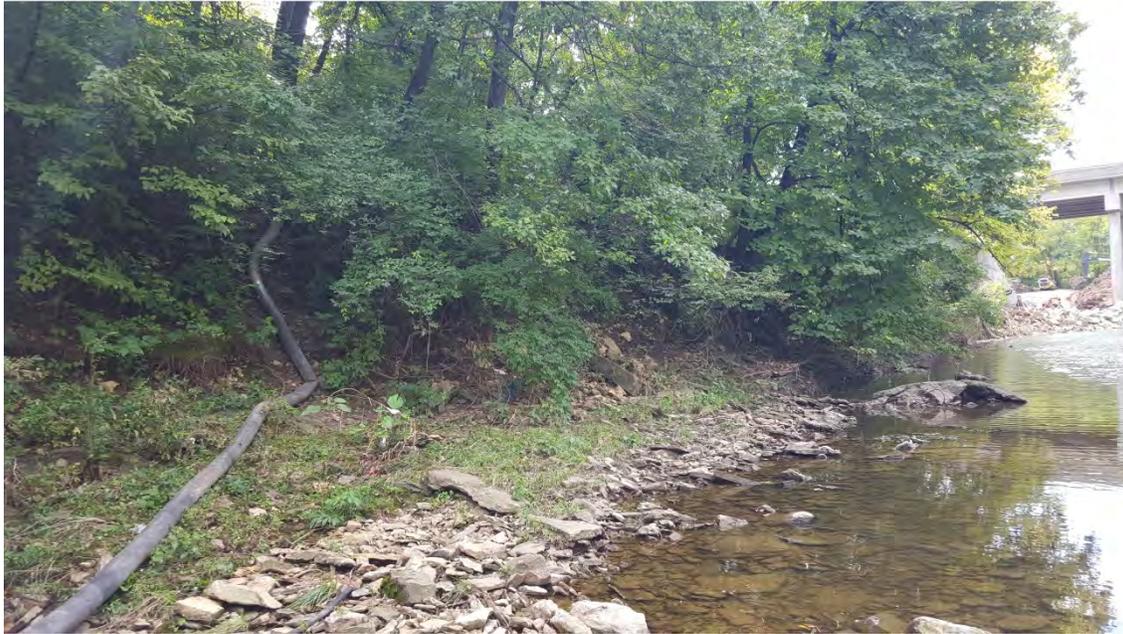
Figure 12: Left: Hose for one of the pumps. Middle: The forest the hoses are laid in. Far Right: Project work area.

damaging them, and they couldn't remove the frozen hoses without driving heavy machinery through the forest the hoses were laid in.

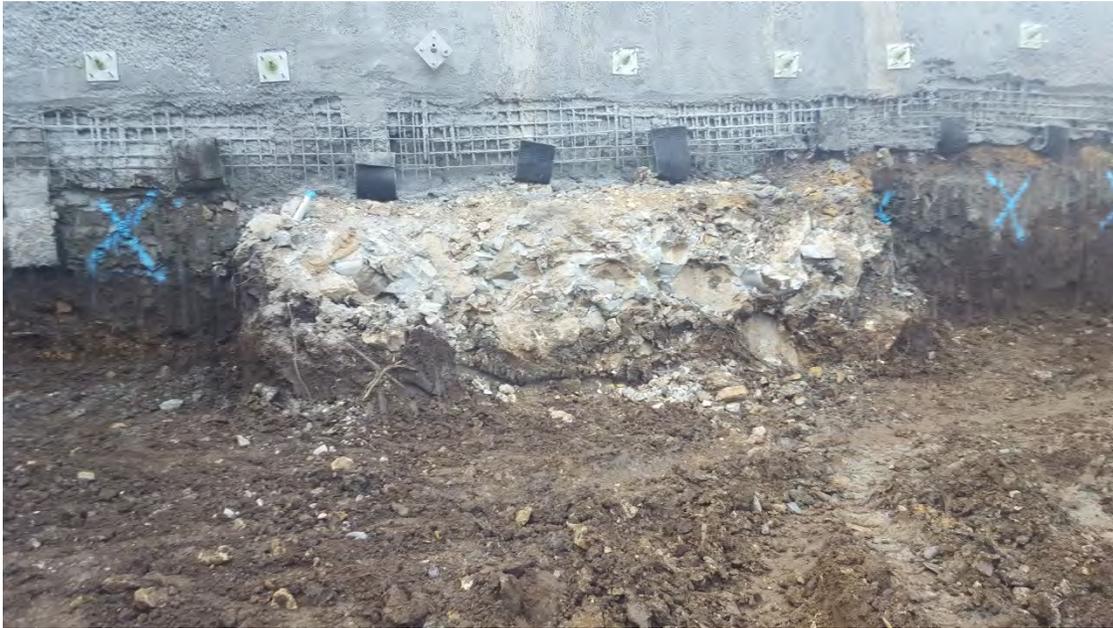
Figure 13: Solidified section of rock fill.

rock fill instead of filling the hole. Instead of using  $2/3$  yd<sup>3</sup> of grout per hole, it took over 3 yd<sup>3</sup> for each hole in the top row in the rock fill. In the lower section of the rock fill all of the grout actually bound the entire section of fill into a solid piece. This allowed the contractor to use their hammer drill to punch through it without needing to use the slow dual string drill.

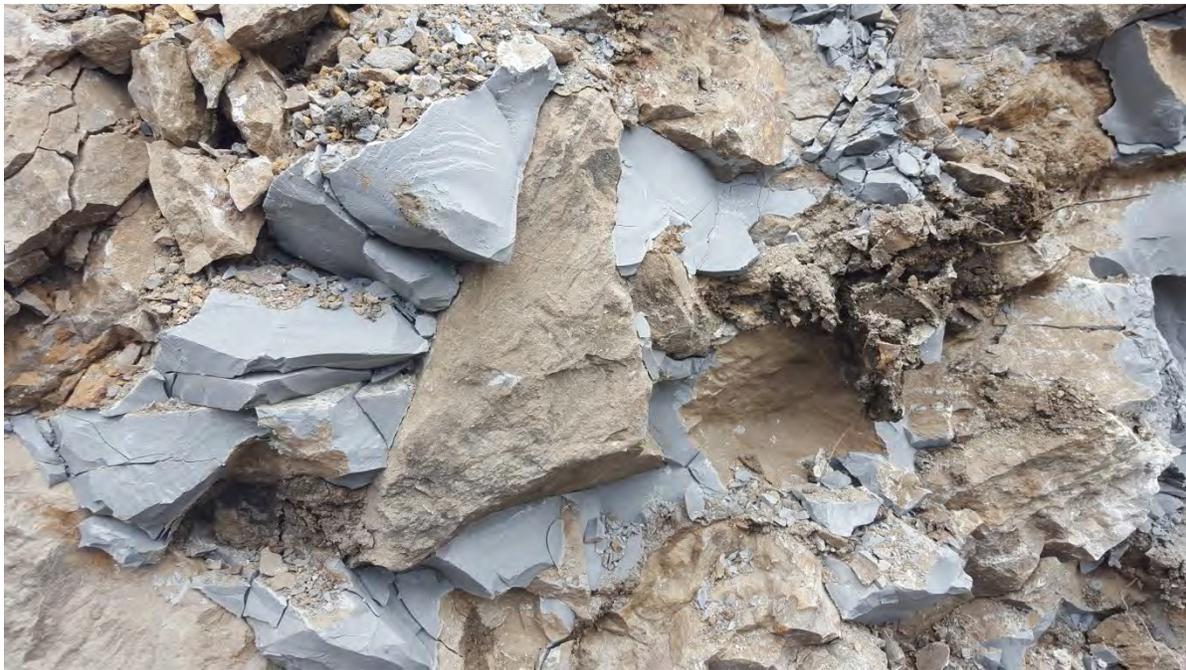
Figure 14: Close up of rock fill grouted together.

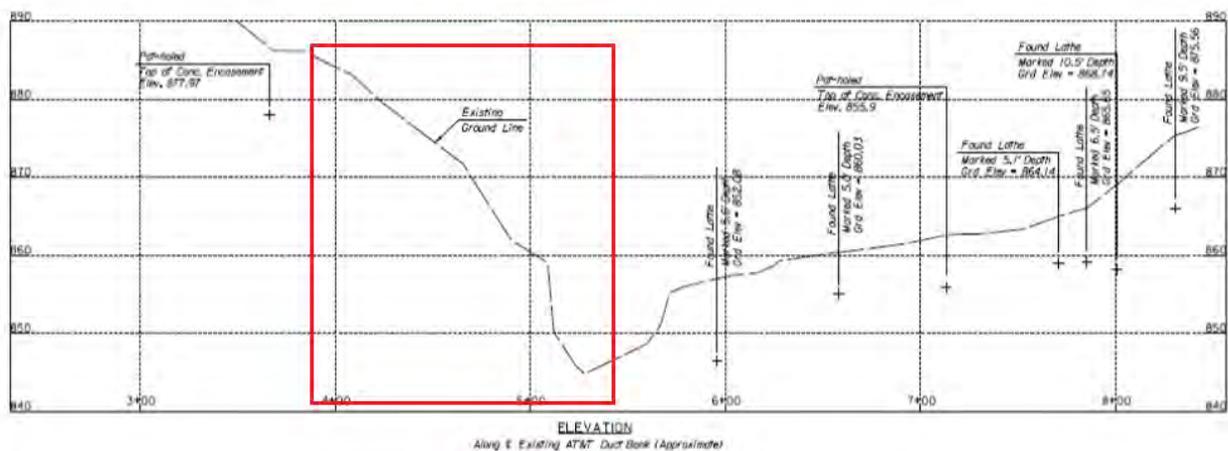
*Figure 15: The stations of the measured elevations along US 69. Marked Area: The project limits.*

Going into the project the AT&T utility conduit was expected to be a problem, but no one realized just how big a problem it would actually be. Before the design was finalized, KDOT hired a surveying contractor to measure the elevation of the conduit at various points in order to complete the design. That contractor wasn't allowed to measure the elevation of the conduit within the project limits because the slope it was under was too unstable to put equipment on. But they were able to locate and measure the conduit on the north side of Turkey Creek and along the road at the top of the embankment south of the project. The results of these shots showed the conduit snaking towards Turkey Creek from the north, dipping under the creek bed, and then showing up 200 feet further south next to the highway. The 200-foot survey gap contains the entirety of the project limits. The plans show an assumption that the conduit makes a straight line between the 2 points on either side of the project, but that alignment was unlikely when compared to the rest of the conduit. The plans also made it explicitly clear that the location shown was an estimate and that the contractor would need to field locate the conduit in order to work around it.

Based on the locations available, it was clear that even though the conduit intersects the wall in the bottom two rows, it sloped up drastically behind the wall and could possibly be in the path of the soil nails in rows 4 through 8. Because of this, the contractor needed to confirm the location and the depth of the conduit at several locations behind the wall in order to ensure they wouldn't drill into it. This proved to be extremely difficult. Utility locators were brought out to the project three times to mark out the location. The first time their markings were nothing like what the plans and existing utility flags indicated, so they were called out a second time to verify the first. But the second time their marks were much closer to what the plans showed so they were called out for a third time just to be absolutely sure. The third time their marks matched what they located the second time so those were what the contractor worked with. The locators weren't able to legally provide a depth using their sensor, so that responsibility fell on the prime contractor. They decided that the best method of confirming the depth and location of the conduit was to simply excavate down until they found it. The conduit is encased in 3-inches of concrete, so if the drill hit it there theoretically wouldn't be any immediate damage to it. After a lot of work (and safety briefings) the contractor was able to excavate two sections of the conduit on the slope behind the wall. They were also able to locate a third section of it in front of the wall.

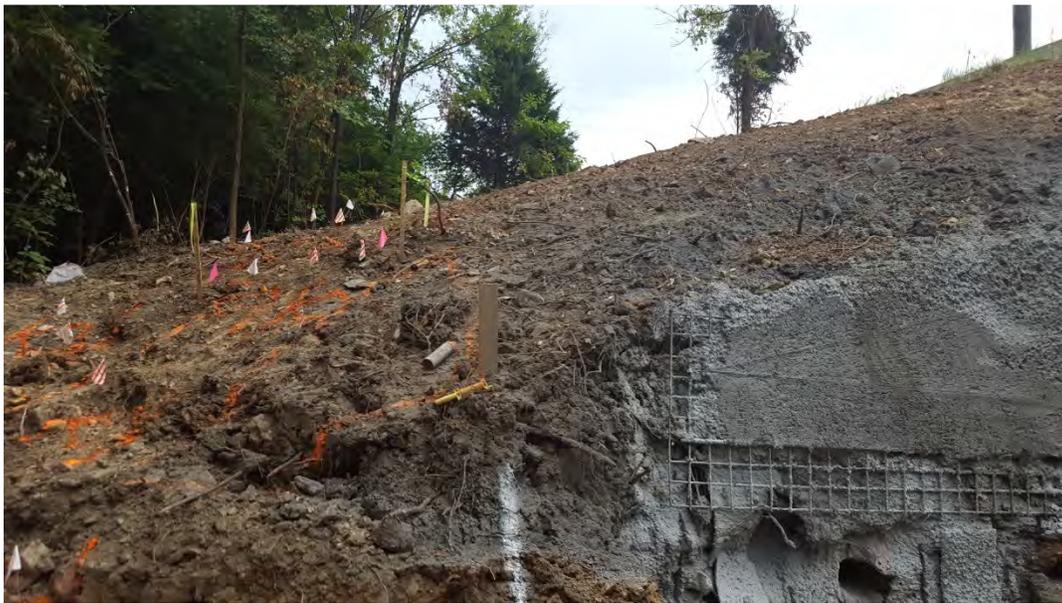
Figure 16: Slope behind the soil nail wall.

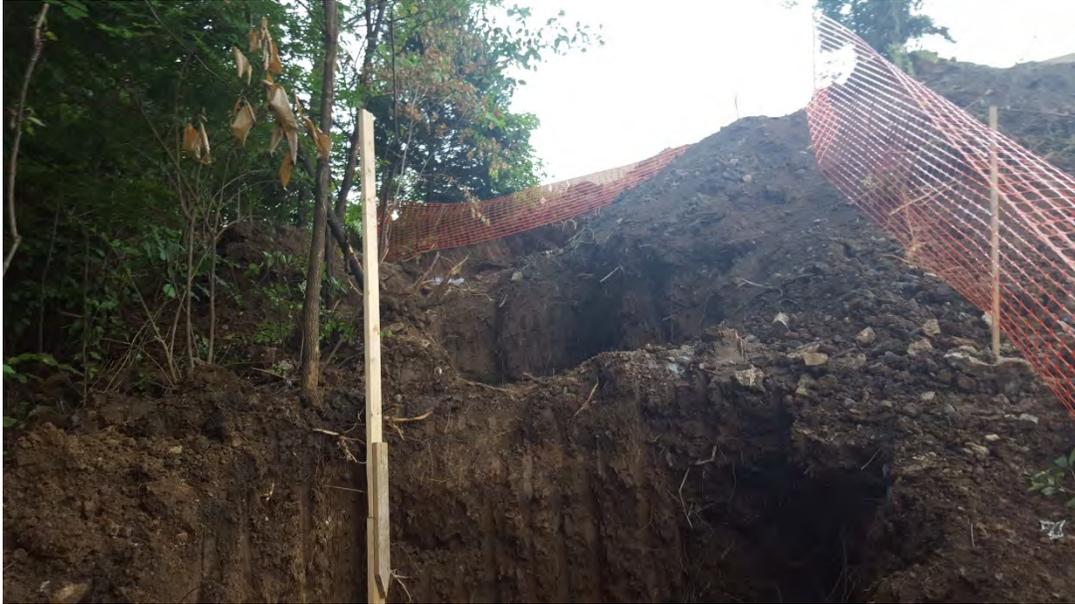
Figure 17: The 3 pot holes excavated on the slope. The conduit was found in only the closest 2.

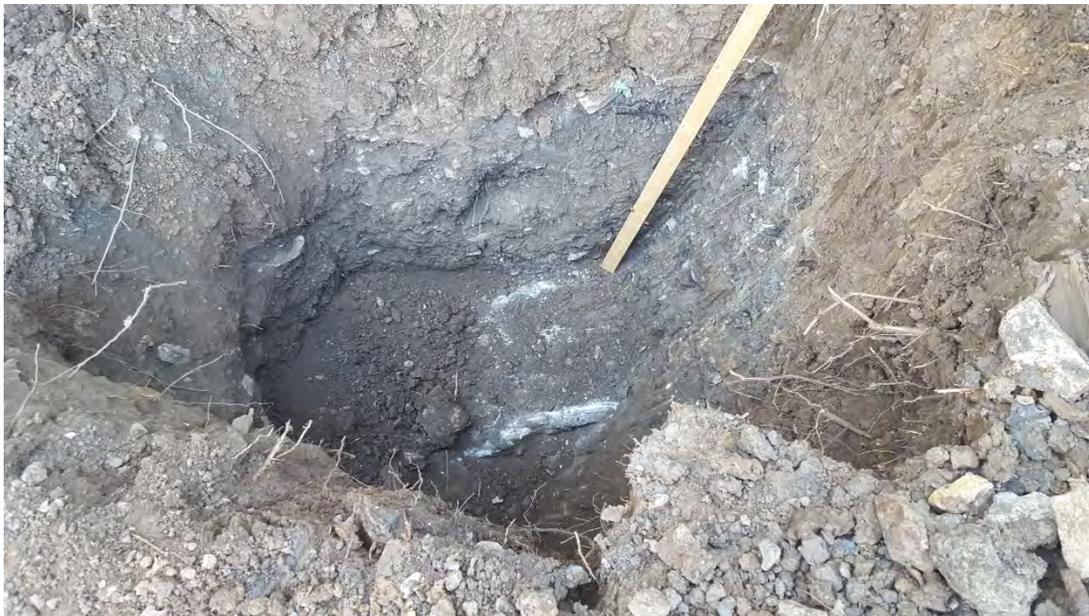
Figure 18: The conduit at the bottom of the excavation.

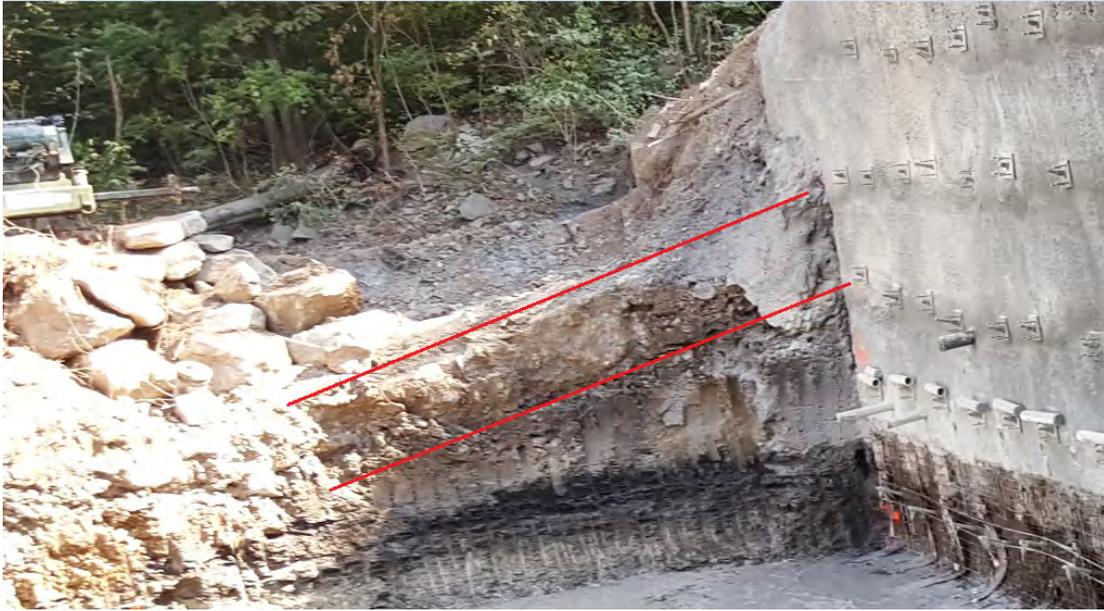
Figure 19: Utility conduit intersecting the soil nail wall.

Once the prime contractor confirmed those three locations, they had a surveyor measure the elevation and location of the conduit and sent that information to the soil nail wall design contractor. Their engineers changed the design of the wall in order to account for the actual location of the utility conduit. The design change consisted of cutting off the first column of nails on the east end of the wall and angling the next column of nails 15° away from the duct bank to avoid hitting it. This plan was submitted to and approved by KDOT in September 2015. After this plan was approved and everyone involved was satisfied that hitting the conduit was not a concern, the rest of the drilling operation progressed without major incident.

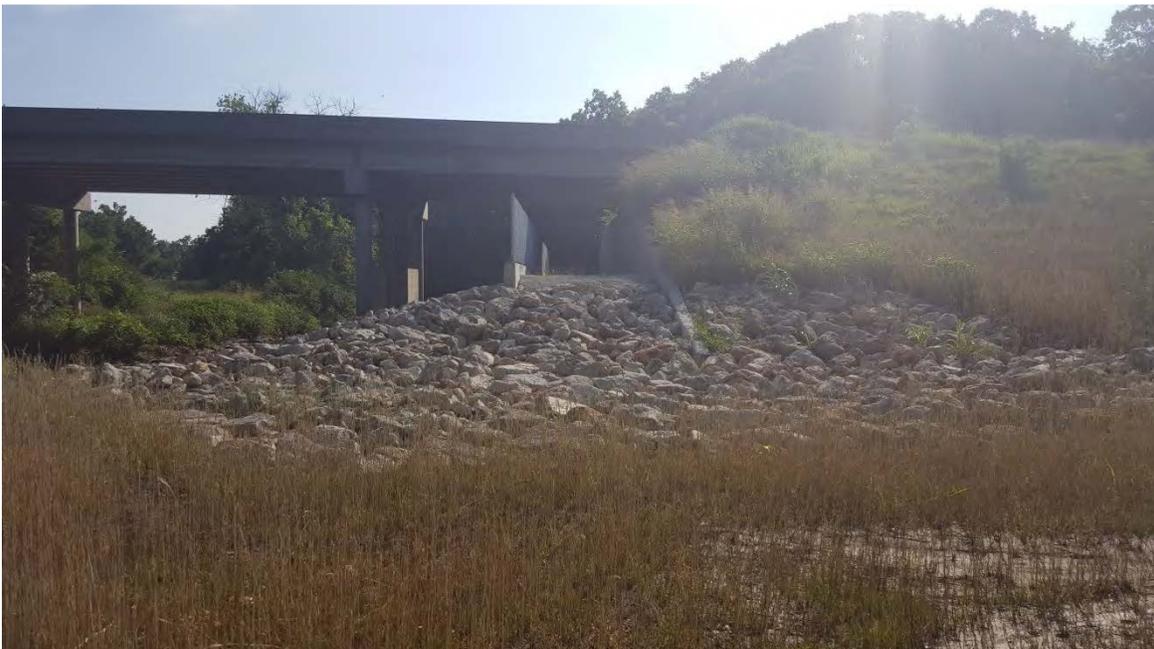
Figure 20: View from the west of the completed project.

Construction of the soil nail wall was started on July 7, 2015 and was completed on November 13, 2015. Construction of the cast-in-place wall began on November 16, 2015 and finished on March 28, 2016. The other work items: backfilling between the walls, placing rip rap stone around the walls, final grading, seeding, and the project punch list were all completed on April 28, 2016.

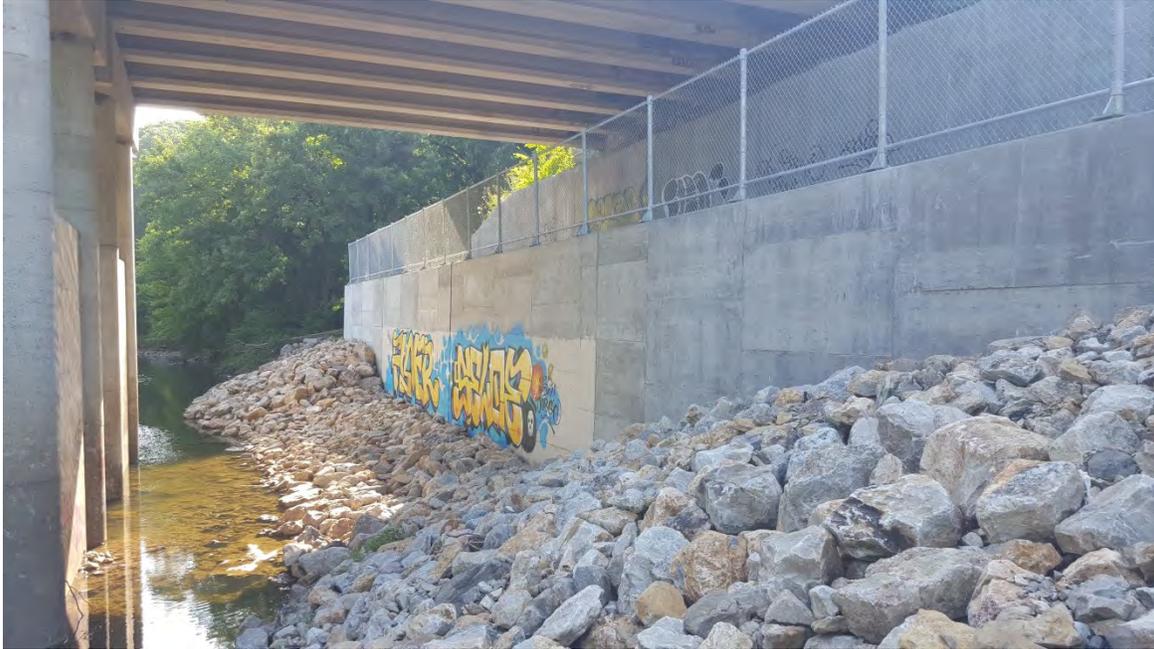
Figure 21: View of the front of the cast-in-place wall.

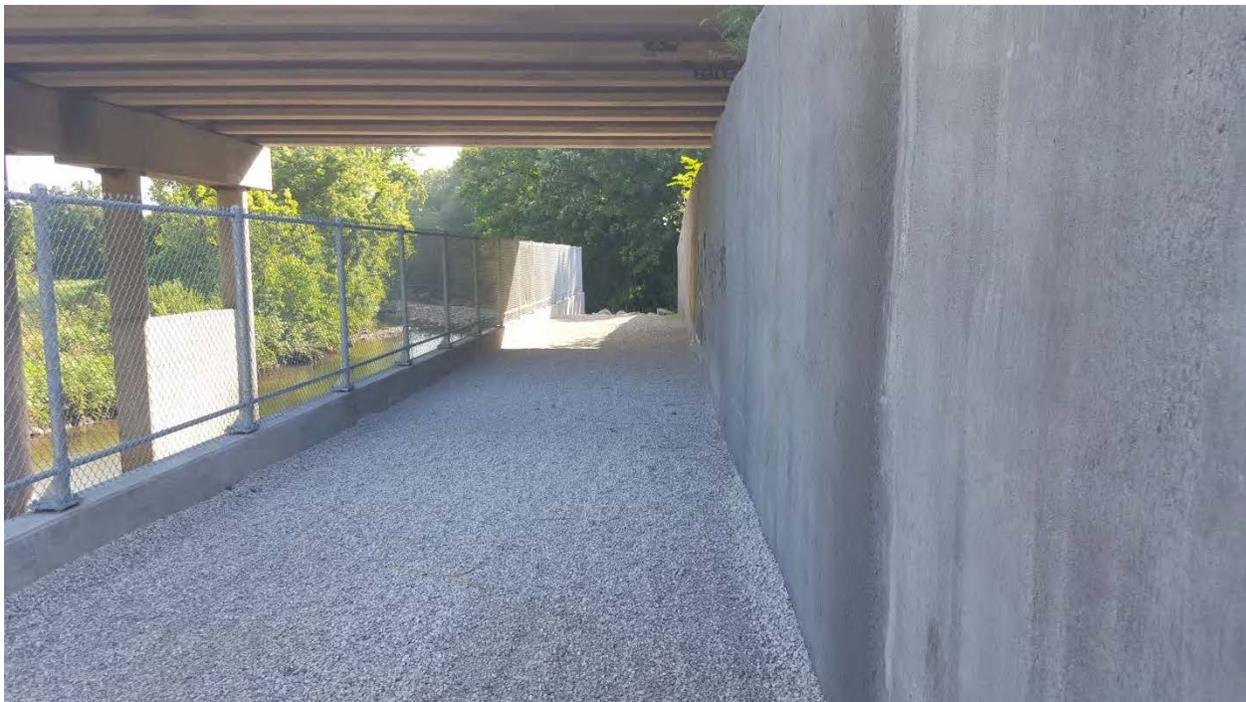
Figure 22: View between soil nail wall and CiP wall.

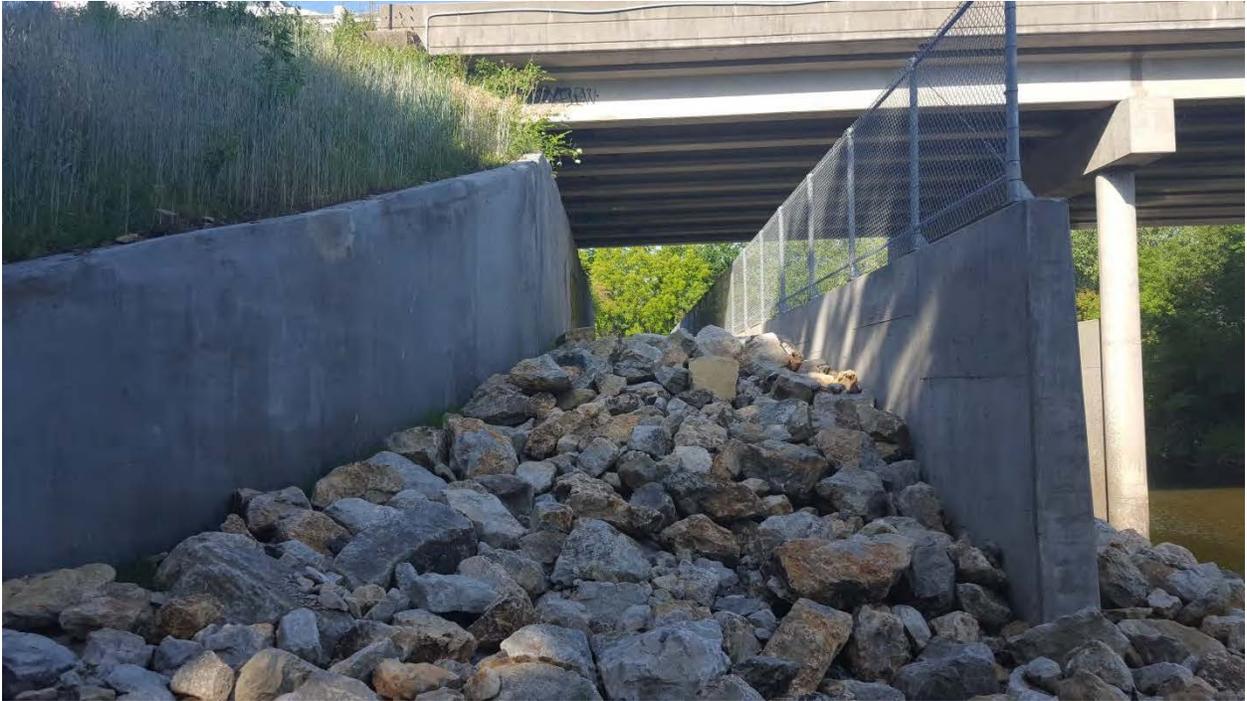
Figure 23: View from east side of the walls.

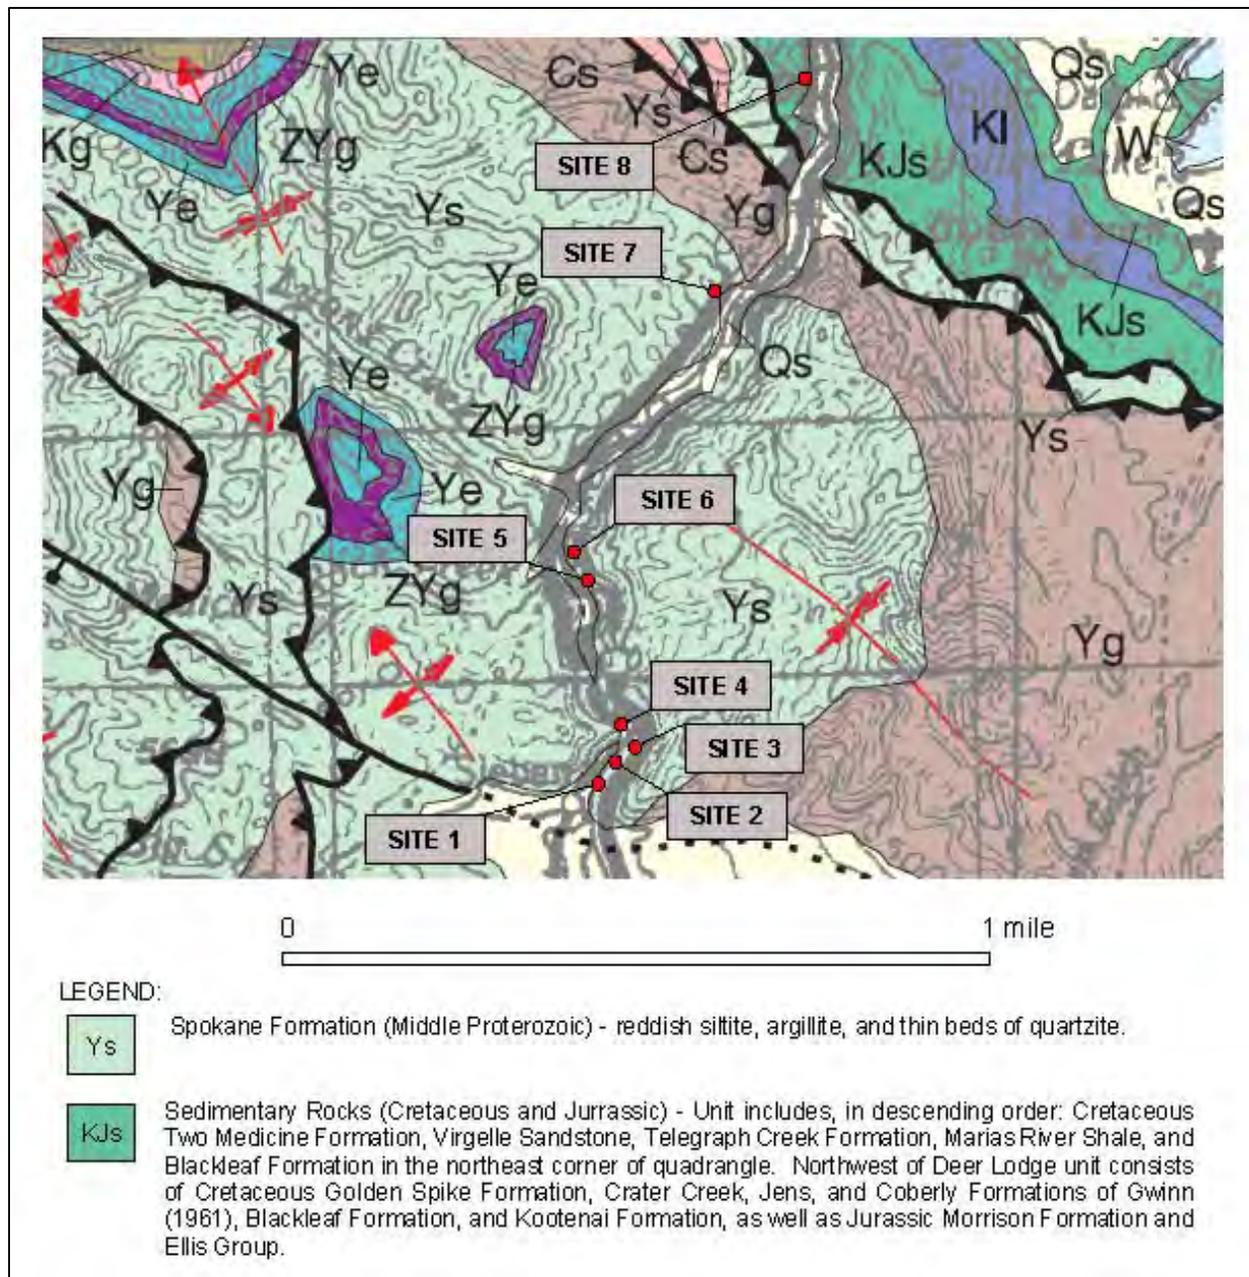
**Figure 2 – Regional geology surrounding Sites 1 through 8 (3).**

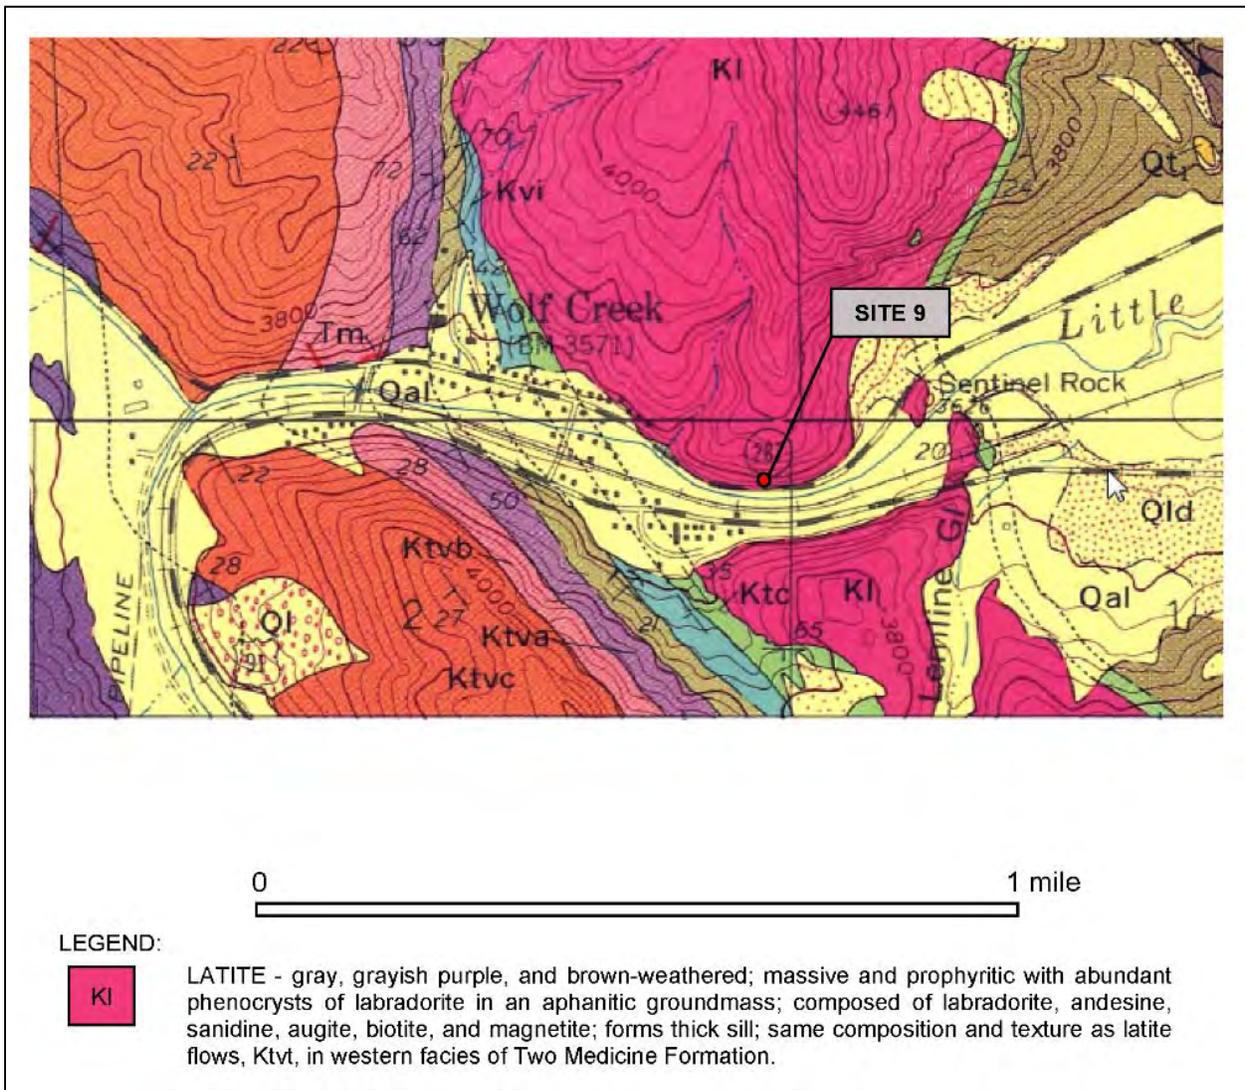
Figure 3 – Regional geology surrounding Site 9 (4).

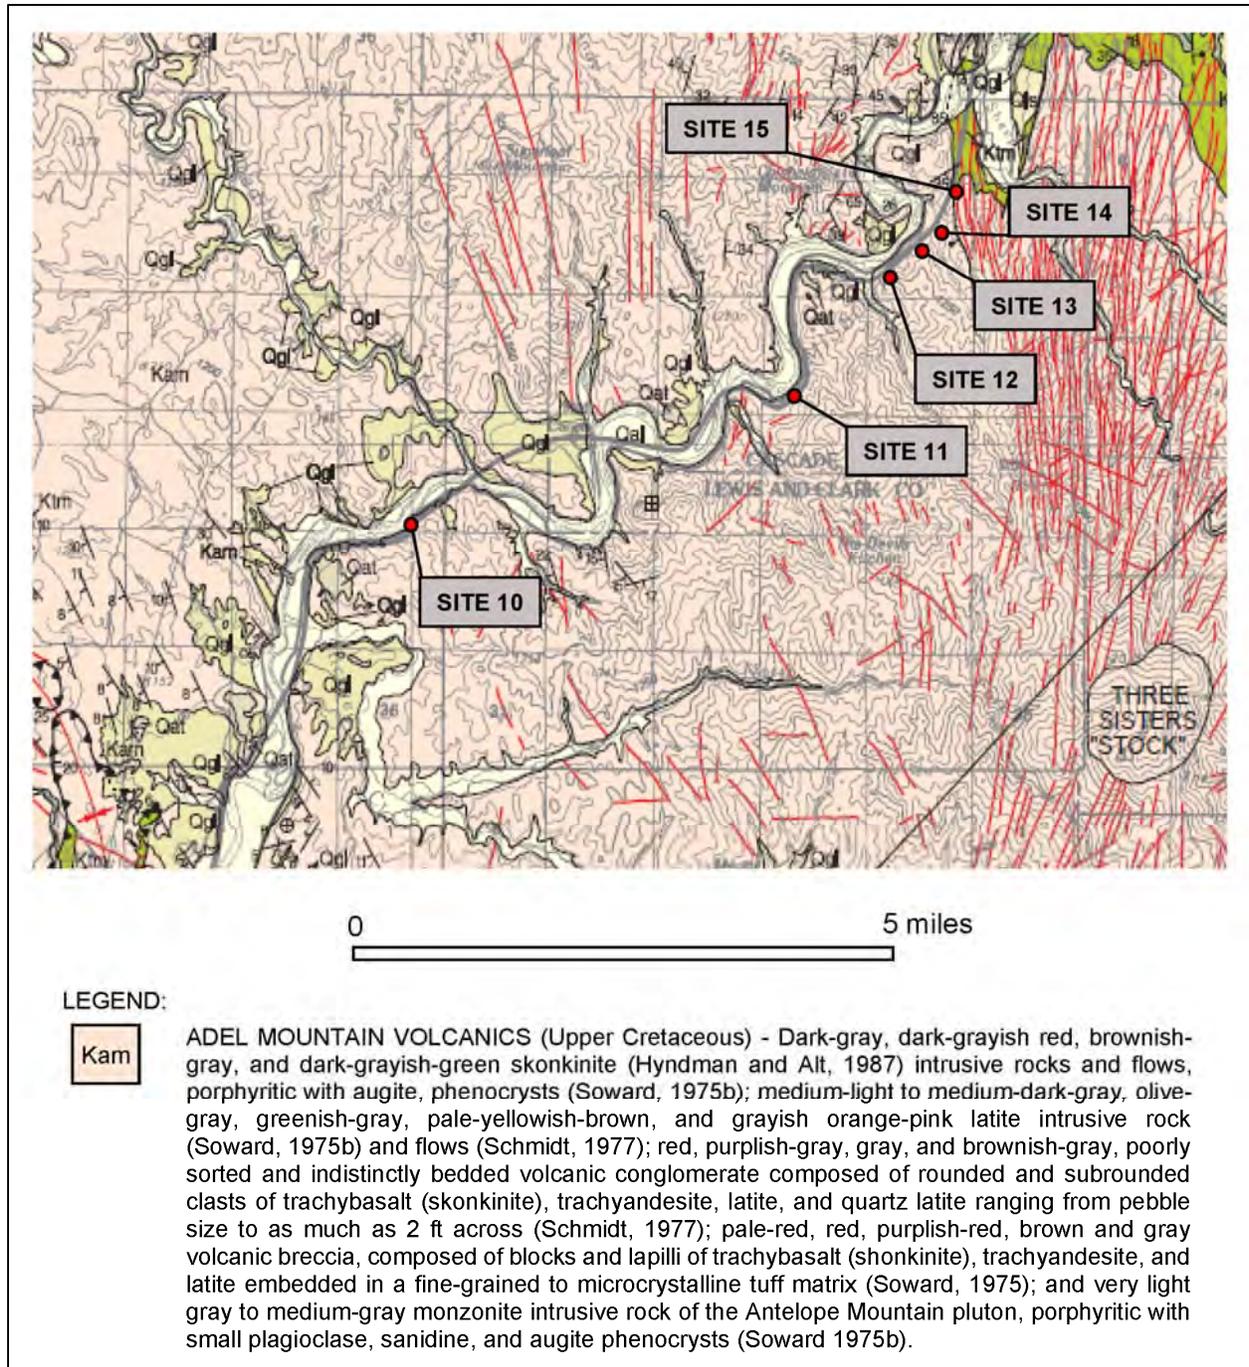
**Figure 4 – Regional geology surrounding Sites 10 through 15 (5).**

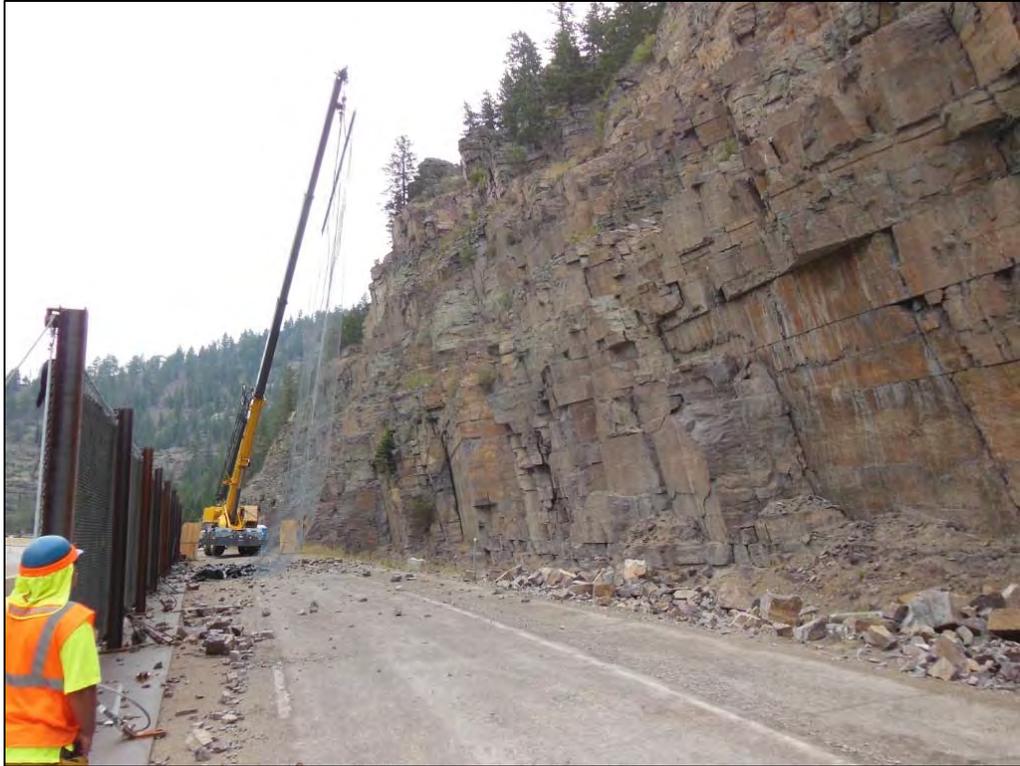
**Figure 5 – MRB and RCN at Site 3 below an active scaling area.**

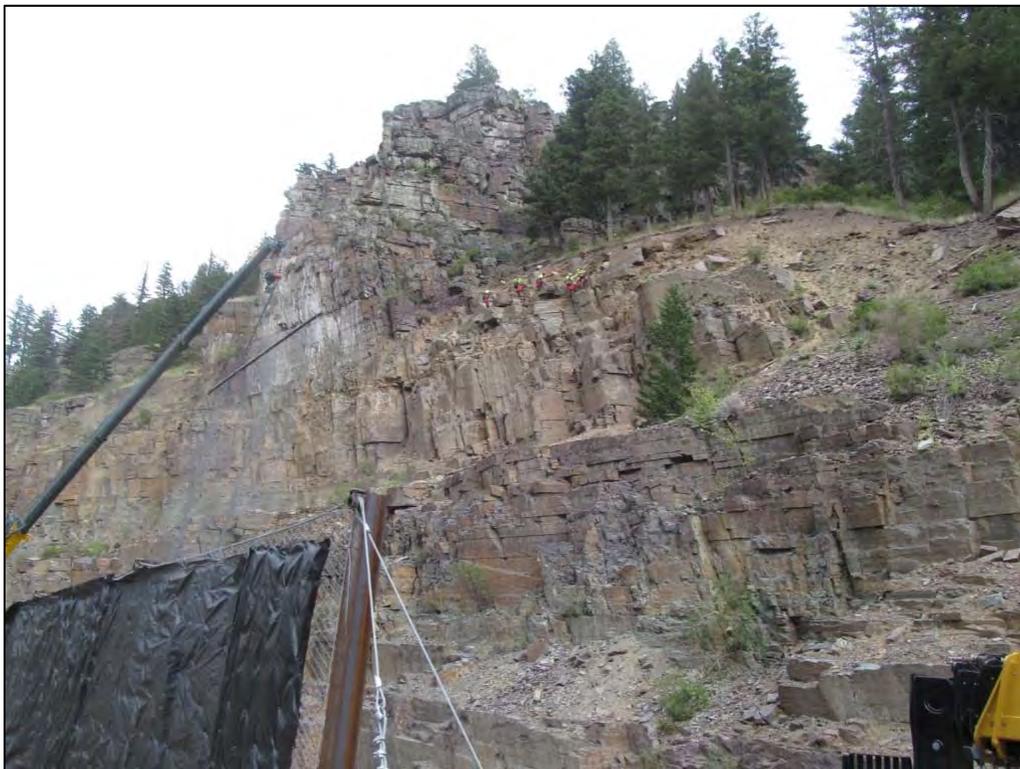
**Figure 6 – Active scaling at Site 2 with a MRB and RCN in place below work.**

Two forms of scaling were recommended for this project: general and heavy scaling. The level of effort required for general scaling typically involves use of hand scaling bars without assistance of other mechanical or breaking means for removing loose material. Heavy scaling requires a more concentrated effort to remove specific rock blocks or less competent rock mass areas, which may require use of mechanical or rock breaking techniques (i.e. jacks, hydraulic splitters, air pillows, etc.). Figure 6 illustrates general scaling conducted in 2015 at Site 2.

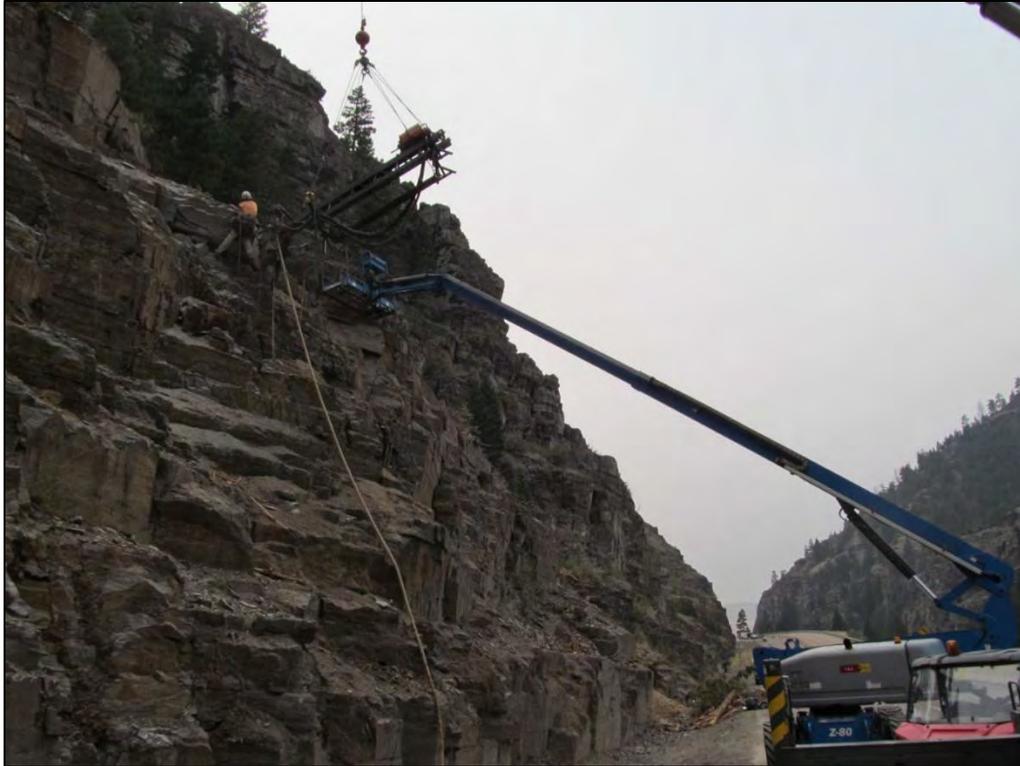
**Figure 7 – Rock bolt drilling at Site 2 with drilling equipment suspended from a crane.**

Typically a key block rock bolting approach was used for this project. Stabilizing key rock blocks will generally improve the stability of surrounding rock blocks. Stabilization of areas not suitable for key block bolting was designed using a pattern bolting approach. Additional rock bolting was included to stabilize foundation areas for the rockfall attenuators (as discussed later). Locations requiring reinforcement were identified in the field and potential rock bolts were marked on topographic maps and photographs.
