HGS 2016  
Proceedings

# 67TH HIGHWAY GEOLOGY SYMPOSIUM

## JULY 11 – 14, 2016

Cheyenne Mountain Resort  
COLORADO SPRINGS, COLORADO

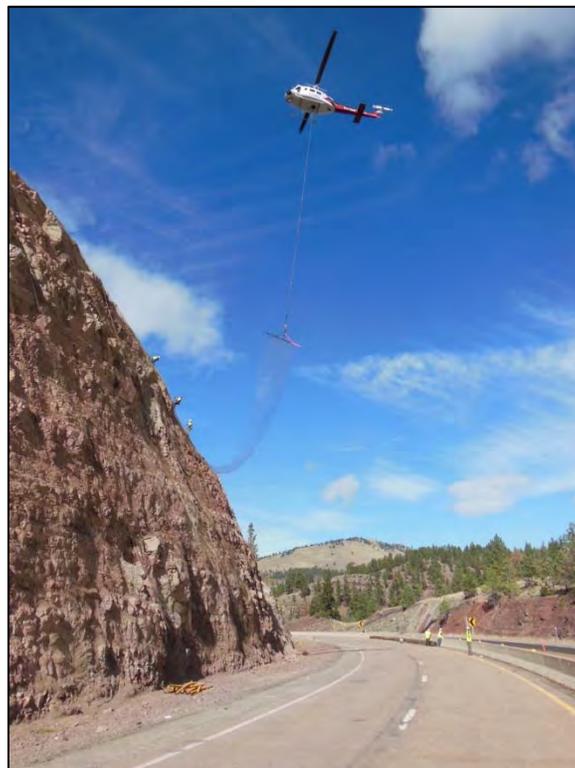
**Figure 8 – Helicopter placement of draped HTS mesh at Site 5.**

Draped mesh is appropriate for rock slopes that are comprised of small block sizes (i.e. maximum dimension of less than or equal to one to five feet) or where the rock mass is moderately to highly fractured. Two forms of draped mesh were designed: high tensile strength mesh (HTS) and twisted wire mesh (TW). HTS mesh is typically used for block sizes on the order of four to five feet in maximum dimension; whereas TW mesh is typically used when the largest block sizes are on the order of two feet. Rock slopes exhibiting these types of features were identified in the field and marked on topographic maps and photographs. Rockfall simulations were used to optimize the ability of the draped mesh areas to control rockfall trajectories to improve effectiveness of ditch catchment. Final designs were achieved by refining the lateral extents and bottom elevations of the meshed sections. Design also considered constructability, public perception, and aesthetics. The slope areas and maximum slope distances were used to design anchor capacities and spacing using anticipated loading conditions (i.e. debris, impact and snow loads). Draped mesh was recommended at Sites 4, 5, 6 and 7. Figure 8 shows HTS mesh being placed at Site 5 with assistance of a helicopter.

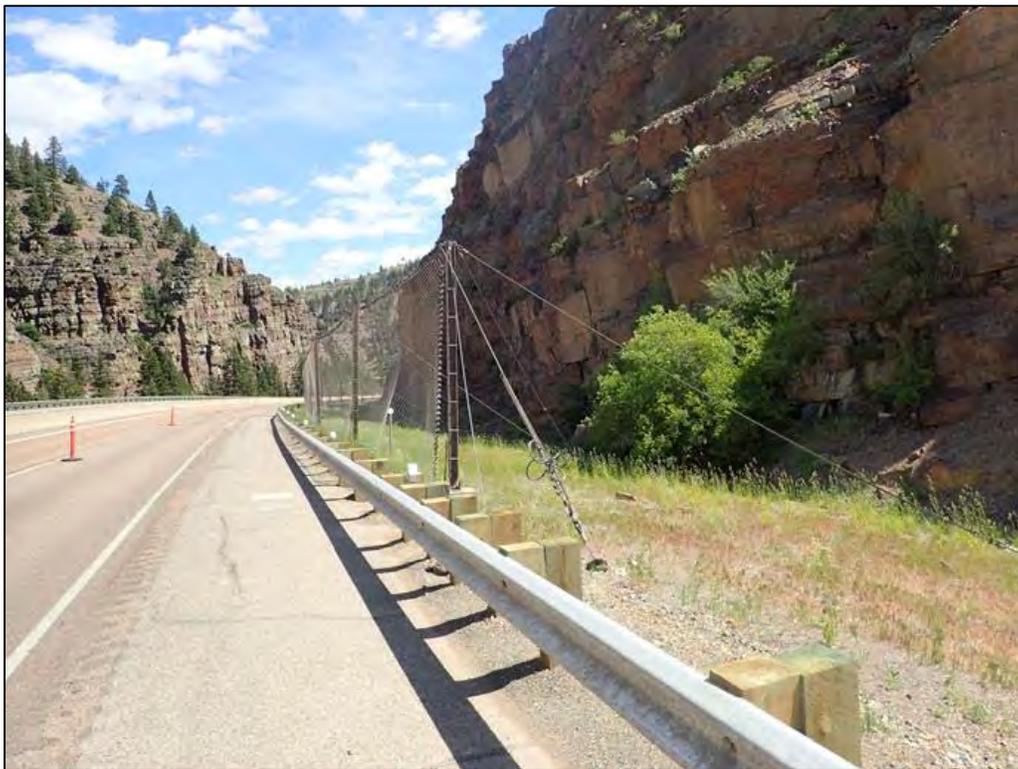
**Figure 9 – Flexible Rockfall Barrier at Site 1**

Sites where the existing ditch was not effectively capturing rockfall, but sufficient ditch width was available, were considered for installation of a flexible rockfall barrier. Potential extents of the barriers were estimated in the field and marked on topographic maps and photographs. Rockfall simulations were then conducted to optimize each barrier location, height and capacity (i.e. energy absorption capability). Design also considered expected barrier deflections, ease of maintenance behind the barriers, public perception, aesthetics, constructability considerations (including ease of installation, cost of materials/installation and post foundation conditions), and general roadway safety. Flexible rockfall barriers were recommended at Sites 1, 8 and 12.

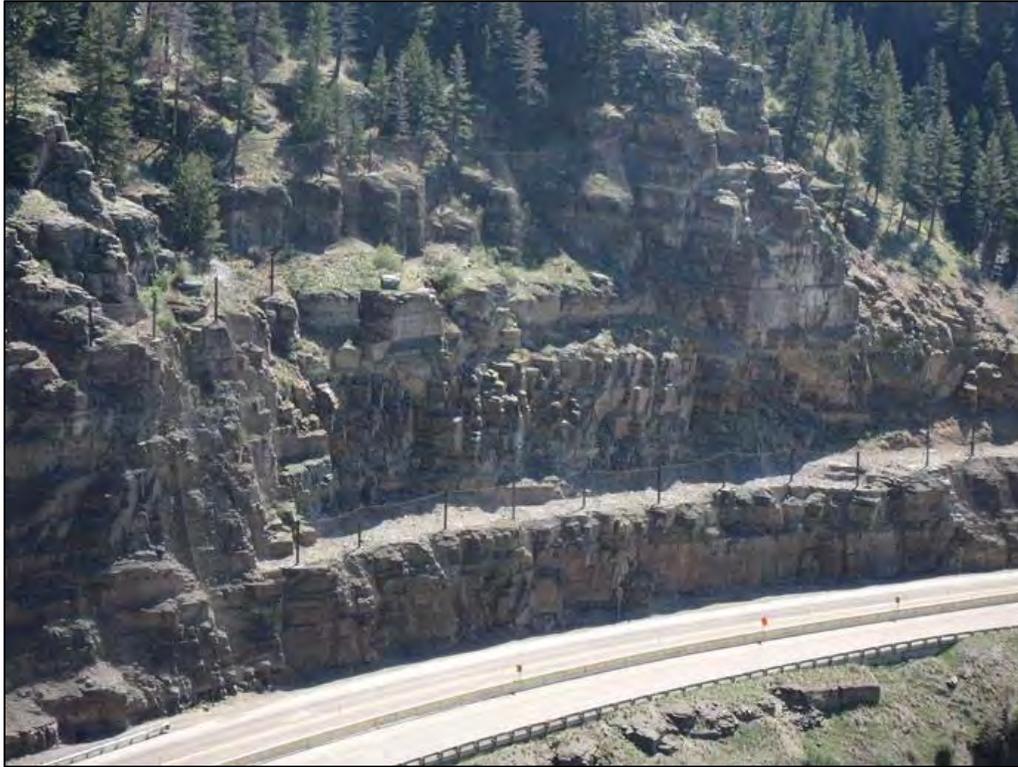
**Figure 10 – Rockfall Attenuators at Site 3**

In general, rockfall attenuators are a hybrid of draped mesh and flexible rockfall barriers. They typically have higher energy absorption capacity than draped mesh but lower than flexible barriers. Attenuators intercept rockfall similar to flexible barriers and control the rock's movement similar to draped mesh. Locations that were estimated to be effective for intercepting and controlling potential rockfall trajectories were identified in the field and marked on topographic maps and photographs. Rockfall simulations were then conducted to optimize each attenuator system location and height. Locations were optimized by selecting potential installation points on the slope that could capture simulated rockfall energies within industry standard available attenuator system capacities and heights. Design also included constructability considerations such as ease of access and installation. In some instances,

multiple attenuators were designed to provide continuous control of rockfall to the ditch elevations. The attenuator systems are based on the State of Washington Department of Transportation Cable Net Slope Protection Type 2 systems. Rockfall attenuators were recommended at Sites 2, 3, and 4.

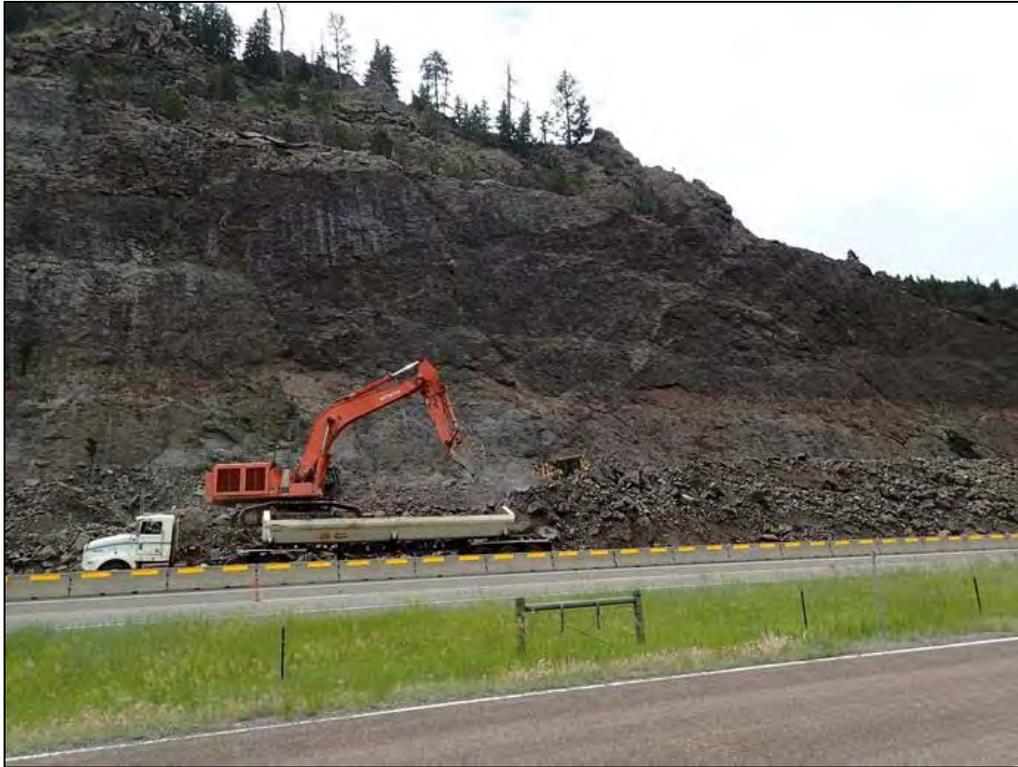
**Figure 11 – Rock Slope Excavation at Site 11**

All excavations were designed with standard cut slope angles considering pre-splitting methods on a 2.5-foot hole spacing to reduce potential back break damage to surrounding rock outcrops and new rock faces. Excavation was recommended at Sites 8, 11, and 12.

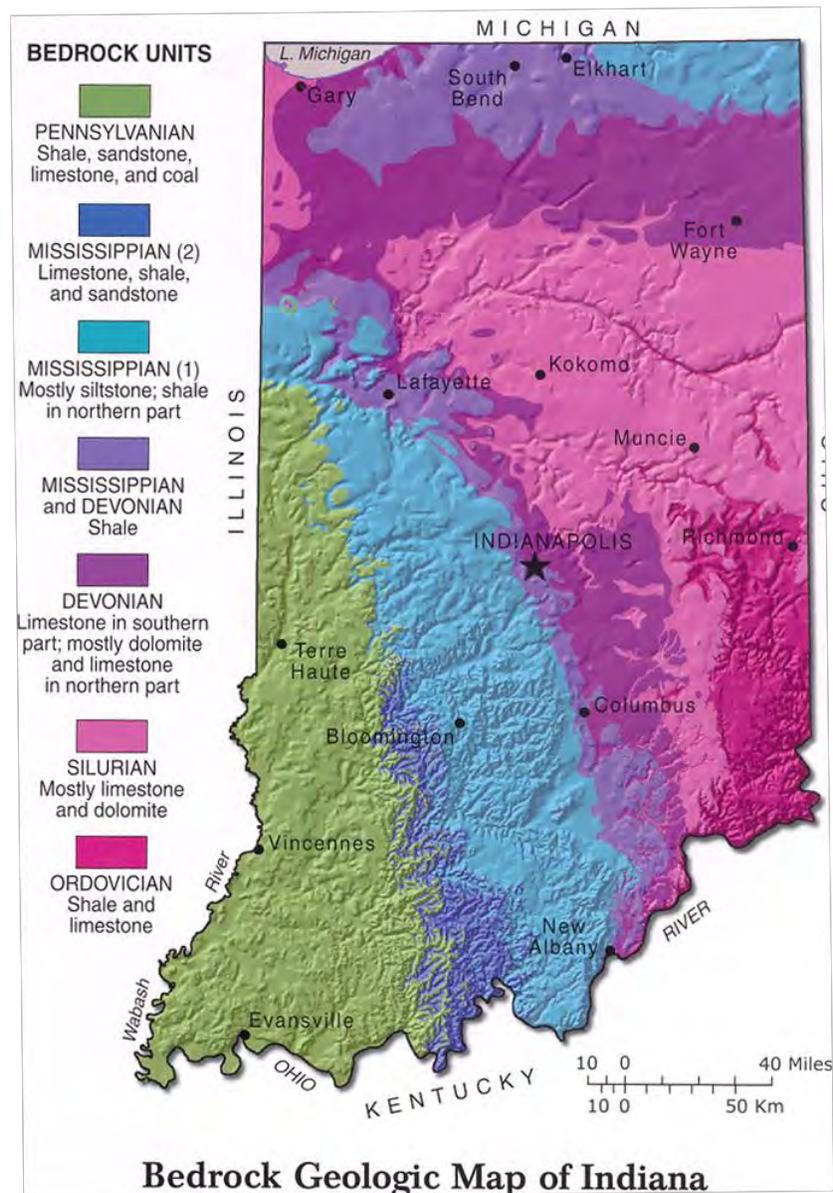
Figure 1 – Bedrock Map of Indiana

In many midwestern states, carbonate rocks provide the most desirable coarse aggregates for concrete construction. As such, limestone and dolomite commonly provide quality aggregates whereas shale and sandstones do not. Crushed stone aggregates in Indiana typically are superior to glacial gravels as these gravels tend to contain, weak, non-durable particles of low quality. In northern Indiana, thick glacial deposits are present which compounds the problem of finding suitable bedrock deposits for use in concrete. Dolomite reefs of Silurian age are prevalent along the strike from north to south near the center of the state and because of their resistance to weathering, stand at elevated positions into the overburden (Figure 1).

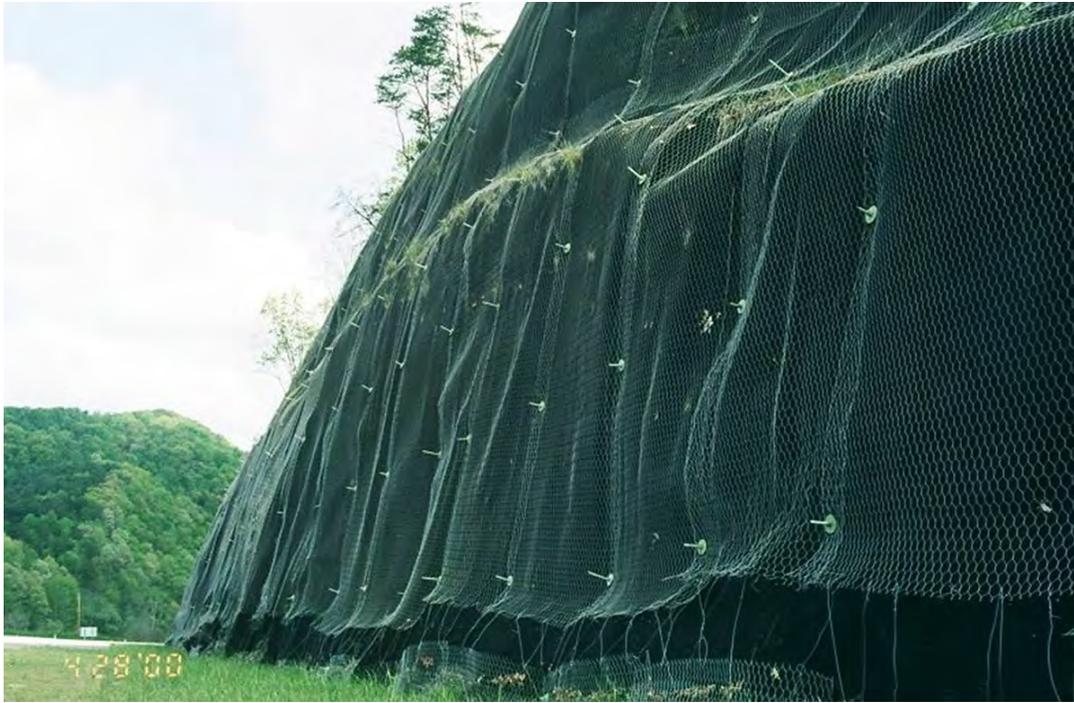
Figure 4 – Rock Cut in Black Shale, Eastern Tennessee

Black Shale is an undesirable material as it contains pyrite that is acid producing. Piles of excavated shale surrounding the quarry opening could produce acid drainage which should be isolated by a soil cover and neutralized by the addition of an alkaline material such as lime or limestone (Figure 4). This practice is used in current day highway construction when such shale is present in a road cut (Figure 5). Black shale also contains an elevated amount of radon which is another reason why the shale should be encapsulated by a soil cover. For safety purposes, soil berms must be built around the quarry. Since it is located on a floodplain, this would tend to reduce the floodway cross section during a high level flow of the Wabash River. Also there is a concern about the water pumped from the overburden and the bedrock. It must be contained in a settling pond to reduce turbidity. An NPDES permit would be required for any water to be released to the Wabash River.

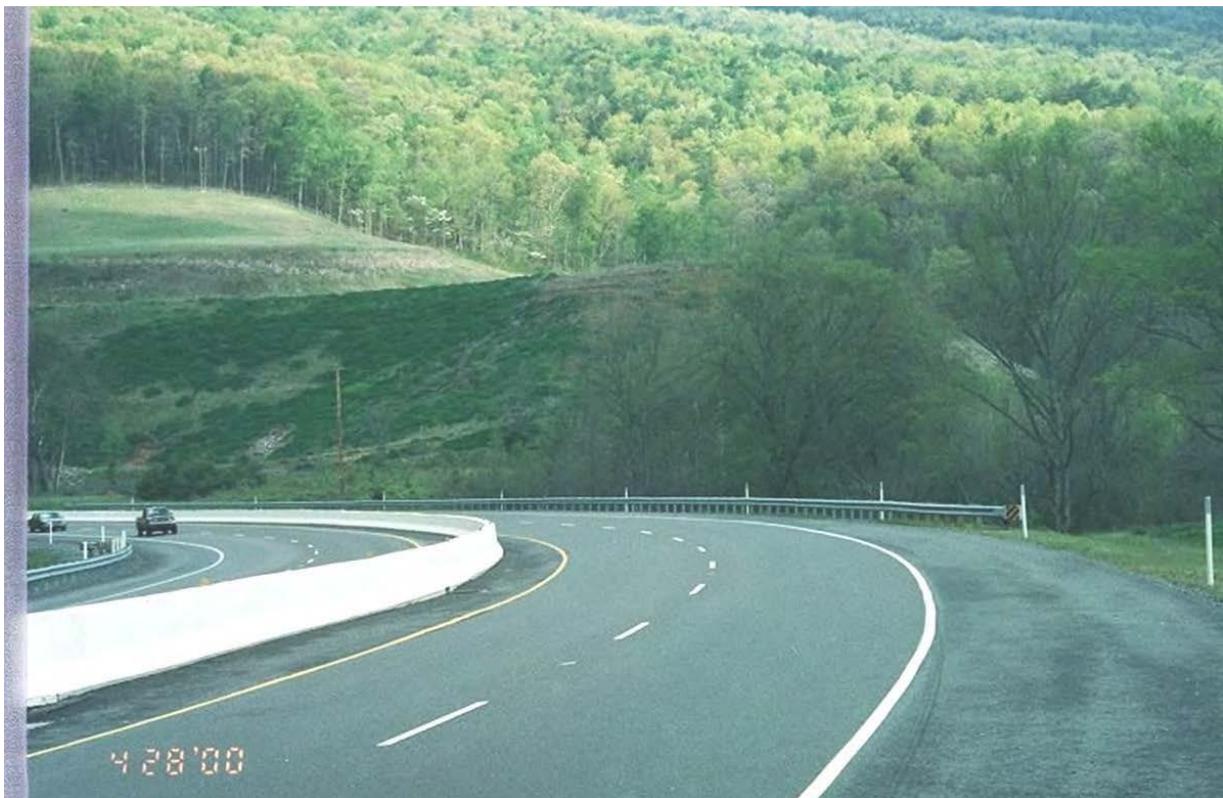
Figure 5 – Encapsulated Embankment, Black Shale

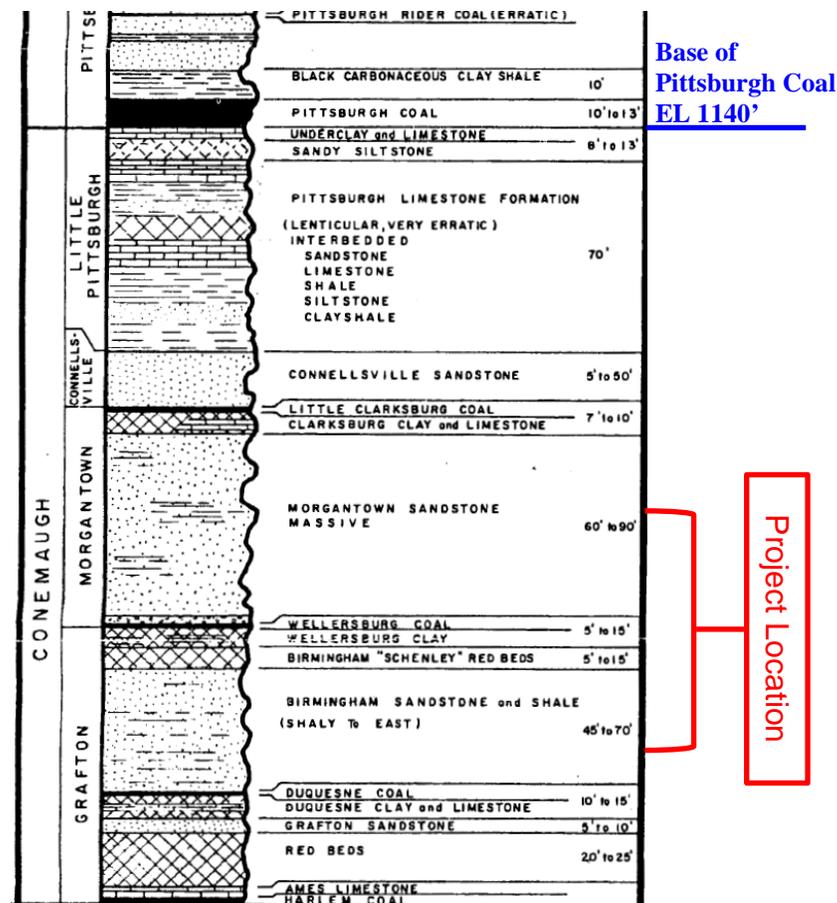
Figure 2 – Generalized Geologic Section of Allegheny County (5)

The geology of the project site was determined to lie within the Conemaugh Group of the Casselman Formation based on the project site elevations, structure contour mapping, and the Generalized Geologic Section of Allegheny County (see Figure 2) (5). The specific rock strata anticipated to fall within the project site elevations include (in descending order): the Morgantown Sandstone; Wellersburg Coal and Clay; and the Birmingham "Schenley" Redbeds, Sandstone, and Shale.

Figure 2 indicates that the Birmingham “Schenley” Redbeds typically have a thickness ranging between 5 feet to 15 feet; however, the “Schenley” Redbeds were much thicker beneath the SR 2018 project site. Boring GF-3 encountered a portion of the “Schenley” Redbeds with a thickness of 36 feet. This boring was terminated within the “Schenley” Redbed strata; as a result, the actual redbed claystone thickness may have exceeded 36 feet in this location. Numerous slickensides and healed fractures were noted at various depths throughout the “Schenley” Redbeds in all of the Final Design borings.

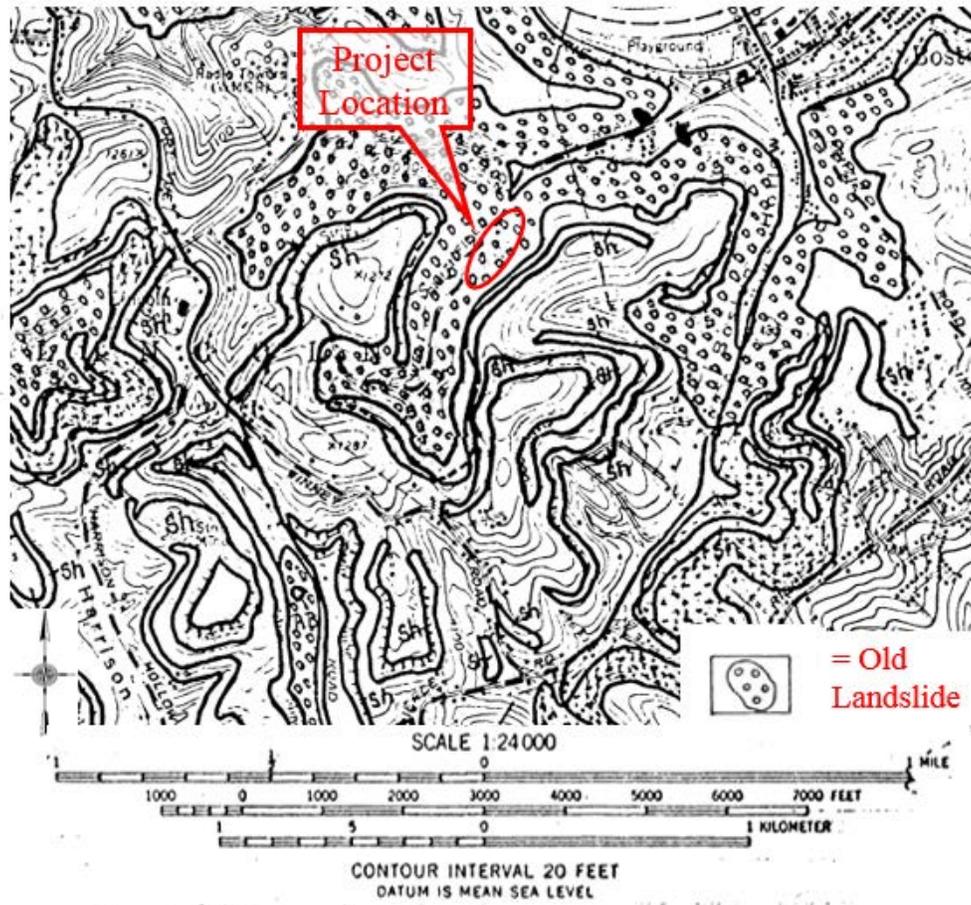
**Figure 3 – Landslide and Related Features Mapping (6)**

Landslide mapping of the project site indicates that the entirety of the right offset slope is located within the limits of an “old landslide” (see Figure 3) (6). Soils located within the boundaries of an “old landslide” are sensitive to changes in groundwater condition. Movement of the “old landslide” may be reactivated by a fluctuating groundwater table. Soils mapping accessed through the U.S. Department of Agriculture (USDA) Web Soil Survey application indicates that the entirety of the project site soils lie within the Gilpin-Upshur Complex (GQF) (7). GQF soils are typically characterized as having very steep slopes, ranging from 25% to 75%, with a severe erosion hazard. The presence of the “old landslide” and the severe erosion hazard of the GQF soils are both indicators of soil slopes with high potential for landslide movement.

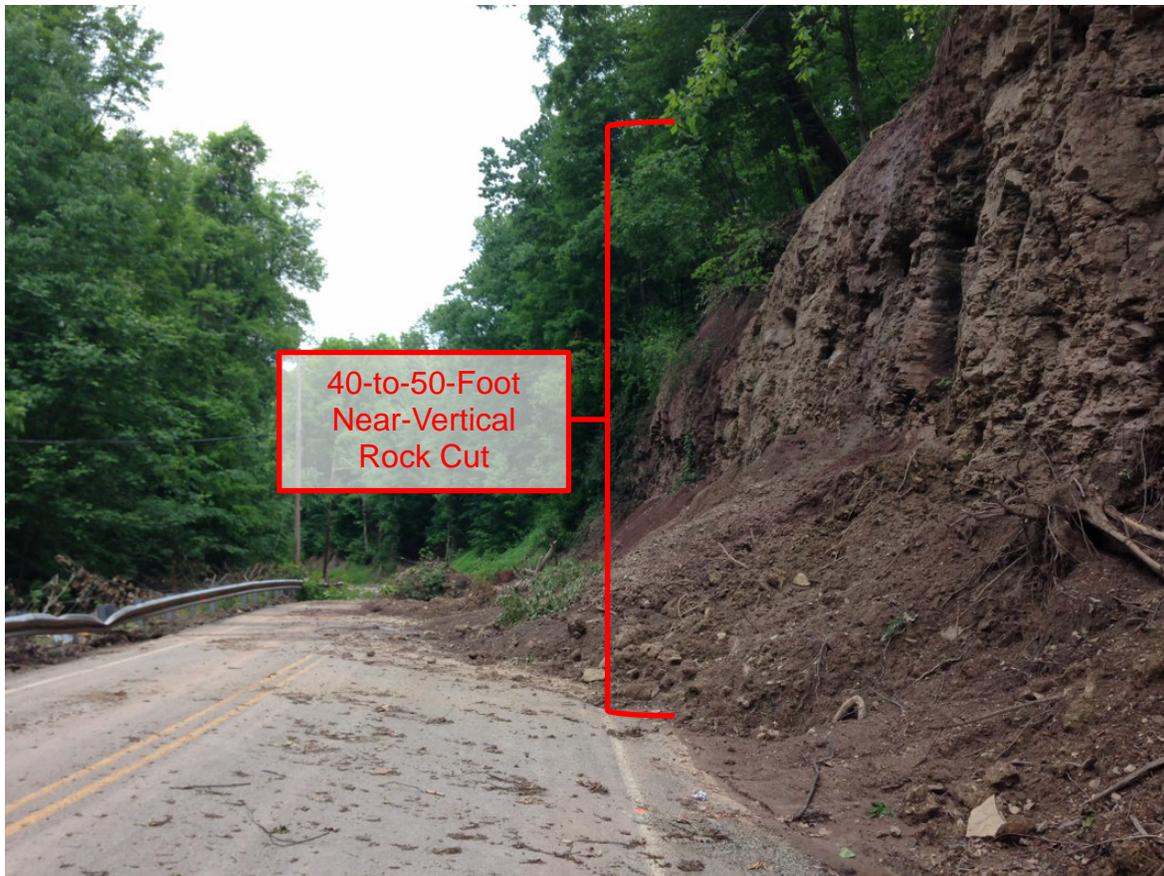
**Figure 4 – Landslide Mass and Right Offset Near-Vertical Rock Cut (June 2014)**

The wooded hillside above the right offset rock cut failed, cascading the landslide mass over the rock cut and into the SR 2018 roadway. The volume of material within the landslide mass impeded both travel lanes and forced closure of the roadway (see Figure 4). Groundwater seeps were observed throughout the active landslide area, indicating a seasonally high groundwater table.

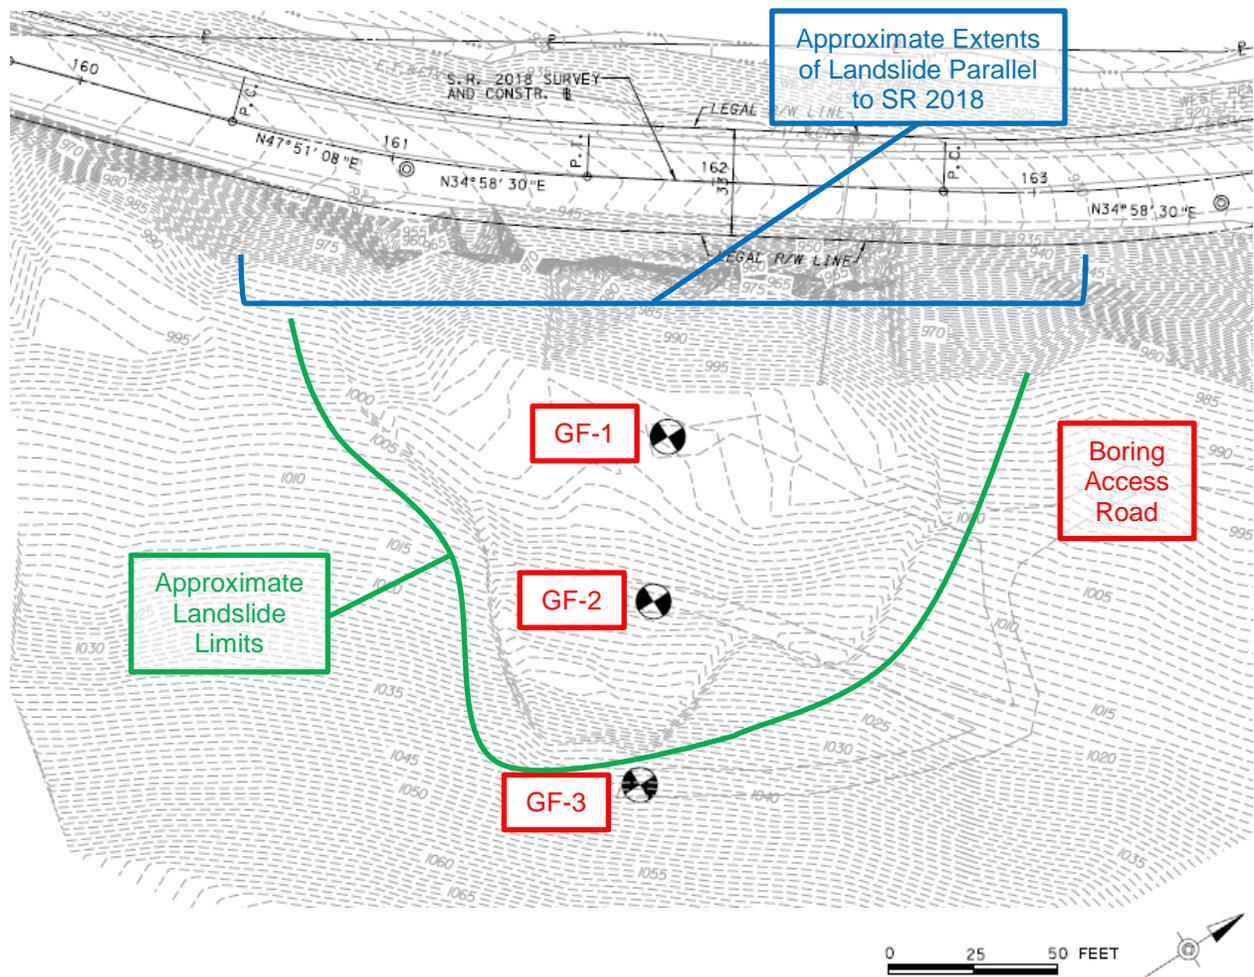
**Figure 5 – Boring Location Plan**

The Final Design subsurface investigation was performed in early June 2014 and included a total of three test borings (GF-1, GF-2, and GF-3). Drilling services were provided by L.G. Hetager Drilling, Inc., with full-time drilling inspection services performed by a PennDOT-certified drilling inspector employed by Gannett Fleming, Inc. The test borings were located to form a subsurface cross section through the center of the active landslide mass (see Figure 5). Borings GF-1, GF-2, and GF-3 were advanced to evaluate the subsurface conditions near the toe, mid-section, and head scarp of the landslide mass, respectively. The subsurface conditions encountered during the Final Design subsurface investigation were utilized to verify the geologic data compiled during the office research period.

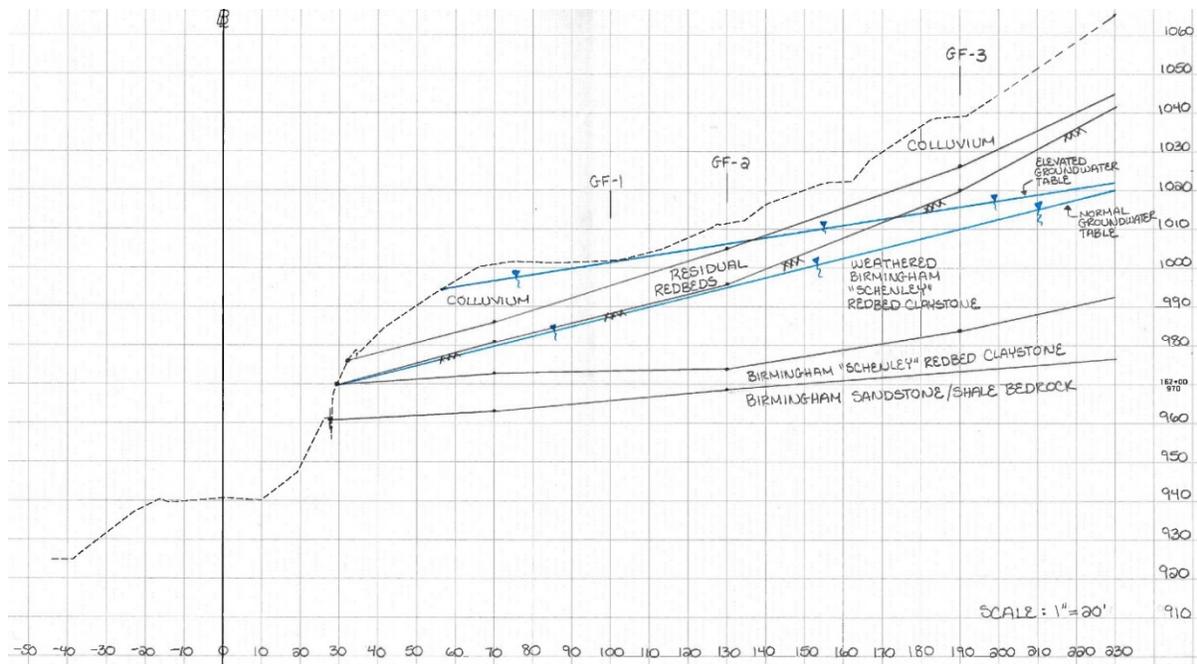
**Figure 6 – Project Site Subsurface Model**

Project site observations indicate variability of the groundwater table within the project slope. Two groundwater tables were included in the site subsurface model to ensure representation of the varying groundwater conditions throughout the year. The normal groundwater table was located within the weathered redbed claystone strata. The elevated groundwater table is located within the colluvial and residual soils and is representative of springtime/thaw conditions when the groundwater table is temporarily high. The site subsurface model in Figure 6 includes both the normal and elevated groundwater tables.

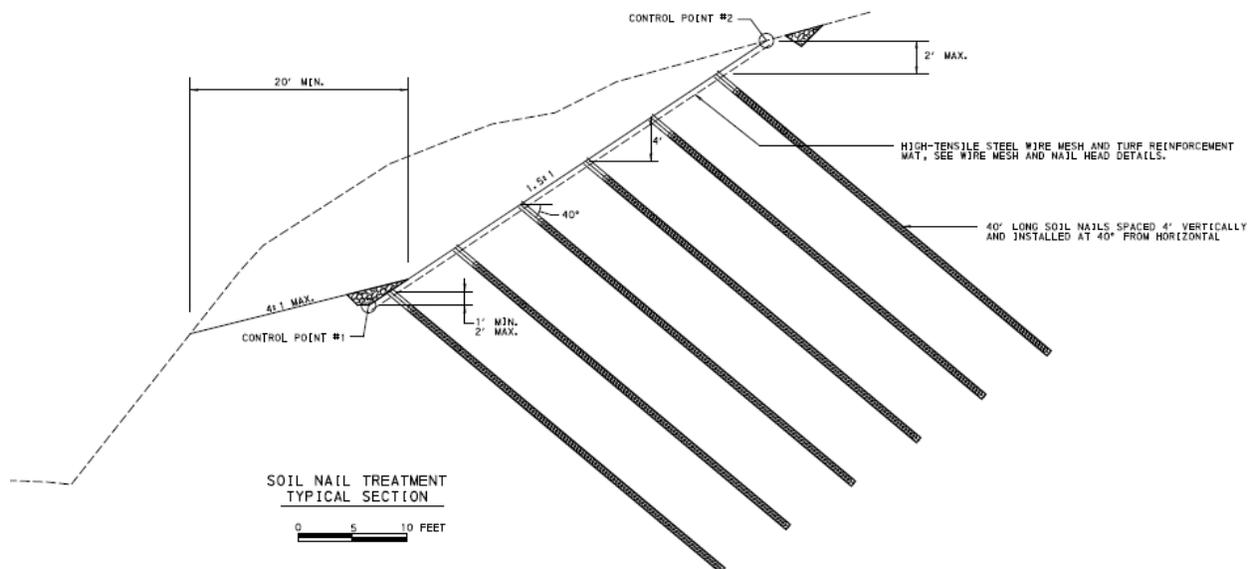
**Figure 7 – Soil Nail Treatment Typical Section**

- Soil Nail Spacing = 4 feet horizontally by 4 feet vertically
- Maximum Number of Rows of Nails = 6 rows
- Soil Nail Declination = 40° from horizontal
- Soil Nail Length = 40 feet
- Soil Nail Slope Finished Grade = 1.5H:1V
- Soil Nail Size = No. 8 Bar (Diameter = 1 inch)
- Total Soil Nail Diameter = 6 inches

Figure 7 shows the Soil Nail Treatment Typical Section that was included in the final drawings.

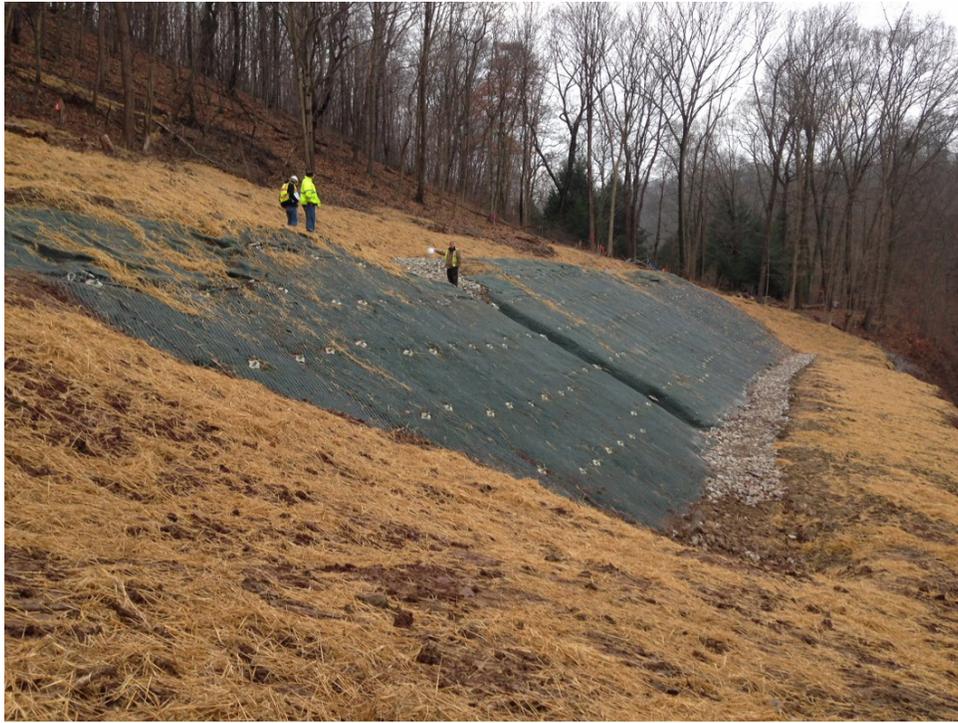
**Figure 8 – SR 2018 Finished Soil Nail Slope Treatment**

Construction of the soil nail slope treatment, with associated drainage, began mid-September 2014 and was completed by mid-December 2014. The primary issue encountered during the Construction phase related to the appurtenances required for installation of the soil nail system. The hexagonal nuts submitted for tightening the spike plate/high tensile steel wire mesh/TRM/soil nail system to the slope face did not seat properly onto the spike plates. The hexagonal nut/spike plate interface was designed to act as a ball joint and allow for flexibility of spike plate installation angle at the slope face. The bottom of the hexagonal nuts initially submitted for installation was flat, which limited the angle of spike plate installation at the slope face. The issue was resolved through submittal of matching appurtenances for installation at the project site. Figures 8 and 9 show the finished soil nail slope treatment and the right offset slope, respectively, at the interim final construction inspection on December 15, 2014.

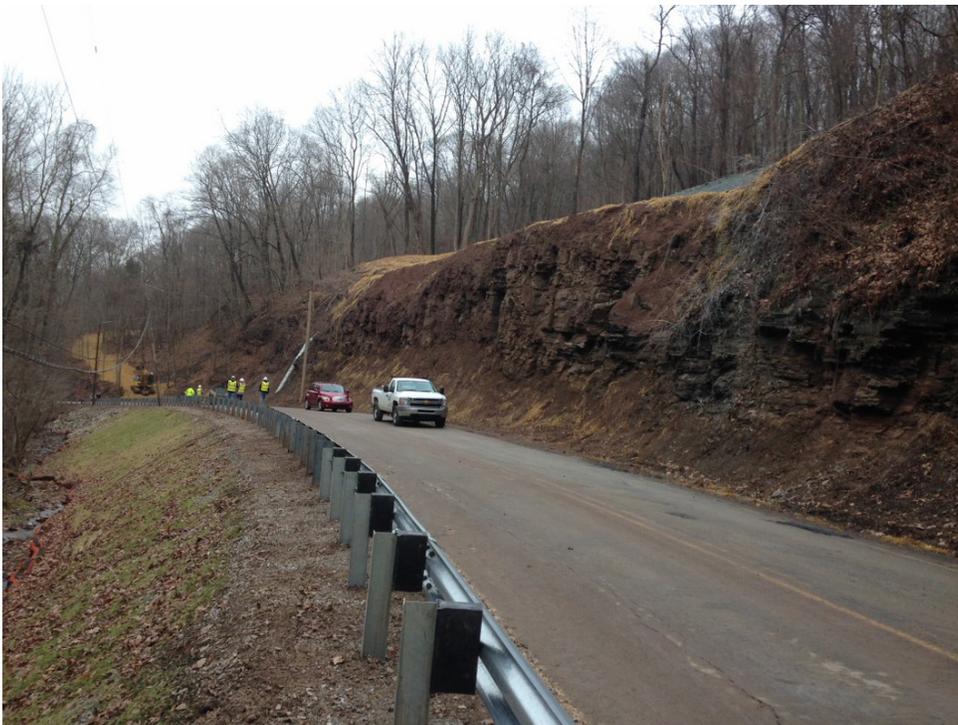
**Figure 9 – SR 2018 and Right Offset Slope Post-Construction**

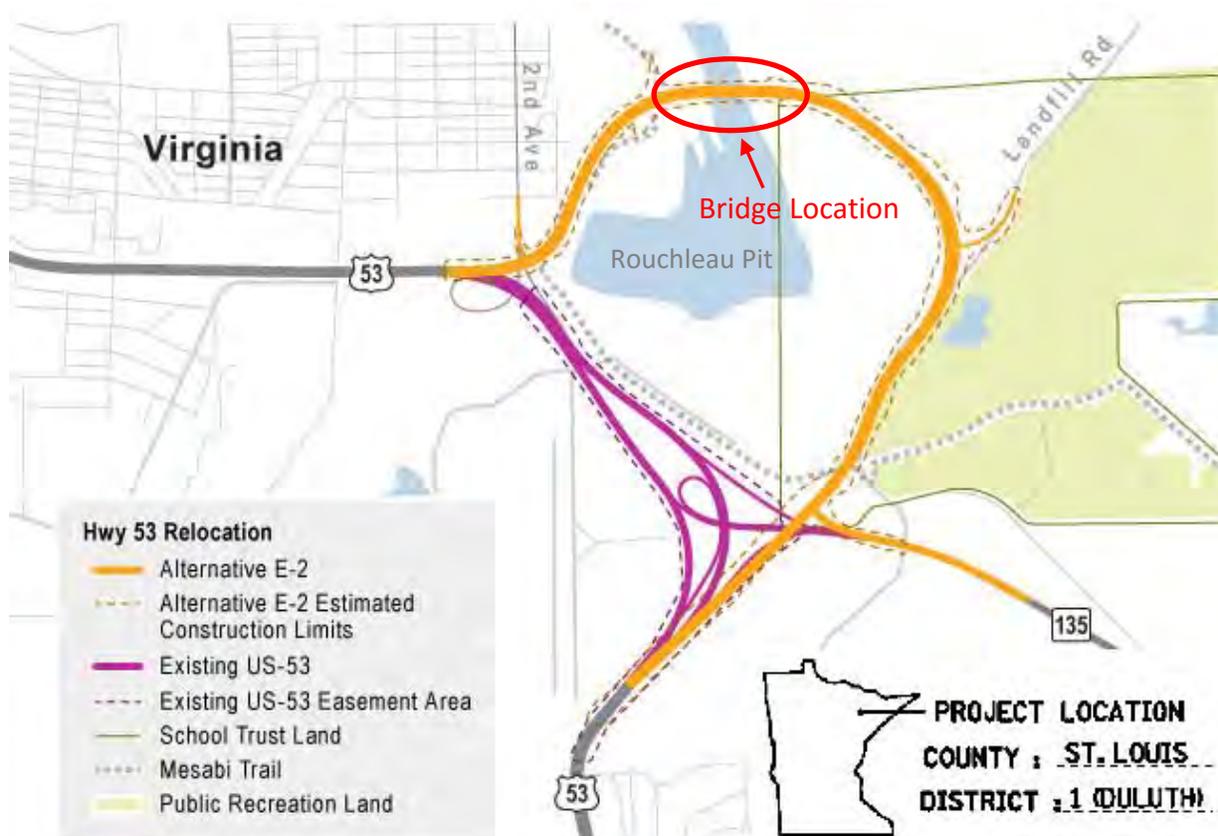
Figure 1 – Project Location and TH-53 Realignment.

Trunk Highway 53 (TH-53) southeast of Virginia, Minnesota, is being realigned to allow for future open-pit iron ore mining of land along the existing highway corridor. The new alignment follows the E-2 option shown in Figure 1. The new section of highway includes a three-span bridge across the currently inactive Rouchleau Mine Pit. The bridge is approximately 1,132 ft long with two abutments and two intermediate piers. The bridge is shown in elevation in Figure 2 and Figure 3 is a conceptual rendering of the bridge.

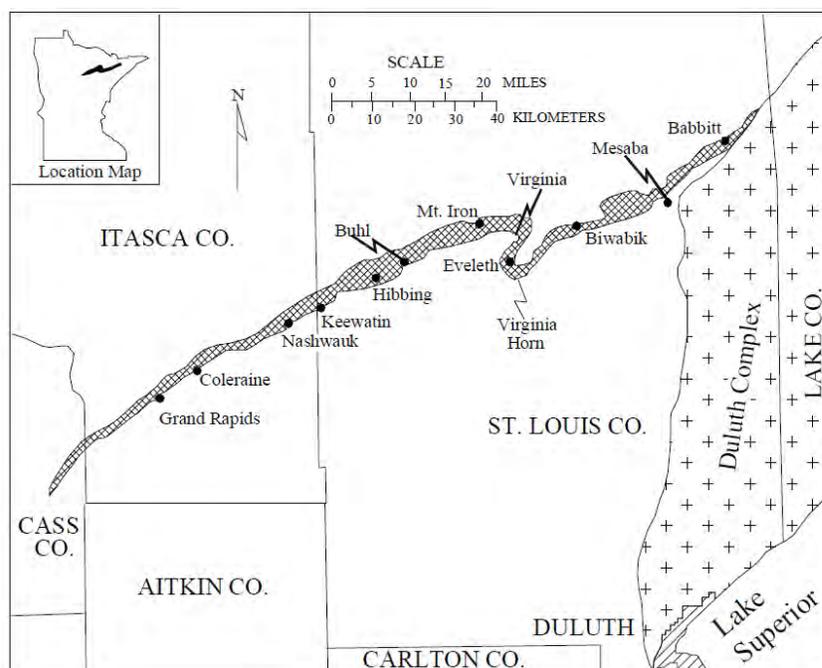
**Figure 4 – Map of the Mesabi Range (Biwabik Iron Formation) with the Duluth Complex shown to the east (1).**

Stretching roughly between the cities of Grand Rapids and Babbitt, the Biwabik Iron Formation is approximately 120 miles long and between 0.25 to 3.0 miles wide, as shown in Figure 4 (1). According to Severson et al. (1), the Biwabik Iron Formation is around 730-780 ft thick in the Virginia Horn area. The formation is subdivided into four units referred to as (from bottom to top): Lower Cherty member, Lower Slaty member, Upper Cherty member, and Upper Slaty member. The cherty members are typically characterized by a granular (sand-sized) texture and thick-bedding (beds  $\geq$  several inches thick). The slaty members are typically fine-grained (mud-sized) and thin-bedded ( $\leq$  ½ in thick beds). “Slaty” is a local mining term indicating parting parallel to bedding in thin-bedded rocks and is not necessarily indicative of metamorphism or slaty cleavage (1). The cherty members are largely composed of chert and iron oxides with zones rich in iron silicates, while the slaty members are generally composed of iron silicates and iron carbonates with local chert beds. Both cherty and slaty iron-formation types are interlayered at all scales, but one rock type or the other predominates in each of the four informal members, and they are so named for this dominance. The repetition of the major cherty and slaty members is interpreted by geologists as being the result of transgressive and regressive ocean events.

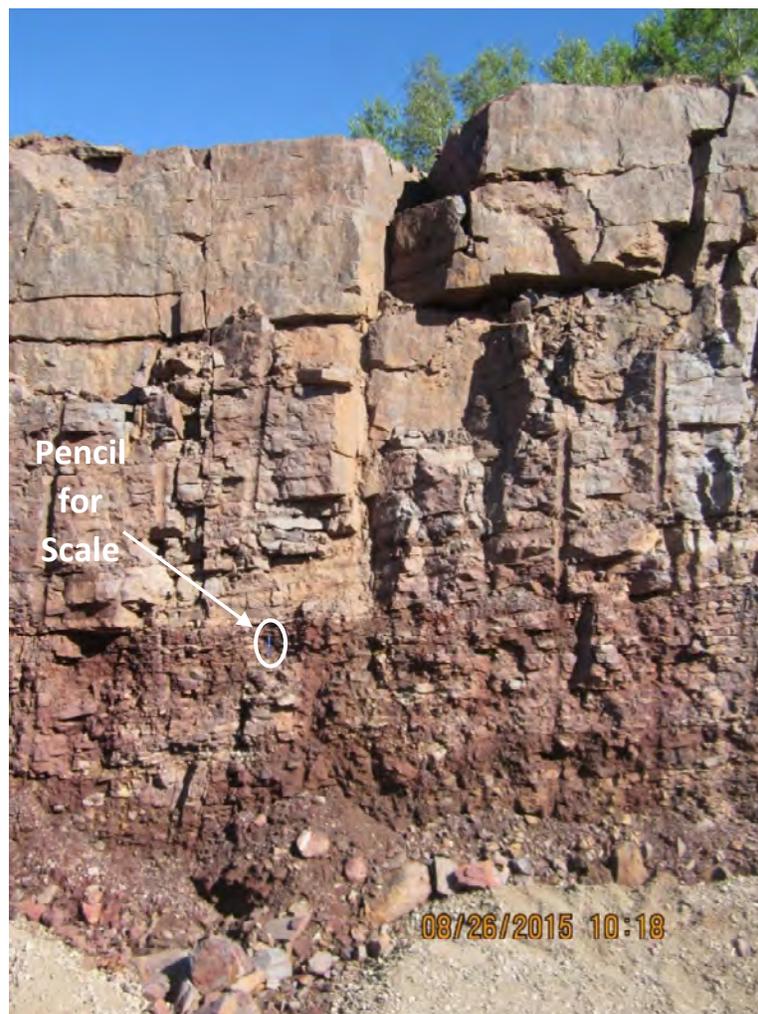
**Figure 5 – Exposed Cut Face showing Variations in Block Size.**

The bridge site is located in the central part of the Virginia Horn “S”. Sub-horizontal bedding plane dip angles typically range from zero to 20 degrees with local variation. Dip direction varies but is predominantly northwest. Joints not associated with bedding planes are predominantly sub-vertical, typically dipping between 70 and 90 degrees. Two or three sub-vertical joint sets exist at locations across the site. The sub-horizontal bedding planes and sub-vertical joints form blocks. The blocks vary in size depending on the spacing of the bedding planes and the nature of the bedding plane contacts. Generally, the slaty layers are comprised of smaller blocks or chips and the cherty layers are comprised of larger blocks of several feet in dimension, as shown in Figure 5.

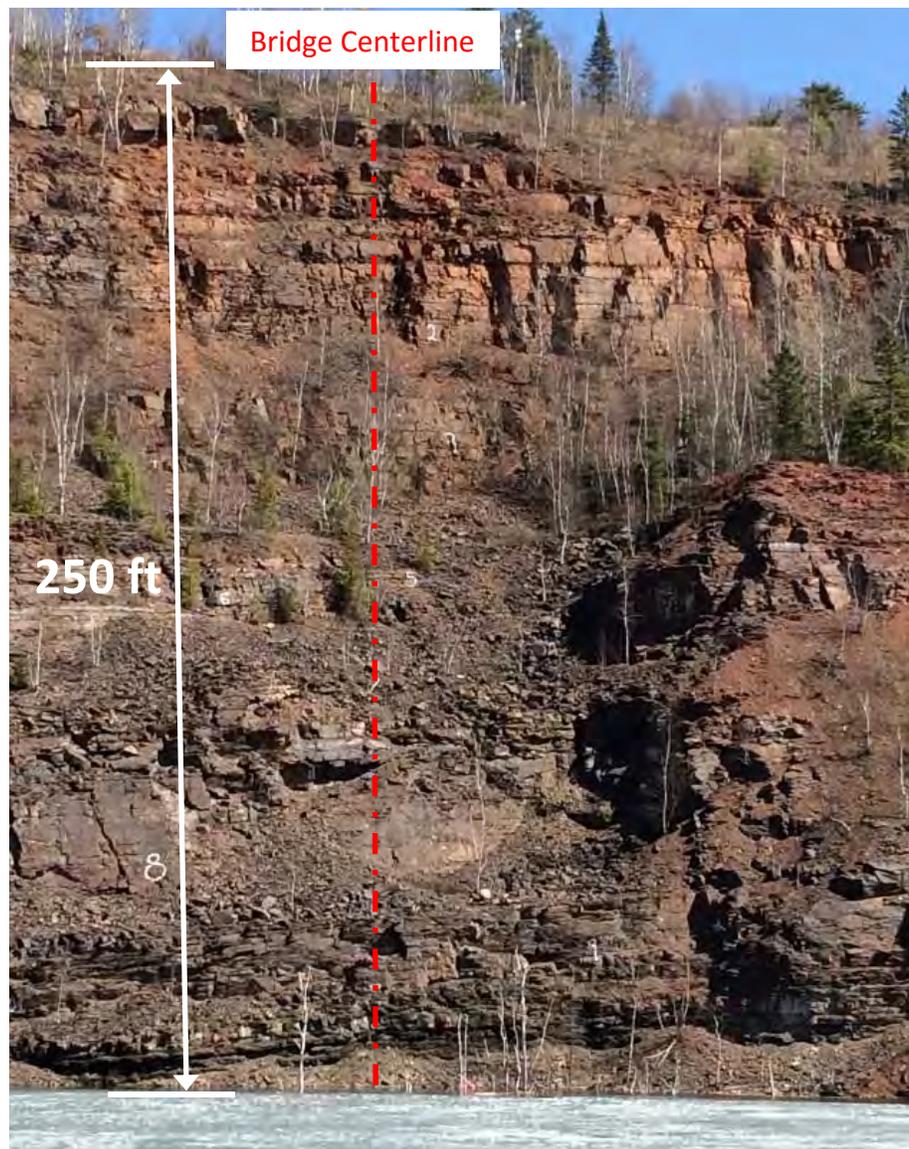
**Figure 6 – East Highwall Face, Existing Conditions Prior to Construction Operations.**

Prior to any clearing, grading, or construction, the East Highwall at the bridge location appeared as it does in Figure 6. Benches were covered in talus and trees were present on the larger benches. Five engineers from Dan Brown and Associates descended and ascended the wall face on ropes during a site visit in April of 2015. During this site visit, observations were made and recorded about rockfall paths, particle size ranges of talus, and the behavior of test rocks rolled from the highwall crest. Most of the rolled rocks stopped on a large bench about halfway up the slope due to the energy absorption of the talus and the natural barrier provided by the trees.

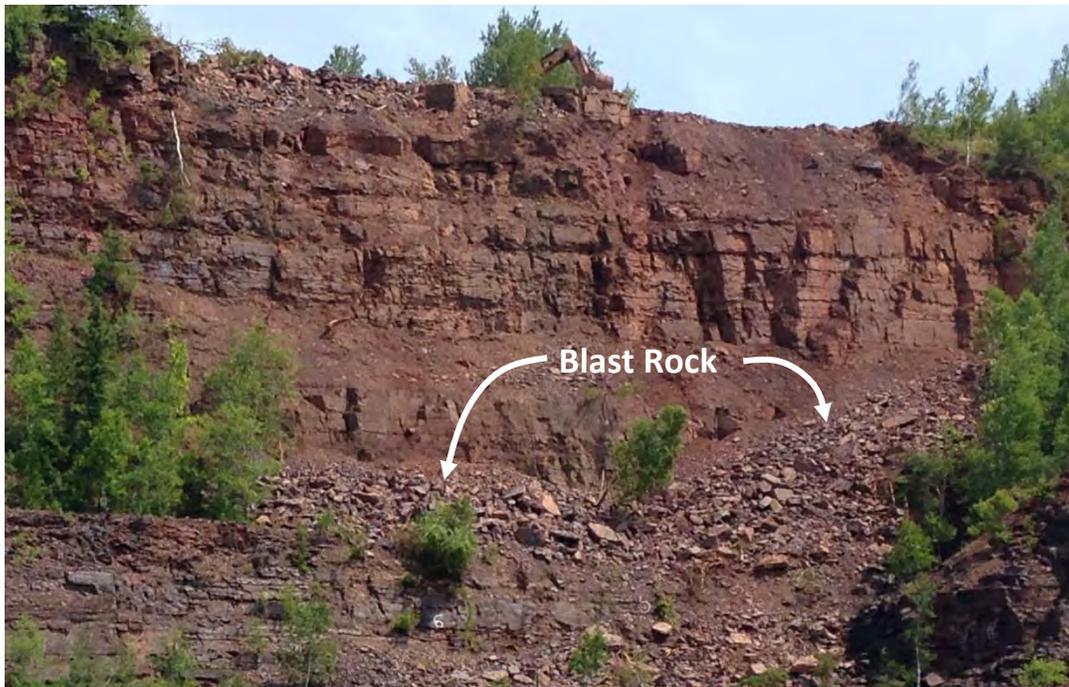
**Figure 7 – Site Conditions after Initial Round of Blasting and Scaling.**

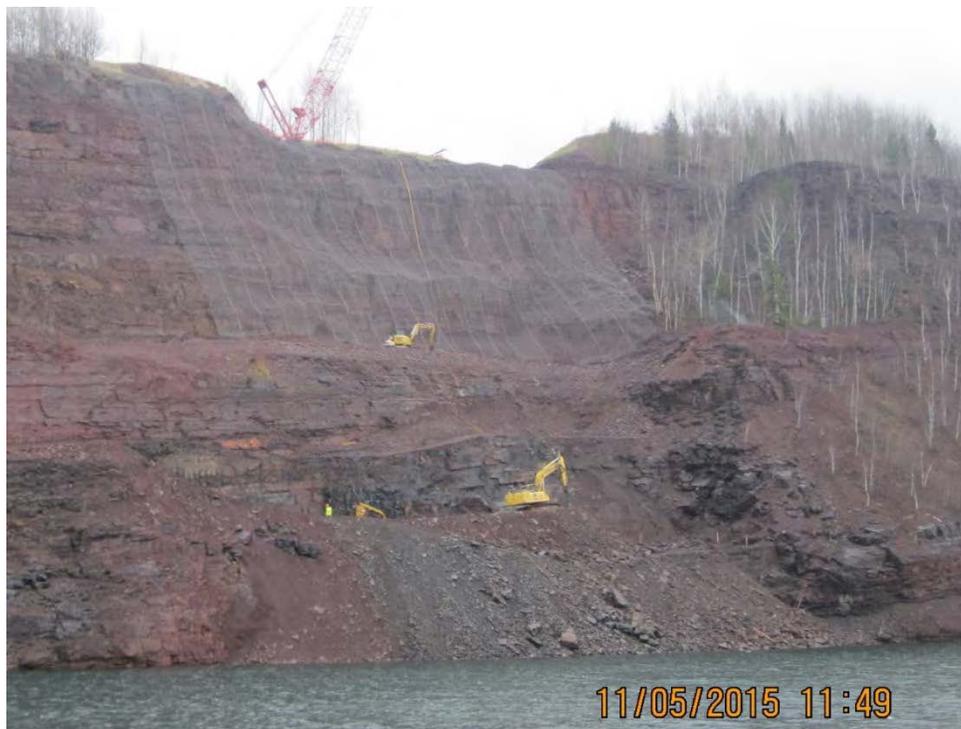
**Figure 8 – Upper Rockfall Drapery.**

In response to the altered conditions, draping the upper portion of the East Highwall was deemed the most safe and feasible means of providing the necessary rockfall protection. Recommendations for covering the upper portion of the slope with combined cable net and wire mesh drapery were provided to the contractor and the upper portion of the slope was covered down to the attenuator bench, as shown in Figure 8.

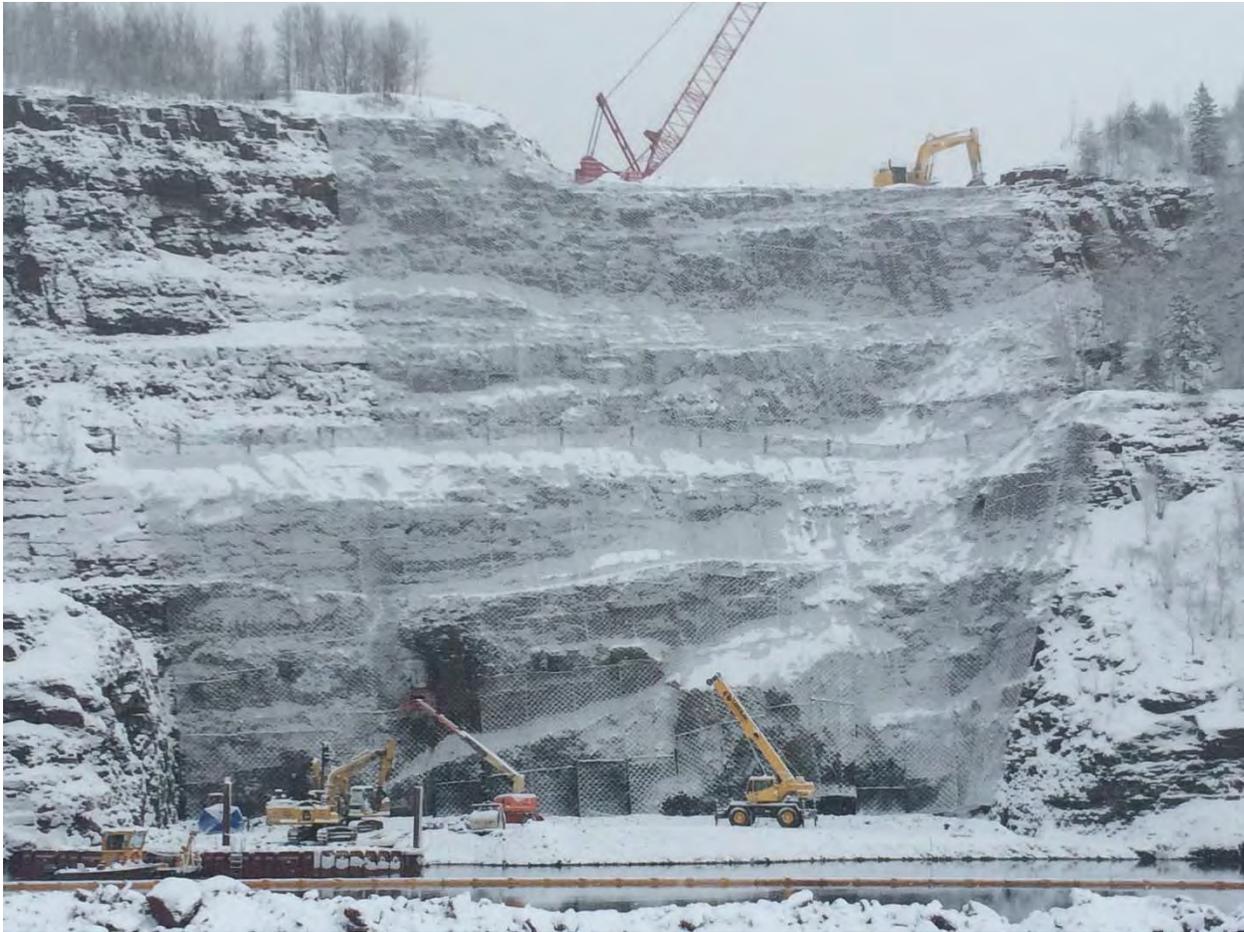
**Figure 9 – Pier 1 Excavation and Attenuator Complete.**

Pier 1 is founded on a bench excavated into the toe of the East Highwall by blasting and mechanical removal of blast rock in October and November, 2015. This work was performed in coordination with the attenuator construction. The attenuator posts and support cables were installed and drapery panels attached but not unrolled. Immediately following the Pier 1 excavation work, the attenuator drapery panels were deployed down the slope, extending to newly excavated Pier 1 work area, as shown in Figure 9. Berms were also constructed along the north, east, and west sides of the Pier 1 work area to create a catchment for rocks exiting from beneath the drapery.
