HGS 2016  
Proceedings

# 67TH HIGHWAY GEOLOGY SYMPOSIUM

## JULY 11 – 14, 2016

Cheyenne Mountain Resort  
COLORADO SPRINGS, COLORADO

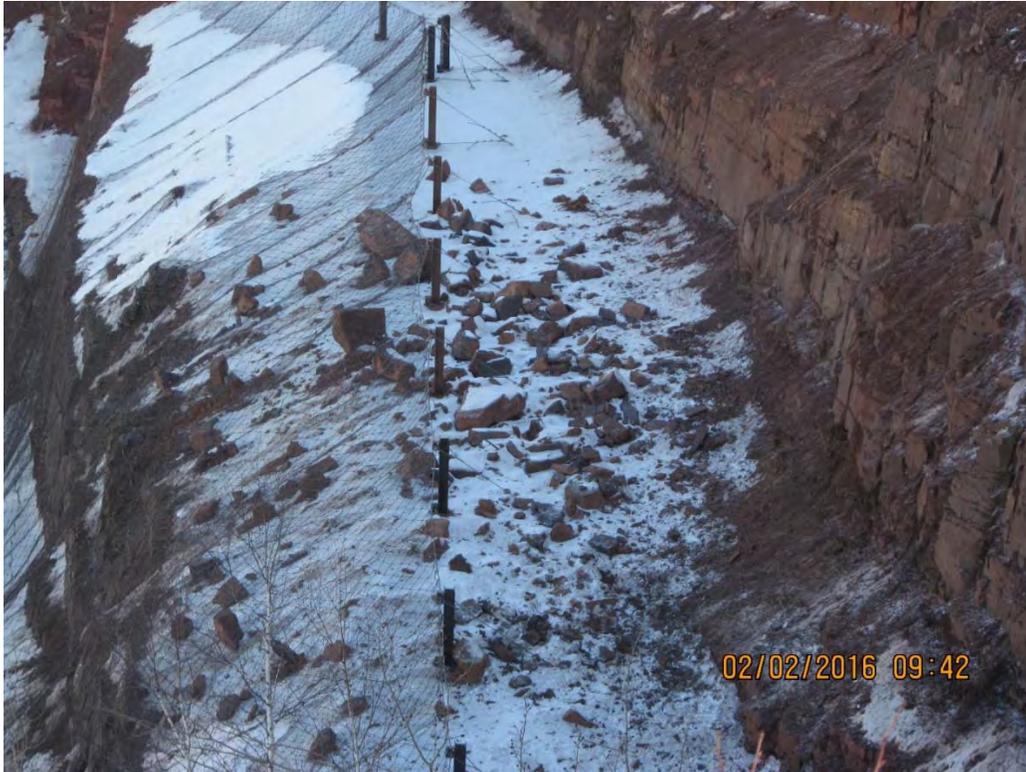
**Figure 10(a) – Attenuator Bench after East Abutment Excavation Blast.**

The drapery on the upper portion of the East Highwall was removed for final excavation of the East Abutment in January, 2016. The excavation work near the slope face was initially planned to be performed using only mechanical means or small controlled blasts; however, a least one blast resulted in significant rock debris being sent down the slope. Although the attenuator was not designed for such an event, it performed well, with relatively little damage. The post-blast conditions are shown in Figure 10. The following damage was observed during a site visit following the blast:

- Severed top cable wires
- Severed support cable wires and strands
- Completely severed lacing cables
- Dented posts with chipped paint
- Torn double twist mesh
- Rocks protruding through the drapery

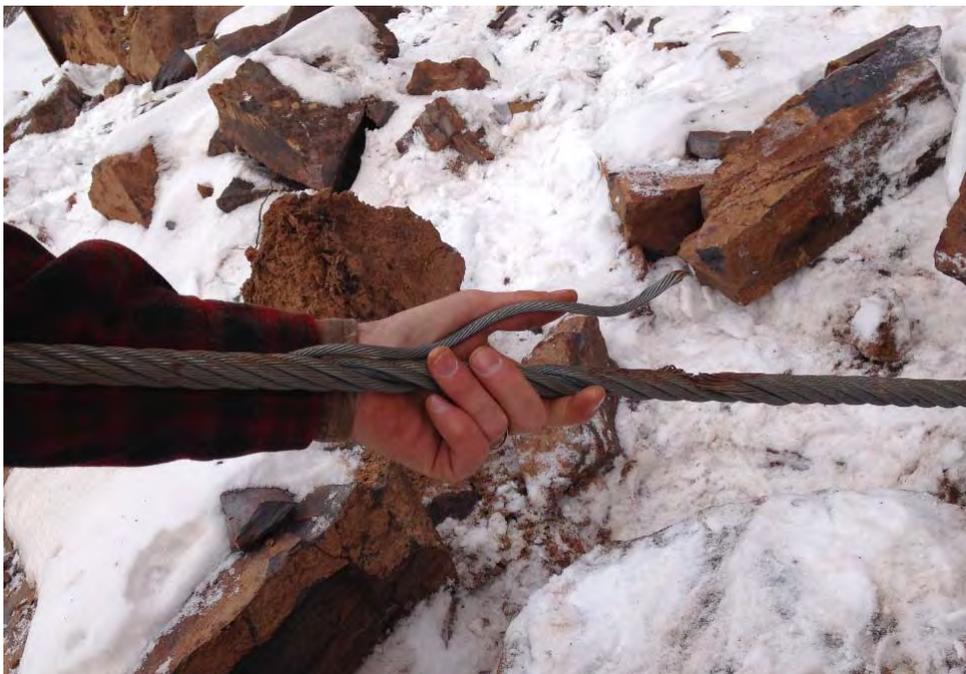
**Figure 10(b) – Damaged post support cable.**

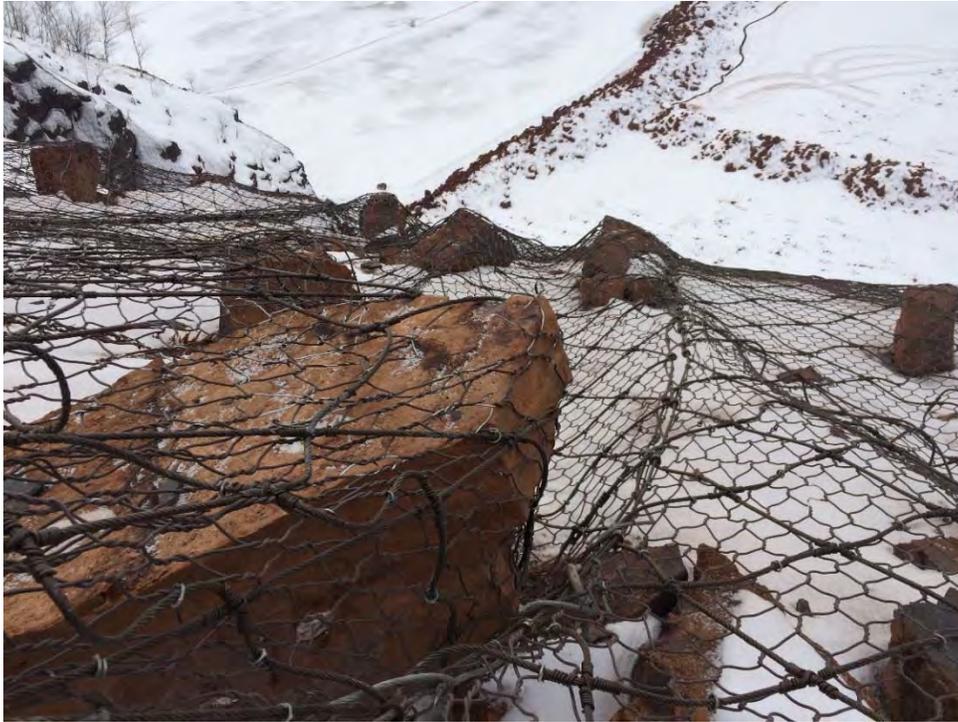
**Figure 10(c) – Rock protruding through drapery.**

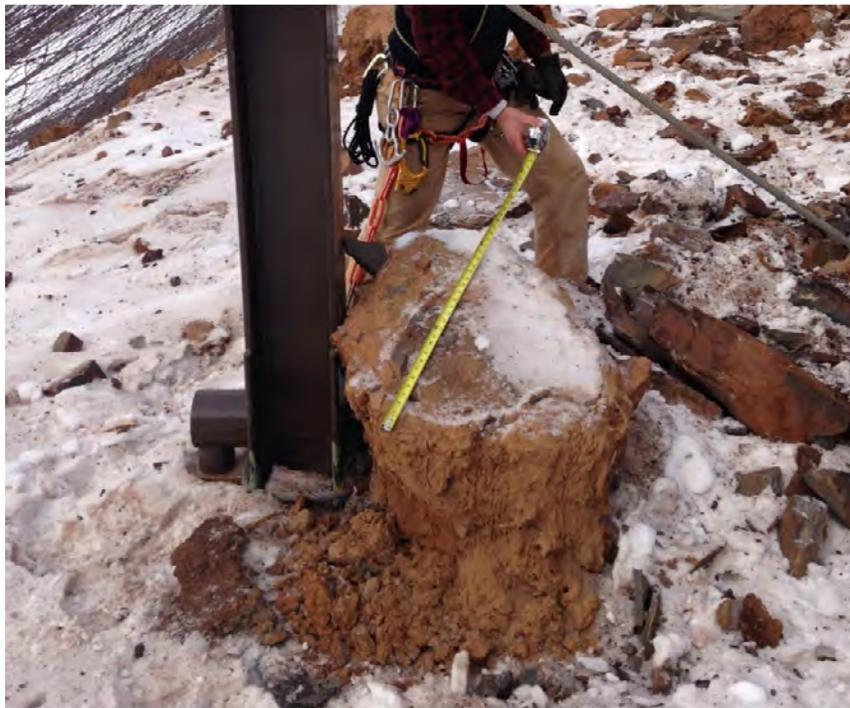
**Figure 10(d) – Impacted post.**

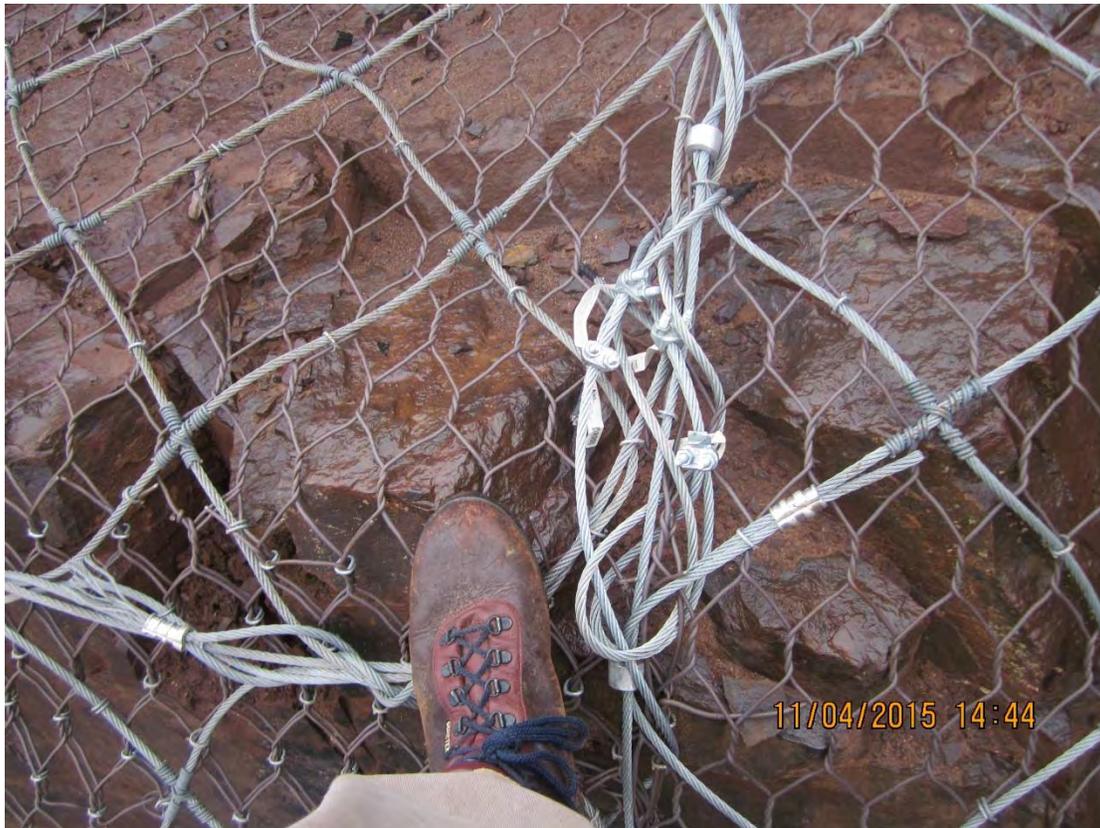
**Figure 11 – Cable Net with Double-Twisted Wire Mesh Backing.**

Given the wide range of rock sizes observed at the site, combined wire mesh backed cable net drapery was selected on the basis of guidance by Muhunthan et al. (6). The wire mesh provides small opening sizes needed to contain small fragments of rock and prevent erosion while the cable net provides the strength and weight per unit area required to restrain rocks exceeding 2 ft in dimension. Figure 11 is a photo showing the drapery product used for this project. Note that the double-twisted wire mesh is both galvanized and PVC coated, while all other steel components and hardware, including the cable mesh, are galvanized for corrosion protection.

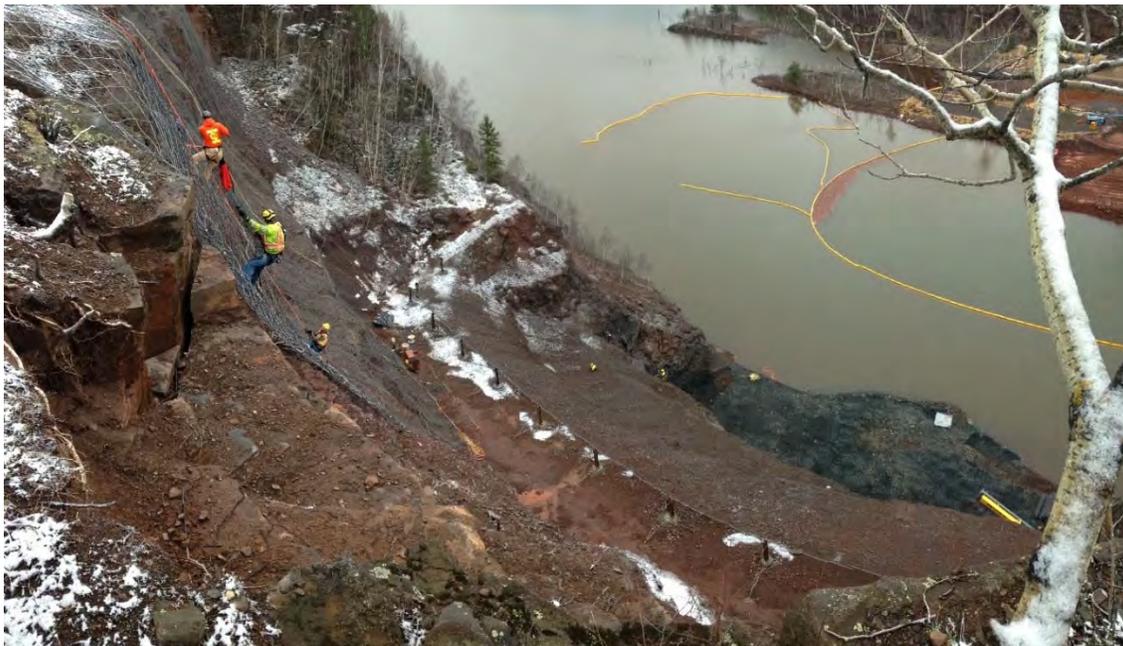
**Figure 12 –Drapery Inspection by DBA and MnDOT Personnel**

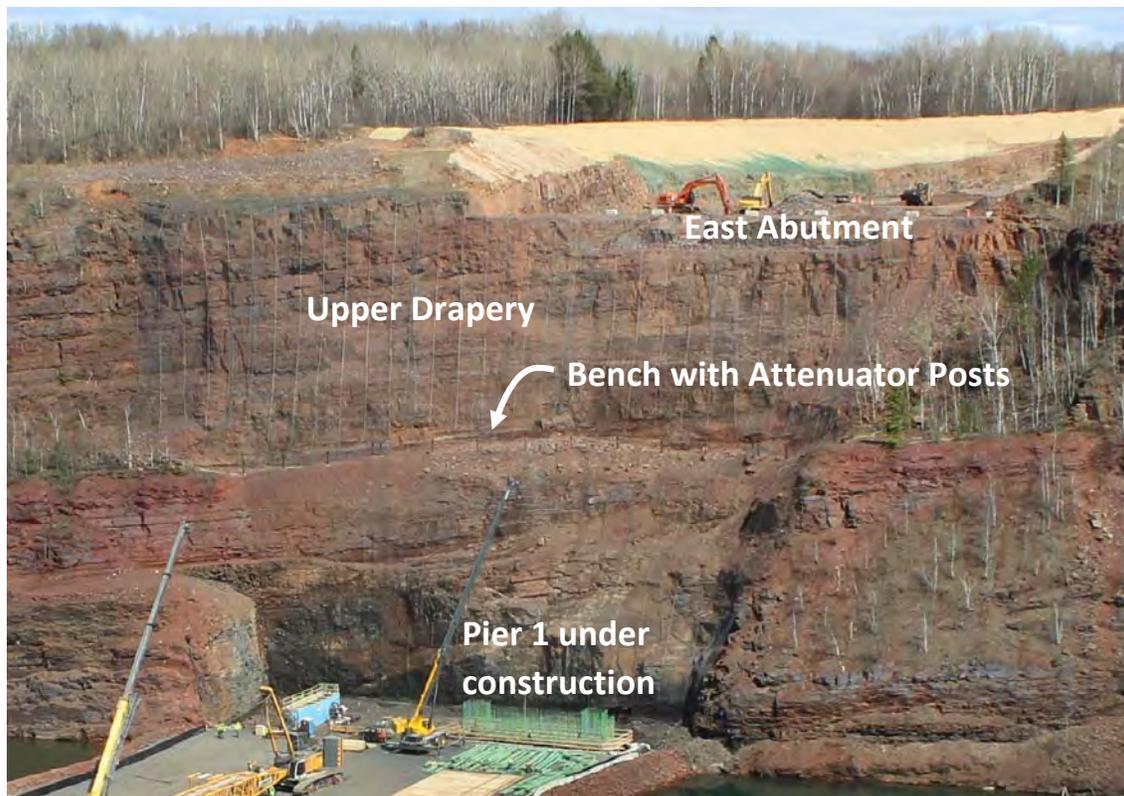
**Figure 13 – Upper Drapery and Lower Attenuator, Final Configuration.**

The primary function of the drapery and attenuator is to provide a safe working environment during bridge construction. During construction, the drapery and attenuator will be maintained by the contractor. After construction, these elements will remain in place, but the owner does not plan on maintaining them. A 10-ft tall berm will be constructed around the base of Pier 1 to serve as long-term rockfall protection. CRSP analyses indicate that such a berm will provide adequate protection without any reliance on any of the other rockfall protection elements. The final configuration of the drapery and attenuator is shown in Figure 13.

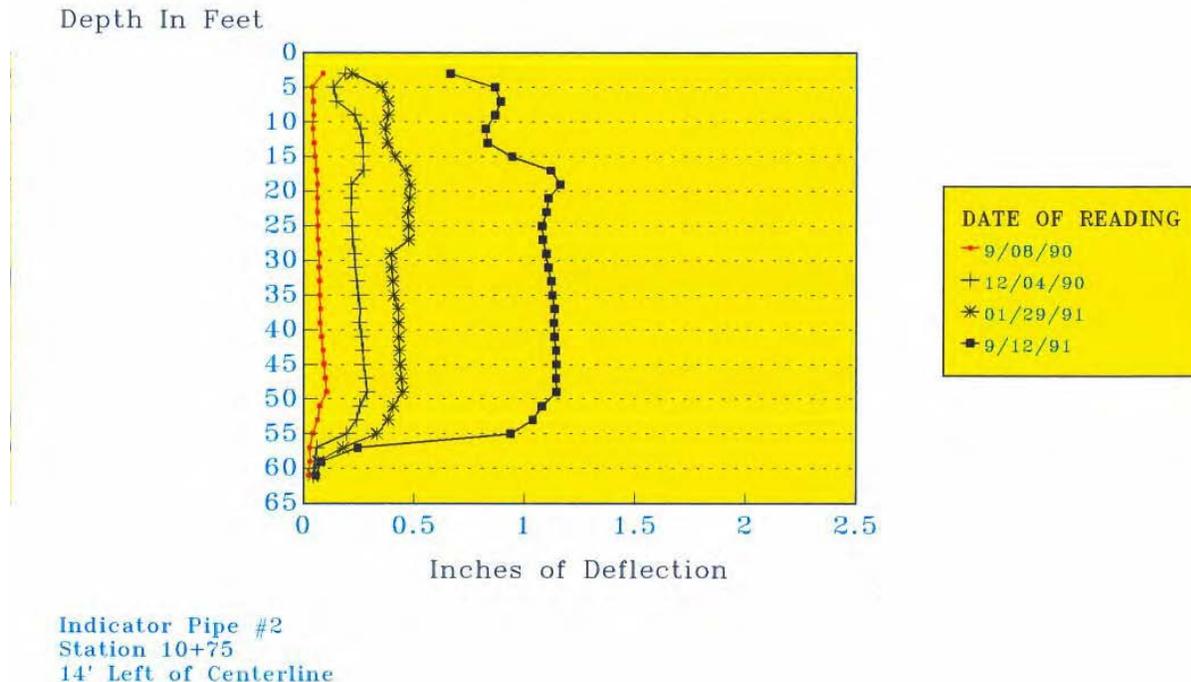
**Figure 1 - Inclinometer Readings**

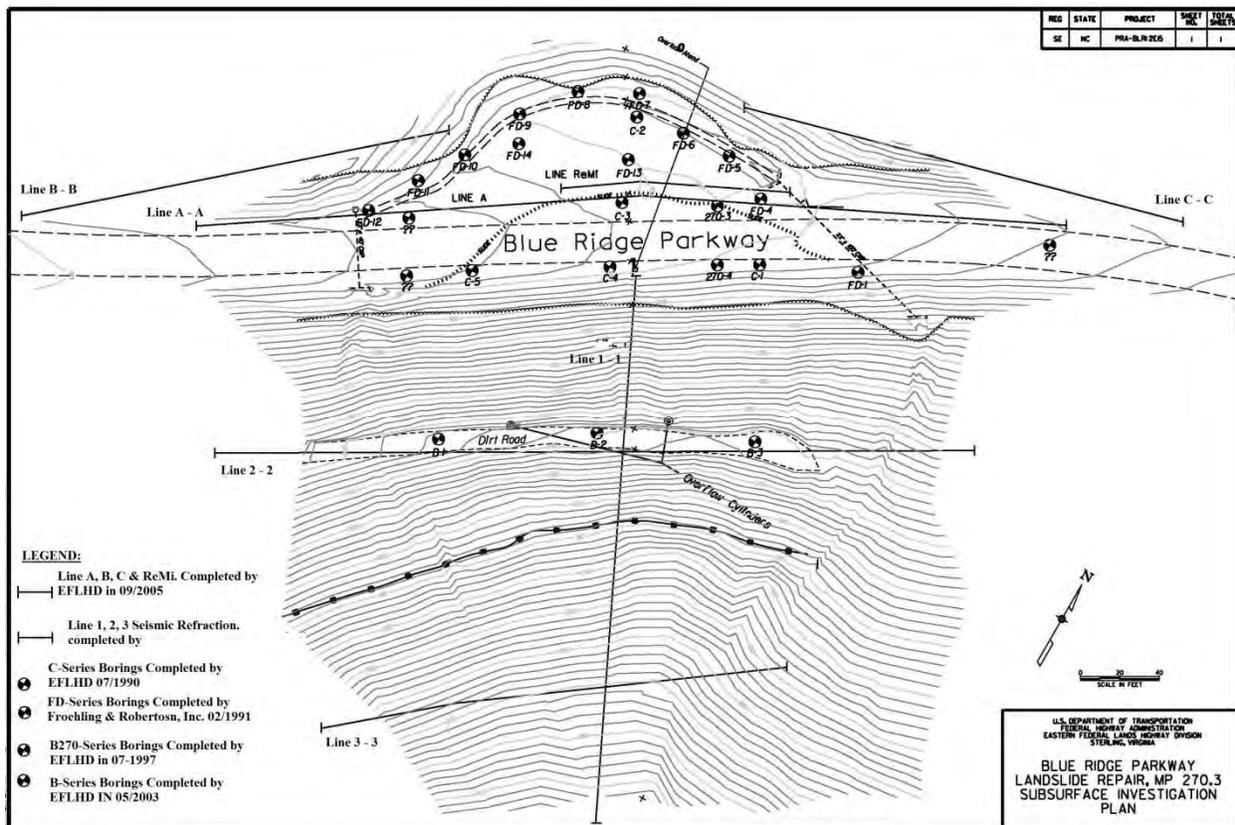
Figure 2 - Subsurface investigation plan

Soil drilling and rock coring were performed at the site in the period between 1990 and 2003. This included site investigations on the following dates; 1) Five (5) C-series borings drilled during July 1990 by EFLHD, 2) Twelve (12) FD-series borings drilled during February 1991 by Froehling & Robertson, Inc., 3) Four (4) B270-series borings drilled during July 1997 by EFLHD to analyze the effectiveness of installed horizontal drains at draining the embankment fill, and 4) Three (3) B-series borings drilled during May 2003 by EFLHD to gather information at mid-slope. No borings were drilled at the toe of the slope because of problems accessing this location. (Figure 2).

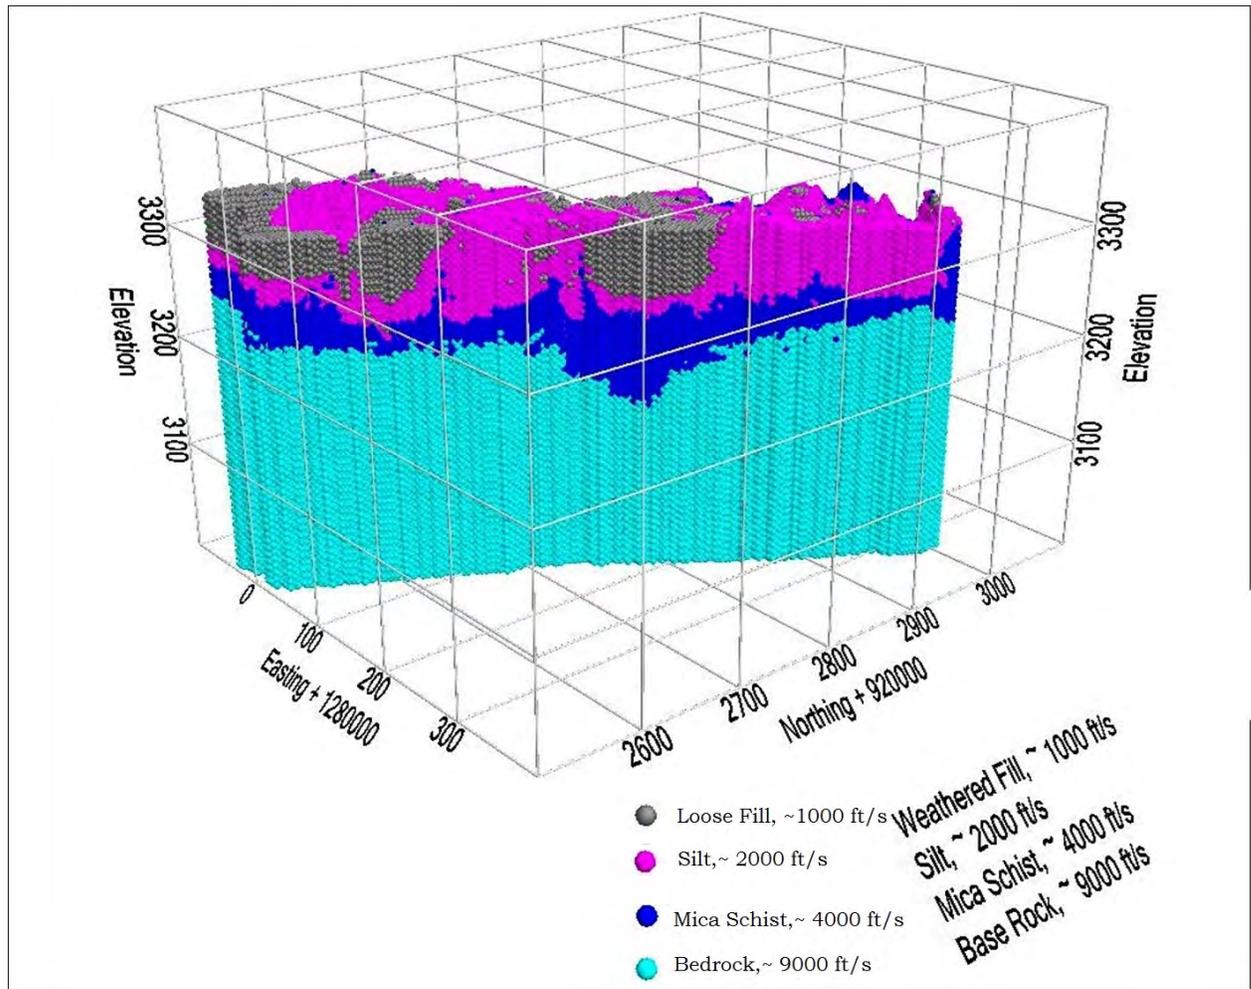
**Figure 3 - 3D Tomograph Showing v Shaped Valley Near Slide Centerline (By: Summit Peak Technologies)**

Geophysical surveys were conducted at the slide site for the different slide repair options that were proposed during the VA/VE Study. Geophysical surveys were performed in September 2005 for additional subsurface information at the location of proposed cuts and a soldier pile wall that was part of a roadway realignment option. EFLHD completed a refraction micrometer (ReMi) line on the north side of the roadway. EFLHD also completed 3 seismic refraction lines that included a) Line A along the northern shoulder of the Parkway, and b) Lines B and C along the proposed cut slopes. Summit Peak Technologies, LLC of Parker, Colorado processed this data using tomographic analysis to create a 3-dimensional subsurface image (Figure 3).

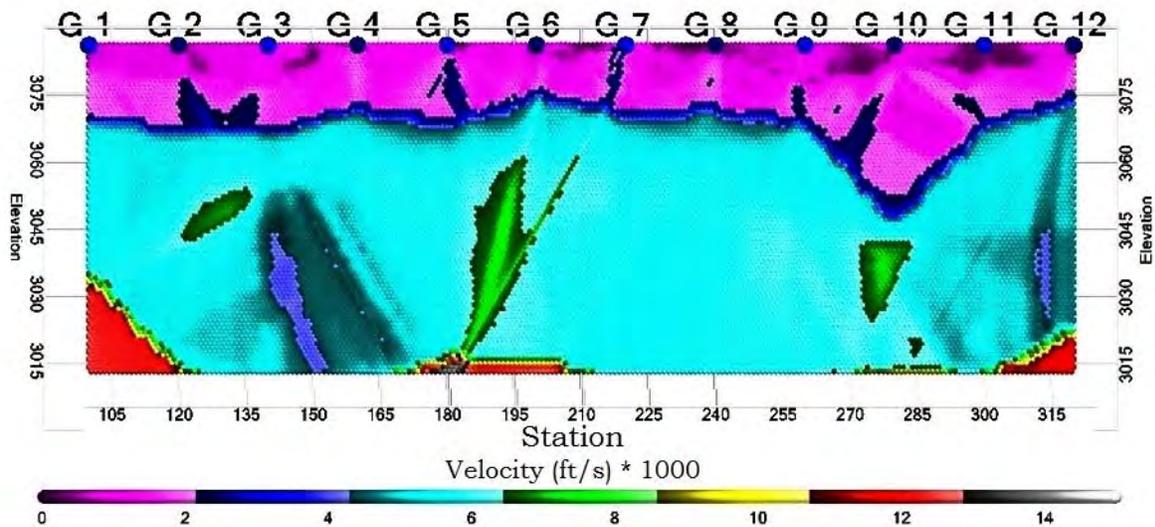
**Figure 4 - 2D tomograph showing similar subsurface conditions (By: Zapata Engineering)**

EFLHD also conducted a geophysical refraction survey at the project site in September 2007 that consisted of three (3) seismic refraction survey lines. The seismic surveys were performed using a Smartseis S24 System with 24 channels. Geophones were spaced at either 15 or 20 feet (4.5 to 6 meters), and the total geophone array length ranged from 220 to 345 feet (67 to 105 meters). Shots were produced using a sledgehammer on a striker plate. Blackhawk – a Division of Zapata Engineering of Golden, Colorado, processed the geophysical data collected by EFLHD (Figure 4).

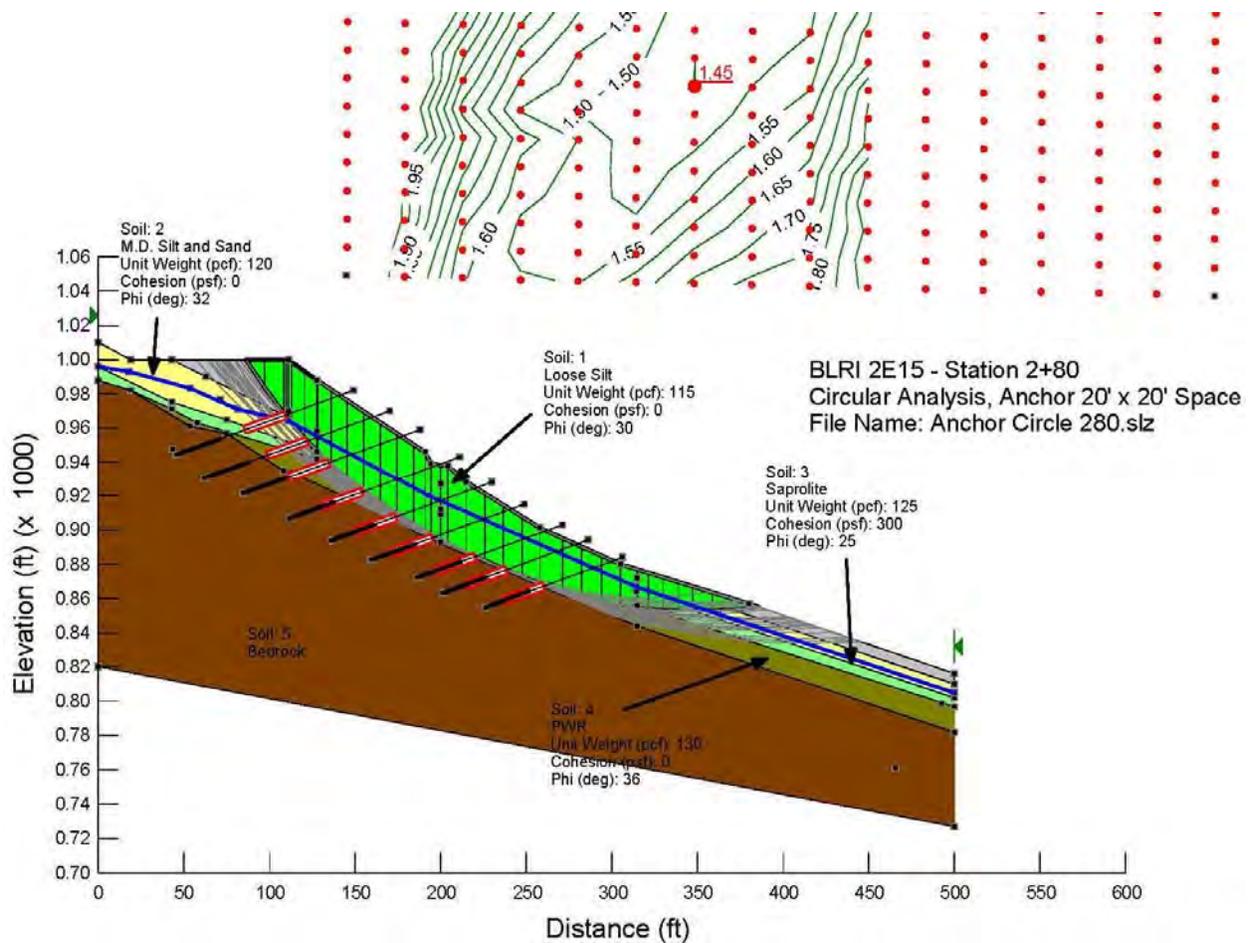
Figure 5 - Slope stability design analysis results (Slope/W (v. 5))

Back analysis was used to refine calculated soil and rock strength parameters assuming an impending slope failure condition (using a safety factor of 1). Slope stability design models included the observed wet and soft or loose material at the interface between the overburden material and rock. The model was adjusted to simulate observed field conditions for the location of the crack at the top of the slope and the exit point of the failure plane at the toe of the slope (Figure 5). Computer software Slope/W (version 5) was used for running limit equilibrium design analysis and the Spencer method was selected because it satisfies both moment and force equilibrium.

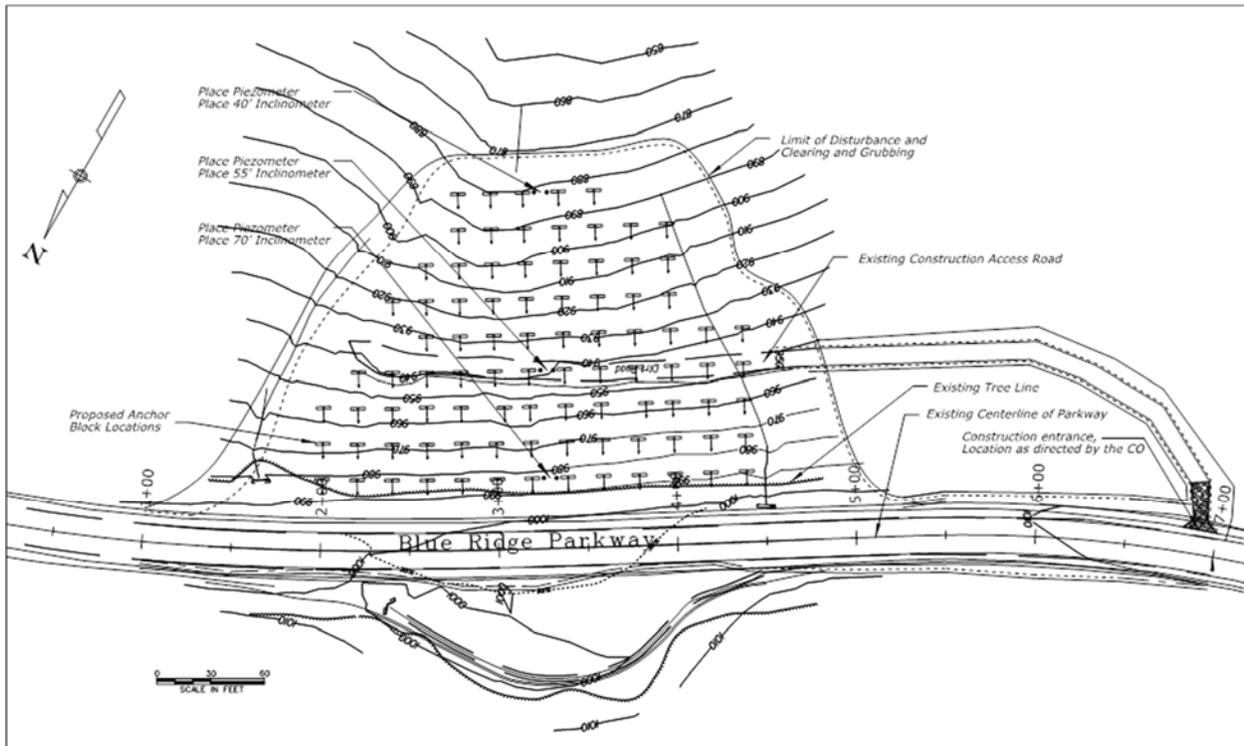
**Figure 6 - Anchor Layout Plan**

Final anchor and anchor block design recommendations consisted of a maximum of 9 rows of ground anchors that depended on location and slope stability requirements to meet a minimum safety factor of 1.3. Anchors were designed with a capacity of 280 kips, a 27-foot (8.2 meters) bond length and installed at an inclination of 20°. The total bonded and unbonded length depended on anchor location and depth to bedrock. The maximum total anchor length was 85 feet (25.9 meters). To achieve a minimum safety factor of 1.3, anchors were laid out on a 20 x 20-foot (6 x 6 meter) grid pattern throughout the slope. Some anchors were eliminated near the outer limits of the slide where analyzed cross sections indicated that they would not be needed for stability (Figure 6). This provided an economical design and reduced the amount of disturbance.

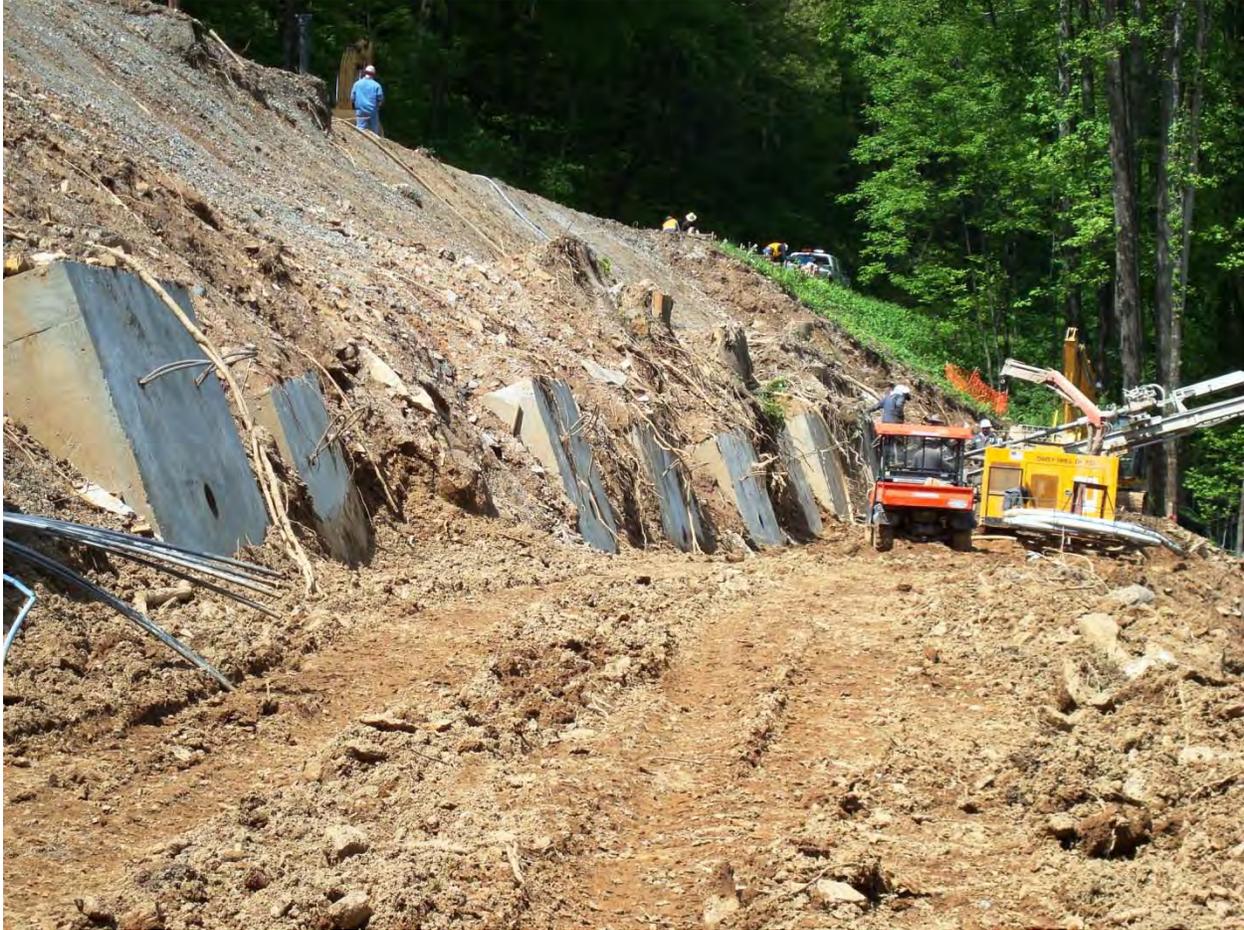
**Figure 7 - Anchors and concrete anchor blocks installation during construction**

The contractor began construction work by excavating a bench for the uppermost row of anchors in order to provide initial stability prior to accessing the lower steep toe of the slope. Heavy rainfall occurred after grouting anchors in the first row and prior to tensioning of these anchors. The rain, likely combined with stored construction materials and equipment loads at the top of the slope, triggered slide movement near the crest of the slope, causing a new crack to form and settlement on the road. This coincided with the inclinometer near the top of the slope showing significant ground movement during the first 4 weeks of construction. The contractor was advised to remove stored concrete blocks and heavy equipment from the roadway section located within the slide limits. After the uppermost two (2) rows of anchors were tensioned and stored material load had been removed from near the crest of the slope, visible movement ceased and inclinometer readings stabilized (Figure 7).

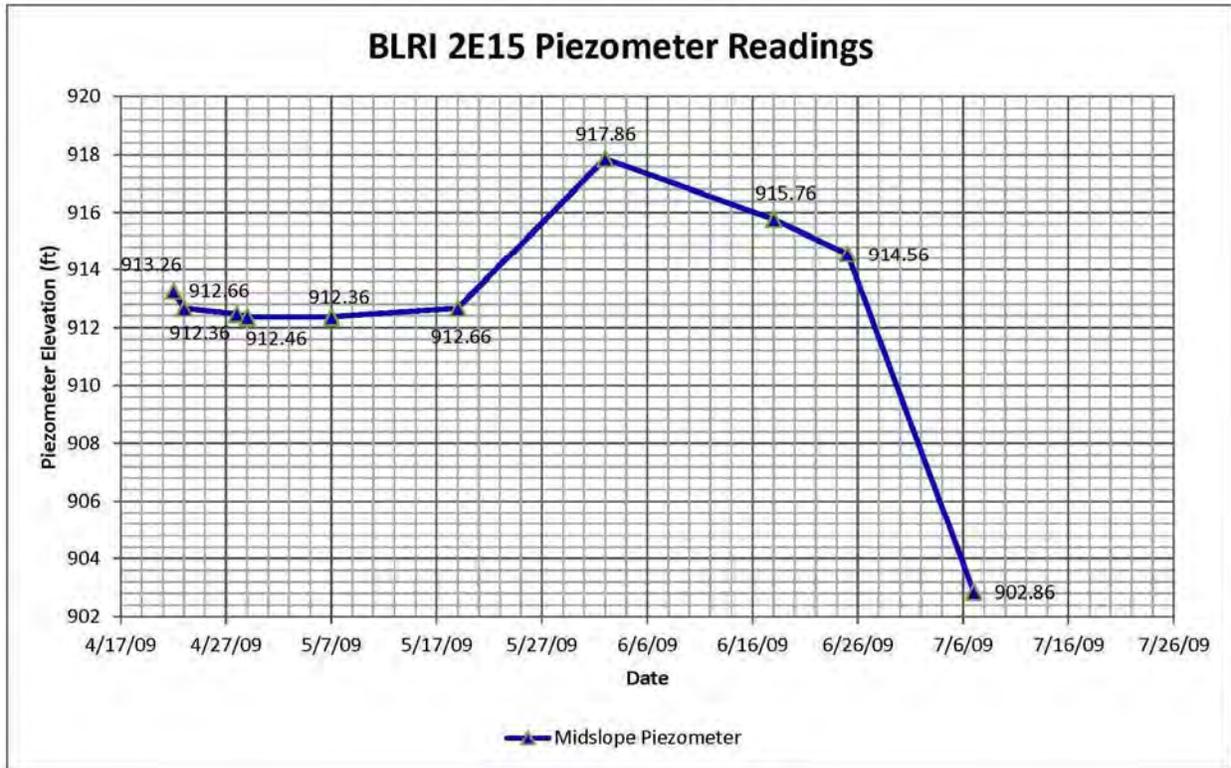
**Figure 8 - Piezometer Reading Showing Subsurface Water Changes During Construction**

Piezometer readings showed subsurface water condition changes during construction. A sharp and then steady increase of pore water pressure was observed as rows of anchors were tensioned (Figure 8). The increase was most apparent at the piezometers closest to the anchors being tensioned. Between the piezometer behavior and observations from anchor drillers, EFLHD deduced that there was at least one large, but discontinuous, confined pervious layer of weathered bedrock that was fed by groundwater discharged from the uplands and funneled into the V-shaped valley.

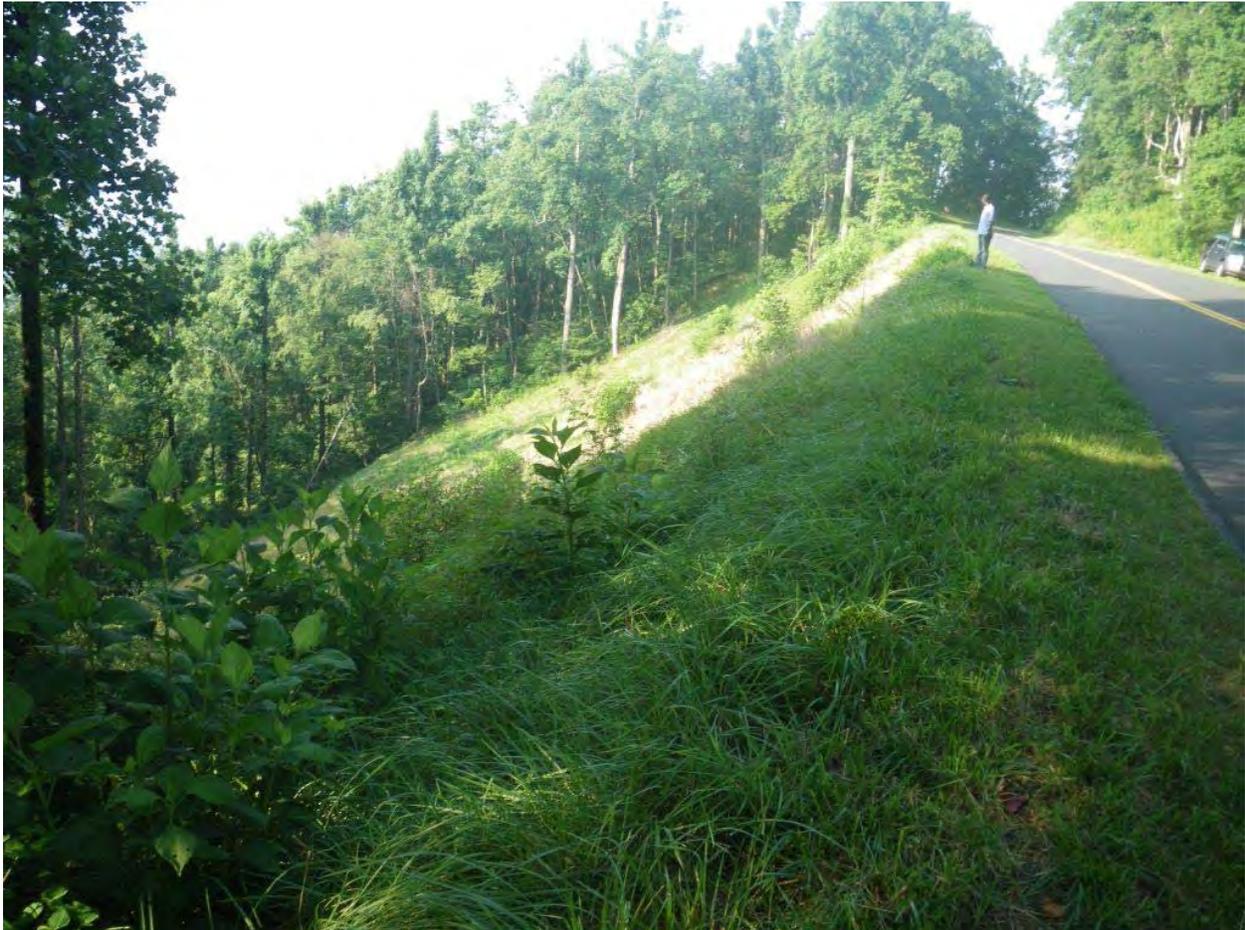
**Figure 8 - Site Condition 2 Years After Completion of Construction**

term slope stability. Removing most of the water in the V-shaped subterranean bedrock valley would be a very difficult and costly solution. There were also intermittent confined layers within the saprolite that were not picked up during the investigations. The final anchor and block solution was able to address the instability by focusing primarily on providing active resisting forces to the slope, and designing with water present, assuming not all water could feasibly be removed. A benefit not foreseen in design was that punching 90 holes into bedrock resulted in at least temporary drainage of subsurface water. Finally, a significant aspect of this project has been achieving a context-sensitive solution that satisfied the NPS (Figure 8).

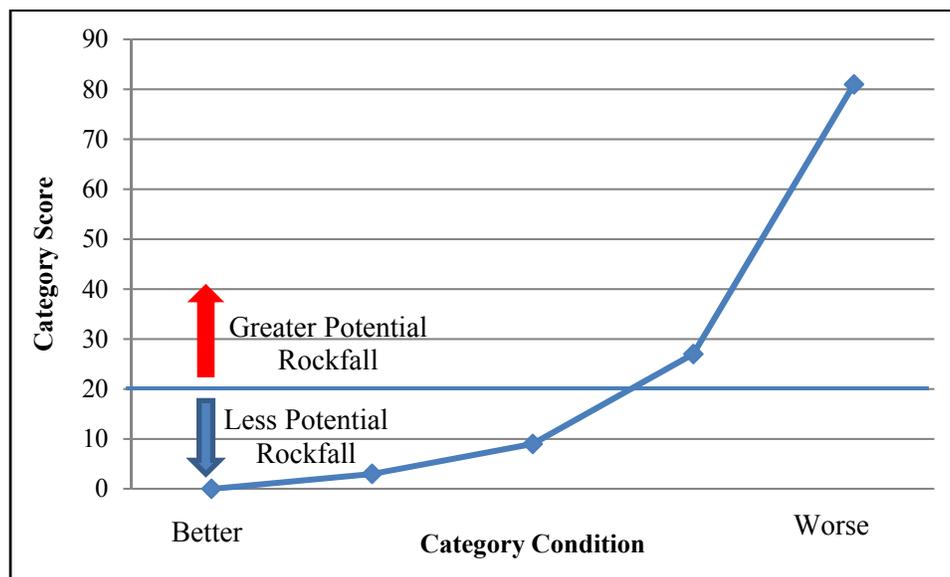
**Figure 1. Likelihood of rockfall issues related to categories in RHRS**

Based on the preceding discussion, it may be reasonable to evaluate the likelihood of a rockfall event to occur from a rock slope based on the score of the Geological Characteristics category. The RHRS and modified systems typically use the 3, 9, 27, and 81 exponential rating systems with higher scores relating to conditions that are more likely to generate rockfall. As a starting point and after cursory review of historical systems, it seems that a rating lower than 9 likely is not as prone to generating rockfalls as a rating greater than 27. This could further be evaluated based on historical databases but the general idea would be as shown in Figure 1.

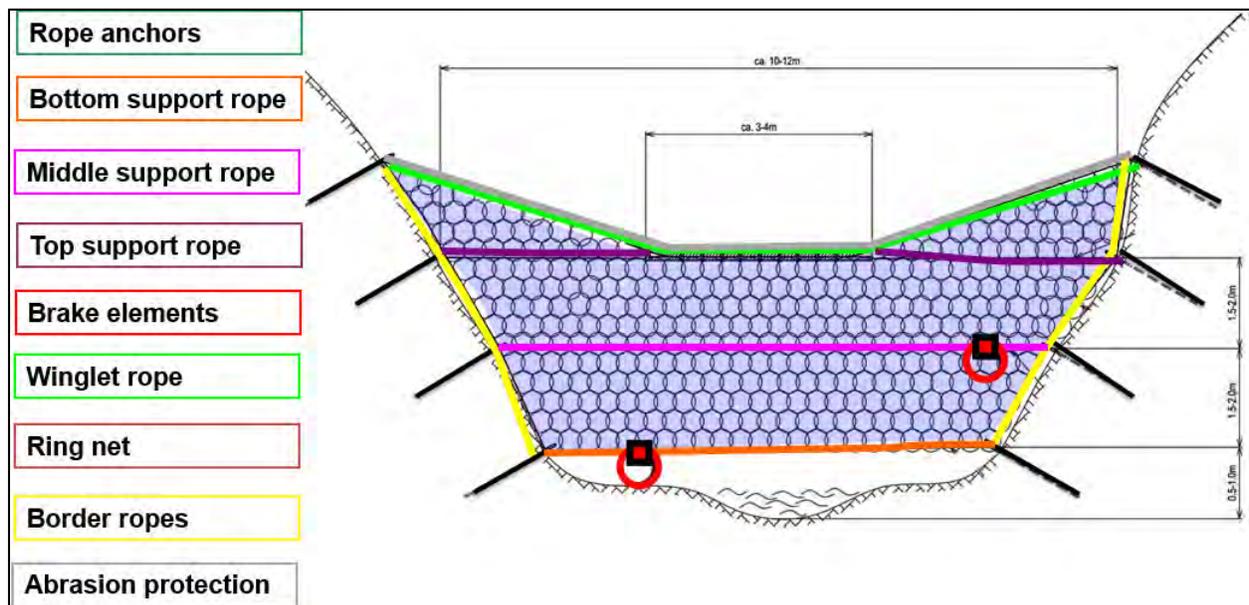
Figure 3. Geobrug VX Debris flow barrier components.

The two barrier types are referred to as VX and UX barriers. VX barriers are intended for use in relatively narrow V-shaped chutes, up to about 15 meters wide. They consist of wire rope anchors between which are suspended wire rope support ropes with braking elements. High-strength steel ring nets are installed on the top, middle, and bottom support ropes, Figure 3. The system is designed to flex outward down slope on impact to absorb and dissipate energy of the debris flow. Consequently, the barrier must flex outward a few meters as it absorbs the energy. Any design must include this distance down slope of the barrier. It is also necessary for the barriers to be designed to withstand a static load after impact, similar to a retaining wall.

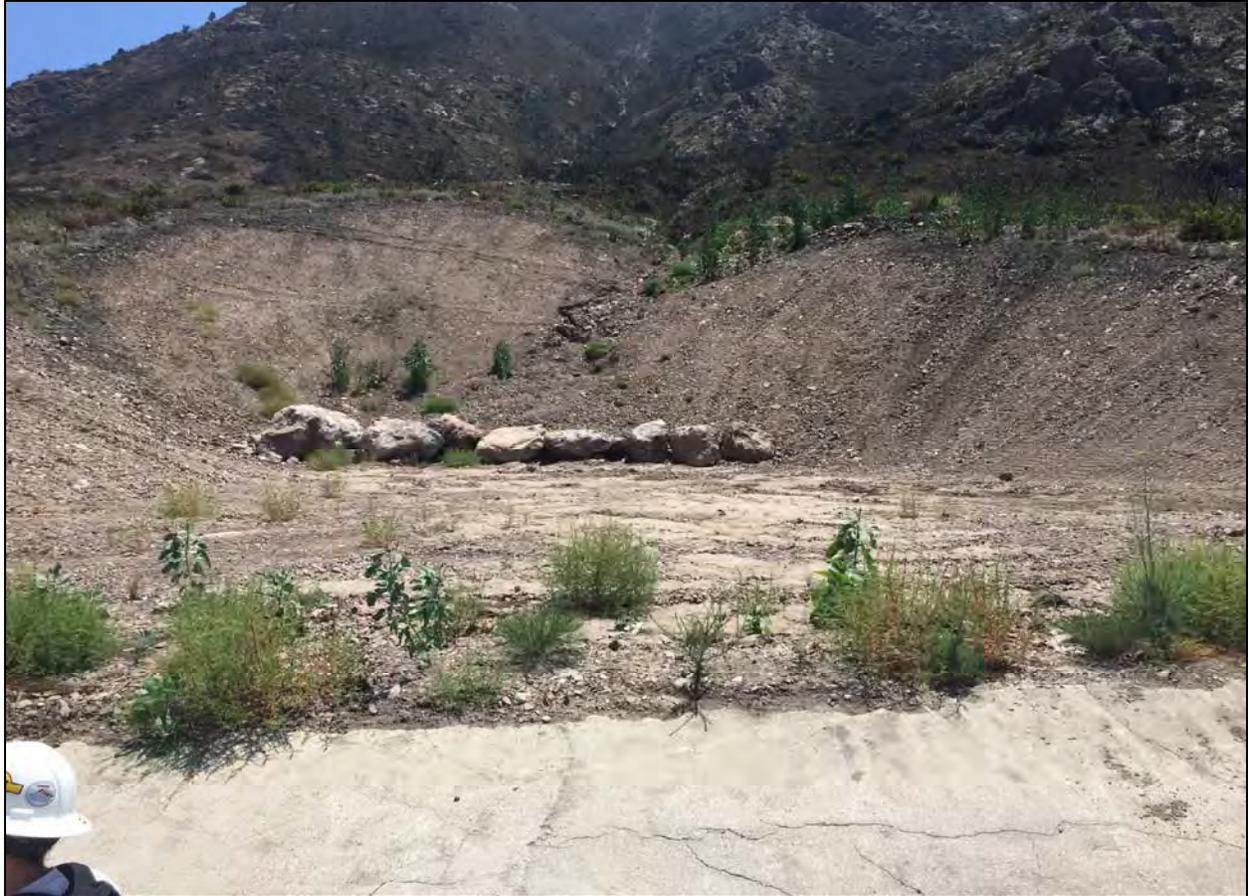
Figure 5. NCRS designed debris flow platform at Barranca 3.

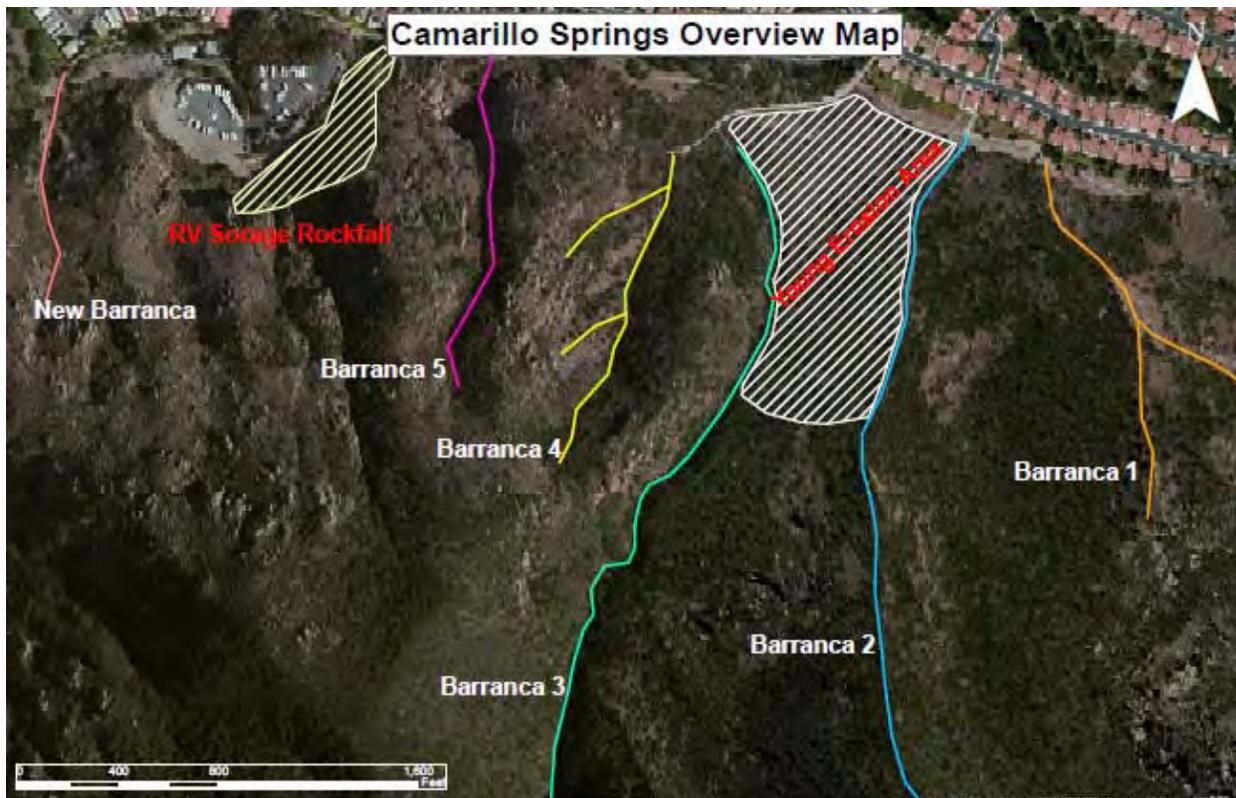
Figure 6. Aerial image used to determine possible barrier locations prior to site investigation.

After developing the general concept, KANE GeoTech personnel gathered general channel and platform dimensions of each proposed barrier location using a measuring tape and a string level. These measurements would be used later for analysis and design purposes.

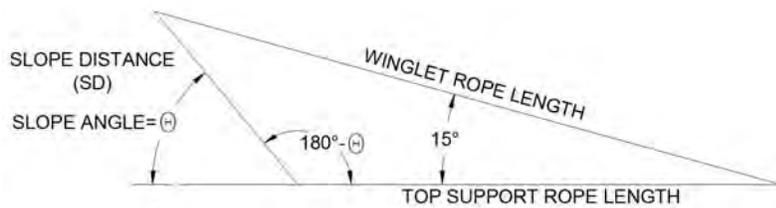
Figure 7. Slope distance equation.

The methodology includes obtaining slope geometry and applying trigonometry to establish anchoring locations according to the manufacturer's parameters. Barrier layout begins with obtaining slope angles on both sides of the channel. Multiple slope angle measurements are necessary if the channel side's inclination changes. On one side of the channel, the top support rope length and anchor group locations are determined by measuring the maximum width, across the top of the channel. The maximum width is standardized by the manufacturer according to the designed system type. Winglet anchor locations are determined by calculating the slope distance (SD) using the Law of Sines, using the standardized 15 degrees horizontal offset, slope angle, and the top support rope length, Figure 7.

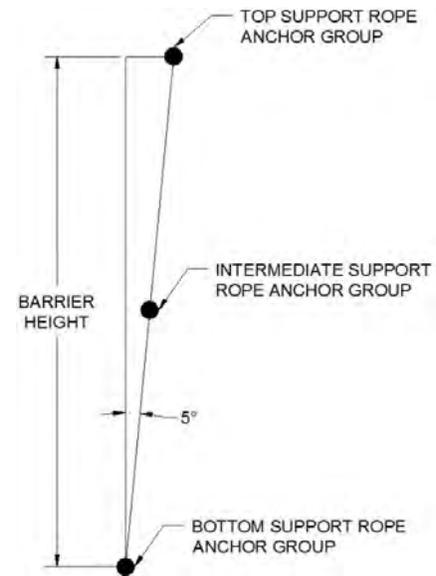
Figure 8. Wire rope anchor offset.  
(side view)

Bottom support rope anchor group locations are marked 12 inches above the bottom of the channel, 5 degrees vertical from the top support rope anchor group location. The barrier height is measured as the vertical height between the top and bottom support rope anchor group locations. The vertical height is then divided by the designed number of intermediate support rope sections. Intermediate support rope anchor group locations are marked at the section divisions, and in line with the 5 degrees offset down slope between top and bottom support rope anchor group locations, Figure 8. After anchor group locations on one channel side are laid out, straight-line lengths and anchor group locations on the other side of the channel can be determined. The support ropes are laid out in line directly across the channel and with a level and lengths are obtained with a tape measure. Slope angles are used to calculate slope distances between top and bottom support rope anchor group locations for border rope lengths.

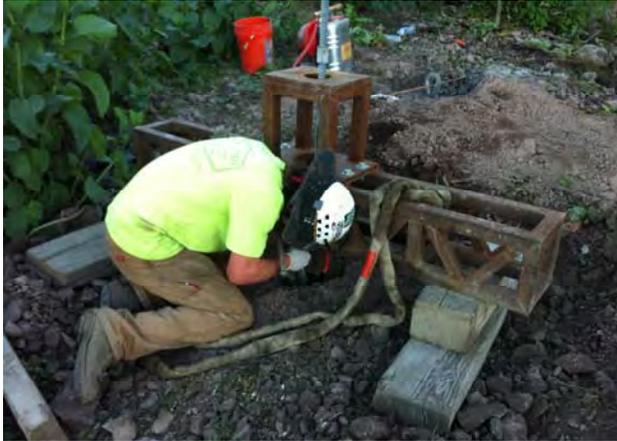
Figure 9. Verification anchor test set-up.

In response to the stringent timeline, the more efficient option of utilizing a verification anchor test to verify the bond strength of the subsurface material at the site was decided to be drilled and performance tested, Figure 9. This verification anchor was located in the worst conditions encountered at the site to exhibit a worst-case scenario for the most conservative results possible. The verification anchor was drilled to 13 feet and passed the anchor test allowing the holes that were located in equally or more competent material to all be drilled to a depth of 13 feet, Figure 10.

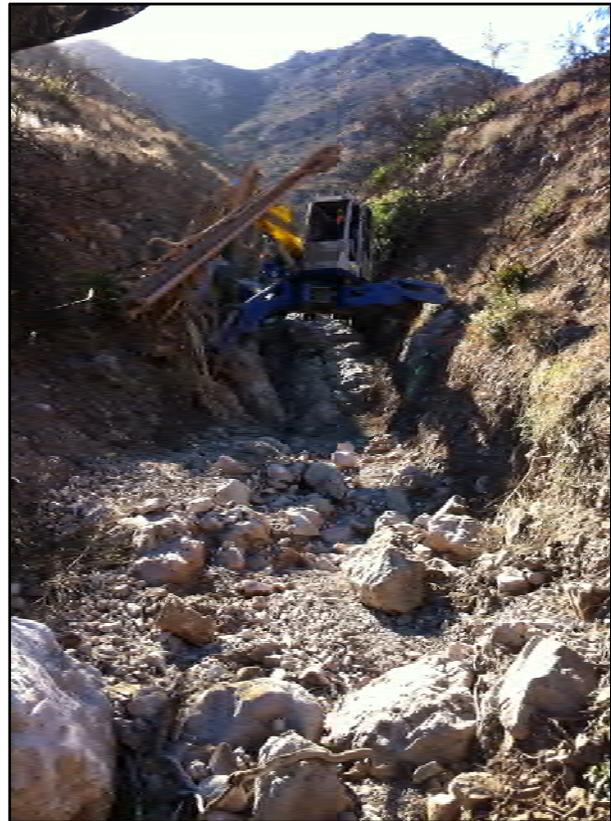
Figure 10. Drilling for the wire rope anchor installation.

Following drilling the anchor holes, the threadbar and wire rope anchors were then installed and grouted into place. Grout samples were taken by an outside contractor during every grout pour to verify the grout strength properties.
