HGS 2016  
Proceedings

# 67TH HIGHWAY GEOLOGY SYMPOSIUM

## JULY 11 – 14, 2016

Cheyenne Mountain Resort  
COLORADO SPRINGS, COLORADO

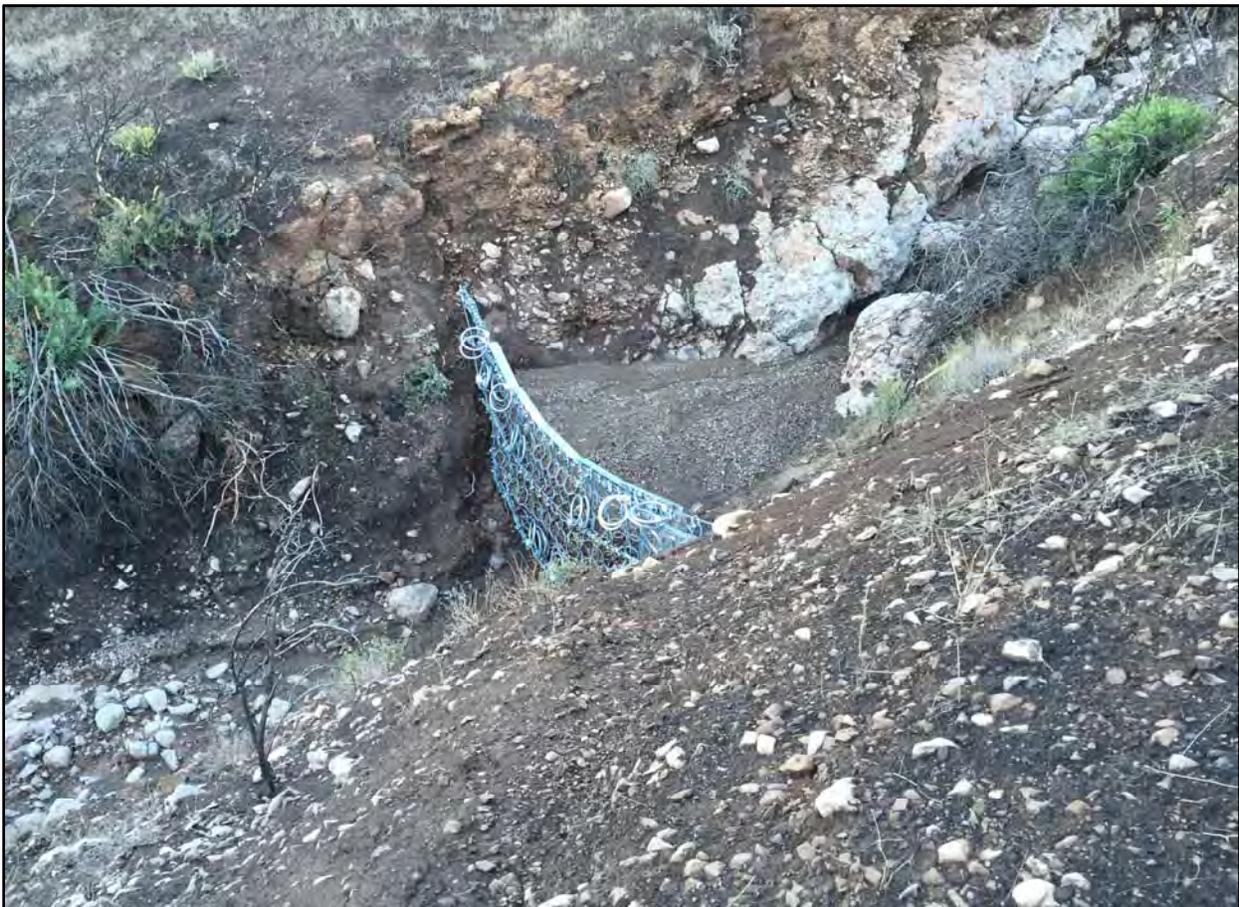
Figure 11. Up slope barrier in Barranca 2 filled to approximately 90 percent of its capacity.

Construction was completed on January 4, 2016, three weeks ahead of schedule. The day following the construction completion, Camarillo experienced the season's heaviest rainfall. The storm event continued for three days and as a result, the newly constructed barriers and berms were impacted and performed as designed. The two barriers located upslope within the barrancas were approximately 75 percent and 90 percent filled by the time the rain ceased, Figure 11. The barriers located in the NCRS debris platforms were minimally impacted with debris filling approximately 5 percent to 10 percent of the barriers, Figure 12. The earth berms successfully diverted the high velocity water and material runoff into the barrancas where the material was stored behind the barriers and in the barrancas themselves. It should be noted that although erosion of these berms did occur, they were design to be temporary structures to aid in the reduction of rapid erosion of the Young Erosion Area until vegetation re-establishes.

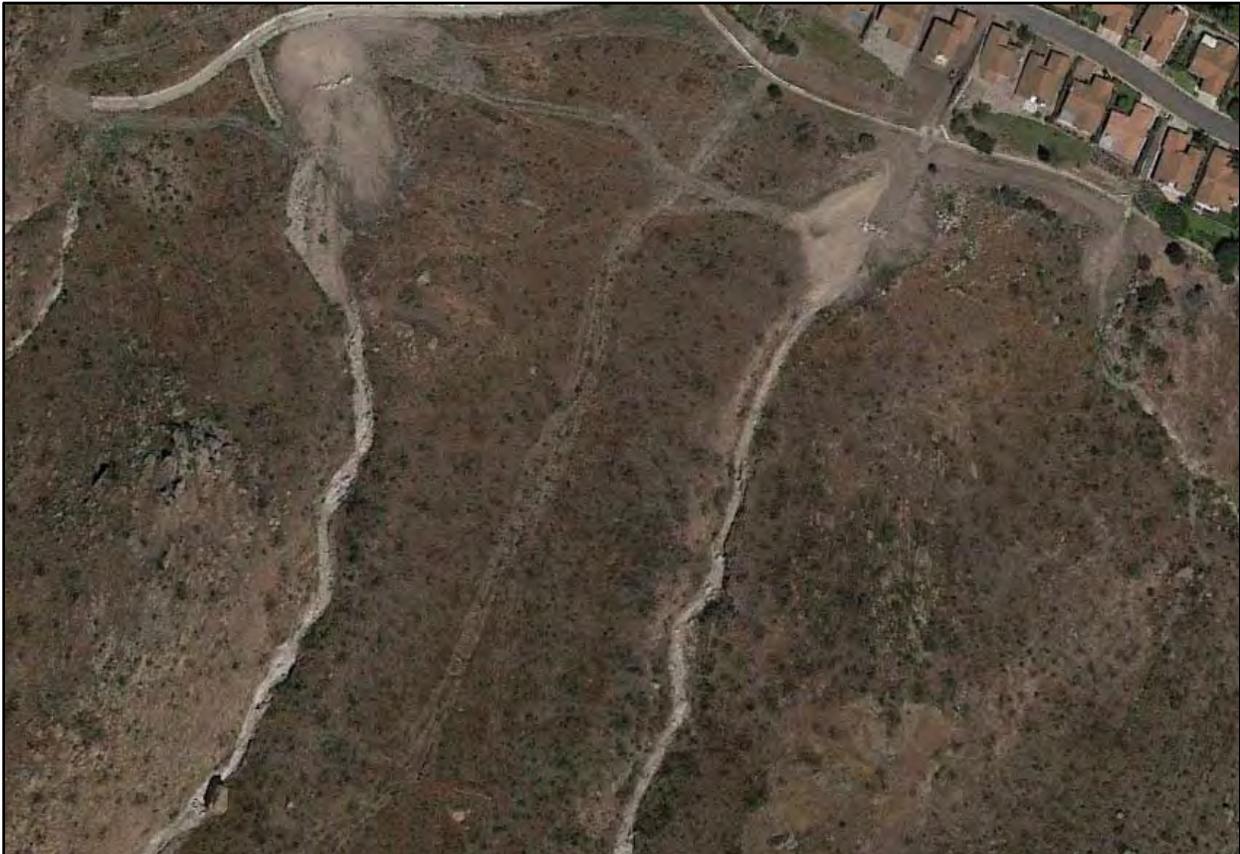
Figure 13. Aerial image of the Project Area prior to mitigation.

Following major debris flows, the threat of El Niño predicted for the upcoming rainy season, an innovative engineered mitigation design was put into action and constructed to mitigation future events. The project was delayed but then fast-tracked to be completed as soon as possible. The project was completed within an unprecedented timeframe and successfully mitigated what could have been a devastating debris flow event the day after construction completion. The conditions at the site have continued to improve with the growth of new vegetation, Figures 13 and 14.

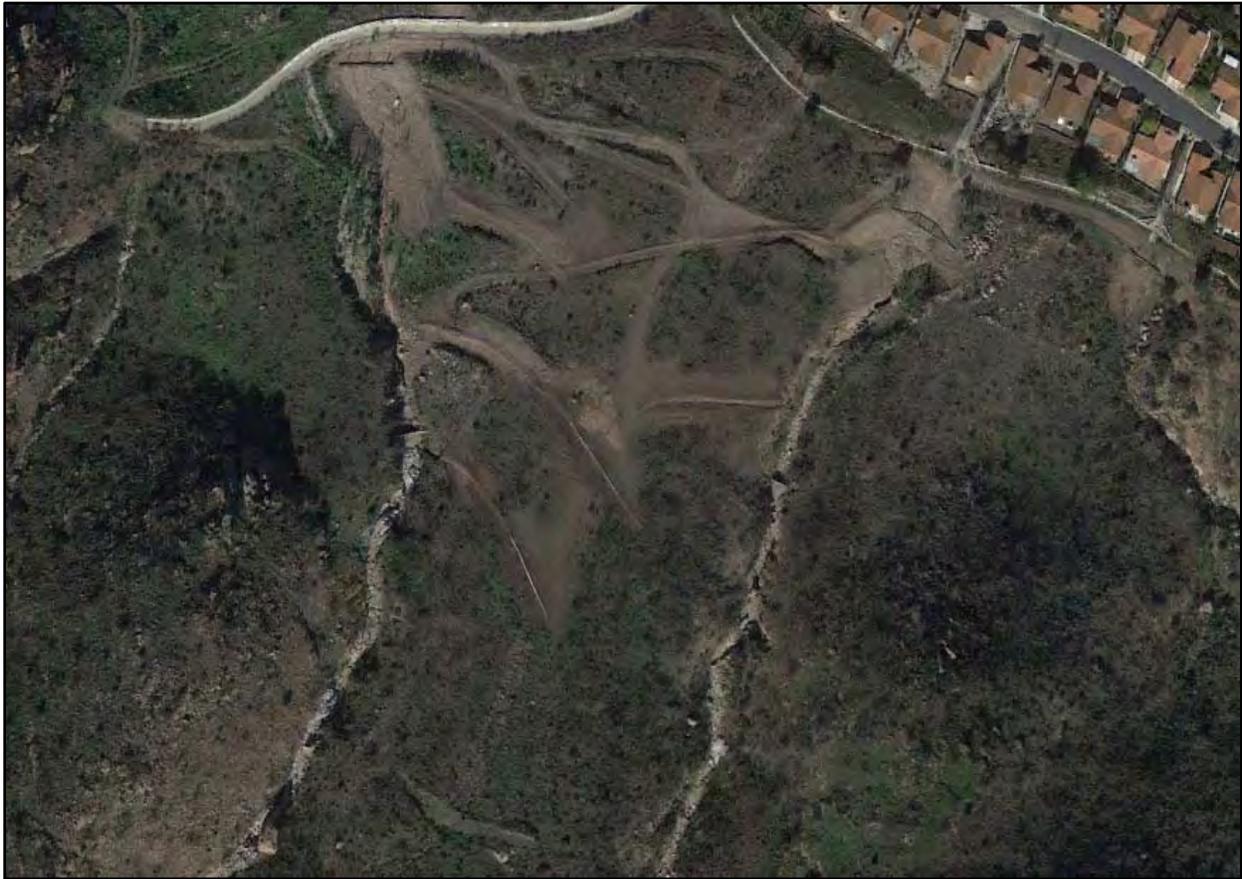
Figure 14. Aerial image of the Project Area after mitigation construction was completed.

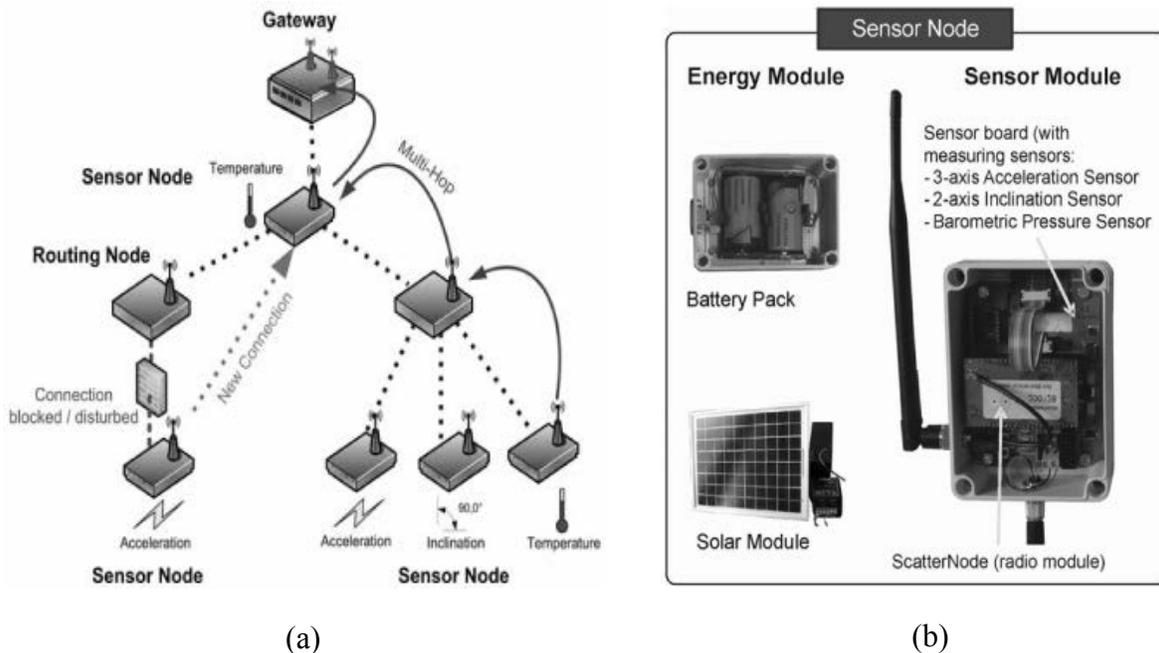
**Figure 1 – (a) Structure of Self-organizing (Ad-Hoc), (b) Modular setup of a sensor node (adopted from Azzam et al., 2010)**

There are several wireless sensor network systems developed in the recent years by different research teams that has future perspective and applicability in the real field monitoring. In 2007, Arnhardt et al. came up with the Sensor-based Landslide Early Warning System (SLEWS), which aims at development of a prototypic Alarm and Early Warning System (EWS) for real-time monitoring (8) and early warning of different types of landslides using wireless ad hoc network. Each sensor node facilitated with individual power supply- normal or solar powered rechargeable battery, transmission and receiving unit, microprocessor, and internal memory enables the sensor devices to perform independently and synchronize themselves with the system. The network structure and modular setup of each sensor node are illustrated in Figure 1. A direct transmission of data packages from each node to the collection point is possible via radio. A multi-hop transmission could also be done i.e. over other nodes to the collection point in order to reduce long-range transmission and thus, the transmission power required (8). Each sensor node consists of 3-axis acceleration sensor, 2-axis inclination sensor, a barometric pressure sensor, and the displacement transducer. Low-cost sensors (Micro-Electro-Mechanical Systems (MEMS)) are adopted for measuring tilt, acceleration or spreading. The system is programmed to check for the errors in the data collection before activating warning system to

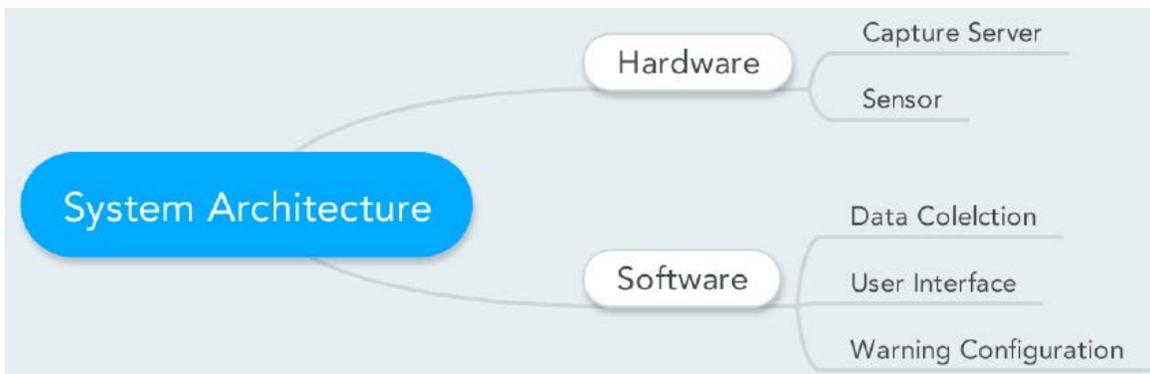
(a) General Component of Sensor Network System

**Figure 2 – Architecture of the Sensor Network System**

architecture of the sensor network system is as illustrated in Figure 2. Hardware and software are the two basic components of the system. Synapse provides RF modules to create a wireless mesh network between the sensors, and a gateway to allow monitoring of the network from a remote location. As per the testing done by our research team in Fairplay, CO, the data transmission distance using Synapse is about 2200m or more. The remote access range is expanded with the availability of both local (Ethernet or USB) and wireless (Cellular, Bluetooth or Wi-Fi) network connections, allowing control of sensor devices over the Internet. Likewise, 2.4GHz Standard receiver for sensor is another wireless technology that can transmit data over 100 m distance. Bluetooth Low Energy (BLE) or Bluetooth 4.0 communication toolset with the maximum communication distance of 100 m is another technology. Various wireless communication technologies can be used to send 6LoWPAN, which allows low-power devices (e.g. sensors) with limited processing capabilities to be in the network enabling data collection and exchange between the devices and the remote computer. The field monitoring makes use of these communication technologies based on the environment and distance from collection server. The primary software used are AngularJS for collecting data, Node-RED for design, and MongoDB for data storage. The hardware and software components of the system are explained in detail in the sections below.

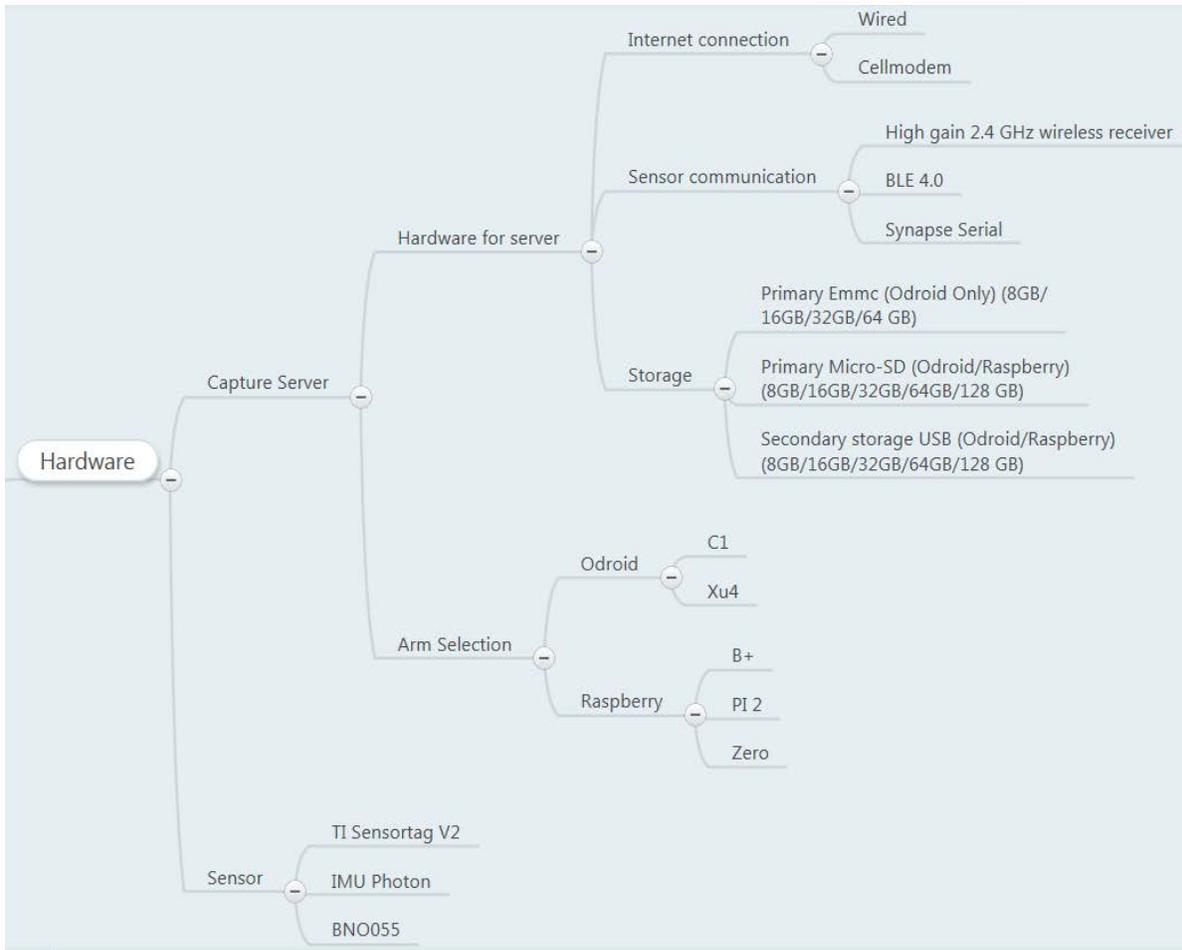
(b) Hardware Component of Sensor Network System

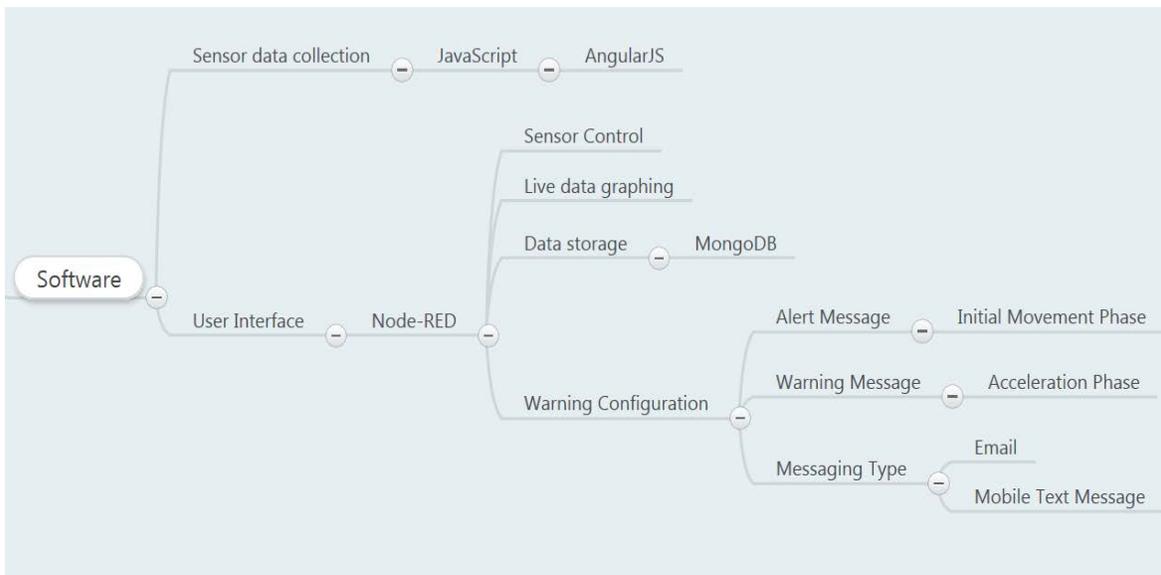
(c) Software Component of Sensor Network System

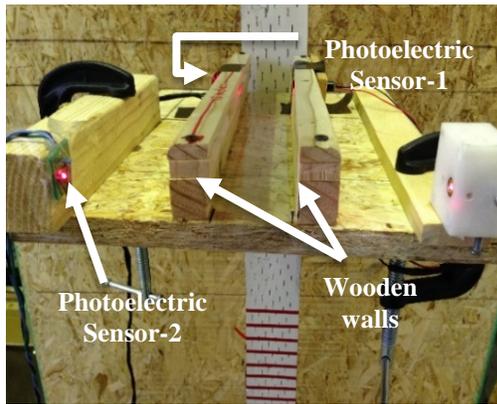
(a) Fall Test Setup (Platform)

Both fall experiments used the same laboratory setup as illustrated in Figure 3, except the two different falling object models used in the roll-fall and slide-fall experiments. The experiment consisted of a wooden box (1.2m×1.2m) with a photoelectric sensor setup at the floor level (Figure 3 (b)) and the platform supported on a wooden post at a height of about 2.2 m above the floor level. The setup was made such that rolling or sliding of the object can be

performed on a platform with variable slope angle and in a fixed path guided by two wooden walls along the platform. Two photoelectric sensors are provided on the platform (Figure 3 (a)). The photoelectric sensor-1 at the back indicates the initiation of sensor movement, the photoelectric sensor-2 on the edge defines the beginning of fall, and the photoelectric sensor-3 at the floor indicates the end of free fall as the sensor device passes through each of those photoelectric sensors (Figure 3 (b)).

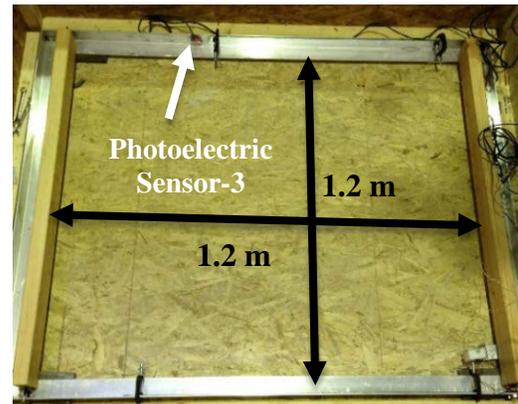
(b) Photoelectric Sensor Setup

**Figure 3 – Experimental Setup for Fall Tests**

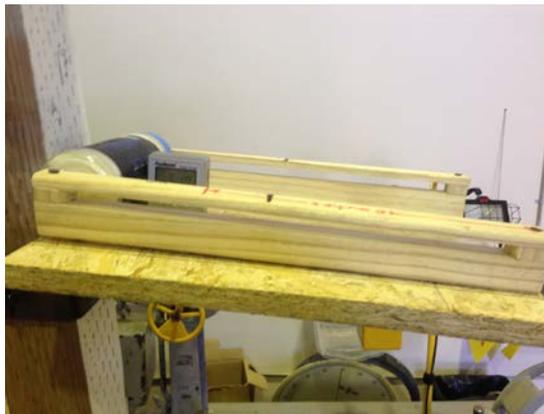
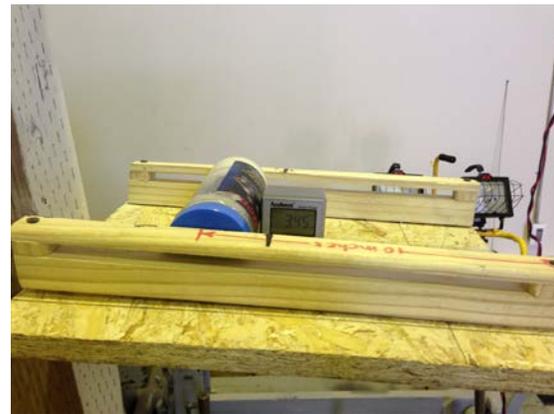
(a) At 5 Degree Slope

(b) At 3.5 Degree Slope

**Figure 4 – Experimental setup for a roll-fall experiment**

To simulate the rolling of rock mass before the free fall, an absolute orientation sensor device was mounted onto a cylindrical object as shown in Figure 4. The platform built for roll-fall experiment was inclined at two different angles – about 3.5° and 5°, respectively. The object was made to roll over the platform under the influence of gravity. The test was repeated 5 to 6 times for each platform slope. However, the sensor orientation were slightly different during each test run for both platform slope experiments. This was done to check the repeatability of the movement pattern obtained for all the sensors within a sensor device irrespective of the sensor orientation as well as considering the time lag during different runs.

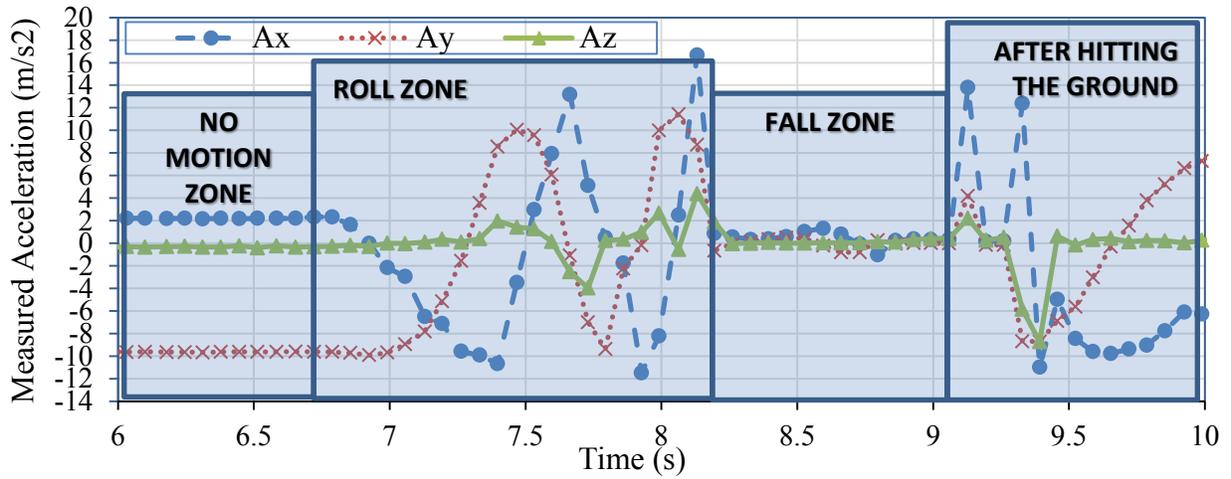
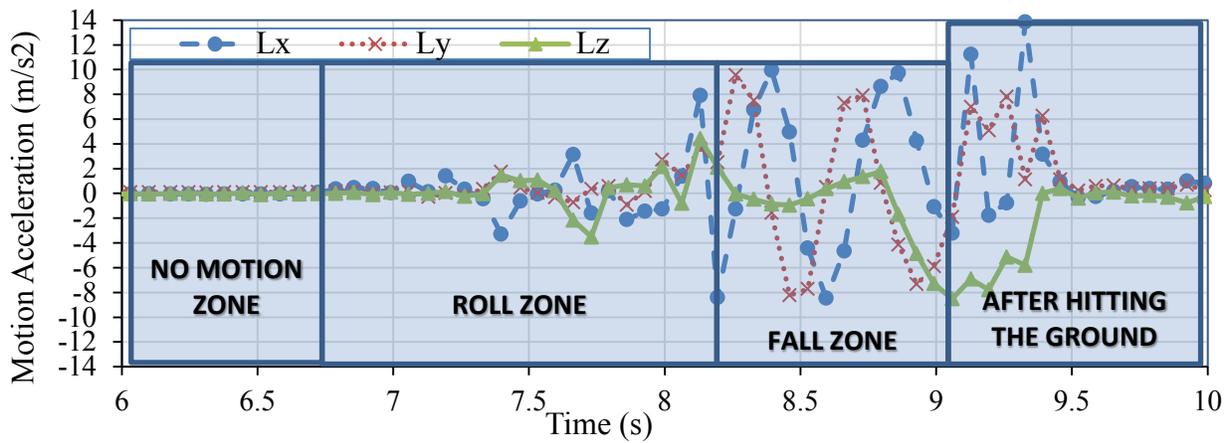
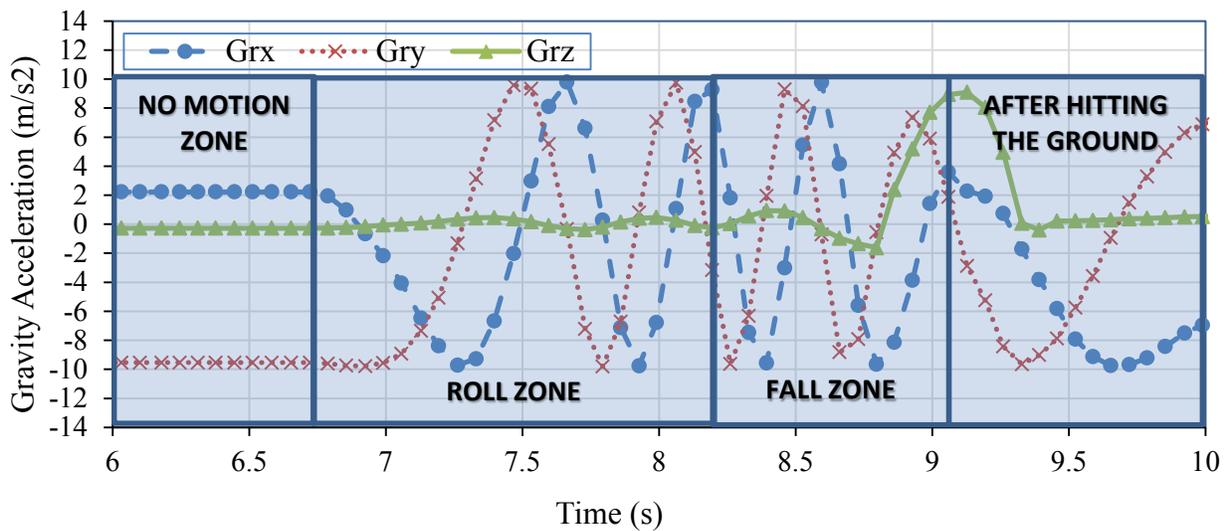
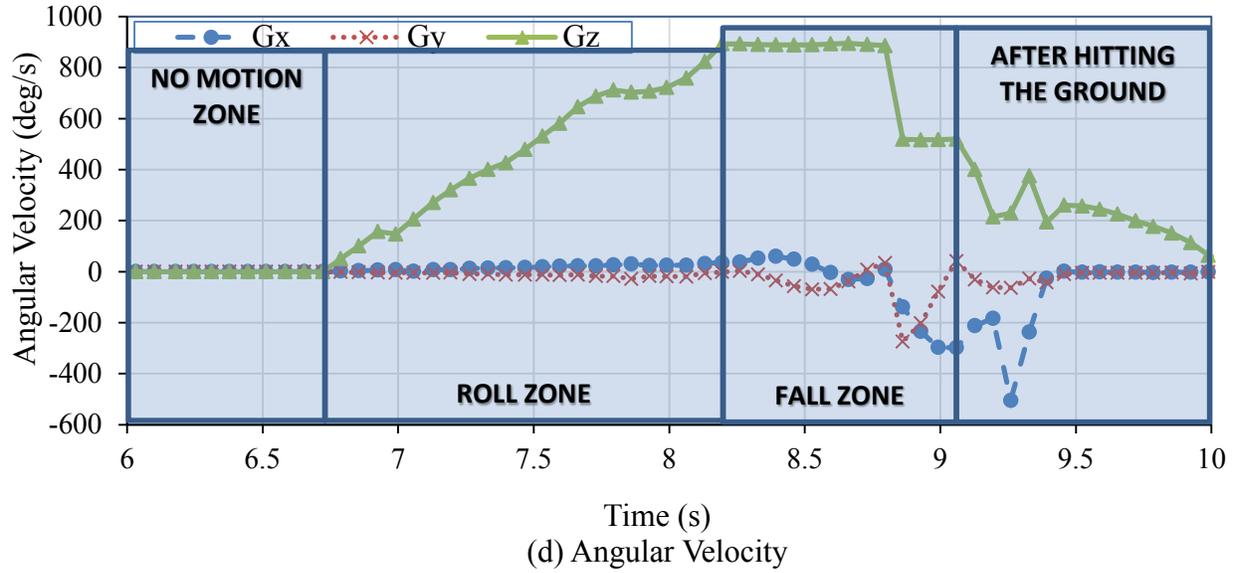
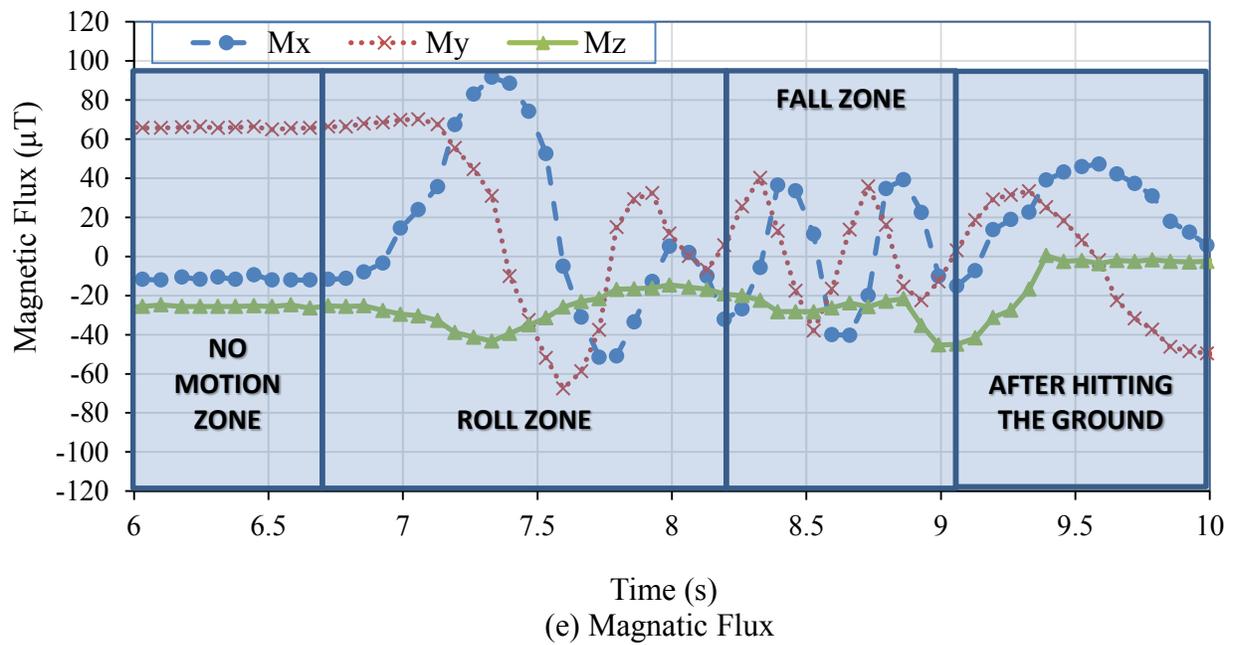
(a) Measure Acceleration

(b) Motion Acceleration

(c) Gravity Acceleration

Figure 5 – Sensor Measurements for the Roll-Fall Experiment

Similar results were obtained for the test conducted with 3.5 degrees of the slope angle. Due to the reduction in slope angle, the rolling speed slows down and hence, the time taken to roll to the edge of the platform increases. The gravity acceleration data followed the same sinusoidal pattern, but the amplitude of the sine curve was wider. In the same way, all other sensor results showed similar pattern to those for 5 degrees slope explained above.

The laboratory experiments showed that a rock fall led by rolling has a distinct pattern of motion, gravity, and measured acceleration data. Also, the gyroscope and the magnetometer results complement the understanding of movement behavior and the confirmation of mass movement itself.

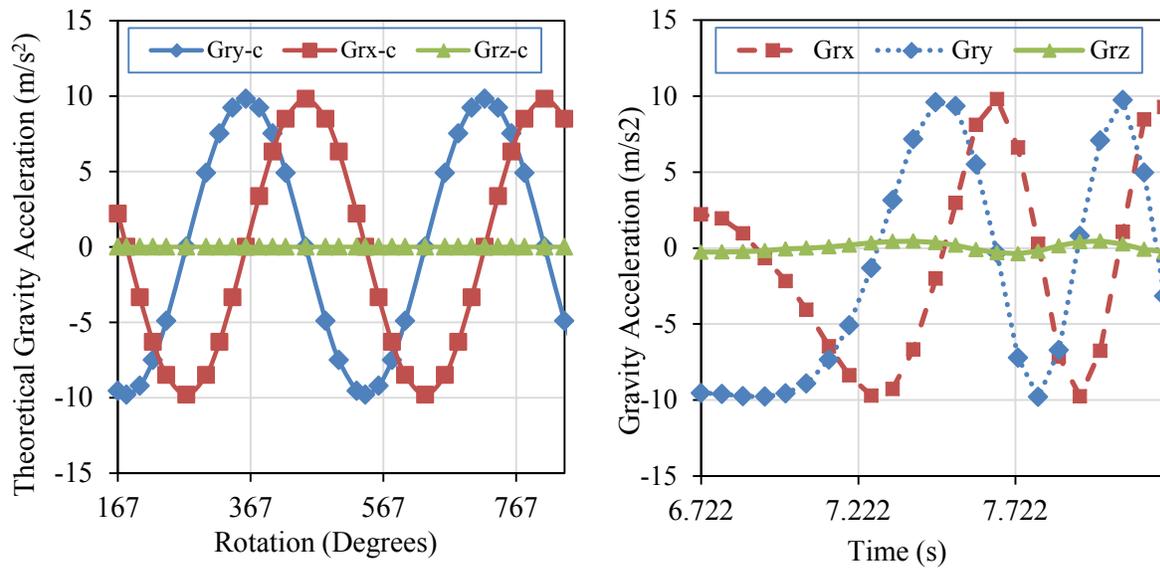
(a) Theoretical Gravity Acceleration      (b) Measured Gravity Acceleration  
**Figure 6 – Comparison of the Gravity Accelerations to Understand the Tilt and Rolling of the Sensor during Rolling**

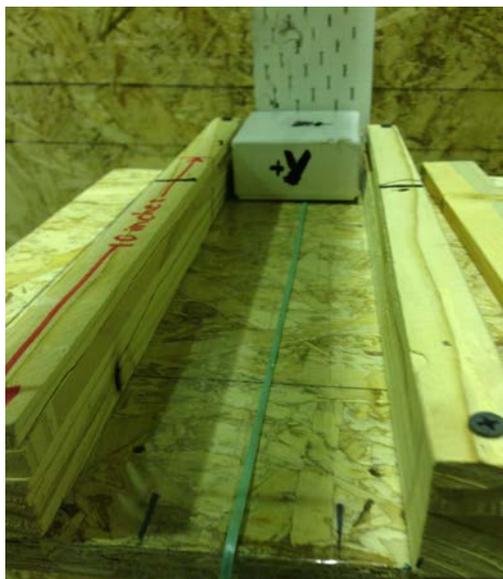
**Figure 7 – Experimental Setup for a Slide-Fall Experiment**

Slide-fall experiment was carried out by using the same setup that was used for the roll-fall experiment. In this experiment, however, the object used was a rectangular box that could slide easily on the platform before falling (Figure 7). The sensor device was placed inside the box and the box was pulled along the horizontal platform mechanically with the help of a string. The purpose of sliding the sensor mechanically was to observe the motion acceleration during the slide. The same three photoelectric sensors setup was used. Six runs of the experiment was conducted with the same setup.

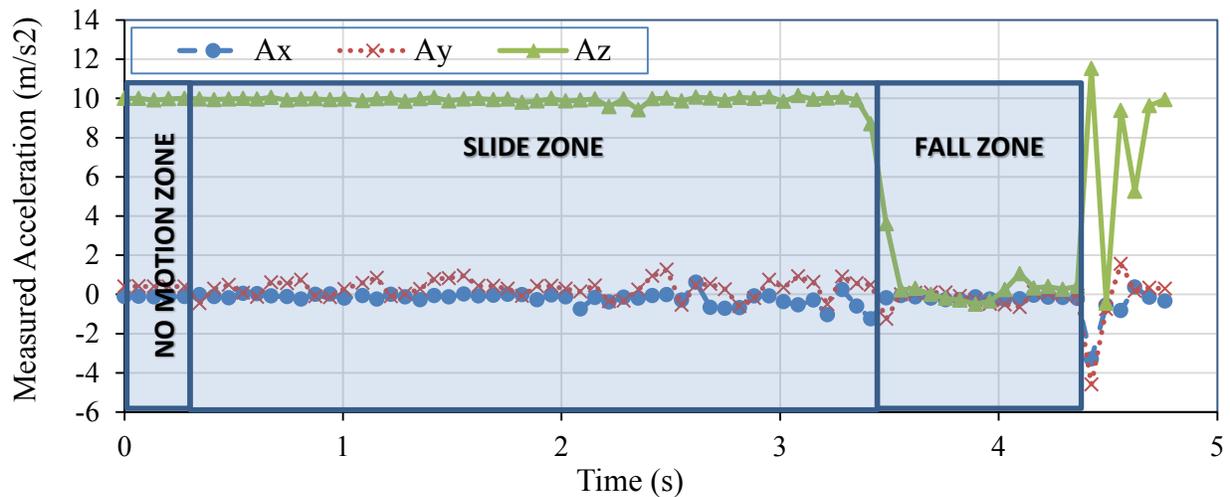
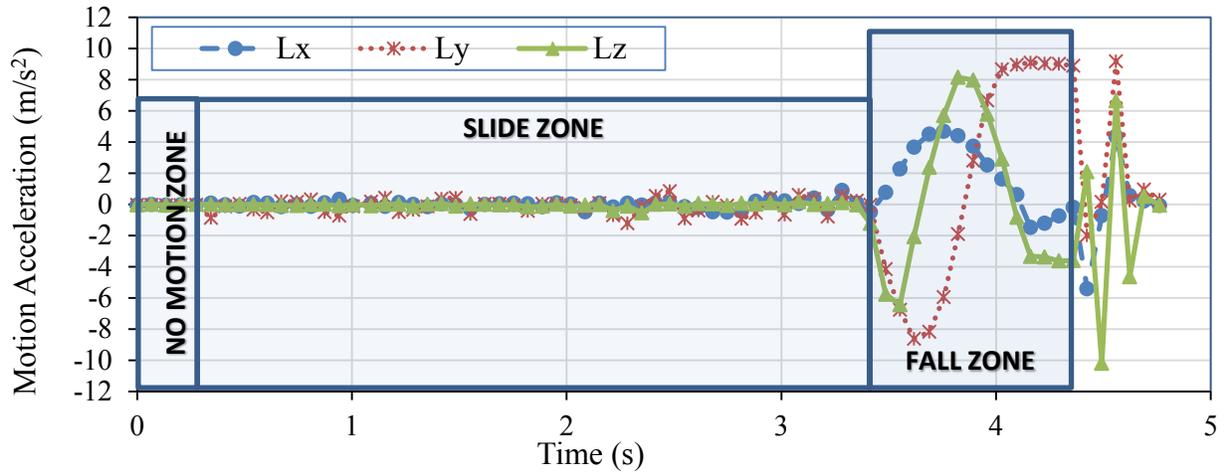
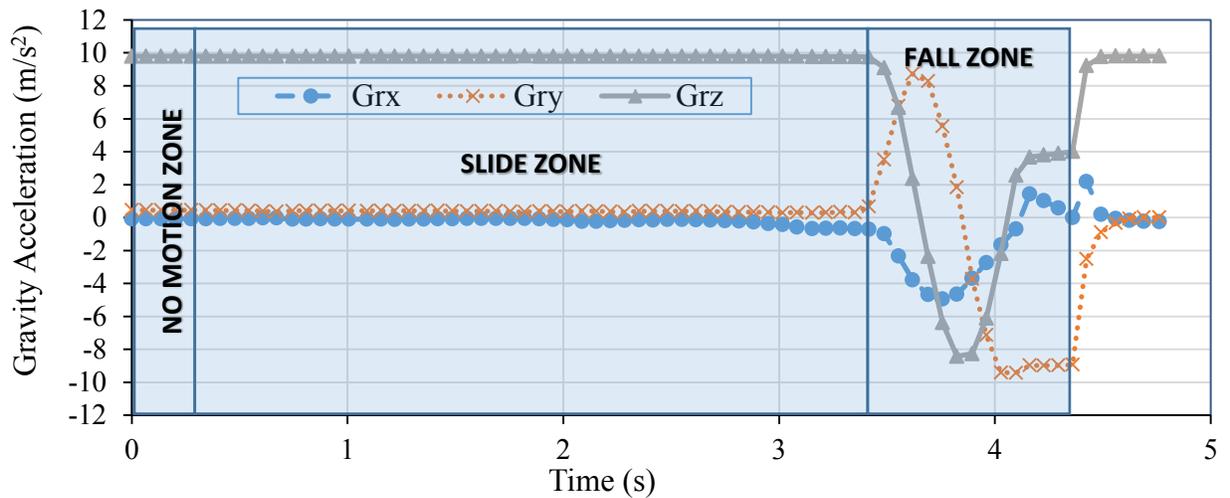
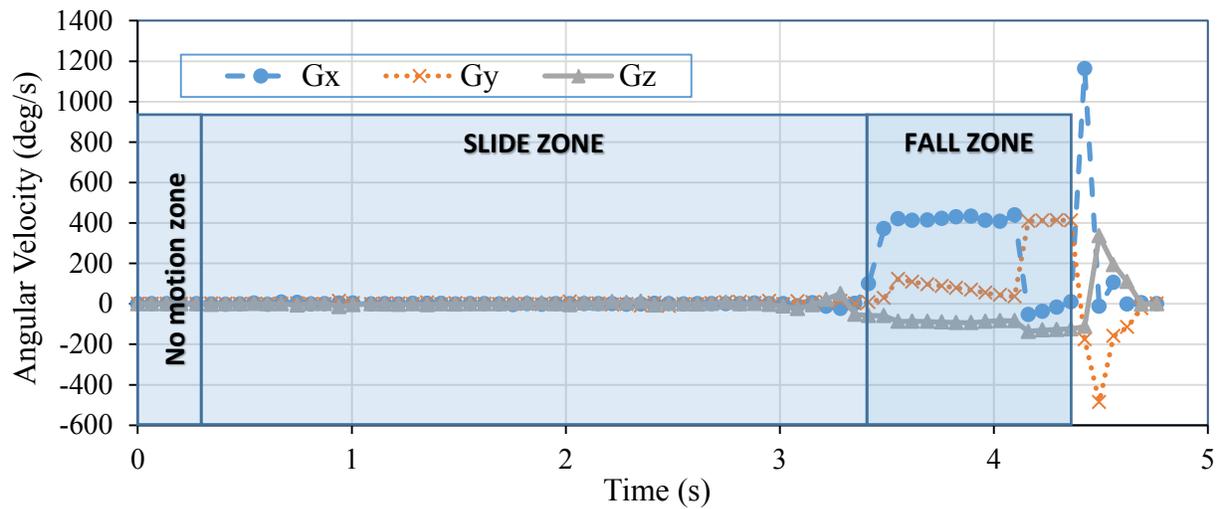
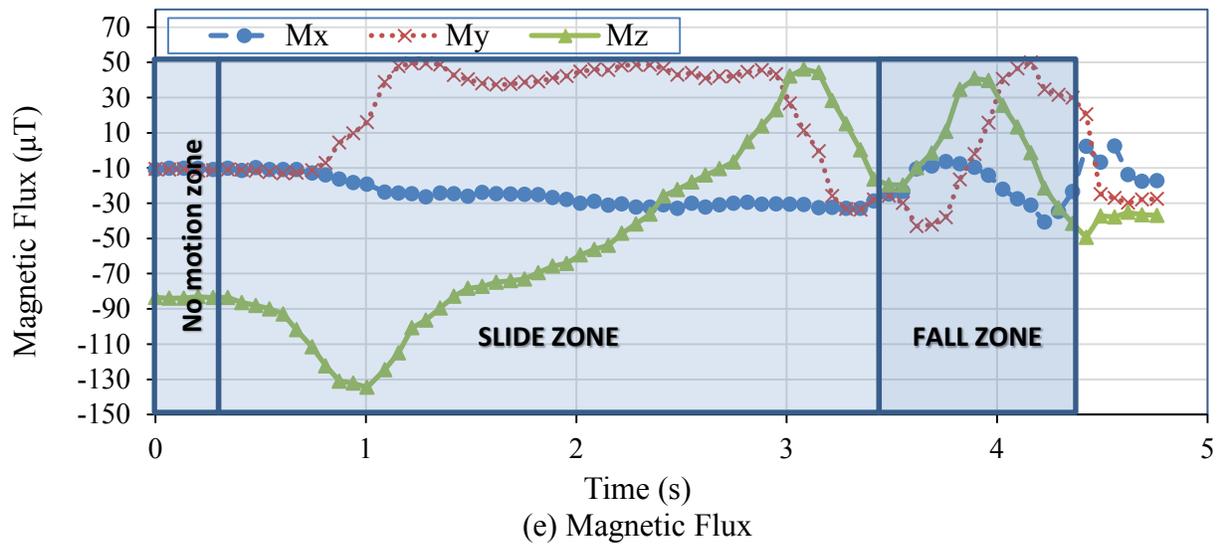
(a) Measured Acceleration

(b) Motion Acceleration

(c) Gravity Acceleration

(d) Angular Velocity

**Figure 8 – Sensor Measurements for the Slide-Fall Experiment**

Results of the slide-fall experiment with +y axis facing forward in the direction of sliding, +y in the direction perpendicular to x in horizontal plane and +z in the direction of gravity, are presented in Figure 8. During the sliding phase, +z facing towards gravity yielded gravity acceleration data ( $Gr_z$ ) equal to  $1g$  ( $9.81\text{m/s}^2$ ), whereas x and y-axes being perpendicular to the direction of gravity yielded results ( $Gr_x$  and  $Gr_y$ ) closer to zero. The discrepancy between expected and measured value was attributed to the wooden platform being not perfectly horizontal. Similar to the fall during roll-fall experiment, the measured acceleration values for all three axes become approximately zero. Figure 8 (a) shows a sudden change or drop of acceleration value in the axis along the direction of gravity from almost constant approximate value of  $9.81\text{m/s}^2$  to close to zero. This is because of the same reason as explained earlier that during the free fall the gravity and motion acceleration measured by the sensor are equal and opposite resulting in zero measured acceleration. A small amount of the motion acceleration was observed during the slide (Figure 8 (b)). During the fall, the motion acceleration was observed to be approximately equal and opposite of the gravity acceleration (Figure 8 (c)). As expected, the gyroscope readings were almost equal to zero during the slide because of no rotation about any of the axes (Figure 8 (d)). However, the gyroscope experiences some rotation during the free fall and hence, the angular velocity of some magnitude was observed during the experiment. Likewise, the change in magnetometer readings during the slide and the fall indicates the motion of the sensor device and hence, the moving mass.

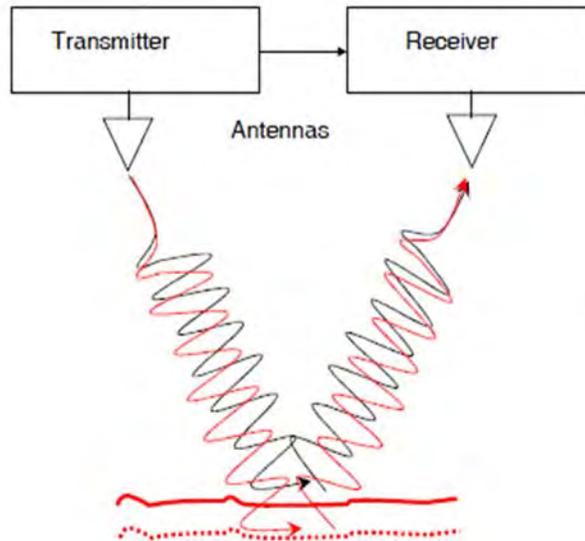
**Figure 1 – Schematic illustrating phase shift in radar signal caused by surface deformations**

Because the deformations are determined from changes in phase and the wavelength of the Ku band system is small, the GBIR is very sensitive to small (mm-scale) surface deformations.

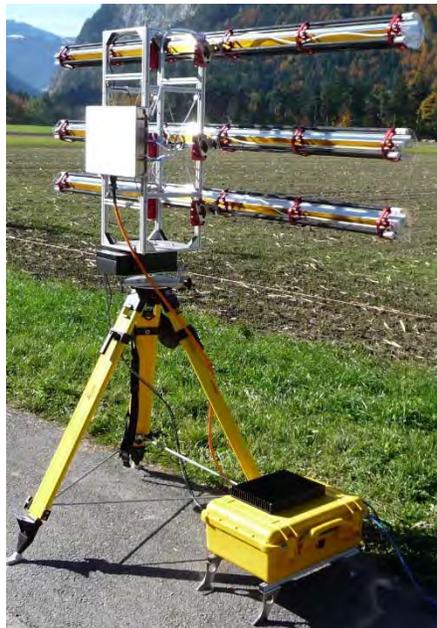
**Figure 2 – Ground-based Interferometric Radar (GBIR) used in this study**

The Ku-band (17.1-17.3 GHz) GBIR at the University of Missouri is a second-generation, real-aperture system manufactured by GAMMA Remote Sensing in Switzerland. The GBIR consists of one transmitting antenna, two receiving antennas, a radio frequency controller, mounting frame, a stepping motor with tribrach, a portable tripod and a field computer. An anchored mast can also be deployed in lieu of the tripod if a more permanent platform is needed. The antennas are approximately two meters in length with slotted waveguide members. The radio frequency box generates the radar signal used for acquisition (Ku-band frequencies). A photograph of the GBIR system is shown in Figure 2.

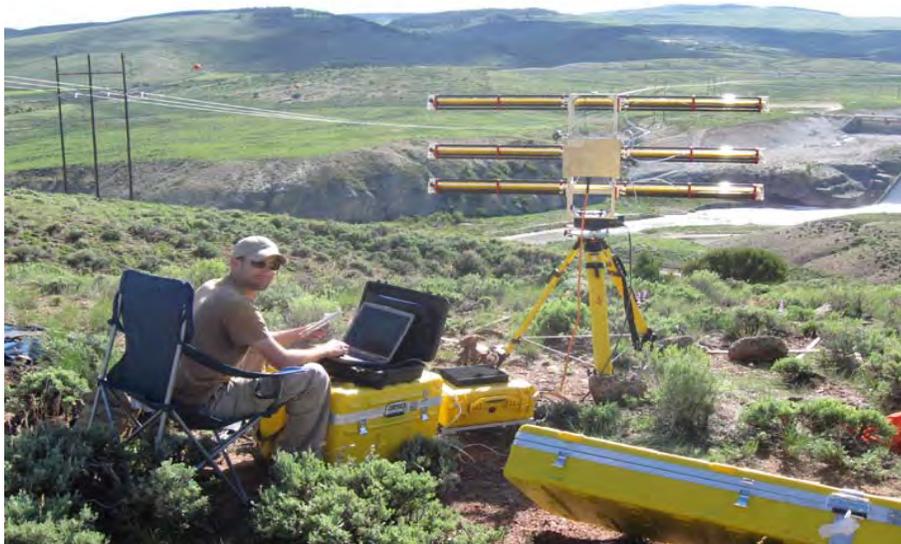
**Figure 3 – Ground-based Interferometric Radar (GBIR) with landslide in background**

Measurements were performed over a span of 24 hrs in June, 2011 and over a span of 36 hrs in August 2011. The GBIR was set up about 500 m from the slide and radar scans of the site were performed at 15-minute intervals. A photograph of the GBIR scanning the site is shown in Fig. 3. The numerous radar scans collected allowed for the calculation of hundreds of interferograms over different increments of time. These interferograms were used to create displacement maps as well as displacement time series of specific points.

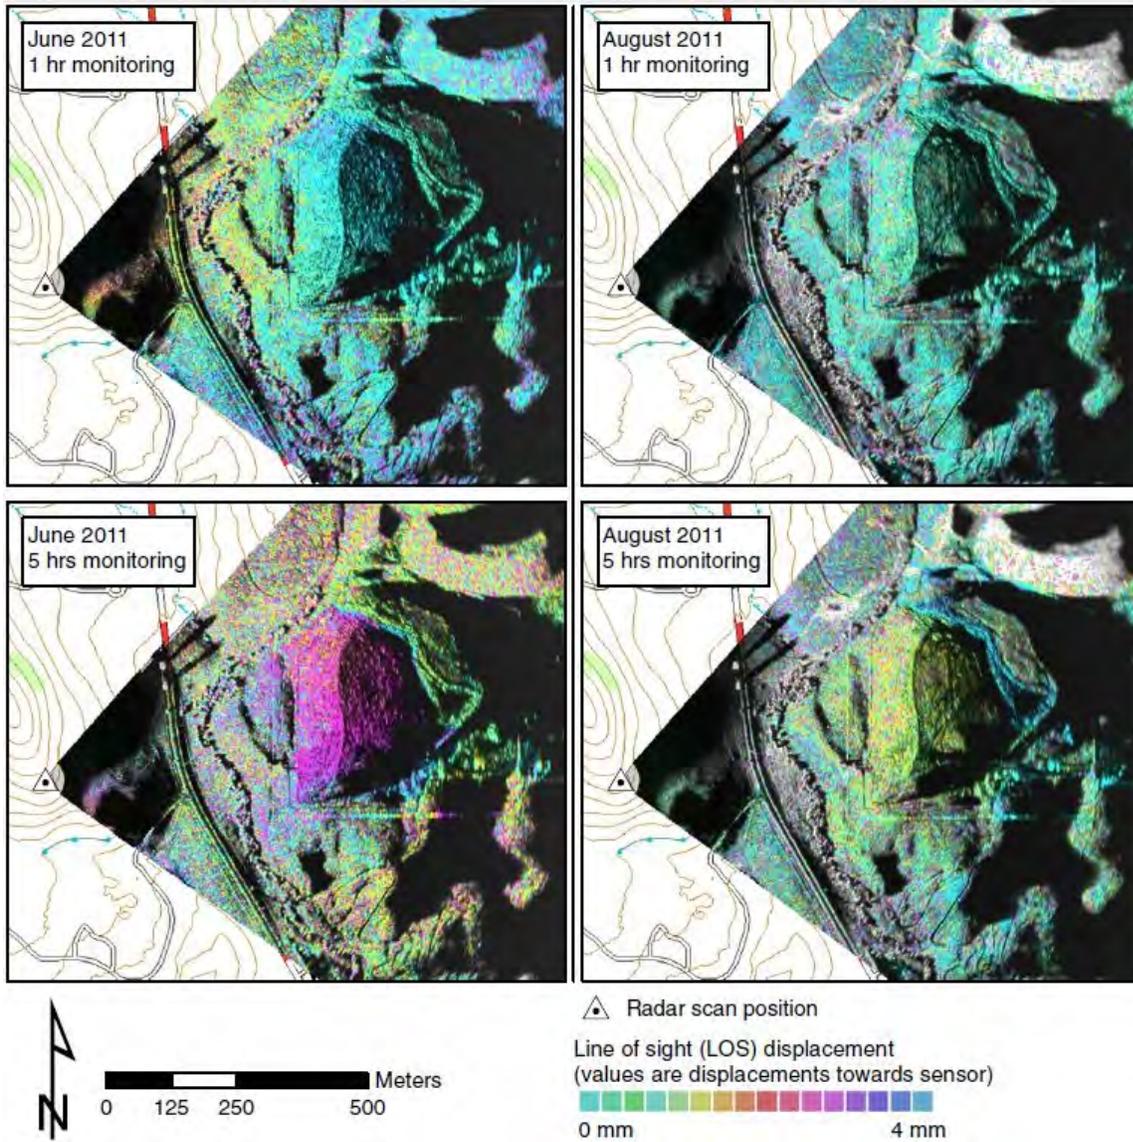
**Figure 4 – Displacement maps derived from continuous monitoring of a slow-moving landslide using the MU GBIR system (3)**

A comparison of displacement maps from June and August is presented in Fig. 4, which shows a clear change in the rate of movement. Of particular note is the very small magnitude (mm-scale) of movement that is detected using the GBIR measurements. This measurement range is below the threshold that can be detected using other remote sensing technologies, such as photogrammetry and LiDAR. Measurements as small as 0.5 mm were detected in this case. Also of note is the clear delineation of the boundaries of movement, which may be difficult to obtain using point-by-point measurements. An example of a time series developed for two specific points is shown in Fig. 5, illustrating the ability to monitor hourly variations in the rate of movement.

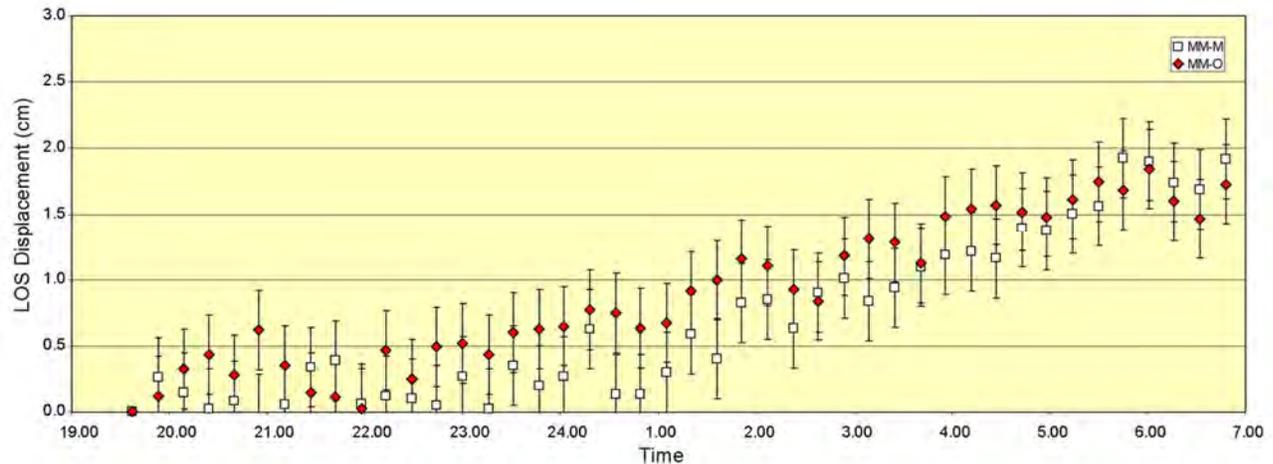
**Figure 5 – Displacement time series from two points obtained during the August, 2011 measurements**

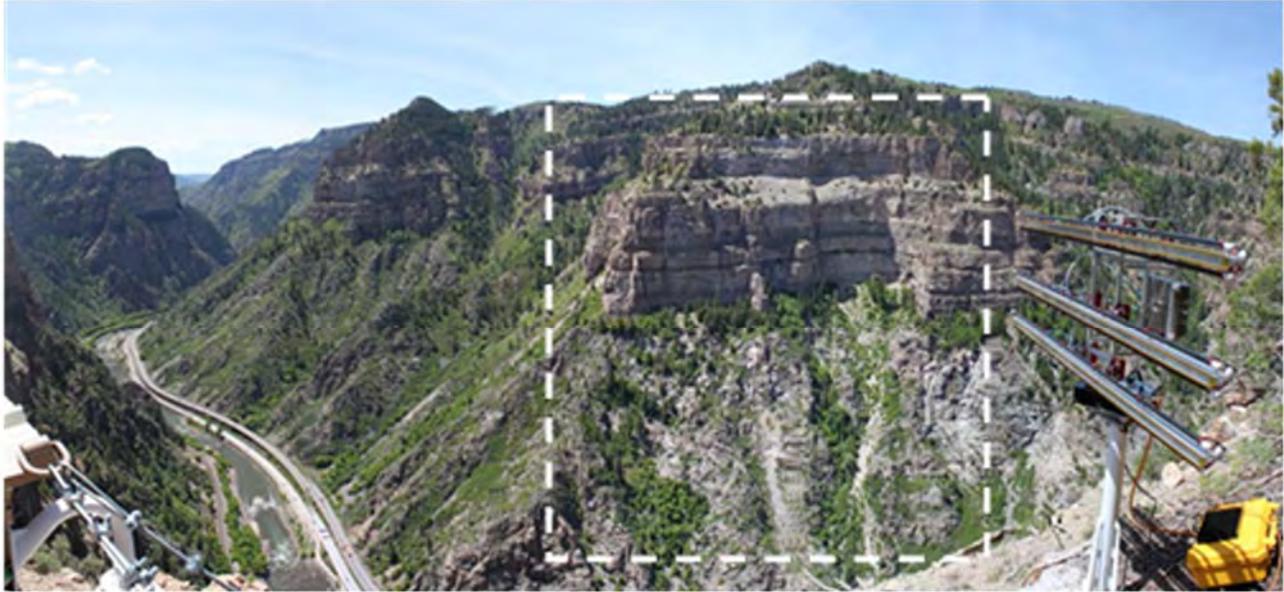
**Figure 6 – Glenwood Canyon rock face and GBIR system installed on opposing cliff across from Interstate 70.**

The Colorado Department of Transportation (CDOT) funded a project to monitor a site near Glenwood Springs, Colorado that has been the source of several rockfall events that impacted Interstate 70. Olson Engineering installed an IBIS-L GBIR system manufactured by IDS of Pisa, Italy. This system is a synthetic aperture radar (SAR) (unlike the real-aperture Gamma system) but in principle operates similarly to the GAMMA system used in this study. The IBIS system was installed on a cliff located across I-70 about 600 m from the rockface of interest. The IBIS system continuously monitored the potential rockfall site over a duration of about 2 months, taking radar scans every 5.5 minutes (10). The objective of this study was to detect small movements of the rock face that may be precursors to a rockfall event. CDOT also provided funding for periodic measurements of this site using the GAMMA GBIR system. The GAMMA system is not setup to operate unattended over months, so it was brought up to the site by helicopter at two-week intervals. A support mast was bolted to the rock at the edge of the cliff face and the GBIR components were installed on top of the mast. A photograph of the GBIR system installed on the cliff with the rockface of interest indicated in the background (dashed box), is shown in Fig. 6.
