HGS 2016  
Proceedings

# 67TH HIGHWAY GEOLOGY SYMPOSIUM

## JULY 11 – 14, 2016

Cheyenne Mountain Resort  
COLORADO SPRINGS, COLORADO

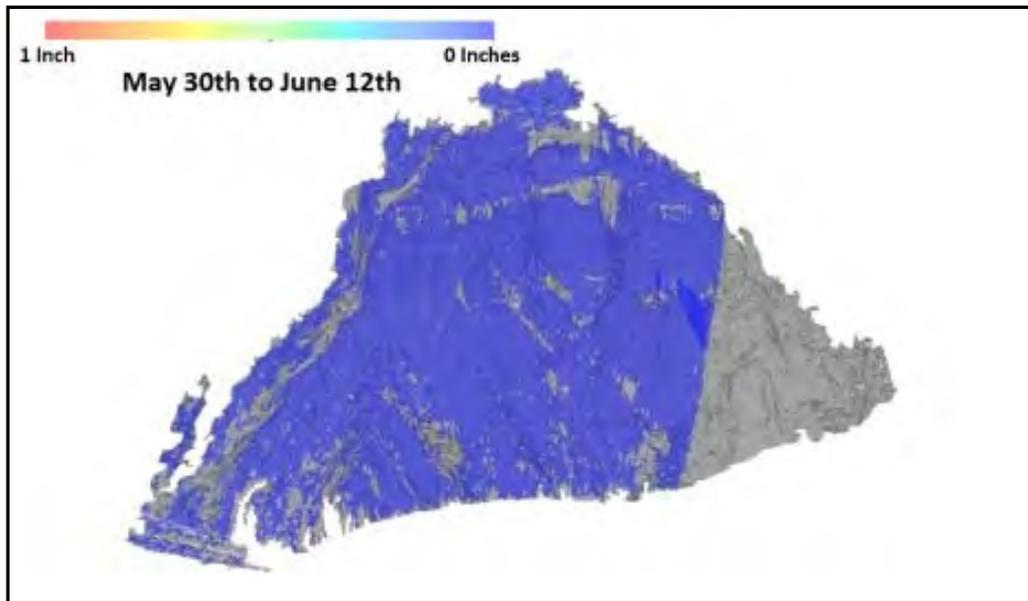
**Figure 7 –Two-week interferogram of the Glenwood Canyon study site showing no movements of the rock face**

The radar images collected from the GAMMA GBIR were used to create interferograms and displacement maps spanning the two weeks between radar acquisitions. An example of one of the displacement maps superimposed on a digital elevation model (DEM) of the slope study area is shown in Fig. 7. As can be seen in this figure, the displacement map showed a uniform color indicating zero phase shift (and hence zero displacement) across the slope. Similar images were obtained from the other time intervals examined. It was concluded that no movements of the slope were detected over the time frame of the measurements using the GAMMA GBIR. In contrast, the continuous measurements obtained from Olson Engineering indicated several locations where movements were measured, some as much as 300 mm (10). A detailed presentation of the IBIS results can be found in Miller et al, 2013 (10).

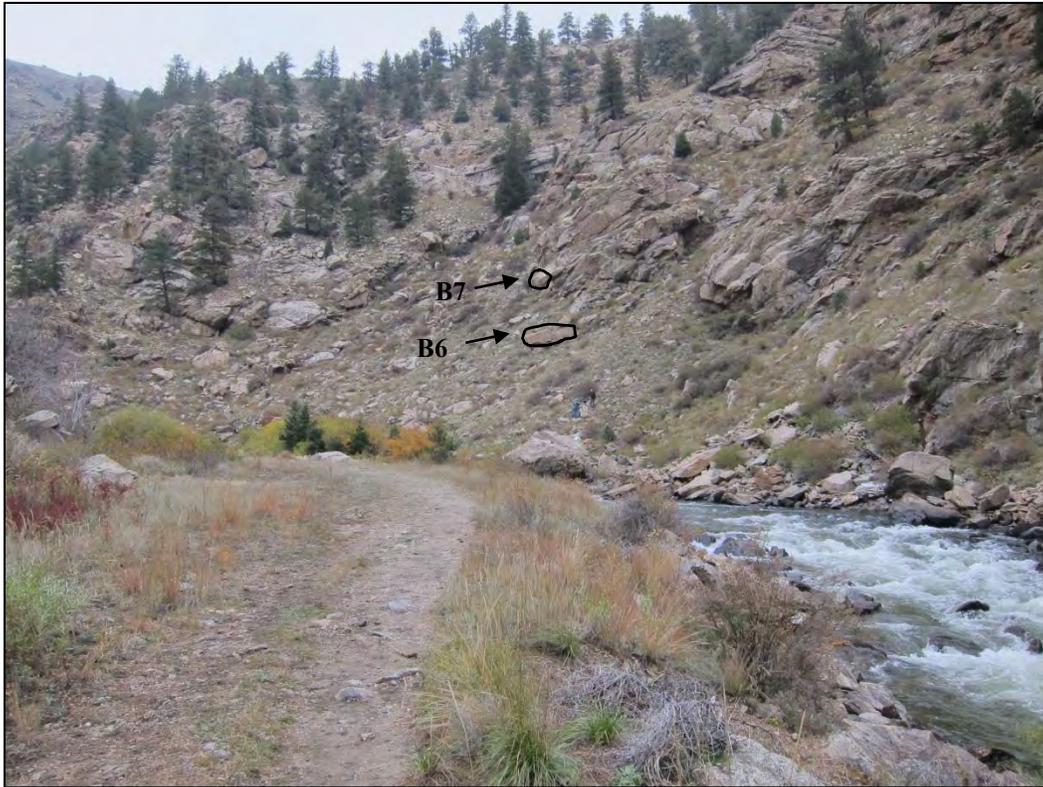
**Figure 8 – Field site of controlled boulder movements from vantage point of GBIR 2. The locations of Boulders 6 and 7, discussed later in this section, are outlined in the photo**

The site of the controlled study is located approximately 50 km west of Denver, Colorado along a meander in Clear Creek. The control site was chosen based on good accessibility for equipment and personnel, clear vantage points to scan a large (approximately 20,000 m<sup>2</sup>) region, and availability of a wide variety of boulder sizes. A photograph of the site taken from one of the GBIR locations (GBIR2) is shown in Fig. 8. As can be seen in the photograph, the site consists predominately of outcropping rock surrounded by lightly vegetated regions, with some trees present. Two GBIR units (one borrowed from the University of Arkansas) were positioned on tripods at separate locations across Clear Creek from the rock slope. Twelve boulders ranging in approximate facial dimensions from less than 1 m to over 5 m were selected for this study. The boulder offsets ranged from about 70 m to over 150 m from the two GBIR locations. A Google Earth image of the site indicating the locations of the GBIR systems, as well as the twelve boulders (black circles), is shown in Fig. 9. In this paper representative results from the study are presented using incremental movements of Boulder 6 and Boulder 7. The locations of these boulders are identified in Figs. 8 and 9.

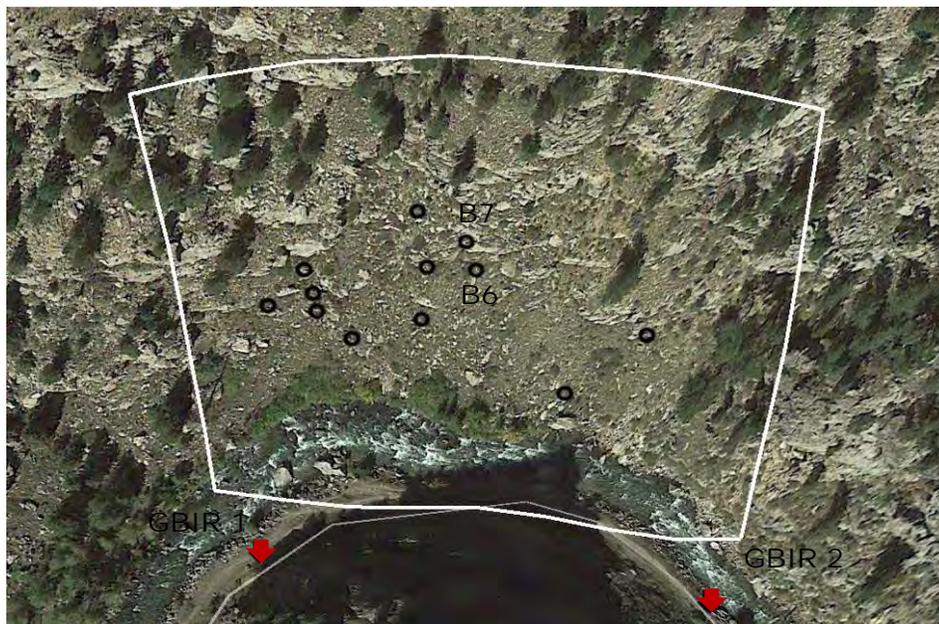
**Figure 9 – Google Earth image of field site showing the location of the GBIR systems and the twelve boulders moved in this study. Boulders B6 and B7 are labelled.**

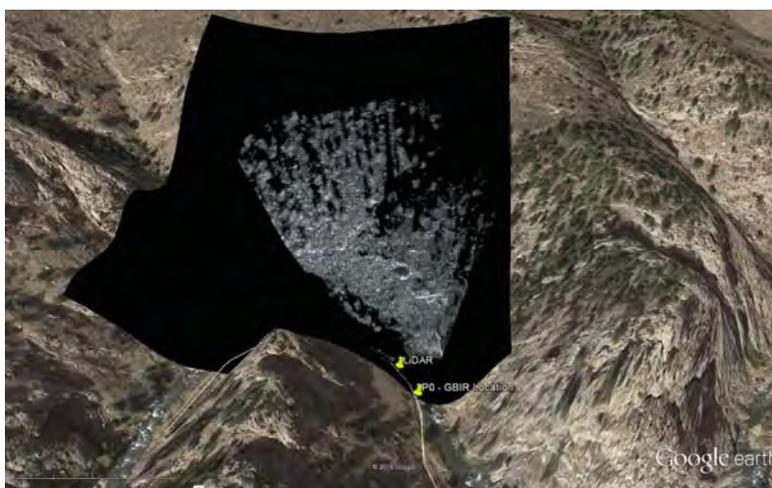
**Figure 10 – Example of radar intensity scan collected from single scan set**

Two tripods were positioned over survey points marking the GBIR1 and GBIR2 locations. After the tripods were positioned the GBIR components were attached. The GBIR antennae were fixed at a 10° inclination from horizontal. A scanning swath for each GBIR was set such that the entire site containing the twelve boulders was scanned from each GBIR location. The rotational scanning rate was set to 5°/sec, resulting in the completion of each scan in under 30 sec. Four scans were performed after each increment of movement with data recorded from both the upper and lower antennae. Therefore, one scan set consisted of eight radar images. An example of a radar intensity image overlaid on the Google Earth image of the site is shown in Fig. 10.

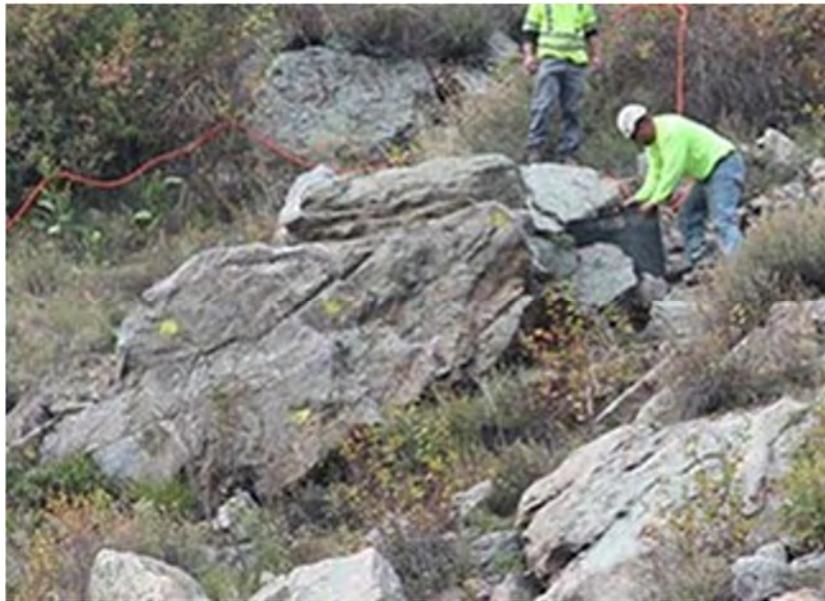
**Figure 11 – Airbag jack being placed behind a large boulder**

On the opposite side of Clear Creek the boulders were nudged slightly using pry bars for small boulders and air bag jacks for the larger boulders. A picture of an air bag jack being positioned behind one of the boulders is shown in Fig 11. Each boulder was moved in mm-scale increments. The intent was to limit each push to about 2 mm in magnitude, however, it proved difficult to precisely control the airbag pressure and increments were often several mm in magnitude. A total station was brought to the site to record ground truth movements. Unfortunately, the total station malfunctioned and another means to record ground truth measurements was improvised. Laser pointers placed a few meters away from the boulder were used to illuminate points on the boulder which were marked before and after each push increment. The distance between the marked points was measured using a steel ruler and the general push direction was measured using a compass. This approach provided reasonable ground truth values for comparison with the GBIR recordings, but due to the generally low accuracy in recording push direction and movement, as well as the contributions of rotation to the boulders movements, it was not possible to obtain high-quality ground truth measurements of line of sight displacement. After the completion of a series of incremental pushes on a given boulder, the air bag pressure was released and the boulder rebounded back towards the slope face. A final scan set was collected after the pressure release.

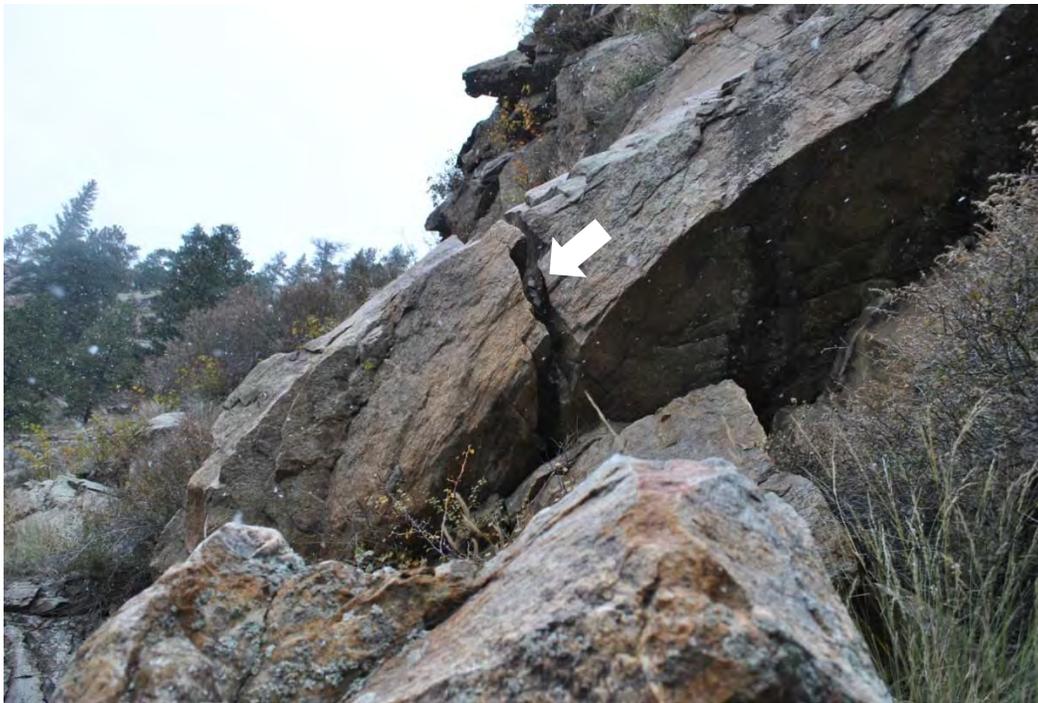
**Figure 12 – Close-up view of Boulder 7. The air bag was inserted in the vertical crack (white arrow) to initiate small outward movement of the rock mass.**

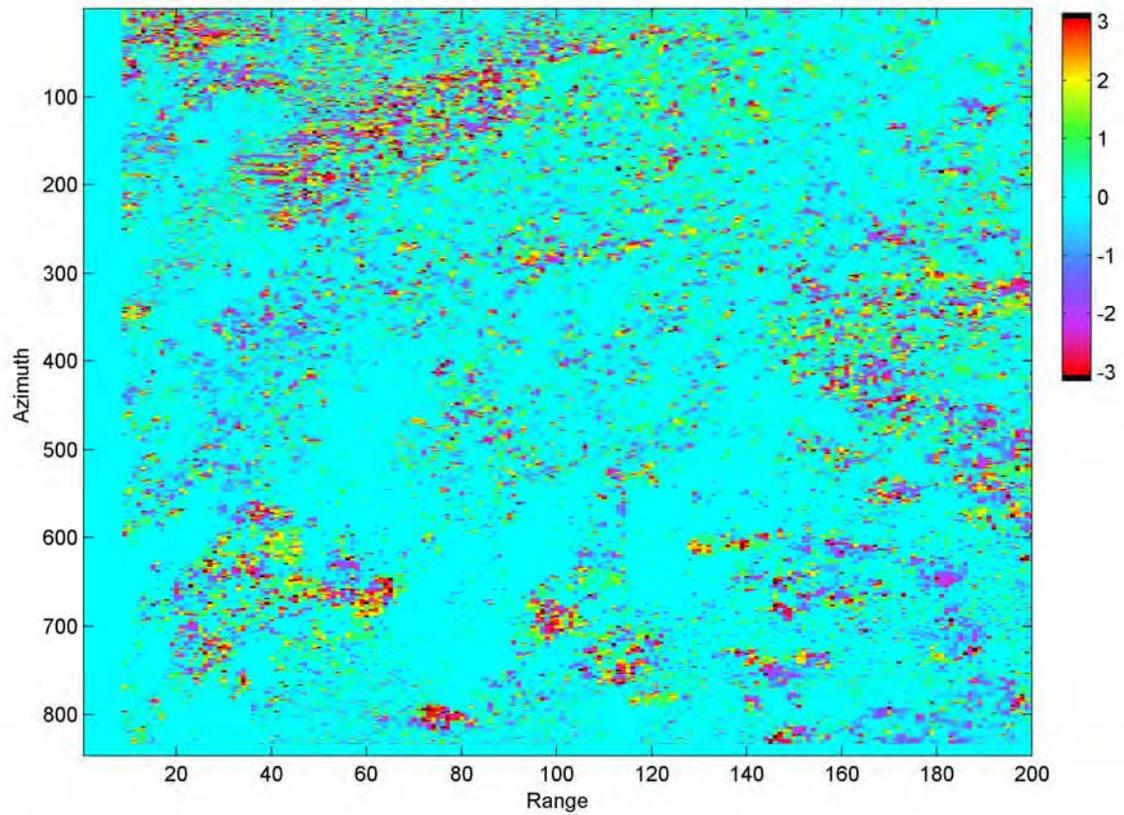
**Figure 13 – Raw interferogram created from scans performed before release of pressure on Boulder 6 and after first increment of movement of Boulder 7. Colors indicates wrapped phase values (in radians).**

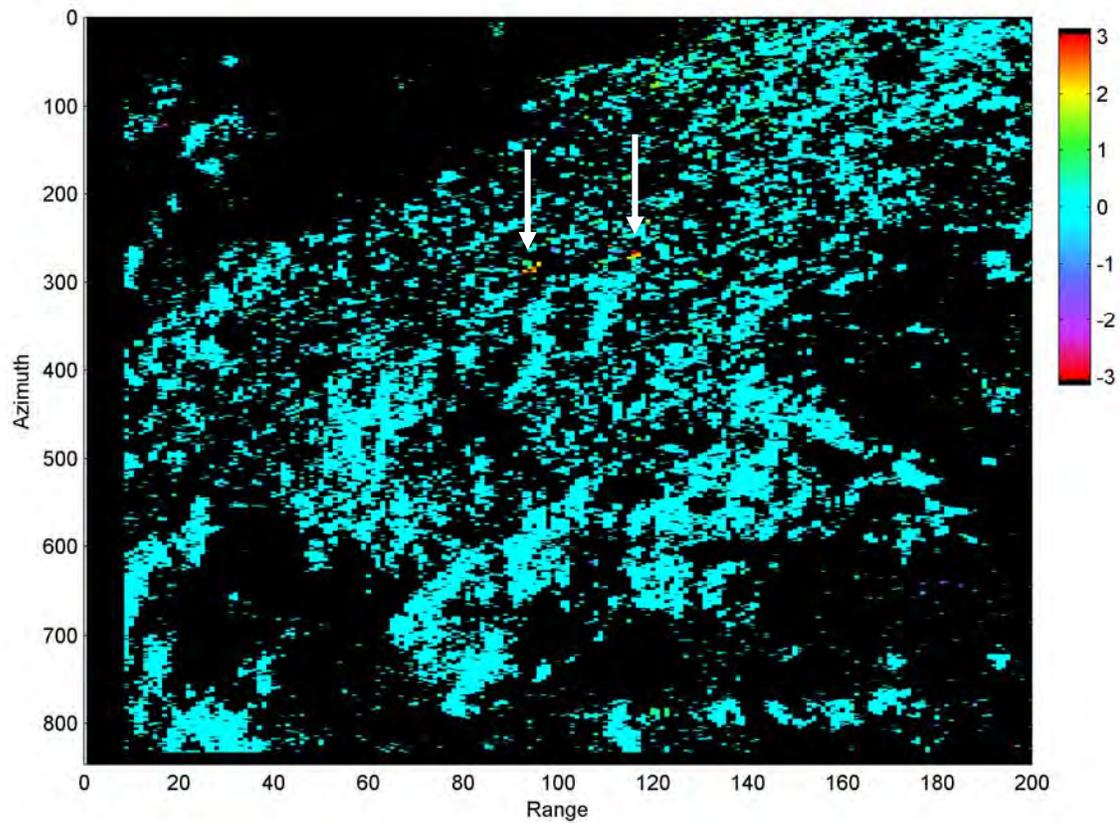
**Figure 14 – Interferogram after masking low coherence regions. Phase anomalies associated with movements of Boulders 6 and 7 are indicated with white arrows. Colors indicates wrapped phase values (in radians).**

coherence values. Using a mask of 95% (i.e. pixels with coherence values greater than 0.95 were retained), the image shown in Fig. 14 was produced. As can be seen in this image, most of the non-zero phase regions were removed leaving a near uniform cyan (zero-phase) image. However, two clear phase anomalies remain in the image, as shown with the white arrows in Fig. 14. A zoomed in image of the interferogram is shown in Fig. 15. These two points correspond to the locations of the two boulders that were moved during the interval between scans. In Fig 16, the radar image is presented in rectangular coordinates and superimposed on the Google Earth image of the site. The locations of the anomalies are directly over the locations of Boulders 6 and 7.

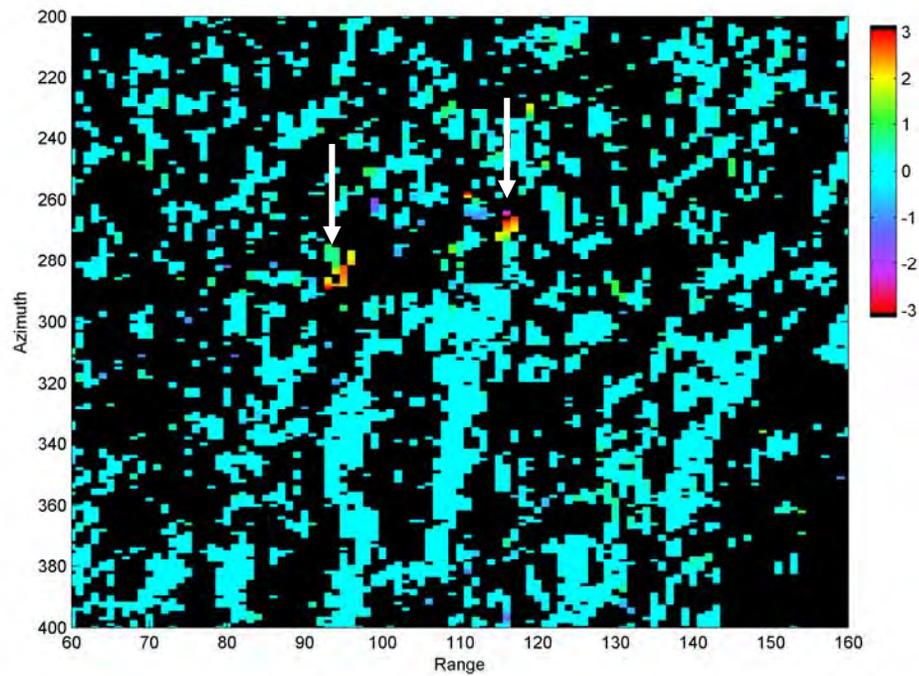
**Figure 15 – Expanded view of phase anomalies in interferogram**

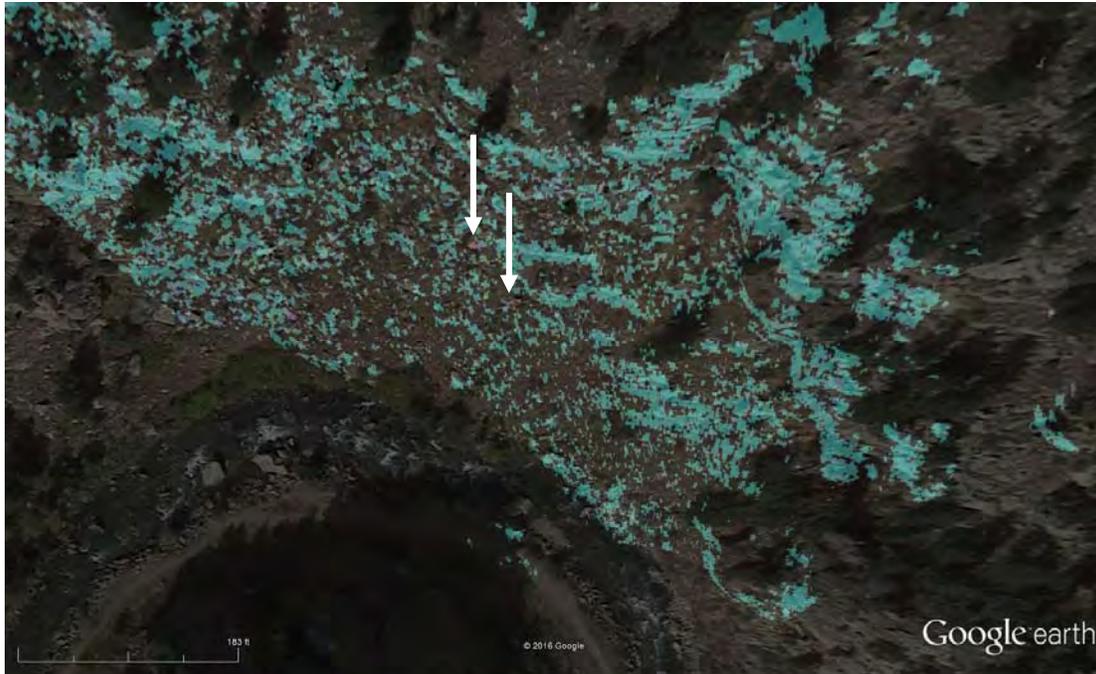
**Figure 16 – Interferogram presented in rectangular coordinates and superimposed over Google Earth image showing the phase anomaly locations are consistent with the locations of Boulders 6 and 7.**

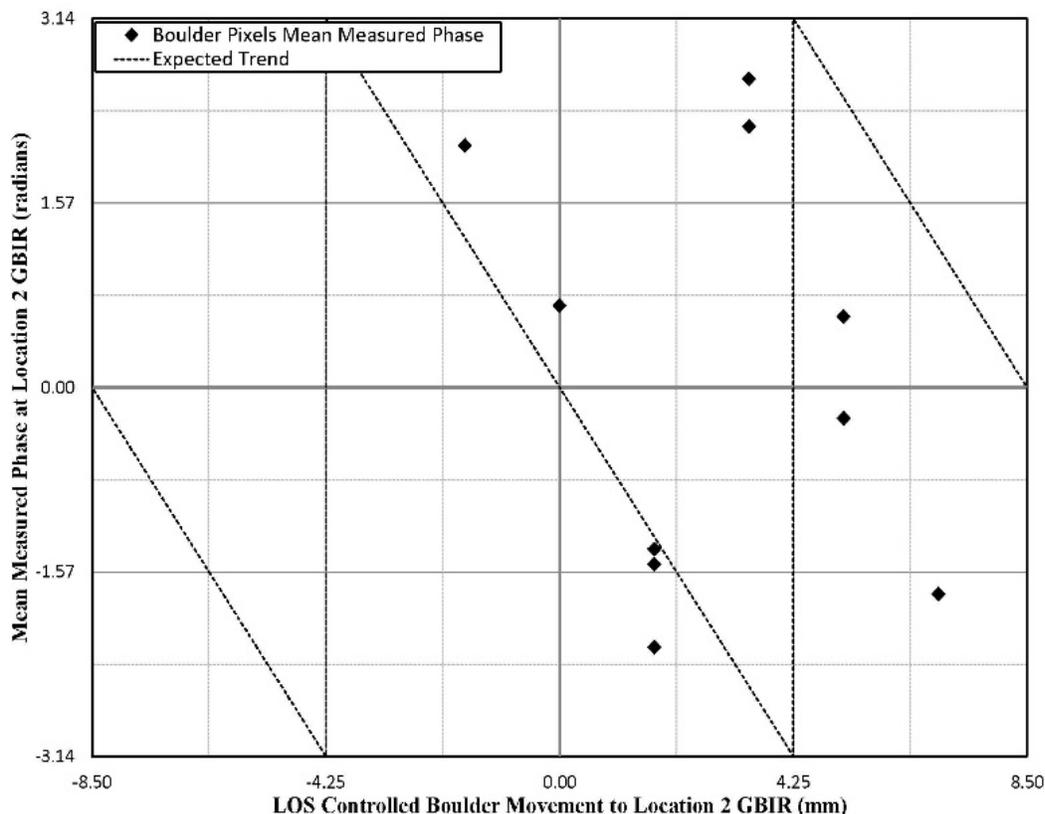
**Figure 17 – Comparison of measured phase values to expected values for Boulder 7 based on ground truth measurements.**

Phase values recorded using the GBIR from multiple push intervals of Boulder 7 were compared to expected phase values based on the line-of-sight movements calculated from the measured ground truth displacements and push direction. The comparison of the measured GBIR phase values with those expected based on the ground truth measurements are shown in Fig. 16. The GBIR phase values exhibit the expected wrapped pattern. The phase trends are slightly different than expected, which is likely attributable to inaccuracies in the ground truth measurements (particularly push direction), as discussed above.

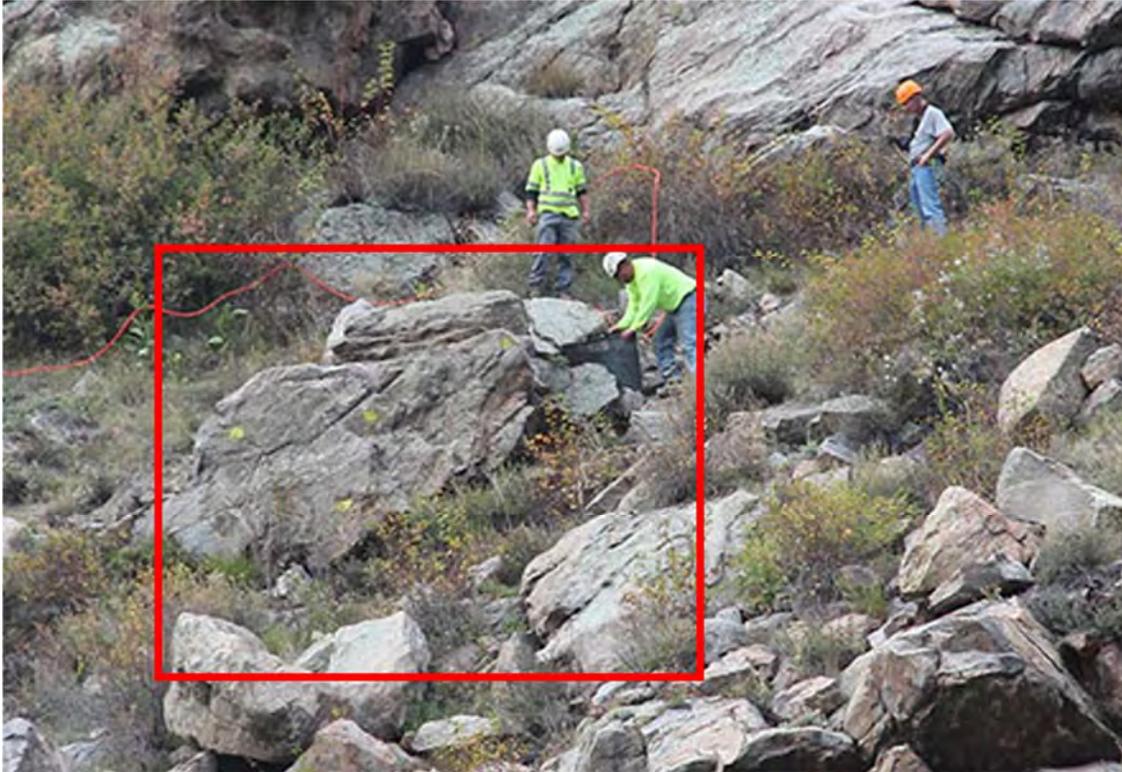
**Fig. 18 Boulder scanned using LiDAR**

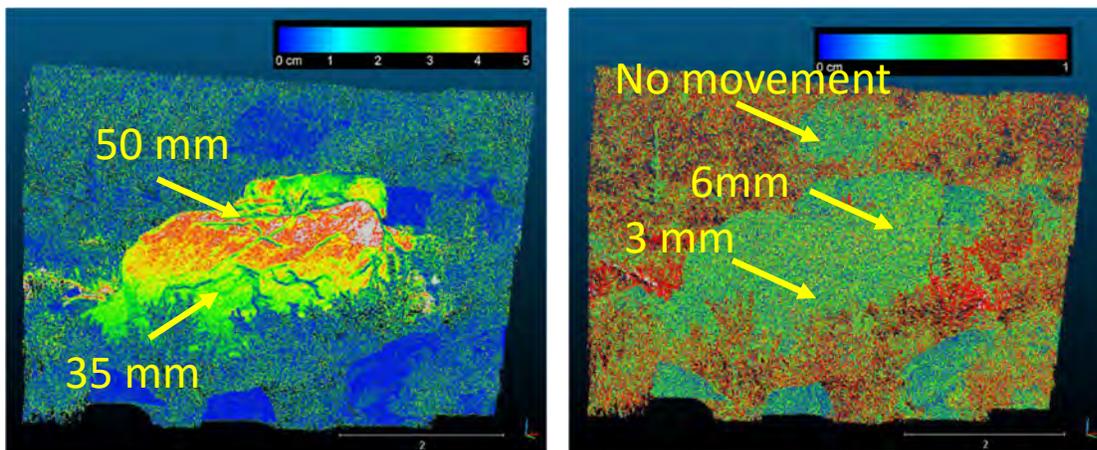
**(a) 50 mm of movement**

**(b) 6 mm of movement**

Detecting mm-scale movements of very localized regions is a difficult measurement problem and one that is important for geotechnical applications. Point-by-point survey methods often cannot provide the necessary spatial resolution to detect very localized movements. Remote sensing methods such as photogrammetry and LiDAR provide excellent spatial resolution but are not able to detect mm-scale changes. To illustrate this point, results are presented from LiDAR measurements of a boulder movement performed at the same site in a subsequent study. A photograph of the boulder is shown in Fig. 18. When the boulder movement was in the range of several cm, LiDAR provided excellent information on the magnitude and spatial distribution of movement, as shown in Fig 19(a). However, when the movement was in the mm range, the moving boulder could not be detected or differentiated from the non-moving boulder in the background, as shown in Fig. 19(b).

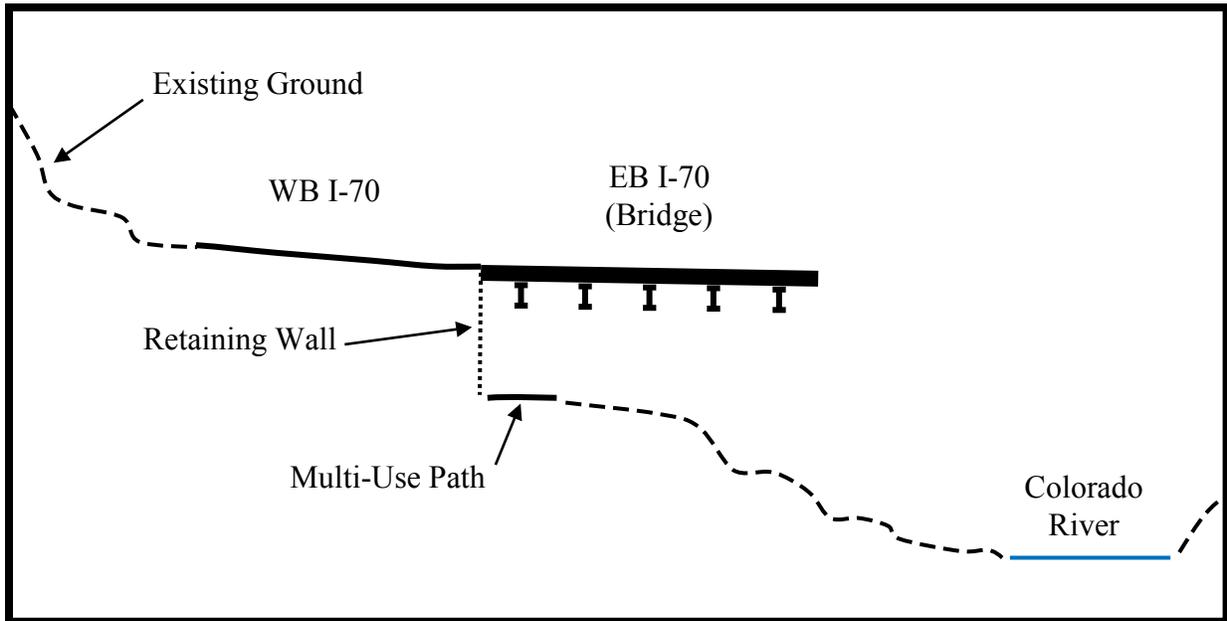
Figure 2 – Typical I-70 cross section at study site

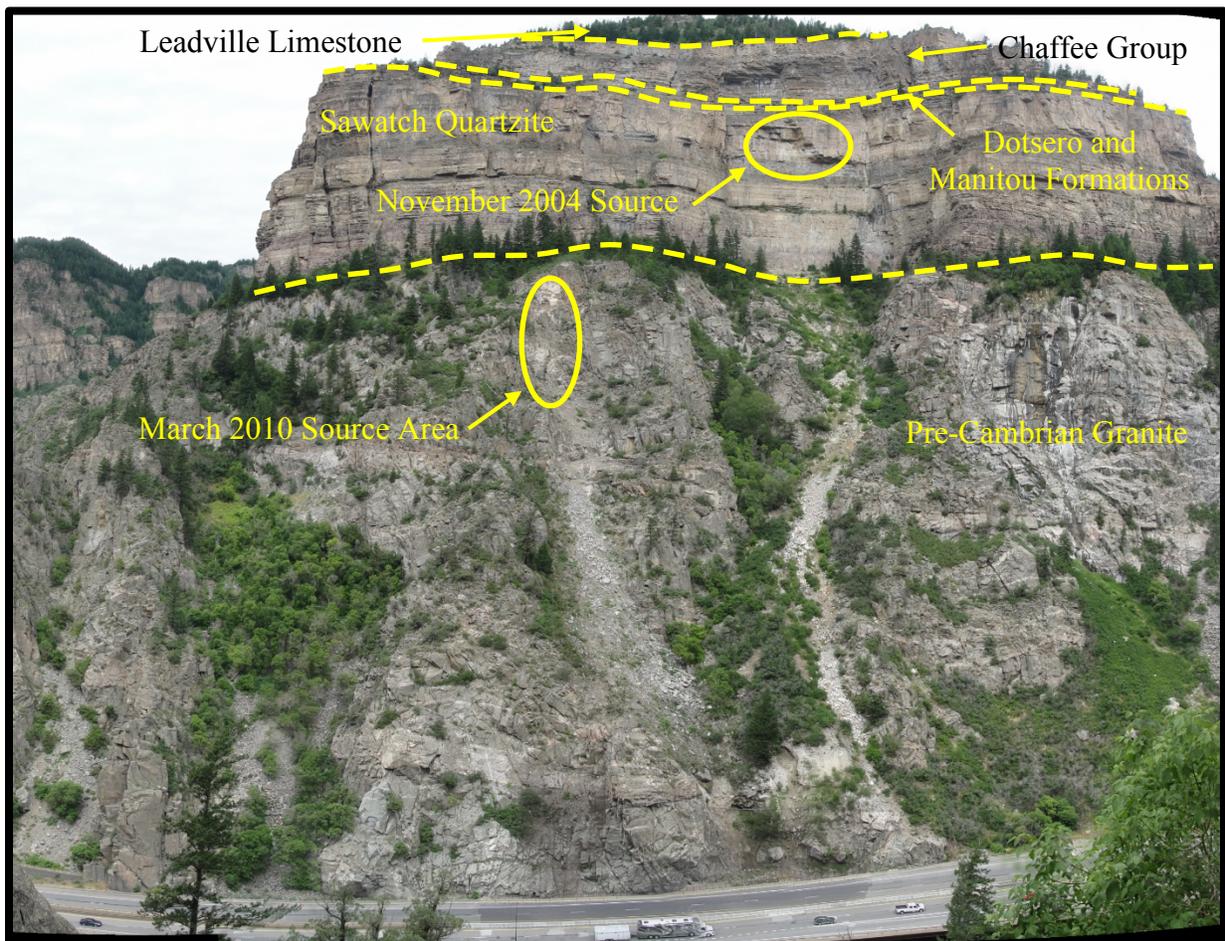
**Figure 3 – Photograph illustrating approximate geological unit contacts and rockfall source areas**

Above the Sawatch Quartzite is the Upper Cambrian Dotsero Formation which consists of sandy dolomite, dolomitic sandstone, and limestone. The Lower Ordovician Manitou Formation (472 to 488 Ma) overlies the Dotsero Formation and is composed of limestone conglomerate, dolomite, and calcareous shale. Above the Manitou Formation is the Upper Devonian age Chaffee Group (359 to 385 Ma) consisting of quartzite, shale, dolomite, limestone, and sandstone. The slopes above the cliffs are composed of Mississippian Age (318 to 359 Ma) Leadville Limestone. Figure 3 illustrates the approximate contact locations for the geologic units present at the site.

In November of 2004, rocks originating from approximately 1,150 feet above the highway in an overhanging section of the Sawatch Quartzite (Figure 3) impacted the highway. The largest rock was approximately 15 feet across. Several holes were punched in the eastbound bridge deck with the largest hole being approximately 20 feet wide by 15 feet long. The highway was closed for one and a half days to allow for rock scaling and bridge deck repairs were completed in about two months.

In March 2010, 3 to 10-foot diameter rocks originating from the Pre-Cambrian Granite approximately 500 feet above the highway (Figure 3) impacted the roadway (Figure 4). Again, several large holes were punched in the eastbound bridge deck (Figure 5). The highway was closed for four days following this event to allow for scaling and stabilization work. Bridge deck repairs were completed within about two months.

The rockfall trajectories reported for spherical rocks in CRSP-3D and RAMMS are illustrated in Figure 6 using the rock velocity plots output from each program. Both models show that the majority of rocks follow a well-defined pathway downslope. This talus covered pathway is apparent in Figure 3. Both programs also show a small number of rocks that leave the well-defined pathway and traverse downslope towards the highway. This pathway is not well-defined but topographic data shows a shallow depression that rocks could potentially follow downslope.

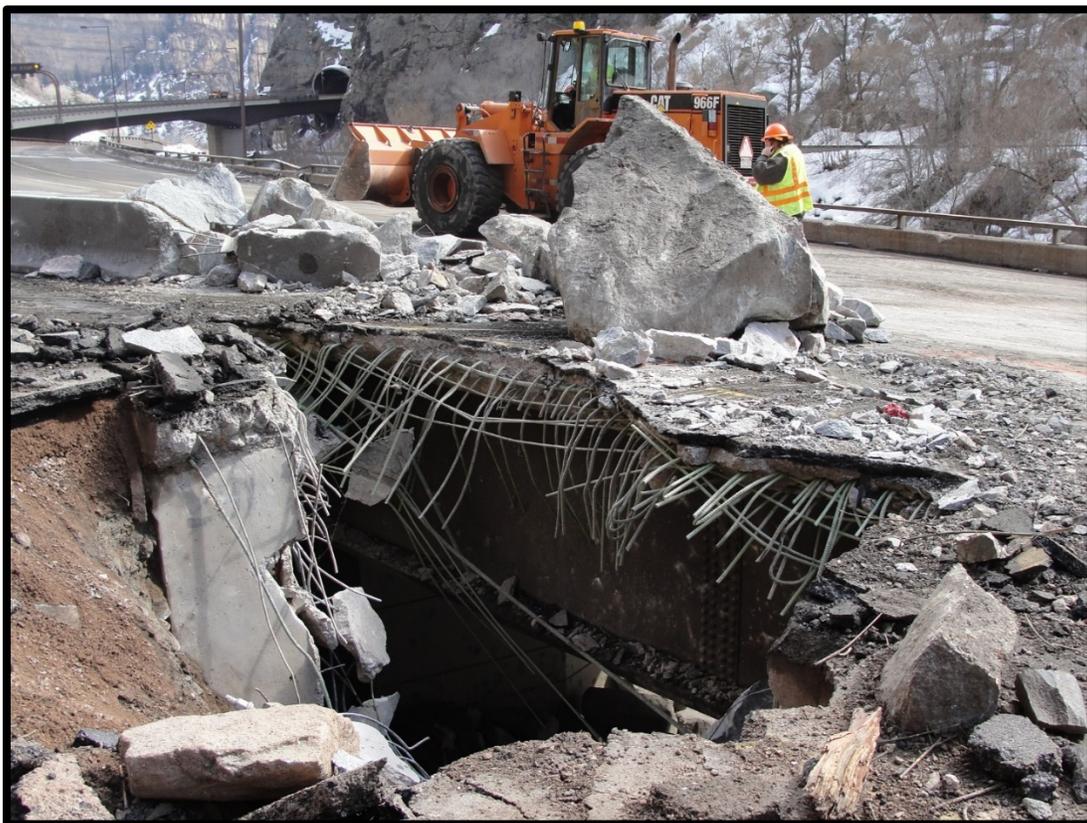
**Figure 4 – Large hole punched in the I-70 EB bridge deck by the March 2010 rockfall event**

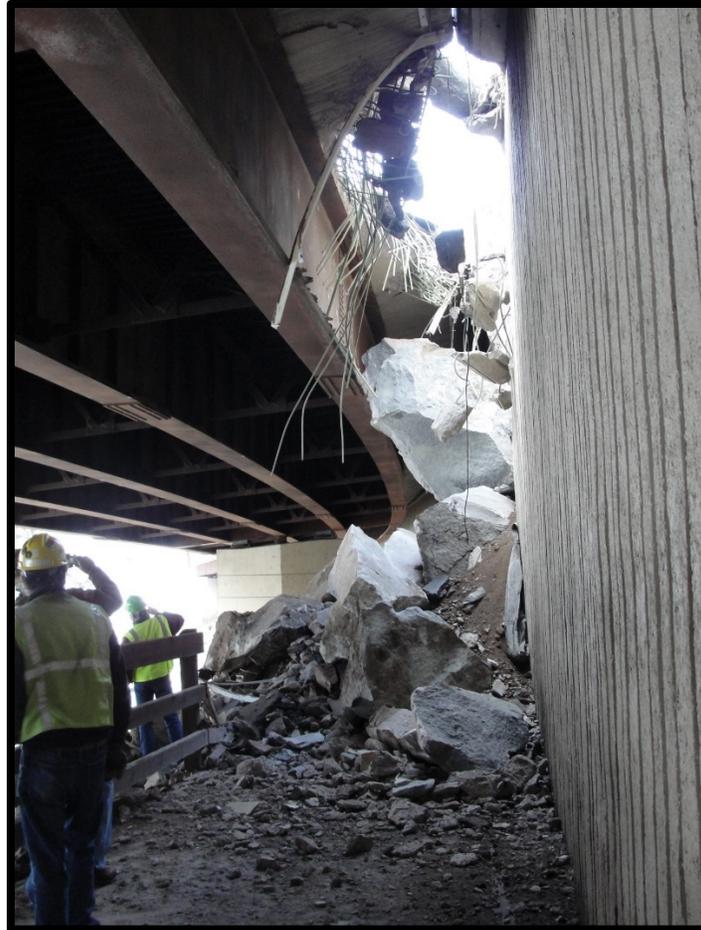
**Figure 5 – Rockfall debris accumulated on the multi-use trail beneath a large hole punched in the bridge deck**

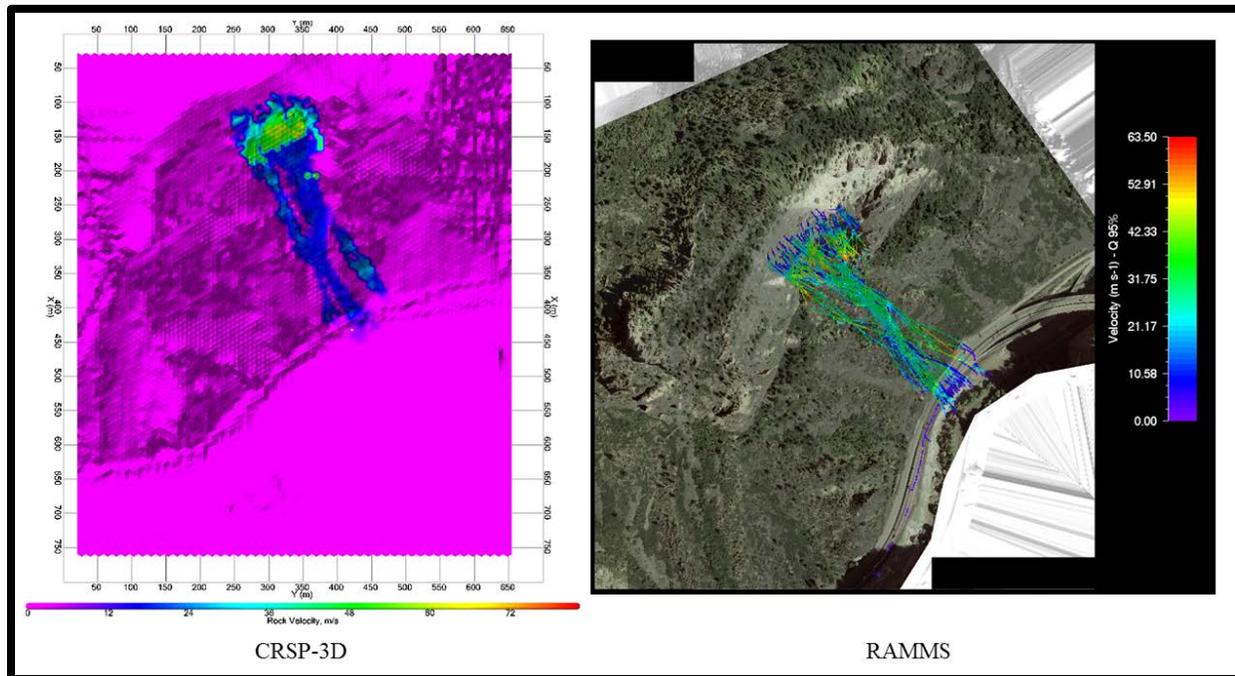
**Figure 6 – CRSP-3D and RAMMS rockfall trajectories for spherical rocks**

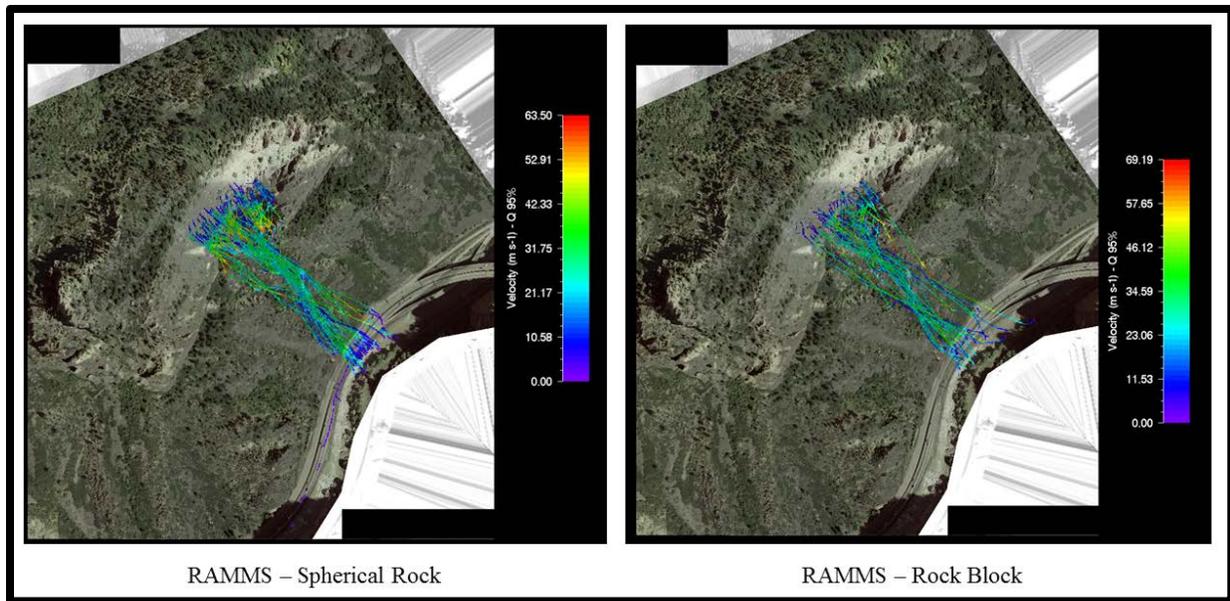
**Figure 7 – RAMMS rockfall trajectories for spherical rocks and rock blocks**

The rockfall trajectories for spherical rocks and rock blocks output from RAMMS are illustrated in Figure 7. The trajectories are similar in that the majority of rocks follow the well-defined pathway but there is slightly more disperse of the rock blocks than the spherical rocks. As with the spherical rock trajectories in CRSP-3D and RAMMS, a small number of rock blocks modeled in RAMMS follow the undefined pathway.

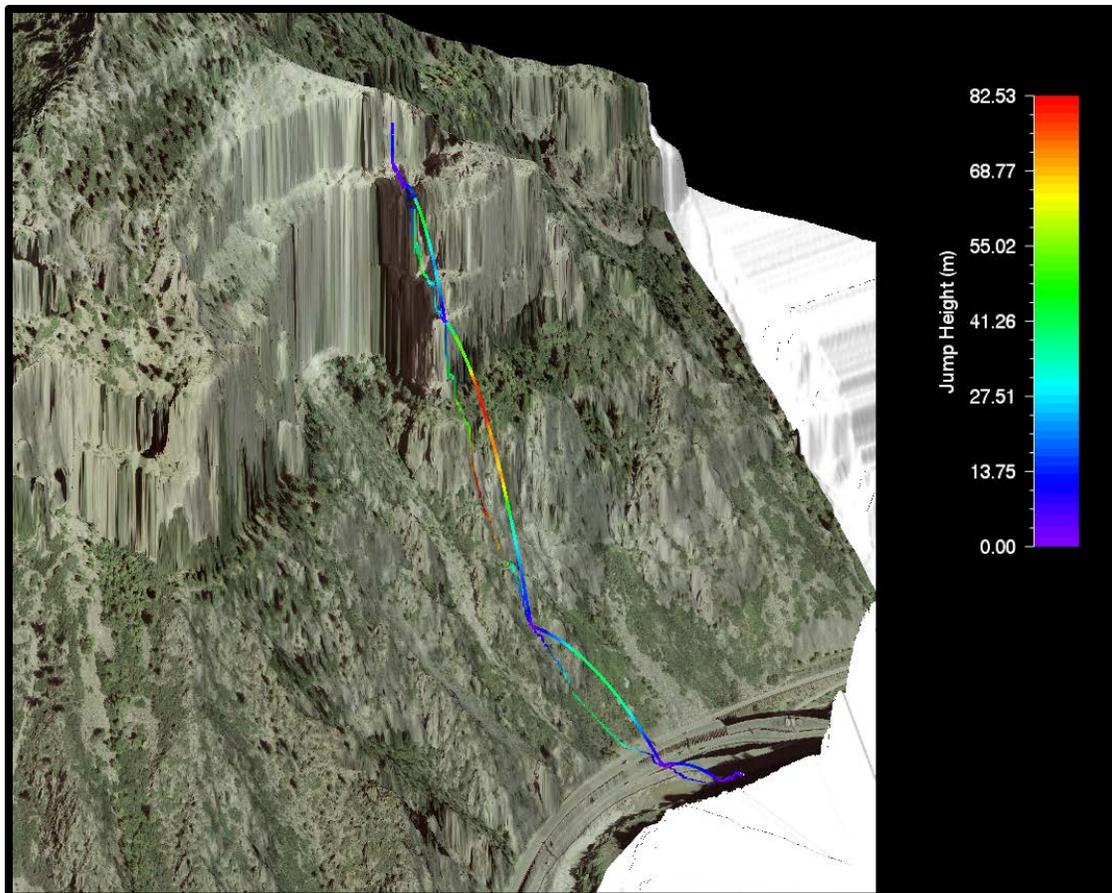
**Figure 8 – Single rock modeled in RAMMS with significant bounce height and free-fall distance**

The significant variation in the maximum velocity, energy, and bounce height reported by RAMMS compared to the CRSP programs appears to be a single rock that launches over the

majority of the slope and is in free-fall for a significant distance (Figure 8). This single rock also appears to skew the RAMMS results for average velocity and kinetic due to the relatively small number of rock blocks passing the analysis point. The presence of launching features that may not be captured in 2D modeling can have a significant effect on the modeling results.

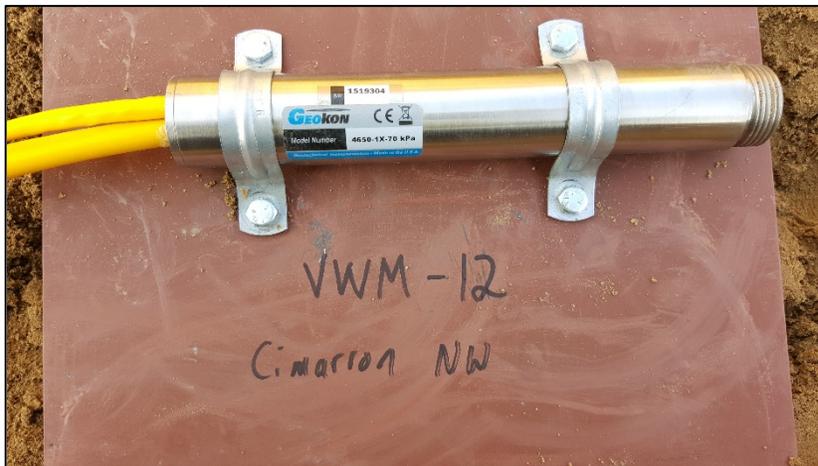
**Figure 1 – Typical VWM Transducer, Plate, and Tubing**

To measure the subgrade settlement beneath the new embankments, vibrating wire manometers were installed near the subgrade elevation. The instrument consists of a pressure transducer mounted on a small steel plate that measures the pressure difference between the buried sensor and an outside reservoir. Two fluid filled tubes connect the buried sensor to a reservoir located outside the settlement area. Figure 1 shows the typical VWM transducer, plate, and associated wires and tubes. The pressure is automatically recorded via a data logger installed within the reservoir housing. Settlement of the transducer and plate are calculated from the pressure difference from the initial pressure reading recorded during installation of the system. Automatic recording of the sensor pressure can be set at a desired frequency and are stored on the data logger and simply downloaded for weekly processing. The use of the data logger allows for easy data collection at regular intervals. This ability to collect and store data at relatively high frequency, made the VWM an ideal instrument to be placed at critical areas identified in the pre-proposal phase. Critical areas include, large potential settlement areas, areas where time rate of settlement was a concern, or areas at critical structures such as bridge abutments.

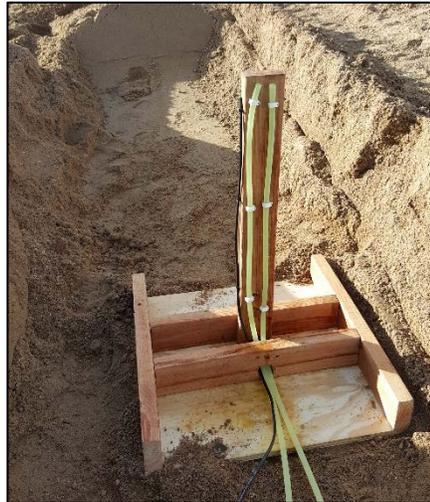
**Figure 2 – Typical MM Sensor End**

Similar to the VWM, manual manometers were also used on the projects to measure the subgrade settlement. The manual manometer consists of a simple U-tube manometer, with one end placed beneath the fill and the second end located outside the fill. Figure 2 shows the typical sensor end of the MM that is buried within the fill. The fluid level at either end of the manometer adjusts as the height of either end of the manometer changes. This direct measurement of the height at either end of the manometer allows for direct measurement of subgrade settlement when one end is placed beneath the embankment fill. In our application, one end of the

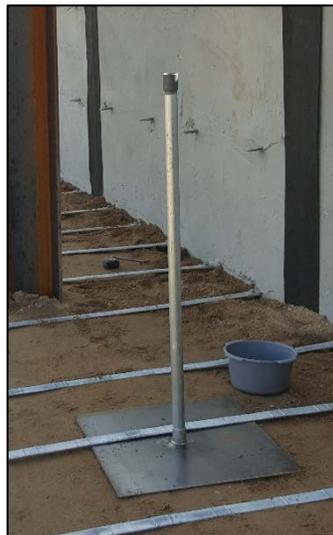
### Figure 3 – Typical Settlement Plate

Settlement plates are standard settlement monitoring instruments that have been widely used to measure settlement. The settlement plate is simple, cheap, and quick to install. Consisting of a 24-inch square steel plate with a 2-1/4 inch steel pipe welded orthogonal to the plate, as shown in Figure 3. The plate is placed at the desired location and the top of the steel pipe is surveyed. As the plate settles the elevation of the protruding pipe changes in elevation. Periodic surveys are taken to record the elevation change of the protruding pipe and corresponding plate. As fill is placed the steel pipe must be extended, additional pipe sections are connected with threaded couplings. For our application, settlement plates were installed near the mid-height of the embankment or at the subgrade elevation in areas with a relatively low embankment height.

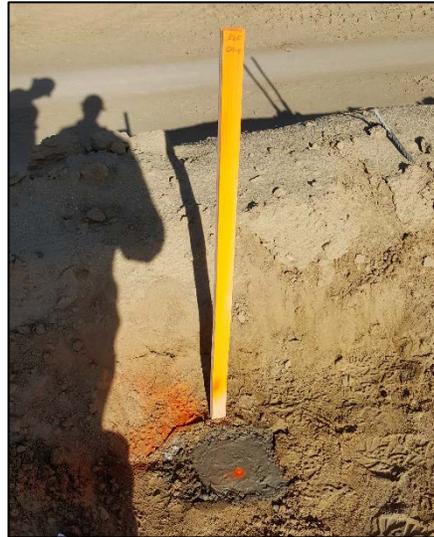
Figure 4 – Typical Survey Monument

The final instruments used on the projects were survey monuments (SM). The monuments consist of a single piece of steel rebar buried and encased in concrete, placed at the surface of the embankment. Figure 4 shows the typical survey monument used on the project. The monument is periodically surveyed to measure and record the elevation difference between successive measurements. Survey monuments were installed at the top of the embankment and used in conjunction with instruments installed at the subgrade, to ensure that the newly placed fill material was not settling.

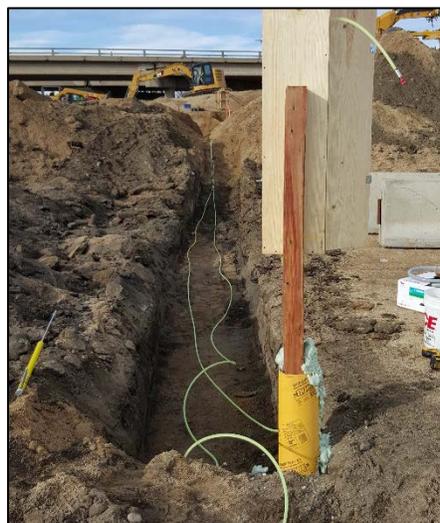
### **Figure 5 – MM Trench and Installation of Fluid Lines**

The manual manometers required the most labor to install, about 10 to 16 labor hours in the field for installation. The location must be determined, excavations completed for the sensor area, and trench line excavated from the sensor to the readout box. Typical distance from the sensor to the readout box was about 100 to 200 feet. Figure 5 shows the typical excavated trench and installation of MM fluid lines. After the excavations were complete, the tubing was installed and the readout box mounted on the readout post. Following the installation, and prior to backfilling, the system and lines must be tested and verified. The manual manometers require field staff to read and record the fluid level in the tubes once a week, labor hours are about ½ an hour a week for each unit installed on the project and an additional ½ an hour per week is also required for data reduction, analysis and reporting.

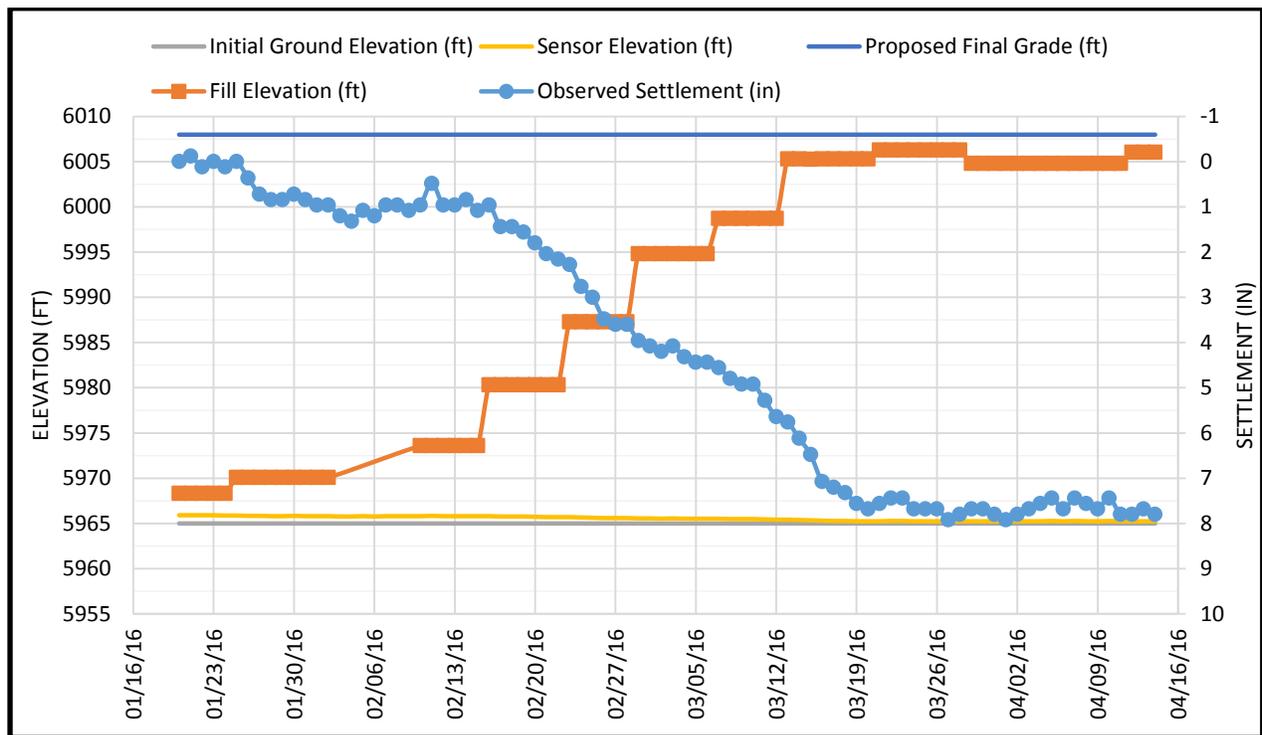
**Figure 6 – Observed Settlement of VWM installed at Subgrade Elevation**

During analysis of the data, we had to keep in mind the overall goal of the settlement programs was to determine if primary settlement was complete. With this in mind, the variations in the data attributed to “noise”, did not have a significant impact on the final conclusions of the data. Analysis of the data showed the general trend of the rate of settlement, and this was the final determination in deciding whether or not settlement was complete. Figure 6, shows an example of the settlement results collected with a VWM showing a very clear trend line.

From the data you can see the specific amount of settlement is difficult to determine within a  $\frac{1}{2}$  inch or so, however it is very clear that the rate of settlement is near zero. The installation of the instruments after placement of fill materials also made it very difficult to determine the total amount of settlement. The instruments measured settlement since installation, which in some cases, was near mid-height of the embankment. In these cases, the instruments were not installed prior to the application of the initial load. Without measuring the settlement due to the initial load, it was very difficult to determine the amount of total settlement experienced. Given that some amount of settlement was not observed, we were still able to show the rate of settlement and from the trend line determine if settlement was complete. Figure 7, shows the settlement curve for an area with similar amount of fill placed as Figure 6. The total settlement in these two areas were calculated/expected to be similar in magnitude. However, the total settlement observed in the instruments vary significantly, this is due to the installation location with regard to fill height. In Figure 7, the rate of settlement clearly trends toward zero, even though the amount of total settlement is much less.
