HGS 2016  
Proceedings

# 67TH HIGHWAY GEOLOGY SYMPOSIUM

## JULY 11 – 14, 2016

Cheyenne Mountain Resort  
COLORADO SPRINGS, COLORADO

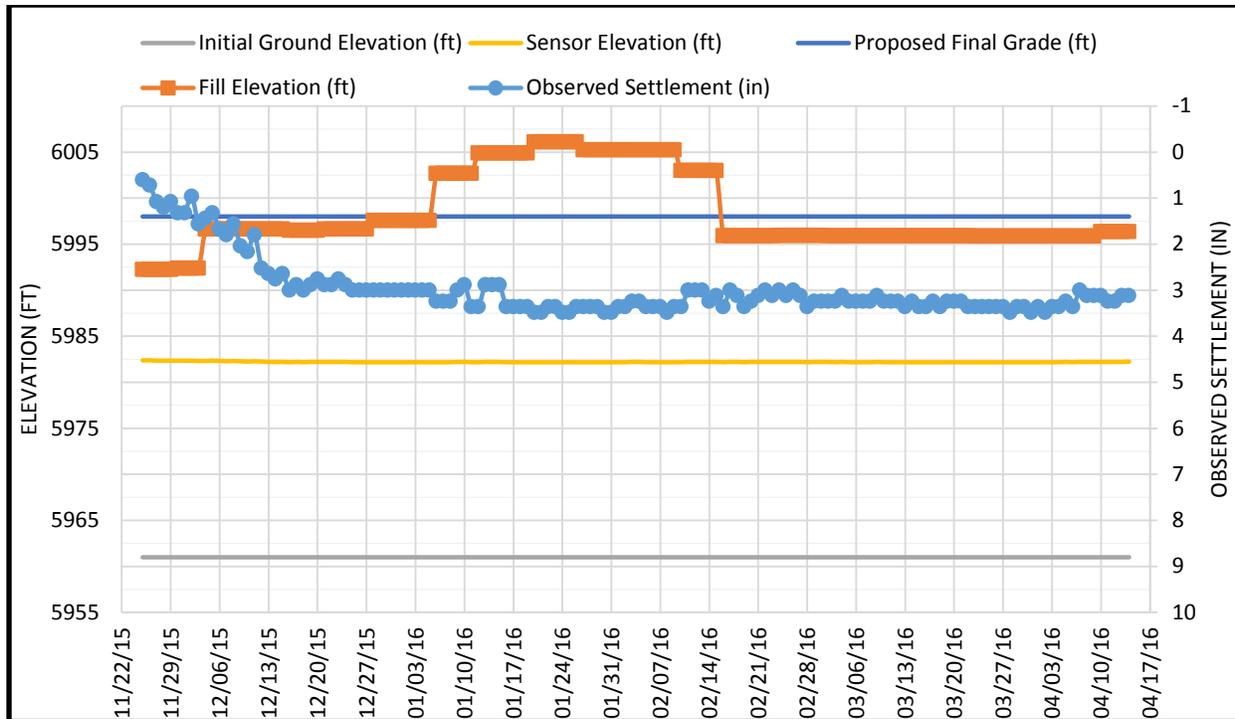
**Figure 7 – Observed Settlement of VWM installed at Mid-Height of Embankment**

From the data you can see the specific amount of settlement is difficult to determine within a  $\frac{1}{2}$  inch or so, however it is very clear that the rate of settlement is near zero. The installation of the instruments after placement of fill materials also made it very difficult to determine the total amount of settlement. The instruments measured settlement since installation, which in some cases, was near mid-height of the embankment. In these cases, the instruments were not installed prior to the application of the initial load. Without measuring the settlement due to the initial load, it was very difficult to determine the amount of total settlement experienced. Given that some amount of settlement was not observed, we were still able to show the rate of settlement and from the trend line determine if settlement was complete. Figure 7, shows the settlement curve for an area with similar amount of fill placed as Figure 6. The total settlement in these two areas were calculated/expected to be similar in magnitude. However, the total settlement observed in the instruments vary significantly, this is due to the installation location with regard to fill height. In Figure 7, the rate of settlement clearly trends toward zero, even though the amount of total settlement is much less.

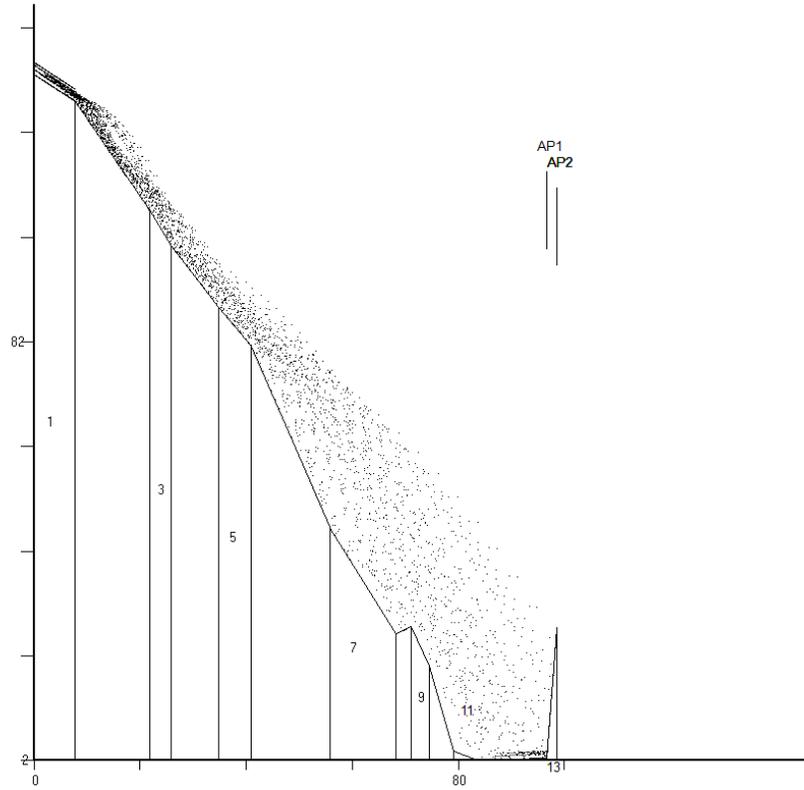
**Figure 1 – Example of output from a 2D CRSP rockfall simulation**

generate two-dimensional rockfall trajectories along cross-sections of interest as shown in Figure 1. Although utilized less frequently here in the U.S., three-dimensional rockfall modeling software can be used, the likes of Hy-Stone and RAMMS, both of which rely on digital elevation models for development of trajectories.

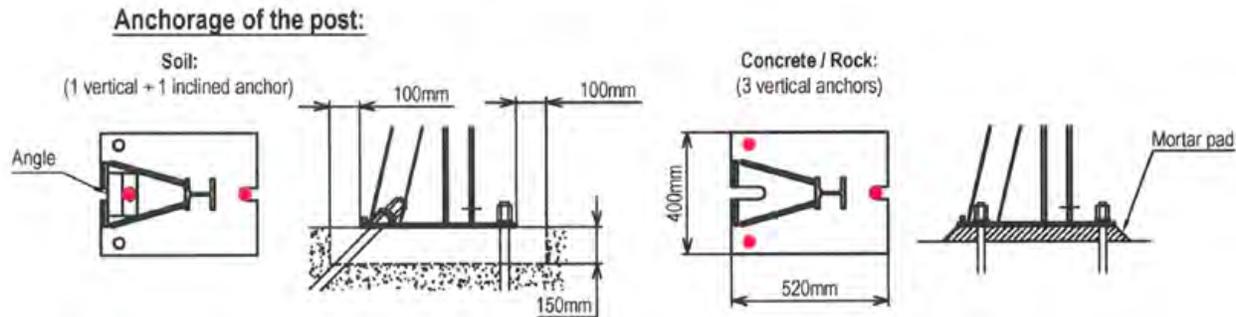
**Figure 2 – Foundation anchorage options for T-35 barrier.  
Image adapted from GeoBrugg Std. Dwg. GS-11393.1e (3)**

The T-35 barrier is a relatively simple low energy barrier, consisting of steel posts, upper and lower support ropes, and Tecco G65/3 mm netting spanning approximately 8 m (26 ft.) between each post (2). Posts can be “direct embedded” or attached to a base plate and bolted to the concrete or bedrock foundation. Based on initial geotechnical information, the upslope T-35 barrier was initially intended to be bolted to the bedrock using a two or three bolt arrangement as shown below in Figure 2.

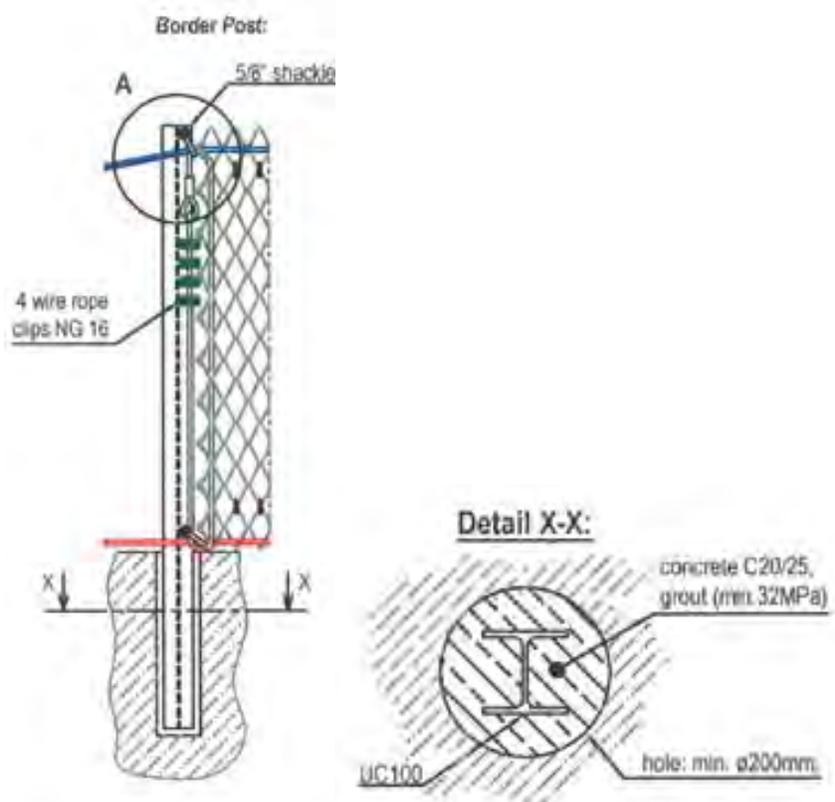
**Figures 3 and 4 – Showing direct column embedment in soil for T-35 barrier  
Image adapted from GeoBrugg Std. Dwg. GS-10869.1e (4)**

Refined location-specific geotechnical data collected during construction indicated that significant clayey soil thicknesses were present. It was subsequently decided that there would be a significant amount of surface preparation and grading required for the bolted foundation option. As a result, the direct embedment option was chosen instead, whereby the “tail” end of the post is embedded within a drill hole and backfilled with neat cement grout. A graphic depicting the direct embedment approach is shown below as Figures 3 and 4.

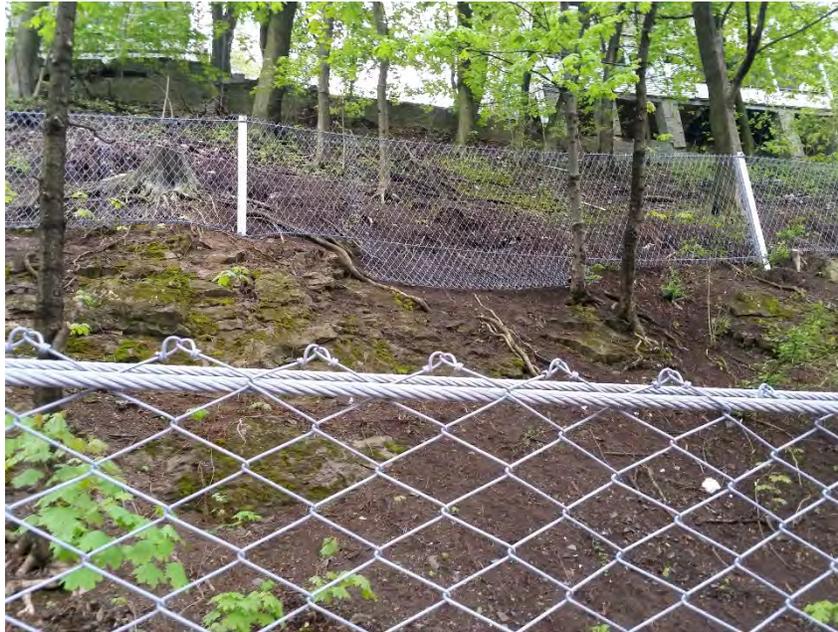
**Figure 5 – Photo of completed T-35 upslope barrier, with GBE-500 in foreground. (Photo courtesy of Merco, Inc.)**

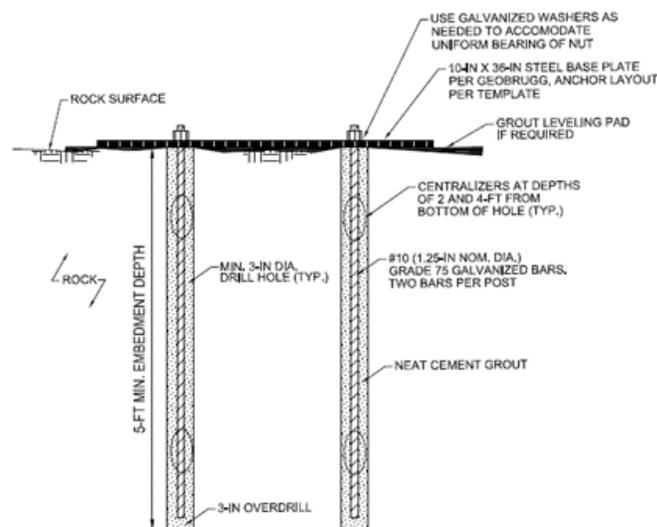
**Figure 6 – Direct bolting to bedrock detail for GBE-500 A-R rockfall barrier posts**

The GBE-500 A-R was installed adjacent to the roadway, and post concrete bearing pads were constructed through upwards of 3.5 ft. of mixed fill and fractured bedrock. In instances where rock was at-grade, minor surface preparation was required to provide a relatively level bearing pad for post base plate placement and drilling of two vertical anchorage elements, as shown in Figure 6.

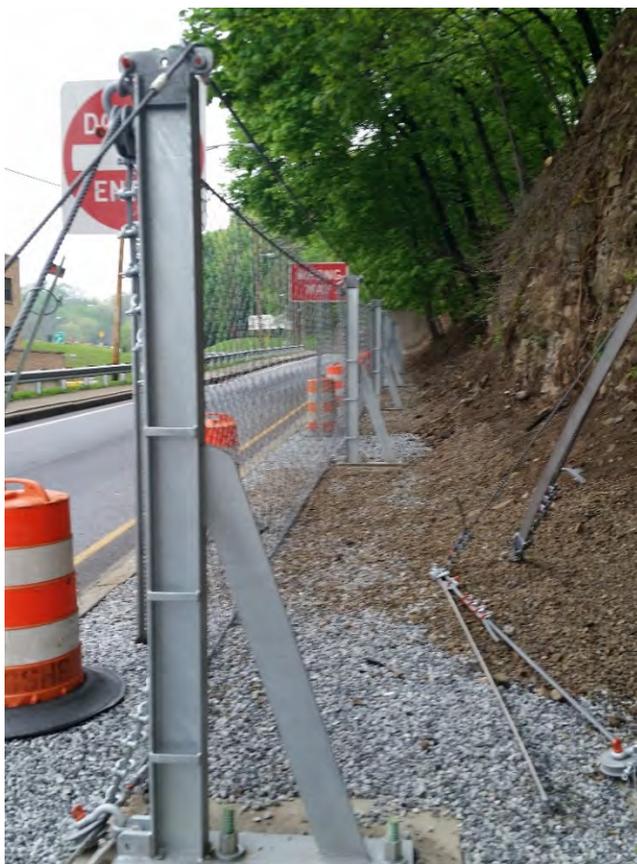
**Figure 7 – Photo of completed GBE-500 A-R rockfall barrier (Photo courtesy of Merco, Inc.)**

Two 1.25-in. diameter (#10) grade 75 passive rock reinforcement elements were installed through the bedrock (or through the concrete pad) and embedded a minimum of 5 ft. in competent bedrock. Anchor forces were derived from manufacturer information for the barrier system (6, 7). A photo of the completed GBE-500 barrier system is shown as Figure 7 below.

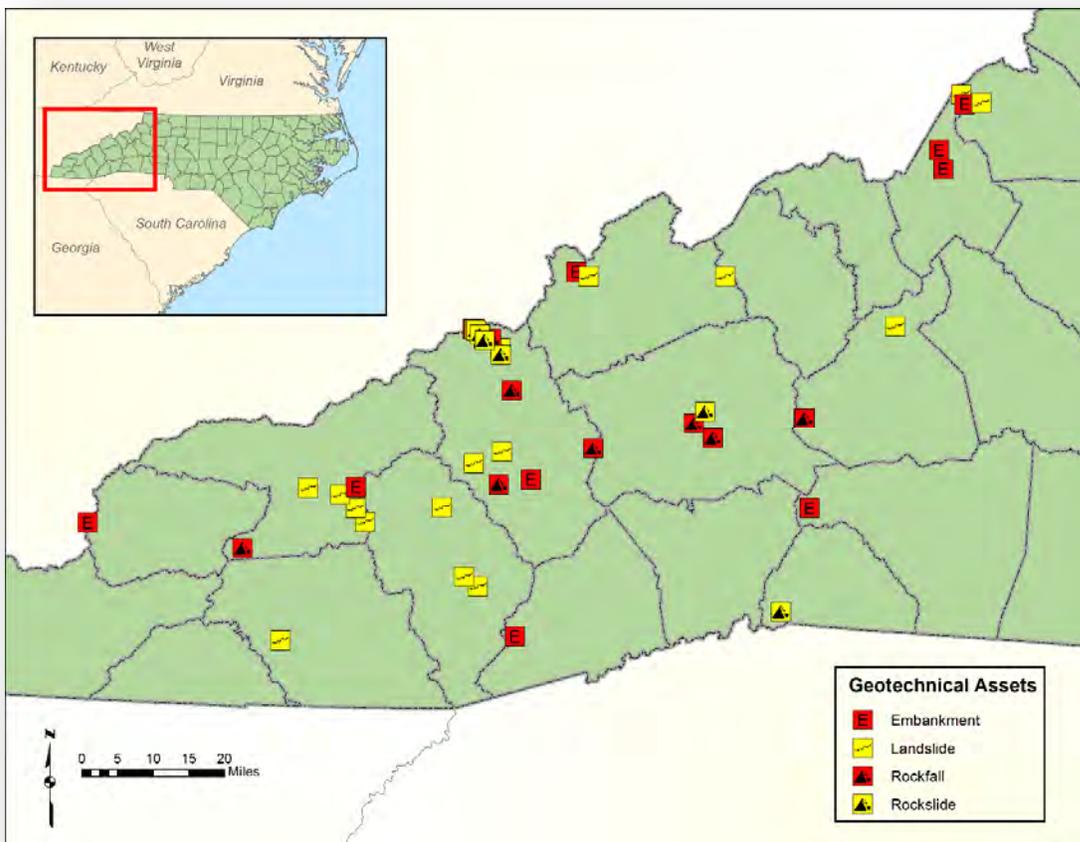
**Figure 1: Initial GAM Assets Documented for Rating Development in the WRO project area.**

NCDOT Geotechnical Engineering Unit - Western Regional Office (WRO) is responsible for all GAM assets located west of Winston-Salem, NC and to the Tennessee border (Figure 1).

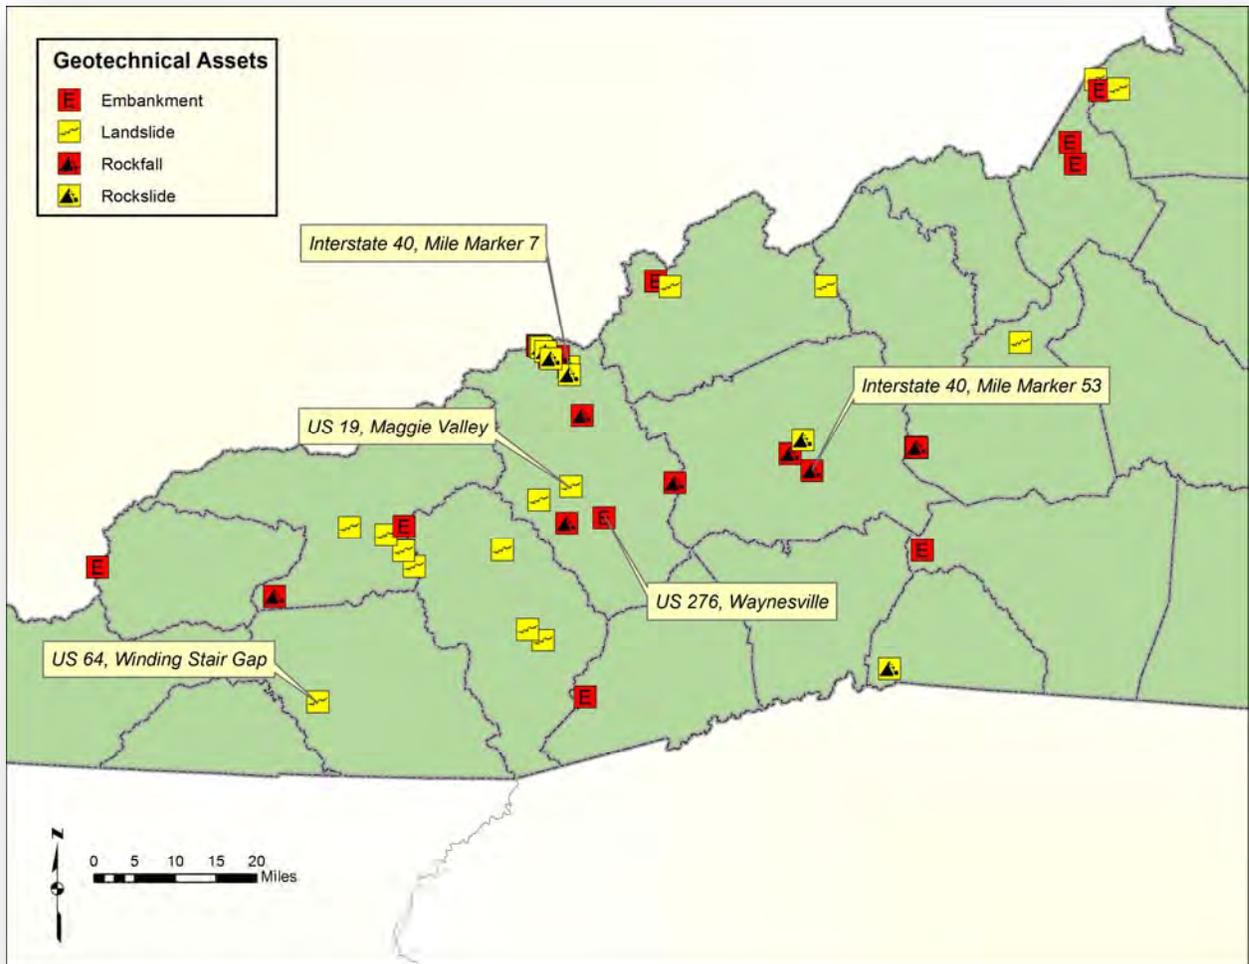
Figure 12: Map of Initial Data Capture and Rating, Western NC

For the purposes of this investigation, 5 GAM assets were hand-picked to develop the Rating System (Figure 12).

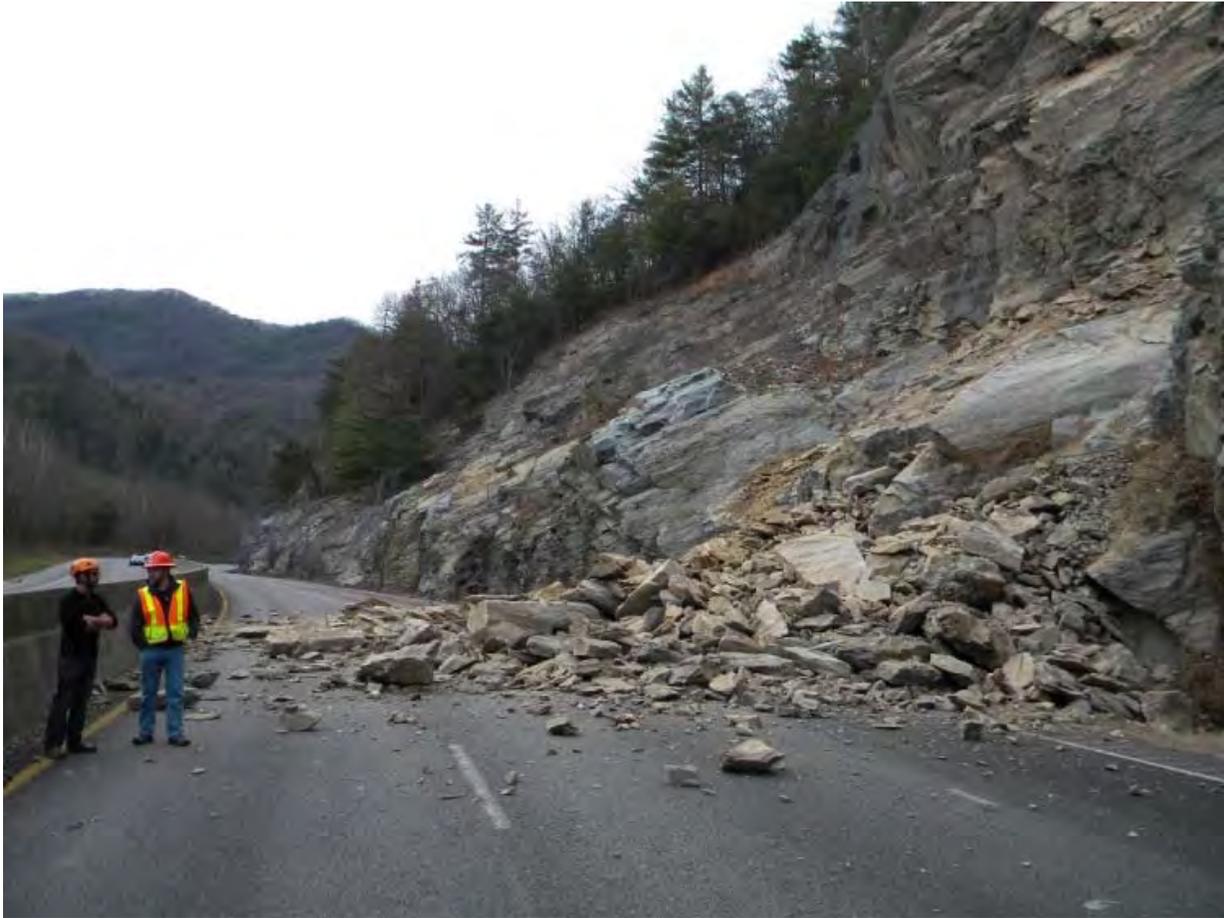
**Figure 13: Rockslide along Interstate 40 at Mile Marker 7.**

The rockfalls along Interstate 40 at Mile Marker 7 provides the basis for modelling rock slide ratings (Figure 13). It has failed several times and blocked half the roadway, has undergone regular scaling and maintenance, and had control measures installed but not a complete engineered mitigation. It underwent complete design and reconstruction in 2016. This takes the emphasis from slope failure, which NCDOT anticipates, to overall performance of the slope as it relates to the highway.

The original rating was 1814.45. The rating after reconstruction is 102.78. The mitigation reduction factor of 0.2 brings the score down to the base value of the Route Type, essentially a benign rating that maintains the record in the database.

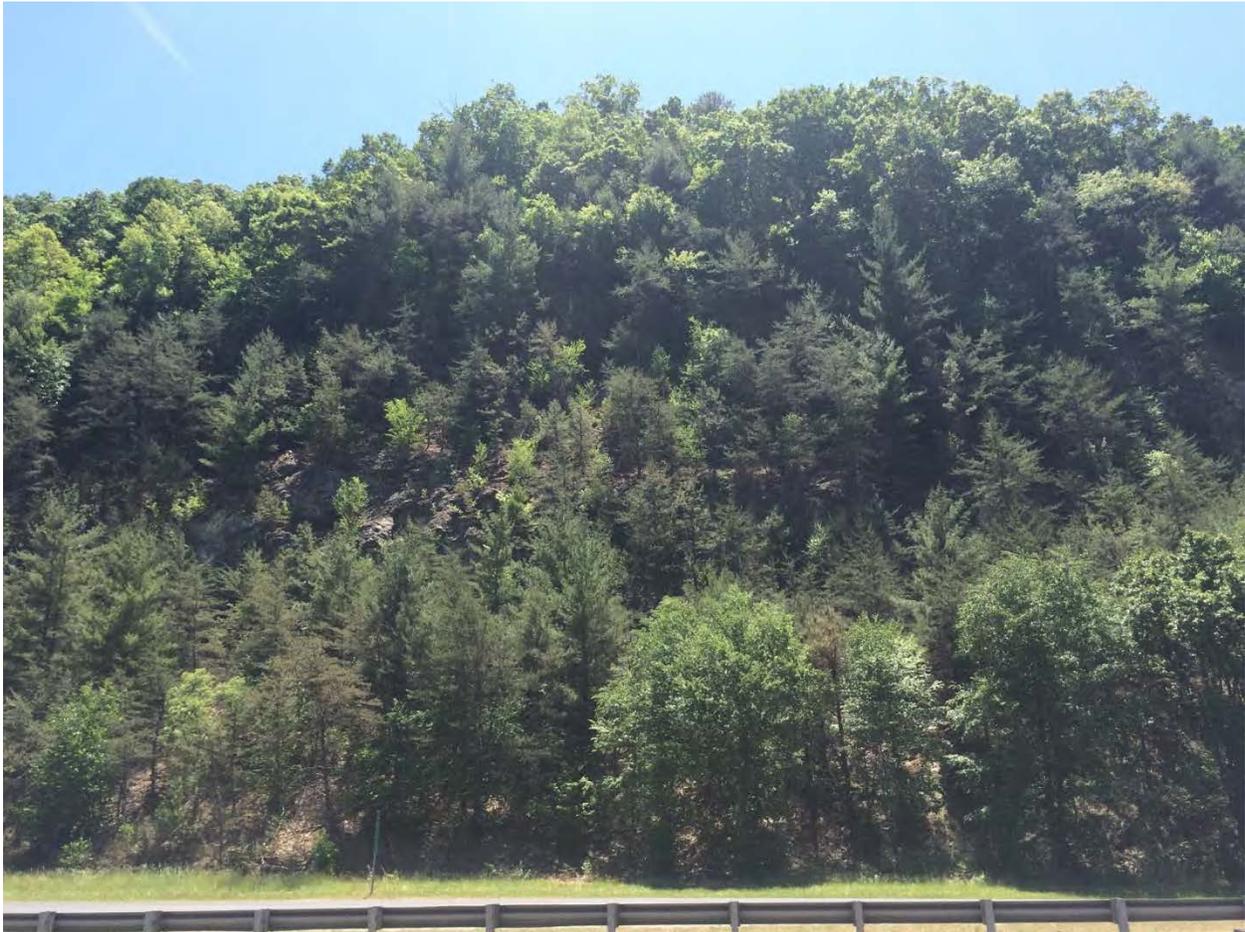
**Figure 14: Example of control slope along Interstate 40 at Mile Marker 53.**

Figure 14 is a slope located on Interstate 40 at Mile Marker 53. This slope is included in the initial ratings as a control to study several of the categories other than highway blockage. It is 200 ft high, raveling, continuous groundwater seepage, mature root growth, Interstate, high ADT, but no maintenance incidents, notable failures or other repair in over 50 years. The rating is 179.37.

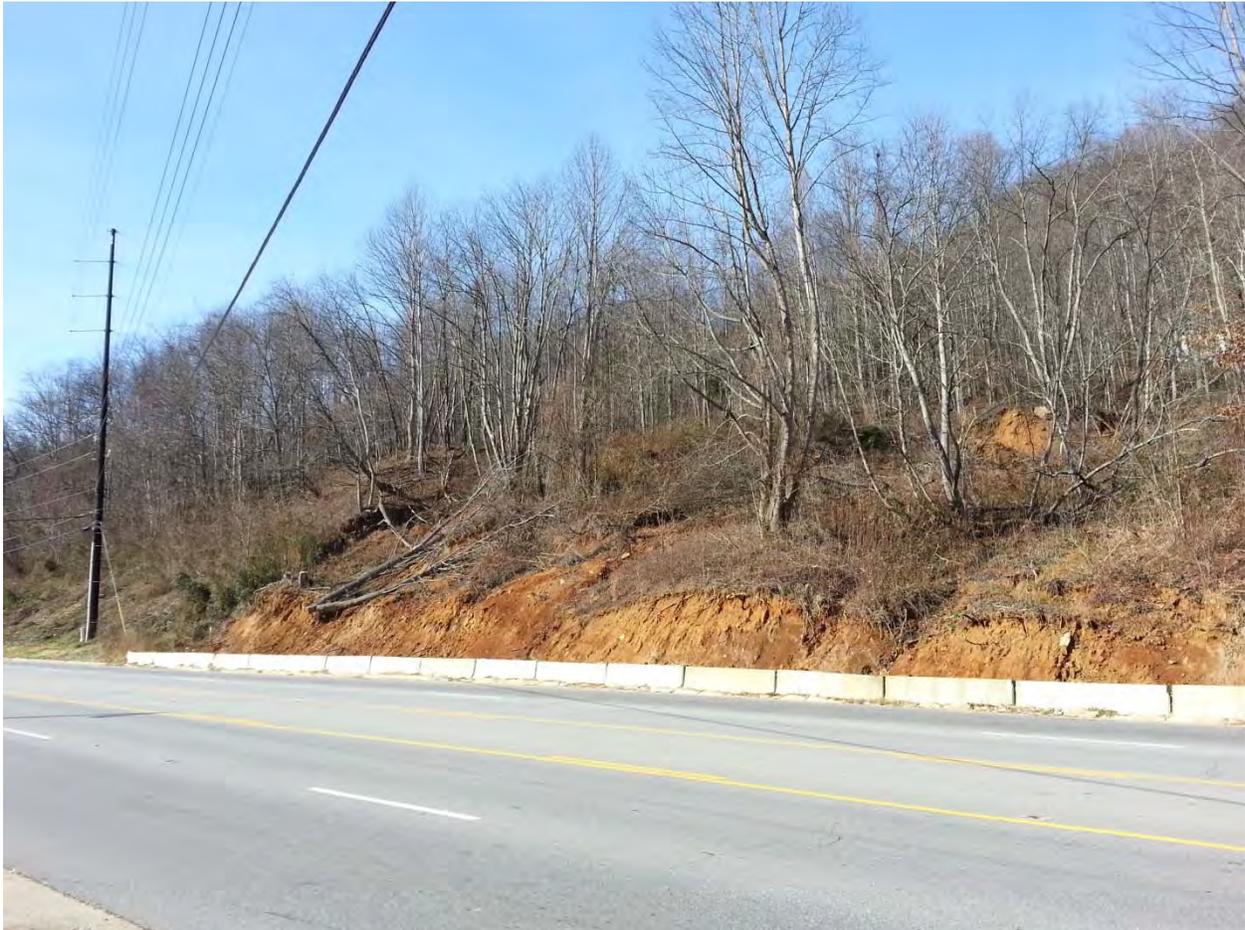
**Figure 15: Slow-moving landslide located in Maggie Valley, NC along US 19.**

The site located in Maggie Valley, NC is a slow moving landslide with a very large volume (Figure 15). Maintenance includes removing approximately 50 yds<sup>3</sup> per year from the shoulder at the toe. Not practical to mitigate but also does not block travel lanes on this 5-lane highway. The low score reflects high LOS and maintenance scores versus the actual low impact of the failure progression: this is a large, high-volume, potentially high detour factor site that doesn't experience spontaneous and crippling lane closures. The rating is 380.68.

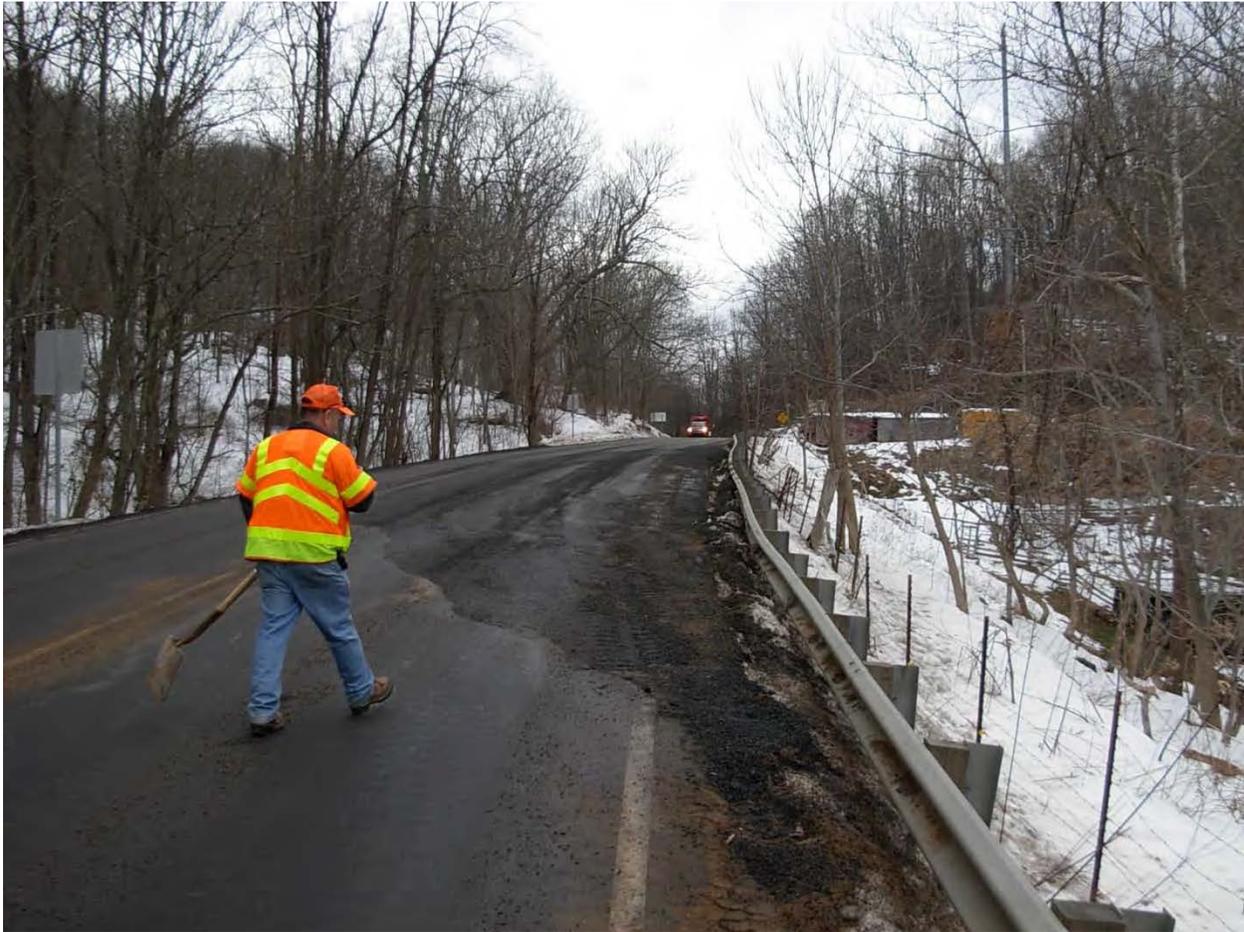
**Figure 16: Long-term embankment slump and lane drop on US 276, Waynesville, NC.**

This site was a saturated over-steepened embankment that required regular yearly maintenance for shoulder sloughing and pavement drop, resulting in a 10' thick buildup of asphalt (Figure 16). It was repaired by realignment and slope flattening. Although it was repaired before the GAM program it is used as a control to study embankments and detour factor. This was easily closed for repair because a tertiary loop is adjacent and the route is primary 2-lane commuter with low commercial traffic. The rating before stabilization was 872.26, after stabilization it is 134.19.

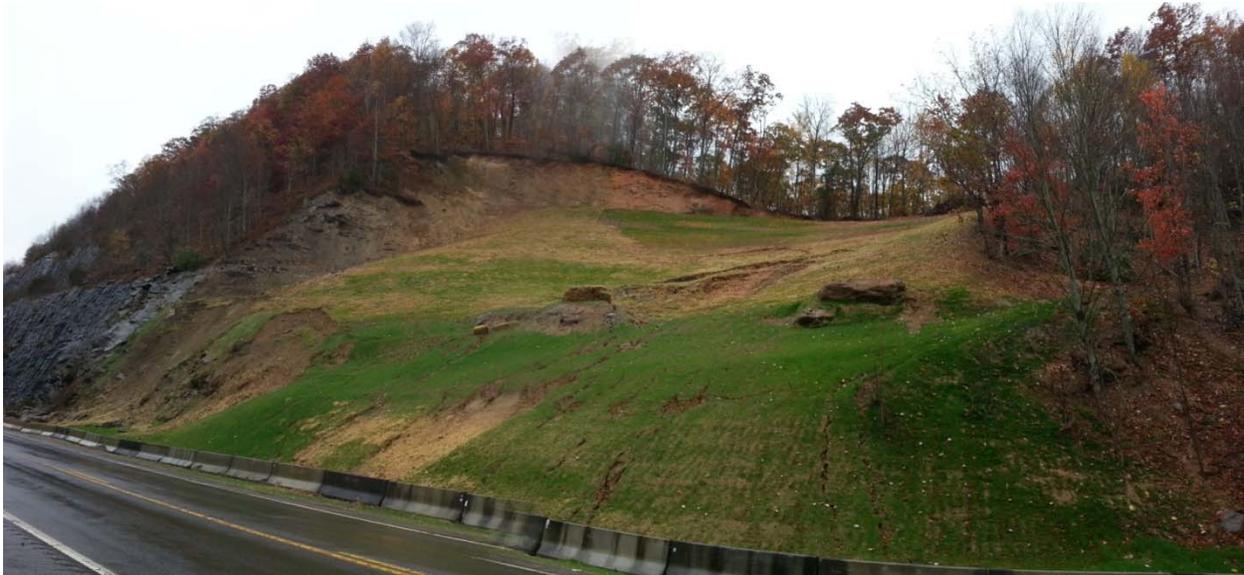
**Figure 17: Repeat Hybrid Slide, US 64, Macon County, NC**

The US 64 site was destabilized after a year of record rainfall in 2013 and despite being heavily mitigated in 1989 (Figure 17). A hybrid slide, it provides a case study for a large slow landslide which is decoupling from and undermining weathered rock and rock above, which then rolls into the roadway. There is groundwater and the route is a strategic 2 lane with high detour factor. It rates high for Failure Frequency (#8) and low for Maintenance Incidence (#10). After cleanup this slope still rates 793.08.

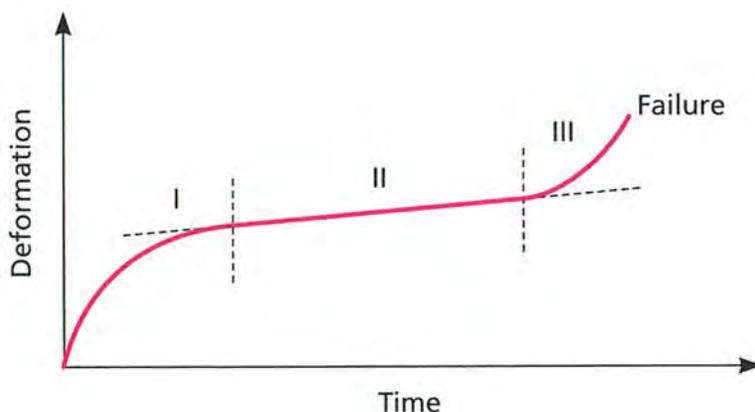
**Figure 1: Time dependent deformation curve [4]. Primary or transient creep (I) changes to secondary or steady state creep (II) as the initial stress conditions have been relieved. This phase can last a very short time or a very long time. As the material gets damaged over time it may enter the tertiary of accelerating creep phase (III) leading inevitably to catastrophic failure.**

Most landslides do not happen instantly. Often there is advanced warning of imminent catastrophic failure. Because of creep phenomenon (Figure 1) slow slip movement has a steady state phase during which the movement, although small, can be observed and recorded. Slides in critical areas are usually recognized during this phase. In those slopes that fail catastrophically, evidence of small movement is recognizable early on. Slides are often first identified by morphological features such as a small head scarp or tension crack at the top of the slide and small bulging at the toe (Figure 2). Additionally there may be indications of the lateral extent of the slide. The movement of the slope at this stage is small but measurable. On the Cruden and Varnes [3] timescale, slow means  $5 \times 10^{-3}$  mm/sec (17" per day) or less. (At this point there is still time to take remediating or mitigating actions.)

During the steady state creep phase (phase II in Figure 1) it is possible to identify the characteristics that determine the stability of the slope. Important characteristics include:

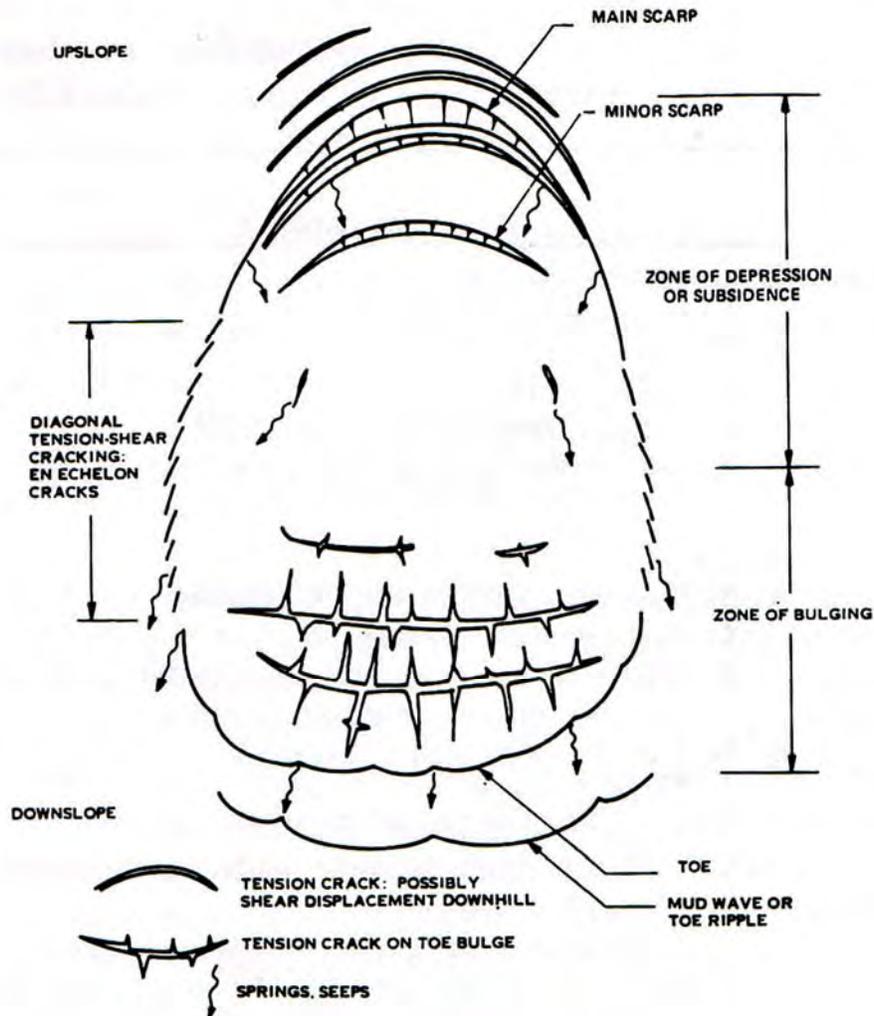
**Figure 2: Morphology of a landslide [5].** An active landslide may have some or all the features noted in this image, including scarps or lateral tension cracks at the head of the slide area, tension cracks and bulging at the toe, and shear cracks along the flanks of the slide.

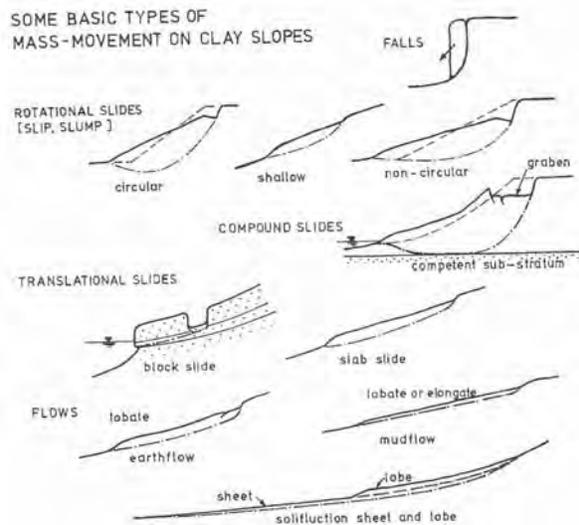
**Figure 3: Types of movements in clay slopes [6].**

Of all these parameters perhaps the most difficult to determine is the location of the slip surface. Figure 3 shows just how variable the single slip surface can be. Figure 4 shows that often there are multiple slip surfaces in a single composite slide. The knowledge of the morphology of the slip surface has significant consequences, including the major concern, the volume of material that may fail catastrophically. However, knowing the morphology of the slip surface also aids in determining the following:

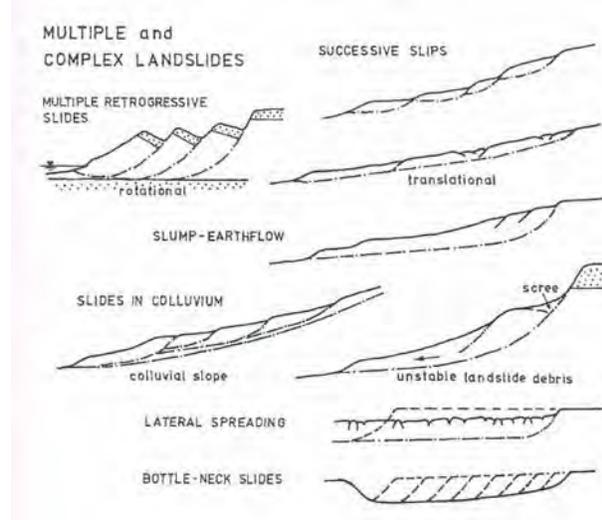
**Figure 4: Types of complex movements [6].**

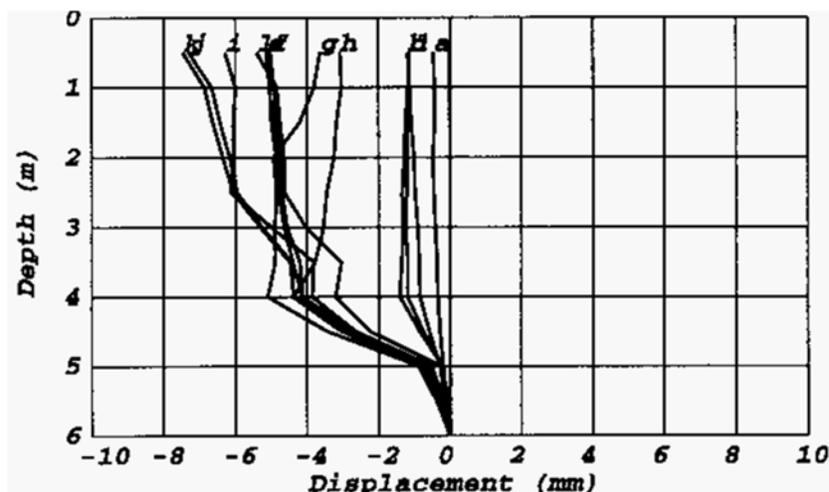
**Figure 5. Inclinometer vertical profile in a 6 m. vertical borehole. Profiles labeled a to k are inclinometer measurements at sequential times. This clearly indicates a slip plane at a depth of about 5 m.**

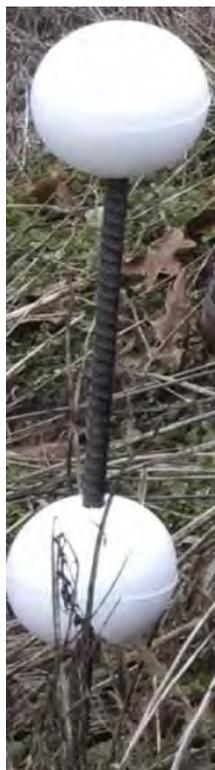
← **Figure 6: 12.7mm rebar driven into the ground with two 100 mm styrofoam balls.**

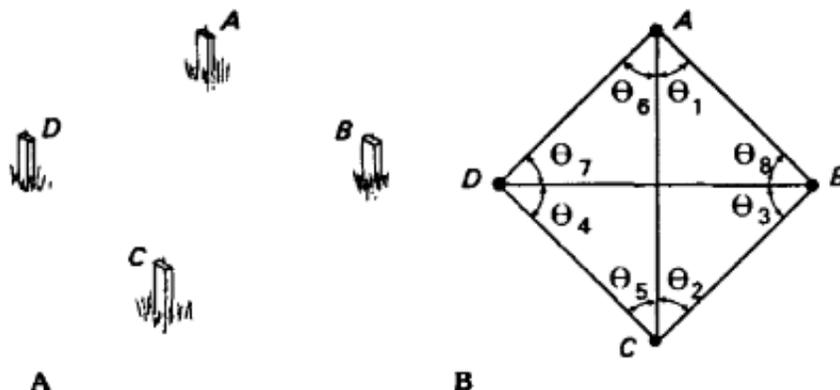
**Figure 7: In an old technique, quadrilaterals are stakes placed into the ground in a fixed pattern to allow manual measurement of surface deformation [13].**

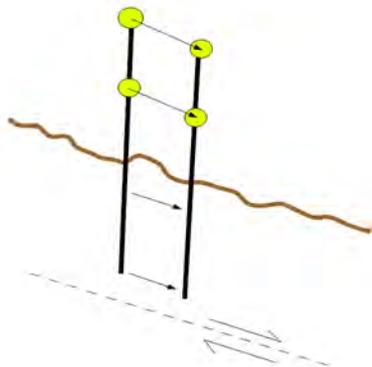
**Figure 8: Idealized movement of styrofoam balls above a planar slip surface, when the base of the rigid rod is above the shear surface.**

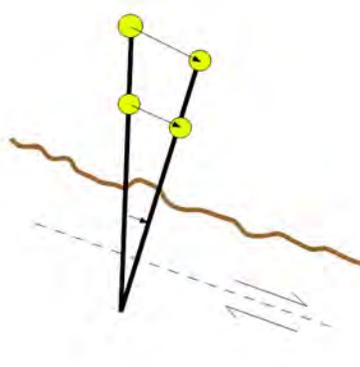
**Figure 9: Idealized movement of styrofoam balls above a planar slip surface, when the base of the rigid rod is below the shear surface.**

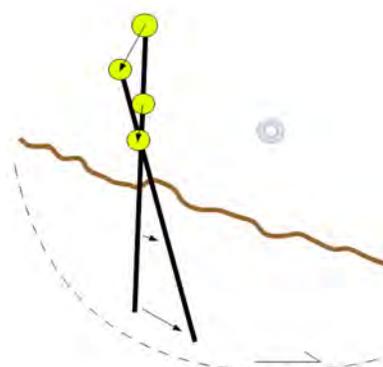
**Figure 10: Idealized movement of styrofoam balls above a circular slip surface, when the base of the rigid rod is above the shear surface.**

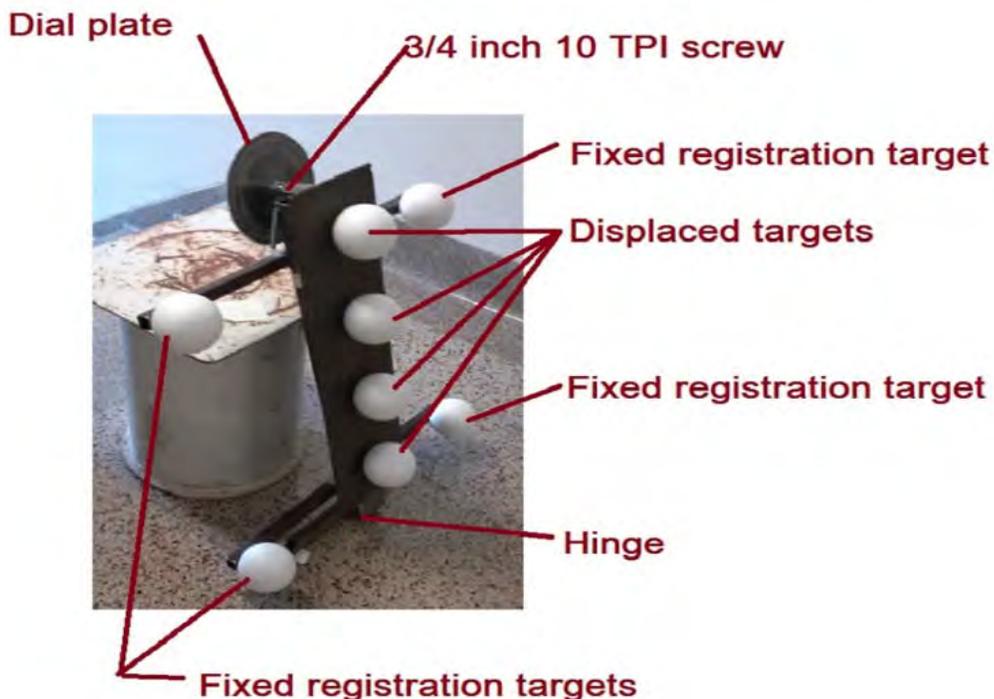
**Figure 11: Apparatus to create small displacements of the 4 target balls. Motion is produced by turning a dial plate connected to a 10 threads per in inch screen. The registration targets are stationary**

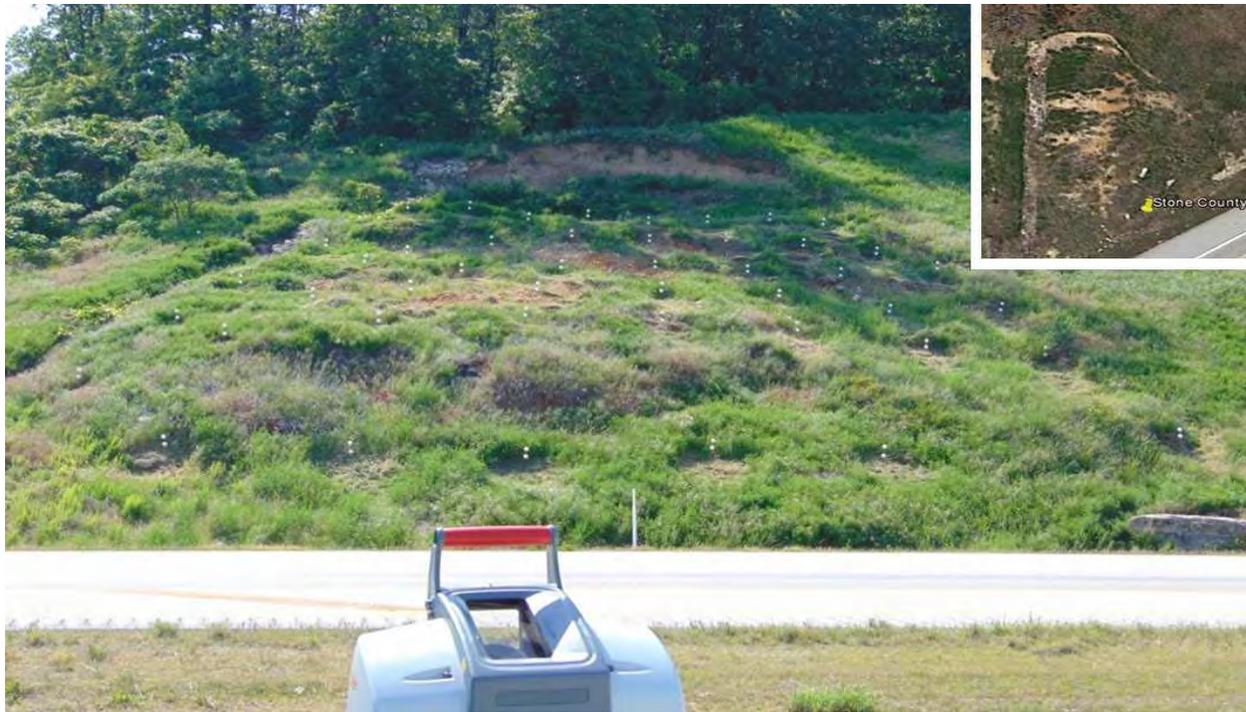
**Figure 12: Landslide on Highway 65 in Stone County Missouri, showing the layout of rods and target balls. Location inset from Google Earth.**

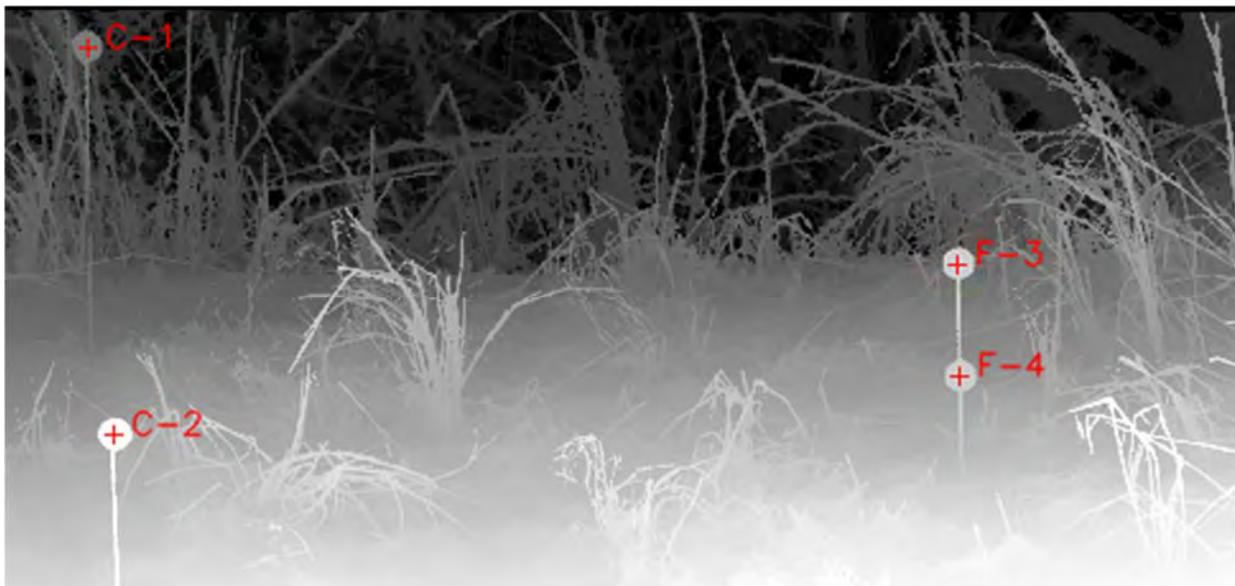
**Figure 13: LIDAR image showing target balls (F) and control balls (C).**

For this study, the landslide was scanned every 3-4 weeks over a period of several months. After each scan, the LiDAR point cloud was processed to identify each spherical target by its unique ID (Figure 13). At the beginning of the project, this step required a user to manually point to each spherical target and assign its established ID. Due to the fact that there were over 100 targets to identify, this manual process was tedious and error-prone. Later, a semi-automated process was developed where just four targets in the stable zone needed to be manually identified. Software was developed to apply the target IDs from the previous scan to the current scan by transforming the whole point cloud to the coordinate system of the previous scan. Because the displacement of each target between scans was relatively small (under 20 mm), this automated process saved hours and improved the reliability of assigning target IDs.

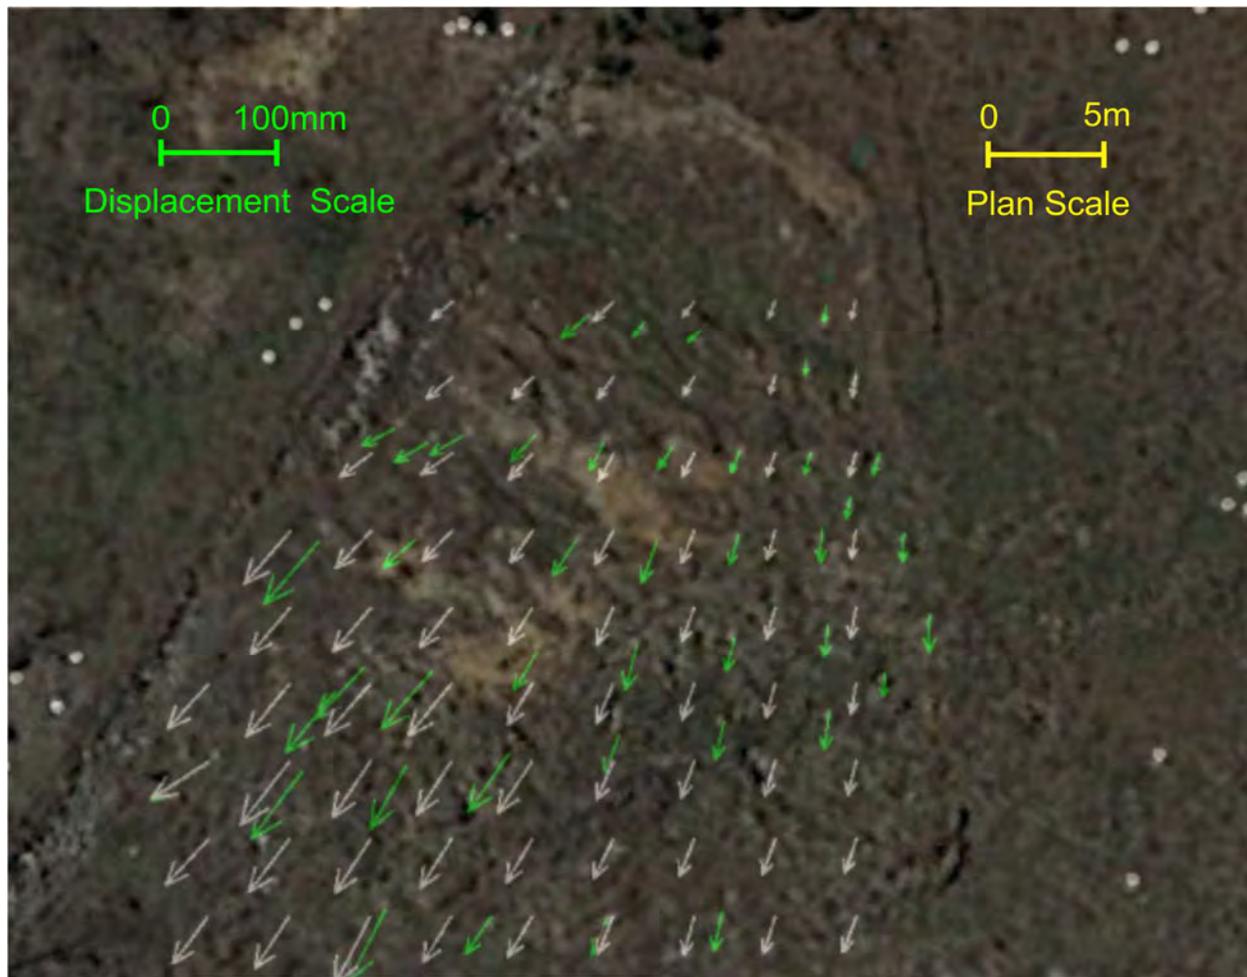
**Figure 14: Downslope movement of the surface of the slide in plan view superimposed on a Google Earth image. Green arrows represent actual movement of targets; white arrows are movements interpolated in a regular grid. White balls outside of the slide area are 150 mm control ball targets. Base image from Google Earth.**

Figure 14 shows the analysis of the planar view of the positions and downslope displacement vectors of the ball targets based on scans taken July 19, 2015, July 29, 2015, August 8, 2015, and August 27, 2015. Displacements ranged from 7 to 75 mm over this period. Most of the targets have been stable over a period of 2 years.

Results show that the slide is moving downslope and slightly to the left. The fastest movements are near the bottom at the left hand side of the slide, and total maximum displacement is approximately 75 mm.
