HGS 2016  
Proceedings

# 67TH HIGHWAY GEOLOGY SYMPOSIUM

## JULY 11 – 14, 2016

Cheyenne Mountain Resort  
COLORADO SPRINGS, COLORADO

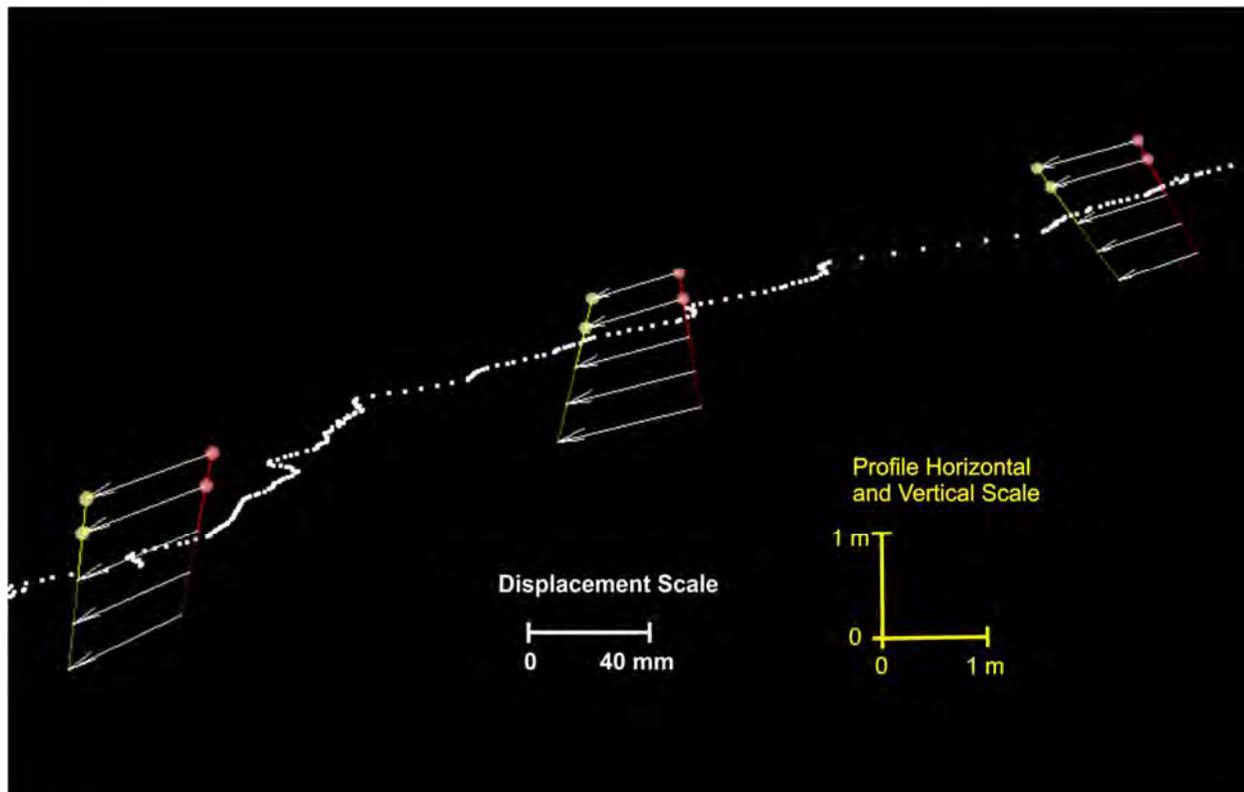
**Figure 15: Downslope movement of 3 ball target pairs. Red and yellow are the before and after positions of the target; white arrows are the actual movement of targets; white dots represent the scanned ground surface. All show downslope movement; the center rod shows back rotation as well**

Figure 15 shows the positions and displacement vectors of the rods and balls in cross section over the same period of time. Figure 15 shows a cross section of the slope surface with three target rods aligned in the downslope direction. In this area there is displacement of about 50 mm downslope. The uppermost and lowermost target rods show more or less parallel downslope movement, which would indicate a planar failure surface. The centermost target rod shows some back rotation, which would indicate that at that point there is some circular rotation taking place.

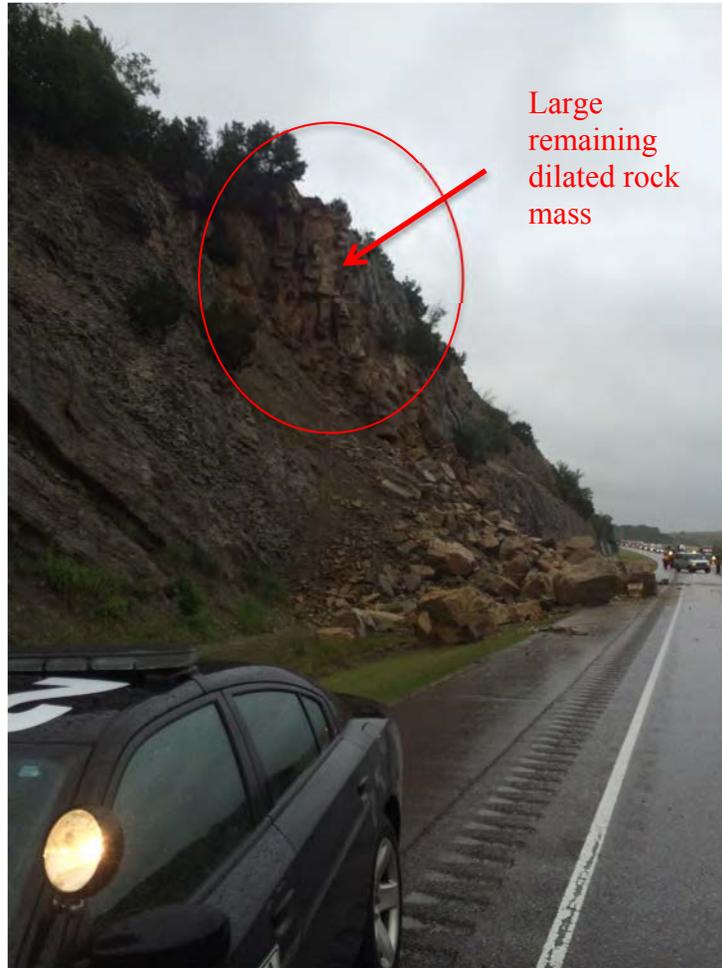
**Figure 2 Image of site on June 18, 2015 after the failure**

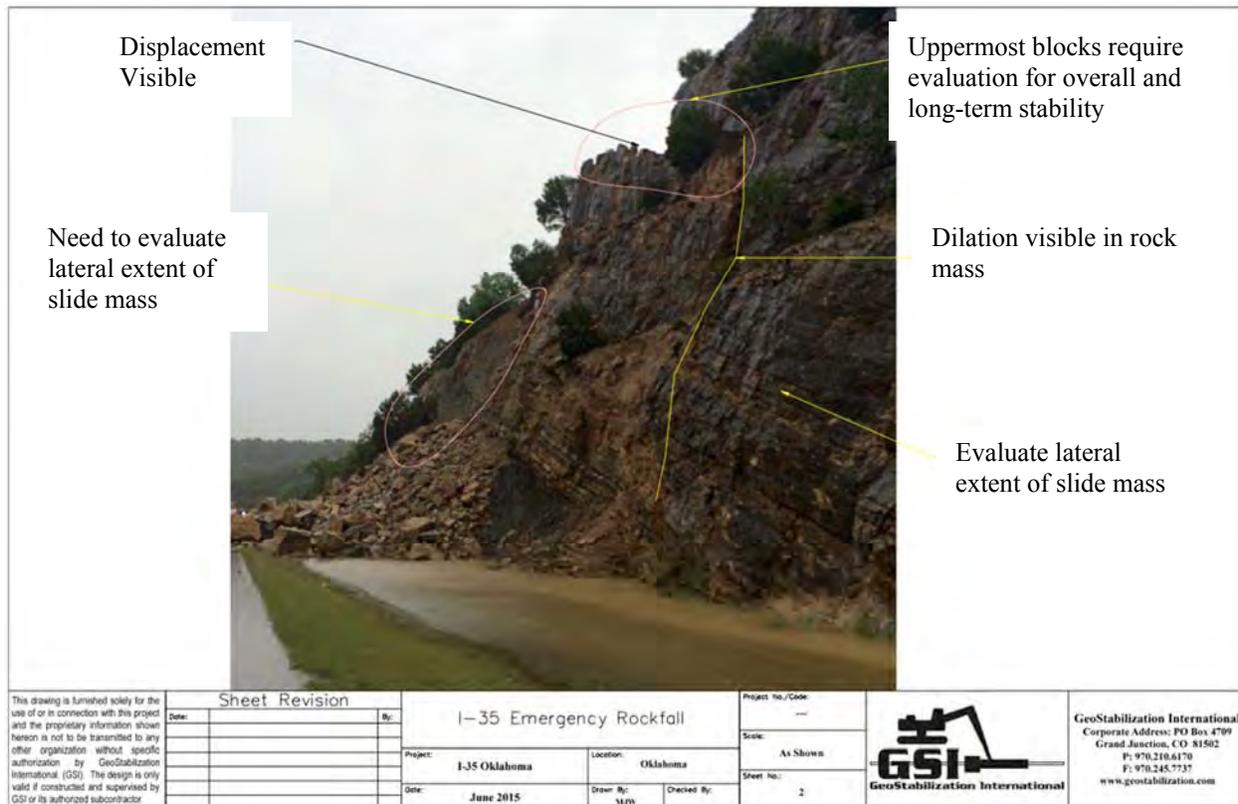
Figure 3 Image used in detail plans provided by GSI during June 25 site visit

After conferring on site the day of the 18<sup>th</sup>, Oklahoma DOT contacted Daniel Journeaux (GeoStabilization International) and Mr. Ty Ortiz (Colorado Department of Transportation) to arrange a site visit for the June 25. Prior to the site visit site photographs were provided and GSI developed a game plan ready for Mr. Ortiz to review upon his arrival. An example of details provided by GSI for the June 25<sup>th</sup> site visit can be seen in Figure 3.

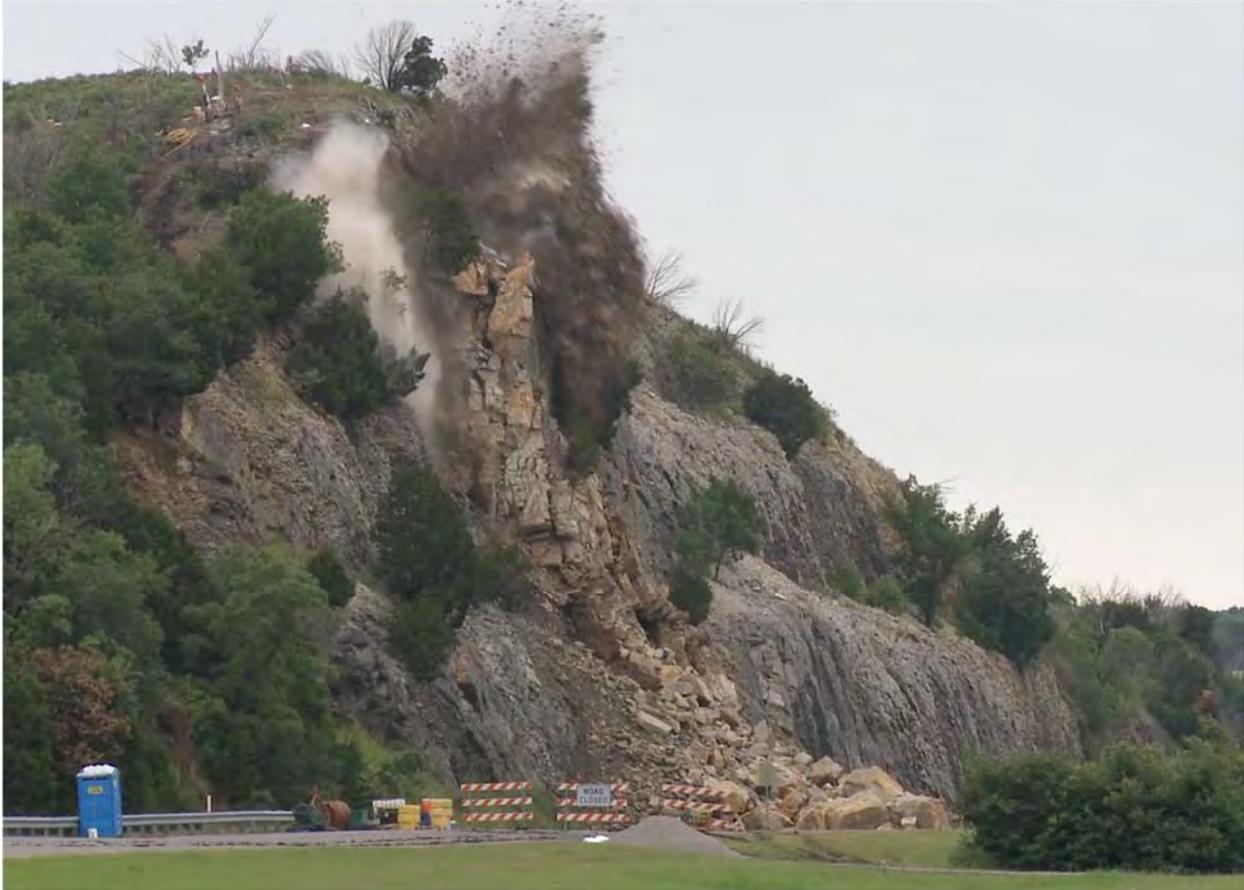
**Figure 4 Initial blast conducted to remove large mass at the top of the failed area**

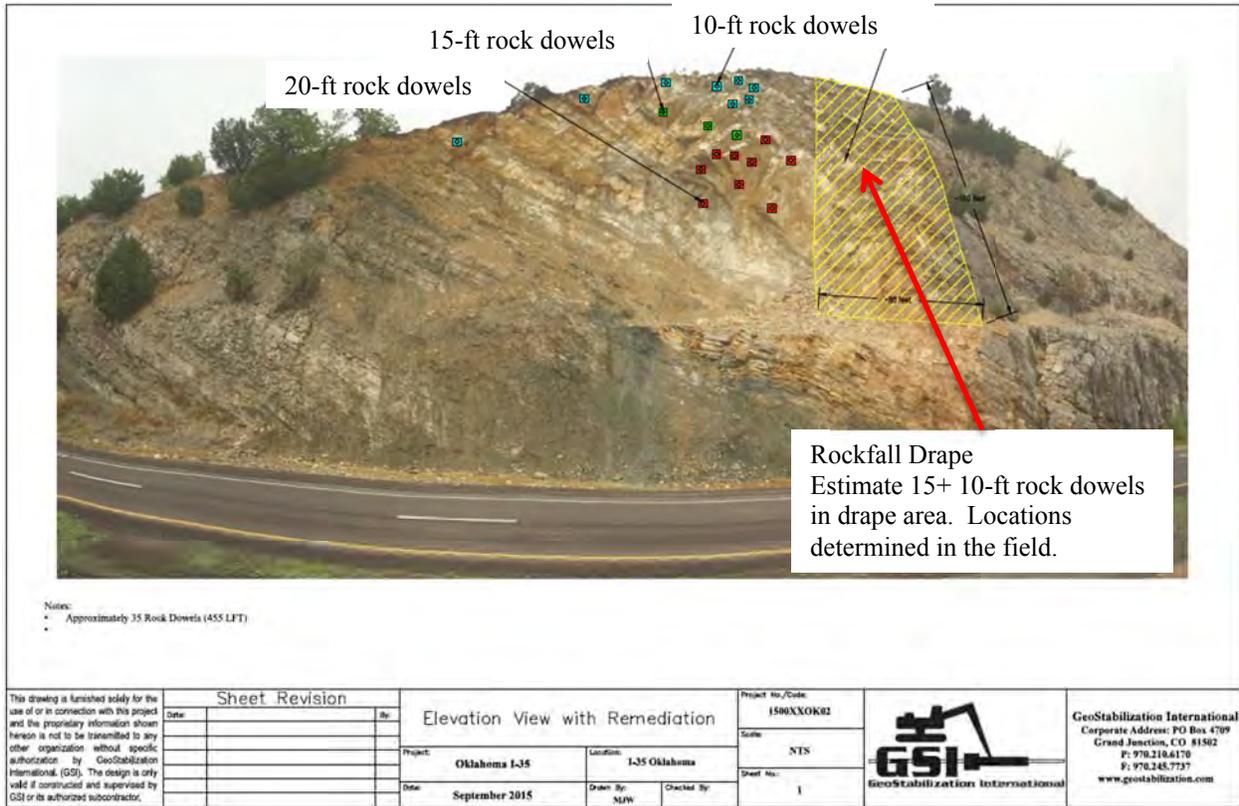
**Figure 5 Final mitigation strategy imposed on an image of the slope after failed mass has been removed.**

After the site had been exposed several blocks required reinforcement with the use of rock anchors as well as an area on the southern end of the slope failure requiring a rockfall drape to mitigate against rockfall hazards. These blocks were initially checked scaled with scaling bars and a 50-ton airbag. Determining that they are stable in their present condition, but having the potential to release in the future they were additionally secured with a series of rock dowels for additional long-term protection. The broken rock mass on the southern end of the project was scaled and deemed sufficient. However, long term freeze and thaw cycles may effect this slope and additional protection for the roadway was provided with the use of a rockfall drape mesh. An image of the slope after the excavation of the failed area can be seen in Figure 5 as well as the mitigation strategy.

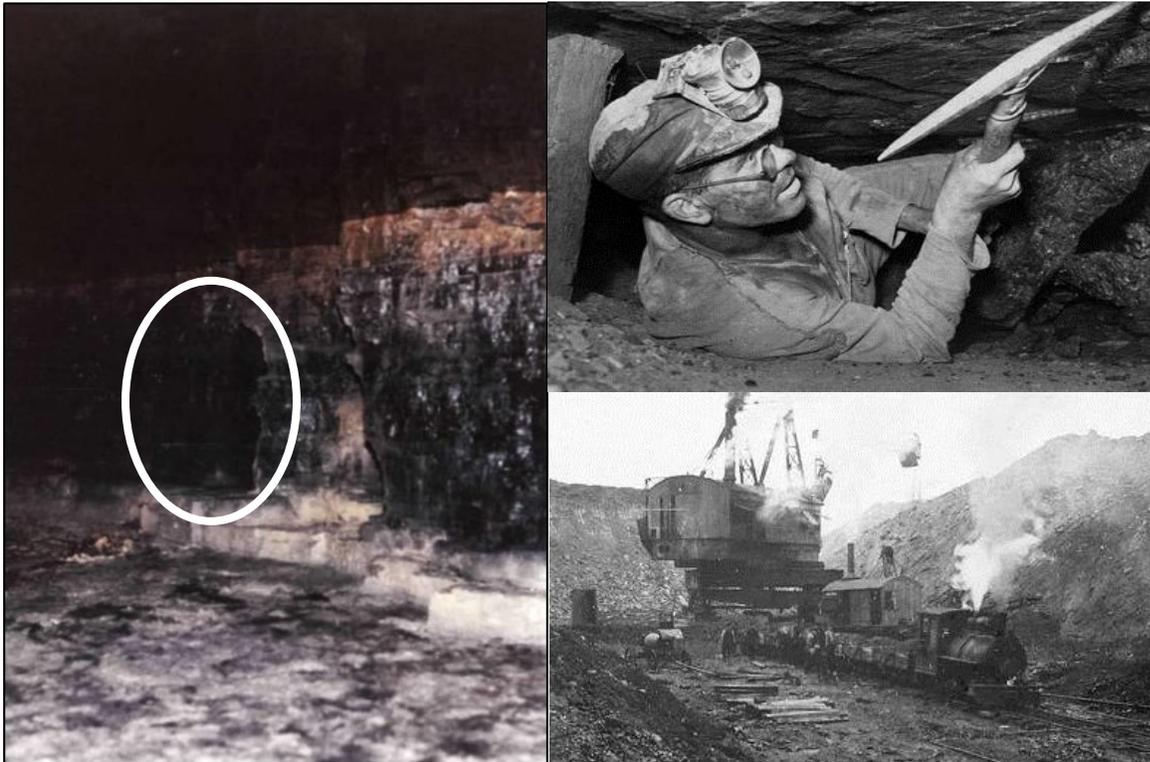
**Figure 2: Past mining techniques used to extract coal in S.E. Kansas**

In the late 1890's through the early 1940's southeast Kansas was mined commercially for coal, lead, and zinc. These ore minerals were mined predominately in relatively shallow subsurface mines, utilizing the "room and pillar" technique (Figure 2). When subsurface mining was the preferred method, there were two primary mining operations: Missouri-Kansas-Texas Railroad Company and St. Louis-San Francisco Railway Company. These companies were mining bituminous coal from the Weir-Pittsburg coal bed. The subsurface mining from these companies were so extensive, an estimated 60,000 acres of Cherokee and Crawford counties are underlain by subsurface mines. As the mining through the project area extended, the mining companies and the State of Kansas reached agreement that mining operations could extend to the state right of way line. Drifts could then be cut perpendicular to centerline of the highway to allow equipment to move to different parts of the mine without having to come to the surface.

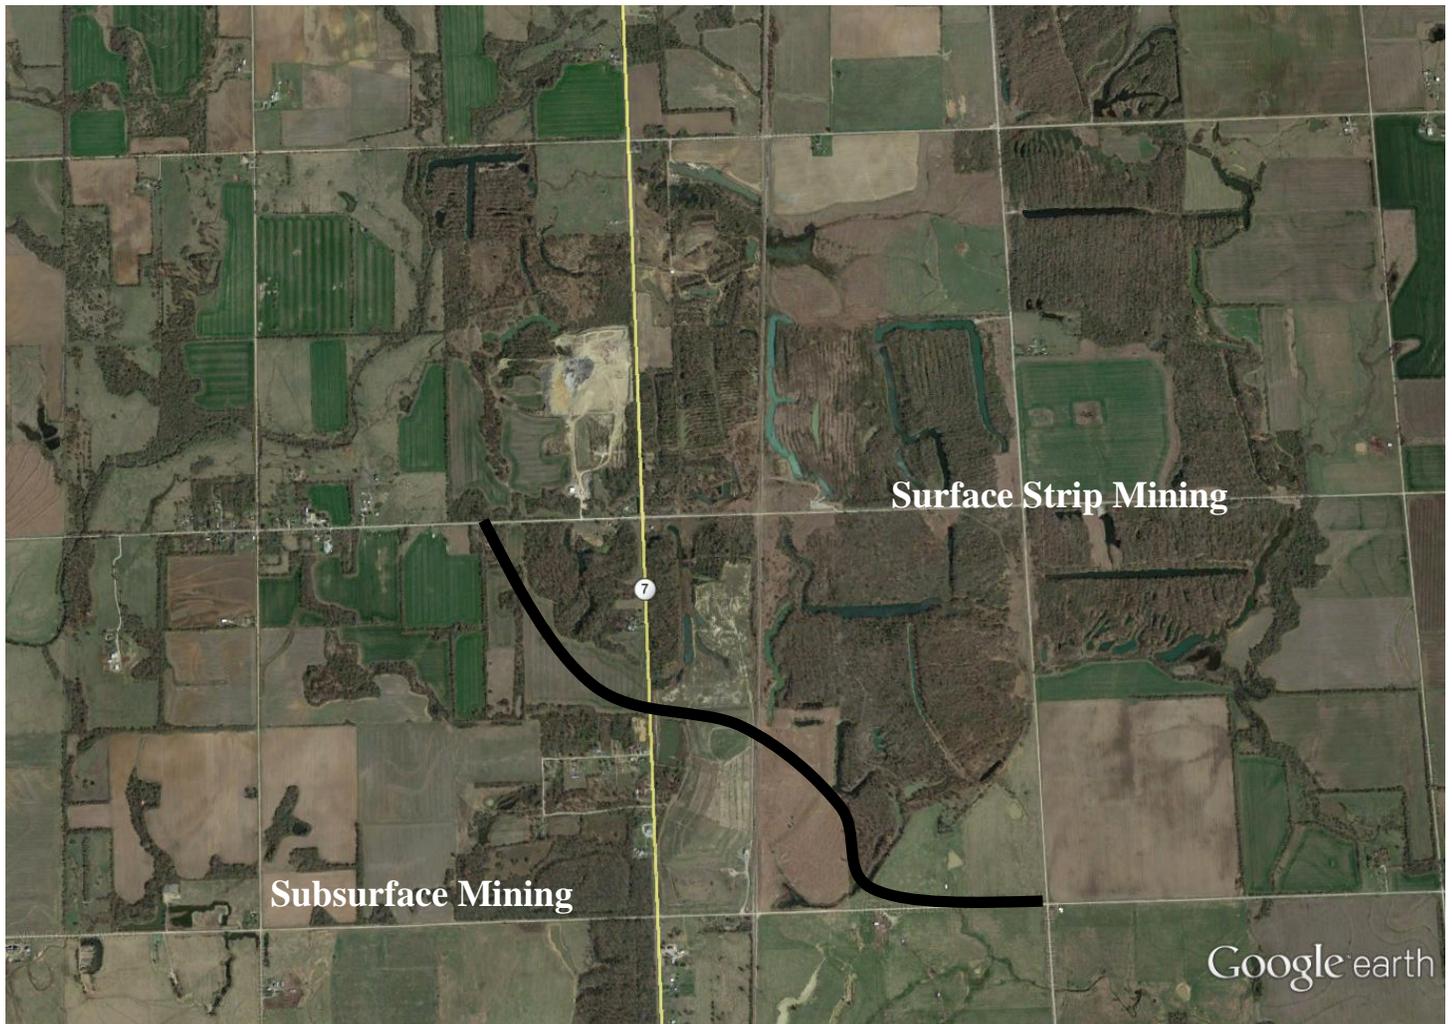
**Figure 3: Aerial of Transition from subsurface mining to surface strip mining**

The issues lie within both predominate mining techniques of the past; from the sinkholes developed from extensive subsurface mining along with acid mine drainage associated with the spoil piles from strip mining (Figure 3).

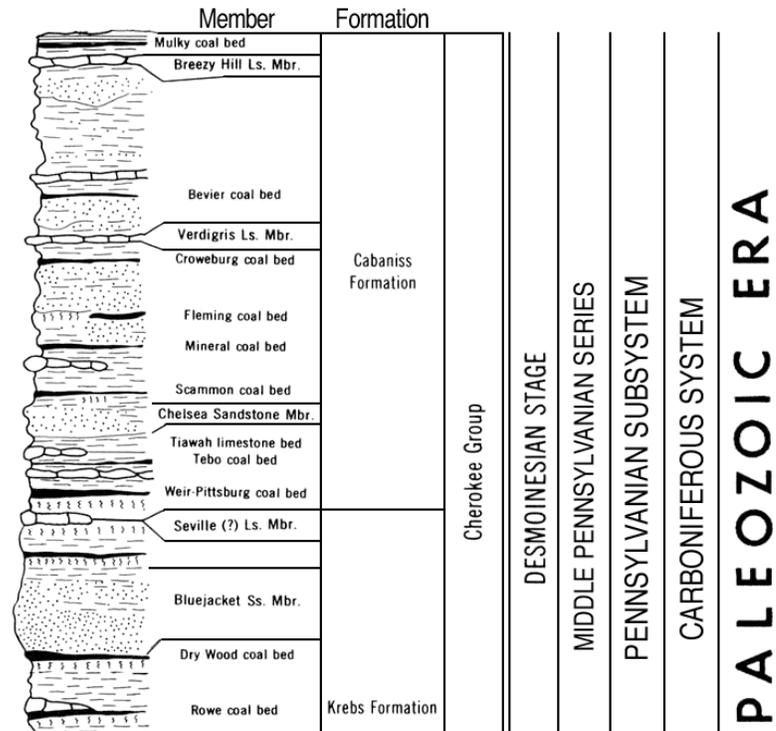
**Figure 4: Stratigraphic Column for the State of Kansas**

The proposed project is located in the far southeast corner of the state within the Cherokee Lowlands. This physiographic region is characterized by gently rolling hills, comprised of sandstones and shales hailing from the middle Pennsylvanian period. Over 300 million years ago, eastern Kansas was predominately at sea level with low-lying areas being covered with dense vegetation and brackish swamps. As a result, eight economically- important beds of bituminous coal were deposited and developed within the Cherokee Group (Figure 4), with the Weir-Pittsburg coal bed being the most significant because of its commercial importance.

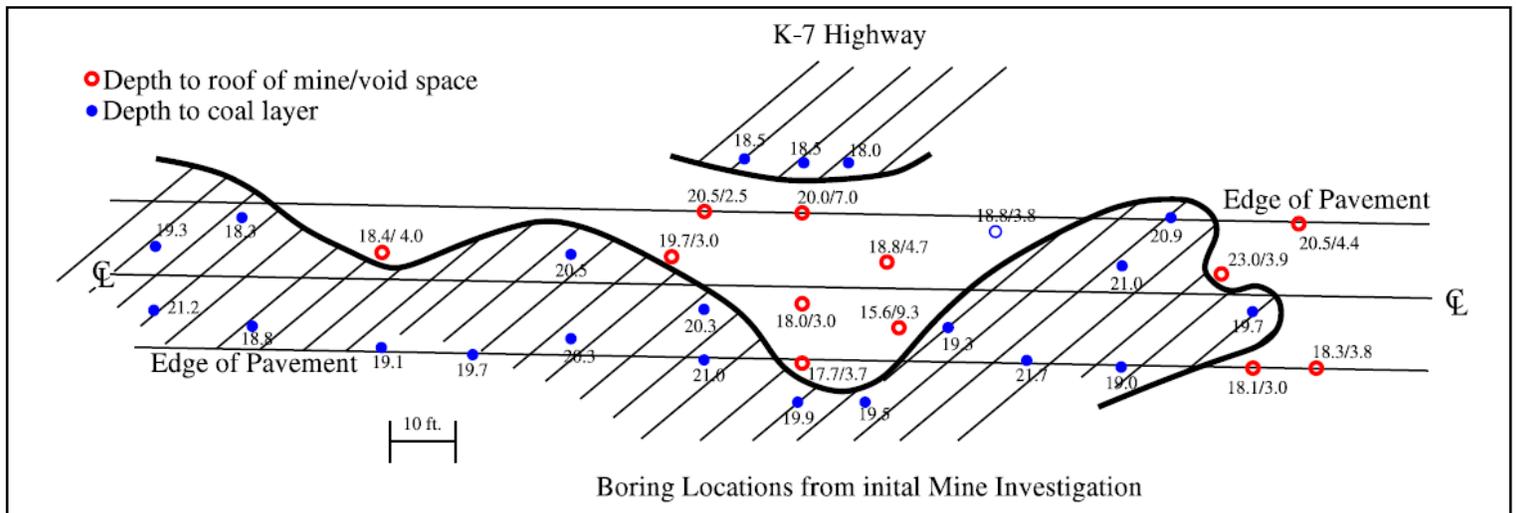
**Figure 5: Boring location map from past geotechnical investigation**

Since the late 1960's K-7 Highway was known to have been significantly undermined; but due to the cost of remediation and no significant surface damage nothing was done along K-7 until the mid-1980s. In 1986, a weight restriction of 24 tons was implemented due to the significant deterioration of K-7 from the increase in traffic. Subsequently, KDOT Geology began a mine investigation to determine the condition and extent of the subsurface mines. The investigation took approximately 3.5 years to complete and consisted of borings approximately every 25 feet, alternating from edge of pavement to a few feet either side of centerline (Figure 5).

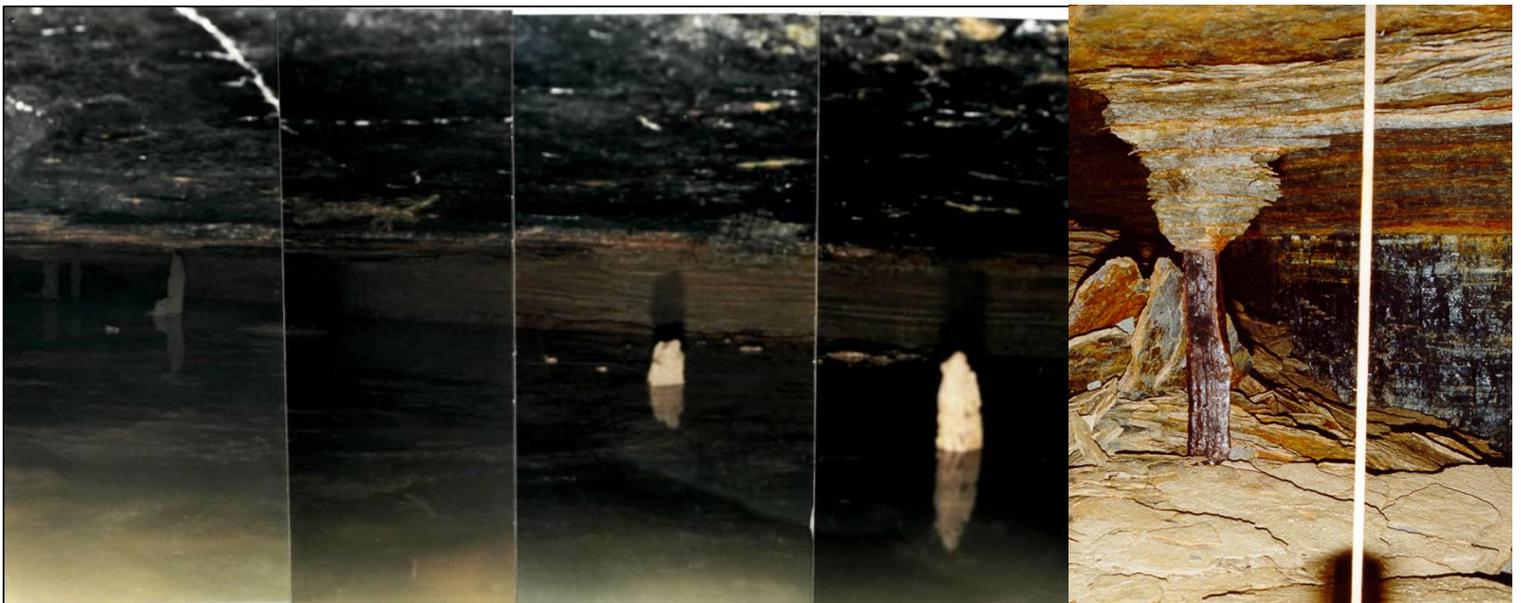
**Figure 7: Mine condition from subsurface photographs**

After the initial borings were completed and the undermined areas determined, larger, eight inch diameter borings were performed to obtain subsurface photos (Figure 6) and determine mine conditions across the project. The determination of the condition of the mine was critical in deciding how the mine should be remediated.

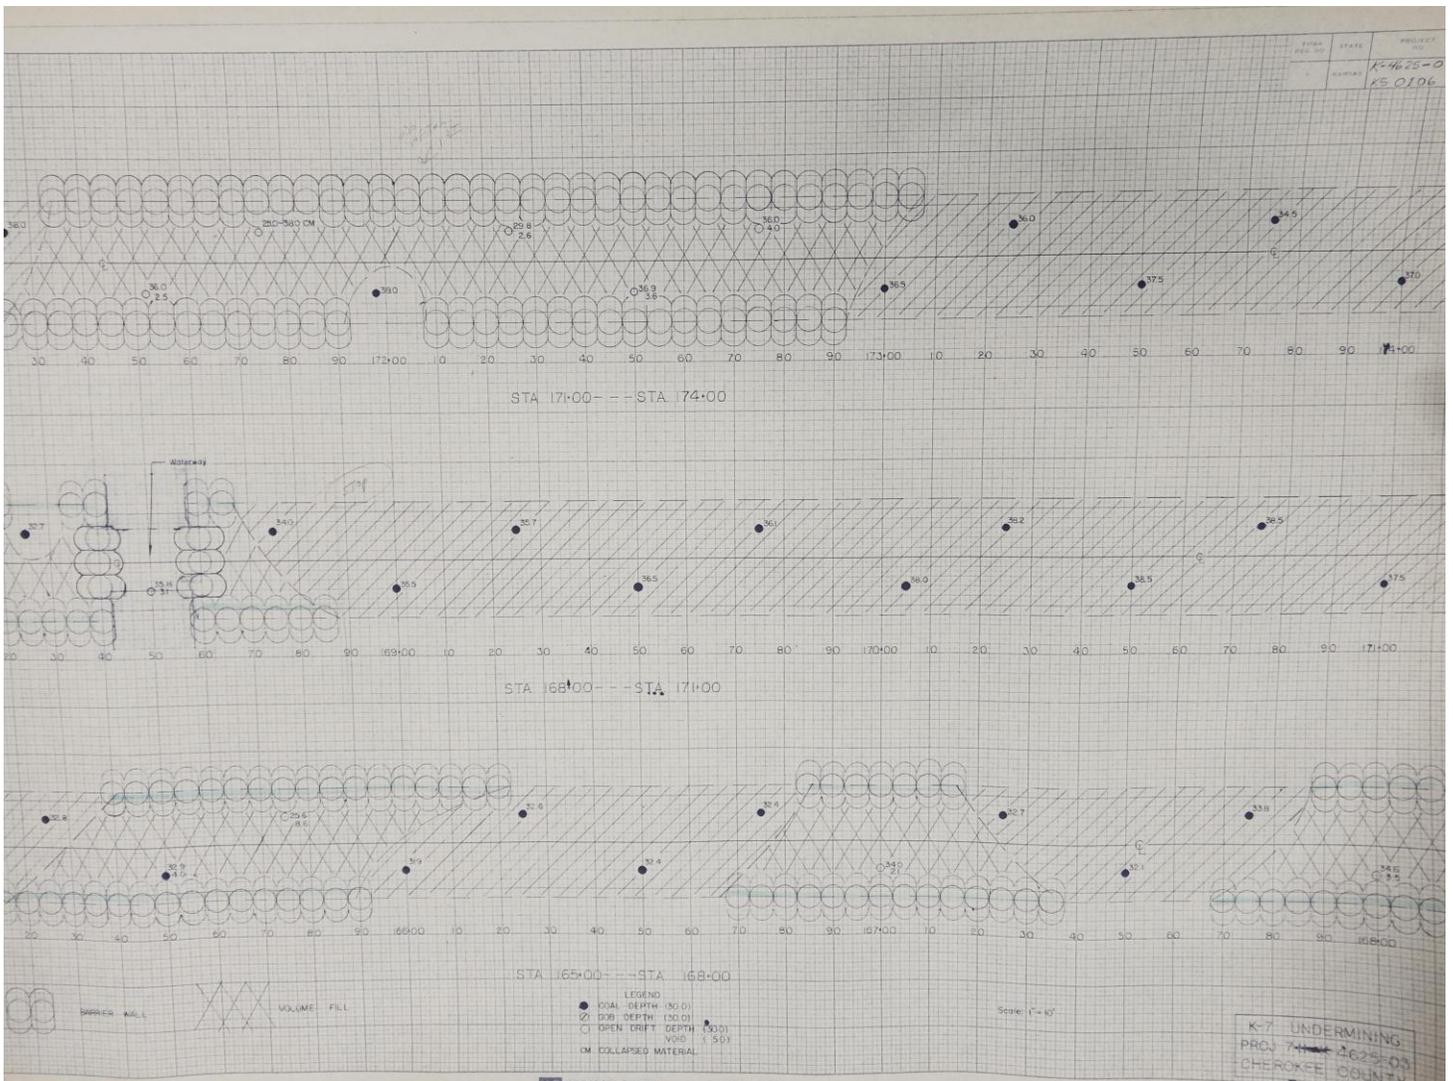
Figure 8: As-Built plans showing boring locations and remediated areas

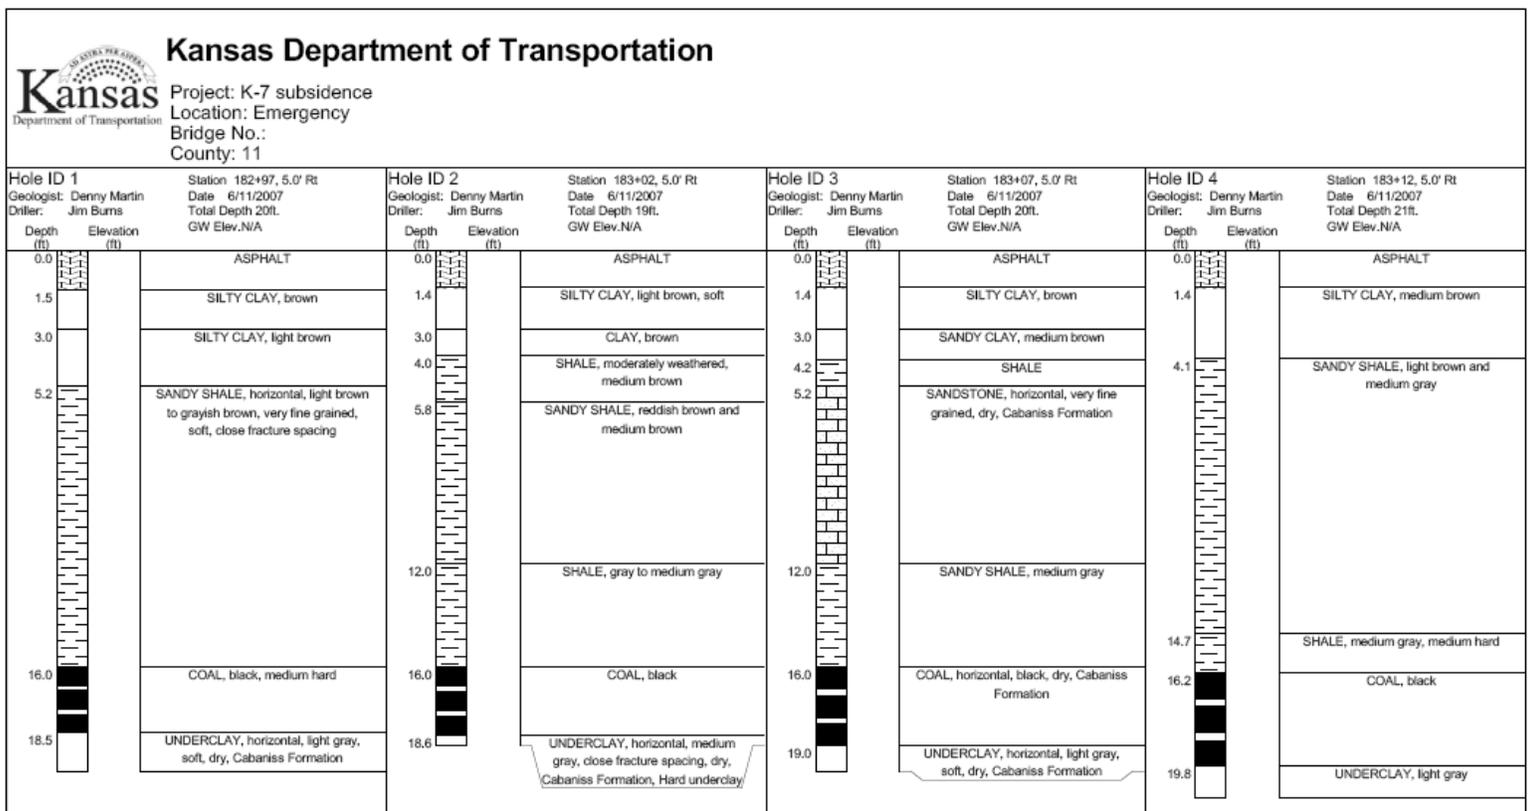
Figure 9: Power auger soundings near a sinkhole that developed within state right of way

In May 2014, KDOT Geology began its geotechnical investigation to determine the subsurface geology and the extent of undermined areas beneath the proposed new alignment for K-7. The investigation consisted of power auger soundings, site reconnaissance, and a review of past geotechnical investigations and boring logs. The historical borings proved to be an extremely invaluable tool due to the extensive amount of borings done during the previous investigations. All the past boring logs, which exceed 1,100, were recorded and kept on file for reference when sinkholes may appear within the right of way (Figure 9). For this investigation of the realignment of K-7, only a small number of additional borings were conducted; predominately where sinkholes had developed within the right of way.

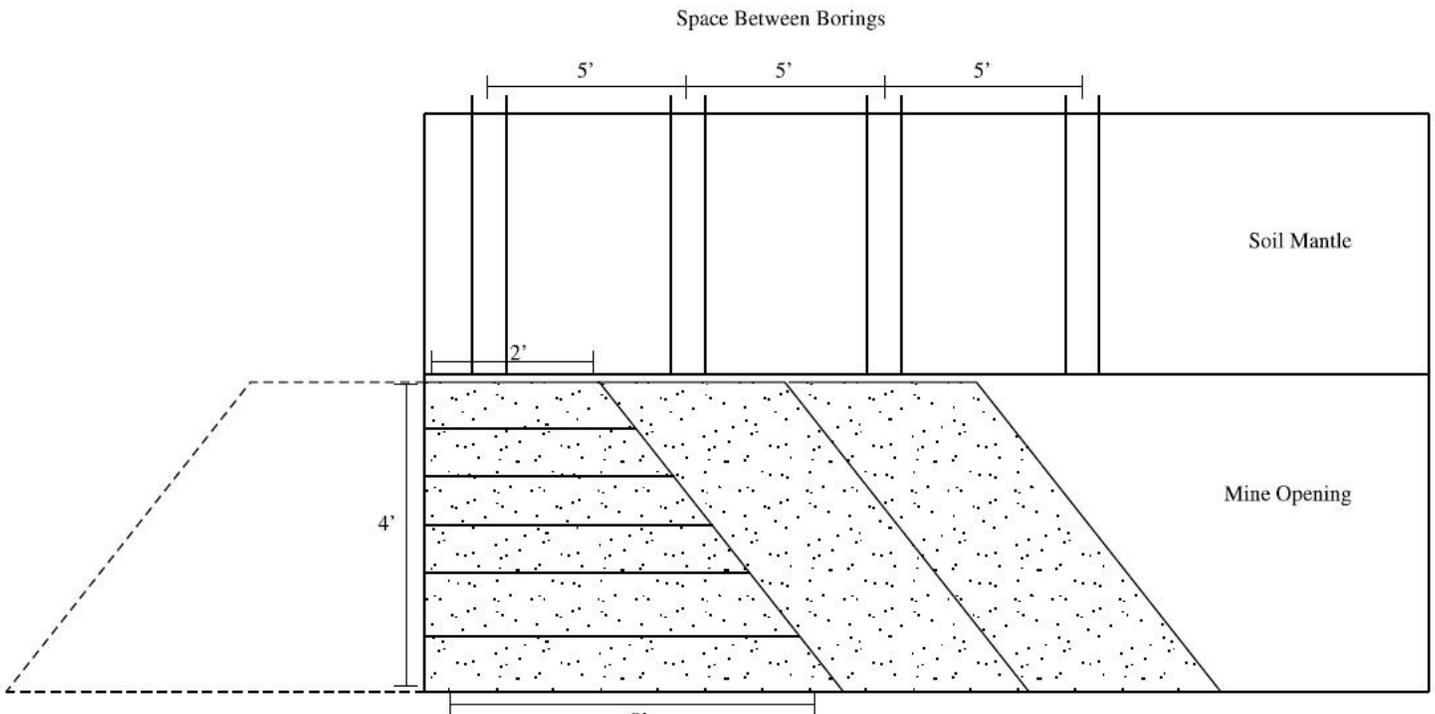
**Figure 11: Simple schematic of barrier wall construction. NOT TO SCALE**

The estimated concrete quantities for the mine filling were calculated using distance (stationing between undermined areas), offset from existing remediated area, and average void height. The barrier walls were calculated similarly. However, the area of the barrier was calculated by figuring the area of trapezoid:  $A = h \left( \frac{a+b}{2} \right)$ . Calculating the area of a trapezoid for the barrier wall was because of the low slump of the concrete. The natural shape of the barrier wall would most resemble the shape of trapezoid when placed (Figure 11).

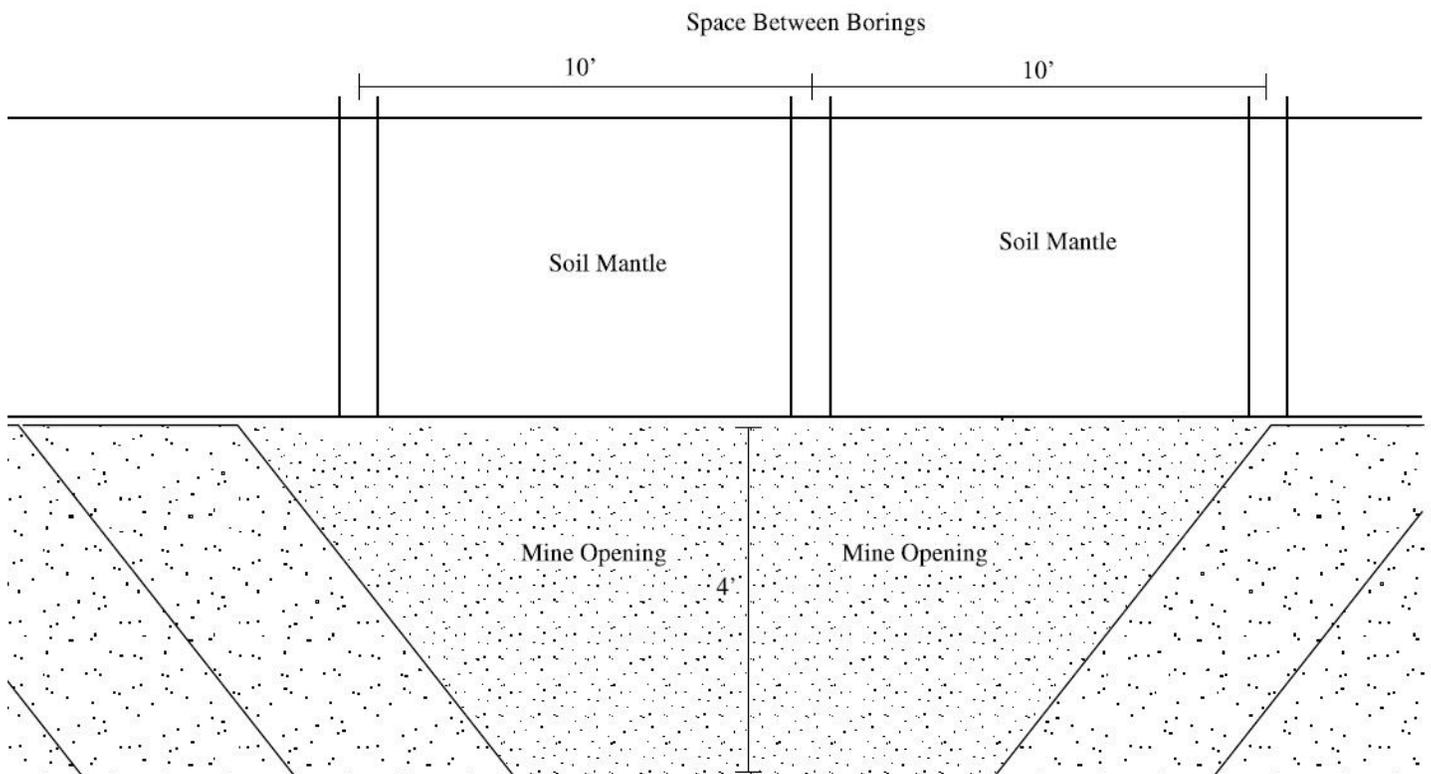
**Figure 12: Simple schematic of in-fill construction. NOT TO SCALE**

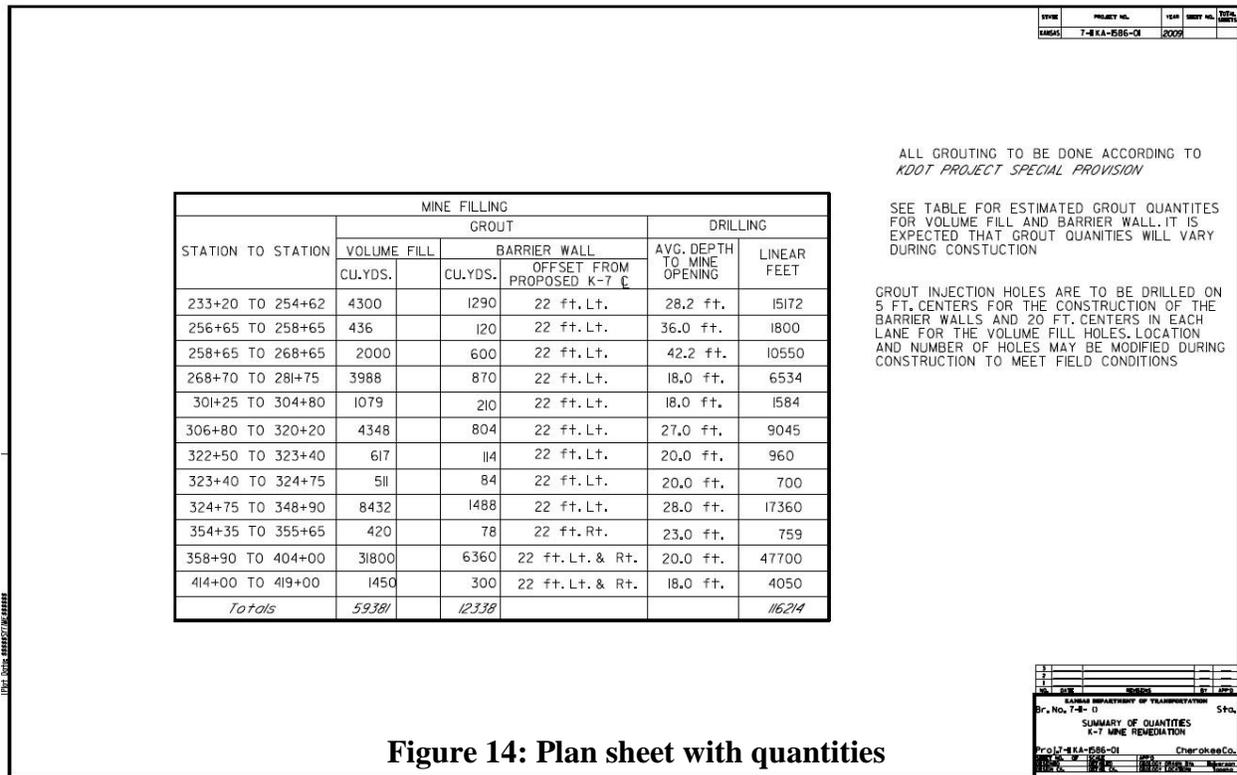
Figure 14: Plan sheet with quantities

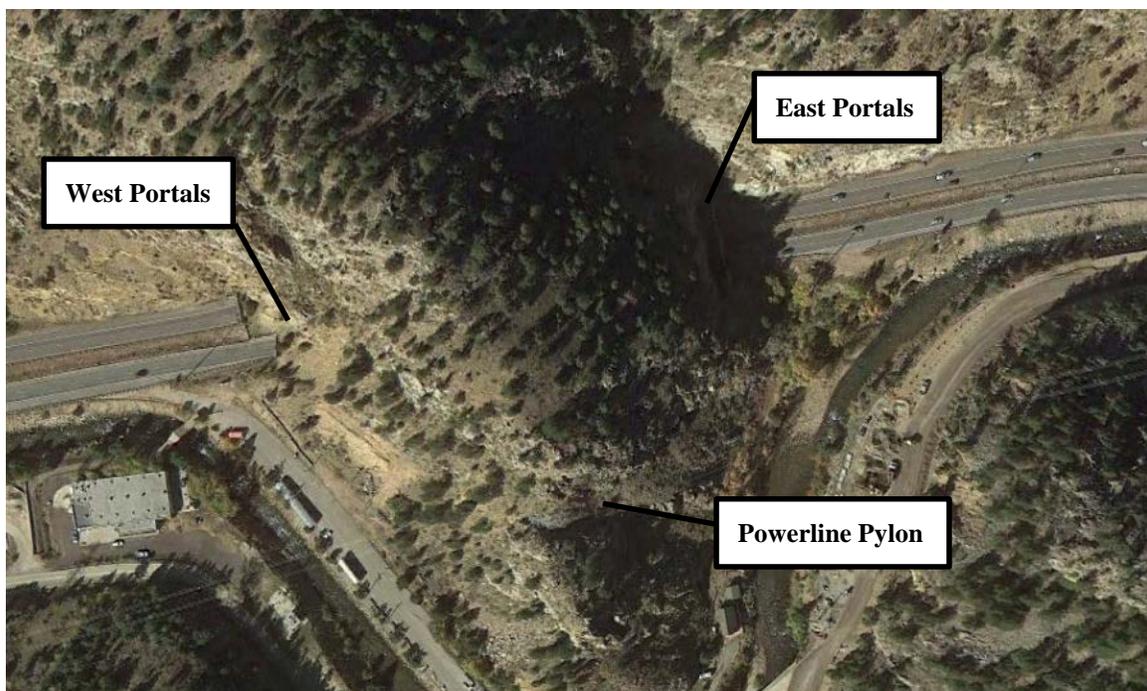
Figure 1: I-70 Tunnel Widening Project in 2012. Note the yellow coloring of the rock at the west portal.

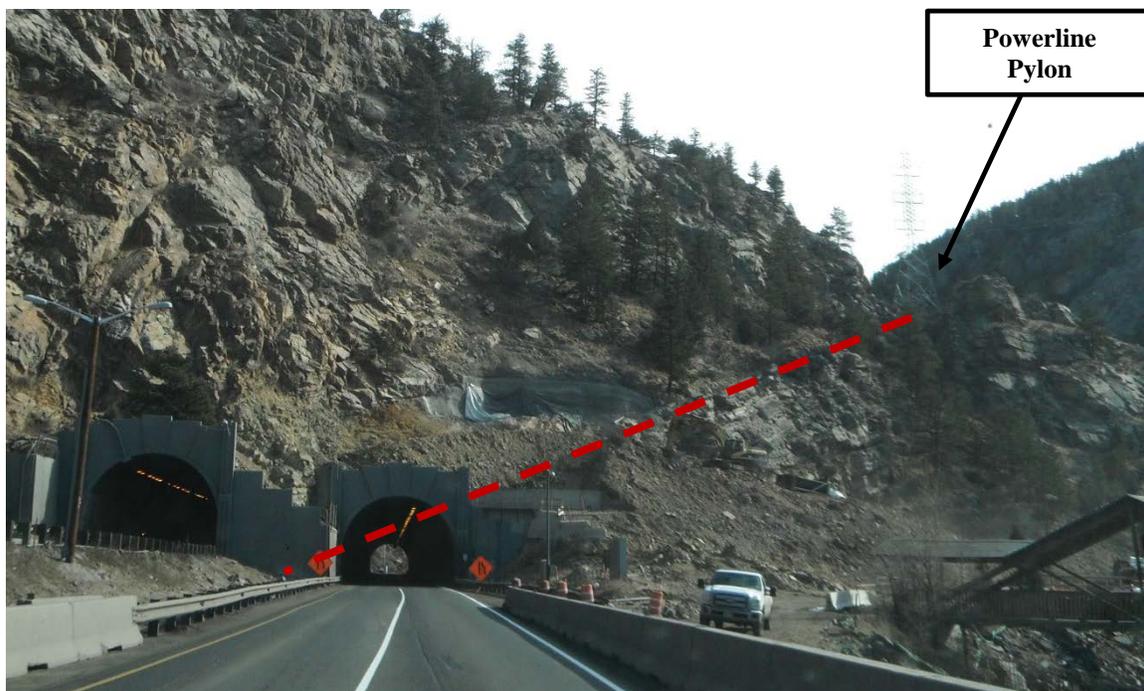
**Figure 2: View of the West Portals and Powerline Pylon from WB I-70, with observed fault (red).**

A fault zone identified during the original Twin Tunnels construction was exposed at the surface above the west portals. The original mapping indicated that a zone containing fault gouge, soft seams, platy crushed rock and pyrite veins was near the West Portals. Yeh geologists confirmed that the fault zone consisted of weak mineralized rock that appeared to continue along an erosional shelf that projected up to the power line pylon. The most corrosive porphyritic rock was found above the existing West Portal concrete structure. Several indicators of a corrosive environment were apparent during mapping but were also encountered during drilling: a noticeable sulfur odor, sulfur crystal growth in the portal cut, and a quick field check of the soil which yielded results between 4 to 3.5 pH. These conditions raised concerns that the portal structure could have suffered significant corrosion.

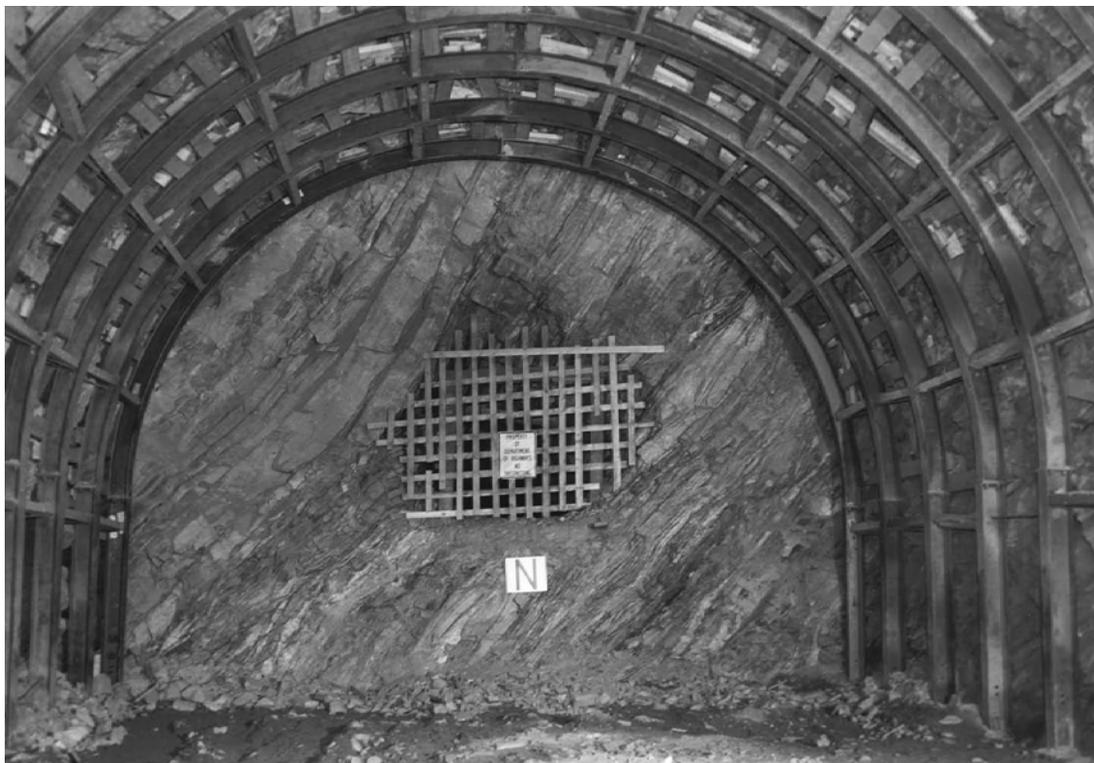
**Figure 3: Pilot Bore Tunnel in Westbound/North Alignment, mining West to East.**

Circa 1958 the CHD assessed the geologic and structural conditions of the bedrock, and working with the Bureau of Mines and Bureau of Public Roads developed plans and specifications for the proposed tunnels. A pilot bore was mined through the ridge circa mid-1959, and later that December two geologists from CHD performed an investigation and produced a geologic map of the proposed alignment. Available photographs from the CDOT archives showed steel sets and timber cribbing placed during tunnel excavation as well as wet seeps in the rock. Figure 3 shows a section of the fully excavated westbound tunnel, with the older pilot bore inside of it.

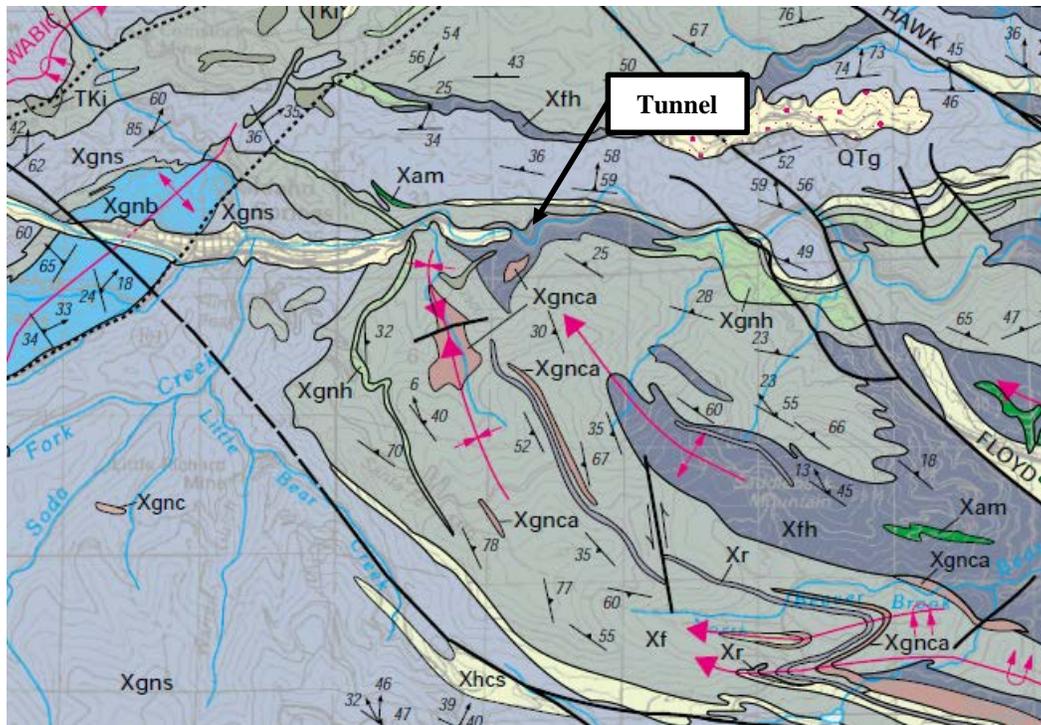
**Figure 4: Relevant portion of Geologic Map of the Squaw Pass Quadrangle.**

The tunnel site is mapped by the USGS as feldspar-rich gneiss (Xf) and interlayered feldspar-rich gneiss and hornblende gneiss (Xfh), as shown on the geologic map of the Squaw Pass Quadrangle in Figure 4 (Sheridan and Marsh, 1976). Feldspar-rich gneiss is described as light-gray and fine- to medium-grained. The rock is conspicuously foliated and granitic in appearance. Locally there are garnet deposits with interlayered hornblende, amphibolite, biotite gneiss and calc-silicate rock. Interlayered feldspar-hornblende gneiss is described as black, white and dark gray or greenish gray. The composition is similar to hornblende gneiss with layers and lenses of biotite gneiss, amphibolite, calc-silicate rock, and biotite-quartz-plagioclase gneiss.

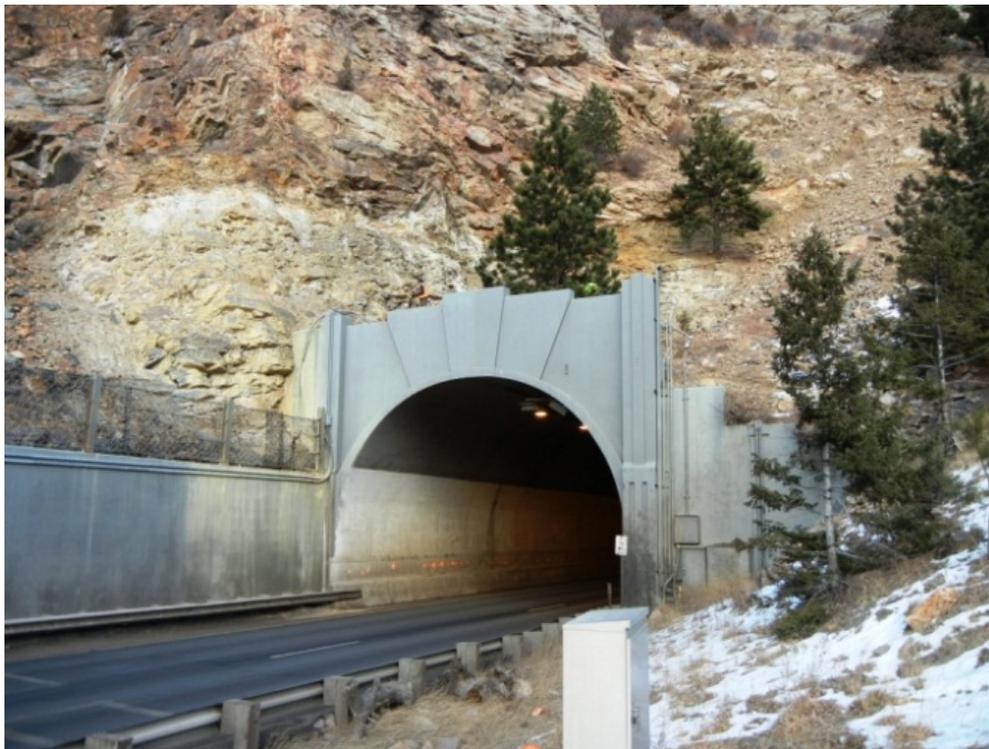
**Figure 5: Mapping of the Eastbound West Portal encountered Altered Rock and Fault Zones.**

Field mapping was the essential component of the structural and geologic characterization. Structural features were measured including the dip angle and direction of foliation planes, joints and fractures. Areas that were mapped included the West (Figure 5) and East portals, the southernmost rock promontory (Figure 6), the slopes directly south of the portals and along the mineralized "vein" from the west portal to the power line pylon.

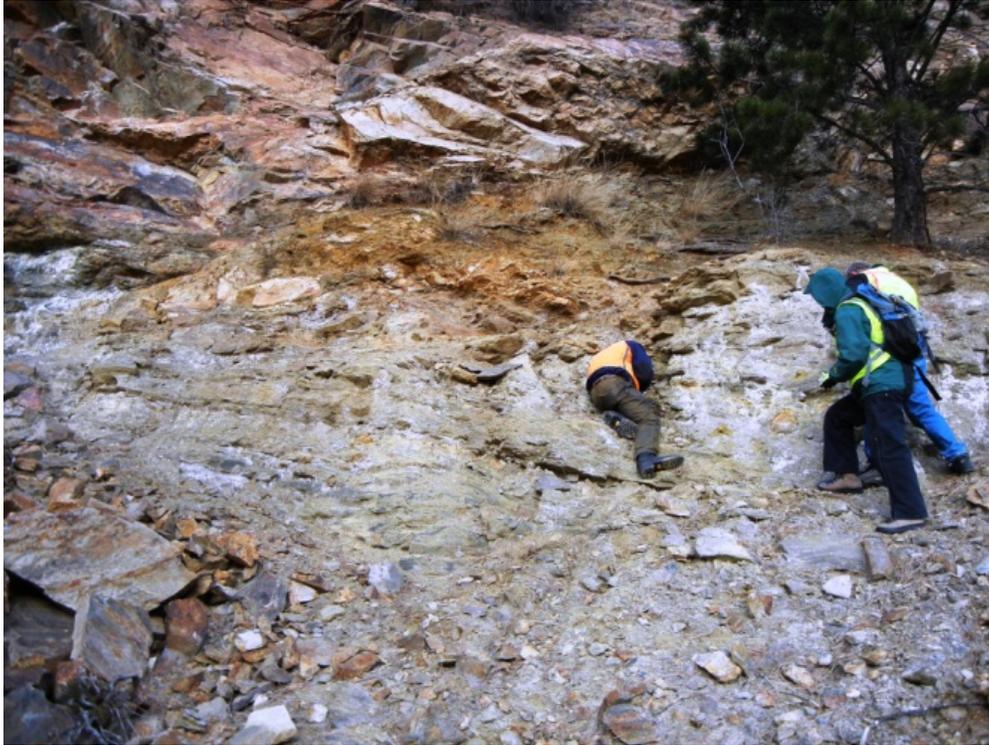
**Figure 6: Yeh's Mapping Team explored the entire Rock Ridge.**
