HGS 2016  
Proceedings

# 67TH HIGHWAY GEOLOGY SYMPOSIUM

## JULY 11 – 14, 2016

Cheyenne Mountain Resort  
COLORADO SPRINGS, COLORADO

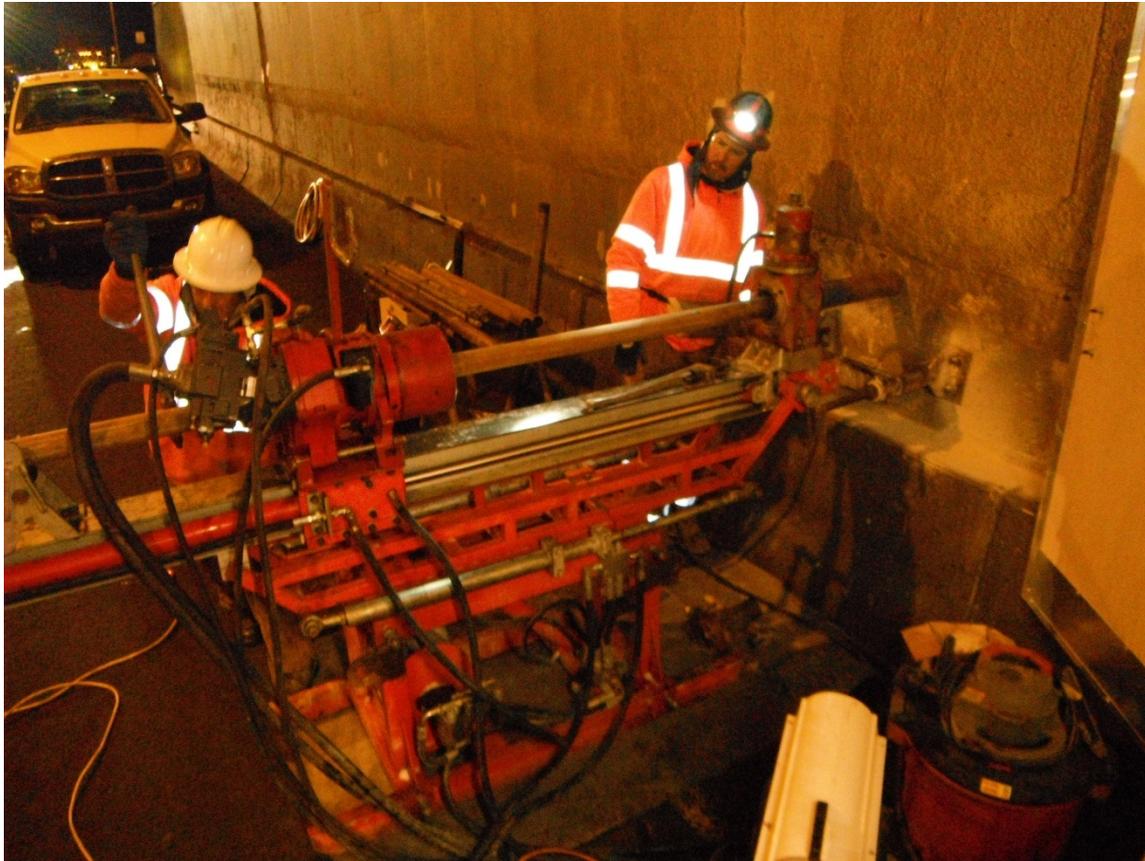
**Figure 7: Ingetrol Explorer 75E horizontal coring in the eastbound pillar, near the West Portal.**

Rock core ranging in size from B (36.5 mm) to H (63.5 mm) was recovered using a skid-mount Ingetrol Explorer 75E (Figure 7) for the horizontal and angled borings and a semi-trailer mounted Deets 1500 for the vertical roof borings. Drilling the angled borings required bolting the skid to the tunnel to develop drilling down pressure. Later the drill was mounted to a semi-trailer which greatly improved deployment and operation of the drilling program.

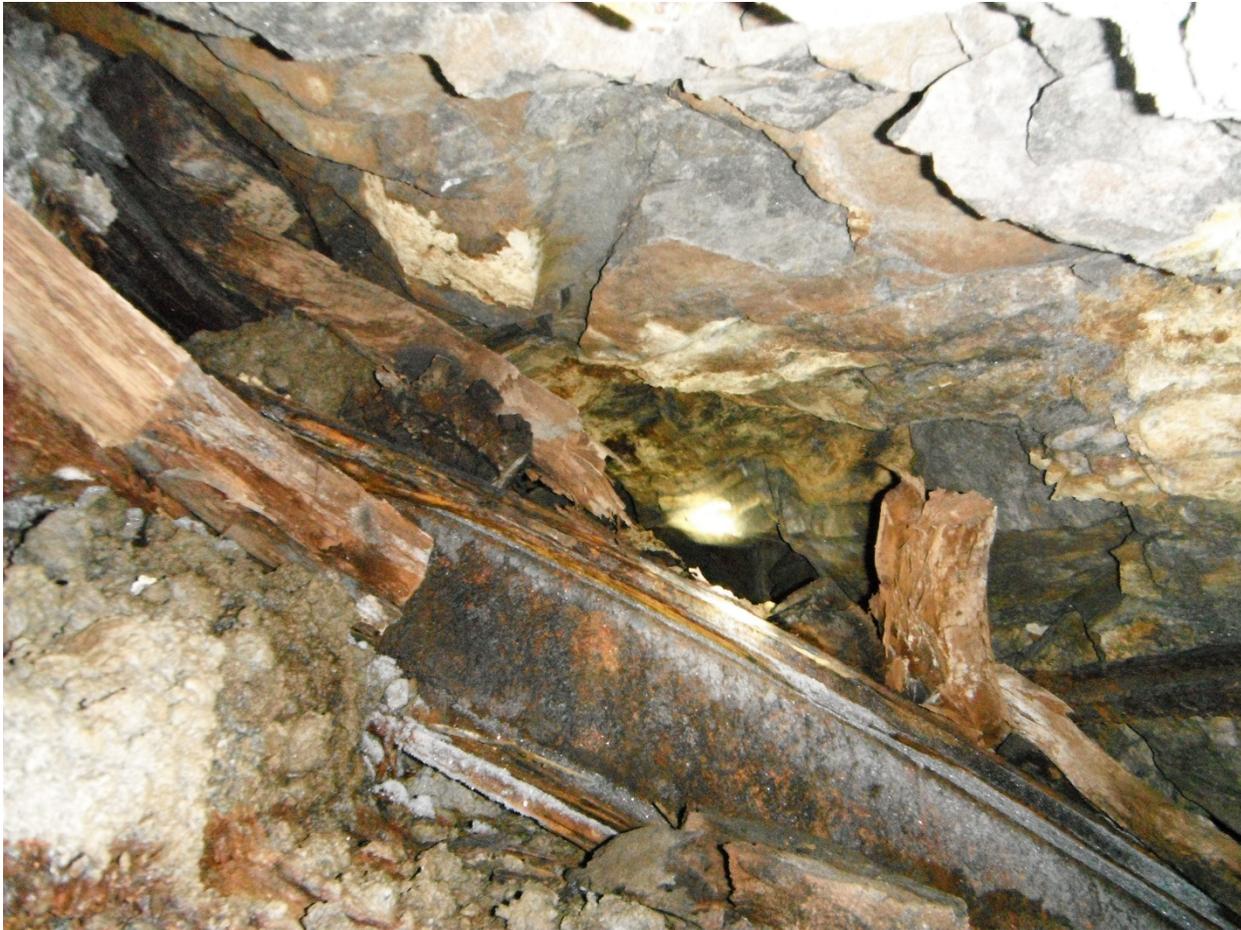
**Figure 8: The conditions in the void included corroded steel sets, rotted cribbing, blasting half casts and ice.**

While drilling in the tunnel, a small hole was observed in the liner of the eastbound tunnel in the left lane approximately 50 feet from the west portal. Further exploration by the engineers revealed that a large void with exposed rebar and steel sets was present behind the concrete liner shown in Figure 8. These findings were reported and the next day, a wider opening was cut to further evaluate the corroded state of the steel and concrete. The cut concrete ranged from 3 to 6 inches thick at the opening. Wood that had been used for blocking during construction was rotten and ice and frost were present inside the void. Several cobbles had fallen from the rock face and were resting on the inside of the liner. It appeared that when the tunnel liner was poured, the voids had not been completely filled with concrete. Fortunately, the liner materials were strong enough to stand for the life of the structure.

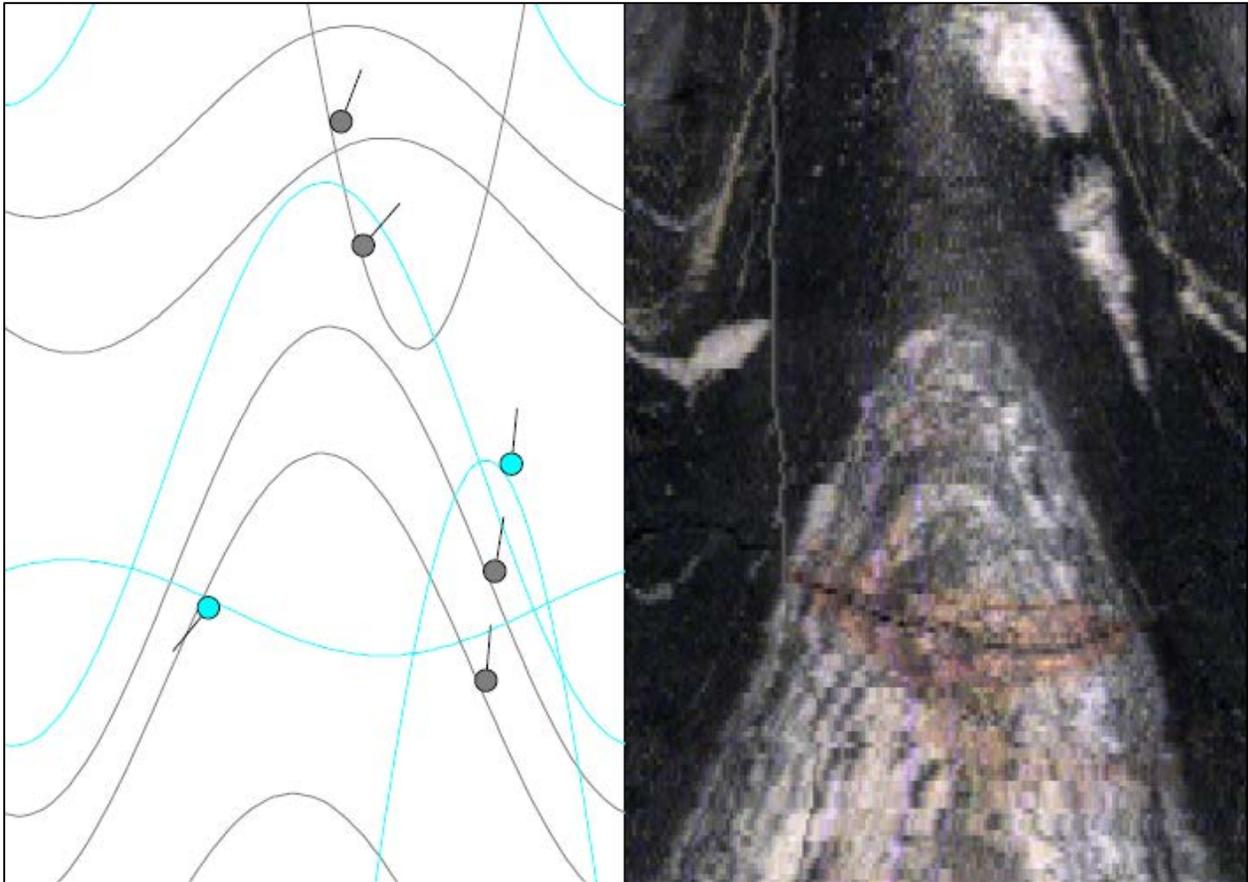
**Figure 9: Example of a borehole photo and selected rock features including foliation and joints.**

Rock core provided samples for determining rock strength and quality and for developing an understanding of rock fabric, mineralogy and general character. Borehole televiewing allowed down-hole inspection of in-situ rock mass conditions and replaced the need for oriented core recovery. Borehole televiewing was able to correlate recovered core to the rock mass at depth. Ten of the twelve tunnel borings were inspected by Colog. Images were evaluated for discontinuities, foliation planes and other major rock mass features. Figure 9 is an example of a borehole photograph analysis. Dip angle and strike/dip direction of foliations and discontinuities were input into kinematic analysis programs to obtain pole plots and rose diagrams for each respective boring. Three of the borings were inspected to full depth and seven were blocked off at varying depths. Using Terzaghi weighting this data was then incorporated into the overall structural mapping of the rock mass. Joints that perpendicularly cross the survey area typically have more measurements taken. Therefore applying Terzaghi weighting accounts for the duplicate measurements of planar features.

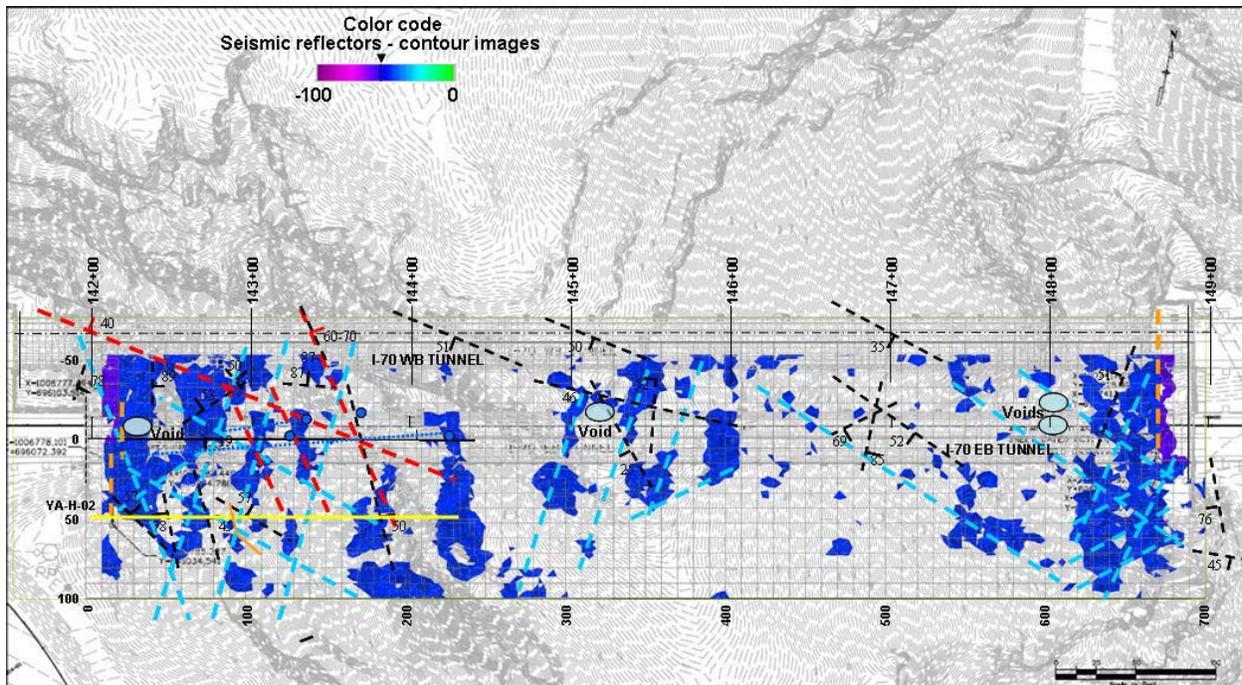
Figure 10: Plan view of the tomography anomalies with mapped discontinuities (C-Thru Ground, Inc., 2012)

images of the local ground properties. Known discontinuities, either measured in 1959 or 2010, were used as a baseline calibration of the final analysis and added credibility to the overall results. Results of the survey are shown in Figure 10.

The tomography survey was useful in capturing a low resolution model of the bedrock structure, but several questions remained following the investigation. The mapped ground anomalies related to local weakness in the rock structure associated with fractures and weathered rock mass. However, the width of detected anomalies were exaggerated due to the image resolution and its relation to the length of the shortest measurable seismic waves (approximately 6 to 7 feet). Also, the orientation of the reflecting surfaces in the rockmass directly affected seismic wave return to the receivers. Sensor installation was limited to the tunnel liners and a few small outcrops outside the tunnel. Sections of the rockmass oriented away from receivers lost signal return and those areas suffered from reduced data recovery. The final model was only from one point of view and at a relatively poor resolution meaning that the size of possible anomalies could not be reliably estimated.

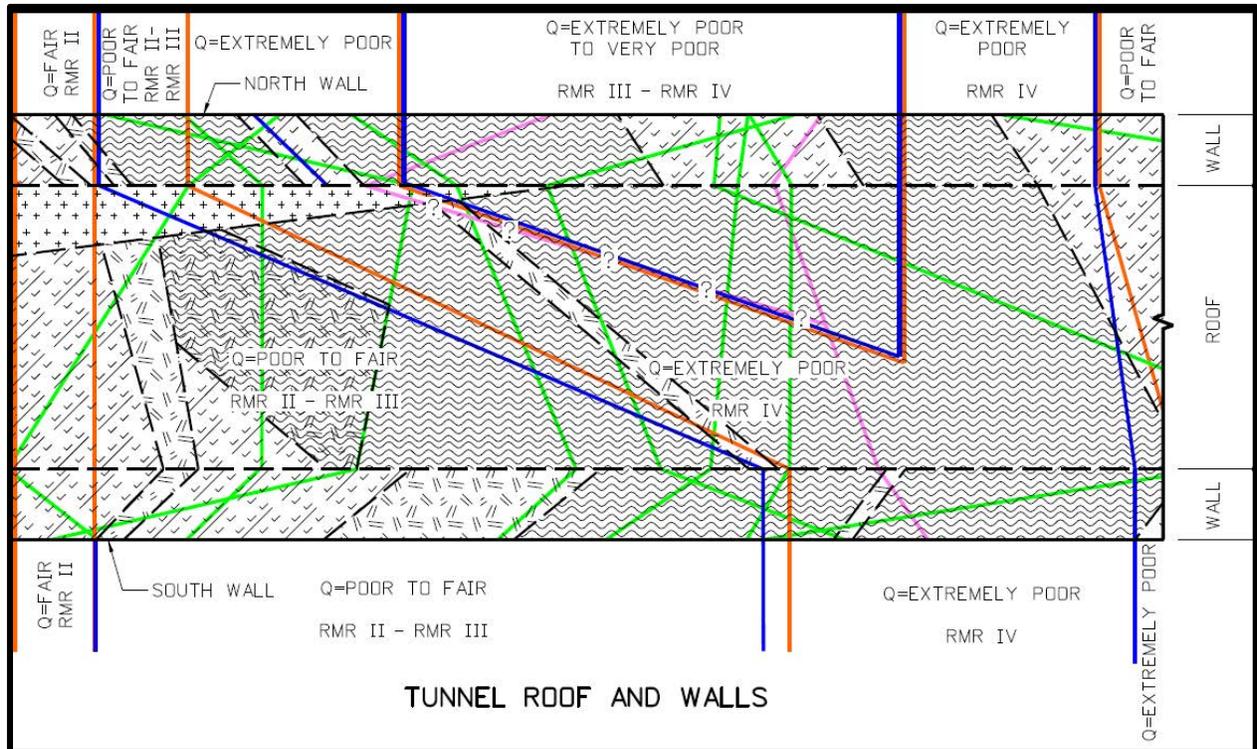
Figure 11: Three-dimensional ground condition map of the West Portal area.

Bedrock structure and conditions were weakest from the West Portal to approximately 200 feet into the tunnel. Alteration and displacement of the bedrock appears to have been associated with the Bostonite Porphyry intrusive dike. Contact metamorphism features such as clay alteration, brecciated rock structure and highly variable mineral composition were encountered in the West Portal pillar and rock outcrops. The discontinuities varied widely throughout the tunnel, ranging from fresh joints and fractures to altered fault zones. Using the field data collected from Yeh's geotechnical investigation as well as CHD historical documents Yeh estimated zones of RMR and Q-ratings with intact rock strength parameters. Yeh created an approximated three-dimensional geologic map which also showed anticipated rock quality, shown in Figure 11.

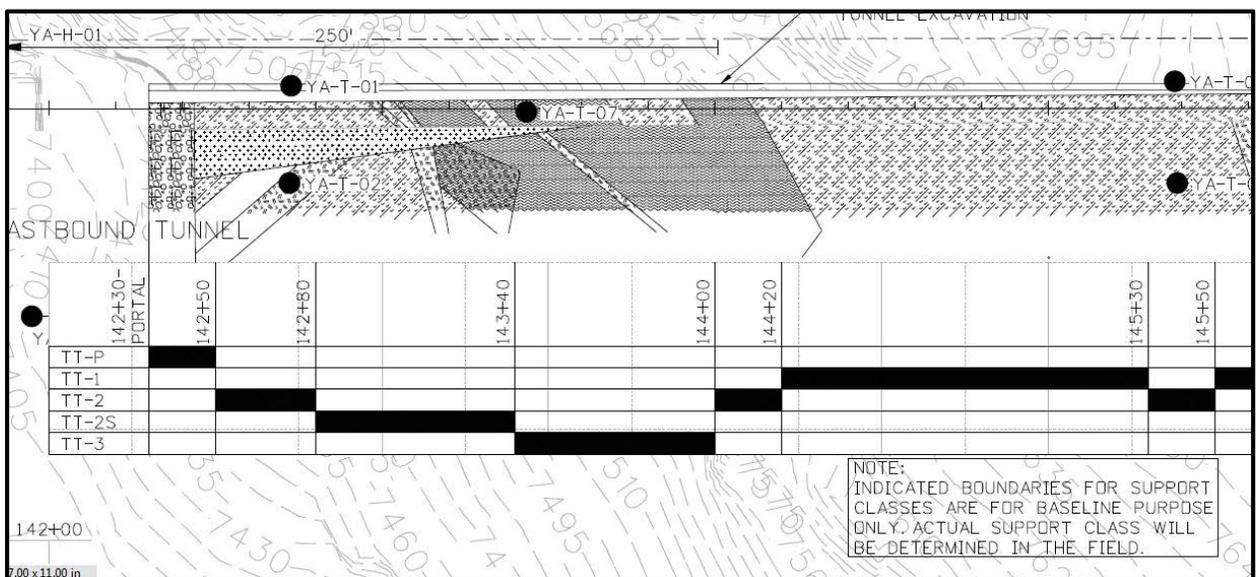
Figure 12: Ground class map of anticipated tunnel excavation requirements.

These maps were provided to the tunnel design team in preparation for construction cost estimates and schedule. Based on Yeh’s data the rock was simplified into four possible conditions from which excavation sequence, round length, staging and appropriate support conditions were developed. The ground classifications were developed for anticipated ground behavior which included portal rock (TT-P), structurally controlled blocks (TT-1), slow raveling rock (TT-2 and TT-2S) and fast raveling or caving rock (TT-3). Figure 12 is an example of the ground class map produced for the three-dimensional tunnel map from the CDOT Bid Plans.

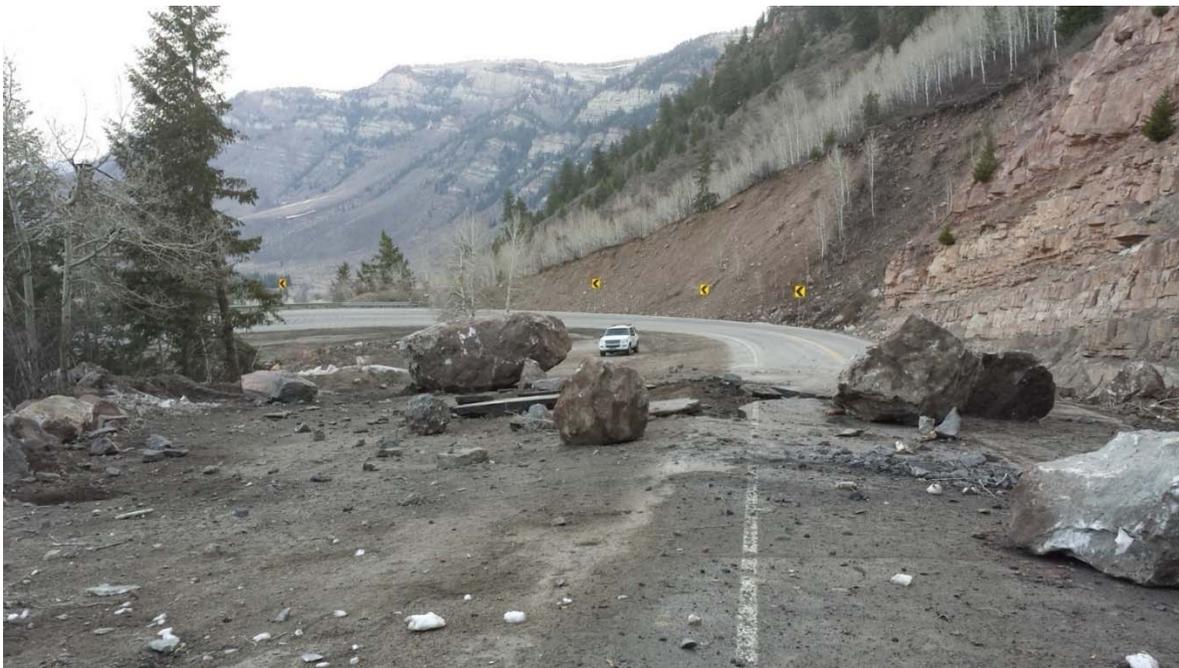
**Figure 1 – April 2014 US 24 rockfall event.**

Notable rockfalls occurred in April and December 2014 (Figure 1, 2). In both events, individual blocks with volumes of about 10 m<sup>3</sup> reached US 24. In each instance, rockfalls initiated from a relatively massive sandstone unit approximately 300 m (vertical) above the highway (“source area” in Figure 3). An aerial photograph of the source area (Figure 4) shows the large in-situ columnar block before it fell in December 2014; the columnar block rested on top of a blocky sandstone and shale “cap block”. An oblique model image (Figure 5) shows the source area in April 2015 after the columnar block had fallen.

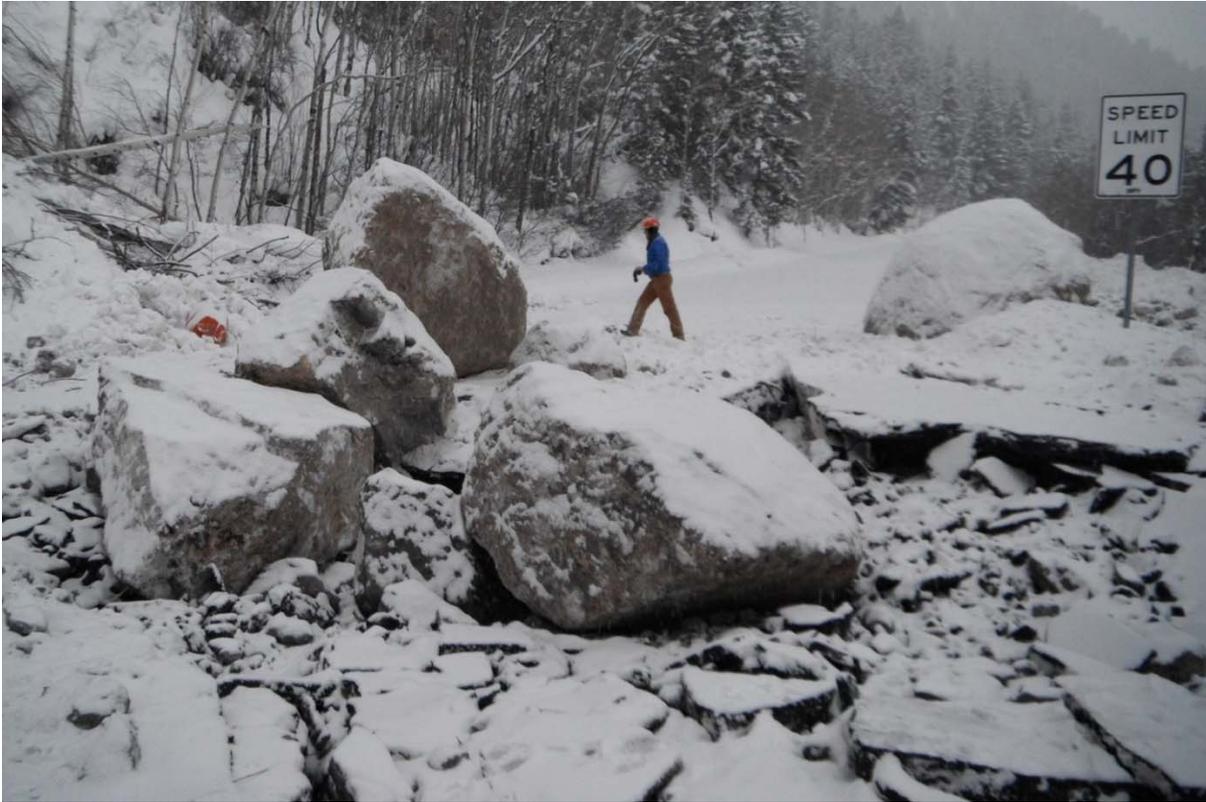
**Figure 2 – December 2014 US 24 rockfall event.**

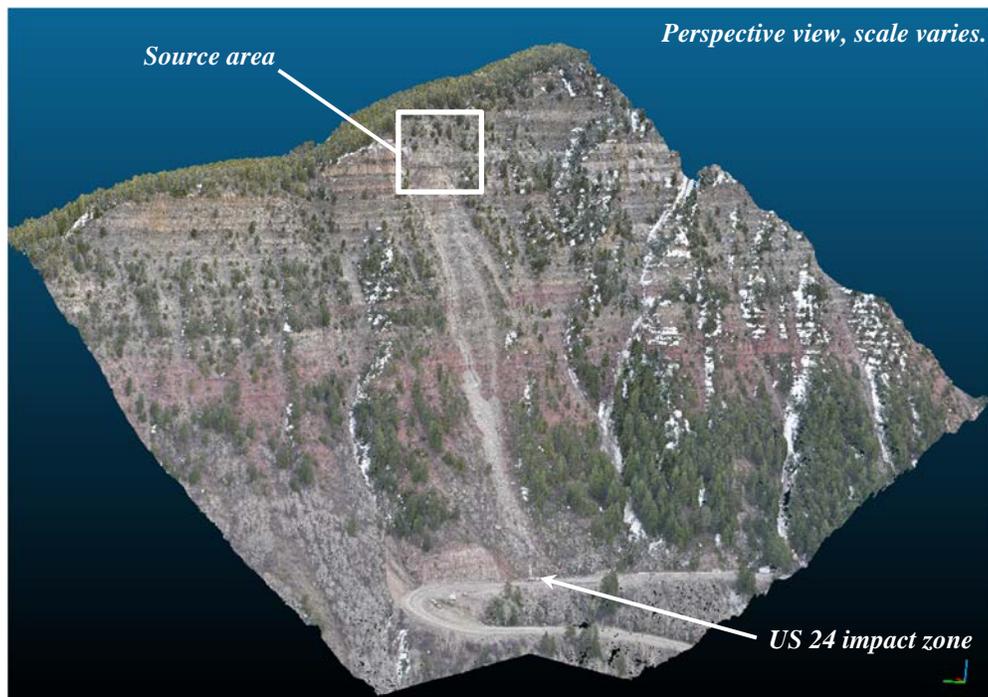
**Figure 3 – Oblique OAP model image of the US 24 rockfall site. The white box indicates the main rockfall source area, and the focus of the current study. US 24 is approximately 300m (vertical) below the rockfall source area.**

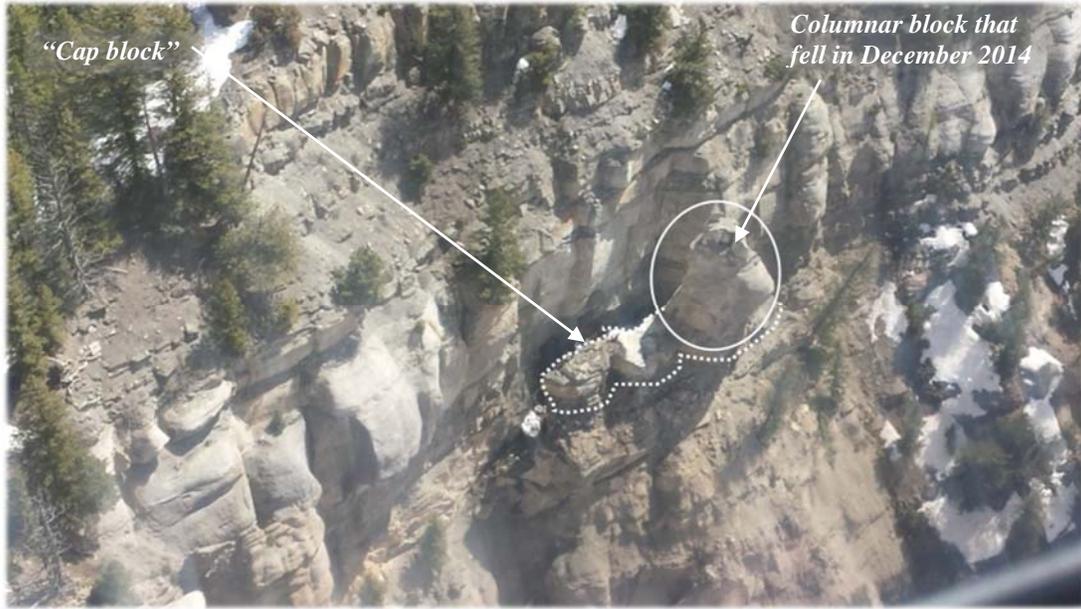
**Figure 4 – Oblique aerial photograph of rockfall source area in 2014, showing the columnar block that fell in December 2014. An adjacent column fell in April 2014.**

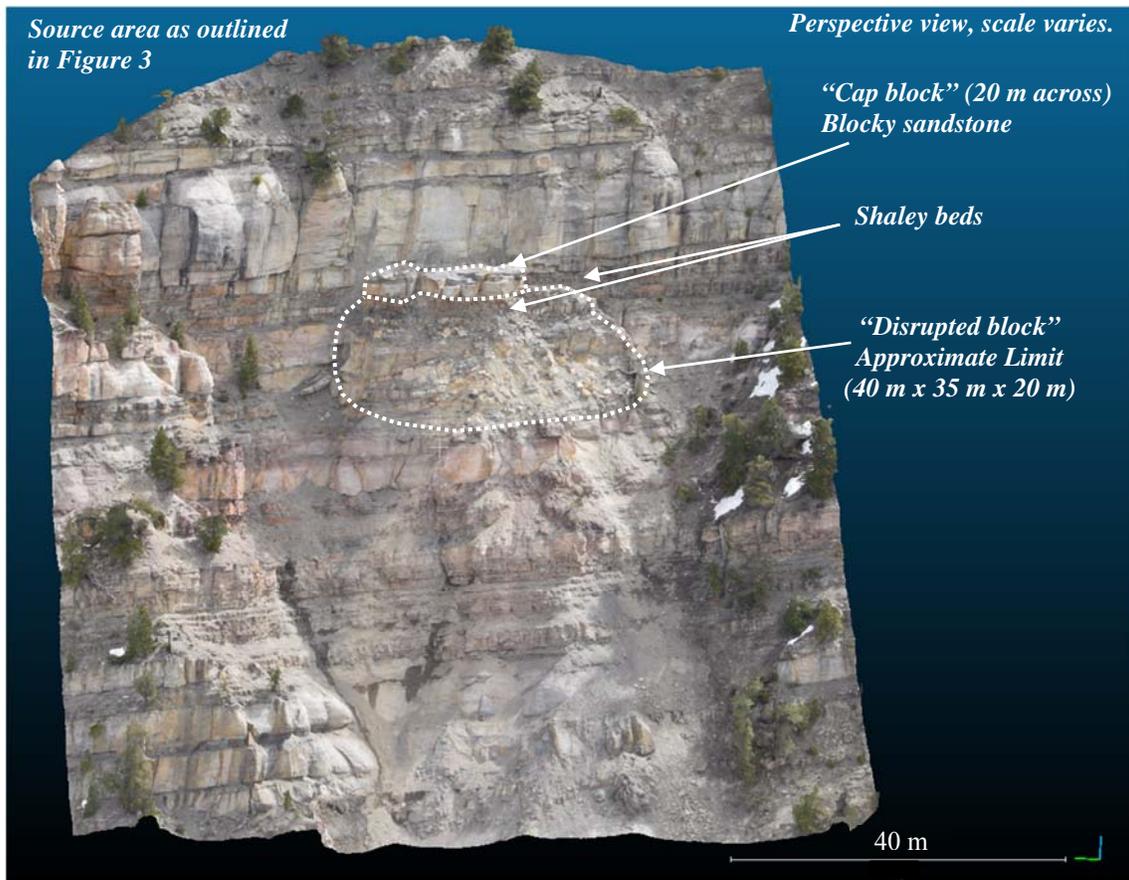
**Figure 5 – Oblique OAP model image of the rockfall source area on April 8, 2015 displaying the “cap block,” “disrupted block,” and shaley beds.**

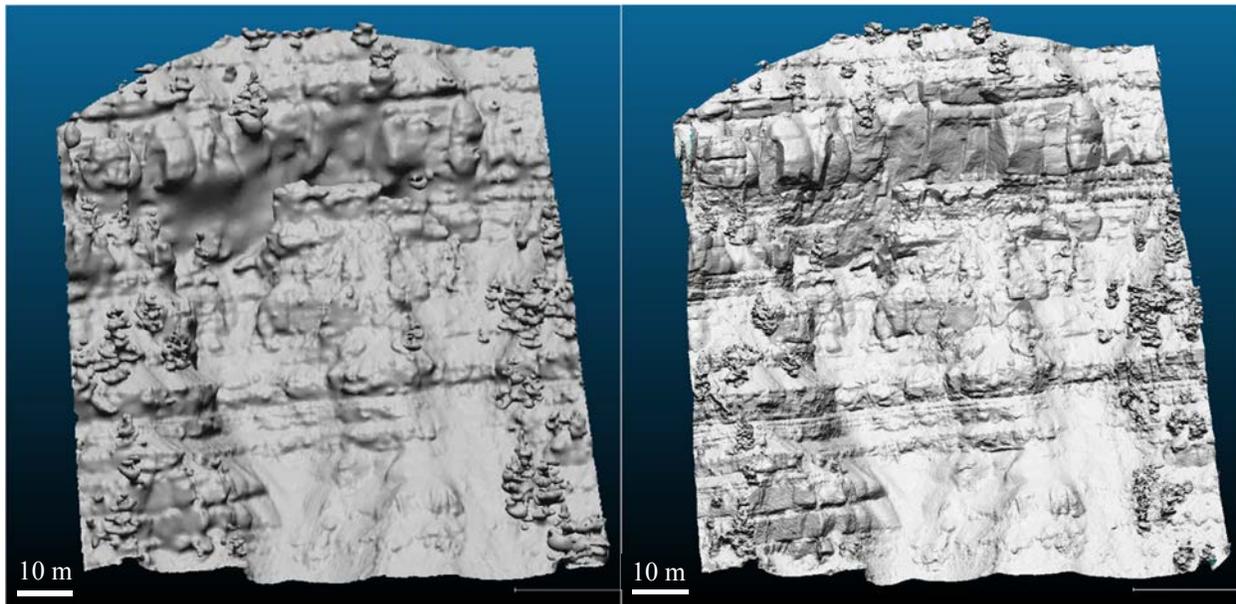
**Figure 6 – April 2015 meshed surface models, Airborne LiDAR scan (left) and Aerial Photogrammetry (right).**

Airborne LiDAR scans were collected by a commercial provider over the site and surrounding area on April 6, 2015, using a fixed-wing aircraft and Leica laser scanner. Raw and classified (bare earth and non-bare earth) point clouds were used in this analysis, to maximize the point density in non-vegetated areas. The ALS data were used as a baseline for spatial registration of the photogrammetry to geographic coordinates, and as a shape-accuracy check for the initial OAP models. A side-by-side comparison of ALS and OAP meshed surface models is shown in Figure 6.

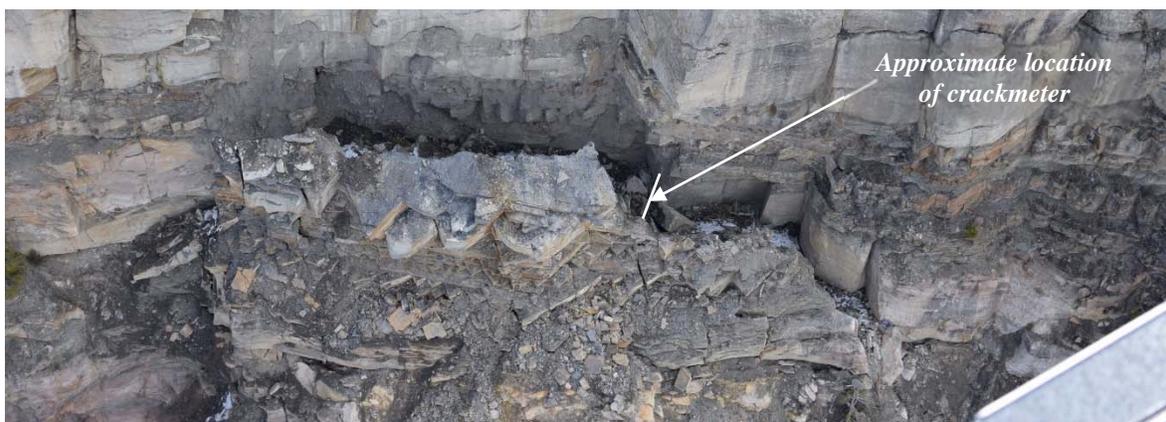
**Figure 7 – Oblique aerial photograph of rockfall source area; approximate location of Celesco string potentiometer (crackmeter).**

To validate the photogrammetric change-detection results, and for better temporal resolution, we gathered data from a Celesco string potentiometer (crackmeter) and Specto WASP datalogger that had been installed at the rockfall source area prior to the ALS and OAP scans (Figure 7). Crackmeter readings were converted from raw signal (mA) to displacement length (mm) based on signal endpoint tolerances and full stroke range and according to Celesco SPD-12-3 specifications. To investigate possible meteorological triggering or conditioning factors, precipitation and temperature data were gathered from a weather station in Vail, Colorado, located 10 km NW of the site (5,6).

Figure 11 shows the displacement signal from the crackmeter between April 8 and June 24, along with the change detected over the entire study period. Note that the crackmeter is positioned at or below the shaley bed (Figure 7), which the OAP data suggest may have moved by about 5 cm, which is just detectable in the OAP method. In any case, the crackmeter and OAP change signal from that area are in good agreement, with both showing close to 5 cm of movement during the course of this study. The 3D analysis for the entire block shows up to 15 cm or more movement close to the top of the block (Figure 10).

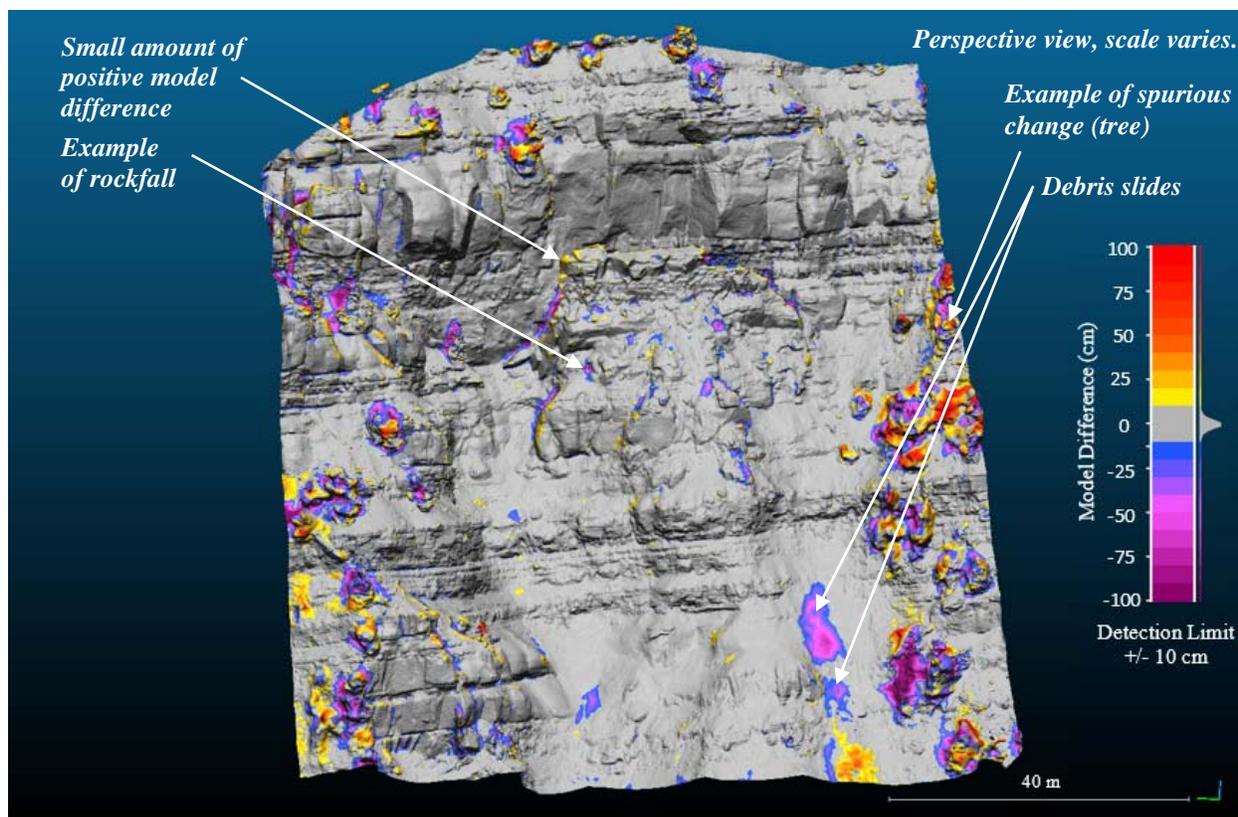
**Figure 8 – April 22, 2015 to May 13, 2015. Change-detection and examples of signal types summarized in Table 2.**

The most active period of discrete rockfalls detected during the change-detection campaign was April 22 to May 13, 2015. The source location for most rockfalls was a yellowish, blocky stratum below the cap block and shaley beds associated with the 2014 failures. Between April 22 and May 13, 2015 two prominent debris slide events occurred in the talus material below the main source of the 2014 rockfalls, as inferred from OAP change detection (Figure 8). These were between 50-100 m<sup>3</sup>, and were located at the top of discrete gullies. A relatively small amount (on the order of 5 cm) of positive model difference was detected during the interval of April 22 to May 13, 2015 in the area of the disrupted block. An area of positive (upward, in this case) model difference was located at the back of a portion of the cap block (Figure 8). This could be interpreted as an indication of a toppling motion during this 21-day interval, although confidence in this assessment came only after noting further movement of this and adjacent blocks over the entire study period.

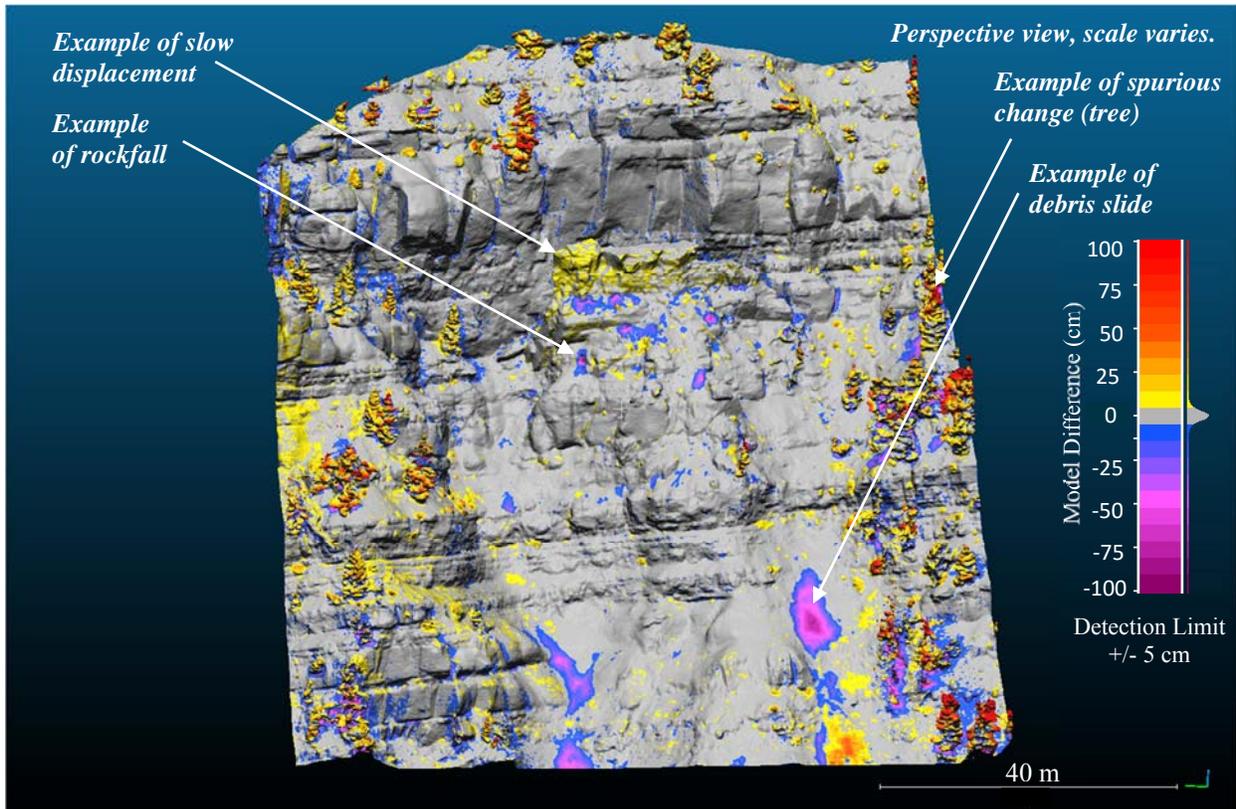
**Figure 9 – April 8, 2015 to June 24, 2015. Change-detection and examples of signal types summarized in Table 2.**

Over the entire study period – April 8 to June 24 (Figure 9, 10) – there was an area of consistent positive model difference across the cap block and shaley strata below. This positive model difference was tentatively interpreted as true deformation, pending supporting evidence from instrumentation. Elsewhere, rockfall blocks typically less than 1 m<sup>3</sup> in volume were detected, and likely ran out into the gully leading to the highway, as no corresponding deposition was noted in the source area or reported at the highway. Often a long-term spatial pattern in small rockfalls delineates an incipient larger failure area, or a slowly moving block (7). The rockfalls detected throughout this study are stratigraphically below the main source area of the 2014 rockfalls, but otherwise no obvious spatial pattern is noted.

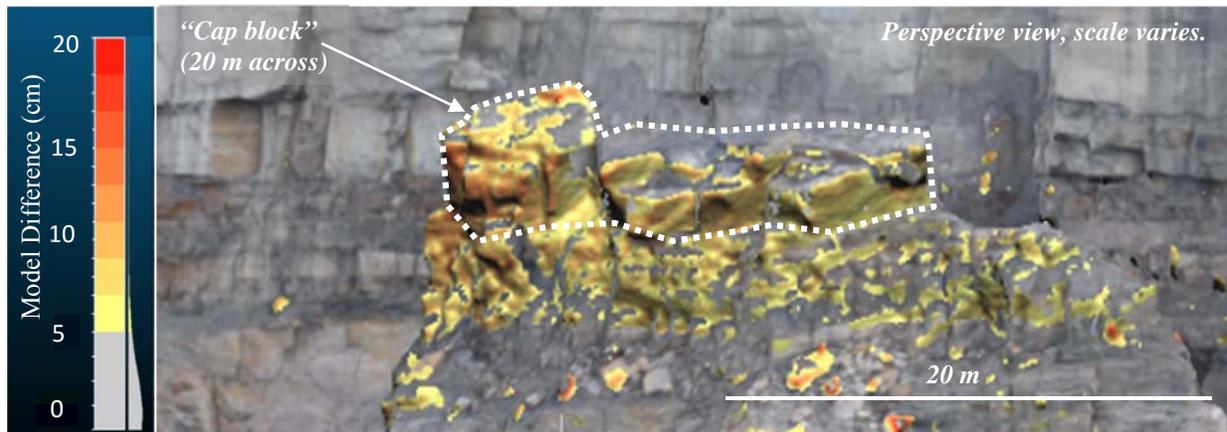
**Figure 10 – OAP change-detection between April 8 and June 24, 2015. Typical model difference between 5 and 15 cm.**

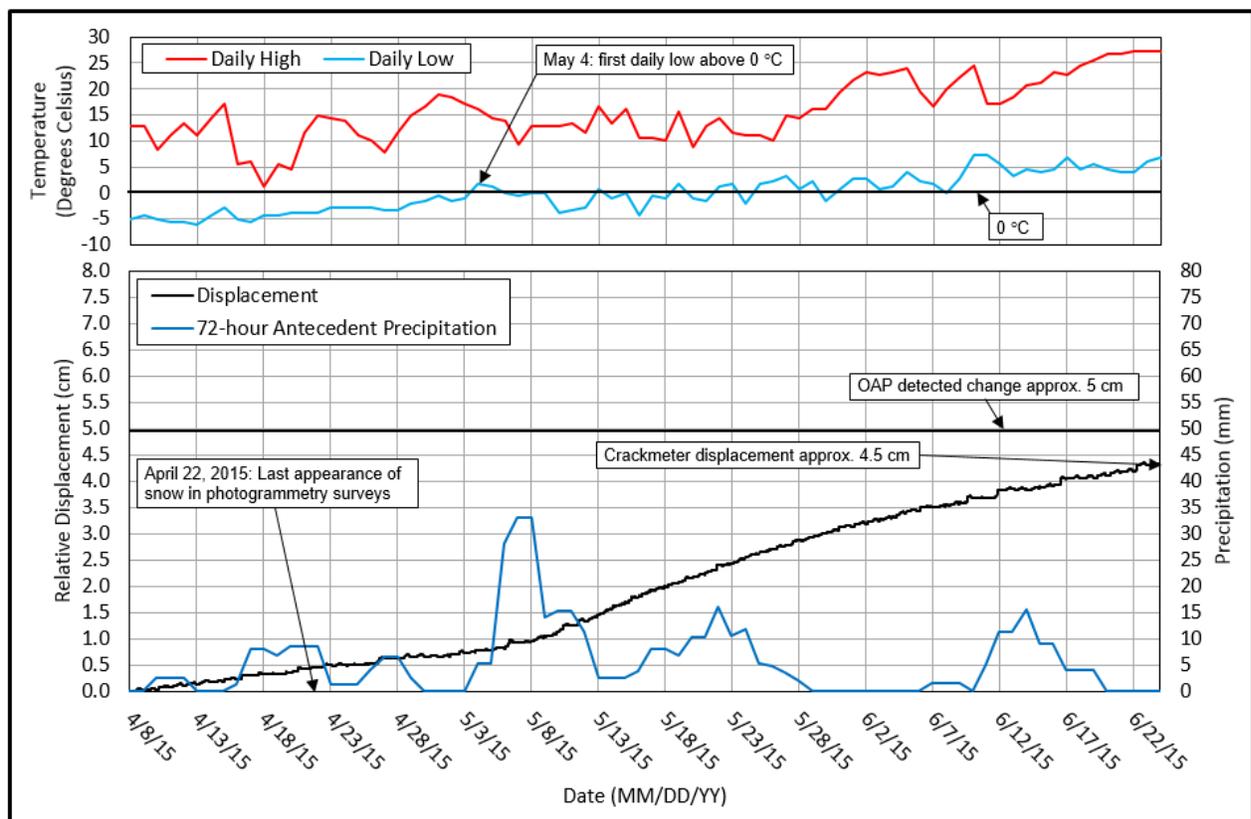
**Figure 11 – Crackmeter displacement, 72-hour antecedent precipitation, and daily high and low temperatures between April 8, 2015 and June 24, 2015.**

Daily high and low temperature and 72-hour antecedent precipitation are plotted along with the crackmeter data in Figure 11. The 72-hour antecedent precipitation signal reached its peak of approximately 35 mm between May 7 and 8, 2015, corresponding with an acceleration in the crackmeter displacement readings. The Vail weather station reported daily air temperatures above and below freezing every day between April 8 and May 3, 2015, which may have driven repeated freeze-thaw cycles at the Tennessee Pass site. May 4 was the first day temperatures did not drop below 0 °C. Between May 4 and May 30, temperatures dropped below 0 °C 12 out of the 27 days. Between May 31 and June 22, the temperature did not drop below 0 °C.

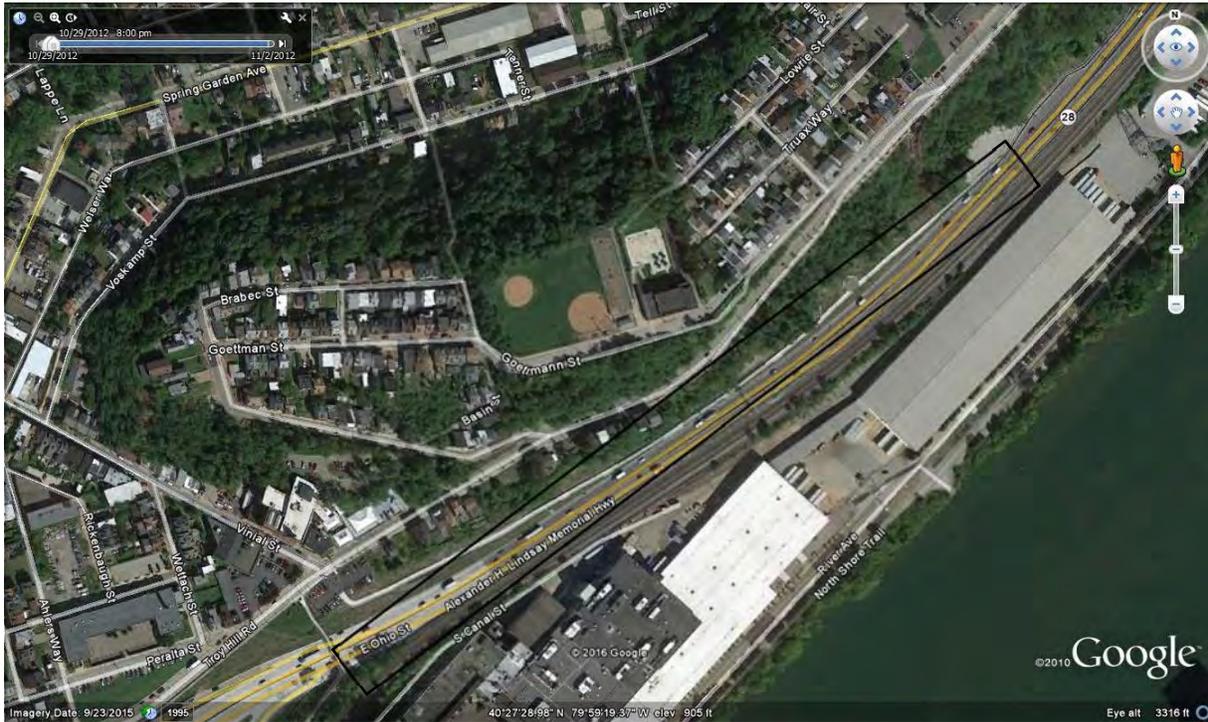
**Figure 2, Location of off-line walkway**

The walkway was added late in the final design process, and required additional surveys, geotechnical investigations, alignment and earthwork plans, and design of a retaining wall. The walkway starts at a parking lot on Troy Hill Road near the south end of the project, and connects with the standard sidewalk along SR 28 at its eastern terminus just under 2000 feet away. As it leaves the parking area, the walkway is 12 feet wide for approximately 150 feet. It then transitions to a 10-foot width that it maintains until it transitions to the standard 5-foot width approximately 200 feet from its eastern terminus at the roadside sidewalk.

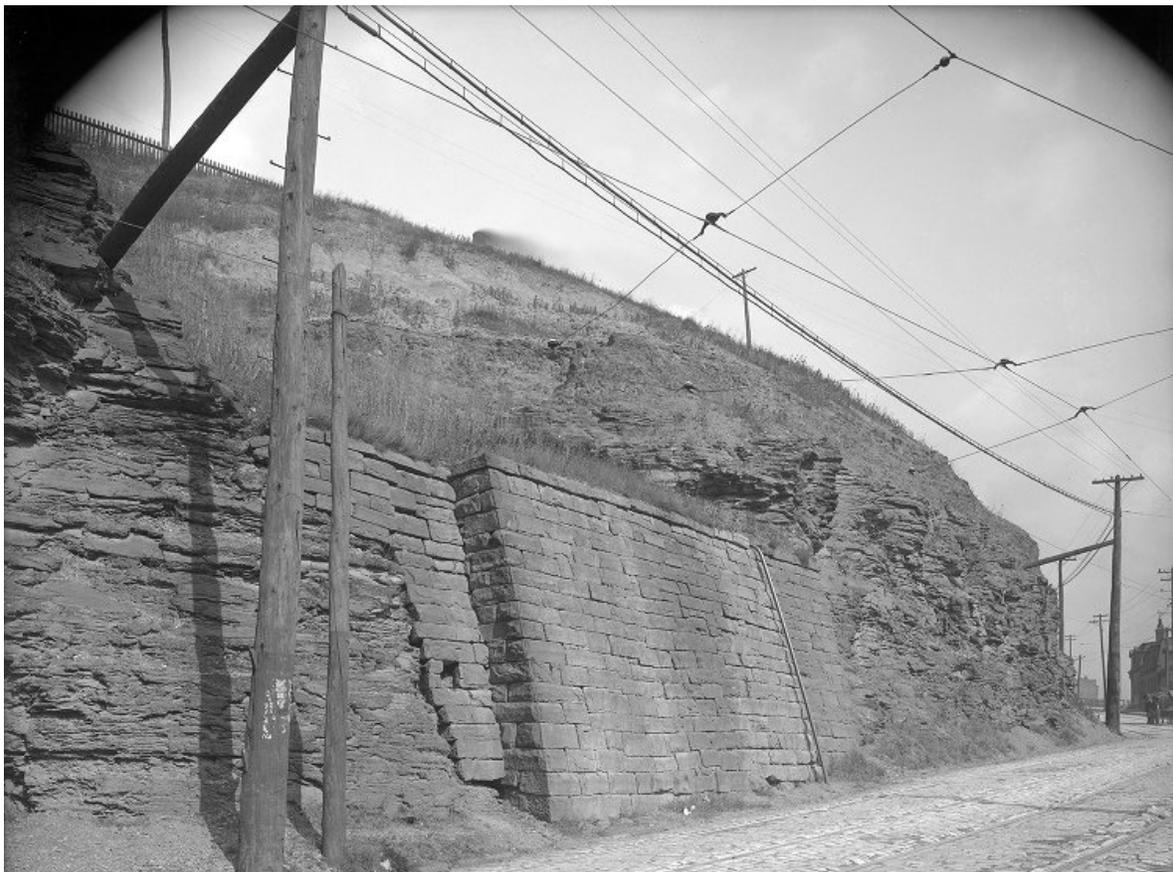
**Figure 3, Location of penstocks above Troy Hill Road**

A historic image related to the reservoir showed a wall constructed between two outcrops above Troy Hill Road where the penstocks went down the hill (see Figure 3).

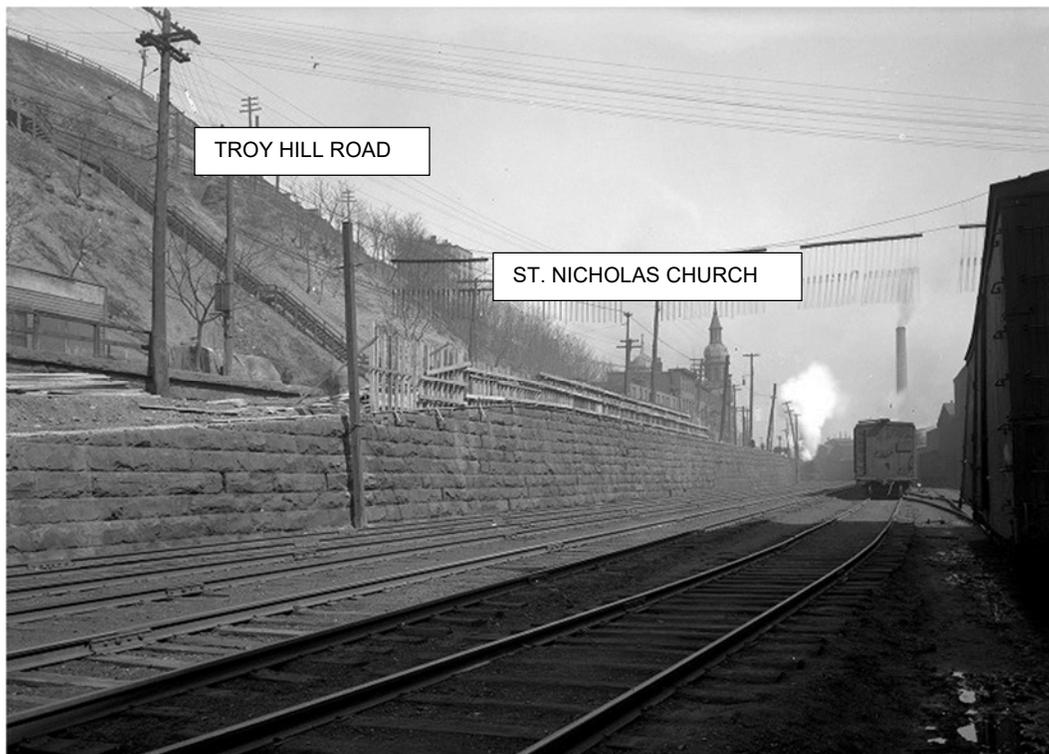
**Figure 4, Sparse vegetation and key features, East Ohio Street, 1921**

Other historic images showed conditions at a time when Pittsburgh slopes were only sparsely vegetated due to air pollution (see Figure 4). The nearly horizontal stratigraphy and poorer quality lower bedrock were evident in these images.

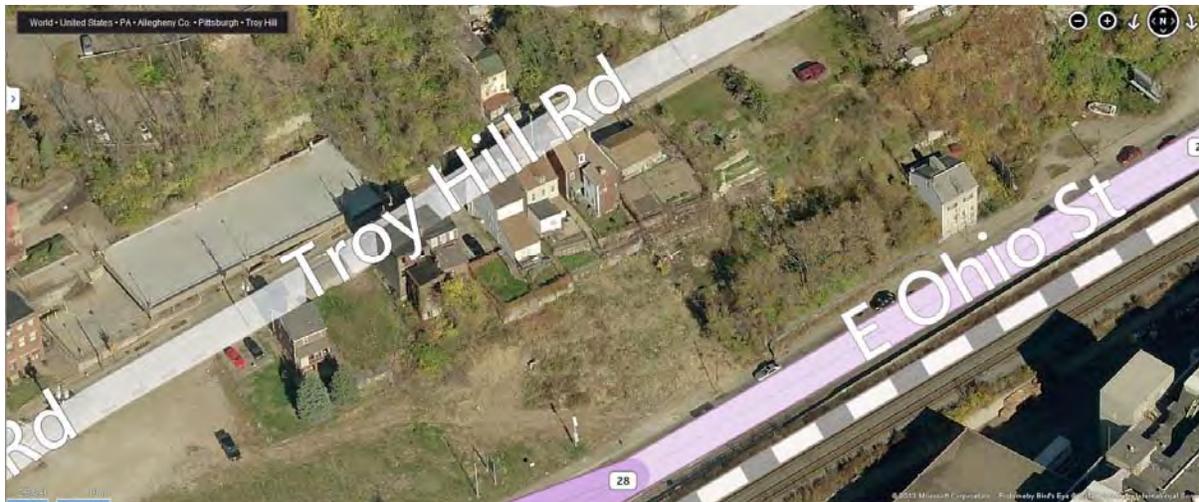
**Figure 5, Construction of terraces behind residences along Troy Hill Road (Bing® photo)**

In addition to recent aerial photography obtained specifically for the project, both Google® and Bing® photography were reviewed for potentially significant site features. Bing® photography confirmed the property owner encroachment and construction of multiple terraces with low walls of questionable design and stability (see Figure 5). Google® photography allowed specific locations of recent demolitions to be determined.

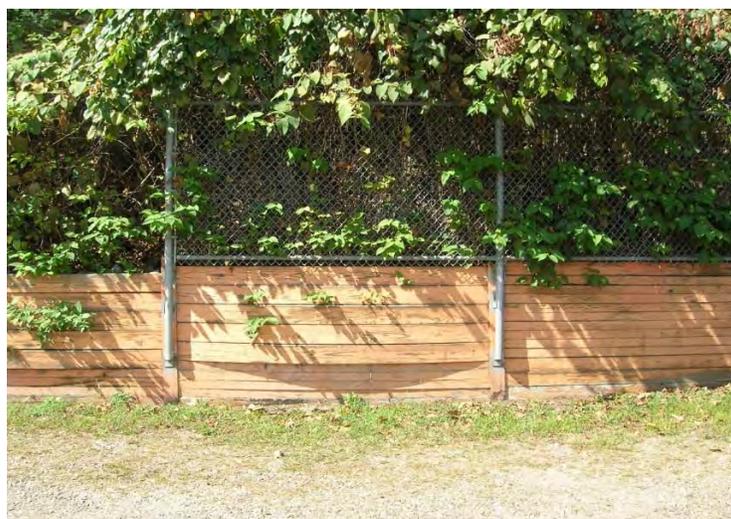
**Figure 6, Local wall in failure near SR 28, with accumulated talus and debris**

Armed with information gleaned from historical research, a very detailed site reconnaissance was performed to document existing conditions on the slope between Troy Hill Road and East Ohio Street. Fifty-scale topographic plans were used as base maps for the reconnaissance notes. Besides natural conditions like bedrock outcrops, man-made alterations like walls and basements were documented. In addition to notes on the plans, many photographs were taken to document conditions. Refer to Figures 6 and 7 for examples.
