HGS 2016  
Proceedings

# 67TH HIGHWAY GEOLOGY SYMPOSIUM

## JULY 11 – 14, 2016

Cheyenne Mountain Resort  
COLORADO SPRINGS, COLORADO

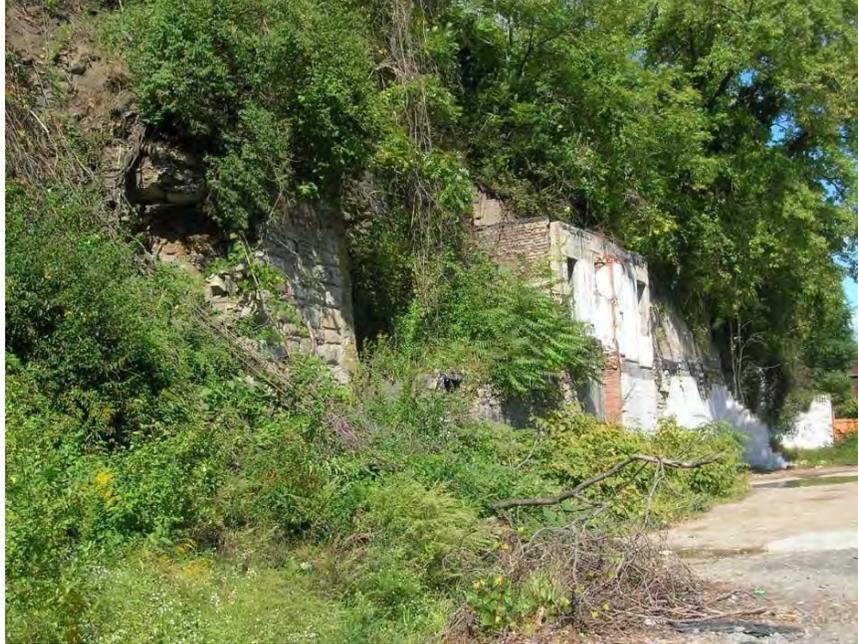
**Figure 7, Failed stone block facing over bedrock; abandoned two-story building walls**

Armed with information gleaned from historical research, a very detailed site reconnaissance was performed to document existing conditions on the slope between Troy Hill Road and East Ohio Street. Fifty-scale topographic plans were used as base maps for the reconnaissance notes. Besides natural conditions like bedrock outcrops, man-made alterations like walls and basements were documented. In addition to notes on the plans, many photographs were taken to document conditions. Refer to Figures 6 and 7 for examples.

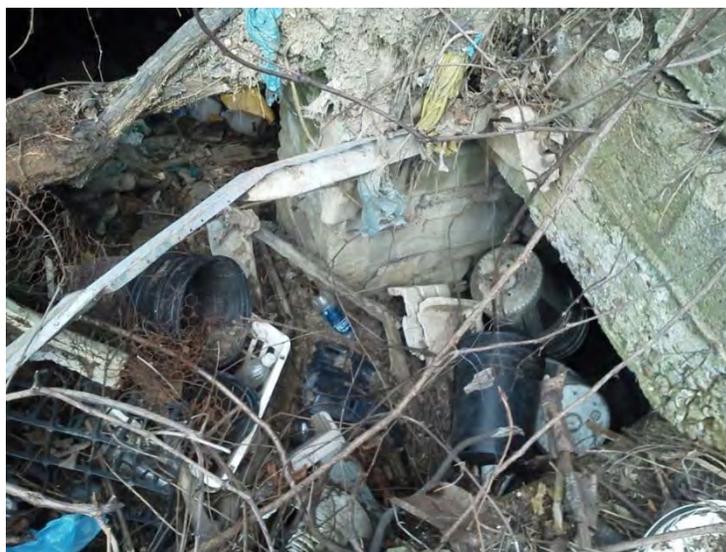
**Figure 8, Basement backfilled with debris**

The penstocks were found to be partially exposed on the slope above SR 28, below the area of wall construction along Troy Hill Road. Areas of previous demolition were checked, and sometimes found to be backfilled with trash or other debris (see Figure 8). Three large underground vaults were found extending into the hillside bedrock from the backs of basement walls (see Figure 9). These were explored as much as practicable, given safety concerns.

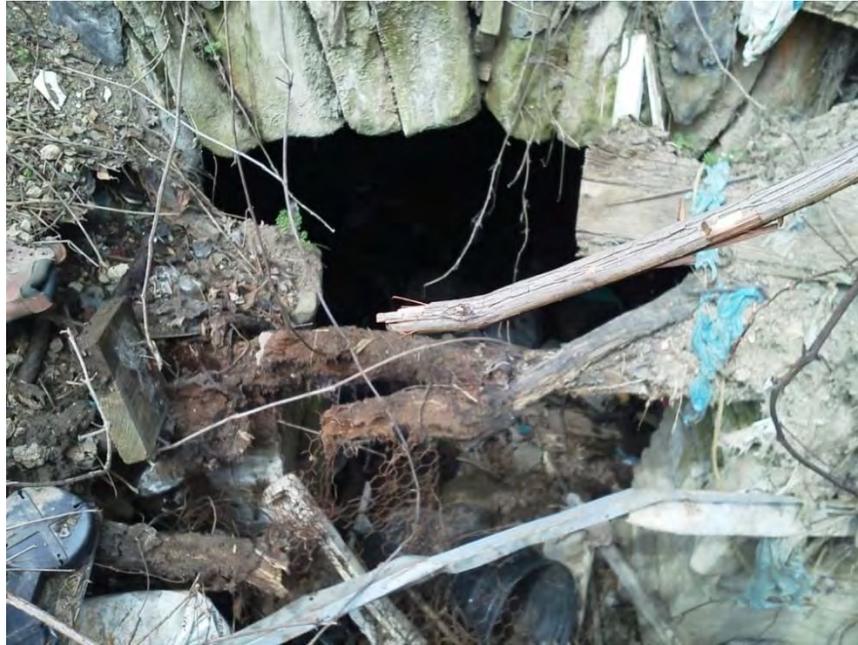
**Figure 9, Arched top of entrance to underground vault**

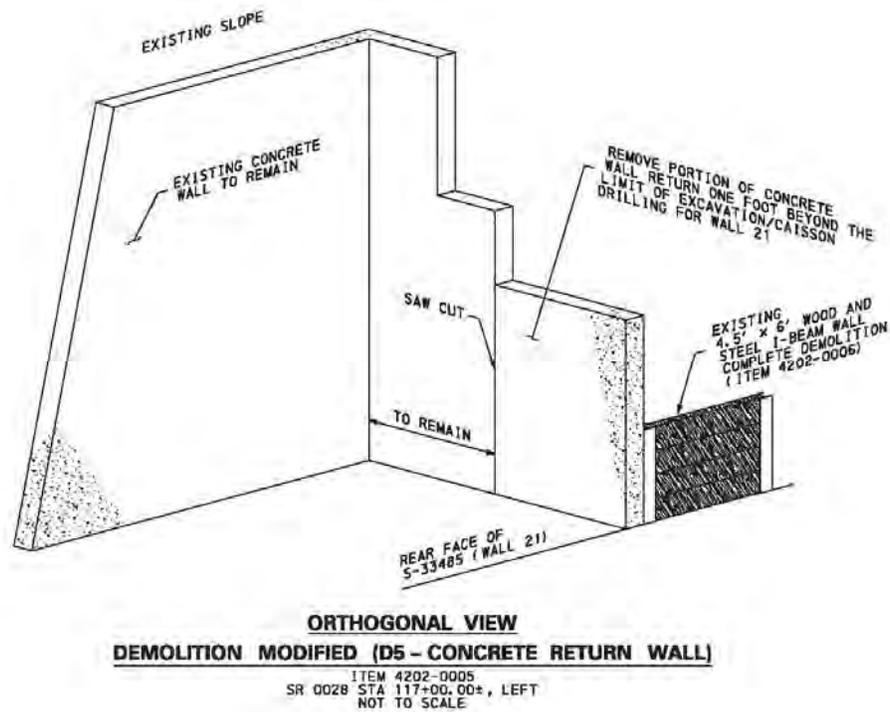
**Figure 11, Demolition detail**

In addition, these Existing Conditions and Demolition Plans identified 14 discrete areas where specialized demolition was required. These various demolitions included removal of a grape arbor, removal of a steel beam and wood lagging wall, saw cut and removal of existing walls not retaining earth, backfill of existing open cellars and underground vaults with flowable concrete

fill, removal of existing demolition debris in the church basement and proper backfill with compacted embankment material, and full demolition of the rectory and church garage, including a failed retaining wall externally braced against the rectory. These plans included details of specific demolitions in plan view, elevation view, and orthogonal view as necessary (see Figure 11).

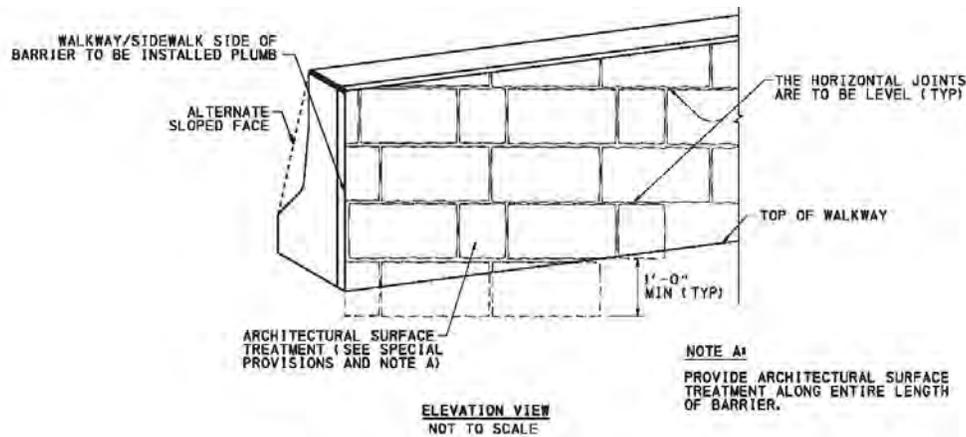
**Figure 12, Special single-faced barrier detail**

The Geometric Layout Plans, Typical Sections, and Contour Grading and Drainage Plans provided the construction direction for the walkway itself. The line and grade assured it would be constructed on embankment, and excavations into the hillside would be minimized. These roadway plans also included details for pedestrian railings, special single-faced barrier along the walkway (see Figure 12), and the octagonal alcove area near the former church area.

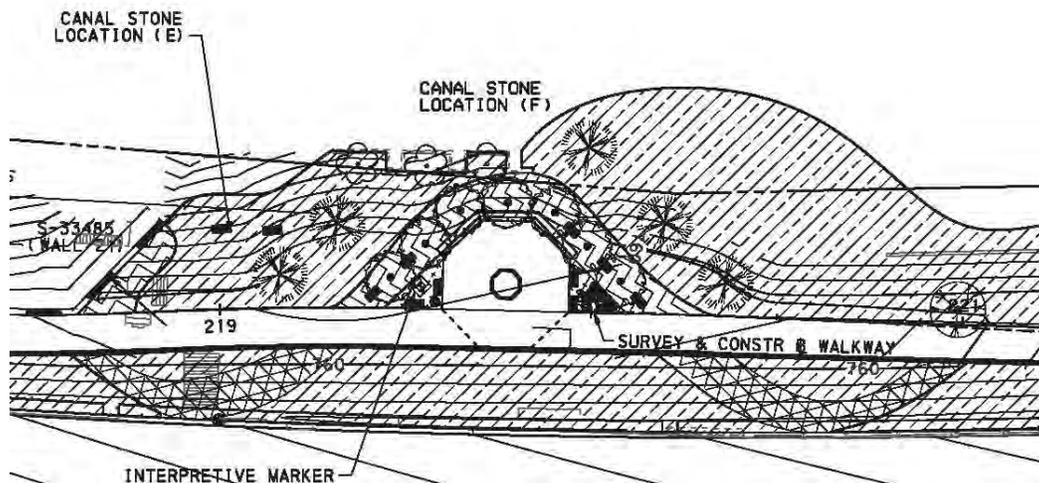
**Figure 13, Landscaping plan at the octagonal alcove**

This walkway was to be aesthetically pleasing to the public from its initial inception. A full set of landscaping plans was developed, including decorative use of historic canal stones and placement of an interpretive marker at the former location of the church as well as special plantings of ornamental trees (see Figure 13).

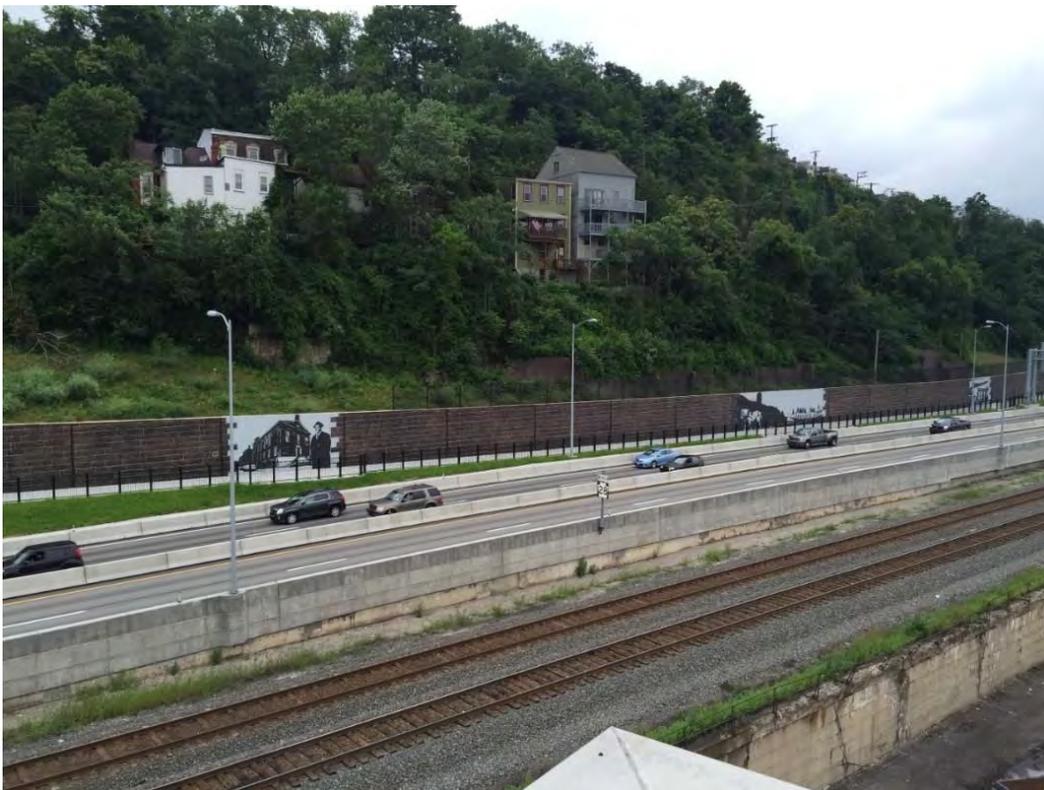
**Figure 14, Walkway, showing retaining wall with images, stained pre-existing walls, and protective fence**

Successful construction of the walkway and its wall is evident in Figures 14 and 15, showing the area soon after completion of construction in 2015.

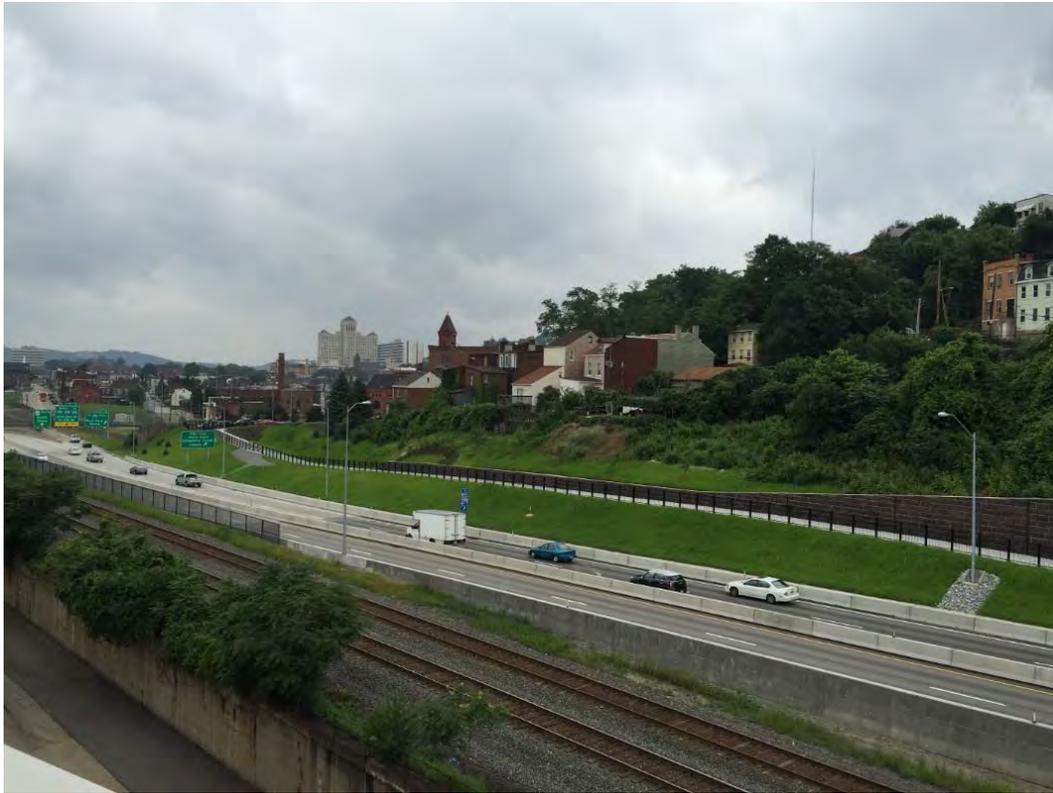
**Figure 15, Walkway with connection to Troy Hill Road in the distance.**

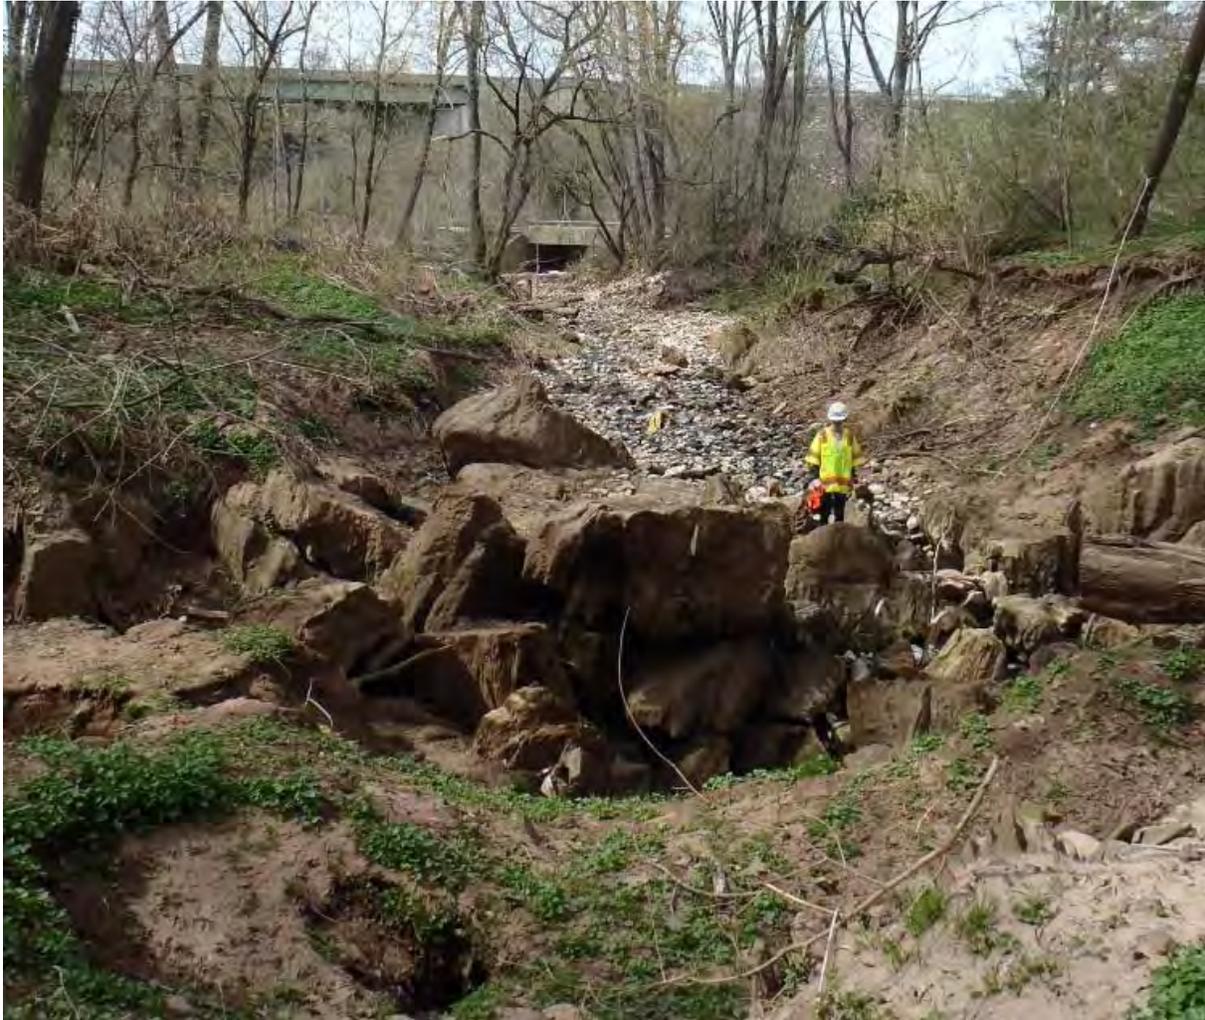
**Downstream sinkhole with the Plymouth Road Bridge and the I-476 overpass in the background.**

Plymouth Creek is riddled with sinkholes, ranging from small to very large. Over the course of the last five decades a significant sinkhole 300 feet downstream from the bridge has been monitored and observed to effectively swallow the creek except during large storm events. This sinkhole is so dramatic the scene is regularly used by Geotechnical Engineers and Geologists as an example of near surface karst activity. While it was known the local geology was prone to karst activity, significant unanticipated sinkhole repairs were needed during construction of the Turnpike interchange. It was reported that \$750,000 was spent to fill in sinkholes (equivalent to \$1.4 million in today's dollars). Throughout the last few decades a few sinkhole events occurred at the bridge which resulted in significant repairs. In 1988 a sinkhole appeared upstream of the bridge between the wingwalls. This sinkhole was repaired using the traditional method of filling with concrete. In 1993, two sinkholes appeared on Department right of way, one upstream near the east wingwall and one in the center of the streambed beneath the bridge in conjunction with sinkholes on the adjacent Turnpike property. Photographs of this event show the sinkhole beneath the bridge was taking the entire flow of the creek. These were repaired using the method of filling the sinkhole with sandbags, "slurry concrete" and debris. This last event and the required repairs resulted in a decision by PennDOT to line the streambed from the end of the lined Turnpike culvert to the ends of the downstream wingwalls. Since the lining was placed in 1994, a few minor sinkholes emerged downstream but not adjacent to the bridge. In 2005

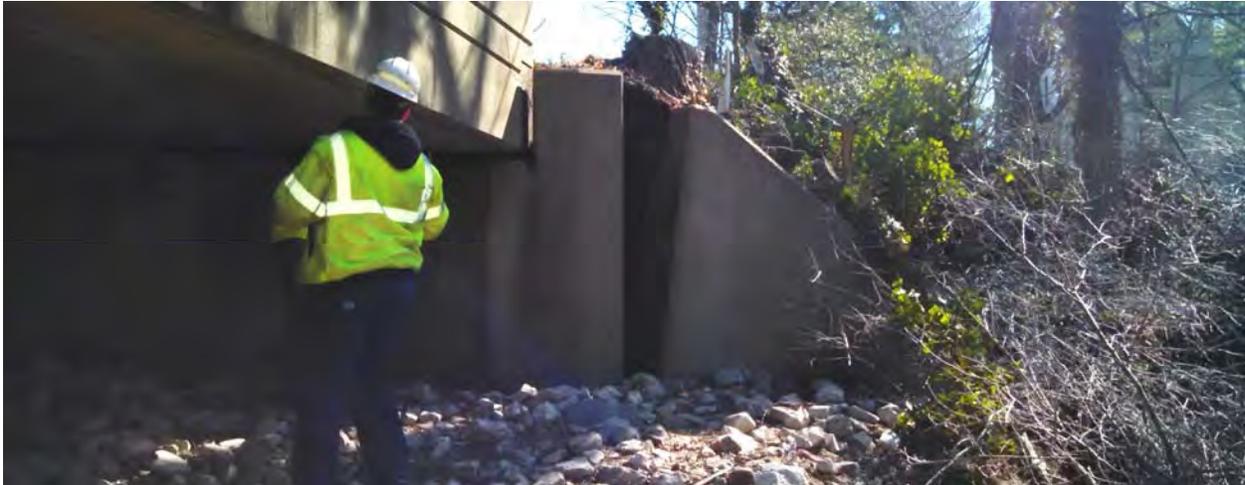
**Subsidence and rotation of the abutment and wingwall**

Because of its history, the site was routinely observed by PennDOT Bridge and Geotechnical staff. In December of 2014 a sinkhole opened up immediately downstream of and adjacent to the end of the apron. On March 12, 2015 during a routine field visit, movement of the east abutment and southeast wingwall were observed and PennDOT bridge inspectors were immediately dispatched to the site for an emergency bridge inspection. Subsidence of the west abutment and rotation of the southwest wingwall were significant and as a result the Plymouth Road Bridge was closed.

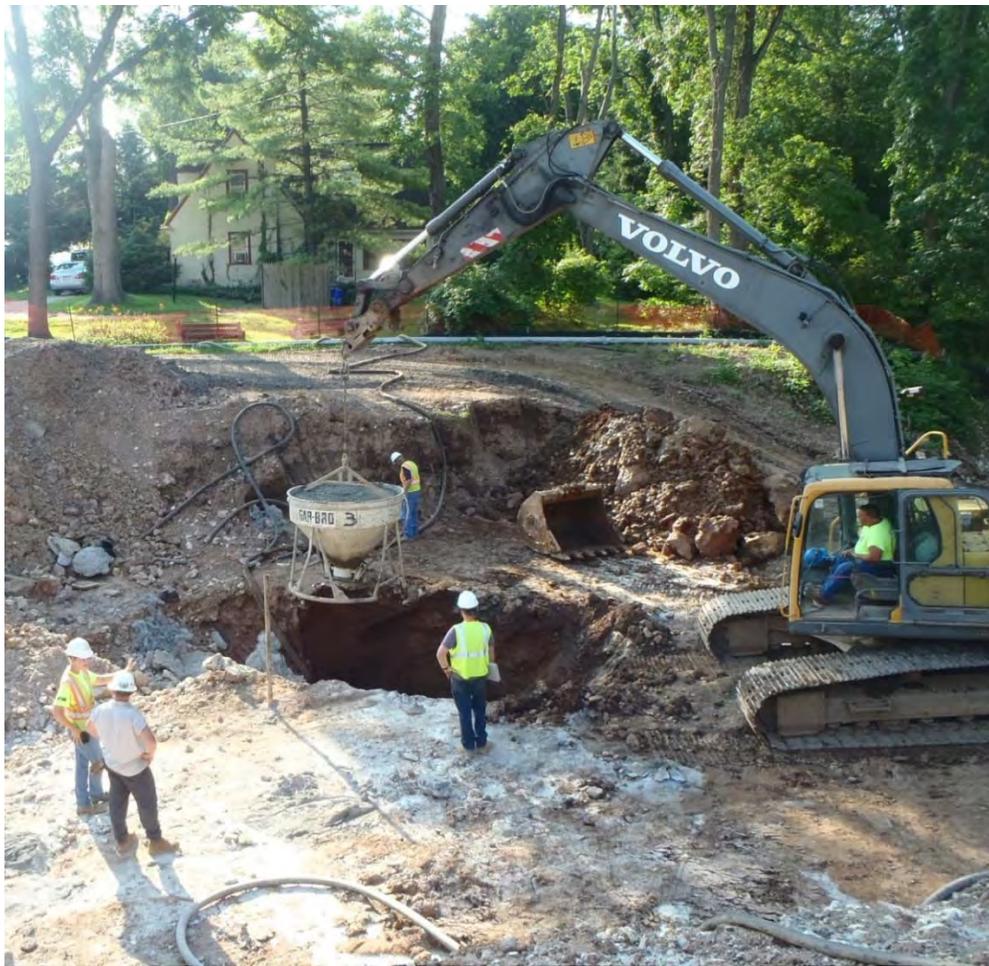
**Repairing the “Monster” Sinkhole**

The largest sinkhole was at the southeast corner, where the bridge had failed. The contractor had difficulty locating the exact throat of the sinkhole. Rock was placed and the apparent opening concreted closed. Soon after the installation of the micropiles began, a significant rain event occurred and the sinkhole opened back up, this time larger than before. An additional micropile was installed at this location to provide added support for the bridge. Over the course of a few wet weeks in late May and early June several sinkholes presented themselves. This highlighted the ever-changing conditions the contractor had to deal with while keeping the construction moving along to meet the open date.

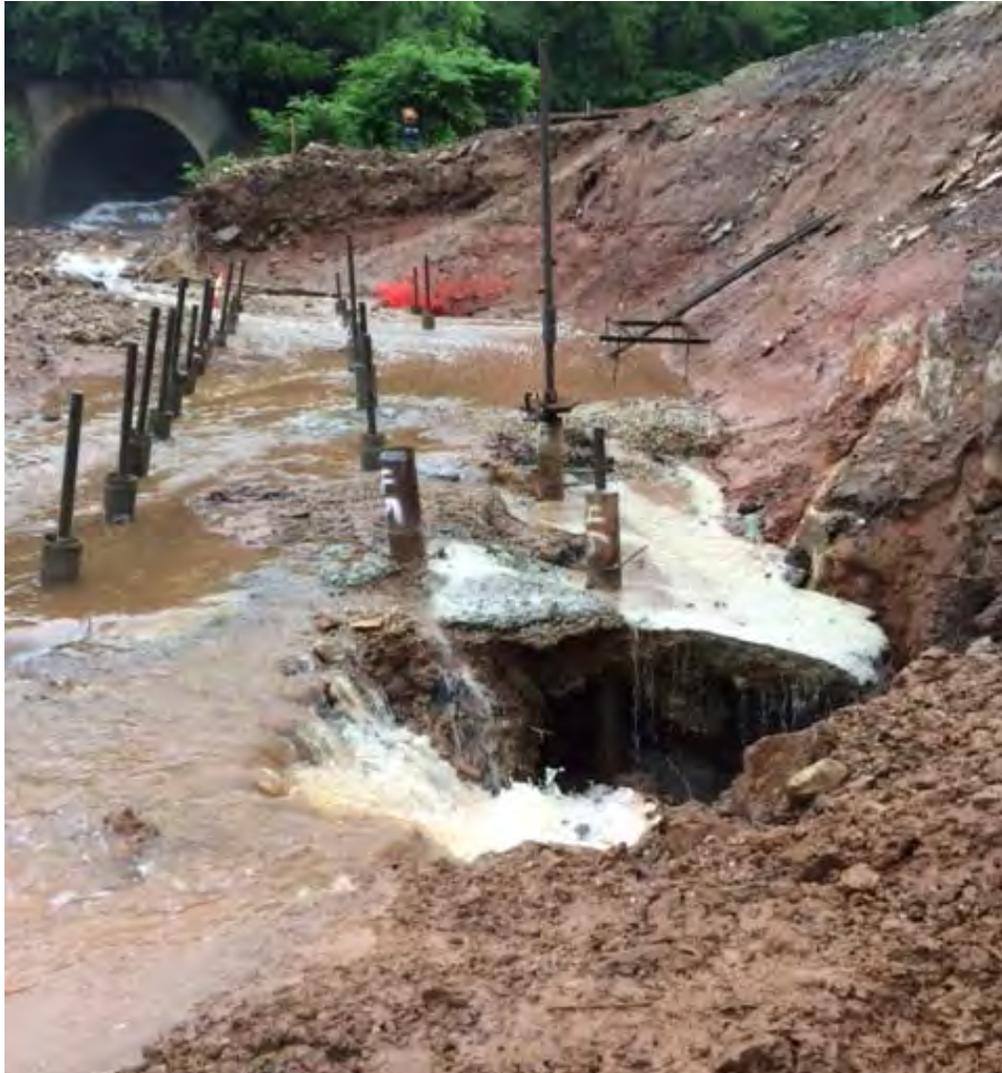
### **Southeast Sinkhole Second Opening**

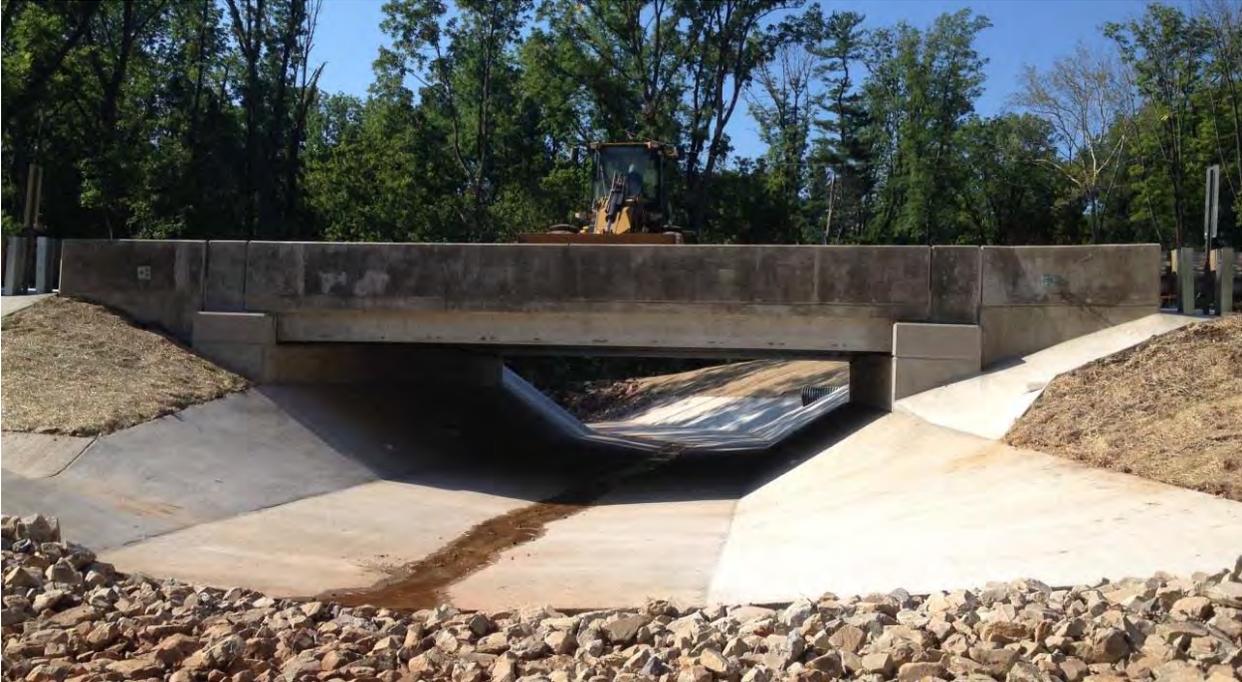
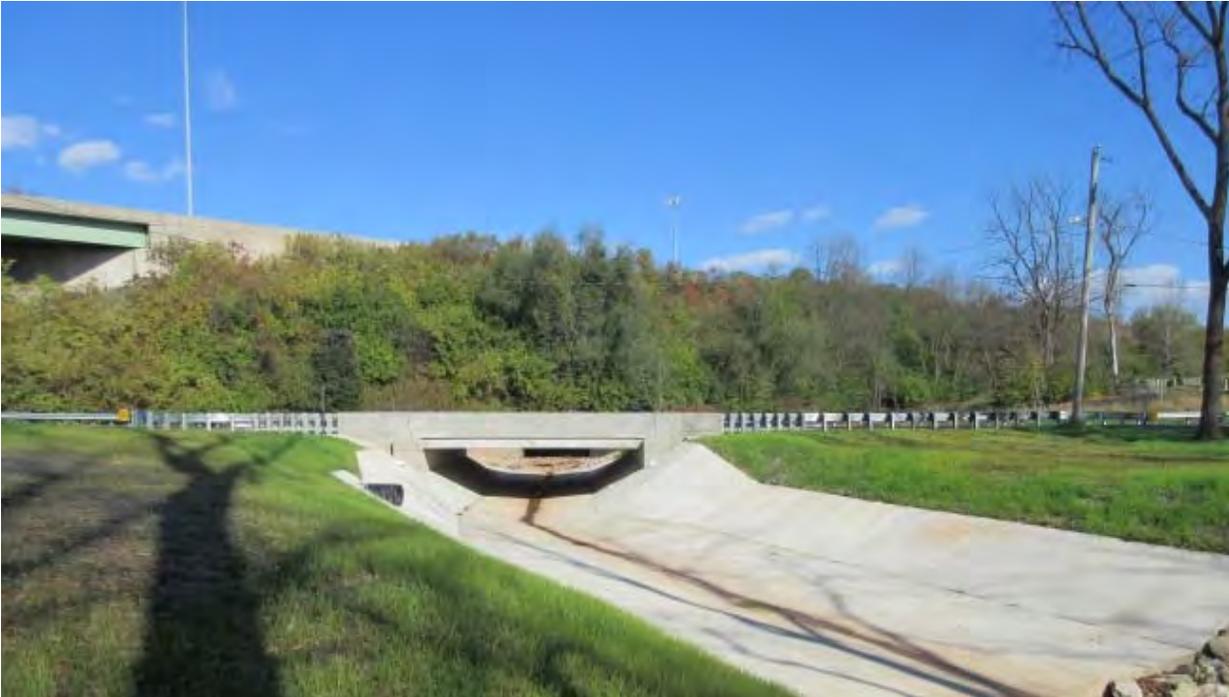
**Completed Plymouth Road over Plymouth Creek**

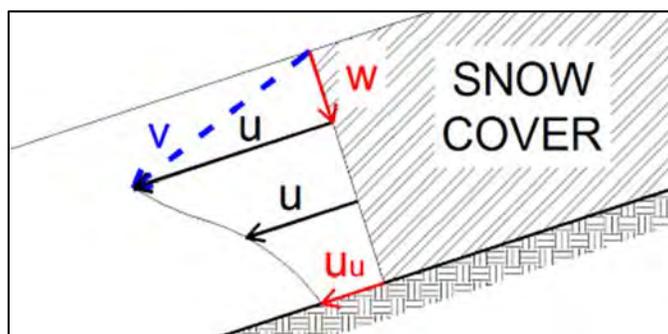
**Figure 1** - Glide and creep velocity in the snow pack. Where:  $w$  = creep velocity normal to the slope;  $u_u$  = glide velocity;  $u$  = velocity component parallel to the slope (shear);  $v$  = resultant velocity vector. (Reference Fig. 4 of the Swiss Guideline, 2007).

1. Creep: it is due to the weight of the snow, which defines the settlement and the shear deformation parallel to the slope:
2. Glide: it depends on the type of soil (roughness) and on the possible water presence at the interface between the soil and the snow. It is the downslope motion of the snow pack.

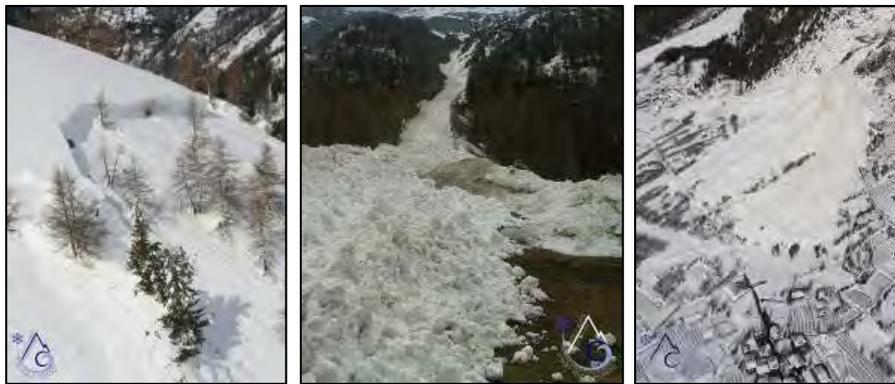
**Figure 2** - Photos of the 3 typical different areas of the avalanche. Left: starting zone; Centre: sliding zone; Right: sticking zone.  
(Photos courtesy of Regione Autonoma Valle d'Aosta – Snow and Avalanches Dept.).

- Detachment area (starting zone): it is the area where the avalanche originates. Normally it is defined above the tree line, or by the mountain crests or ridges, or where there is a snow accumulation due to new snow falls or wind transport. In this area the unstable snow starts to move downslope. Creep movement and a subsequent glide mechanism can occur at the ground surface level. The movements depend on several factors, such as: slope inclination (generally between 30 and 60 degrees), snow thickness, soil roughness, type of snow (humidity, friction, unit weight, plasticity, etc.), wind and sun exposure, etc. (Figure 2, left).

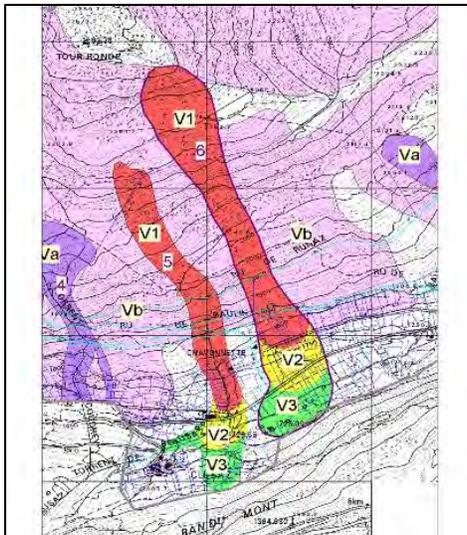
**Figure 3** - Highlight of a cartographic map of avalanche risks. Legend: Va (in purple): areas exposed to avalanche phenomena; Vb (in pink): areas with high probability of avalanche; V1 (in red): area with high risk; V2 (in yellow): areas with medium risk; V3 (in green): areas with low risk. (Avalanche map of Aise municipality, Aosta Valley Region (Italy). Courtesy of Geol. Stefano De Leo).

The first tools used to reduce avalanche hazards are specific maps (Figure 3). Usually these plans identify potential areas affected by avalanche phenomena. These maps are based on historical and observed evidence, on geomorphological and geological parameters, on the type of vegetation and air photos, etc. These specific maps give all the information necessary to plan construction of new structures; (i.e., houses and other residential complexes), infrastructures; (i.e., roads, highways, railways, etc.) and ski areas; (i.e., lifts and ski slopes). Moreover, they allow strategic planning in order to locate the avalanche mitigation systems.

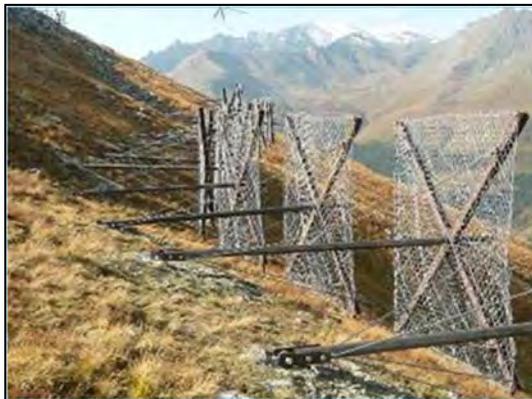
**Figure 4** - Lateral view of an Umbrella Structure (ErdoX).

As shown previously, several types of active retaining snow structures are available in the market. In recent years we have seen more and more projects using umbrella systems due to the speed and ease of installation. Umbrella structures are formed by modular mono-anchoring elements. The single unit is a cross-shaped structure made with beams supporting a facing composed of a wire rope panel combined with a double twist mesh. The connection between the front panel and the anchor is made through a tubular tie with the housing for a ball joint. The upslope bracing cables for load transfer connect the front panel with the anchor and the tubular tie. The anchor consists of a flexible double leg anchor.

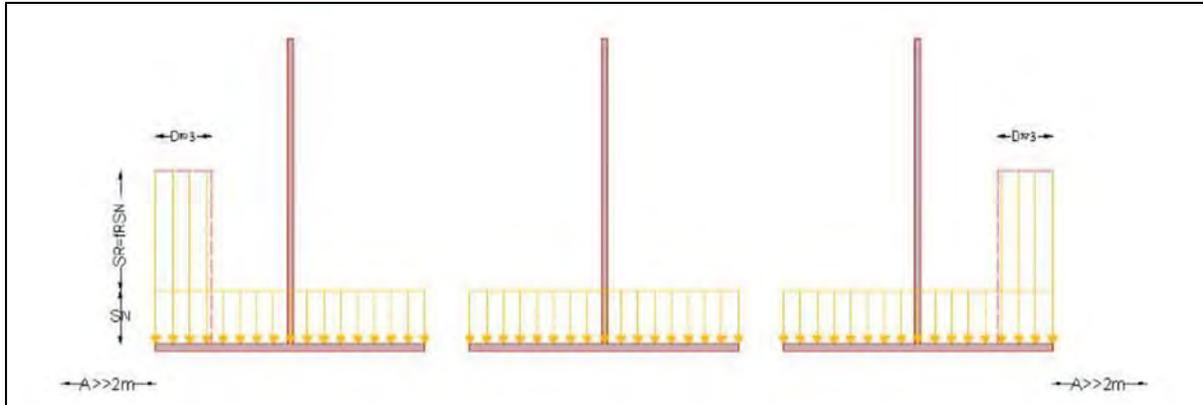
**Figure 5** - Simplified graph of the snow pressure distribution acting on an umbrella system. (Reference Fig. 17 of the Swiss Guideline, 2007).

- $f_R$  = marginal factor that depends on the lateral distance between the structures ( $A$ ), and the coefficient  $N$ ;
- $\Delta L$  = length where  $S'_R$  is acting, it depends on  $A$ .

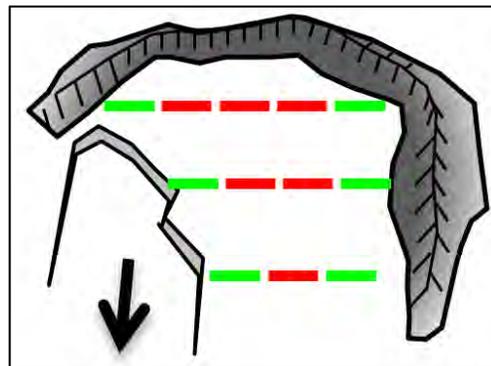
**Figure 6** - Disposition of Umbrella structures: green dashes represent the position of interval and end sections (RF, WF); red dashes represent the position of the intermediate section (MF).

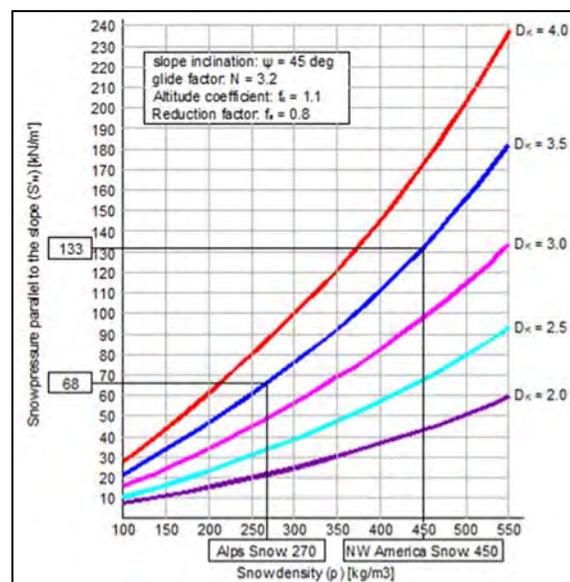
**Figure 7** - Variation of the snow pressure ( $S'_N$ ) with different snow density values ( $\rho$ ). The figure shows also the comparison between the Alps ( $\rho = 270 \text{ kg/m}^3$  [ $16.86 \text{ lb/ft}^3$ ]) and the North Western America environments ( $\rho = 450 \text{ kg/m}^3$  [ $28.10 \text{ lb/ft}^3$ ]). (Castaldini, 2012).

The previous graph shows that the pressure components parallel to slope of the specific pressure of the snow ( $S'_N$ ) increases if the snow unit weight ( $\rho$ ) increases as well. These increments follow a parabolic behaviour. It can be noted that with the increase in  $\rho$  the different curves (one

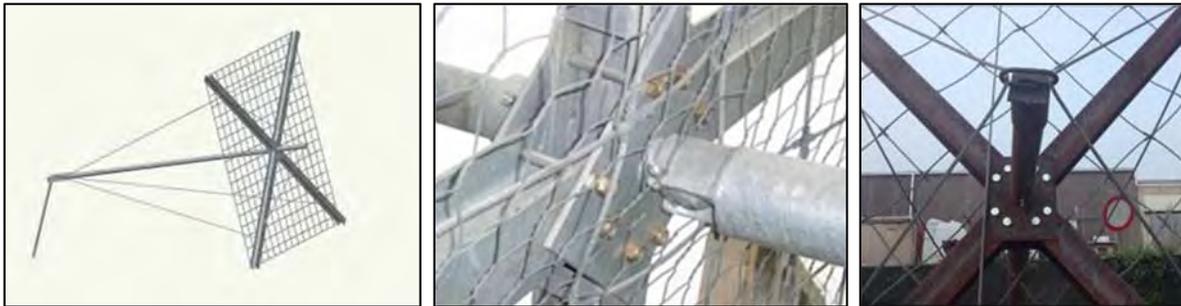
**Figure 8** – Umbrella structure: details.

1. Reinforce all of the individual components of the structure;
2. Equip the beams of the umbrella with a special spherical joint aimed to reduce the stresses, combined with a front wind bracing device to limit deformation;
3. Adapt the umbrella structure and the site conditions in order to reduce the pressure on the structure.

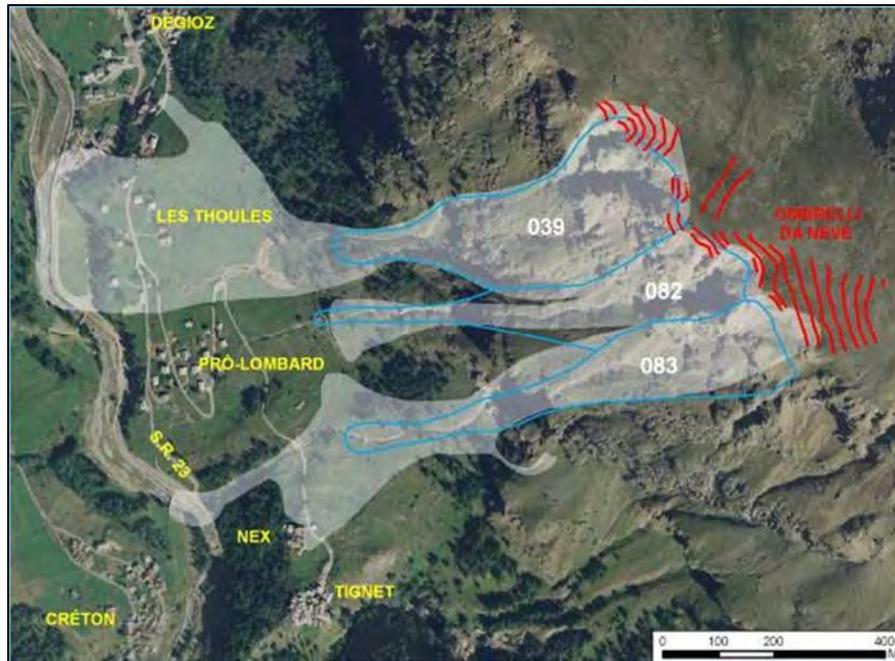
**Figure 9** - Location and schematic of the problem.

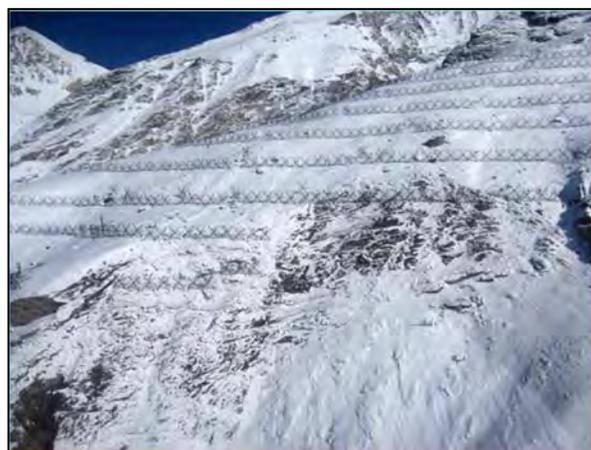
**Figure 10** - View of the installed Umbrella structures.

The solution to the problem was developed using the Umbrella structures: 718 elements for 2,600 total linear meters (8,530 ft) of developed area.

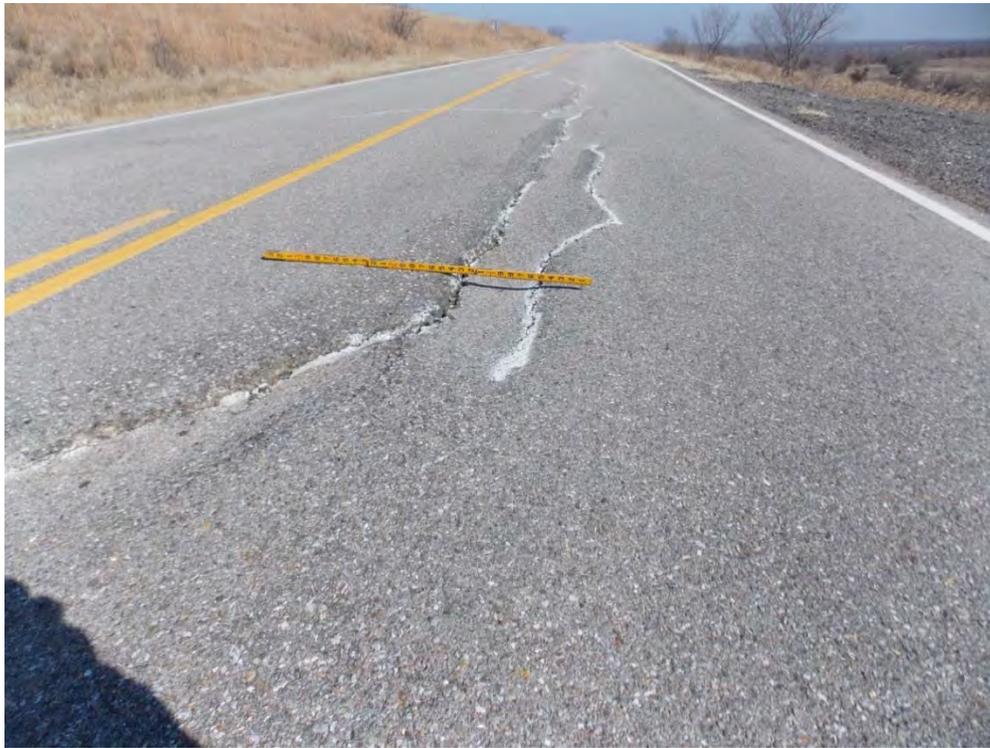
Figure 3. Area A scarp looking North along SH 99.

- a. A scarp in the north bound lane with a few exceptions the scarp extending into the southbound lane, with a length of approximately 256 feet
- b. Vertical displacements of the scarp ranged from 0.5 to 3 inches
- c. Significant longitudinal cracking and undulation of the pavement surface.
- d. Toe of the slide could not be determined
- e. Out of plumb right of way fence posts, leaning eastward.

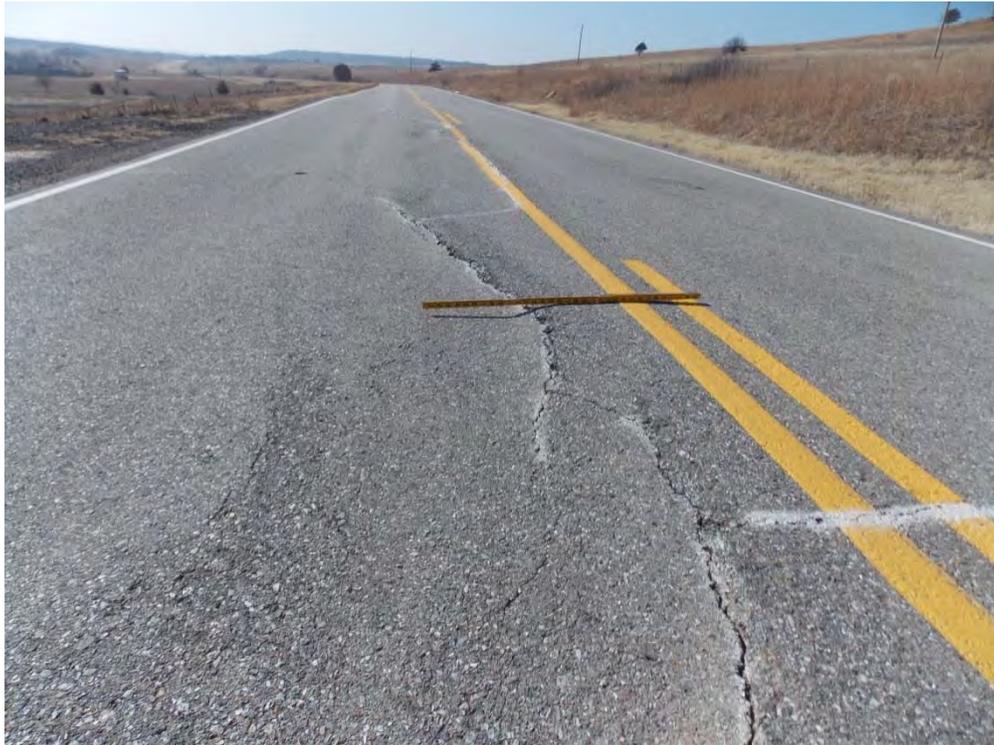
Figure 4. Area A scarp looking South along SH 99.

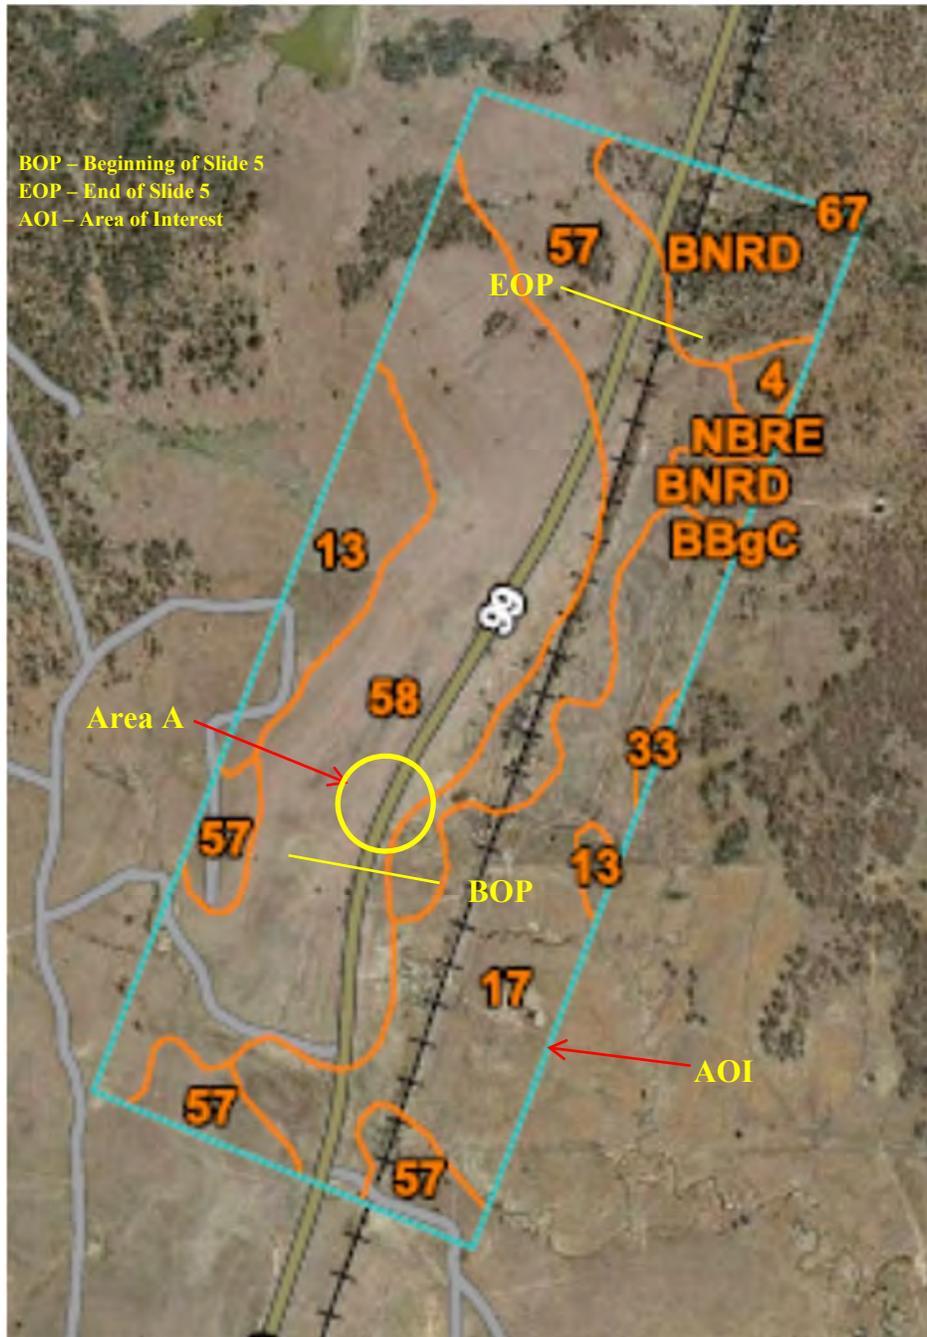
Figure 5. Enlarged soil map from the Web Soil Survey 3.1 indicating the AOI, soil map units, and the beginning and ending of Slide 5.

and–Lucien complex ranges from slow to rapid to very high. As can be seen in Figure 5, two soil map units have an impact on the embankment instability, and they are the following:

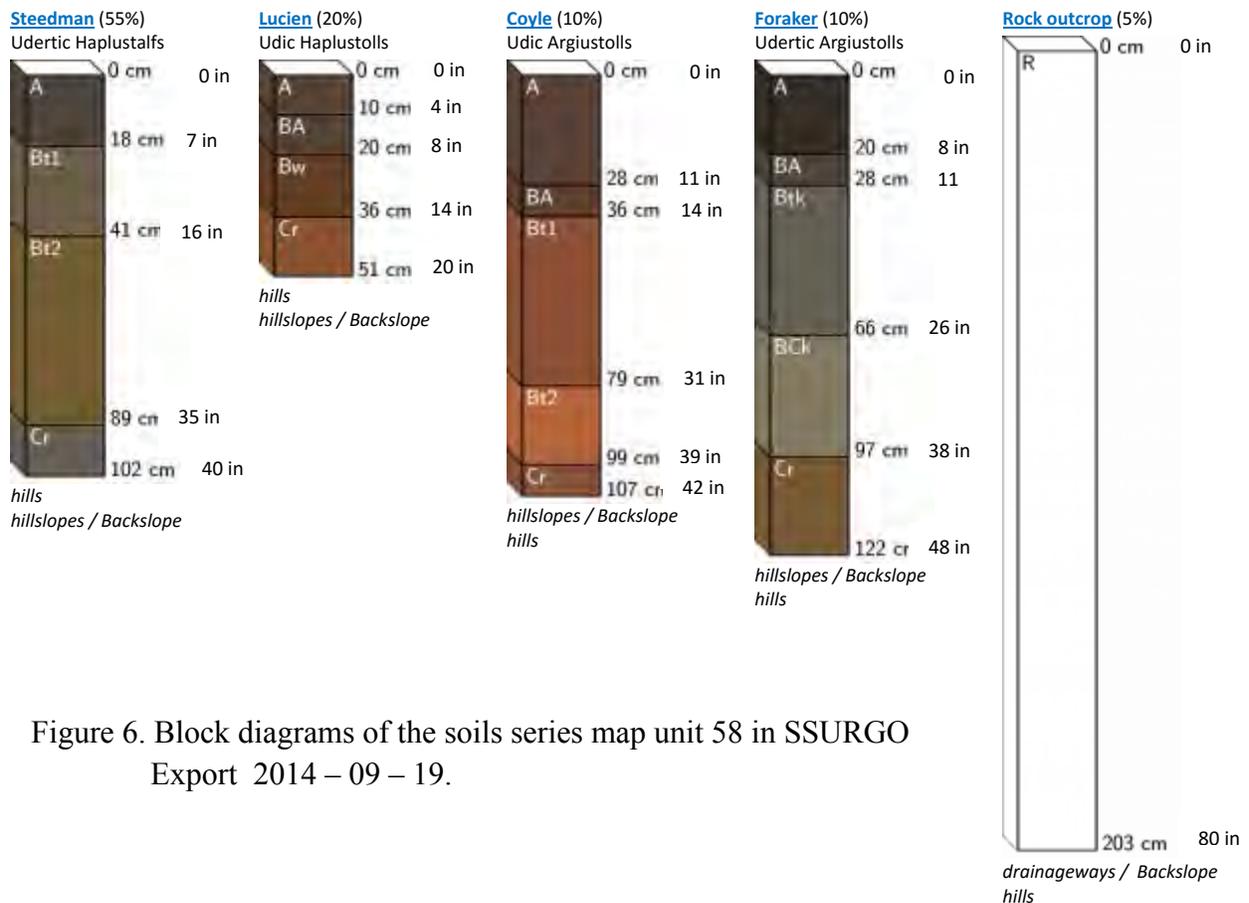
Figure 6. Block diagrams of the soils series map unit 58 in SSURGO Export 2014 – 09 – 19.

Map unit 58 underlies the SH 99 grading within the right of way limits of Part A, and directly influences the embankment instability. The horizon depths for the soil series in map unit 58 are indicated in Figure 6 and 9 respectively. The map unit 13 is located on the ridge crest of the cuesta above Area A and has only an indirect affect in that it is an additional source of the colluvial mantle that makes up the predominant Steedman soil series A and parts and /or all of the Bt1 and Bt2 horizons. The colluvial mantle was shown in detail in Borings 21 and 22 where rock fragments are found to depths of 2.6 and to approximately 4.0 feet respectively in the soil profile. The percentage of rock fragments found in the (Steedman, Foraker, Coyle, and Lucien) soil series based on the NRCS Official Soil Description (OSD) that contribute to the colluvial mantle are as follows:

The soil maps in the Web Soil Survey 3.1 have now been integrated with the block diagrams from the NRCS Soil Survey Geographic Database (SSURGO) into Google Earth, and the soil maps in Google Earth are inclusive and show all soil profile data historically found within a soil series map unit. As seen in the block diagrams in Figure 6, soil map unit 58 that underlies the embankment grading consists predominantly of the Steedman soils at approximately 55 percent of the map unit. Including the Foraker soil series shown in Figure 6, map unit 58 consists of approximately 65 percent of soils that develops from a shale parent material mixed with a clayey colluvial mantle with rock and fragments. Other inclusions are the Lucien, Coyle, and Rock outcrop at collectively at 35 percent. The rock fragments observed on the ground surface above and below the right of way fence and in the existing eroded features of the side-hill cut-section west of the center line of survey within station extent 379+60 to 390+51 were all observed to be predominantly sandstone.

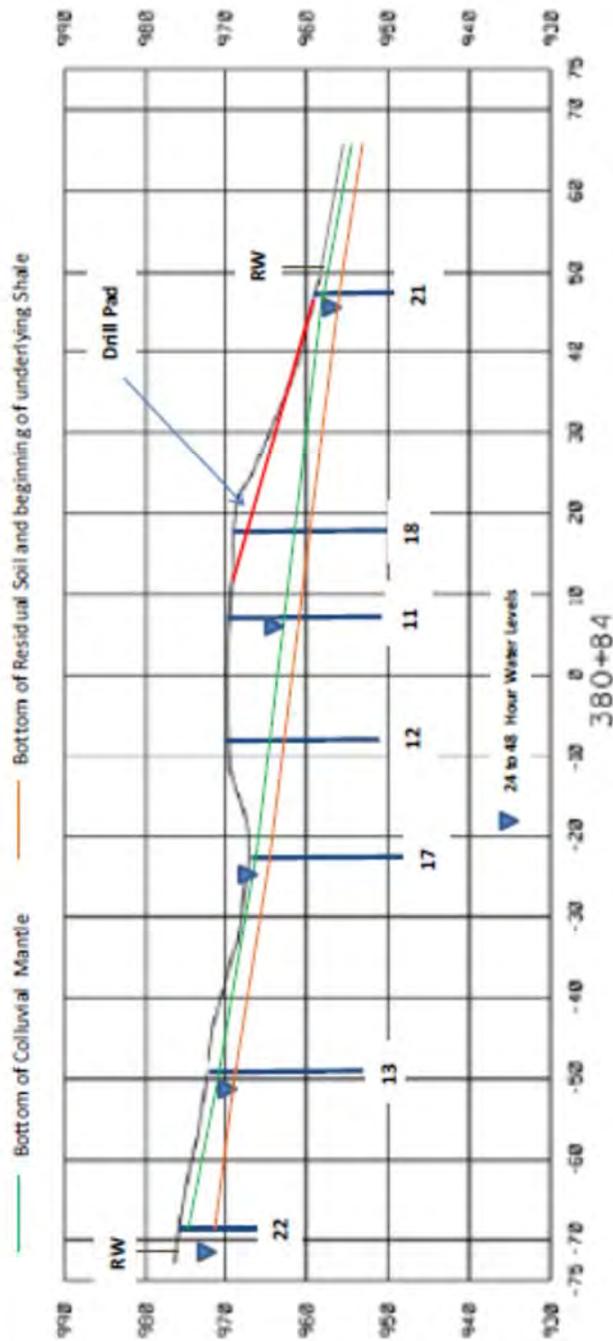
Figure 7 . Cross-sectional profile A-A for Area A at station 380+84.

To access the geologic profile through the grading section representative of Area A, Borings 22, 13, 17, 12, 11, 18, and 21 were plotted in a cross-sectional profile view at station 380+84 designated as profile A-A, see Figure 7. These seven borings were drilled and logged to determine the underlying ground condition and water table within the approximate station extent station 379+60 to 382+16 for Part A by the Materials Division Geotechnical Branch drill crew. These borings were of following three types:

gINT Version 8i format. For Borings 11, 17, 21, and 22 in profile A–A in Figure 7; the liquid limit, plastic limit, percent passing No. 200 sieve), and moisture contents for the samples tested with depth are reported within the boring log format.
