HGS 2016  
Proceedings

# 67TH HIGHWAY GEOLOGY SYMPOSIUM

## JULY 11 – 14, 2016

Cheyenne Mountain Resort  
COLORADO SPRINGS, COLORADO

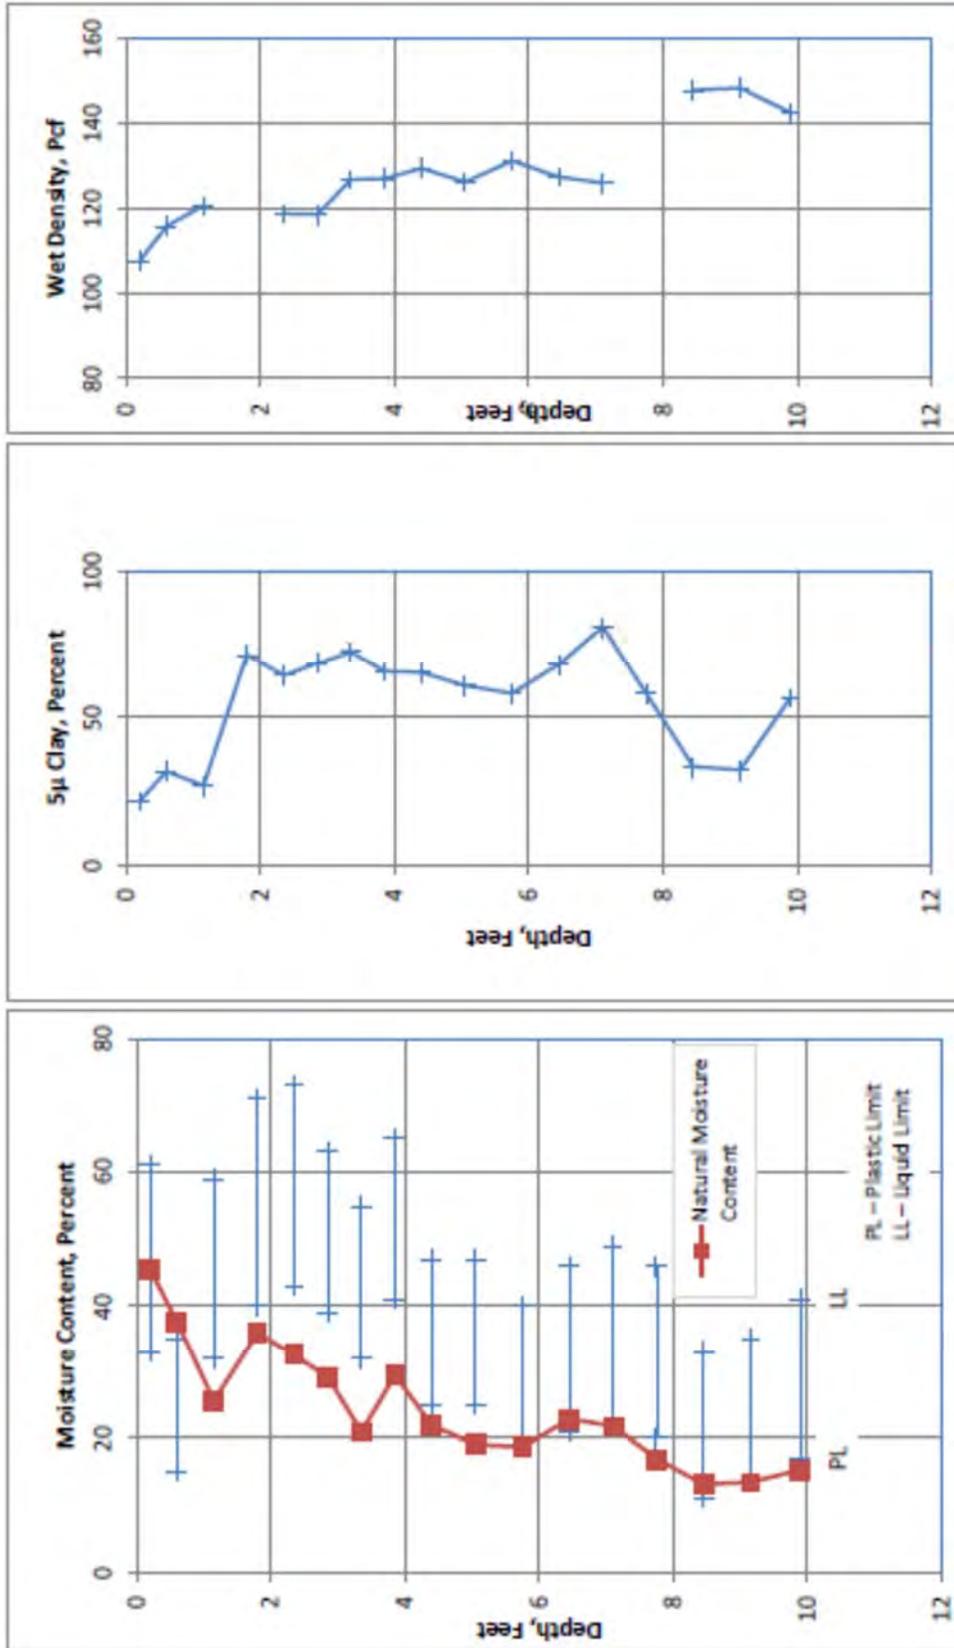
Figure 8. Boring 21 Moisture content, 5µ clay content, and wet density plotted versus depth.

The test results for the Atterberg limits, clay fraction, and wet unit weight from Boring 21A are presented graphically for Boring 21 with depth in Figure 8 and in a tabulated format for Boring 21 at the end of the gINT boring logs. A soil profile of the Steedman soil series is attached to the Boring 21 gINT log description in Figure 9.

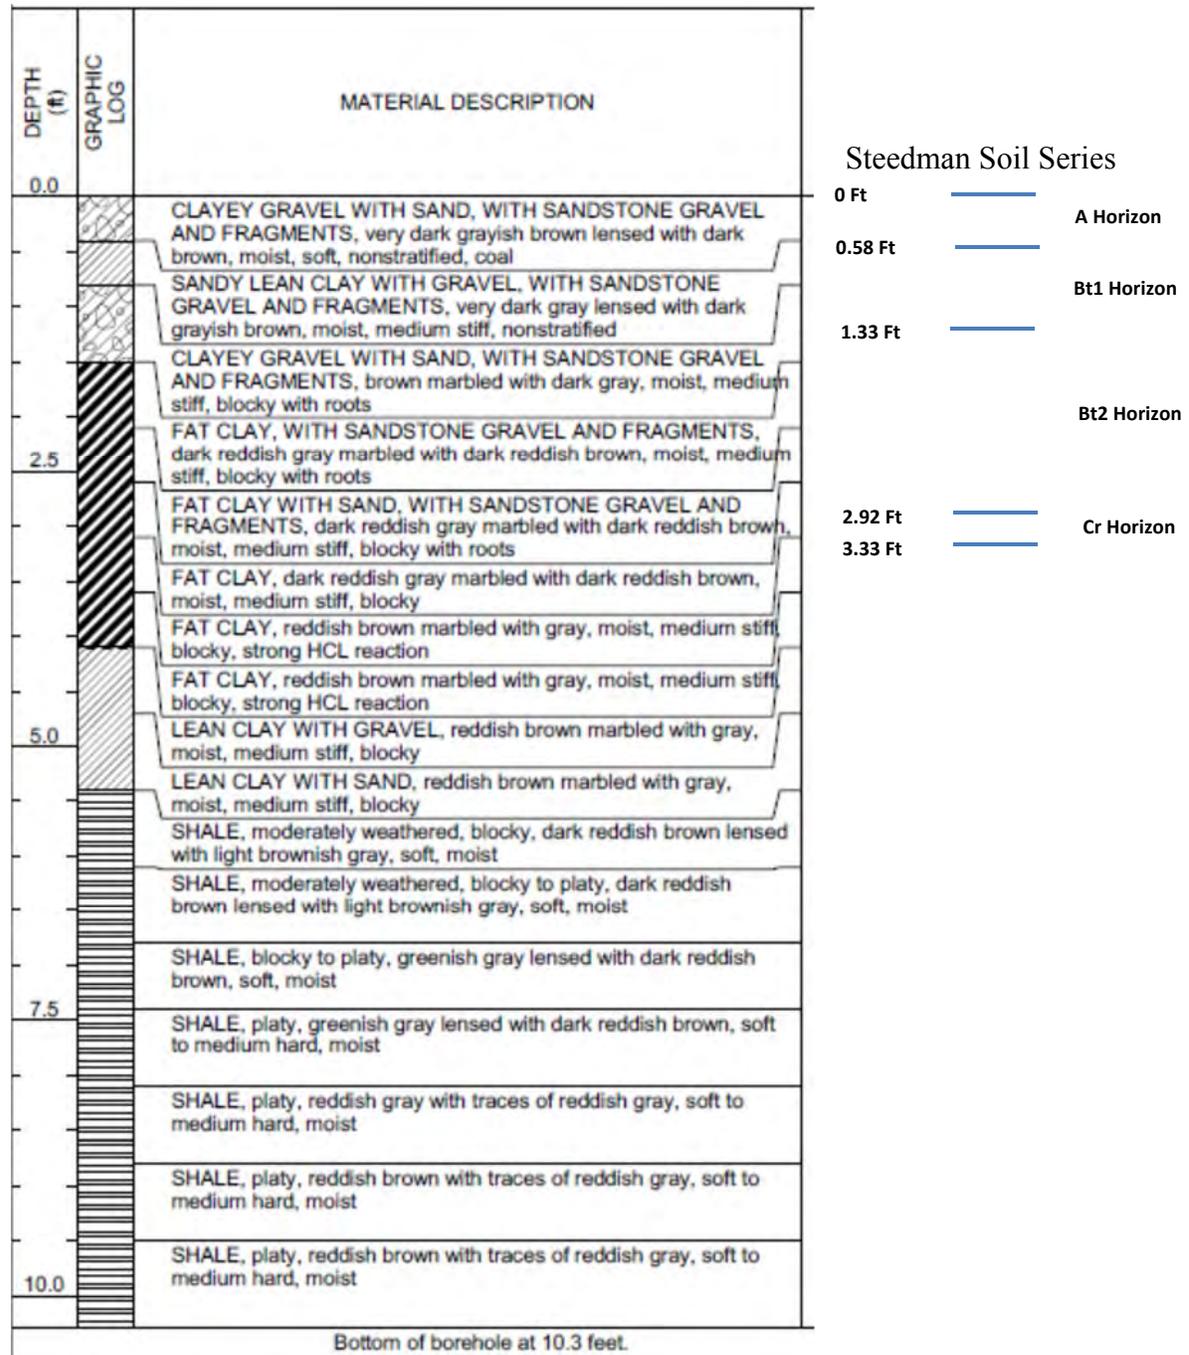
Figure 9. Boring 21 gINT log and adjacent Steedman soil series profile.

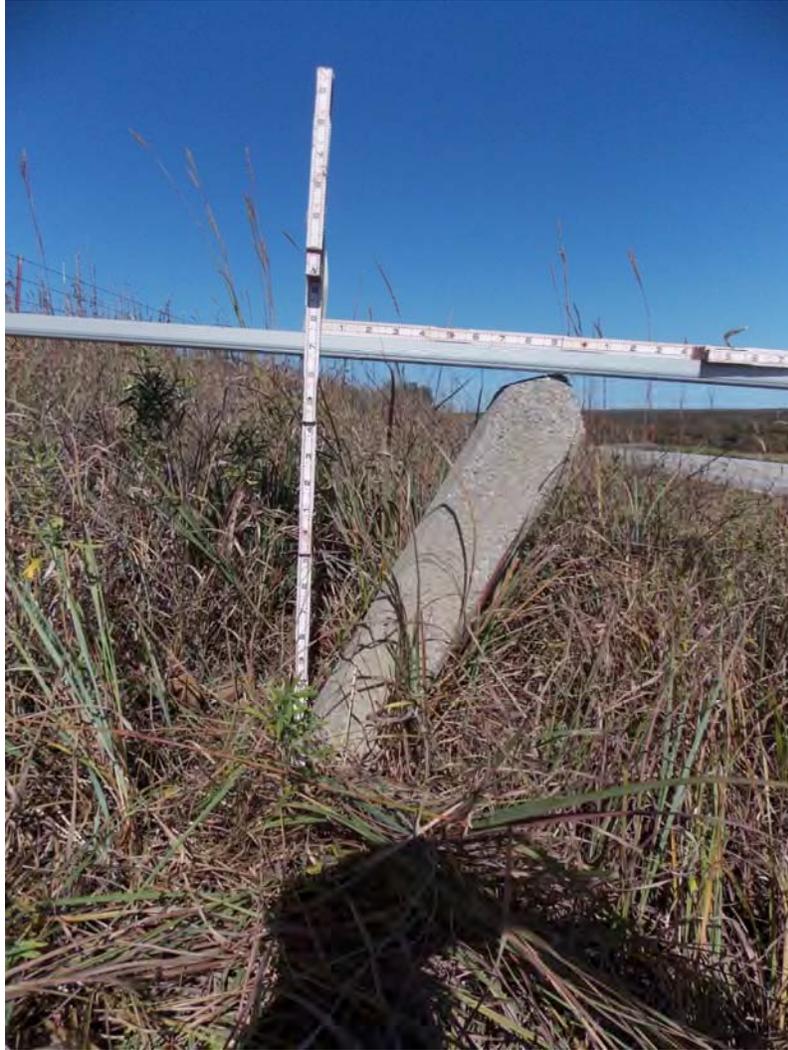
Figure 10. Right of way marker leaning.

- a. A scarp in the north bound lane with a few exceptions the scarp extending into the southbound lane, with a length of approximately 256 feet
- b. Vertical displacements of the scarp ranged from 0.5 to 3 inches
- c. Significant longitudinal cracking and undulation of the pavement surface.
- d. Toe of the slide could not be determined
- e. Out of plumb right of way fence posts, leaning eastward.

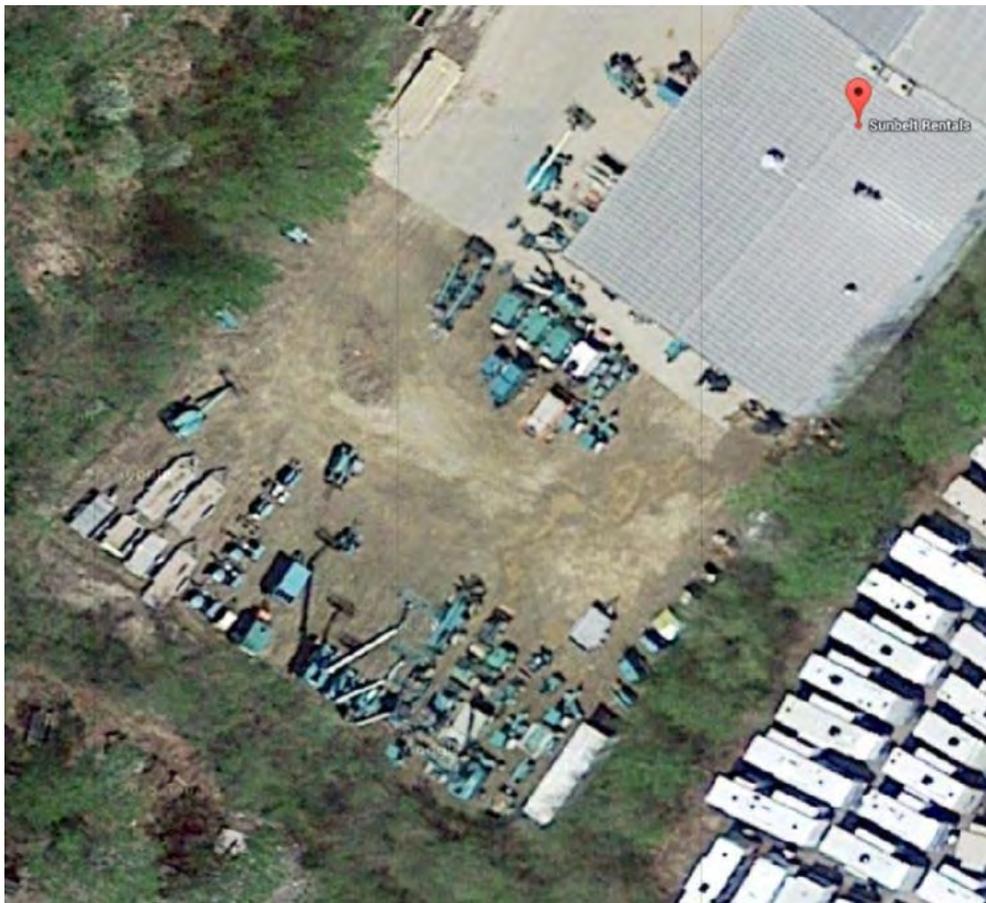
**Figure 1 – Rutted Aggregate Surface**

SunBelt Rentals is a company that rents all sorts of equipment for construction projects. The SunBelt Rentals storage yard in Bangor, ME was deteriorated to the point where the equipment was constantly rutting the ground surface and getting stuck in the mud during the Springtime (figure 1). They would routinely have to pull their rental equipment out of the mud and wash off the tires and tracks before renting. During the Spring they would have to load the equipment on the paved surface to keep the tractor trailers from having to drive on the unpaved areas. The owner contacted Sargent Corp., a local contractor, to rebuild the parking/loading and drive areas. They were hoping Sargent Corp. would be able to utilize a typical section of 12 inches of dense graded aggregate (DGA) over a light weight slit tape geotextile.

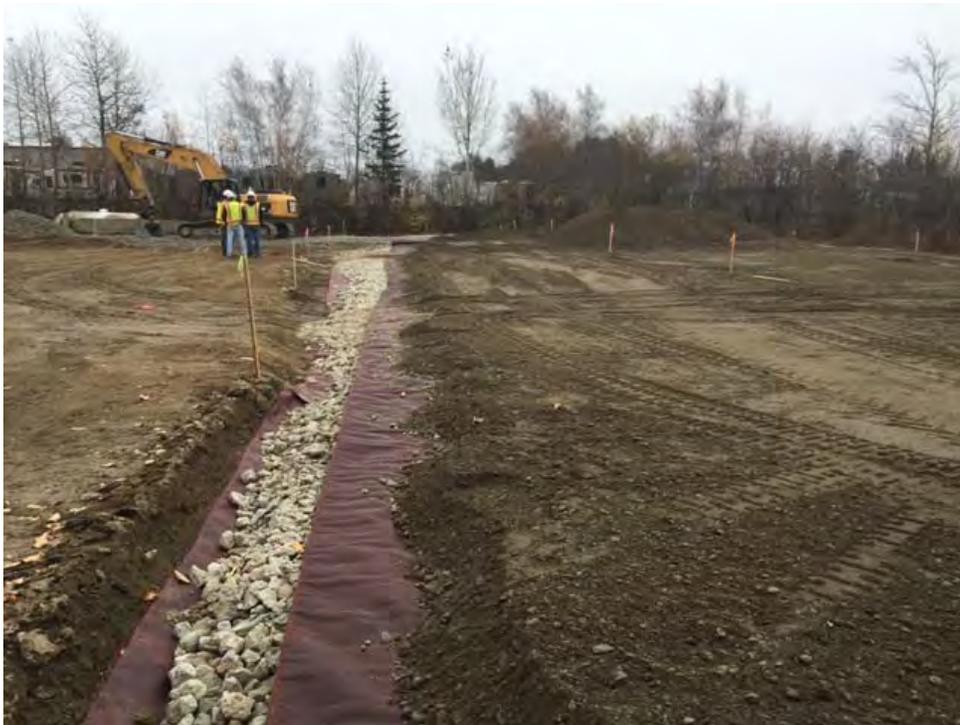
**Figure 2 – Two Layered Section**

The value engineered solution indicated that a section utilizing two layers of high strength geotextiles (figure 2) and a total reduced section of 14 inches of aggregate would be sufficient. A high strength wicking geotextile was also evaluated, but with no place to drain the water, it was quickly passed over. Geogrids were also dismissed as separation was determined to be extremely important with such a low CBR value. The chosen design was to place the highest strength geotextile directly on the subgrade followed by 8-inches of open graded stone. The open graded stone was designed to help with water storage during the Spring thaws. A second layer of high strength geotextile (the lower strength of the two) was then placed perpendicular to the first layer. This was done to make sure there were no seams aligned that could potentially cause a failure. The wearing surface of the equipment yard was designed to be 6-inches of DGA.

The geotextiles used (TenCate Mirafi® RS280i and RS580i) were chosen based on their high tensile modulus (30,000 and 51,000 lbs/ft) at 2% strain, high flow rates (70 and 75 gal/min/ft<sup>2</sup>), high interaction coefficient (.89 and .90) and the pore size distribution at  $O_{50}$  (196 and 185 microns) and  $O_{95}$  (345 and 350 microns). The interaction of these four parameters are key factors in its superior performance.

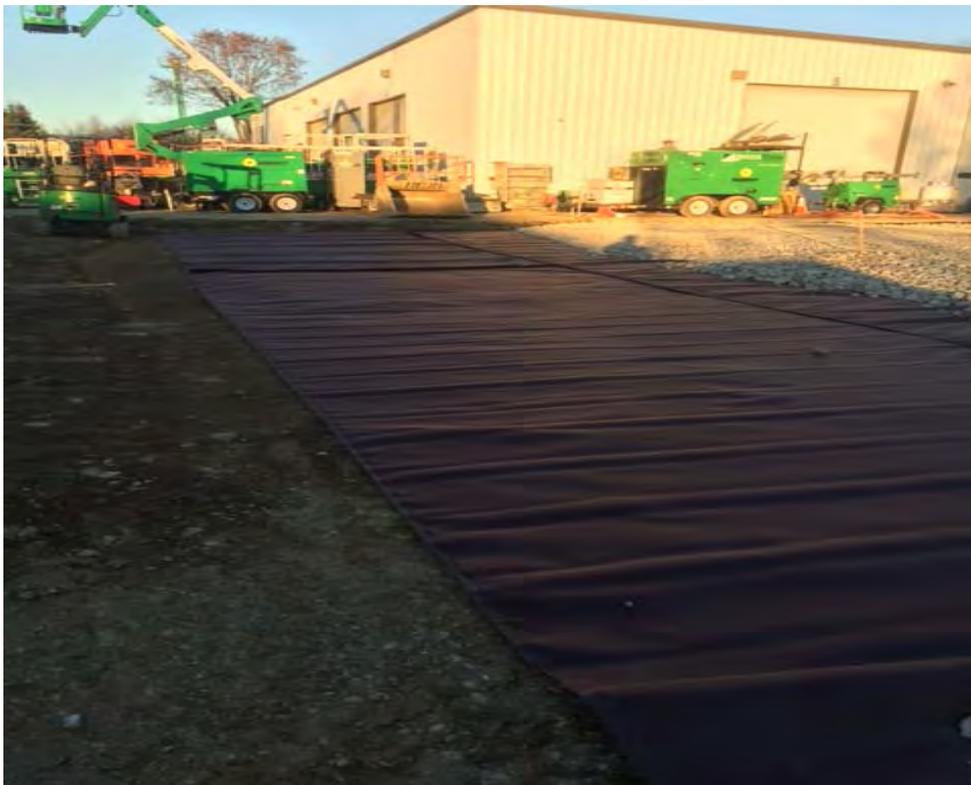
**Figure 3 – High Strength Geotextile with 3-Foot Overlap**

Construction began with the excavation of approximately 14 inches of the existing clay contaminated aggregate. A layer of high strength geotextile was placed directly on the subgrade with a 3-foot overlap (figure 3). The large overlap was necessary due to the low CBR soils encountered. The geotextile roll widths utilized were 17 feet, which helped to reduce waste in the overlaps. The 8-inch layer of clean, open graded stone fill was then placed (figure 4) and compacted with a smooth drum, vibratory roller. At the time of construction, the subgrade was dry making it easier to install without causing deep ruts.

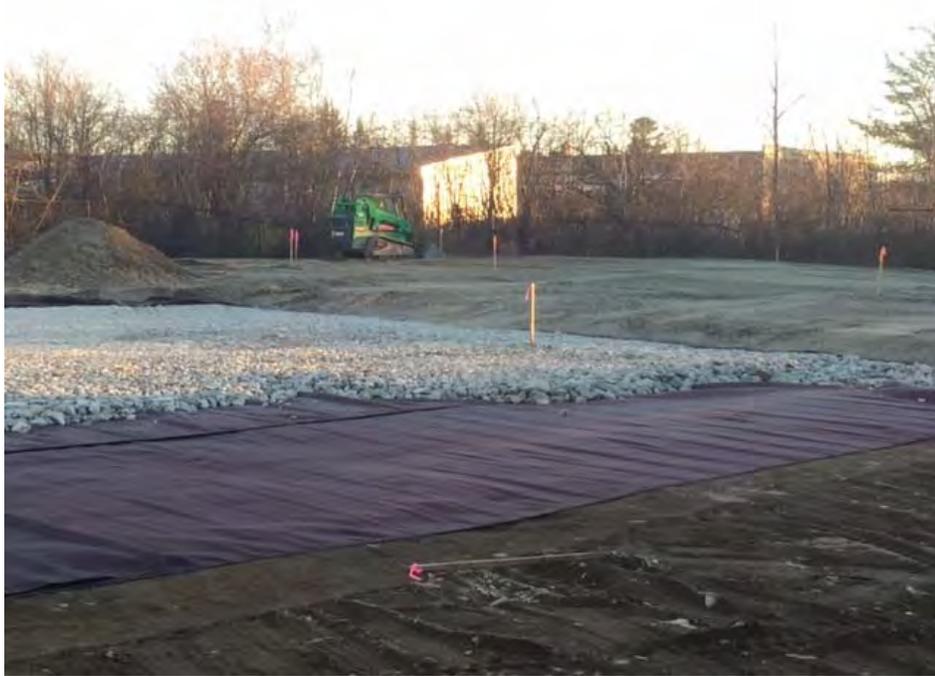
**Figure 4 – Clean, Open Graded Stone Fill**

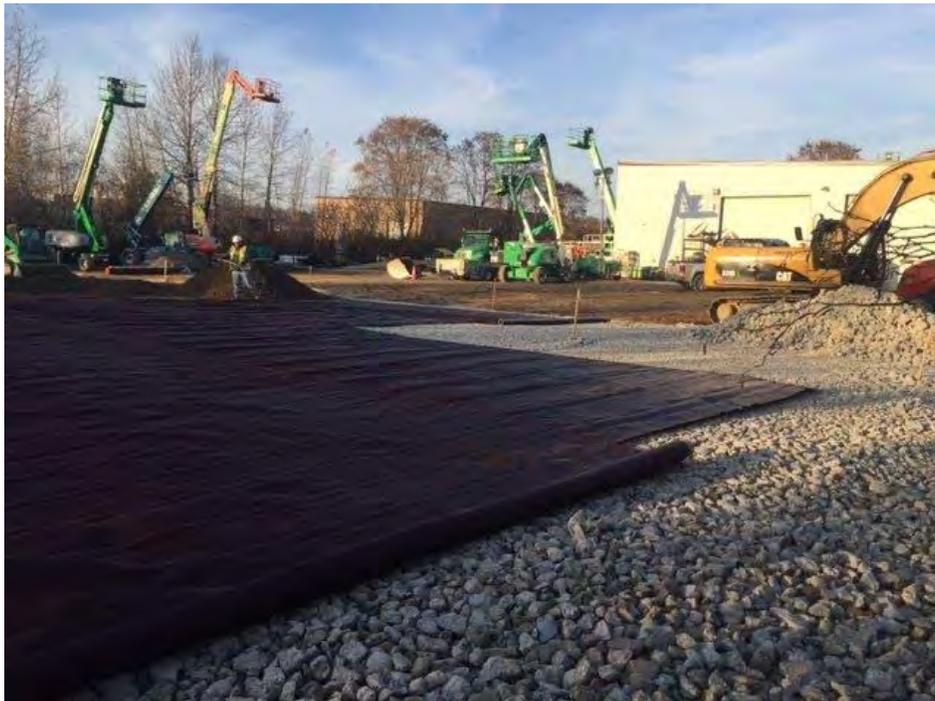
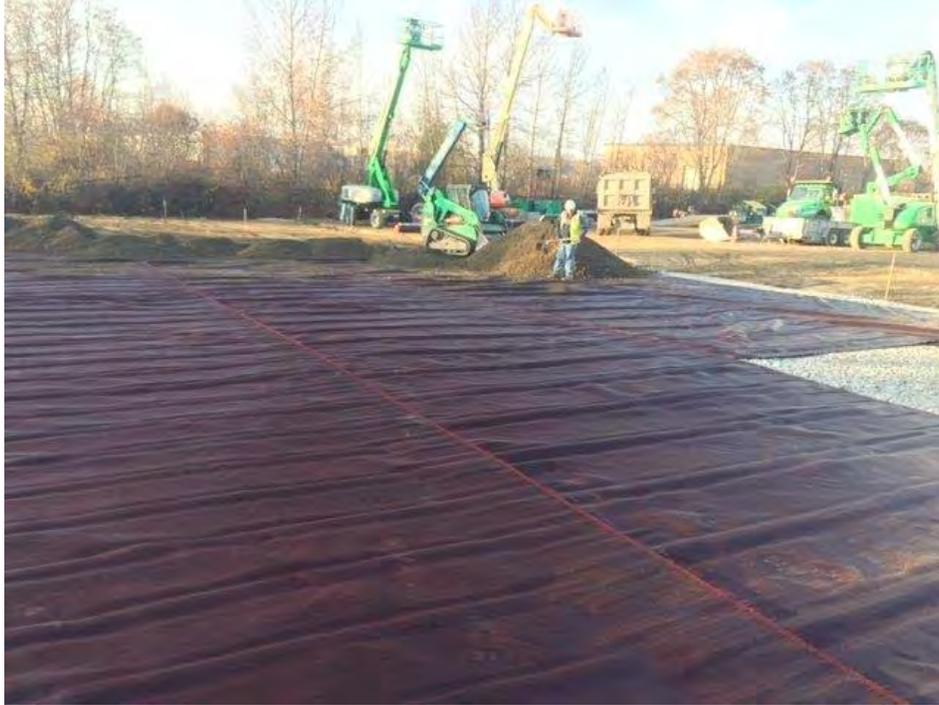
**Figure 5 – Second Layer of High Strength Geotextile**

**Figure 6 – Second Layer of High Strength Geotextile**

The second layer of geotextile was then placed perpendicular to the first layer (figures 5 and 6). The second layer was also used to separate the DGA from the open graded stone. The geotextiles were rolled out smooth with no large wrinkles.

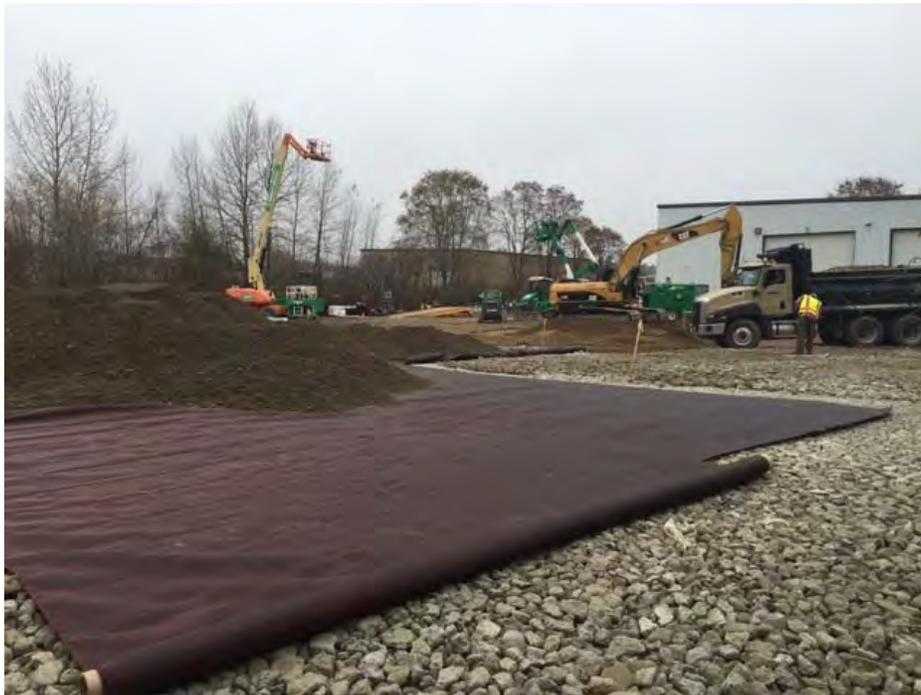
**Figure 7 – Dense Graded Aggregate Fill**

The DGA was placed on top of the second layer of high strength geotextile making sure the dozer pushed it in the direction of the overlap (figure 7) to minimize wrinkling and bunching of the geotextile. The final grade was also compacted using the smooth drum, vibratory roller.

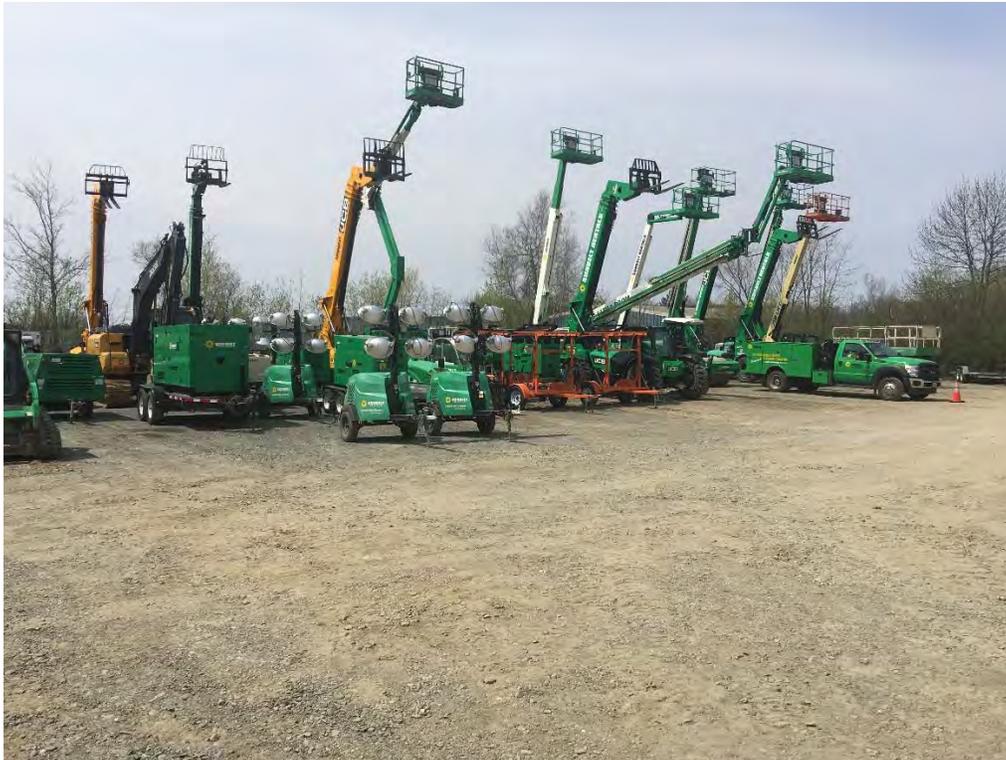
**Figure 8 – Finished DGA Surface (Equipment Parking Area)**

The project was accomplished in two phases to allow for moving the equipment out of the way. Upon completion of the two layered section, the equipment was immediately able to be parked on the DGA surface (figure 8).

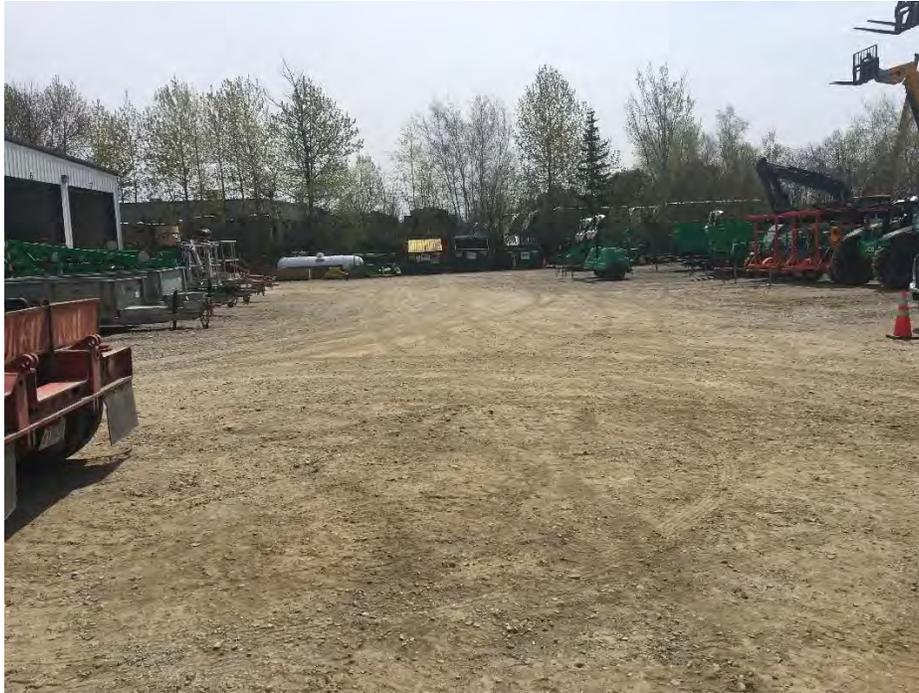
**Figure 9 – Finished DGA Surface (Drive Area)**

Construction of the new parking/loading area and drives lanes was completed in the Fall of 2015. A site visit was made at the end of the Spring of 2016 to observe the rental yard surface. During the visit very little surface rutting and no “bird bath” depressions were observed (figure 9). The owner was very pleased with the results and the equipment operator could only say “Unbelievable..Unbelievable!”

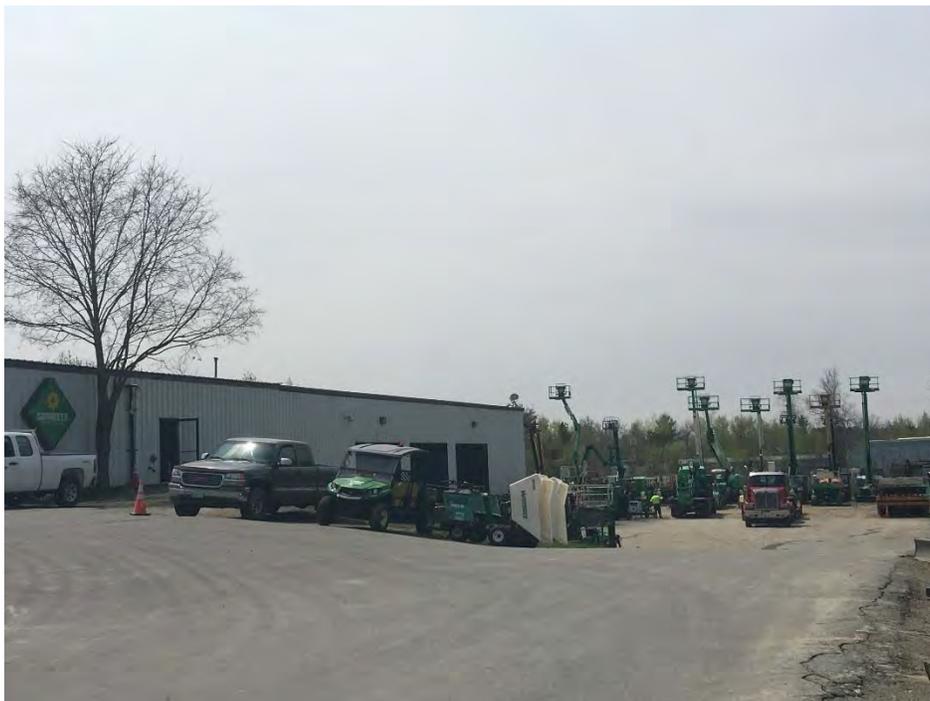
**Figure 10 – Finished DGA Surface (Loading Area)**

SunBelt Rentals is now able to load the equipment (figure 10) in the yard again with no issues thanks to the use of the high strength geotextile reinforced DGA surfaced area that was constructed.

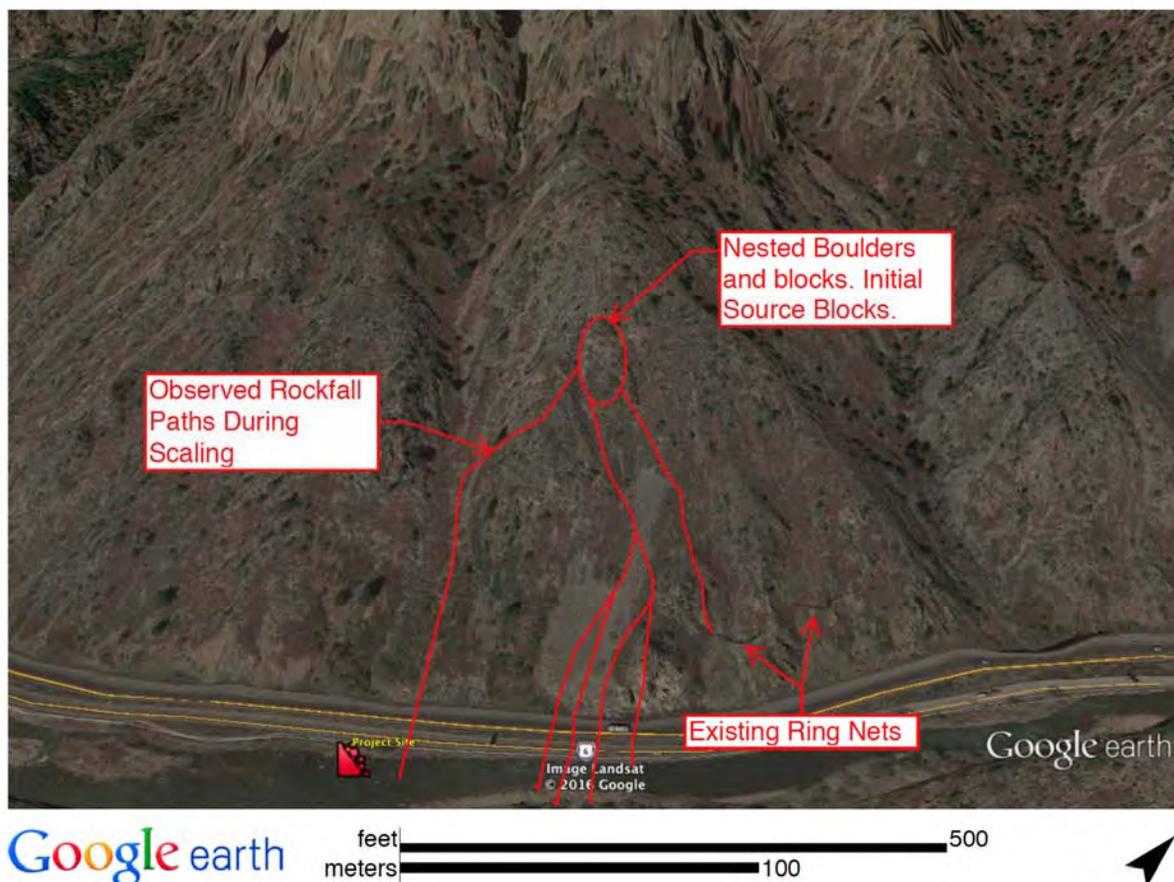
**Figure 3 – Project Slope (Google Earth 2016)**

The project site is located at Mile Post 124, approximately 8 miles east of Glenwood Springs, Colorado (see Figures 2 & 3 ). This particular rockfall event struck a car and immobilized a semi tractor-trailer. Although nobody was injured in the rockfall, the decks of both the Eastbound and Westbound lanes were heavily damaged. Some of the large rocks even came to rest on the south bank of the Colorado River.

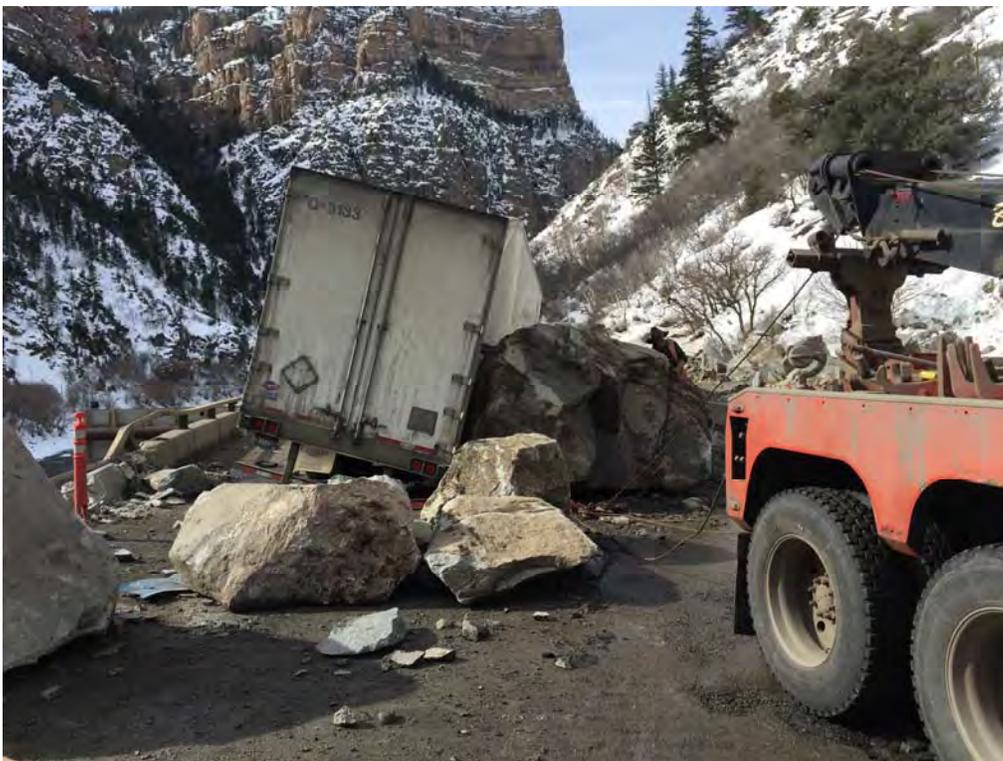
Figure 4 – Initial Carnage

Upon arrival at the site, there were large boulders scattered about both the Eastbound and Westbound decks of the Interstate. A tractor-trailer, still pinned by a large rock that struck and came to rest against the trailer, but it was in the process of being towed away (see Figure 4).

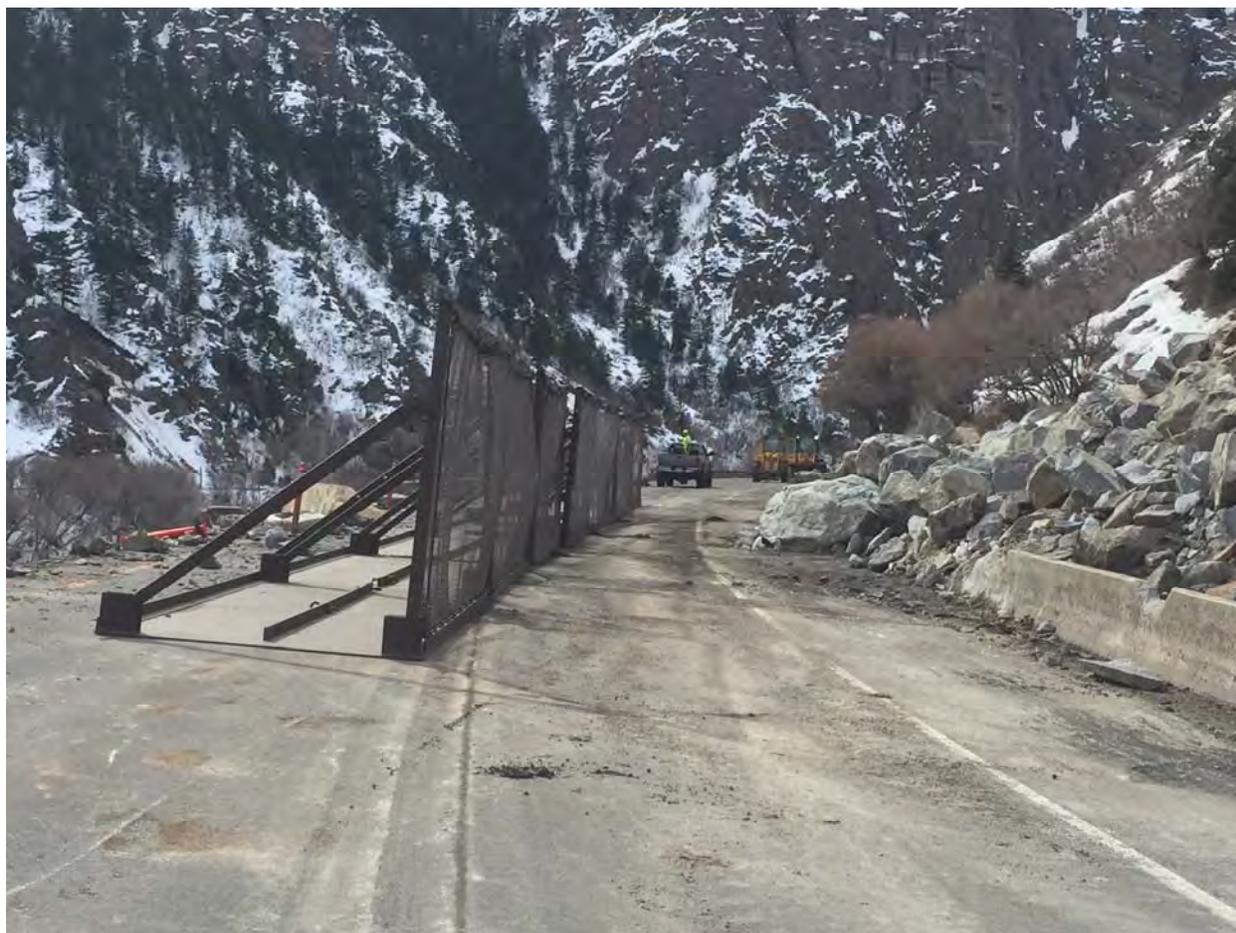
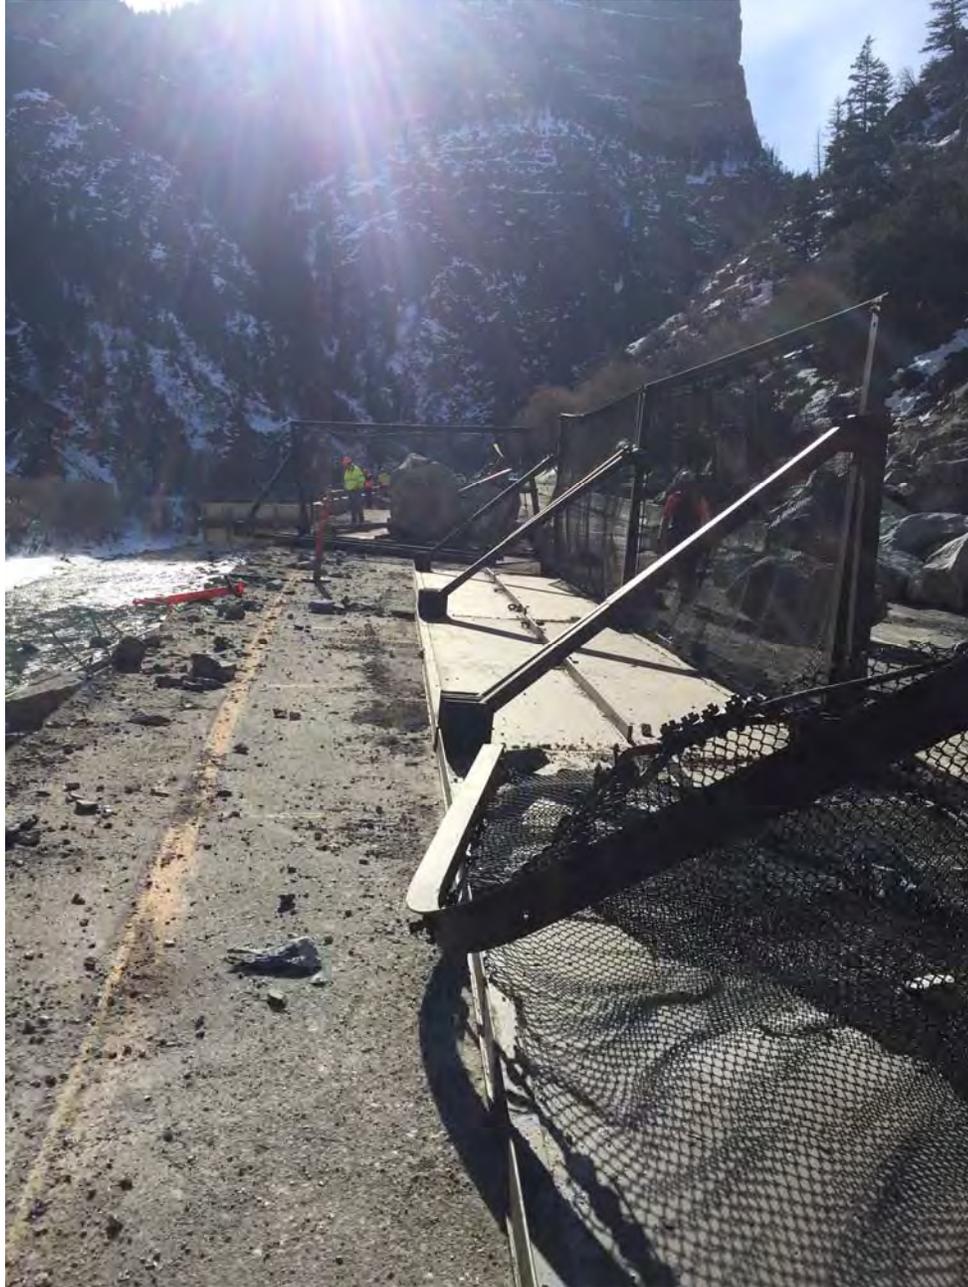
**Figure 5 – Moveable Barriers Before Scaling**

**Figure 6 – Moveable Barriers After Scaling**

To help minimize damage to the upper deck (Westbound) and the lower deck (Eastbound) during scaling operations, temporary movable rockfall barriers were provided by CDOT and placed by GSI (see Figures 5 - 6). These barriers, no doubt minimized some further destruction to the interstate's decks and parapets during scaling, but many of the rocks proved to be too big and generated too much energy for the barriers. Most of the barriers were badly damaged and some of the barriers were breached by larger rocks. This was good information to have since there was a lot of pressure to open the interstate to traffic in any capacity. Without the assurance that the movable barriers would keep rocks from reaching the lower deck, the decision was made to keep scaling the worst of the potential rocks that might otherwise fall on their own before allowing any traffic to pass the work area.

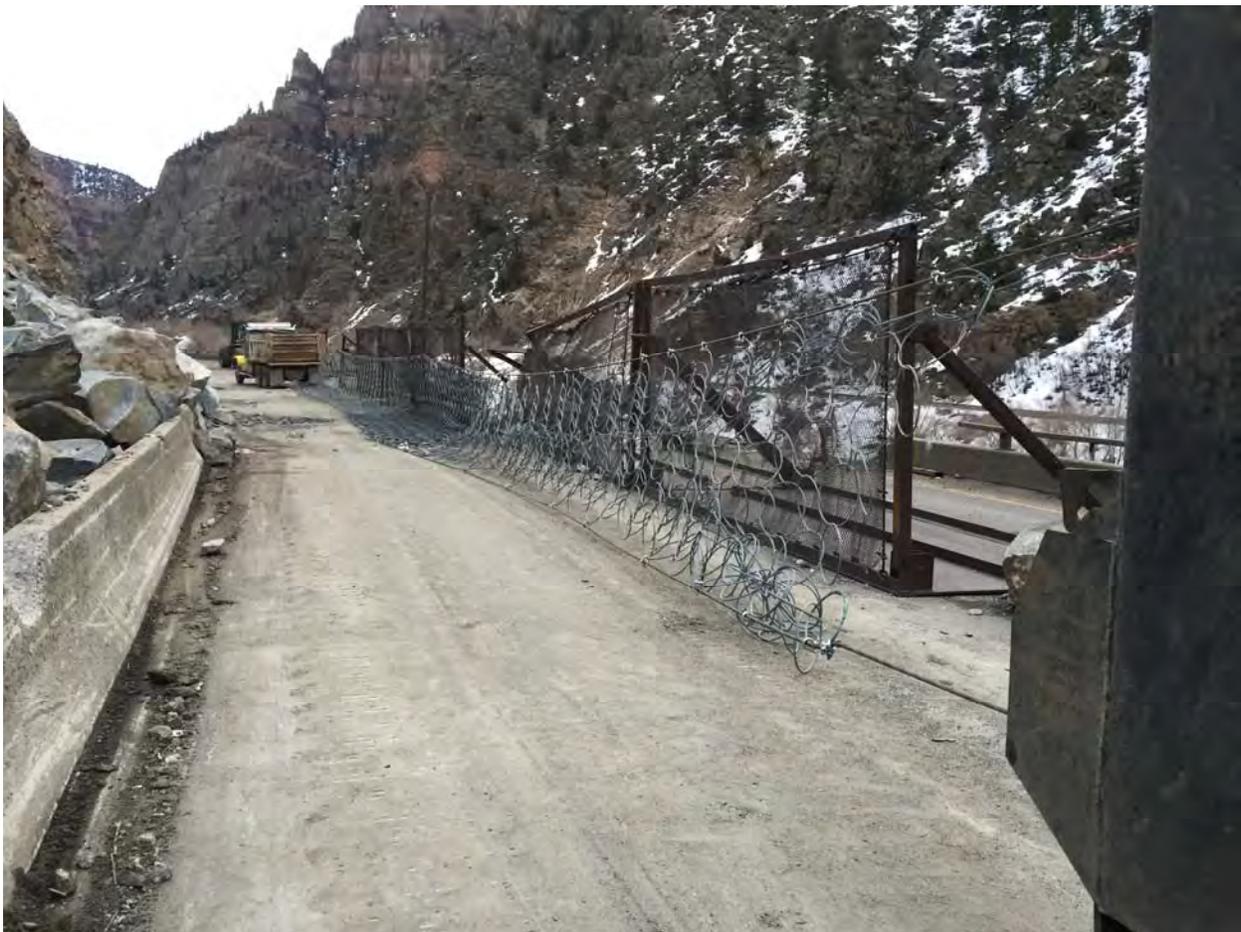
**Figure 7 – Moveable Barriers and Ring Nets Between Trucks**

reaching the lower deck. GSI and Martinez Excavating collaborated to use two of Martinez's tandem axle dump trucks to act as end posts for 150-LF of ring net to contain larger rocks (see Figure 7). Both GSI and Martinez knew the risks of the strategy, but were collectively willing to take that risk in order to release traffic. Rockfall behavior can be unpredictable as was observed in this case. The rock was released from the slope and with it, brought smaller rocks along the way. All of the rocks were caught or attenuated by either the ring net or the movable barriers. One large rock, however, climbed out of the fall line and struck one of the trucks. This was one of the larger rocks and it too was prevented from reaching the lower deck just 2 hours before the anticipated opening to escorted traffic. The trucks were unoccupied at the time and the immediate area was cleared during scaling. The truck was a total loss, but the interstate was reopened as planned to one-way, alternating, piloted traffic. Mission accomplished.

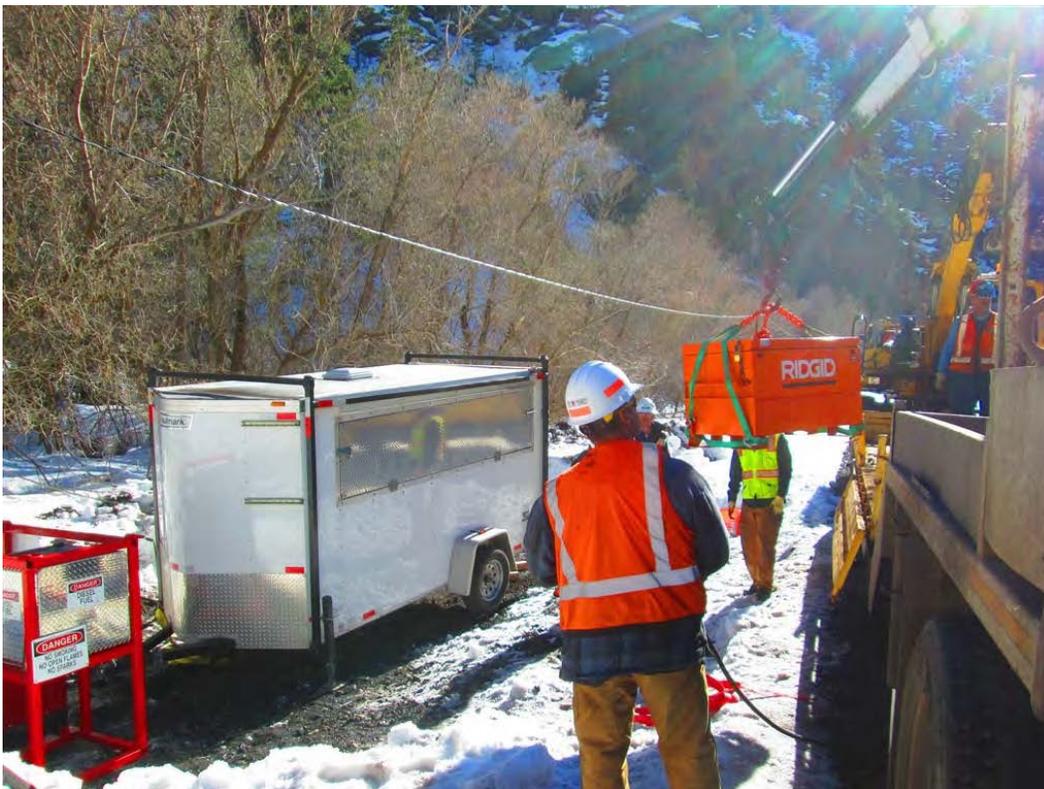
**Figure 8 – UPRR and IDSNA offloading radar-monitoring station**

IDS North America (IDSNA) was brought in to set up and monitor the slope for movement using radar technology. IDS Ingegneria Dei Sistemi is headquartered in Pisa (Italy) with offices in six countries (Italy, UK, Brazil, Canada, USA and Australia) and around 500 employees worldwide. One of the challenges of using such instrumentation was finding a suitable area to place the radar station. This in itself was challenging in Glenwood Canyon given the steep terrain. It was finally decided that the most suitable place for the monitoring station was the south side of the Union Pacific tracks. There was a very specific area near the tracks that allowed enough area for the station setup and gave a clear view of the slope to be monitored. Placing this monitoring station presented its own logistical challenges. Not only would permission from the railroad need to be granted in order to place a facility on railroad property, but the railroad maintenance staff would be required to haul and place the cargo trailer that housed the radar station. This cargo trailer was approximately 16-foot by 8-foot single axel cargo trailer (see Figure 8-10). Data collected from this radar station was remotely monitored in real time through cellular data transmission for any large movements that may cause concern for the traffic below. Alarms were established so the team could decide whether or not to reclose the interstate if a subsequent impending large failure could be detected early.

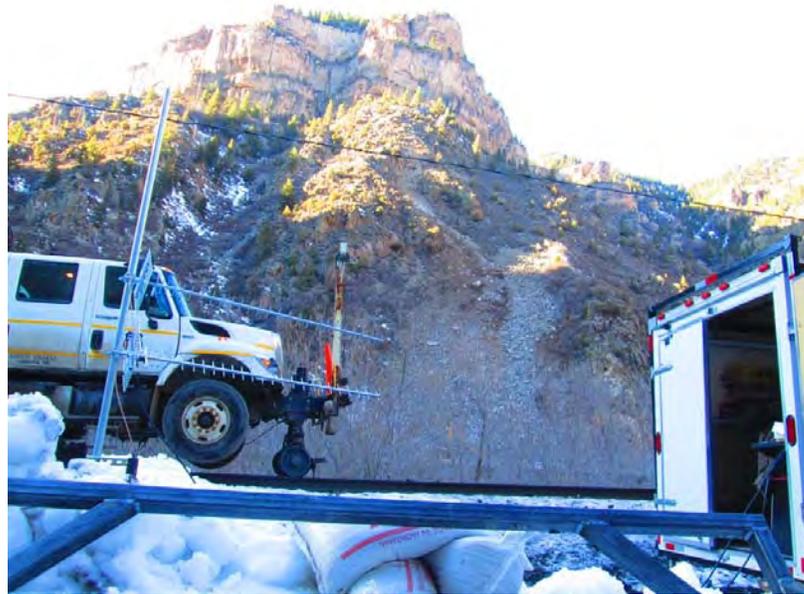
– **Figure 9 Slope as seen from radar station**

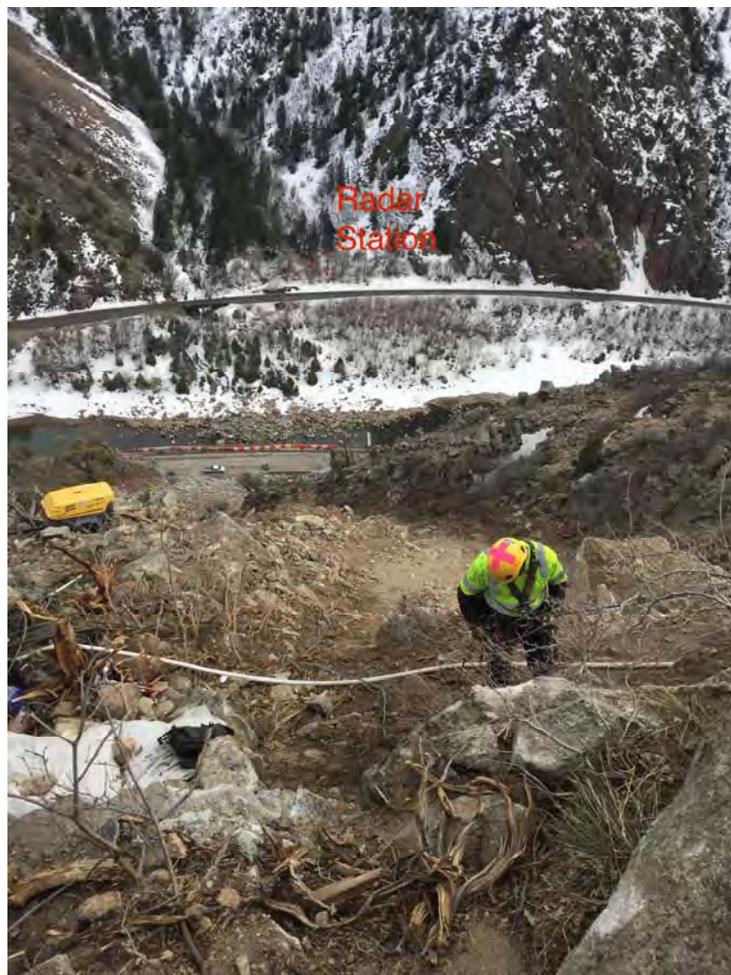
– **Figure 10 Slope as seen from site**

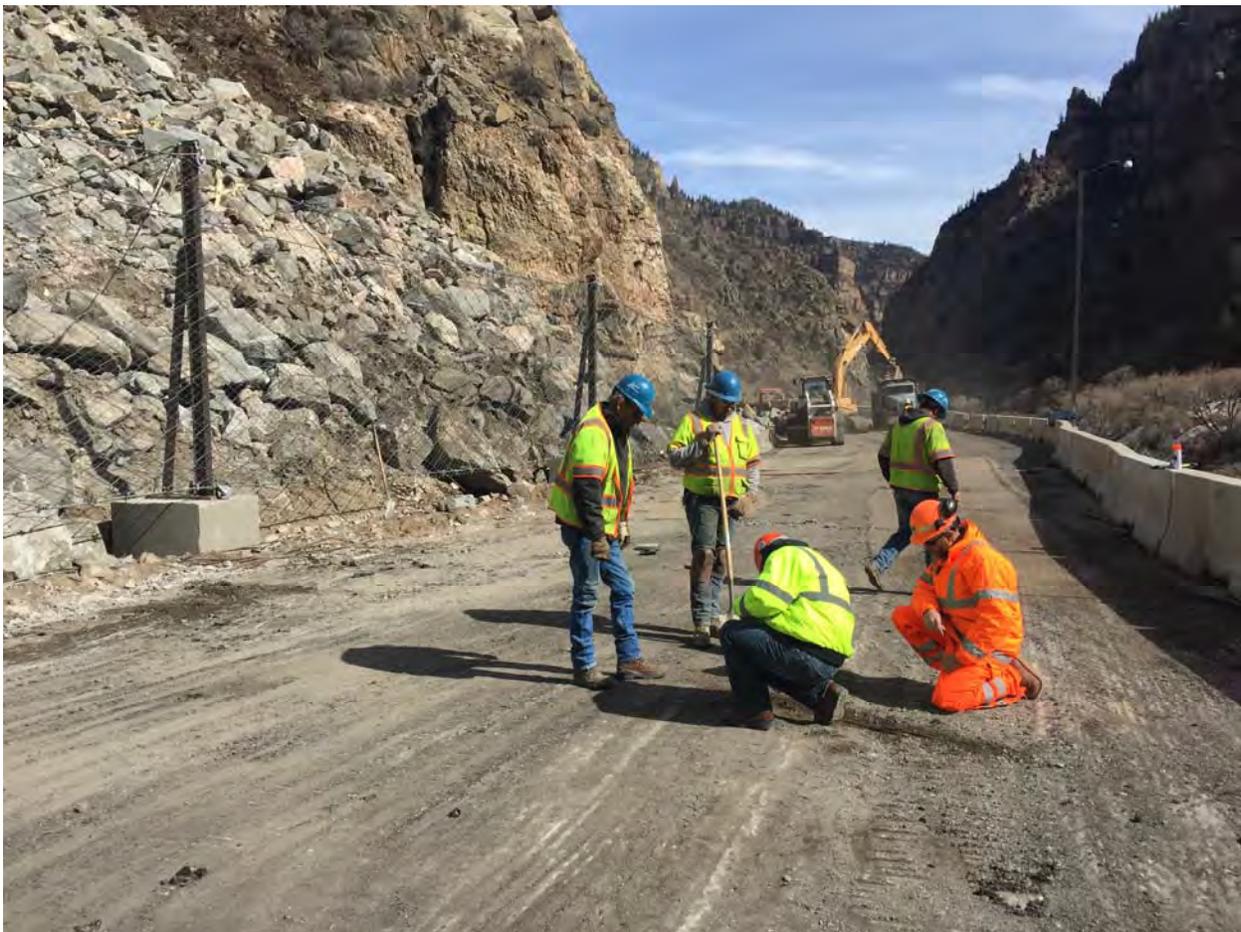
**Figure 11 – 500 kJ Barrier shown behind crews working to repair westbound deck.**

After the initial safety scaling, CDOT had GSI install 140-LF of 500 KJ barrier (see Figure 11) at the bottom of the slope as an added precaution for any smaller rocks that may continue to fall during the continued construction and in anticipation of traffic back on the Westbound (Upper) deck. This barrier also afforded additional protection for the crews repairing the damaged deck structure. This fence was procured and arrived for installation within a couple of days prior to installation. Spotters were also utilized throughout the project to warn workers of any subsequent rockfall.
