HGS 2016  
Proceedings

# 67TH HIGHWAY GEOLOGY SYMPOSIUM

## JULY 11 – 14, 2016

Cheyenne Mountain Resort  
COLORADO SPRINGS, COLORADO

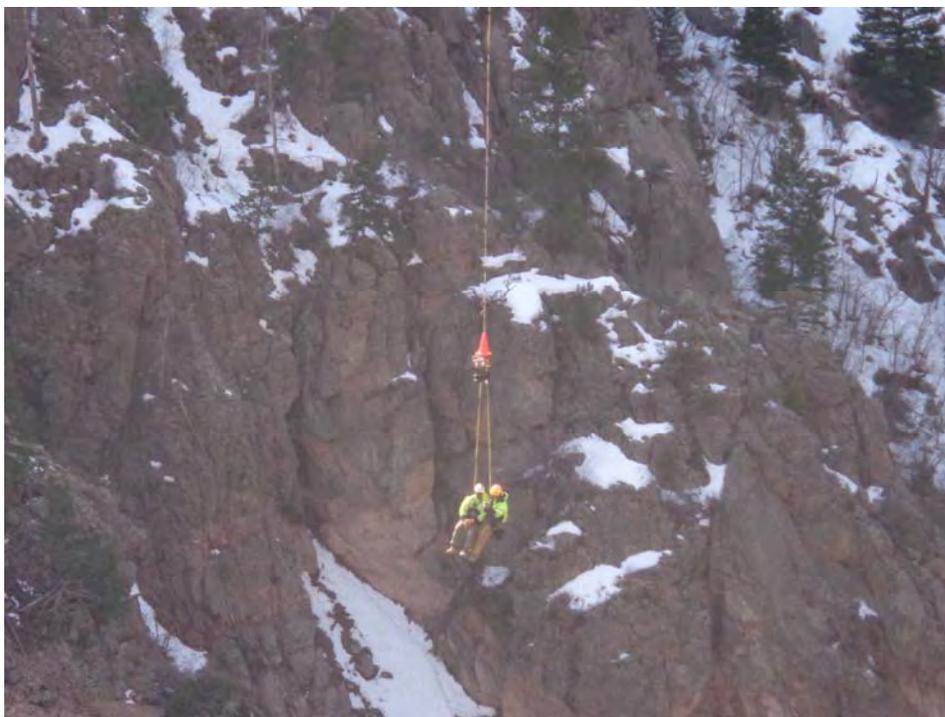
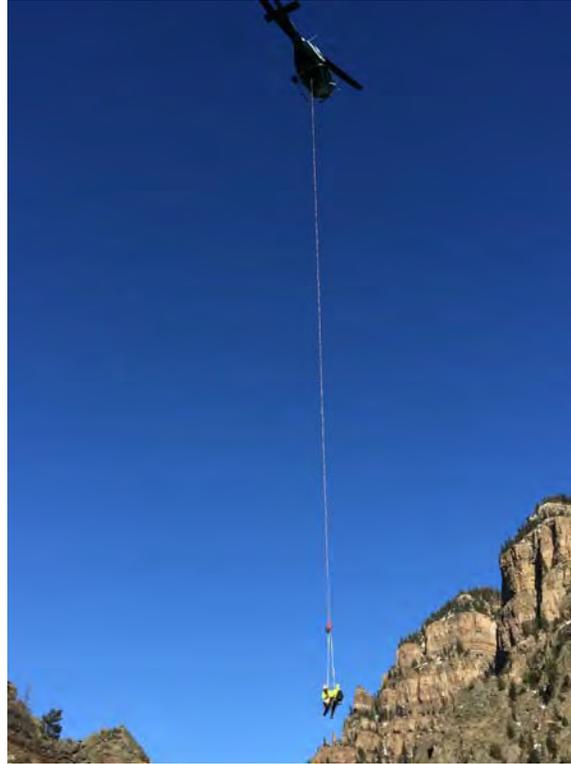
**Figure 12 – Short-Haul to Work Area**

**Figure 13 – Short-Haul to Work Area**

On helicopter days, the men were short-hauled to and from the work area as well (see Figure 12-13). This meant that men, two at a time, were clipped into the long-line of the helicopter and ferried to the work area to avoid the steep, time-consuming climb and allowed them to be more productive on anchor and mesh installation. A total of 20 each 3/4", 10-ft long wire rope anchors (see Figures 14-16) and 9,800 square feet of Spider<sup>®</sup> Net were installed. All of these materials and all of the tools required to install were ferried by helicopter to the work area.

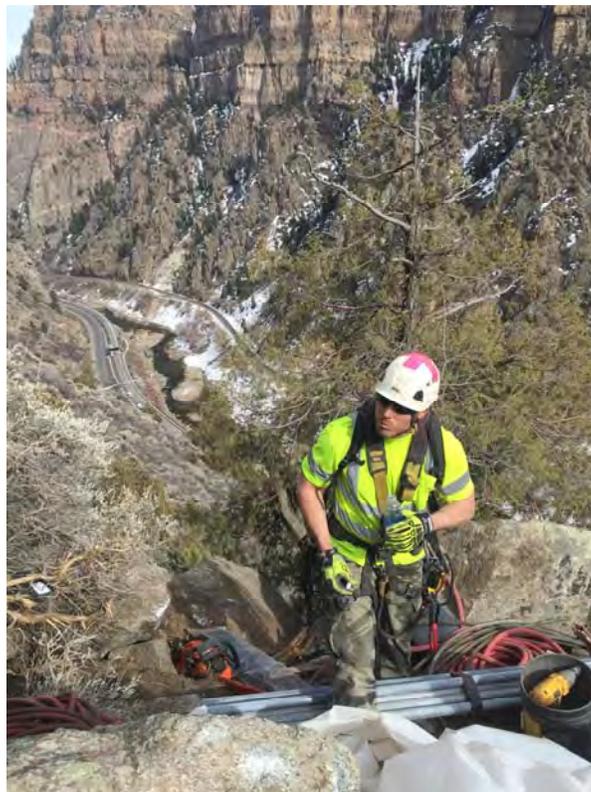
**Figure 14 – Preparing to drill Anchors**

After the scaling and temporary barrier installation came another tough task. By deciding that some of the nested rocks should be stabilized in place, the logistics of how to accomplish that task was magnified greatly. Scaling required scalers to access the area by ropes and dislodge precarious rocks using bars, air bags and other mechanical means. Stabilization requires, the safety scaling to be performed, but also additional tools, equipment and materials to be flown to the site. The plan was to secure the remaining nested boulders using Geobrugg Spider<sup>®</sup> Net, rock anchors and cable lashing. Golder Associates formalized the plan and also prescribed strain gauges for the cables associated with the cable lashing. Data was to be collected remotely with data boxes installed near the instrumentation. Each of 2 data boxes required a 1-1/2" diameter galvanized post to be drilled and grouted into rock as well as grounding rods drilled nearby.

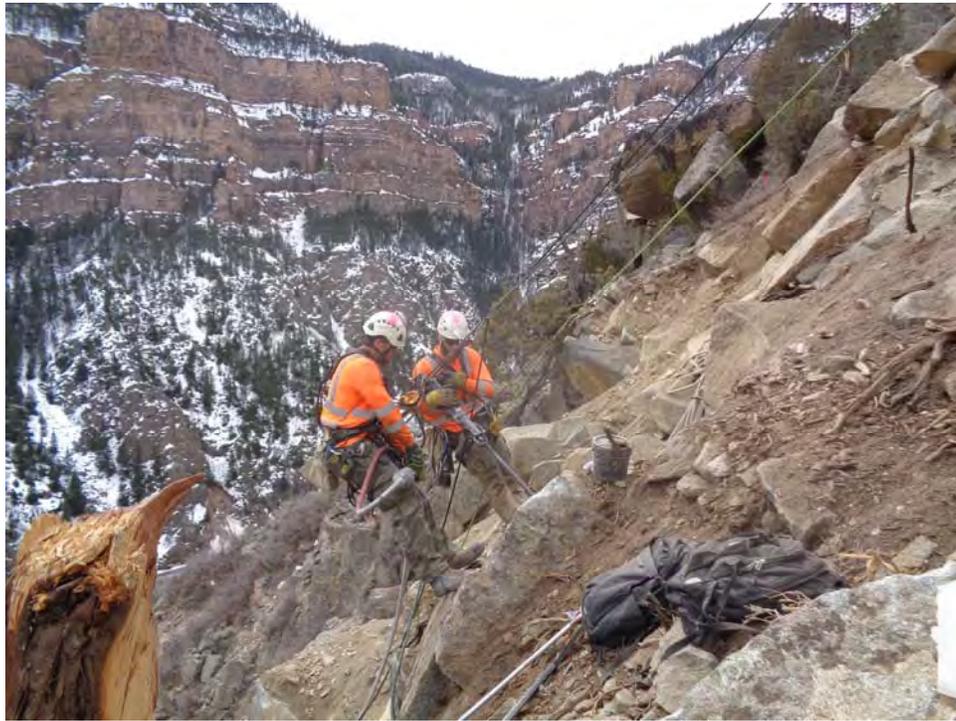
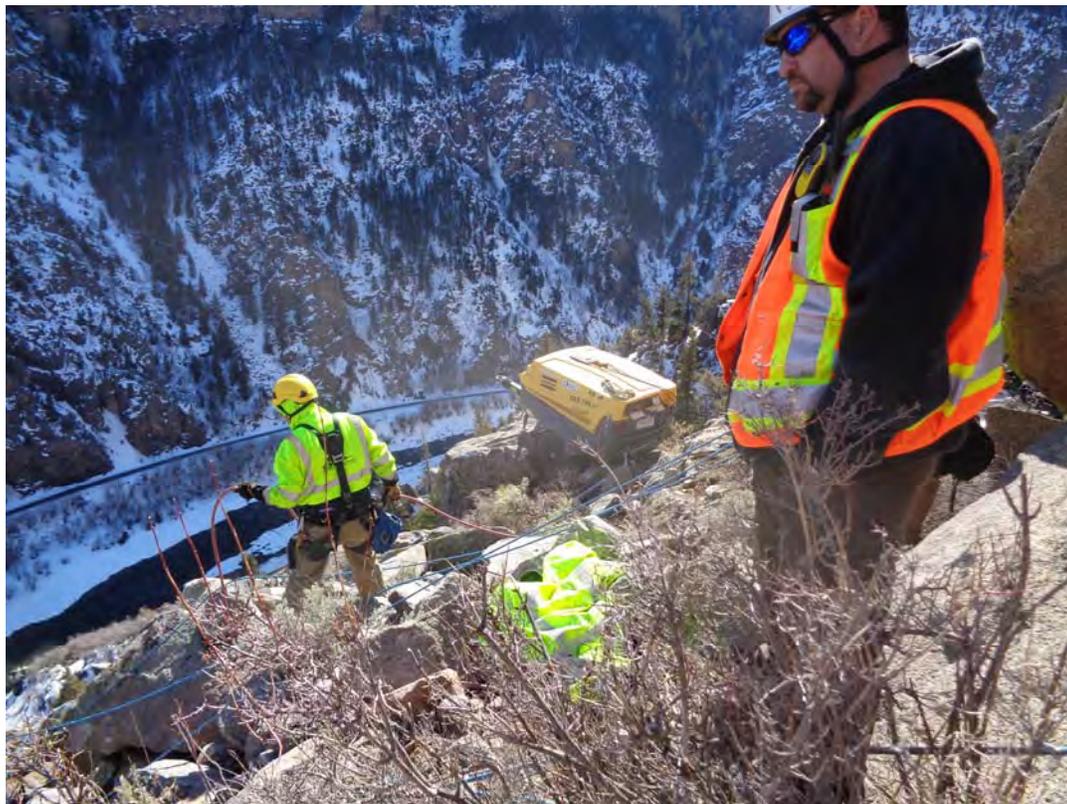
**Figure 15 – Drilling Anchors**

**Figure 16 – Drilling Anchors**

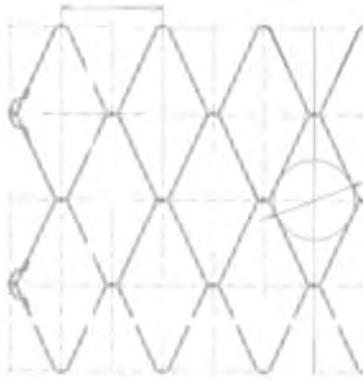
Figure 1: SPIDER® net S4 - 230

### – Figure 17 Geobrugg Spider® Net

With all of the anchors installed, the mesh was flown to the work area and secured. (See Figures 17-19) The mesh used was Spider® Net from Geobrugg.

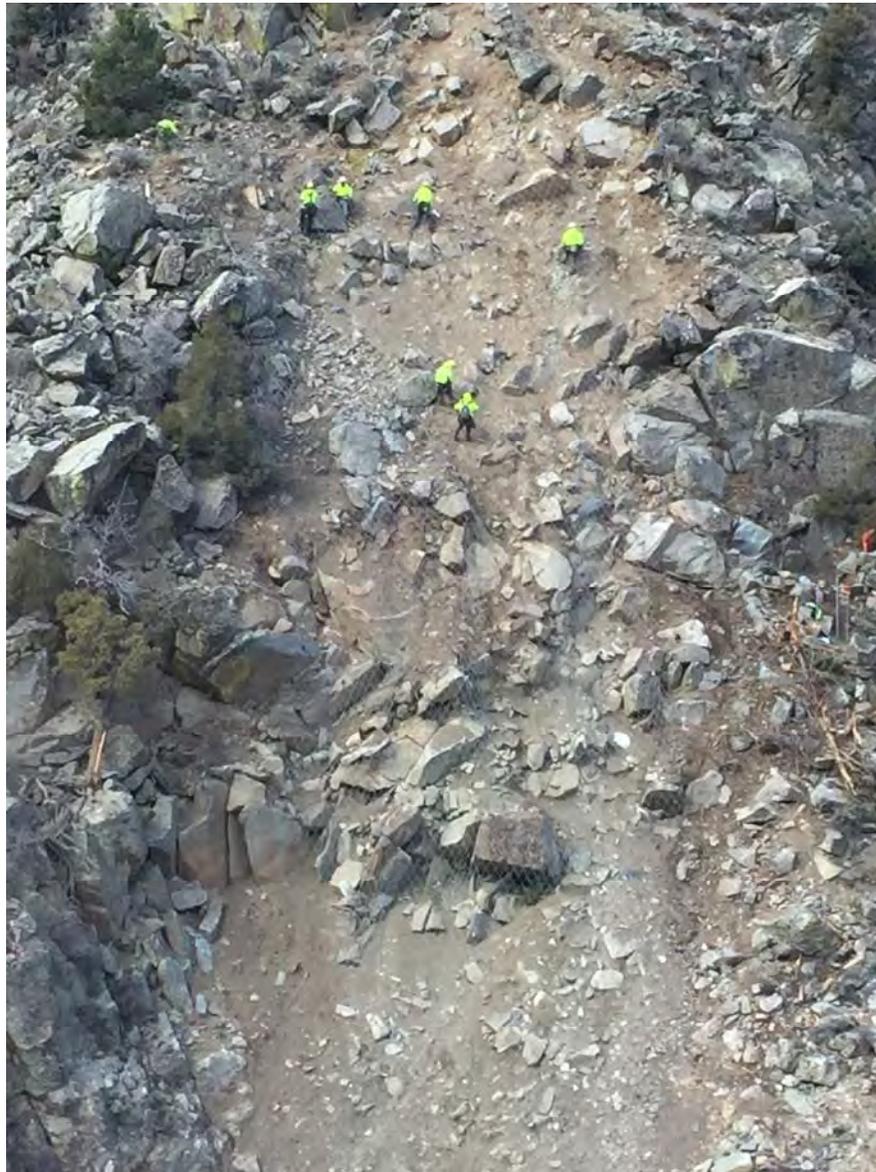
**Figure 19 – Final Meshing and Fitting**

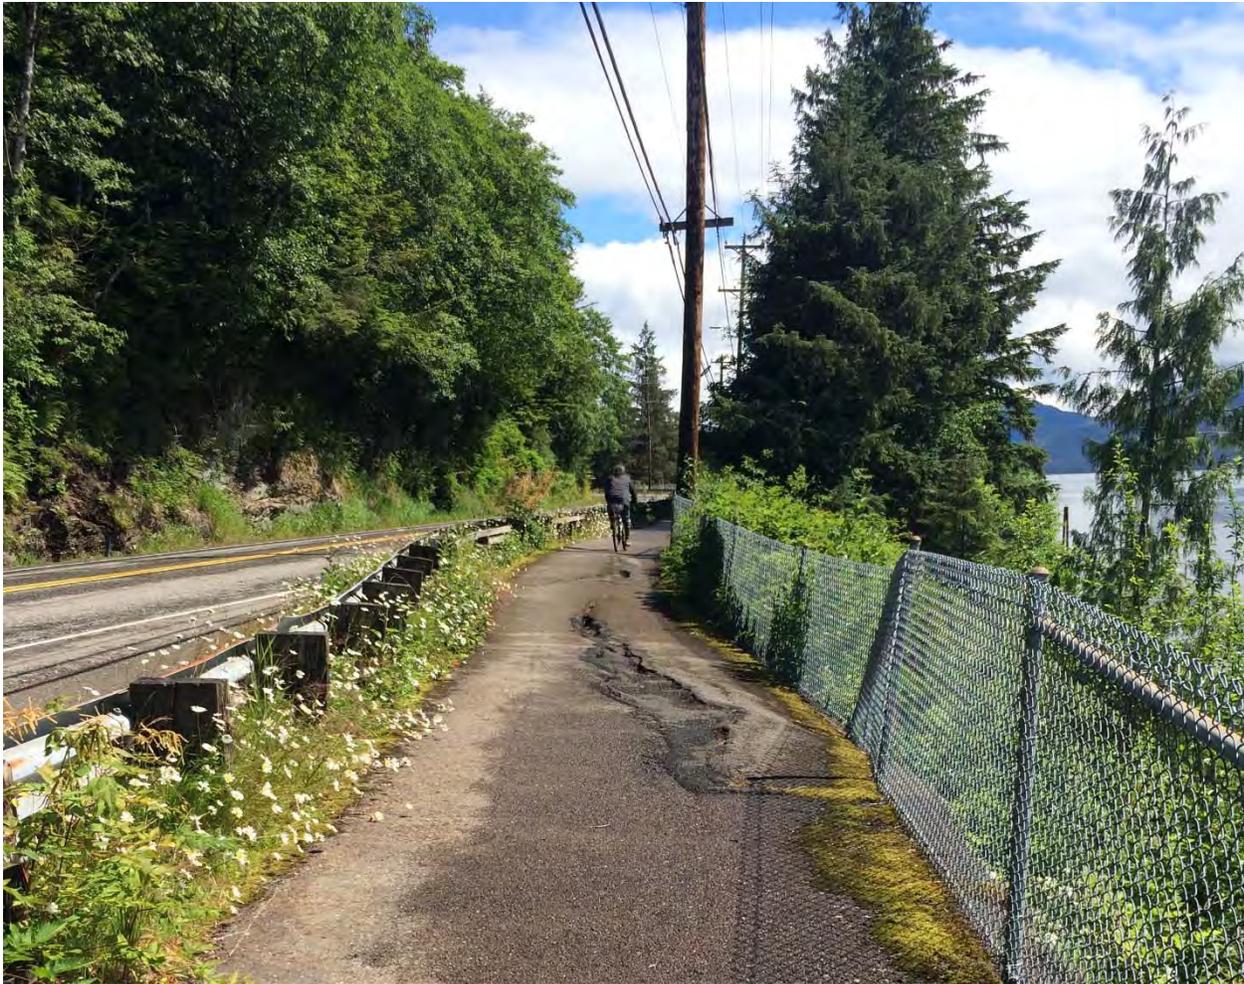
**Figure 2 – Pathway Above a Welded Wire Retaining Wall that has Moved.**

The current project aims to improve the roadway corridor for its users. With this there will be a balance of cuts upslope and fills downslope. Because the retaining walls are predominantly downslope, we evaluated the condition of these walls and asked ourselves one overarching question: should the existing walls be removed and replaced as needed, or is there any benefit gained by designing around them and leaving them in place? This question significantly differs from the question an inspector providing a GAM rating is interested in. In general, the GAM rater is interested in a snapshot in time and does not estimate the

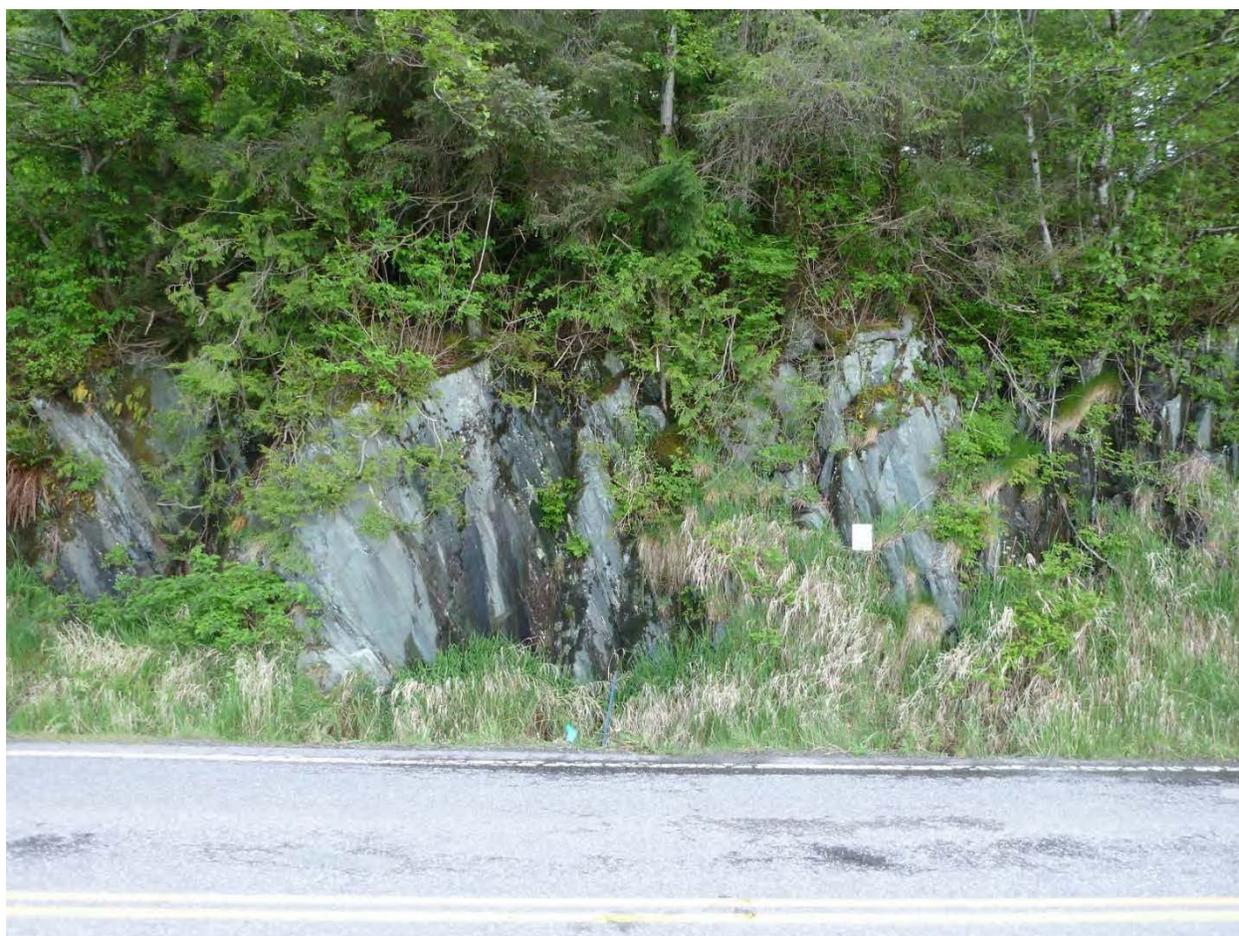
**Figure 3 – Example of Existing Rock Slope, View Northeast Approximately Perpendicular to Slope. Rectangular Clipboard on Slope is Approximately 1 Foot Tall for Scale. Overall Rock Slope up to 15-20 Feet in Height.**

the current highway and the proposed alignment is to the southeast. The relationship between the existing southwest-facing rock cut slopes, northeast-dipping foliation, and discontinuity sets results in toppling and wedge failures. Figure 3 provides a typical example of an existing rock cut, with foliations seen steeply dipping to the northeast into the cut as shown in Figure 4. In order to plan for a field program, we reviewed the GAM database in the project area.

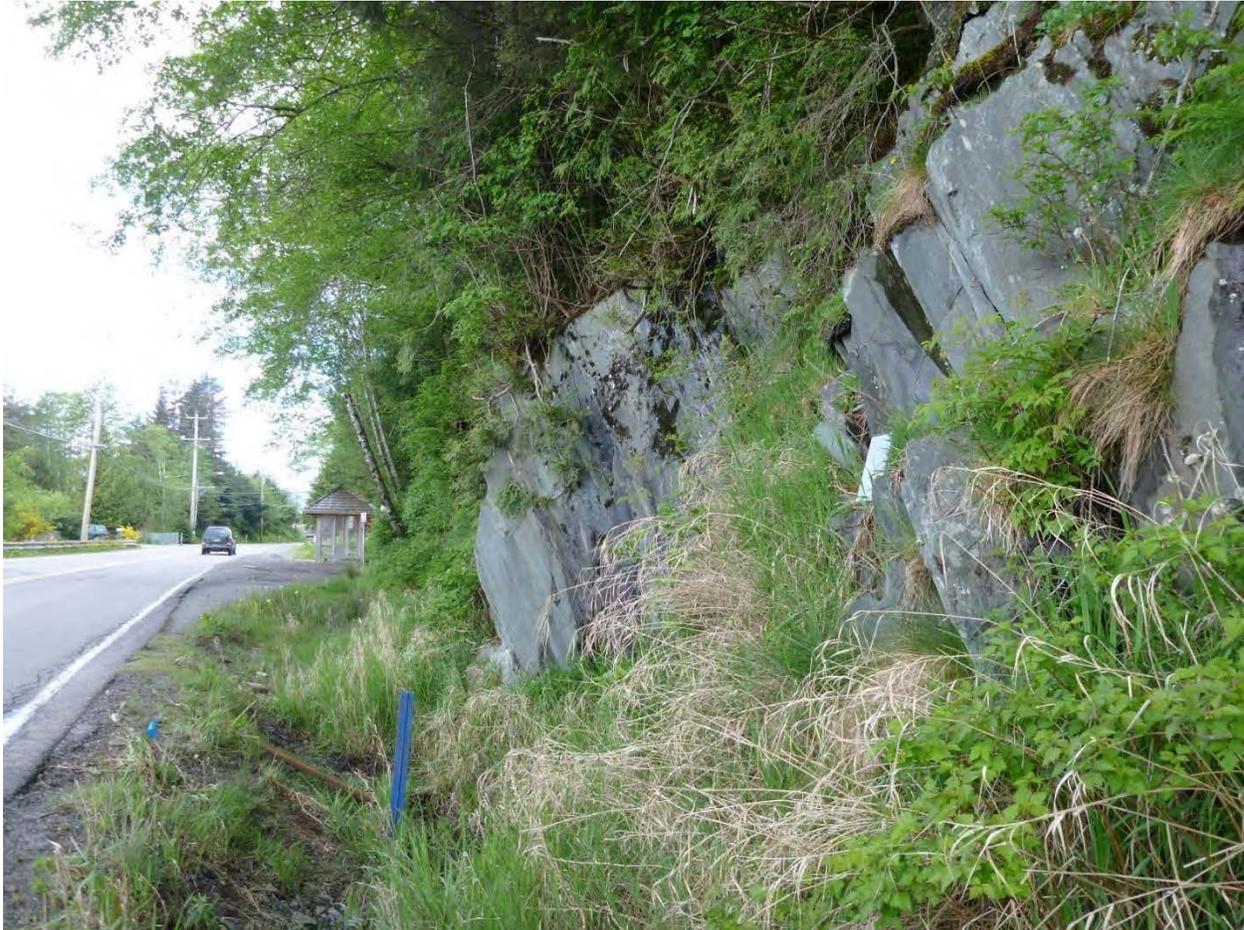
**Figure 4 – Example of Existing Rock Slope, View Northwest Approximately Parallel to Slope. Rectangular Clipboard on Slope is Approximately 1 Foot Tall for Scale. Note Foliation Dipping Northeast Steeply Into the Rock Slope.**

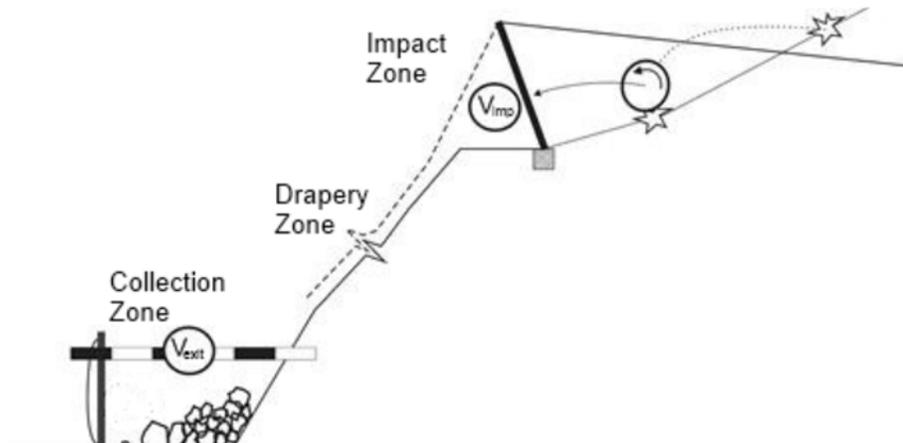
**Figure 1: Sketch of typical post supported attenuator system**  
 $V_{imp}$  = impact velocity;  $V_{exit}$  = exit velocity (Image, J. Glover).

Rockfall attenuator systems do not completely halt falling rocks, but intercept the rockfall trajectory and guide it under a tail drape (Figure 1 and 2). Attenuators are a combination of traditional rockfall barriers and draped net systems. The principal function of rockfall attenuator systems is to absorb only a portion of the impact energy and redirect the rock into the ground at the base of the slope where the rock is contained. In this way, the kinetic energy is only partially dissipated through barrier impacts deforming the netting and interaction with the slope during its passage to the base of slope (Glover et al., 2011). Attenuator systems hybridize the best features of both a traditional rockfall barrier and a slope drapery system. Hybrid drapery (attenuators) addresses rockfall source areas, both underneath and upslope of the installation, and controls the

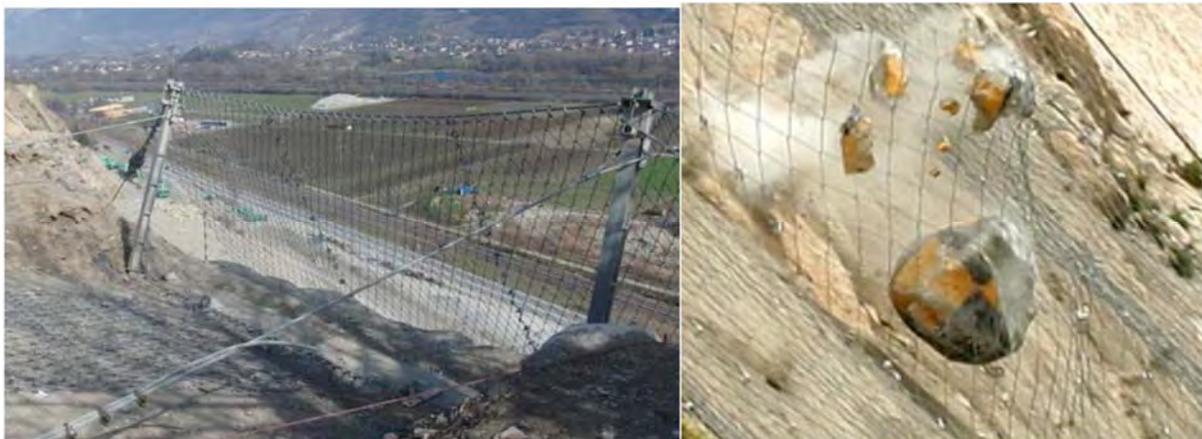
**Figure 2: Catchment area of attenuating structure (left) and guided boulder along rock face (right) from Glover et al., 2012.**

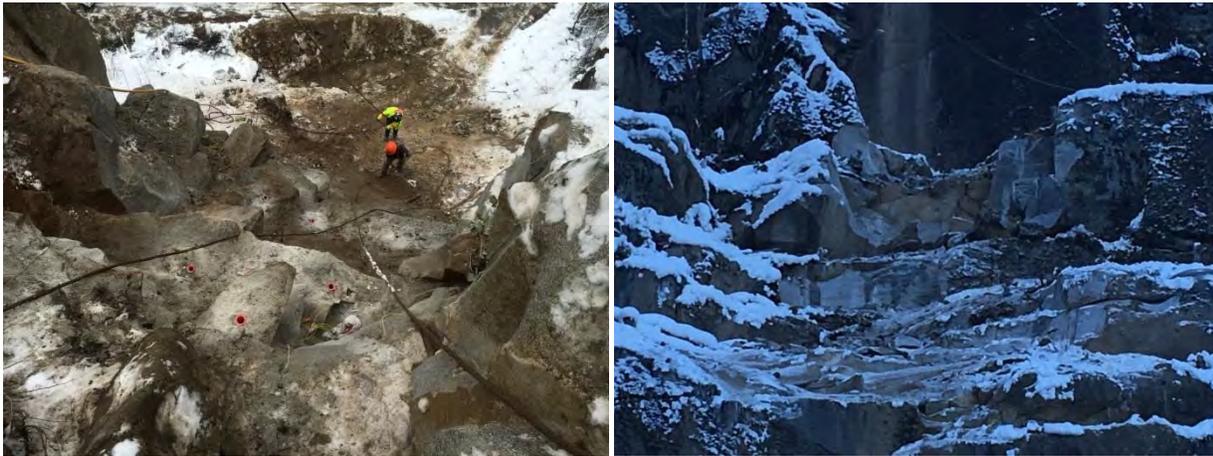
**Figure 5: Trim blasting work for improvement to rockfall path alignment (Image, James Glover).**

During the 2015 proof of concept testing, it was observed that many of the rocks took an eastward rockfall path due to slope topography often missing the attenuator system. Improvements to the rockfall pathway were made with trim blasting of the upper rock slope to better direct the rockfall toward the attenuator system (Figure 5). An additional goal was to smooth out the topography to reduce the energy losses due to impact on the rock face (Glover and Ammann, 2016).

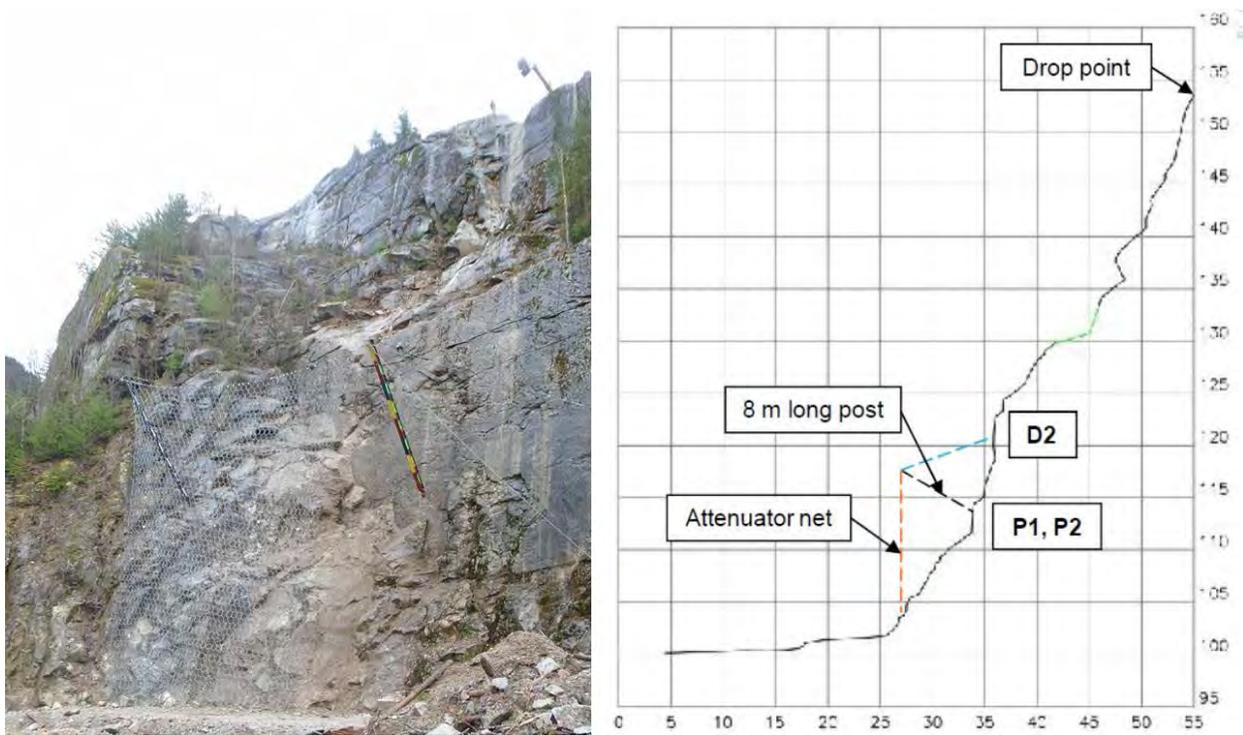
**Figure 6: RXE-1000 Attenuator Net System from Geobrugg Protection Systems (left), slope profile of the test site with location of the attenuator barrier (right).**

The tested attenuator system was Geobruigg's RXE-1000A rockfall barrier modified to act as an attenuator (Figure 6). The system had a structural net length of approximately 36 ft (11 m) terminating approximately 3.25 ft (1 m) off the ground. The netting was hung vertically from a top support rope suspended from two steel posts each 26.25 ft (8 m) long, angled at 45 degrees. The steel posts were spaced at approximately 47.5 ft (14.5 m) and attached to the rock face using hinged bases so negligible forces are generated in the post foundations. Additional rope infrastructure included upslope anchor ropes, lateral ropes, and vertical side ropes. The support ropes were attached to the granite rock face with 6.5 ft (2 m) long wire rope cable anchors.

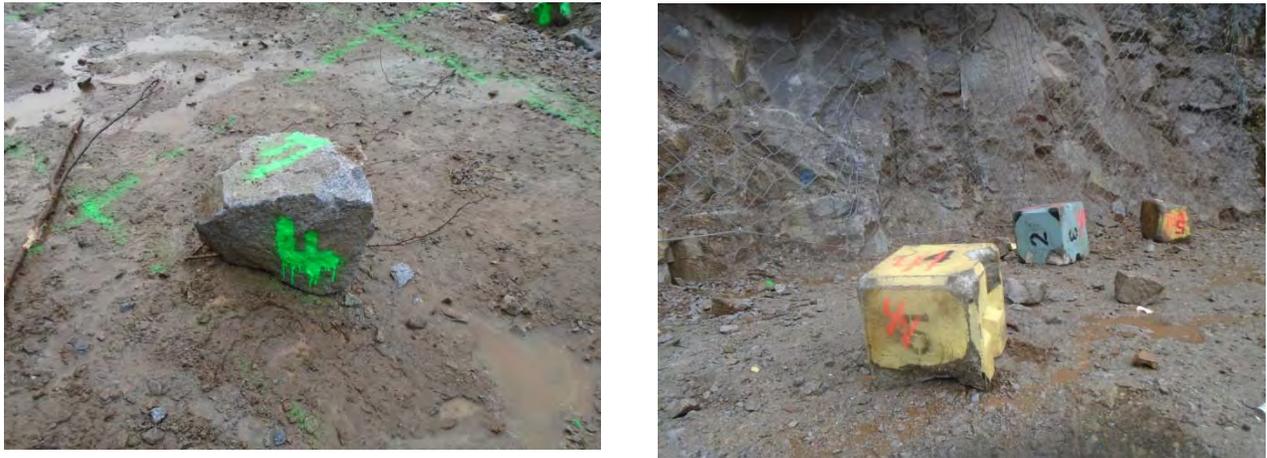
**Figure 7: Granitic test rock (left) and concrete test blocks (right).**

Natural granitic blocks up to approximately 1.5 ft (0.45 m) in diameter and cubic reinforced concrete blocks were used for testing (Figure 7). The concrete blocks were 14.88 ft<sup>3</sup> (0.42 m<sup>3</sup>) and 35.28 ft<sup>3</sup> (1 m<sup>3</sup>) cubes. The concrete blocks incorporated lifting eyes on two faces

and were painted yellow with emphasis on the corners, and each face numbered to maximize their visibility in the videos.

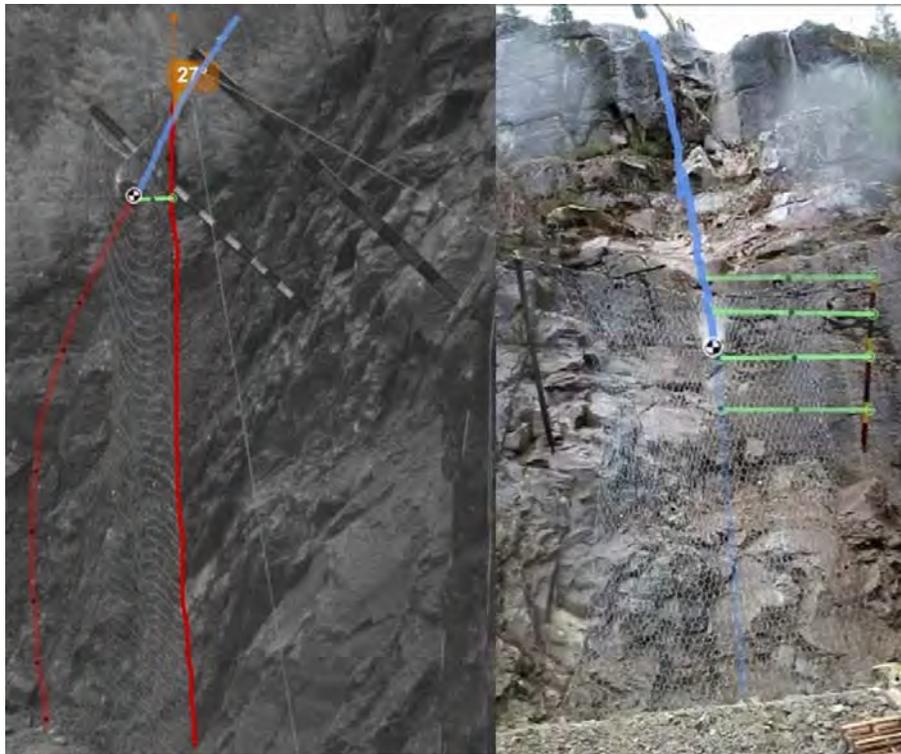
**Figure 8: Video analysis performed using Kinovea motion analysis software. (Left) Side camera view and (Right) front camera view.**

Video documentation of the tests was taken from a number of perspectives and frame rates. The primary cameras used for the video analysis were placed at the side and directly in front of the attenuator system. The main velocity analysis and observations of the rock-net interaction are performed using the data from the side view camera capturing video at a frame rate of 250 fps. The side view camera captures the initial rock impact trajectory, the rock-net interaction, and attenuated rock trajectory. The front view camera is used to document the netting hit location and the depth of field of the rock relative to the side view (Figure 8). Three additional cameras were utilized during the testing including a top view from the rock release position and two additional bottom views.

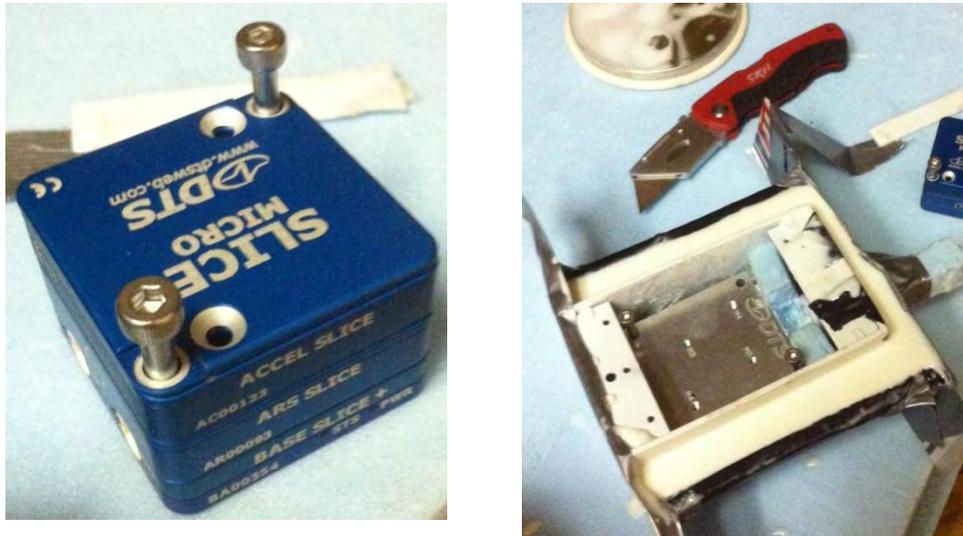
**Figure 9: (Left) DTS micro-slice Accelerometer and Gyroscope. (Right) The custom-resin housing. (Image, James Glover).**

- Tri-axial accelerometer 500 g rated and measurable range of up to 750 g.
- Tri axis gyroscope measuring up to 18000 °/sec.
- Sampling rate is up to 20 kHz.

There were seven rockfall tests in which concrete blocks were equipped with a rock motion sensor placed in a resin housing.

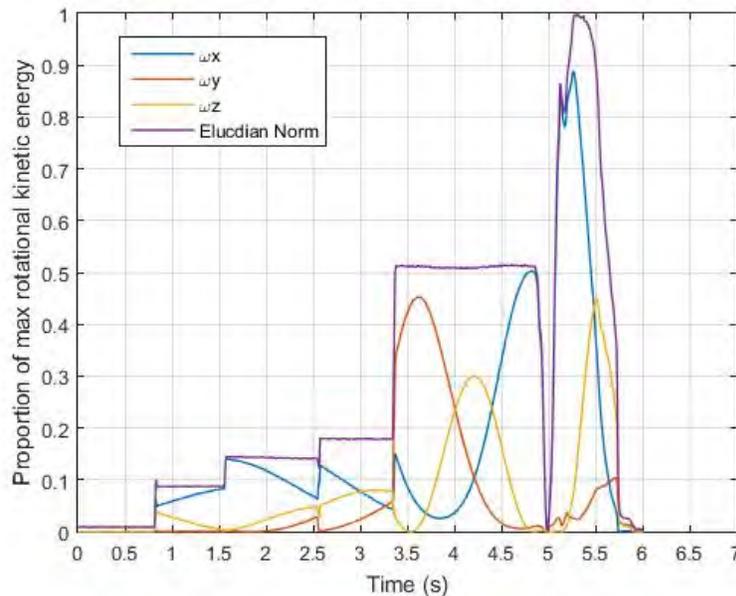
**Figure 11: Plot of the rock's total rotational kinetic energy and for each principal axis of inertia (X, Y, and Z) (Glover and Ammann, 2016).**

Figure 11 plots the proportion of the rotational kinetic energy for each principal axis and the Euclidean norm of the rotations experienced during the experiments. The variation in the rotational energy with time represents the tumbling motion of the concrete test block.

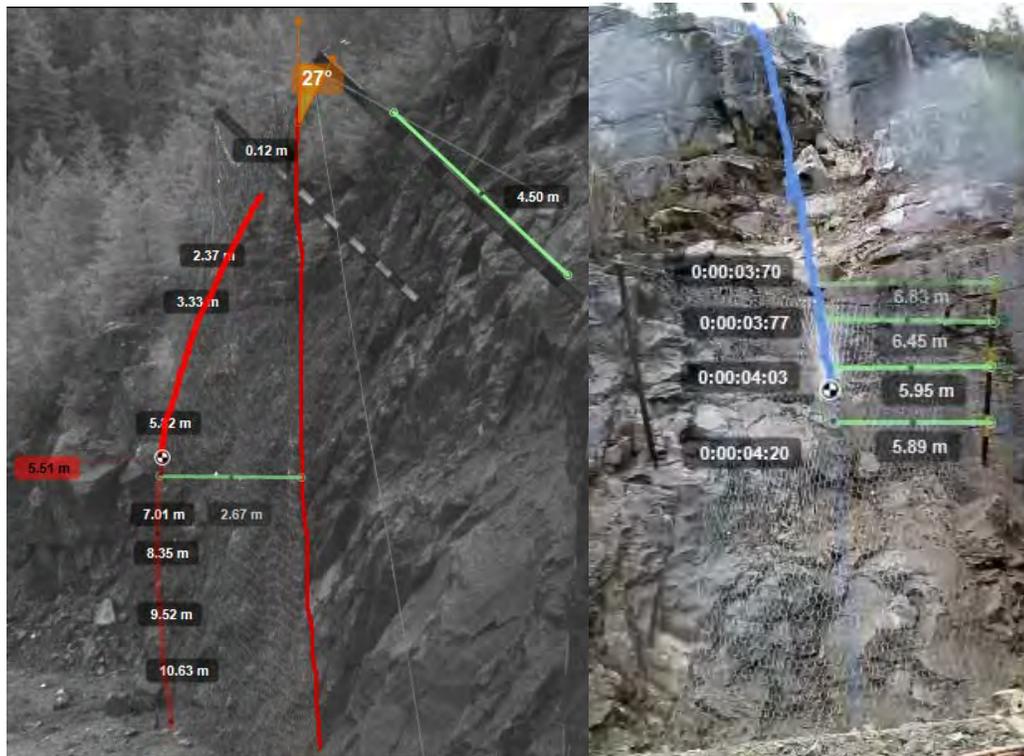
**Figure 12: (Left) Video analysis software Kinovea applied to the side view camera. (Right) View from front camera (Image, James Glover).**

The high speed videos running at 250 fps are being analyzed with ProAnalyst and Kinovea software that have the ability to measure both translational and rotational velocities frame-by-frame (Figure 12). The analyses require a dimension scale being visible in the image which was provided by the scales painted on the two support posts, with allowance being made for the changing perspective due the varying distance of the test blocks from each reference post. The impact angle is measured of initial impact with the netting. The position of the rock during free fall, and whilst in contact with the net is plotted over time. Net deflection is also obtained over the trajectory.

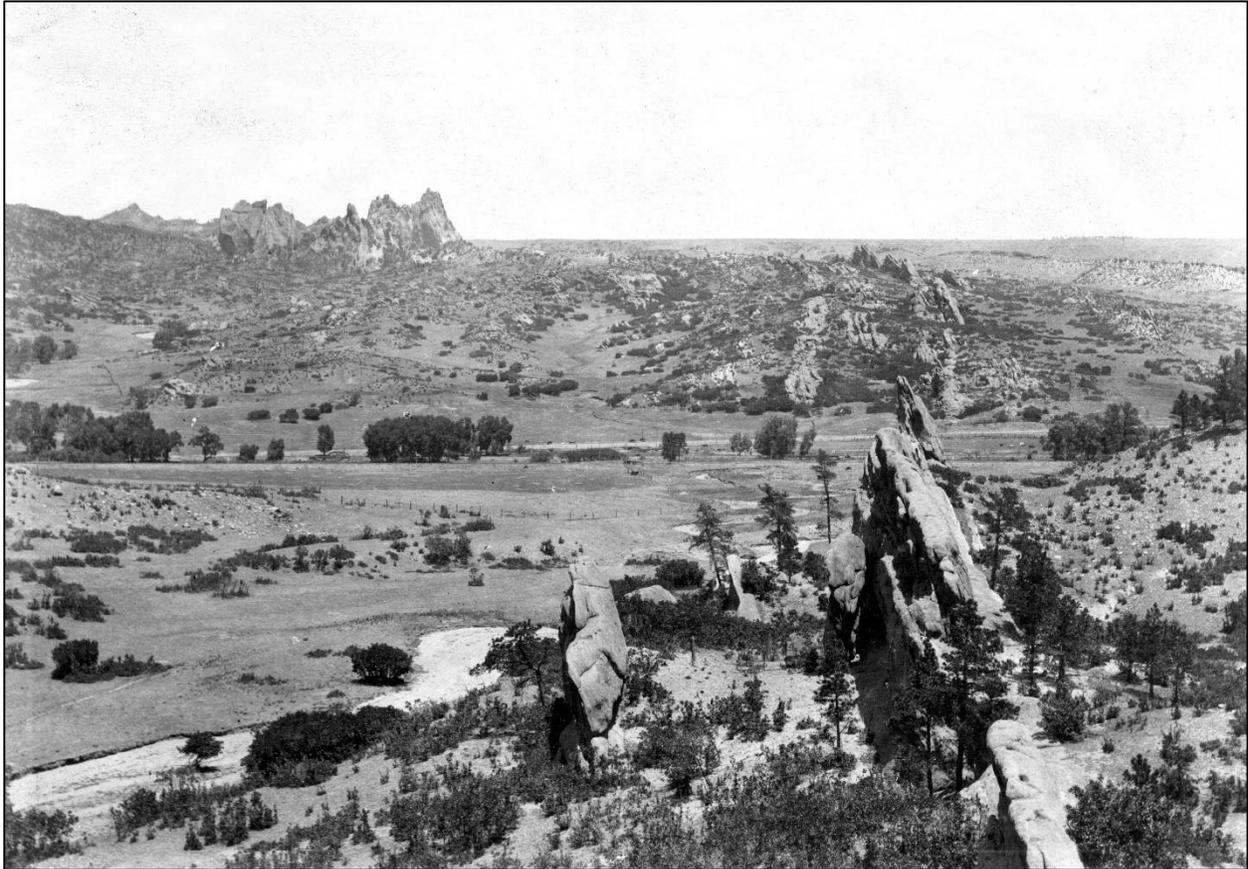
Historic USGS photograph by I.C. Russell from the 1890s is a north-facing view along strike of Fountain Formation outcrops from Red Rock Canyon to across Fountain Creek. This linear formation of steep east-dipping rock outcrops ends abruptly in the background (near the horizon), juxtaposed against weaker Cretaceous strata along Rampart Range fault. Taller spires at Garden of the Gods in left background are back-thrust slivers on the opposite (downthrown) side of the fault. Image is photographic plate XVII(a) from Darton (1906).

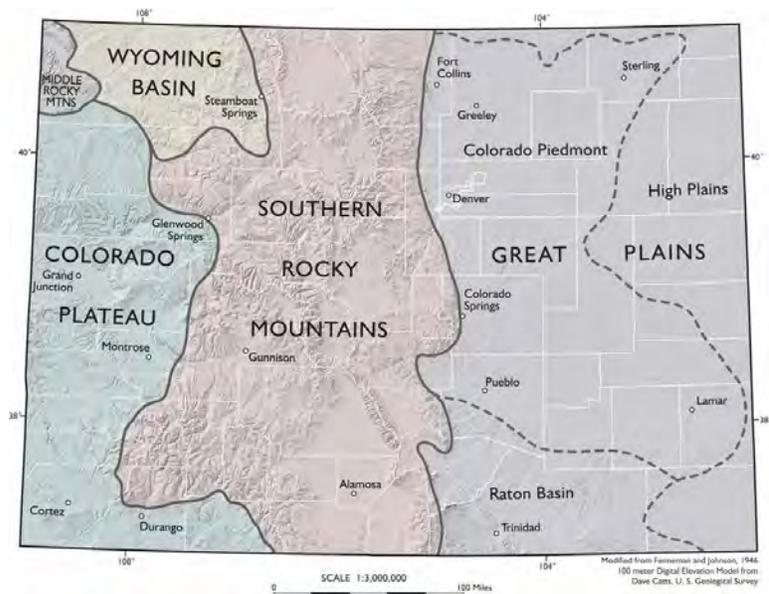
**Figure 3.** Physiographic provinces of Colorado. Image from Colorado Geological Survey.

Physiographically, Colorado Springs lies within the Colorado Piedmont section of Great Plains along the base of the Front Range foothills (**Figure 3**). The Piedmont is the eroded surface of the Great Plains where erosion of Tertiary and mountain-front older sedimentary rocks has lowered the base level of the ground surface over a thousand feet. The high area of the Colorado Piedmont topography, ~7,500 ft in elevation, is along the Palmer Divide, about 18 mi north-northeast of downtown Colorado Springs. Palmer Divide, underlain by Dawson Formation, is the drainage divide that separates the Arkansas River basin to the south from the South Platte River basin to the north. The higher elevation climate there is suitable for the growth of Ponderosa pine trees. Known as the Black Forest, it is the only pine forest that occurs on the Great Plains in Colorado.

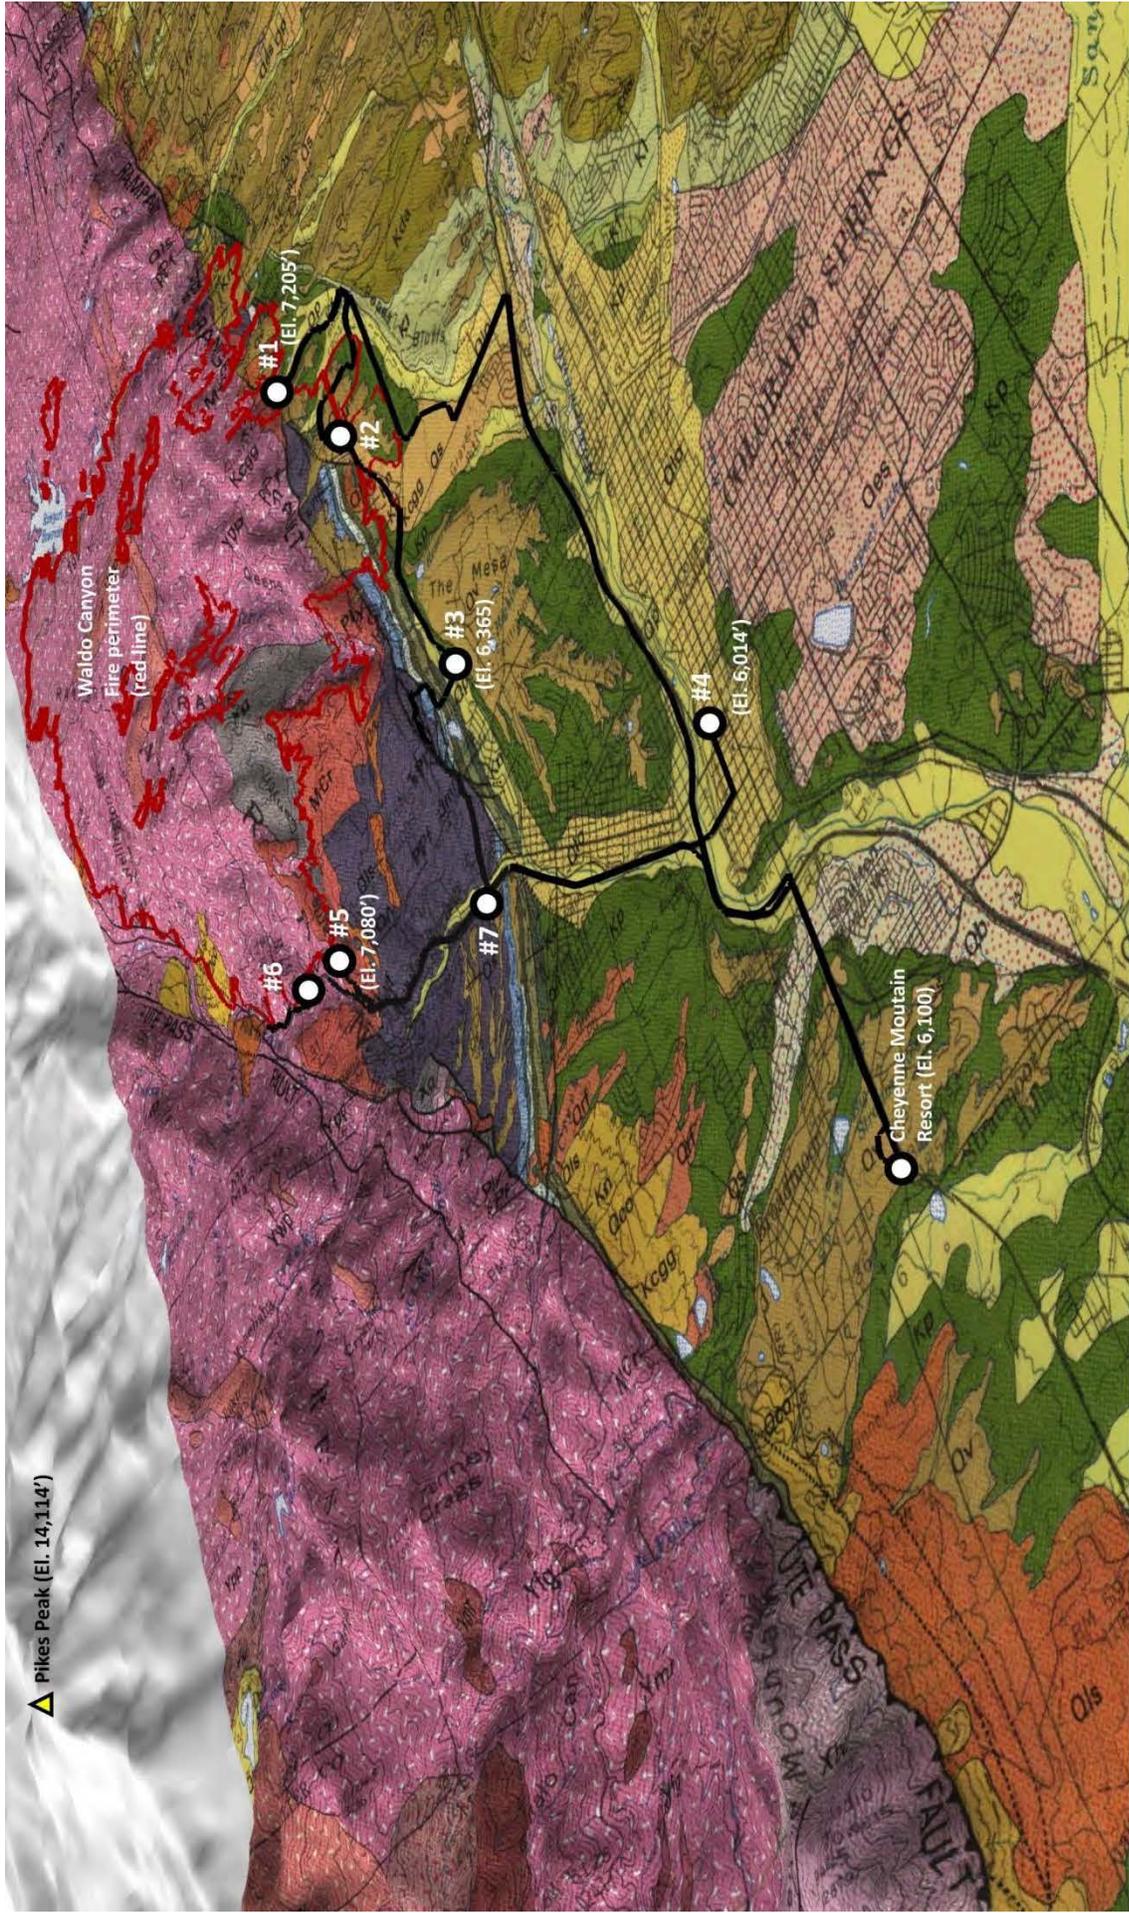
**Figure 4.** Oblique geologic map on 30-m DEM basemap with labeled field trip stops. View is to the northwest. Geologic map is USGS 1:100,000-scale Front Range Urban Corridor map by Trimble and Machette (1979). Field trip route is shown as heavy black line. Waldo Fire perimeter is shown by heavy red line. Image was created using ESRI ArcScene. Geologic color palette varies from CGS 1:24,000-scale maps used in the guidebook but units are the same except for Quaternary alluvial units that have been numbered by CGS, from oldest to youngest: Qv - Verdors Alluvium becomes Qg2; Qs - Slocum Alluvium becomes Qg1; Ql - Louviers Alluvium becomes Qt3; and Qb - Broadway Alluvium becomes Qt2.

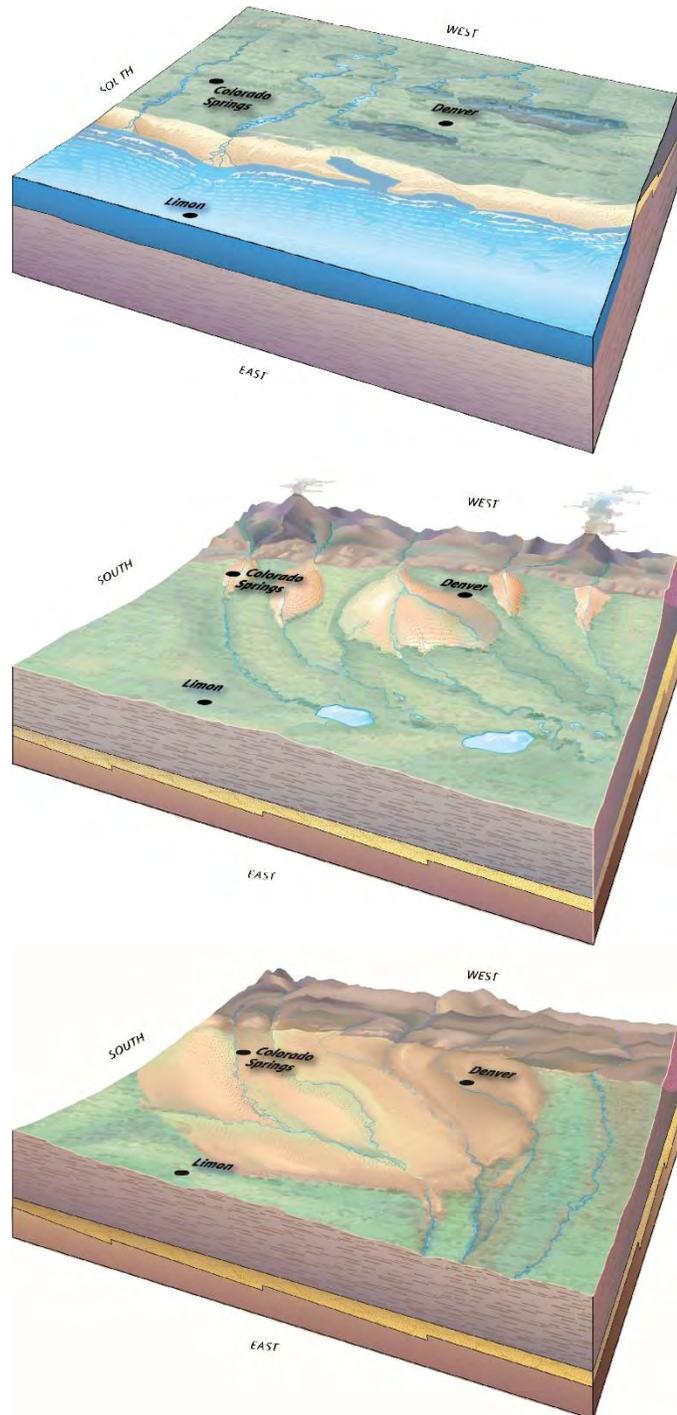
**Figure 6.** Paleogeographic reconstructions of the Front Range corridor during the Laramide Orogeny. Top image is about 68-70 Ma when the Fox Hills shoreface of the mid-continent sea was regressing eastward with Laramie coal-forming swamps and floodplains behind. Second image from about 64-47 Ma shows fully regressed sea and alluvial fans from the upthrown mountain front beginning to cover the Denver/Laramie floodplain within the Denver Basin. Bottom image from 54-55 Ma shows continued shedding of sediments from the Front Range and filling of Denver Basin. Images from Dechesne and others (2011).
