HGS 2016  
Proceedings

# 67TH HIGHWAY GEOLOGY SYMPOSIUM

## JULY 11 – 14, 2016

Cheyenne Mountain Resort  
COLORADO SPRINGS, COLORADO

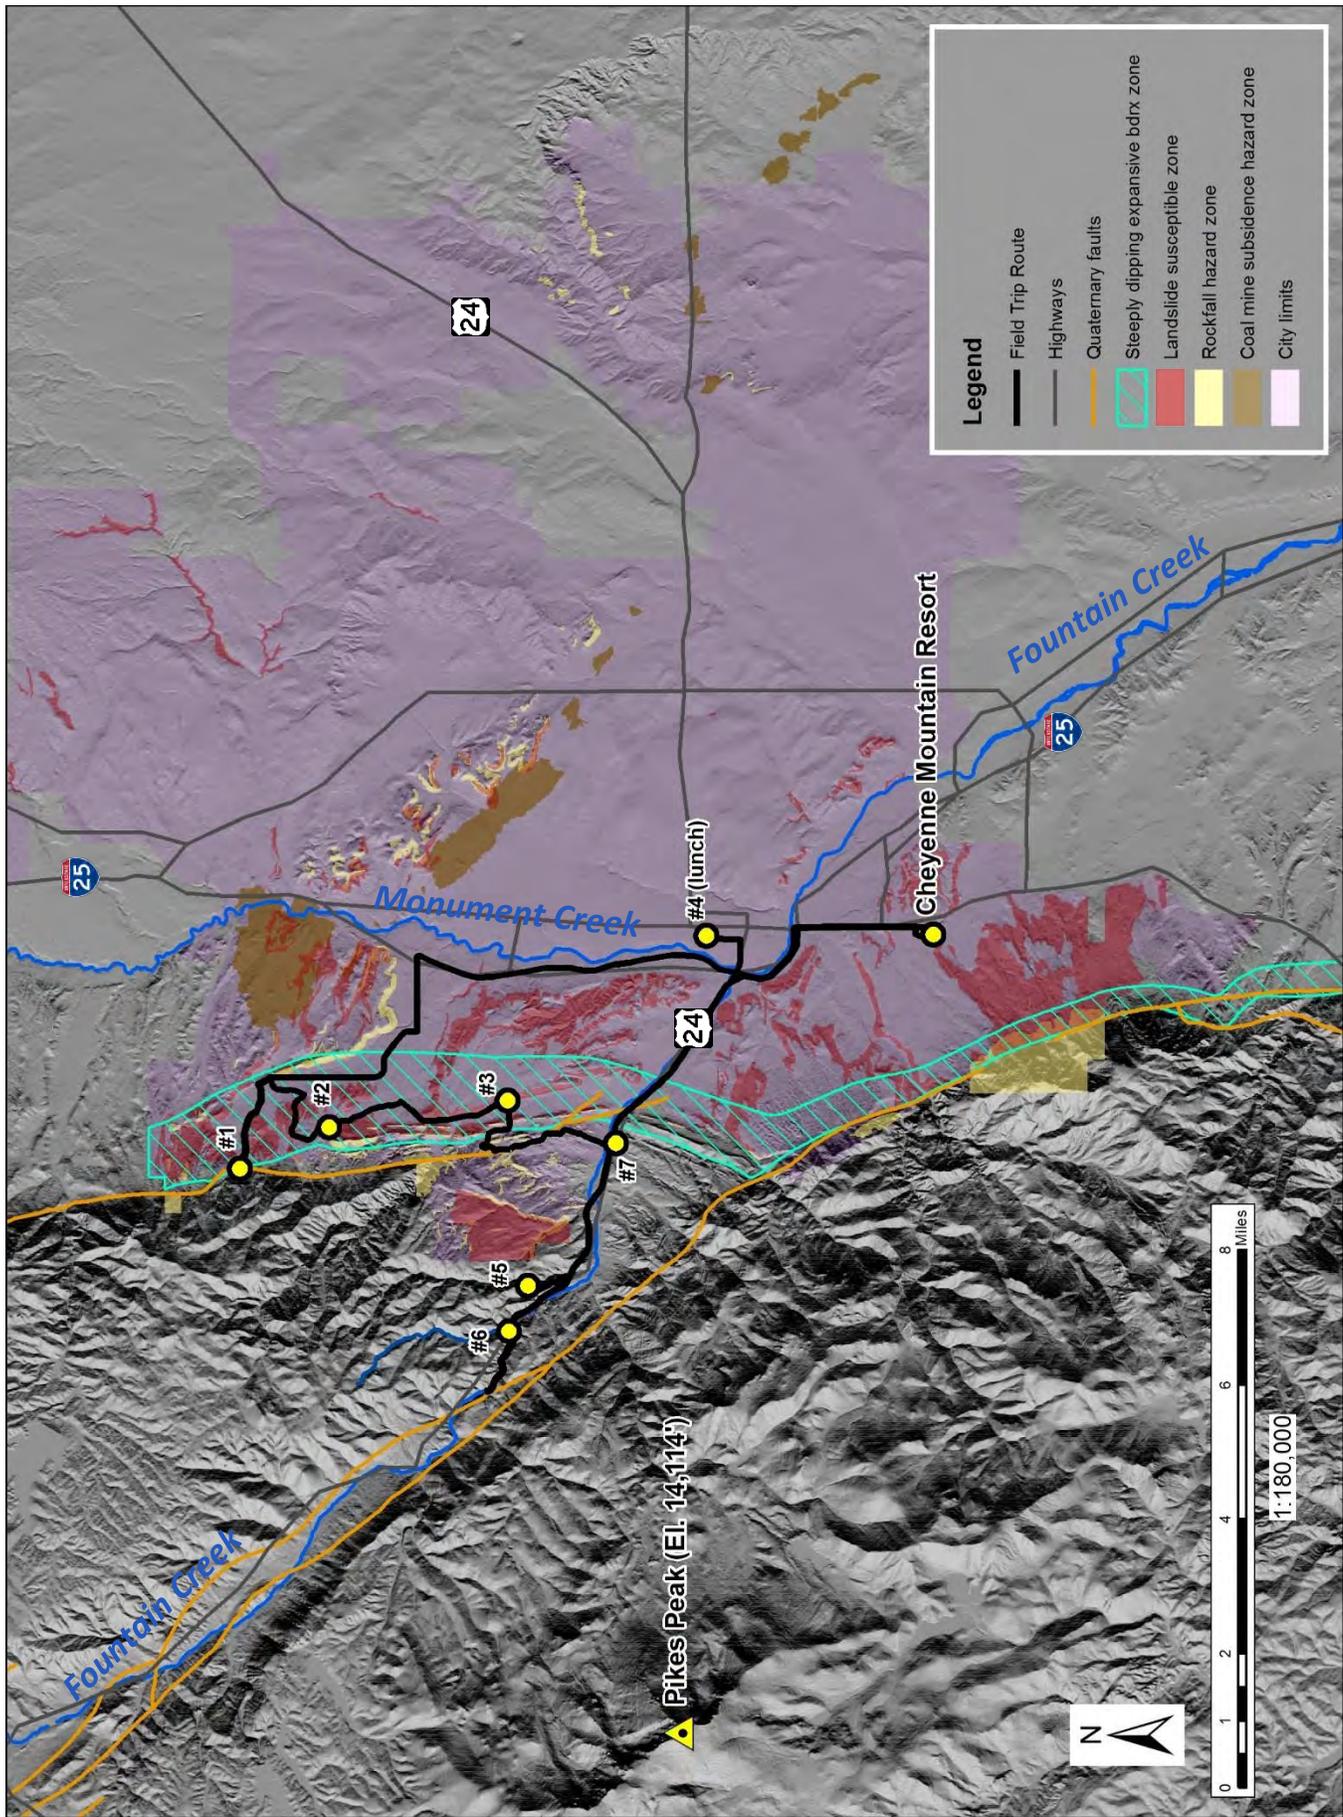
Figure 7. Field trip route. Stops shown by yellow dots. Geologic hazards coverages on USGS 10-m DEM hillshade baemap.

The geologic conditions discussed in the Regional Geology section above has left landforms and adverse underlying geology that is amenable to exposure and risks to most types of geologic hazards in Colorado Springs’ vicinity. Geologic mapping by the Colorado Geological Survey (CGS) emphasizes mapping of surficial deposits (soils in engineering terms) because their modes of deposition can be correlated, to some degree, to soil engineering properties. The CGS also completed applied geologic hazard maps for the Colorado Springs area including landslide susceptibility, rockfall hazards, steeply dipping expansive bedrock, coal mine subsidence maps, and maps of Quaternary-age faults. Those coverages are shown in **Figure 7**.

**Steeply dipping expansive bedrock:** The steeply dipping expansive bedrock coverage of Colorado Springs shown in Figure 7 is from (Himmelreich and Noe, 1999). In addition to being low strength and prone to instability, Cretaceous claystone commonly contain expansive clay minerals that can result in a heaving bedrock phenomenon at the surface. Swelling clay soils are a common problematic soil property along the entire Front Range piedmont corridor. However, along the flank of the mountains, where bedding is steeply dipping ( $>30^\circ$ ) (**Figure 10**) and the soil mantle is thin, the swell differential in shale beds can cause relatively narrow, linear heave features in bedrock that can severely damage structures that span them (**Figure 11**). Only through trenching of near-surface bedrock, perpendicular to strike, can an informed assessment be made of heave potential. Typical mitigation has been to remove and replace the top 10 ft of bedrock when developing where this condition exists. For more information, see Noe (1997), Noe and Dodson (1999), and Himmelreich and Noe (1999).

The following potential geologic hazards are not shown on the **Figure 7** map but also have a history of impacting Colorado Springs.

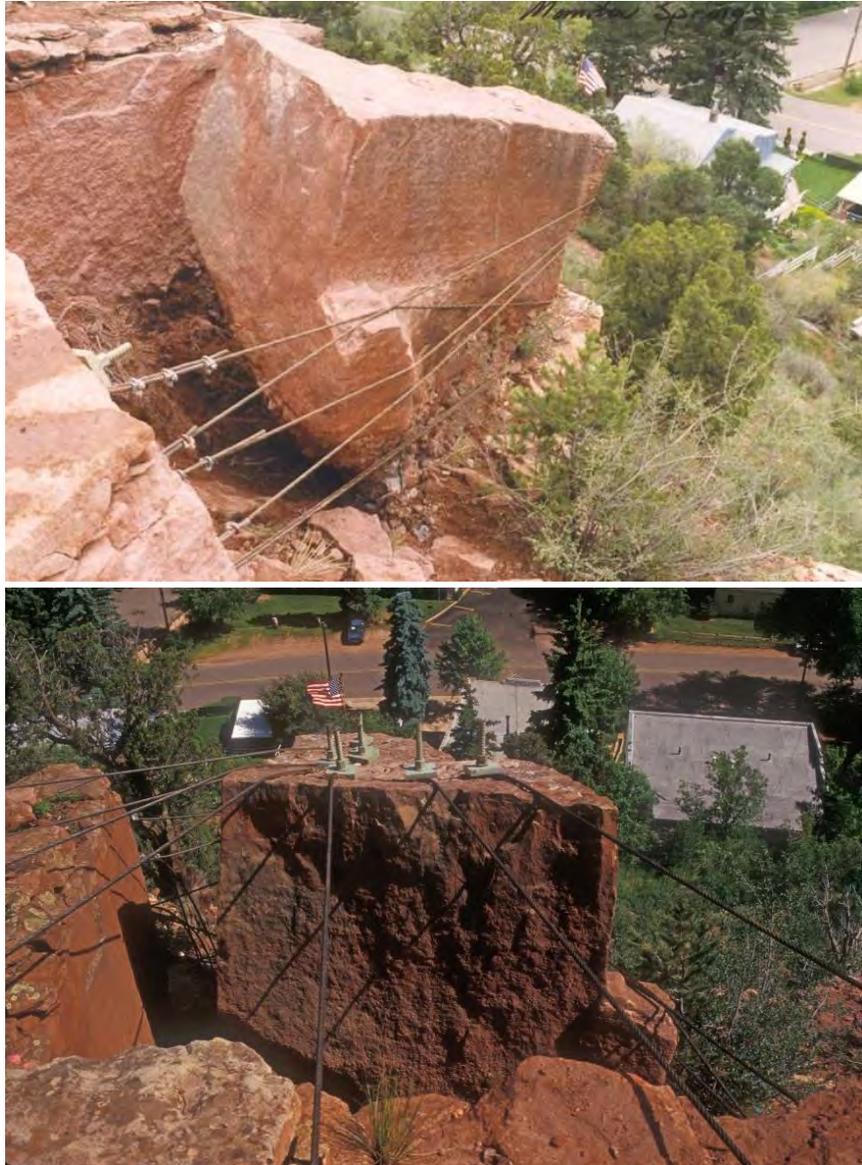
**Figure 9.** Large, joint-controlled block of red Fountain Formation sandstone and conglomerate slipped and was in precarious position in 1995, directly above homes in Manitou Springs. Block could not be removed safely so was initially restrained by 7/8-in perimeter cables (top photo) then anchored to additional cables that fanned out to anchor points in intact rock at top of bluff.

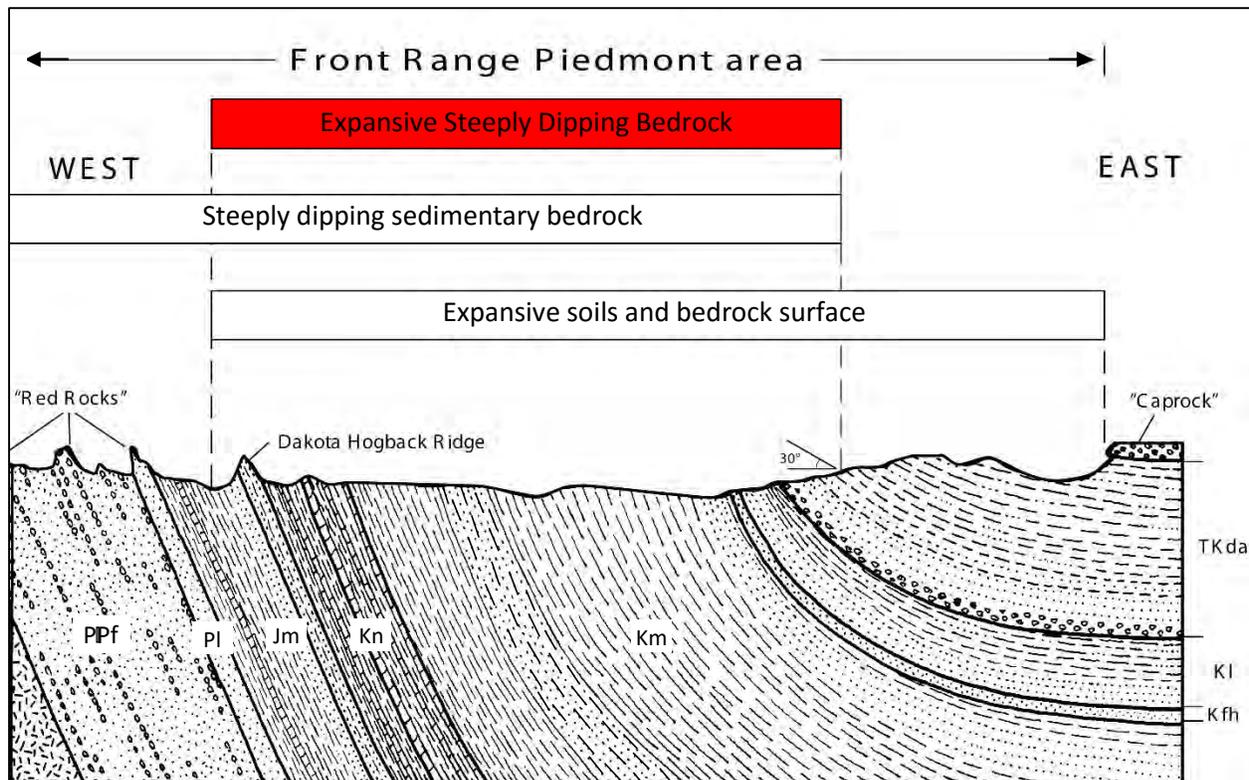
**Figure 10.** Those formations that lie within the steeply dipping expansive bedrock zone where formation dip exceeds 30°. Image modified from Noe and Dodson (1999).

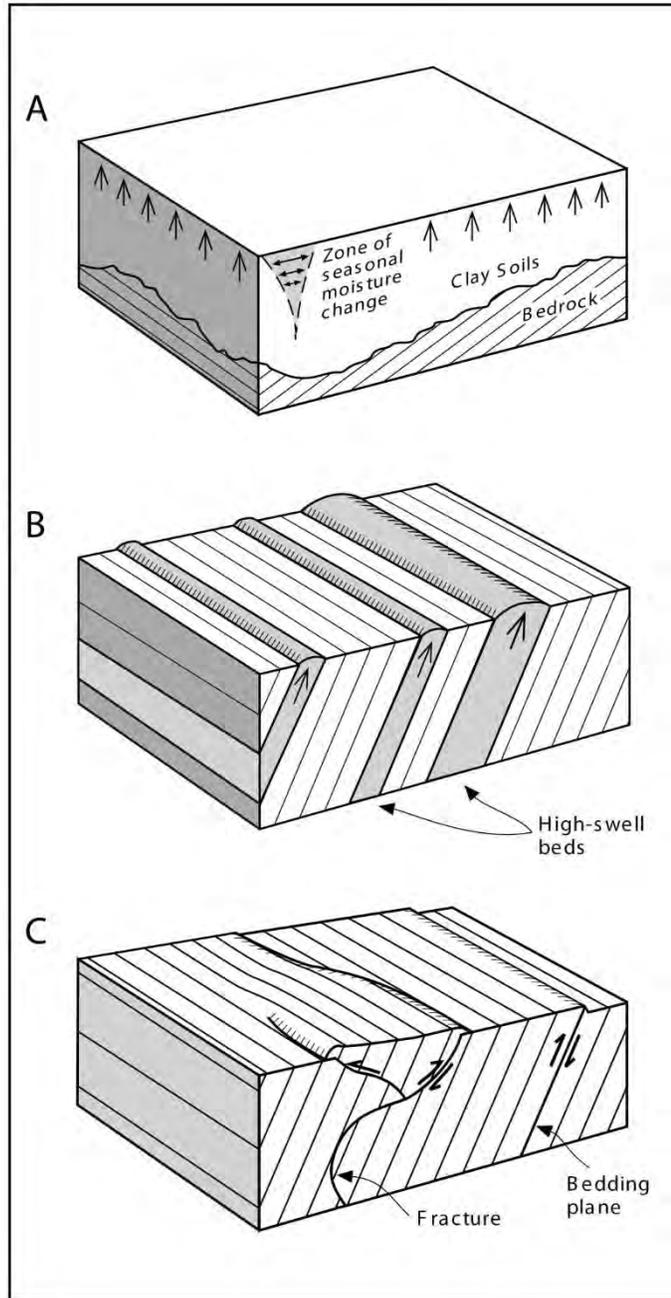
**Figure 11.** Illustrations from Noe (1997) showing differences between typical clay (A) soil with expansive clay minerals and two types of surface to near-surface bedrock heave: B) differential heave of high-swell beds generally along strike of strata, and C) fracture and bedding plane thrusts. Note that fracture thrusts can have random orientation at the ground surface.

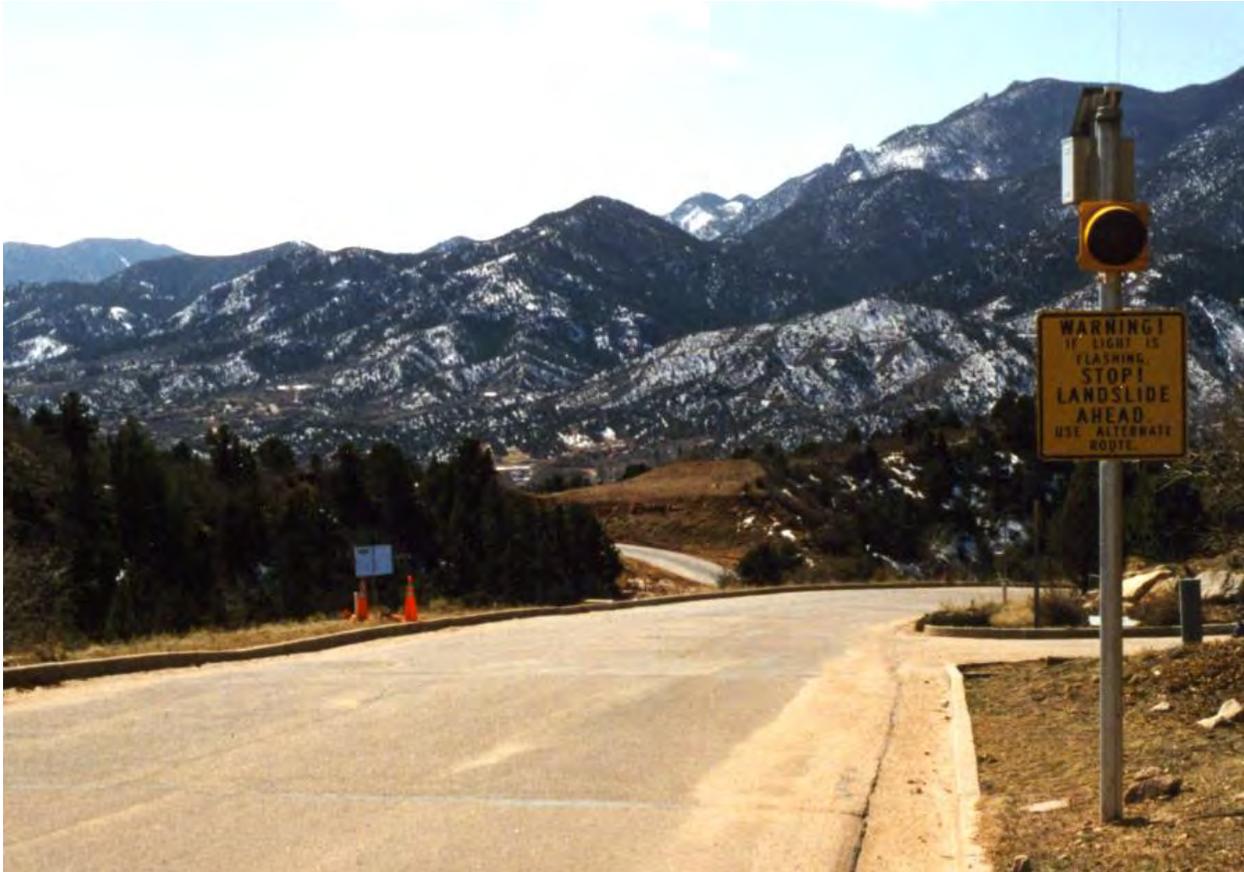
Landslide warning system in Cedar Heights, Colorado Springs. The gated community of Cedar Heights is underlain by the Glen Eyrie Member of the Fountain Formation. Eastward dip slopes of weak mudstone strata have presented instability problems in the neighborhood. View is to the south.

**Landslides:** Many areas of Colorado Springs are underlain by weak clay shales. The most potentially unstable areas in Colorado Springs are the flanks of Cheyenne Mountain and Rampart Range, and other hilly terrain underlain by the Pierre Shale (Kp) west of Interstate 25. Another is the Cedar Heights neighborhood that is underlain by the Glen Eyrie Shale Member of the Fountain Formation. These high-risk terrains are at higher elevations with incredible views of Colorado Springs and the eastern plains, so are desirable for developers to build high-value residential homes. However, in that terrain the eastward strata dip direction approximates the slope directions, which can cause dip-slope movements where the ground can slip more easily along formational bedding planes. Colorado Springs has had several episodes of landslides activations and reactivations of old landslides during high precipitation periods (**see extended abstract #1**). After a high-precipitation event in 1999 that resulted in government buyouts for owners of homes damaged or destroyed by landslides, the CGS published a landslide susceptibility map of Colorado Springs (White and Wait, 2003). The spring of 2015 was also very wet and Colorado Springs is having another news-worthy spate of landslide activity (**Figure 8**). In the media, the focus is on: where responsibility lies when the city approves development in areas known for landslide risk; risk isn't disclosed to prospective home buyers by the city, the engineering consulting community, land developers, or real estate agents; and should government funds be used for buyouts for those people who have lost their homes.

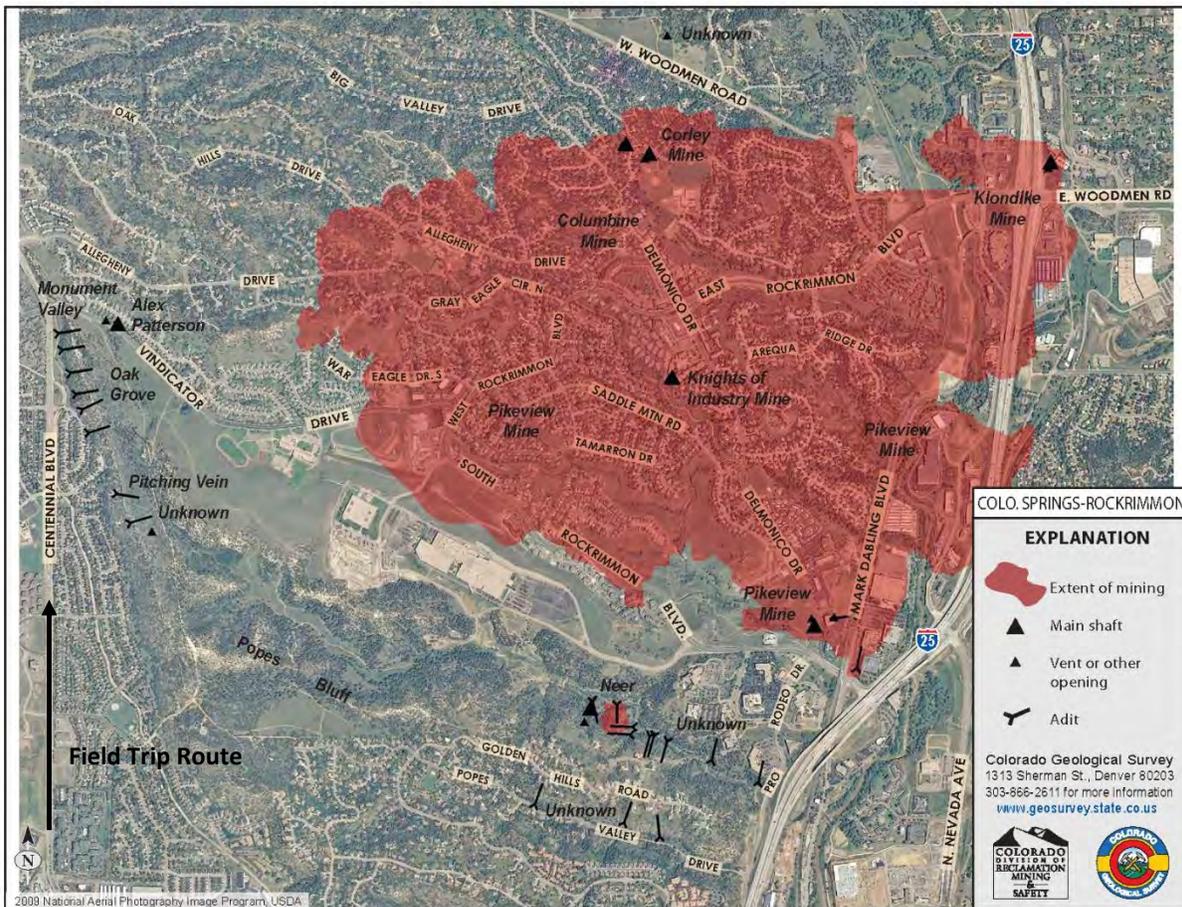
**Figure 13.** Undermined areas of the Rockrimmon area of Colorado Springs. Several abandoned adits along the field trip route on Centennial Blvd. served the coal mines. These tunnel openings have been sealed and the surface mostly reclaimed.

Traveling north and west along Centennial Boulevard one enters the steeply dipping bedrock zone. Northward on Centennial Blvd., as the road nears Popes Bluff, the cuesta steepens to a ridgeline hogback where dips exceed 50°. Several coal adits and tunnels serving the Rockrimmon/Pikeview coal field occur along the ridge line (**Figure 13**). The

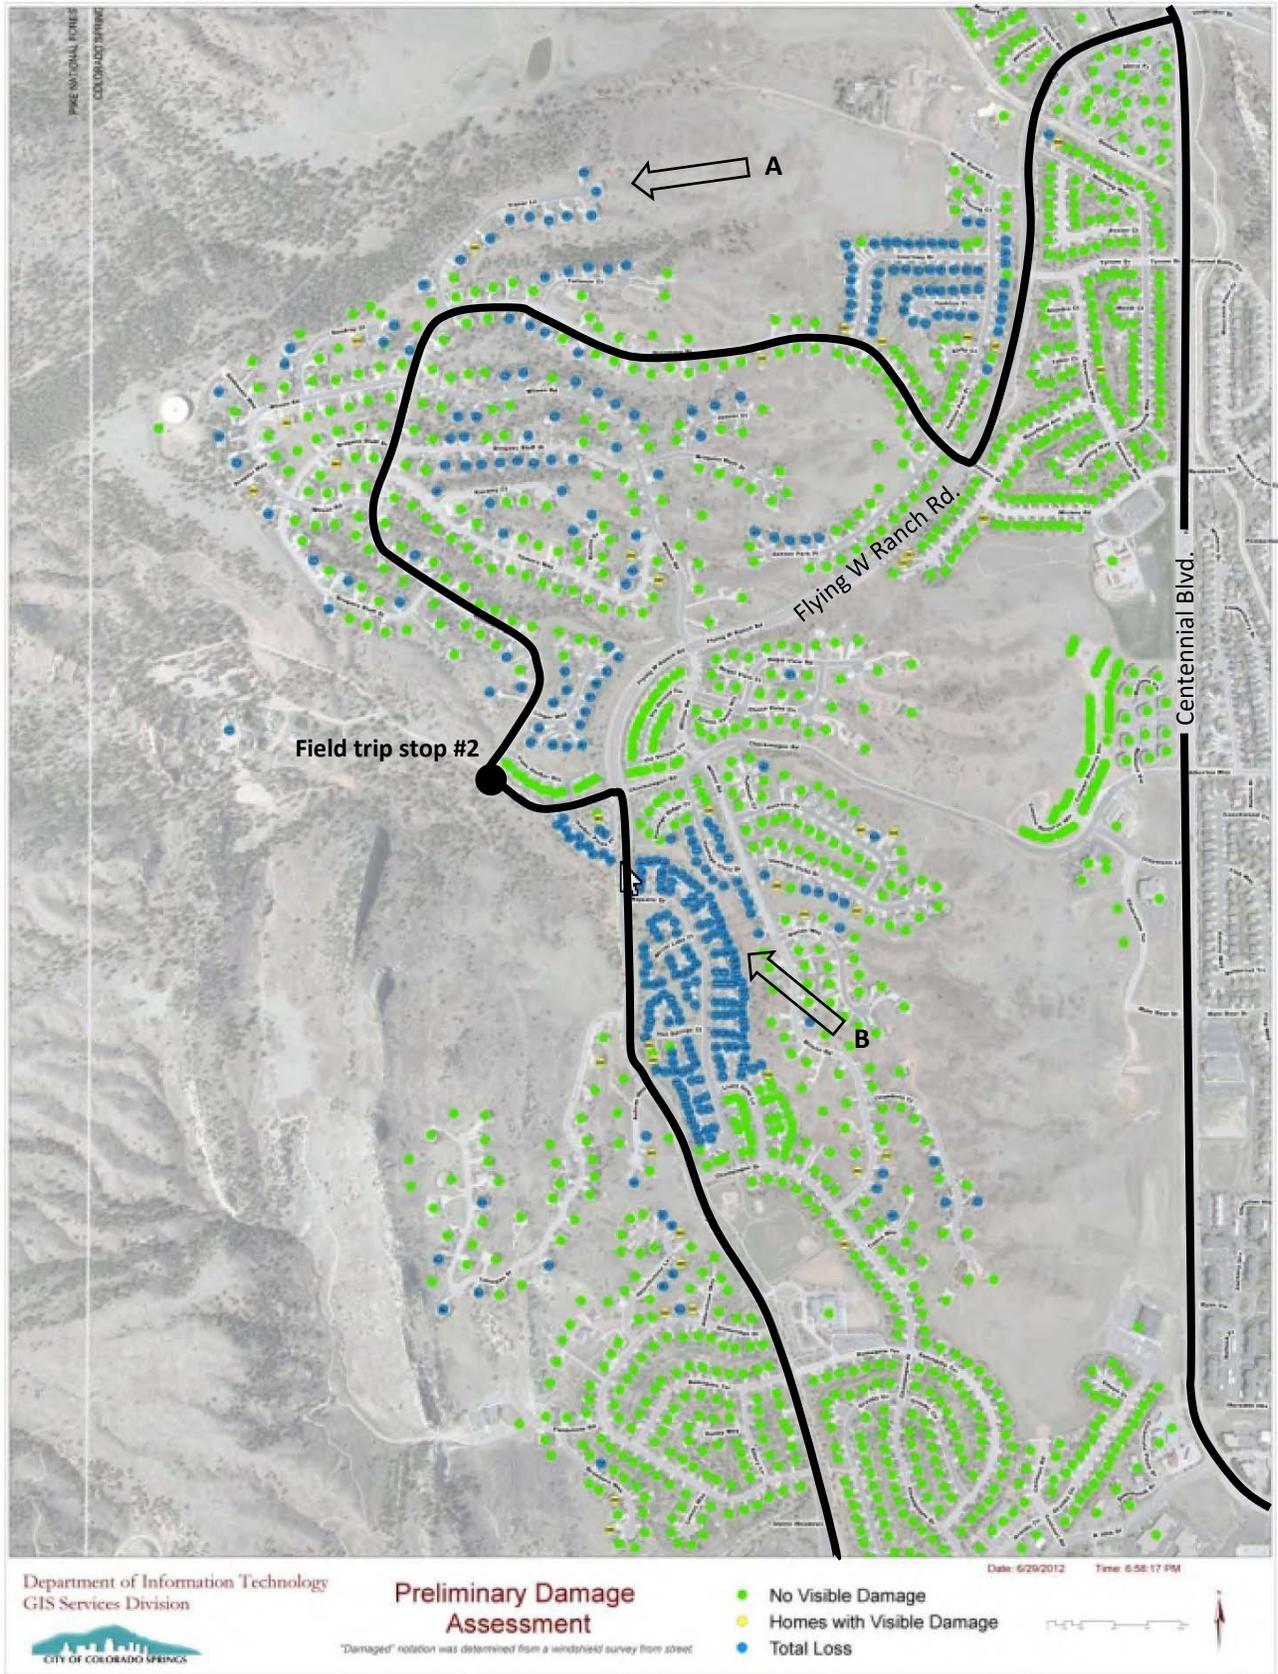
**Figure 15.** Colorado Springs Map of home destroyed or damaged in June 2012 Waldo Canyon wild fire. Arrows show view direction in photos A and B of **Figure 14**. Field trip route shown as heavy black line.

*The Waldo Canyon wild fire entered the city limits of Colorado Springs along Flying W Ranch Road. About 300 homes were destroyed in the Mountain Shadows neighborhoods on both sides of Flying W Ranch Rd. **See Figure 14 and 15.***

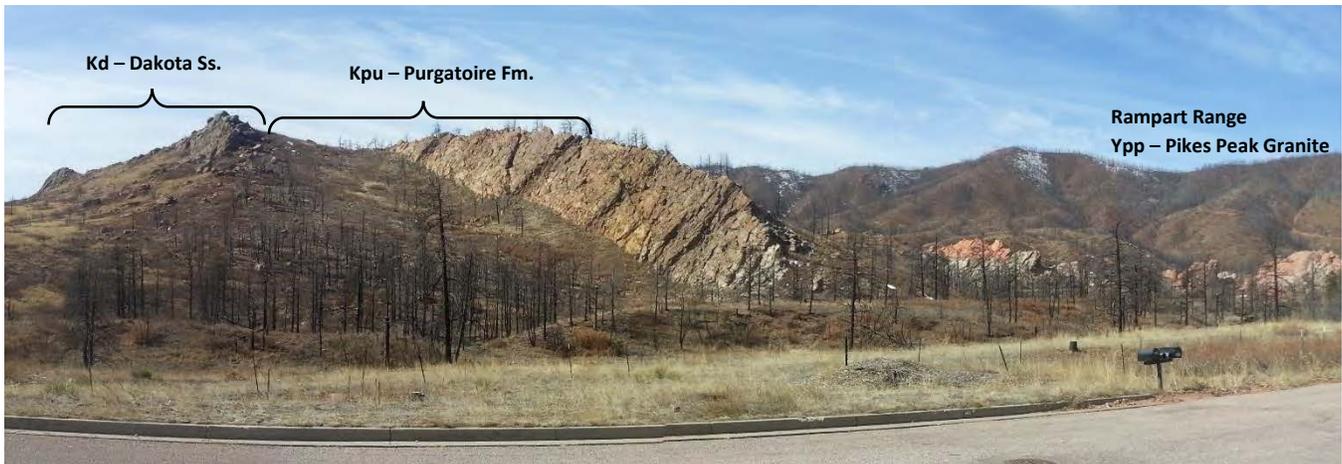
**Figure 16.** Dakota and Purgatoire hogback at Chuckwagon Road. Note burned trees that extend onto Rampart Range. Exposed rock formations not labeled in right side of photo include the Lyons Ss. (white rocks) and the Fountain Fm. (light red rocks). The drainageway below, as are many from basins in the Waldo Canyon burn area, is now prone to flash flooding and mud/debris flows.

Chuckwagon Road leads to the Flying W Ranch. This working, mountain cattle ranch is also a major tourist venue in Colorado Springs with chuckwagon dinners, theatre plays, and other western-theme entertainment. The Waldo Canyon wild fire swept through the ranch and completely burned it down June 26, 2012. The fire swept eastward down the drainageway south of the Chuckwagon Road into the Mountain Shadow neighborhoods. The hogbacks of Cretaceous and Late Paleozoic strata are now better exposed in the fire-swept hillsides (**Figure 16**).

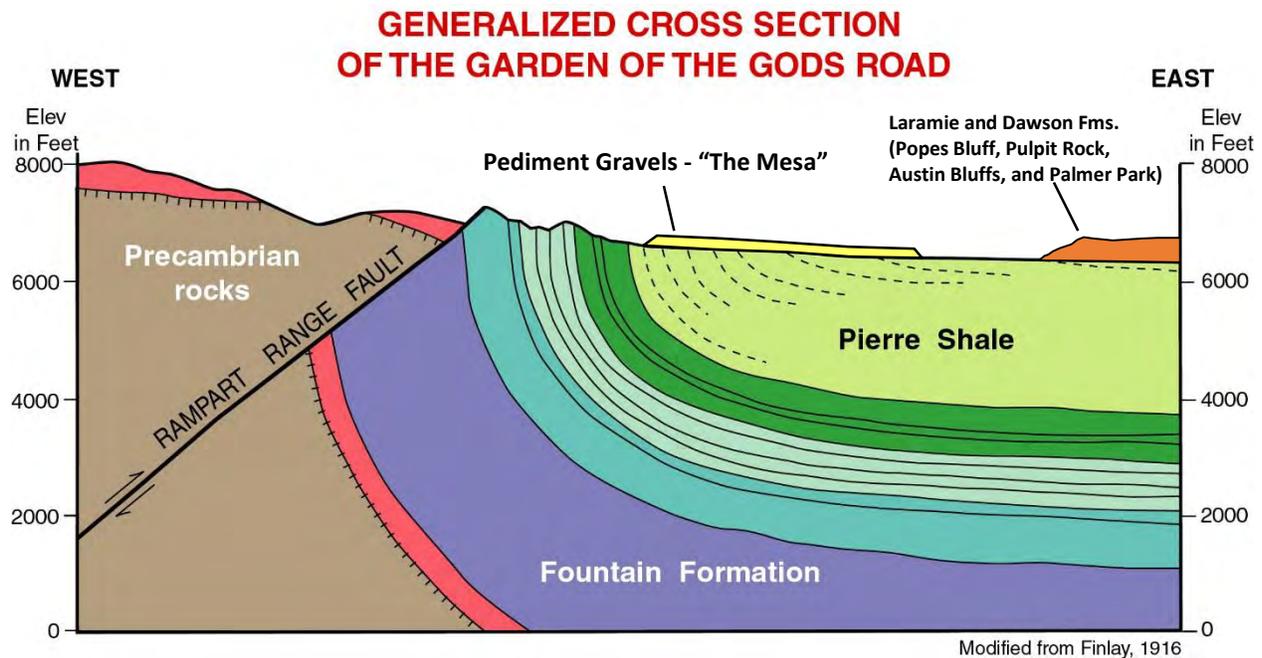
**Figure 17.** Cross section modified from Himmelreich and Noe (1999). Garden of the Gods Road can be seen in Geologic Map B in Appendix B.

*The prominent hogbacks at the Chuckwagon Road stop continue southward towards Garden of the Gods. Unlike the Ute Pass fault to the south that faulted Cheyenne Mountain granodiorite against soft Pierre Shale, near 30<sup>th</sup> St. and Garden of the Gods Boulevard, more resistant formations from limestones of the Niobrara Formation to the Lyons Sandstone are exposed as prominent hogbacks. See cross section in **Figure 17**.*

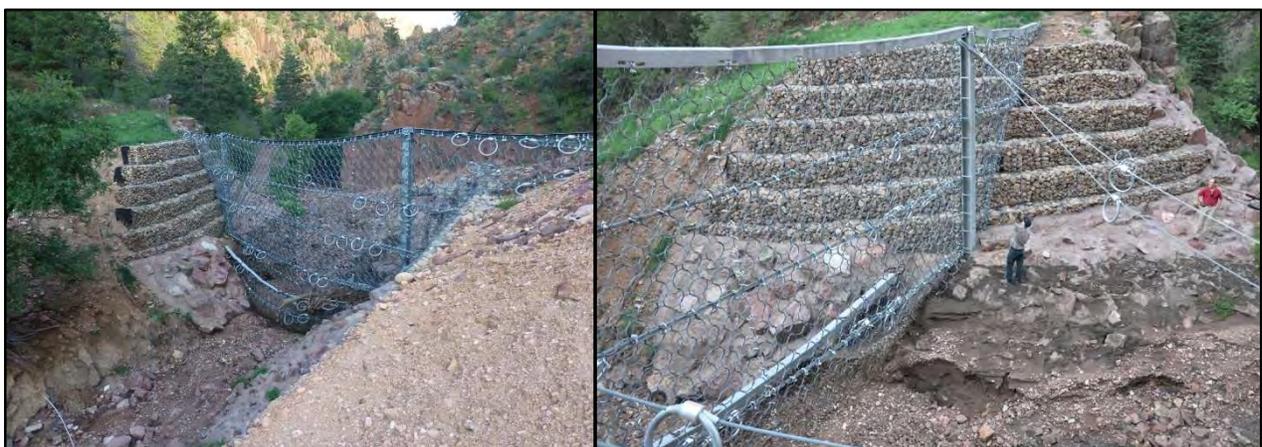
**Figure 18.** Debris-flow mitigation nets installed at Camp Creek in Queens Canyon after the Waldo Canyon wild fire. Note men in right photo for scale. Grouted rip-rap and tiered gabion boxes were installed at anchors to mitigate scour. Photos from Keaton and others (2013).

*In the Navigators compound is Glen Eyrie, a castle built along the bank of Camp Creek at the mouth of Queens Canyon by General William Jackson Palmer; the wealthy industrialist, rail magnate, and philanthropist who founded Colorado Springs. Now owned by the Navigators religious organization, Glen Eyrie estate is nestled around spires of vertical sandstone outcrops where Queens Canyon exits Rampart Range. The Navigator’s grounds were luckily spared by the Waldo Canyon wildfire. However, areas in proximity to the banks of Queens Canyon creek are now at risk of post-burn debris-flow flooding (See extended abstract #4) and mitigation was quickly installed after the 2012 fire (Figure 18).*

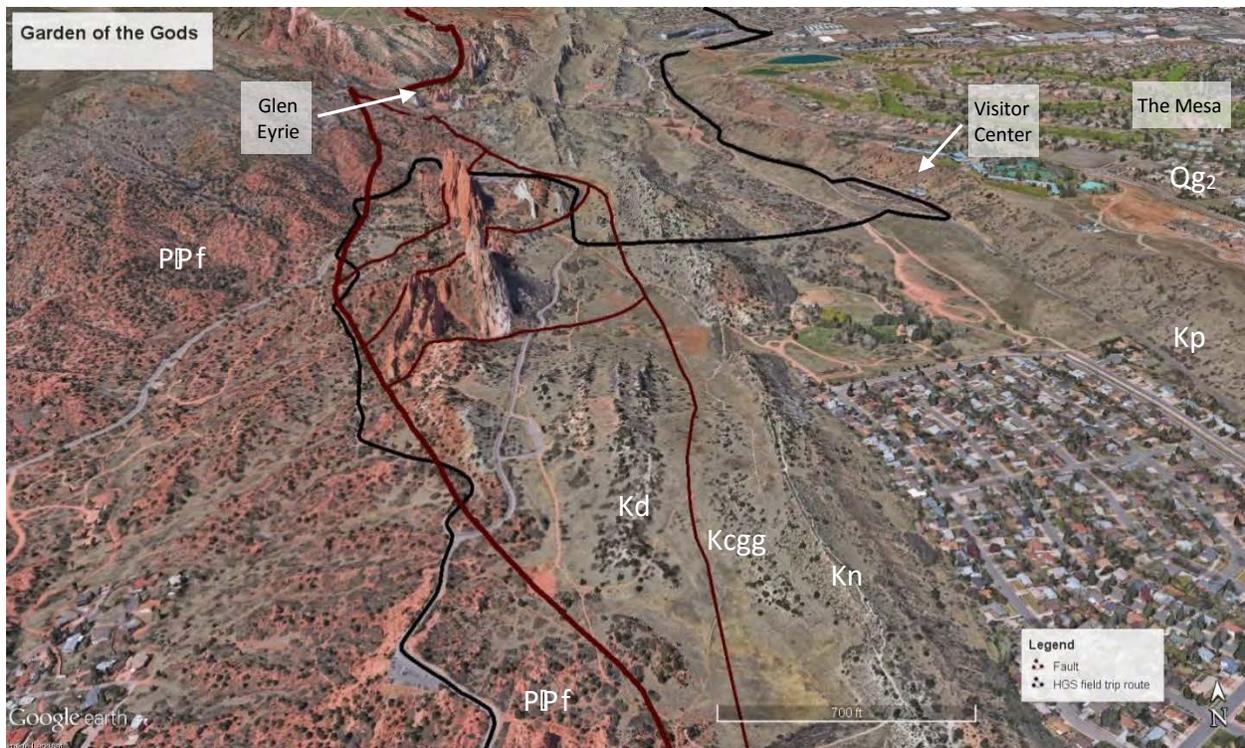
**Figure 19.** Annotated north-facing oblique image of Garden of the Gods. Black line is field trip route. Fault traces are from Siddoway and others (2013). Thickest red line on the left is trace of Rampart Range fault, lighter red traces are oblique thrust sheets, and right red line is the roof thrust. See geologic map in Garden of the Gods extended abstract. Image created from Google Earth Pro™ urban high-resolution 3D imagery.

*Though not easily seen, the turn off onto Ridge Road obliquely crosses the trend of Rampart Range fault where the Fountain Formation is faulted against the Morrison Formation. Steeply dipping red rocks of the Fountain Formation occur along Ridge Road. The low ridgelines immediately to the east are formed by the Dakota Sandstone and, further to the east, the prominent chalky-white limestones of the Niobrara Formation (**see Figure 19**).*

Both **Figure 3-1**, **figure 19** in the road log, and the **geologic map B in Appendix B** illustrates the complexity of the Rampart Range fault system as it passes southward through the Garden of the Gods Park and “dies out” below Fountain Creek. The Rampart Range fault is a high-angle thrust fault with the up-thrown block on the west side. However, the southern segment of the north-south striking fault is interpreted to contain both a floor thrust and roof thrust, creating a triangular zone cross section model where east and west back-thrust sheets can be accommodated in a single structural system (Morgan and others, 2003; Siddoway and others, 2013). See **Figure 3-2**.

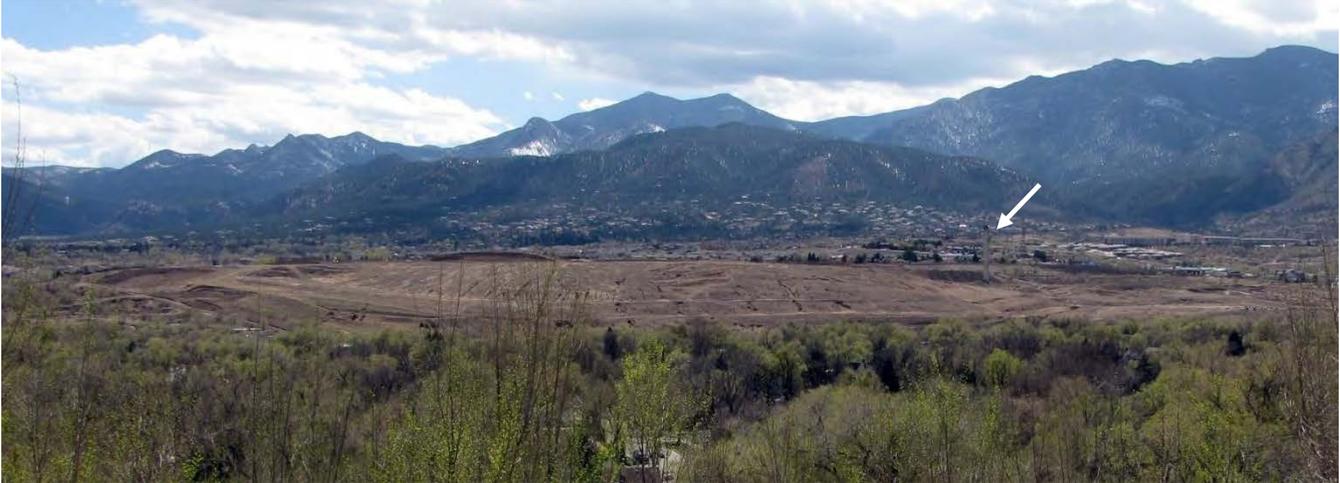
**Figure 20.** Mill tailing of Golden Cycle Mining Company, now called Gold Hill Mesa. All that remains of the original mill is the smokestack shown by white arrow. Note rills and gullies in the tailings embankment.

*Two miles east on US 24, past 21<sup>st</sup> Street, a wide embankment appears on the south side of the highway that is heavily rilled and gullied (Figure 20). This is Gold Hill Mesa, the site of the historic Golden Cycle Mining Company gold processing mill in Old Colorado City (See Mining History section in guidebook).*

*The hilltop site has impressive 360-degree views so is being built out as a large residential development called Gold Hill Mesa. While portions of the development have been built, much of the north facing slopes are still rilled and gullied from runoff flowing into a drop-out detention pond before entering Fountain Creek. Serious settlement issues are present on the thick mill tailings and foundation damage is reportedly occurring in new homes of the development.*

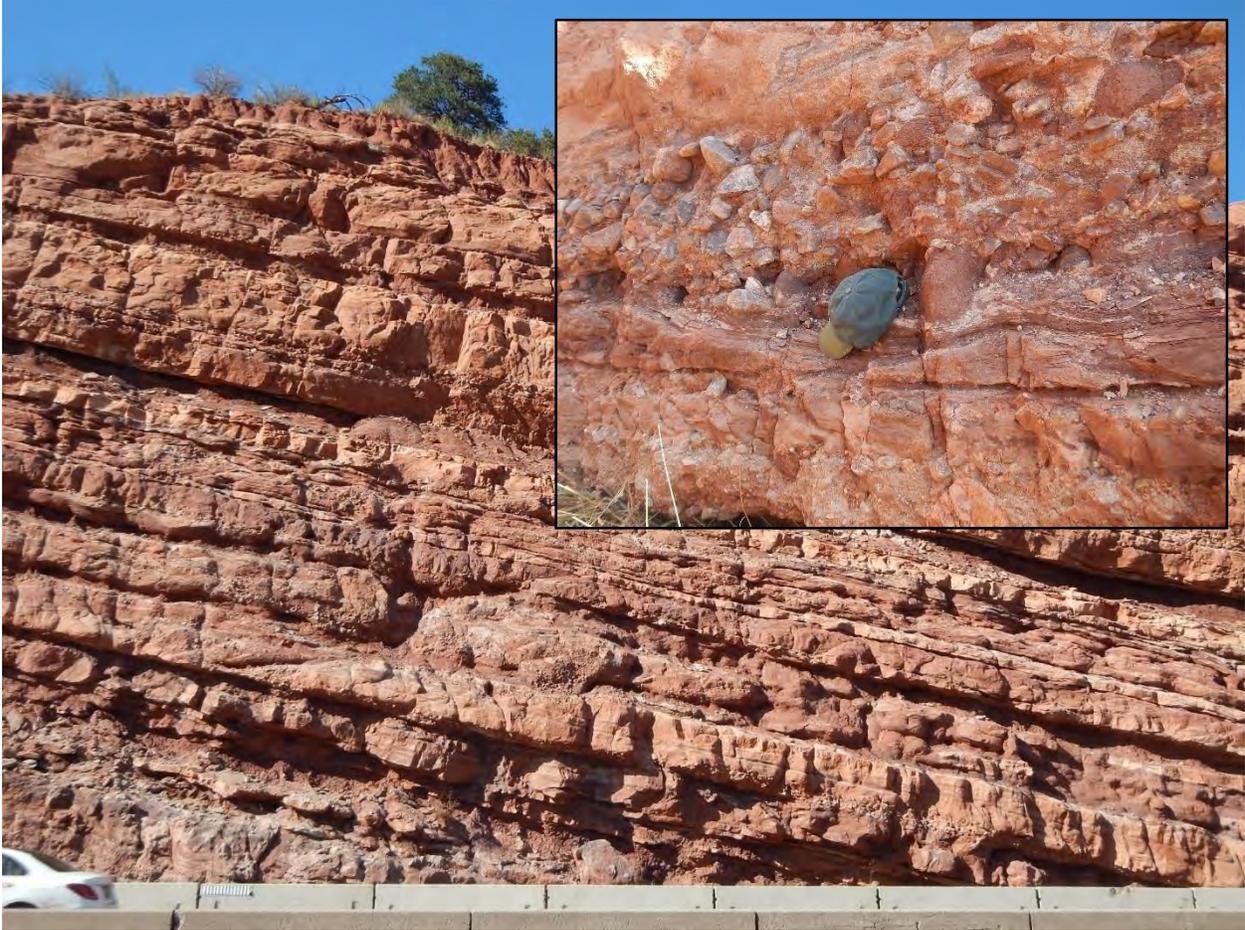
**Figure 21.** Tilted interbedded sandstone, conglomerate, and mudstone of the Fountain Formation in rock excavation for US 24 alignment above Manitou Springs. Baseball cap in inset photo shows scale of cobble conglomerate in some beds.

*Westward of the Manitou Springs exit, US 24 climbs in grade. This portion of the highway was realigned in the 1960s. Early roads and the original US 24 used to go through downtown Manitou Springs. To keep a suitable road grade in the newer alignment, high rock-excavated cutslopes were required on both sides of the highway. These rock excavations provide excellent exposures of coarse-grained red-bed strata within eastward-dipping Pennsylvanian/Permain Fountain Formation (**Figure 21**) (See **Geologic maps B in Appendix B**). This is the type locality for the Fountain formation where it is at its thickest - 4,050 ft, representing a localized synorogenic depositional center that flanked the Pennsylvanian Ancestral Rockies (Frontrangia) uplift. The formation thins rapidly northward to only 650 ft thick at Glen Eyrie in Queens Canyon, which is about 3 miles north on the other side of the Garden of the Gods Park (Keller and others, 2003).*

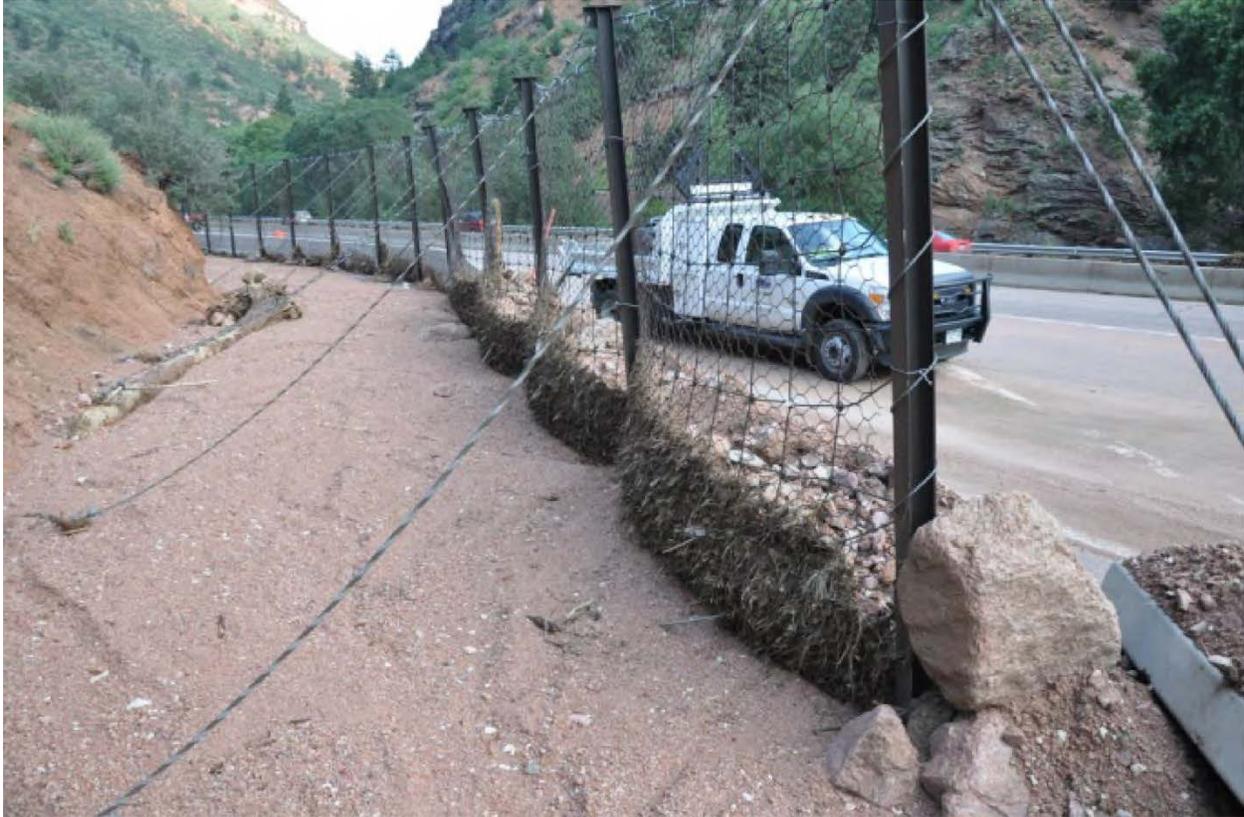
**Figure 24.** August 9, 2013 debris flow caught by cable-net rockfall fence. Note barrier on the opposite side of the WB lanes and height of the debris caught on the road side of the fence. Photo from Keaton and others (2013).

See extended abstract #5 in appendix about debris flow mitigation on US 24 at the mouth of Waldo Canyon. Significant debris flows exited Waldo Canyon and, constrained by road-separation barriers, flowed down the WB lanes. **Figure 24** is a photo of the roadside cable-net rockfall fence at Waldo Canyon taken shortly after the August 9, 2013 flooding event and shows the height of debris that washed down the highway.

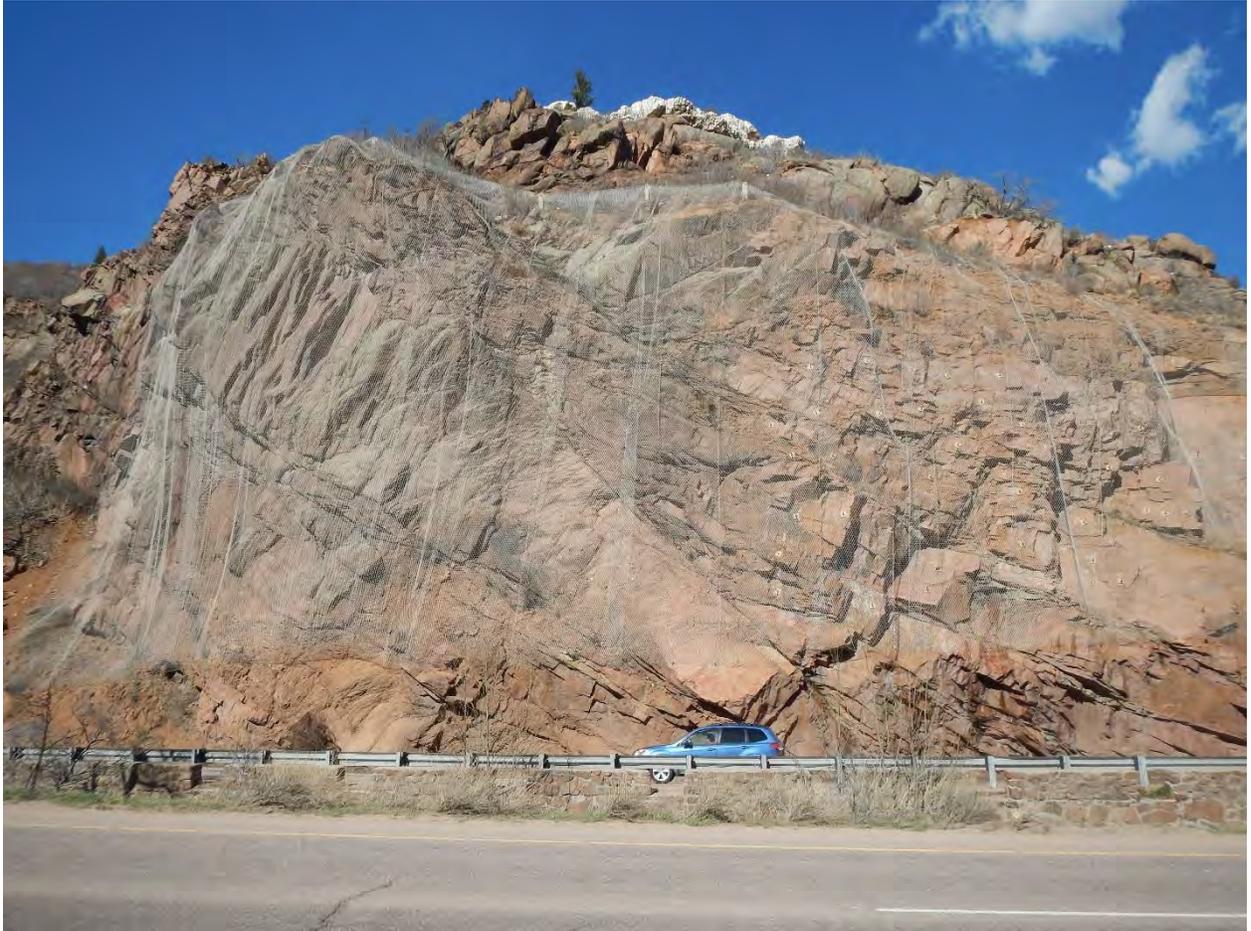
High rock excavation for US 24 westbound lanes in Fountain Creek valley west of Manitou Springs. Note level of jointing in Pikes Peak Granite. Rockfall mitigation includes rock bolt reinforcement and draped wire netting.

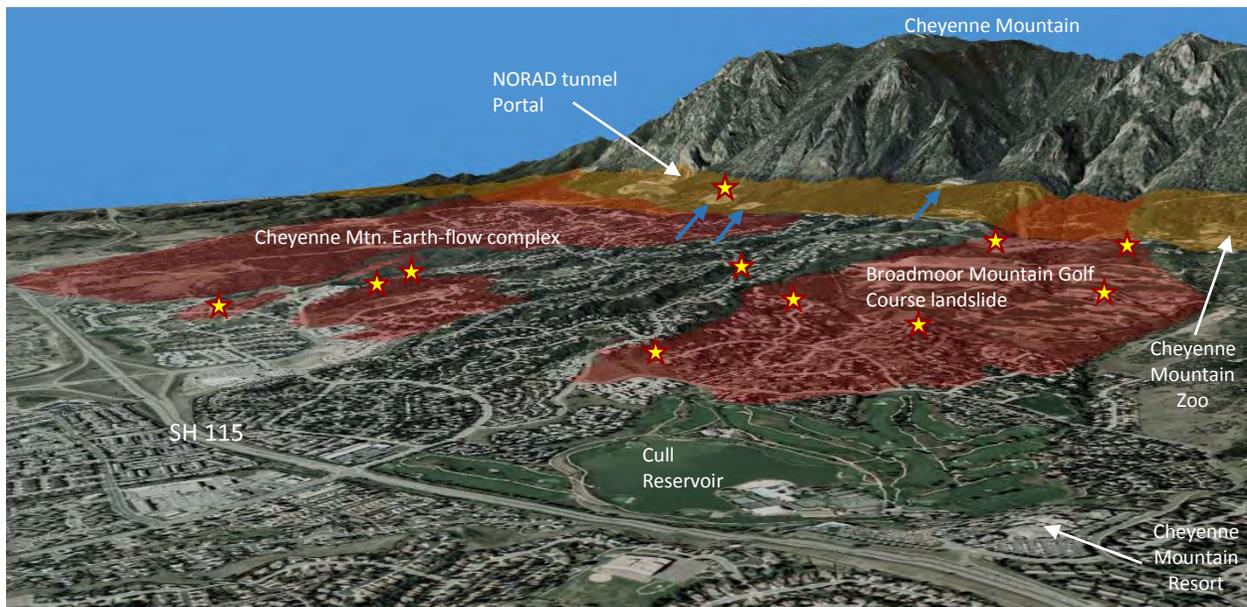
**Figure 1-1.** Oblique 1(H):1(V) image of Cheyenne Mountain with view to the southwest. Orange-shaded strip is the zone of expansive steeply dipping bedrock from Himmelreich and Noe (1999) that is mostly covered by coalesced alluvial fans. Back end of the orange strip is the trace of the Ute Pass fault. Red-shaded polygons are mapped landslides from Carroll and Crawford (2000). Yellow stars are locations of landslide activity since 1995 that damaged homes or infrastructure. Blue arrows are debris-flow detention basins on active alluvial fans. For scale, mountain front is about 2 miles from SH 115 at label. Image created with ERDAS Imagine.

The decks of Cheyenne Mountain Resort have impressive views of the eastern flank of Cheyenne where Precambrian granodiorite has been thrust upwards along the Ute Pass fault. Pierre Shale is the underlying bedrock on the east side of the fault. The proximity of the steep Cheyenne Mountain front has exposed newer neighborhoods to geologic hazards. Unstable slopes, landslides, and debris-flows are the major geologic hazards along the moderate slopes along the eastern flank of Cheyenne Mountain. Other concerns are expansive Pierre Shale bedrock and its derived swelling soils, and unknown potential for catastrophic rockslides, earth flows, and landslides if an earthquake were to occur along Ute Pass fault, a risk not known at this time for what is inferred as a middle to late Quaternary fault (Widmann and others, 1998). While difficult to see because of the weak nature of the bedrock, claystone strata is folded steep upwards and dips to the east. Downcut by erosion and subaerially exposed, the gently to moderately dipping weathered claystone surface is now mantled by Pleistocene gravel pediments, a late Pleistocene to early Holocene large earth-flow complex that extended to SH 115 (Terry and others, 2003), and more recent Holocene debris-fan sediments along the steeper slopes at the base of Cheyenne Mountain (**Figure 1-1**).

Several steep drainage basins of Cheyenne Mountain outlet onto the greater Broadmoor residential areas that have been developed since the early 1990s. Those steep basins can be seen in **figure 1-1**. At the outlet of all the mountain's basins there is evidence of geologically recent debris-flow activity, including terminal lobate deposits on mountain-front alluvial fans, flow diversion and abandoned channels, lateral levees, and boulder trains and piles stacked against larger trees. Debris flows have occurred historically, including very recently. In July 1965 debris-flow flooding occurred at the mouth of every basin along the flank of Cheyenne Mountain. These flows blocked State Highway 115 and significantly impacted the NORAD tunnel portal and the Cheyenne Mountain Zoo (see **Figure 1-2**). Large boulders from Cheyenne Mountain were moved across State Highway 115 during this event. A 2015 spring flooding, which impacted much of the greater Broadmoor area, also caused debris to, once again, block the NORAD portal and damaged homes where flows entered the neighborhood below.

New landslides and reactivations of older, existing landslides occurred during the wet spring of 1995. A brief flurry of media attention occurred after the landslides of that wet spring, and areas of susceptibility were briefly discussed in a CGS field trip guide book in 1996. In 1999, another spring of heavy precipitation triggered flooding, caused renewed landslide movement, and activated additional landslides. Ground movements impacted several neighborhoods west of Interstate 25 and many homes and properties were threatened, damaged, destroyed, or condemned. Although all of these neighborhoods lie within landslide-susceptible areas, many had no history of landslide activity prior to the 1999 events, and homeowners had no knowledge of the risk they were potentially exposed to. Many of the homes and properties impacted were over 20 years old and apparently had no previous problems with lateral earth movements. Because of the flooding and landslide movements, Colorado Springs was declared a presidential disaster area. Many homes damaged by flooding and landslides became eligible for a buy-out program. A FEMA grant funded an investigation and mapping of landslides after the disaster and the Colorado Geological Survey published a landslide susceptibility map of Colorado Springs in 2003 (White and Wait, 2003). Several years of movement dormancy ended in 2013 when another wet spring occurred. New landslides occurred and many of the existing landslides reactivated. More homes, some recently built in susceptible areas known for landslide risks after 1999, experience distress from lateral ground movements that continue today (2016). Areas of ground movements from 1995 to 2016 in the greater Broadmoor area are shown by yellow stars in **Figure 1-1**.
