HGS 2016  
Proceedings

# 67TH HIGHWAY GEOLOGY SYMPOSIUM

## JULY 11 – 14, 2016

Cheyenne Mountain Resort  
COLORADO SPRINGS, COLORADO

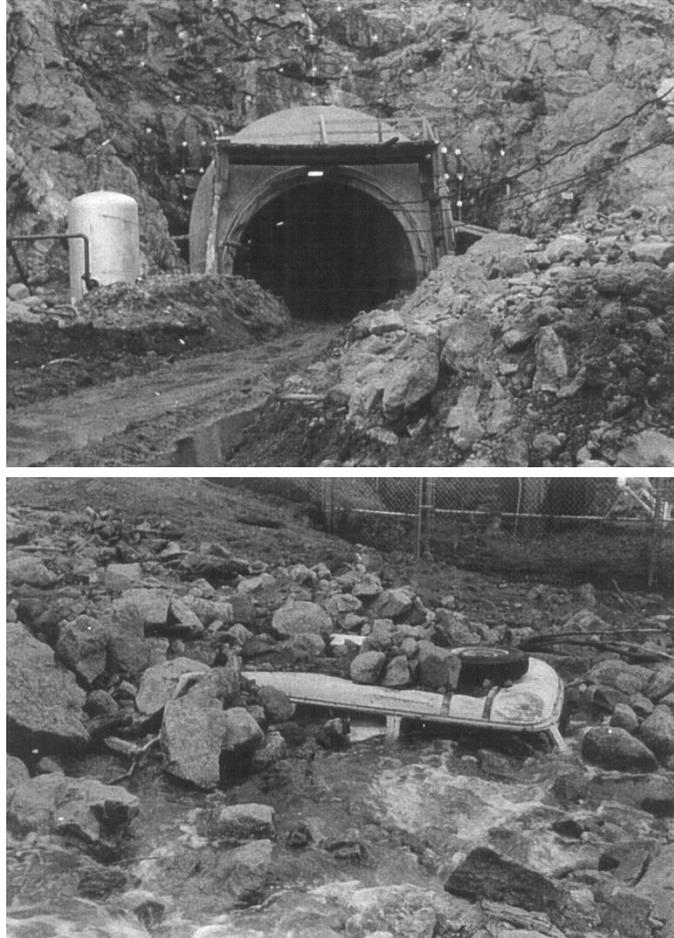
**Figure 1-2.** Archival pictures from July 1965 debris-flow flooding along Cheyenne Mountain. Upper photo shows bouldery debris-flow sediment at NORAD tunnel portal. Lower photo shows VW van buried almost to roof by debris-flow sediment at Cheyenne Mountain Zoo parking lot. Photo attributions are unknown.

Several steep drainage basins of Cheyenne Mountain outlet onto the greater Broadmoor residential areas that have been developed since the early 1990s. Those steep basins can be seen in **figure 1-1**. At the outlet of all the mountain's basins there is evidence of geologically recent debris-flow activity, including terminal lobate deposits on mountain-front alluvial fans, flow diversion and abandoned channels, lateral levees, and boulder trains and piles stacked against larger trees. Debris flows have occurred historically, including very recently. In July 1965 debris-flow flooding occurred at the mouth of every basin along the flank of Cheyenne Mountain. These flows blocked State Highway 115 and significantly impacted the NORAD tunnel portal and the Cheyenne Mountain Zoo (see **Figure 1-2**). Large boulders from Cheyenne Mountain were moved across State Highway 115 during this event. A 2015 spring flooding, which impacted much of the greater Broadmoor area, also caused debris to, once again, block the NORAD portal and damaged homes where flows entered the neighborhood below.

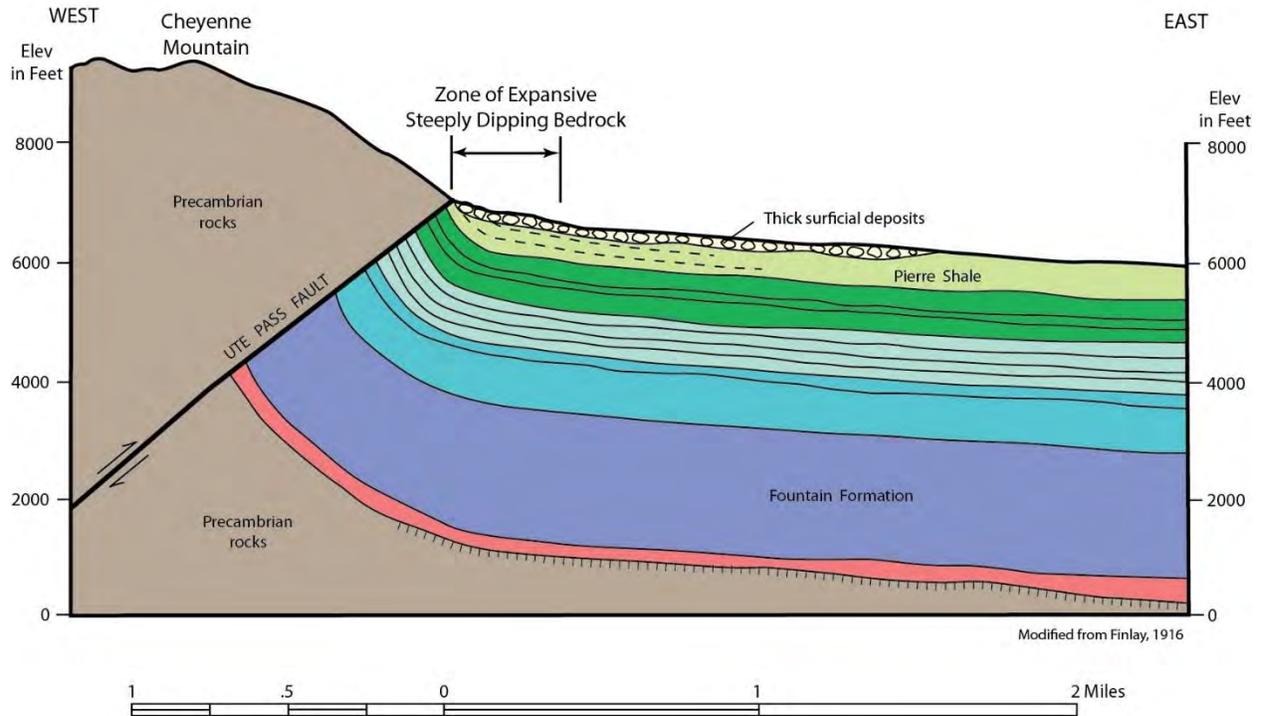
**Figure 1-3.** Generalized cross section at Cheyenne Mountain showing zone of expansive steeply dipping bedrock (seen in figure 1) where bedrock can dip from slightly overturned to 30°. Bedrock bedding flattens from 5° to 10° at SH 115. Illustration from Himmelreich and Noe (1999).

Dip-slope slope instability and landslides are a significant hazard in this area because of the inherent weakness of the claystone bedrock and a general ground slope direction that approximates the steep to moderate eastward dip of the strata (**Figure 1-3**). The Pierre Shale is a Cretaceous marine clay shale with common thin bentonite beds. The erosion and removal of thousands of feet of overburden along the Front Range Piedmont has now exposed an overconsolidated clayshale with significant percentages of expansive clay minerals. Loss of overburden confinement and wetting has caused rebound in the rockmass. In cores of “intact” claystone, slickensides have been observed by the author in thin bentonite beds. The clayshale has been covered by a mantle of pediment gravel and alluvial fans. These granular soils are highly permeable and ground water passes through quickly to the contact with

the clayshale. There it perches, percolating into the clayshale and moving laterally down the gravel/shale contact to the east. Ground underlain by dipping Pierre Shale is highly sensitive to disturbance and landslides occur. Even modest cuts and fills have caused landslides in this area.

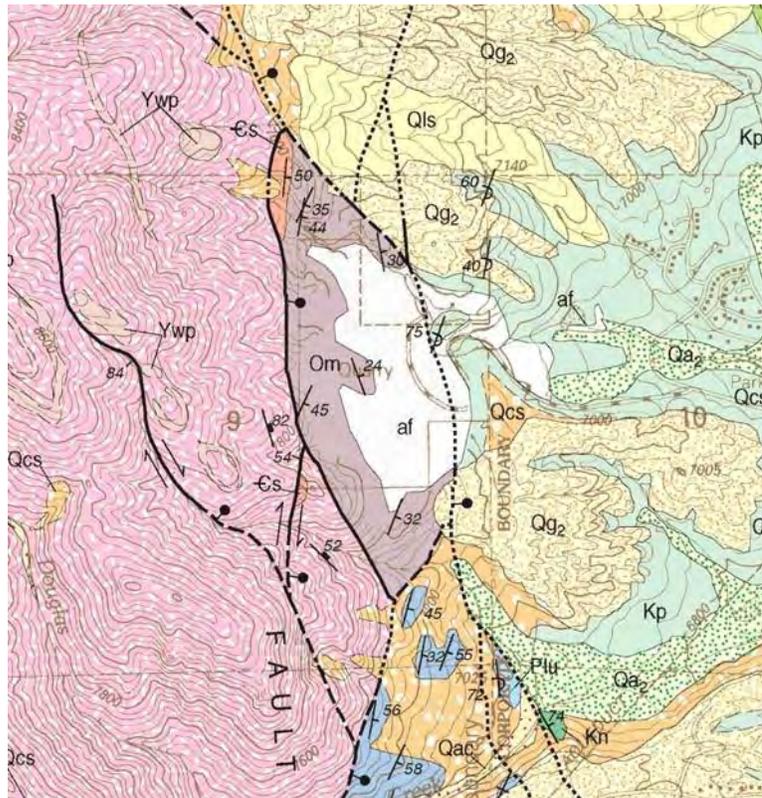
**Figure 2-1.** Geologic map of the mine and the immediate vicinity from Morgan and others (2003). Map scale is 1:24,000 (1 inch = 2,000 ft.).

The mine is located within the north-striking trend of the of the Rampart Range fault zone that marks the Laramide tectonic boundary of the Front Range mountain uplift with flatter erosional landforms in the sedimentary strata of the Colorado Piedmont to the east. Geologically, this is a structurally complex zone, where five faults are mapped by Morgan and others (2003) near, and within, the mine boundary location (**Figure 2-1**). The structural surroundings of Pikeview Quarry can be better seen in **Geologic Map A in Appendix B** of the guidebook. Movements of high-angle normal and reverse, and strike-slip faults have

caused a 0.8 mile-long sliver of lower Paleozoic rocks to be folded upwards and structurally isolated. Brittle deformation features are abundant within the Precambrian granite, sandstone, and limestone outcrops in the vicinity of the fault zone (e.g., slickensides, deformation banding, altered zones, fractures, and fault gouge), which indicate additional numerous, small, unmapped fault and shear zones within the mine area. Subsequent Tertiary and Quaternary erosion, and differential topographic lowering of the Piedmont along and east of the fault trend has exposed the Manitou Limestone (Om) outcrop along the range front, which is the aggregate resource being mined. The west boundary of the quarry has steep east-dipping (dips up to 70-80 degrees reported in the mine permit) Cambrian Sawatch Sandstone (Es) and Manitou Limestone (Om) against Precambrian Pikes Peak Granite (Ypp). At the base of the quarry wall the eastward bedding flattens to 35° to 40°. At the east boundary of the mine, another north-south trending high-angle fault occurs where over 6,000 feet of stratigraphic offset has juxtaposed steep east-dipping Manitou Limestone (west) against structurally overturned Upper Cretaceous Pierre Shale (Kp) strata of the downthrown block (east).

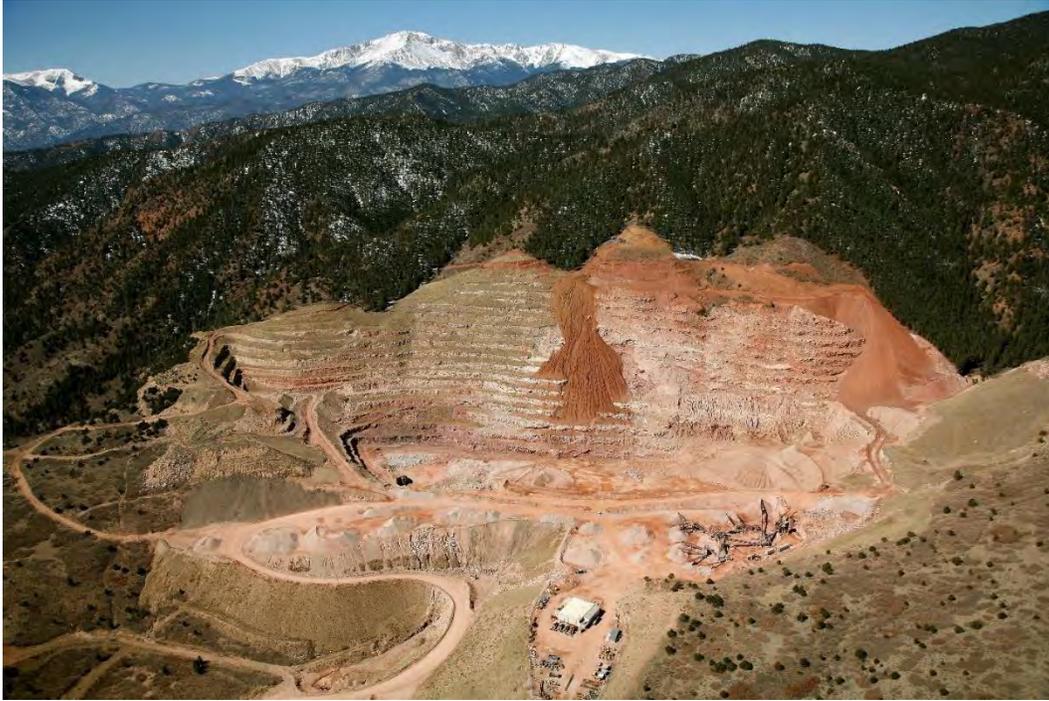
**Figure 2-2.** Intact Pikeview Quarry in early winter of 2008. Pikes Peak is in the background. Note excavation into weathered Pikes Peak Granite above quarry benches and red-brown slope of grus on quarry benches. The Waldo Canyon wildfire of 2012 burn most of the forest above the quarry seen in this photo.

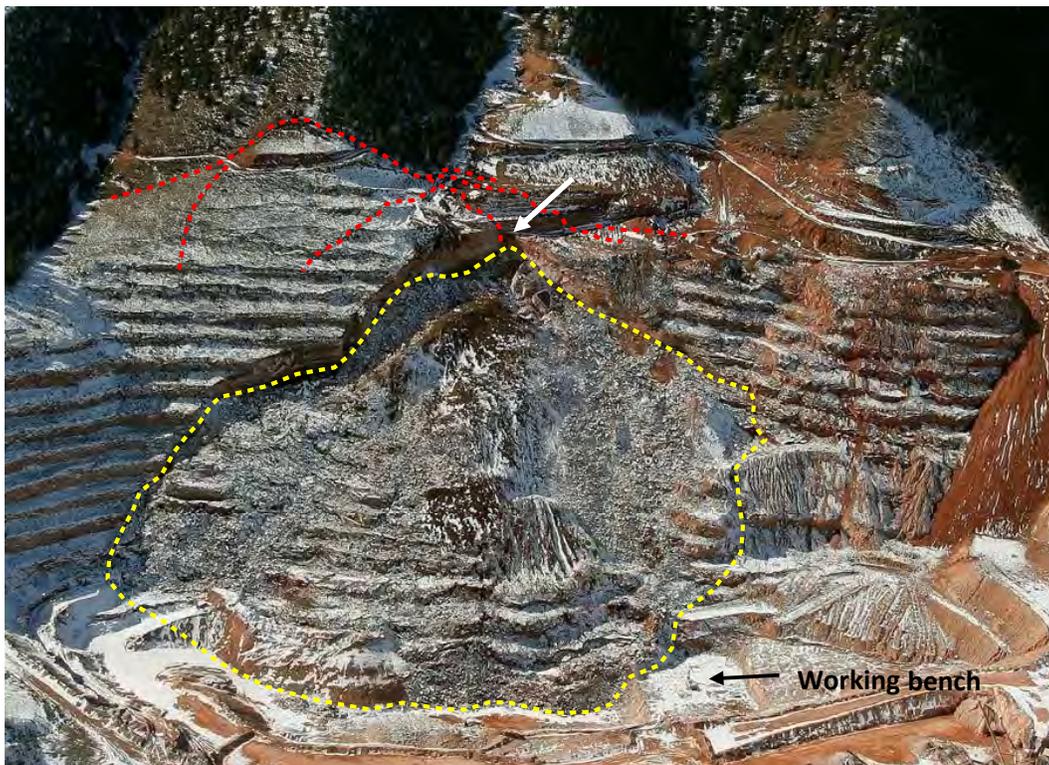
**Figure 2-3.** Oblique aerial photo of quarry wall failure looking west. Yellow dashed lines show perimeter of rockslide. Red dashed lines are concurrent tension cracks and incipient scarps that also opened. Not all tension cracks are marked on photo. White arrow shows scarp location of visible exposure of Sawatch Quartzite and Precambrian granite. Black arrow shows active bench that was currently being mined. Photo taken December 5, 2008.

On December 2, 2008, a large translational rockslide at the benched west wall of the quarry failed (**Figure 2-3**). The rockmass quickly rubblized and behaved much like a soil-type rockslide, exhibiting spreads at the toe and pressure ridges. The disturbed and deformed rockmass obscured the original corrugated bench geometry as it slumped down the slope into the quarry floor and heaved up against the active quarry bench being drill for production blasting at the time of failure (**Figure 2-4**). There were no injuries or loss of equipment. The rockslide occurred either along the Precambrian nonconformity or within bedding planes of steeply dipping sedimentary strata. The rockslide was roughly triangular in shape and, at the apex of the landslide, the slip plane at the 40-ft high scarp was observed at the contact of the Sawatch Quartzite and weathered, disturbed, and grussified Pikes Peak Granite. Additional rock movements also occurred above the main landslide scarp, evidenced by large tension cracks (insipient scarps) that extend into the weathered granite above. Mining was suspended and Transit Mix developed a monitoring plan of the potentially unstable blocks between the current headscarp and the tension cracks observed in the granite above. An array of prisms were installed on the rock face and periodically read with a robotic total station. Survey data showed continued creep of these areas. On September 13, 2009,

large retrogressive reactivations of the rockslide began to occur. The tension cracks shown in Figure 3 developed into scarps with up to 50 feet in additional movement, large grabens formed, and a large remnant of the benched quarry wall on the south side detached and slipped into the rubble below (**Figure 2-5**). Creep movements continued into 2010 and 2011. The last major movement occurred on May 11, 2015 where further displacement of the headscarp occurred and the entire hanging block of the benched quarry wall below the south part of the scarp failed (**Figure 2-6**).

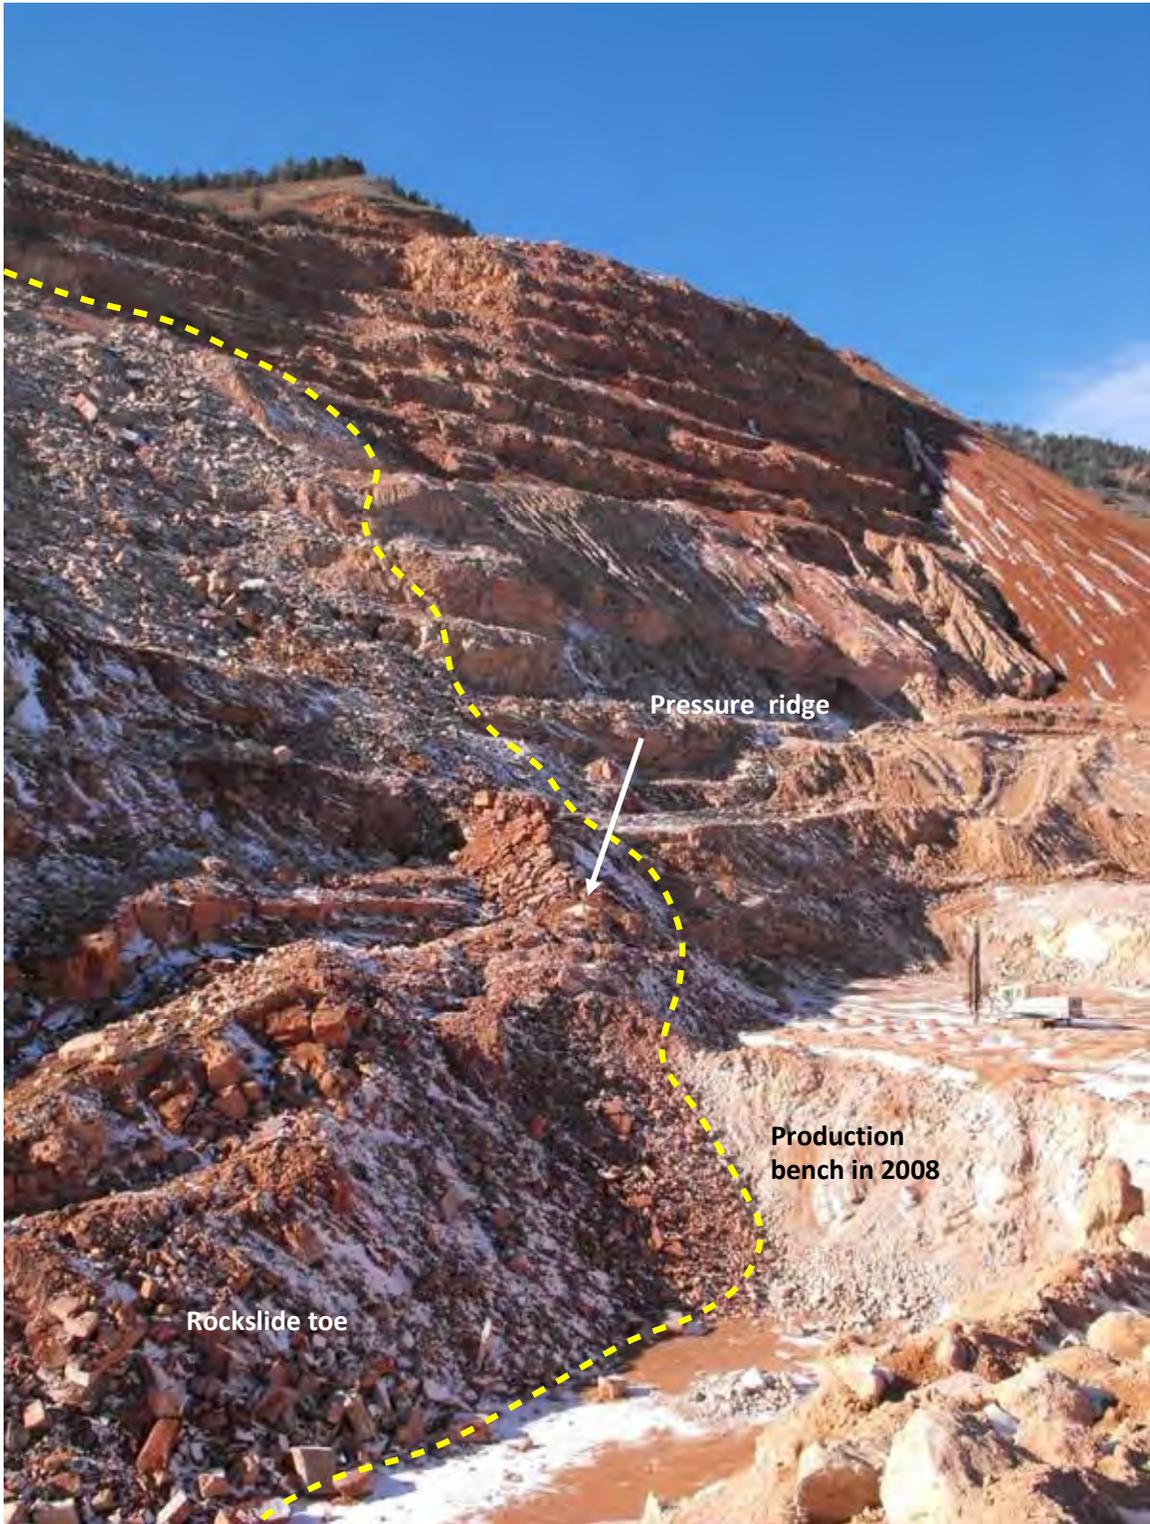
**Figure 2-4.** Northwest view of rockslide (shown by dashed yellow line) showing pressure ridge against the active production bench that was being drilled at the time of failure. Note drill rig and blast hole pattern.

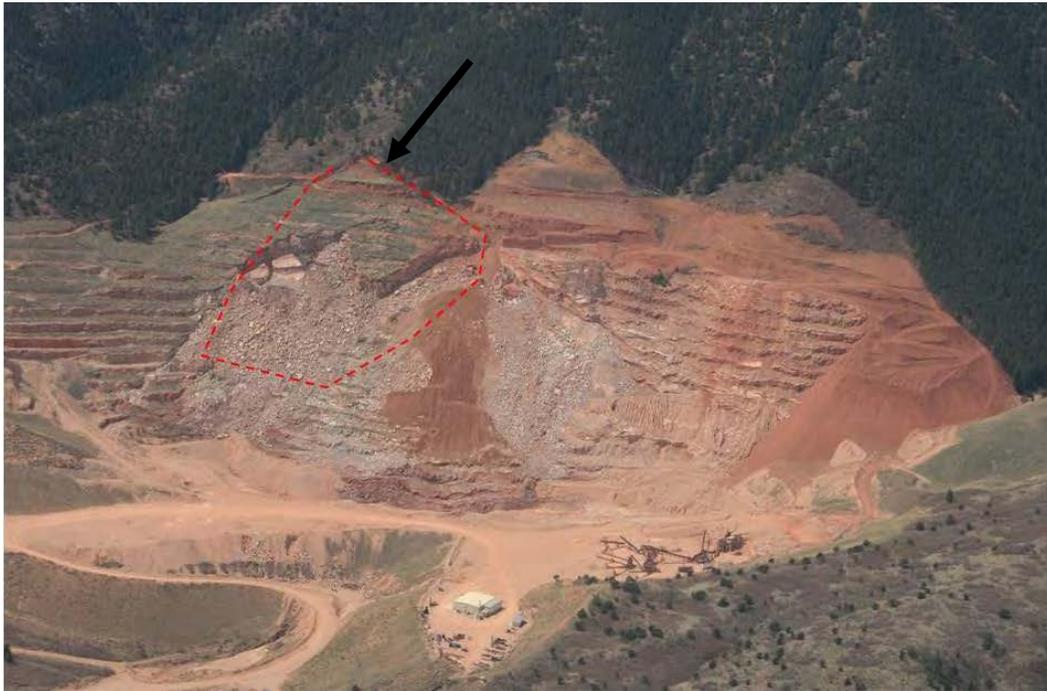
**Figure 2-5.** Oblique aerial view of quarry in 2010. Note further loss of benched quarry wall within red dashed area compared to Figure 2-3. Black arrow approximates same arrow in **figure 2-6**.

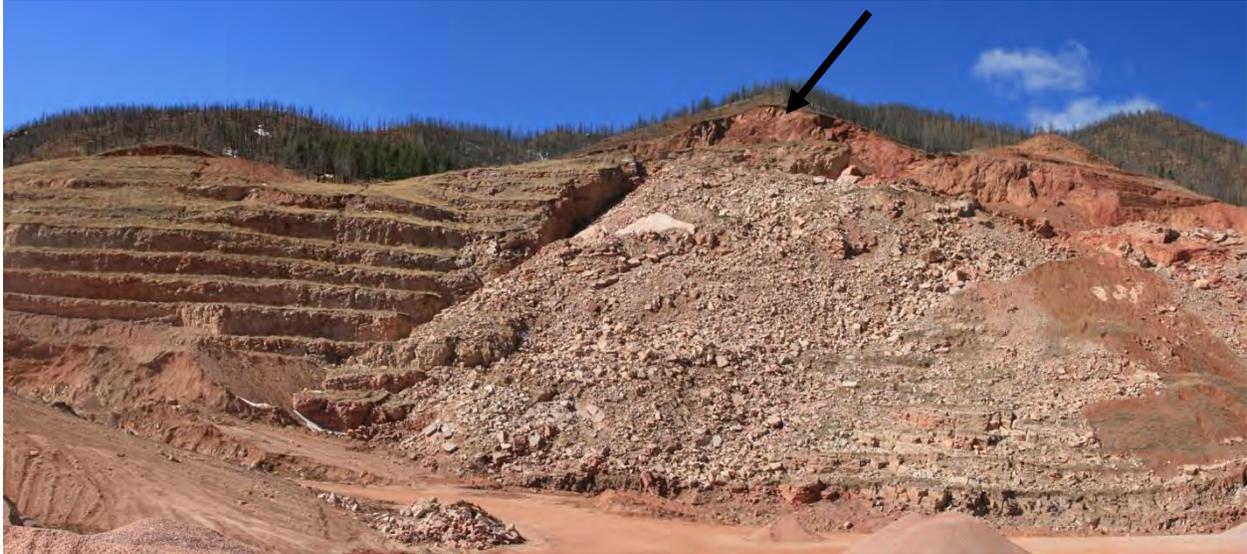
**Figure 2-6.** Continued failure of the bench quarry wall on south side in May 2015. Area shown by red dashed line in Figure 2-5 now completely failed and rubblized. Note widening exposure of top scarp in Pike Peak Granite (black arrow) compared to Figure 2-5 and burned dead trees above from the Waldo Canyon wildfire.

The quarry wall failures were likely a combination of 1) adverse steeply inclined strata dipping towards the quarry floor, 2) the inherent weakness of the rockmass caused by the abundant discontinuities related to the Rampart Range faulting, 3) continued quarrying of the Manitou Limestone at the toe of the slope, 4) possibly loading the top of the quarry benches with spoils from the more recent expansion and excavation into granite at the top of quarry, and 5) water introduction from the drainage basins above; especially in the last movement in 2015 when flows rates were significantly higher from the barren slopes after the Waldo Canyon wildfire.

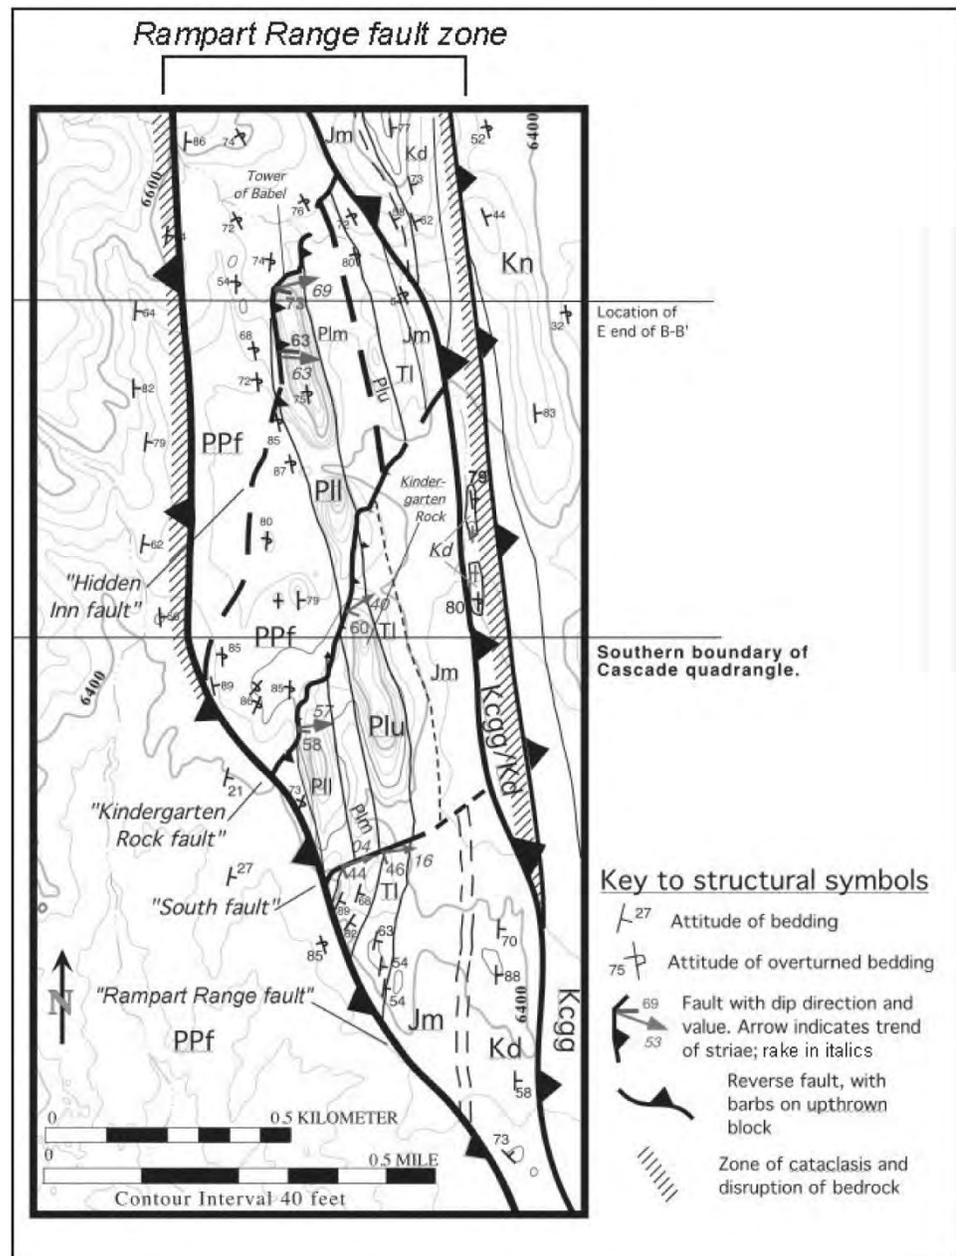
**Figure 3-1.** Larger-scale geologic map of Garden of the Gods. Illustration from Morgan and others (2003).

Both **Figure 3-1**, **figure 19** in the road log, and the **geologic map B in Appendix B** illustrates the complexity of the Rampart Range fault system as it passes southward through the Garden of the Gods Park and “dies out” below Fountain Creek. The Rampart Range fault is a high-angle thrust fault with the up-thrown block on the west side. However, the southern segment of the north-south striking fault is interpreted to contain both a floor thrust and roof thrust, creating a triangular zone cross section model where east and west back-thrust sheets can be accommodated in a single structural system (Morgan and others, 2003; Siddoway and others, 2013). See **Figure 3-2**.

The backthrust slivers of rock have been rotated vertical to overturned and differential erosion is responsible for the spectacular vertical “fins” of colorful sandstone outcrops that make the park an attraction for geologist and tourist alike. Through the entire Park, the Rampart Range thrust fault hanging wall is composed of steeply dipping Fountain Formation. The Rampart Range fault foot wall, composed of vertical or overturned Lyons Sandstone, is further offset by the three faulted backthrust slivers such that, along the fault in the park, the Fountain Formation is set against Lyons though Morrison formations. These dipping faults, from north to south are the Hidden Inn Fault, Kindergarten Rock Fault, and the South Fault (**Figure 3-1**).

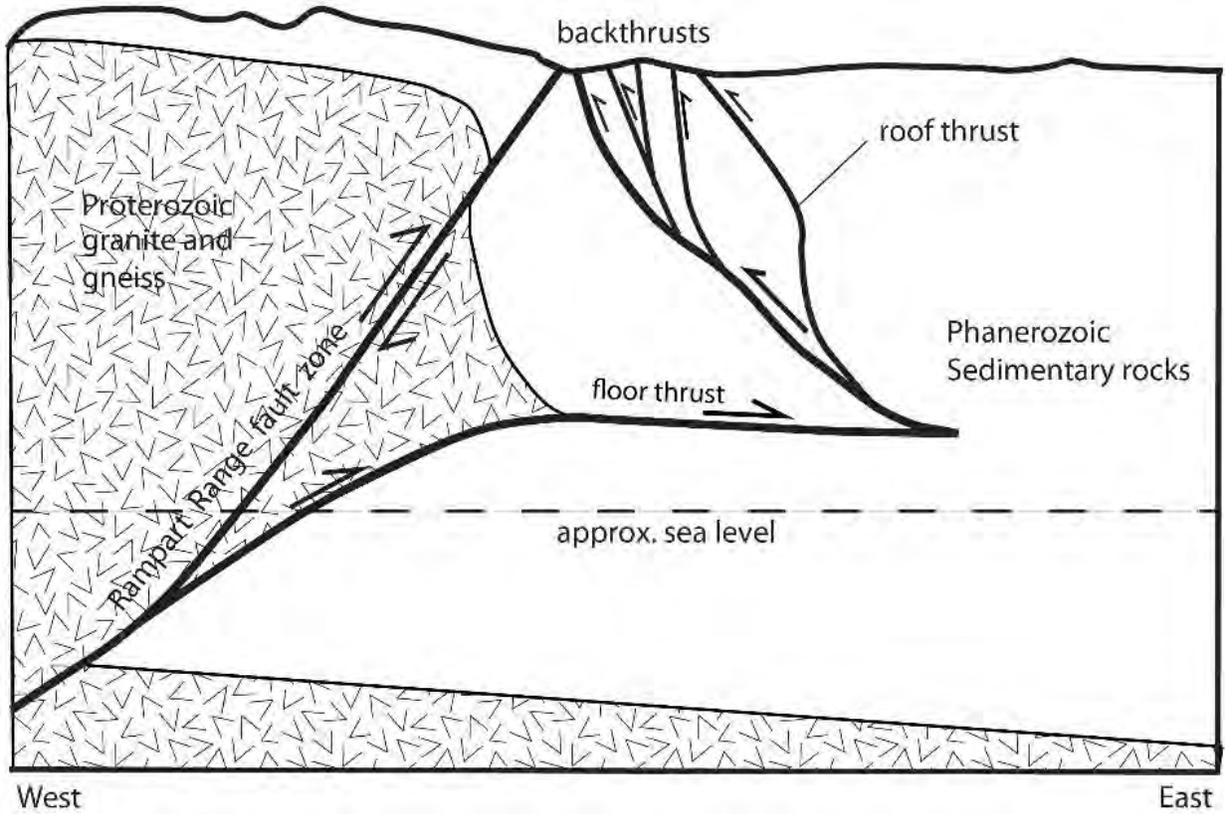
**Figure 3-2.** Conceptualized cross section using a triangular thrust model for the Rampart Range thrust fault at the Garden of the Gods. Modified from Siddoway and others (2013).

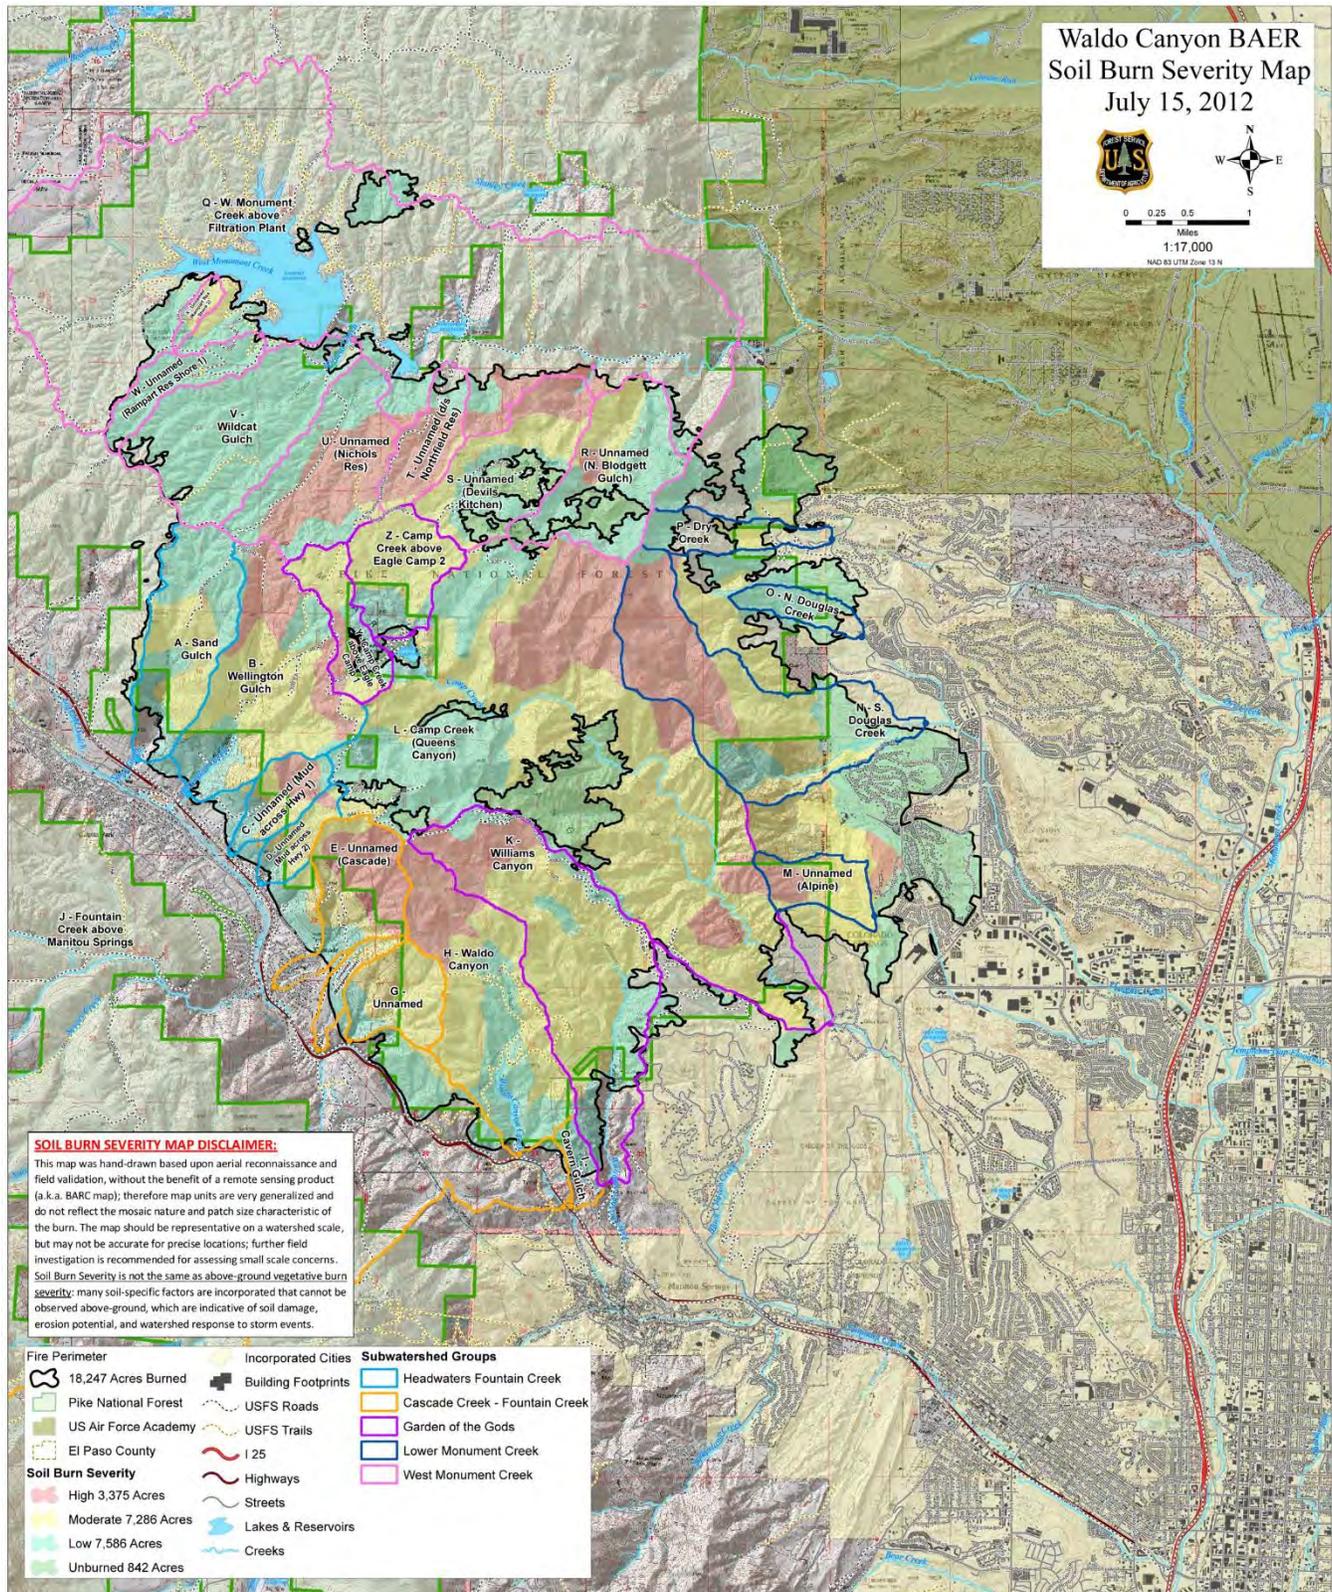
Figure 4-1. Waldo Canyon BAER soil burn severity map from U.S. Forest Service

The Waldo Canyon Fire initiated on June 23, 2012 and was contained on July 10, 2012. Approximately 18,247 acres, nearly entirely within foothills and mountains of the Rampart Range, were burned by this fire. There were two fatalities, 347 homes destroyed, and more than 32,000 people evacuated. The fire cost more than \$16 million to fight and incurred a half billion dollars in insured losses. The initial Burned Area Emergency Response (BAER, 2012) assessment includes an executive summary report, as well as maps of fire progression, burn severity, and photographs of the burned areas. **Figure 4-1** shows the USFS BAER soil burn severity map of the Waldo Canyon fire.

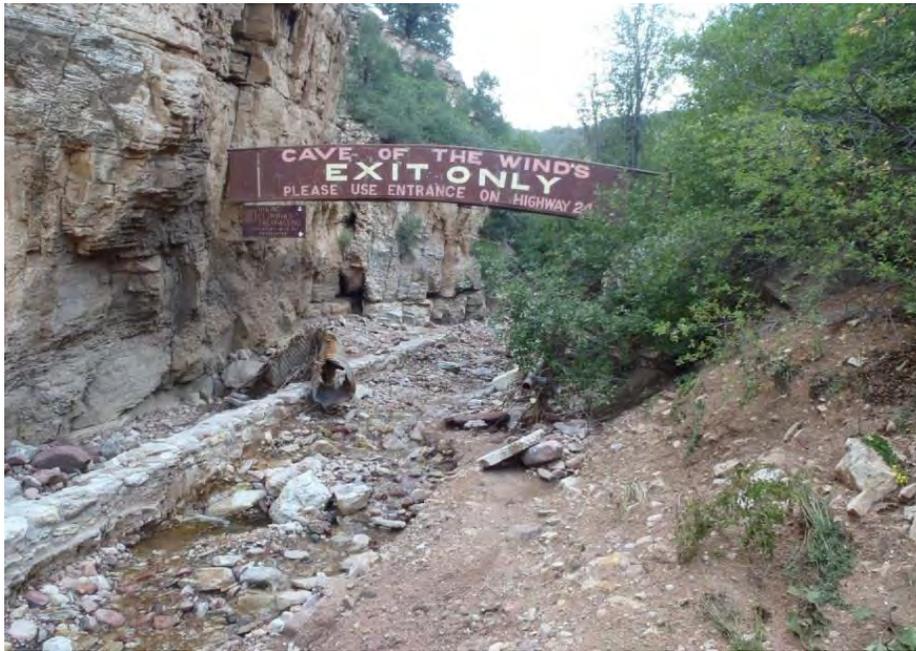
**Figure 4-3.** Cave of the Winds exit road completely washed out by flood of August 9<sup>th</sup>, Mortared rock wall in photo was the retaining wall for the original road that was on right side. Creek originally flowed to left of rock wall against rock face. This road has now been abandoned above the switch back to Geneva Trail road at the approximate location of the photo. Photo from GEER report (Keaton and others, 2013).

town. Almost all of the culverts became blocked by debris so that creeks jumped their channels and washed down roadways. There are many videos on YouTube of the flooding of Manitou Springs. Bouldery debris washed down Williams Canyon and destroyed the historic original Cave of the Winds road (**Figure 4-3**) and many homes below (**Figure 4-4**). An extensive mitigation effort along Williams Canyon creek from the mouth of the canyon was completed in 2015 at a cost of \$6.1 million. It included improved concrete flumes with elevated walls, a succession of cable-net debris catchment devices, and an enlarged detention basin at the mouth of the canyon (**Figure 4-5**). Future phases are still being planning as funding becomes available.

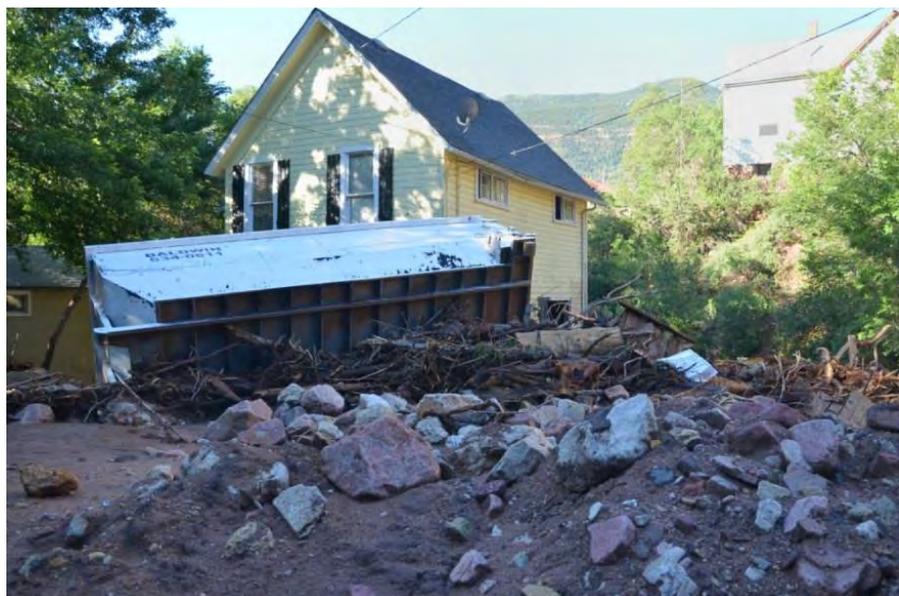
**Figure 4-4.** Post-flood image of neighborhood of Manitou Springs near mouth of Williams Canyon showing size of boulder debris that was washed into town.

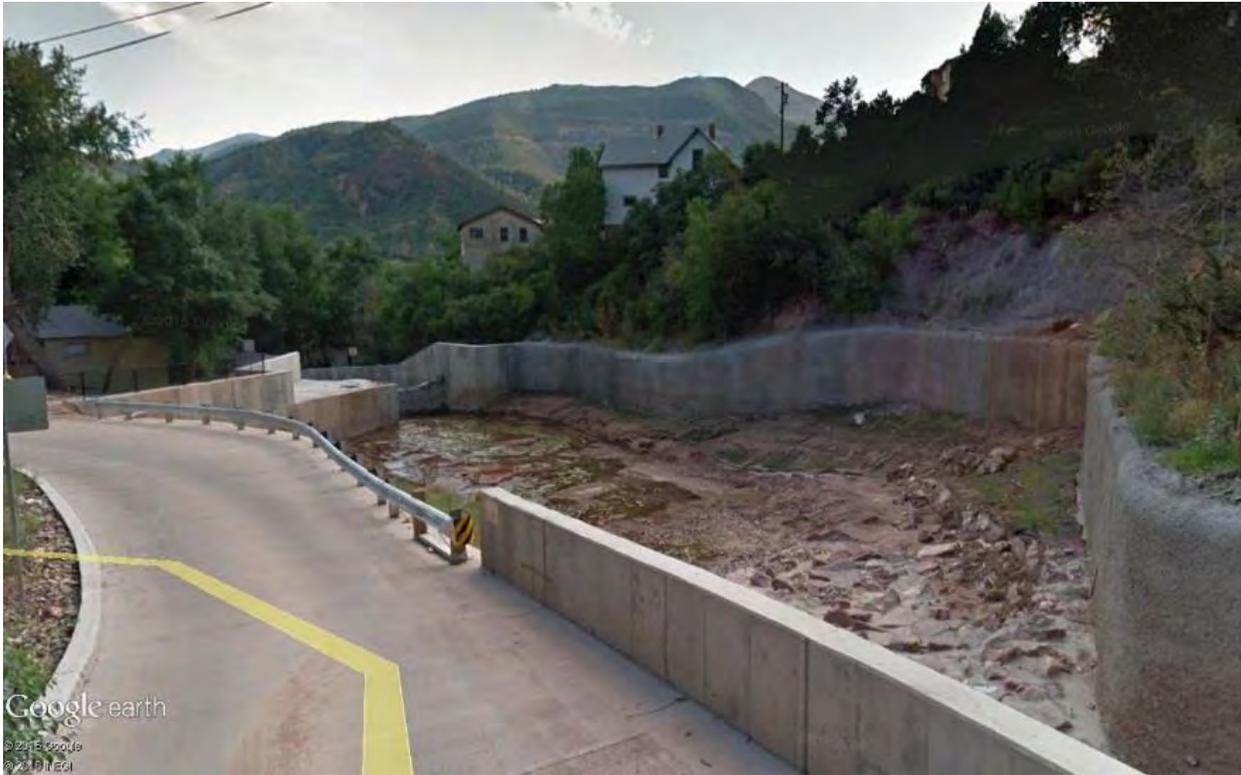
**Figure 4-5.** Basin constructed at mouth of Williams Canyon after 2013 flood. Note cable-net spanning flume at far end of detention basin. Image saved from Google Earth Pro™ Street View.

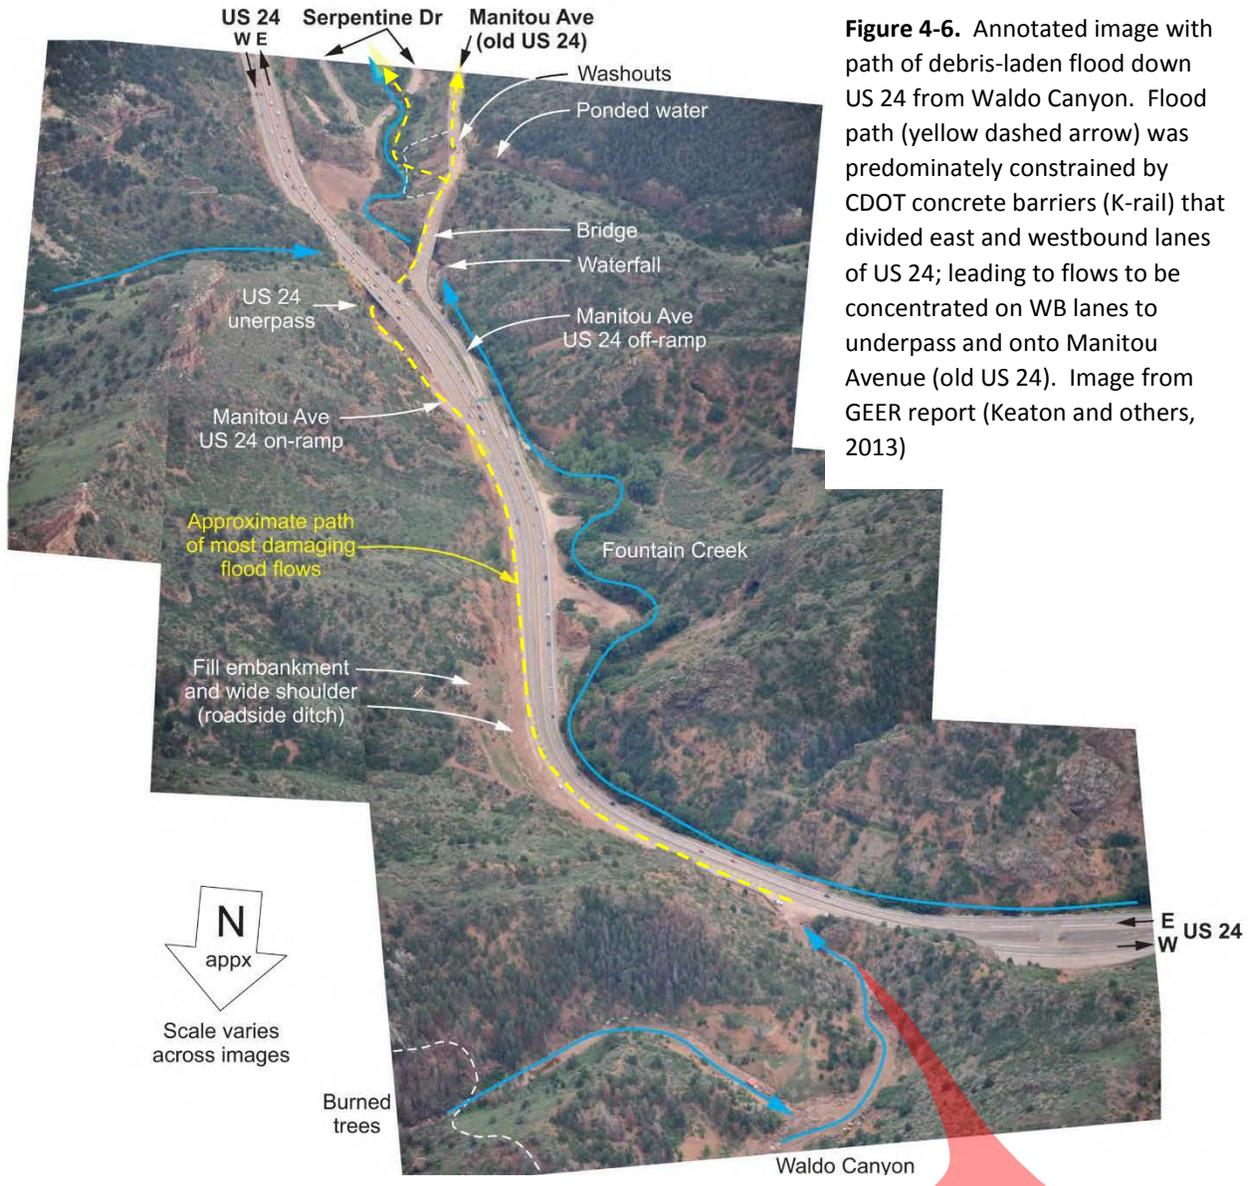
**Figure 4-6.** Annotated image with path of debris-laden flood down US 24 from Waldo Canyon. Flood path (yellow dashed arrow) was predominately constrained by CDOT concrete barriers (K-rail) that divided east and westbound lanes of US 24; leading to flows to be concentrated on WB lanes to underpass and onto Manitou Avenue (old US 24). Image from GEER report (Keaton and others, 2013)

The Waldo Canyon creek flooding didn't enter Fountain Creek until within Manitou Springs. The debris-laden flows quickly plugged the US 24 culvert and redirected onto the highway, with the majority flowing down WB US 24 lanes (**Figure 4-6**) where the flow was constrained by the north valley wall and Type 4 barrier that divided the highway. Flows up to 4 feet deep washed ½ mile down the WB lanes floating several occupied cars (See **figure 24** in road log). CDOT mitigated debris flooding at Waldo Canyon by the construction of a new wide concrete box culvert, excavation of a basin, and installation of cable-netting spanning the narrows near the mouth (See **extended abstract #5**).

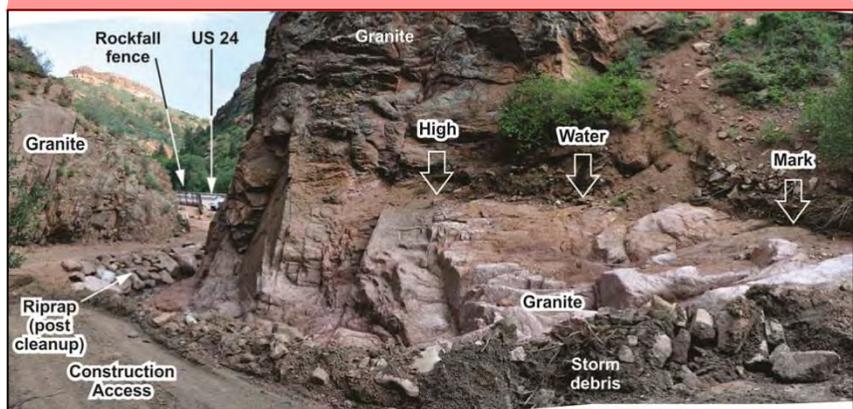
**Figure 4-6 (cont.)** Annotated image on left is at mouth of Waldo Canyon near US 24 and confluence with Fountain Creek showing high water mark from August 9, 2013 flood. Image from GEER report (Keaton and others, 2013)

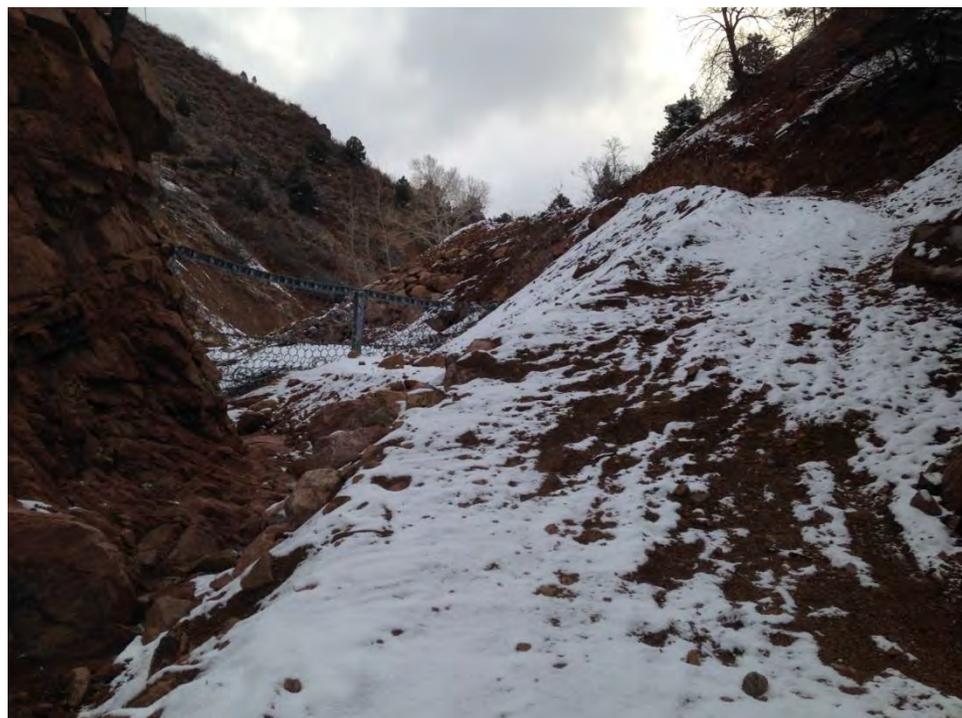
**Figure 5-1.** Debris barrier location prior to construction (3/6/2014).

Following the debris flow event of August 9, 2013, the Colorado Department of Transportation (CDOT) contracted with the water resources division of RESPEC and with Yeh and Associates, a geotechnical engineering firm, to design debris flow mitigation measures in Waldo Canyon (**Figure 5-1**). The mitigation effort was required to protect US Highway 24 from flood waters and debris flows that impacted mobility and safety along the corridor. Notable project constraints were as follows: allow normal runoff flows to pass under US 24 to Fountain Creek, stay within CDOT right-of-way, and allow CDOT Maintenance crews access for regular maintenance and cleaning.

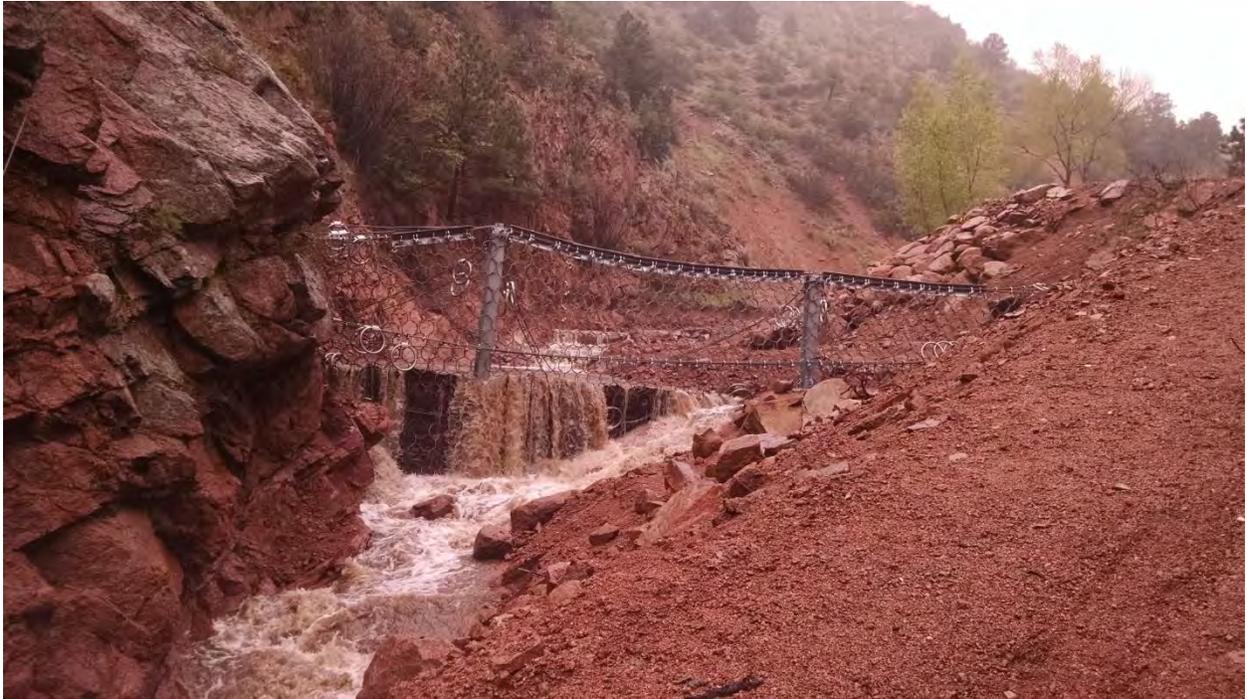
**Figure 5-3.** Debris barrier partially inundated (5/21/2015).

The consultant design team worked closely with the CDOT Region 2 engineering office, CDOT hydraulic engineers, the CDOT Geohazards Unit, and the CDOT Geotechnical Unit to create a multi-discipline solution. The first phase involved replacing the 72-inch corrugated metal pipe (CMP) cross-culvert under US 24 with a larger double cell concrete box culvert (CBC). The original inlet of the CMP was plugged with debris during the 2013 event. The second phase involved constructing a sediment basin and debris barrier upstream of the CBC. The sediment basin is designed to collect low flow sediment that can be maintained with regular cleaning by Maintenance crews to keep it functional. When high flow debris events occur that overwhelm the sediment basin, a downstream debris barrier prevents large debris from impacting and plugging the CBC under US 24 (**Figures 5-2, 5-3, and 5-4**).

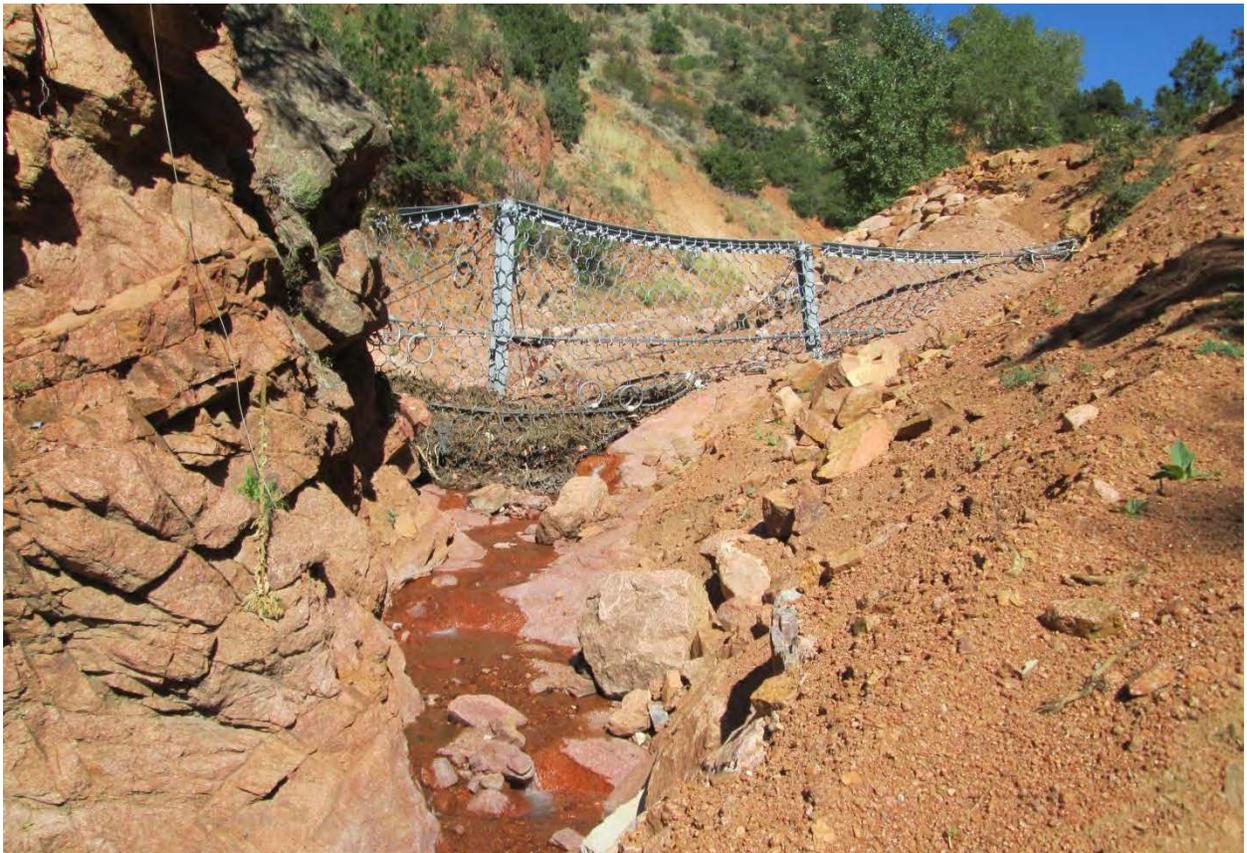
**Figure 5-4.** Debris barrier cleaned out (9/9/2015).
