HGS 2016  
Proceedings

# 67TH HIGHWAY GEOLOGY SYMPOSIUM

## JULY 11 – 14, 2016

Cheyenne Mountain Resort  
COLORADO SPRINGS, COLORADO

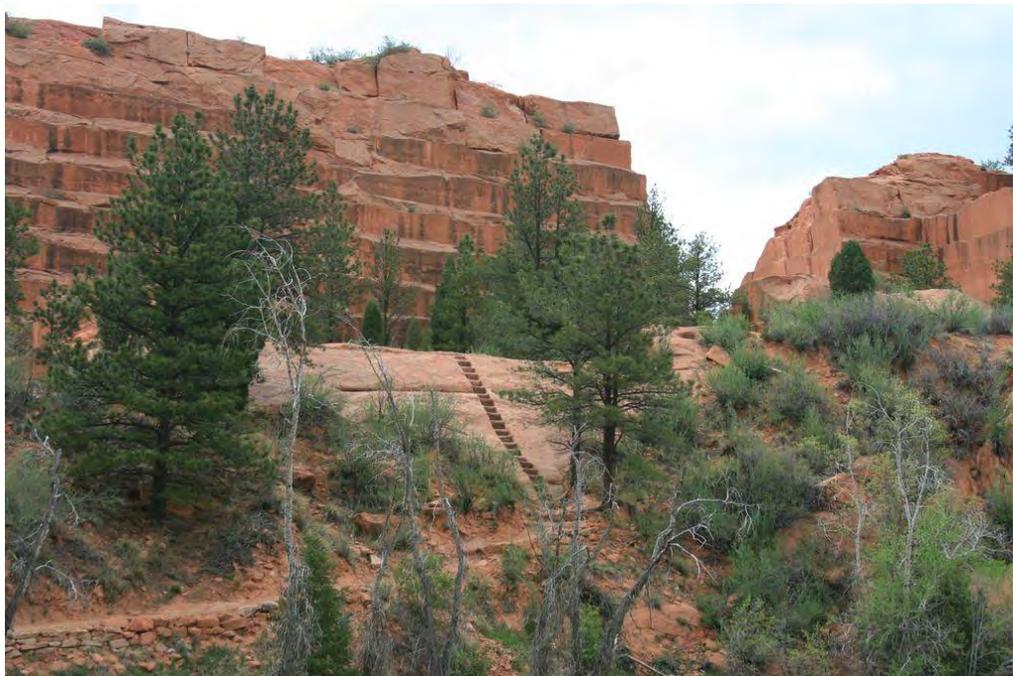
**Figure 6-1.** Historic quarry in lower Lyons Sandstone (PlI) at Red Rock Canyon Open Space. Photo courtesy of F. Trenkler, [www.cospringsstrails.com/hikes/redrock.html](http://www.cospringsstrails.com/hikes/redrock.html)

Red Rock Canyon Open Space is a popular hiking area with a trail network through the many rock features. Notable sights in the open space are trails that meander through steep dipping spires and fins of Fountain Formation sandstone on the west side. On the east side are benches, notches, and steep walls from historic, long-abandoned quarries that cut into the lower Lyons Sandstone ridgeline for dimension stone from the 1880s to 1910s (**Figure 6-1**). Those quarries, and world-class exposure of

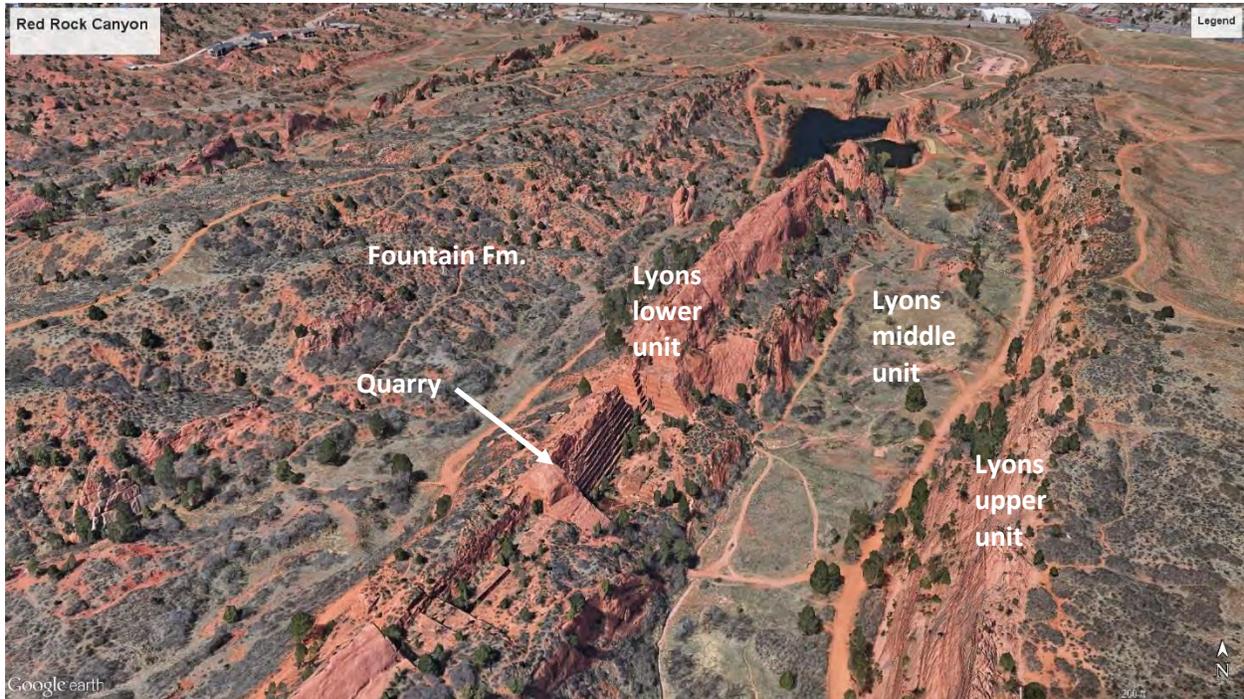
**Figure 6-2.** Oblique image of Red Rock Canyon showing location of historic quarry in steeply dipping Lyons Sandstone approximately 6/10<sup>th</sup> of a mile from parking lot. View is to the north to northwest. Image created from Google Earth Pro™ urban high-resolution 3D imagery.

planar bedded, cross-set (dune) sandstone (**Figures 6-2 and 6-3**) are within easily walking distance from the parking area. A full-page trail map (**Figure 6-4**) of Red Rock Canyon Open Space and the geologic map at the same scale (**Figure 6.5**) are in the back of this extended abstract.

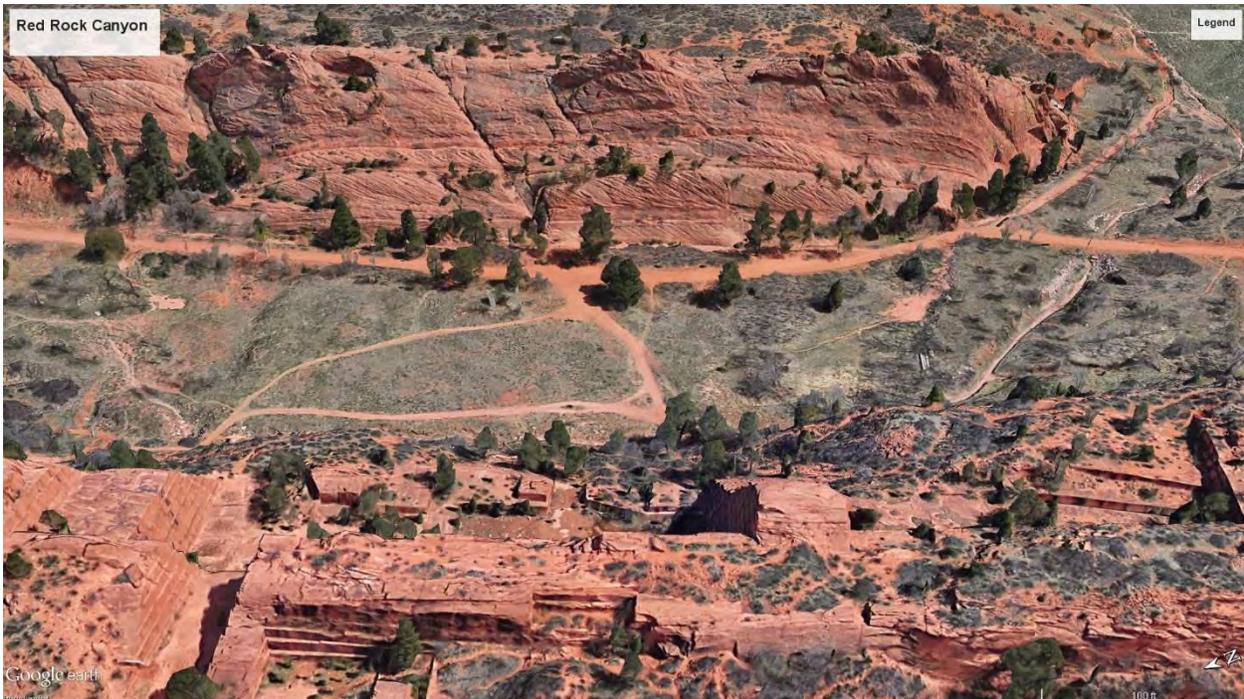
**Figure 6-3.** East-facing oblique image of quarry in **figure 6-2** showing Lyons Sandstone lower unit (quarried sandstone in bottom of image), middle unit strike valley, and upper unit at top of image. Note the exposures of planar bedded strata with dune cross sets in exposure of upper unit. Beds are dipping about 75° to east. Image created from Google Earth Pro™ urban high-resolution 3D imagery.
