70TH HIGHWAY GEOLOGY SYMPOSIUM

“Better Highways Through Applied Geology”

October 21-24, 2019

2019 Proceedings

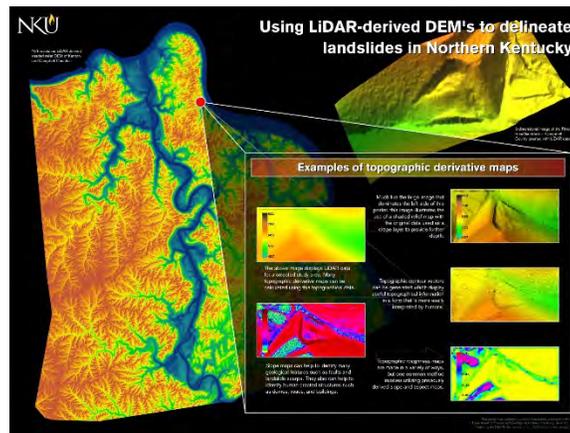
Figure 1: Processed LiDAR Data (Website, 4)

LiDAR, when available, provides the ability to analyze the topography of a landslide in more detail than satellite imagery or topographic maps alone. Critical features of landslides, including head scarps, toe bulging, and limits of the failure are often easily identifiable. Topographic features, including ravines, rivers, and slope geometries are also more easily recognizable. Point cloud data can be downloaded and processed to generate cross-sections in areas of interest. When information derived from onsite investigation is limited or unavailable, cross-sections created from LiDAR datasets can provide a slope geometry to perform a back analysis. Figure 1 displays different perspectives of processed LiDAR data.

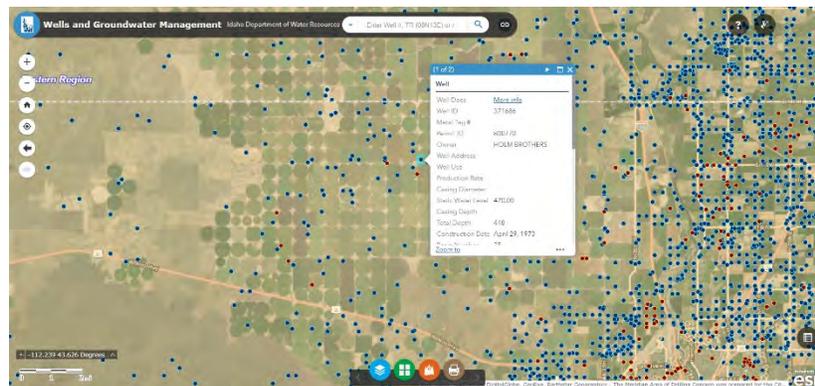
Figure 2: GIS Well Log Map (Website, 5)

Well logs typically include information such as date and location of drilling, drilling conditions, observed subsurface material types, static water levels. The driller/operator records the observed conditions during the well's installation; however, the logs may not have been reviewed by an engineer or geologist. Therefore, judgment should be used when reviewing well logs and incorporating data into the design solution. Additional information such as geologic maps and/or web soil surveys may also be needed to verify drilling conditions. Figure 2 displays well logs that can be obtained from online GIS databases.

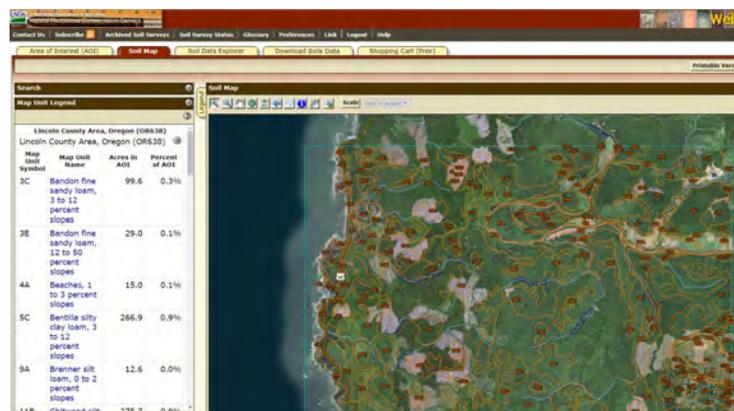
Figure 3: Web Soil Survey Data (Website, 6)

The web soil surveys are useful in landslide analysis because they give insight into the near-surface soil conditions as determined by the USDA. Typical surveys will provide engineering and chemical properties for soils up to approximately six feet deep. Engineering properties from the surveys include USCS and AASHTO soil classification, USDA texture, hydrologic properties, sieve analysis, liquid limits, plasticity index, and soil PH. This information can be used to estimate important soil strength parameters, create soil profiles, identify the potential presence of water, and estimate the corrosion potential of the soils. Figure 3 displays soil data from the web soil survey application.

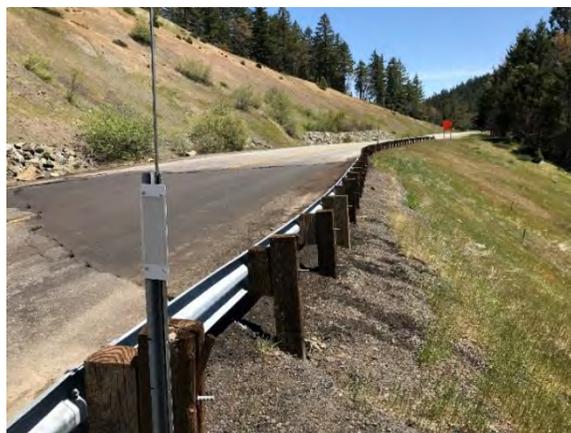
Figure 4: Existing Head Scarp Near Mad River, California

reoccurring issue requiring yearly maintenance to keep the road safe for the traveling public. Traditional solutions had been evaluated but were not economically feasible. Figure 4 displays the pre-construction conditions of the area of interest.

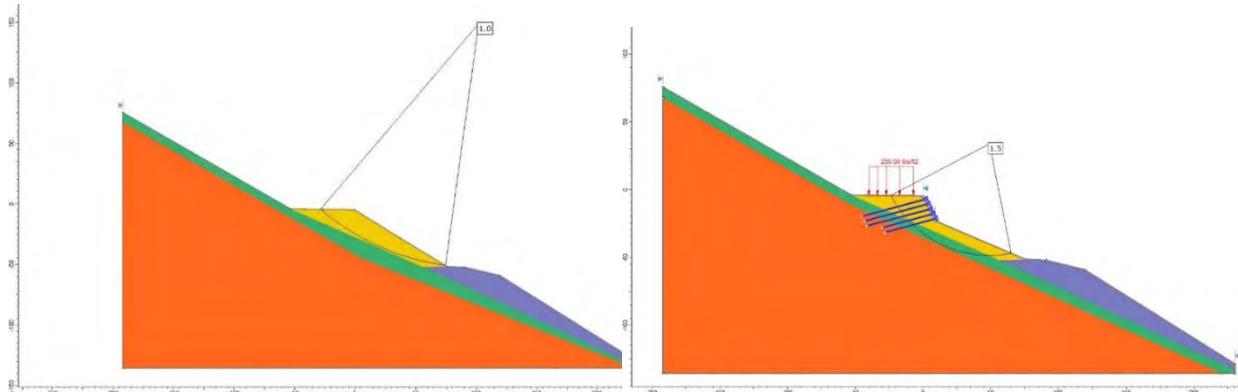
Figure 6: Back Analysis and Repair Analysis for Case Study 1 (Website, 9)

length of the repair, and in areas groundwater was encountered during drilling. The anchors were conservatively designed with allowable bond capacities non-dependent on bond values for a homogenous soil for full embedment. However, all the anchors were installed with at least 10 feet embedment into bedrock. Design assumptions, including subsurface profiles and anchor bond capacities, were vetted during construction and field testing. The model created in Slide by Rocscience for the repair can be seen in Figure 6.

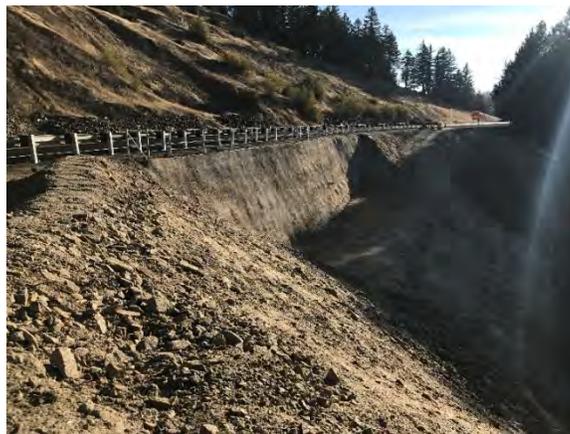
Figure 7: Final Repair for Case Study 1

The desired outcome of the project was to stabilize the landslide quickly with an economically feasible solution. The project duration lasted approximately six weeks, and the highway remained open during construction with limited impact on traffic. While important slide information collected from previously installed inclinometers and piezometers were never obtained, data derived from free online resources and field reconnaissance helped provide crucial subsurface information necessary for the design. The final product of the project can be viewed in Figure 7.

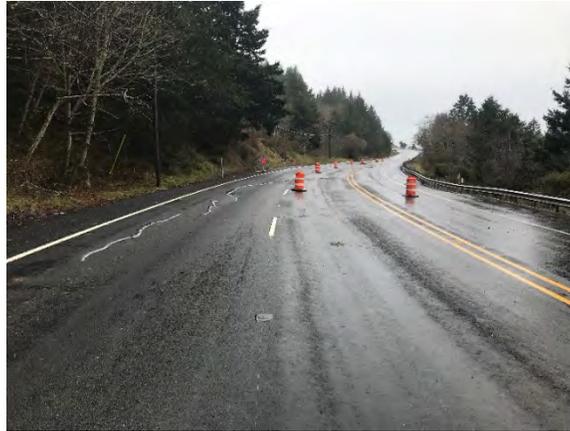
Figure 8: Site Photo of Highway 101

Case study two was located along Hwy 101 south of Coos Bay, Oregon. A massive winter storm passed through the area resulting in approximately 14 inches of rainfall within three days. Multiple landslides were triggered due to the large concentration of moisture, and this landslide of interest sat on the flanks of a larger landslide complex. Figure 8 displays the pre-construction conditions of the area of interest.

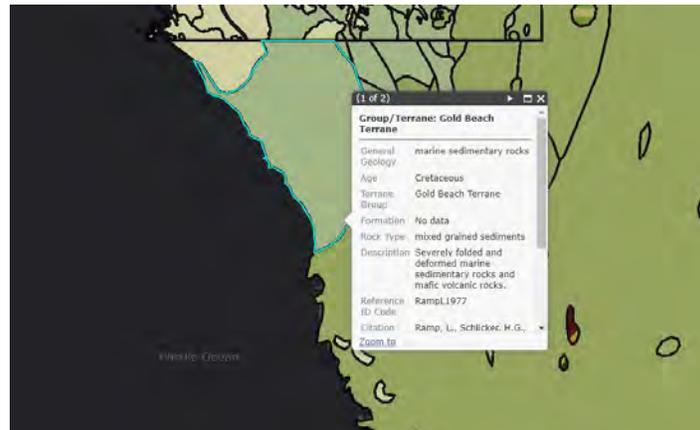
Figure 10: Geologic Map of Case Study 2 (Website, 12)

Geologic maps and web soil surveys were used to understand the geology in the area, so engineering properties of the subsurface materials could be estimated. Geologic maps provided by the Oregon Department of Geology and Mineral Industries indicated the bedrock in the region was composed of severely folded and deformed marine sedimentary and mafic volcanic rocks of Cretaceous age (Website, 12). The overlying soils derived from these deeply weathered parent rocks were inferred to be weak with moderate cohesion and moderately lower phi angle values. A USGS web soil survey indicated the overlying soils consisted of a low to high plasticity clay with silt with slow infiltration rates (Website, 6). Soil chemical properties were also evaluated, indicating the soil PH ranged between 5 and 6 in the upper soils. Figure 9 shows a geologic map of the project area procured from the Oregon Department of Geology and Mineral Industries Website (DOGAMI).

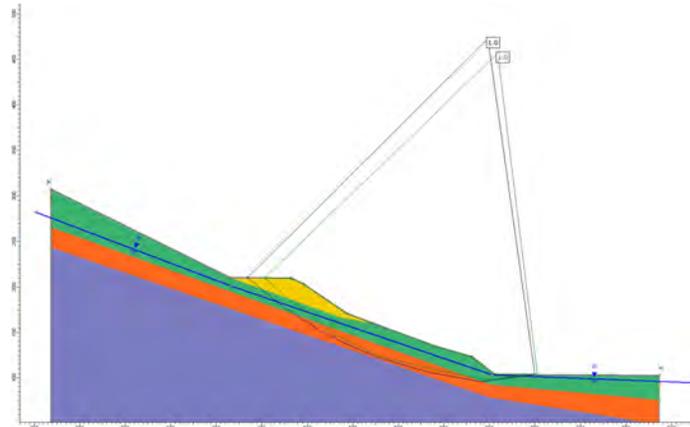
Figure 10: Back Analysis of Highway 101 (Website, 9)

and layer profile depths until the critical failure surfaces matched conditions observed in the field. The representative back analysis showed the two failures were deep-seated and likely failed through the weathered bedrock layer. The model created in Slide by Rocscience for the repair can be seen in Figure 10.

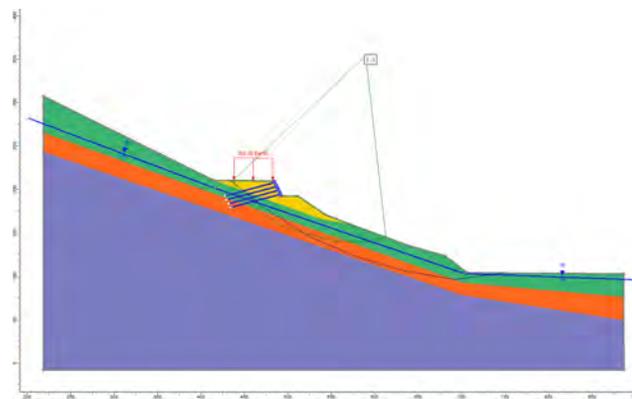
Figure 11: Repair of Highway 101 (Website, 9)

The repair consisted of a soil nail wall varying in height up to 19 feet tall at the critical section. Hollow bar soil nails were installed in varying lengths up to 60 feet with a reinforced shotcrete facing. Subsurface conditions and anchor lengths required injection anchors so grout encapsulation would be maintained during installation. Horizontal drains were installed along the base of the soil nail wall for anticipated groundwater and connected to toe manifold for positive drainage. Design assumptions were vetted during construction based on real time drilling feedback and anchor testing. The model created in Slide by Rocscience for the repair can be seen in Figure 11.

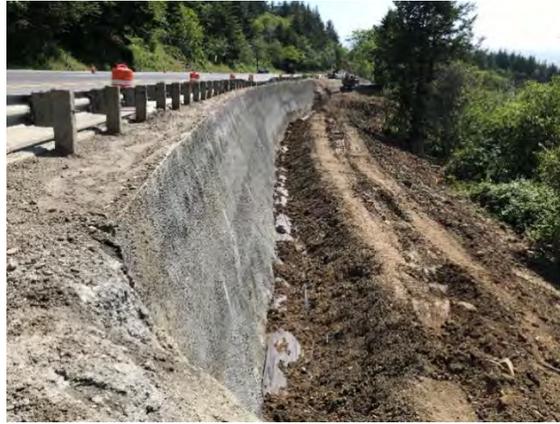
Figure 12: Final Repair of Highway 101

traffic. As a result, access to free innovative GIS tools was a crucial factor in the successful stabilization of the landslide. Work was performed in lift construction from the platform where possible and a construction bench below as required. The project was designed and priced in less than three days, and construction took approximately eight weeks to complete. Figure 12 shows the final repair of this project.

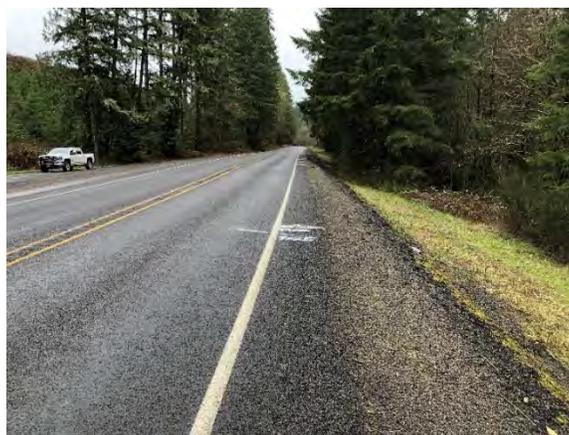
Figure 13: Site Photo of Highway 138W

Case study three was located on Hwy 138W in Douglas County south of Elkton, OR. As seen below in Figure 13, a large head scarp extending a couple of feet beyond the inboard fog line was observed for approximately 195 LF as measured along the outboard fog line. The head scarp was clearly delineated as it approached the bottom of the slope with signs of toe bulging. Another smaller head scarp appeared to extend along the outboard shoulder of the road surface. Figure 13 displays the pre-construction conditions of the area of interest.

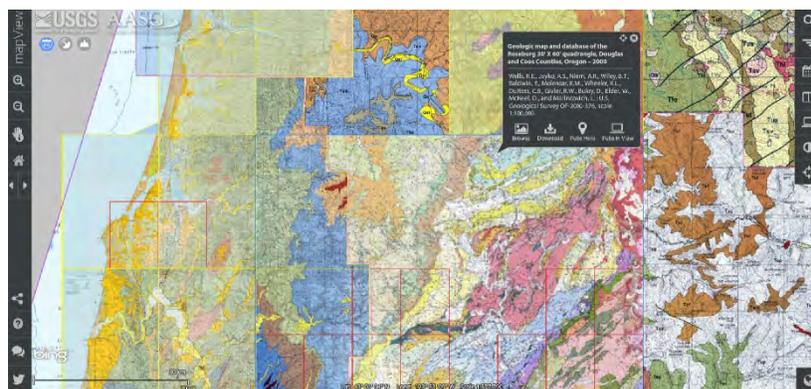
Figure 14: Geologic Map of Case Study 3

Geologic maps provided by the Oregon Geologic Survey and USGS were then consulted to get a general understanding of the local geology of the area (Website, 1). Bedrock, if encountered, would consist of sedimentary rocks, including sandstone, siltstone, and mudstone. Web soil surveys were then used to get a general understanding of the typical surface soil conditions in the area. The results of the web soil survey indicated the native soils consisted of low to high plastic silts and silty clays low to moderate infiltration rates when thoroughly wet. Figure 14 below displays how the geologic map was procured for the case study south of Elkton, OR.

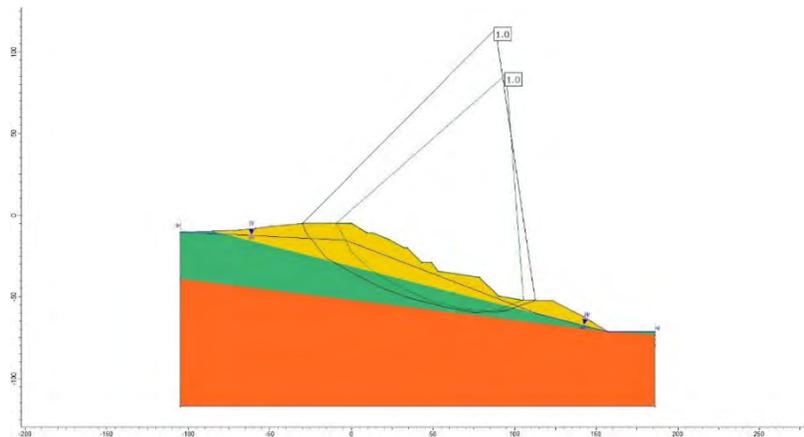
Figure 15: Back Analysis for Highway 138W (Website, 9)

From the freely available information, supplemented with the site visit, gave enough detailed information about the landslide to prepare a representative back analysis of the failure. The critical failure surface was modeled with a deep-seated non-circular failure extending through the native and fill materials. Soil profiles and groundwater depths were estimated based on the boring log information provided by ODOT. Sensitivity analyses were performed to evaluate the effects of varying depths of native soil, rock, and groundwater. The final analysis showed failure surfaces at approximately the same locations as measured in the field. The model created in Slide by Rocscience for the back analysis can be seen in Figure 15 below.

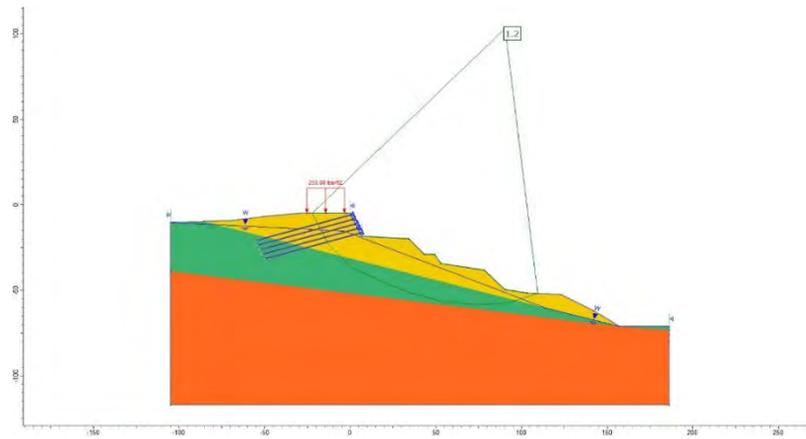
The proposed repair consisted of a soil nail wall in varying height up to 15-feet in the critical section. An array of hollow bar injection anchors varying in lengths up to 60-foot embedment and reinforced shotcrete was designed in the critical section. The wall heights and embedment lengths were optimized based on scarp measurements and cross-sections taken at various locations throughout the slide mass. Hollow bar injection anchors were selected and designed based on anticipated drilling conditions for a sandy fill material and silty clay w/sand native material identified in the free available information. The model created in Slide by Rocscience for the repair can be seen in Figure 16 below.

Figure 16: Repair of Highway 138W (Website, 9)

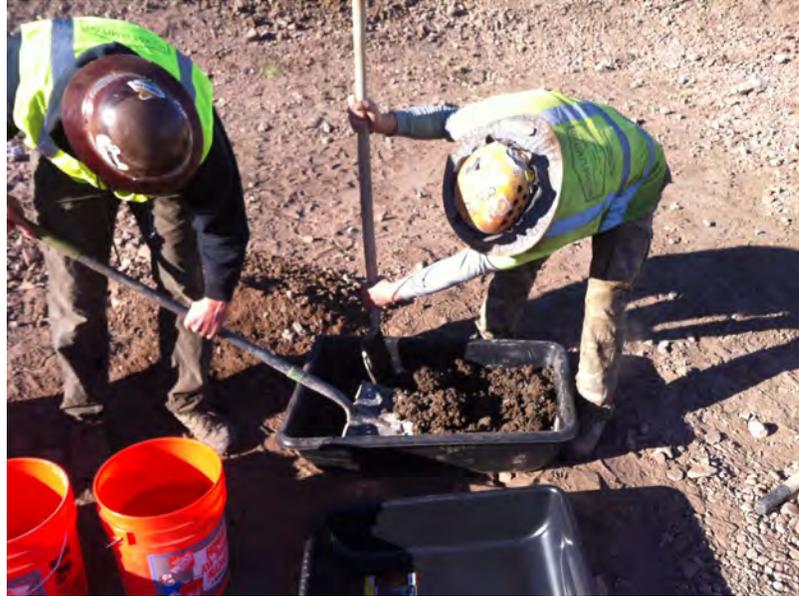
Figure 1 - Soilcrete Mixture on-site in Camarillo, California.

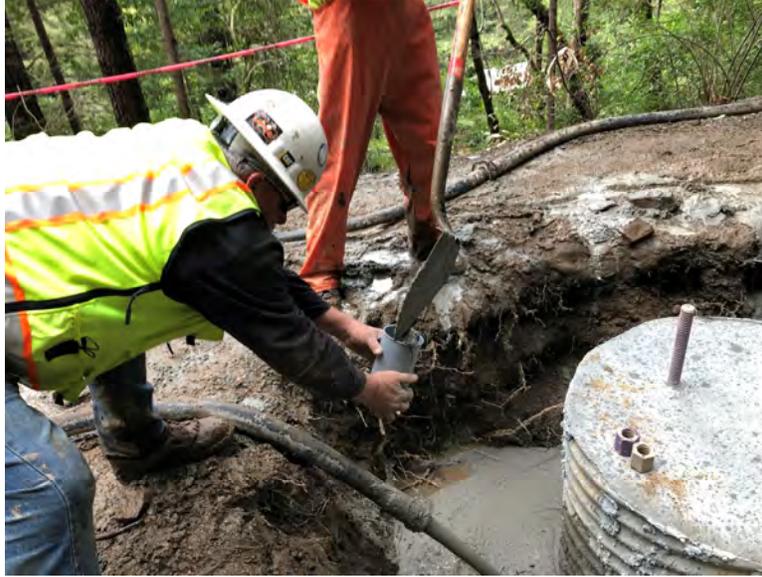
Figure 2 – Control Density Fill Mixture in Felton, California.

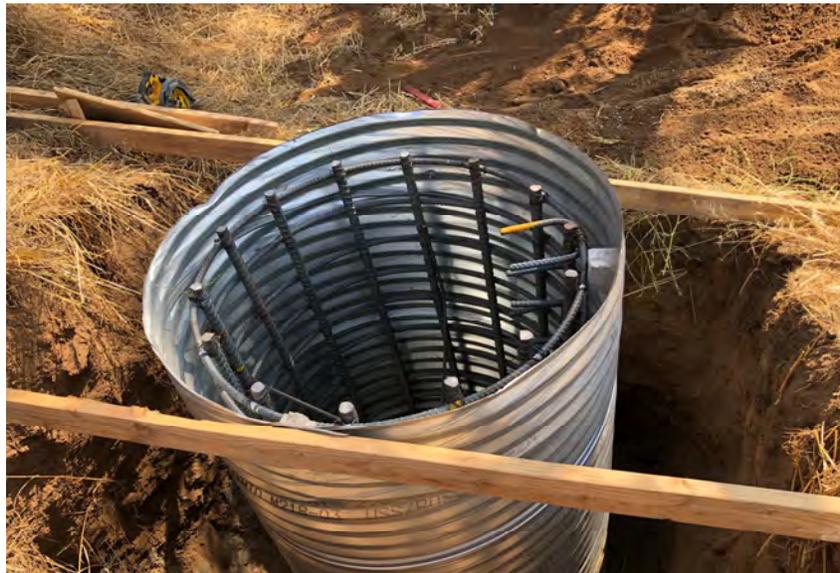
Deep foundations require a substantial amount of steel and concrete material for construction. Depending on the pile depth, additional steel rebar for concrete confinement, bar alignment, and flexural bending may be required. The time required for deep foundations to reach design drilling depths increases overall materials and labor costs. For deep foundations, large drill rigs with augers are often attached to large construction equipment such as drill rig semi-trucks and excavators. Geohazard mitigation systems are commonly placed in limited site access areas including sloped surfaces, debris channels, and secluded locations. These areas make large standard drilling rigs accessibility limited or impossible due to machinery safety constraints, Figure 3.

Figure 3 - Typical Deep Foundation Pile.

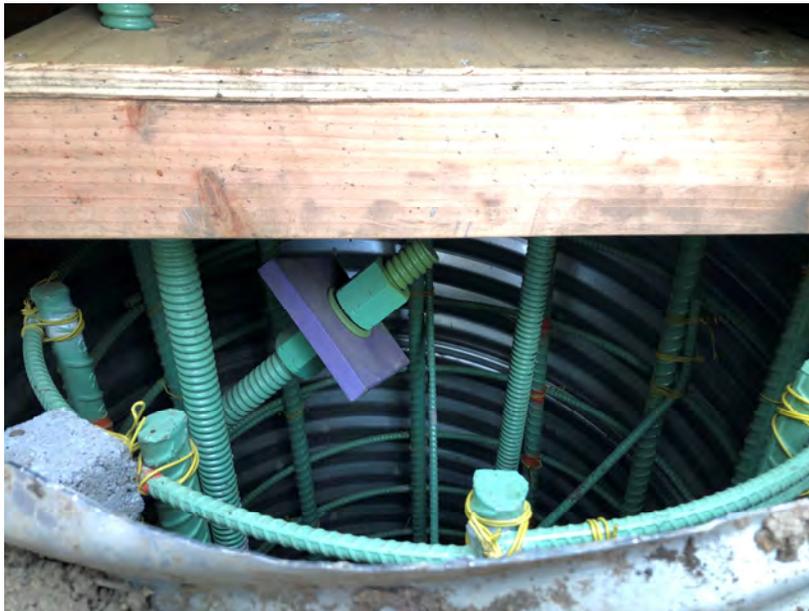
Tieback micropiles are efficient when bedrock is shallow for anchorage, Figure 4. Tieback micropile anchors are often deep in soil strata due to low achievable anchor grout/ground bond strength. Theoretical design anchor grout/ground bond strengths are used in the design and tend to be conservative for soil conditions. Increase in the drill hole diameter correlates to an increase in the skin friction but is more efficient in anchor length reduction. Locating the micropile tieback anchors from previous observations tend to be difficult depending on drill equipment used. Inclined drill rigs can provide an accurate drill hole where drills mounted to wagons or hand drills can be difficult. The inclination of the tie-back micropile is critical to the design for shear and moment resistance.

Figure 4 – Post Foundation Upslope Micropile Tieback Anchor.

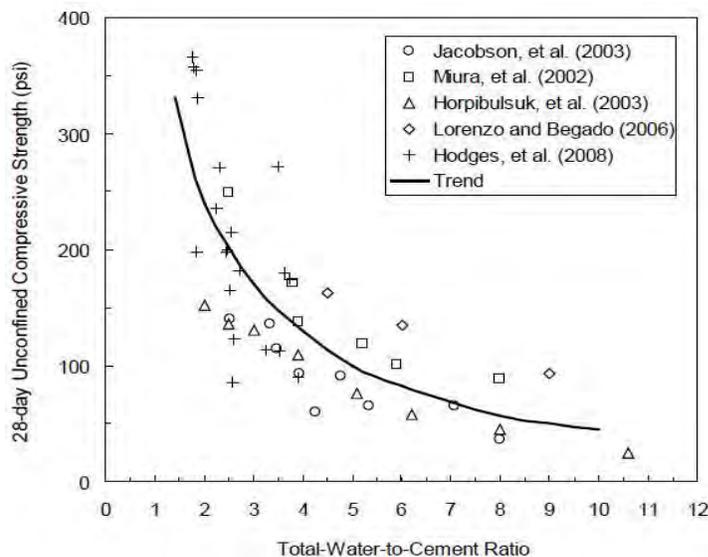
The focus of CLSM and Soilcrete in this report is the design strength factors. Per FHWA the strength for Soilcrete and CLSM can be determined using a materials unconfined compression strength. The CLSM and Soilcrete compression strengths are both influenced by multiple mixture materials including; binder mixing ratios, additive types, curing temperature, and curing duration. Studies show that Soilcrete strength increases with improved mixing efficiency, curing time, organic soil, and water content (1). Therefore, a decrease in the water to base (w:b) ratio of a mixture increases the unconfined compressive strength. This theory is true for similar concrete mixtures. Higher water to cement (w:c) ratios results in a higher slump and high flowability with strength reduction, Figure 5.

Figure 5 - FHWA Figure 29. Compressive Strength Sample Comparison.

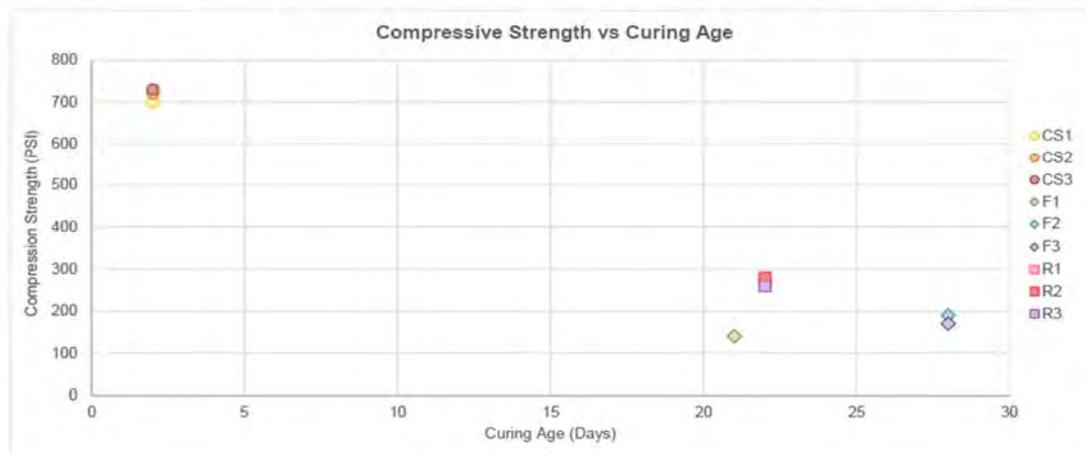
INPUT - Comarillo Springs, CA				
Testing Data - Break Results				
Specimen Sample No.	Curing Age (Days)	Maximum Compression Load Applied (LBS)	Maximum Compression Strength at Failure (PSI)	Maximum & Minimum Values
1	2	8,810	700	Minimum
2	2	9,000	720	
3	2	9,220	730	Maximum

INPUT - Felton, CA				
Testing Data - Break Results				
Specimen Sample No.	Curing Age (Days)	Maximum Compression Load Applied (LBS)	Maximum Compression Strength at Failure (PSI)	Maximum & Minimum Values
1	21	1,750	140	Minimum
2	28	2,340	190	
3	28	2,120	170	Maximum

INPUT - Riverside, CA				
Testing Data - Break Results				
Specimen Sample No.	Curing Age (Days)	Maximum Compression Load Applied (LBS)	Maximum Compression Strength at Failure (PSI)	Maximum & Minimum Values
1	22	7,720	270	
2	22	7,890	280	Maximum
3	22	7,360	260	Minimum

Figure 6 - KANE GeoTech Backfill Support Testing Results.

Additional CLSM and Soilcrete samples have been tested specifically for geohazard mitigation post foundations. The tests were to determine unconfined compression strengths to compare with published results. The compression strength data for backfill support is presented in Figure 6. Three Soilcrete samples provided 700-psi unconfined compressive strength in 2-days of curing. Six CLSM samples provided unconfined compression strengths with a maximum of 280-psi and a minimum of 140-psi, Figure 6. The results have a similar comparison in compression strength with referenced published results.

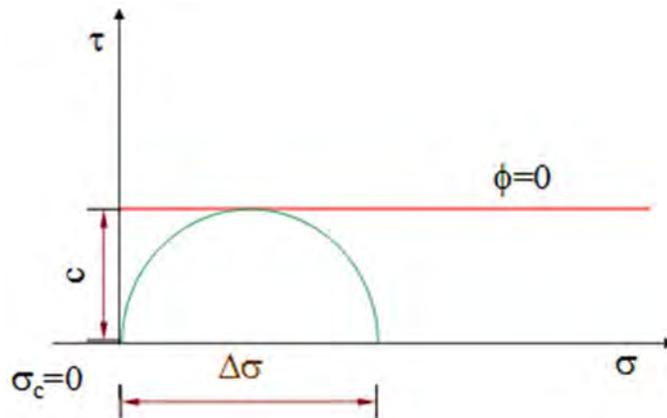
The Soilcrete and CLSM strength design criteria have not been accepted as a worldwide standard of practice due to the differences in the strength envelope development (1). It is recommended by the FHWA that a reasonable but conservative strength envelope be used for design. The total stress should include a negligible internal friction angle of $\phi = 0$ -deg and tensile strength, Figure 7. The standard of practice in the United States does not rely on the tensile strength of the mixed ground for design (1). The conservative approach incorporates a total stress internal friction angle of $\phi = 0$ -deg and a cohesion (c) intercept of $c = 1/2(q_u)$ where q_u is the unconfined compression strength (1). For design, the foundation backfill support should include a minimum factor of safety (FOS). The standard of practice for foundation FOS includes a minimum of 3.0. The FOS provides resistance against the variability in the mixture strength and the shearing capacity through the backfill support zone. Using this design method provides a minimum unconfined compression strength required for the backfill support.

Figure 7 - Typical Mohr Circle for Unconfined Compression.

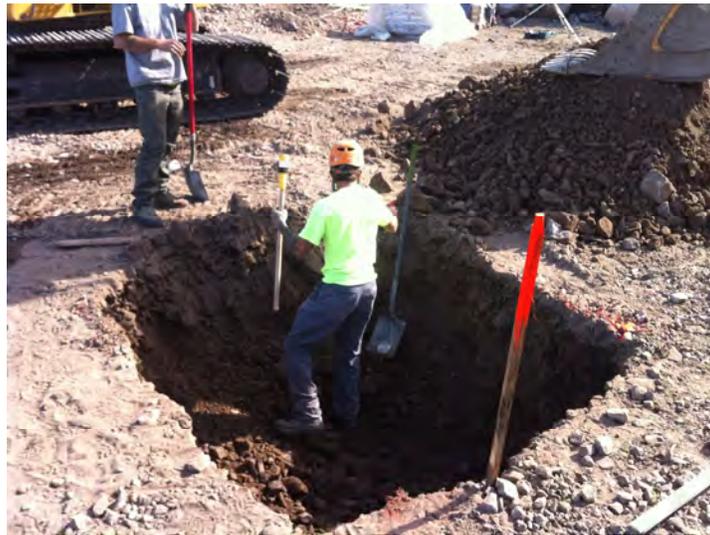
To shorten the project construction timing, the post foundations were designed using Soilcrete backfill. The backfill reduced the foundation construction time in-place of deep piles requiring large on-site drilling rigs. By using the soilcrete backfill design approach, the same drilling equipment to install the mitigation system anchors were used to excavate the shallow foundation footprints, Figure 8. Accessibility for large drilling equipment was limited due to steep terrain at the foundation locations. The debris flow mitigation systems designed were Geobrugg UX180-H6 and Geobrugg SL-150 type systems. The Geobrugg UX180-H6 system post foundations were designed to resist the lateral loading of 95.4-kips and an axial compressive load of 67.4-kips (8). The Geobrugg SL-150 system post foundations were designed to resist lateral loading of 63.6-kips and an axial compressive load of 78.6-kips (8).

Figure 8 - Shallow Foundation Using Soilcrete Method.

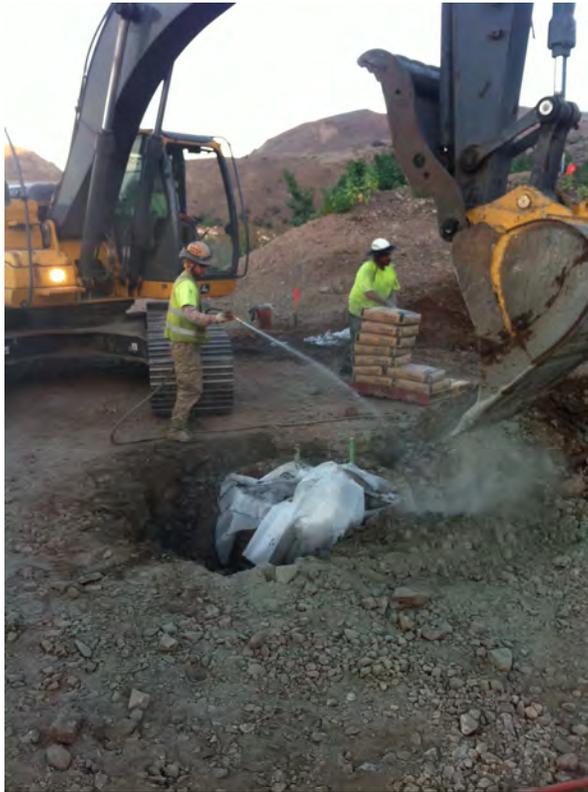
Figure 9 - Contractor Mixing Soilcrete Backfill.

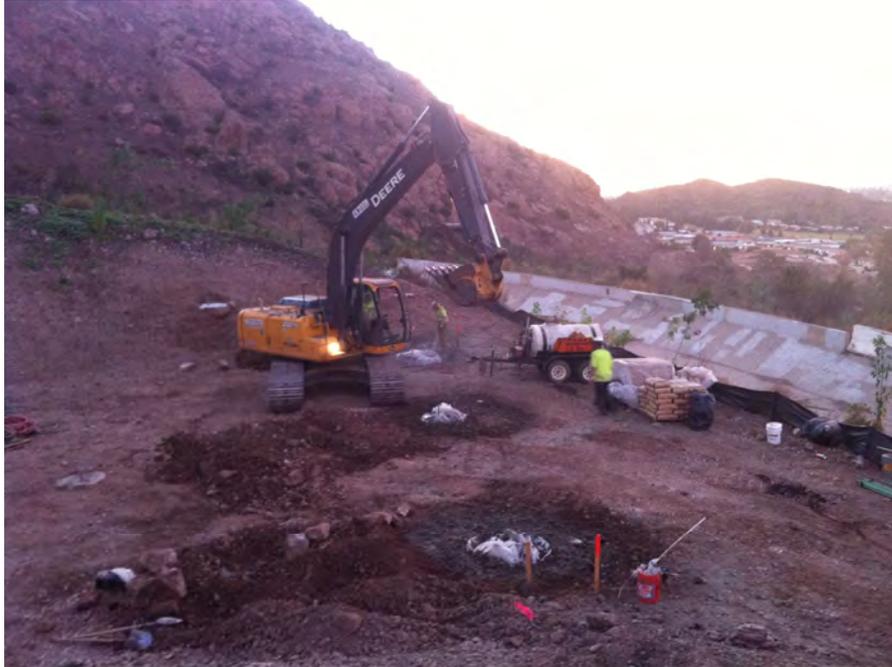
Figure 10 – Completed Shallow Foundation with Soilcrete Backfill.

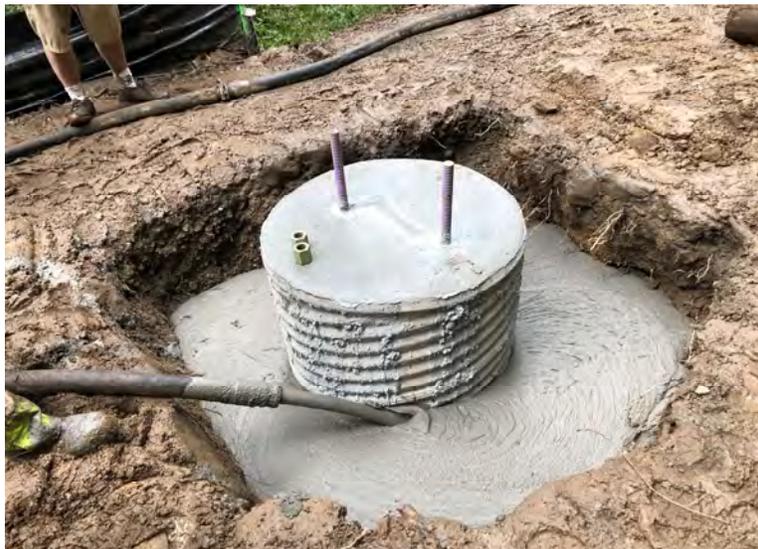
Figure 11 - Contractor Pumping CDF Backfill Around Foundation.

difficult to use for Soilcrete mixture. CLSM was used in lieu of the Soilcrete. The CLSM was pumped through long hoses from slurry vehicles on wider sections of the road, Figure 11. The debris flow mitigation system design was a Geobrugg SL-150 type system. The Geobrugg SL-150 system post foundations were designed to resist lateral loading of 66.7-kips and an axial compressive load of 82.3-kips (13).

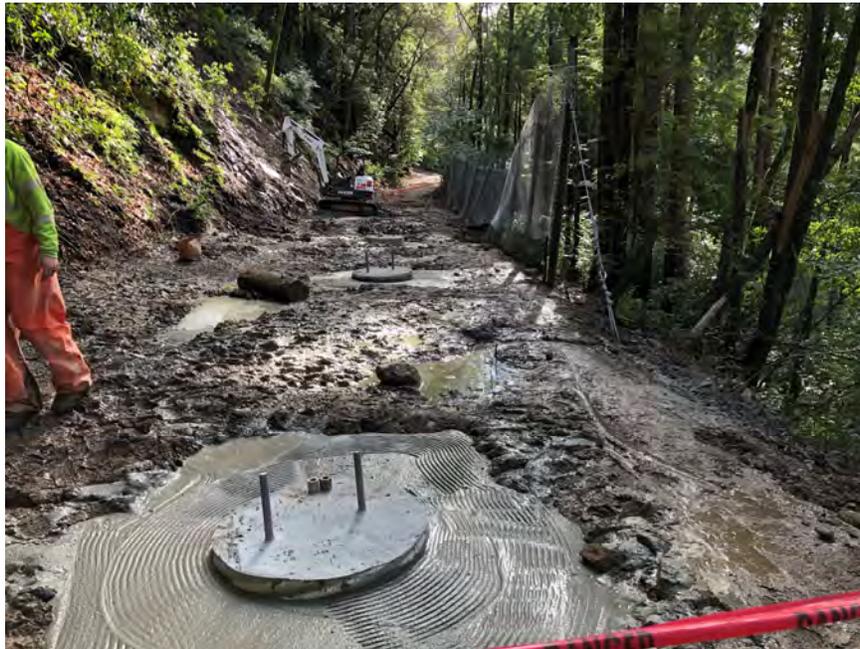
Due to the narrow and sloped area below the roadway, the available passive pressure resistance was relatively low resulting in an increased strength required for the backfill, Figure 12. For design compacted soil cohesion of 10,800-psf (6) was used for backfill support to resist lateral deflection and reduce bending of the foundation. The minimum unconfined compressive strength required for the design was 150-psi (21,600-psf) (15). The CLSM volume was relatively small at 3-CY per foundation. Since the CLSM is a flowable and self-leveling and compacting backfill, no vibration or compaction lifts were performed during installation. The CLSM was pumped on-site with samples collected for testing to verify minimum compression strength. The CLSM contained ASTM C-150 cement with fine sand aggregate. The CLSM mixture slump was 6-in with 4-sacks of cement per mix (14). The unconfined compression strength values for all three samples were between 140-psi to 190-psi with the average at 167-psi exceeding the required 150-psi for design (15). Due to the cold and wet climate and long pumping distances, the flowability of the CLSM was high resulting in lower range CLSM values.

Figure 12 - Completed CDF Backfill Around Foundation.

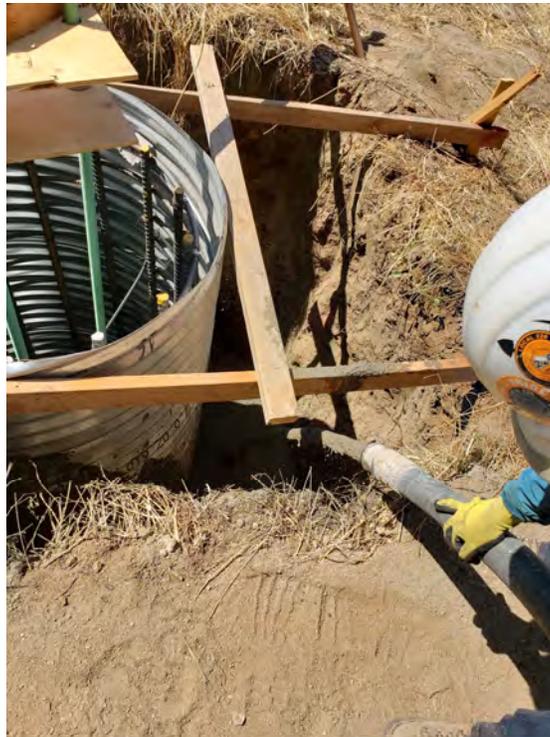
Figure 13 - Contractor Pumping CDF Backfill Around Foundation.

collected for testing to verify minimum compressive strength, Figure 13. The CLSM mix contained Portland type II / V cement with fine aggregate. The CLSM mixture slump was 5-in with 2.3-sacks of cement per mix (18). The unconfined compression strength values for all three samples were between 260-psi to 280-psi with the average of 270-psi (19) exceeding the minimum 100-psi design requirement. Due to the warmer climate and admixtures, the CLSM compressive strength was improved with a reduction in water content, Figure 14.

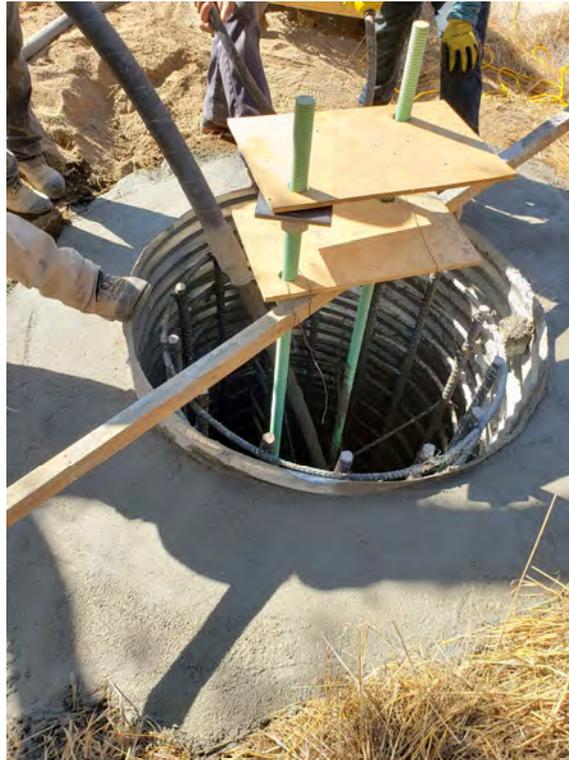
Figure 14 - Completed CDF Backfill Around Foundation.

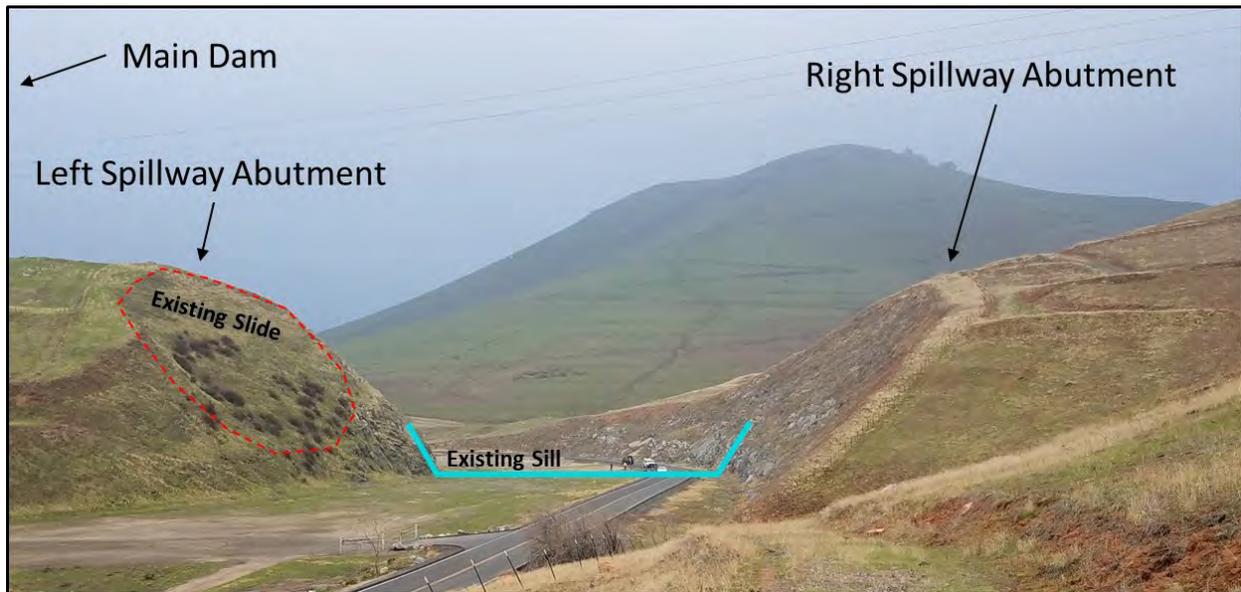
Success spillway was constructed as the emergency outlet structure for Success Dam. It is located about 700 feet northwest of the right abutment of the main dam, with a large knob of existing rock between the structures (**Figure 2**). The spillway was blasted and excavated through colluvium and the underlying bedrock.

Figure 2: Spillway features – looking downstream (west)

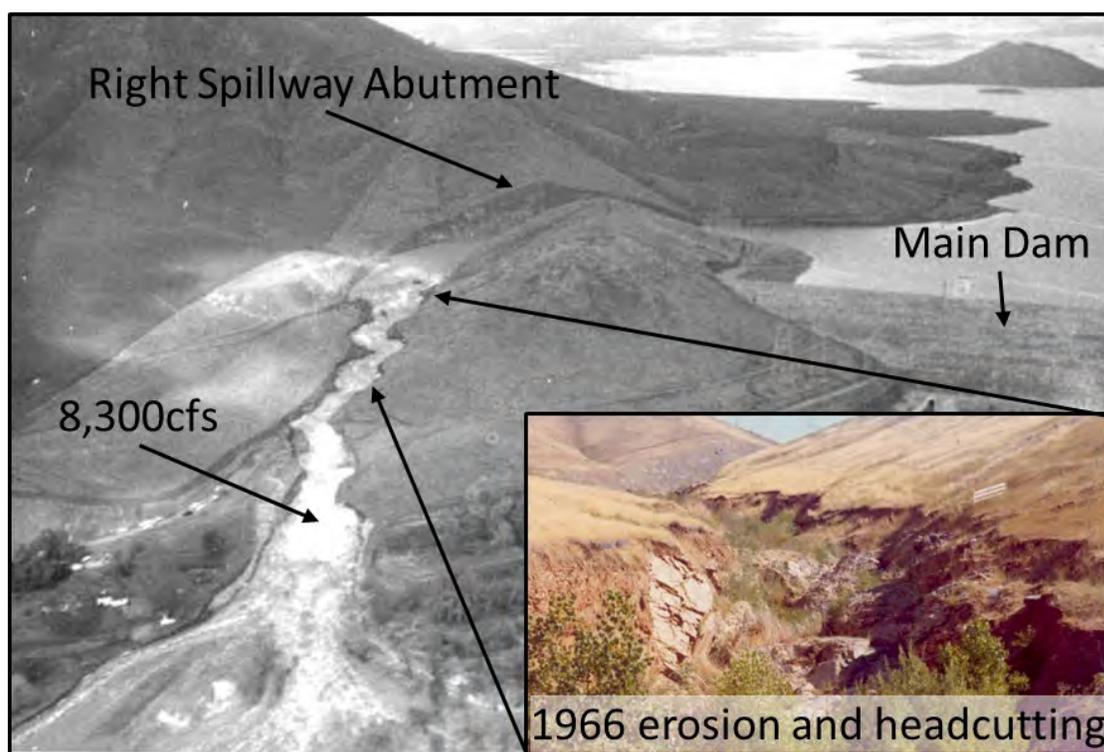
The spillway has only operated once since initial construction. This event occurred in December of 1966 and had a maximum flow of 8,300 cfs through the spillway. Erosion within the excavated spillway was minimal upstream of the existing sill and downstream for about 450 feet. After that point, erosion began to cut into the spillway floor with a max depth of about 15 feet from original grade and headcutting moving upstream (**Figure 3**).

Figure 3: 1966 spillway flow

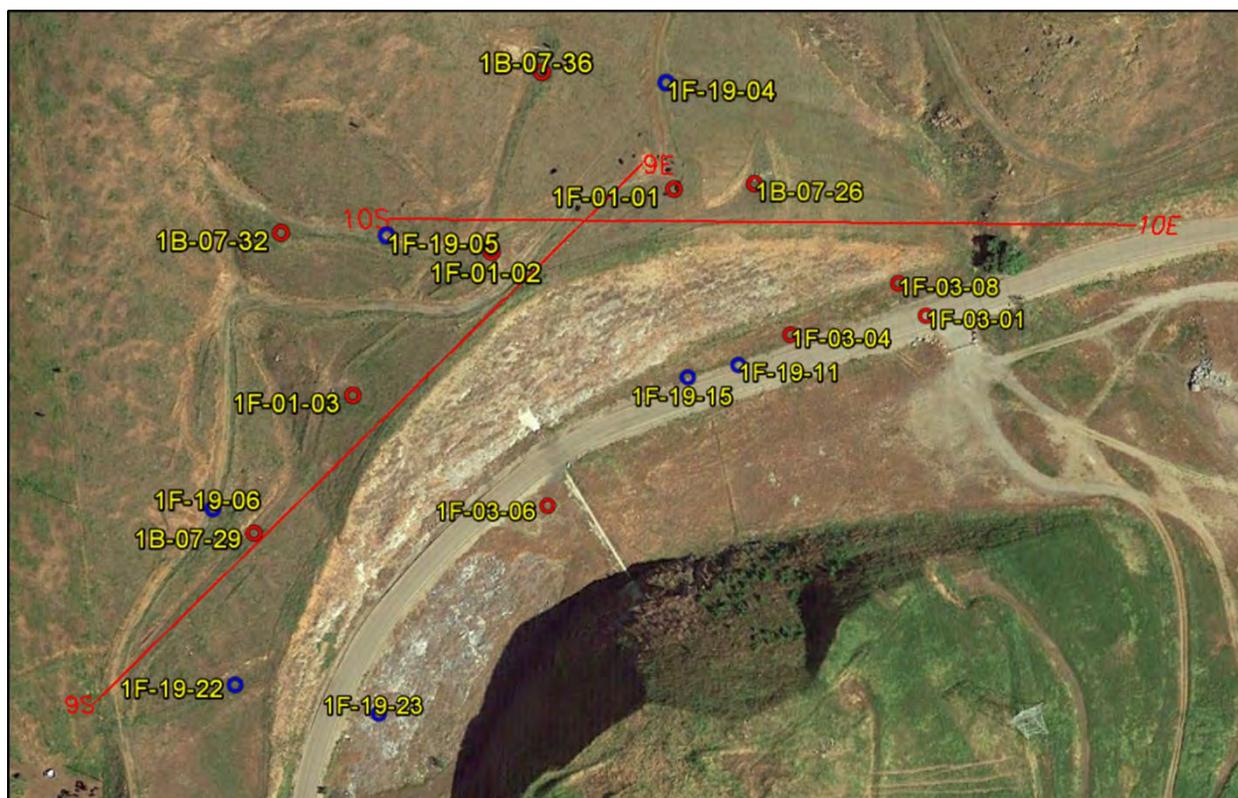
Numerous field investigations have taken place onsite before and after spillway construction. All historical investigations were reviewed and through project development and planning it was determined that additional field investigations were needed. To date, the 2019 field efforts have included: structural geologic mapping, rock mass classifications, sub surface explorations (rock coring), seismic refraction lines, and laboratory testing. All investigations related to the right spillway abutment are summarized below and shown in **(Figure 4)**.

Figure 4: Map of borings and seismic lines for the right spillway abutment

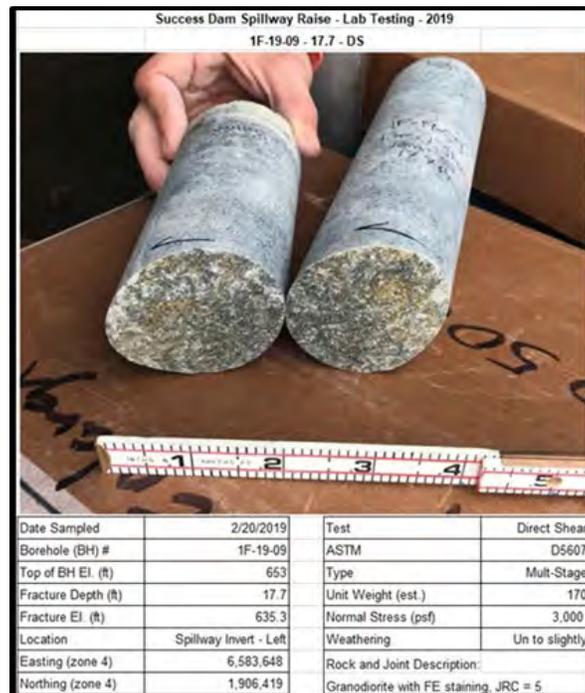
Figure 5: Direct shear lab specification test sheet - rock core

magnitude of the insitu stress at the fracture depth. Interestingly, the moderately weathered surface gave a higher friction angle than the slightly weathered surface, which is likely due to samples surface condition and fracturing. Laboratory specification sheets were made for the lab as shown in **Figure 5**. Residual shear stress was used as the failure criterion with the results for each weathering grade shown in **Figure 6**. A second phase of testing will be performed during the next subsurface investigation program that will take place this summer.

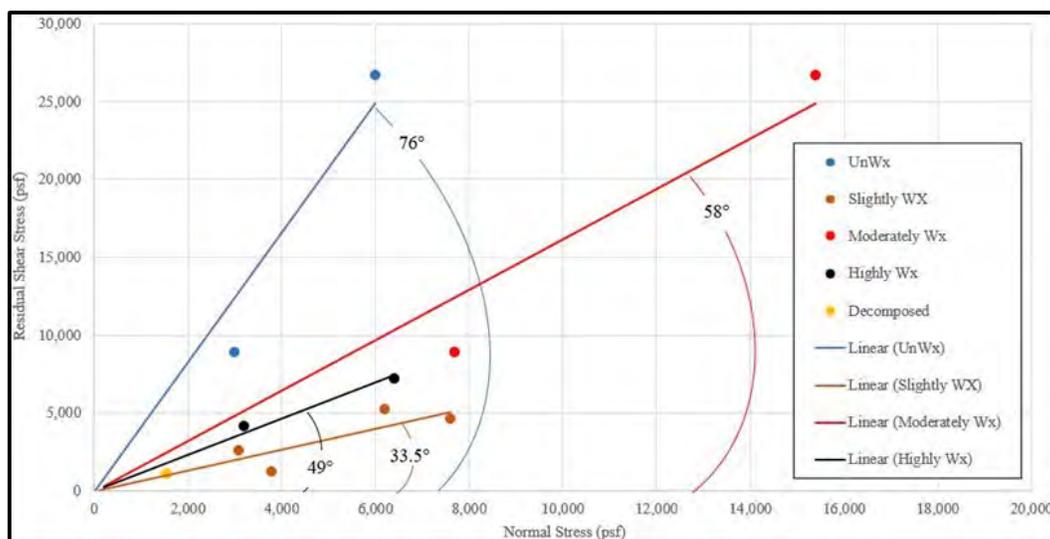
Figure 6: Direct shear test results - Phase 1

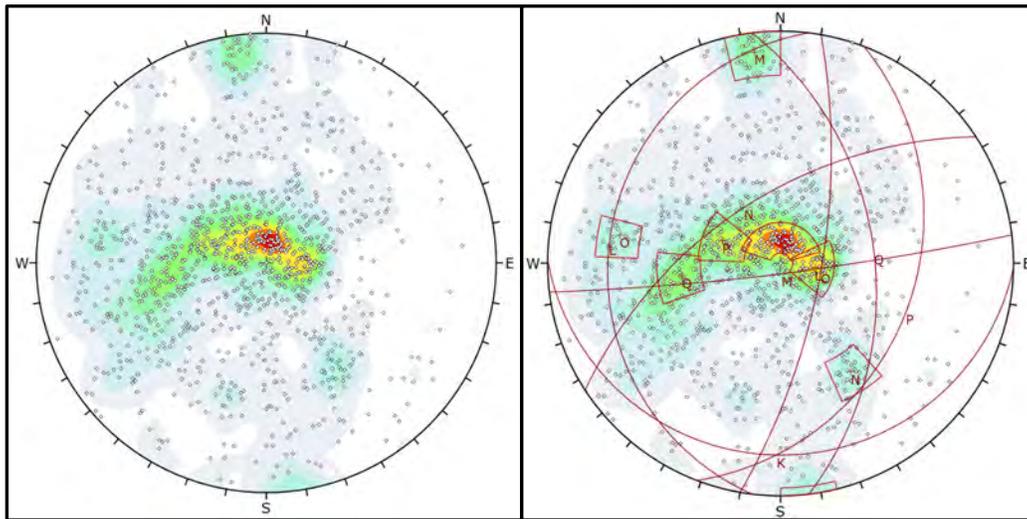
Figure 7: Right spillway wall pole plot and pole plot with seven representative joint sets. Fisher distribution, equal angle, lower

All structural joint measurements from surface geologic mapping and downhole televiewer for the right spillway abutment were combined to create a representative stereographic plot of the geologic structure. The resultant stereoplot (**Figure 7**) shows that the geologic structures are scattered for the low angle jointing, but that a few prominent, higher angle, joints are persistent throughout the site. Using this stereonet, 7 key joint sets were selected as representative for the right spillway abutment (**Table 3**). These joint sets were then used to create a simplified stereoplot, which was used to run the kinematic analyses for rock wedge, planar, and topple failures.

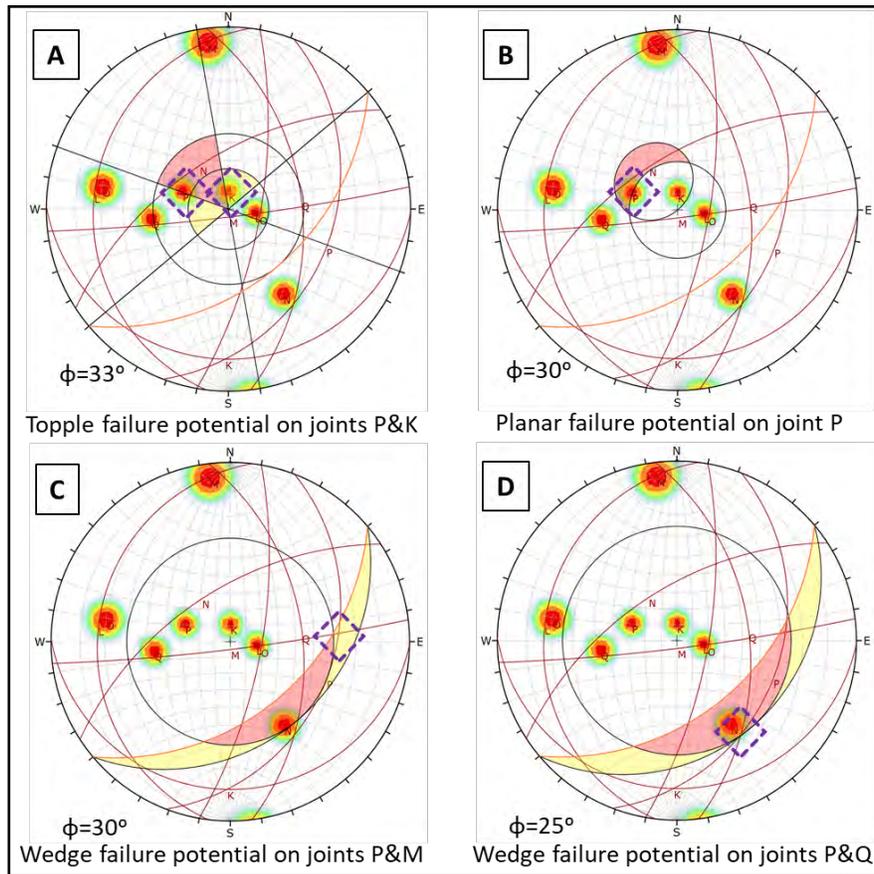
Figure 8: Representative kinematic analyses for Slope C

Figure 8 shows representative examples of the kinematic analyses for wedge, planar, and topple failures on Slope C. This slope has potential for all types of failures depending on varying ϕ values. Topples occur at $\phi=33$ degrees, planar and wedge at $\phi=30$ degrees, and a secondary wedge at $\phi=25$ degrees. As **Table 4** shows, this sensitivity analysis was performed for each of the 4 slope orientations. The results were then modeled for slope stability in SWedge and RocTopples (next section) to determine FS and potential block size of each failure type.

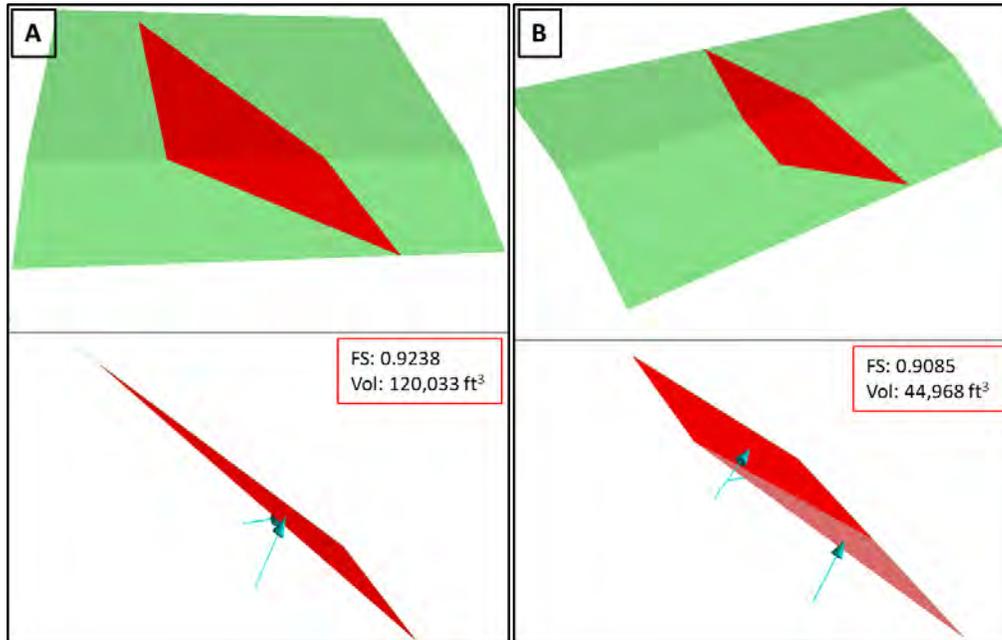
Figure 9: A) Potential wedge failure and B) Potential planar failure, on slope D at $\phi=30$ degrees and a 1:1 slope

- Stereographic analysis showed that slopes B, C, and D have potential for planar failures on joint set P. These potential planar failures were also modeled in SWedge by adding a 3rd plane to the analysis (Basal Plane) (this is also supported by the wedge analyses since P is the base plane of all identified wedge failures). Joint set P was input as the basal plane, then all other joint sets were paired and input to find potential failures. The lowest FS was found in slope D, when M & N were input to produce a FS=0.46 and a volume of 2,910 ft³. When a slope of 1.2H:1V was modeled for M & N, the FS increased to 0.71 and the volume also increases to 4,894 ft³. The largest volume with a FS less than one was found when M & Q were input and resulted in a FS=0.91 and a volume of 44,968 ft³ (**Figure 9 – B**). When a slope of 1.2H:1V was modeled for M & Q, the FS increased to
