70TH HIGHWAY GEOLOGY SYMPOSIUM

“Better Highways Through Applied Geology”

October 21-24, 2019

2019 Proceedings

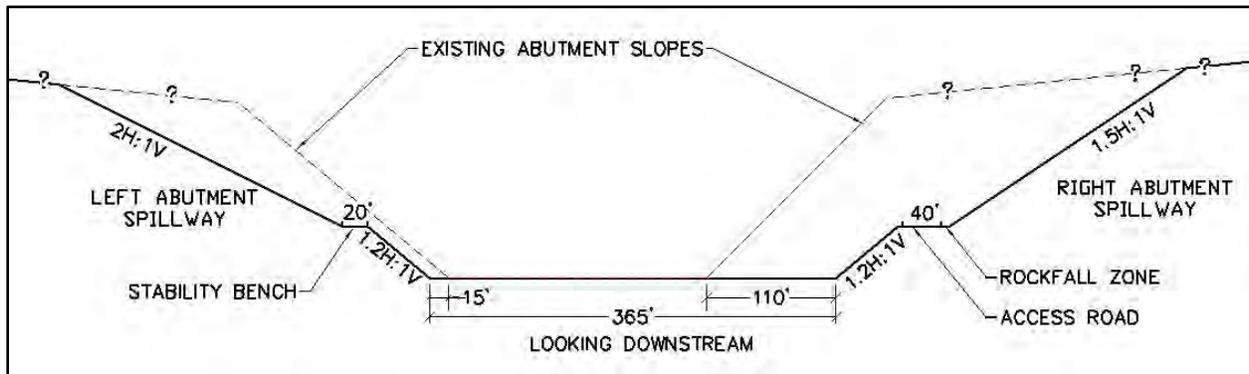
Figure 10. Proposed design slopes of spillway at ogee weir

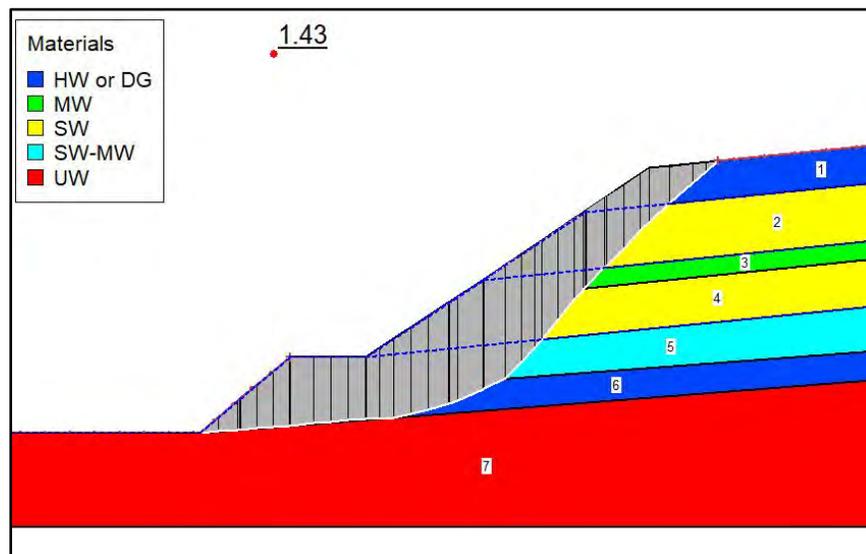
Figure 11. Right abutment (LE) slope stability - normal piezometric condition

Even though the site is mainly composed of highly weathered to unweathered rock with a mantle of decomposed rock and colluvium, a limit equilibrium (LE) analysis was also used to provide factor of safety guidance on global slope stability analysis using the shear strength data from the rock joint testing, and various levels of piezometric lines. This analysis was used to supplement the kinematic and block failure analysis and several different models were developed based on varying sequences of rock weathering profiles based on borehole stratigraphy at different locations along the spillway right abutment. Three piezometric lines were used per model that represent normal, unusual, and extreme conditions based on estimated combinations of reservoir seepage and rainfall infiltration. The design slope stability factors of safety proposed for the normal, unusual, and extreme piezometric conditions were 1.4, 1.2, and 1.0 respectively. Based on the kinematic and block analysis, the right abutment was modeled in GeoStudio with a lower slope of 1.2H:1V, a 40-wide bench road (which is located just above the PMF water profile elevation), and a 1.5H:1V slope above the bench as shown in **Figure 10**. The results of the slope stability analysis for one of the models with a normal piezometric condition and a

resulting FS of 1.43 is shown in **Figure 11**. Modeling slopes steeper than shown in **Figure 11** produces lower FS and therefore the LE model supports the findings of the block analyses.

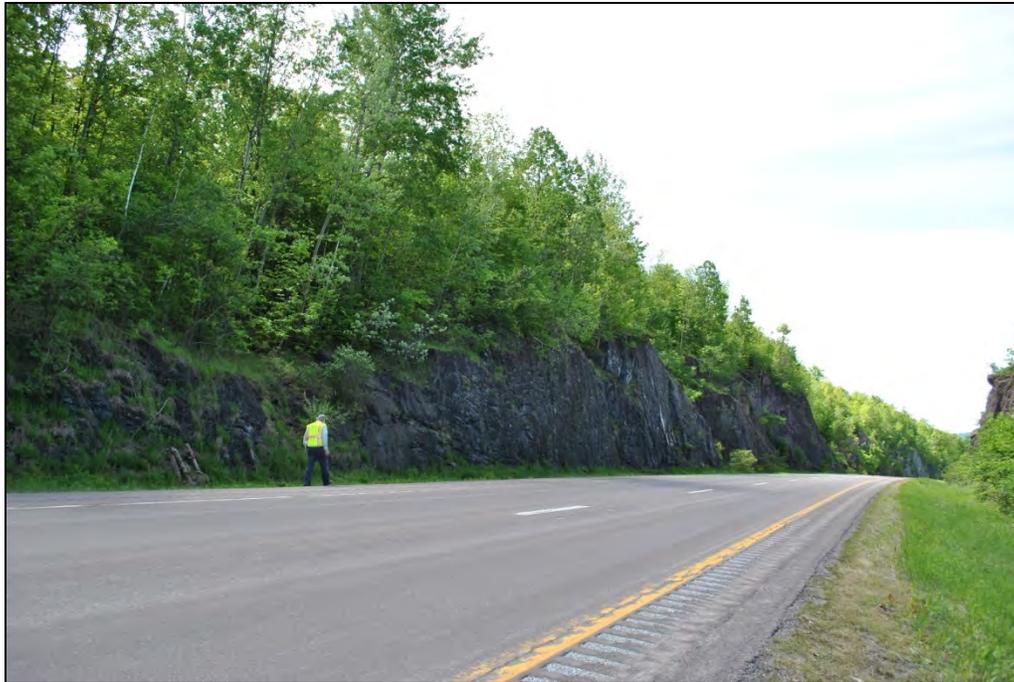
Figure 2 – View of rock cut looking to the south east. Note the extensive vegetation along the crest and the variable slope height.

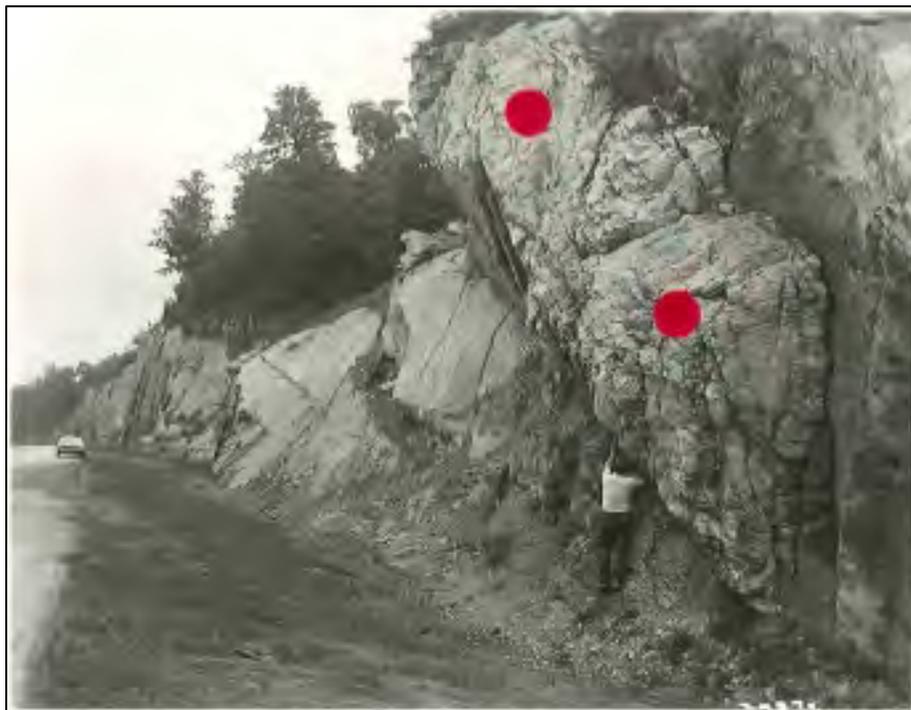
Figure 3 – Unstable rock mass exposed after rockfall in 1972 near project Sta 5687+00 to Sta 5687+50. View is to the north north-east. Red dots denote joint sets parallel to overhanging rock face.

Figure 3 and **Figure 4** below show the unstable rock mass exposed after the rockfall. At the time, VTrans Chief Geologist Frank Lanza recommended that the unstable rock mass be removed utilizing controlled blasting techniques using a maximum drill hole diameter of 3" on a 1.5 foot to 2 foot spacing to produce a stable, near vertical wall.

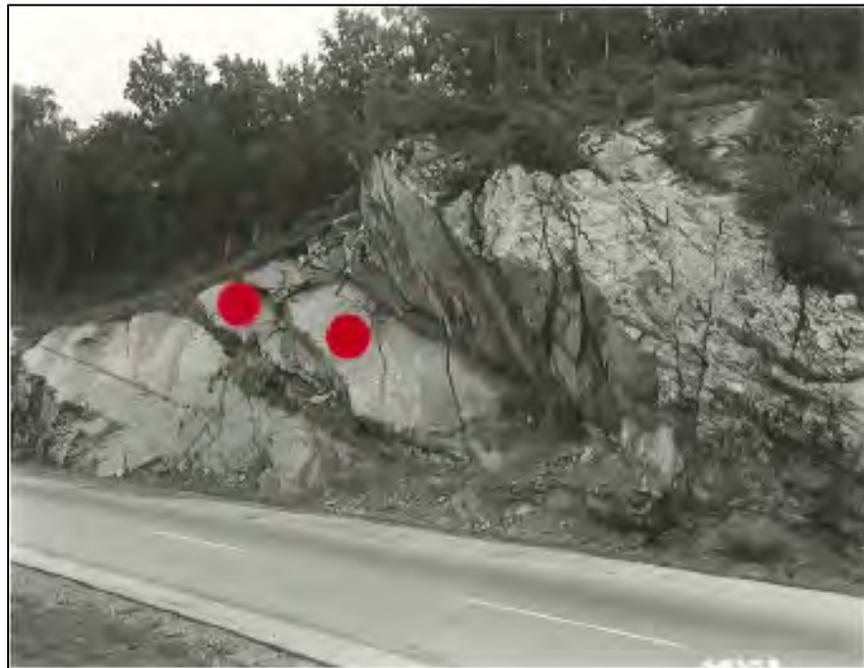
Figure 4 – View of unstable rock mass looking east north-east near project Sta 5687+00 to Sta 5687+50. Red dots denote west dipping tabular rock masses exposed after rockfall.

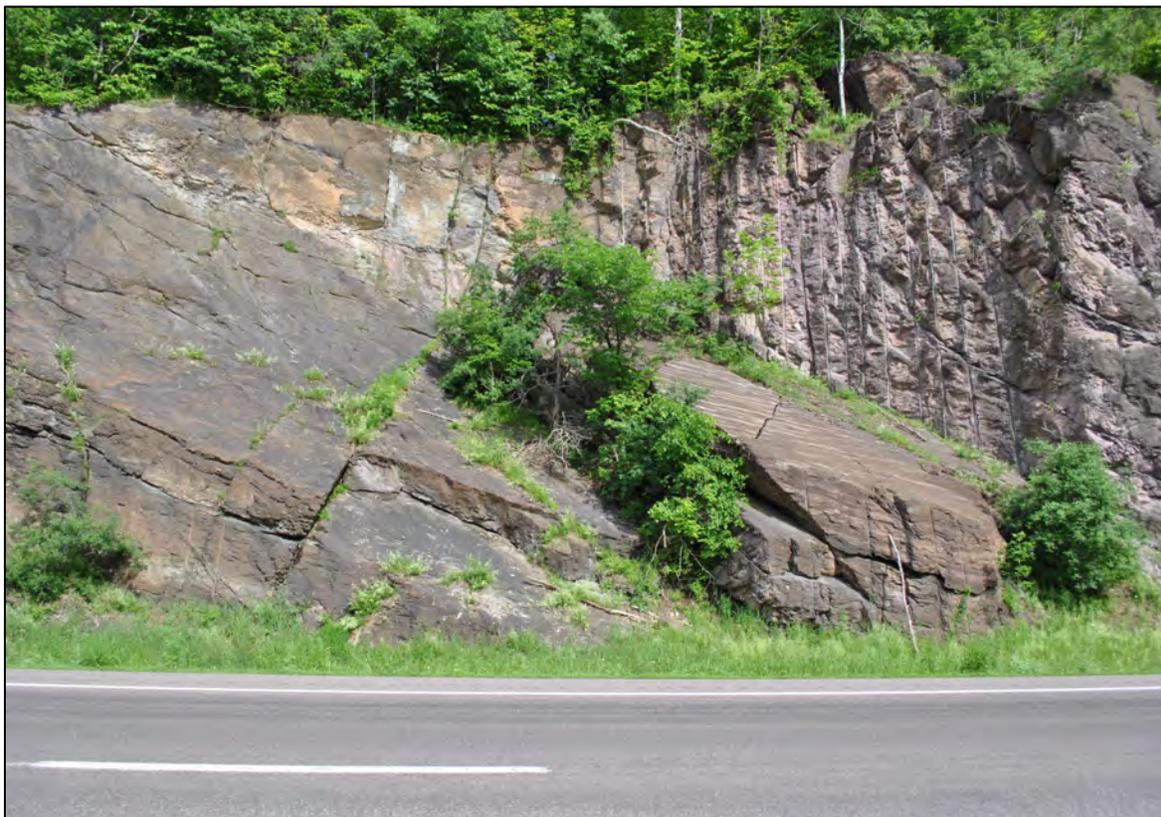
Figure 6 – Rock cut conditions between Sta 5692+00 to Sta 5692+50. Note curved beds of the eastern limb of a syncline (left), and presplit blasting mitigation following the 1978 rockfall event (right), which occurred down station.

- Sta 5692+00 to Sta 5692+50 (see **Figure 6**): Steeply dipping curved beds of the east limb of a syncline with its axis nearly parallel to the roadway.
- Sta 5687+00 to Sta 5687+50 (see **Figure 7**): Vegetated face consisting of moderately to steeply dipping beds similar to the area exposed in Sta 5692+00 to Sta 5692+50. This is the source area for the rockfall events in 1972 and 1978. A large overhanging rock mass was exposed approximately 40 feet up on this cut after vegetation was removed during construction as discussed later in this paper.
- Sta 5685+00 to Sta 5685+50(see **Figure 8**): Recent wedge failure, possibly associated with karst solutioning. This section also contains a large rock block with dilated discontinuities, indicating movement has occurred.

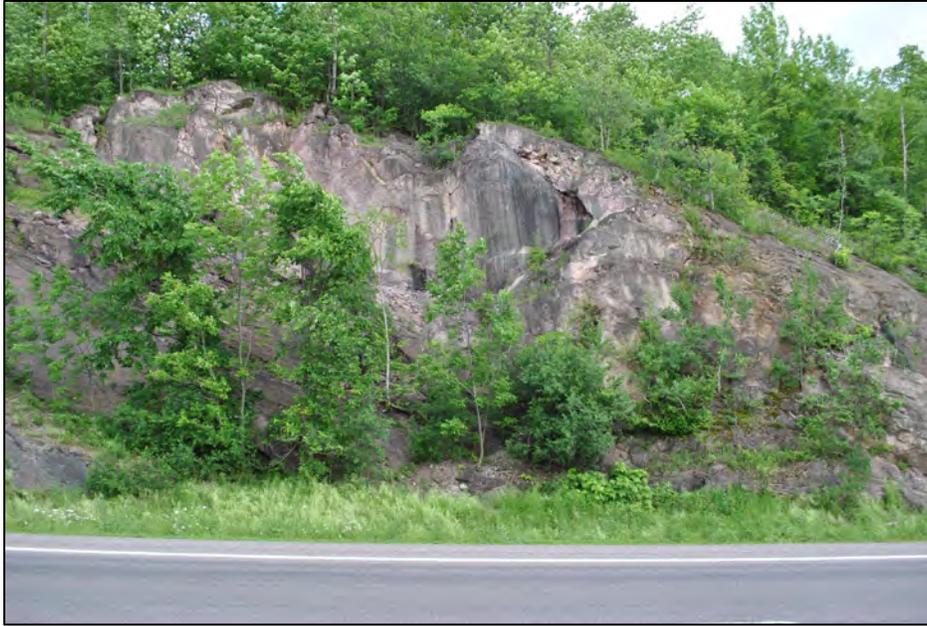
Figure 7 – View of rock cut conditions between Sta 5687+50 to Sta 5687+00. This is the area that produced rockfall in 1972 and 1978. View of rock cut conditions is obscured by vegetation.

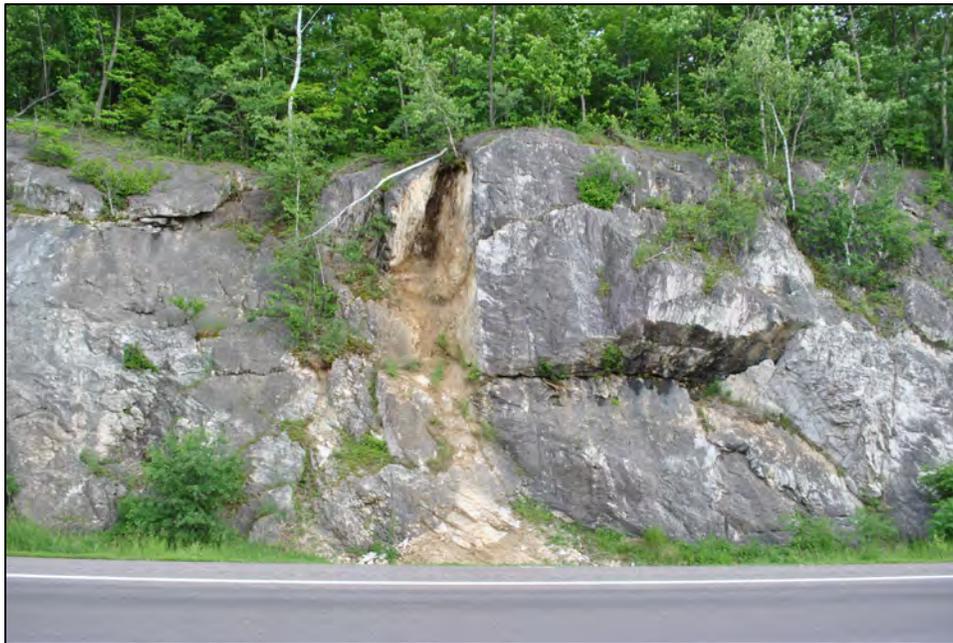
Figure 8 – Large overhanging block of dolostone and recent wedge failure along solutioned joints near Sta 5685+33.

Trim blasting was performed at four designated trim blast areas using five blasting events, and was followed by extensive hand and machine scaling. **Figure 8** above shows a typical unstable rock mass condition that was designated for remediation through trim blasting, and is identified as Trim Blast Area 1. Blasting in Trim Blast Areas 2, 3, and 4 was difficult due to venting of blast gases and explosive energy out of open back joints/back break in seams present in these areas. After the three blasts performed in Trim Blast Area 2, the Contractor opted to remove the remaining rock by machine scaling and hand scaling. Hand scalers were not readily available on-site during blasting activities and the blasters were forced to scale rock near the crest utilizing their drill rig after Trim Blast 2. This method was time consuming, risky for the blaster, and resulted in damage to the drill rig leading to a delay in drilling and blasting operations.

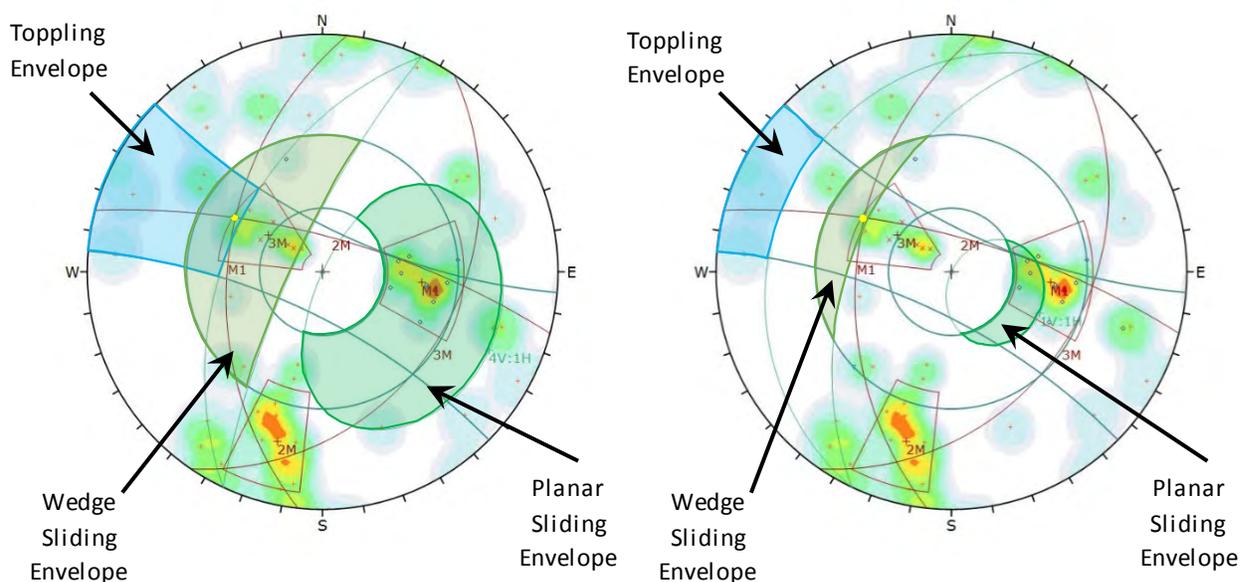
Figure 9A and 9B - Stereonets of the pre-mitigation slope conditions (Figure 9A, left), and of the mitigation design conditions (Figure 9B, right)

Stereonets created using Rocscience's Dips V5.0 program, presenting the kinematic analyses are presented in **Figure 9**. The discontinuities form three distinct sets (above the 4% contour), consisting of bedding, joints and cleavage. The kinematic analysis indicates that at the original cut slope configuration, i.e. 4V:1H, the slope is susceptible to planar sliding failure and wedge failure (**Figure 9A**). This conclusion is evidenced by the past rock slope failures and observed conditions. The kinematic analysis indicated that the rock slope failure mechanisms can be reduced by reducing the slope cut angle to as low as 1V:1H (**Figure 9B**). The curvilinear nature of some of the features associated with the syncline made use of the kinematic analysis highly variable based on location on the slope, therefore, kinematic analysis was used only to assess gross trends of structural orientations.

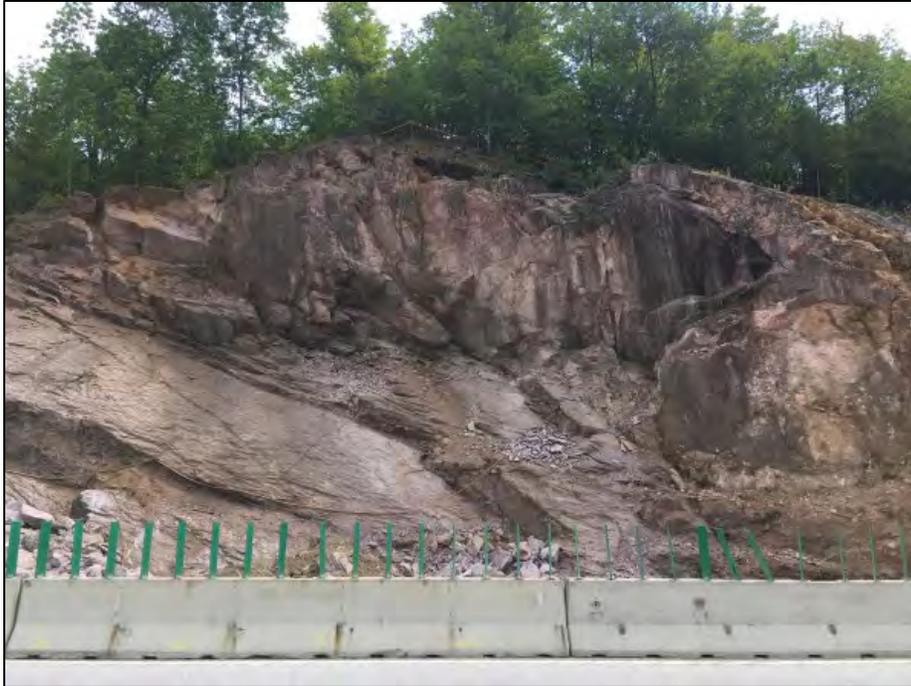
Figure 10 – Overall view of rock cut at Sta 5687+50 to 5687+00 after vegetation has been removed, showing the extent of the overhang.

Clearing and grubbing of the crest, rock cut face, and ditch line was then performed. Once the vegetation was removed it became readily apparent that the rock slope conditions at the source area for rockfall in 1972 and 1978 were worse than assumed in the mitigation design. A fractured overhanging rock mass was exposed near the upper part of the slope, as shown in **Figures 10** and **11** below. The overhang was 6 feet to 8 feet deep, by 12 feet tall, by 32 feet wide. Field adaptation of the design for this overhang is discussed below.

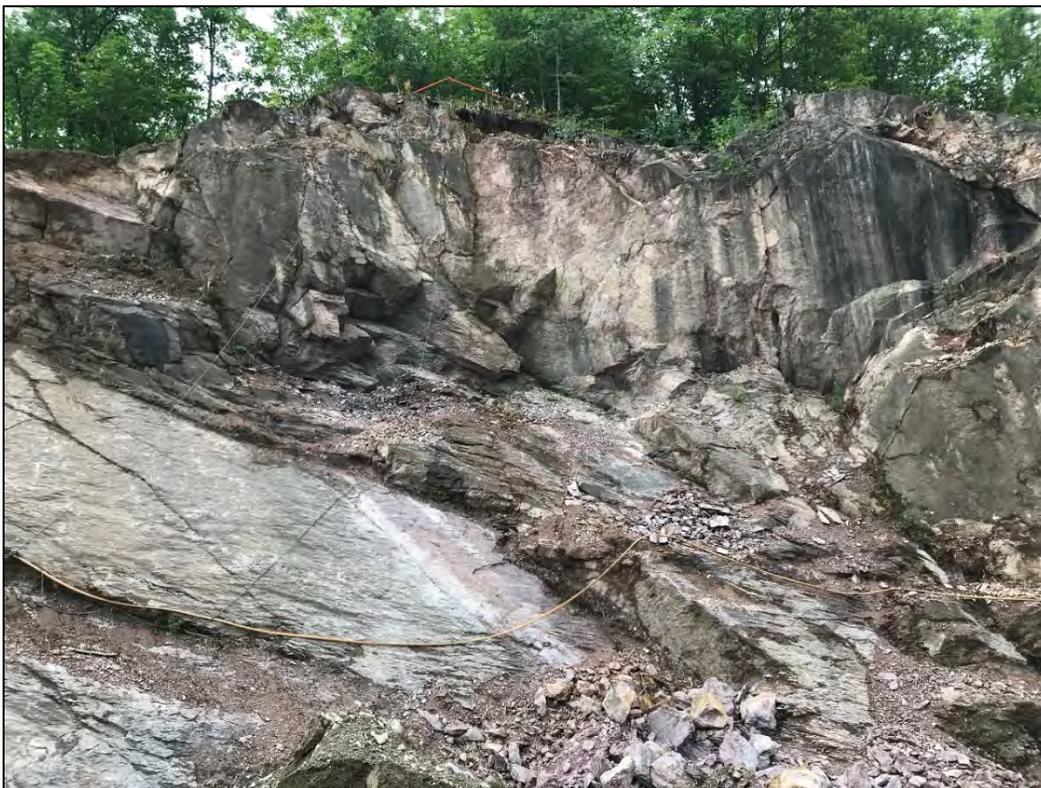
Figure 11 – Close up view of unstable rock mass exposed after vegetation removal.

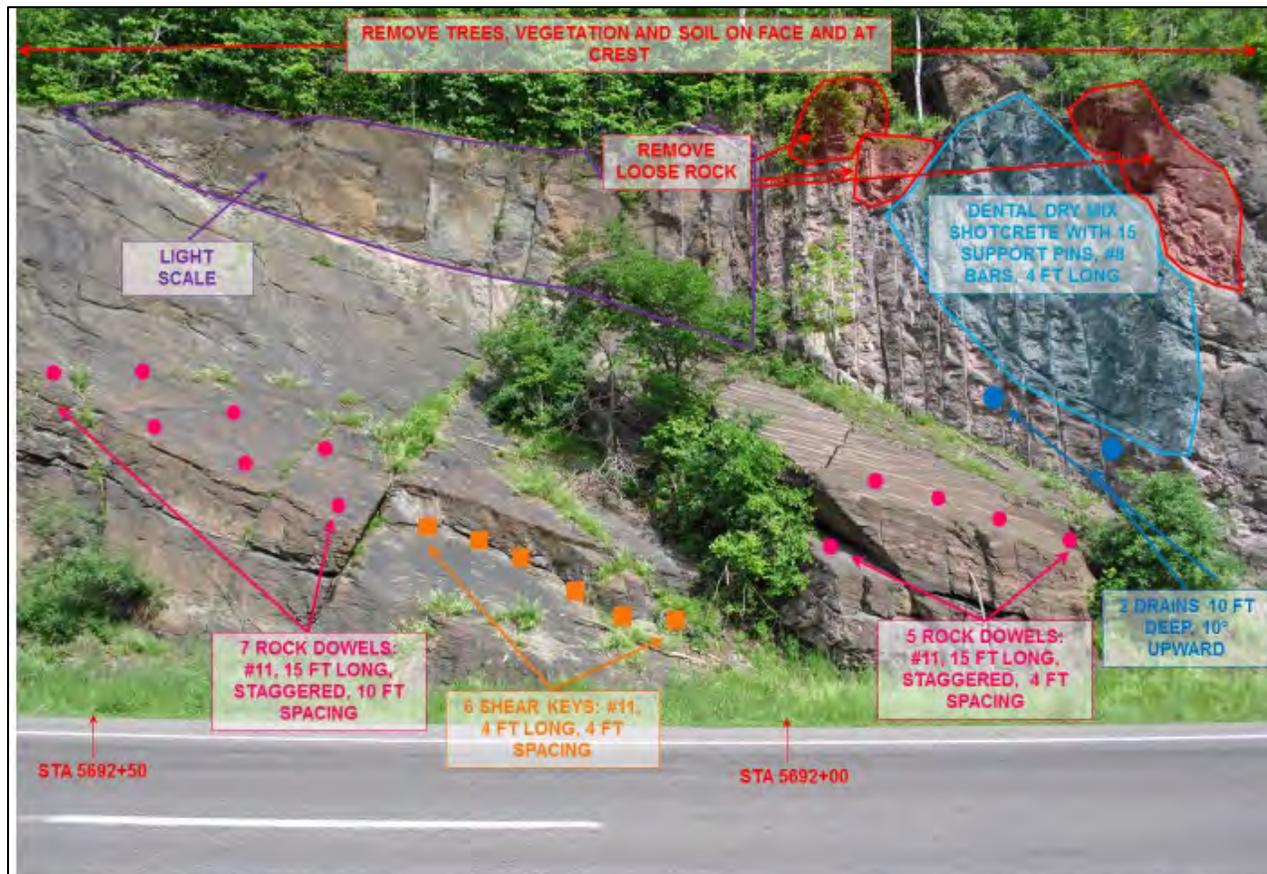
Figure 12 – Annotated photo showing planned remediation options at Sta 5692+00 to Sta 5692+50. Note the area highlighted in blue designating dental shotcrete.

Dry mix steel fiber-reinforced shotcrete was utilized on this project. Originally shotcrete was intended to be used as dental shotcrete to fill small voids located in the presplit face at Sta 5692+00 (see **Figure 12** below). With the 8-foot-deep void exposed under the fractured rock mass at Sta 5687+00 (mentioned earlier), it was determined that the most appropriate remediation option was to install rock dowels within the fractured rock mass and create a shotcrete buttress along the base of the overhang. Removal of the overhanging rock mass would

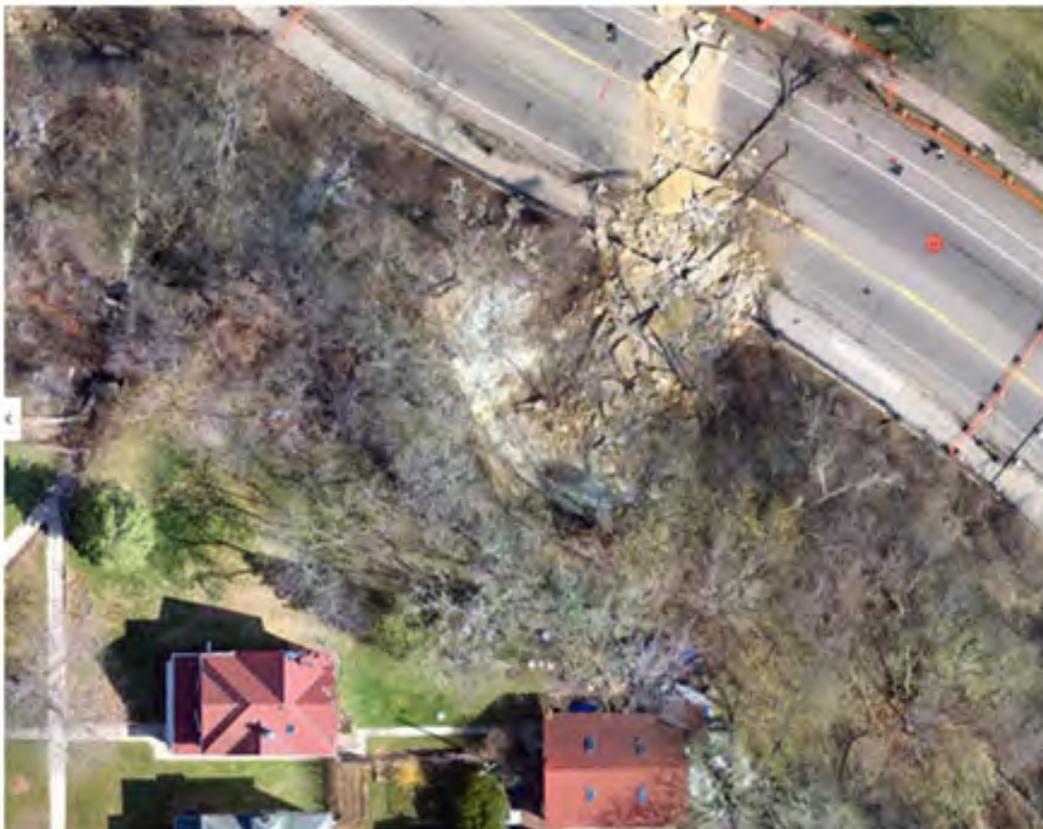
Figure 1 – Aerial view of April 2018 rockfall.

A rock slide on April 30, 2018 blocked Wabasha Street between Plato Boulevard and Cesar Chavez Street in Saint Paul, Minnesota. A Platteville limestone block weighing approximately 384,000 lbs. toppled off the bluff, broke into pieces, slid down the slope, overtopped a low concrete wall, and blocked the west sidewalk and lanes of Wabasha Street (Figure 1). After the limestone block fell, the affected section of Wabasha Street was closed until an investigation could be performed. Upon examining the bluff after the rockfall, another potentially unstable limestone block was identified adjacent to the block that had fallen.

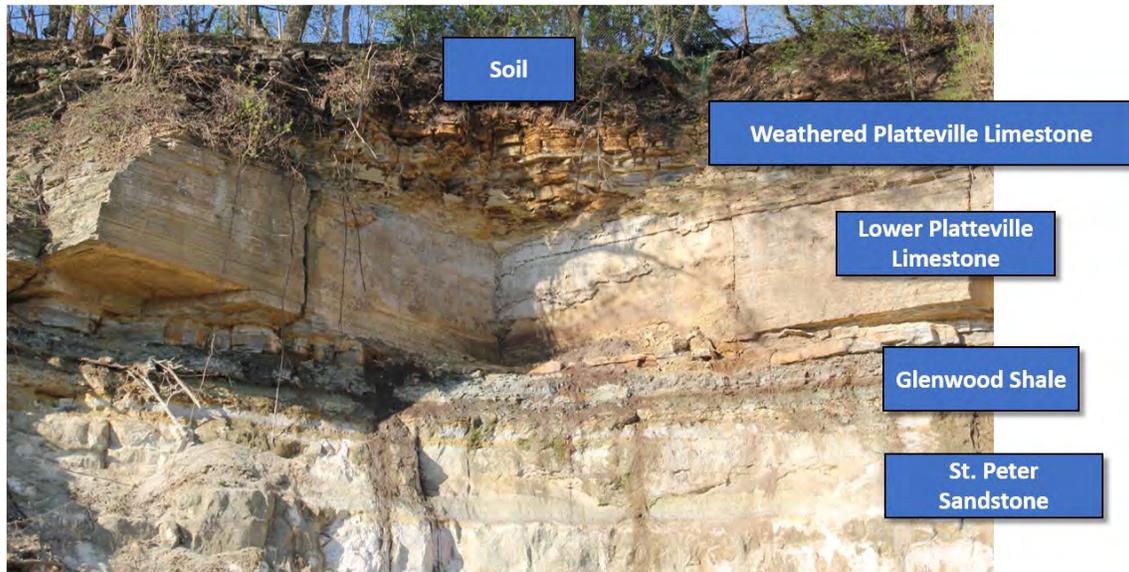
Figure 2 – Geologic units present at the rockfall site.

There were five major rock units present along the bluff where the rockfall occurred. These geologic units are shown in Figure 2. Understanding the nature of the rock units played an important role in determining the cause of the rockfall and in engineering an appropriate solution for protecting the road from future rockfall events. Consequently, these units will be described in detail in the sections below.

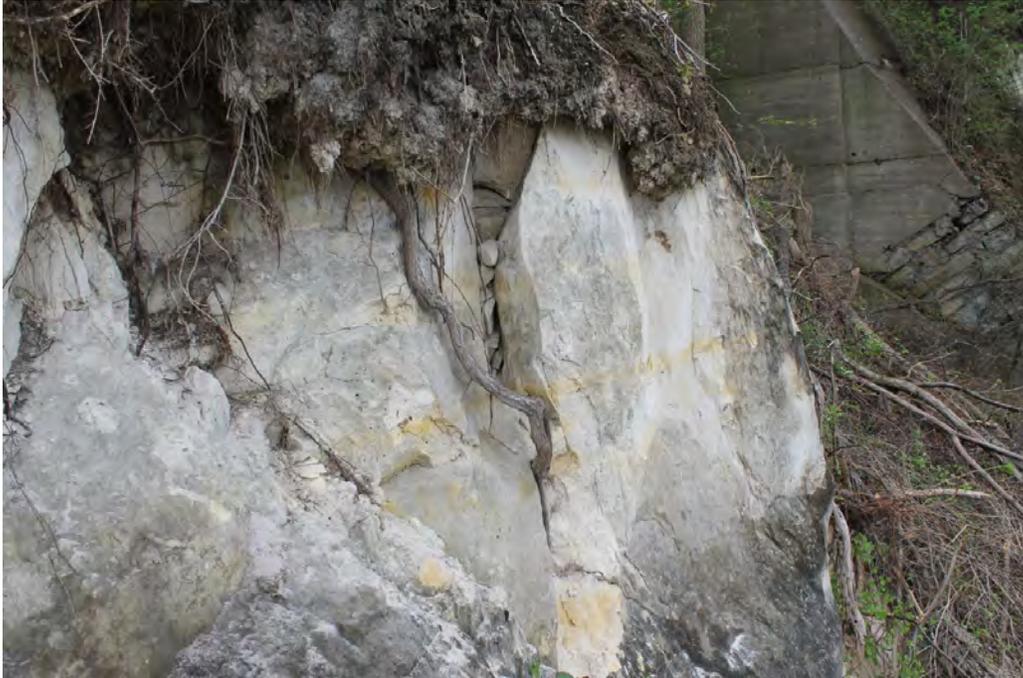
Figure 3 – Raveling St. Peter sandstone with tree roots growing in the joints.

The St. Peter Sandstone was actively raveling along the bluff (Figure 3). In addition, trees and shrubs grew from many of the open joints along the bluff.

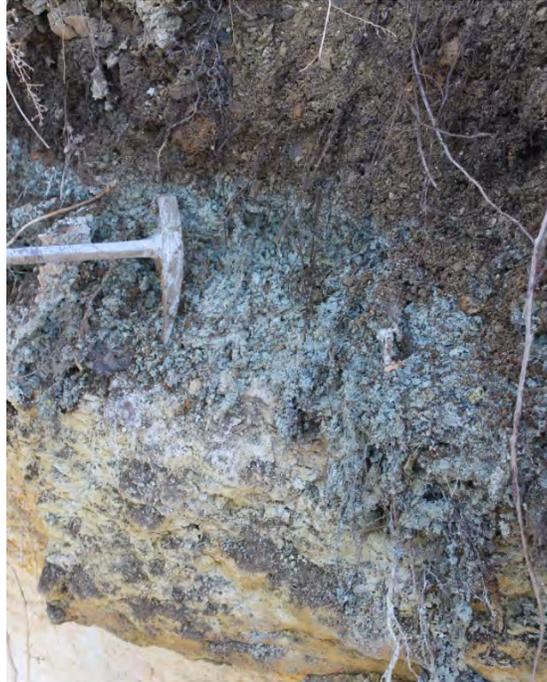
Figure 4 – Example of a heavily eroded section of the Glenwood shale.

The Glenwood shale layer appeared to be heavily eroded. In some places along the bluff, the shale layer was eroded to loose shale fragments, which a rock hammer could easily penetrate (Figure 4). Additionally, due to the water-bearing nature of this layer, it was common to see roots and vegetation growing from the shale.

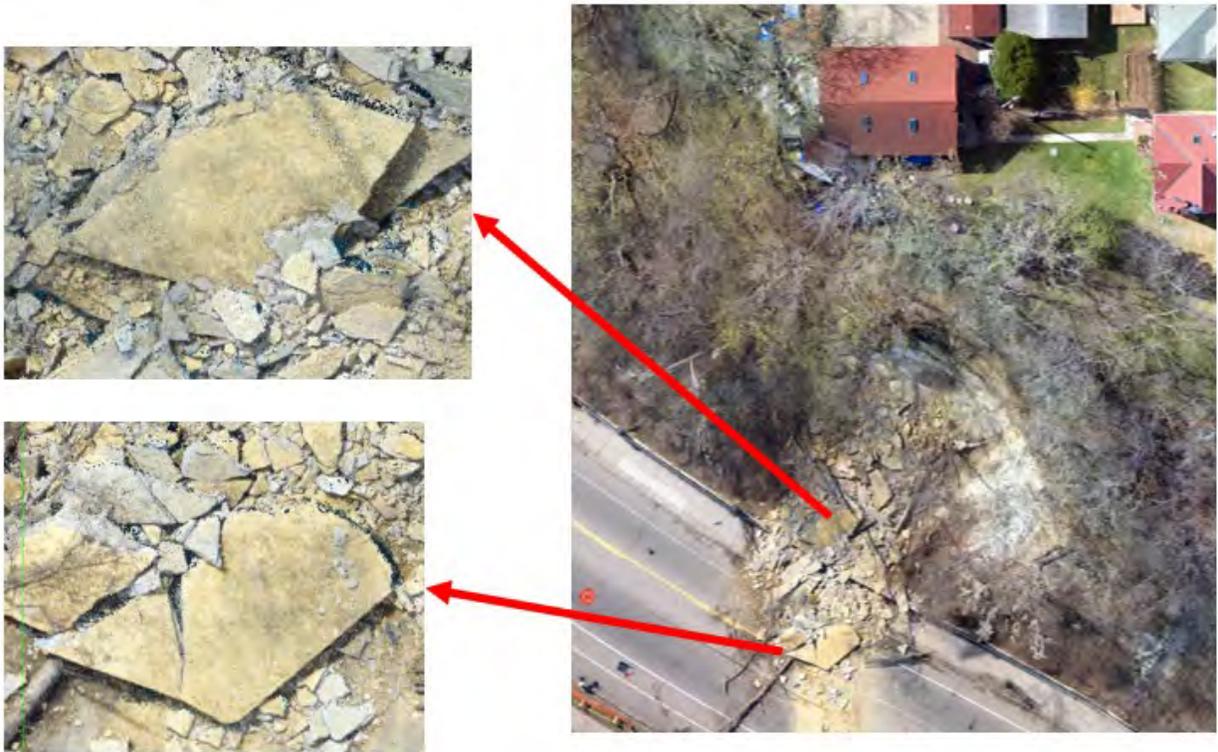
Figure 5 – Examples of intact limestone sheets.

Once the block dislodged and hit the slope surface, the weaker shaley layers caused the block to break into slabs. The high strength of the lower Platteville caused some of the sheets to remain intact even after the block fell (Figure 5). Because the slabs were thin and wide, sliding rather than tumbling or rolling was the principal rockfall mechanism. This is significant when determining the impact and extent of future rockfalls.

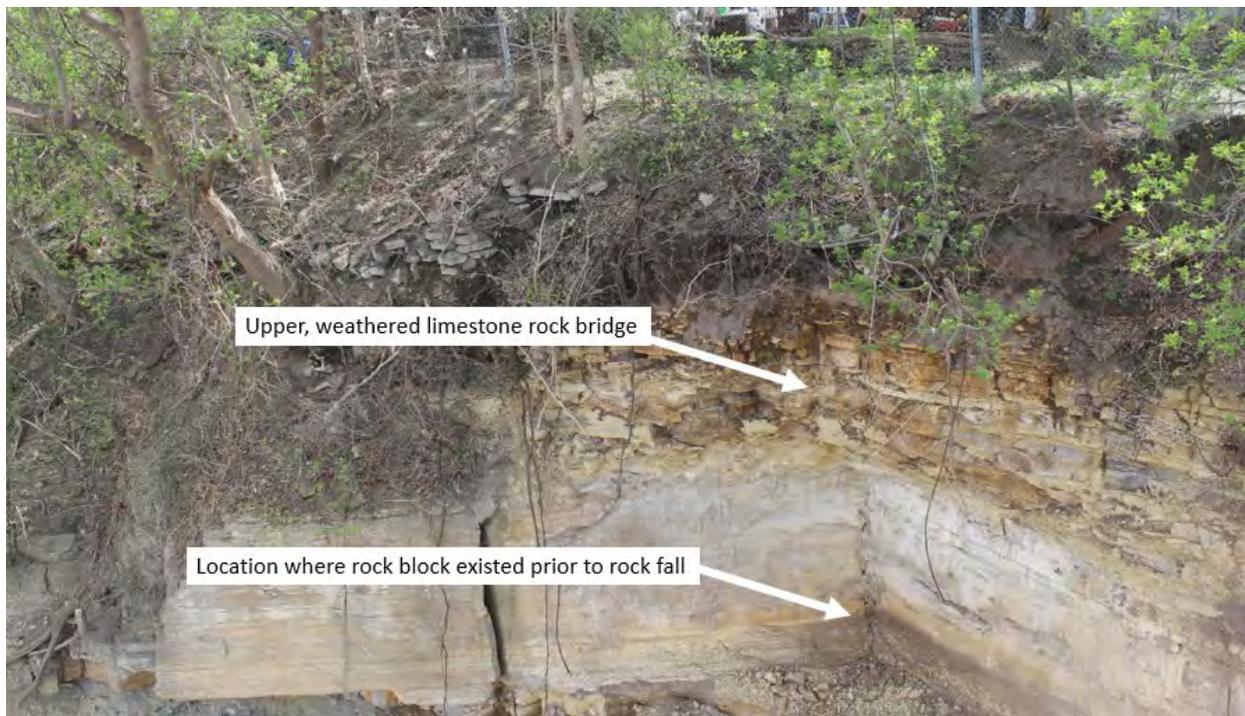
Figure 6 – Image showing the upper, weather limestone overhang.

Some of the upper, weathered limestone fell with the rock block, but a section of weathered Platteville remained, creating an overhang above the location where the rock block existed (Figure 6). After the rockfall, the upper, weathered limestone also continued to support a few feet of soil and vegetation.

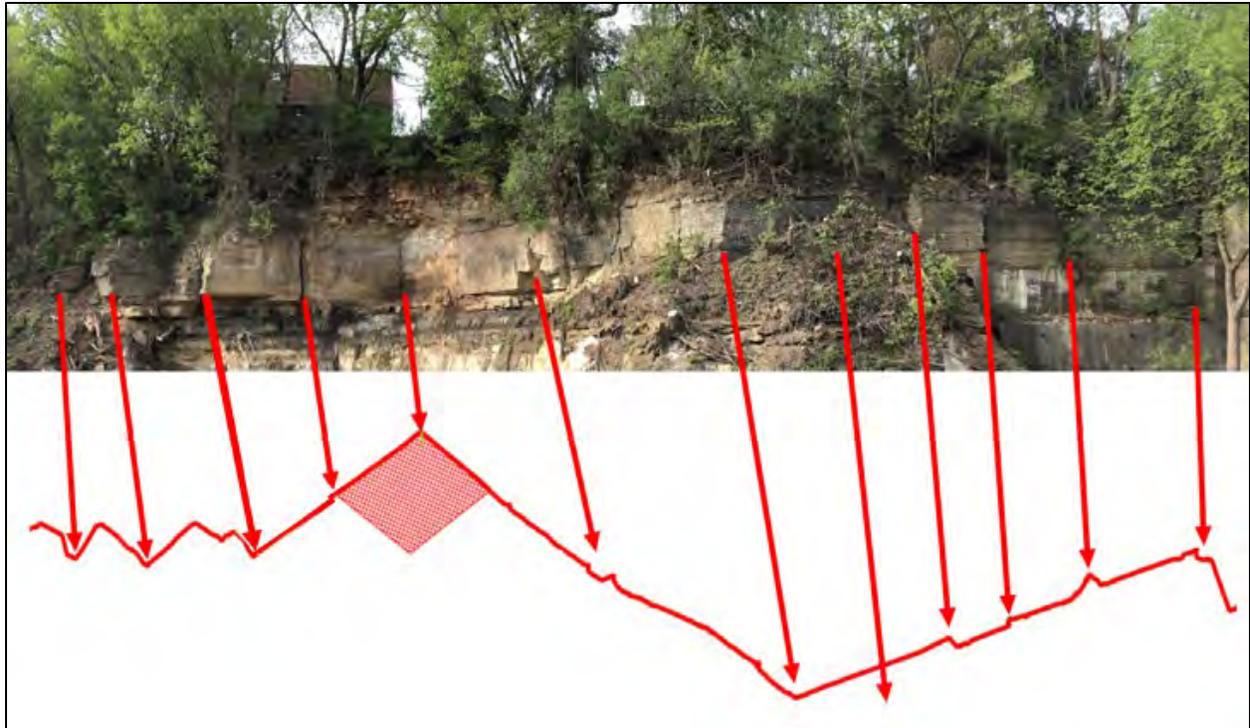
Figure 7 – Horizontal slice of the photogrammetry aligned with an image of the bluff.

To capture the bluff geometry, photogrammetry data was collected using a drone. Later, ground-based scanning provided additional coverage. Both techniques produced a point cloud that was used as a base to place and organize site information. Figure 7 shows a horizontal section through the limestone unit of the bluff. The arrows correlate the image of the bluff face to related locations in the photogrammetry. The red block indicates the approximate geometry of the block that fell.

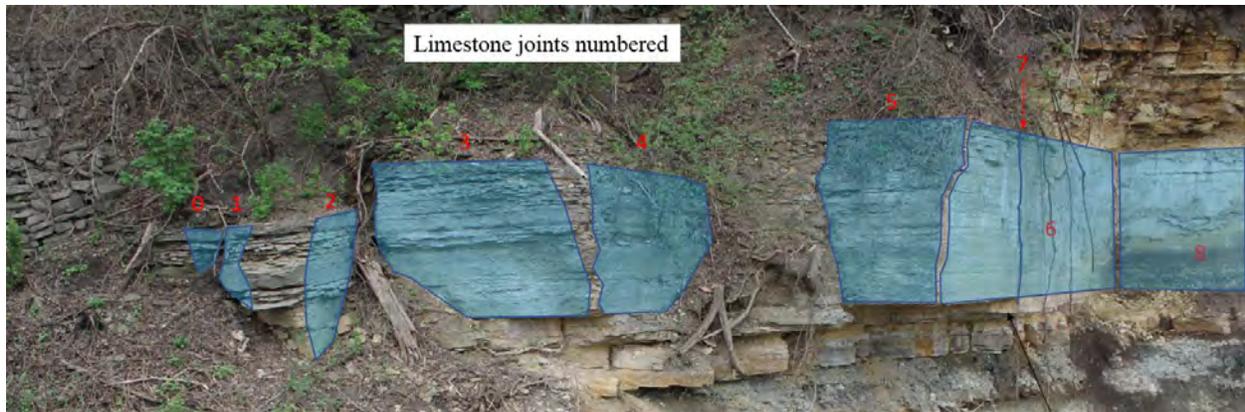
Figure 8 – Example of mapped limestone joints.

To understand the nature and geometry of the rock units along the bluff, the site was extensively mapped, and the collected data was incorporated into the digital model of the site. A 90-ft boom lift was used to access the lower regions of the bluff. From the lift, most areas could be mapped and measured. To map the upper section of the bluff, which was inaccessible from the lift, the St. Paul Fire Department assisted in rope access. Joint location, characteristics, and orientation were recorded. These joints were then numbered and incorporated into the digital model. Examples of limestone joints and sandstone joints mapped on site are shown in Figure 8 and Figure 9.

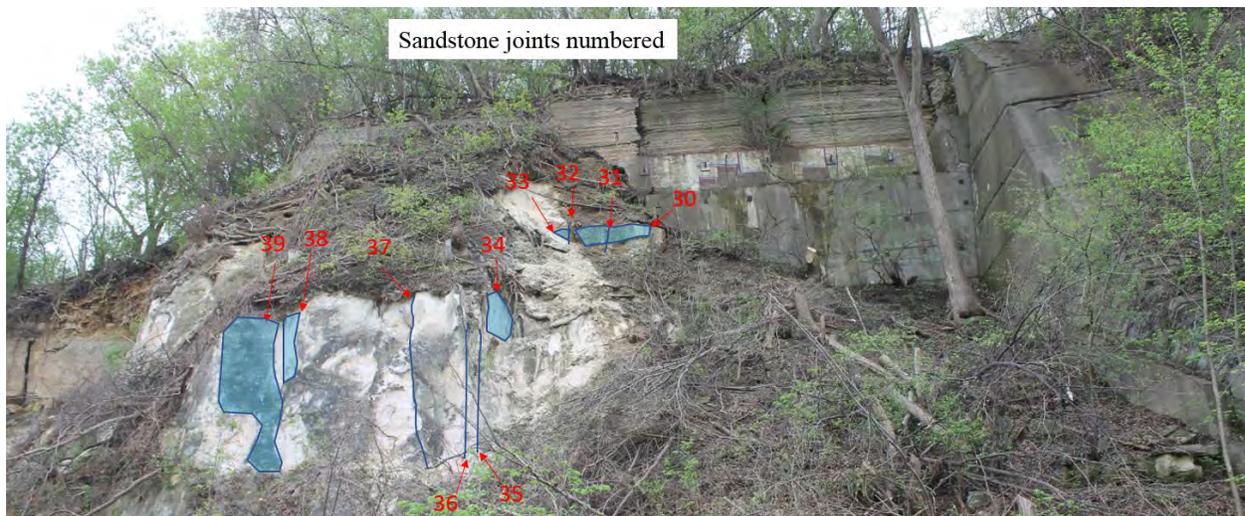
Figure 9 – Example of mapped sandstone joints.

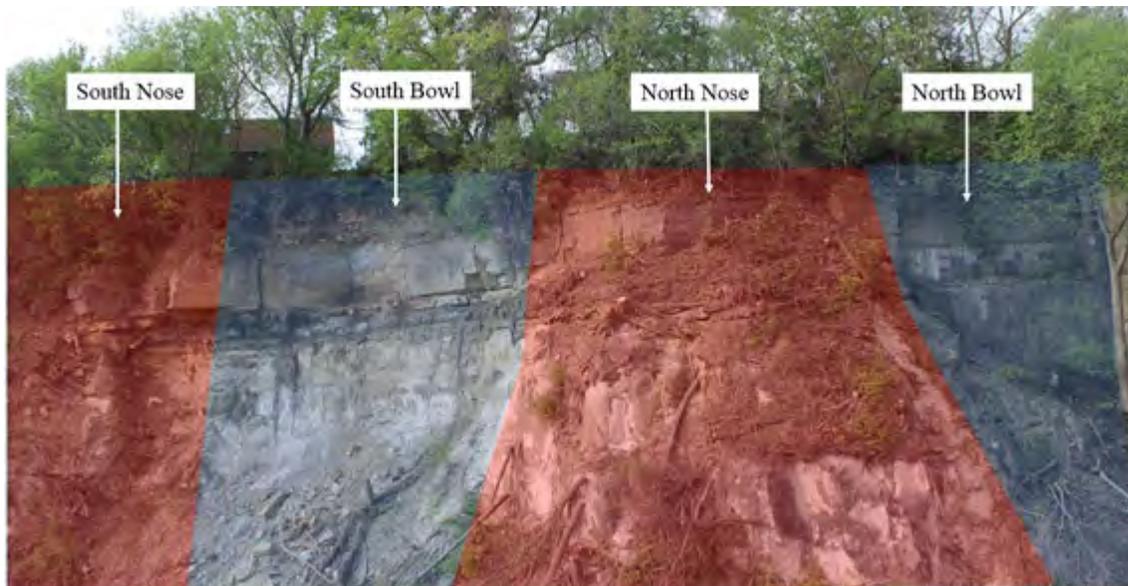
Figure 10 – Photograph of the site highlighting the north and south bowls, and the north and south noses.

The pre-rockfall slope had two large bowl-shaped recesses that are laterally concave and characterized by near-vertical sandstone faces in the upper slope, transitioning to a flatter slope near street level. Prominent sandstone noses, which are vertically and laterally convex, are present on either side of the bowl-shaped recesses (see Figure 10). The slope was excavated to a

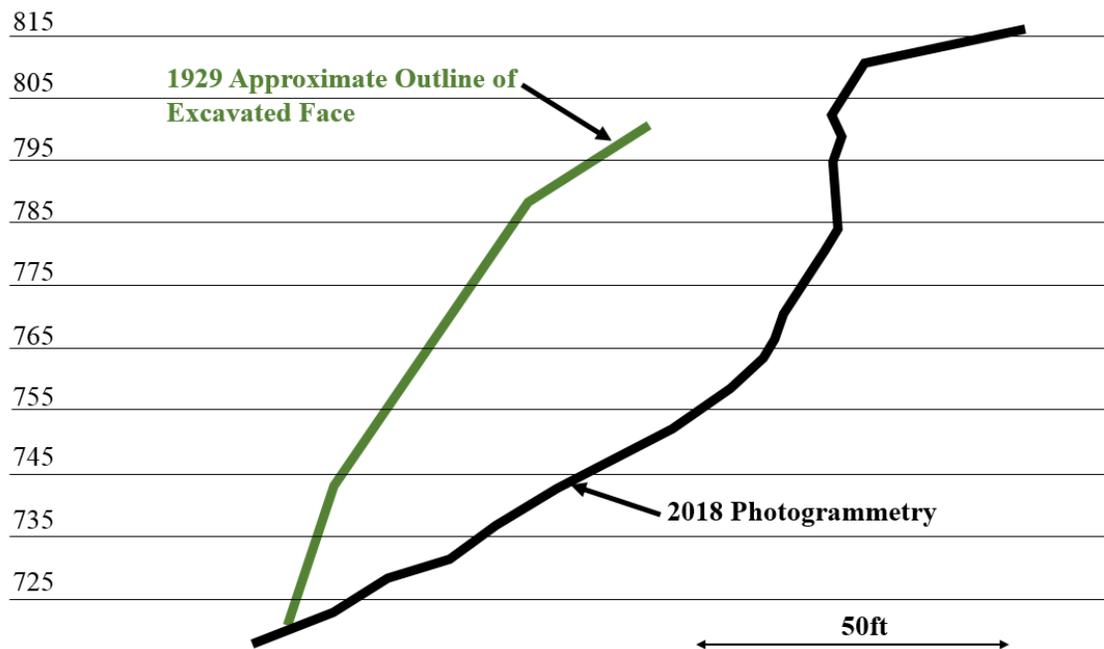
Figure 11 – Past and current slope profiles in the south bowl.

uniform convex shape in 1929—the bowls have since formed by decades of erosion. The amount of erosion was analyzed using historic plans provided by the City. Plans of the 1929 Wabasha Street construction were compared to the present-day photogrammetry to visualize the significant amount of sandstone erosion that had occurred over the past 89 years. A cross-section taken in the south bowl is presented in Figure 11, showing the profile of the as-built cliff geometry (green) and the present geometry (black). The figure shows that some sections of the sandstone slope have eroded of the order of 50 ft in about 90 years. This rate of retreat is expected to continue, further undercutting the limestone.

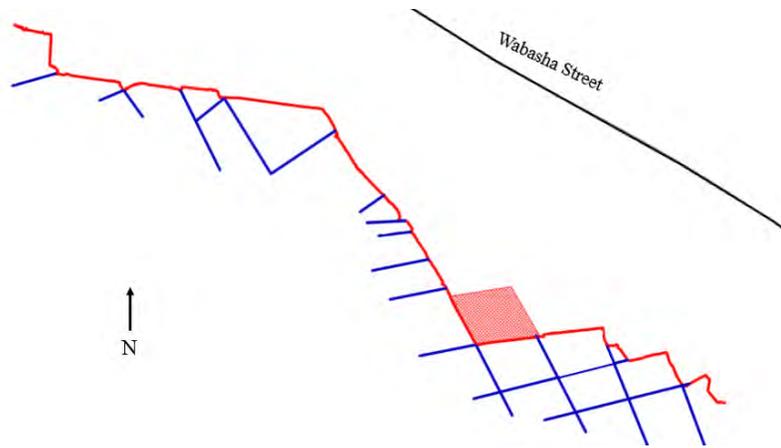
Figure 12 – Vertical joints (blue) in the Platteville limestone overlaying photogrammetry (red) and Wabasha Street (black).

A plan view of the location and orientation of the jointing in the limestone is shown in Figure 12. Note that the extent of the joints is unknown, so the length of the blue lines cannot be interpreted as fact. The vertical jointing in the limestone is cut by horizontal bedding planes.

The limestone joints were vertical to subvertical. There were three major joint sets in the limestone, striking at 320, 250, and 280 degrees. Many of the vertical joints were open and rough. One joint was measured to be open at least 17 ft deep. This led to the belief that the joints may extend deep into the bluff face.

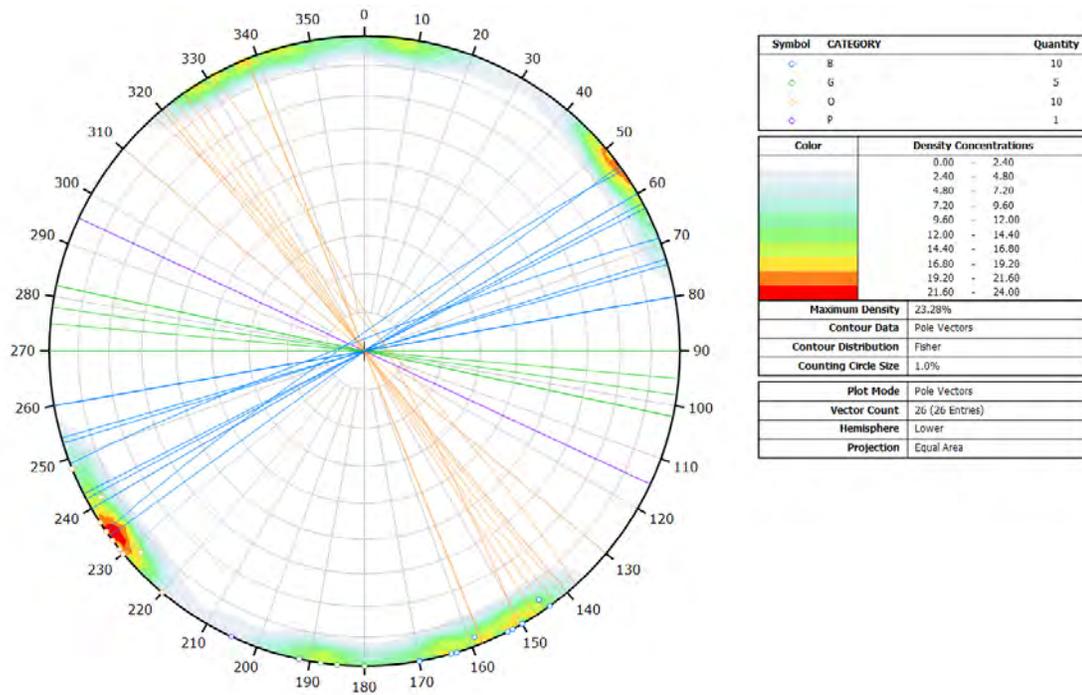
Figure 13 – Stereonet showing joint sets in the limestone.

The joints sets are shown on a stereonet in Figure 13, and the locations of the joints corresponding to the joint sets are shown on the bluff face in Figure 14.

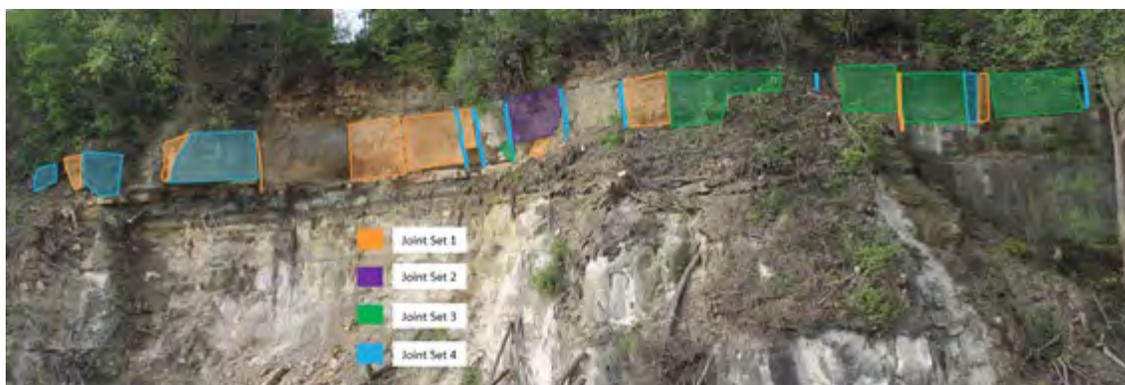
Figure 14 – Joint locations in the limestone, with colors corresponding to the joint sets in Figure 13.

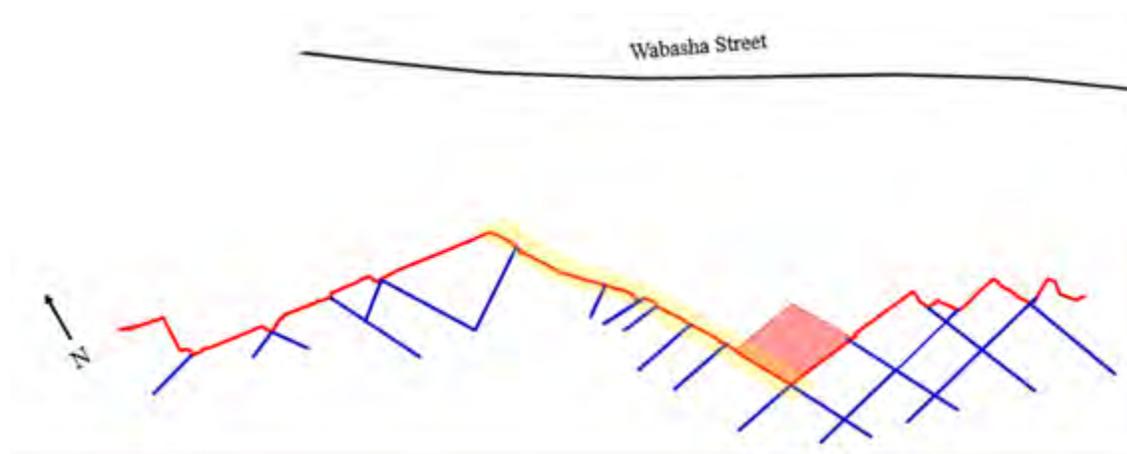
Figure 15 – Location of joint that doglegs to the west (highlighted).

One of the major northwest striking joints doglegs to the west, then doglegs again back to approximately the same orientation. This joint is highlighted in Figure 15. Due to this variation in joint orientation, it was not certain which joints could be projected straight back from the bluff face, making it challenging to approximate the size of limestone blocks.

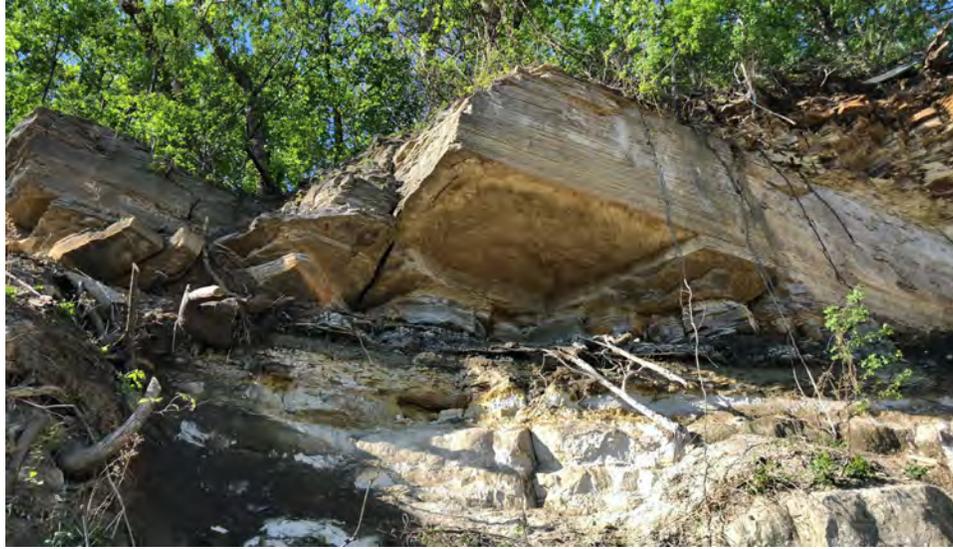
Figure 16 – An undercut limestone block located along the Wabasha Street bluff.

- Groundwater seeps out of the Glenwood shale. The St. Peter sandstone and Glenwood shale at the site has significantly eroded in the past 89 years, on the order of 50 ft.
- Both the surface and groundwater cause freeze-thaw action and the rapid erosion experienced. The erosion in the shale and sandstone leads to undercutting the Platteville limestone.
- The vertical joints in the Platteville limestone form discrete rock blocks, which are subject to undercutting and toppling. An example of an undercut limestone block is shown in Figure 16.
