70TH HIGHWAY GEOLOGY SYMPOSIUM

“Better Highways Through Applied Geology”

October 21-24, 2019

2019 Proceedings

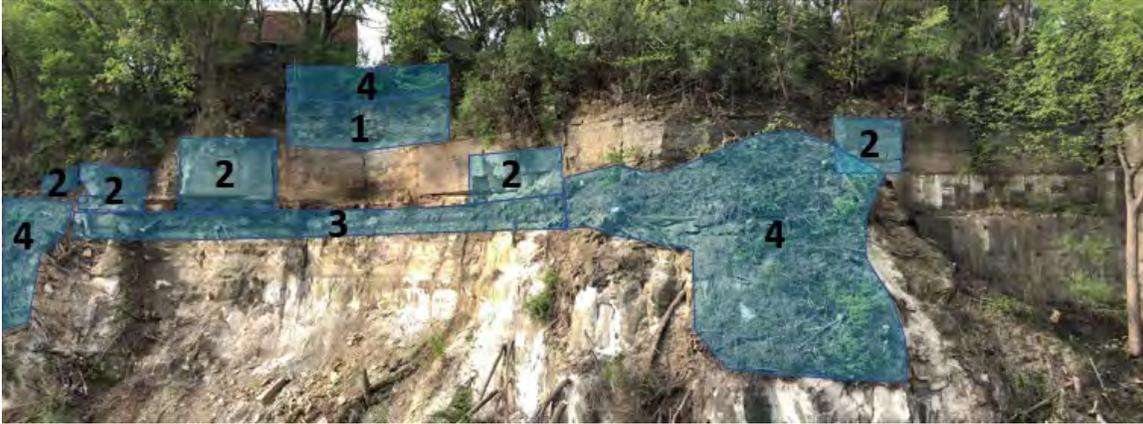
Figure 17 – Identified remedial areas, numbered.

Based on the site investigation findings, four site features were identified as potentially needing remedial measures. Referring to Figure 17, the identified site features include the following:

1. Weathered Platteville limestone: The weathered limestone could fall off the bluff and into the street.
2. Lower, hard Platteville limestone blocks: The limestone blocks could topple out of the bluff and into the street.
3. Glenwood shale at the limestone-shale-sandstone interface: The interface could erode underneath existing limestone blocks, accelerating the process of blocks toppling off the bluff.
4. Soil and sandstone: Soil or sandstone masses could slide off the bluff and reach the street.

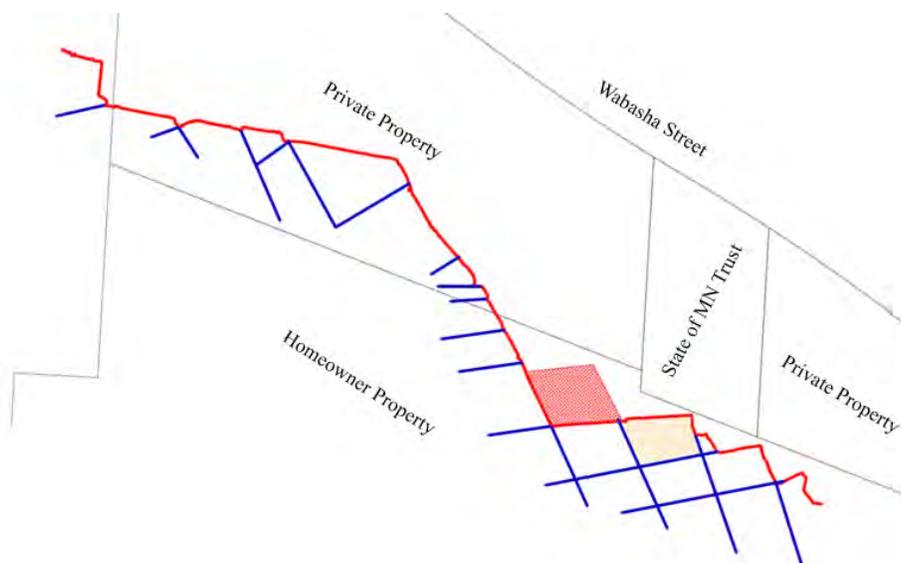
Figure 18 – Land designations along the Wabasha Street bluff.

A challenging aspect regarding the remediation involves the land ownership along the bluff. The bluff is owned by multiple private entities, one being a homeowner. Figure 18 shows the land ownership along the bluff. The limestone block that fell in April 2018 and most of the overhanging, loose limestone blocks are on homeowner property. For this reason, supporting or removing the limestone blocks would be a greater liability risk to the City, since they would be constructing on private property.

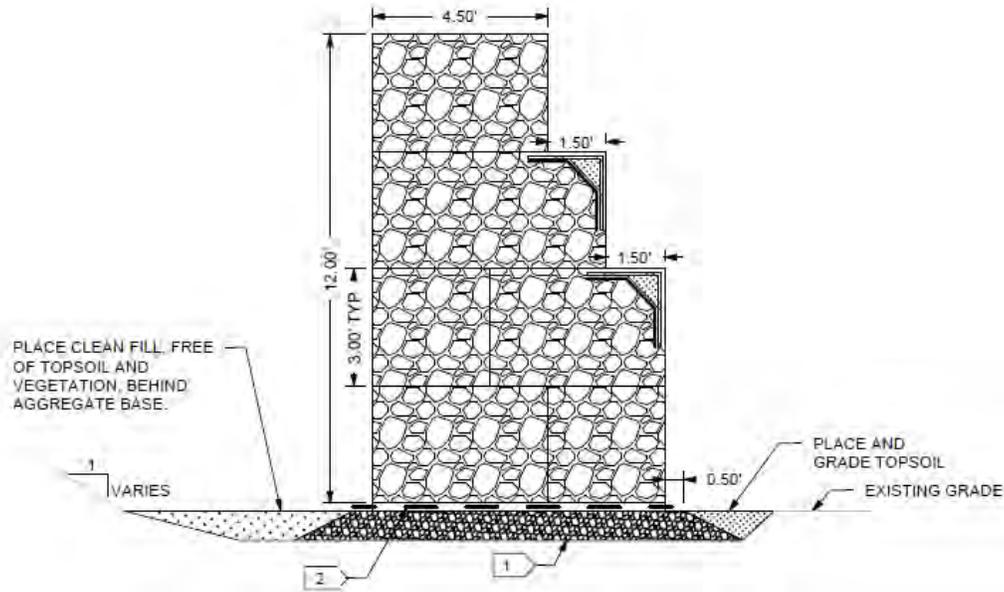
Figure 19 – Wabasha Street gabion wall section.

The gabion wall was designed to be 12 ft tall, 9 ft wide, and 260 ft long. The wall cross-section is shown in Figure 19. Most of the wall volume was constructed using 4- to 8-inch Prairie Du Chien limestone. The rock facing the street was constructed using beige stone to match the bluff. Wire mesh coating used in the gabion baskets consisted of zinc overcoated with PVC to extend the life of the gabion wall. A geotextile filter material was placed at the base of the gabion baskets.

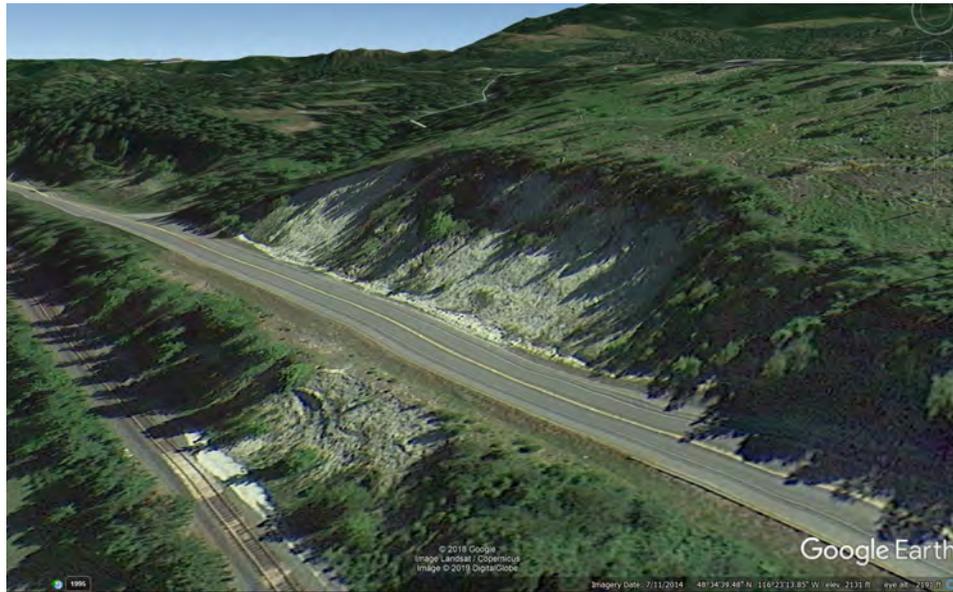
Figure 2. Google Earth oblique aerial view of US95 MP498 cut slope in 2014.

Historic aerial imagery available since 1992 indicates vegetation has been mostly unable to establish itself on the slope as shown in the oblique aerial imagery from 2014 shown in Figure 2.

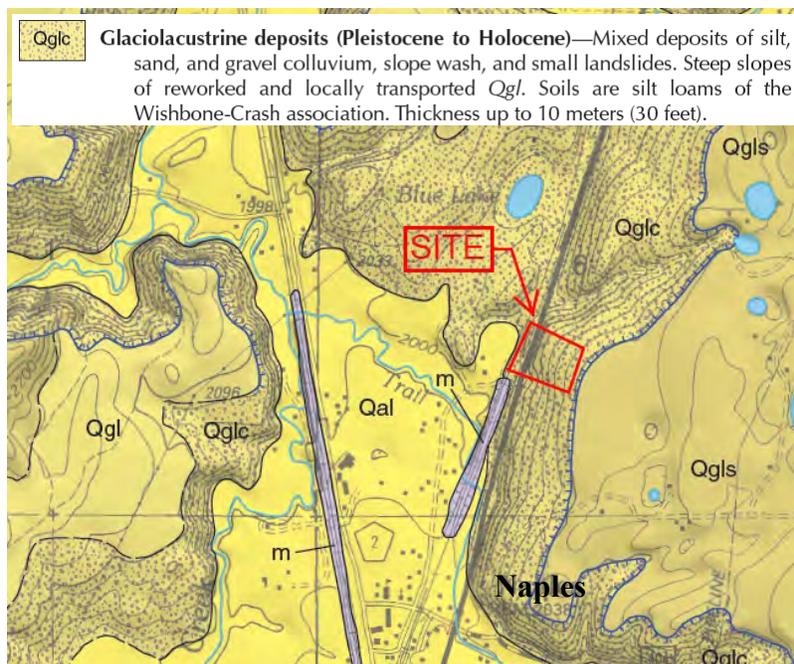
Figure 3. Geologic Map, 1:24,000 scale (McFadden et al., 2009)

Slope materials consist of sensitive, glaciolacustrine silt deposits, susceptible to flow slides when saturated. The regional geology of the Naples area is heavily influenced by past glaciation. Pleistocene glaciation advanced south from British Columbia and carved out the Purcell Trench all the way to Coeur d'Alene, Idaho. Retreat of more recent Holocene glaciation deposited the glaciolacustrine materials that form the slopes in the project area. The geologic map of the Naples area is shown in Figure 3 with the MP 498 site highlighted in red.

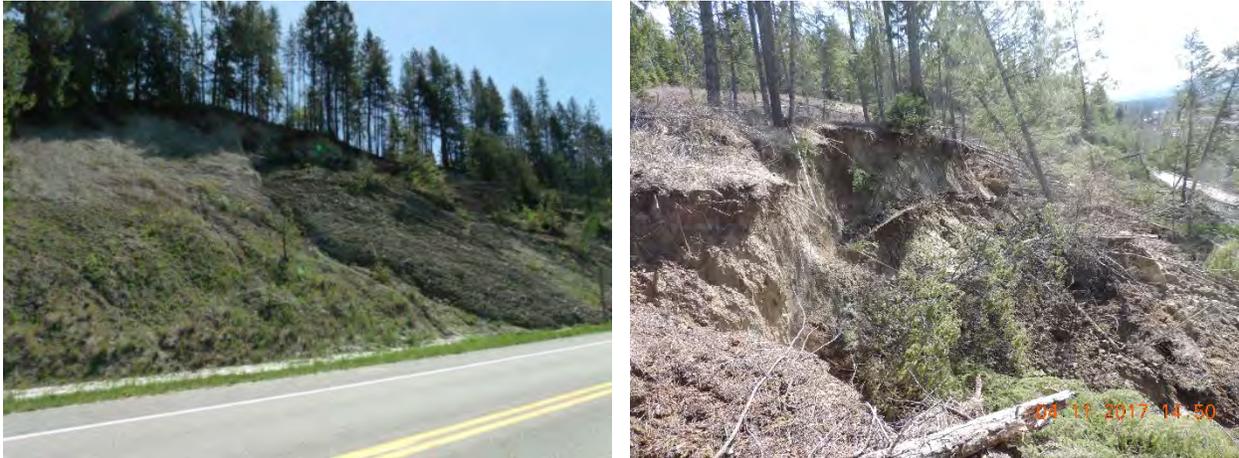
Photo 1 and 2: Condition of northern slump and headscarp in August 2016

In the spring of 2016, a slump formed a head scarp at top of the northern end of the cut slope. Photos 1 and 2 show the slump condition in August 2016. The site remained in this condition until winter.

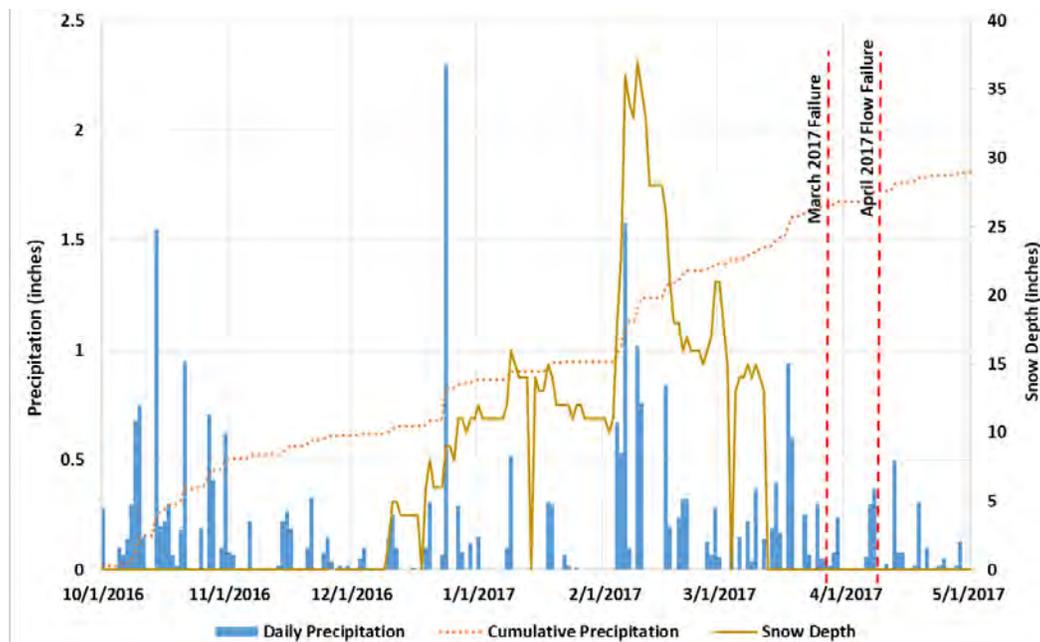
Figure 4. Daily precipitation and snow depth from October 1, 2016 to May 1, 2017 (NOAA)

The Idaho Panhandle saw near-record precipitation in the winter and spring of 2016/2017. Historic climate records from the Bonners Ferry weather station, 10 miles north of MP 498, indicate that on average approximately 20 inches of precipitation falls from October through May. In the 2016/2017 season over 30 inches of precipitation fell in this time period and snow depths peaked later than usual at 37 inches in mid-February. Increasing temperatures culminating in a rain-on-snow event decreased the snow pack to zero by March 13, 2017. Precipitation and snow depth from the 2016/2017 winter-spring season are shown in Figure 4.

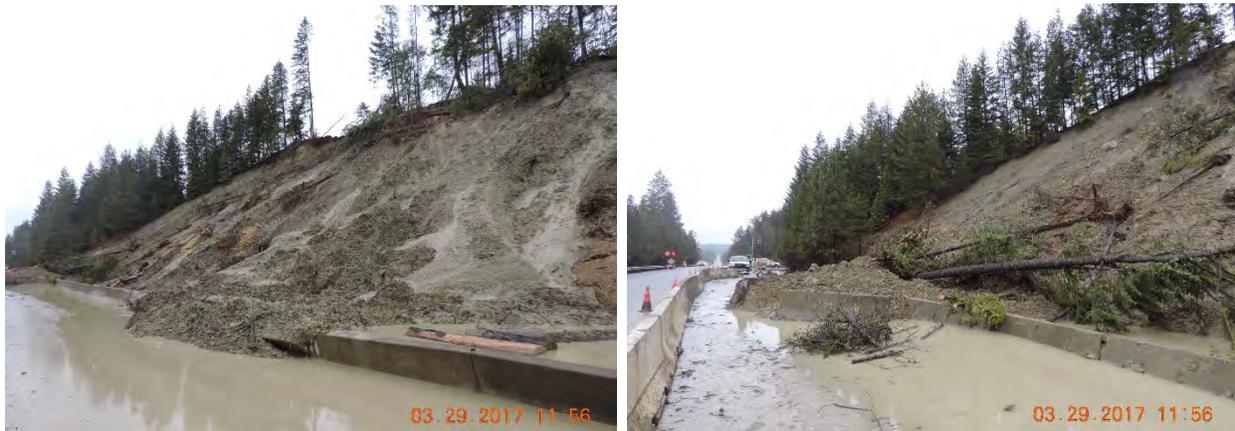
Photo 3 and 4. Concrete barrier rails displaced after slide debris impact

Retrogressive slumping and earthflow slides occurred in the cut slope between March 21 and March 29 after the rapid melt off. Oversteepened headscarps calved and slumped, increasing the amount of unstable material in the slide mass. Continued calving and slumping of the headscarp caused trees to tilt and fall, creating an additional hazard to traffic. The ongoing accumulation of soft, saturated slide debris caused the toe of the slide mass to progressively bulge out of the cut slope and run down towards the highway. Liquefied slide debris had long runout distances, which made material containment difficult. Slide debris and earthflows reached and covered the northbound lane of the highway impacting traffic. ITD closed the northbound (NB) lane of US 95 and traffic control was established to maintain alternating one-way traffic. Concrete barriers were installed to contain slide debris and protect traffic; however, subsequent flow slide events pushed the barriers west towards traffic as shown in Photos 3 and 4. A secondary line of barriers was installed to improve slide debris containment.

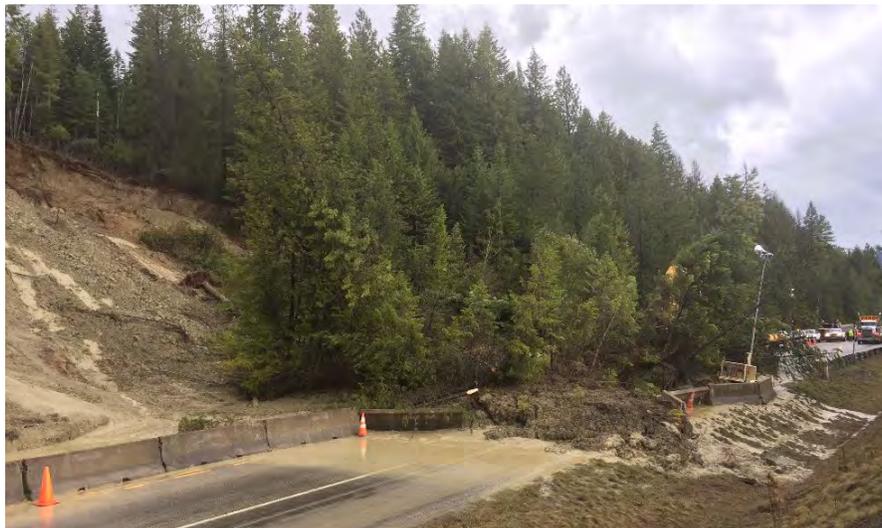
Photo 5. Liquefied slide debris crossing US 95 on April 7, 2019

On April 7th just after 2:00 pm, a rapid earthflow slide developed in the southern portion of the cut slope. ITD promptly closed the roadway before the accelerating flow slide broke through the concrete barriers and deposited slide debris and trees across both lanes of the highway (Photo 5). Following cleanup of the debris, ITD established alternating one-way traffic with 24/7 flaggers.

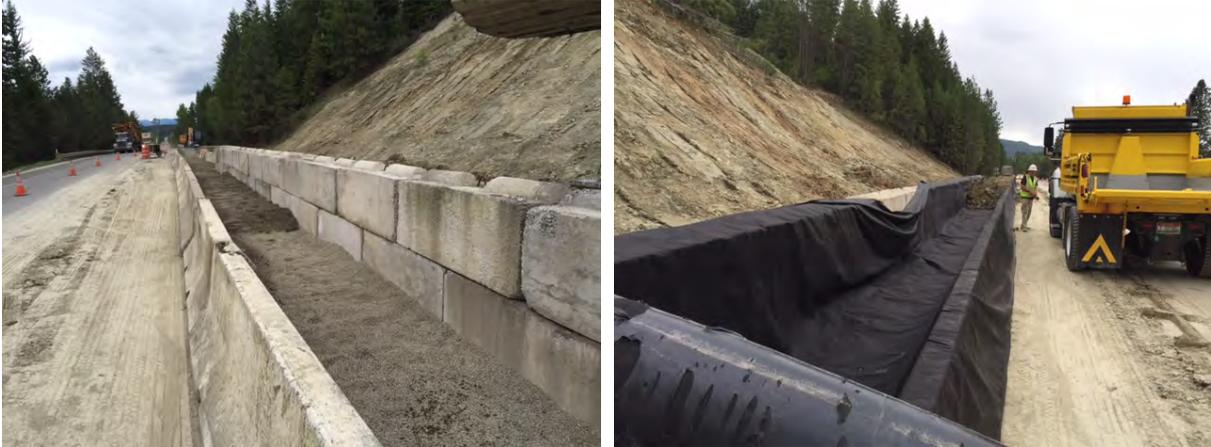
Photo 6 and 7. Temporary debris containment barrier construction

The first action identified to meet the aforementioned objectives was to construct a more robust temporary containment barrier that would retain slide debris and allow ITD to eventually resume two-way traffic. A simple gravity barrier system was developed to increase containment capacity and resistance against sliding from rapid flow slide impact. The roadside ditch was cleared of slide debris and an improved containment barrier was constructed using readily available materials from a nearby ITD maintenance yard. A row of concrete ecology blocks were stacked, two high, approximately 4 feet inboard of the roadside concrete barrier rails. The space between

the ecology blocks and concrete barrier rail was backfilled with 12 inches of sand backfill material. The top of the sand backfill was then lined with geotextile separation fabric and the remaining space between the concrete barrier and ecology blocks was backfilled with native soil from the site for additional weight to resist sliding. The sand layer allowed the saturated native backfill soils to drain and stiffen over time. Barrier construction is shown in Photos 6 and 7.

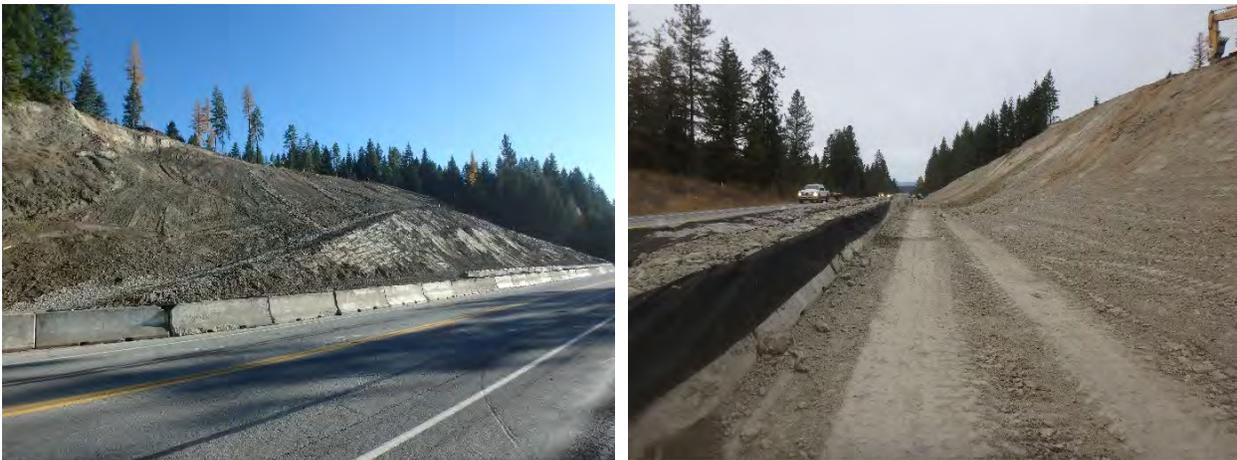
Photo 8 and 9. Regraded slope conditions in September 2017

A series of survey points was established along the slide allowing ITD maintenance personnel to collect regular measurements and monitor slope deformations. By late-May of 2017, slumping and flow sliding had ceased, groundwater levels had decreased appreciably, and the surface of the slope began to dry. Anticipating reactivation of slide movement and further retrogression of the head scarp the following winter, ITD obtained a contractor under emergency contract in September 2017 to remove slide debris and lay back the upper slope. The contractor also installed French drains after regrading the cut slope to intercept and direct surface water and shallow groundwater away from the slope. A 10-foot wide bench was constructed from the roadway elevation on the north and south sides of the slope up to approximately 50 feet vertical distance above the roadway to allow drill rig access for geotechnical subsurface explorations. The slope below the bench was graded to 1.25H:1V and the slope above the bench to approximately 2.5H:1V.

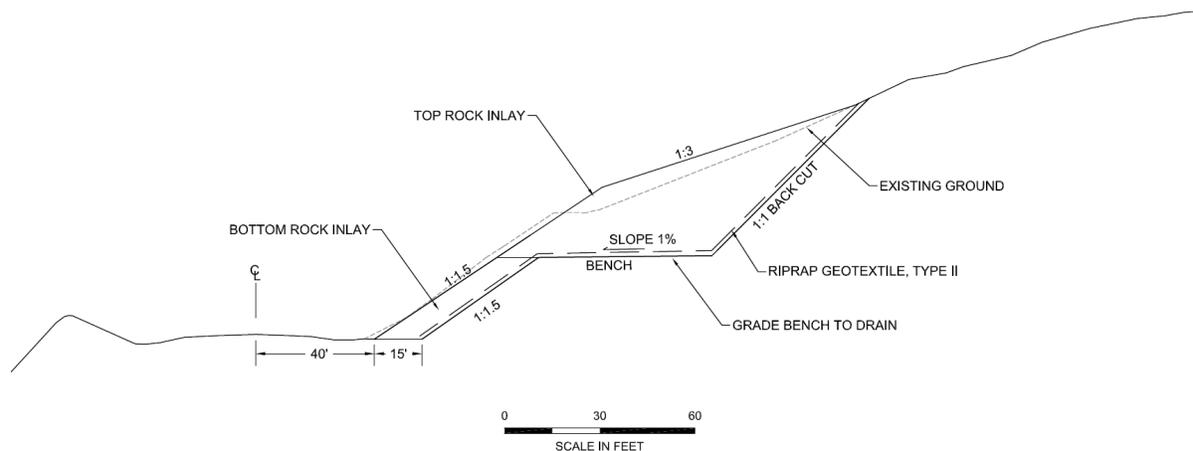
Figure 5. Rock Inlay Schematic

A permanent mitigation design was developed in 2018 to remove slide debris and prevent continued upslope retrogression of the slide. A rock inlay was designed to replace disturbed glaciolacustrine soils and slide debris with free-draining, high strength rockfill material. The additional confinement applied by the rock inlay will increase local stability at the cut face and decrease potential for piping erosion processes from high gradients and seepage forces during major precipitation and snow melt events. A schematic of the rock inlay design is shown in Figure 5. A contract has been awarded for the rock inlay and construction is underway with expected completion in late summer 2019.

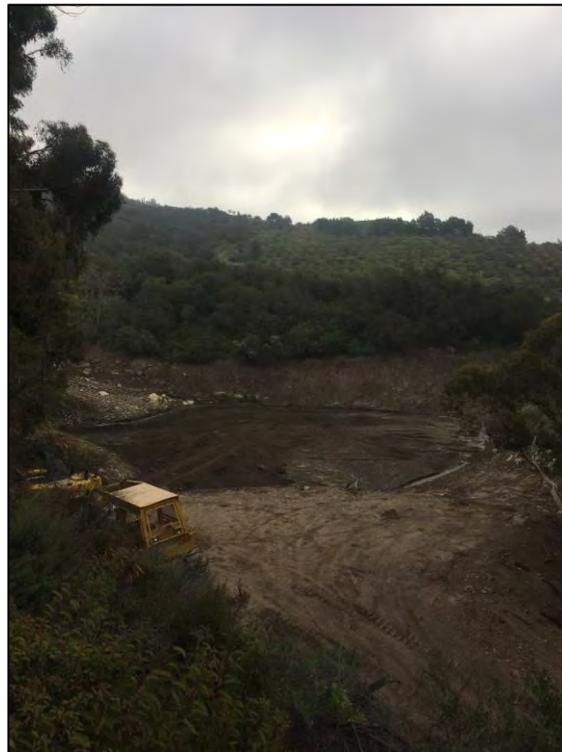
Figure 1 - Debris basin in Montecito, California

Excavating debris basins is a common mitigation approach. They are generally constructed in the depositional area of a debris flow torrent or channel. Debris basins consists of an earth dam or other barrier constructed across a drainageway or other suitable location for collecting sediment. The dam is provided with properly designed spillways to dispose of excess runoff water at safe velocities that will not damage the dam or other improvements (1). Basins are often large, flat areas at the mouth of debris channels where high velocity flows able to carry large sediment can lose velocity, Figure 1. As the flows lose velocity, they are no longer able to carry large, heavy sediment decreasing the particle size and sediment load of the flow. Debris basins are designed to retain significant amounts of material and if overtopped, are designed to keep flows channelized and minimizing flow energy.

Debris basins are designed and required to be maintained and cleaned overtime and basically become ineffective if retained debris material is not excavated and removed. In unburned watersheds, debris basins are cleaned out once they are 25 percent full. The number of years it takes to reach that level varies. In burned watersheds, where the potential for mudflows is higher, debris basins are cleaned out once they are five percent full. A watershed that has had more than 20 percent of its area burned within the previous five years is considered a burned watershed. For some debris basins in burned watersheds, this may lead to multiple cleanouts within a year, (2). Debris basins are designed using estimated volume of past events; however, their design is often constrained by available space. This is especially true for areas that are heavily populated. Debris

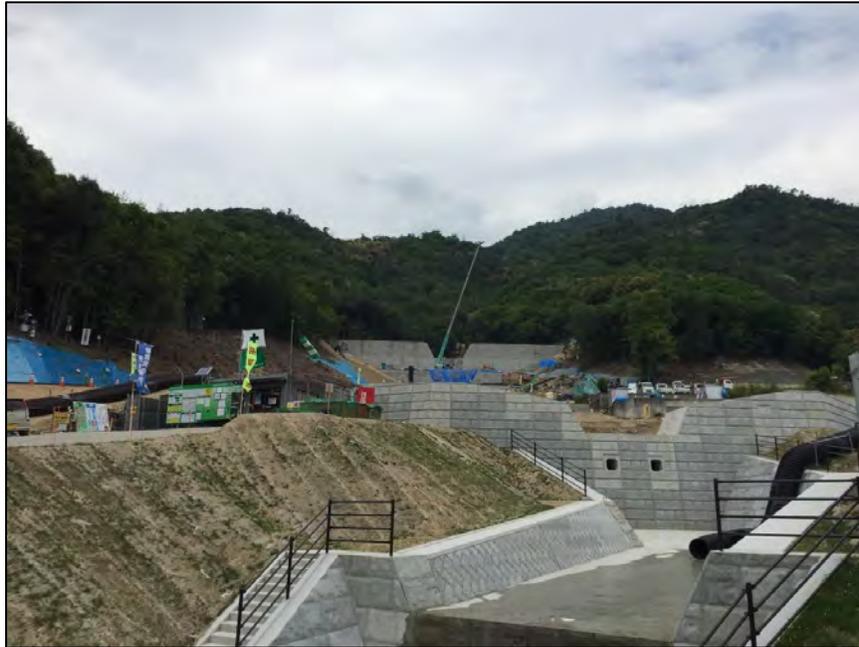
Figure 2 - Sabo Dam under construction in Hiroshima, Japan

particular designer. Figures 2 and 3 show Sabo dams under construction in Hiroshima and Fukuoka Prefectures in Japan.

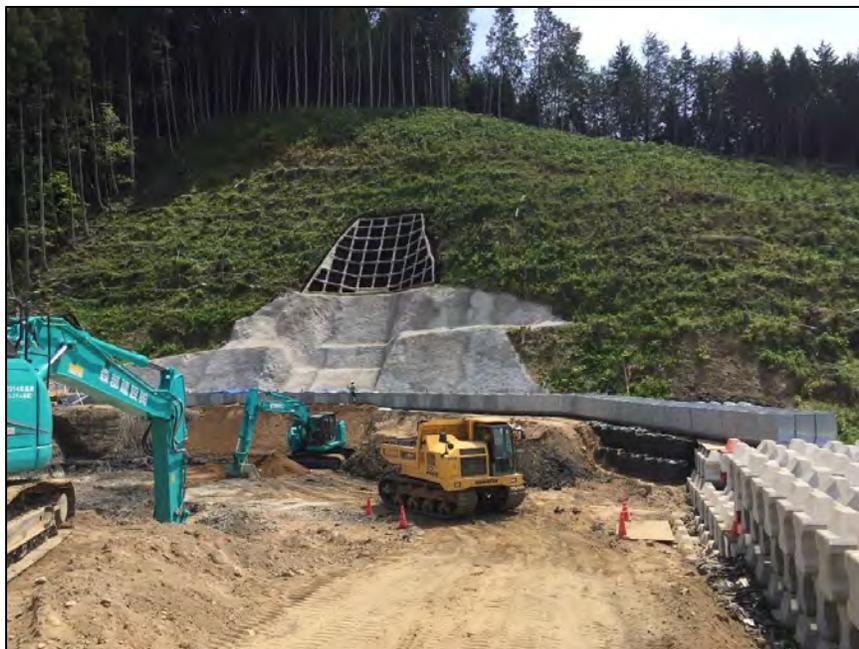
Figure 3 - Sabo Dam construction in Fukuoka Prefecture, Japan

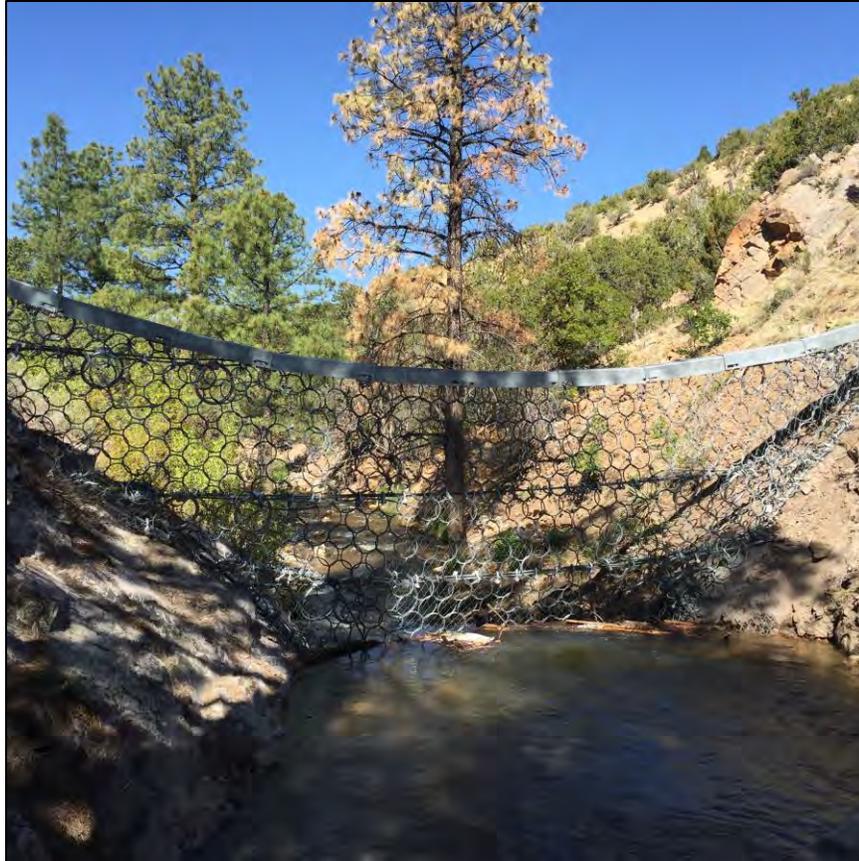
Figure 4 - Flexible Debris Flow Barrier constructed in the Nambé Pueblo in New Mexico allows natural stream to flow and fish to pass below

The basic debris flow protection system consists of a custom ring net engineered to resist the velocities and dynamic and static pressures unique to debris flows. Support ropes are installed into channel banks and transfer debris impact and pressure loads from ring nets to the ground. Excessive energy is absorbed by net braking elements in the support ropes. In addition, the

system net rings allow the passage of water and fine sediment beneath and through the net, Figure 4.

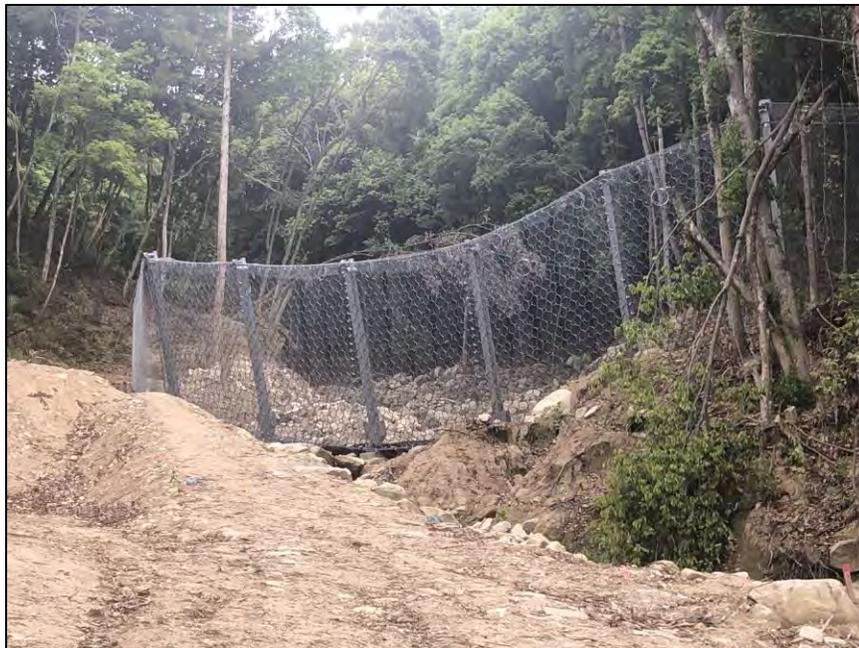
Figure 8 - Installation of Flexible Barrier for emergency protection in Hiroshima Japan

Events, Figures 8 and 9. These barriers are quickly erected and provide immediate protection. After constructing the flexible barriers, large, concrete Sabo dams were constructed as permanent protection structures in both Fukuoka and Hiroshima. These permanent structures provide a high level of protection, however large areas and a lot of construction materials are necessary for construction.

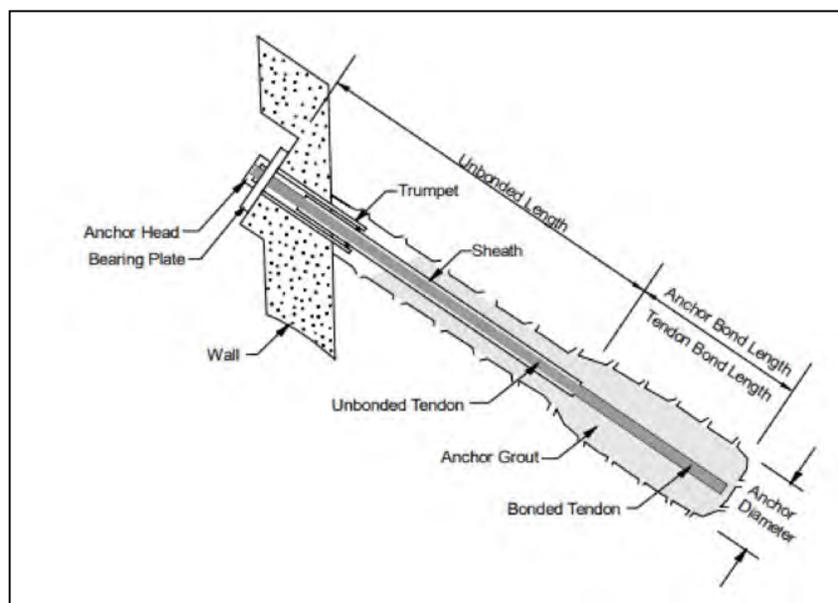
Figure 1 — Permanent Ground Anchor Diagram (8).

The FHWA defines ground anchors as “cement grouted, prestressed tendons that are installed in soil or rock” (8), Figure 1. Tendons are placed in boreholes ranging from 2.5 in. (63 mm) up to 12 in. (305 mm) in diameter. Anchor lengths can vary from 5 ft. (1.5 m) to over 50 ft. (15 m) long. They are used extensively as common practice in landslide stabilization, rock bolts, and excavation support. Their potential cost savings versus other methods, as well as their ability to reduce land required for stabilization, have made permanent ground anchors popular.

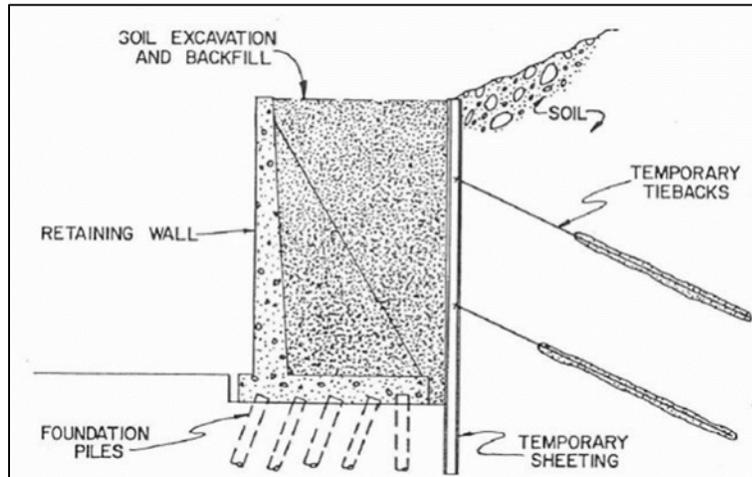
Figure 2 — Conventional Retaining System Design Prior to Permanent Ground Anchors (8).

At first, only a few states allowed ground anchors as an alternate design to conventional concrete retaining walls, Figures 2 and 3. The alternate design provided significant cost savings which encouraged the FHWA to do further research. They conducted an instrumentation program to increase understanding on how the systems functioned and analyzed their performance over time. It was not until the 1980s that permanent ground anchors were widely accepted (6). As their popularity grew, so did the necessity for a standard set of guidelines for engineers and contractors to consider.

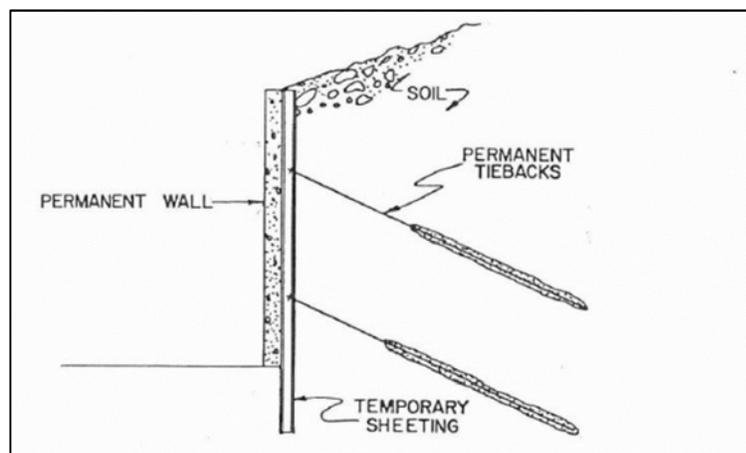
Figure 3 — Alternate Permanent Ground Anchors (8).

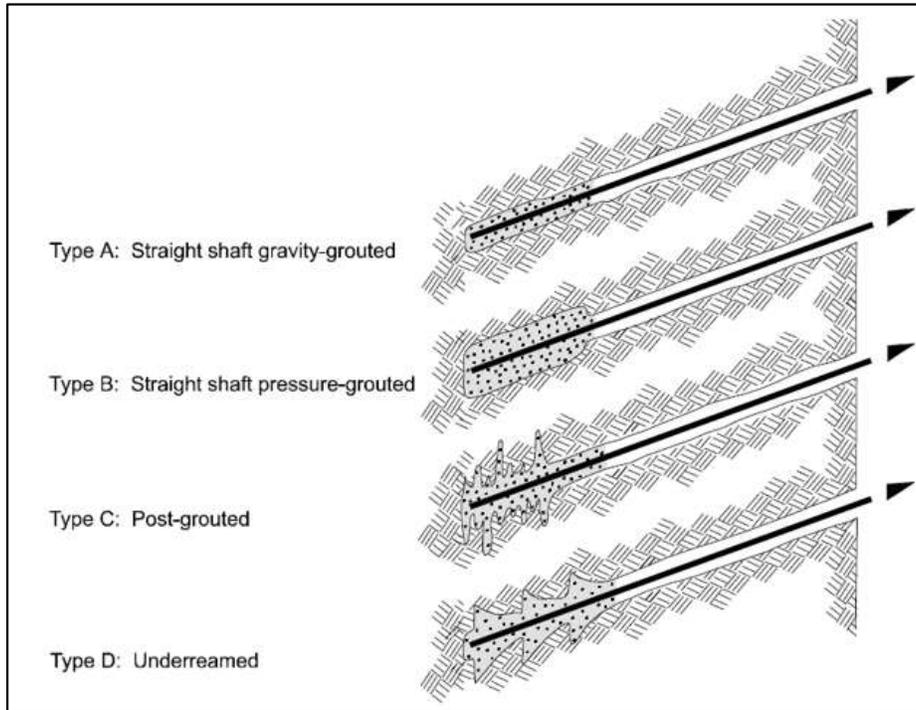
Figure 4 — (a) Gravity-Gouted Anchor. (b) Pressure-Gouted Anchor. (c) Post-Gouted Anchor. (d) Anchor Grout Via Underreaming. (8).

Advancements in construction techniques such as pressure grouting, post-grouting, and under-reaming allows the grout to infiltrate voids or expand the grout pack in soil. The fracturing or expansion of grout increases shear resistance, thus increasing pullout resistance, Figure 4. However, these practices are typically performed by specialty contractors and can be costly compared to conventional techniques. Conservatively, simple construction techniques are often assumed (i.e. gravity-grouted anchors) and lower grout-ground bond values are used for preliminary design.

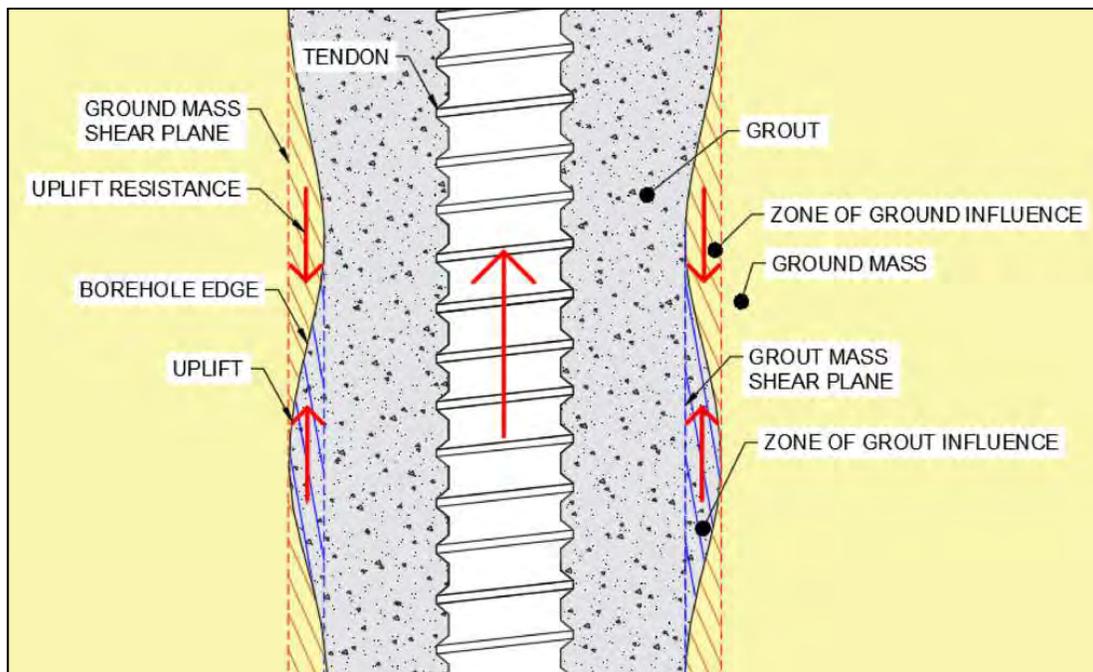
Figure 5 — Shear Plane Develops Due to Grout-Ground Interlocking When the Borehole is Non-Uniform (Rough).

When the external forces exceed the shear resistance generated between the grout and ground, the bonding between the grout and surrounding ground deteriorates, Figure 5. This causes the grout column to move and insufficient residual resistance is generated throughout the bonding zone. This results in the anchor pulling out the ground.

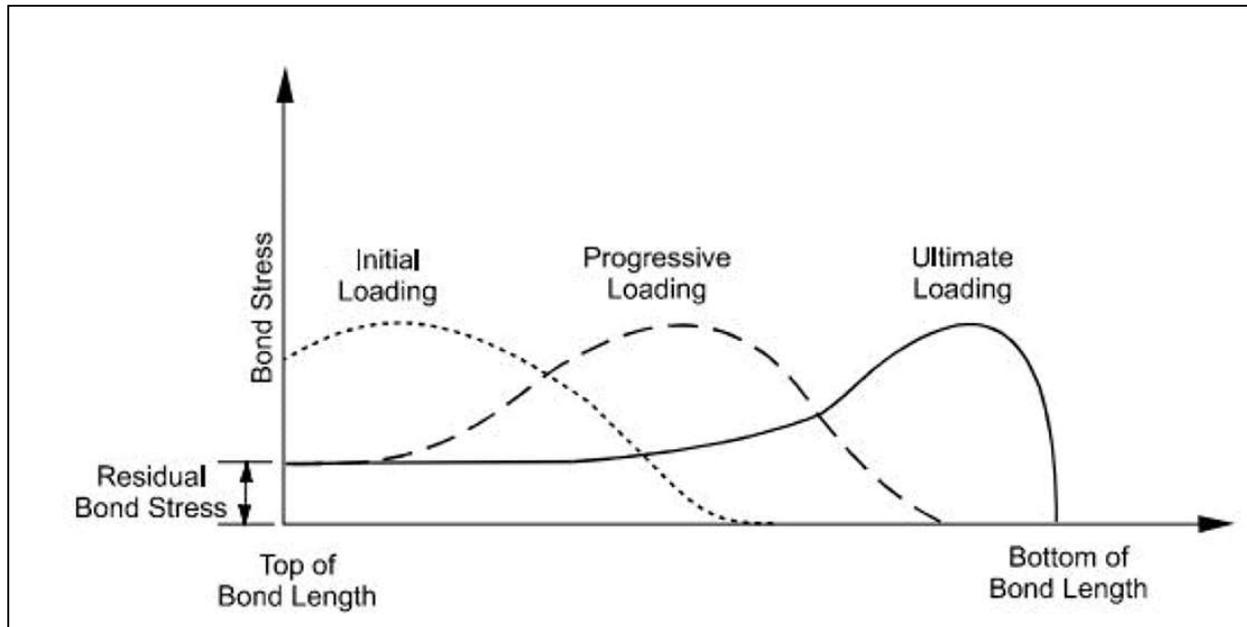
Figure 6 — Loading Sequence of a Ground Anchor (8).

Since mobilized shear strength is the primary mechanism for resistance, relative movement must occur between the grout-ground interface to develop friction. Typically, when the anchor is loaded in tension, loading is transferred to the top of the grout column and propagates downward toward the bottom of the bond zone, Figure 6. If enough resistance cannot be developed by the time the load transfers to the bottom of the grout column, then anchor pullout (failure) is likely.

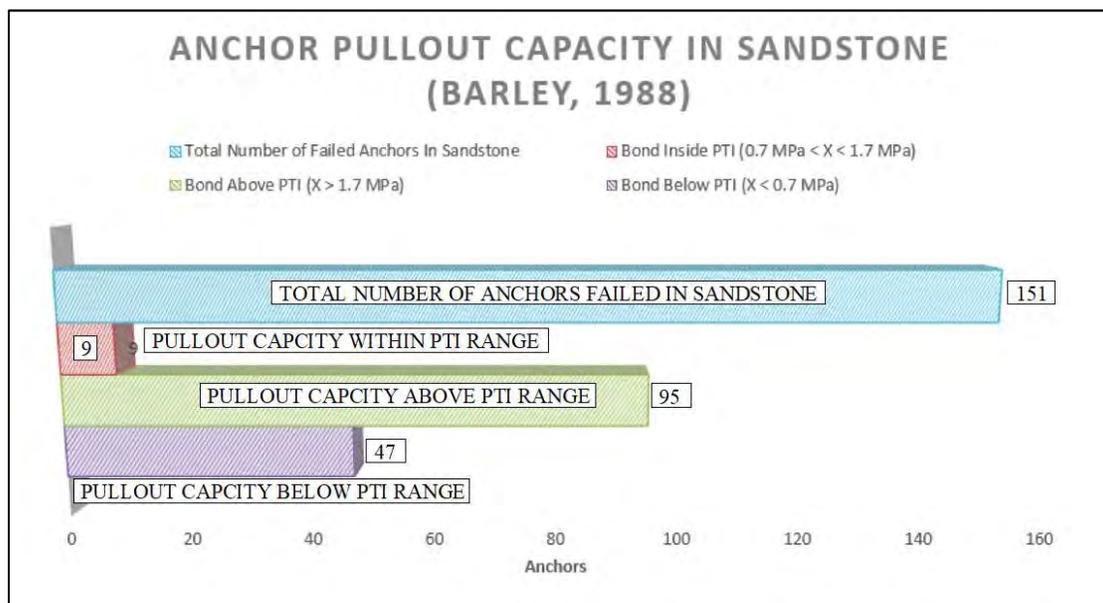
Figure 7 — Comparison of the Anchor's Ultimate Grout-Ground Bond Strength that Failed in Sandstone Compared to the PTI's Presumptive Range of Ultimate Bond Stresses (151 Total Anchors) (10).

Bond stresses can vary greatly in the same kind of material. Barley (1988) documented the installation of 10,000 ground anchors installed in Europe. Figure 7 shows that of the 151 anchors that pulled-out (failure) in sandstone only nine anchors (6%) were within the presumptive range of the PTI. This highlights the following:

1. Grout-ground bond can be highly variable. Expected rock type is insufficient for estimating bond lengths.
2. Preproduction or predesign anchor testing can be highly beneficial. Accurate bond lengths can be determined which allows the contractor to reduce the anticipated drilling requirements. This consequentially reduces construction time and total materials required.

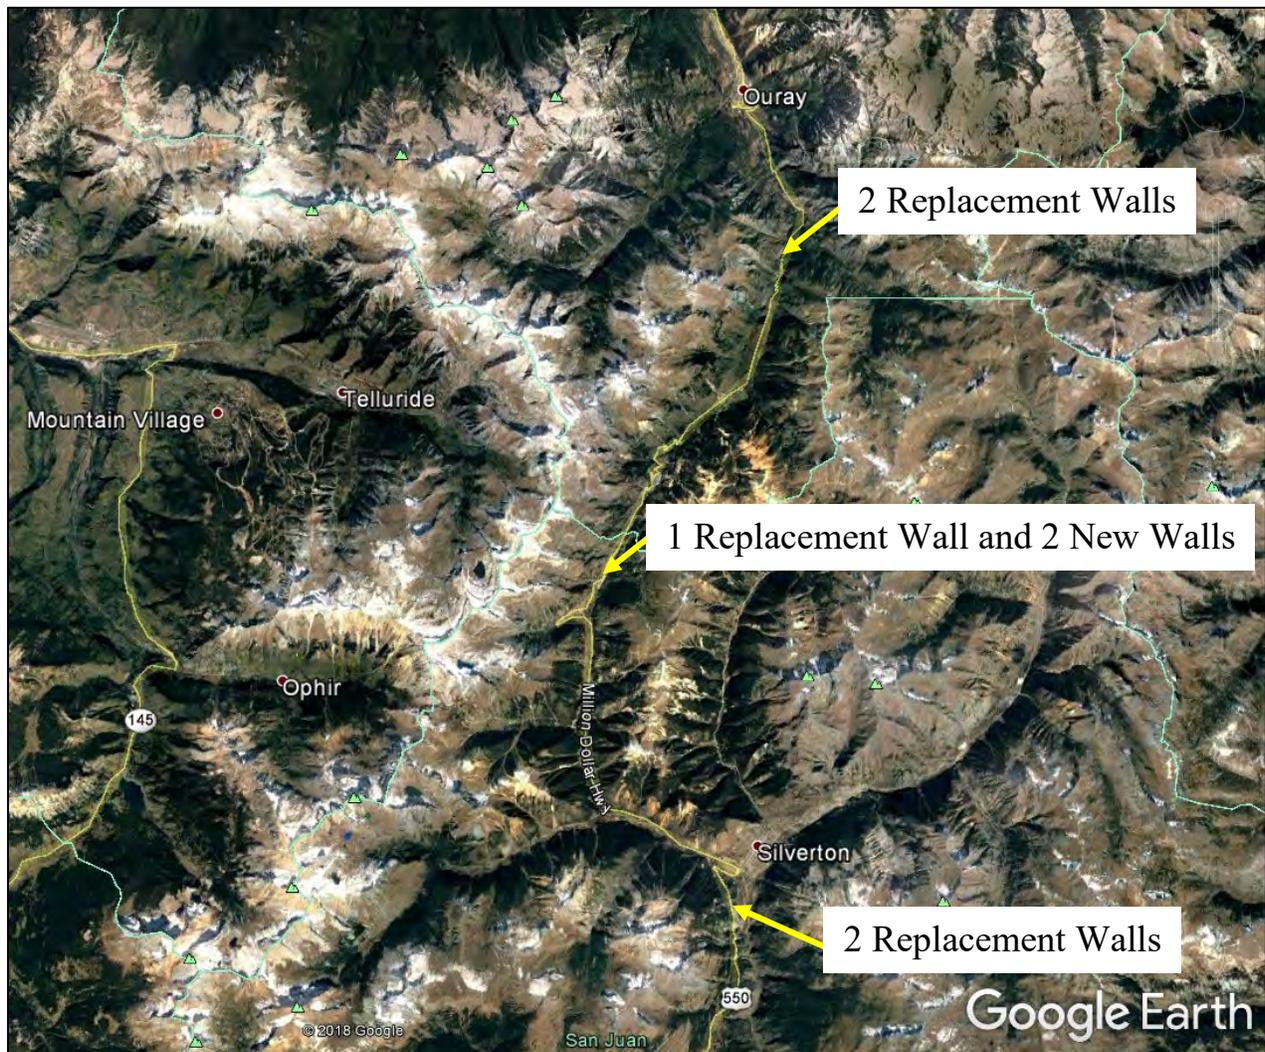
Figure 1 – Retaining Wall Locations

United States Highway 550 (US 550) is a primary route traveling north and south through southwestern Colorado. The highway was built through difficult mountain terrain including high mountain passes and along steep canyon walls. Red Mountain Pass, at an elevation of 11,075 feet, is at the apex of the highway between Ouray and Silverton. The highway was originally constructed in the 1880s and operated as a toll way until it was rebuilt in the 1920s. The highway is commonly referred to as the Million Dollar Highway however the origin of the name is still debated. Towns like Silverton and Ouray rely on US 550 to bring goods, services, and tourism to the area. Due to the importance of the highway corridor, the Colorado Department of Transportation (CDOT) proactively identified numerous walls that were in various states of deterioration resulting in roadway damage. A total of five retaining walls were replaced and two additional walls were constructed along the highway to improve the corridor. The locations of the retaining walls are shown in Figure 1.

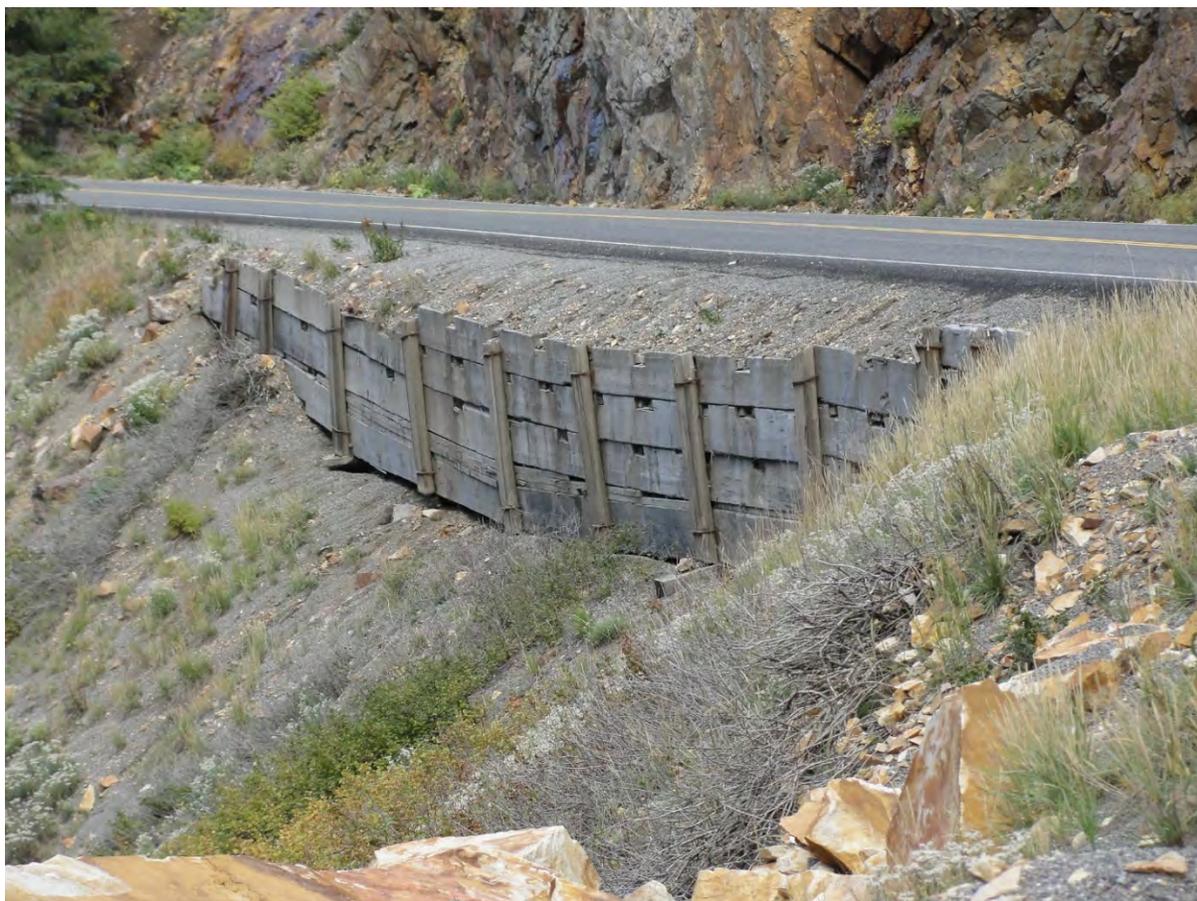
Figure 2 – Deteriorating Timber Faced Crib Wall

This timber faced crib wall along US 550 consisted of approximately 12x4 rough sawn timbers (Figure 2). Vertical timbers holding horizontal lagging timbers were anchored behind the wall face with steel cables. The wall face had a notable curve in plan view and appeared to have settled near the center of the wall. The wall was not embedded leading to loss of backfill from below the timber facing. Surface water drainage from the roadway had resulted in erosion of the fill material on top of the wall. The inlet of a corrugated steel pipe was noted in the roadside ditch on the opposite side of the highway; however, the pipe could not be located daylighting on the downhill (wall) side of the roadway.

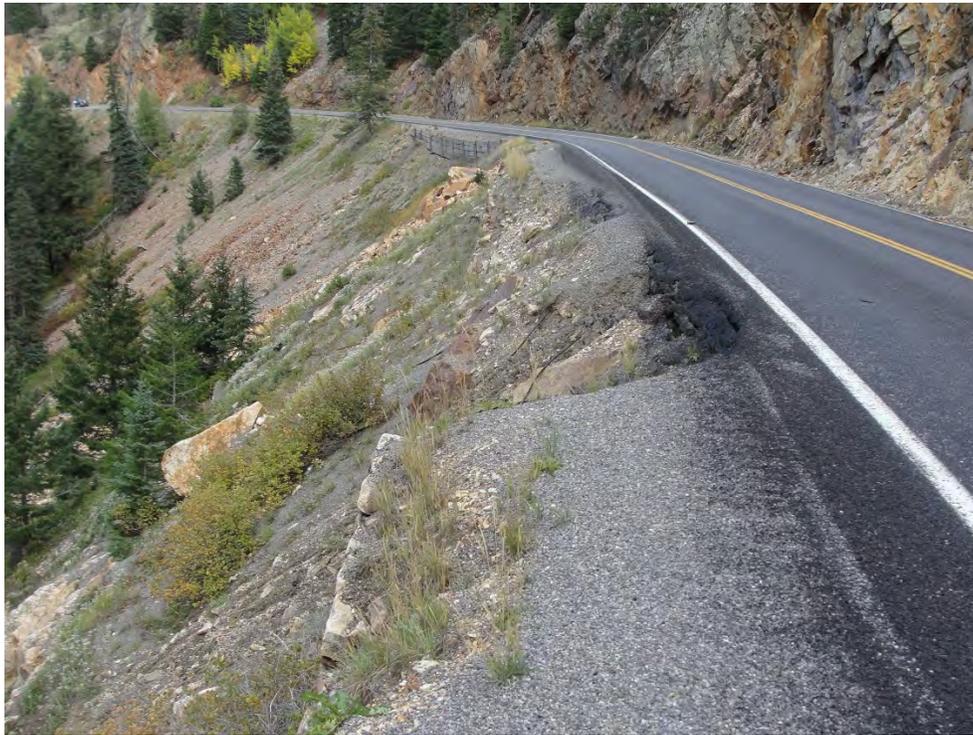
Figure 3 – Collapsed Section of Stone-Faced Gravity Wall (note timber faced crib wall in the background)

This stone-faced gravity wall was also constructed directly below the highway. Sections of the wall had collapsed likely due to large rocks being pushed over the top of the wall after falling from the rock cut on the uphill side of the highway. The roadway shoulder was eroded away in the collapsed wall sections (Figure 3). A section of the stone-faced wall that had not collapsed is shown in Figure 4.

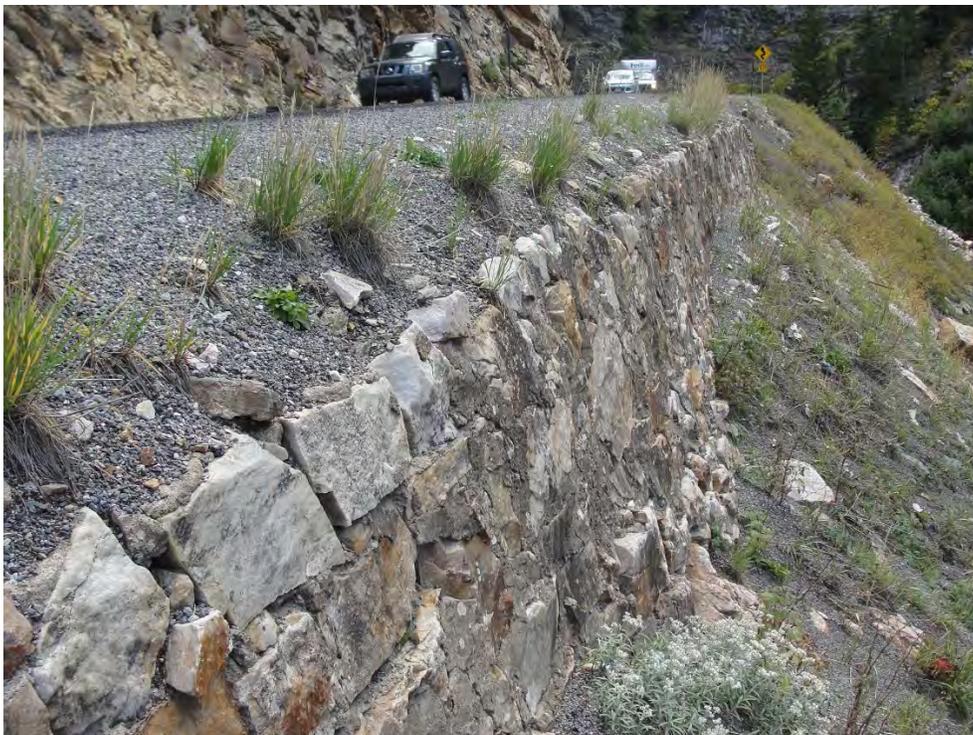
Figure 4 – Stone-Faced Gravity Wall Section Still Standing
