70TH HIGHWAY GEOLOGY SYMPOSIUM

“Better Highways Through Applied Geology”

October 21-24, 2019

2019 Proceedings

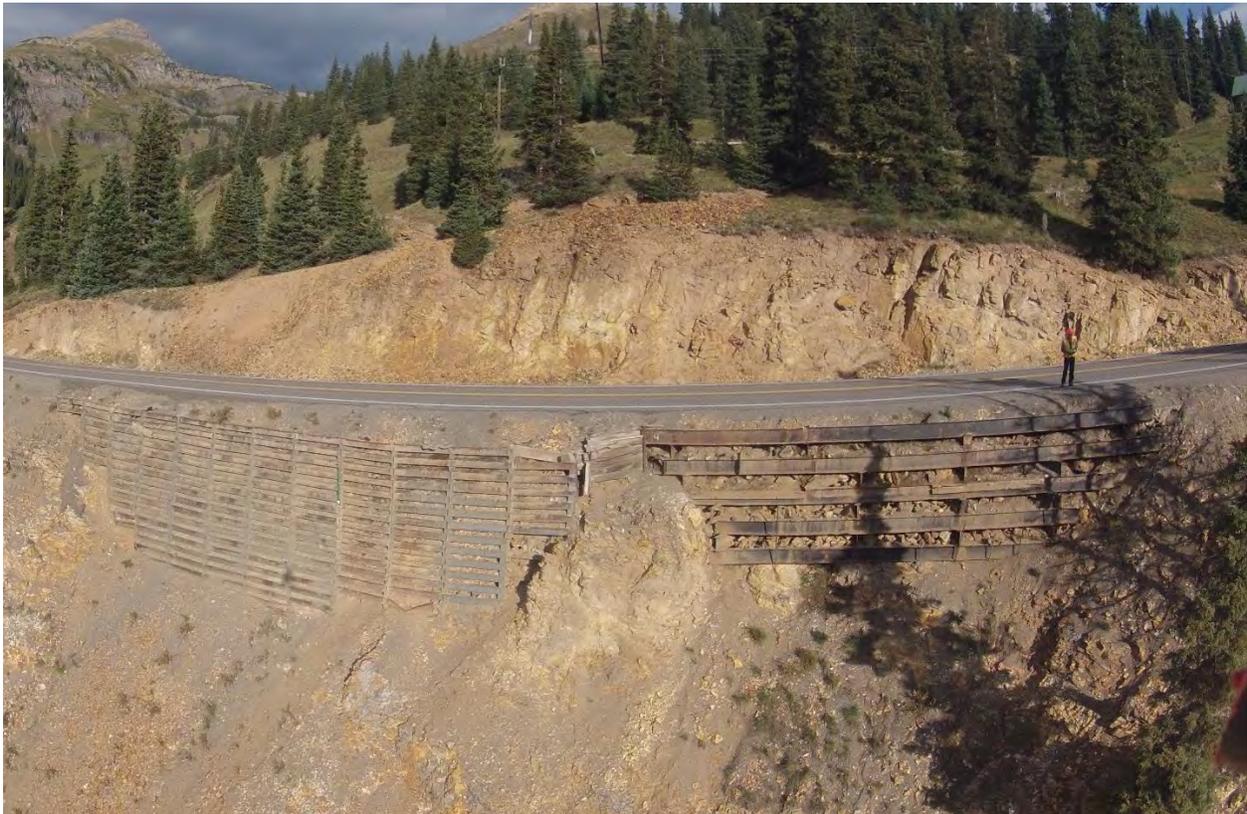
Figure 5 – Steel Crib Wall and I-beam Wall

This deteriorating wall consisted of two different wall facings: steel cribs and I-beams (Figure 5). Numerous elements of the crib wall were damaged, and some were missing. Backfill was raveling out between the steel elements. Additionally, the slope above the wall was over-steepened and experiencing erosion which was undercutting the roadway pavement. The steel crib wall and I-beam wall were separated by a rock outcrop with timber lagging above the outcrop and spanning between the two walls. As with the crib wall, backfill was raveling out of the I-beam wall through the gaps between beams. Steel bars were drilled into the rock at the base of the wall to provide support.

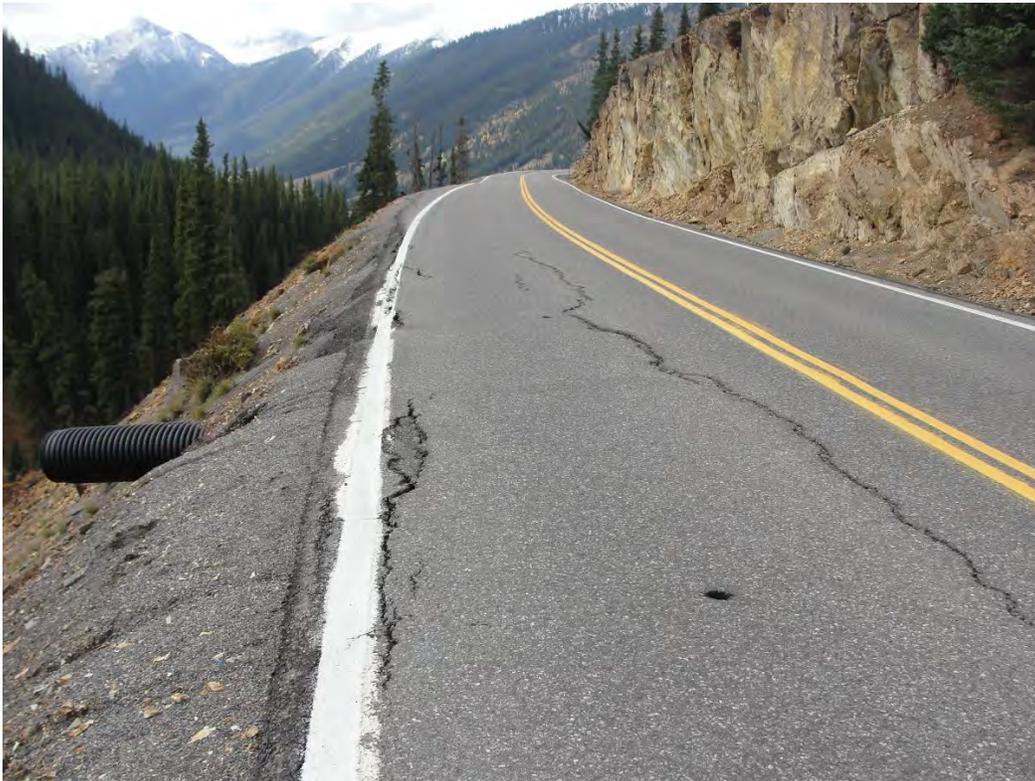
Figure 6 – Pavement Damage and Culvert North of the Steel Crib and I-beam Walls

Just north of the steel crib wall and I-beam wall, the highway pavement was cracked in several locations due to the over-steepened and eroding slope below the roadway (Figure 6). A culvert pipe daylighting on the slope below the roadway was contributing to the slope erosion and instability. A thickened pavement section was present along the edge of the road where pavement overlays were used to reestablish the roadway edge lost to erosion and instability.

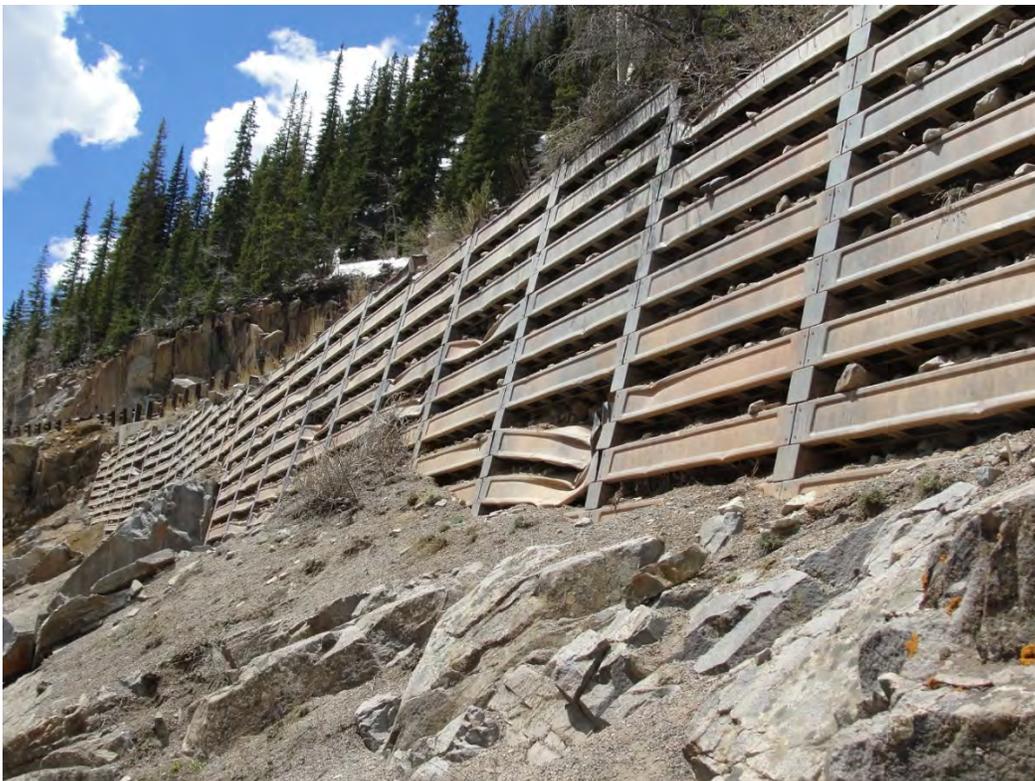
Figure 7 – Steel Crib Wall with Damaged Elements and Backfill Raveling

South of Silverton on the ascent of Molas Pass two additional steel cribs walls were in various stages of deterioration. One crib wall had numerous damaged steel elements and raveling of backfill material between the elements (Figure 7).

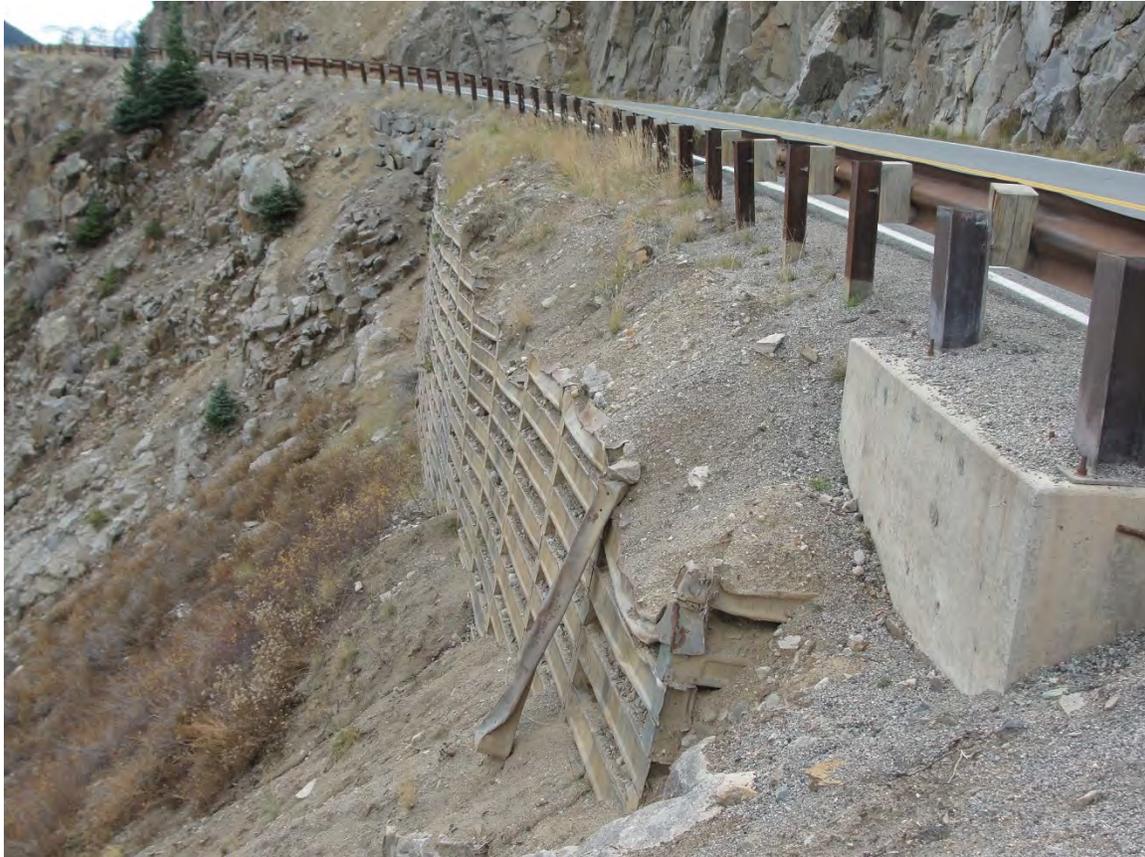
Figure 8 – Crib Wall Experiencing Movement

A second steel crib wall in the same area also had damage to numerous facing elements (Figure 8). This wall was experiencing movement which resulted in a crack within the pavement behind the wall. Both crib walls had large concrete blocks anchoring the guardrail likely where the slope above the wall had eroded and undermined the guardrail and pavement.

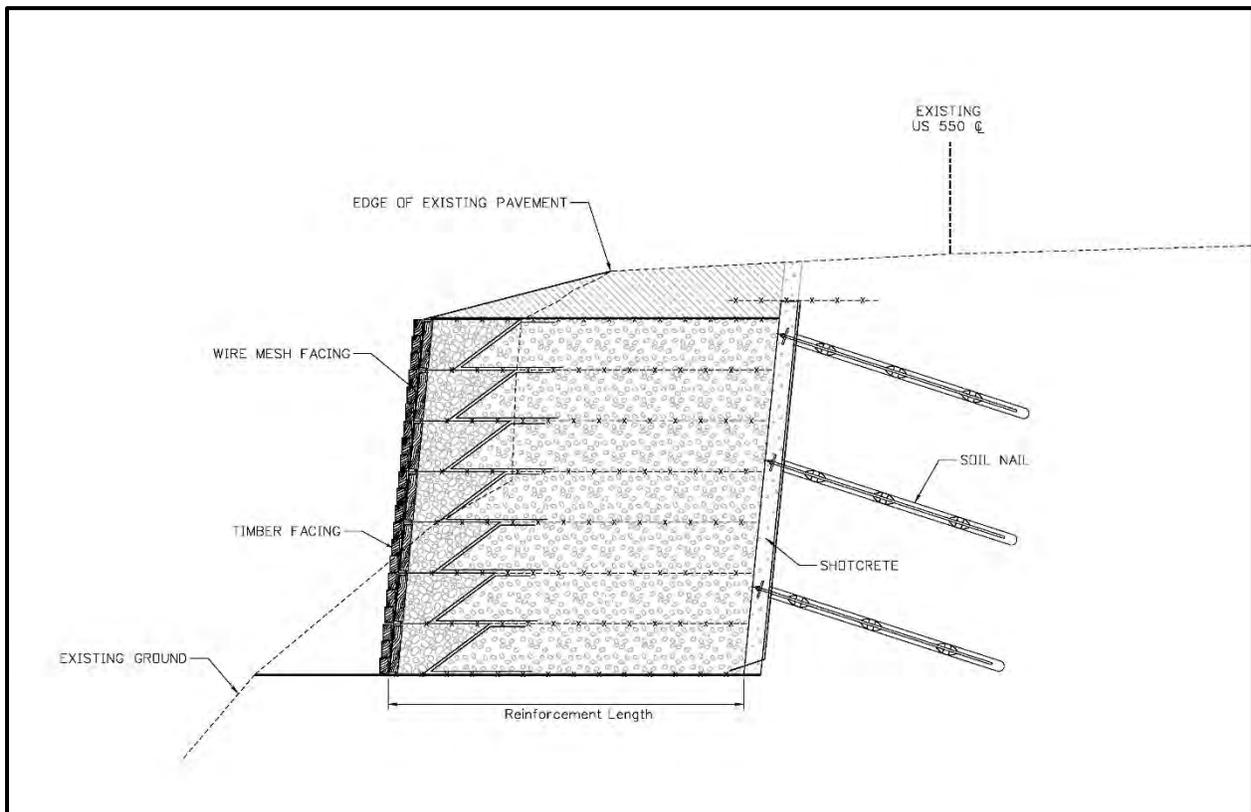
Figure 9 – Typical Section of Timber Faced MSE Wall and Soil Nail Wall

The geotechnical investigation for this wall encountered soils overlying quartzite with shale partings of the Uncompahgre Formation (1) at the approximate elevation of the bottom of the existing wall. In order to maintain a single lane of traffic during construction shoring was required to construct the necessary reinforcement length for the wall. A permanent soil nail wall was designed to both act as shoring during construction and to reduce the required MSE wall reinforcement length. The truncated base MSE wall (Figure 9) was constructed with a timber facing to match the facing of the previous wall (Figure 10). A new culvert was placed through the wall facing providing a connection to the inlet on the cutslope side of the highway. Construction modifications for this wall, and other walls on the project, included placing the wire MSE baskets to match the grade of the roadway rather than horizontally. This modification eliminated the need to cut the top of each basket to match the road grade.

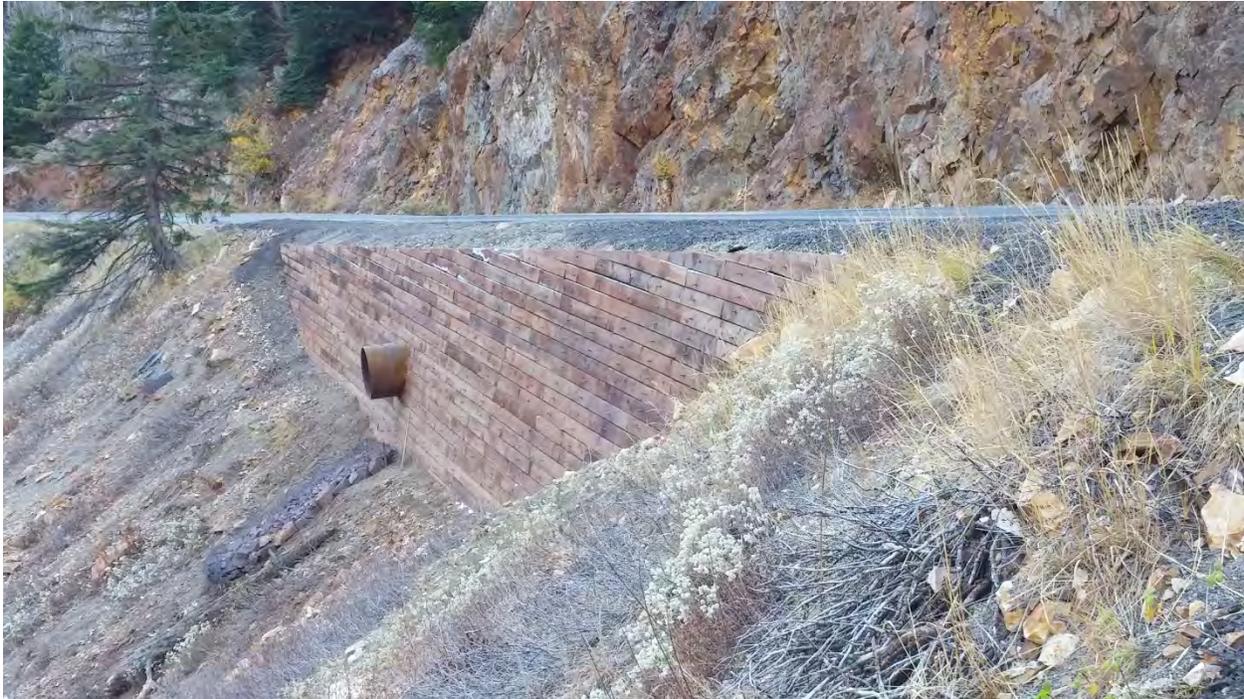
Figure 10 – Completed Timber Faced MSE Wall

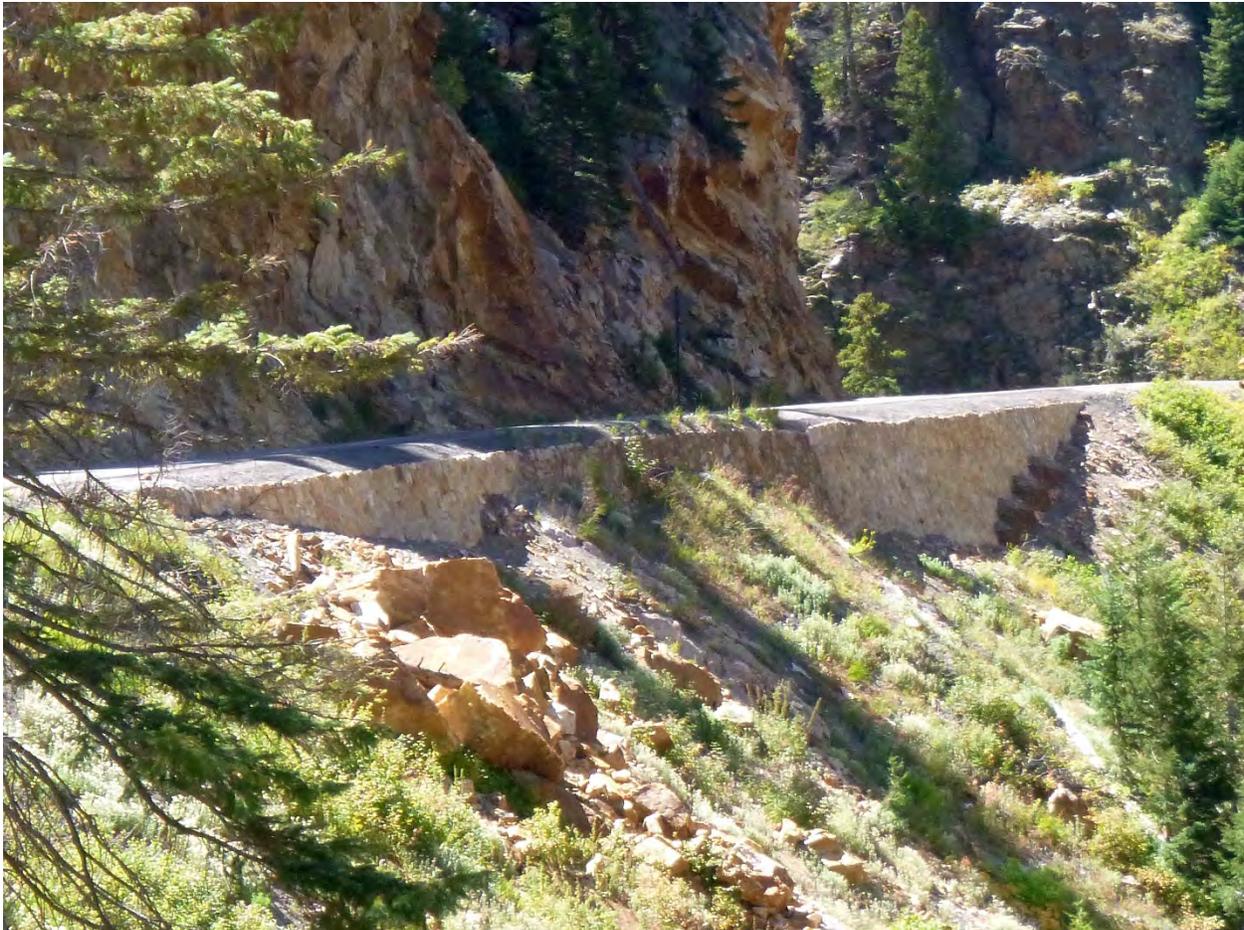
Figure 11 – Stone Face MSE Wall

Quartzite, also of the Uncompahgre Formation, was encountered at a shallow depth behind the stone-faced gravity wall. The previous wall appeared to have a relatively shallow depth which was likely stable because of the shallow bedrock and limited lateral loading. Because of aesthetics and the apparent stability of the stone-faced gravity wall, only sections of the wall that had collapsed were replaced (Figure 11). Stone facing rock was locally sourced to match the surrounding rock as much as practical. Using the wire mesh MSE wall baskets allowed for the bottom basket to be offset from baskets above to create footing to support the rock facing. Bedrock was excavated behind the MSE wall where required to achieve the minimum reinforcement length necessary for stability. Construction modifications including changing the structural connection between the MSE baskets and stone facing from using continues welded wire fabric to using discrete ties to save time and money.

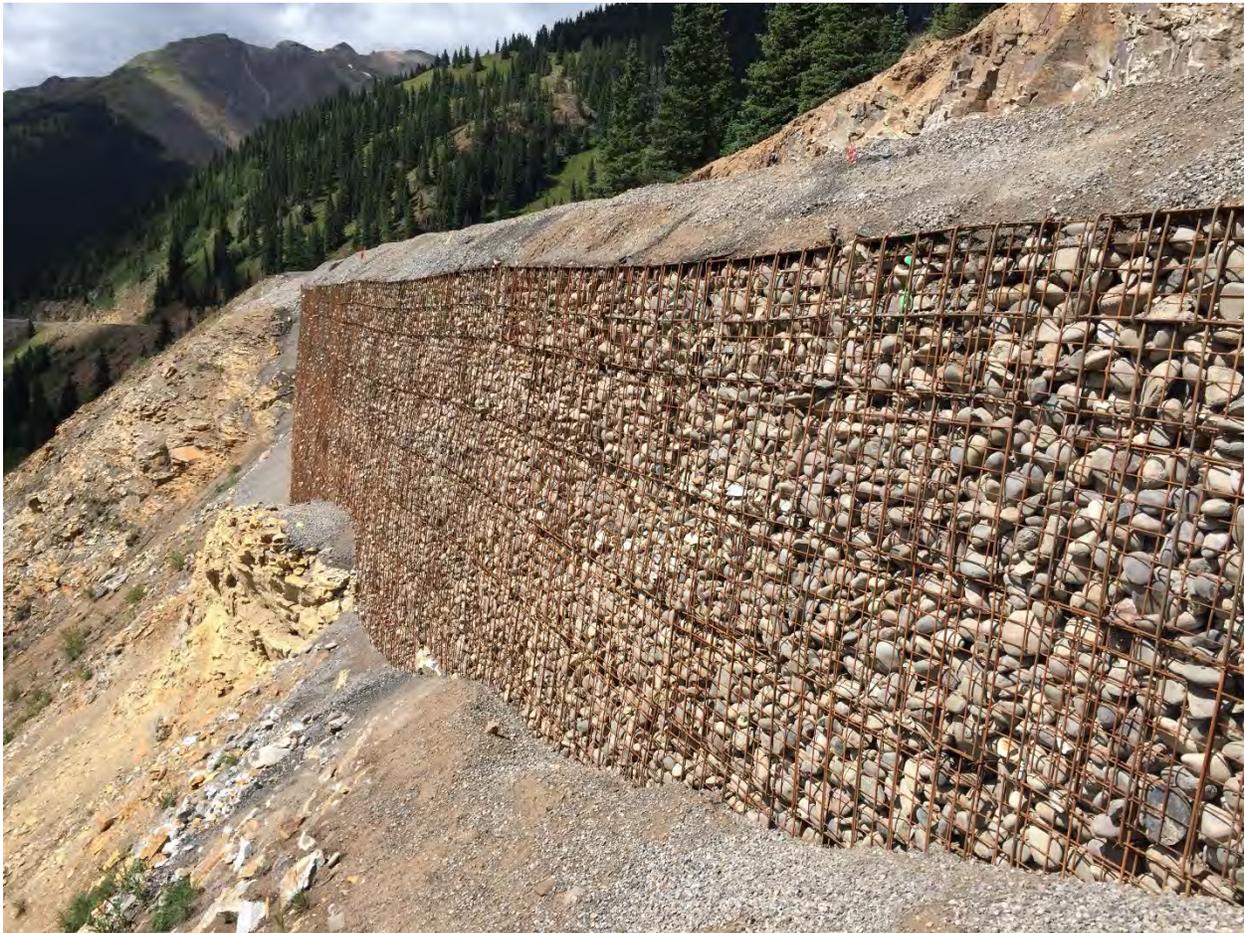
Figure 12 – Wire Mesh Faced MSE Wall near Red Mountain Pass

The geotechnical investigation near the steel crib wall and I-beam wall encountered volcanic tuffs and rhyolite of the Burns Formation (*I*) at an elevation near the base of the existing walls. Because of the depth of soil and limited roadway width, shoring was necessary to construct the wall while maintaining a single lane of traffic during construction. A permanent soil nail wall was designed to provide shoring and to reduce lateral loading on the MSE wall.

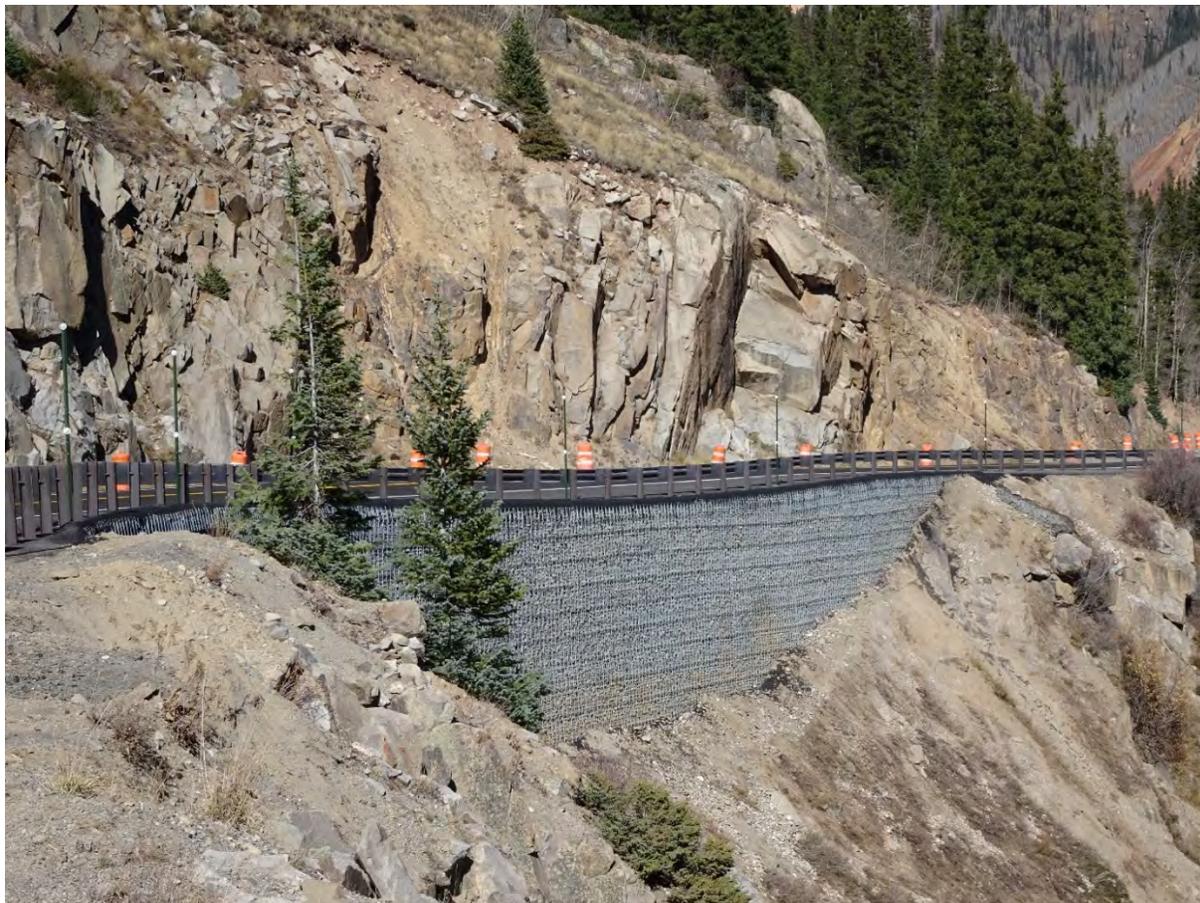
Figure 13 – Wire Mesh Faced MSE Wall near Molas Pass

Pass was used as backfill behind the facing stone. The backfill rock was tested for corrosivity as the area is known to be highly mineralized. The results of the corrosion testing showed that corrosivity met AASHTO specifications for nonaggressive backfill but numerous heavy metals were present in the rock. The steel wire of the galvanized wire mesh baskets was upsized to account for the higher potential of corrosion due to the heavy metals in the backfill material.

During excavation of the rock supporting one of the MSE walls, planar discontinuities with adverse orientation were discovered below the proposed wall location. The potentially unstable rockmass was stabilized using post-tensioned rock bolts.

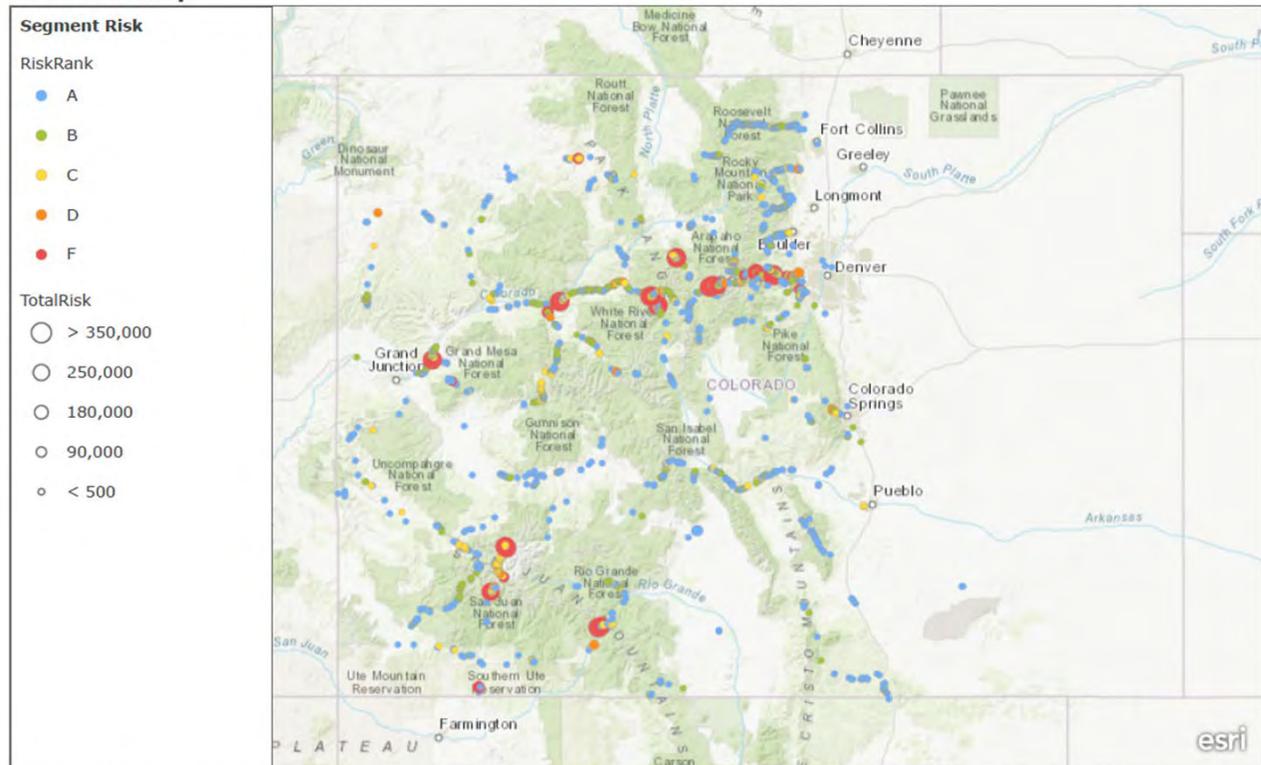
Figure 1 – CDOT Risk Map (segment total risk cost) created by Shannon and Wilson 2018

they can have significant impacts on the traveling public. Risk cost separated into the limits seen in Figure 1 to give each segment a letter grade. One benefit of using segments is that it allows for some discrepancies in event mile marker reporting. Another is that segments allow for multiple hazards to affect one single segment. High risk corridors are selected for feasibility studies which is the first step in designing mitigation to effectively reduce risk and increase slope performance.

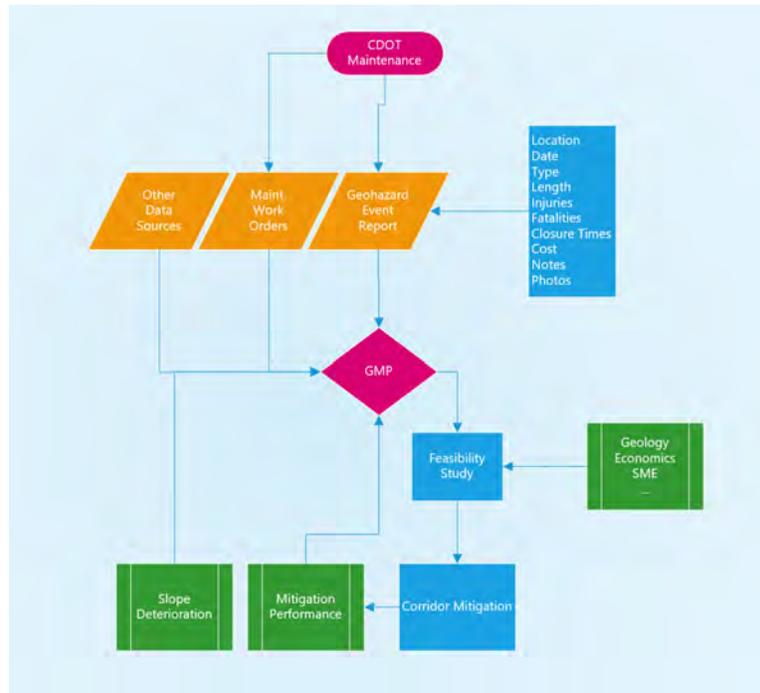
Figure 2 – GMP Flow Chart

CDOT's GMP is intended to guide high level decision making, and is not meant to dictate specific sites for mitigation. Corridor feasibility studies allow for geologic conditions and other factors to be taken into consideration. In these feasibility studies, sites within the corridor are evaluated in order to select areas to mitigate such that the risk grade for the corridor can be improved. In this stage expert judgment and available corridor event data is used to make decisions on site specific mitigation techniques with safety, mobility, and maintenance metrics in mind. Currently, CDOT does not incorporate feasibility study findings into the GMP, but future work will allow for integrating in depth corridor studies to show a risk grade which is more in line with true field conditions. Figure 2 displays a flow chart which outlines the current and aspirational inputs into the GMP.

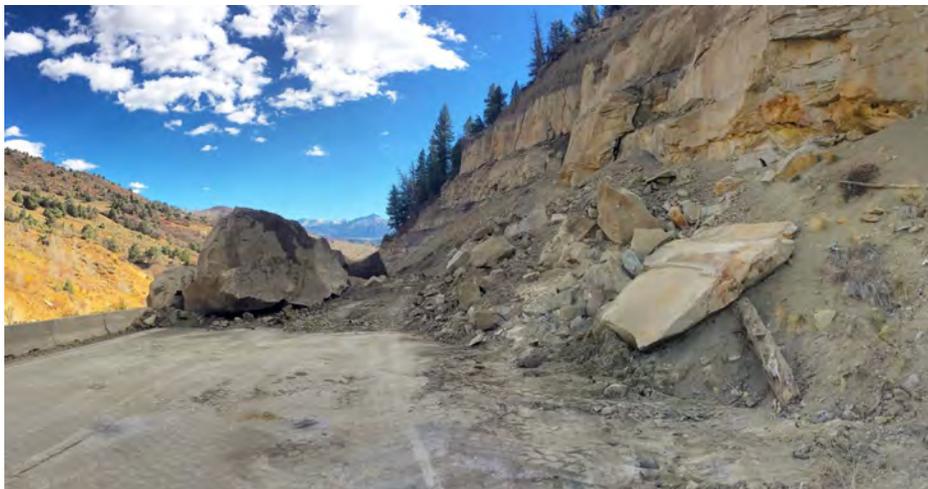
Figure 4 – Large Rockslide on SH 133 near MM 29 Occurred on October 21, 2016

Reported events range in size from small basketball size rocks that are seen during routine rock runs to large scale mobility disruptions as shown in Figure 4. In these cases, specialty contractors are utilized in order to mitigate the remaining hazard on the slope, and assist with downsizing and cleaning the material. In these cases, estimates for the work are included in the maintenance cost for that specific event.

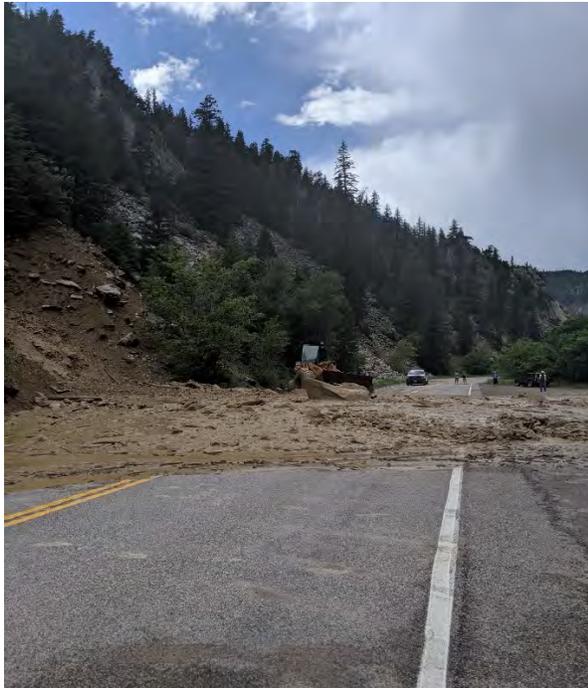
Figure 5 – Debris Flow on SH 133 near MM 53.6 Occurred on July 16, 2019

Small embankment failures are a common occurrence, and are especially active during the spring snow melt season. Often these regular maintenance costs are not accounted for unless there is direct communication with maintenance patrols to specifically request cost data for these fixes. Debris flows as seen in Figure 5 occur following heavy rains which come through the high country each summer. These debris flows often have hours of mobility impact and require the use of maintenance time and equipment to clean.

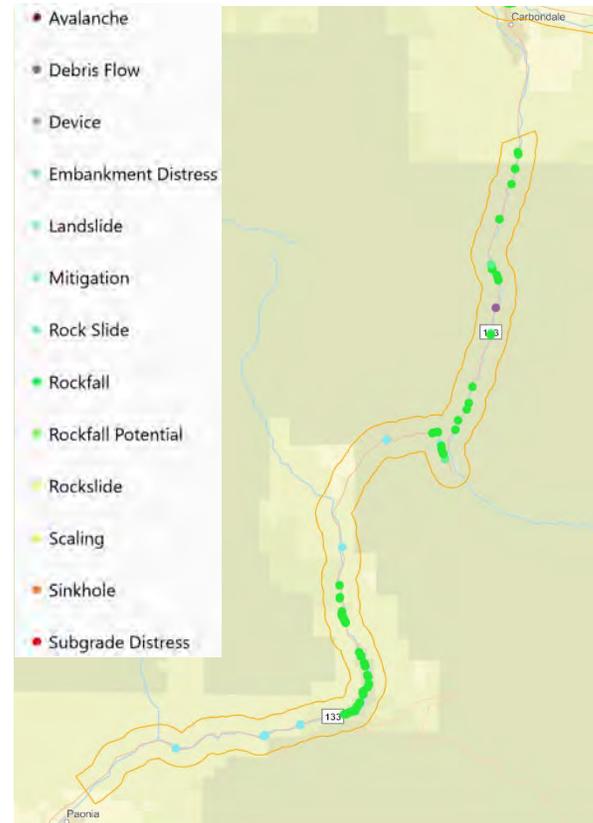
Figure 6 – Reported Geohazard Events on SH 133

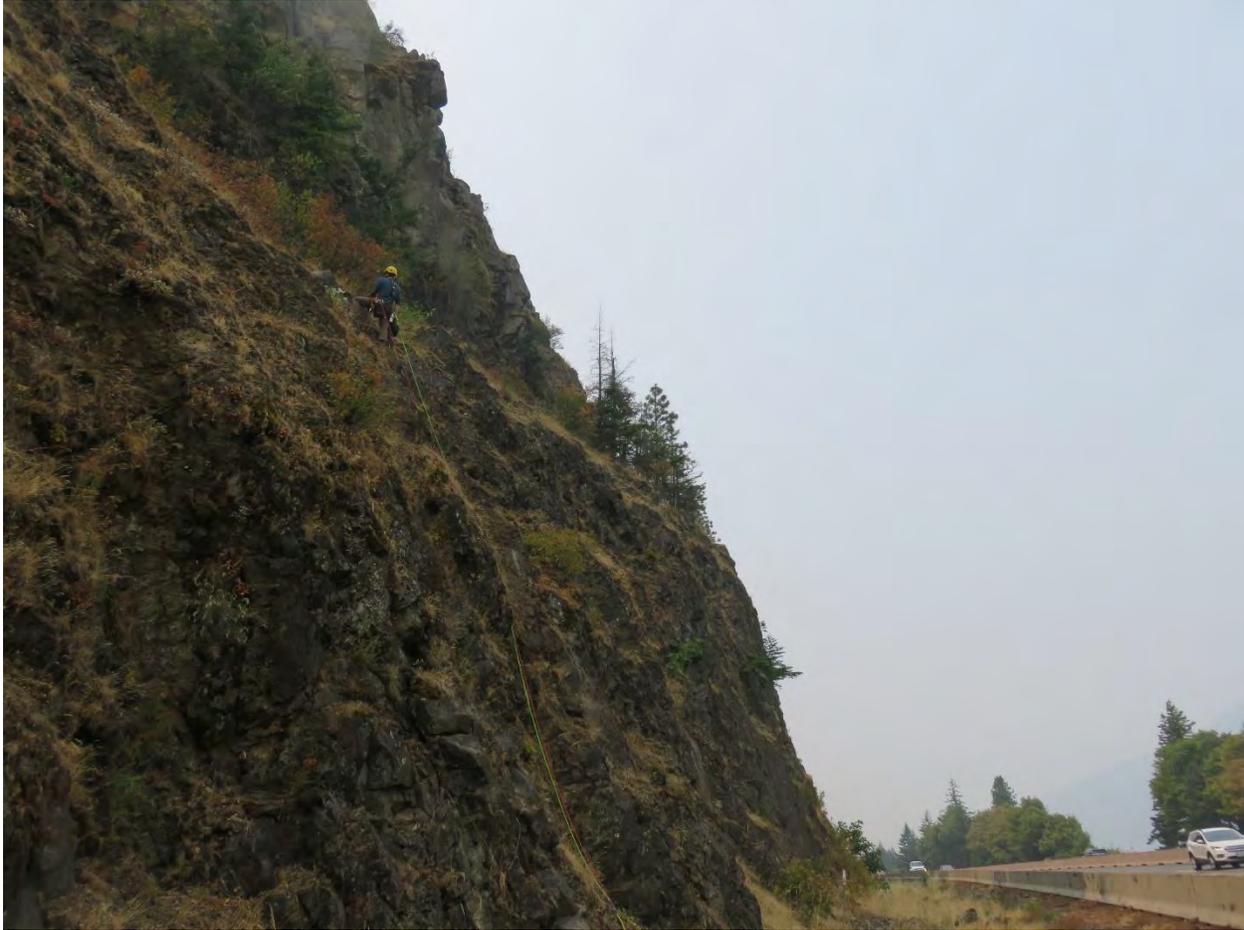
Figure 2: Aid climbing to access the mid-slope bench at Stepped Cut

Rope access techniques were employed at select rock slope reaches to obtain access to upper, steeper slope sections to assess rock mass conditions, rockfall potential, and the constructability of risk reduction measures. Rope access techniques utilized included top-down access (i.e. rappelling off of anchors at the top of the slope to access points of interest on the slope) and ground-up access. Ground-up access was utilized at Rockfall Reach E, Stepped Cut, to access a prominent mid-slope bench on the slope. Due to the relatively large height of the slope (280 feet above I-84) and the potential for loose rocks to be knocked down the slope towards the highway, top-down access was considered to be hazardous. Ground-up access involved aid climbing from the ditch on bolts installed in the cut slope to the mid-slope bench (Figure 2).

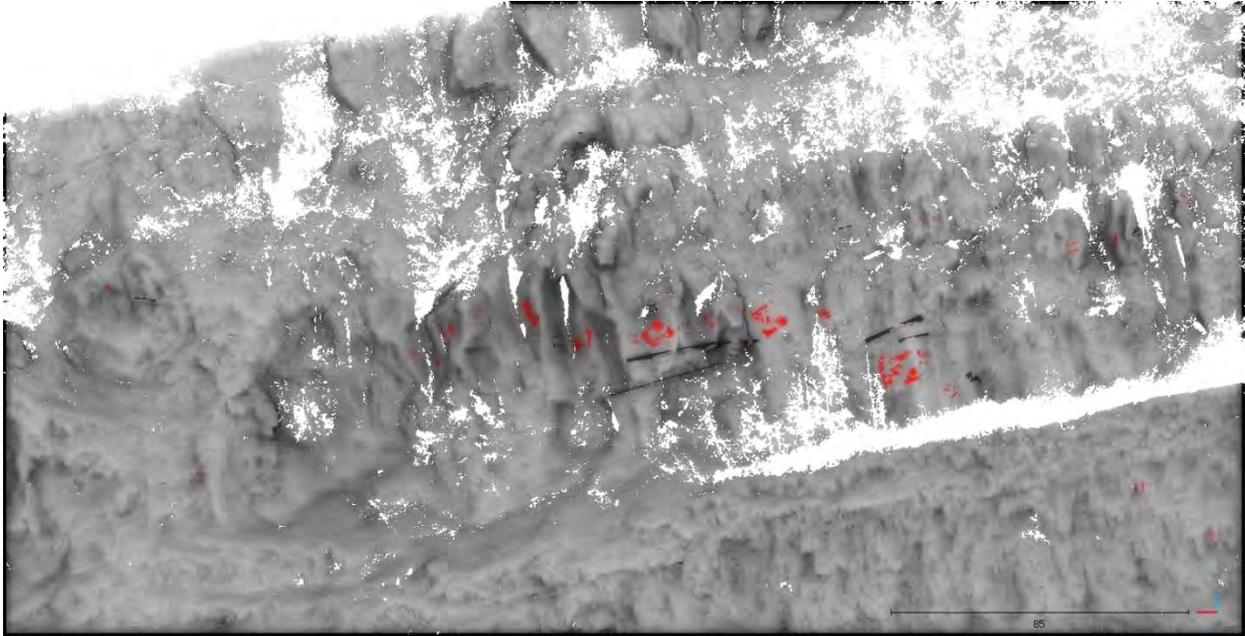
Figure 3: Structural measurements obtained from CloudCompare® on the terrestrial LiDAR obtained point cloud of Stepped Cut. Structural measurements are displayed as red planes on the underlying, gray, point cloud.

Structural mapping was conducted on the seven slope sections along Segment E using LiDAR point clouds with the software program Cloud Compare® (version 2.8.1), and specifically the plugin “Compass”. Compass is a structural geology toolbox for analysis of virtual outcrop point clouds. Within the Compass plugin, the Plane Tool and Trace Tool were used to extract structural measurements from the LiDAR point clouds. The Plane Tool allows the orientations of fully exposed planar structures to be measured while the Trace Tool allows the orientation of geologic structure without fully exposed planar surfaces to be estimated based on the apparent plane’s intersection with the point cloud. A single LiDAR point cloud was produced and provided to LT for each slope section using terrestrial-based LiDAR collected by WFLHD. The resulting clouds produced 426 structural measurements across the seven slope sections. The structural measurements obtained from LiDAR data were supplemented with hand-collected measurements. Figure 3 shows a screen capture from CloudCompare® with structural measurements displayed as red planes overlaid on the gray, point cloud. The slope shown in this figure is Stepped Cut (Rockfall Reach E). Figure 4 shows the location of Figure 3 on a UAV-obtained aerial photograph of Stepped Cut.

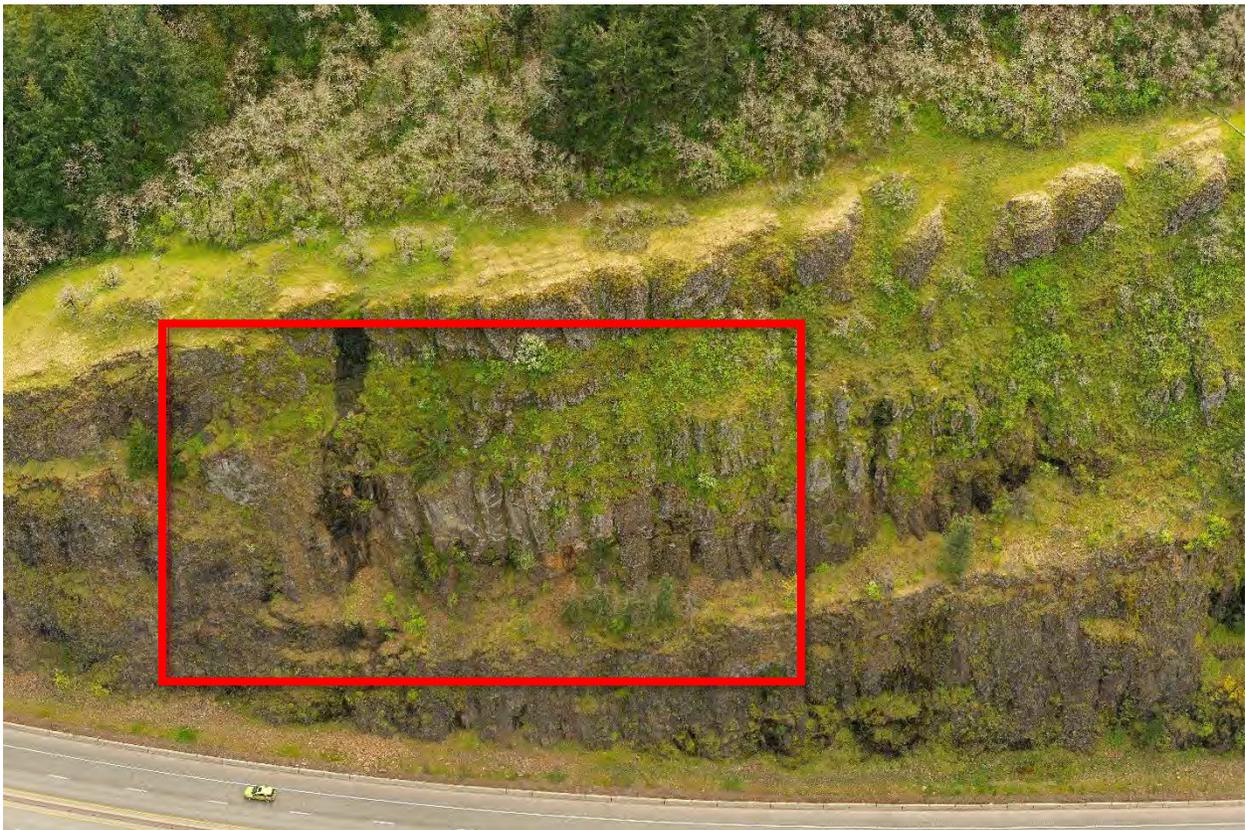
Figure 4: Area of structural measurements on Stepped Cut shown on Figure 3

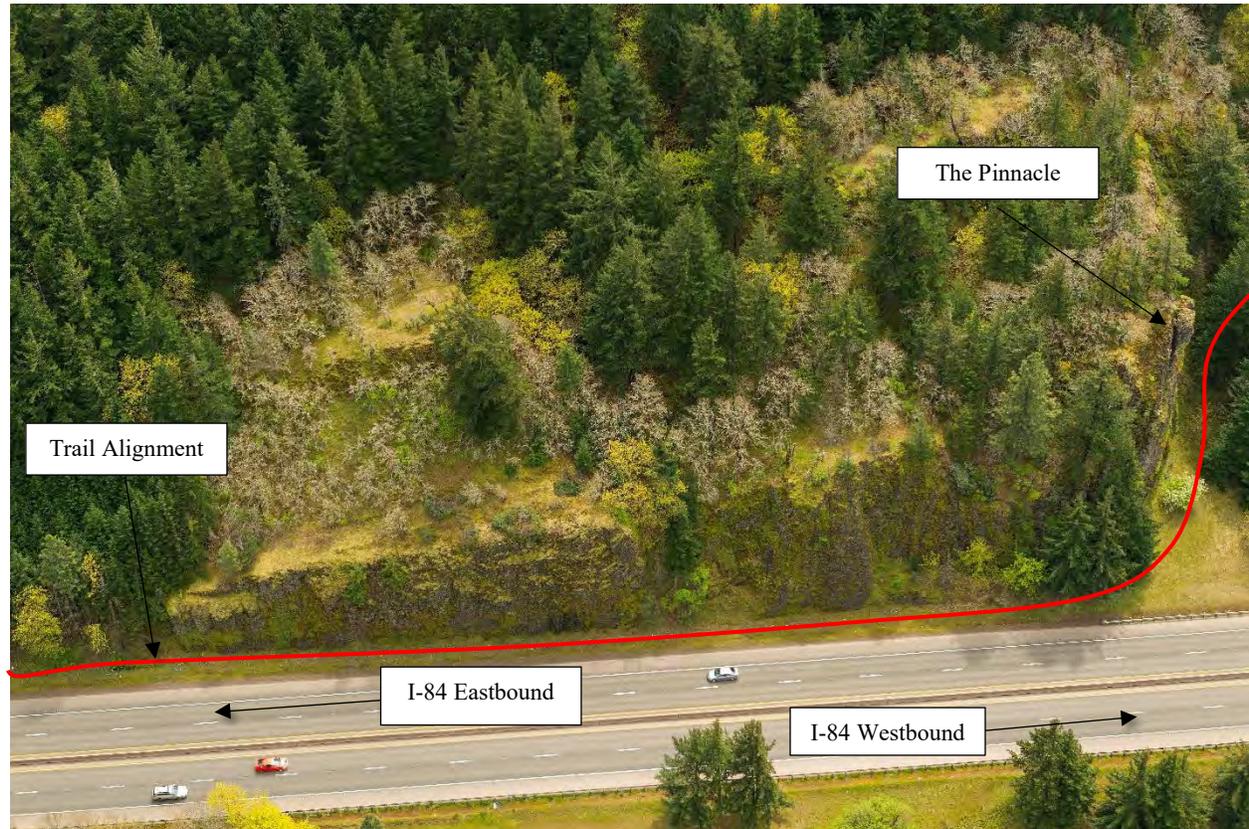
Figure 5: UAV obtained aerial photograph of Rockfall Reach D, The Pinnacle.

Rockfall Reach D, known as the Pinnacle, is a west- to north-facing rock cut, approximately 700 feet long, that ranges between 60 feet and 90 feet high, shown in Figure 5. The trail alignment follows the historic highway grade as it approaches the western outcrops, traveling parallel to talus

slopes. The rock slope is vertical to overhanging at its western extent. At this location, a large pinnacle of rock is separated from the main rock mass by a large crack up to three feet wide. This pinnacle of rock is approximately 32 feet tall by 32 feet wide along its base, and 90 feet above the trail alignment at its top. The portion of the rock slope running parallel to I-84 is cut between 1/4H:1V to 1/5H:1V and tapers downward in height towards the east from approximately 90 feet to 60 feet.

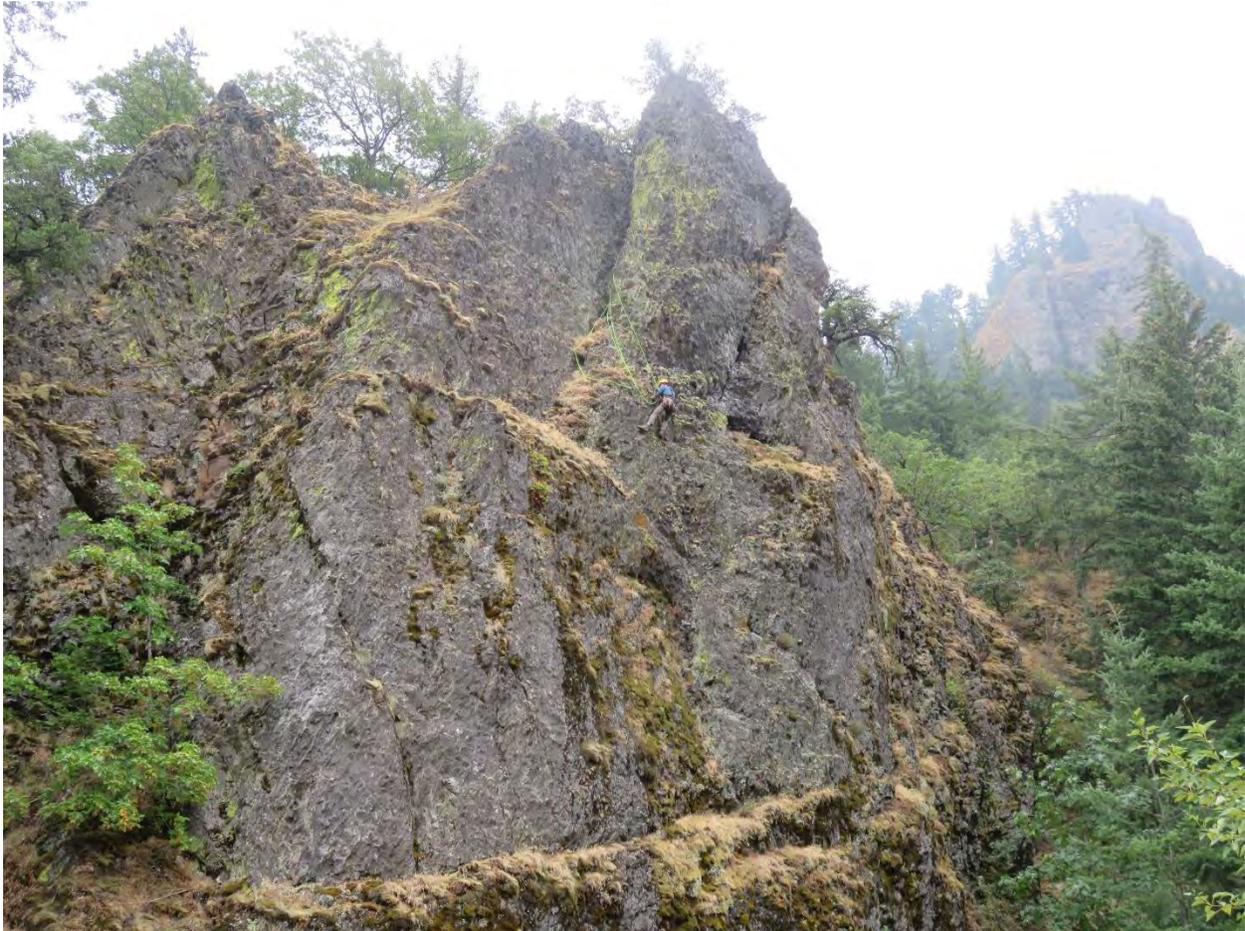
Figure 6: Photo of the pinnacle of rock at the western extent of Rockfall Reach D. Rope access techniques were utilized to obtain structural measurements of the pinnacle.

typically less than one foot in size. Rope access techniques were utilized to further observe the pinnacle of rock at the western extent of the rock slope (Figure 6). Although it appears that the bounding joint set on the east side of the pinnacle has eroded away to the point that a three-foot gap is present, the base of the column is comprised of relatively sound and tight rock. A basal or potential release joint was observed at the base of the rock column. This joint dips towards the northwest at an angle between 38 and 44 degrees. The joint is relatively tight (not open or inflated) and the surface is irregular. Given the favorable characteristics of the joint and the rock mass properties, it is likely that a relatively high internal shear strength condition exists. The basal joint does not appear to daylight on the west side of the column, indicating that it is currently not a through-going joint. Given the above and the fact that there is no historical evidence of recent large-scale failures along the rock slopes in Segment E, the likelihood of a large-scale block, or global failure of the pinnacle is relatively low.

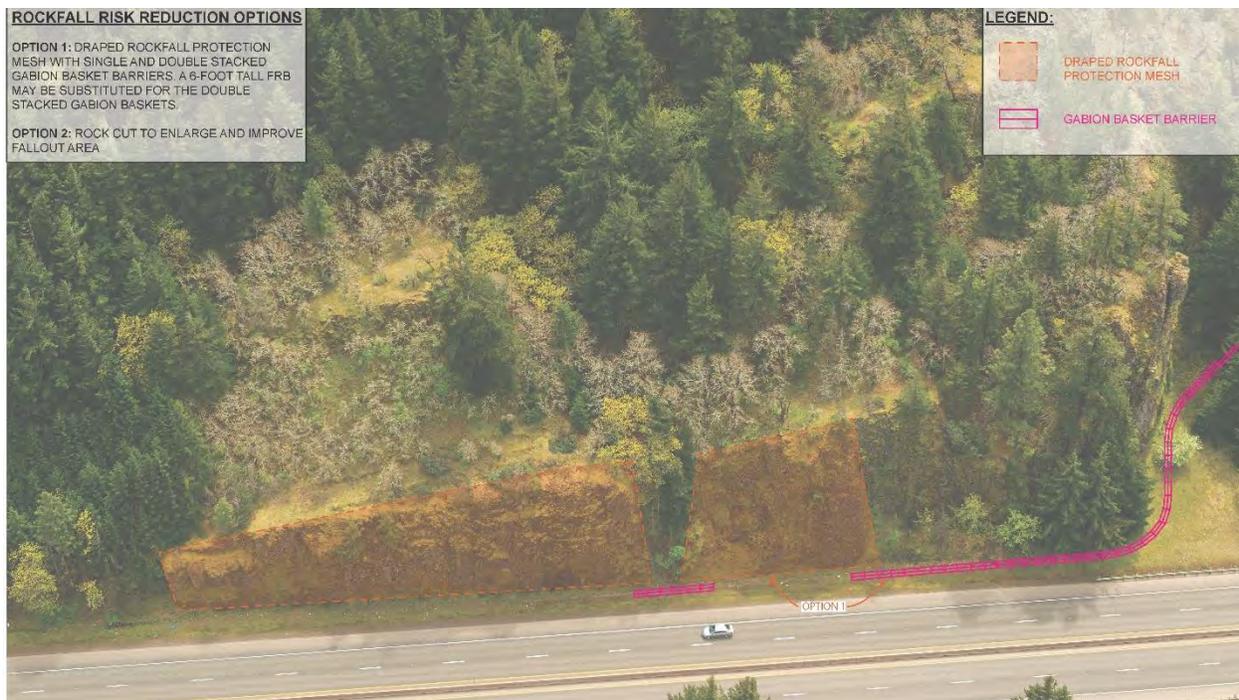
Figure 7: Rockfall Reach D, The Pinnacle, risk reduction options

This option includes the installation of high-tensile strength draped rockfall protection wire mesh along the rock cut slope above the trail alignment, and gabion baskets along two portions of the slope. Two separate areas of draped rockfall protection wire mesh are recommended, with approximate limits shown on Figure 7. To minimize aesthetic impacts to the slope, it is anticipated that the draped mesh would consist of high-tensile strength mesh due to its ability to better contour to the slope when compared to traditional twisted wire mesh. Contouring the mesh to the slope will consist of installing short anchors strategically throughout the rock slope to hold the mesh closer to the rock surface where it would otherwise drape freely. Contouring the mesh will require scaling prior to installation of the anchors to reduce the rockfall risk for workers on the slope. To further minimize the aesthetic impacts to the slope, the draped mesh is expected to be treated with a weathering agent to allow it blend with the natural slope.

This option includes making a rock cut to increase the size of the rockfall catchment area between the slope and the proposed trail alignment. This option would use controlled blasting techniques to construct a ¼H :1V to ½H:1V cut slope to create an additional 20 to 25 feet of fallout between the slope and the proposed trail alignment. Depending upon conditions encountered during the rock excavation, this option may require the use of rock dowels or rock bolts to reinforce select sections of the newly excavated rock slope. It is also recommended that any mid-slope offset benches created by blasting in lifts be limited to 2-feet or less in width or cut at 1H:1V to limit rocks from bouncing off of the bench and into the trail or the interstate. This option would have substantially higher costs and traffic disruptions than option 1.

WFLHD has elected to move forward with the rockfall risk reduction measures presented in Option 1, with the substitution of a six-foot tall, low-deflection, FRB for all gabion baskets. An FRB was selected over gabion baskets to minimize visual obstructions between the trail and the rock slope.
