70TH HIGHWAY GEOLOGY SYMPOSIUM

“Better Highways Through Applied Geology”

October 21-24, 2019

2019 Proceedings

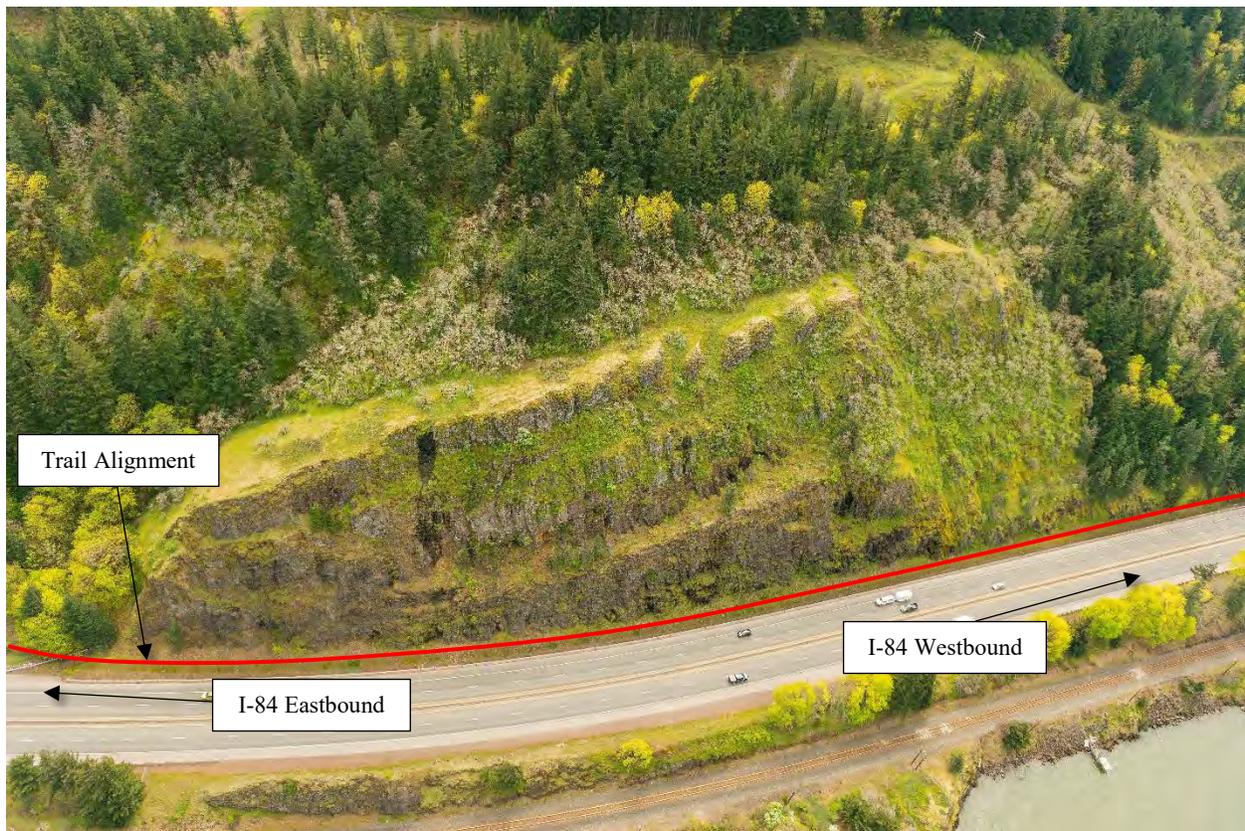
Figure 8: UAV obtained aerial photograph of Rockfall Reach E, Stepped Cut.

Rockfall Reach E, known as Stepped Cut, is a north-facing rock cut, approximately 1,450 feet long with a maximum height of 280 feet, shown in Figure 8. Stepped Cut is the largest rock slope in Segment E. Concrete barriers are currently installed along I-84. It appears the lower portion of the natural slope was cut during construction of I-84. The rock cut slope is relatively short (less than 30 feet high) in the westernmost 200 feet of Stepped Cut; however, the natural slope above the cut extends to 280 feet above the trail. Further towards the east, the height of the rock cut gradually increases to 130 feet. At this location, it appears that the top of the cut follows a natural bench within the rock mass located at elevation 250 feet. This bench gradually dips to the east over a distance of approximately 440 feet until it terminates at elevation 180 feet. At this point, it appears the cut transitioned higher on the slope to approximately elevation 290 feet (approximately 170 feet above the trail), where the top of the cut dips again to the east to an elevation of 250 feet. This section of Stepped Cut is relatively steep with an average inclination of 65 degrees.

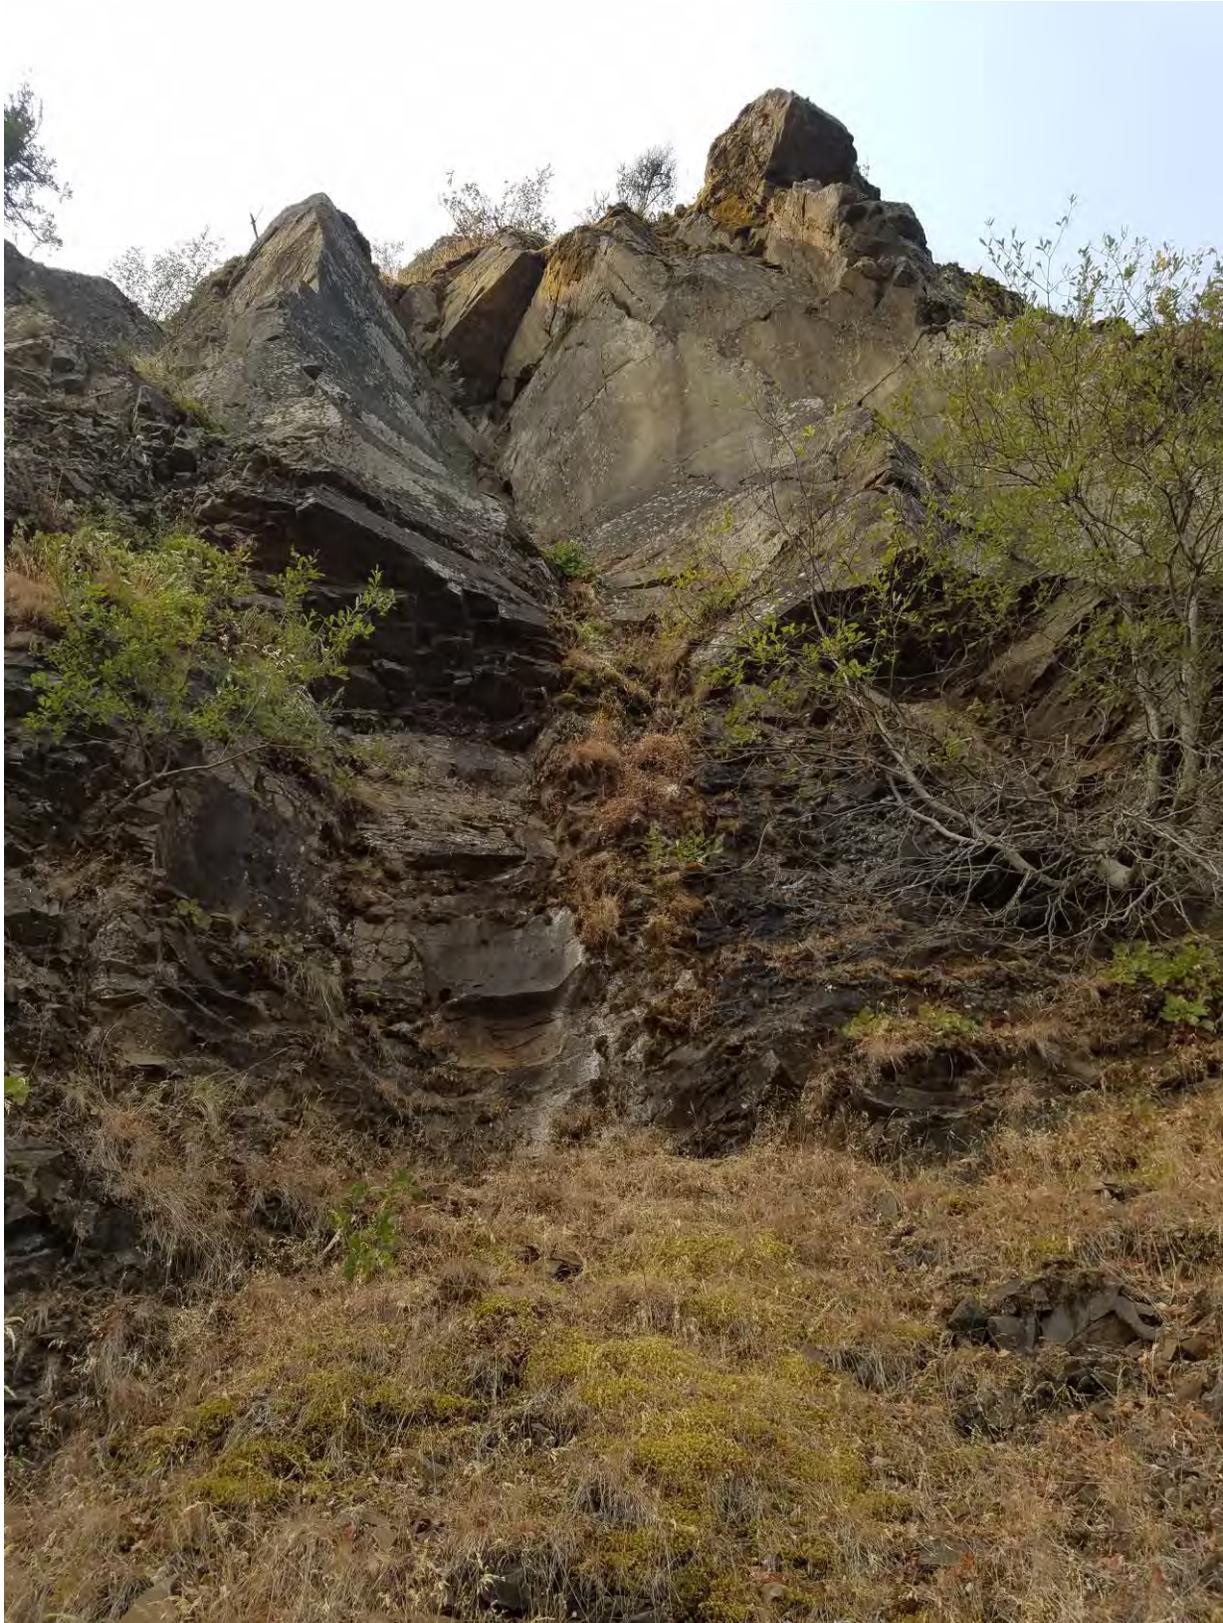
Figure 9: View looking south at undermined, massive columns above the midslope bench of Stepped Cut.

The midslope bench in this area was accessed to evaluate constructability of mid-slope risk reduction measures and to further observe the conditions of the slope above the bench. The slope above the bench appears to be a separate flow. Along the bench, the base of the flow is highly jointed and brecciated. This material is weaker and more prone to differential weathering than the rock in the center of the flow. Rock in the center of the flow also has a wider joint spacing than the base of the flow. This results in the formation of larger rock blocks and columns that are subsequently being undermined by differential erosion. Over an approximately 300-foot-long section above the eastern extent of the midslope bench numerous large rock columns are losing basal support as shown in Figure 9. Although there is no historical evidence of large-scale failures at this site, given continued differential erosion and time, these areas and appear to be a potential large-scale failure concern.

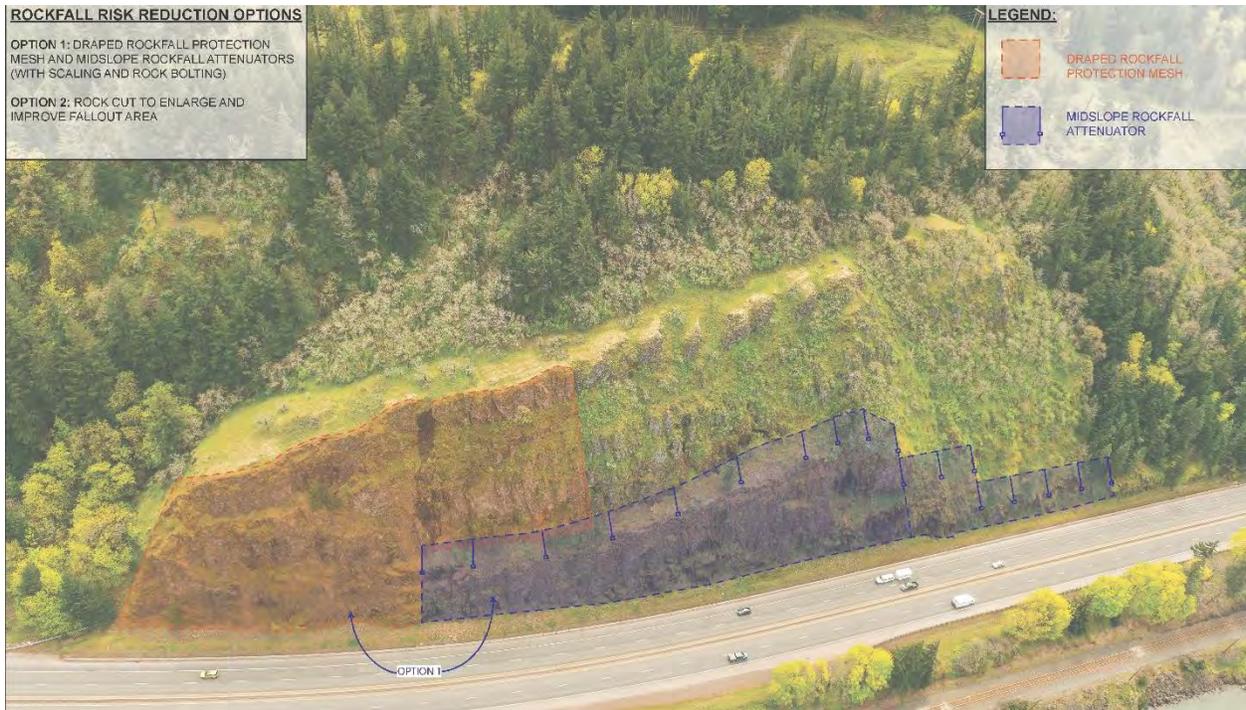
Figure 10: Rockfall Reach E, Stepped Cut, Mitigation Options

This option includes making a rock cut to increase the size of the rockfall catchment area between the slope and the proposed trail alignment. This option would use controlled blasting techniques to construct a $\frac{1}{4}H:1V$ to $\frac{1}{2}H:1V$ cut slope to create an additional 20 to 25 feet of fallout between the slope and the proposed trail alignment. Depending upon conditions encountered during the rock excavation, this option may require the use of rock dowels or rock bolts to reinforce select sections of the newly excavated rock slope. It is also recommended that any mid-slope offset benches created by blasting in lifts be limited to 2-feet or less in width or cut at 1H:1V to limit rocks from bouncing off of the bench and into the trail or the interstate. This option would have substantially higher costs and traffic disruptions than option 1.

WFLHD has elected to move forward with the rockfall risk reduction measures presented in Option 1.

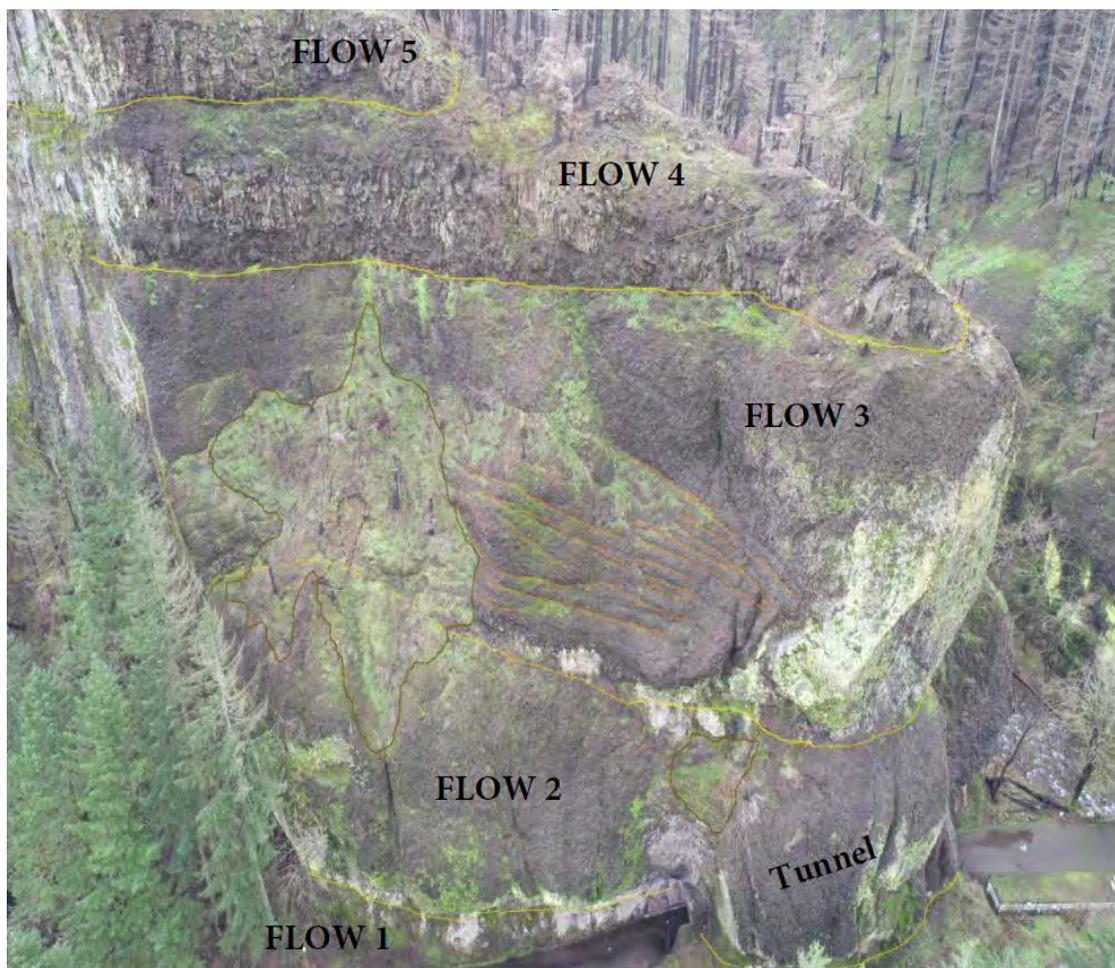
Figure 2 – Oneonta Promontory Showing Basalt Flows (1-5) and Tunnel

Oneonta Tunnel was constructed through the OP basalt outcrop at the mouth of Oneonta Creek where the Oneonta Creek Gorge meets the Columbia River Gorge. The HCRH crosses a bridge at the mouth of the Oneonta Gorge about 100 ft west of the tunnel. The roadway is situated at about elevation 45 ft and is about 15 ft above the bed of Oneonta Creek. Near vertical to overhanging basalt rock cliffs extend up to about elevation 300 ft south of the portals, and north of the portals along the northern terminus of the OP prior to reaching the HCRH.

The flows exhibit varied geologic and volcanic structures, including large- and small-diameter columnar (vertical) cooling joints, flow banding, vesicles, and variable weathering. A set of near-vertical fractures with iron oxidation, weathering of mafic minerals, and secondary clay seams cross the west side of the tunnel. Following heavy precipitation these fractures transmit water to the tunnel crown.

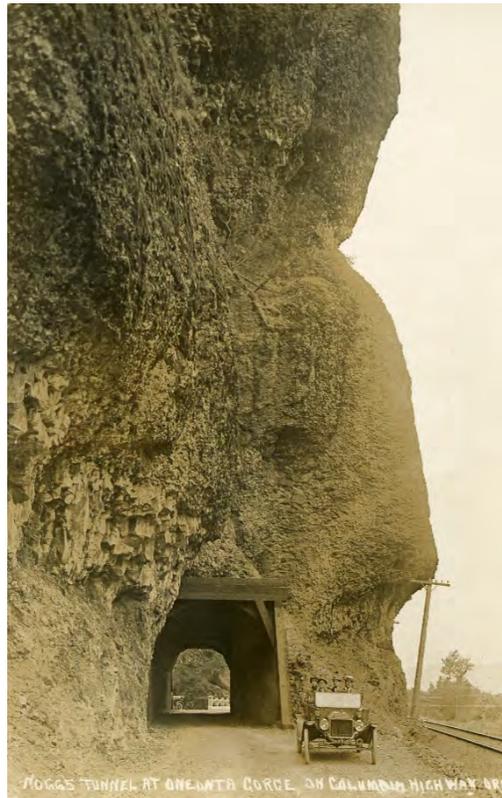
**Figure 3 – Oneonta Tunnel East Portal, circa 1920.
Note railroad is located on current alignment of HCRH.**

Oneonta Tunnel measures 115 ft in length, 20 ft in width, with a nominal vertical clearance of 19 ft. The tunnel is horseshoe-shaped in cross section. The tunnel was constructed using boring and mining techniques. Areas of weak rock were present in the center of the tunnel and resulted in local crown heights on the order of 25 to 30 ft. A timber liner was constructed to protect tunnel users from falling rocks inside the tunnel.

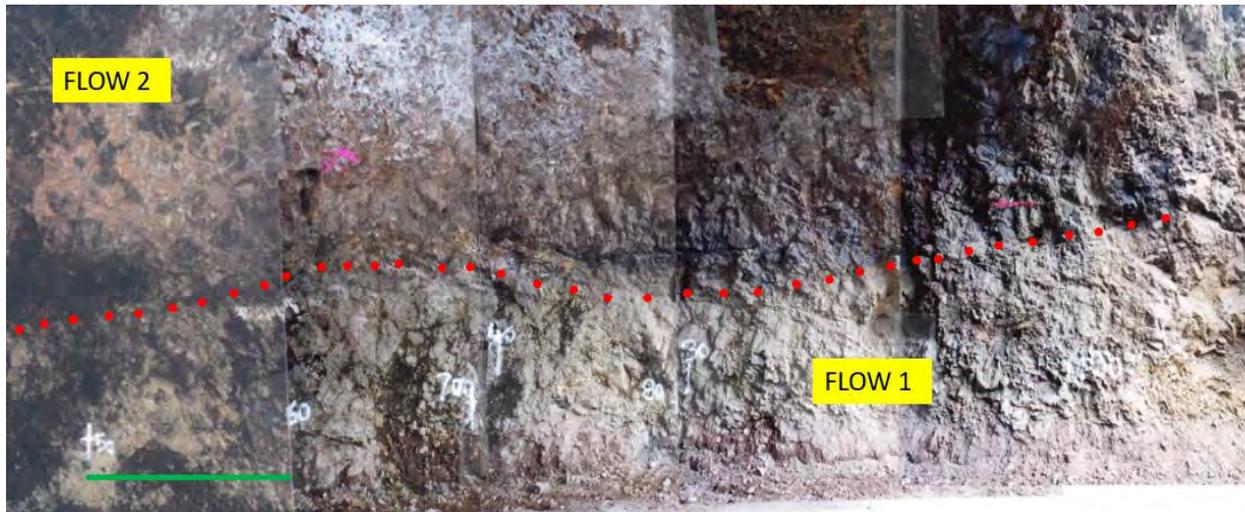
**Figure 4 – South Wall of Tunnel Showing Contact (Red Dots) Between Flow 1 and Flow 2.
Green bar = 10 ft.**

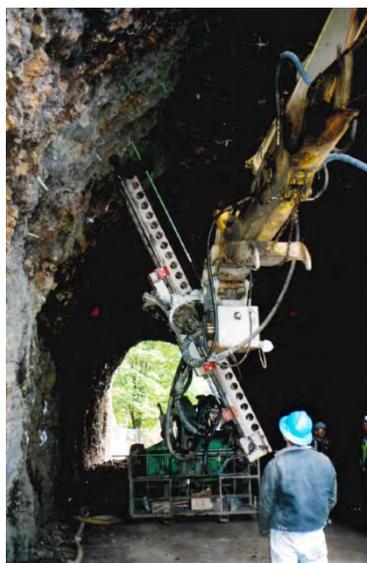
Figure 5 – Installation of Rock Dowels in Tunnel Crown

Between 2006 and 2009, ODOT contracted for restoration of the tunnel. Restoration included installation of about 250, 10 ft long resin-grouted rock dowels in the tunnel, installation of mine straps in areas of jointed/weak rock, installation of strip drains, and construction of structural shotcrete liner and a non-structural wood liner. To address an area of particularly weak and weathered rock and thin roof cover associated with the Flow 1/Flow 2 contact, mine strap and a series of steel sets were installed near the East Portal. The tunnel was reopened in 2009 as a pedestrian-only feature.

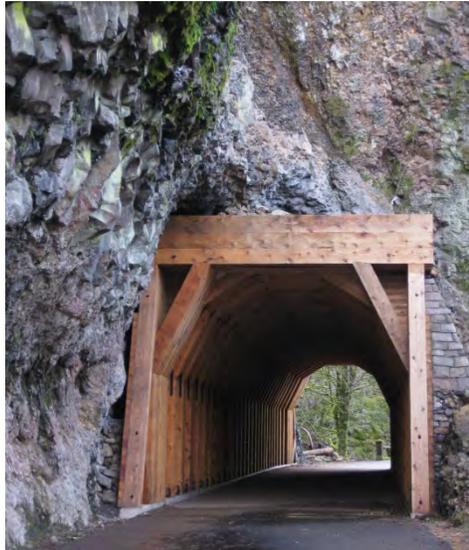
Figure 6 – Restored Tunnel with Wood Liner. View of East Portal.

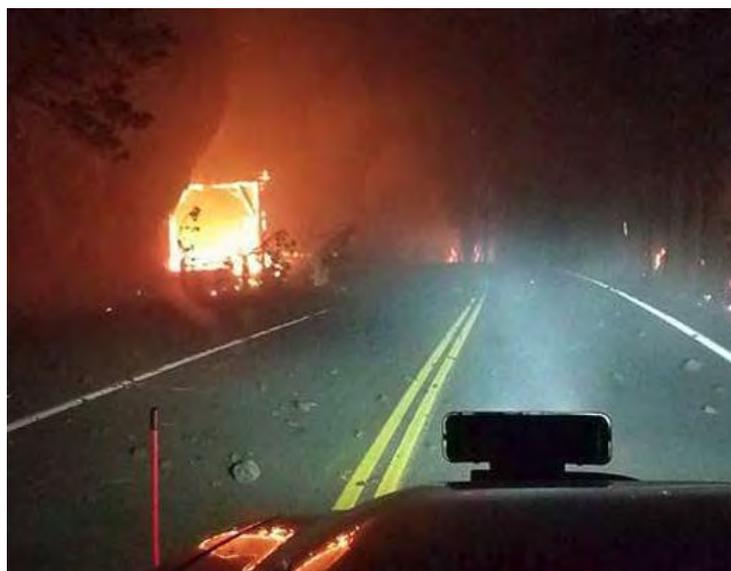
**Figure 7 – Tunnel Wood Liner Burning.
Note fire-related rockfall debris in roadway.**

In September 2017, the entire wood liner of the tunnel burned during the Eagle Creek Fire.

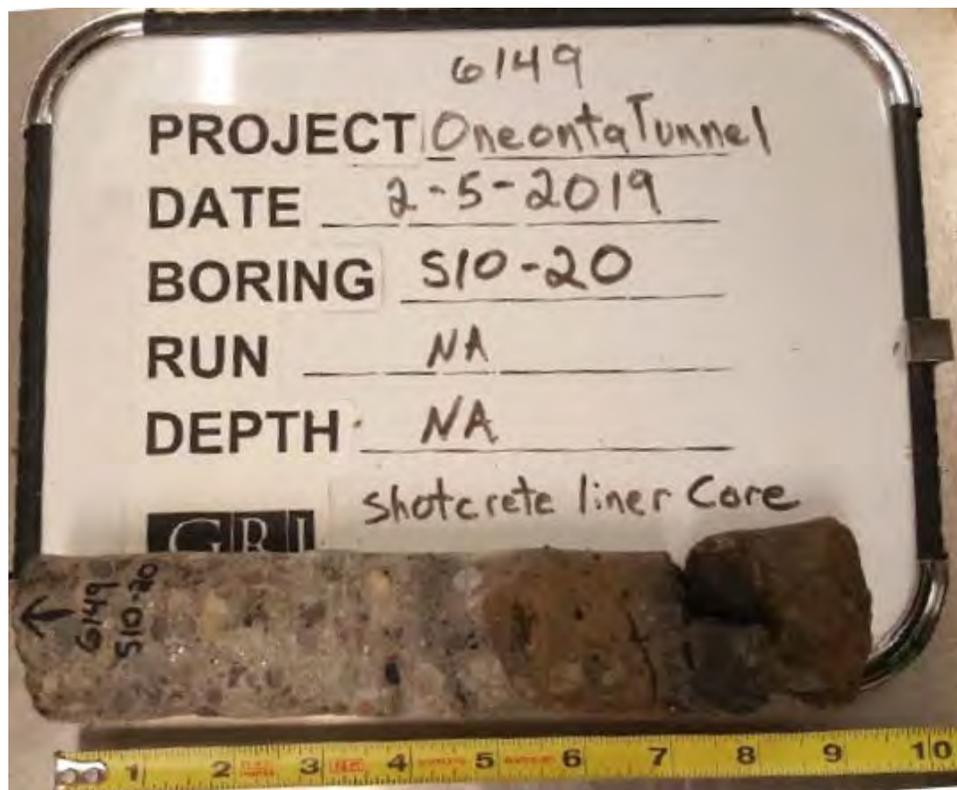
Figure 8 – Shotcrete core S10-20.
Note excellent bond of shotcrete (gray, left) to tunnel wall rock (brown, right).

As part of a second planned tunnel restoration, the post-fire performance of the tunnel support system was evaluated in February 2019 using a program of dowel tension testing, shotcrete coring and strength testing, and structural mapping. The shotcrete liner consisted of two layers: an inner layer with contact on the rock face of the tunnel, and an outer, rougher top coat or “cover” layer. The outer cover layer appeared to be locally damaged by spalling. The inner layer did not appear to be damaged by spalling. Two small (less than 1 sq ft in size) localized areas of the outer and inner layer appeared to be damaged by the fire, resulting in exposed sections of the strip drain. Some areas of the shotcrete were wet from tunnel seepage. Over the course of very cold weather in February 2019, icicles were noted due to seepage from the tunnel crown. Minor accumulations of ash, presumably from the burned timber liner, were locally observed on the shotcrete. Six cores of the shotcrete liner were drilled and collected. In general, the shotcrete cores were observed to be in good condition. The test results ranged from 4,374 to 6,070 psi with a corrected average of 5,080 psi. Each of the shotcrete cores tested close to or in excess of the tunnel design minimum compressive 28-day strength of 4,500 psi.

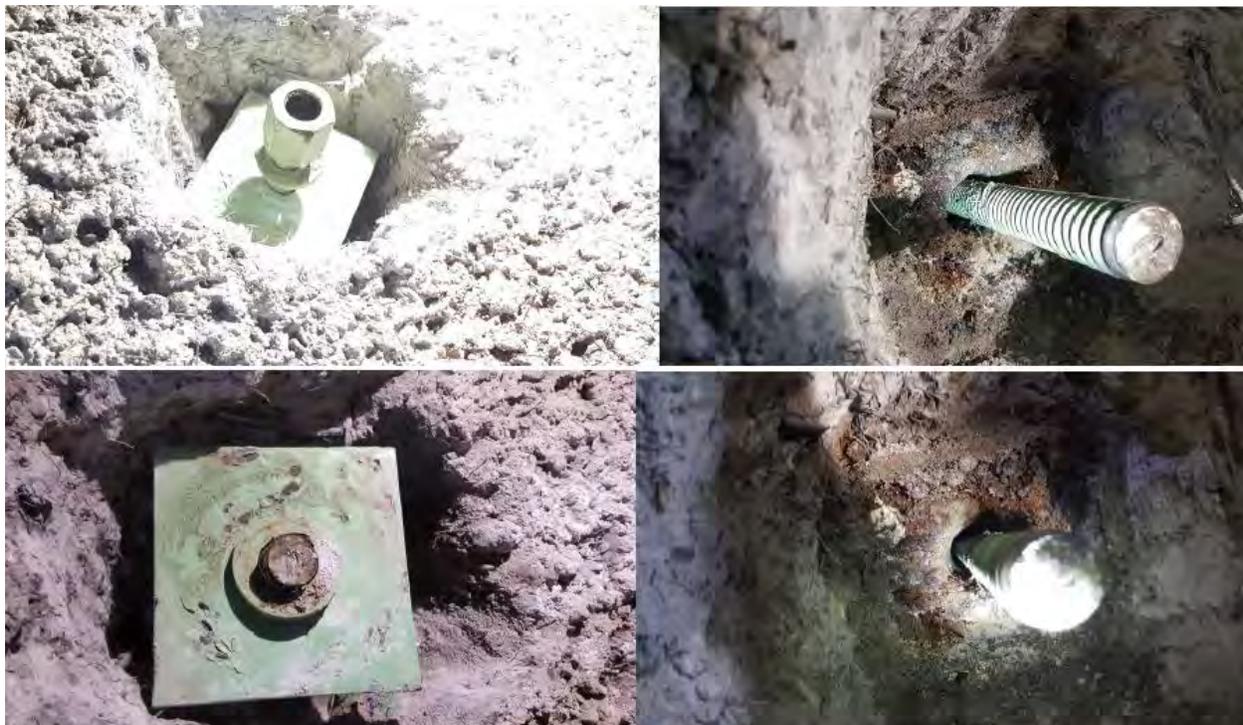
**Figure 9– Dowel S50-15. Tension test = Pass.
Note green epoxy coating in good condition with no noticeable fire damage.**

In February 2019 seven rock dowels from the tunnel were exposed and tension-tested by a local specialty contractor. GRI personnel observed and documented the dowel evaluation and testing work. The dowels were tension-tested under a 30-kip load, which was the load applied to several test dowels during construction. Six of the dowels were located in the tunnel beneath shotcrete. One dowel (S110-20) was located outside the tunnel proper in the south wall of the East Portal and outside of an area of shotcrete cover.

Five of the seven dowels passed the 30-kip tension load test. One of the failed dowels (S10-10) was installed in the west portion of the tunnel in an area with numerous clayey seams and fractures noted during original construction. The other failed dowel (S110-20) was not covered by shotcrete and was noticeably damaged by the fire. Two other dowels also not covered with shotcrete were observed near failed dowel S110-20 and appeared damaged by the fire.

The remaining five dowels passed the load test and did not appear to have noticeable fire damage.

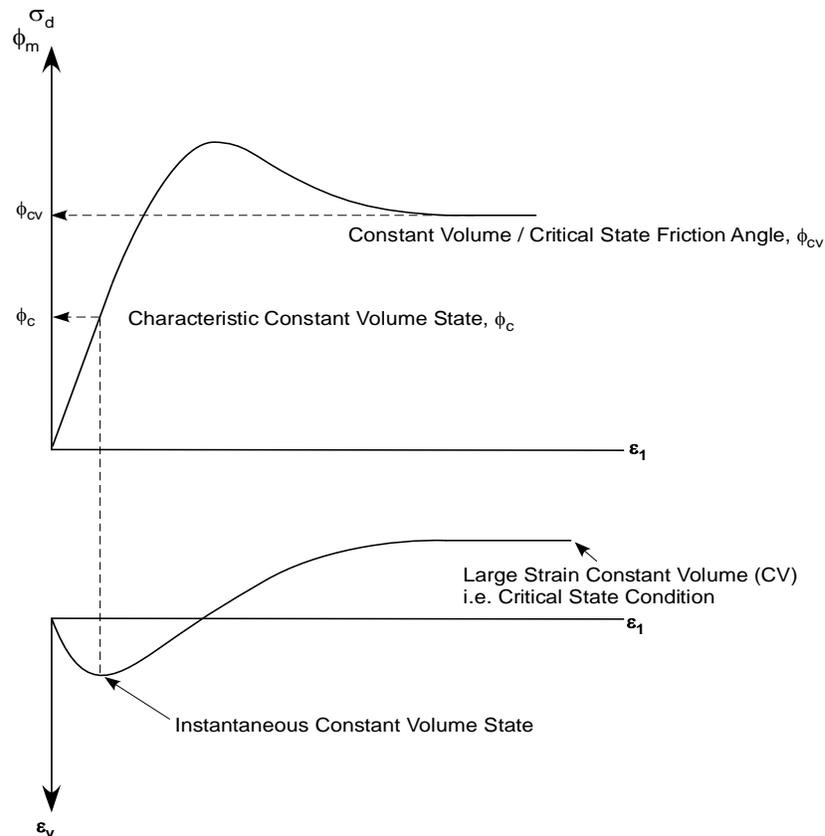
Figure 1 - Assessment of Characteristic (ϕ_c) and Constant Volume (ϕ_{cv}) Friction Angles of Sand (after Lade and Ibsen 1997)

Concurrent with the stress-strain response, the volumetric strain ($\epsilon_v = \Delta V / V_o$) of the sample is also recorded. Such response is portrayed in Fig. 1. Of note are the characteristic or phase transformation friction angle (ϕ_c or ϕ_{PT}) and the constant volume or critical state friction angle (ϕ_{cv}). As shown, the characteristic friction angle occurs when the volumetric strain reaches its maximum compressive value. By contrast, the constant volume friction angle corresponds to the volume change flattening out and becoming constant post peak strength.

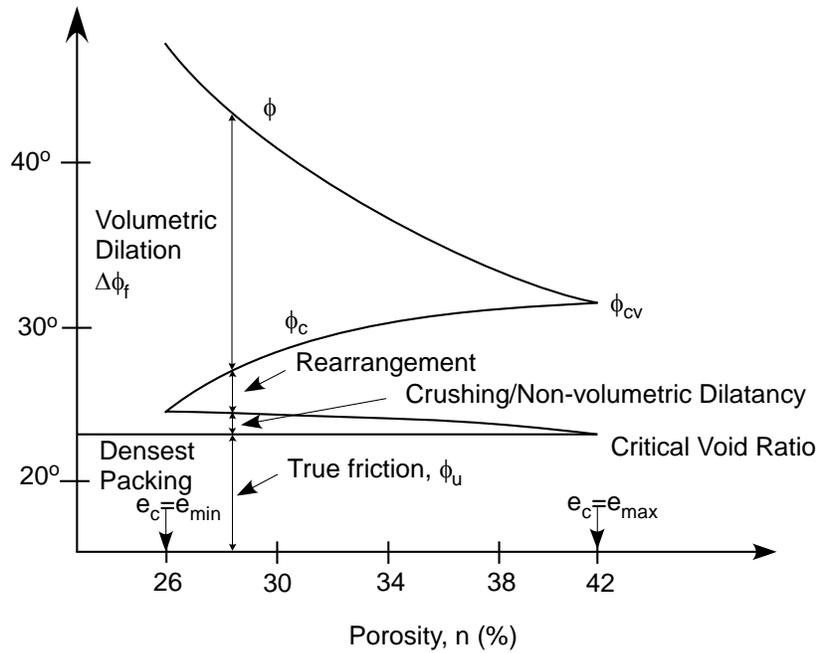
Figure 2 - Components of Peak Friction Angle (Modified from Mitchell 1993, after Rowe 1962)

Figure 2 shows how the characteristic friction angle is envisioned and how it changes with density as expressed in terms of porosity (n = volume of voids / total volume) or void ratio [e = volume of voids / volume of solids, which is equal to $n / (1 - n)$]. The characteristic friction angle is that part of the peak friction angle (ϕ) less the volumetric dilatant component of strength ($\Delta\phi_f$). At the loosest state (the critical void ratio), the peak, the characteristic and the constant volume friction angles become one and the same. See Fig. 3.

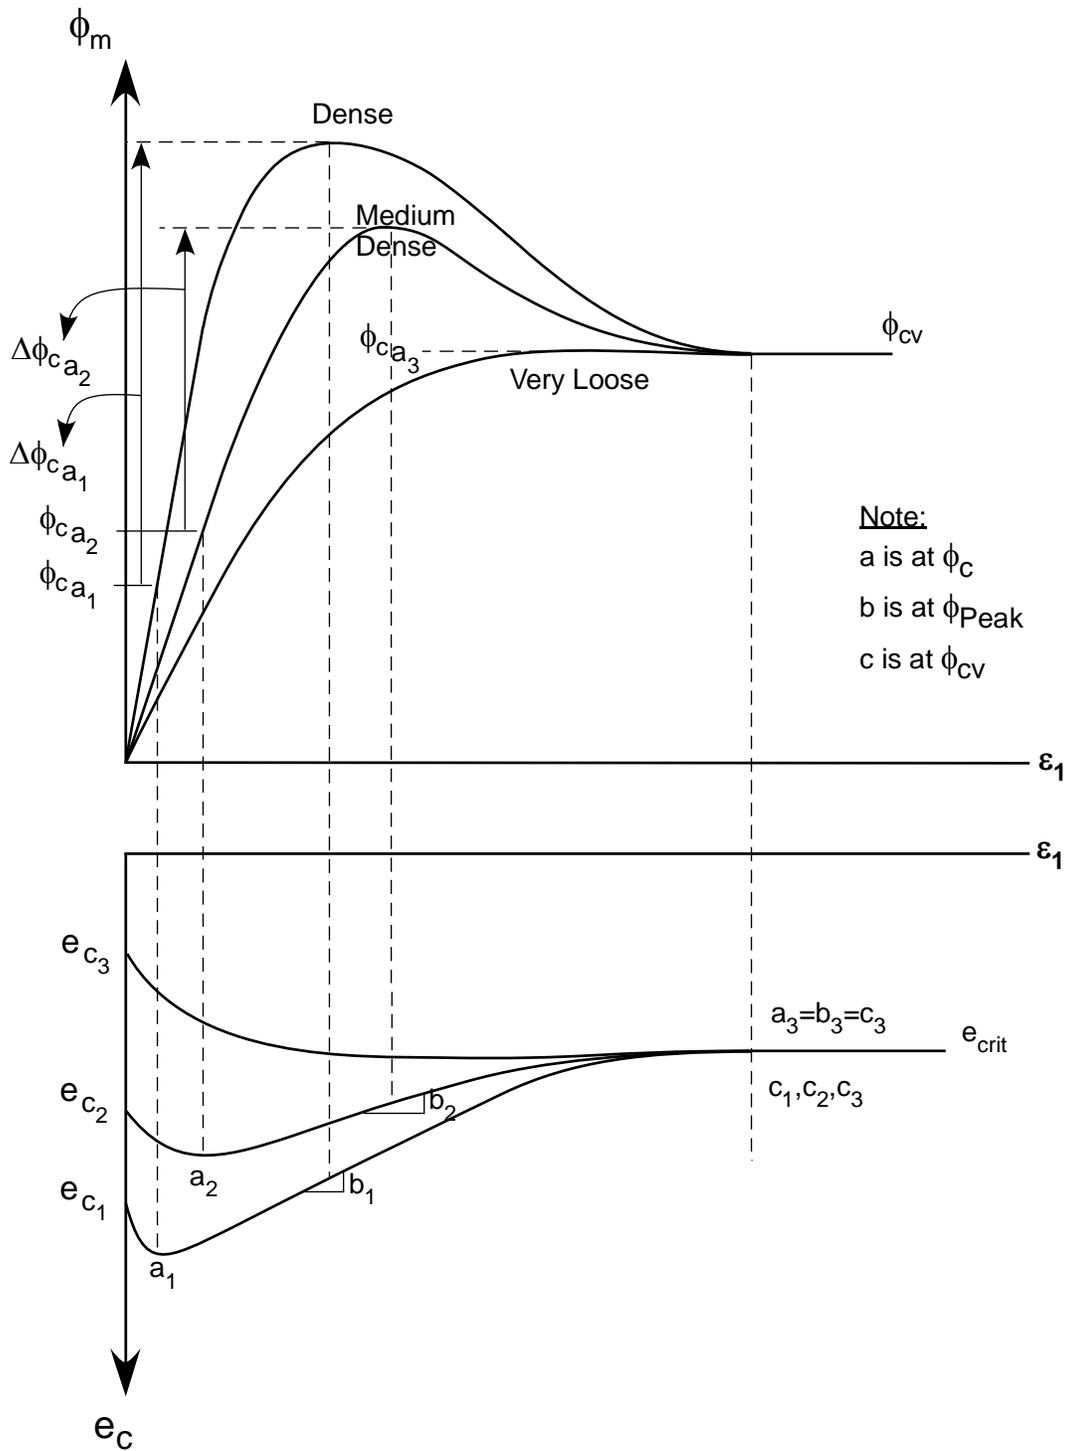
Figure 3 - Convergence of ϕ_c and ϕ to ϕ_{cv} at Very Loose Conditions (i.e. ϕ_{cv} as a special case of ϕ_c)

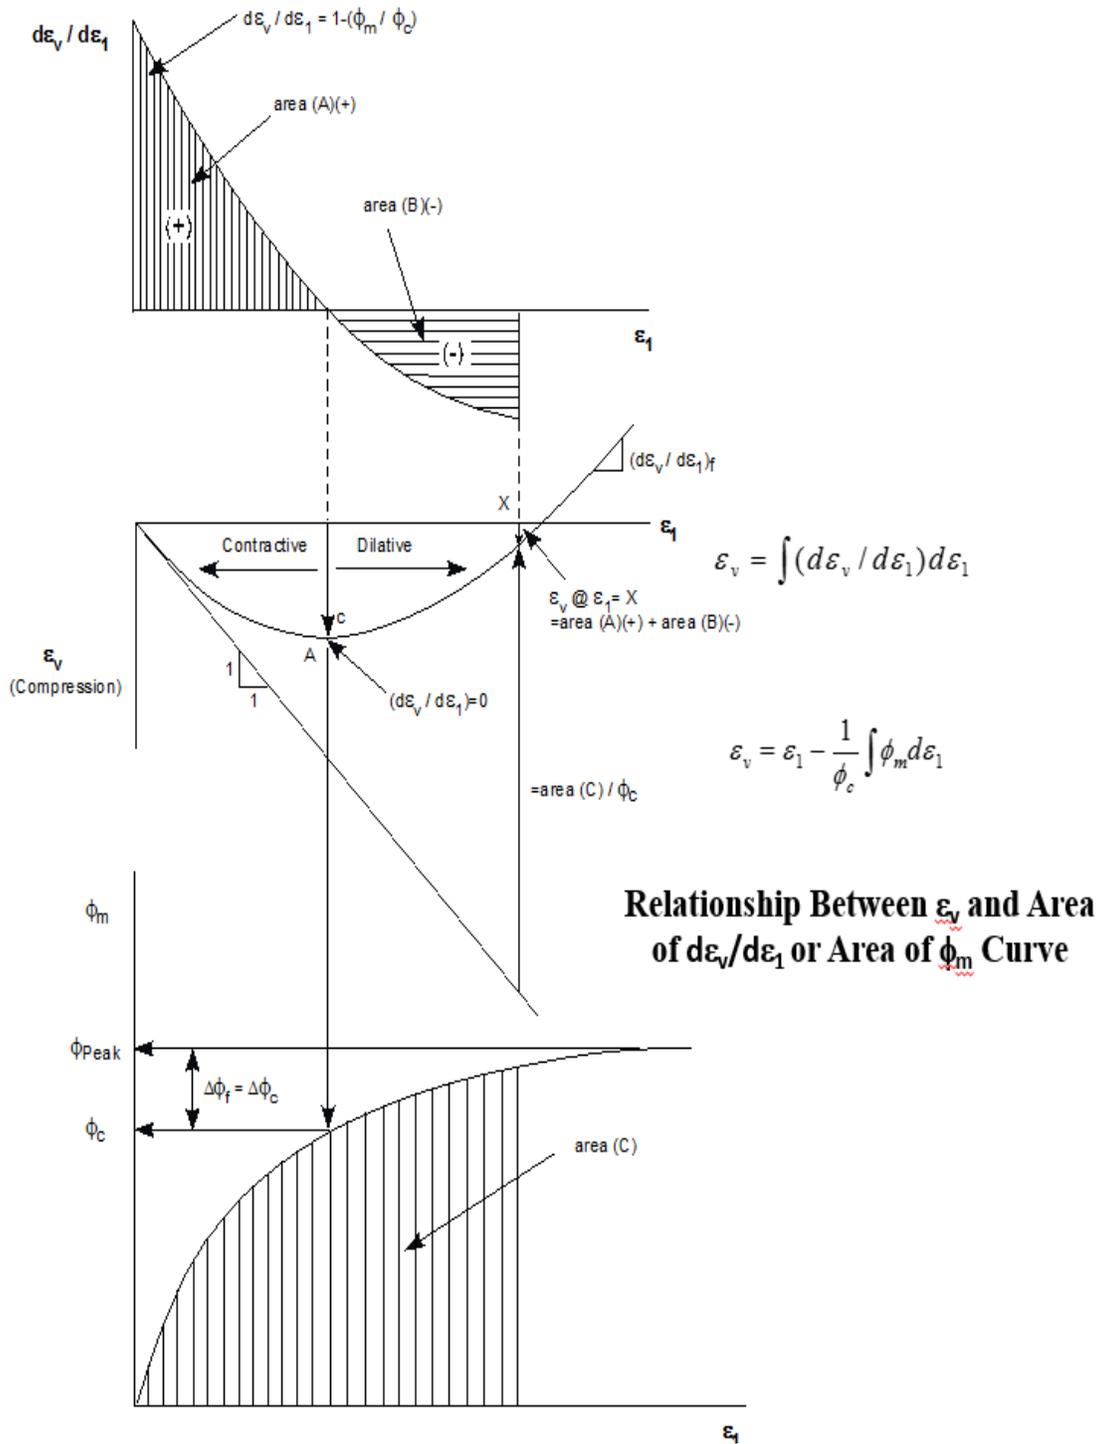
Figure 4 - Important Relationship Linking Stress-Strain and Volume Change Behavior: $d\varepsilon_v/d\varepsilon_1 = 1 - \phi_m/\phi_c$

As shown in Fig. 4, the characteristic friction angle becomes an integral factor in linking volume change behavior to developing stress as expressed in terms of the mobilized friction angle (ϕ_m) as given by the expression

The volumetric strain, ε_v , at any ε_1 is the offset from a 1:1 line of ε_v versus ε_1 equal to the area under the ϕ_m versus ε_1 curve, divided by ϕ_c , up to the value of ε_1 in question.

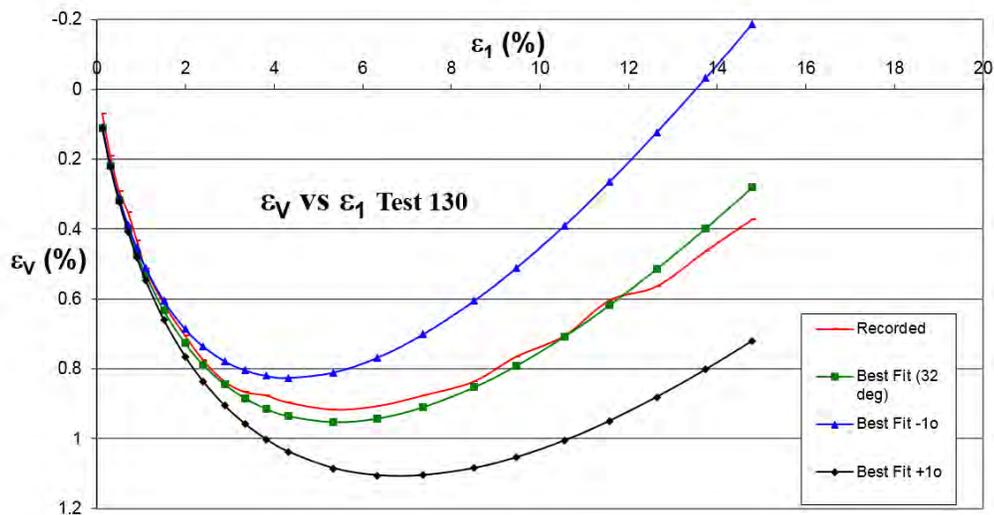
Figure 6 – Determination of Best Fit Value of ϕ_c of Loose Sand

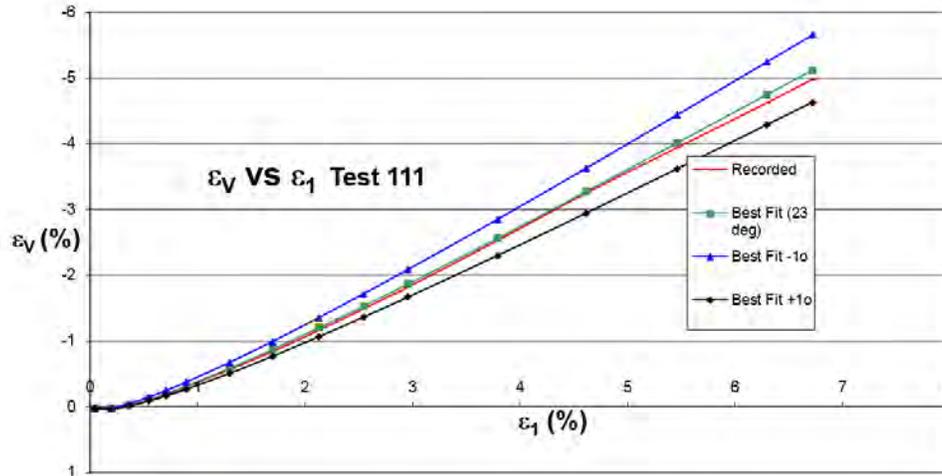
Figure 7 – Determination of Best Fit Value of ϕ_c of Dense Sand

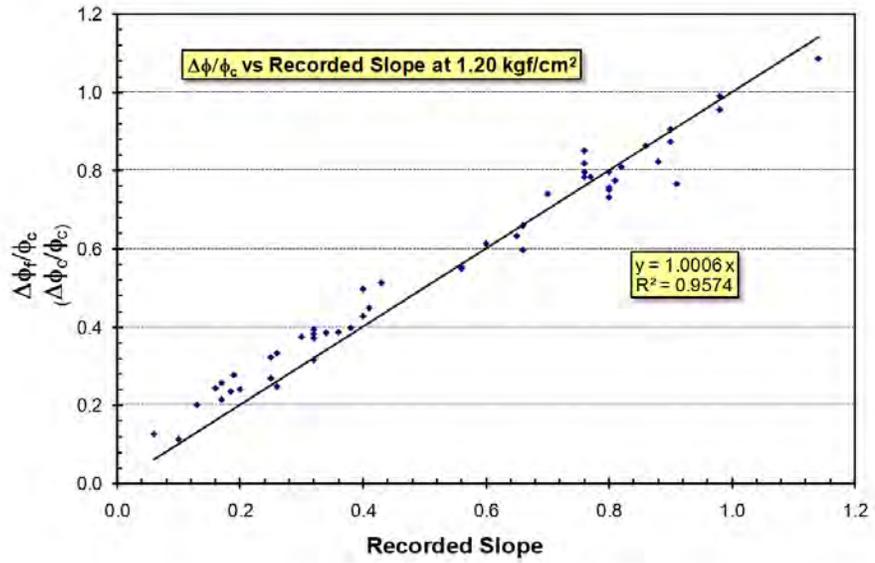
Figure 8 – Assessed (i.e. $\Delta\phi_f/\phi_c$) versus Recorded $(-d\varepsilon_v/d\varepsilon_1)_f$ Slope at Peak Resistance

If ϕ_m in Eq. 3 is set equal to the peak friction angle (ϕ), then the corresponding $\epsilon_v/d\epsilon_1$ at failure becomes the negative of the difference $\Delta\phi_f = \phi - \phi_c$ divided by ϕ_c . Figure 8 provides a comparison of the recorded vs predicted dilatant slope $(d\epsilon_v/d\epsilon_1)_f$ at failure from those tests at the confining pressure of 1.20 kg/cm^2 . Similar results were obtained at the two other confining pressures.

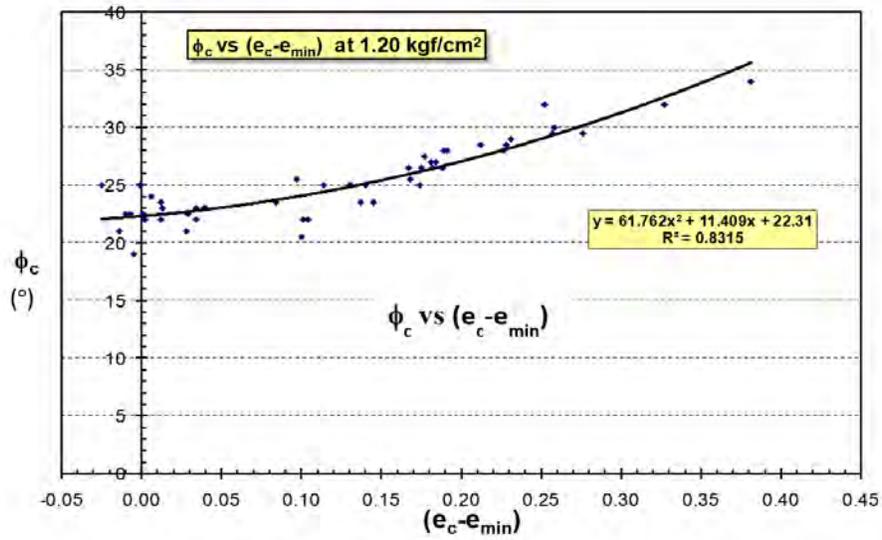
Figure 9 – ϕ_c as a Function of Density versus Recorded $(-d\varepsilon_v/d\varepsilon_1)_f$ Slope at Peak Resistance

The variation of the characteristic friction angle with density as expressed in terms of the void ratio of consolidation (e_c) relative to e_{\min} is shown in Fig. 9. A simpler but more memorable relationship in terms of the porosity of consolidation (n_c) can be found in Fig. 10 for the 1.20 kg/cm^2 confining pressure. There is only a slight difference (in the fourth decimal place, i.e. $0.600x$) for the other two confining pressures.

Realize, however, Figs. 9 and 10 are for (virtually) the monosize sand fractions ($C_u = 1.18$) tested.

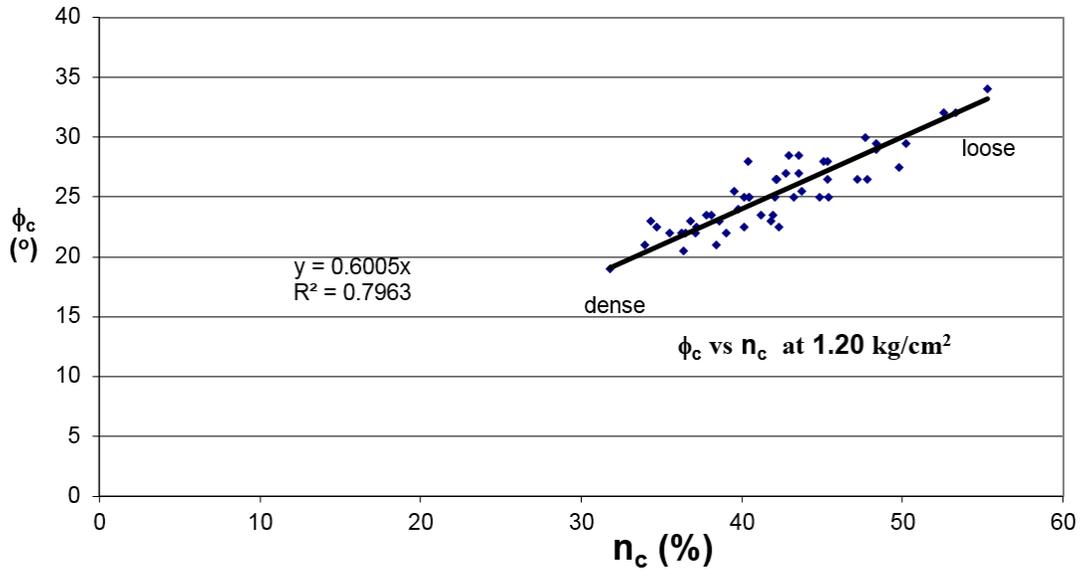
Figure 10 – A More Memorable Relationship

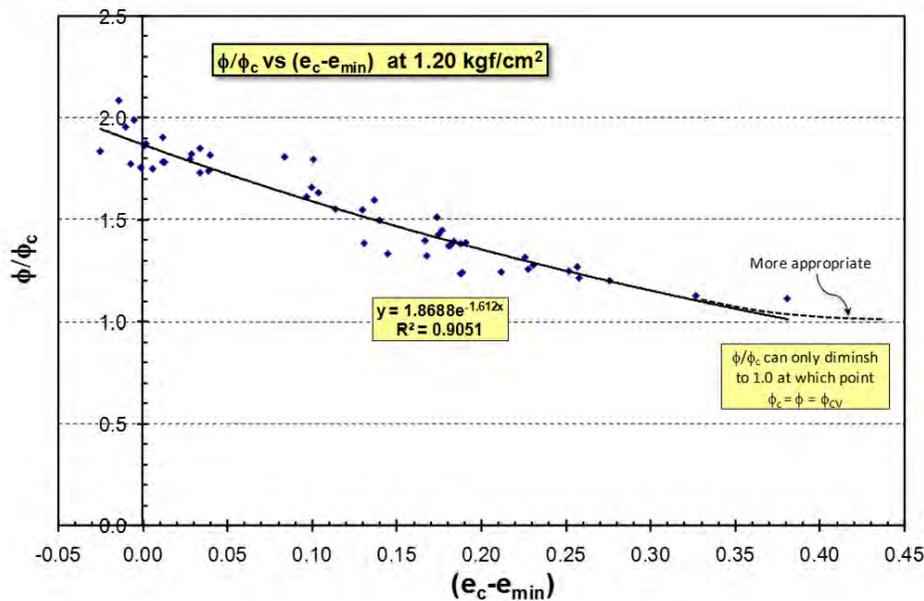
Figure 11 – Normalized Peak Friction Angle versus Density

Figure 11 is a plot of the ratio of the peak to the characteristic friction angle versus density for tests at 1.20 kg/cm^2 . The availability of this relationship suggests that knowing the peak friction angle, one might evaluate the characteristic friction angle knowing the density state, and then use the characteristic friction angle to predict the volume change behavior even for those tests where volume change was not recorded. From the drained response, the undrained response is then achievable (Ashour and Norris 1998).

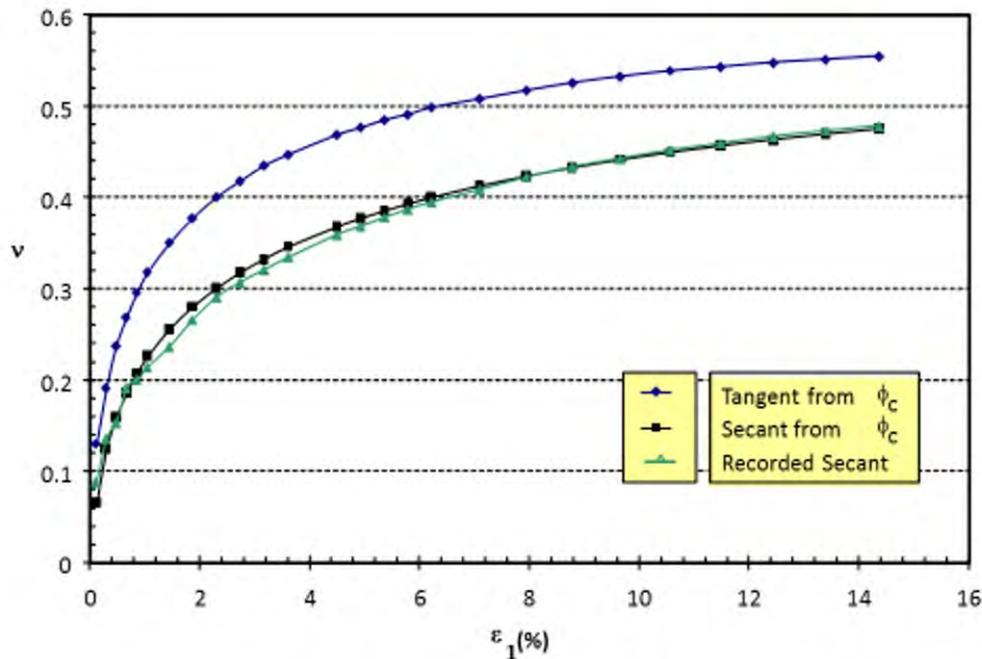
Figure 12 – Variation in Poisson's Ratios (Tangent and Secant) with Strain, Test 139

Figure 5 shows the evaluation of ν_{sec} from Eq. 6 versus the recorded value $[= \frac{1}{2} (\varepsilon_1 - \varepsilon_v) / \varepsilon_1]$ in the Excel sheet for Test 77. Figure 12 shows such variation as compared to the recorded variation with strain for Test 139.

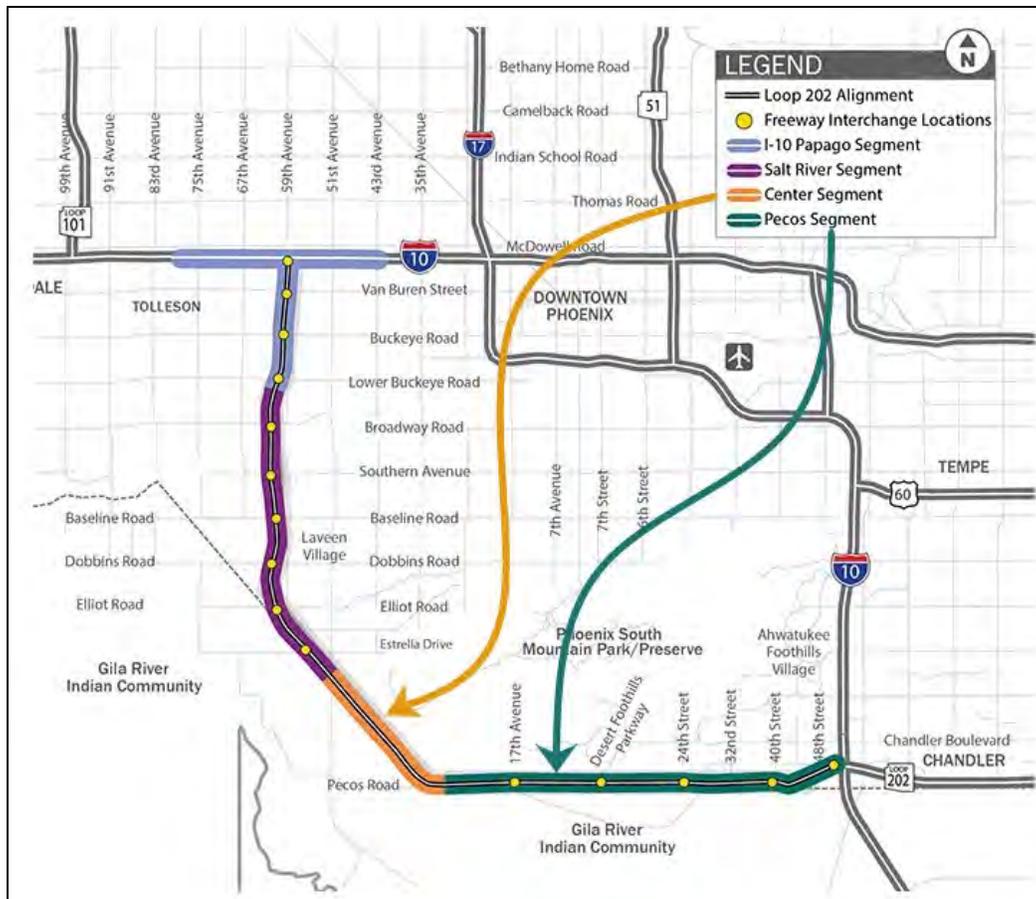
Figure 2 -- Location of Pecos and Center Segments

The roadway alignment was divided into four reaches, or Segments, according to the character of road and its surroundings. Rock excavation has only been required in the Pecos and Center Segments (Figure 2, next page).

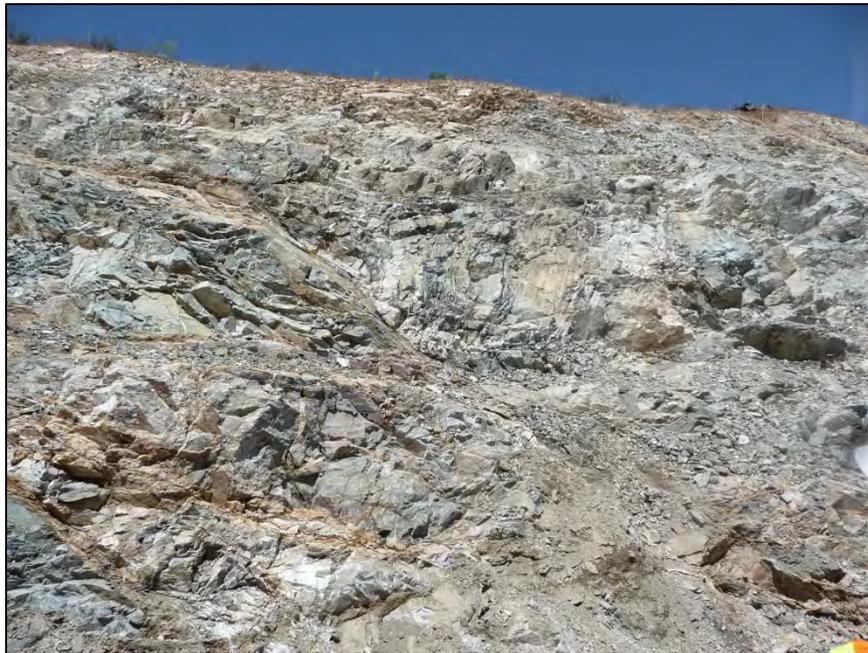
Figure 3 -- Wavy Complex Shears and Fractures Overlain on Foliation Patterns

These multiple deformation events imposed a complex combination of faulting, fracturing, folding and mylonitization on the rock and resulted in a highly variable rock mass condition over relatively short distances (Figure 3).
