70TH HIGHWAY GEOLOGY SYMPOSIUM

“Better Highways Through Applied Geology”

October 21-24, 2019

2019 Proceedings

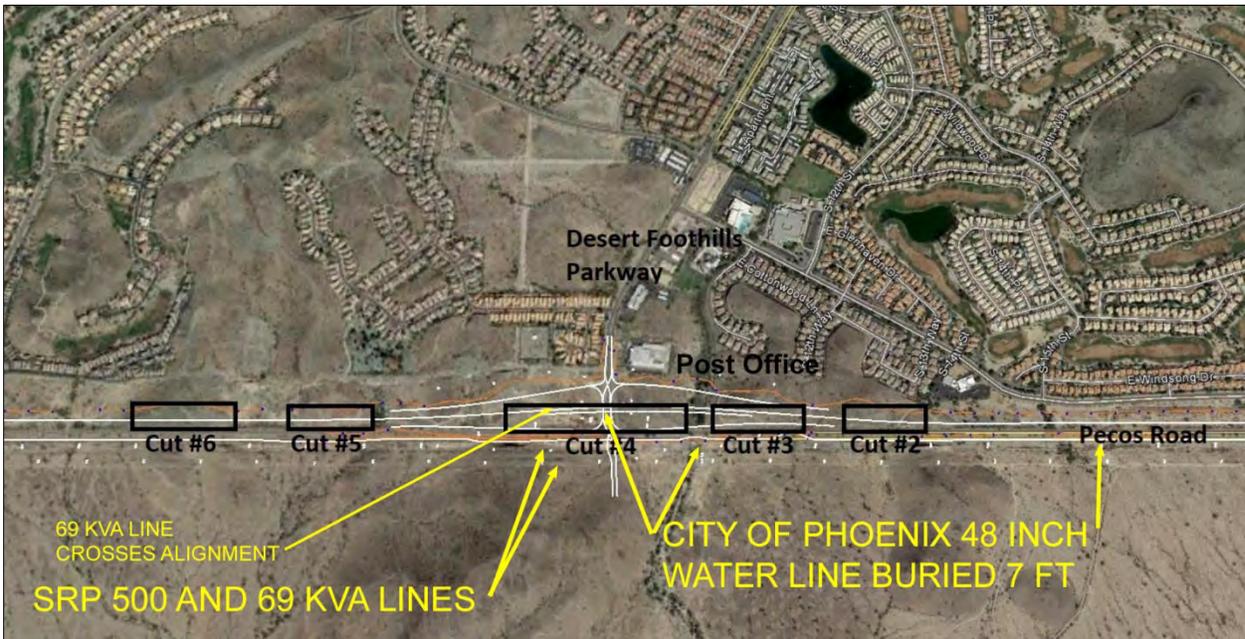
Figure 4 -- Pecos Segment Rock Cuts Requiring Blasting

The Pecos segment contains 6 significant cut slopes, 5 of which required blasting (Cut 1 was ripped to grade). Figure 4 shows the distribution of the cuts.

Figure 4 shows that excavation was on the north side of existing Pecos Road, close to the existing subdivision developments. A major interchange is within the limits of Cut 4 at Desert Foothills Parkway. The mainline will pass beneath Desert Foothills Parkway in a long depressed section. Through most of the depressed roadway section, Cut 4 sides were ramp cross-slopes designed at 3H:1V and 4H:1V. The geometries of the rock cuts in Figure 4 are summarized in Table 1 below.

As is apparent from Figure 4, rock excavation for the Pecos Road segment had to contend with nearby residential development, the Post Office at the intersection of Pecos and Desert Foothills Parkway, buried pipelines, a pump station, sequencing of excavation and detours on Desert Foothills Parkway, traffic control on roadways adjacent to the blasting areas, and overhead high-voltage power lines. Houses were as close as 160 ft from rock cut limits and less than 200 ft from the limits of large production blasts (Figure 5).

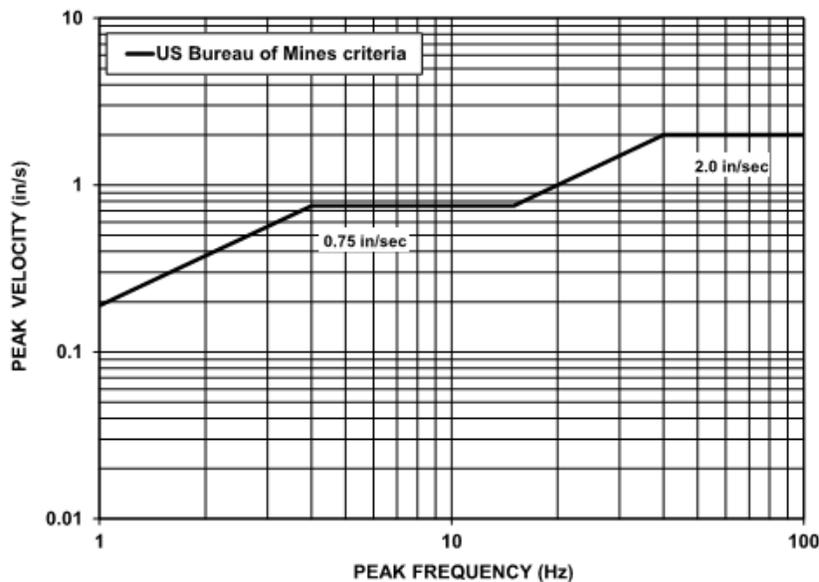
Figure 6 -- USBM Criteria for Above-Ground SRP facilities

Feature	Ground Vibration, ips	Air Overpressure, dBL	Agency
Residential and commercial buildings	1.0	129	City of Phoenix FD
Buried Pipelines (general) and pump station	2.0 for <20 Hz, 4.0 for >20 Hz	N/A	City of Phoenix
48-in.-diameter waterline	0.25 (revised to 0.39)	N/A	City of Phoenix
Overhead Power (monopole and lattice tower)	See Figure 6	133	Salt River Project
Buried Utilities	2.0 for <20 Hz, 4.0 for >20 Hz	N/A	Salt River Project

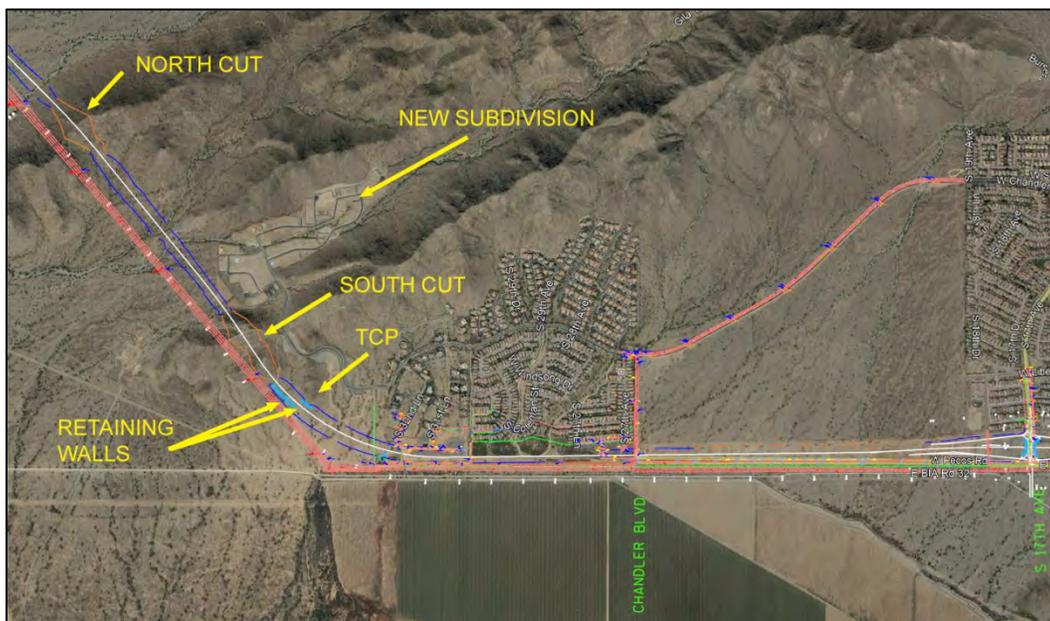
Figure 7 -- Center Segment Major Rock Cuts

The Center Segment contains 2 significant cut slopes (Figure 7), and a third much shallower cut slope to the northwest (“Alta Ridge” area, not shown on Figure 7). The North and South cuts were removed almost entirely by blasting; about half the height of the Alta Ridge cut slope and most of its ends were removed by ripping.

Figure 7 also shows other notable surface features. The TCP noted is a petroglyph site that will be discussed in the next subsection. A summary of the cut slope geometries is given in Table 3.

As is apparent from Figure 7, rock excavation for the Center Segment was in an area of more rural character. Of significant concern were the nearby transmission towers. SRP Tower 84 was at the summit of the South Cut, a little less than 100 ft from the west cut slope crest. There was a similar tower near the crest of the North Cut that was a little further away. The subdivision, the petroglyph site, and the 48-in. diameter water line merited consideration but were of subordinate impact. Figure 8 shows this arrangement in more detail.

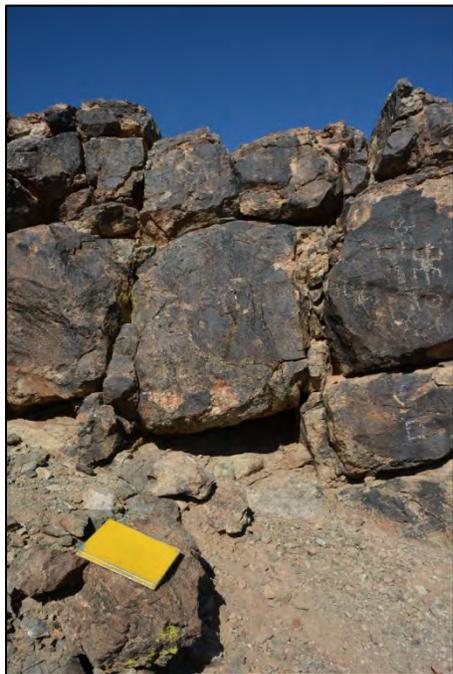
Figure 9 -- Design-Basis Rock Block at the Petroglyph Site

marked boulders. The unmarked boulder was supported partly on a narrow ledge of rock to one side (Figure 9) and partly by native ground at its opposite rear corner.

SGS then performed a pseudostatic analysis to see if potential blast-related acceleration could crush or dislodge this support point. The contact area was measured and the crushing strength of the supporting rock was assumed to be around 4,500 psi. It was conservatively assumed that, during blasting excitation, lateral translational movements could reduce side friction against the adjoining blocks to zero, allowing freer vertical movement of the rock block. Assuming that blasting could induce vertical transient acceleration of the rock and thereby increase the dead weight force imposed on the supporting rock ledge, it was recommended that the blasting accelerations should be limited to less than 0.13g. It was found that the allowable charge weight per delay associated with this acceleration would be far greater than the allowable charge weight to meet the ppv limits at the transmission towers, which were far closer to the blasts.

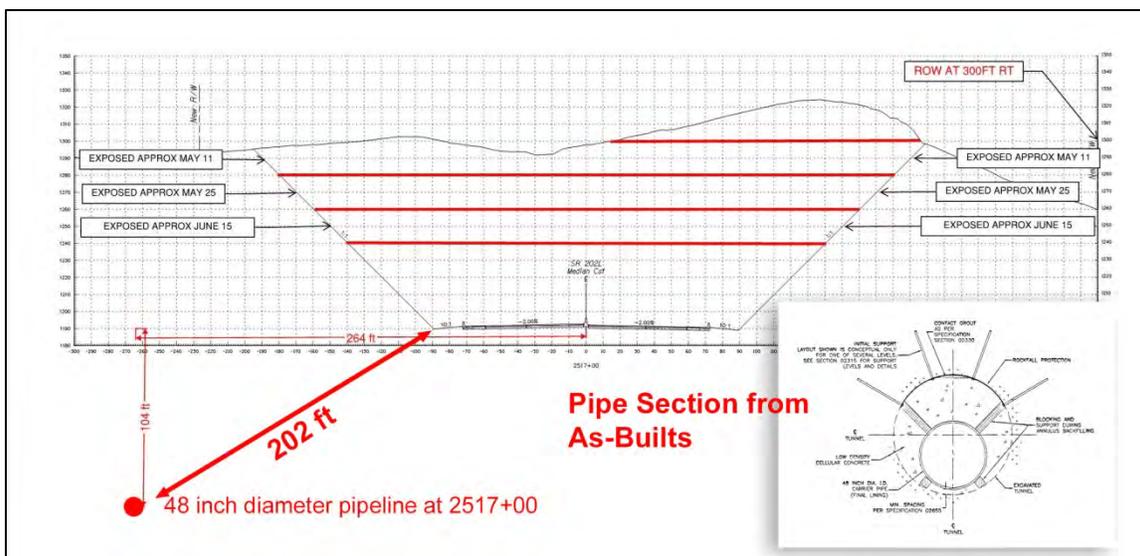
Before the Center Segment blasting commenced, there had been months of blasting near this pipeline on the Pecos segment. Prior to Center Segment excavation, the City had inspected the pipeline within this Segment and it appeared to be in good condition. Nonetheless, because this section of the pipeline was to remain in service, and because it is not easily repairable, special consideration was warranted. A vertical attenuation seismograph array was placed at the

South Cut margin prior to test blasting, to collect data that could aid in assessing the influence of blasting should any degradation in the pipeline occur during construction or in the future.

Figure 10 -- South Cut Typical Section with Pipeline Location and Cross Section (Inset)

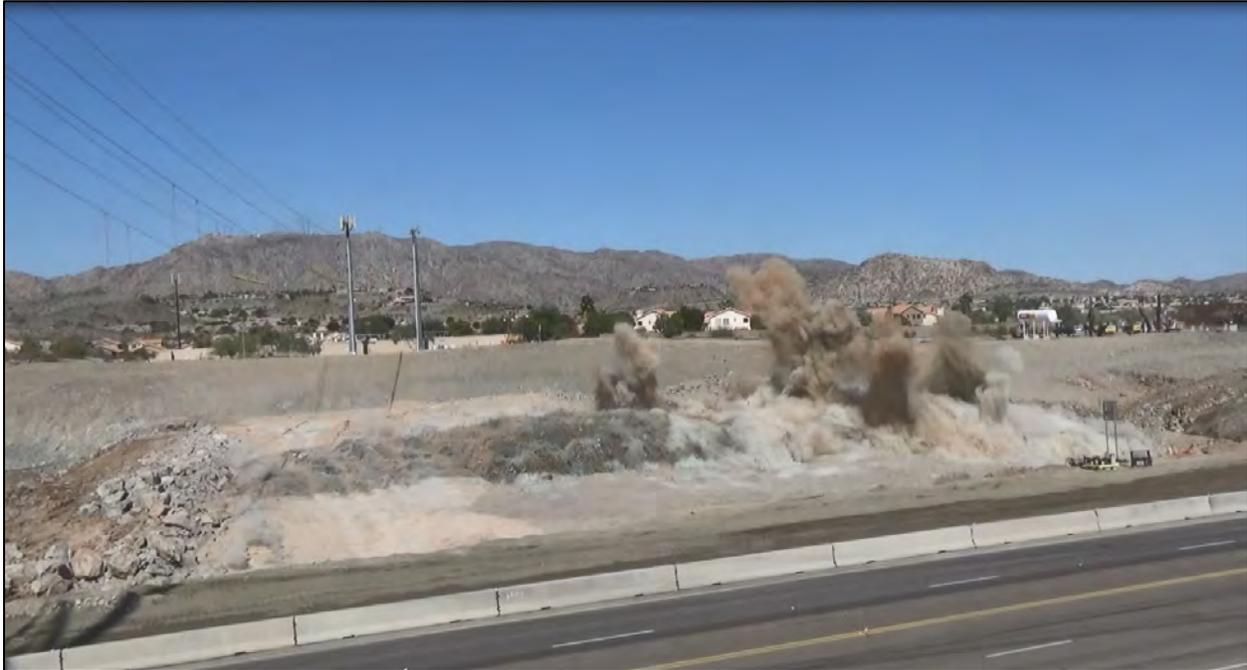
SRP required covering shots when blasting within 50 ft laterally of its power lines, and this situation occurred where the 69 kVa lines crossed the alignment at Cut #4. Earthen cover was used rather than blasting mats, not just because of the number of mats that would be required, but because there was insufficient vertical clearance below the power lines to safely handle and place mats. The first blasts used post-covering, which is more reliable than pre-

covering (and then drilling blast holes through the cover material) because it provides a more continuous blanket and precludes stemming ejection. However post-covering with the required 3 ft of earthen cover proved unworkable for area blasting because the low-headroom equipment required could not reach the interior of the shot after it was tied in. For post-covering, the blast had to be tied in and covered in stages using equipment lightweight enough that it would not disturb the buried lead lines. With the approval of SRP, subsequent blasts were pre-covered with 3 ft of earthen material, and conventional stemming practices were used. This was proved sufficient (Figure 11).

Figure 11 -- Effect of Pre-Covering within 50 ft of 69 kVa Overhead Power Lines (Left Half of Shot) and Uncovered Blast Holes Outside 50-ft Limit (Right Half)

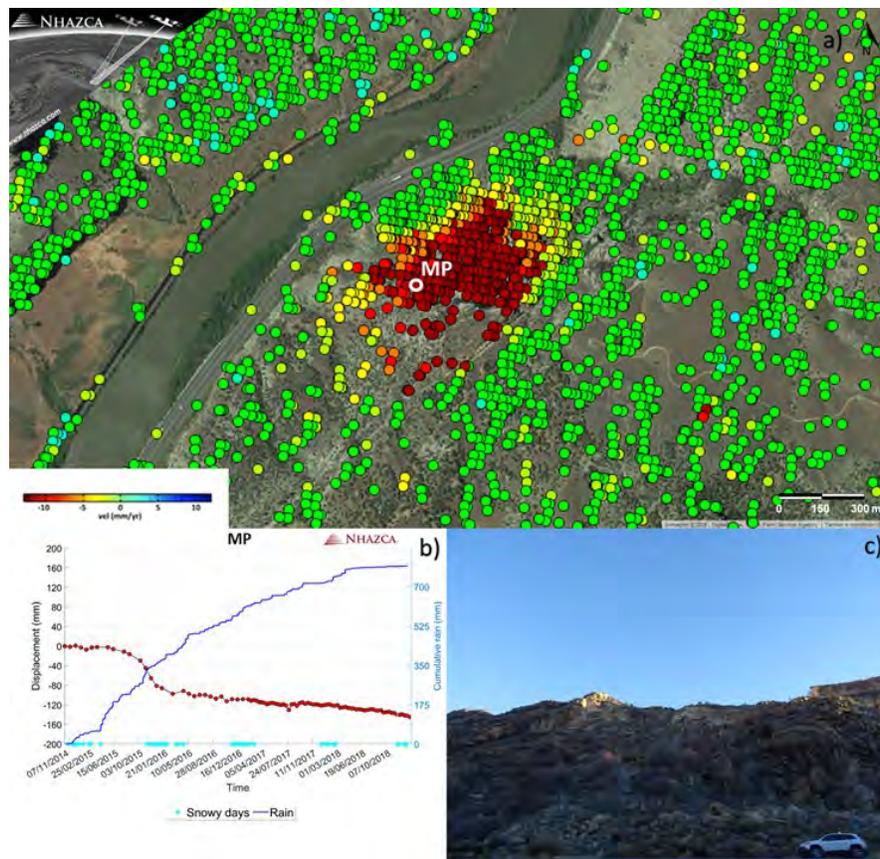
Satellite SAR interferometry is a powerful tool to monitor wide areas or local site, ground or structures deformation with high accuracy, in all-time, with all-weather conditions (Ferretti et al., 2001). SAR images consist of a matrix of resolution cells containing two types of information: the amplitude and the phase. The phase difference between two SAR images collected in different times (Differential SAR interferometry – DInSAR) allows one to investigate the superficial deformations of targeted areas or objects (i.e. displacement occurred between the two acquisitions) along the satellite Line of Sight (LOS). Moreover, by analysing several satellite SAR images (Advanced-DInSAR analysis) acquired with specific characters over the same area, it is possible to retrieve the average displacement of measurement points with millimetre accuracy and the time series of displacement. Using archive SAR data collected by different Spatial Agencies, it is possible to perform historical A-DInSAR analyses since in the early 1990s. An example of the achievable results is reported in Figure 1, showing the average displacement rate of the measurement points and a time series of displacement in correspondence of a landslide process interfering with a highway.

Figure 1-Example of Satellite A-DInSAR technique application to slope interfering with transportation network prone to instability phenomena. The main outputs are a) Displacement rate in mm/year; b) time series of displacement; c) view of the monitored slope.

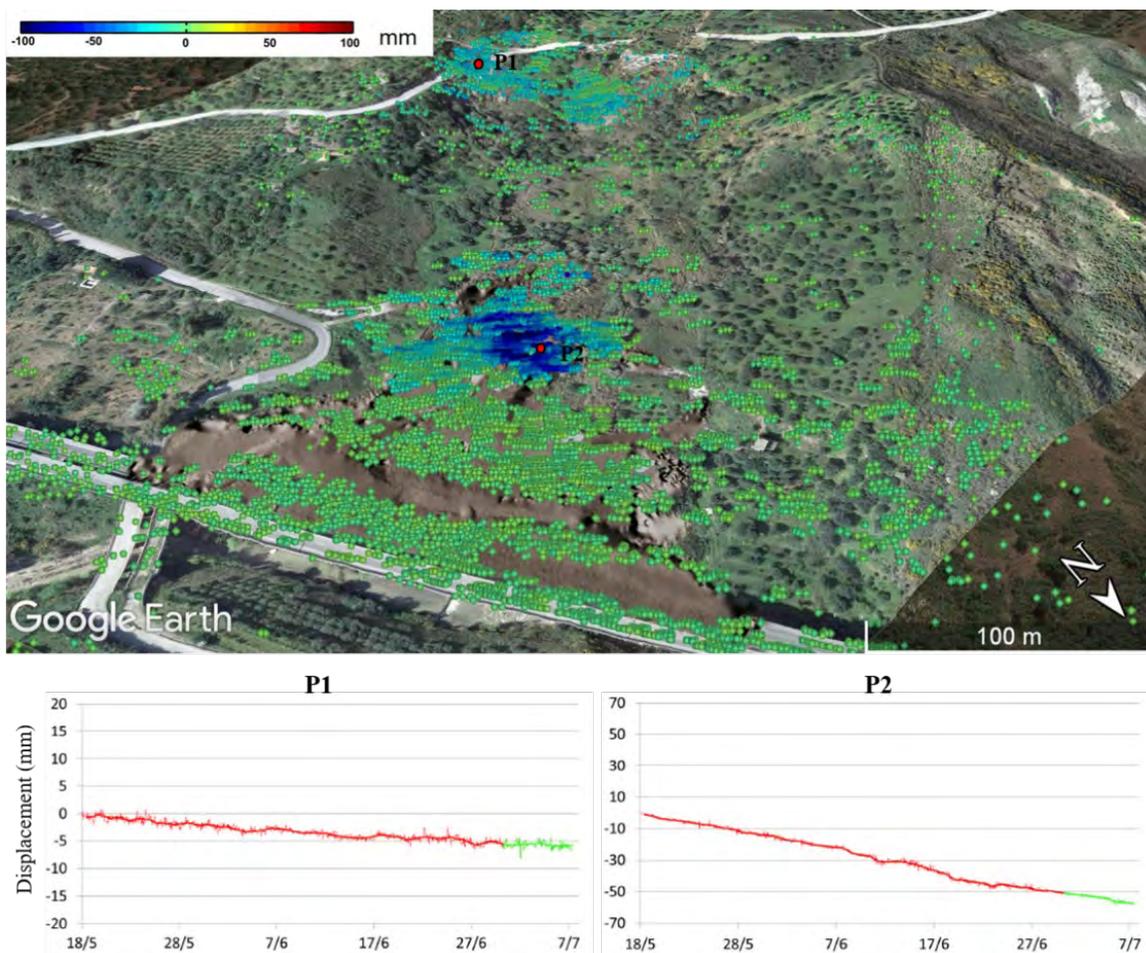
An application of TInSAR technology to monitor a viaduct in Sicily (South Italy) exposed to slope instability phenomena is shown in Figure 2. During 22 months of monitoring, localized discontinuous displacements have been detected corresponding to the SP24 roadway and in the central sector of the landslide body, while the viaduct appeared to be stable (Moretto et al., 2018). The cumulative displacement along the LOS towards the sensor direction (Figure 2) was quantified to allow assessment of the deformational behavior of the landslide.

Figure 2 - Example of Terrestrial InSAR technique application to infrastructures exposed to slope instability hazards. Multi-temporal deformation maps (top) and time series of displacement (bottom) of the measurement points P1 and P2 located on the instable slope nearby the Imera viaduct in South Italy (modified from Moretto et al. 2018).

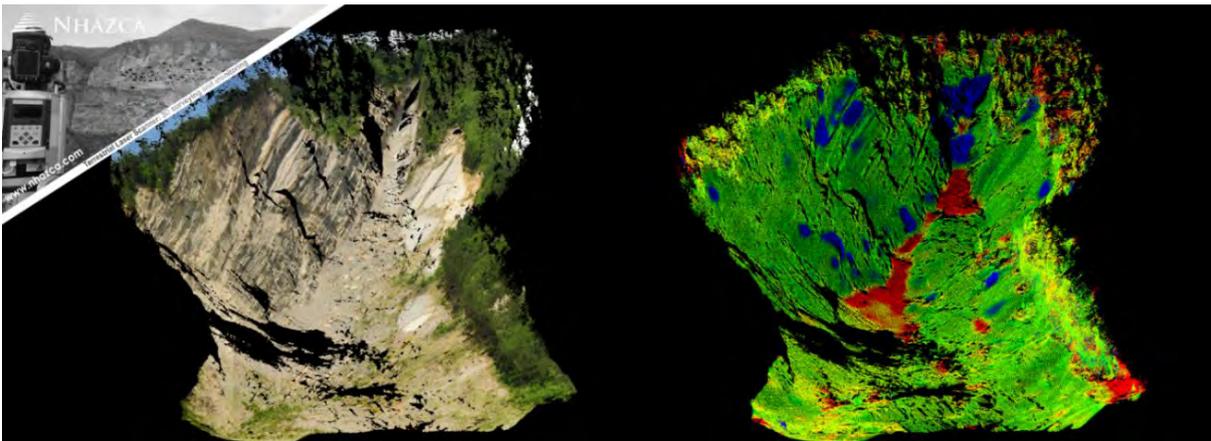
In addition to SAR interferometry, techniques capable of providing detailed point-based information are gaining importance. Among these, Terrestrial Laser Scanning (TLS) is one of the most applied. This technique is a ground-based active imaging method consisting in a device that emits a laser pulse and records its backscattered radiation, measuring the distance between the sensor and the reflecting target (Milenković et al., 2015; Mazzanti et al., 2018). The distance measurements are developed by considering the time-of-flight information of emitted and received laser signal by the sensor and permit retrieval of 3D high-resolution digital models of both natural and anthropogenic objects. Terrestrial Laser Scanning from different positions allows the 3D modelling of complex objects and/or areas of interest. Through the integration with a HR digital camera, it is possible to obtain three-dimensional models in true colors, suitable for better data visualization and interpretation (Figure 3). In addition, by comparing multitemporal TLS surveys, it is possible to quantify volumetric variations of monitored objects (i.e. landslides, rock scarps, etc.). An example of 3D modelling and the volume changes estimation due to rock falls is shown in Figure 3.

Figure 3 – Example of 3D high resolution model in true colors (left) and volume changes estimation (right) from TLS. Blue colors identify the volumetric losses while red colors the accumulation zones.

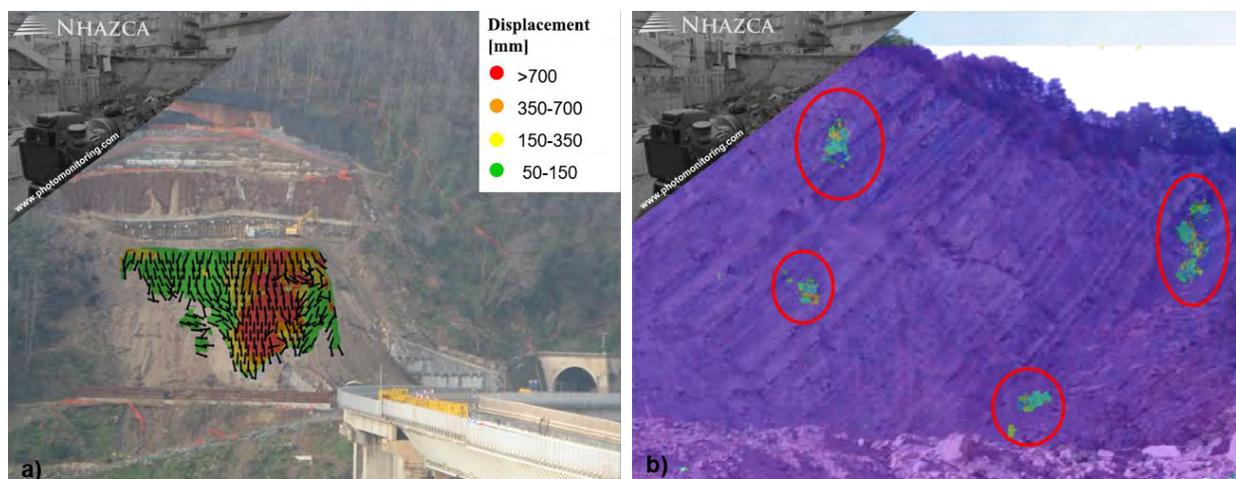
Figure 4- Example of PhotoMonitoring™ application for slope stability. a) Displacement map (in term of intensity and direction) of a slope nearby a linear infrastructure; b) Change detection analysis of a slope prone to rock falls (red circles).

The increasing of optical and multispectral sensors, from low-cost and low-resolution to very high resolution (VHR) cameras, facilitates collection of a large amount of data suitable for geotechnical and structural monitoring. The PhotoMonitoringTM solution, with Change Detection (CD), Digital Image Correlation (DIC) techniques, represents an innovative remote sensing technology to identify and quantify changes of objects and/or areas from optical and multispectral data. The correlation of co-registered images collected at different time intervals allows the user to identify, describe and quantify any changes of the area of interest and to measure the "full-field" deformation on the surface of investigated area thanks to CD and DIC approaches respectively (Caporossi et al., 2018; Sutton et al., 2009; Lava et al., 2009). This technique has been successfully applied to monitor slopes prone to instabilities (Figure 4) in terms of shallow landslides as well as rockfalls.

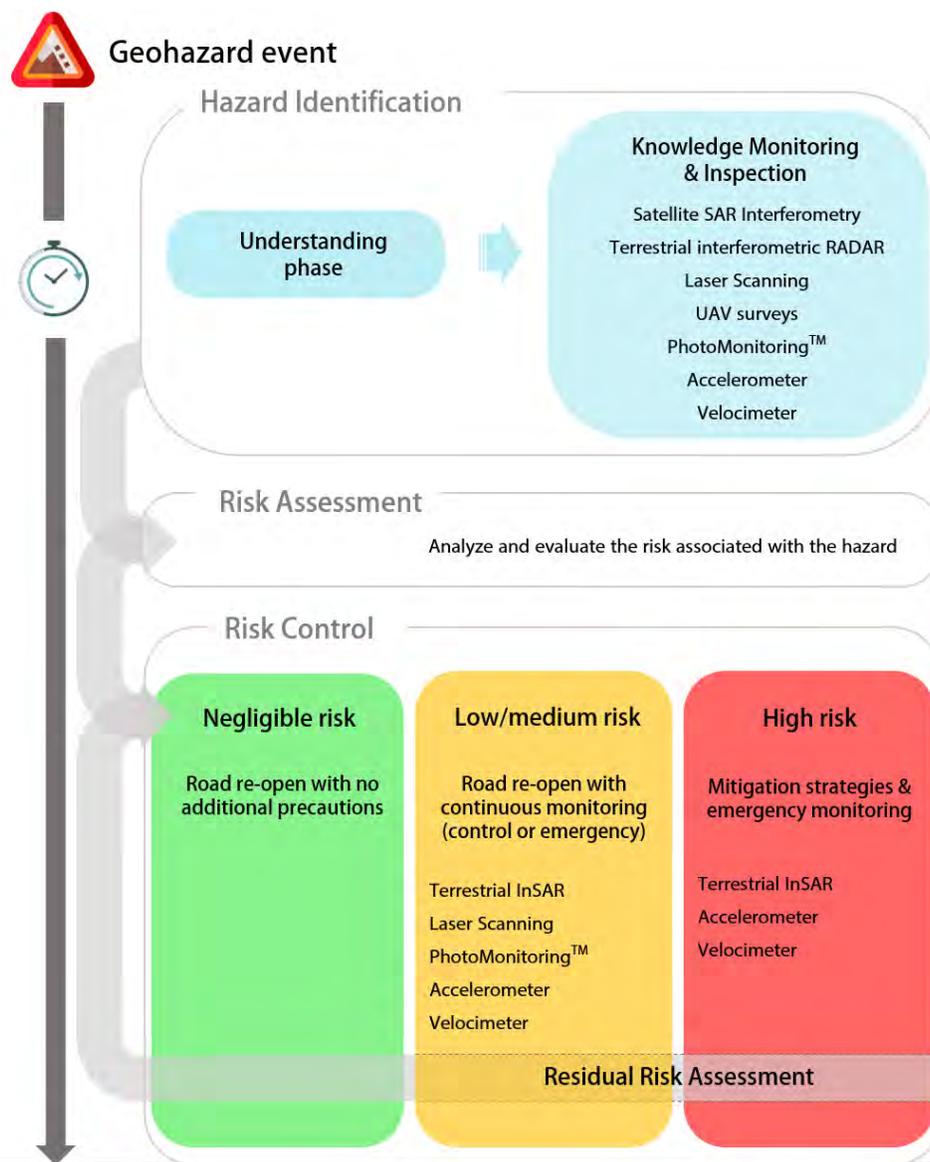
Figure 5. The PRIMO protocol workflow in the framework of risk assessment

After an extreme unexpected event leading to an emergency road closure (e.g. geohazard event, structural critical condition, etc.), a first cognitive phase must be carried out to characterize the phenomenon and assessing the potential risks (understanding phase in Figure 5). To this aim, the actions that can be implemented include:

The results of the understanding phase allow evaluation of the risk, identifying appropriate actions to eliminate the hazard, or control of the risk when the hazard cannot be eliminated. The risk control phase can involve different measures, including monitoring activities, according to the level of the risk recognized (Figure 5):

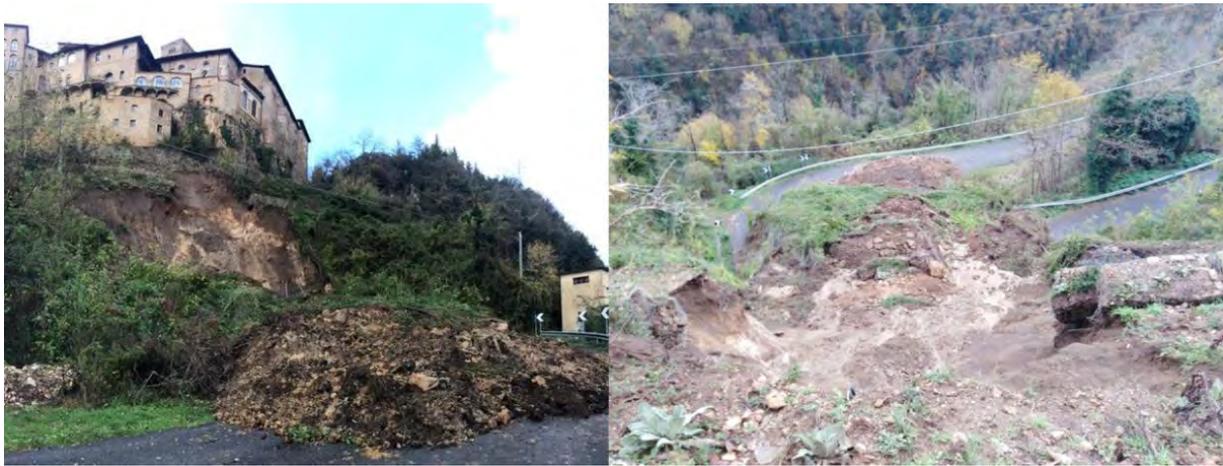
Figure 6. Overviews of the 26th November 2018 landslide (sources: <http://www.confinline.it> and <http://www.cinquequotidiano.it>).

On the night of 26th November 2018, a landslide occurred in the Municipality of Subiaco, in the vicinity of the Monastery of S. Scolastica, one of the oldest monasteries in Italy (Figure 6). Although the landslide involved only few hundred cubic meters not causing injuries and losses, it immediately generated a serious concern among citizens and the media. This was because the

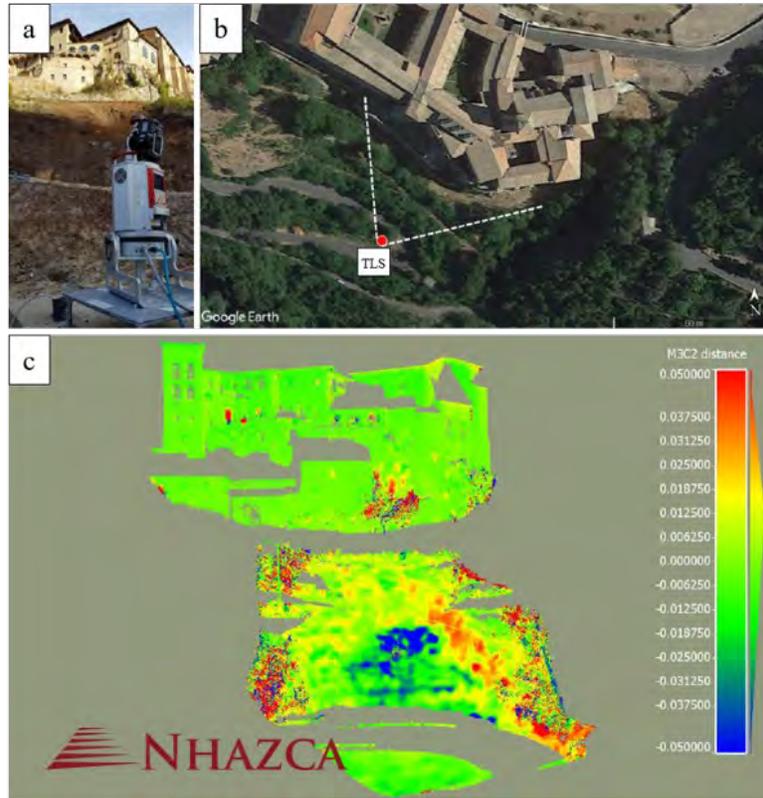
Figure 7. a) TLS placed on a fixed platform; b) map of the study area, the red circle indicates the TLS location; c) cumulated displacement by computing distances between two TLS point clouds (12/19/2018 - 01/07/2019).

Following the first on-site inspections by technical experts to complete a Hazard Identification assessment, multi-temporal surveys using a long-range Terrestrial Laser Scanner (TLS) were performed. This stage of monitoring (knowledge monitoring) was aimed at identifying the unstable area and detecting possible changes/movements in progress in the slope. In this regard, in less than one month (19 December 2018 - 07 January 2019) ten TLS surveys were carried out from a fixed position (Figure 7a). Thanks to this first stage, some significant evidence was detected:

- no evidence of displacement was found for the area of the Monastery (green colors Figure 7c);
- displacements on the order of few centimeters were detected in limited portions of the slope, specifically on the right and left flanks of the landslide (red colors Figure 7c);
- erosive processes were concentrated in the central portion of the slope (blue colors Figure 7c).

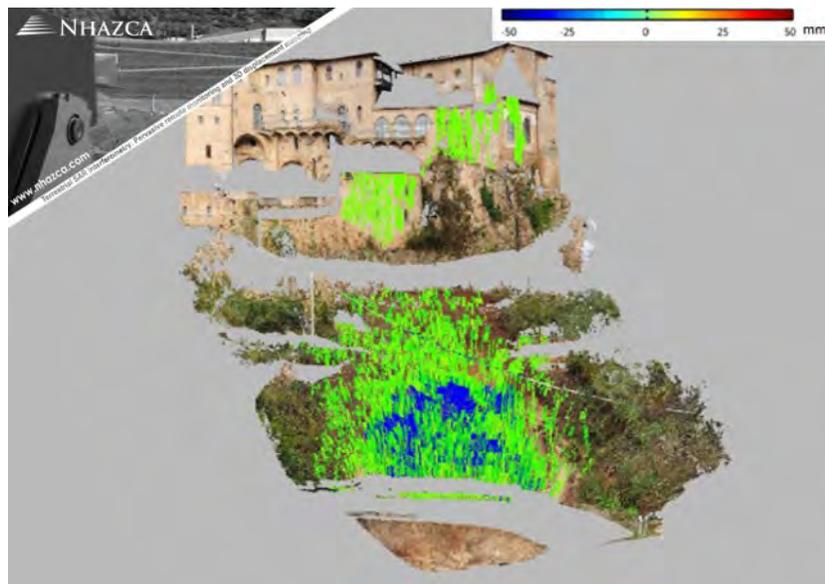
Figure 8. Radar map with cumulative displacement (January-March) overlaid on RGB colored point cloud acquired by TLS. Negative values correspond to movements toward the radar sensor (distance shortening along the Line of Sight); positive values correspond to movements away from the sensor (distance increasing along the Line of Sight).

The main results from the Terrestrial SAR Interferometry, confirmed the evidence shown by the multi-temporal analysis using TLS (Figure 8). This technique permitted continuous monitoring of the slope in all weather and lightening conditions, thus representing a suitable technique for the real-time monitoring and early warning.

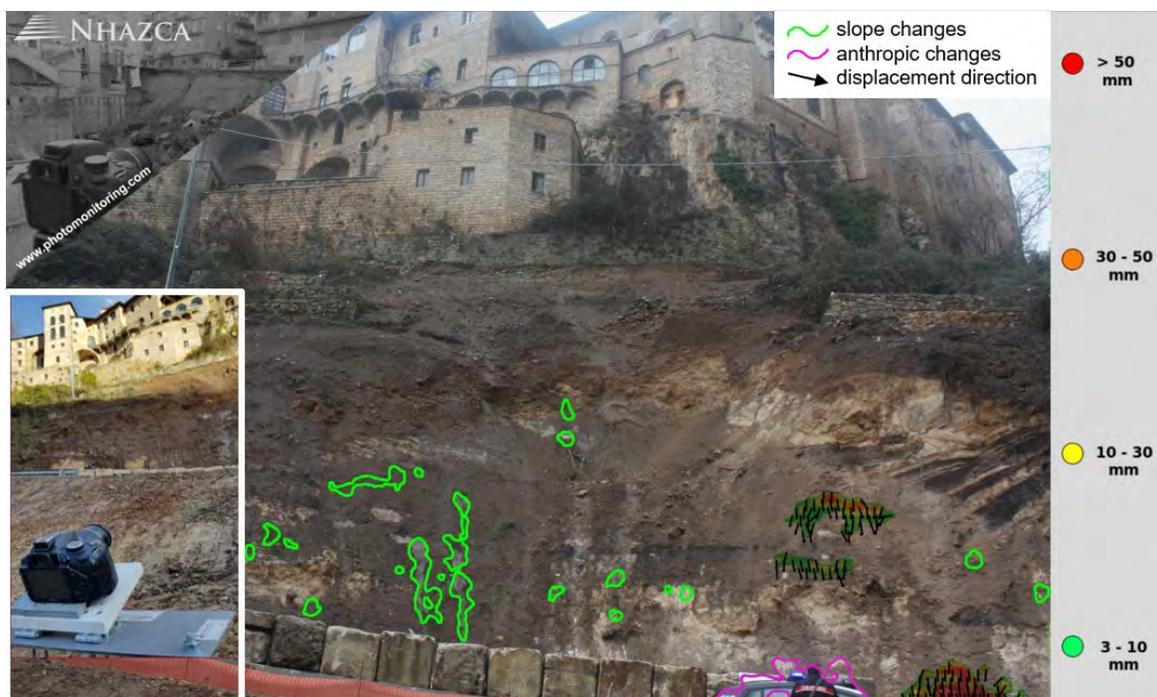
Figure 9. Example of results obtained with PhotoMonitoring™ techniques during 1 day observation period. Slope changes are reported in green (ascribable to localized rock falls and surficial movements), while anthropic changes in pink. 2D displacement field have been obtained using proprietary software tools developed by NHAZCA implementing DIC technique. In the bottom left corner, the PhotoMonitoring™ station.

Once again, the analysis showed localized displacements and changes corresponding to the left and right side of the landslide (Figure 9). In the central portion of the slope, during the last period of monitoring, even where affected by widespread vegetation growth, no appreciable movements were detected.

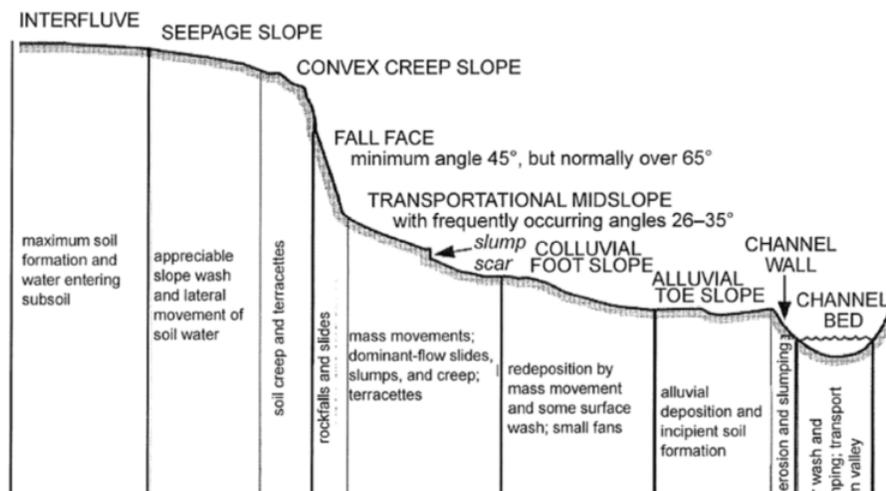
Figure 1 – Dalrymple Sketch

Dalrymple (1968)¹ devised a schematic of the geology of the project site which is reproduced below. The Dalrymple sketch (Figure 1) shows the transitional nature of the geology. The project site straddles the Colluvial Foot Slope and the Alluvial Toe Slope. The colluvium forms from the weathering of the shale and is predominantly low-plasticity clay with

limestone cobbles and slabs throughout. A key feature is the convex shape of the slope forming a prominent foot slope zone with a scarp zone at the sharp transition. In this area, the Fall Face is usually formed by the Fairview and Grant Lake formations. These formations overlie the Kope Formation and display significantly less non-durable shale (less than 50 percent). Subsurface water is a significant contributor to slope instability in the Kope Formation. Discrete wet zones are often observed on the hillside as water bleeds from the hillside. The Kope weathers to a distinct brown clay with limestone slabs. It quickly transitions to gray shale with limestone below the weathered zone. Most of the seepage zones and slides occur within the colluvium, the brown weathered rock zone or at the interface between the weathered and unweathered bedrock.

Reconnaissance of the hillside above the wall revealed a tension crack in the hillside that lined up well with the bowed section of the grade beam. We also noted the hummocky terrain comprised of a series of narrow benches spaced about 75 feet apart all the way up the hillside. In our opinion the benches represented progressive head scarps from historic landslide activity. At the top of the hill we observed a fifteen foot high vertical wall of limestone with interbedded shale. This was the Fall Face (see Figure 1 - Dalrymple Sketch) and confirmed our suspicion.

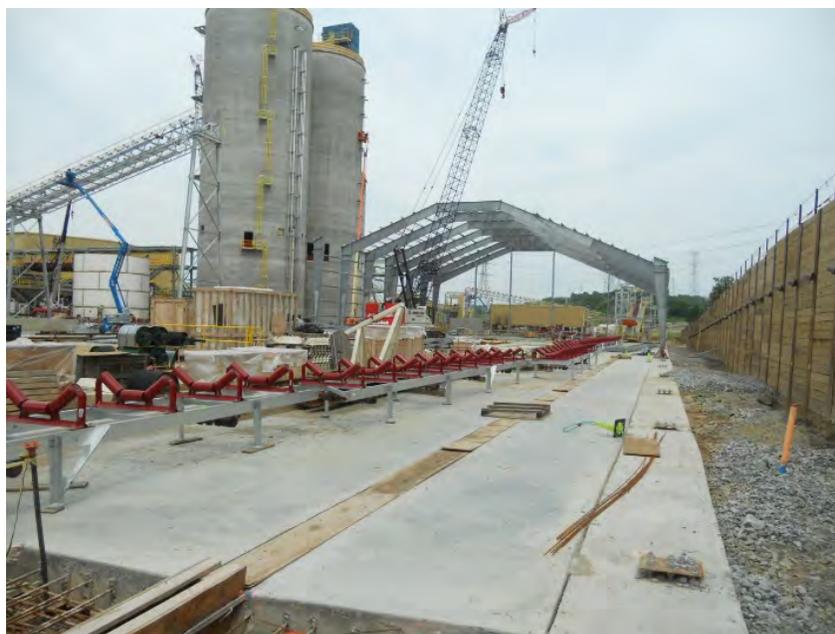
Figure 2 – Construction Progress

The gypsum storage building is 130 feet wide and 450 feet long. Initial construction activities for the gypsum building included site grading including constructing the building pad for the gypsum storage building pad. The site grading required making a cut into the base of the north facing hillside and constructing a soldier pile and lagging tiedback wall. The wall height was predominantly between 12 feet and 18 feet, tapering down to five feet at the ends of the wall. Soon after constructing the tiedback wall, foundation and slab construction began. By the time of our involvement, the perimeter grade beam foundation was essentially complete, the slab placed, the rails for the Reclaimer installed, the Reclaimer installed on the rails and the steel erection was taking place. The construction progress is shown on Figure 2.

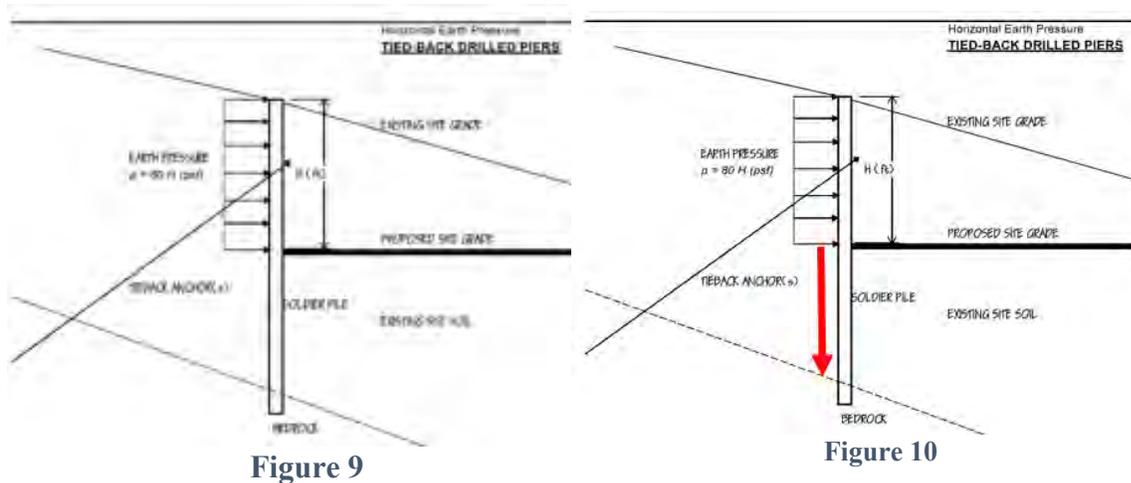
This difference is significant. The recommended Design Load from the GEF was $80H$, where H is the height of the wall as shown on the graphic reproduced from the report. The actual load was computed to be $200H$ with H being from the top of the wall to the failure surface.

earth pressure distributed only along the face of the wall in Figure 9. The actual earth pressure is shown on the right in Figure 10 as with the earth pressure distribution extending down to the failure surface as indicated by the red arrow.

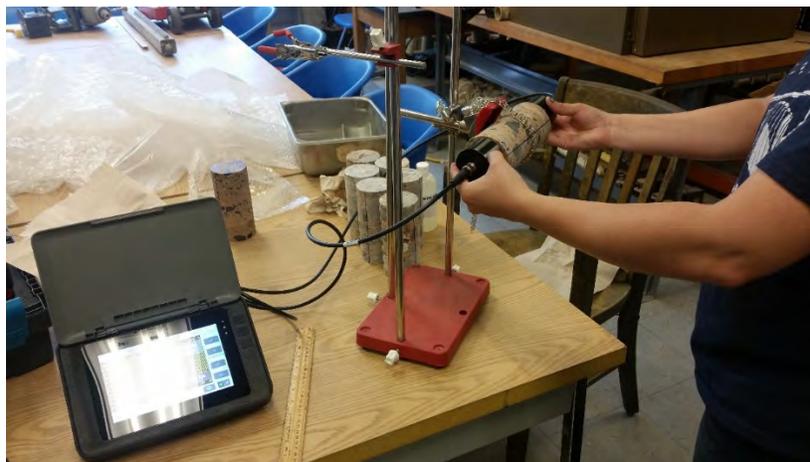
Figure 1 - Ultrasonic Testing Configuration

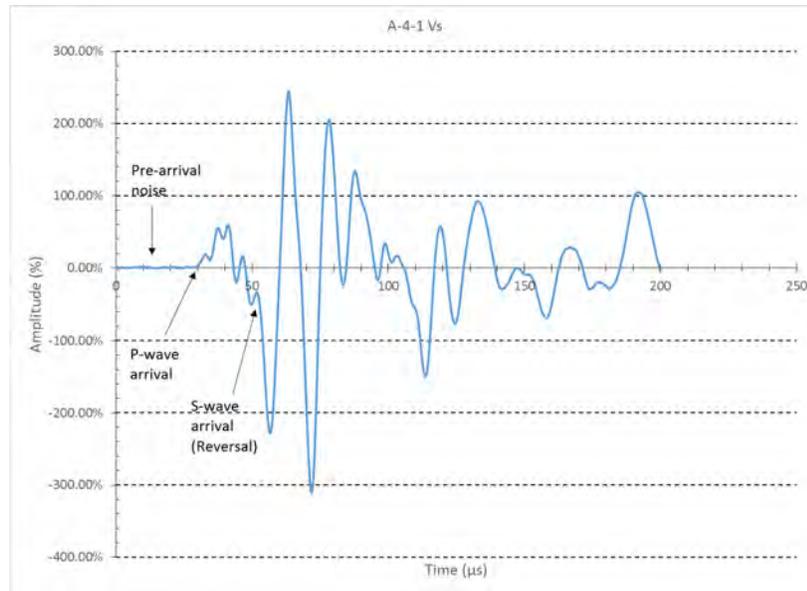
Figure 2 - Seismic Velocity Plot from Excel using Exported Data of Specimen A-4-1

When measuring the P-waves, the equipment established the first arrival automatically. On the other hand, when measuring S-waves, this selection had to be done manually. Because shear waves are linear, one of the transducers would be rotated 90 degrees causing the shear waves to disappear, thus confirming that the wave interpreted to be an S-wave was indeed that. Figure 2 presents waves observed for specimen A-4-1 as an example.

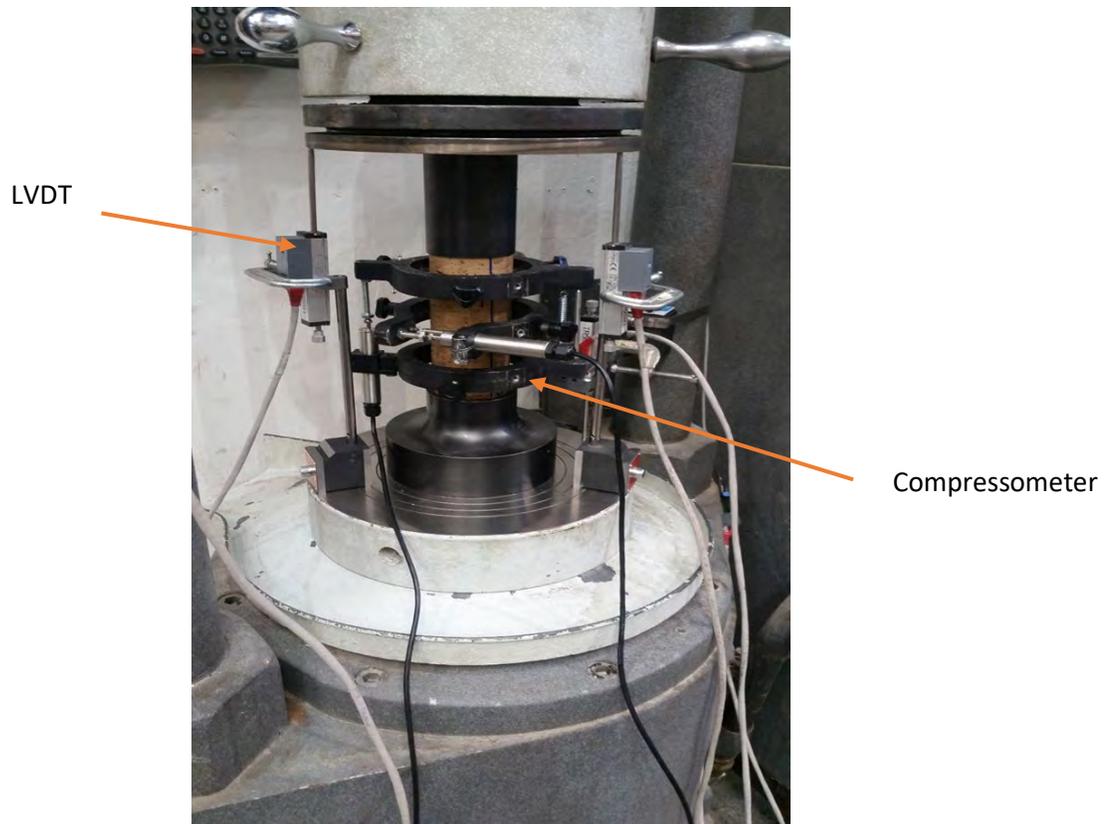
Figure 3 - Specimen with Mounted Compressometer Surrounded by Series of LVDTs

While LVDTs were employed throughout to record vertical sample deformation, it is with 16 of these tests that a compressometer was also used that is of interest here. The compressometer, which is used in tests of concrete samples, is not a piece of equipment that is typically used in the testing of rock samples. It records deformation in the central portion of the sample, away from the sample ends, thus reducing the end effects. Measurement is acquired in a single axial plane, from a hinged clamp equipped with a displacement sensor at one end. Since the axial displacement is measured from one end, a correction factor to the raw data should be applied per ASTM C469-14. This factor is based on the compressometer geometry and is equal to 0.505 for the compressometer used in this project. A significant advantage of the compressometer is that it also records lateral deformation of the sample. Figure 3 shows the mounted compressometer as well as the traditional LVDTs.

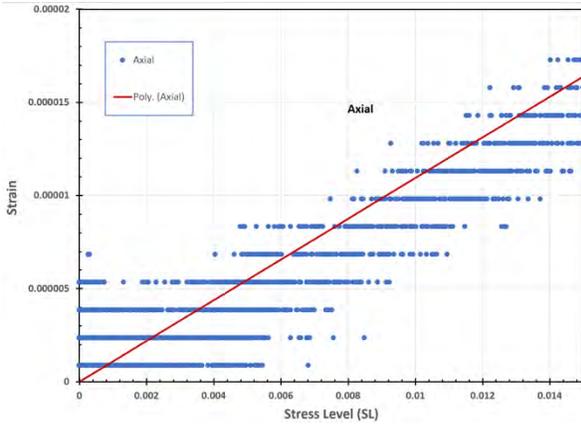
Figure 4a - Variations in Axial Strain (ϵ_a) with SL at low SL.

While Figure 4a through 4c present the variations recorded for sample C-1-6, they represent a typical response recorded for all samples. Such response may also be due in part to fractures closing as load is reapplied after having been released due to sample retrieval and preparation. By contrast, assessing best fit equations for separate variations of ε_a and ε_L with SL, the ratio of the two equational values at the same SL was determined and Poisson's ratio assessed versus SL in this manner. Figure 6 presents the best fit equations for the variations of ε_a and ε_L with SL for sample C-1-6, as an example. It is noted that in many cases it was necessary to terminate the fitting short of SL = 1 because of the difficulty in finding best fit equations that would include data beyond where they were terminated (i.e. as SL approaches 1).

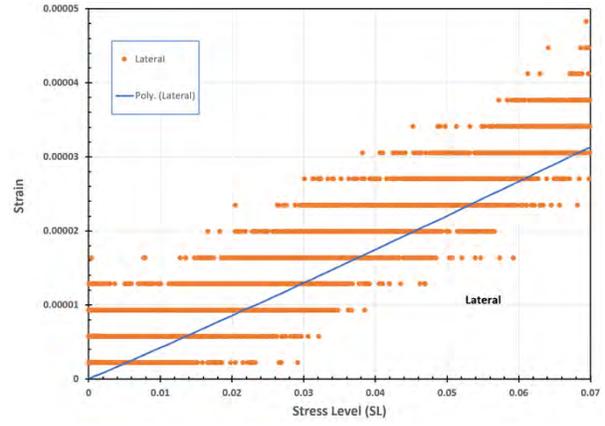
Figure 4b - Variations in Lateral Strain (ϵ_L) with SL at Low SL.

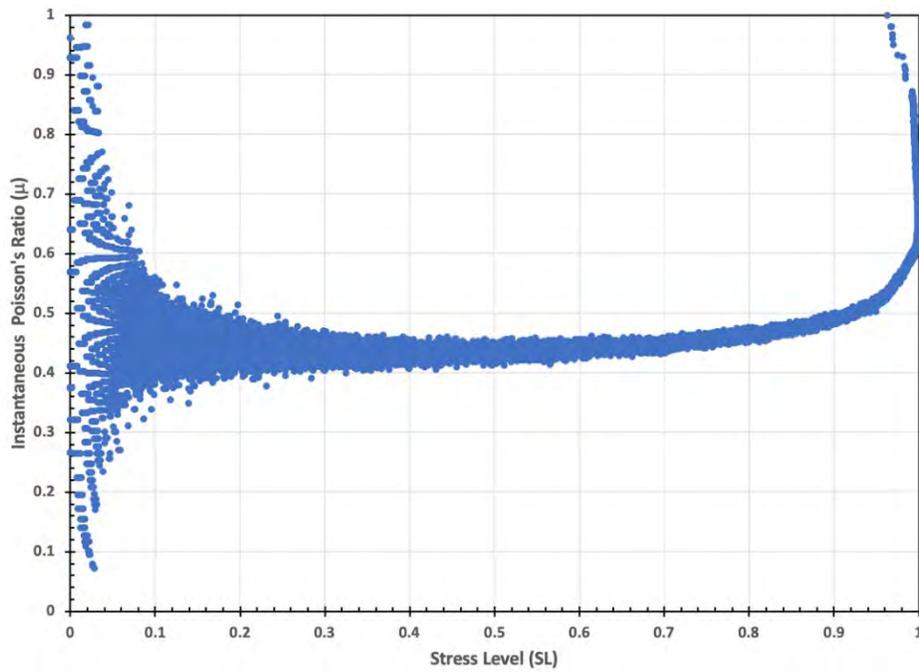
Figure 4c - Variation in Instantaneous Poisson's Ratio with SL

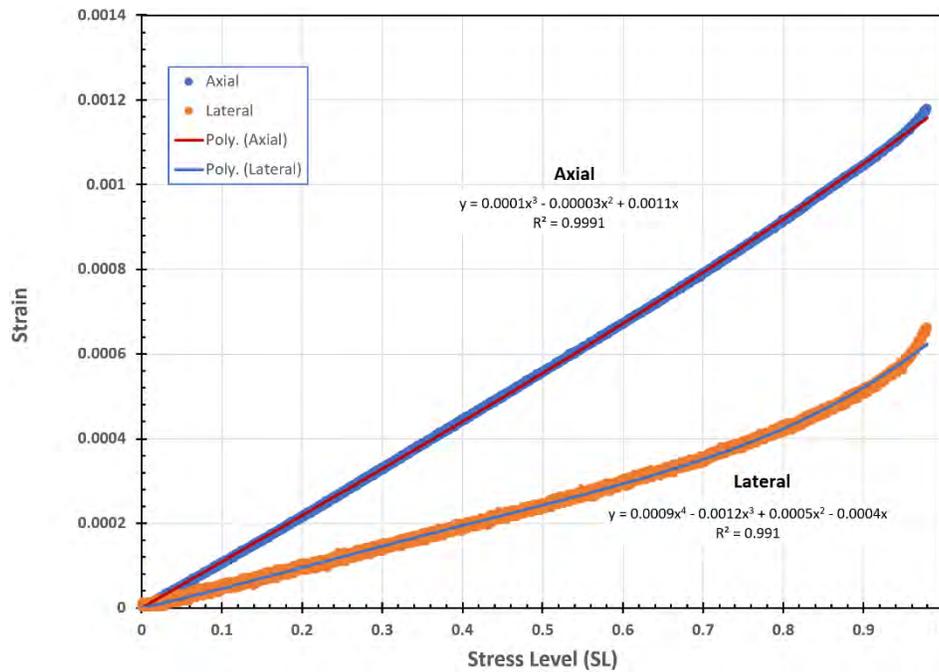
Figure 5 - Best Fit Equations for the Variations of ϵ_a and ϵ_L with SL for Sample C-1-6
