70TH HIGHWAY GEOLOGY SYMPOSIUM

“Better Highways Through Applied Geology”

October 21-24, 2019

2019 Proceedings

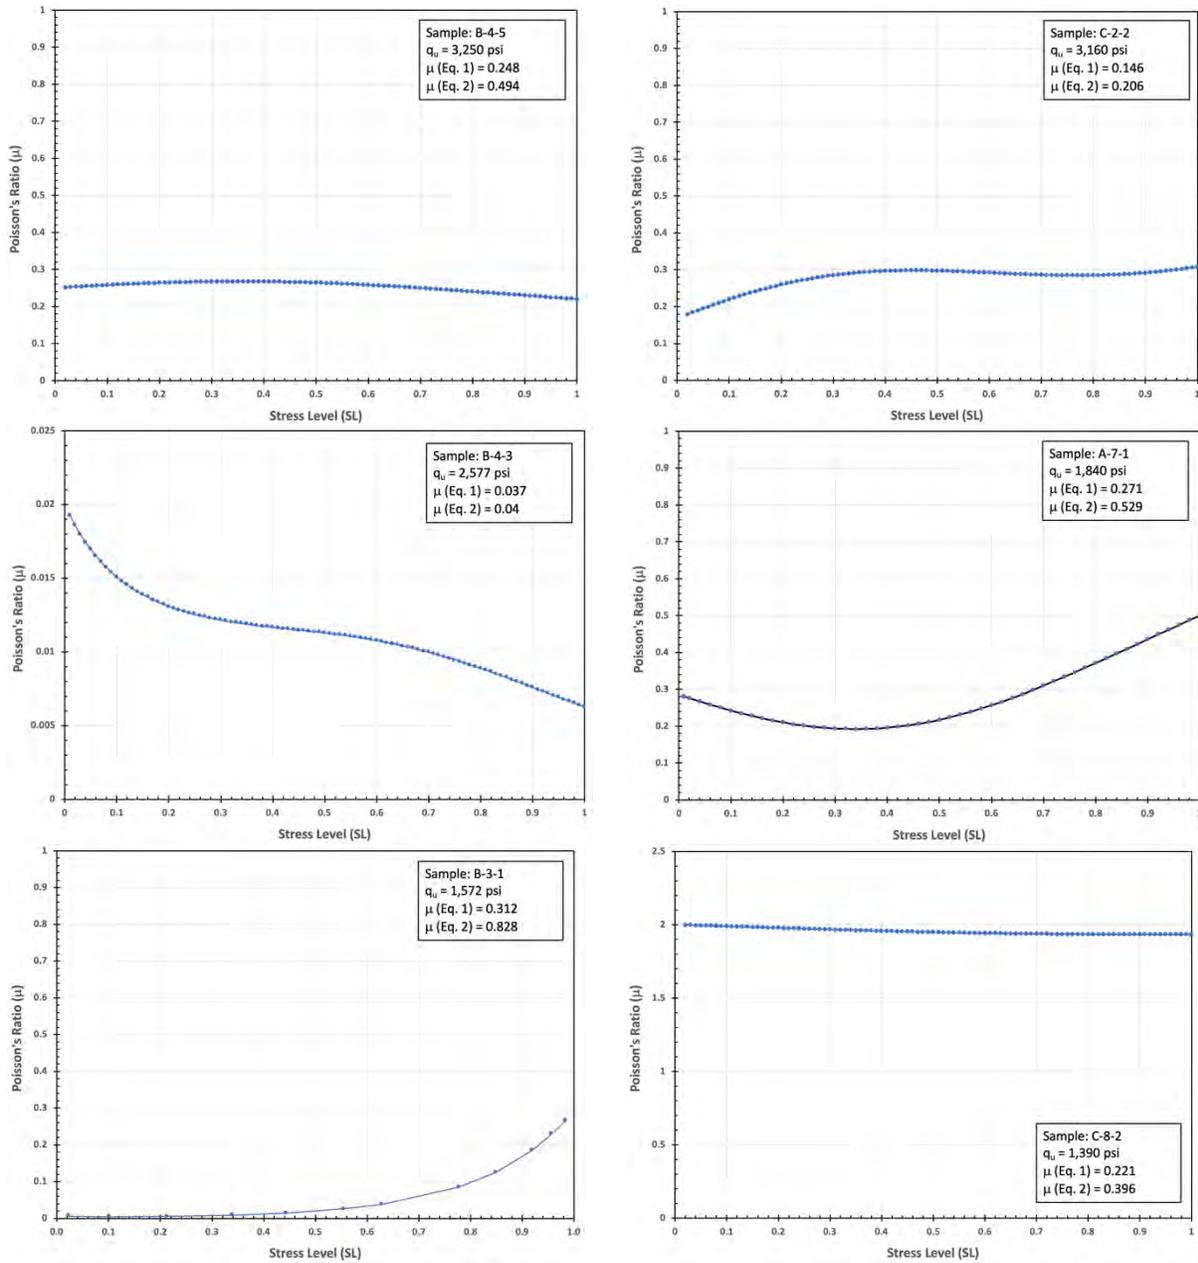
Figure 6 - Poisson's Ratio Assessed from Separate Best Fit Functional Variations of ϵ_a and ϵ_L

Figure 6 presents the results of Poisson’s ratio assessed using the aforementioned technique for 16 tests where deformations were recorded with the compressometer. As it can be judged, Poisson’s ratio obtained from separate best fit functional variations of ϵ_a and ϵ_L show a continuous variation with SL, even approaching SL = 0. Values of Poisson’s ratio at discrete values of SL (0, 0.5 and 1) taken from the various tests of Figure 6 are compared with those from wave velocity measurements (Eqs. 1 and 2) at SL = 0 in Table 1. Table 1 shows a summary of Poisson’s ratio values for all the samples tested arranged in decreasing value of unconfined compressive strength (q_u).

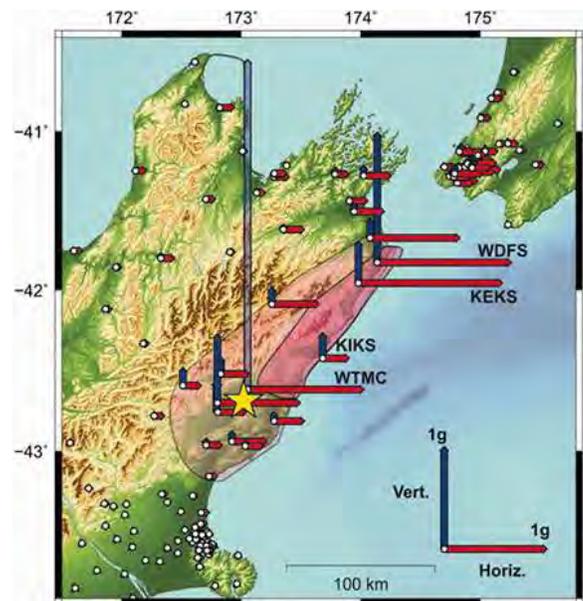
This graphic shows peak ground accelerations in the horizontal and vertical directions recorded by GeoNet strong motion instruments during the magnitude 7.8 Kaikōura earthquake of November 2016. The epicentre of the earthquake is shown as a yellow star. The vertical value of 3g recorded at Waiu in North Canterbury has unusual characteristics which scientists are still investigating. The approximate extent of mapped landslides is shown as pink shaded areas, with the majority occurring in the darker shaded region.

Figure 1 – Area affected by November 2016 M7.8 Kaikōura earthquake (3)

The 14 November 2016 M7.8 Kaikōura earthquake was a complex event that involved rupture along multiple faults. Figure 1 shows the area most affected where significant ground shaking occurred. The event was felt throughout most of New Zealand. Fault rupture propagated northwest from the epicenter; surface ground rupture was observed along at least 20 faults spanning a distance of about 100 km.

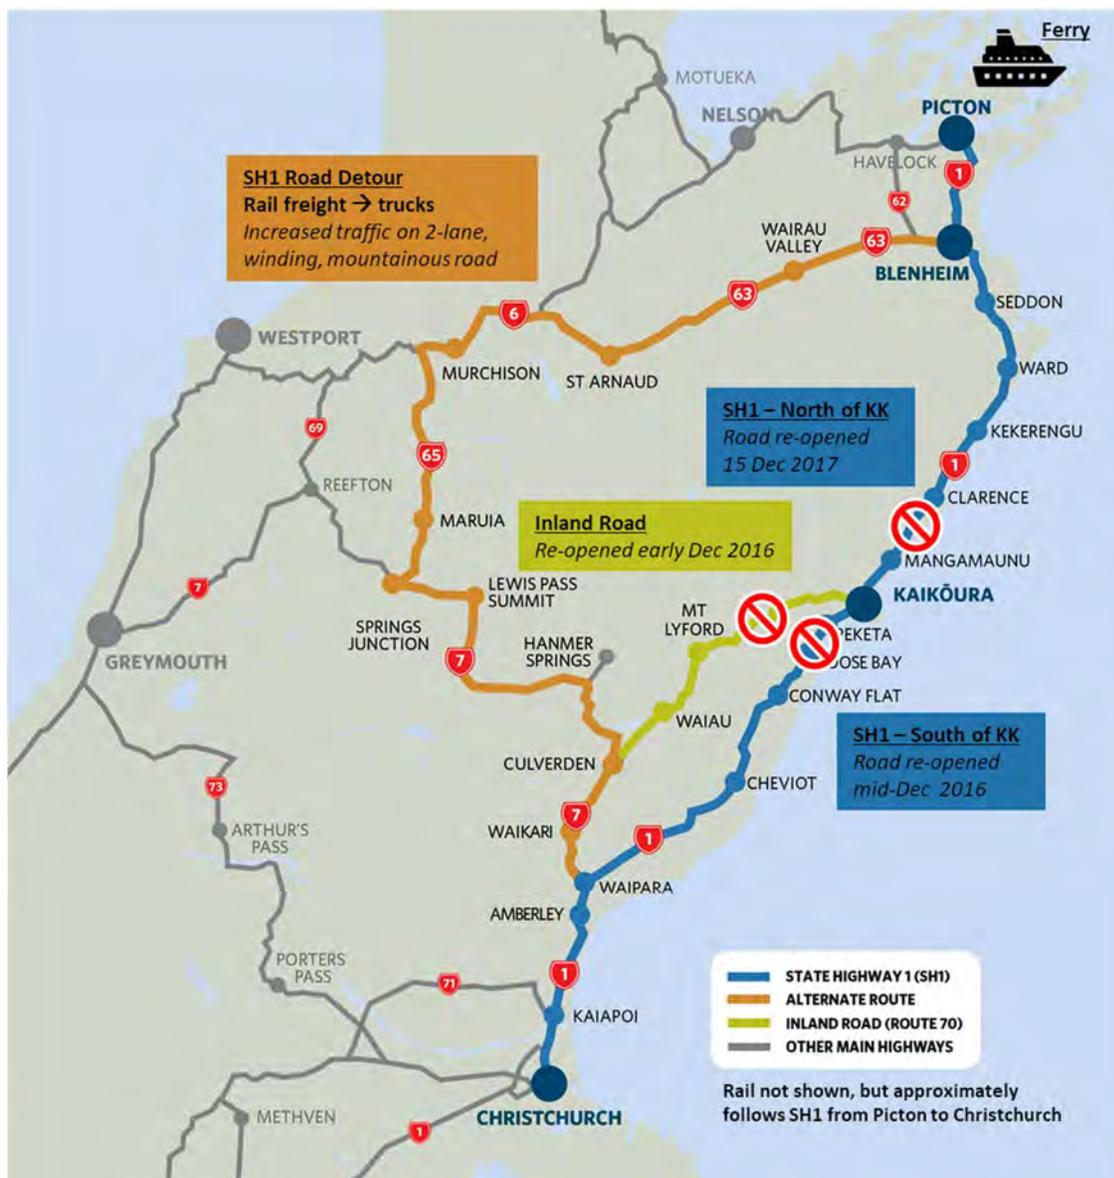
Figure 2 – Transportation network affected by Kaikōura earthquake (base map from NCTIR)

More than 80 landslides either directly affected or occurred upslope of the transportation corridor. Due to the landslides, as well as damage to road and rail infrastructure, access to Kaikōura (Figure 2) was completely cut off for 2-3 weeks until the Inland Route was re-opened as part of the Civil Defense emergency response works. Access via the main state highway (SH1) south of Kaikōura was re-established by mid-December 2016, but only during daylight hours due to increased rockfall risk from the tens of

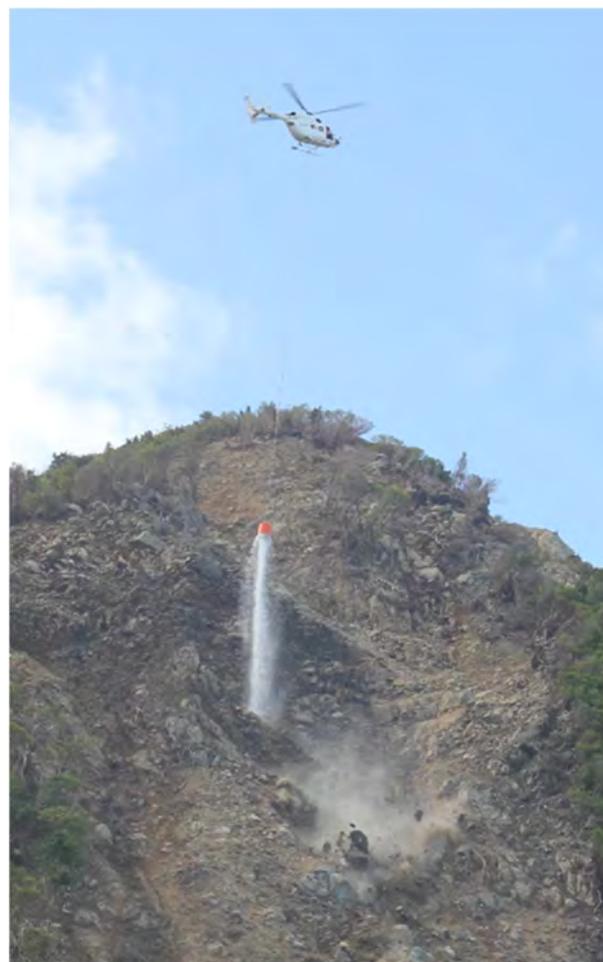
Figure 3 – Helicopter sluicing, Kaikōura (photo from NCTIR)

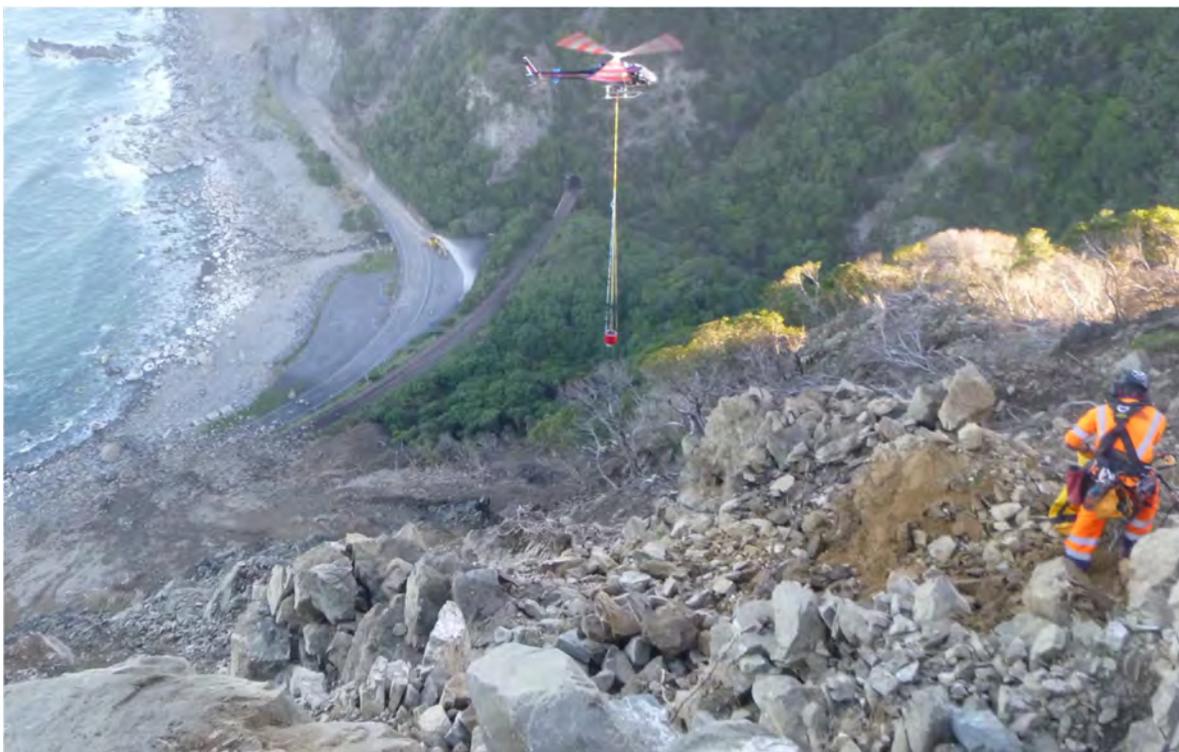
Figure 4 – Sluicing and scaling operations on an earthquake-damaged slope north of Kaikōura (photo from R. Musgrave)

Site geotechnical personnel (“site geos”) established sluicing plans with pilots daily due to the rapidly changing nature of the site conditions; rope-access technicians participated in the process where sluicing operations were undertaken in conjunction with scaling (Figure 4).

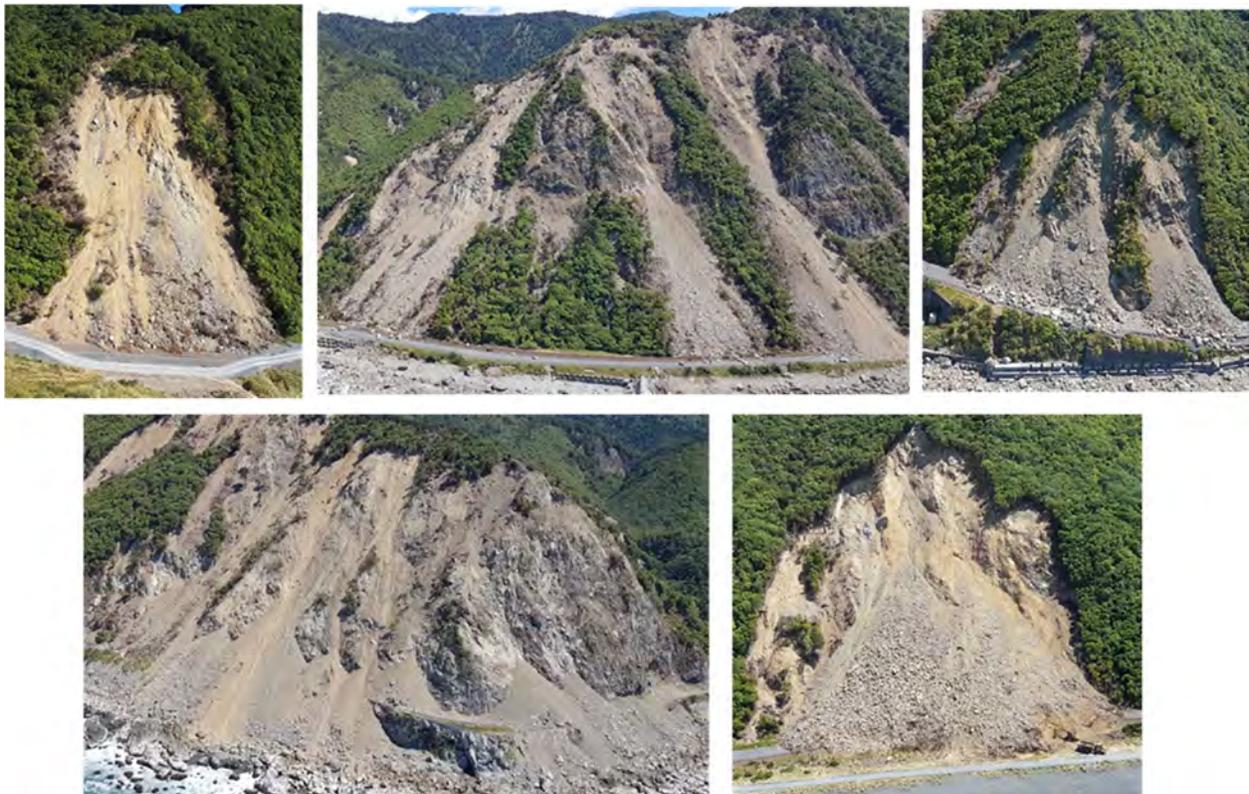
Figure 5 – Five of seven major sluicing sites north of Kaikōura before mitigation (photos from NCTIR)

An overview of some of the outcomes is illustrated via “before and after” photos in Figures 5 and 6. The photos show five major sluicing sites before and after mitigation works were undertaken; the mitigation works included a significant sluicing component together with varying levels of rope-access supported scaling and a limited amount of blasting.

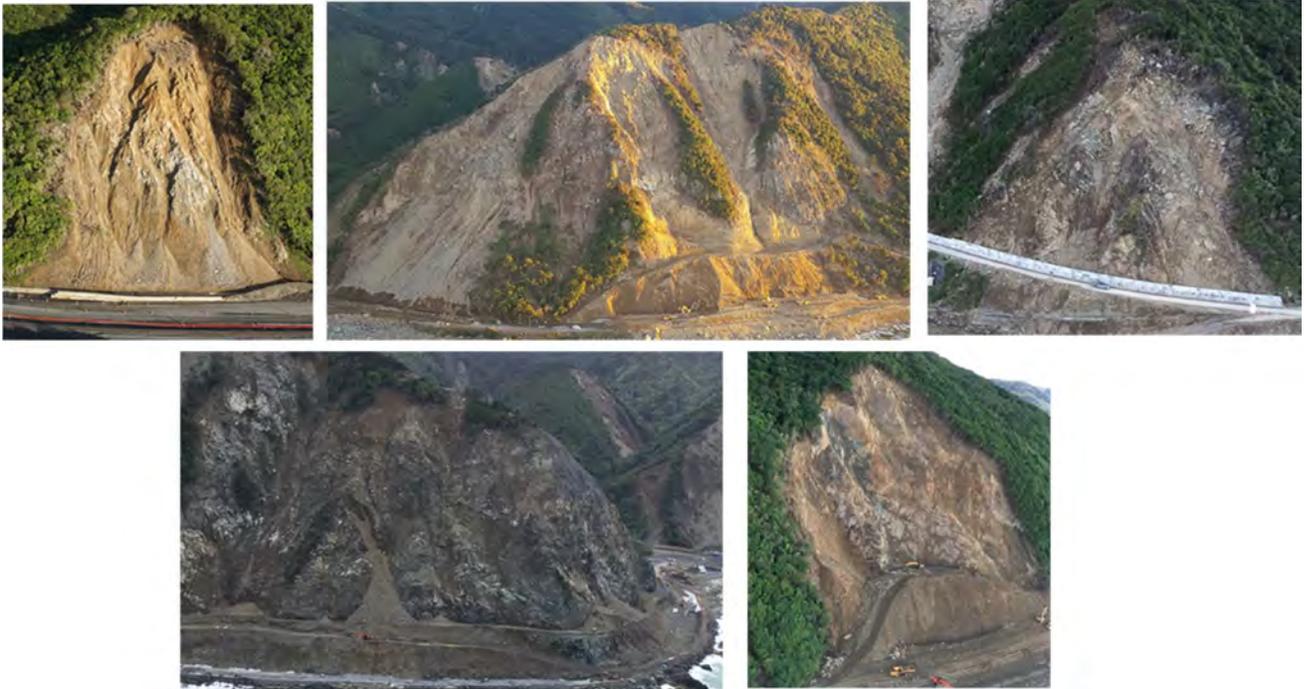
Figure 6 – Five of seven major slicing sites north of Kaikōura after mitigation; photos taken 7 to 11 months post-earthquake (photos from NCTIR)

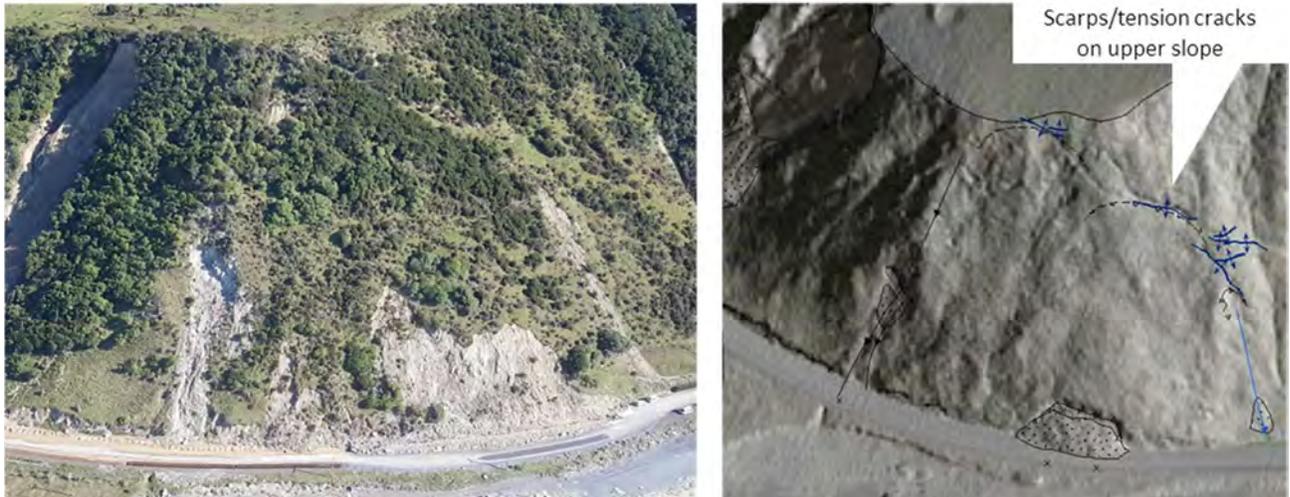
Figure 7 – Example of site where slicing was considered, but rejected due to potential to negatively impact slope stability (photo from NCTIR; LiDAR image from NCTIR GIS webviewer)

Sluicing was considered, but rejected, at several sites where it was judged it would likely worsen the stability of the slope. This was particularly where landslide debris was situated above potentially erodible material, such as in-situ colluvium; it was also rejected as an option where there was a potential to cause further upslope regression of the landslide (Figure 7)

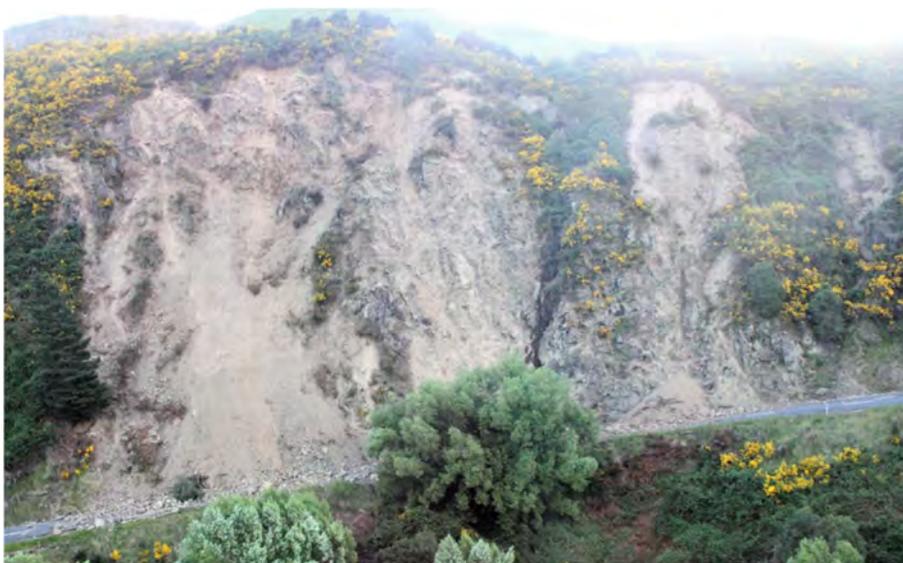
Figure 8 – Conway Bluffs before (photo from NCTIR)

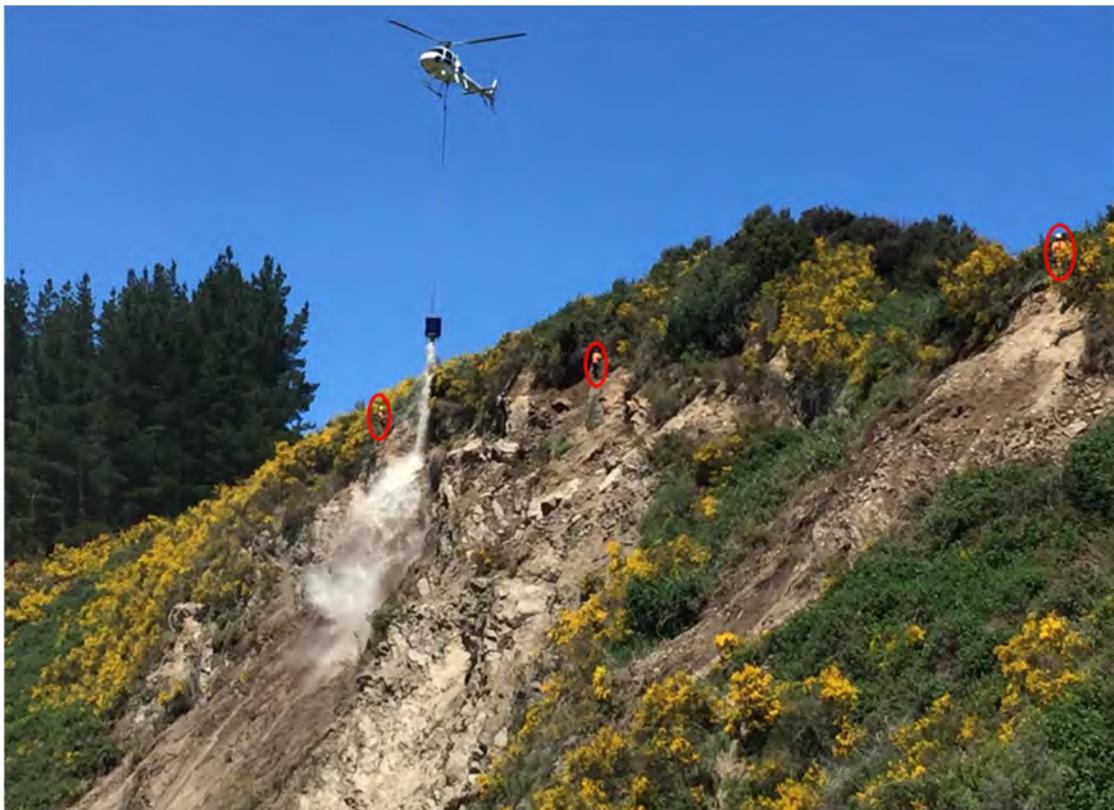
Figure 9 – Sluicing at Conway Bluffs; rope access technicians circled (photo from NCTIR)

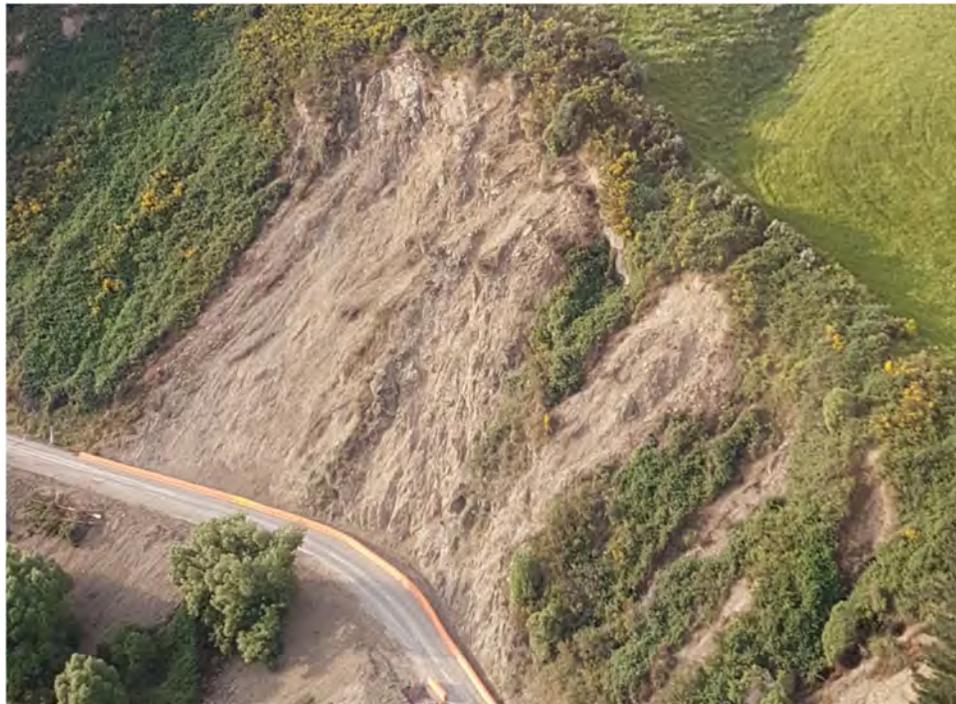
Figure 10 – Conway Bluffs post-mitigation, 3 weeks after earthquake (photo from NCTIR)

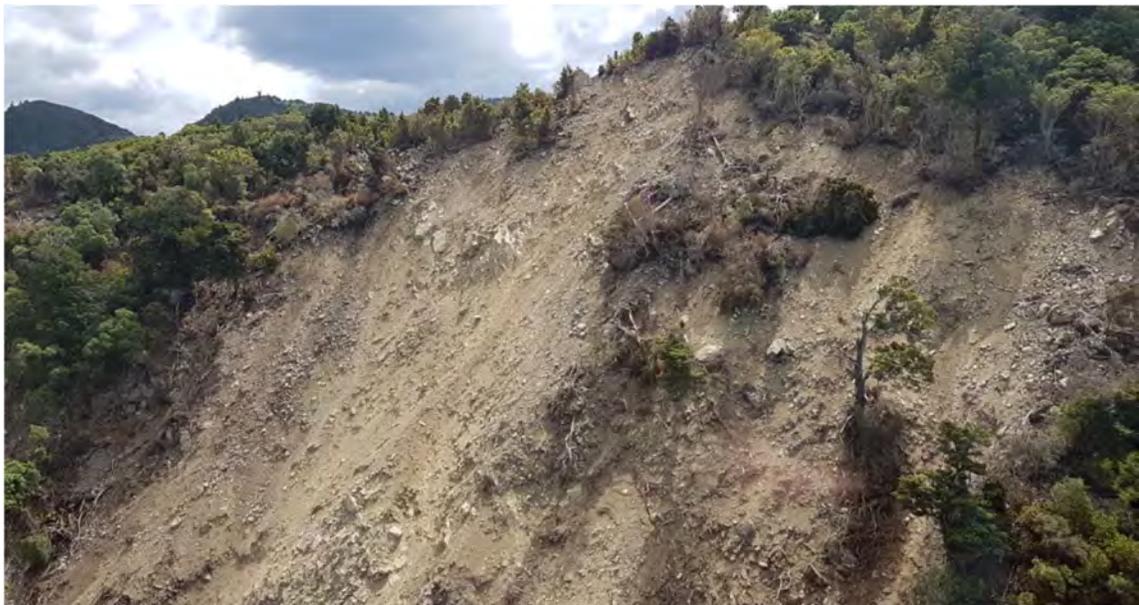
Figure 11 – Slip 7, Chute C headscarp area before mitigation (photo from NCTIR)

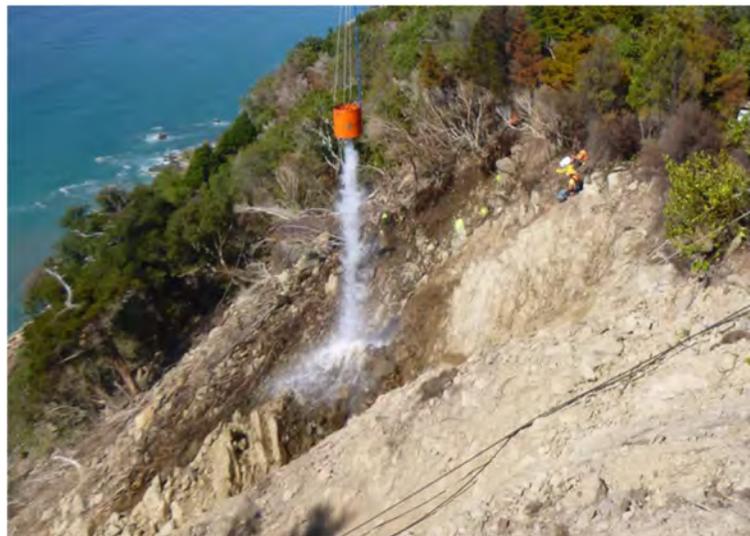
Figure 12 – Slip 7, Chute C sluicing from top-down to enable safer access for rope-access scaling teams (photo from R. Musgrave)

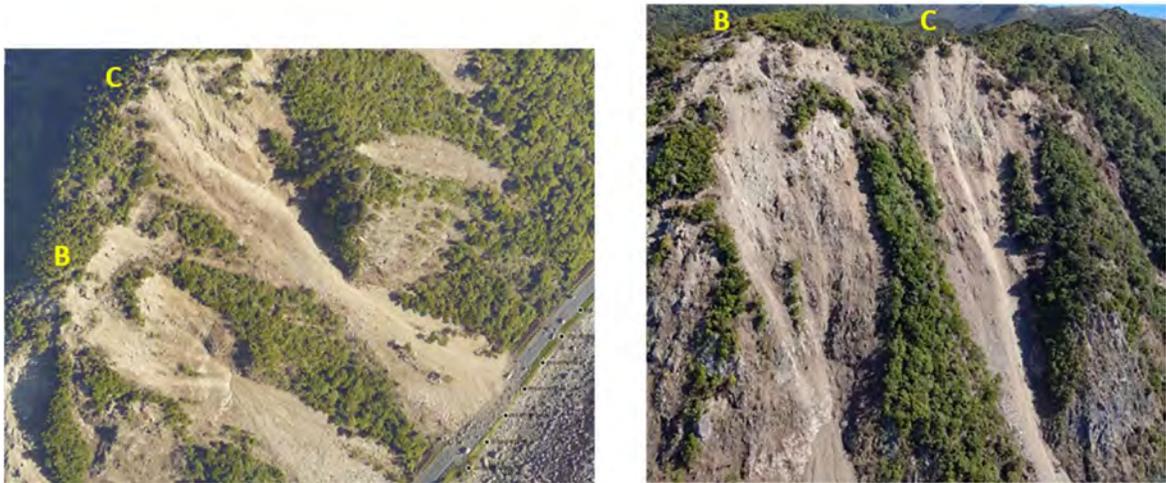
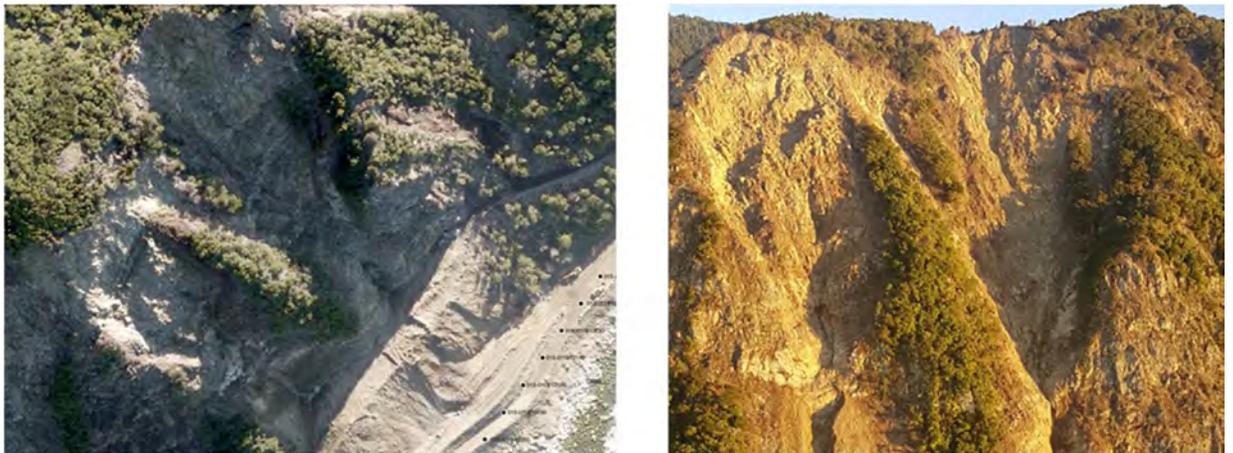
Before mitigation

After mitigation

Figure 13 – Slip 7 Chutes B and C before and after mitigation (aerial images from NCTIR GIS webviewer; oblique aerial photos from NCTIR)

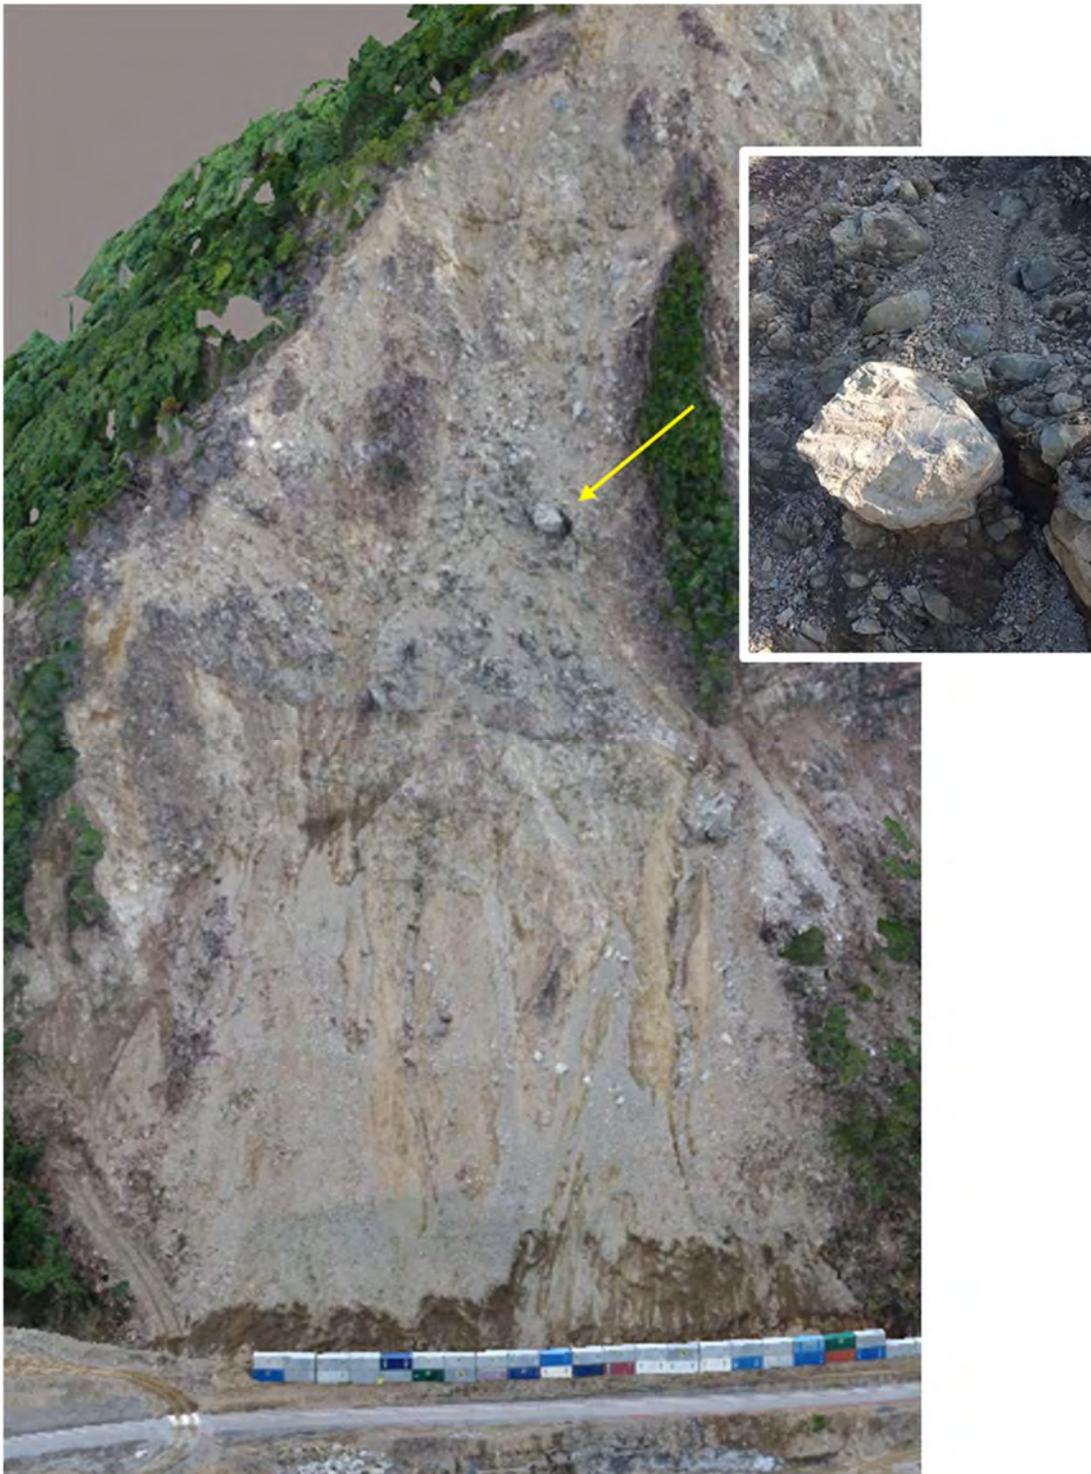
Figure 14 – Overview of slope post-slucing, Millie indicated (inset photo and 3D photogrammetry image from NCTIR)

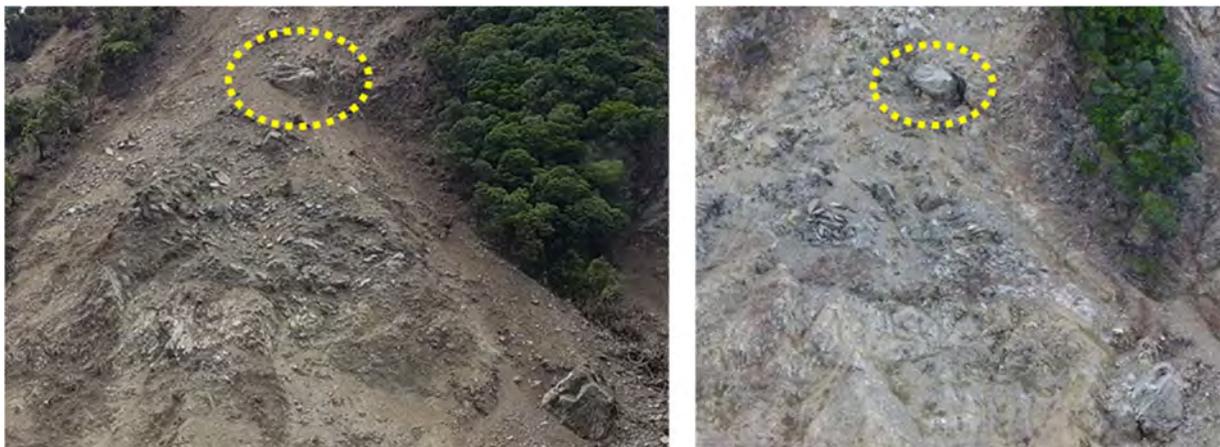
Figure 15 –Millie before (above) and after sluicing (photo and 3D photogrammetry image from NCTIR)

Issues Encountered	Millie unable to be successfully removed via sluicing; very large boulder left in a potentially precarious position; visually very scary; rope access teams not able to safely access for further assessment or removal
Outcome to Date	Millie successfully removed via blasting; considerable effort expended considering range of options for safe removal and executing the selected removal plan

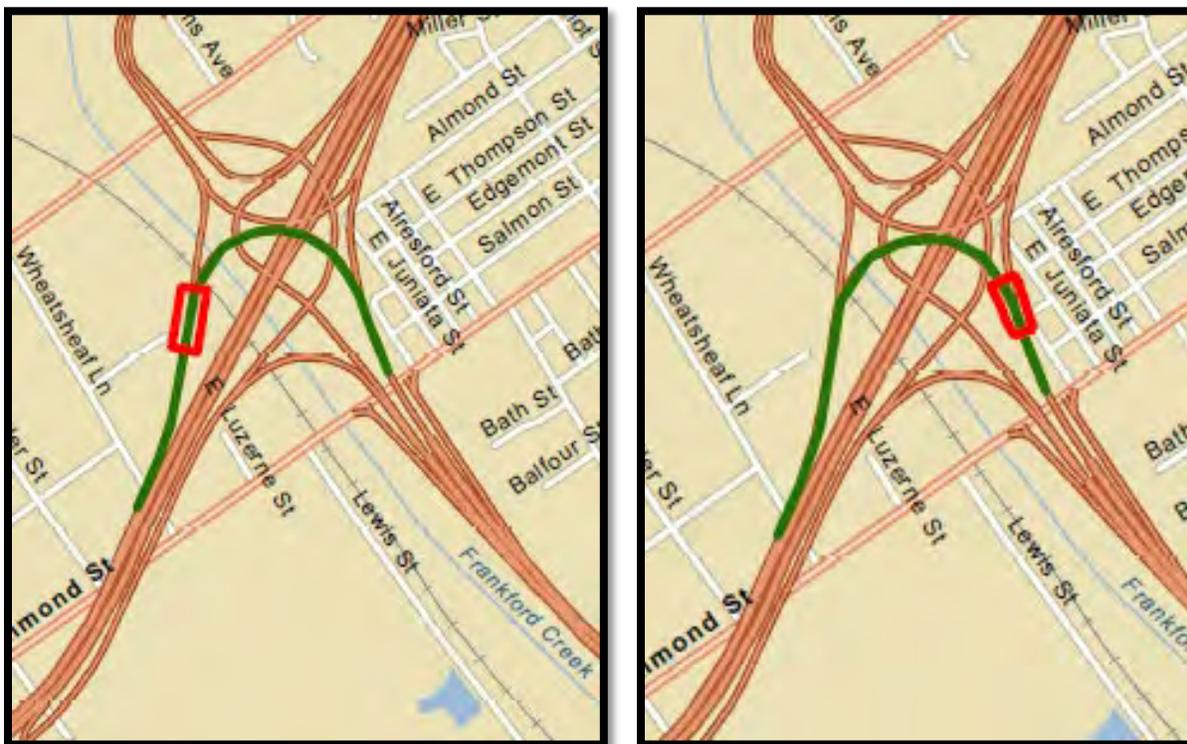
Figure 2: Location of Ramps BD (left) and BH (right)

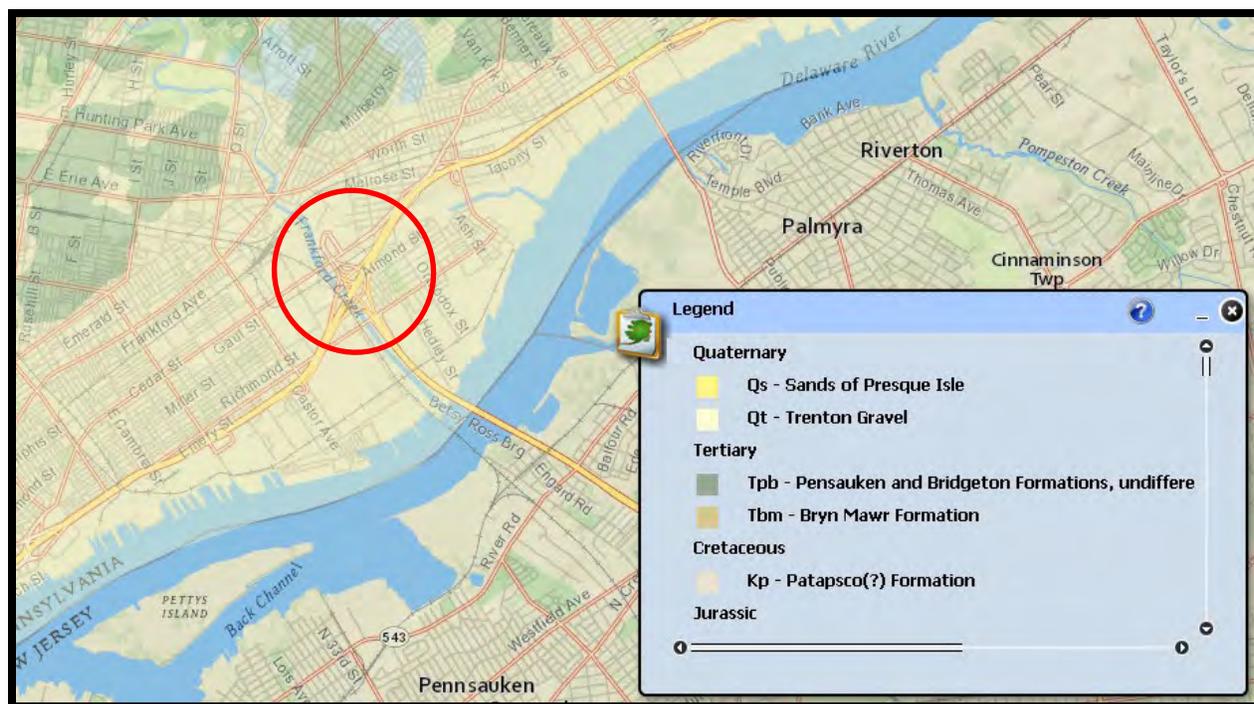
Figure 3: Geology Map

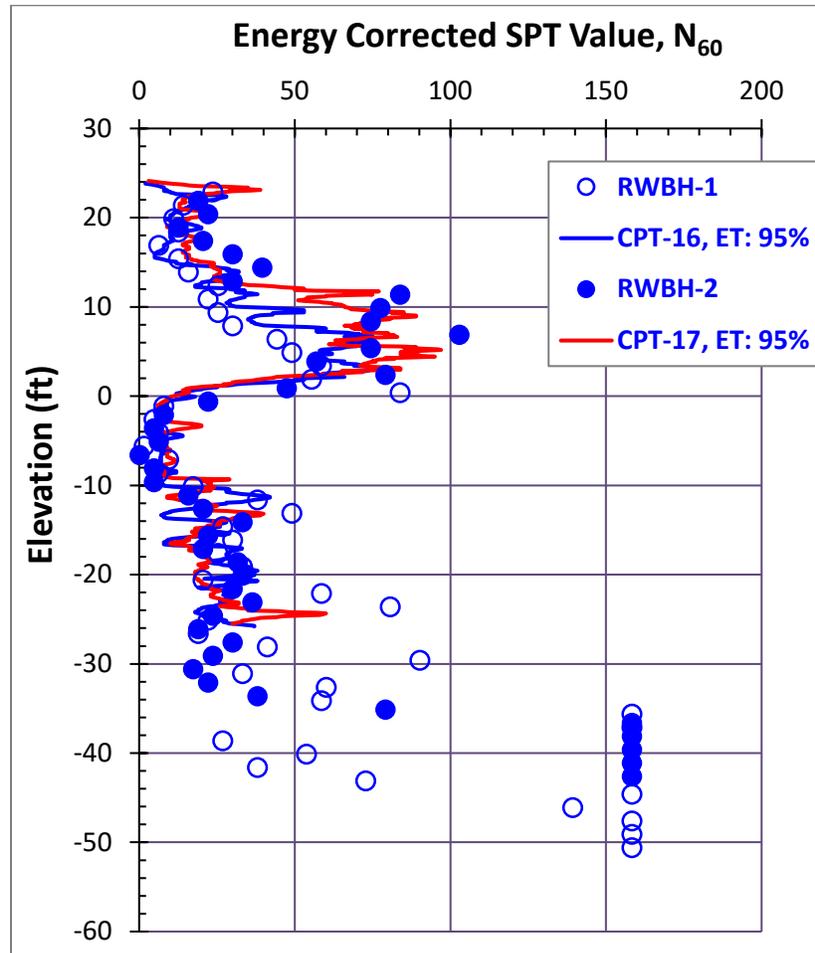
Figure 4: Comparison of SPT N₆₀ Values with CPT Derived Blow Counts

At Ramp BH, two CPT borings were drilled next to SPT test borings. Figure 4 presents the energy corrected SPT blow counts (N_{60}) from test borings and CPT borings. Commercial CPT interpretation software CPET-IT was used to obtain the equivalent blow counts. By comparing the CPT derived blow counts and measured blow counts from the drill rig with an automatic hammer it is concluded that the Energy Transfer Ratio (ETR) of the SPT drill rig was approximately 95%. “Calibration” using CPT results shows the advantage of providing continuous soil properties over the blow counts provided by test borings.

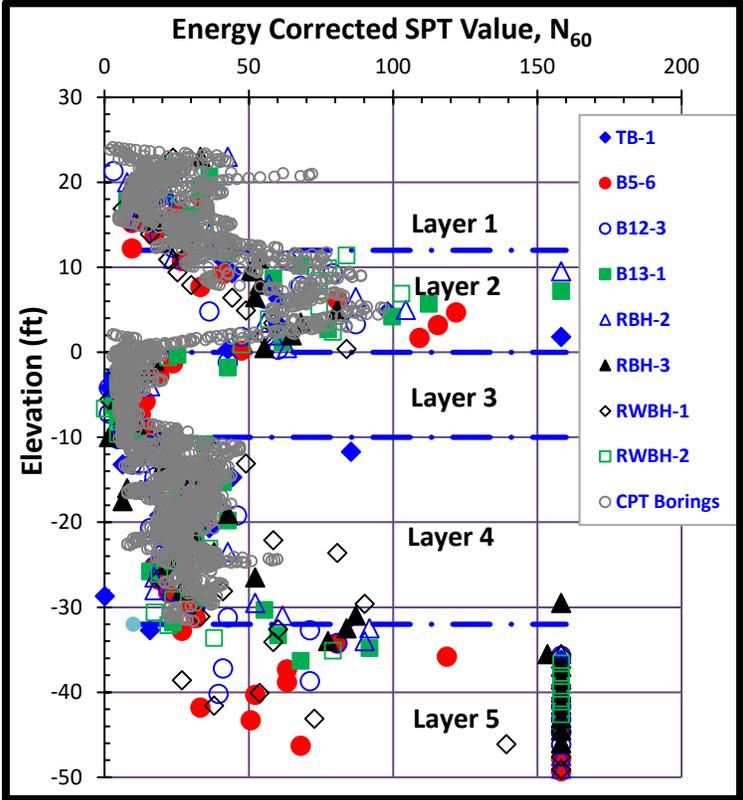
Figure 4 Subsurface Conditions at Ramp BH Area

Overall, the subsurface conditions at both ramps were generally consistent. Figure 5 summarizes the subsurface conditions obtained from both SPT and CPT borings at Ramp BH general area.

Ramp BH area is relatively flat. The original ground surface elevation varies between 20 ft and 23 ft. The competent rock, which is defined as the bedrock that can be cored and has a variable recovery, is generally below elevation -50 ft. As shown in Figure 5, the soil above the bedrock can be classified in five (5) soil layers based on the field-tested blow counts, and material properties from the laboratory test results. The soil stratigraphy is presented in Table 1.

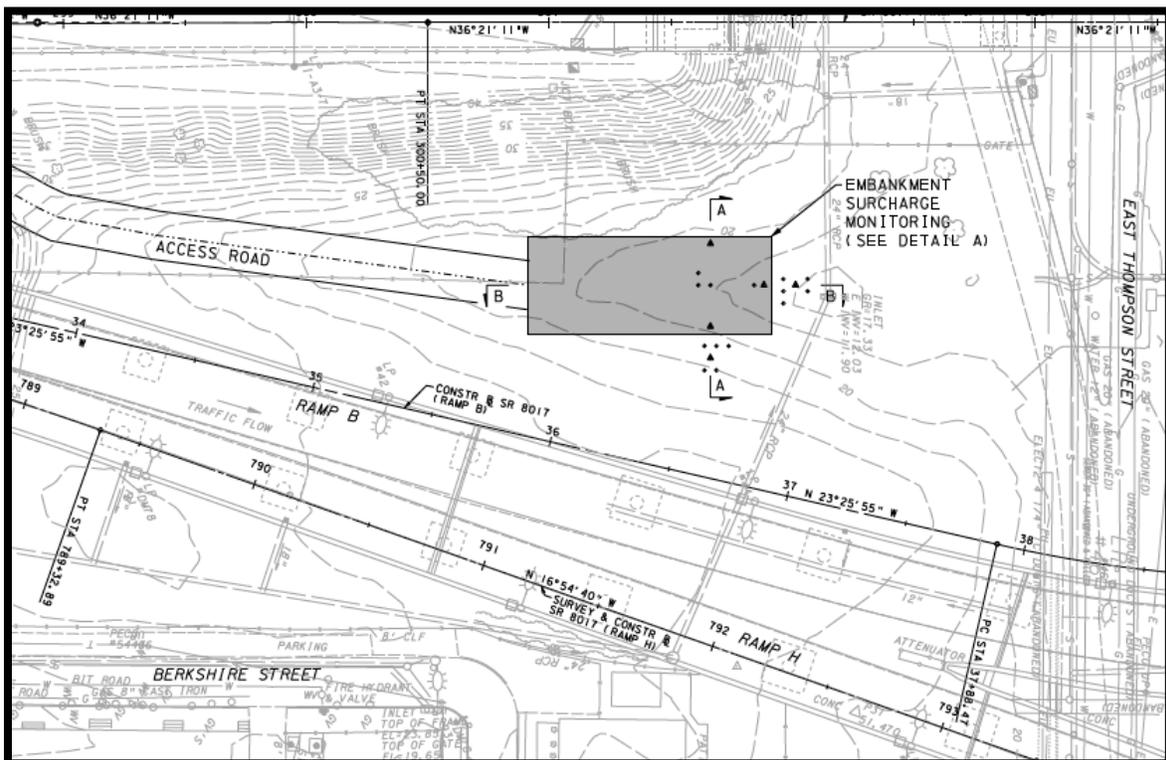
Figure 6: Test Embankment Location Adjacent to Proposed Ramp BH

available space, constructability and access requirements at the test location a 40 ft. wide and 30 ft. high embankment with wire mesh temporary MSE walls on three sides could be constructed adjacent to the proposed Ramp BH roadway on fill (Figure 6). Instrumentation included settlement plates, vertical and horizontal extensometers, inclinometers and vibrating wire piezometers (Figure 7).

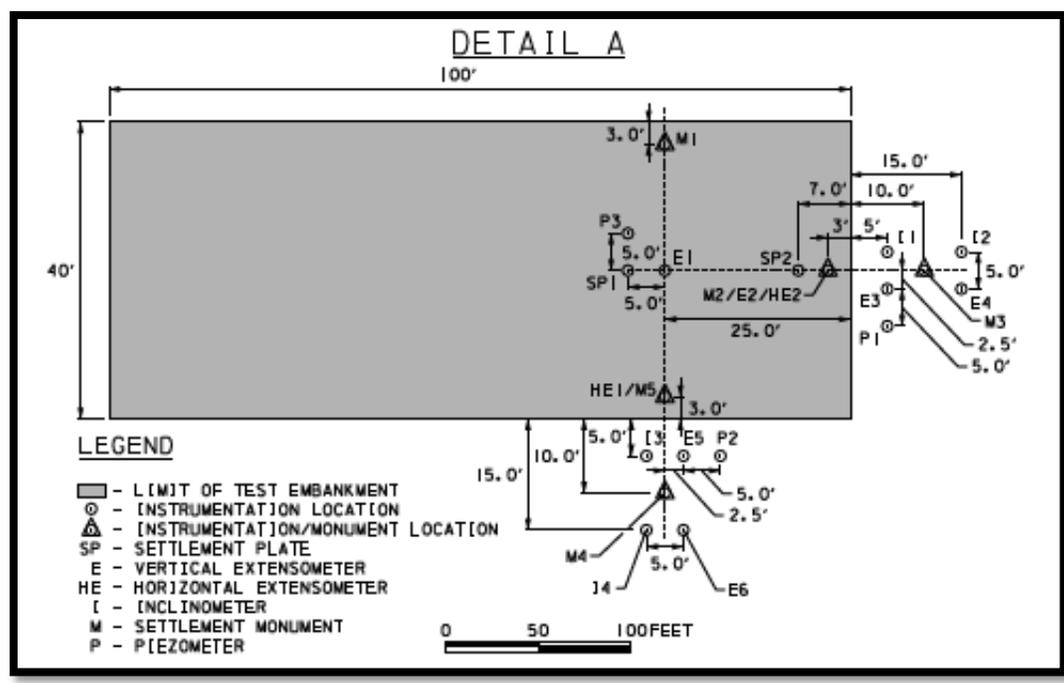
Figure 7: Test Embankment Instrumentation Plan

Settlement plates (SP1 and SP2) were at the ground surface below the test embankment. Six vertical extensometers were installed at different locations below the ground to measure the effect of test embankment loads on the vertical deflections at various depths outside of the test embankment footprint. The horizontal and vertical deformation inside the embankment during construction was also monitored through horizontal and vertical extensometers. To capture the potential lateral movement of existing foundations adjacent to the embankment four inclinometers were installed at varying distances from the test embankment. Vibrating wire piezometers were installed in the Layer 3 low to non-plastic fine-grained soils to monitor the groundwater head changes under the embankment loads.

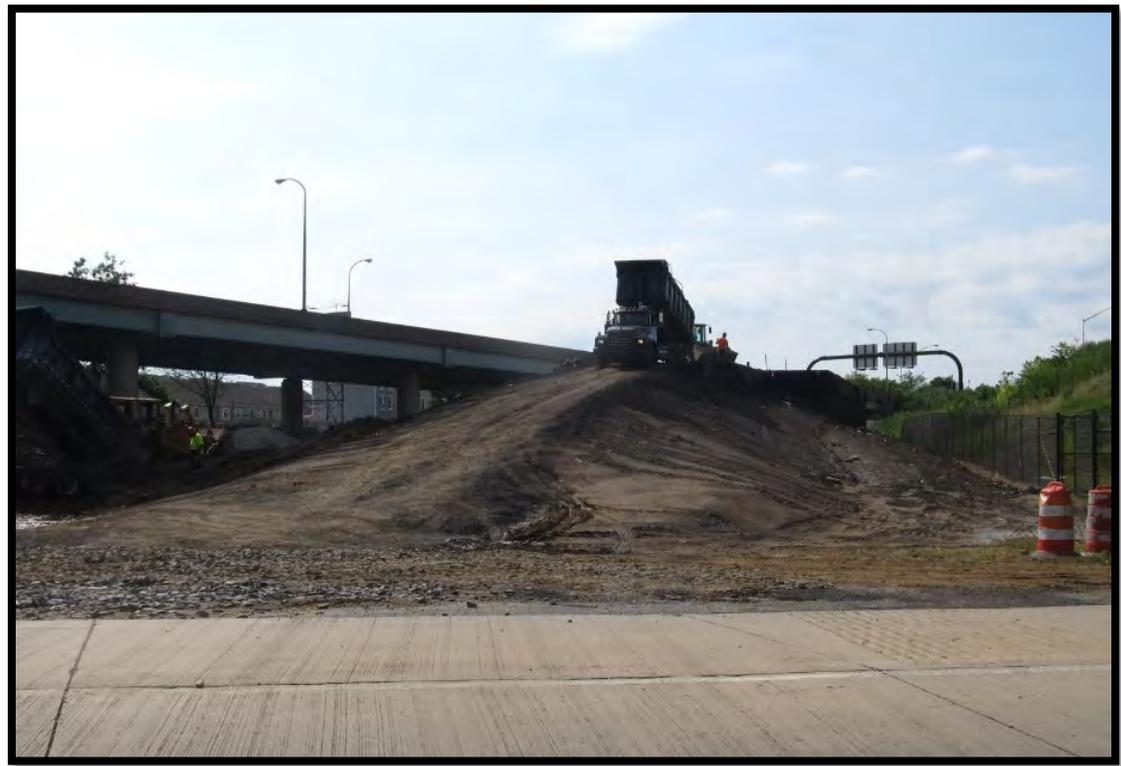
Figure 8: Test Embankment Construction Adjacent to Proposed Ramp BH

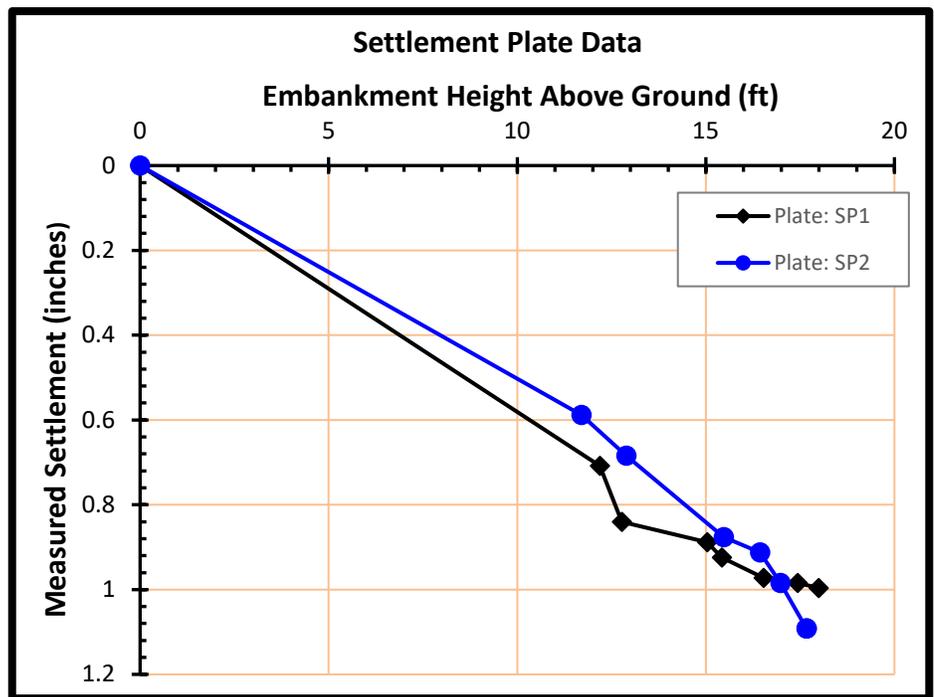
Figure 9: Observed Settlement with the Test Embankment Height

Prior to embankment construction, two settlement plates were installed at the centerline of the test embankment 20 ft from both sides of the wall on the surface of original ground. Plate SP1 is 30 ft away from the end and Plate SP2 is 7 ft from the edge of the wire mesh MSE wall. Figure 8 presents observed settlement with embankment height. At the current embankment height of 18 ft, observed settlement at both plate locations is approximately one inch. Although Plate SP2 was only 7 ft away from the end of the embankment, both plates demonstrate similar settlement magnitudes.
