70TH HIGHWAY GEOLOGY SYMPOSIUM

“Better Highways Through Applied Geology”

October 21-24, 2019

2019 Proceedings

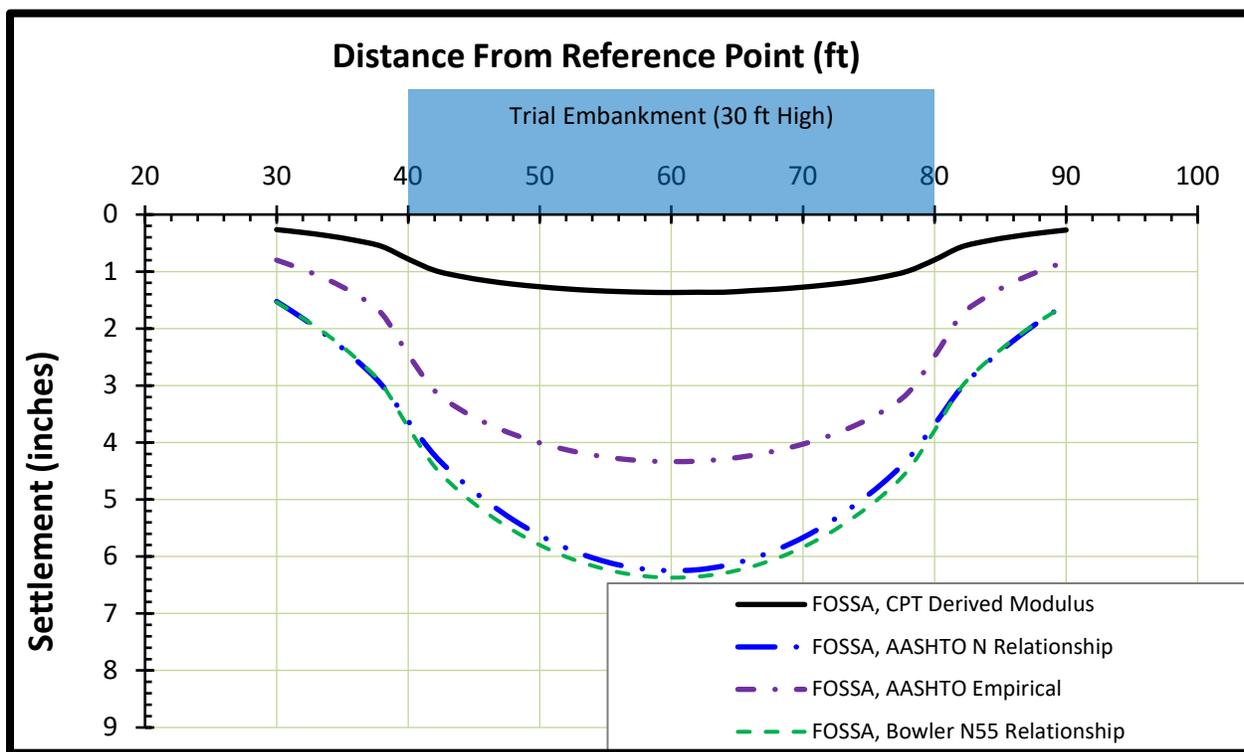
Figure 10: Predicted Settlement Values Across the Test Embankment

As indicated in Figure 9, the maximum settlement values vary significantly ranging from 1.4 inches using modulus derived from CPT results (Robertson, 2009) to 6.4 inches using AASHTO N₁₆₀ relationship (AASHTO, 2017) and Bowles' N₅₅ relationship (Table 5-6, 1997). The construction of this instrumented test embankment provides a valuable opportunity for the engineering professionals to select elastic moduli values that can provide more reliable settlement values. Figure 10 present the maximum settlement values using different approaches at the center of the test embankment with different embankment heights. The observed settlement at settlement plate SP1 is also plotted in this figure for the comparison purposes.

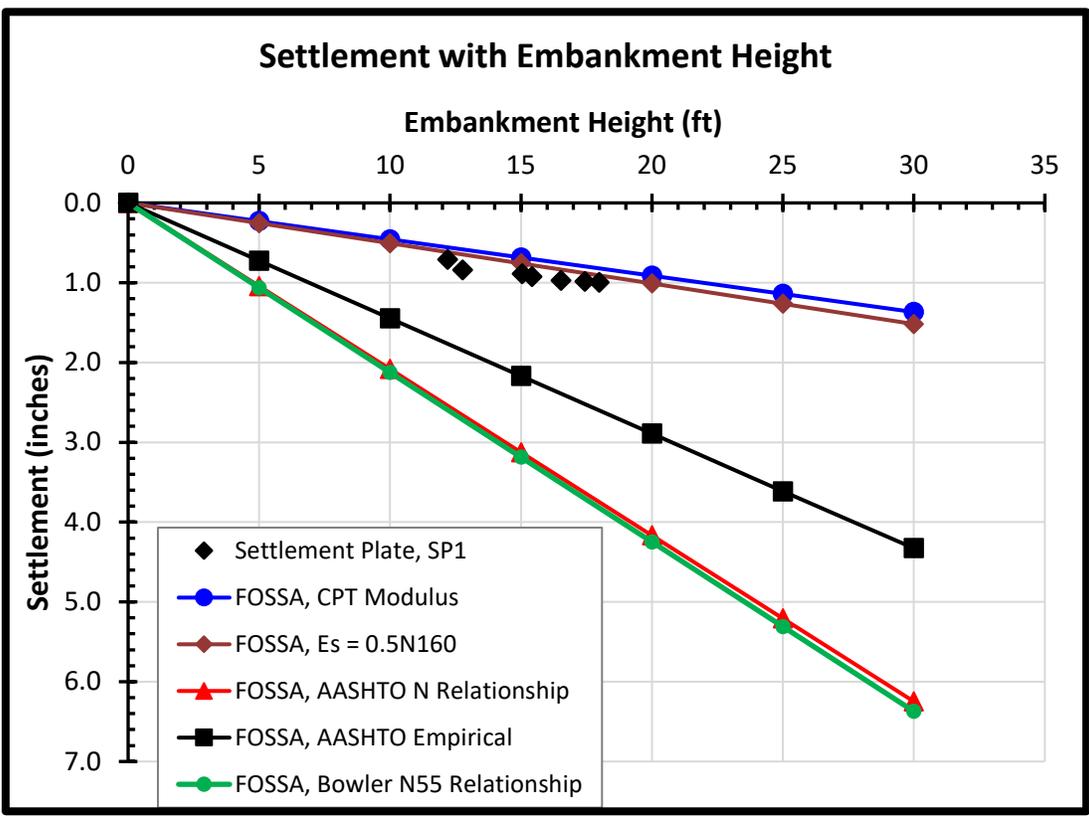
Figure 11: Comparison of Observed and Predicted Settlement at Center of Test Embankment

Figure 10 indicates that the modulus values derived from CPT results have a better overall prediction of ground settlement under the test embankment load. Compared with modulus values in the first four soil layers (except for the saprolite soil layer 5) listed in Table 2, the CPT derived modulus is 3 to five times higher than those recommended by current AASHTO (2017) and Bowles (Table 5-6, 1997).

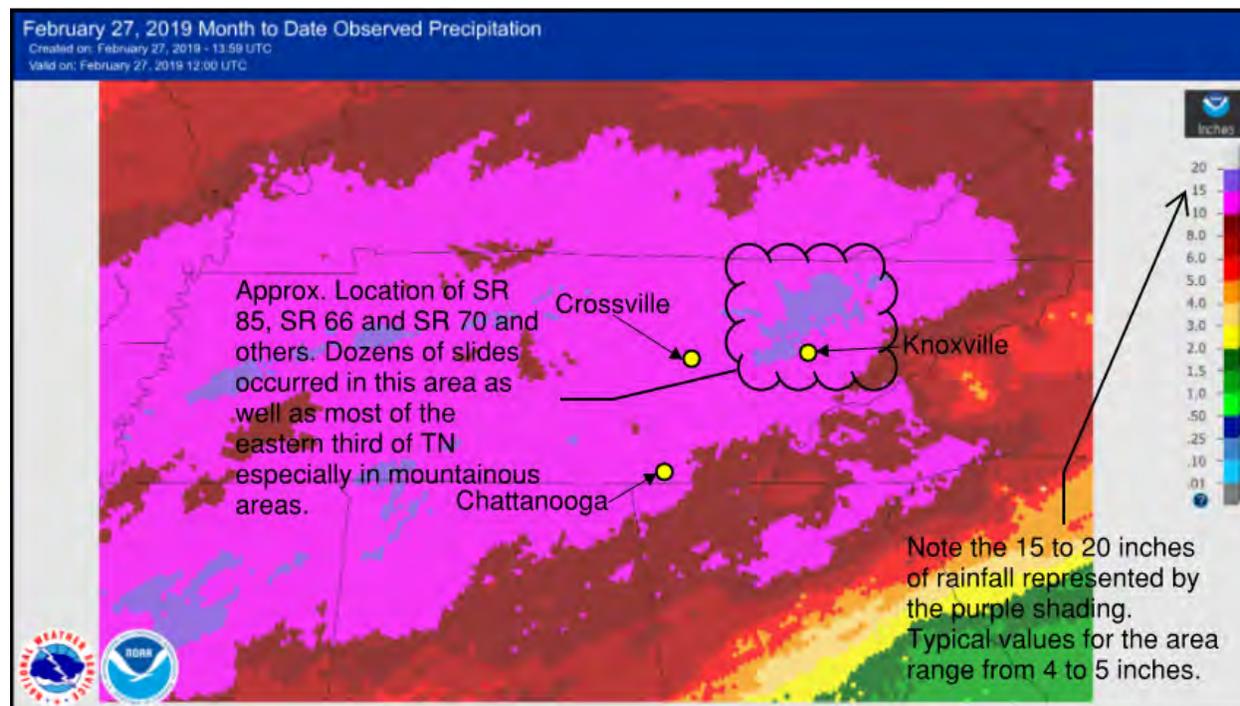
Figure 3: February 27, 2019 Month to Date Observed Precipitation

Figure 3 below represents the “Month to Date Observed Precipitation” for the Tennessee Valley on February 27th, 2019. Note that the Cumberland Plateau and Valley and Ridge Province lies at the epicenter of this sustained period of rainfall.

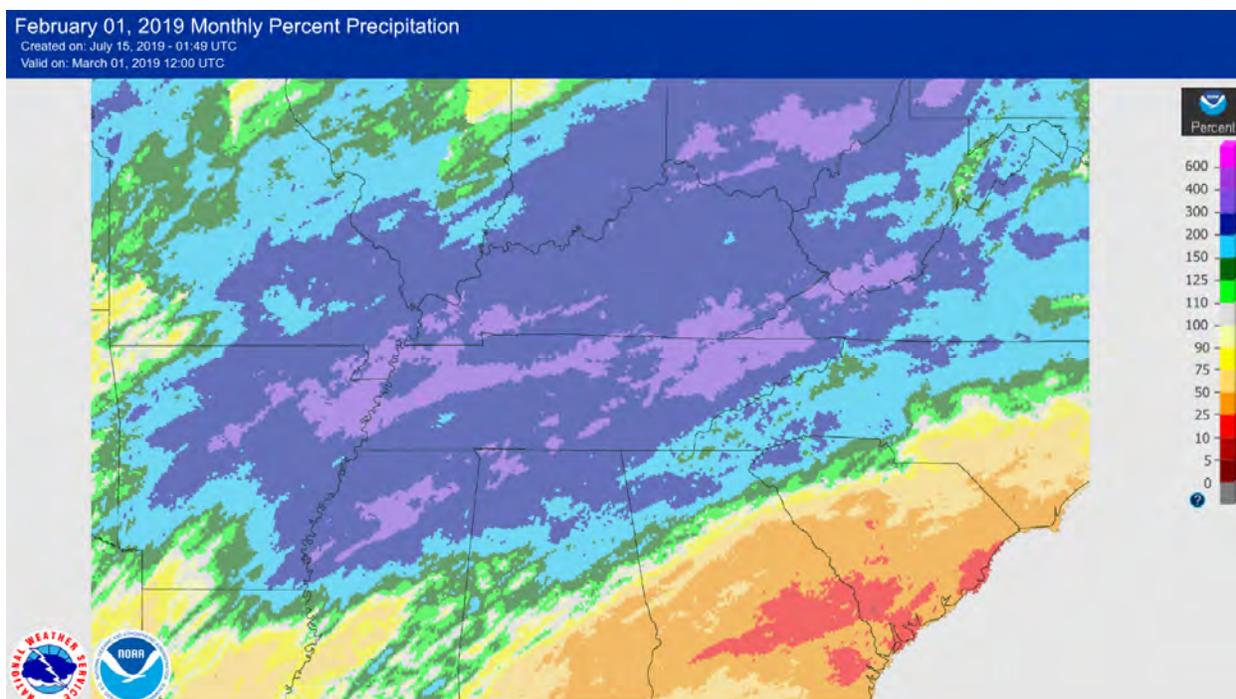
Figure 4: February 2019 Monthly Percent Precipitation

To understand the magnitude of rain that fell in this region Figure 4 shows February 2019 precipitation as a percent of normal precipitation. This shows that approximately 95 percent of the state of Tennessee received between 300 and 400 percent of normal precipitation for the month.

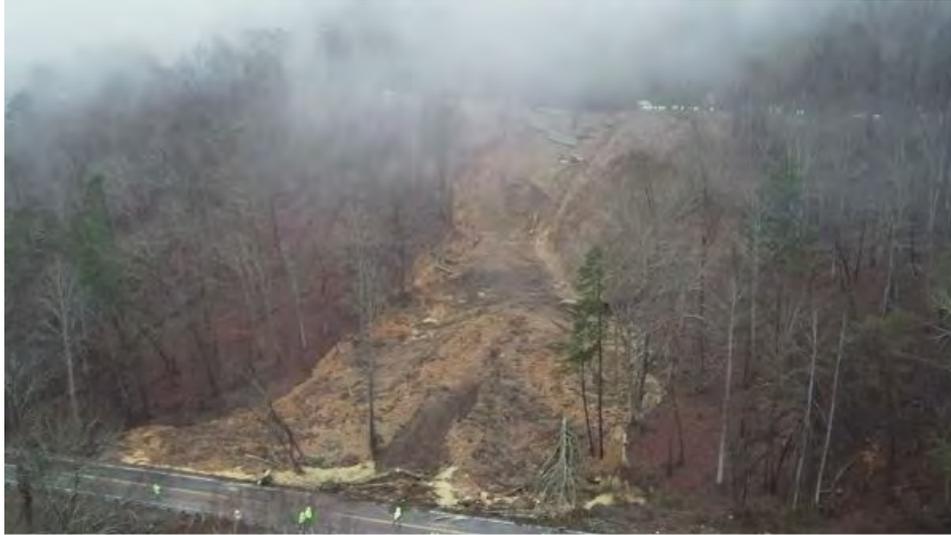
Figure 5: Aerial View of SR 70 Hawkins County Post-Slide, taken from a WVLT-TV drone survey. Two men in two separate vehicles drove over the edge of the landslide during the early morning hours of February 21, 2019 with one fatality.

Due to the significant rainfall and saturated ground conditions of this event a significant increase in the number of geohazard events impacting transportation routes in the region occurred. Figures 5 and 6 represent landslides and rockfall events which occurred during late February. Dozens of significant landslides and rockfall events impacted the eastern two-thirds of the state causing government and private agencies to be stretched thin and resorting to unconventional methods in dealing with the sheer number of roadway disasters throughout the state. For example, State Routes 70 and 66 in Hawkins County, Tennessee, major state routes, were shut down completely. Figure 5 is a photo of one of the failures.

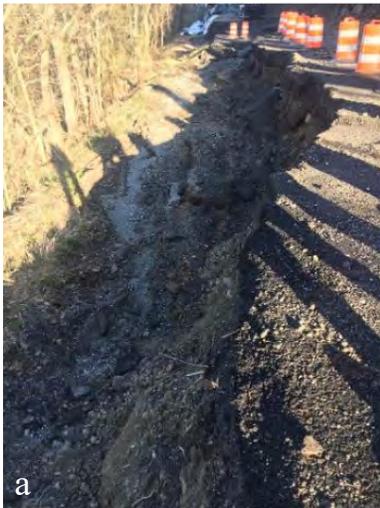
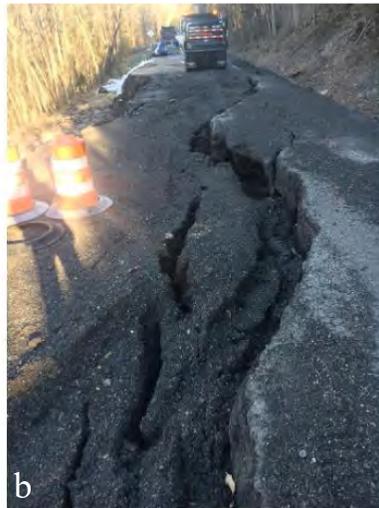
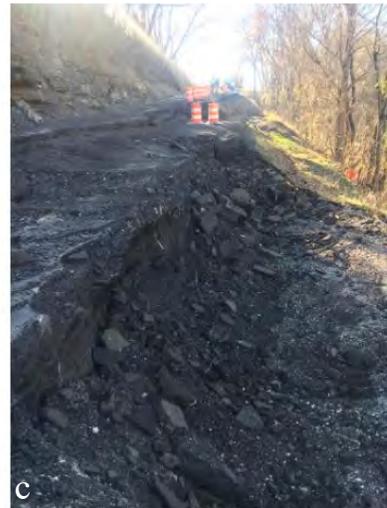
Figure 6: Site Photos of SR 262 from February 25, 2019. At this point, the roadway became impassable and was completely shut down.

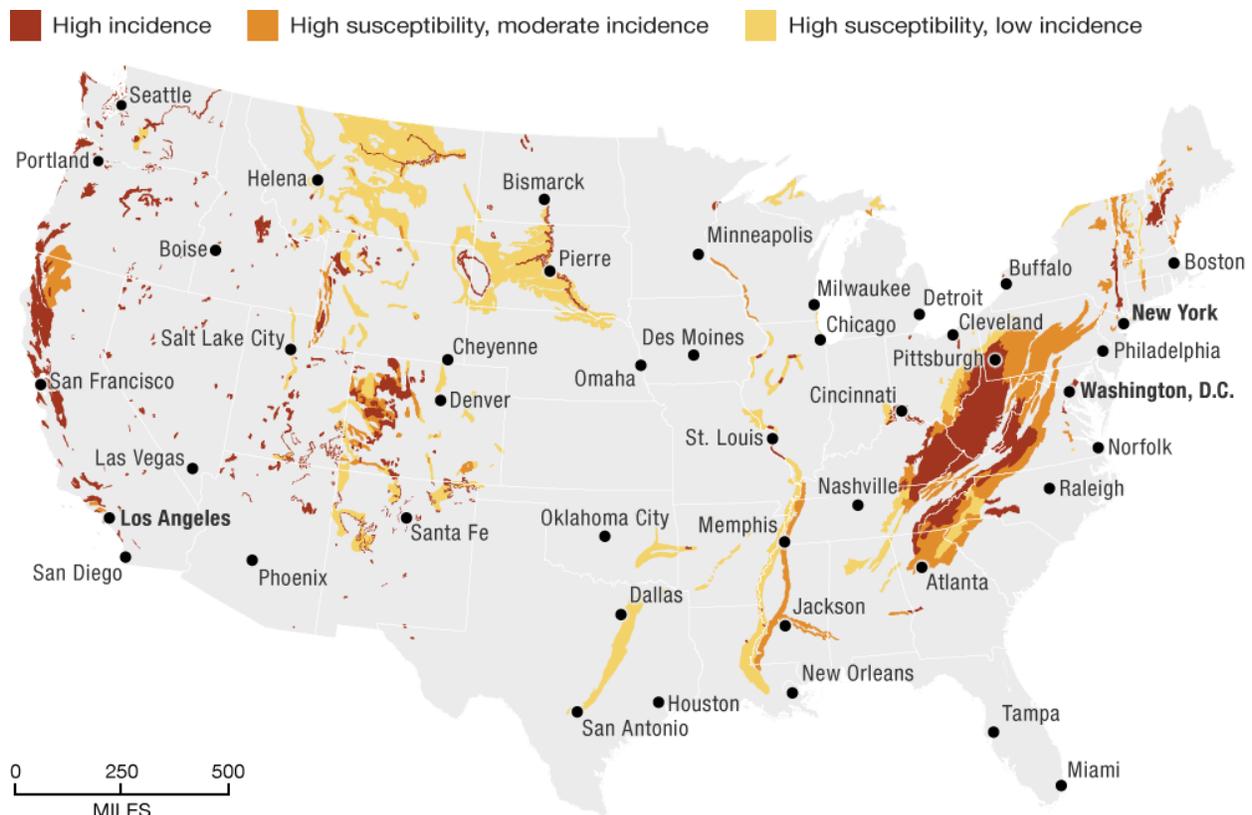
Figure 7: United States Landslide Susceptibility Map

The Appalachian Plateau with its steep hillsides, thick soil cover, and precipitation of 35 to 50 inches per year, with the greatest amounts occurring in late winter and early spring has long been recognized as an area of major landslide severity (Reference 2). As illustrated in Figure 7 below, the Appalachian Mountains have a very high susceptibility for landslide activity (Reference 3).

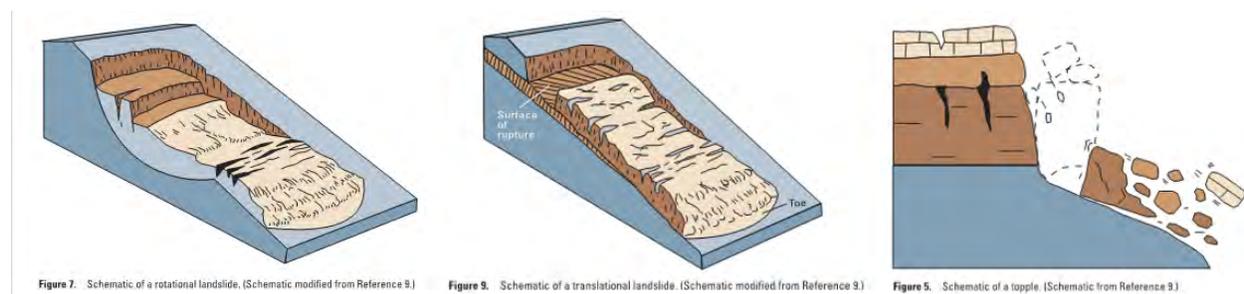
Figure 8: Rotational and translational landslide, and rock block topple, respectively.

Below in Figure 8 are three images (Reference 4) illustrating the difference between rotational and translational landslides, as well as rock topples.

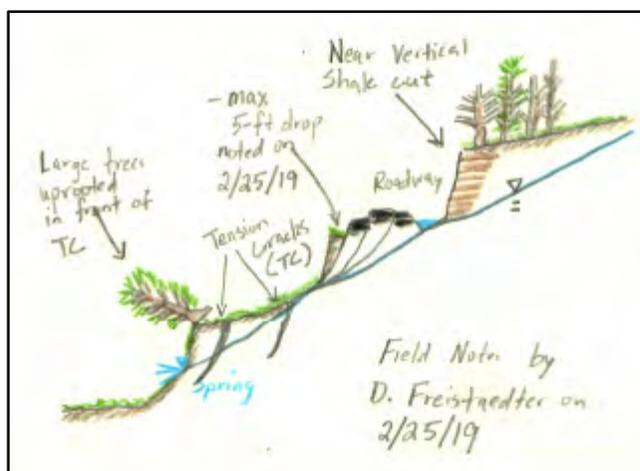
Figure 9: SR 262 MP 8.8 Field Notes Dated February 25, 2019

Figure 9 below portrays a site sketch, from our February 25, 2019 site reconnaissance, showing excessive ground movement, slumping and tension cracking within the landslide complex. The site, located about 30 minutes northwest of Cookeville, TN is located well within the area of extreme rainfall as shown on Figure 3. Historically, the site showed signs of slope failure and roadway repairs were planned when the February 19 through 24 heavy rainfall temporarily shut down work. Upon arrival back to the jobsite on February 25, the roadway conditions, as shown in Figure 6 were noted by GSI and their affiliates. The initial intent of the roadway repairs was to maintain one lane of travel with temporary stoplights. However, after the heavy rainfall event, the entire roadway had to be closed due to the severity of the landslide.

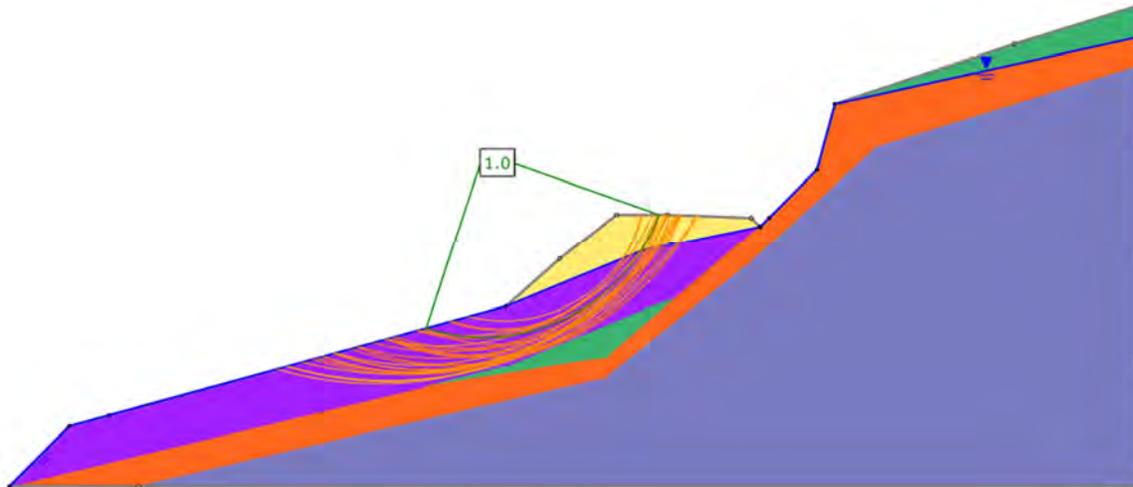
Figure 10: Back Analysis Factor of Safety

Results from our stability analysis are included below in Figures 10 and 11. In Figure 10, the interpreted field conditions were obtained from our back analysis as indicated by the limit-state condition along the failed slope (FS of approximately 1). Following, the permanent stabilization system indicated in Figure 11 shows the repaired slope is stable under static conditions with a local FS of approximately 1.3 through the repair section and a global FS of 1.2.

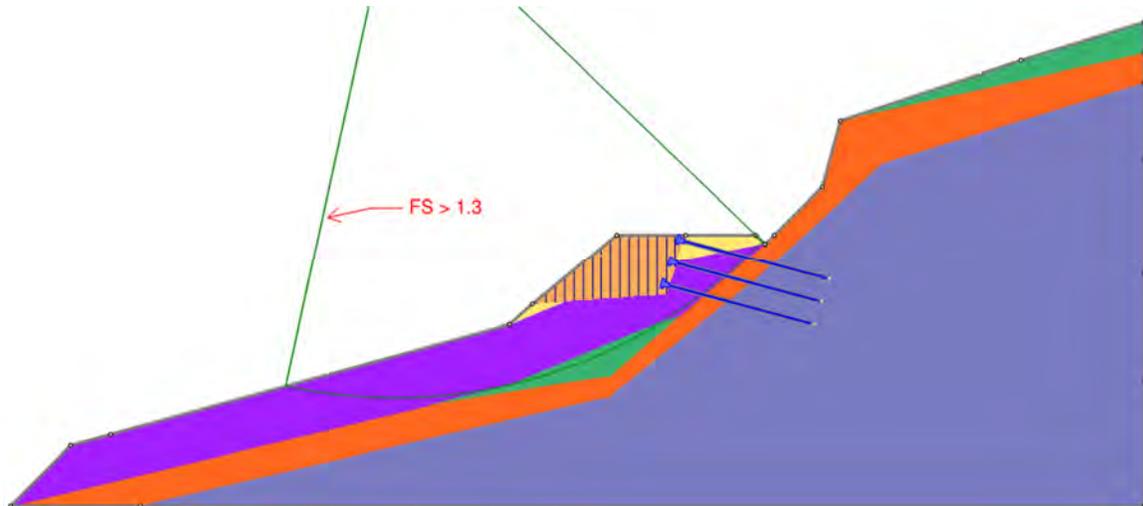
Figure 11: Repair Analysis Cross Section

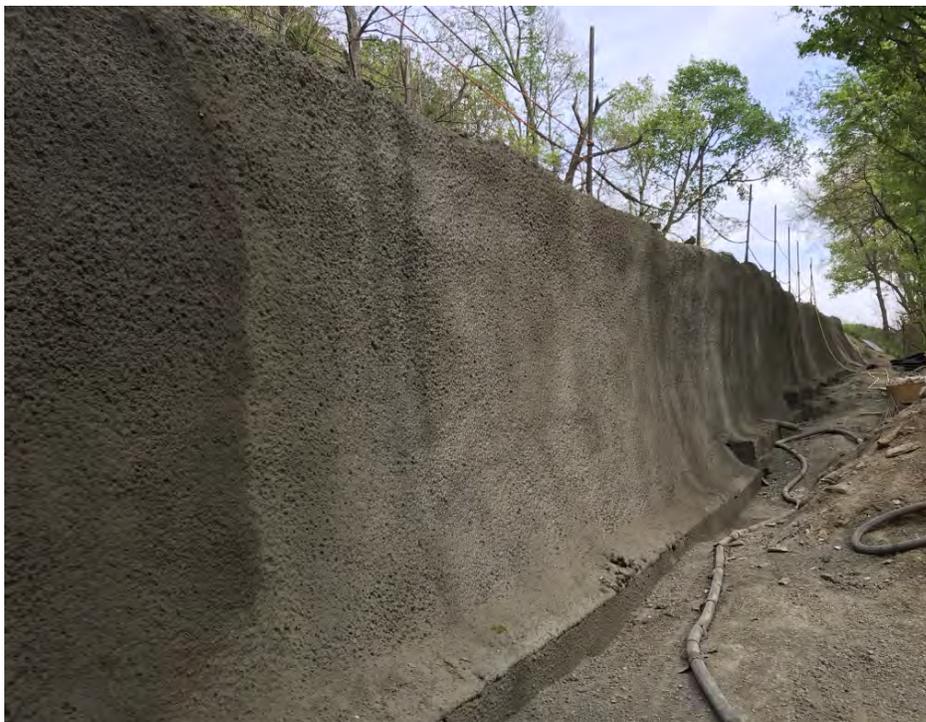
Figure 12: Photograph portraying repair near end of construction at SR 262 MP 8.8

Figure 12 below shows a portion of the repair at SR 262 MP 8.8 near end of construction. The full repair took approximately 3 months to complete, beginning in late February and ending in late May. However, crews worked long hours and 7 days straight initially to meet the Client's requested deadline of being able to open 1 lane of traffic after 7 days of work. Many people had to take long detours and school bus and trucking routes were heavily impacted due to the complete road closure. Being able to open the roadway to one lane of traffic within 7 days greatly minimized the impact to the public by turning a long detour into a short delay with timed traffic lights creating on average about 5 to 10 minutes of delay as opposed to up to 2 hours.

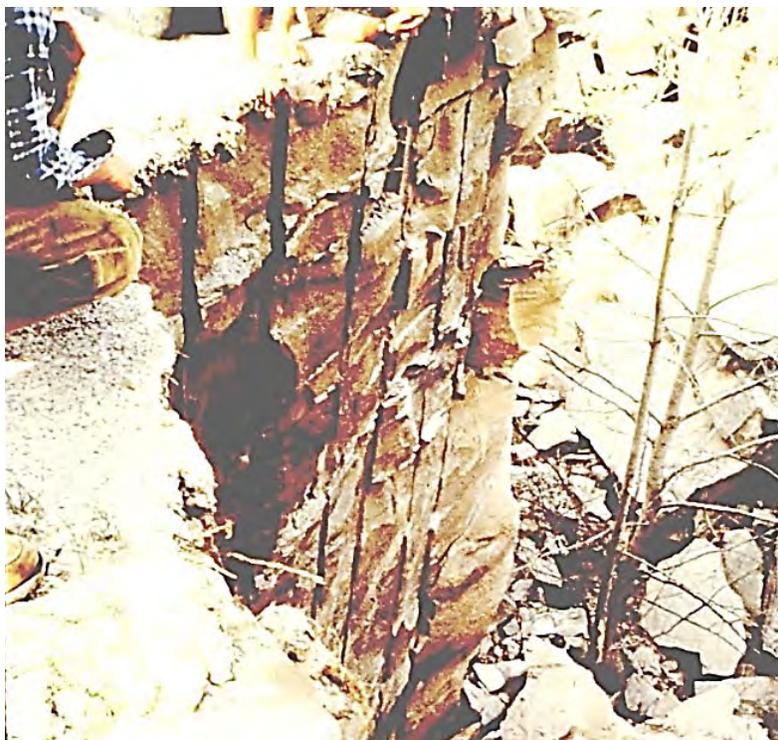
Figure 1 - Original Precision Presplit Testing with Variations to Spacing

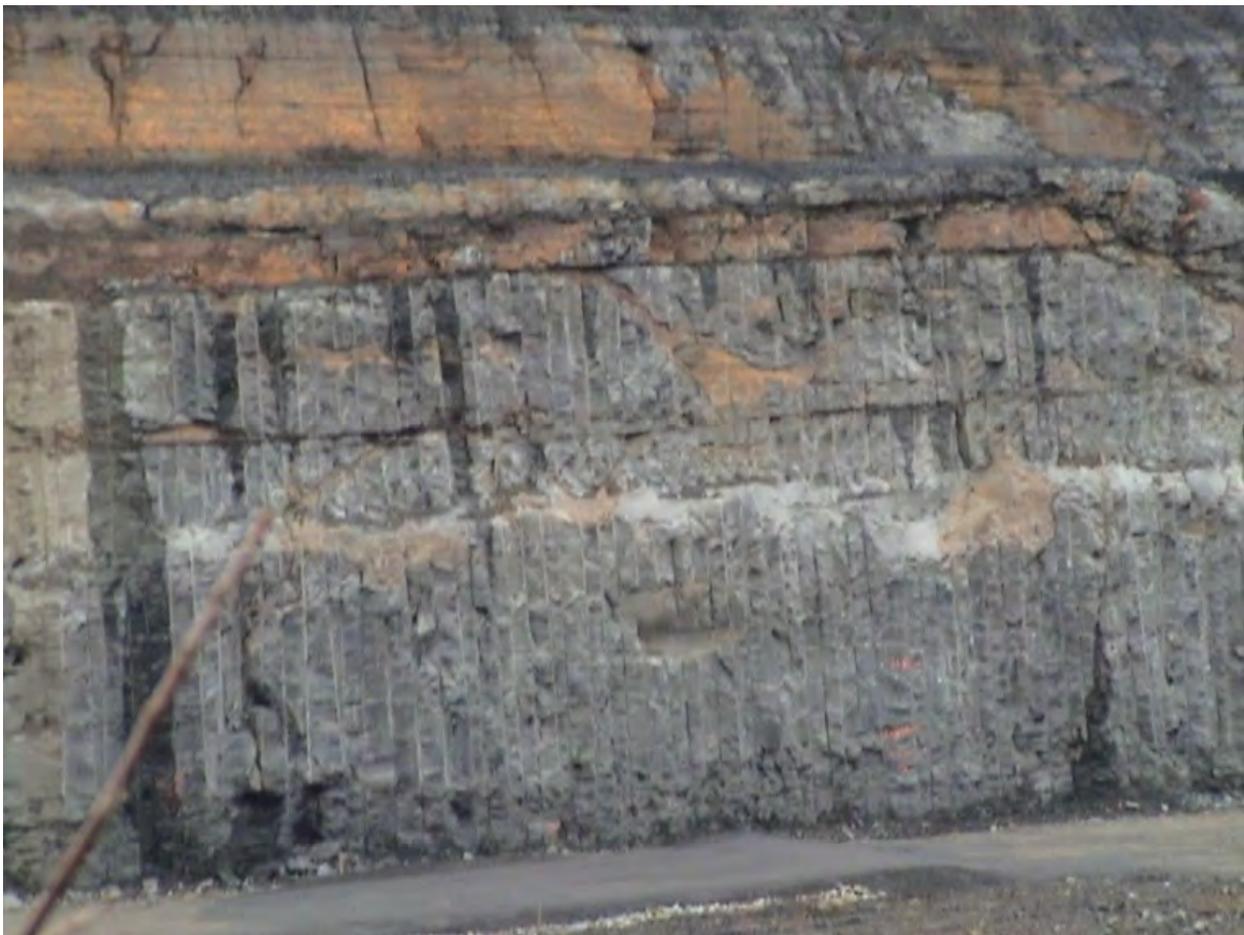
Figure 2 - Precision Presplit in Four Rock Types (Grundy, Virginia)

The explosive of choice for a Precision Presplit is detonating cord. This is because detonating cord provides a consistent, controllable amount of energy throughout its length. Detonating cord is also easy to work with, with proper techniques it is simple to load, and explosive load variations can be made throughout the borehole to account for different rock types in a single blast (figure 2).

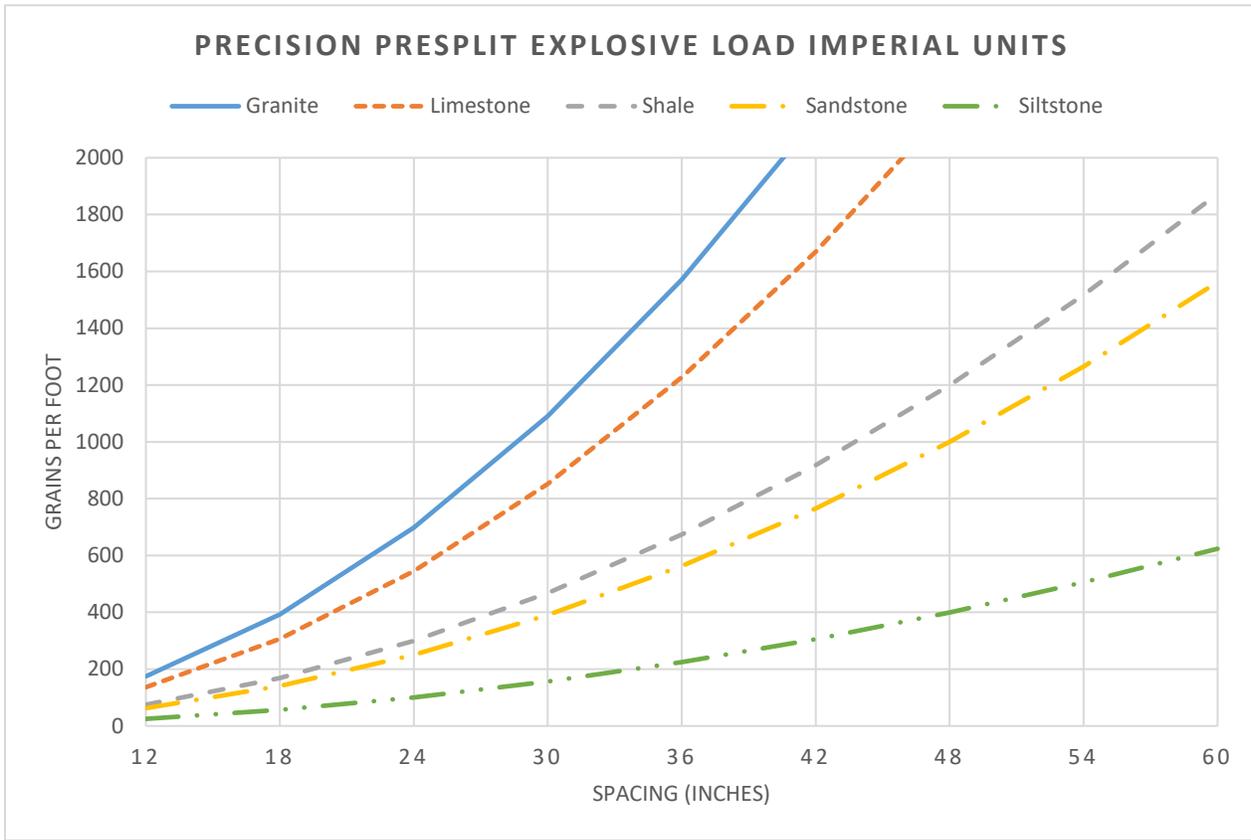
Figure 3 - Explosive Load Variations for Varying Spacing and Rock Type

This equation has then been run for the average type of rock from multiple different classes and has been graphed in figure 3. This can then be used by taking the designed spacing for the rock and finding the appropriate line for the rock type (or similar rock type).

For example, if one is to use a 36-inch spacing in an average limestone, they would find 36 inches on the x-axis and go to the limestone line. Then match this point to the y-axis and get the optimal explosive load, for limestone with a spacing of 36 inches. The explosive load for this would be approximately 1200 grains per foot.

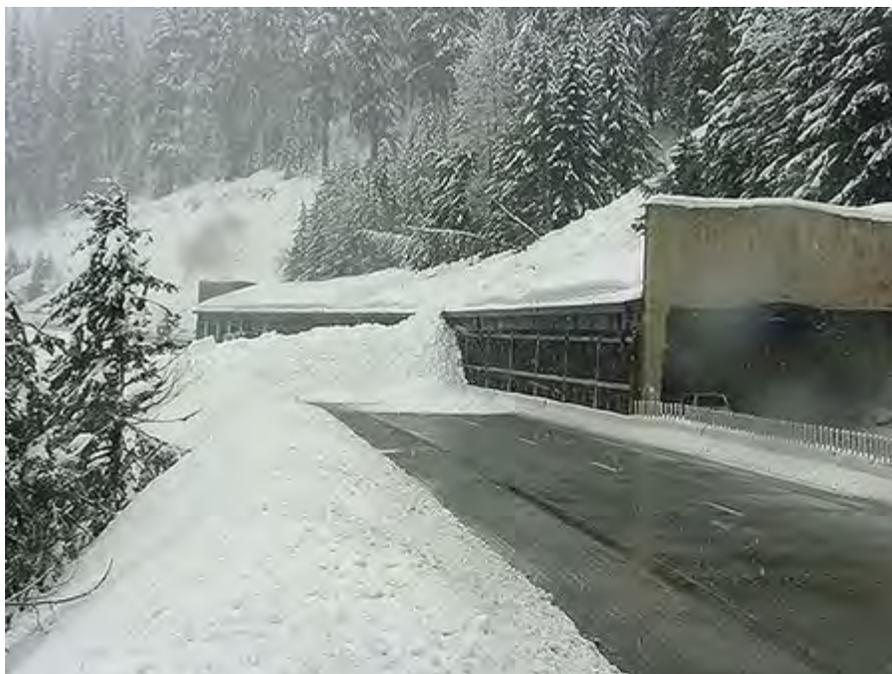
Figure 2 – View in the Westbound Direction with 1950 Snow Shed on the Right Covering the WB Lanes Leaving the EB Lanes Susceptible to Avalanche Closures.

The snow bridge concept was the result of WSDOT's Cost Reduction Incentive Program (CRIP). The CRIP process is a method for contractors to propose alternative designs to the original design concepts if cost reductions are realized as well as achieving the original design objectives. The WSDOT design concept was to replace the original reinforced concrete snow shed built in 1950 with a much larger snowshed structure that would span all six lanes through the avalanche chute section. The 1950 snow bridge only spanned the west-bound two lanes. Frequent closures were common during the winter months in order to clear snow and avalanche debris that traversed over the west bound lanes only to accumulate and close the east-bound lanes as shown on Figure 2.

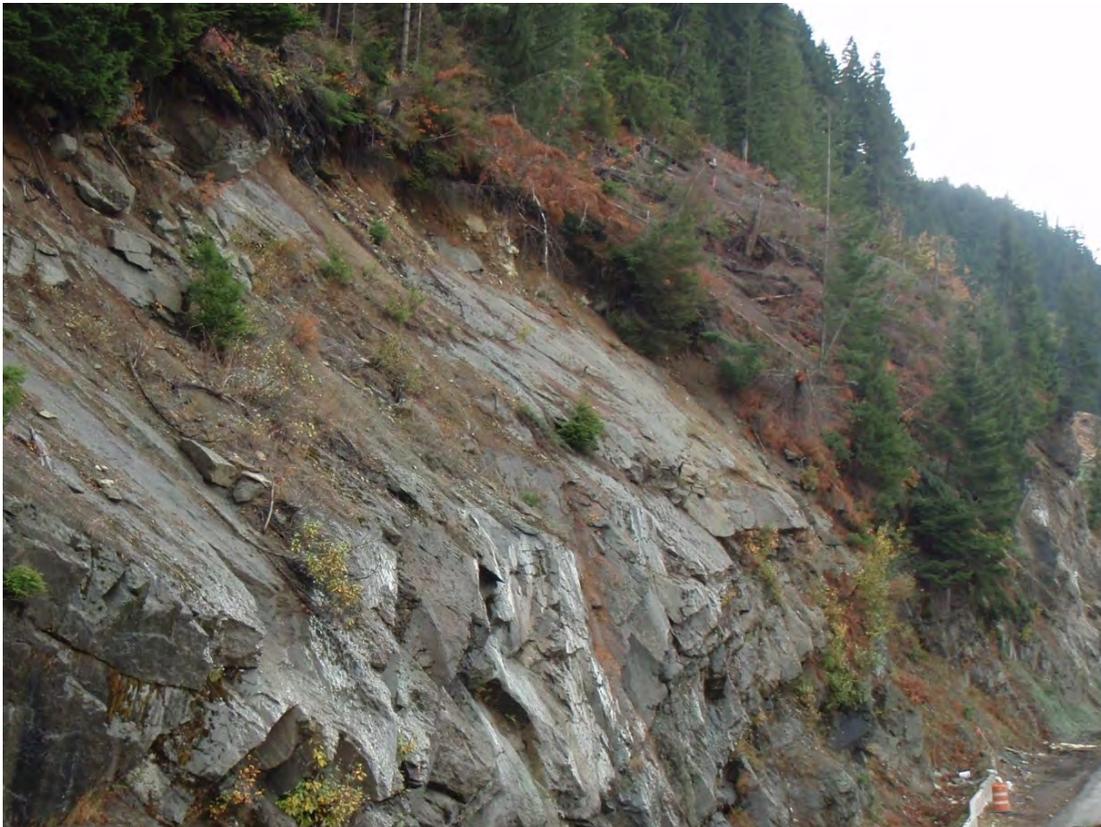
Figure 3 – Persistent Dip-Slope Joints Exposed in the Original 1950 Era I-90 Rock Cut.

Well developed, persistent joint sets control the kinematic stability of the rock mass. The most dominant joint set is a planar joint set dipping out of or parallel to the slope. See Figure 3. These joints are persistent over distances of tens of feet. Secondary intersecting near vertical joints form local wedges.

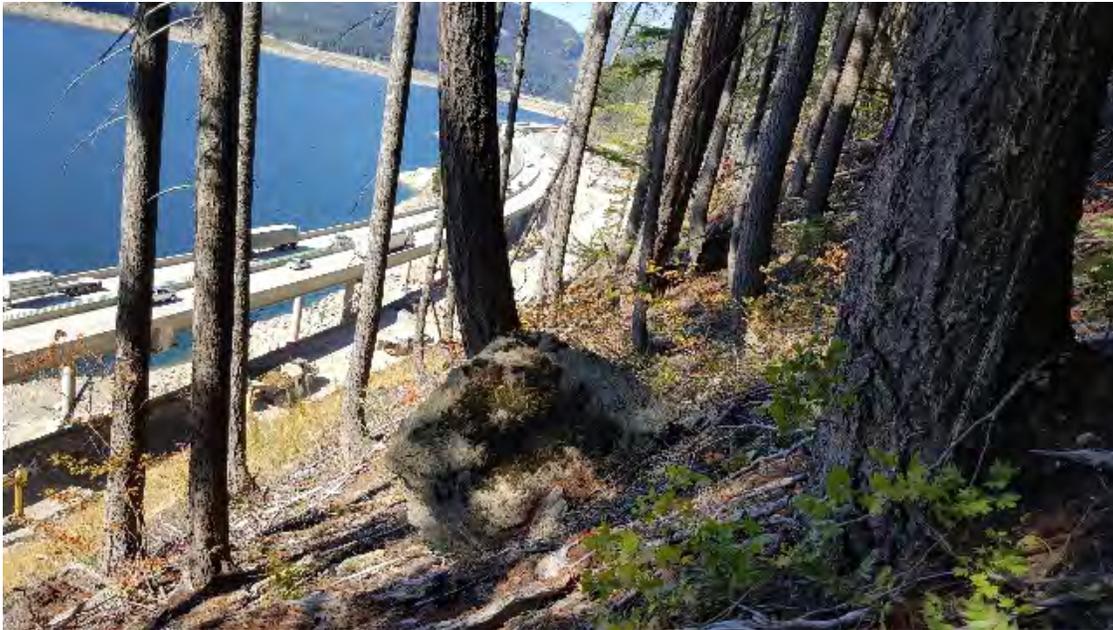
Figure 4 – View in the West-Bound Direction. Both WB and EB traffic is temporarily on the new EB snowbridge structure.

Evidence of older rock fall events was observed in the forested slope located above the proposed cut. Rock fall originating above the forested slope was stopped by the mature, second growth timber as shown on Figures 4 and 5.

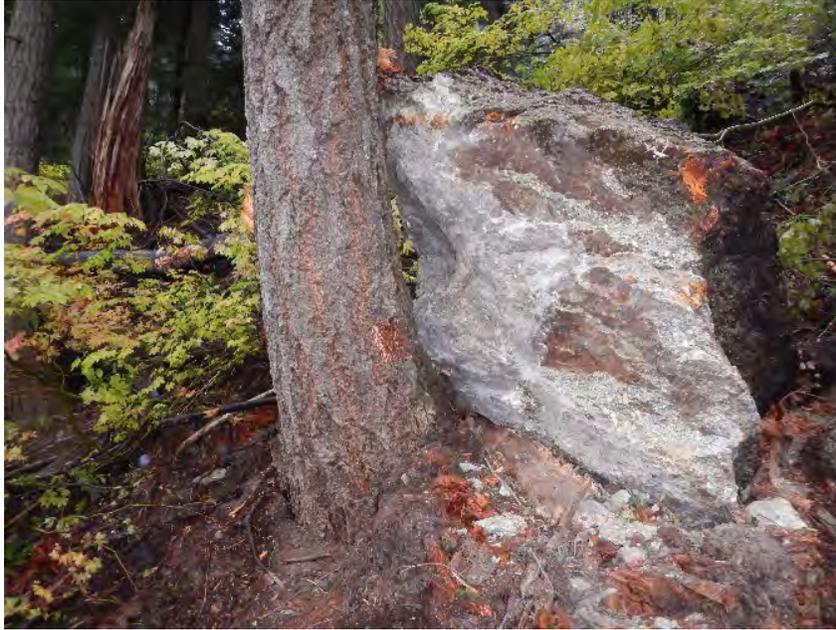
Figure 5 – Bedrock Rockfall Debris Stopped by Second Growth Timber.

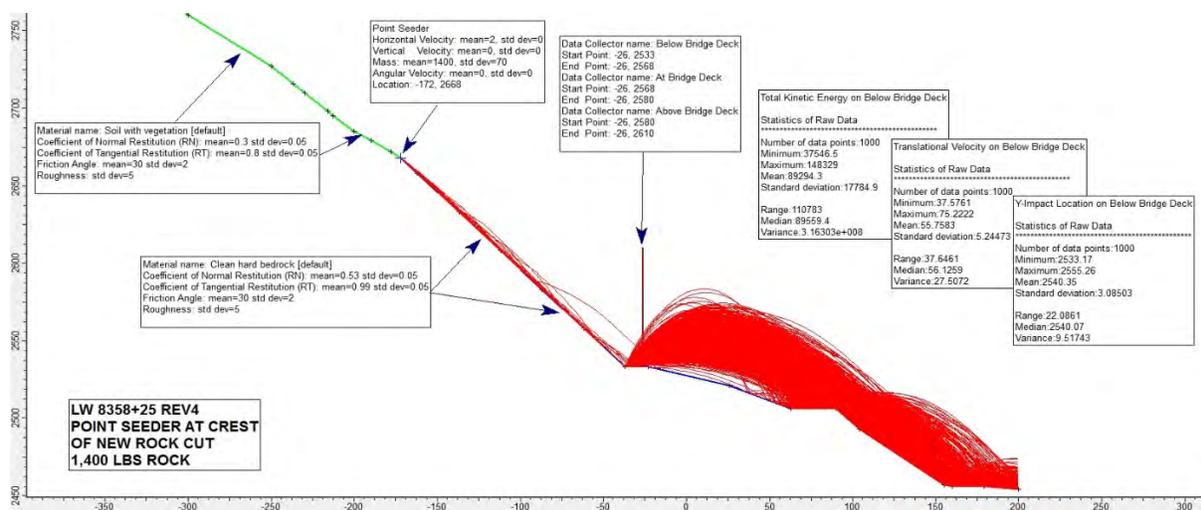
Data Collector	Maximum Bounce Height [feet]	Maximum Kinetic Energy [ft-lbs]	Maximum Translational Velocity [ft/sec]
Below Bridge Deck	22.26	1.5E+05	75.2
At Bridge Deck	n/a	n/a	n/a
Above Bridge Deck	n/a	n/a	n/a

Figure 6 – Top of Cut Low Energy Source, Small Rock.

These two source areas were evaluated along five cross sections through the project section. One of the sections located near Pier 5 (project Station 8358+25) is shown as representative of the process output on Figure 6 through Figure 9. Table 1 summarizes the rockfall simulation at Pier 5 (Sta. 8358+25).

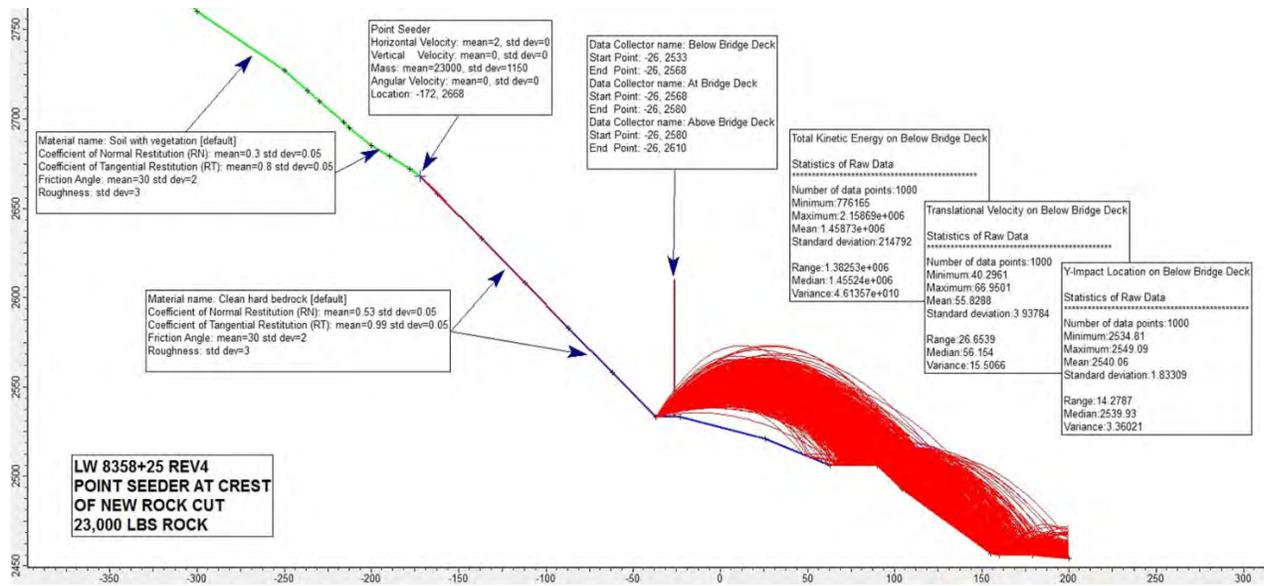
Data Collector	Maximum Bounce Height	Maximum Kinetic Energy	Maximum Translational Velocity
	[feet]	[ft-lbs]	[ft/sec]
Below Bridge Deck	16.09	2.2E+06	67.0
At Bridge Deck	n/a	n/a	n/a
Above Bridge Deck	n/a	n/a	n/a

Figure 7 - Top of Cut Low Energy Source, Large Rock.

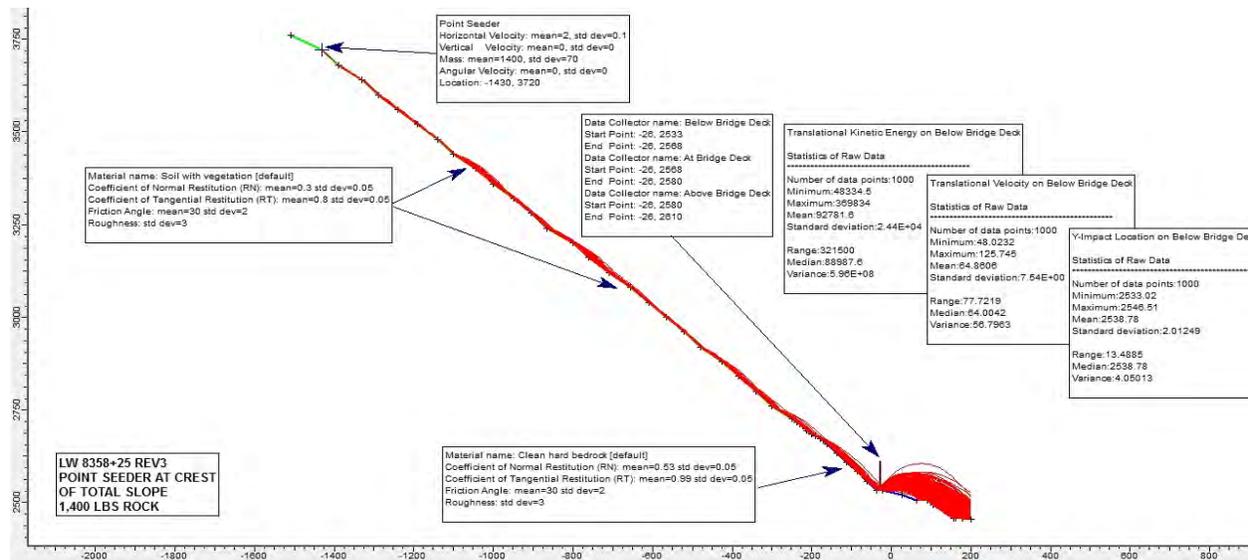
Data Collector	Maximum Bounce Height	Maximum Kinetic Energy	Maximum Translational Velocity
	[feet]	[ft-lbs]	[ft/sec]
Below Bridge Deck	26.86	4.4E+05	124.2
At Bridge Deck	n/a	n/a	n/a
Above Bridge Deck	n/a	n/a	n/a

Figure 8 – Top of Slope Crest High Energy Source, Small Rock.

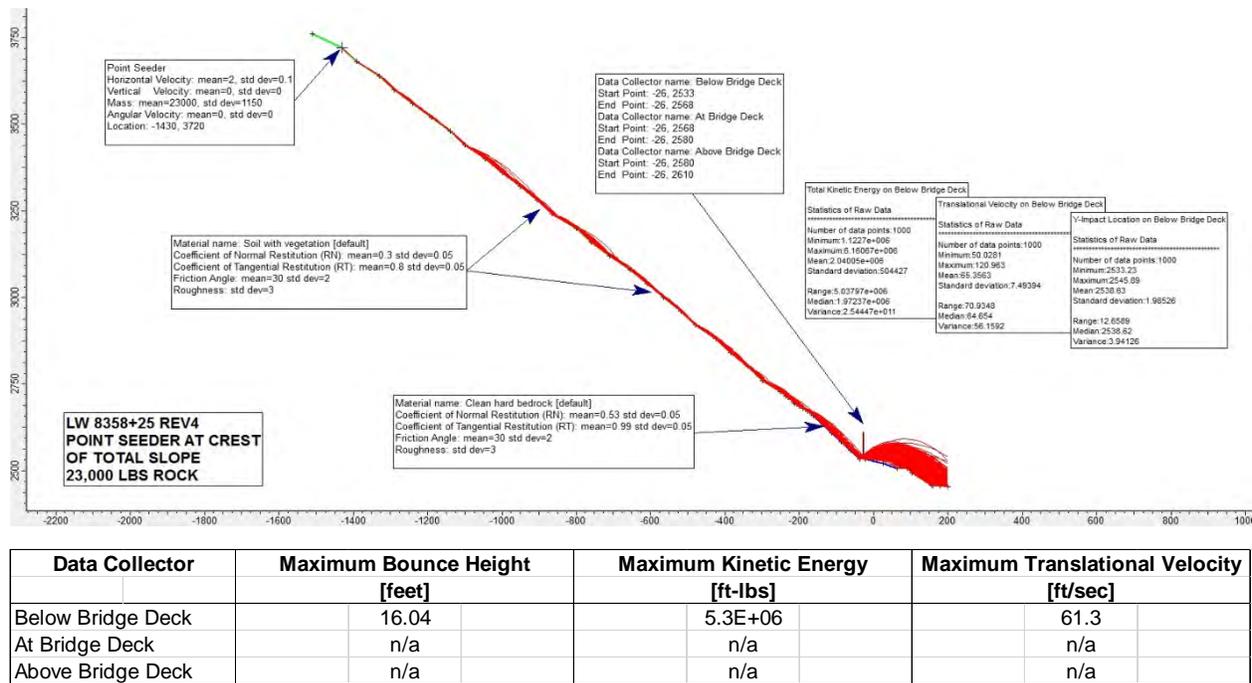
Figure 9 – Top of Slope Crest High Energy Source, Large Rock.

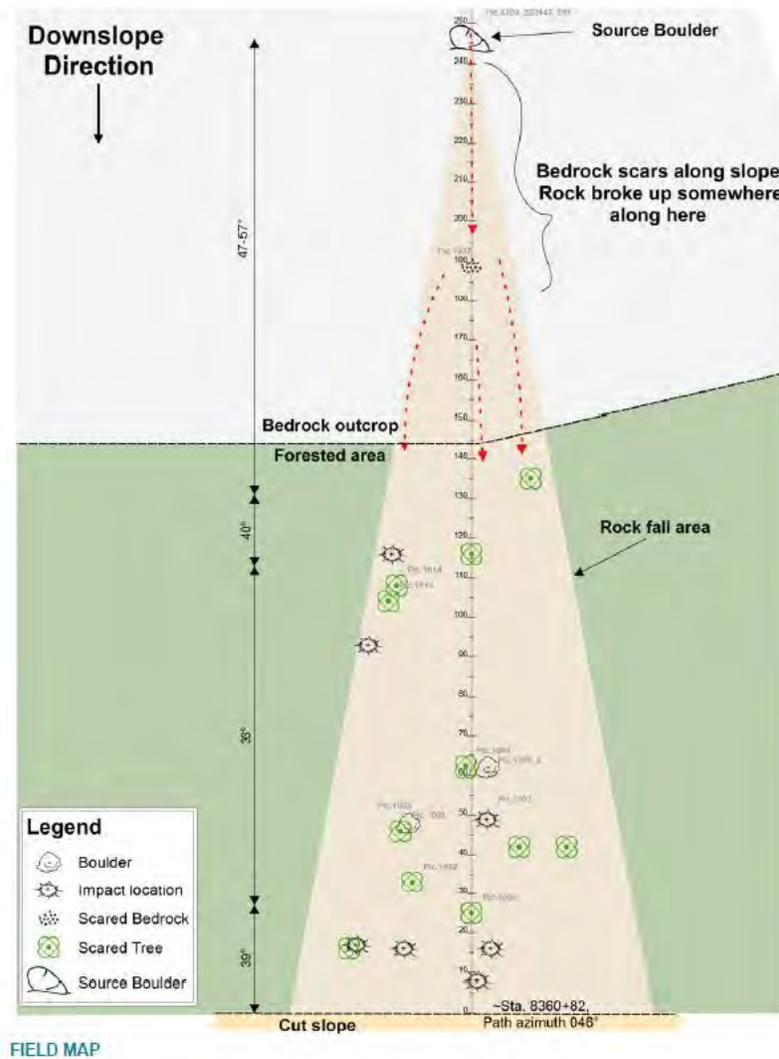
Figure 10 - October 3, 2013 Rockfall Event Field Reconnaissance Observations.

A field reconnaissance was completed to assess the October 3, 2013 rockfall event. The source area of the rock fall was identified. The source area was a single boulder located approximately 245 ft. (slope distance) from the crest of the cut slope and based on field observations the single boulder broke up into smaller blocks on the descent down the slope. Field observations and measurements included impact locations, tree scar heights, boulder locations, slope length and angle, and path orientation. An approximate rock fall debris envelope was determined as shown on Figure 10.

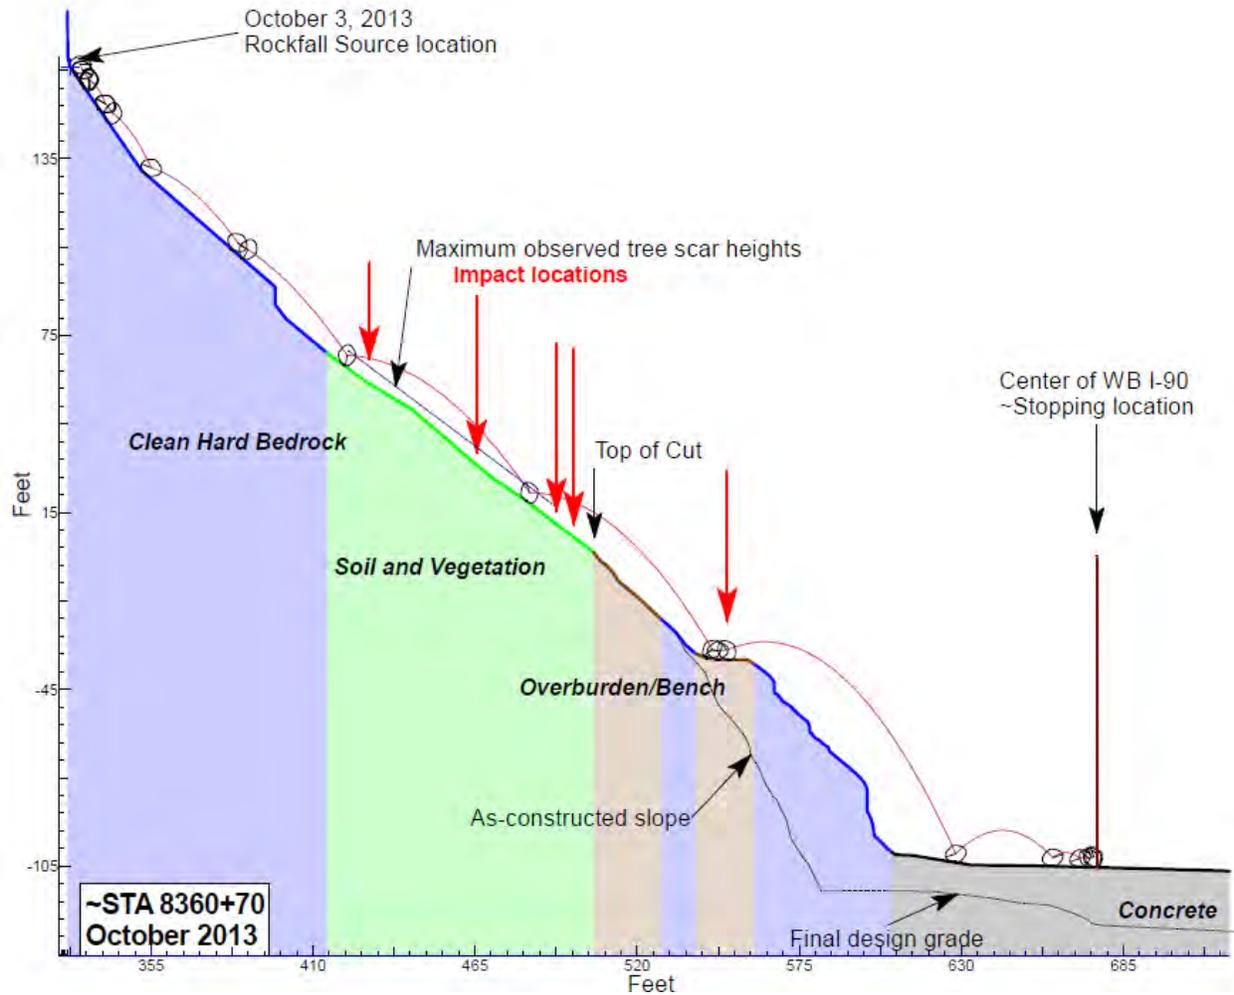
Figure 11 – I-90 Snowbridge section Rockfall Calibration using Rigid Body Impact Mechanics (RBIM).

The previous rock fall analysis had used computer code default values for the various input parameters to model the rock fall using RocFall (2). The back analysis used the updated, commercially available software RocFall v5.014 by Rocscience (3). For the back analysis, Golder initially used both the Lump Mass and the Rigid Body Impact Mechanics (RBIM), models available within the software. The results based on both models were assessed and it was concluded that the RBIM model (that considers rock shape and size) appeared to produce more realistic rockfall trajectories based on limited field observations, compared to those based on the Lump Mass model (Figures 8 and 9). See Figure 11 for rockfall calibration using the RBIM model.

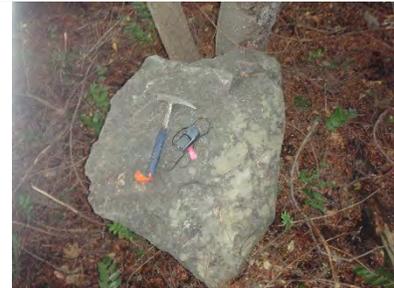
Shape			Super Ellipse^4
Mass (lbs)			Large – 23,00 Small – 1,400
Density (lb/ft ³)			165
Example of boulder caught in forest, 2012		Shape selected in RocFall

The boulder shape and mass used in the analysis were based on field observations made in 2012. The boulders observed along the slope were slightly tabular with length to width ratios slightly greater than 1; average ratio of 1.4. To be conservative, a square shaped boulder with rounded corners was modeled. The assumed boulder masses were the same as those used in the previous analyses. The large rock block was 23,000 lbs and the small rock block was 1,400 lbs. Table 4 summarizes the rock fall source rock properties assumed for the October 3, 2013 back analysis.

Note: The boulders used in the October 2013 back-analysis have a different shape than those observed during the 2012 slope reconnaissance. Rockfall, from the October 2013 event, caught in the timbered forest where rhombus in shape.
