70TH HIGHWAY GEOLOGY SYMPOSIUM

“Better Highways Through Applied Geology”

October 21-24, 2019

2019 Proceedings

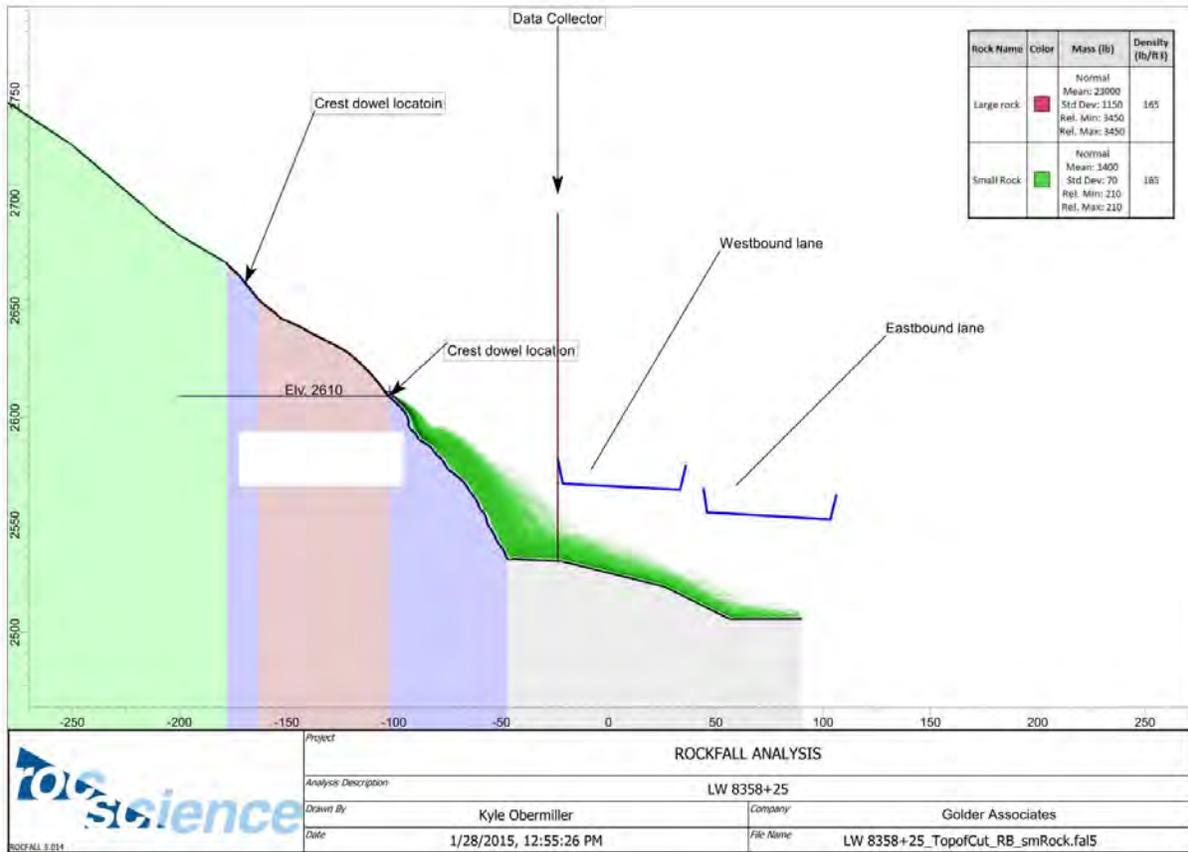
Figure 12 – Rockfall Analysis for Sta. 8358+25 for Small Rocks.

Representative rockfall runs using the back analyzed data from the October 2013 rockfall event are shown on Figures 12 and 13.

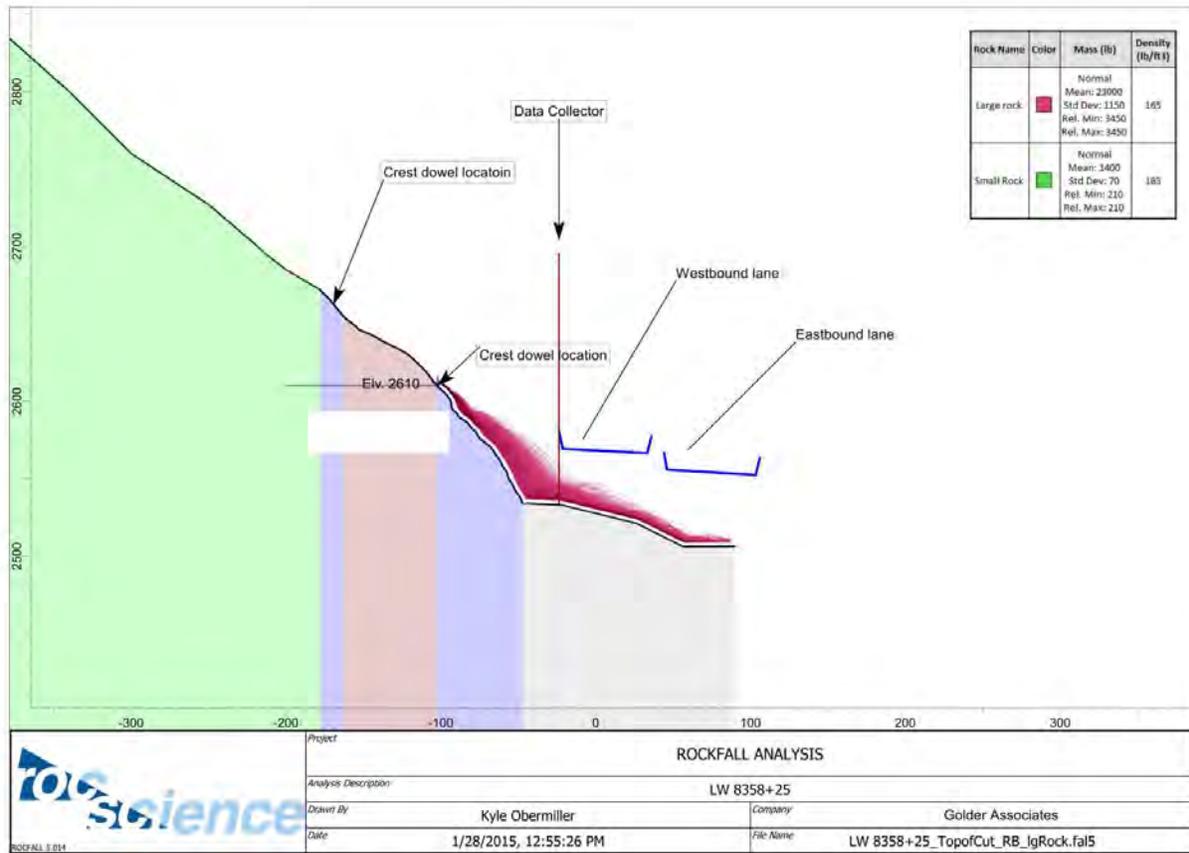
Figure 13 – Rockfall Analysis for Sta. 8358+25 for Large Rocks.

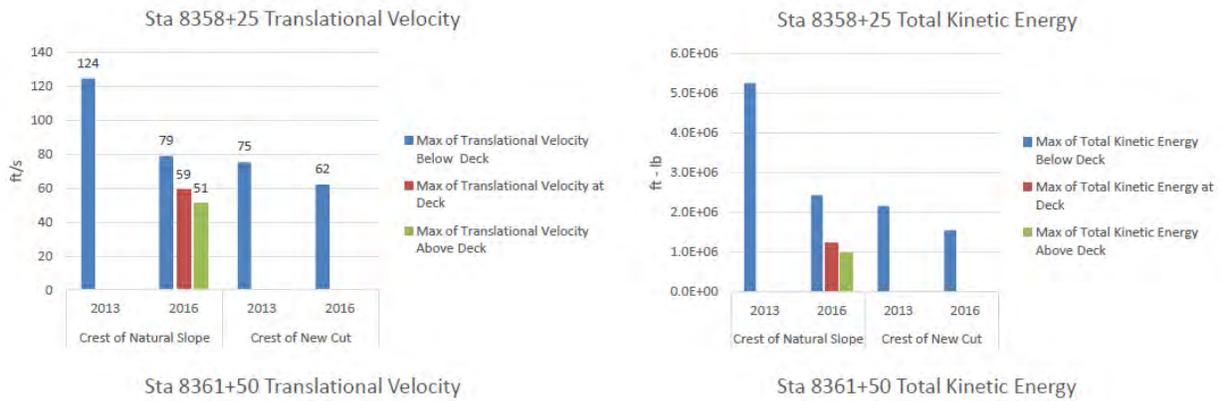
Figure 14 – Comparison of Translational Velocity and Total Kinetic Energy at Sta. 8358+50.

Upon completion of the back-analyses of the October 2013 rockfall event, we were able to apply the back-calculated coefficients of restitution, for the material upslope of the rock cut, and re-analyze all sections previously analyzed in 2013 and all under/over excavated slope analyzed in 2015 for a total of ten sections in the vicinity of the westbound snow bridge. In general, the results of the 2016 updated analysis show a similar percentage of rockfall impacting or passing under/over the bridge, however, the rockfall maximum translational velocity, and the rockfall maximum total kinetic energy all along the snow bridge sector have decreased (Figures 14 and 15).

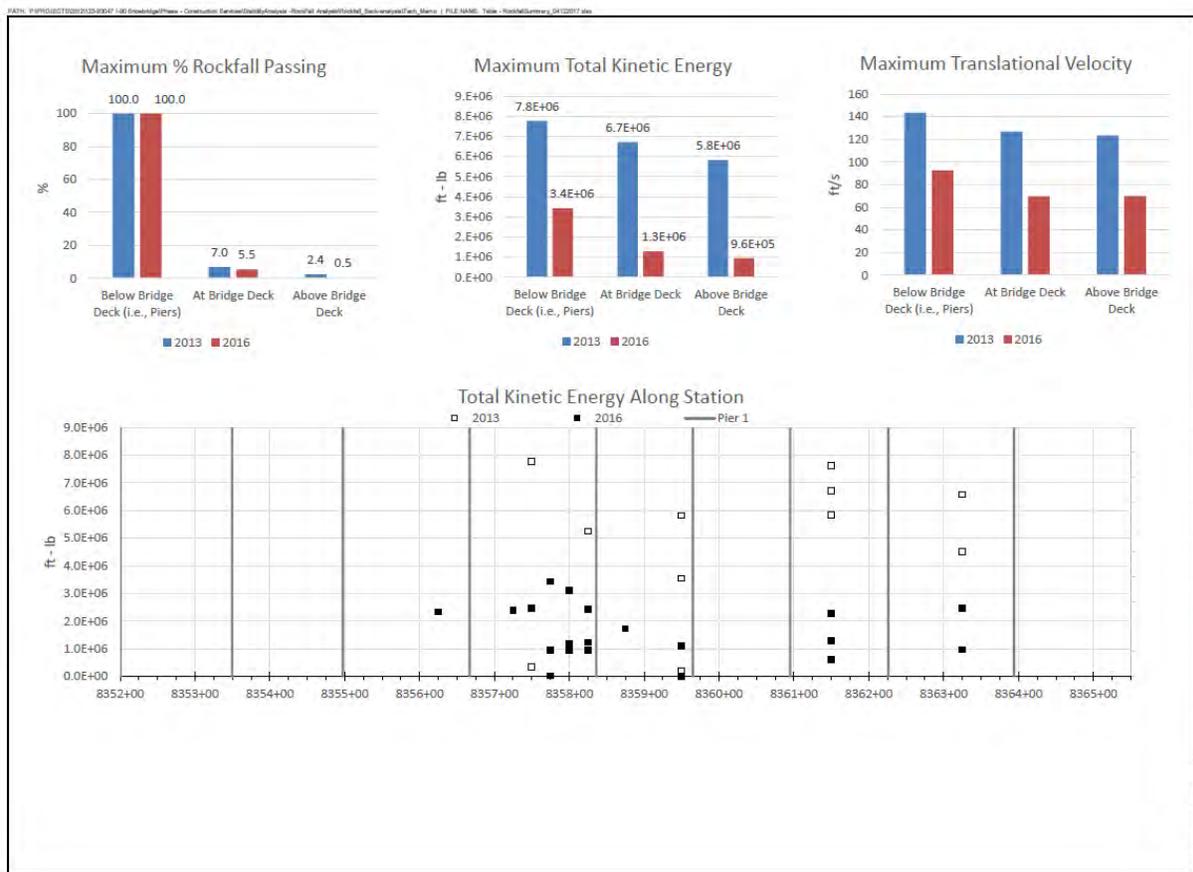
Figure 15 – Summary of 2016 Rockfall Data with Calibrated Model.

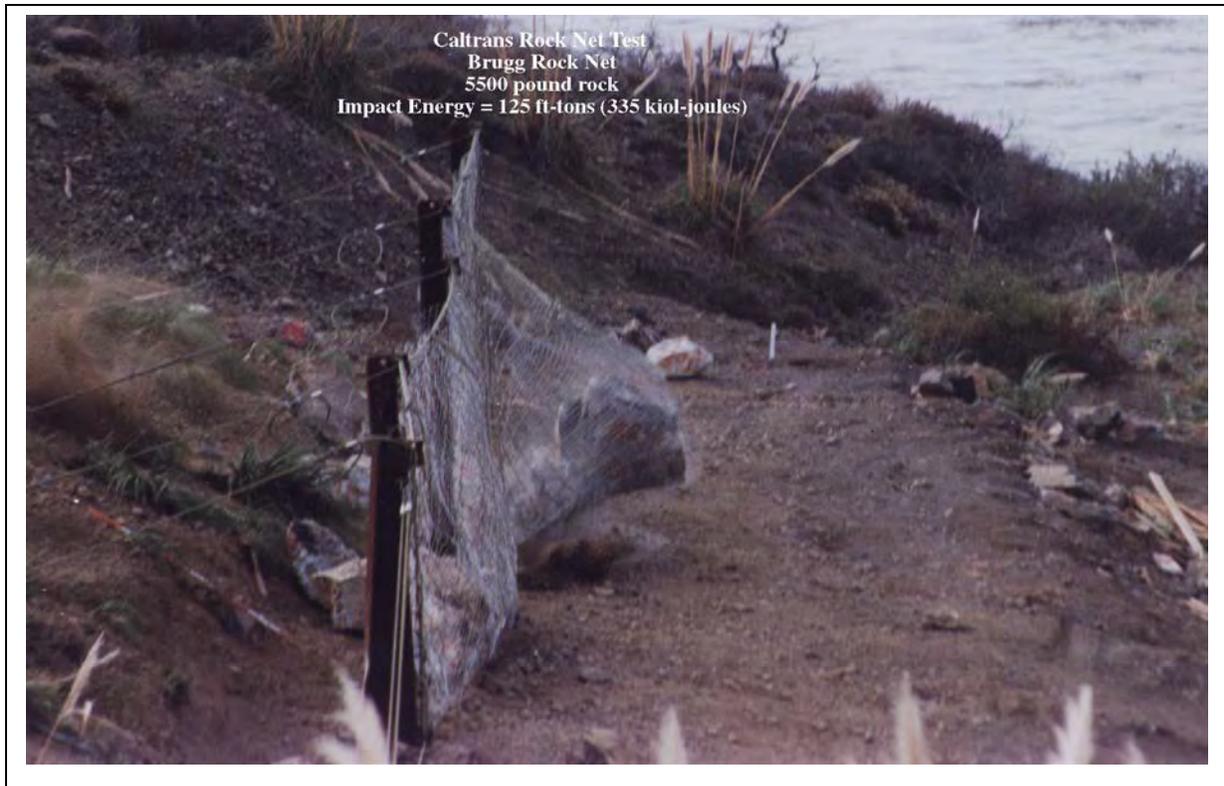
Figure 1: Flexible Rockfall Fence Tests, California Department of Transportation, Grey Slip Test Site, 1989.

The data analyzed in this report correlate two key pieces of information: 1) mass of the rock and height of the slope at the initiation point, (i.e., potential energy) 2) the translational and rotational velocities and maximum moment of inertia of the rock about the rotational axis, (i.e., kinetic energy) at the base of the slope. Test sites vary in slope and rock characteristics, but the essential elements of the test setups were the data were collected using high speed and video cameras to determine the time of travel and number of rotations the rock made between defined distances marked on the slopes, and the use of a load cell that measured the mass of the rocks before or after the rock roll.

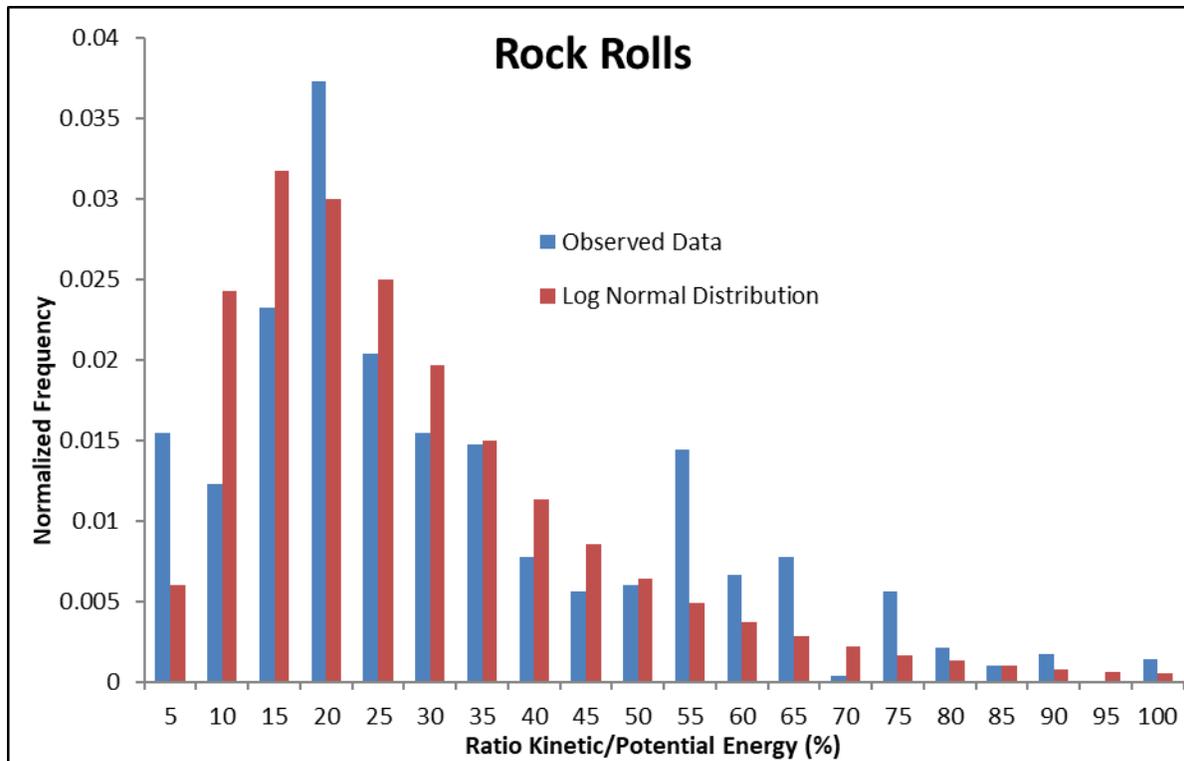
Figure 2: Normalized frequency diagram of the sample rockfall data (blue), plotted versus the log-normal distribution of the data defined by the sample mean and standard deviation of rockfall data (red) (Huang, Turner 2013).

Without any experience in performing modeling or statistical analysis, a designer can measure the slope height and rock mass of potential rockfalls in the field to get an estimate of the potential energy, and use that information with the chart to determine a design kinetic energy at grade by considering an acceptable percentage of rockfalls that could potentially exceed the energy ratio predicted by the distributions. The actual data was compared to the log-normal distribution considering 10% and 5% exceedance, where for the measured data, 90% of the observed rockfalls had energy ratios of 60.9% or less, so 10% of rockfalls could potentially exceed energy ratios of 60.9% (Huang, Turner 2013). The results for the 90% and 95% interval are summarized in Table 3.

Energy ratio values predicted by the log-normal distribution are reasonably close to the results of the measured data. As with many best-fit distributions, the tail of the best-fit distribution varies slightly from the actual data, as can be observed in Figure 2. The tail is typically where the critical analyses needed for design take place; considering acceptable limit for exceedances are likely between 90-99%. Despite the variation in the tails of the distributions, the log-normal distribution could be used to make preliminary estimates of energy ratios when considering the variability in the random variables from Equation 1 (Huang, Turner 2013).

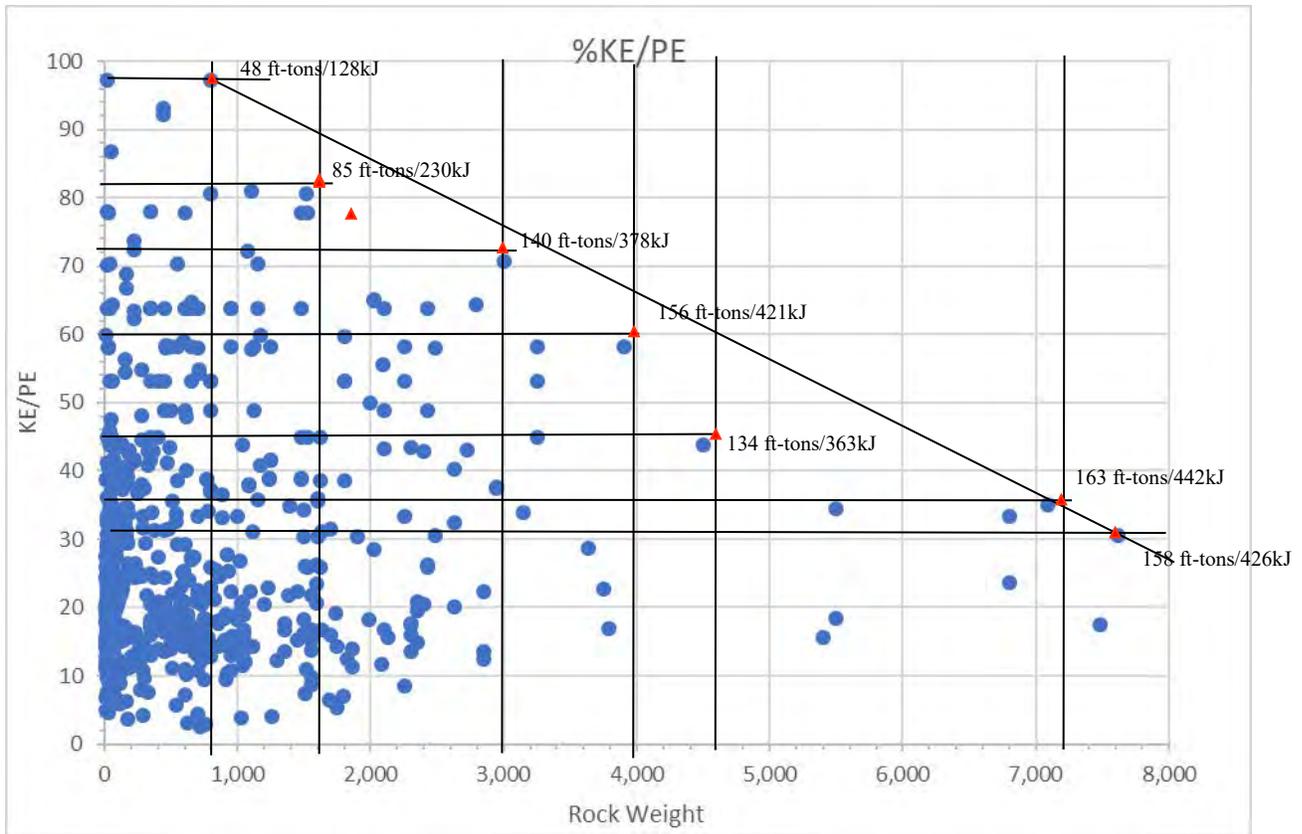
Figure 3. Percent KE/PE vs Rock Mass. Rocks \leq 8,000 Pounds and Slope Heights \leq 130 feet.

Smaller rocks were observed to be more likely to approach the full limit of their initial potential energy during a rock rolling event. As the rock weight increased for a given slope height, the initial potential energy also increased, but there was a reduction in the KE/PE ratio for larger rocks. The reduction observed for the larger rock was likely due to the impact mechanics of a rolling rock on a slope. As rocks roll and bound down a slope, energy is dissipated into the ground upon each impact. The heavier the rock the greater reduction in energy ratio will occur during ground impact. The data in this study indicate that lightweight rocks lose less energy during their trajectory than heavier rocks. This does not mean that heavier rocks have less impact energy at the base of slope than lighter rocks, only that the percentage of kinetic energy that developed during rock rolls relative to the initial potential energy was less for heavier rocks than for lighter rocks. This data also indicates the rockfall energy at the base of these slopes for all rock rolls never exceeded 500 kilojoules regardless of the rock weights that were tested. This finding could be significant because when considering the available rockfall barriers on the market today, 500-kilojoule barriers are very common “off the shelf” systems.

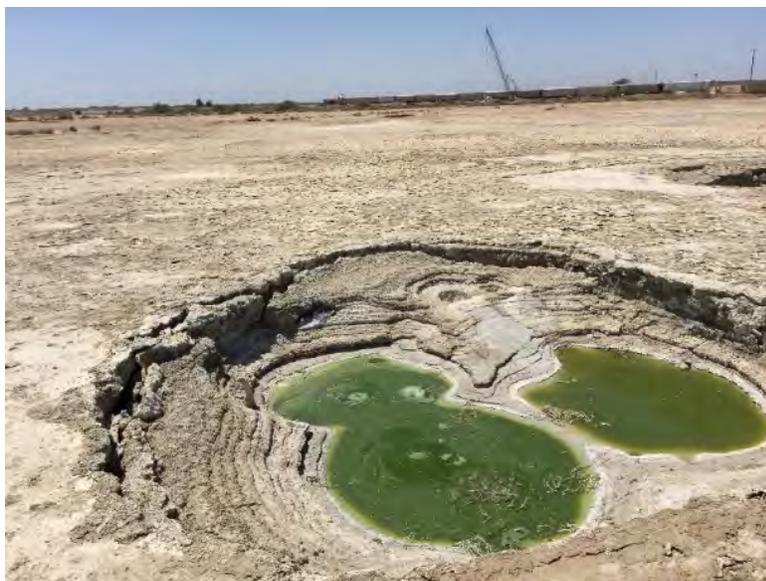
Figure 1-Active static mud pots located about 1000 feet north of the Mundo site.

A series of mud pots in the area have been studied by scientists for over a decade (Lynch and Hudnut, 2008). The mud pots may appear and disappear over time but typically remain stationary (Figure 1). The mud pots generally lie along the trend of the Wister Fault, which may be a southeast extension or an inactive segment of the San Andreas Fault. One mud pot on this trend, designated W9 by workers studying these features, was located 4.5 miles northwest of

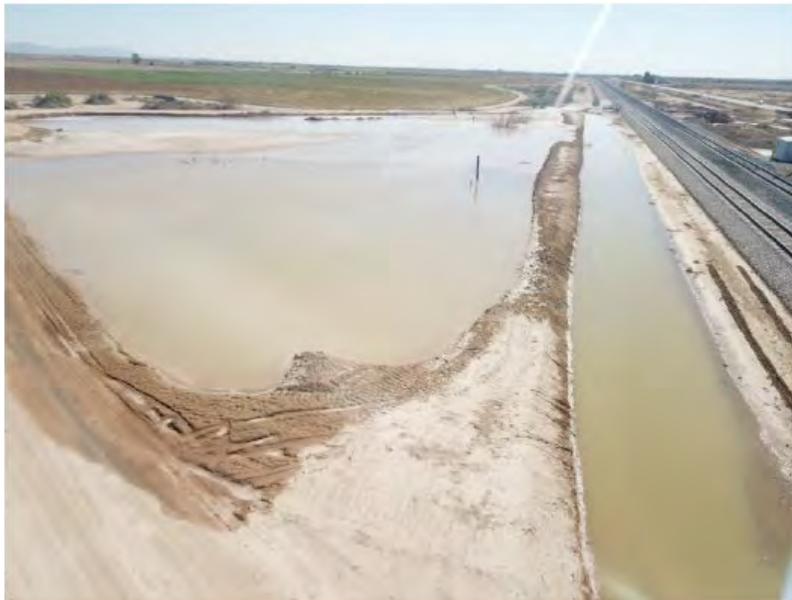
Figure 2-Southeast view of the Mundo mud spring in October 2017. The ponding of water is due to the plugging of the bridges below both the UPRR tracks and Highway 111 to the right. Image courtesy of the Union Pacific Railroad.

UPRR began experiencing difficulties with the W9 mud spring when muddy water surged out of it in October 2017. The mud-water slurry flooded the field and ditches on the east side of the UPRR tracks. The ditches carried the slurry to the southeast, where it entered Gravel Wash, a dry arroyo that flows southwest towards the Salton Sea under the UPRR tracks and parallel Highway 111 under separate bridges. The shallow gradient allowed sediment carried by the mud slurry to settle, accumulating in the ditches and Gravel Wash, blocking flow and diverting additional flows of the mud slurry discharge towards the tracks (Figure 2).

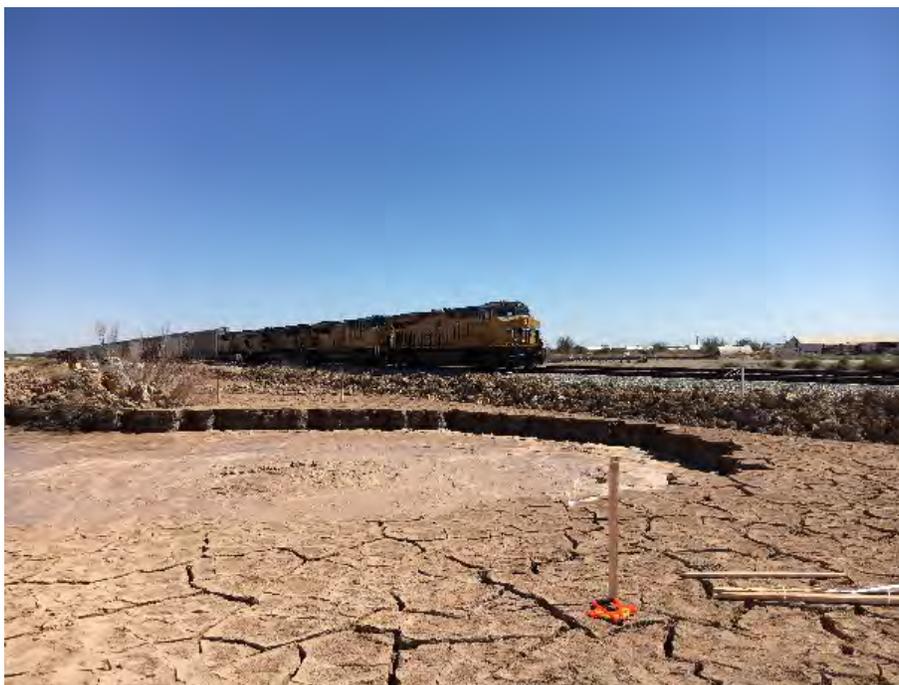
Figure 3-Mud spring in May 2018, approximately 80 feet west of the Union Pacific tracks. View to south.

arrived on site, the mud spring was about 125 feet closer to the UPRR tracks than shown on the Google Earth October 19, 2016 aerial image (Figure 3).

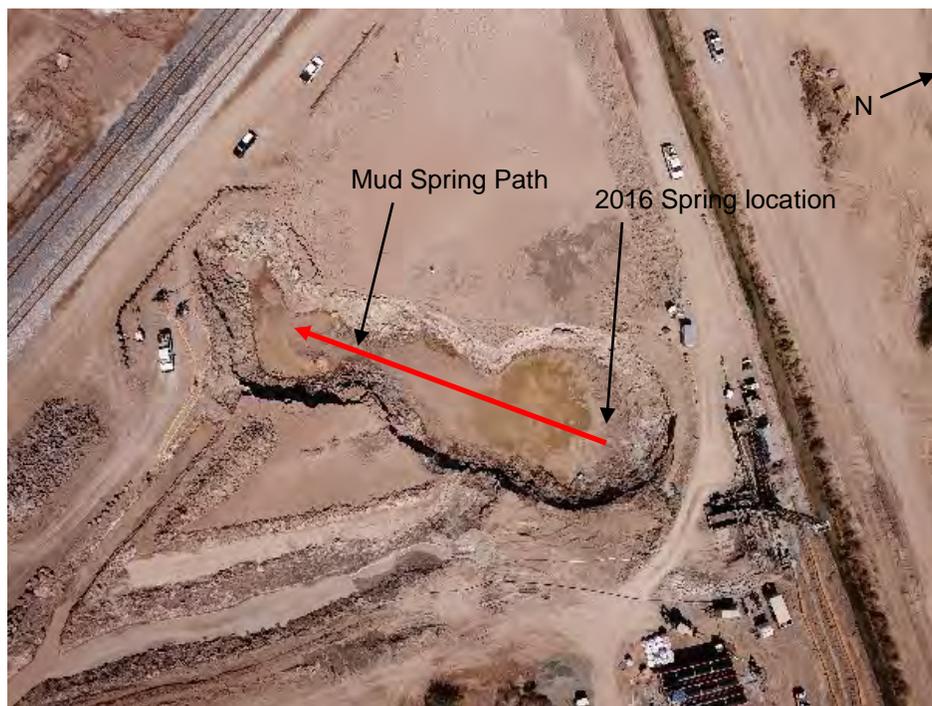
Figure 4-Path of mud spring from its location in October 2016. Image courtesy of D. Lynch.

The mud spring has carved a roughly 75-foot wide path towards the southwest since 2016, which was filled with the discharge mud slurry, creating an oblong-shaped pond (or caldera) about 150 feet in length (Figure 4). In early May 2018, the mud spring was located in the southwest portion of the caldera pond. Agitation of the pond water caused by the mud spring discharge created small waves that were actively eroding the caldera edges towards the southwest as the mud spring moved. The erosion was generally 25 feet beyond the mud spring location. During our May 4, 2018 site visit the mud spring was approximately 80 feet from the eastern main line track and the eroding caldera edge was 60 feet away. In mid-May, the mud spring movement accelerated towards the southwest, moving over 20 feet to the southwest in a one-week period. The rapid movement towards the mainline tracks spurred rip rap placement along the west edge of the advancing caldera to slow the erosion caused by the mud spring surface agitation. UPRR was concerned that future rapid movement could compromise the main

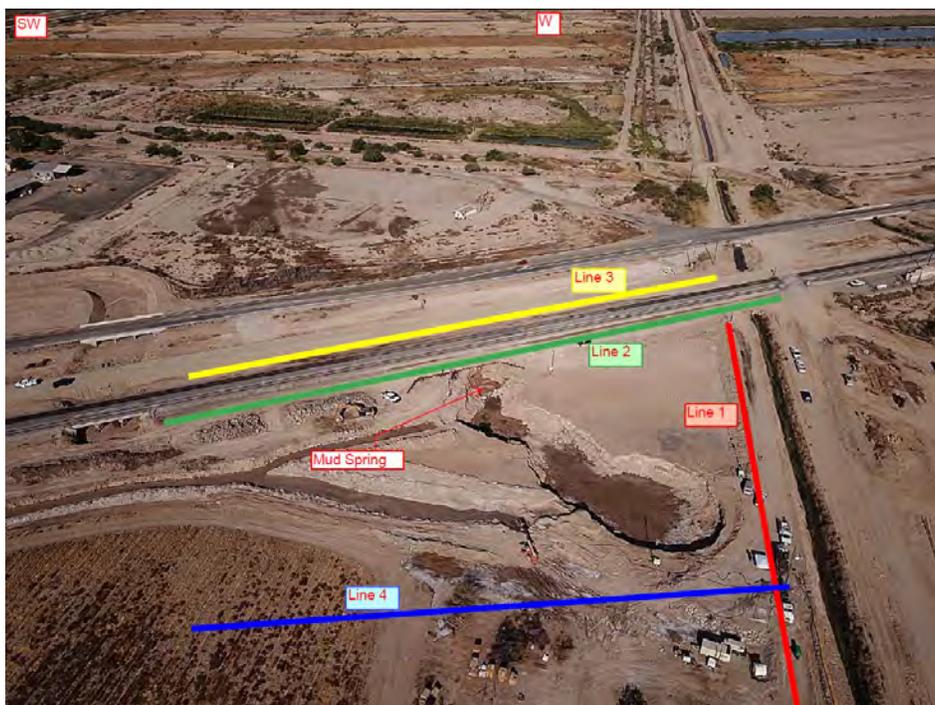
Figure 5-Locations of Geophysical section lines, relative to the caldera and the UPRR tracks. View to the west.

We performed the geophysical imaging on up to four lines, designated Lines 1 through 4 (Figure 5).

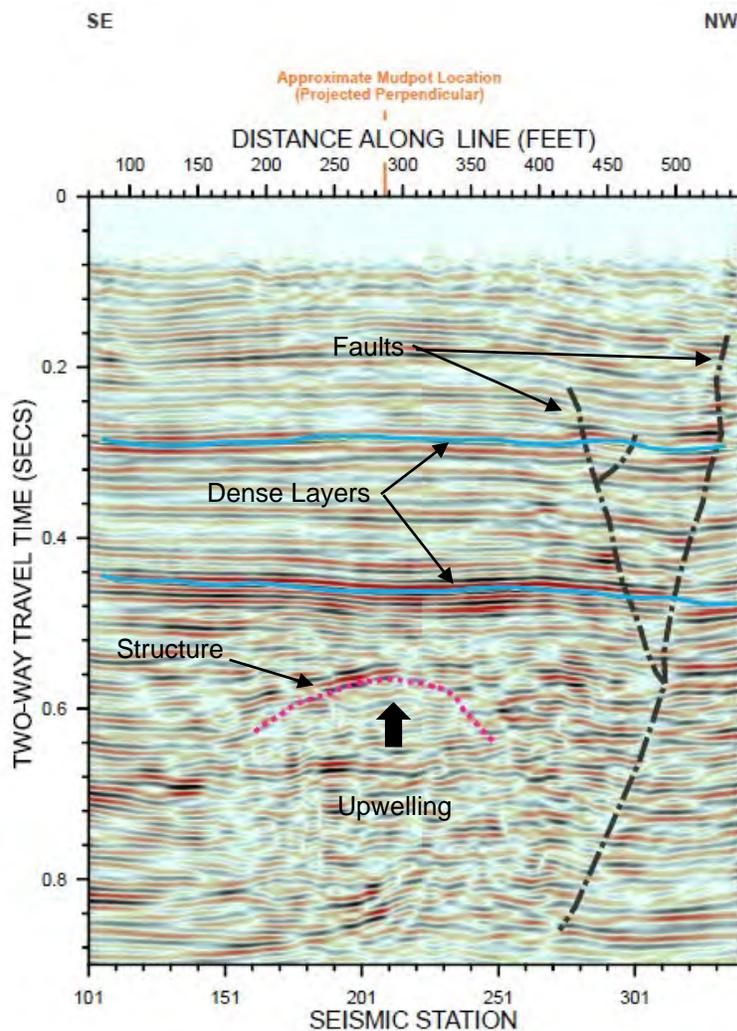
Figure 6-Geophysical S-Wave Seismic Reflection Line 2 along the east side of the Union Pacific track alignment with interpreted fault and upwelling structure.

Of the methods utilized, the High-Resolution S-wave Reflection provided the best quality results of the subsurface conditions. Images collected using this method indicated a relatively horizontal subsurface profile in the upper half of the imaged depth. The subsurface profile indicated two distinct, near-horizontal dense layers (Figure 6). These dense layers were relatively continuous except for linear, near-vertical disruptions that were interpreted as faults breaking through these layers. Below the deeper dense layer, the subsurface images indicated a more chaotic profile than the upper horizontal beds. The chaotic profile was interpreted as upwelling of groundwater that was focused at a parabolic-shaped structure that aligned with the

path of the mud spring. The depth of this parabolic structure below the mainline tracks was about 200 feet below ground surface (GeoVision, 2018). The parabolic structure was more pronounced at Line 1 paralleling Gillespie Road to the north of the mud spring. The structure became less pronounced at Line 3 located between the UPRR tracks and SR 111.

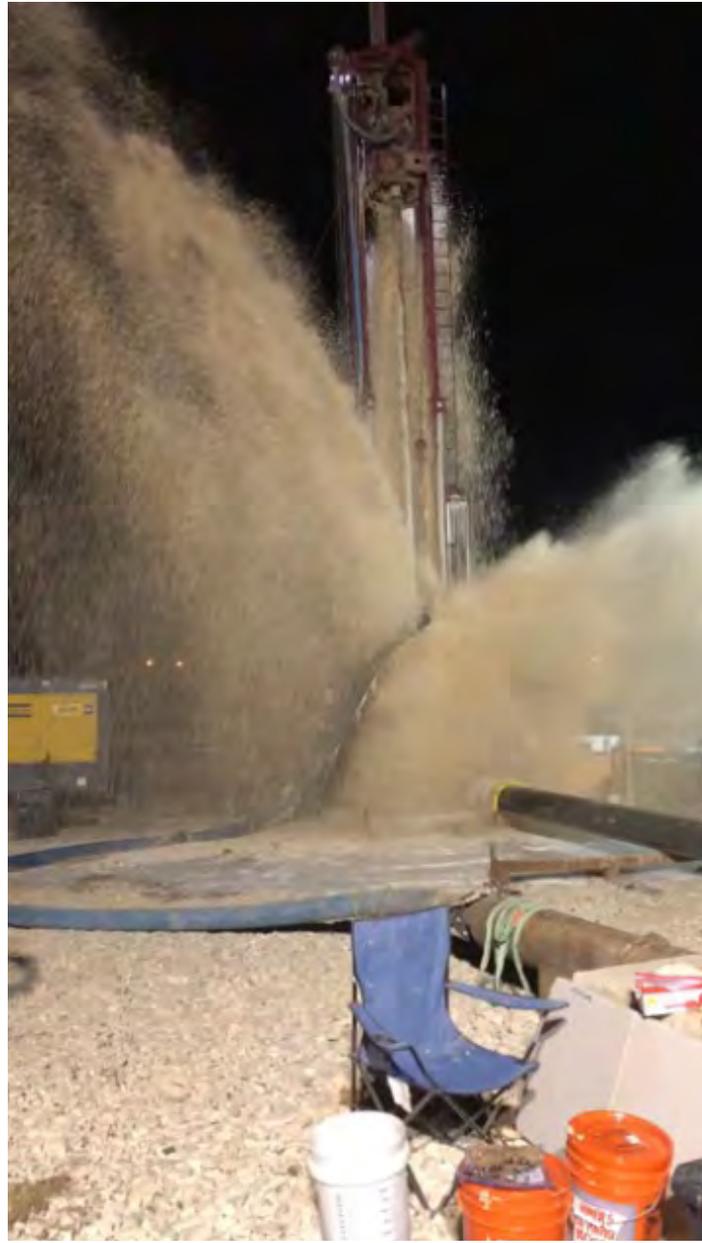
Figure 7-Mud and gas blow-out during drilling of well B-3 at a depth of approximately 400 feet.

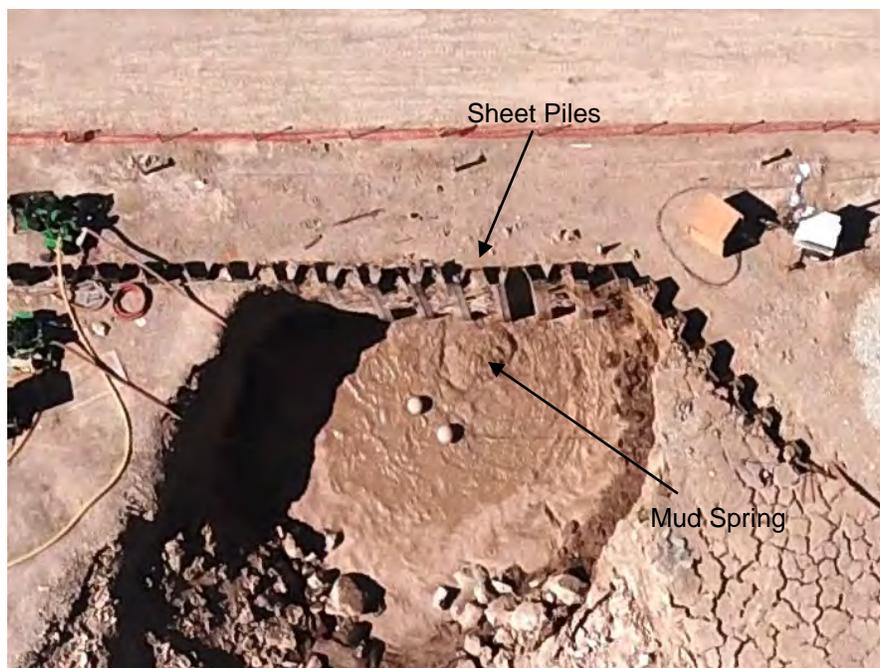
*Figure 8-Aerial drone view of mud spring adjacent to the sheet piles prior to the breach.
Image courtesy of D. Lynch.*

As the mud spring eroded out much of the soil supporting the lower portion of the sheet piles, causing the piles to tilt towards the caldera. In mid-August, we observed a tension crack open up on the railroad track side of the sheet piles followed by visual deflection and sinking of the central sheet piles. We installed a tiltmeter on the sheet piles that allowed us to monitor the magnitude of the tilt. In September, the tilting accelerated towards the caldera (Figure 8).

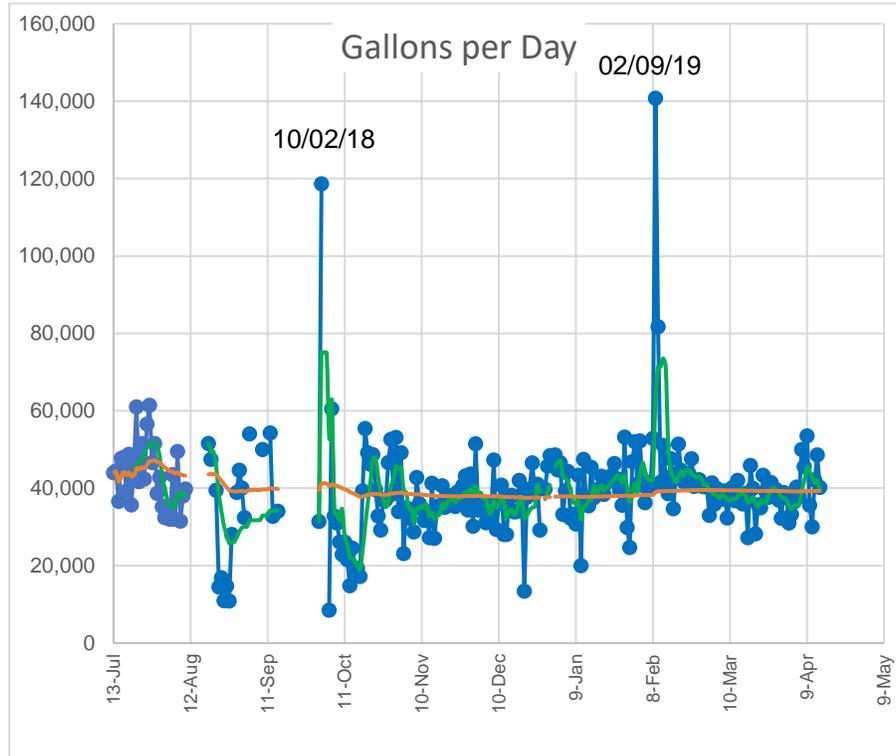
Figure 9-Daily volume of pumped slurry from mud pot caldera.

On October 2, 2018, the tiltmeter recorded an anomalous movement of the sheet piles. We noted that certain sheet piles had been sinking up to 1 inch relative to its neighboring sheet pile. Most alarming was a spike in the mud discharge, which was three times the normal daily flow at about 120,000 gallons for that day (Figure 9). This was the highest amount of mud discharge recorded to date during our monitoring. A similar spike occurred on February 9, 2019, for unexplained reasons.

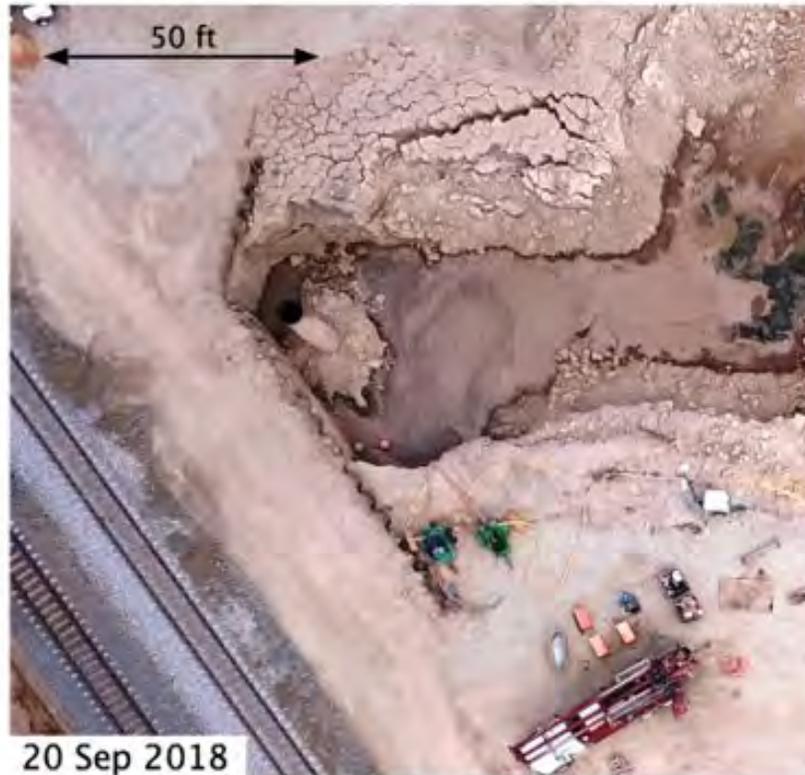
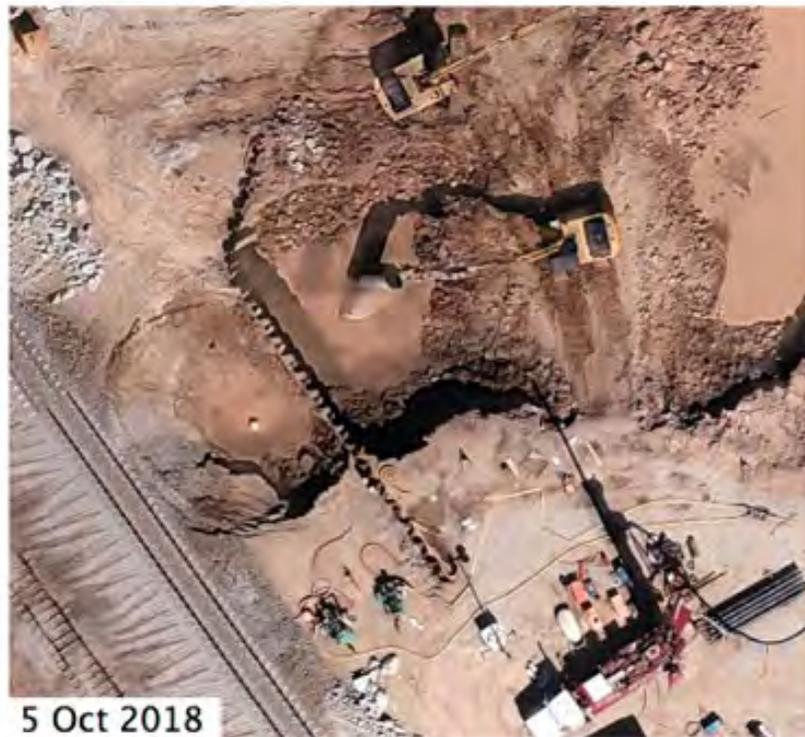
Figure 10- Aerial drone images of the mud spring and caldera both pre- and post-breach of the sheet pile containment structure. Images courtesy of D. Lynch.

We further concluded that breaching of the sheet piles by the mud spring was in progress and a work train was dispatched to deliver rip rap to the site. The rip rap would be placed at either end of the sheet piles in an effort to contain the erosion of the emerging mud spring between the sheet piles and tracks. In the early afternoon of October 4, a fountain of dust driven by gas was being expelled on the track side of the sheet piles in the new mud pot location. The ground between the sheet piles and the main line tracks failed by heaving upwards and then collapsing, forming a sinkhole between the sheet piles and tracks (Figure 10).

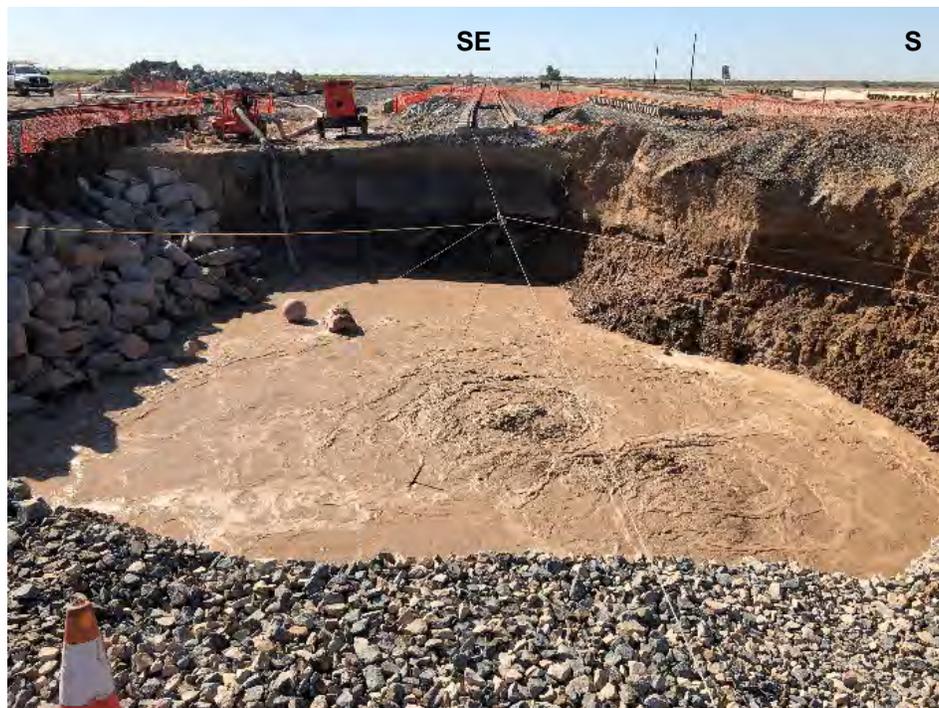
Figure 11-View of the mud spring within the original main line track alignment. Original tracks are cut on the opposite wall of the mud pot caldera. View to the southeast.

Contractors for the UPRR backfilled the entire caldera area to the east of the sheet piles with rip rap and soil. The eastern shoofly track became operational later in October. While functional, the eastern shoofly track required weekly tamping of the ballast due to settlement of the fill. The sheet piles, which had previously been tilting to the east prior to the sinkhole formation, began tilting west towards the sinkhole, adding to the settlement of the eastern shoofly track. Despite these issues, the railroad was operating trains on the eastern and western shoofly tracks with the mud spring located in the main line tracks alignment (Figure 11).

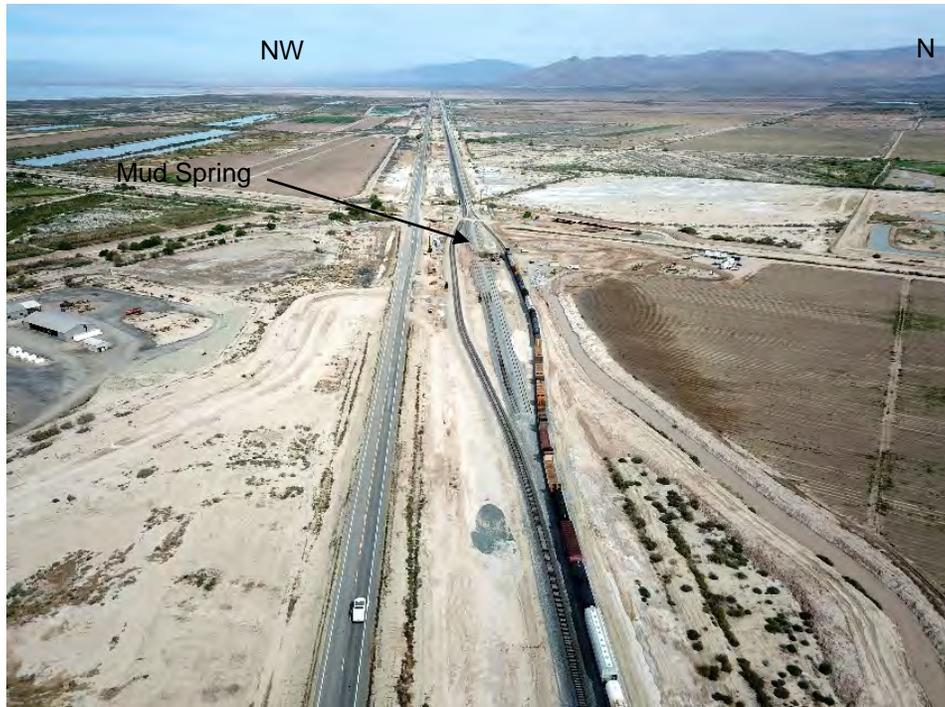
Figure 12-Aerial drone image of the Mundo mud spring site showing the current shoofly railroad tracks around the mud spring and adjacent Highway 111. State owned park land and parking lot are on the west side of Highway 111. Image courtesy of D. Lynch.

The final critical infrastructure in the mud spring's path is Highway 111 owned by the California Department of Transportation (Caltrans). Caltrans engineers devised concepts for protecting the highway, but after reviewing the costs, we understand they will likely close the highway, or detour traffic around the area. Should the mud spring continue its trend towards the southwest, a gravel parking lot and county road remain in its path. Beyond that are fields and duck ponds before encountering the Salton Sea, a distance of about 2 miles (Figure 12).

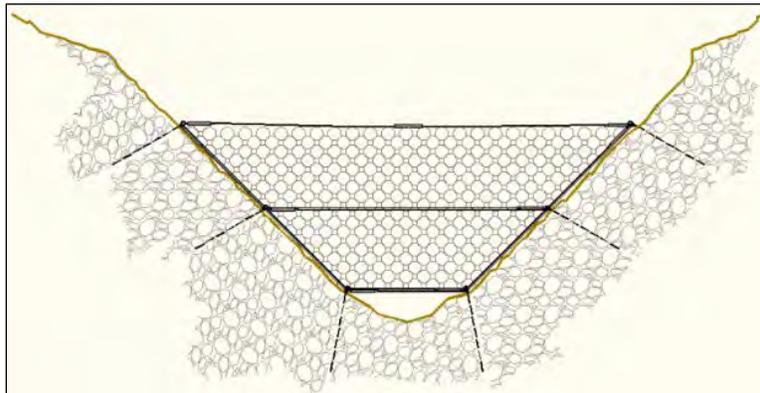
Figure 1: Typical drawing for debris flow barrier in channel. (Courtesy of Maccaferri)

One of the most popular solutions for debris flow protection is flexible barriers. The main goal of these kinds of applications is to stop all the material flowing down the slope, or through a channel, at a given location. After each event, the barriers are partially or completely clogged by sediment, and requires maintenance for the barrier components after debris removal. Sometimes the barriers need to be completely replaced due to major damage because of the debris front impact. For these reasons, flexible barriers are usually utilized as a last protection means against debris flow events.

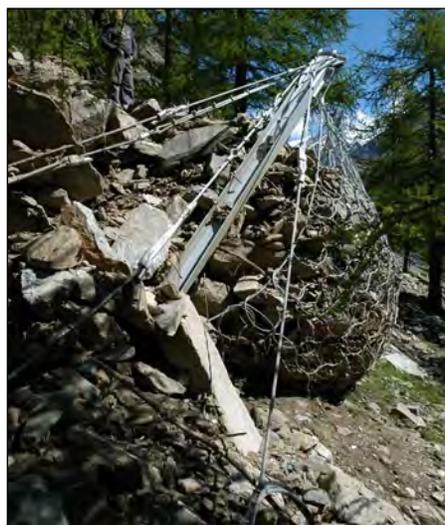
Figure 2: Clogged open slope debris flow barrier requiring maintenance. (Courtesy of Maccaferri)

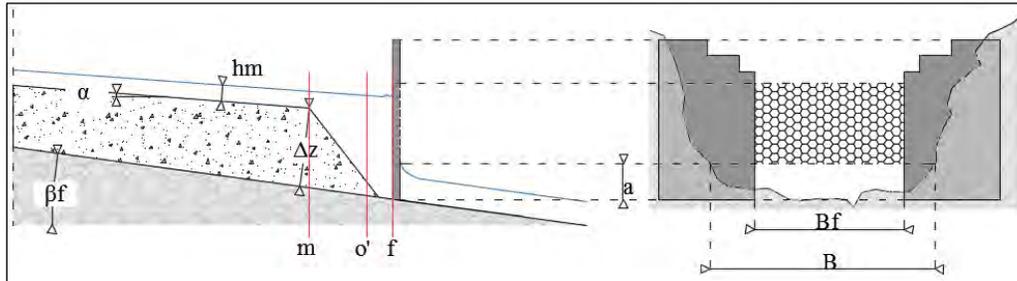
Figure 3: Example of a MSCD [2].

The Maccaferri Innovation Centre (M.I.C.) started a research program, in cooperation with the University of Trento, aimed at implementing a solution for debris flow protection without major maintenance operations. From the program a new solution has been identified with a product called Mini Skirt Check Dam (MSCD) [1]: a conceptual drawing for the MSCD is shown in Figure 3.

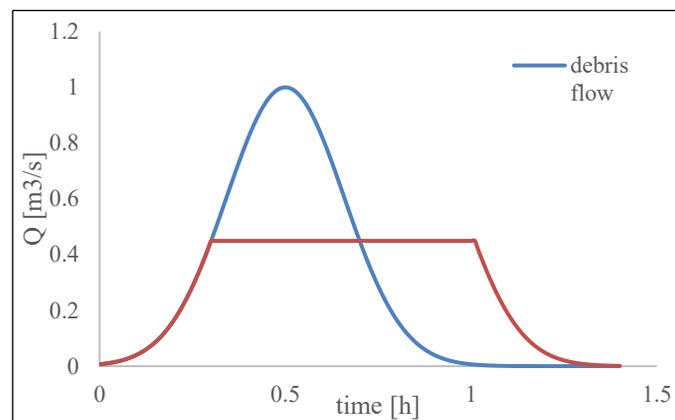
Figure 4: Flow rate per hour comparison for a site with and without a MSCD installation [2].

The MSCDs are designed using a formula that allows an accumulation of sediments in the netting; the sediments flow out of the structure after a wave peak of the biphasic material. Based on that peak, a solution is developed that ensures a complete self-cleaning system that discharges accumulated debris, considerably reducing maintenance. The dimensioning formula must be properly calibrated according to specific debris characteristics and the type of netting used by the system. Less concrete, better hydraulic properties and reduced maintenance give interesting characteristics to a Mini Skirt Check Dam from both performance and environmental points of view [4].

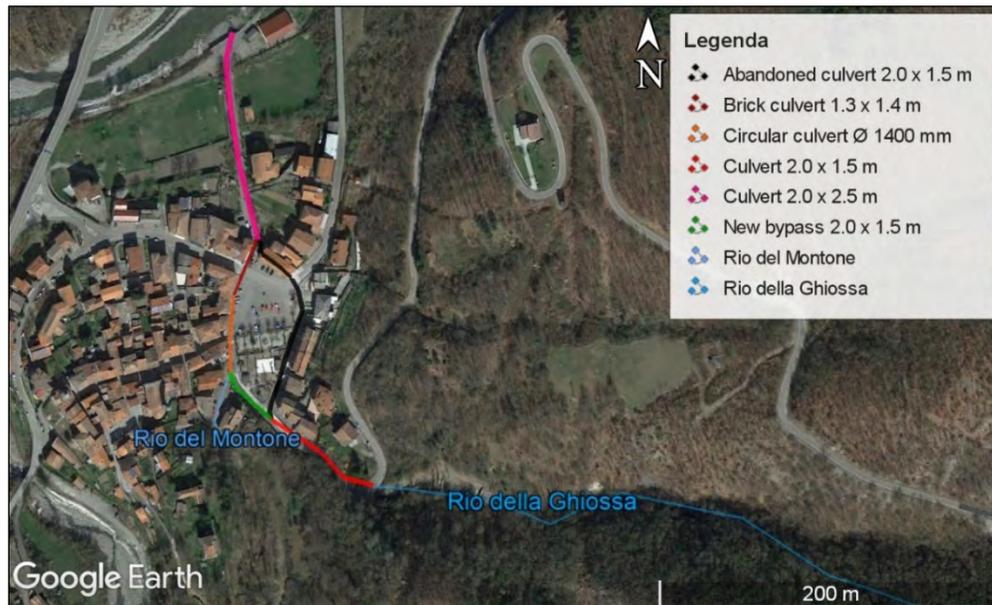
Figure 5: channel system below Piazza Vittoria after the first restoration [2].

The first test installation project was chosen in the municipality of Ottone (Piacenza, Italy). The most challenging part of the project was the presence of a sewer made of masonry having a vaulted roof and two hydraulic sections of $1.30 \times 1.40\text{m}$ and $2.00 \times 1.50\text{m}$ in section. The drainage disposal capacity, assessed with a maximum filling level of the sections equal to $2/3$ of the available height and considering clear water, was equal to $8\text{m}^3/\text{s}$ considering a multi-centennial flow rate. However, the flood events in the two streams were characterized by the presence of solids transportation that could plug the drainage system. This scenario of blockage by massive debris transport has occurred more than once in the recent history; the most relevant events happening on: 19th September 1953; 13th -16th October 2000; and 13th -14th September 2015.

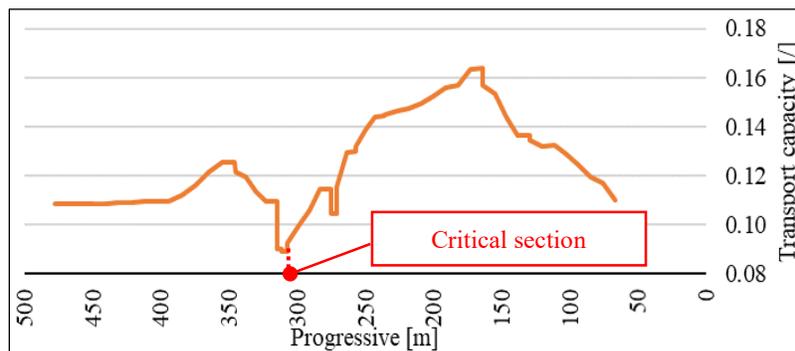
Figure 6: transport capacity based on Hec Ras model (Brunner et al., 2016).

The most critical section was identified using a Hec Ras model implemented in cooperation with the Politecnico of Milano. 88% of the 64 sections have a fixed geometry (sewer dimensions are known). Starting from this data, the peak of the flow rate was selected from previous studies (Menduni, 2016) and approved by the local administration.

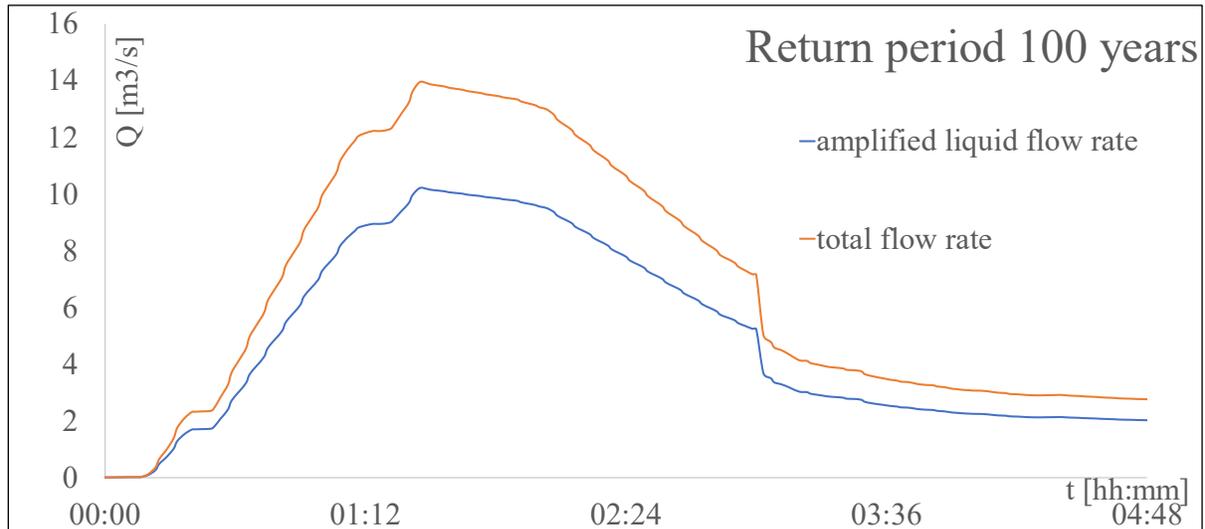
Figure 7: amplified liquid flow rate (blue) compared to the total flow rate (orange) [2].

The total flow rate is represented by the sum of liquid and solid transport, and it was obtained by applying Takahashi criteria (Takahashi, 1991).

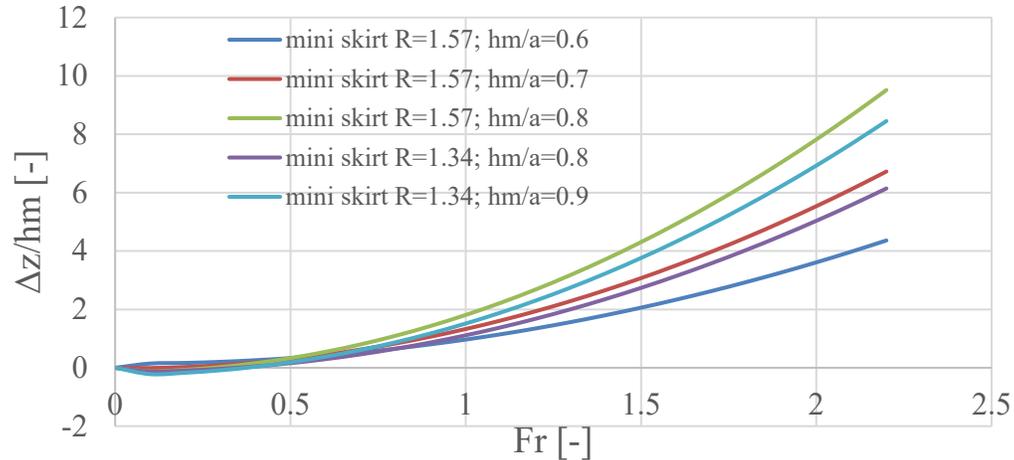
Fig. 1: Example of resulting design abacus for R=1.57 and R=1.34 with different hm/a parameter values

The design cross-section is 4.7 m wide, and two values of Bf were chosen ($Bf = 3$ m and $Bf = 3.5$ m). This approach led to two design options: one with ratio $R = 1.57$ and one with $R = 1.34$. The resulting design graphics for these two options are shown in Fig. 8.
