70TH HIGHWAY GEOLOGY SYMPOSIUM

“Better Highways Through Applied Geology”

October 21-24, 2019

2019 Proceedings

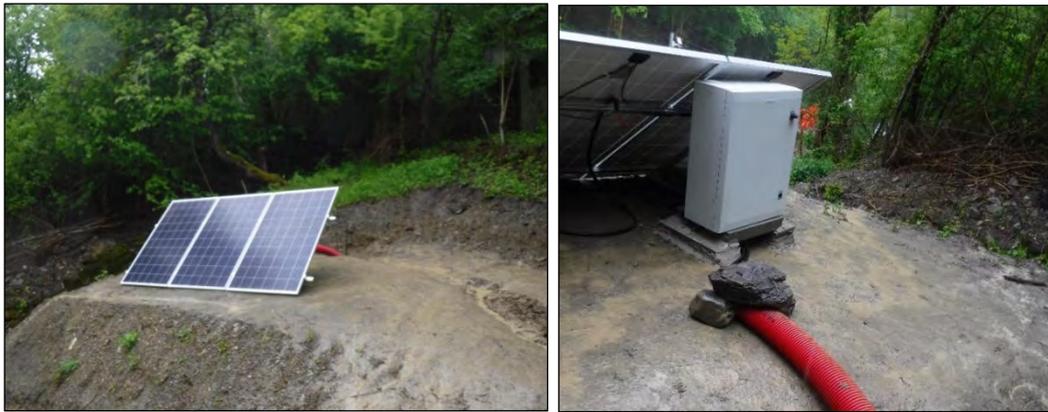
Figure 8-9: installed solar panels and box containing the data logger.

The first step for the monitoring system installation was the positioning of the solar panels: a small area on the right side of the stream was levelled for installing the solar panels and connecting them to a control unit and to the concrete plinths. The pipe for connecting the control unit to the plinths was installed before and then covered by soil. Figures 8 and 9 show this phase and some details of the control unit.

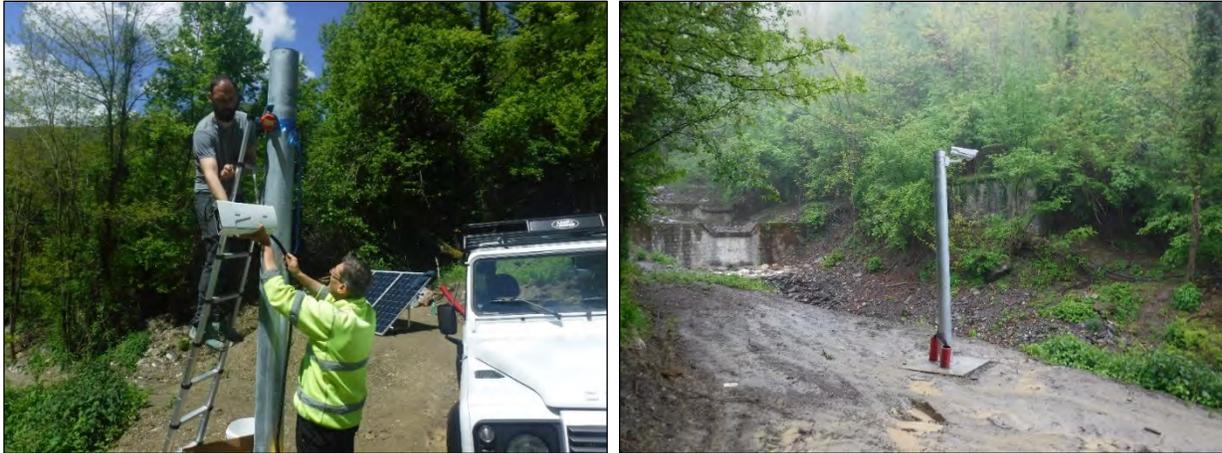
Figure 9-11: installation of the upstream camera and one downstream camera.

The three monitoring cameras were installed on top of three steel posts. The posts were founded on concrete plinths having plastic pipes cast inside as conduits for connecting wires (see Figure 10 and Figure 11).

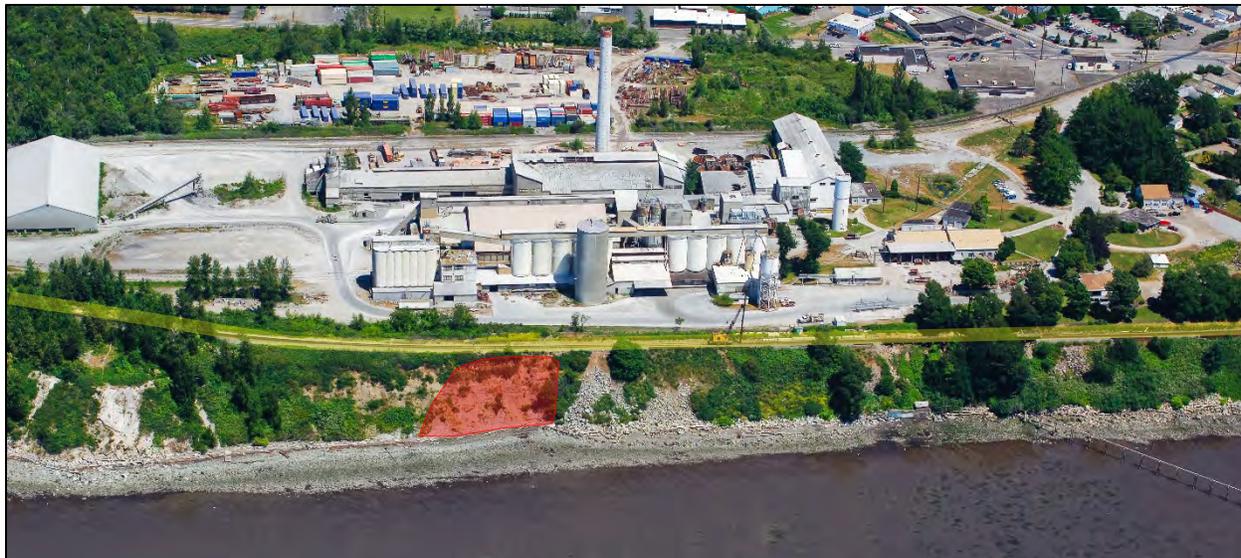
Figure 2 – Site Photograph view due northeast, June 2006. Note BNSF Bellingham Subdivision (yellow highlight), Cement Plant (top, center), MP 99.2 site (red shading), and Bellingham Bay (at bottom). Photo Courtesy of Washington Department of Ecology.

The BNSF Bellingham Subdivision line was constructed beginning in 1888 by the Fairhaven and Southern Railroad Company and subsequently sold in 1891 to the Great Northern Railway company, a predecessor railroad to the BNSF (Lewis, 1912). At MP 99.2, the BNSF Bellingham subdivision consists of a single main line with a roughly 1 percent grade to the south. The track is aligned on a short tangent section that passes along the top of approximately 70- to 80-foot-high coastal bluffs just east of the track. The coastal bluffs stand at overall angles on the order of 1H:1V (Horizontal to vertical), and in early 2016 regressed to within approximately 10 feet of the west rail along an about 75-foot-long reach of track. At the north end of the project area, the line transitions to curve that diverges eastward from the bluff crest. A Portland cement manufacturing plant covering about 20 acres is present to the east of the track (see Figure 2).

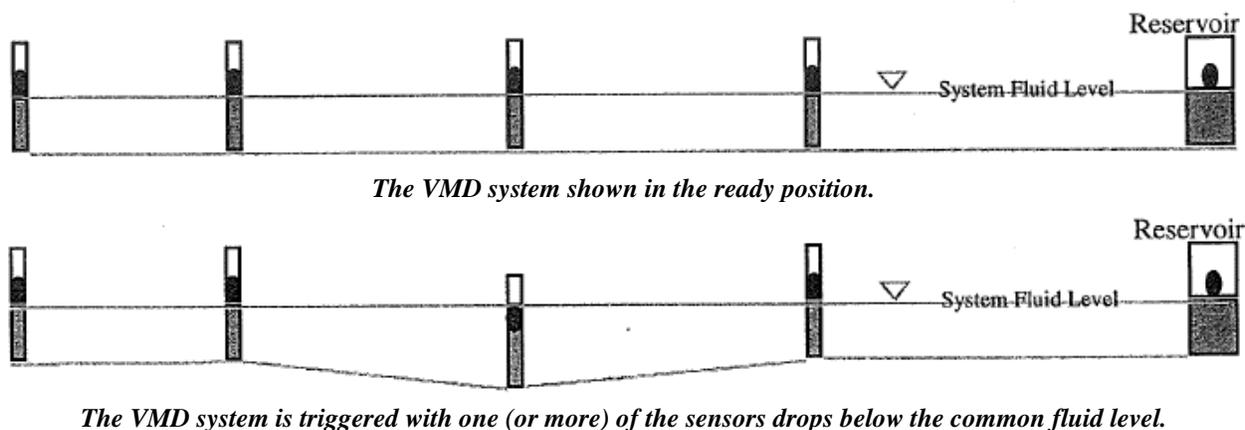
Figure 3 – Schematic of Typical VMD System

The VMD system at this location (Figure 3) consists of a line of partially liquid-filled chambers or “pots,” each containing float switches mounted approximately 1 to 2 inches above the fluid surface. The chambers are connected in series via buried flexible tubing, and the system is connected to a fluid reservoir containing a substantially larger volume of the reference fluid. If any of the chambers moves vertically within the tolerance of the system (e.g. the distance between the float sensor and the fluid level in the chamber), the fluid level seeks a common hydrostatic level by flowing from the reservoir into the depressed chamber. The rising fluid level engages the float switch and activates electronics to activate the track signals and alert oncoming rail traffic. The VMD system also includes electronic sensors to detect fluid losses or catastrophic system failure, conditions that would also activate the track signals to alert approaching rail traffic.

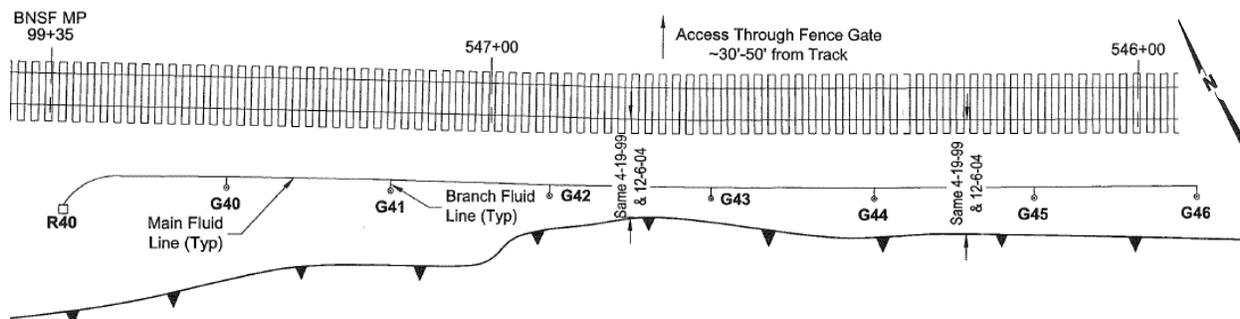
Figure 4 – VMD System Components and Bluff Crest, December 2004 (not to scale)

The VMD was constructed parallel to a 150-foot-long section of rail with roughly equal spacing of 25 feet between individual pots (Figure 4). The VMD alignment is offset approximately 10 feet west of the western rail. Individual VMD pots were located between about 3 and 7 feet uphill of the bluff crest (hachured line at bottom of Figure 4).

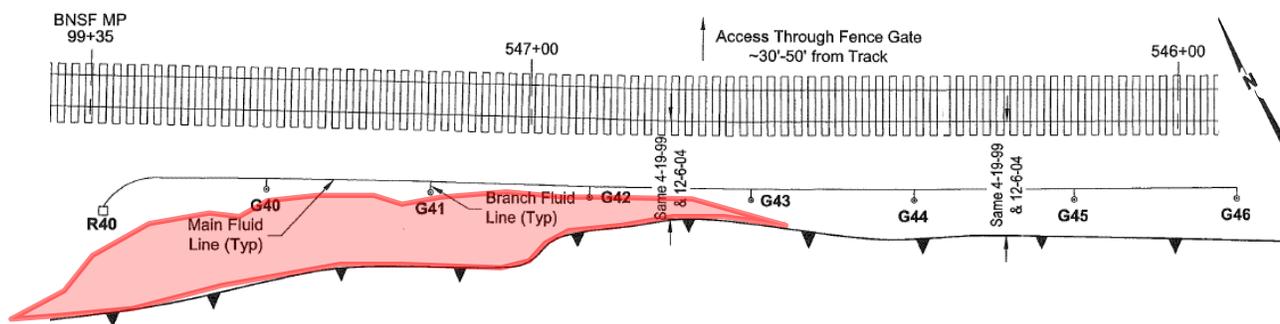
Figure 5 – VMD System and Bluff Retreat December 2004 to February 2016 (not to scale)

The bluff crest regressed to the edge of one of the pots (designated G42 – see Figure 5), causing downhill rotation, but not activating the switch and track signal. The bluff retreat was reportedly

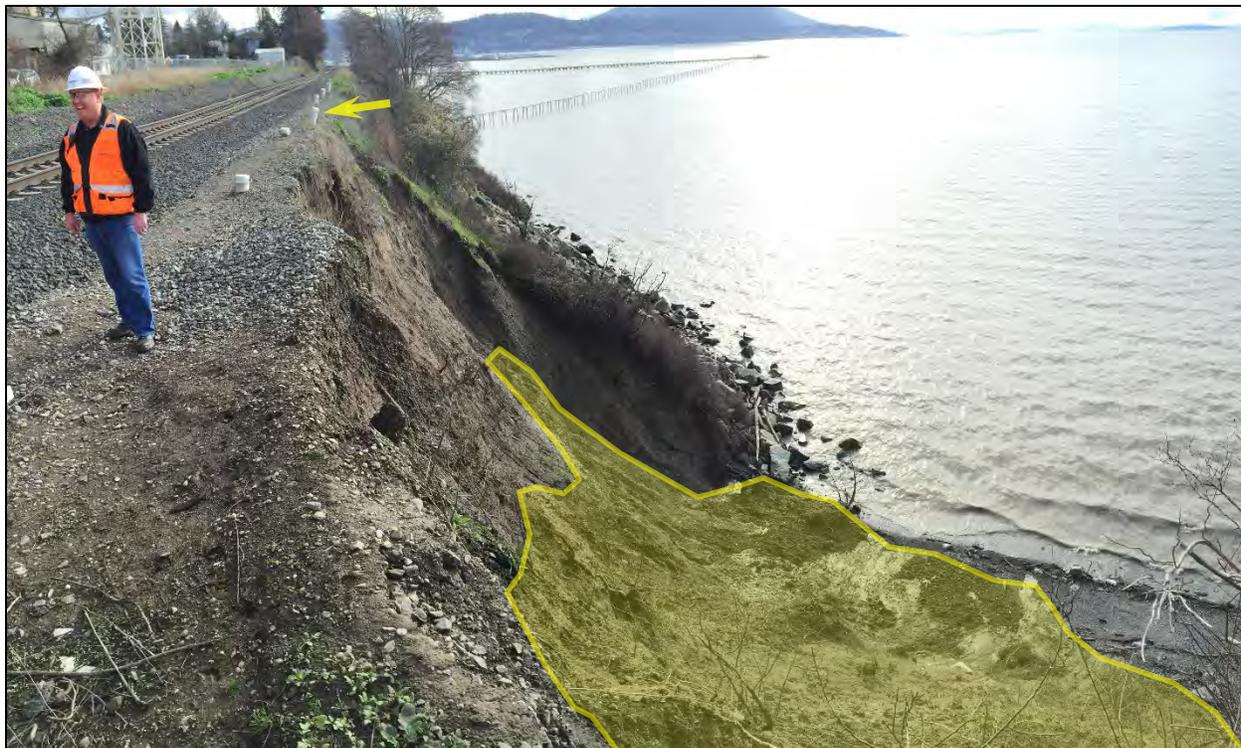
**Figure 6 – MP 99.2 Bluff Crest and Debris Runout Following February 2016 Landslide
Note rotated VMD pot (yellow arrow) and Debris Runout (Yellow Shaded).**

observed by a BNSF locomotive engineer familiar with the area. As shown on Figures 6 and 7, the debris avalanches covered much of the tidal flat along the toe of the bluff slope with up to 6 feet of saturated soil debris. Following the 2016 event, the upper slopes of the bluff stood at angles of up to about 70 degrees.

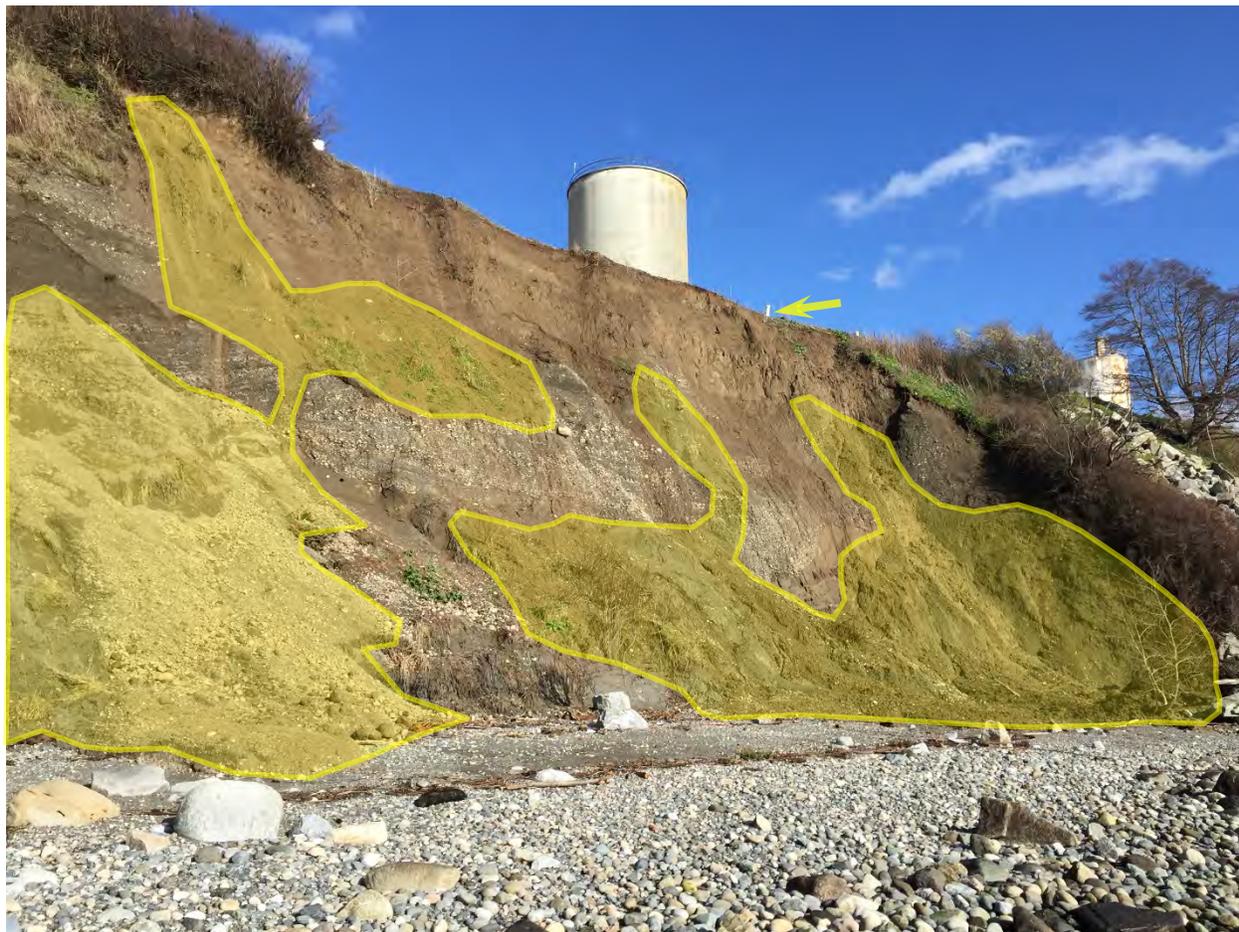
**Figure 7 – MP 99.2 Bluff Slope Following February 2016 Landslide
Note rotated VMD pot (yellow arrow) and Debris Runout (yellow shaded).**

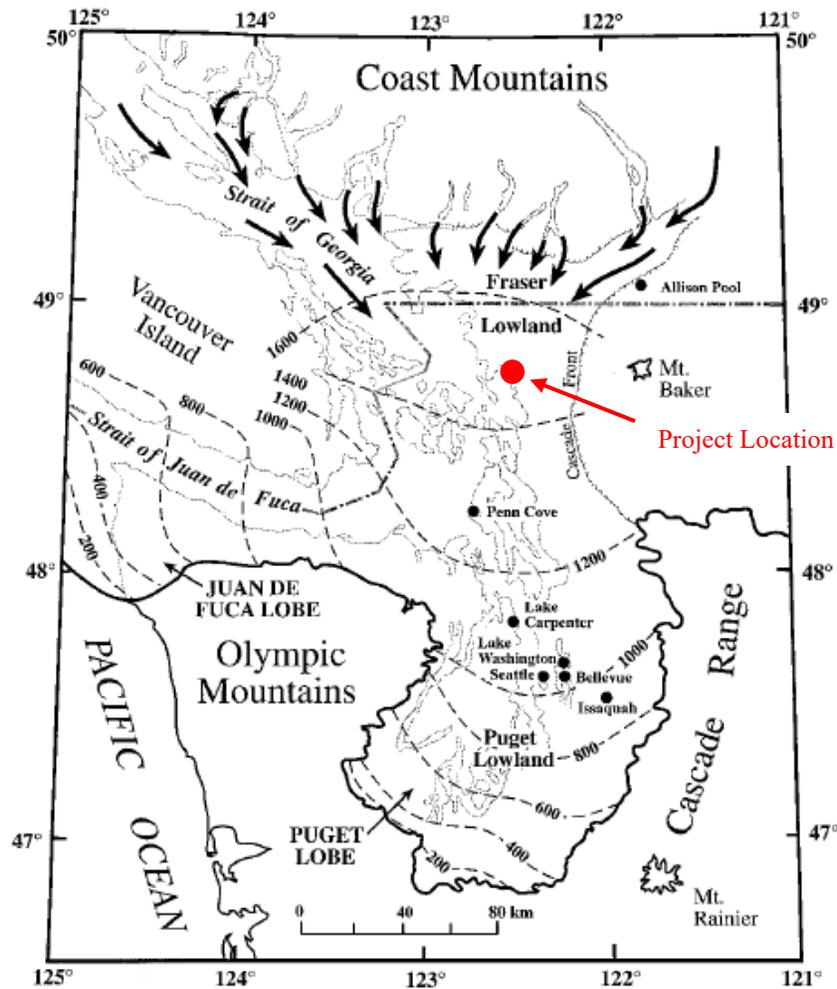
Figure 8 – Maximum Vashon Stade glacial extent, ca. 16.9 ka with ice elevation contours shown in meters above sea level (modified from Porter and Swanson, 1998).

The CIS reached its maximum extent ca. 16.9 ka, at which point the top-of-ice elevation on the “Puget Lobe” of the CIS at Bellingham was on the order of 5,000 feet (1,500 meters) above sea level (Porter and Swanson, 1998 – see Figure 8). Beginning at about 12.5 ka, the now-stagnant Vashon ice sheet had thinned sufficiently to allow seawater originating from the Straits of Juan de Fuca and the Pacific Ocean to float the ice sheet, forming an extensive ice shelf. As a result, a laterally extensive glaciomarine deposit consisting of massive clays with marine fossils and dropstones (gravel- to boulder-sized clasts that melted out of the ice shelf) was deposited in the northern Puget Lowland (Weber and Kovanen, 2000 and Easterbrook, 2003). Due to isostatic depression of the crust beneath the Vashon Lobe, sea level elevations at 12.5 ka were on the order of 400 to feet higher than current sea level. As the crust rebounded prior to about 11.7 ka,

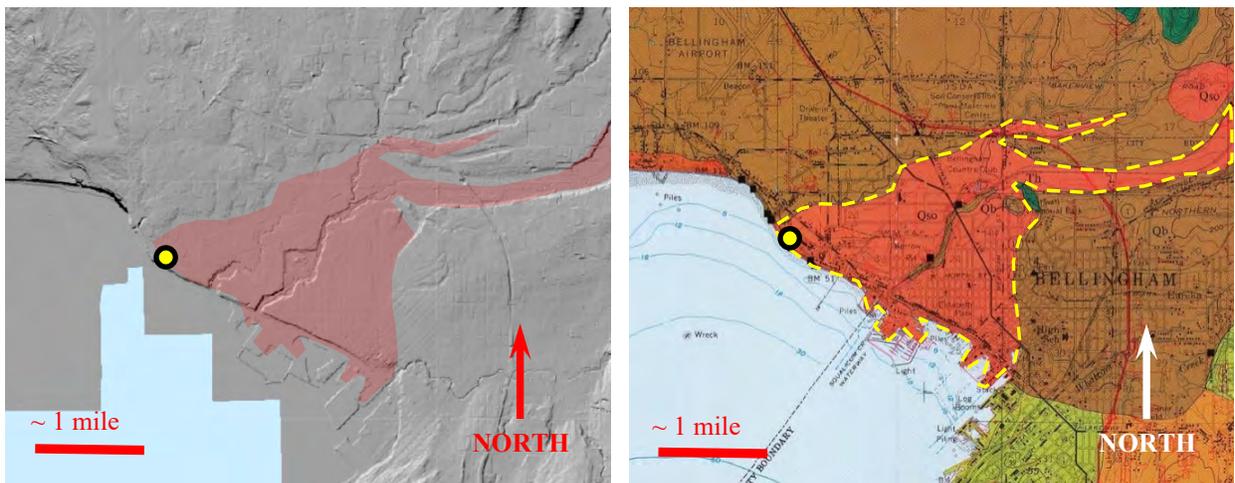
Figure 9 – Squalicum Creek Outwash Channel showing Sumas Stade outwash deposits within shaded regions (WDNR, 2019 and Easterbrook, 1976).

Easterbrook (1976) mapped glacial and bedrock features in the Bellingham 1:62,500 quadrangle, including Sumas Outwash sands and gravels at the MP 99.2 project site and Everson Interstade age Bellingham Glaciomarine Drift north of the site. Examination of Light Ranging and Detection (LiDAR)-derived hillshade maps in the Bellingham area (Washington Department of Natural Resources, 2019) suggests that Easterbrook (1976) mapped the contact between Sumas Outwash and Bellingham Glaciomarine Drift along the northwest margins of the nearly 3-mile wide, topographically prominent mouth of the Squalicum Creek outwash channel (Figure 9).

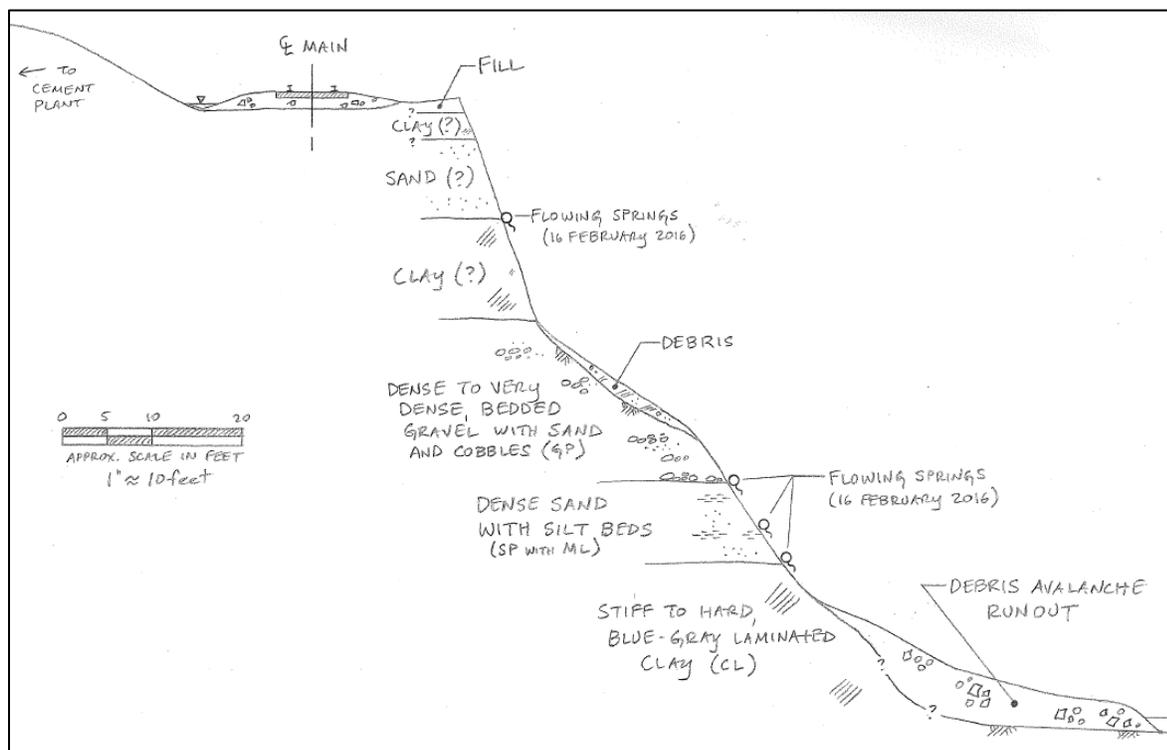
Figure 9 – 2016 Field Drawing of bluff face (modified from Shannon & Wilson project records). Ground surface profile from field measurements with a handheld clinometer and recreational laser rangefinder; geologic interpretations queried at inaccessible locations.

During the February 2016 reconnaissance, Shannon & Wilson photographed and mapped the eroded bluff face. Figure 9 shows a field drawing of the bluff face with engineering geologic conditions. A 1998 boring log from track level indicated a very similar interbedded sequence consisting of (approximate thicknesses and cumulative depths below track level [btl] listed from top to bottom):

The field engineering geology observations were consistent with published mapping in the area. We interpret the uppermost 5-foot clay layer to be a fill deposit, with underlying Sumas outwash gravels and fluvial overbank deposits (about 5 to 50 feet btl) incised into the underlying Everson Interglacial-age Bellingham or Kulshan glaciomarine drift.

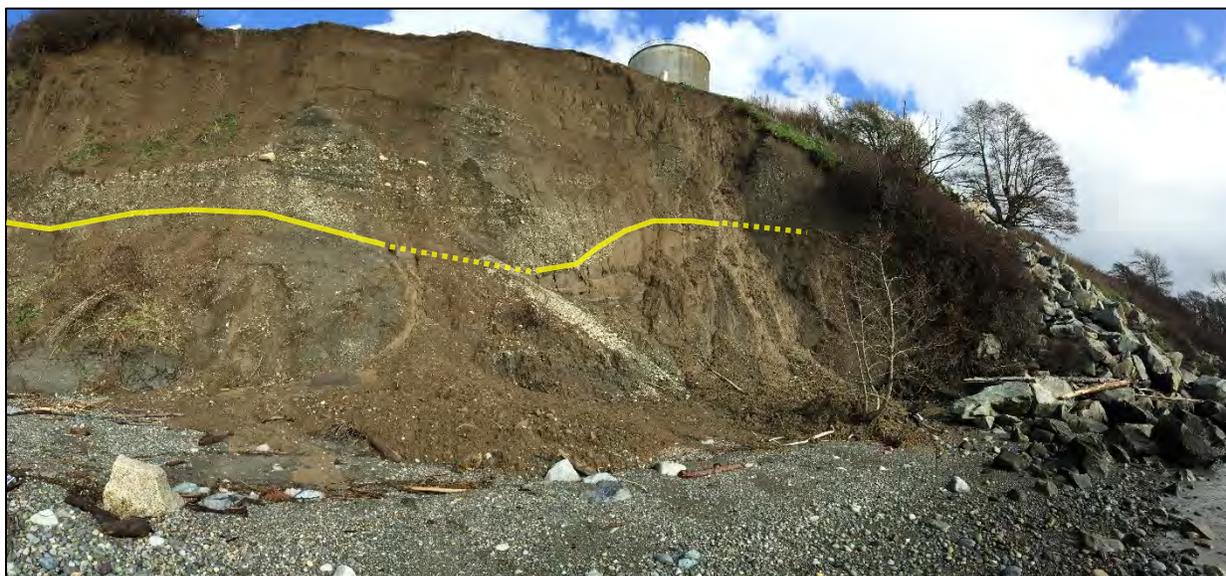
Figure 10 – February 2016 Site Photo showing contact between Sumas Outwash and underlying Bellingham Glaciomarine Drift (dotted where concealed by debris). Note incised channel geometry at base of outwash.

We noted flowing springs in the bluff face during the 2016 field reconnaissance, each of which occurred as a perched groundwater horizon where a sand or gravel beds overlie a relatively impermeable bed. The flowing springs occurred at three horizons within the Sumas Outwash deposits, including (1) the base of sand beds overlying a clay overbank deposit about 10 feet btl, (2) the base of an incised gravel bed overlying silt and sand at about 40 feet btl, and (3) the base of the silt and sand bed above the clayey glaciomarine drift at about 50 feet btl. We observed some springs flowing at estimated rates of several gallons per minute, with surface drainage rills extending to Bellingham Bay. We also noted that cohesionless deposits tended to erode back into the face at the location of the springs.

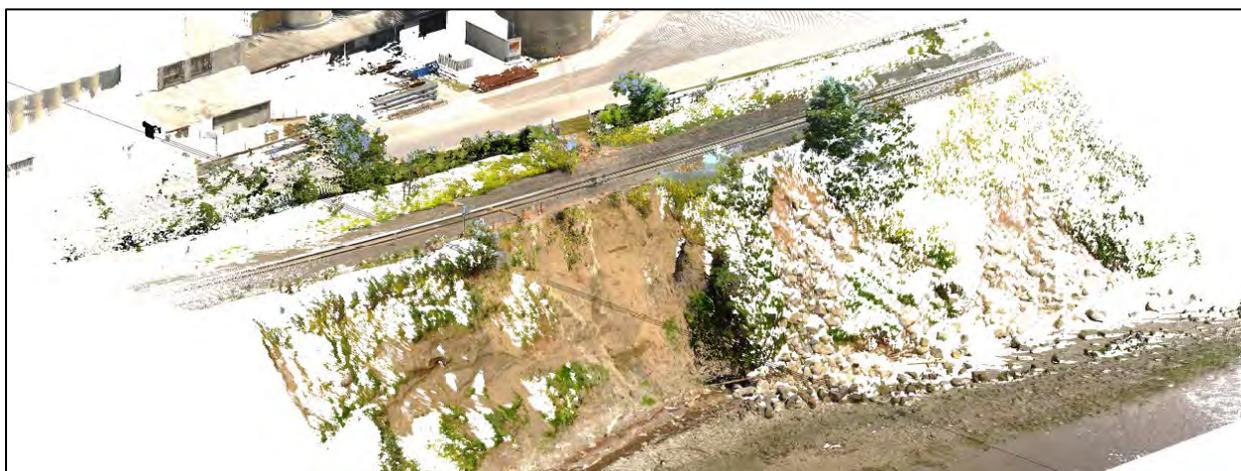
Figure 11 – Photogrammetric Model Showing MP 99.2 Site (center bottom).

The Shannon & Wilson design utilized a photogrammetric topography survey. The photogrammetric imagery was acquired with an unmanned aerial vehicle by the BNSF contractor's survey subcontractor. The survey deliverables included a three-dimensional surface model of the project site. Due to the denuded condition of the ground surface in the area of greatest bluff retreat, the photogrammetric methods yielded an accurate survey with limited interference from vegetation (Figure 11).

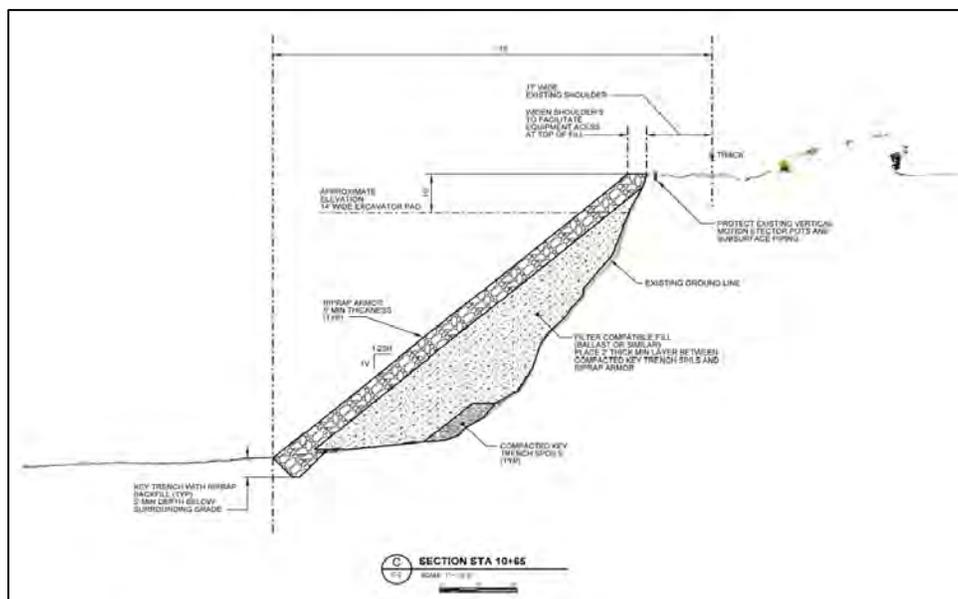
Figure 12 – Excerpt from Plan Set; note photogrammetrically derived topographic surface.

Shannon & Wilson prepared a simplified plan set utilizing four individual cross sections and a plan sheet derived from the photogrammetric survey (Figure 12). Concise specifications were incorporated directly into the plan set as dimensions and notes.

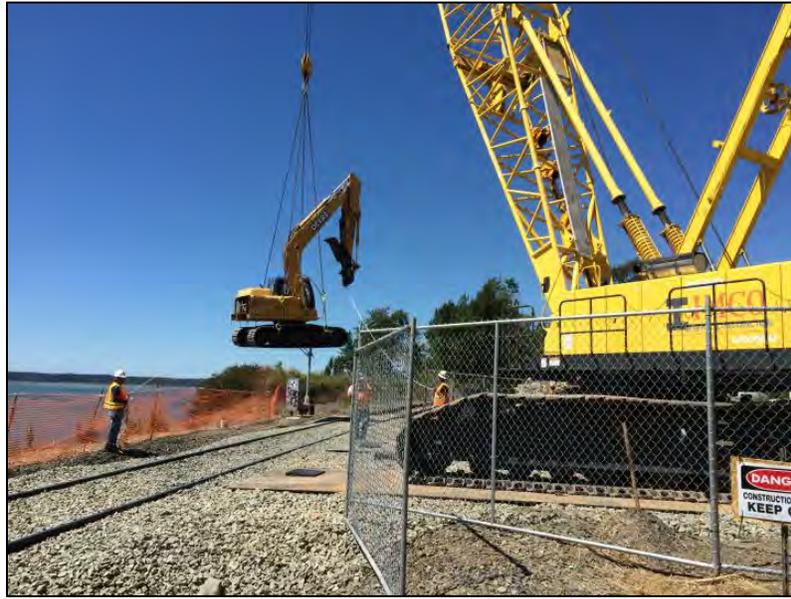
Figure 13 – Mobilizing Excavator at Start of Construction

Revetment construction began on July 28, 2016 and was completed on August 29, 2016. The BNSF contractor determined that a relatively lightweight excavator (Deere 160C) could be placed on the beach using the same crane (Kobelco CK 2000 1F – see Figure 13). The crane would be maintained onsite to ferry construction materials to the bluff toe (Figure 14). This mobilization approach eliminated the risk and expense of barging the crane to the site. To avoid damage to the excavator by seawater, excavator mobilization occurred as tides receded. The contractor subsequently delivered riprap material onto the beach to allow the excavator to construct and move onto a “dry pad” above high tide.

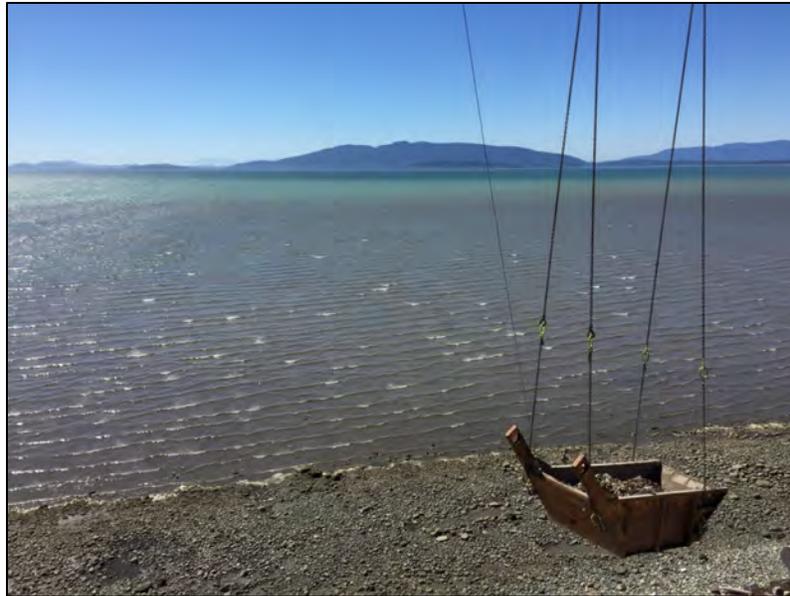
Figure 14 – Crane-Mounted Skid Bucket Ferrying Fill Materials to Bluff Toe.

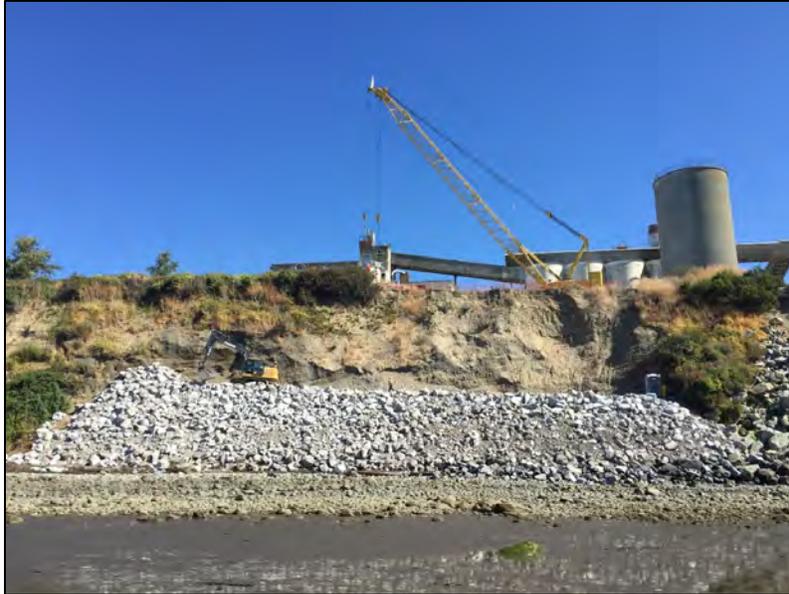
Figure 15 – Partially Completed Revetment During Construction

The contractor constructed the revetment in lifts, placing a pad of 8-inch minus fill compacted by the excavator followed by a facing of riprap. The contractor maintained grade and riprap thickness within design limits by mobilizing a Deere 160G excavator with GPS grade control. Shannon & Wilson observed progress to confirm materials and construction were completed in accordance with project plans and specifications. The contractor elected to use materials coarser than specification for the fill zone of the revetment. The fill materials consisted of 8-inch-minus quarry spall blended with recycled aggregate road base. Shannon & Wilson determined that these materials would meet filter compatibility requirements.

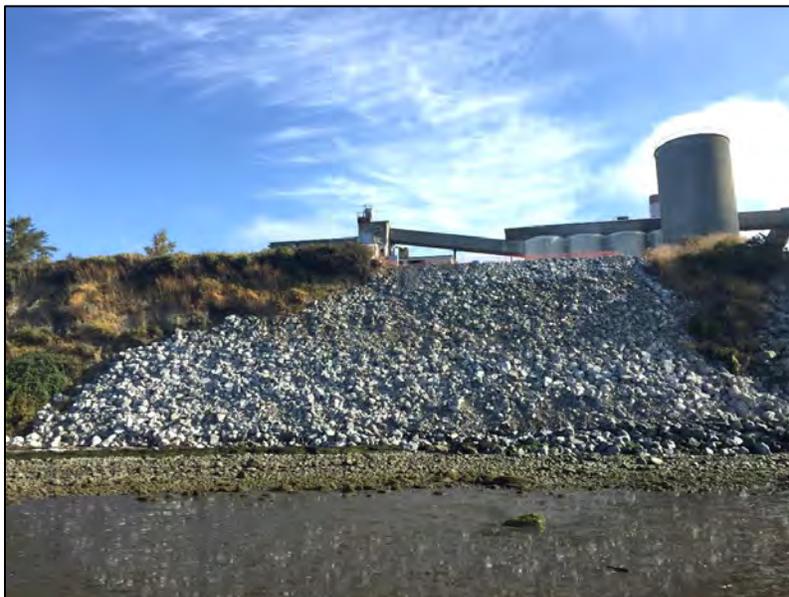
Figure 16 – Completed Revetment Following Construction.

After approximately two weeks of construction, the revetment surface was at an elevation of about 55 feet above bluff toe, and the bench was becoming too narrow for the excavator to efficiently work. At this point, the contractor removed the excavator and used a heavier excavator with a longer reach to complete placement of the revetment from track level. By August 29, 2016, the revetment was substantially complete. Shannon & Wilson measured the final face at about 38 degrees, or slightly flatter than the 1.25H:1V design grade.

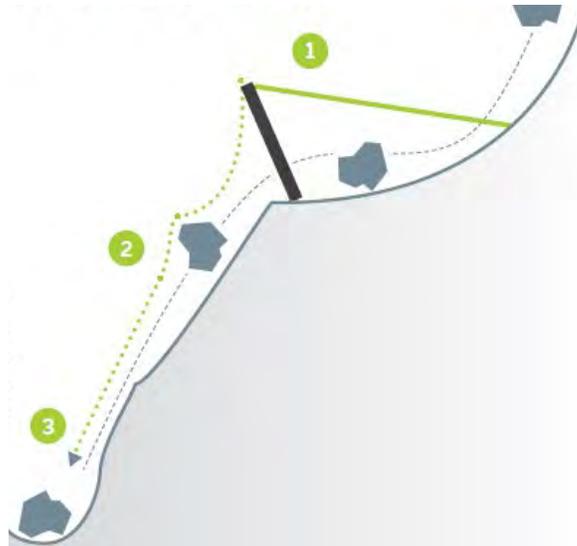
FIGURE 1 Simplified geometry of the attenuator tested in Canada (Geobrugg AG), showing the evolution of a block passing in an attenuator in three steps.

Attenuator systems therefore offer the interception function of rockfall barriers while, like rockfall drapery, further guide the rocks to a catchment ditch at the base of the slope instead of collecting them (Figure 1). Intercepting rockfall during freefall or after slope rebounds, the mesh system redirects the rockfall trajectory, reduces its bounce height, and can reduce velocity (8; 9). Both, the

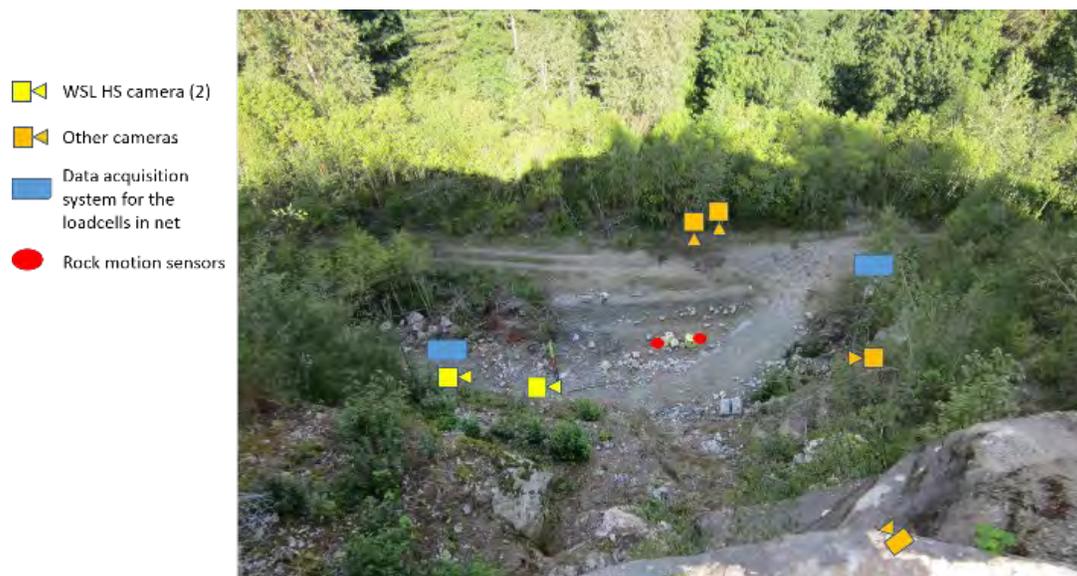
FIGURE 2 Whole instrumentation setup on site. The view looks from the top down onto the slope and the attenuator location.

Load cells were installed in all support ropes with two DAS systems (QuantumX MX840-B with eight channels and a HBM Spider system) on either side of the test site to accommodate 10 load cells (Figure 2).

The testing was recorded with two high speed cameras, kindly lent by the Swiss Federal Institute of Forest, Snow and Landscape (WSL) and several other cameras to cover most angles of view (front, side, top; see Figure 2).

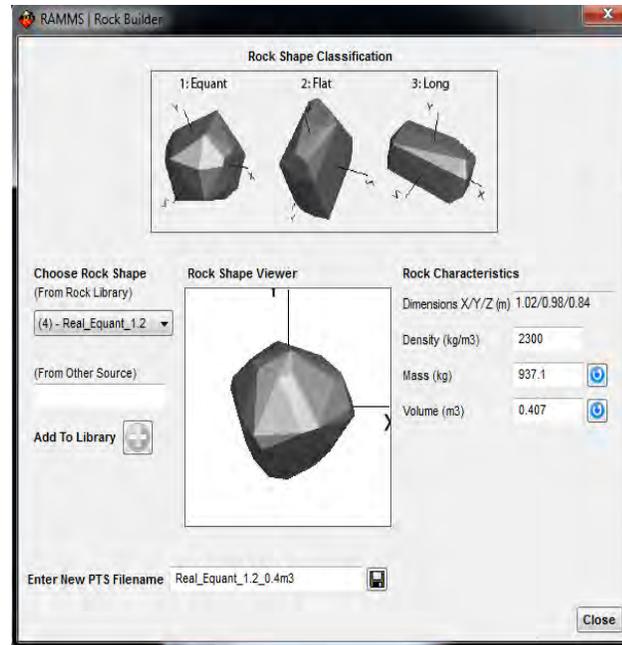
FIGURE 3 Rock shape library in RAMMS::ROCKFALL. Equant normal was chosen as most rocks and the concrete testing cubes resemble closest this shape. Mass and density are set in this example to fit the concrete test block of test T030, used throughout this contribution for comparison purposes.

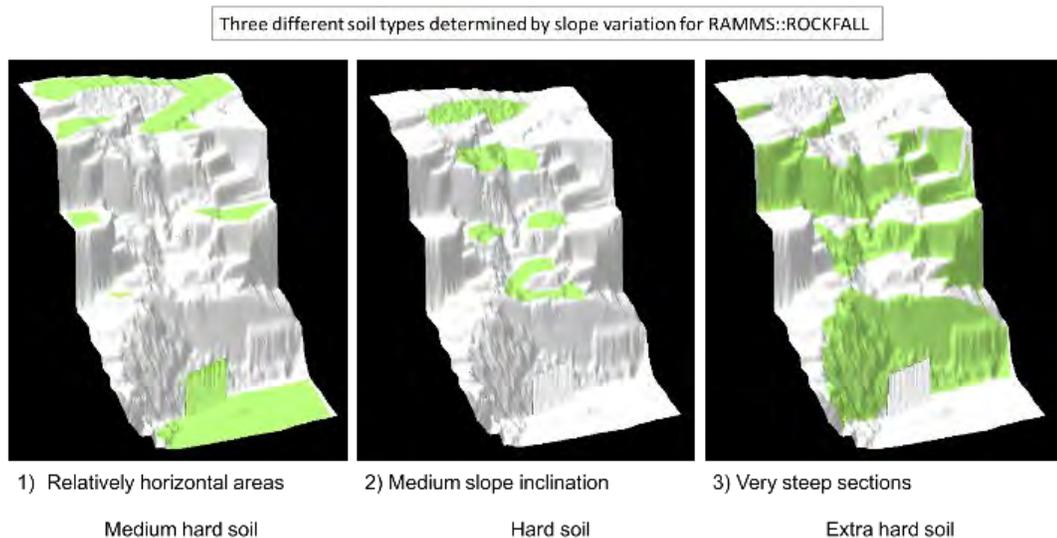
FIGURE 4 DEM and polygons chosen according to slope angle to define soil types. The steeper the angle the less soil cover does the granite slope have and the above-mentioned soil types in RAMMS::ROCKFALL correspond best to the field description.

- **Topography** was obtained with photogrammetric methods applying structure from motion (SfM) algorithms to obtain digital terrain model (DTM) of the test site. The soil types are defined in three categories depending on slope angle (approximately 0 to 15°; 15° to 40° and 40° to 90°) and are characterized by extra hard, hard and medium hard according to the user manual (Figure 4).

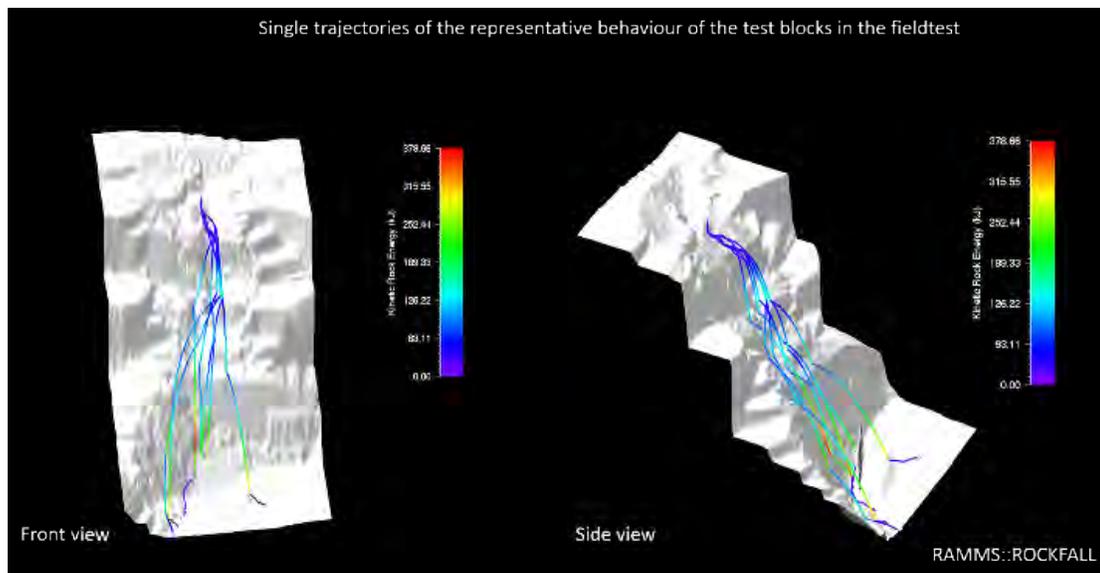
FIGURE 5 Single trajectories modelled, which resemble closely some eccentric behaviour observed while testing, confirming the accuracy of the model.

Of the $n=1000$ trajectory simulations modelled with RAMMS::ROCKFALL, the trajectories showed congruence with some of the measured rockfall events during the field testing were selected for analysis. Figure 5 provides an overview of the spatial distribution simulated rockfall trajectories. RAMMS::ROCKFALL saves every calculated trajectory of one run and single trajectories of choice can then be combined on one DEM. In general, the trajectory distribution on the slope matches the field observation (Figure 6).

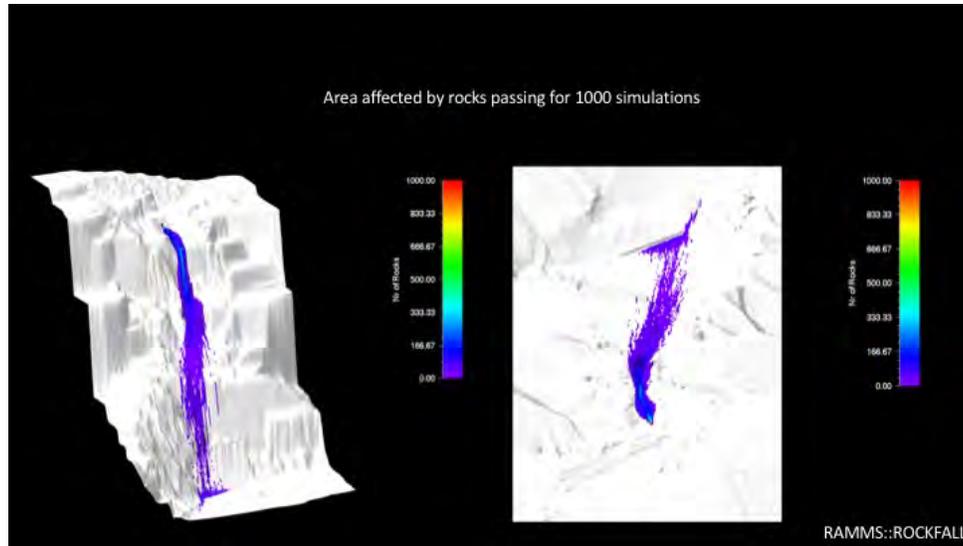
FIGURE 6 Area affected by passing rock, modelled with RAMMS::ROCKFALL for 1000 blocks.

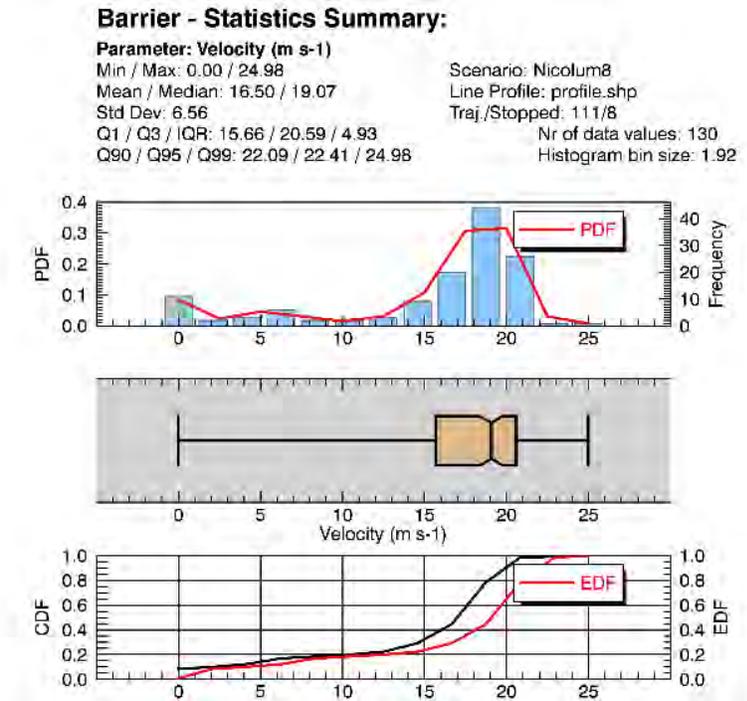
FIGURE 7 statistical distribution of the translational velocities modelled for 119 blocks with associated probability density function (PDF), cumulative distribution function (CDF) and empirical distribution function (EDF).

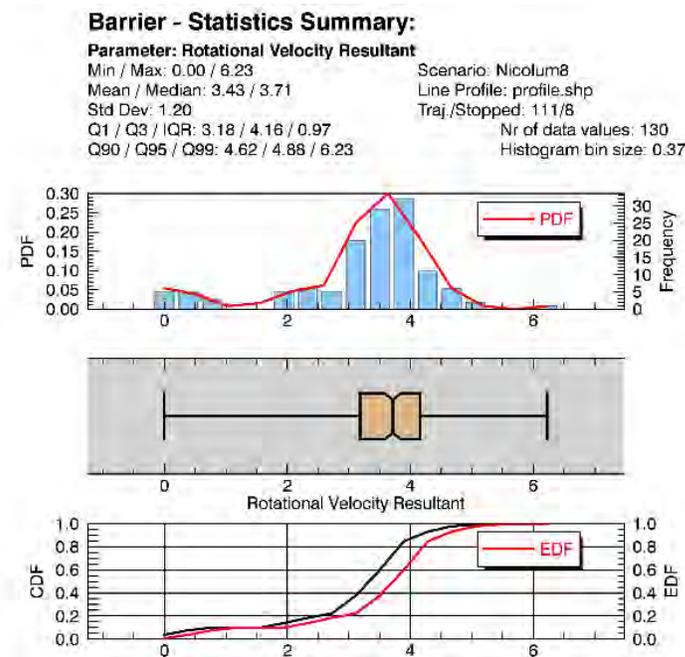
FIGURE 8 statistical distribution of the angular velocities computed for 119 blocks.

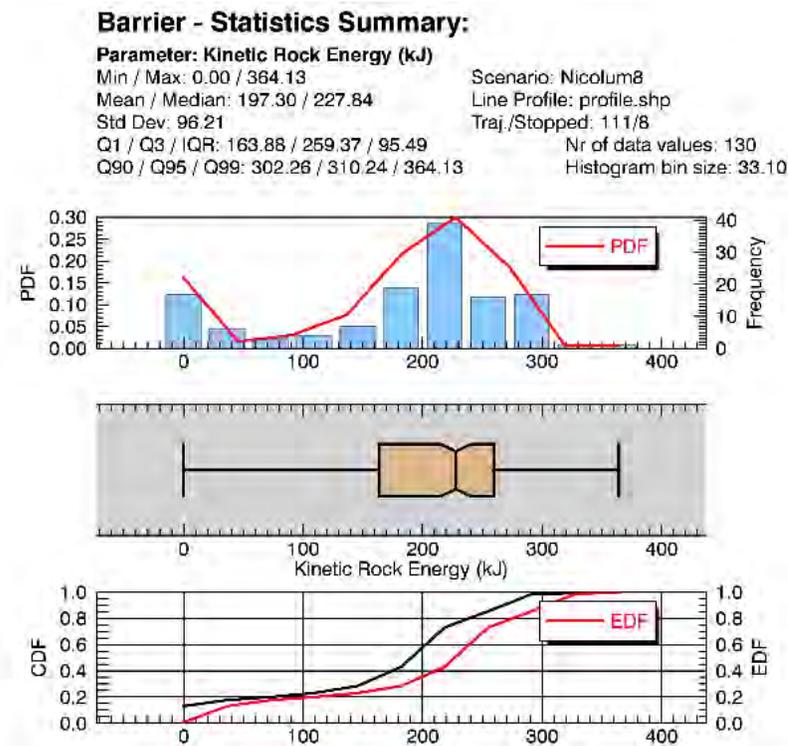
FIGURE 9 Calculated kinetic energies by RAMMS::ROCKFALL for 119 trajectories.

Total kinetic energy (Figure 9) being a function of translational kinetic energy (depending on velocity) and rotational kinetic energy (depending on angular velocity), its distribution is slightly underestimated with most values around 230 kJ whereas 300 kJ would be more realistic when compared to the field test.

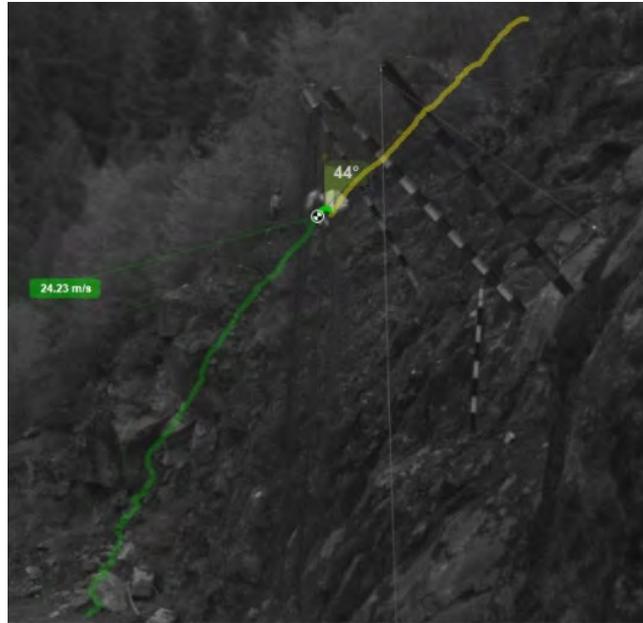
FIGURE 10 Tracking of a block throughout its fall with the software Kinovea.

The impact velocity and angular velocity are measured from the videos, with the help of a video analysis software. In this case, Kinovea (16) was used as it is an open source software and relatively easy to handle as a beginner. Originally it is a sport motion analysis software but can be used for rock rolling experiments. Once a certain distance was calibrated (here the post of 26.25 ft (8m) length, the rock can be tracked automatically and manually, depending on lighting conditions, from first appearing in the frame all the way down to the ground through impact with the net (Figure 10). The velocity is then computed from the x and y points obtained from tracking and corrected for depth as described as in (17).

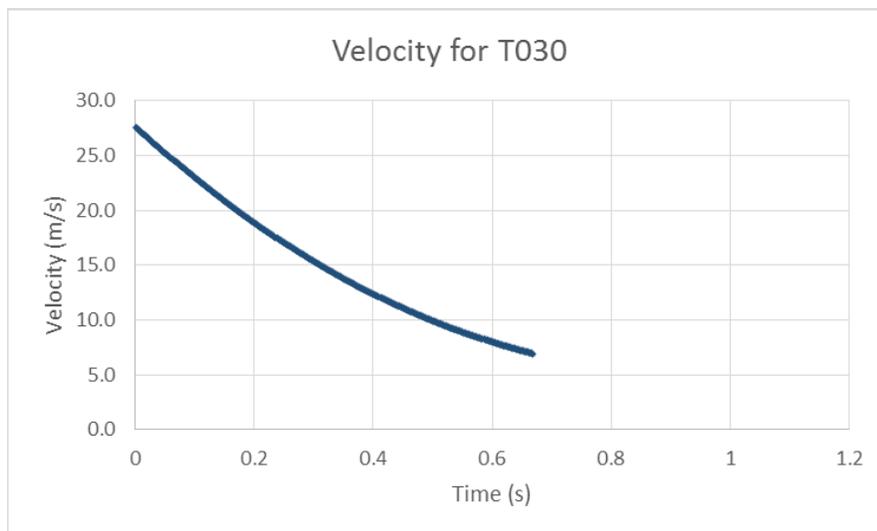
FIGURE 11 Velocity in m/sec for block T030 from impact with mesh until shortly above ground.

The velocity evolution throughout the fall is represented in Figure 11. Velocity at impact is of 88.5 ft/sec (27 m/sec) and decreases towards 19.7 ft/sec (6 m/sec) just above ground. This illustrates the attenuation process, it is observed how the block does not come to a full stop, but only attenuates its dynamics as the rock passes through the system.

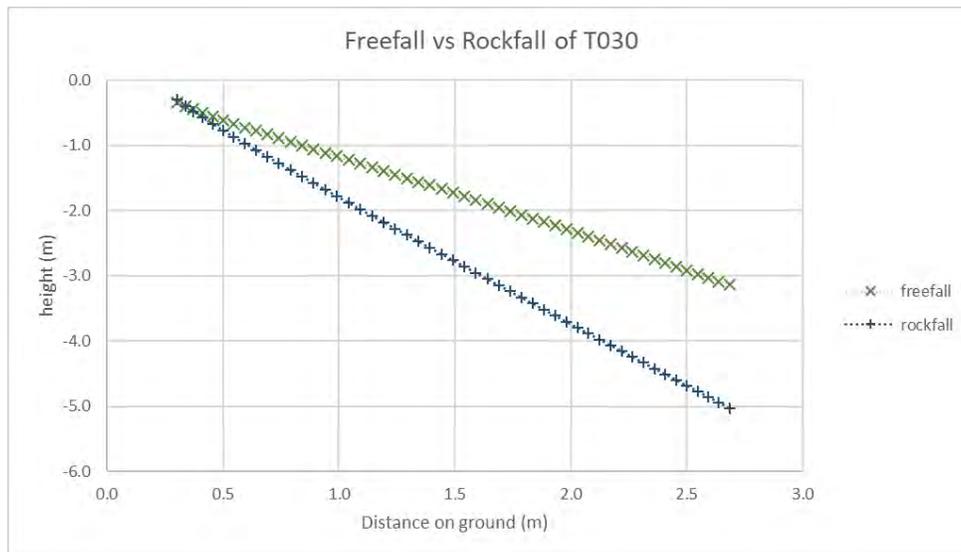
FIGURE 12 Comparison between theoretical freefall behaviour of block T030 versus the actual trajectory with impact of the protection structure from time of impact onwards.

It is possible to compare the theoretical freefall of block T030 with its actual trajectory, illustrating the attenuation process in the perspective of distance travelled. Figure 12 shows how the trajectory of the block is intercepted, and its anticipated height is considerably dampened when impacting the attenuator instead of freefalling without any protection structure.

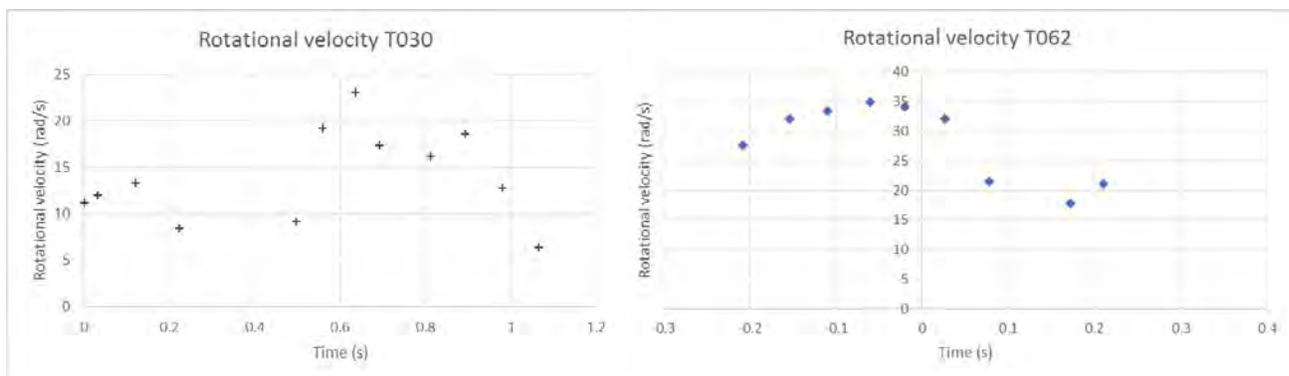
FIGURE 13 Angular speed (rad/sec) of block T030 (left) and T062 (right). Time of impact at T= 0s.

The video analysis was also applied to measure the block's angular velocity. This was achieved by tracking given face of the block and marking every 90° rotation in the software. The time stamp of these frames then allows the computation of the angular speed in rad/sec. Figure 13 illustrates the evolution of T030 and T062 from impact with mesh onwards. The angular velocity extracted from the video analysis could then be compared with the measurements made with the gyroscope measurement of the rock motion sensor (Figure 14).
