70TH HIGHWAY GEOLOGY SYMPOSIUM

“Better Highways Through Applied Geology”

October 21-24, 2019

2019 Proceedings

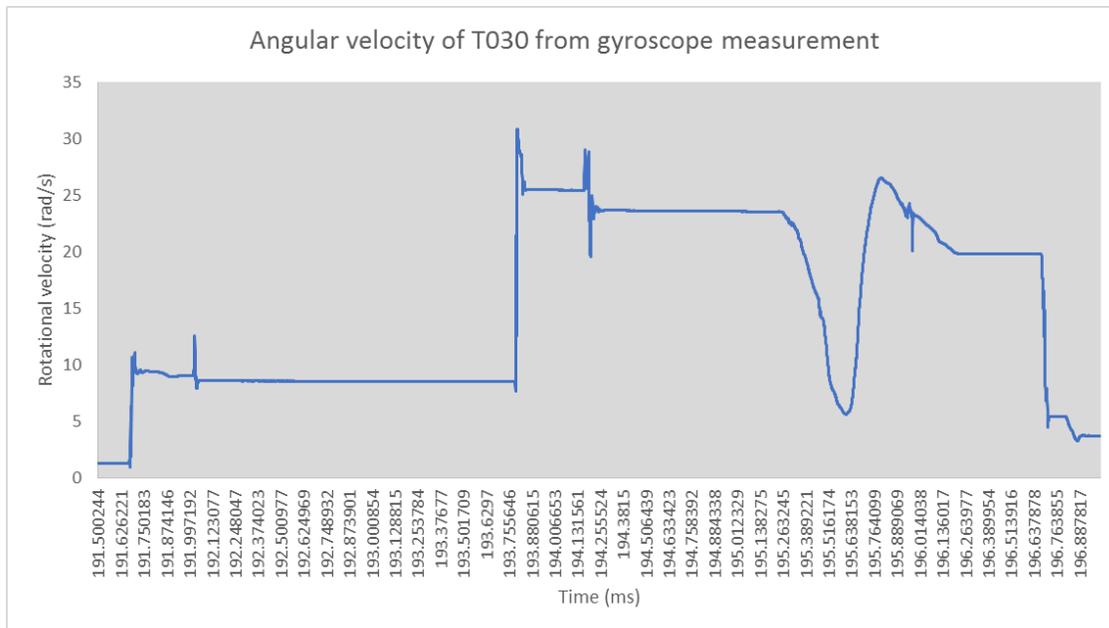
FIGURE 14 Plot of the three-axis gyroscope resultant positioned in the concrete blocks. Example of test T030. Angular velocity evolution ranges in the same order of magnitude then for the video analysis. Time of impact is $t = 195.2$ Ms.

The gyroscope measurement shows the same evolution of angular velocity to the video analysis results yield. Block T030 comes into the mesh with an initial rotation of approx. 10 rad/sec and 35 rad/sec, decreases and then increases again up towards 25 rad/sec before decreasing in steps (slightly visible as well on Figure 13) towards 0 eventually when reaching the ground. The T030 example shows well the problem with the sampling steps. Although the analysis of the video catches the trending rotation in freefall of 10 rad/sec, it misses the short acceleration before impact where the gyroscope indicates a velocity of 33 rad/sec (Figure 14). The left part of figure 13 and figure 15 show a similar evolution for test T062, therefore the angular velocities through video analysis seem to be coherent and the video analysis method can be applied when no rock motion sensor data is present.

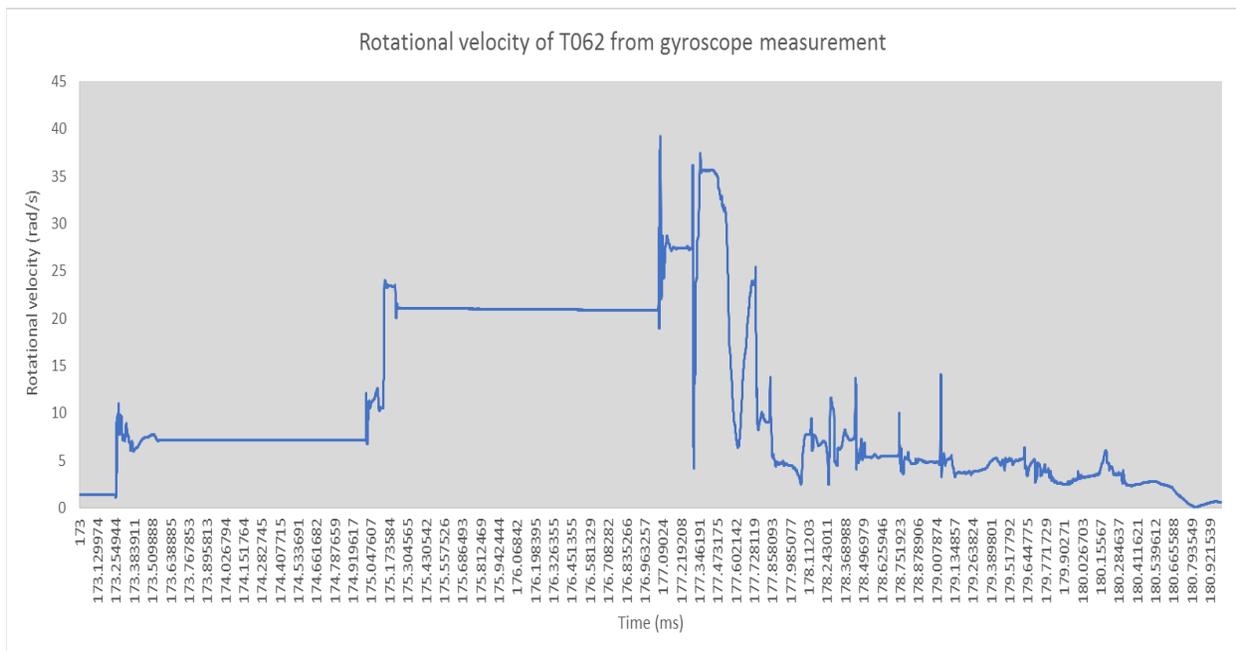
FIGURE 15 Plot of the three-axis gyroscope resultant, positioned in the concrete blocks. Example of test T062. Angular velocity evolution ranges in the same order of magnitude then for the video analysis. Time of impact at $t = 177.4$ ms

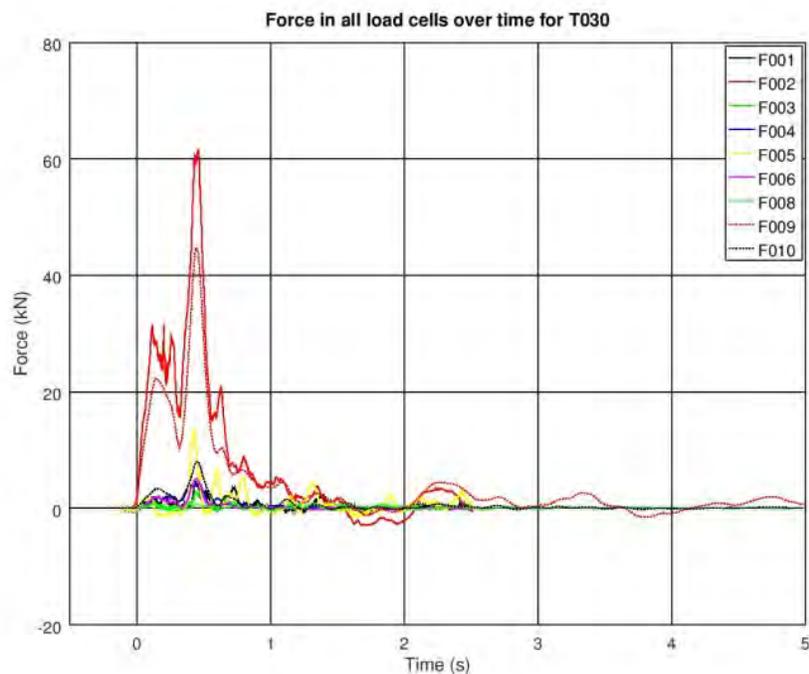
FIGURE 16 Two peaks recorded with load cells (F002 and F009 correspond to the top rope), t=0 corresponds to the time of impact.

First analysis of the load cell data captures well the classic behavior of attenuator systems (Figure 16). The first peak corresponds to the initial impact of the block with the mesh and the second peak corresponds to the peak torque generated as the friction between the attenuator netting and the rock causes a reversal of the rocks rotational direction while rolling along the mesh (time steps match between the load cell graph and the video analysis where the reversal in rotational direction is observed).

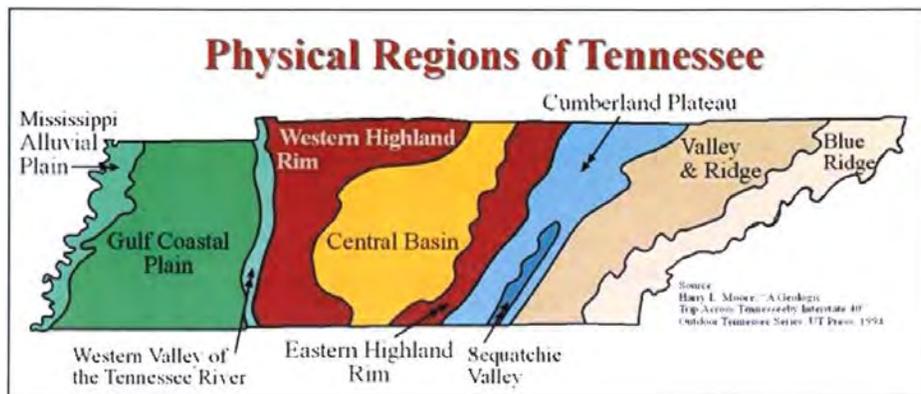
Figure 1: Geophysical Boundaries of Tennessee (Source, Harry L. Moore, “A Geologic Trip Across Tennessee Interstate 40”, *University of Tennessee Press*, 1994.)

Tennessee is often referred to as having three “grand divisions”, West, Middle, and East Tennessee (Hargett, 2018). Topographically however, Tennessee is divided into eight physiographic boundary regions (Miller R., 1974). Although precipitation records were set in West Tennessee in February 2019, the most severe slope movements occurred in Middle and East Tennessee, where the physiographic boundary regions Blue Ridge (Unaka), Valley and Ridge, Cumberland Plateau, Highland Rim, and Central Basin are located.

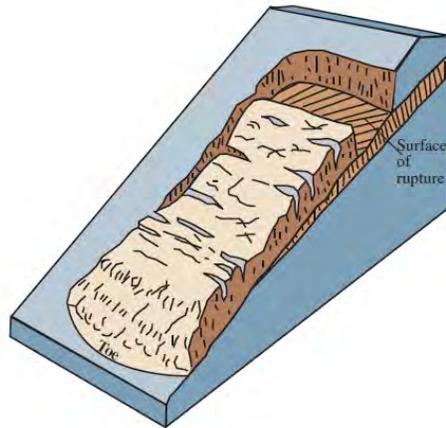
Figure 5: Translational Landslide (source Highland, 2004)

It is with certainty, the writer agrees with Royster (1978), in that the most common slope *movements* in Tennessee are best described as translational slides. And the material type is most often best described as debris in size. Shown below in Figure 5 is an image of a translational landslide.

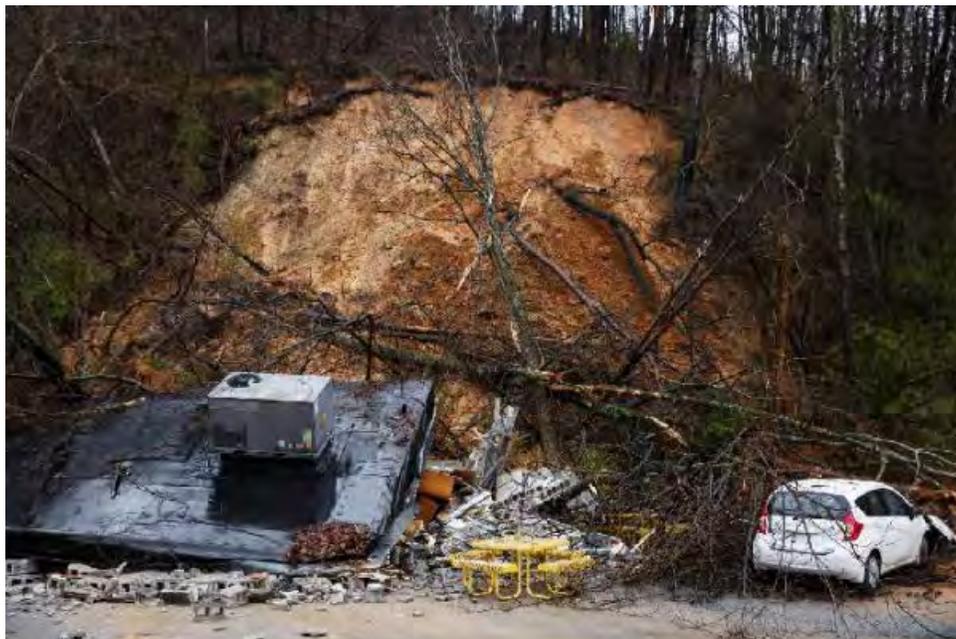
Figure 7: Landslide Destroys Sandwich Restaurant (source Chattanooga Times Free Press, Strickland, D.)

Example: Shown in Figure 6 is a roadside sandwich restaurant located in Chattanooga, TN along SR-8 (Signal Mtn. Road) at the foothill of a rather large ridge. The restaurant, destroyed by a landslide on February 23, 2019, would be best described by the Cruden and Varnes categorical method of landslide types, as an extremely rapid, translational, debris slide. The restaurant was closed, and there were no personal injuries reported, but the application for insurance coverage was denied (Pace, M., 2019).

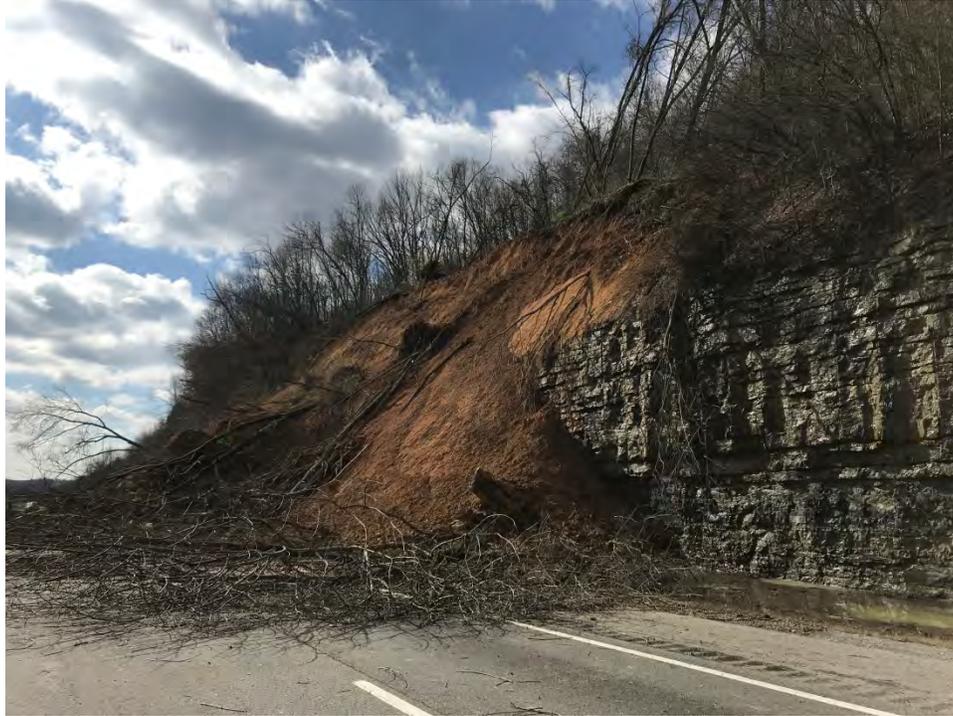
Figure 9: Looking southerly at I-24, Davidson Co. Debris-Slide, February 24, 2019 (source: Robert Jowers)

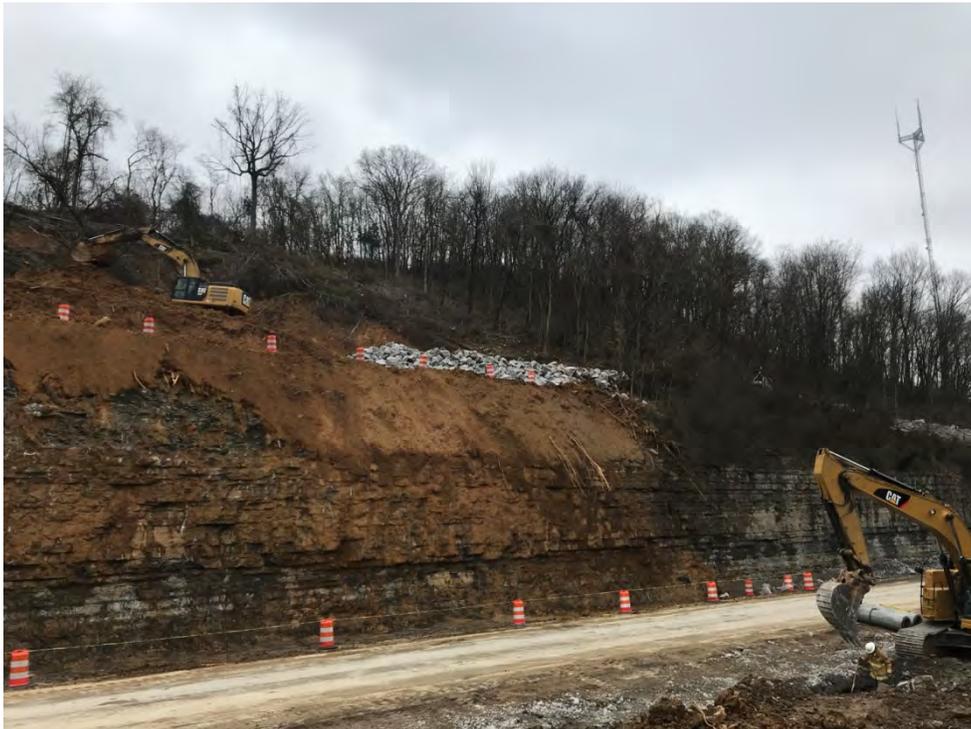
Figure 10: I-24, Davidson Co., Haul Road Being Built, late February, 2019 (Source: Hartman, J., TDOT)

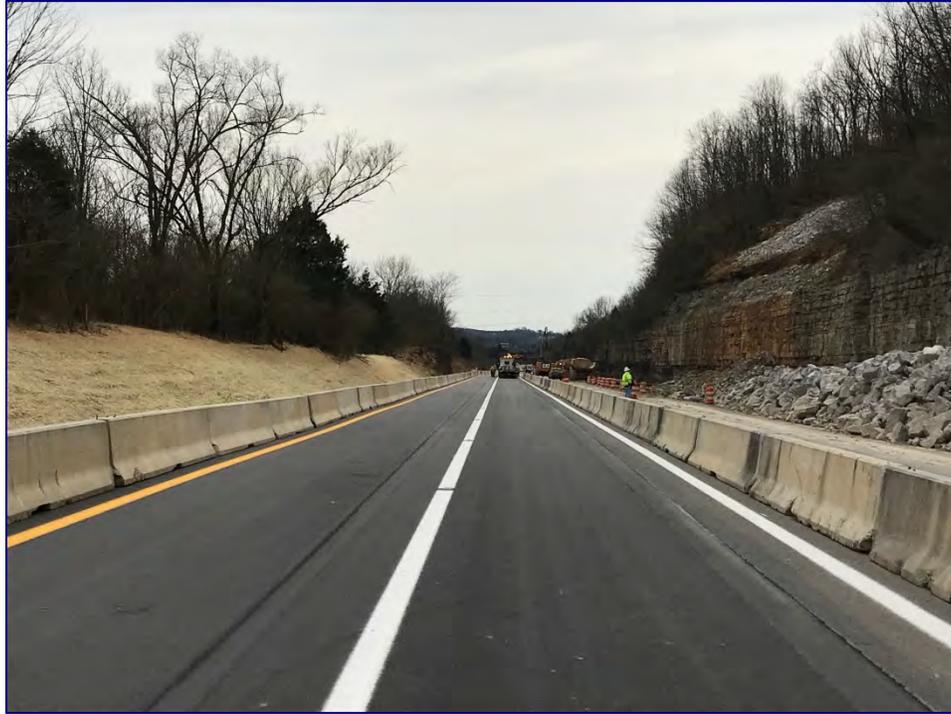
Figure 11: I-24, Davidson Co., Temporary Traffic Control lanes in Place 3/13/2019 (Source: Hartman, J., TDOT)

Sunday morning the author's team, roadway designers, TDOT leadership, surveyors, and a grading contractor met on site and made decisions on a plan necessary to get the interstate open again. The surveyors provided adequate ground information for the transportation engineers to design a temporary traffic control plan (TCP). The TCP consisted of grading work and pavement work necessary for a build out into the median to accommodate two southbound lanes of temporary travel. The interstate detour was unsafe and time consuming, so it was with great relief that the emergency traffic control plan opened to traffic on March 13, 2019.

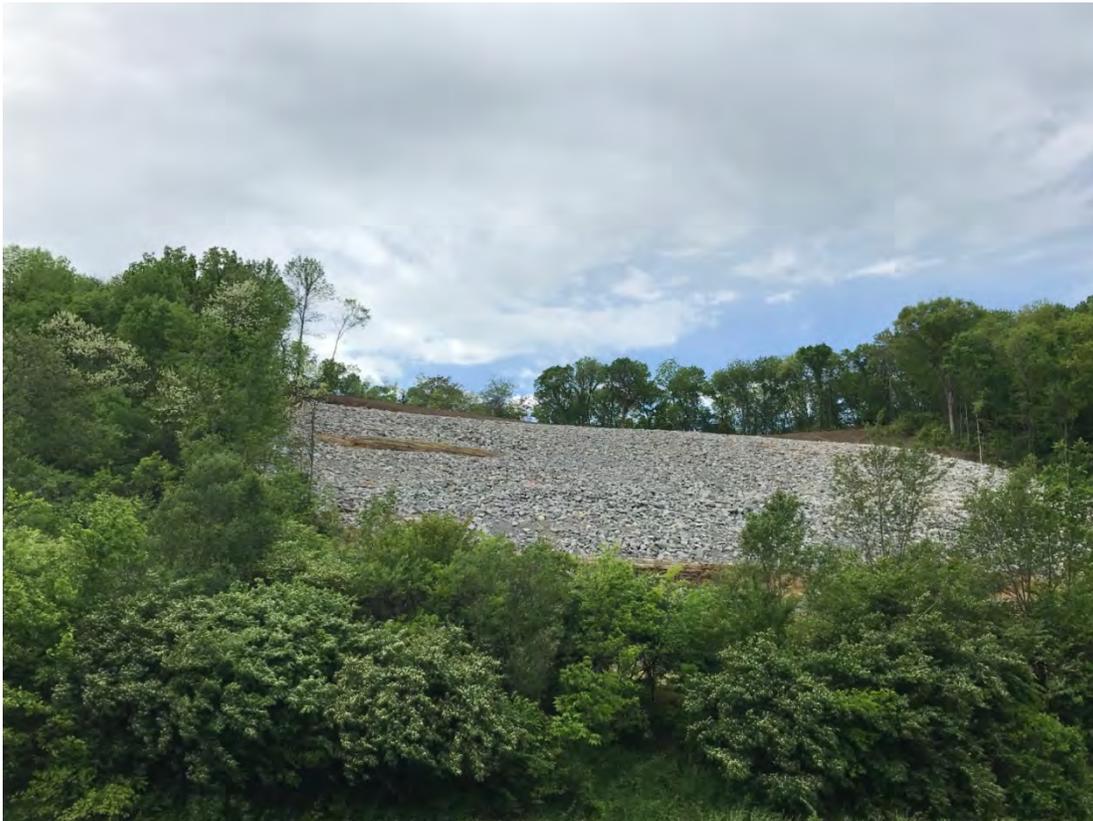
Figure 12: I-24, Davidson Co., Buttress in Place 4/30/2019 (Source: Hartman, J., TDOT)

The stabilization effort involved removing the slide material entirely, from the interstate and also the slope, and then restraining the slide with a graded rock buttress. The buttress was completed April 27, 2019.

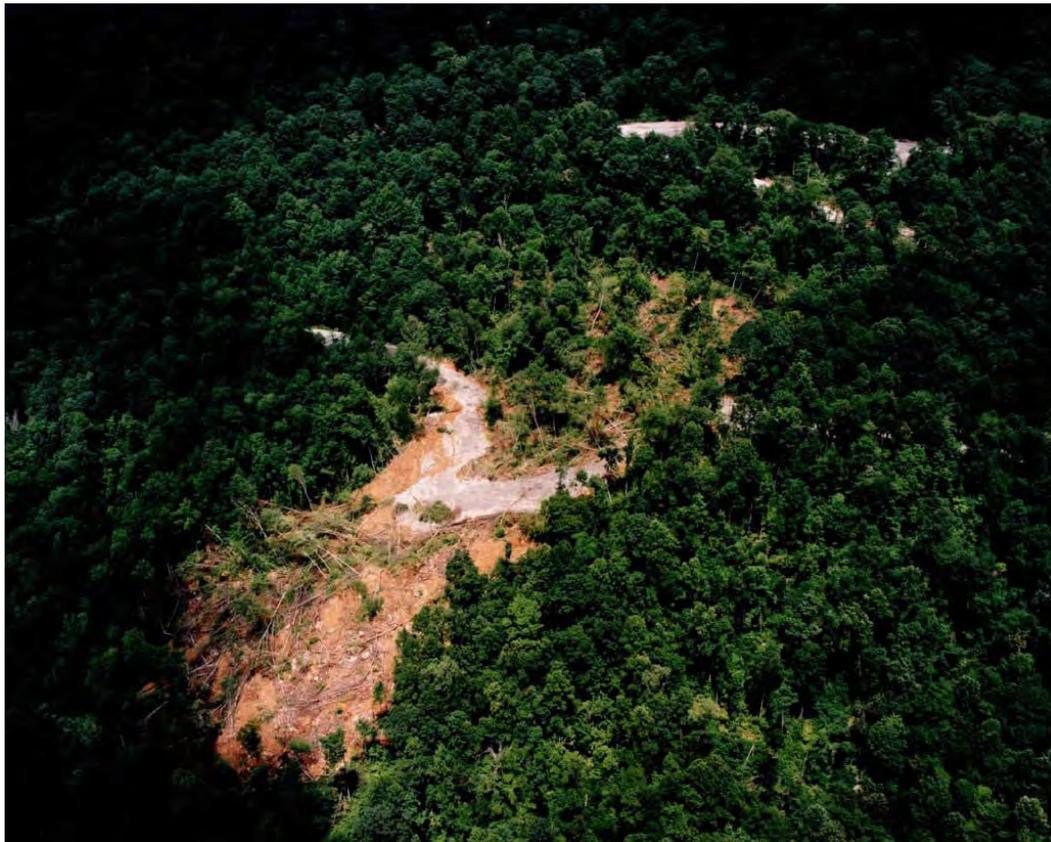
Figure 13: SR-85, Overton Co.- Slide in late 90’s, 6/15/1999 (Source: Hornal, G., TDOT)

The subject landslide was first reported in 1998, to the author’s knowledge, but is assuredly ancient and has been sliding in terms of recent geologic time. Several mitigation proposals for slide stabilization were presented in 1998 including a graded solid rock buttress, but due to cost and relatively low traffic count, an option of re-grading, re-paving, and observation was selected. The movement was arrested, likely because the slide had reached a new driving forces/resisting forces equilibrium, and for a period of about twenty years the road was relatively stable, moving only following during intense precipitation.

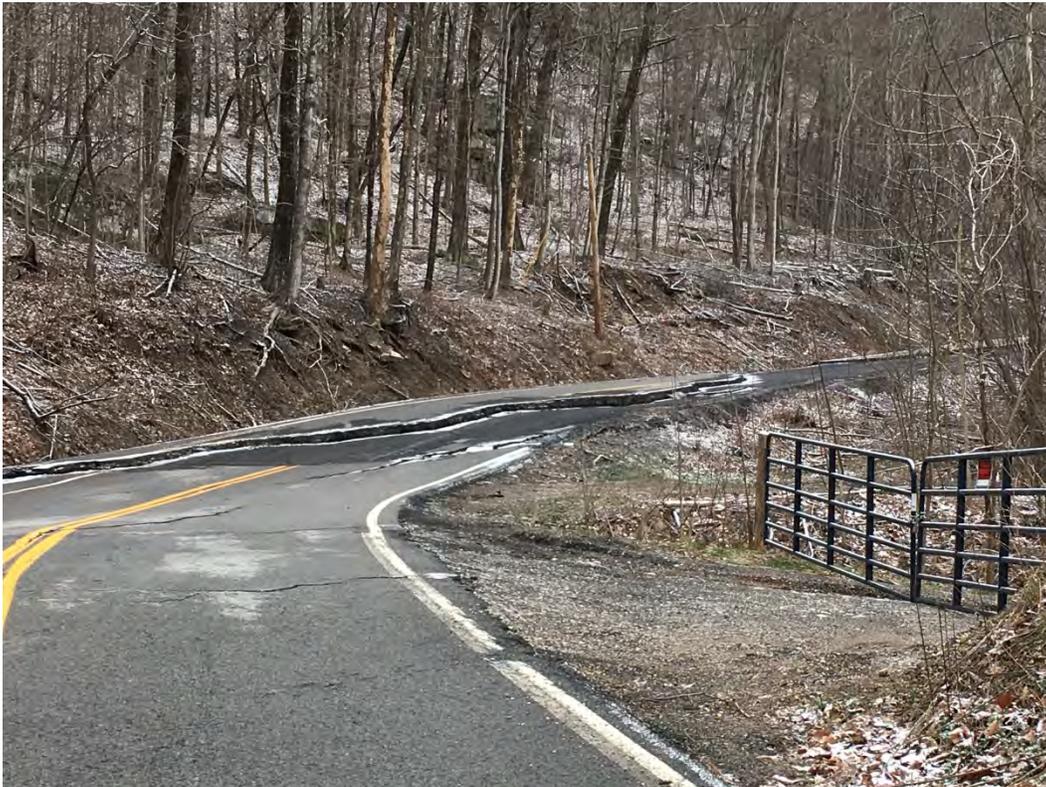
Figure 13: SR-85, Overton Co.- Slow moving, Debris-Slide 3-4-2019 (Source: Williams, S., TDOT)

The landslide was triggered by the February 2019 intense flooding and became active again. The road had to be closed and a time consuming detour of over fifty miles was posted. Plans were rapidly developed to mitigate the slide and reopen SR-85. The plans included reducing the pore pressures through installation of horizontal drains, and resisting the slope movement with construction of a rock buttress. Several smaller individual landslides along SR-85 in Overton Co. and Fentress Co. were also stabilized with concurrently in the contract using stabilization techniques that included reticulated micropiles, soil nails, and mechanically stabilized earth / geosynthetically reinforced soil.

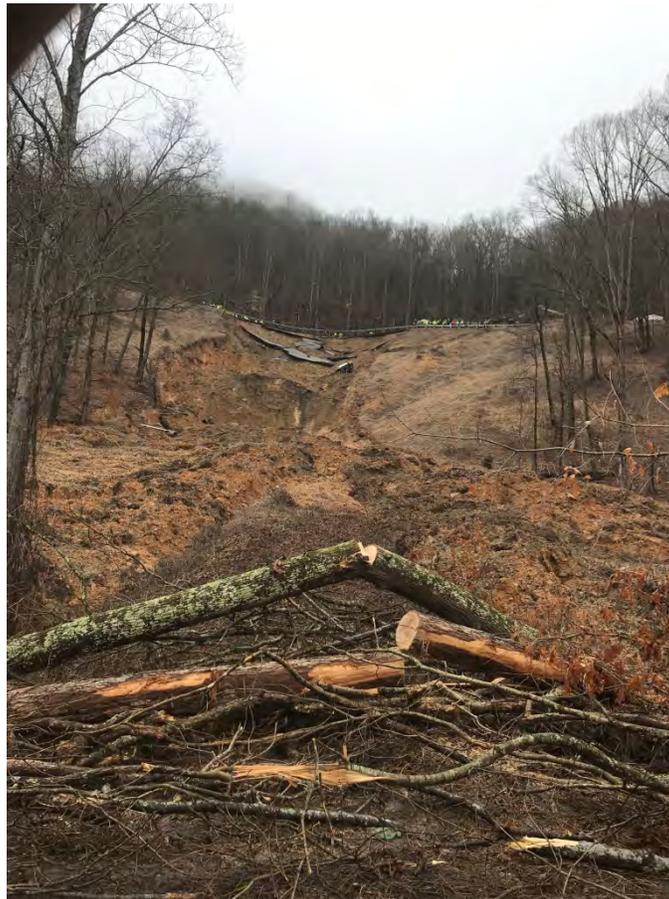
Figure 12: SR-70, Hawkins Co. Devastating Debris-Slide 2/21/2019 (Source: Robert Jowers, TDOT)

The stabilization application involved restraining a temporary slope face from the roadway surface downward. The temporary slope was temporarily soil nailed using a pinned geofabric\wire mesh face. With a stable temporary slope in place, a graded rock buttress could be installed. The project construction is still underway. During excavation, adversely dipping rock was encountered, and that appears to be the failure plane along which the colluvium slid.

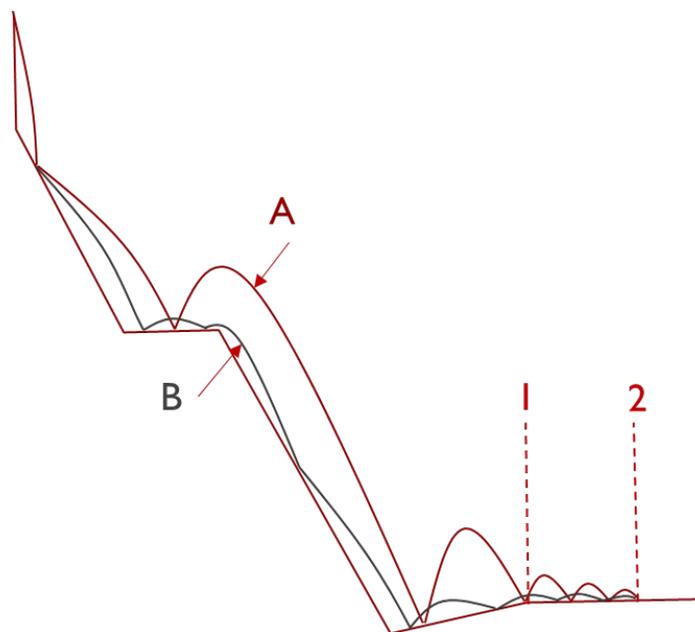
Figure 1. Two potential trajectories (A and B) with similar bounce height and velocity at points 1 and 2.

A valid rockfall model will need to satisfy these observations and generally appear to provide a reasonable result to someone who has observed rockfall. Figure 1 shows two hypothetical rockfall trajectories. Trajectory A may be appropriate for falling basketballs, but trajectory B looks more like rockfall observations. Note that at Points 1 and 2, both trajectories will have similar bounce heights and velocities. Qualitative comparison between the simulation and experience should be the first validation test that any simulation must meet.

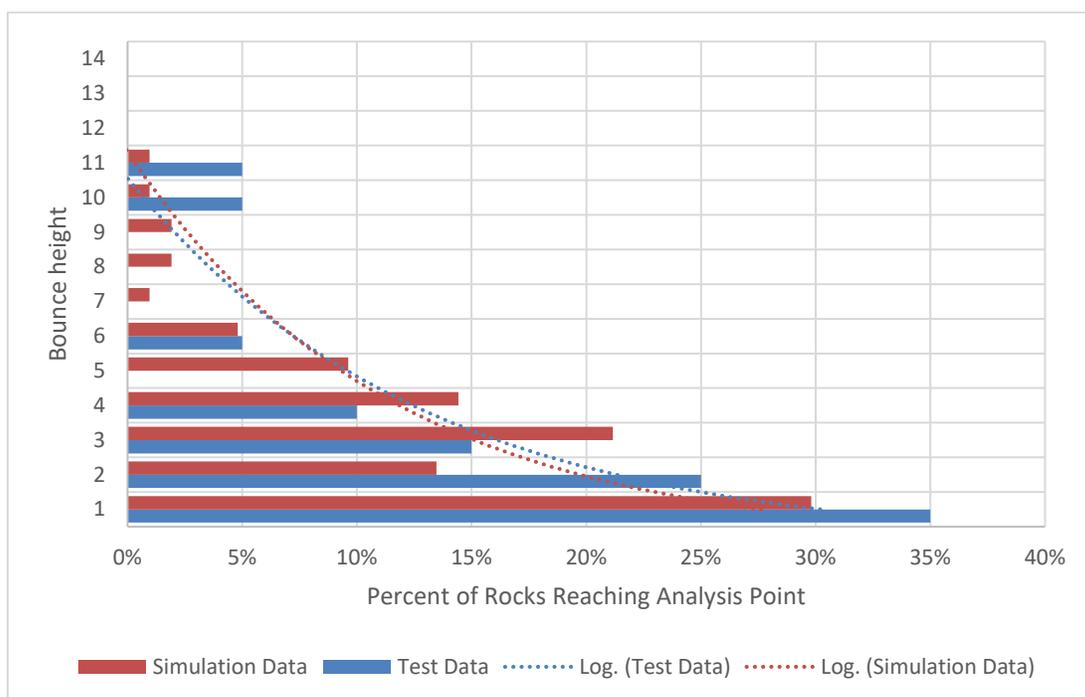
Figure 2. Comparison of bounce height from rockfall simulation data and field test results.

During the development of the Colorado Rockfall Simulation Program, the Colorado Highway Department rolled rocks down a 320-foot high by 400-foot long slope near Rifle, Colorado. Bounce height data was collected at two points on the sparsely vegetated slope. Figure 2 provides a histogram of the bounce height from the field testing and from the simulation model using the Colorado Rockfall Simulation Program. While there is substantial variation between the experimental data and the simulation data, the log trend lines appear similar. The simulation trend line shows higher bounce heights at low probability (5). This over estimation is an intentional conservative bias for software intended to be used in the design of mitigation features. However, this feature may be misleading if applied to risk analysis at low probabilities.

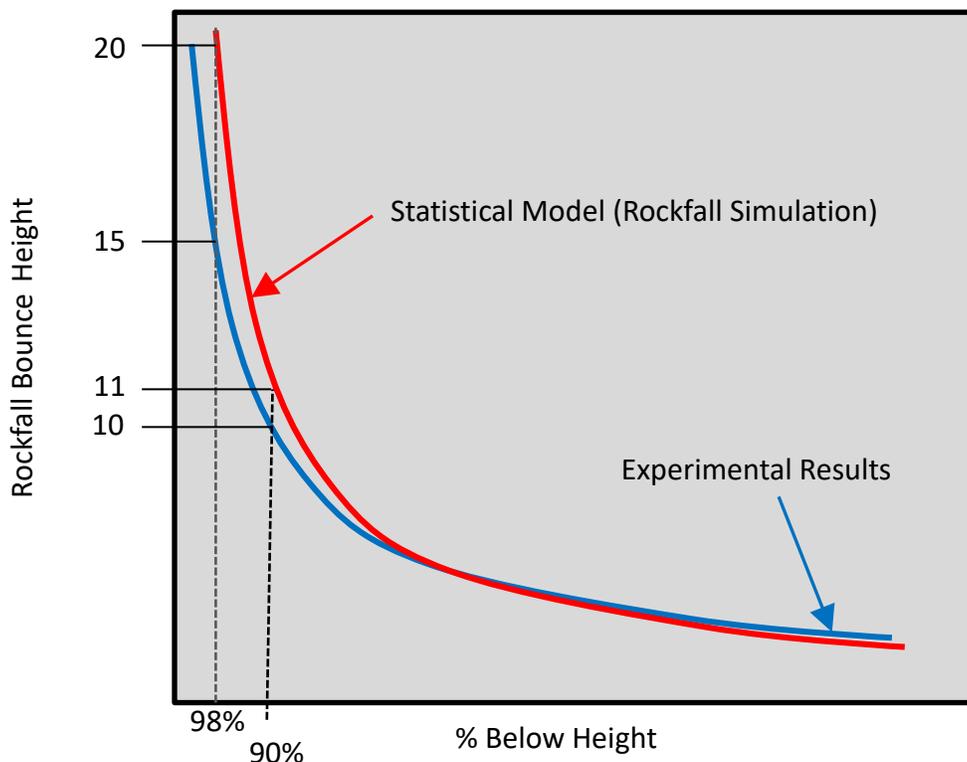
Figure 3. Comparison of bias for a log-normal distribution at low probability.

In the example above, the slope geometry limited the maximum bounce height. At a taller or steeper site, the impact of the log-normal bounce height distribution may be far more pronounced. Figure 3 illustrates how the conservative bias provides an 11-foot bounce height at 95% probability compared to a 10-foot experimental bounce height. However, the simulation

bounce height at 98% probability is 20 feet compared to an experimental value that may be 15 feet. While the 20-foot bounce height may be possible, it likely represents far less than 2% of rockfall at the site and may provide misleading statistics if used in a risk analysis.

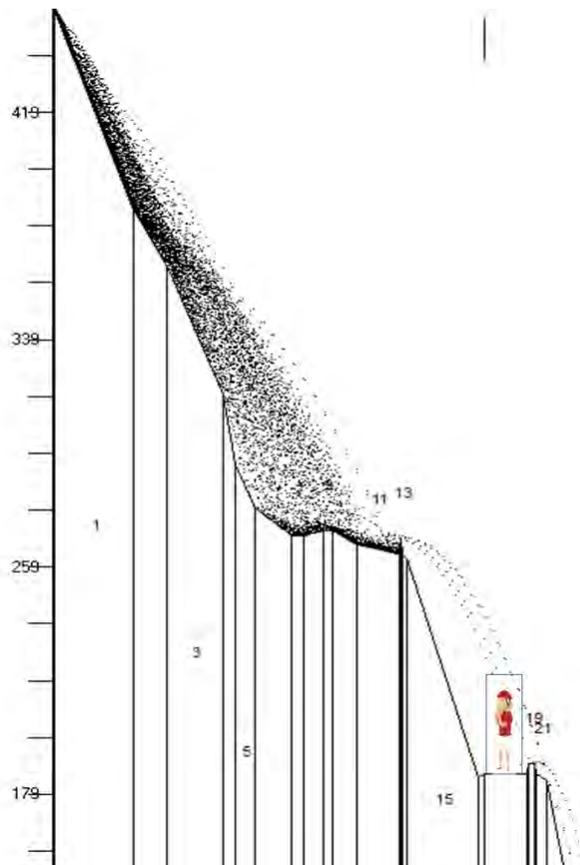
Figure 4. Simulated rockfall trajectories for a site where the annual risk to all users is calculated to be between 5×10^{-5} and 3×10^{-8} and the individual risk is between 6×10^{-10} and 3×10^{-13} .

Presentation of rockfall simulation results may inadvertently encourage misperception of rockfall risk. A figure showing the potential trajectory of rockfall impacting a site will tend to be perceived as a dangerous condition. However, an expert analysis may show the rock trajectory is a very rare event and the probability of impact and injury is very low. Figure 4 shows the trajectory of 1,000 simulated rockfall events. The caption states that the individual risk is

calculated to be between 6×10^{-10} and 3×10^{-13} per year and the annual risk to all users is between 5×10^{-5} and 3×10^{-8} . However, the figure clearly shows someone getting hit by a rock. Considering personal risk assessment is primarily an emotional reaction, a picture of someone getting hit by a rock likely has far greater impact on the perception of risk than the scientific notation in the caption.

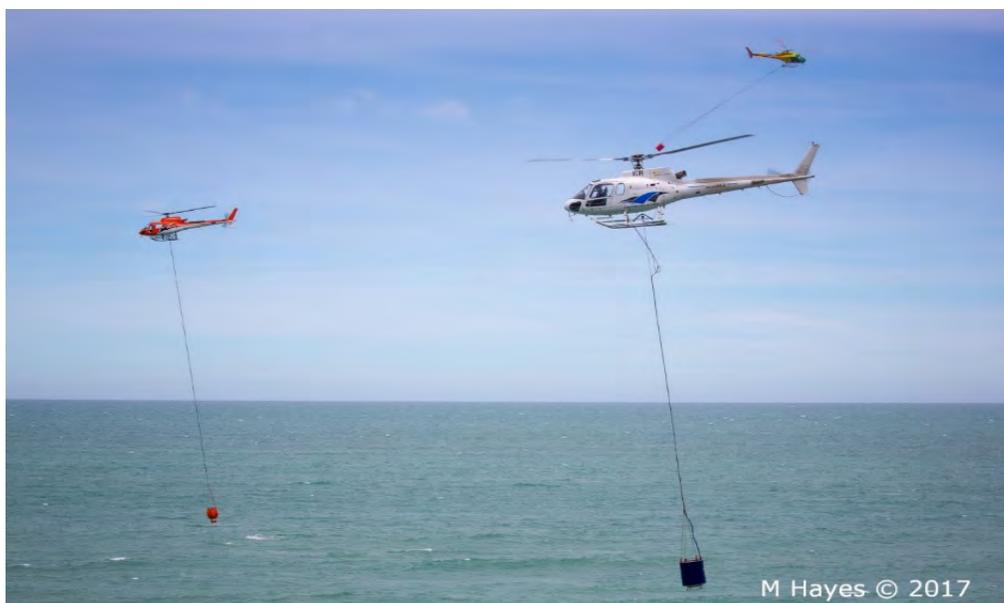
Figure 1: Kaikoura heli-sluicing operations - www.matthayes.co.nz

Heli-sluicing was quickly identified as the most appropriate primary means of treating the slopes while the ground shaking activity subsided; this would also allow time to consider more direct, permanent treatment options. Heli-sluicing involves the use of helicopters fitted with firefighting 'monsoon' buckets dropping around 1000 litres of water at a time directly onto the slope. In the case of Kaikoura, the buckets were filled from the ocean and water washed onto the slopes in a targeted manner. Geotechnical engineers monitored the sluicing operations directing the helicopter pilots to target areas.

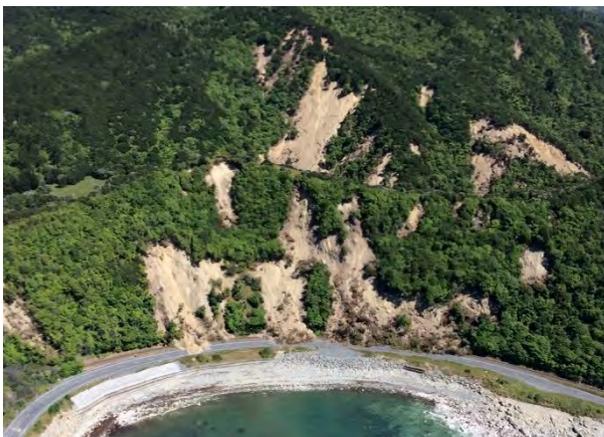
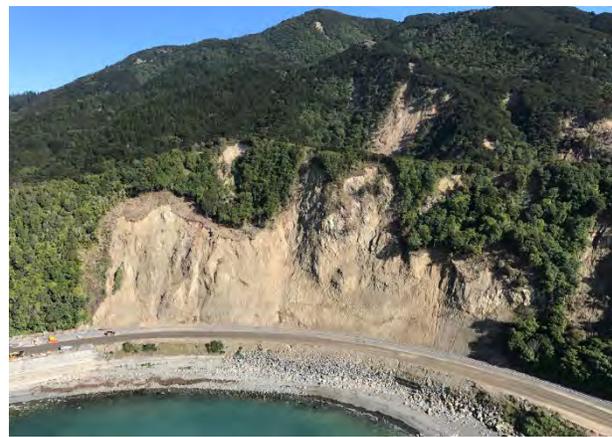
Figure 2: Before and after extensive heli-sluicing (and some earthworks) on Slip 3 North

After some weeks of heli-sluicing, several of the sites were able to be treated through more traditional manual scaling operations using geotechnical rope access techniques. The slopes were treated from the top down with scaling work focused on the head scarp area of the failures. This was to reduce the risk to the geotechnical rope access technicians by limiting their exposure to rockfall further down the slopes, while still managing to create safer work areas at the base of the slopes for protected machinery to operate.

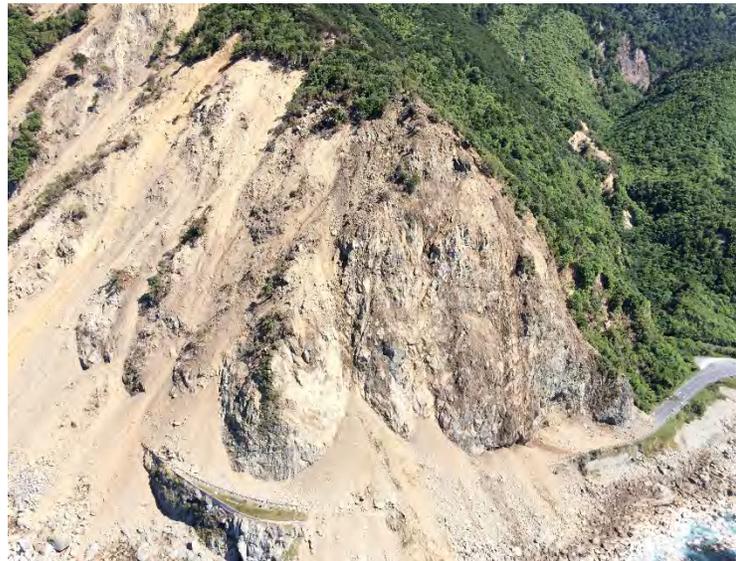
Figure 3: Ohau Point, December 2016 (photo courtesy Opus)

Following Christmas of 2016, the focus moved onto designing and constructing more permanent stabilization solutions, as well as focusing on reopening the road in the northern zone (SH1 north of Kaikoura). The first durable design, for Slip 6 North Ohau Point, was released to invited tenderers in February 2017. This site was identified as the largest, most hazardous site on the network, and a potential choke point for rebuilding the road north of Kaikoura; due to its sheer size, the significant area requiring treatment, and the high degree of exposure from out-sized rockfall.

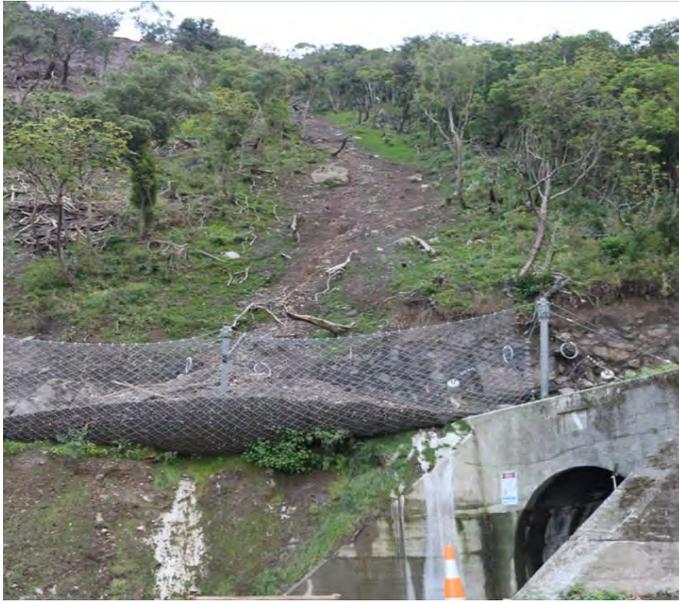
Figure 4: Rockfall barrier adjacent Raramai Tunnels

In addition to the slope treatments, extensive rockfall and debris flow barrier installations were completed in the south with several long, moderate capacity (2000 to 3000 kJ) systems planned for construction in the north zone during 2018. The majority of the systems have been installed at or slightly above road level which reduced installation time and costs. In areas where space was available, rockfall and debris flow bunds were constructed. All these systems have already been proven effective with several requiring emptying and repair following recent (early 2018) rainfall-triggered slope failures. At these specific sites, no material reached the highway.

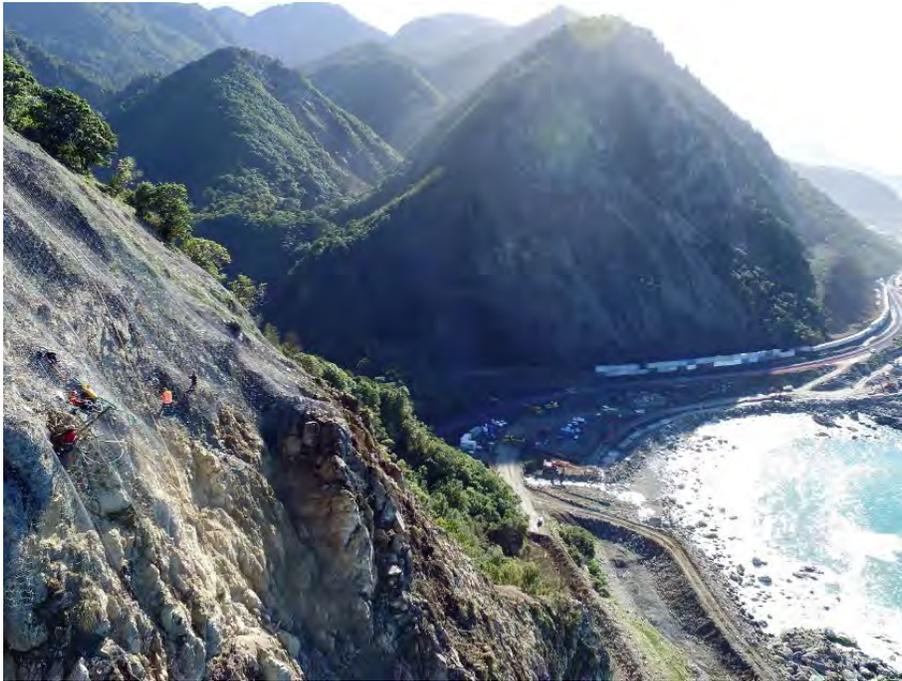
Figure 6: Installing the drape on Ohau Point

While in many situations the original high tensile mesh could be installed to act as a drape and no further work would be required, the large size of potential rock failures behind the mesh at Ohau would have risked compromising a high tensile system. The ring net was chosen to protect against more significant potential failures, with the high tensile secondary mesh installed to contain the smaller material. A 6-on-1 ring net was chosen as it maintains its width when lifted (i.e., doesn't choke in the middle) – which is critical when installation is conducted via helicopter. The ring net was installed first as it conforms to the slope better than the high tensile mesh. At the completion of the drape, the pattern bolts of the original design were installed directly through the drape with all components (ring net and high tensile mesh) which completed the permanent system.

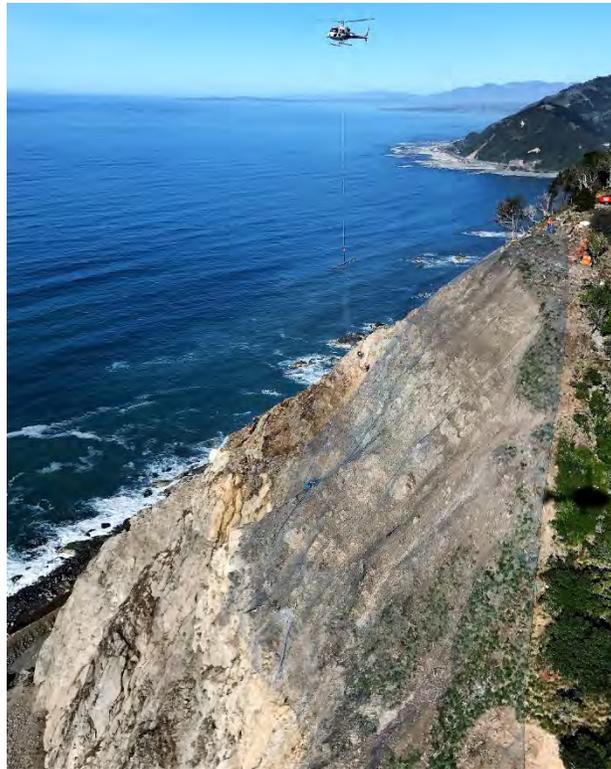
Figure 7: Installing the drape on Ohau Point

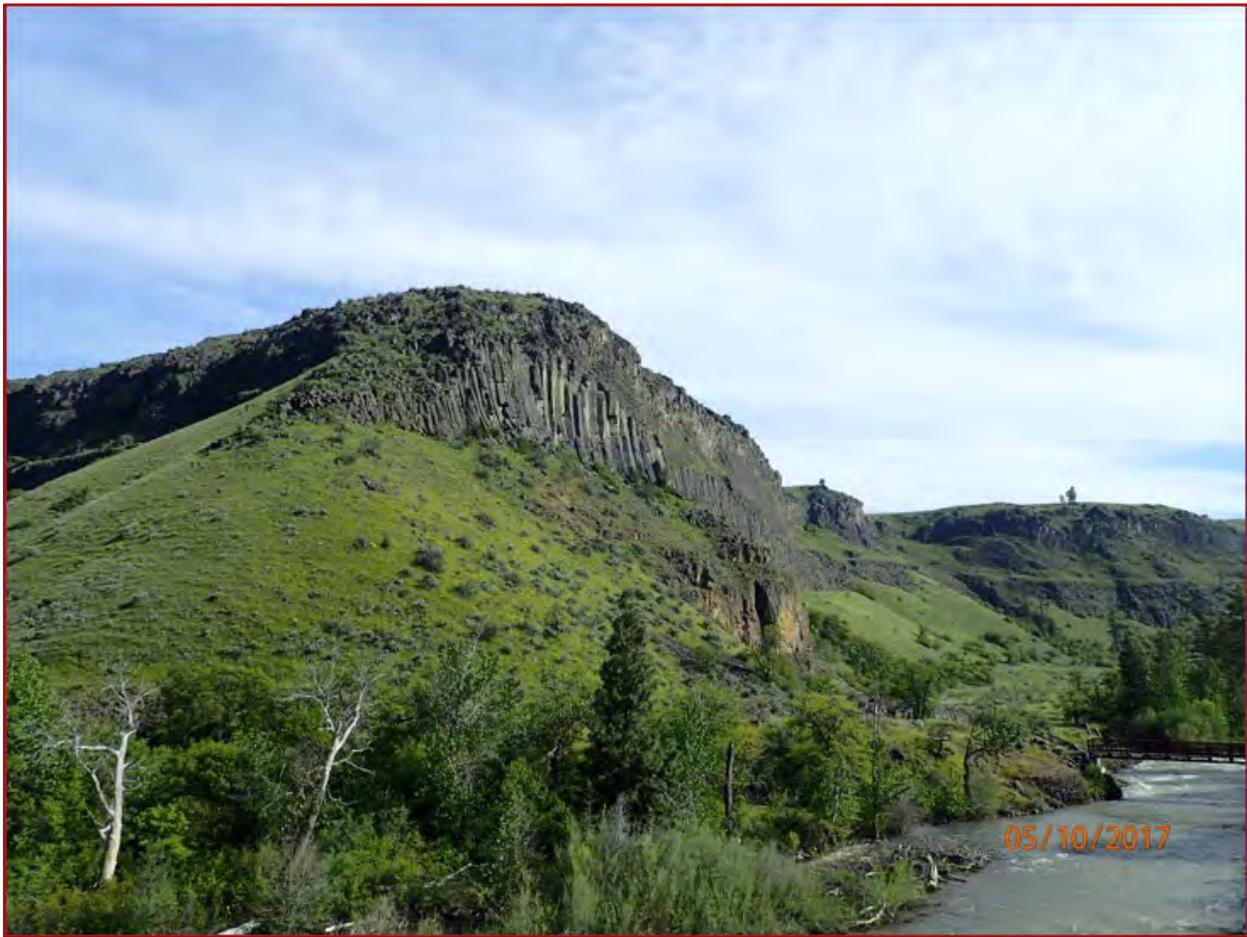
Figure 2 – The Tieton andesite rims the Tieton River canyon in many locations; because of the columnar structure, the local rimrock was named Royal Columns. This is a very popular rock climbing area in Eastern Washington. The Tieton River in the foreground.

Royal Columns are part of the natural rimrock which borders the Tieton River at many locations along SR-12. The rock units are part of the Tieton andesite volcanic flows which cooled approximately one million years ago (1). Gusey and others (2) have postulated based on age dating that the Tieton andesites erupted from vents at Bear Creek Mountain near the core of the extinct Goat Rocks volcanic complex in the Cascade Mountains south of White Pass, WA; about 40 miles west and up river from the Royal Columns. In addition, the authors have suggested that this volcanic unit may be the longest know andesite flow in the world (2). The Tieton andesite is well known for its remarkable examples of columnar jointing. Royal Columns (Figure 2) is a great example where the rimrock forms clean classic sub-vertical columnar joints or colonnades that crop out above the river and US-12. Rockfall from the unstable columns is a common problem along US-12.

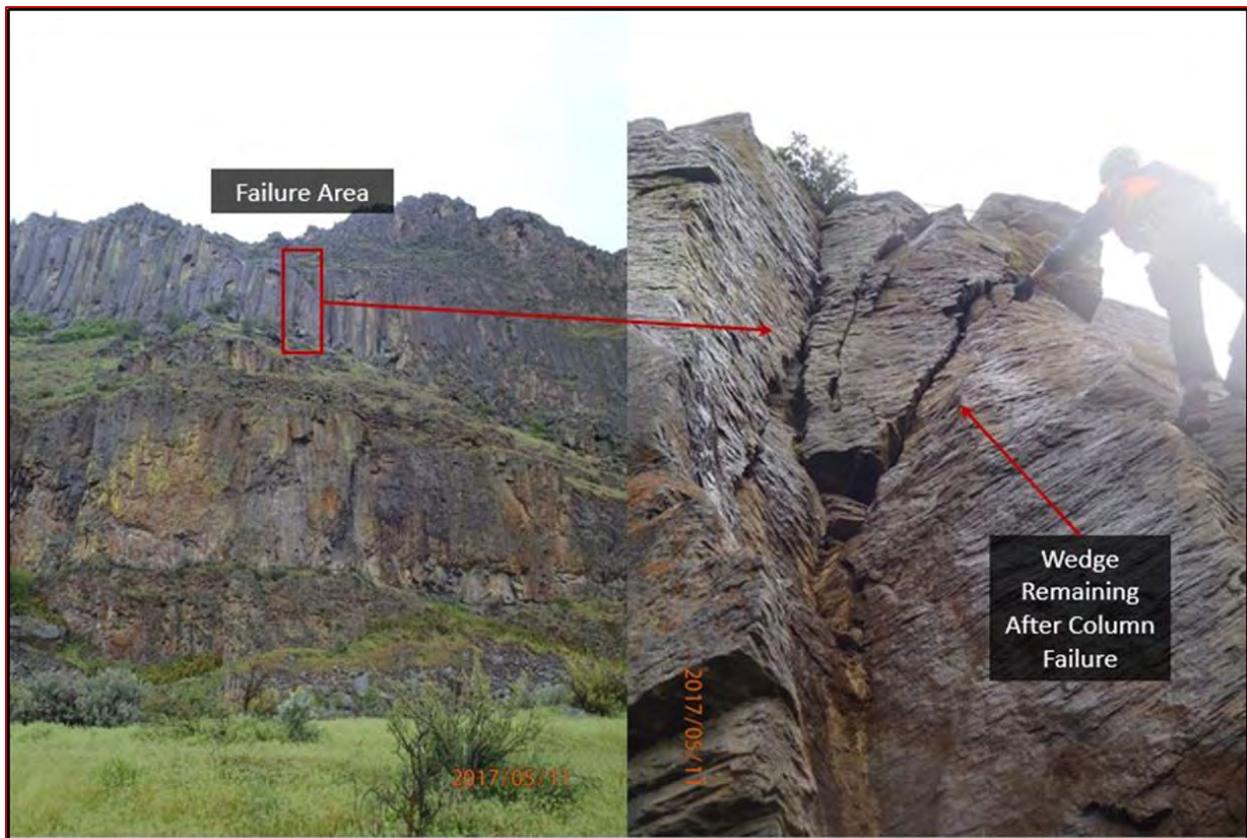
Figure 3 – Photo on left identifies the present source area for the rockfall. The photo on the right shows one of the remaining andesite wedges after the column collapsed.

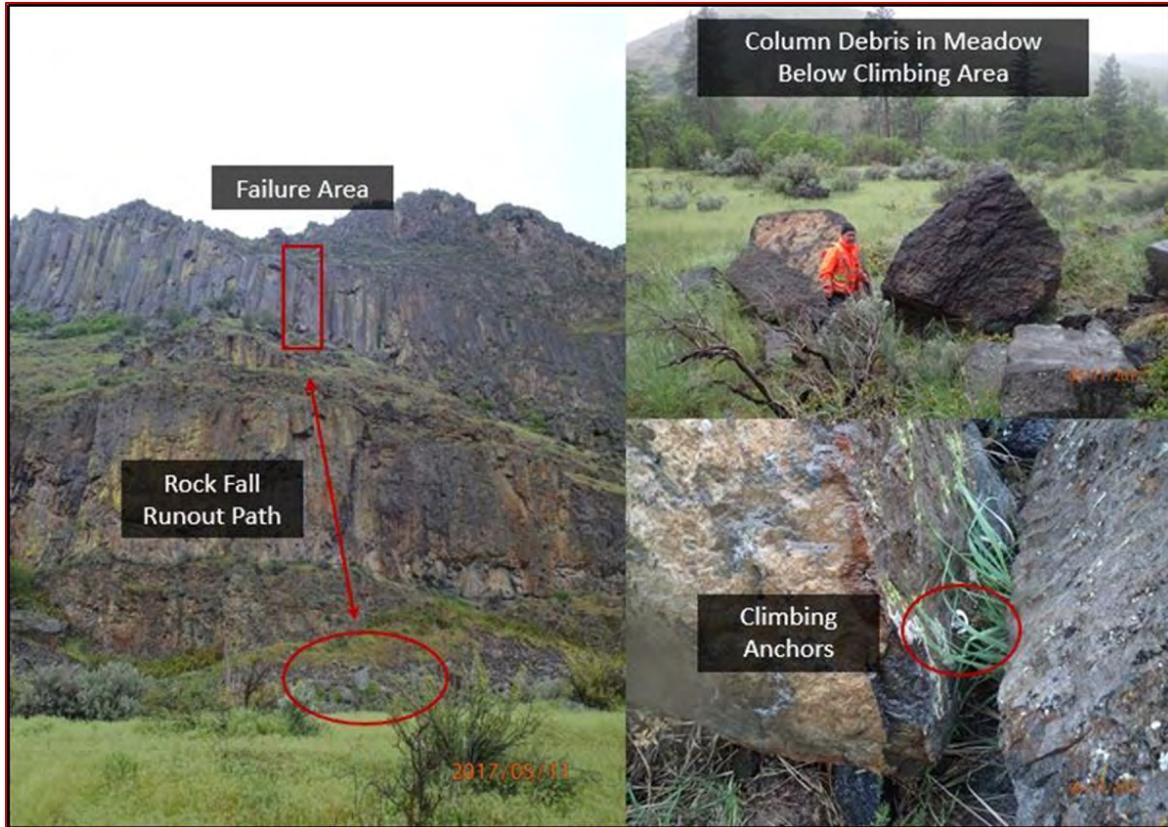
Figure 4 - Failure area and rockfall runout path. Note size of blocks and climbing anchors (rock bolt hangers).

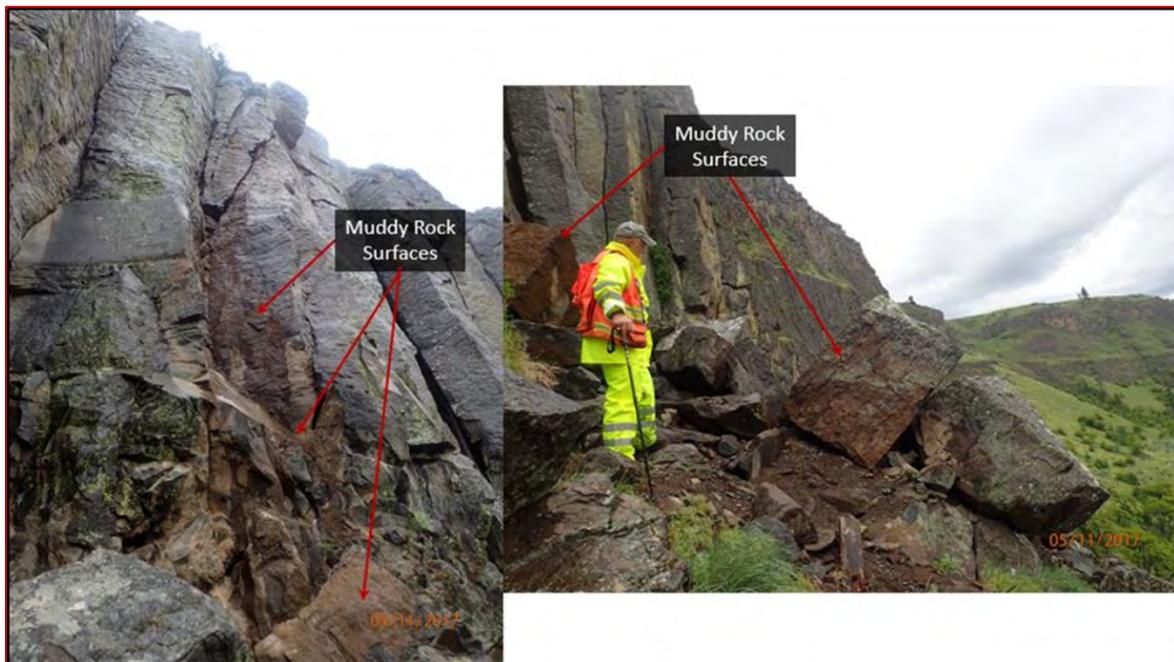
Figure 5 – Bill Gates inspecting muddy surfaces on rock blocks linking detached blocks to failure area.

The authors mobilized to the Royal Columns climbing area in the Oak Creek Wildlife area Thursday May 11th of 2017 and met with WDFW to discuss the scope of the project. WDFW discussed the events leading up to the column failure, including interactions with a climber who frequented the area, who had been tracking the opening tension fracture behind the column before the block collapsed. Rock blocks from the column collapse were deposited between the toe of the slope and the meadow below (Figures 3 & 4). Blocks as large 7-CY were observed to have fresh broken and muddy surfaces suggesting they originated from the column failure (Figure 5).
