70TH HIGHWAY GEOLOGY SYMPOSIUM

“Better Highways Through Applied Geology”

October 21-24, 2019

2019 Proceedings

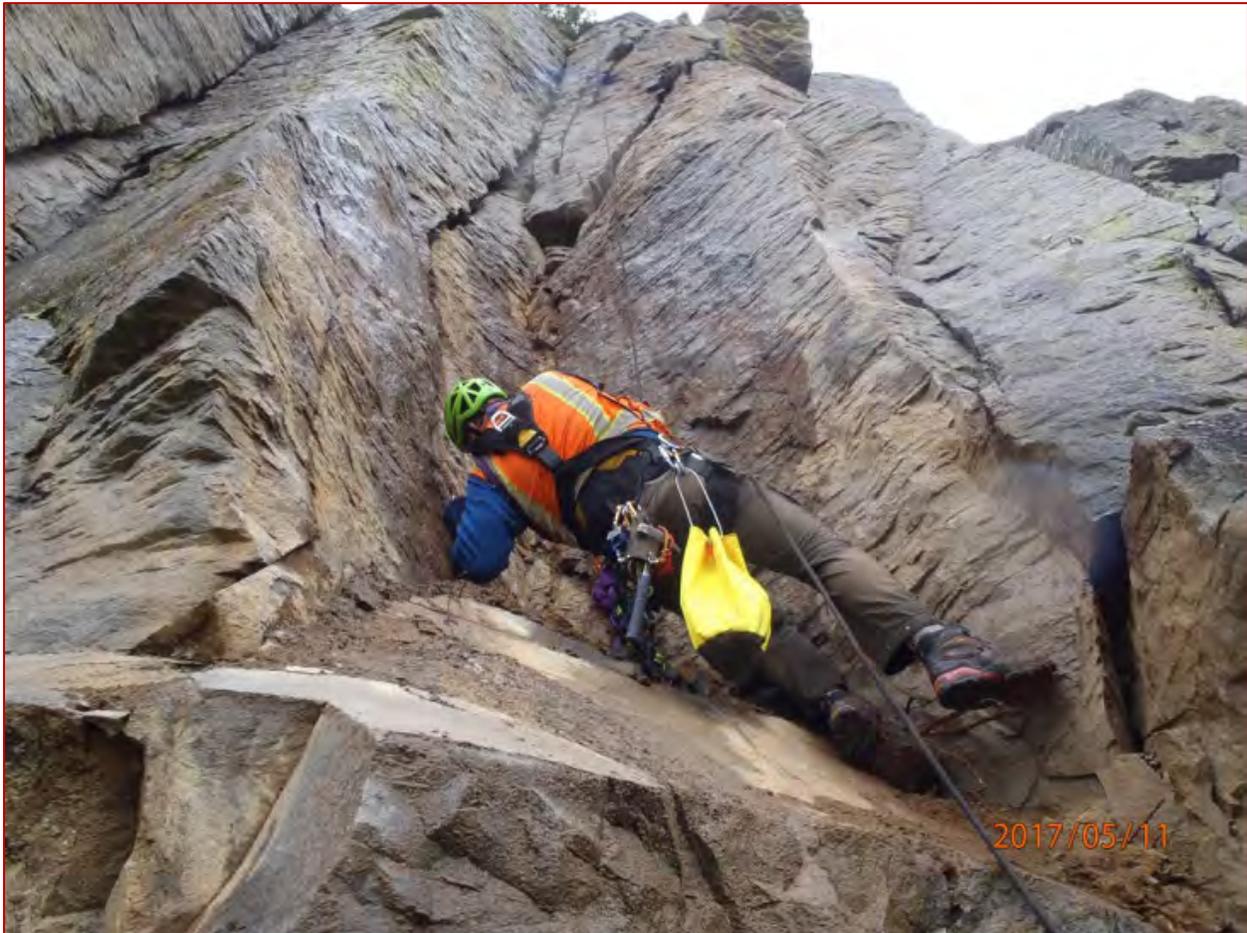
Figure 6 – Dale Moore using rope access techniques to characterize the engineering geology and structure.

To evaluate the rock mass geology where the rockfall event occurred; the authors rigged a rappel line above the failed column and conducted a vertical scan line by rope access techniques to characterize the engineering geology (Figure 6).

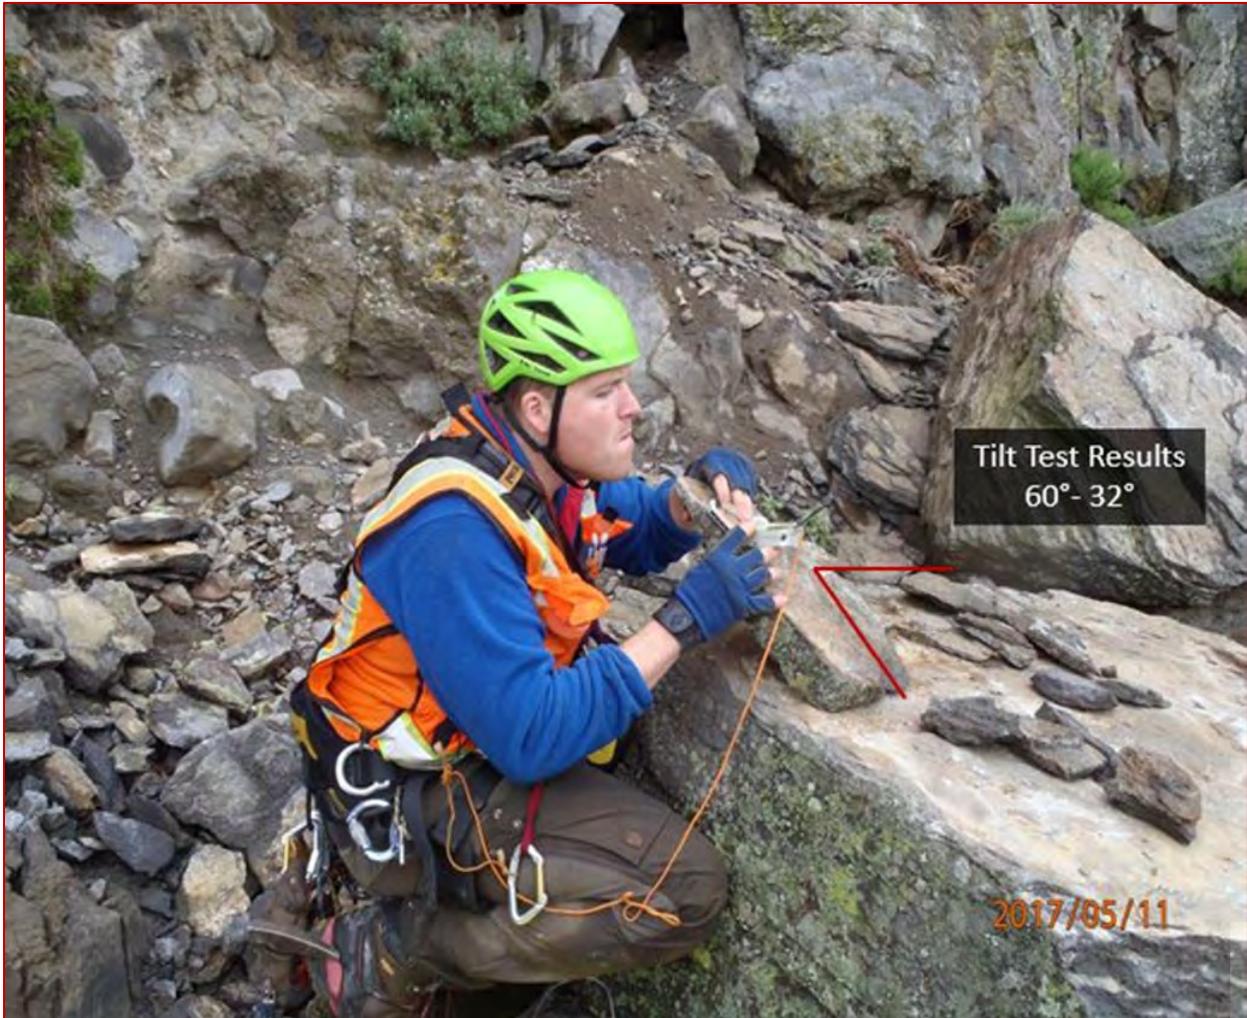
Figure 7 – Dale conducting tilt tests of matching rock clasts to estimate peak friction.

To estimate peak friction of the rock blocks, the authors completed ten separate tilt tests described by Kliche (10) (Figure 7). The highest and lowest peak friction values (60° and 32°) were removed from the data set and the average of the remaining data was assumed to be the peak friction angle, 40°.

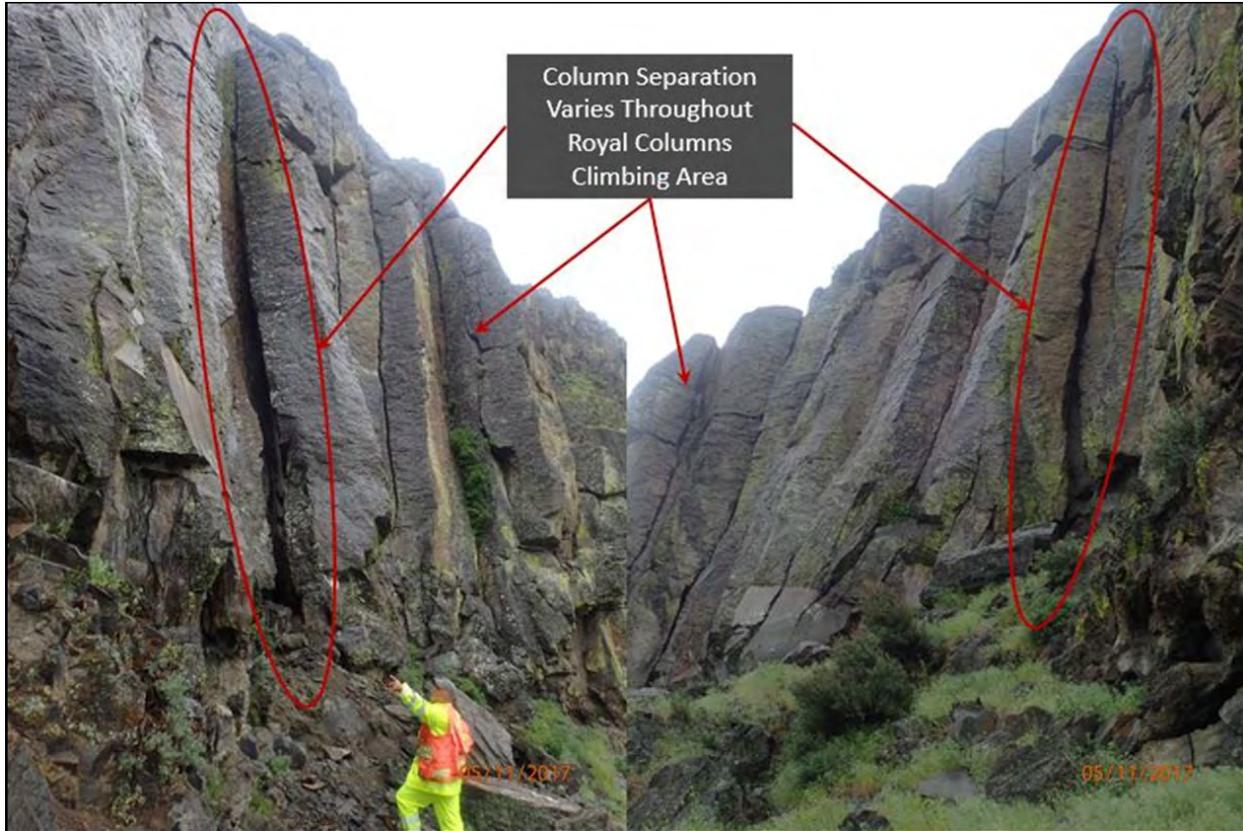
Figure 8 – Gates observing variable aperture widths between rock columns.

Rockfall occurs routinely from the Royal Columns as evidenced by talus deposits at the base of the columns and on the east side of the meadow below the climbing area. Column separation varies between 1 to 12 inches (Figure 8) along the length of the climbing area.

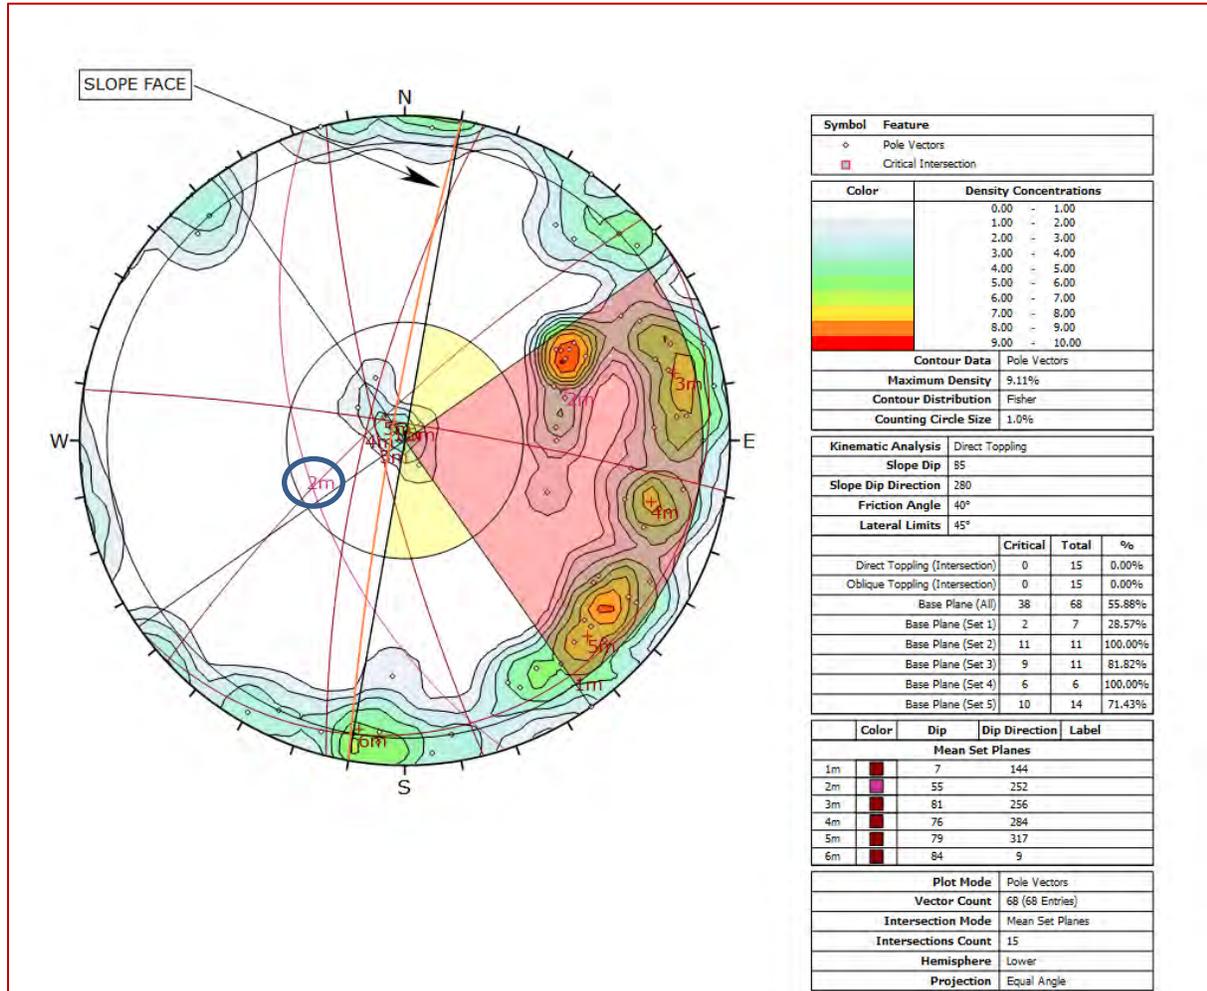
Figure 9 – Stereonet displaying kinematic analysis of direct toppling rock block failure, Joint set 2 is the basal plane on which the block failed. The joint faces of the neighboring columns intersect forming sub-vertical arms of unique wedges sitting on the basal plane. This column failed by sliding on the basal plane then transitioning into direct toppling.

The results of the Markland analysis show the columnar andesite at the Royal Columns is most likely to fail by direct toppling. In addition, observations in the field indicated an inclined basal plane of 55° (Figures 9 & 10) which further exacerbated the column instability by allowing the columns to slide on the basal plane in a wedge like fashion or special type of planar failure then topple. Of interest, the new Version 6 of Swedge[®] by RocScience[®] (12) allows the investigator to analyze the basal plane of a wedge. In this case, the arms of the wedge are sub-vertical (Joint sets 3 & 6) and the intersection lies on the basal plane (Joint set 2) which dips out of slope and exceeds the friction angle. Furthermore, for sliding and toppling to happen, the

following conditions were met. The dip of the basal plane exceeded friction ($55^\circ > 40^\circ$) and the ratio of the base width of the column to the height (b/h) was less than the tangent of friction ($7/70' < \tan 40^\circ$).

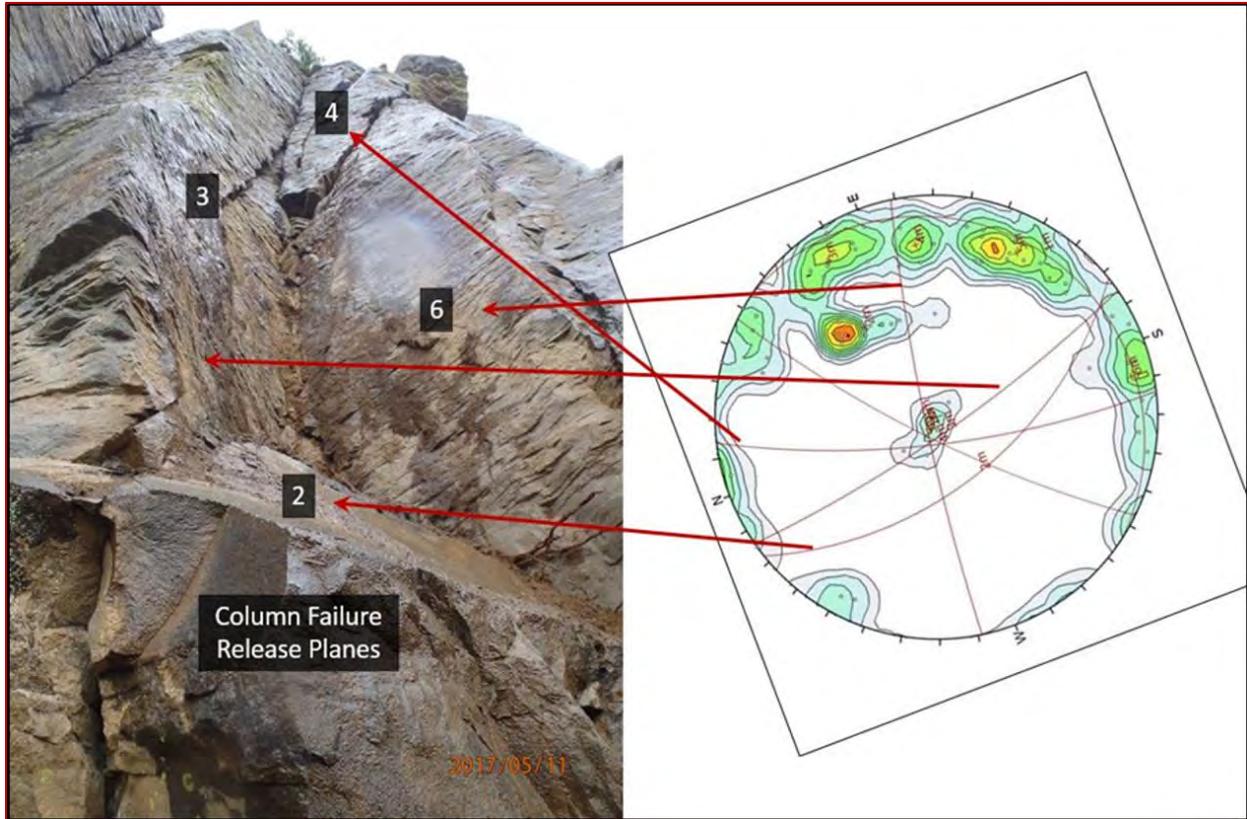
Figure 10 – Photo shows the release planes (3, 4, 6) and basal plane (2). Stereonet displays the mean set planes from Dips[®] analysis; note, the stereonet has been oriented to the slope. Joint number labels reference set numbers in Dips[®] analysis.

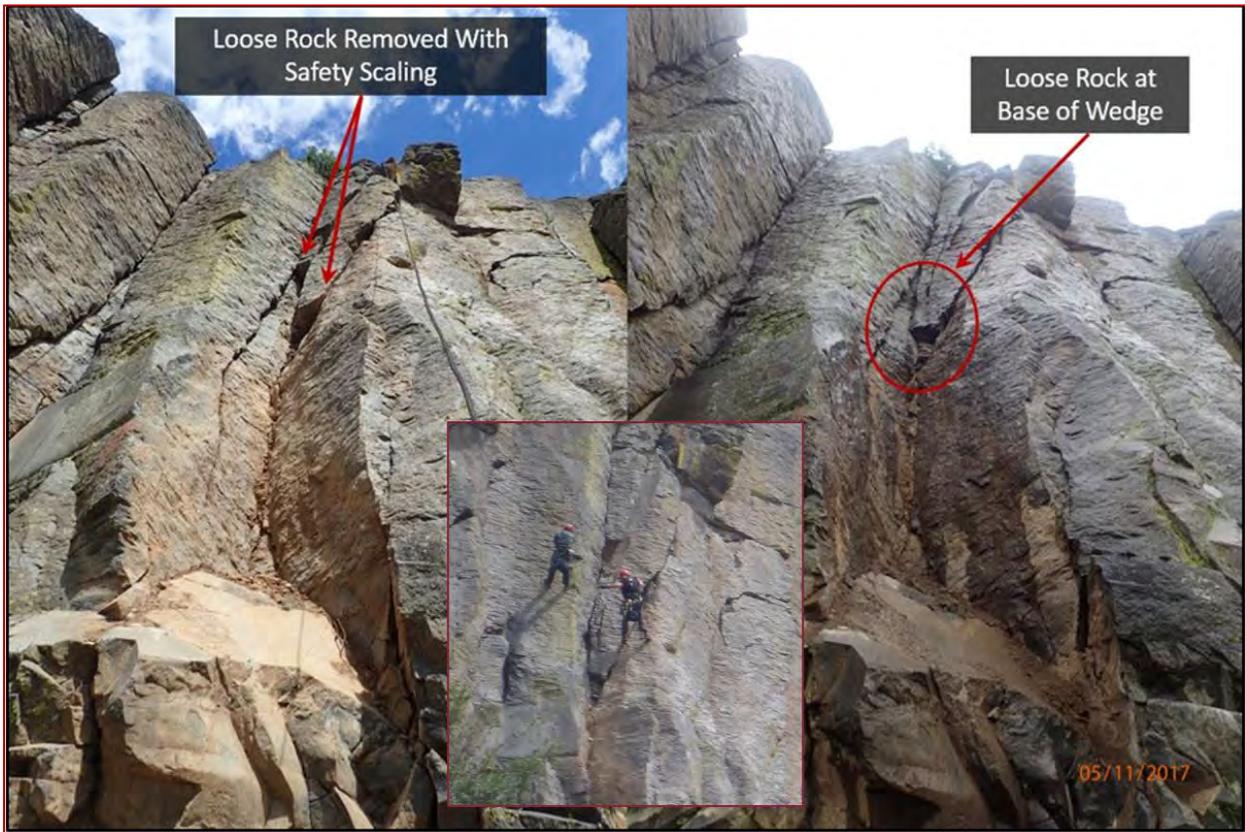
Figure 11- Before and after safety scaling. The loose wedge of rock on the left was removed with a scaling bar.

The authors returned to the site on May 25th, 2017 to complete safety scaling in the project area. The goal of the safety scaling was to remove loose material from the residual rock wedge left behind after the column failure. The authors used steel hand scaling bars to pry loose rock from the residual rock wedge. Approximately 3-CY of material was removed near the base of the wedge (Figure 11). Safety scaling reduced but did not eliminate the rockfall hazard at the climbing area. After safety scaling, the authors recommended WDFW reopen the Royal Columns climbing area for recreational use (3).

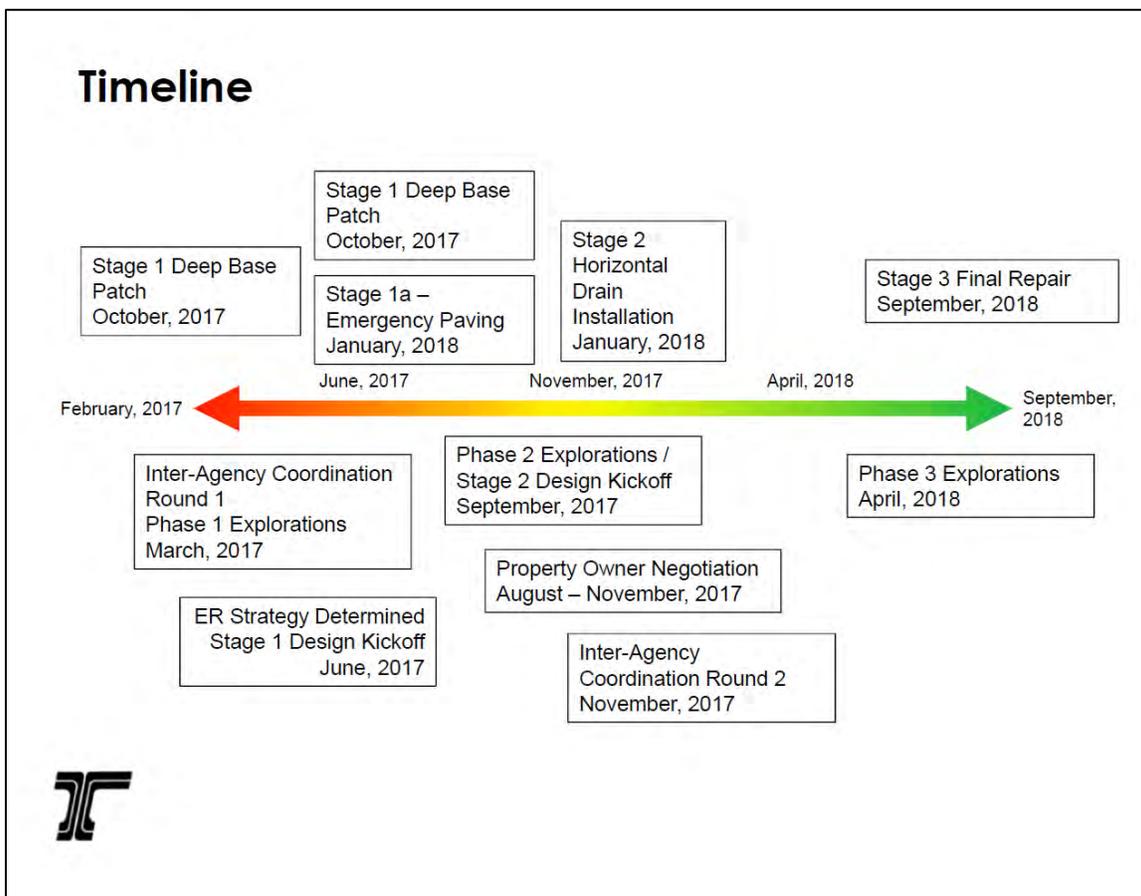
Figure 1: Project timeline

Staff members from ODOT Region 1 Geo/Hydro/Hazmat Unit (R1 Geo) were alerted to surface cracking in late February, 2017. Final horizontal drains and long term monitoring equipment were installed March, 2018. Figure 1 details the two schedule paths for this project, the Stage timeline predominantly on the upper half of the figure represents construction activities managed by ODOT Maintenance District 2B staff (D2B). The Phase timeline on the lower half represents design and analysis work conducted by Oregon Department of Transportation Geotechnical Engineers and Engineering Geologists (R1 Geo) and Landslide Technology, Inc. (LTI) staff.

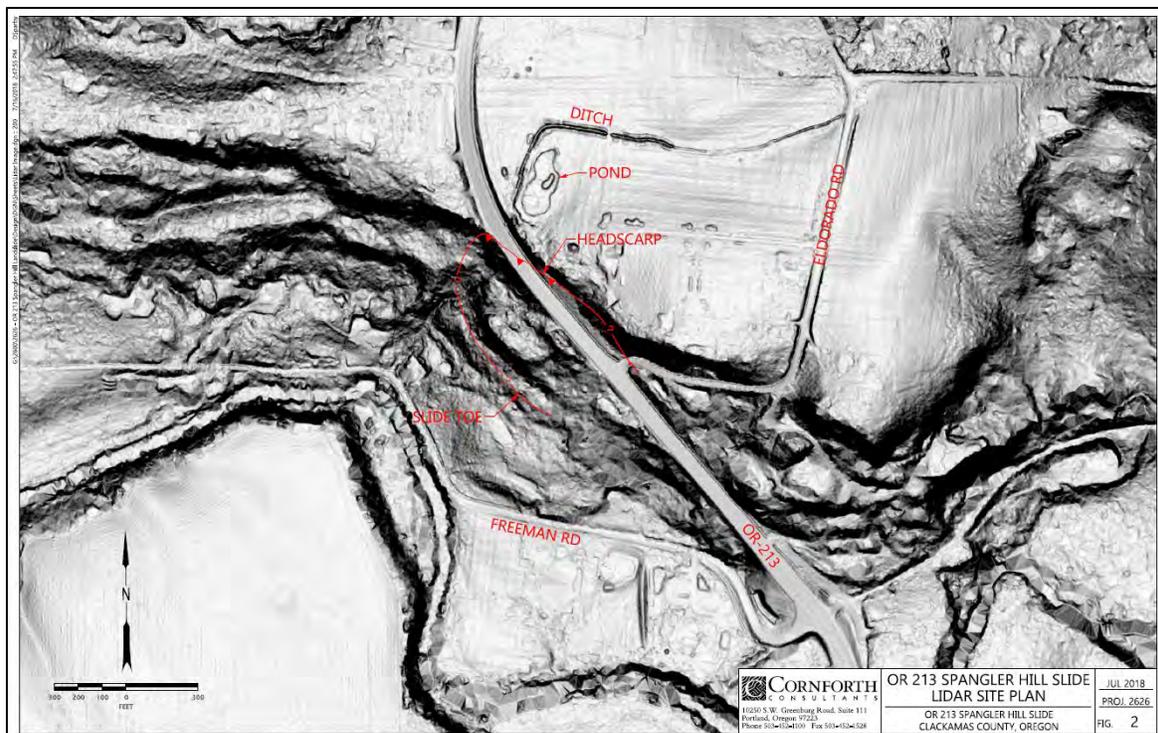
Figure 3: LiDAR imagery of slide complex

Published geologic maps of the area indicate the site is underlain by Pliocene-age basalt from the Boring Lavas and Miocene-Pliocene-age siltstone and sandstone of the Troutdale Formation (LTI, 2018). This portion of OR213 crosses onto and traverses a previously mapped, very large landslide complex, as shown below in Figure 3.

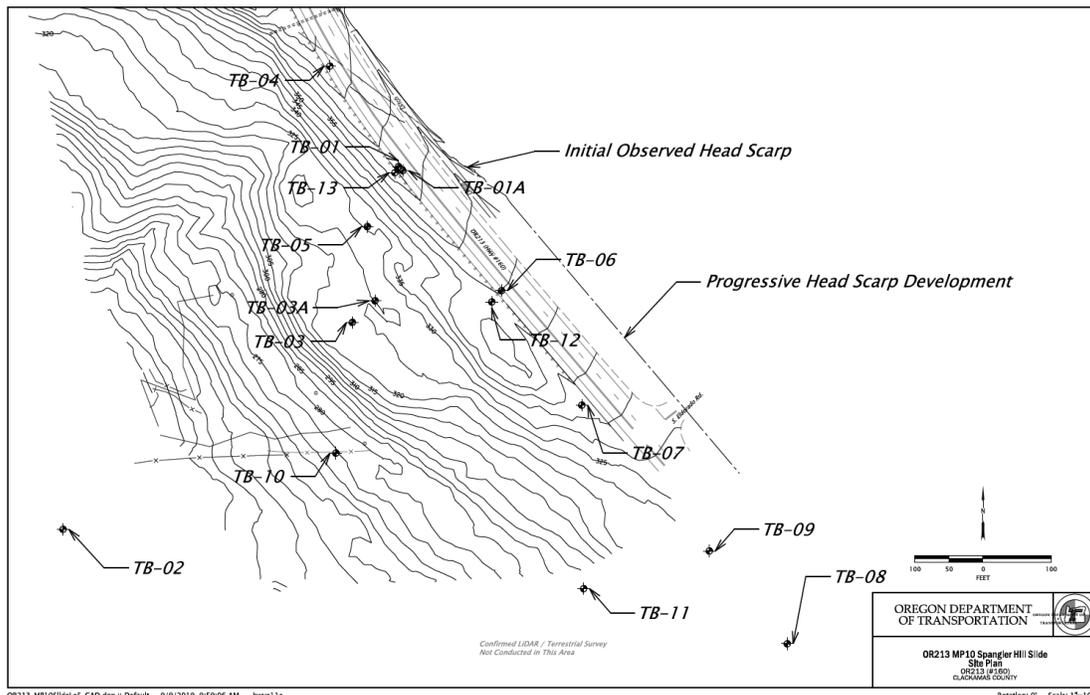
Figure 4: Site plan

Figure 4 below shows the locations of all the exploration phases.

Geologic units encountered at the project site, listed from youngest to oldest, include the following: Overburden soil (embankment fill, colluvium, and landslide debris), Boring Lava Rubblized, Boring Lava Basalt, and fine grained sedimentary rock of the Troutdale Formation. Locations of the borings are shown on Figure 4 and a brief discussion of each geologic unit is given below.

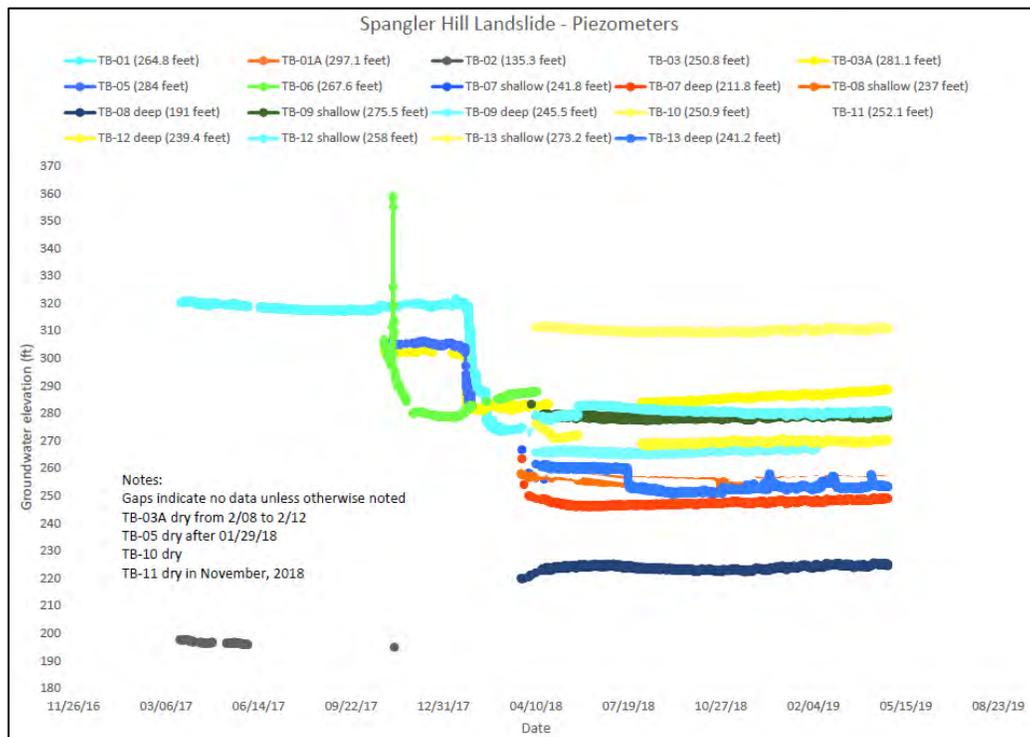
Figure 5: Cumulative groundwater monitoring data

SI casing depth, and VWP tip elevations are summarized in Table 1. Cumulative groundwater levels measured in the VWPs are shown below in Figure 5.

As described previously, the horizontal drains were installed in January and February, 2018. The significant drops in hydraulic head shown in TB-01, -03A, -05, and -06 illustrate the effectiveness of the installed drains.

As can be seen in Figure 5, a ground water elevation decrease of more than 30 ft. was achieved in the most active area of the slide. Manual measurements of crack width and RTK survey observation indicated that the slide movement significantly decreased following drain installation.

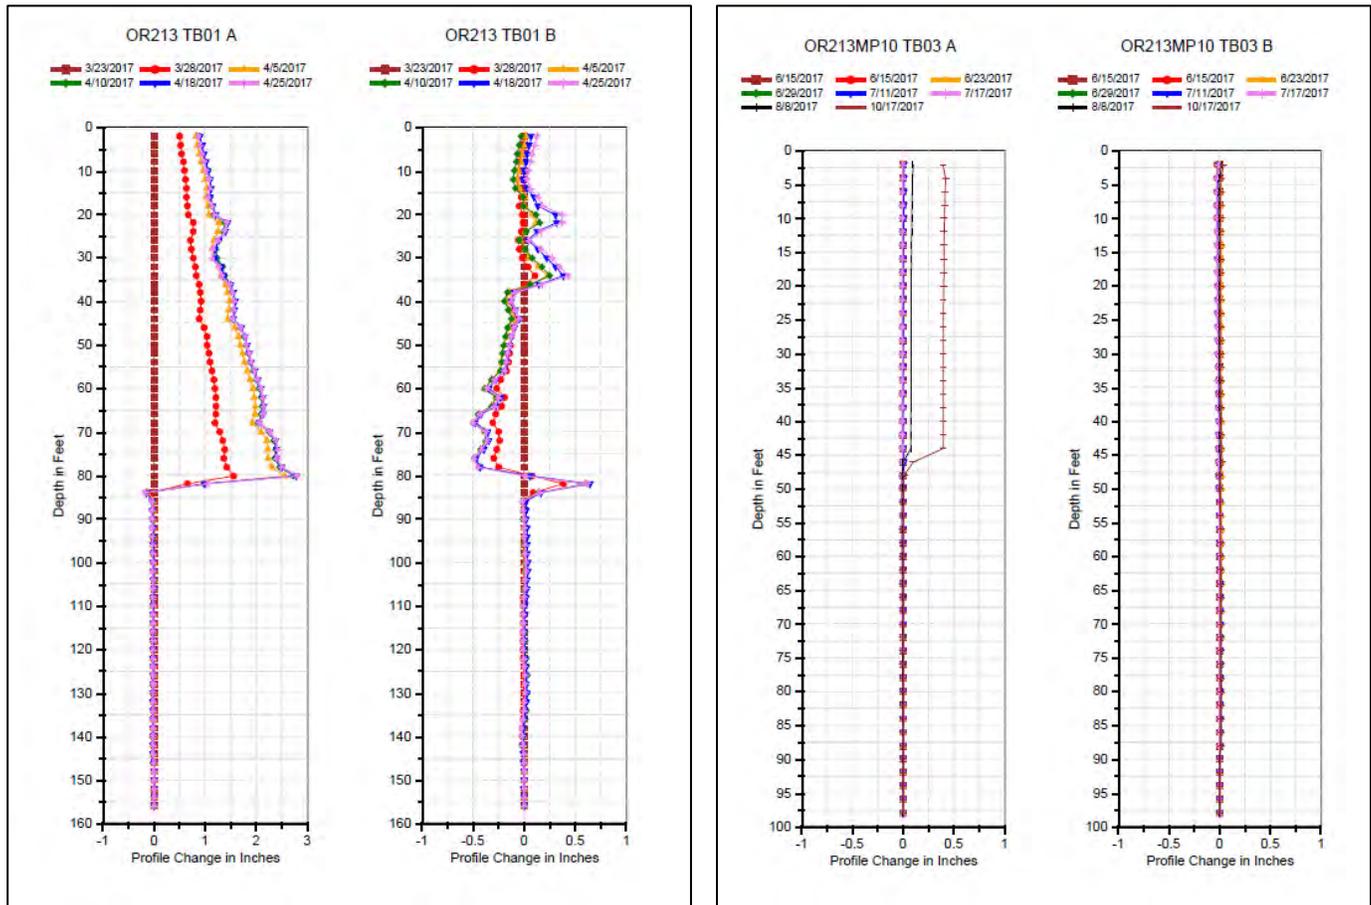
Figure 6: Phase 1 displacement profiles

The figures below display representative movement profiles from Phase 1 and Phase 3 explorations.

Phase 1 displacement profiles, combined with the initial subsurface investigation, led R1 Geo and LTI to develop the design geologic model

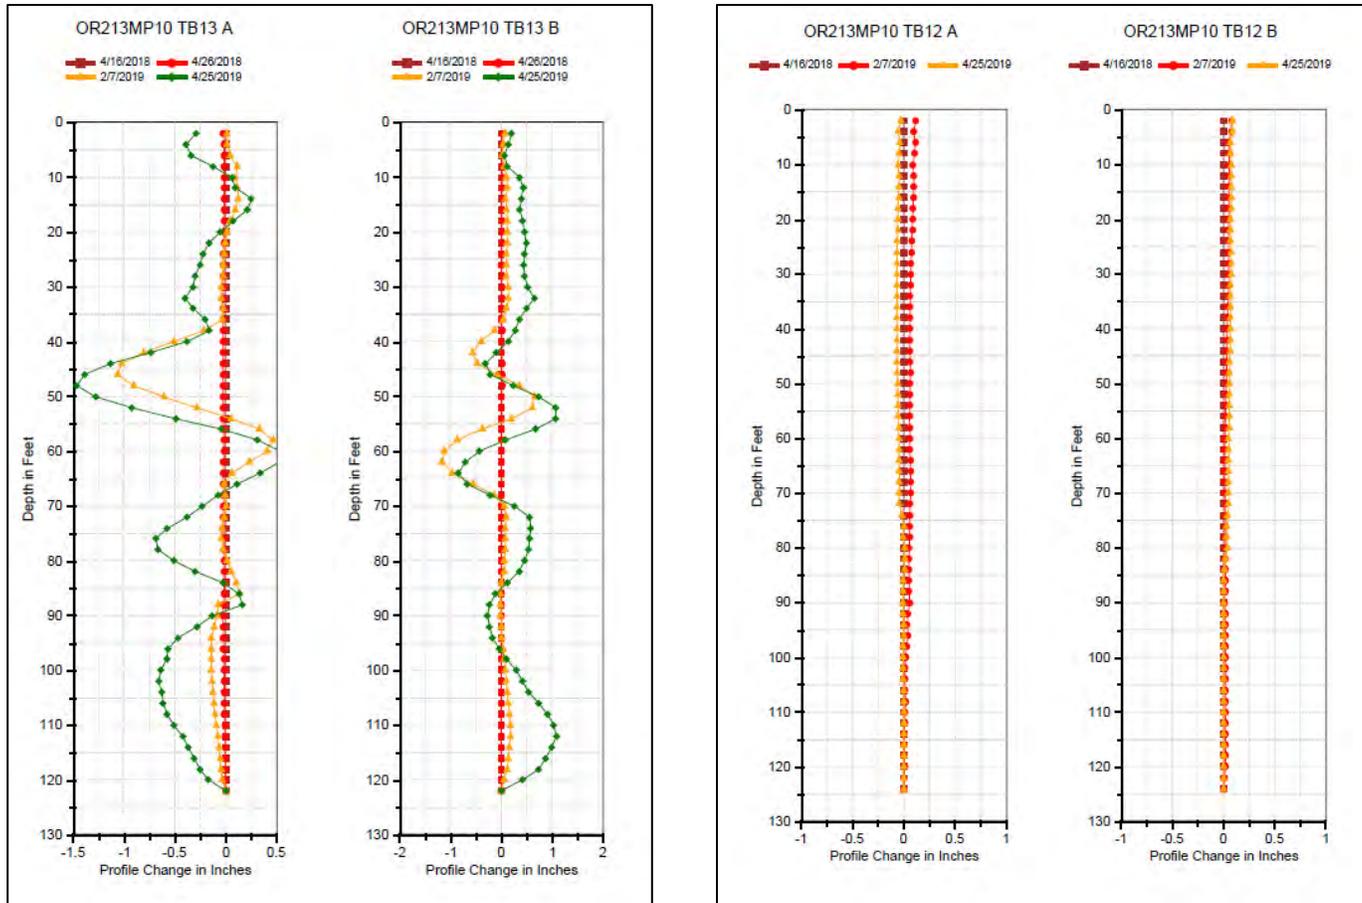
Figure 7: Phase 3 displacement profiles

Phase 3 displacement profiles indicate predominantly vertical displacement as a result of pore pressure redistribution, resulting in casing crushing at TB-13, which corresponds with the location of maximum displacement. Displacement profiles outside of the area of recent activity (TB-07 through TB-12) displayed little to no horizontal deflection, confirming suspected failure mechanisms.

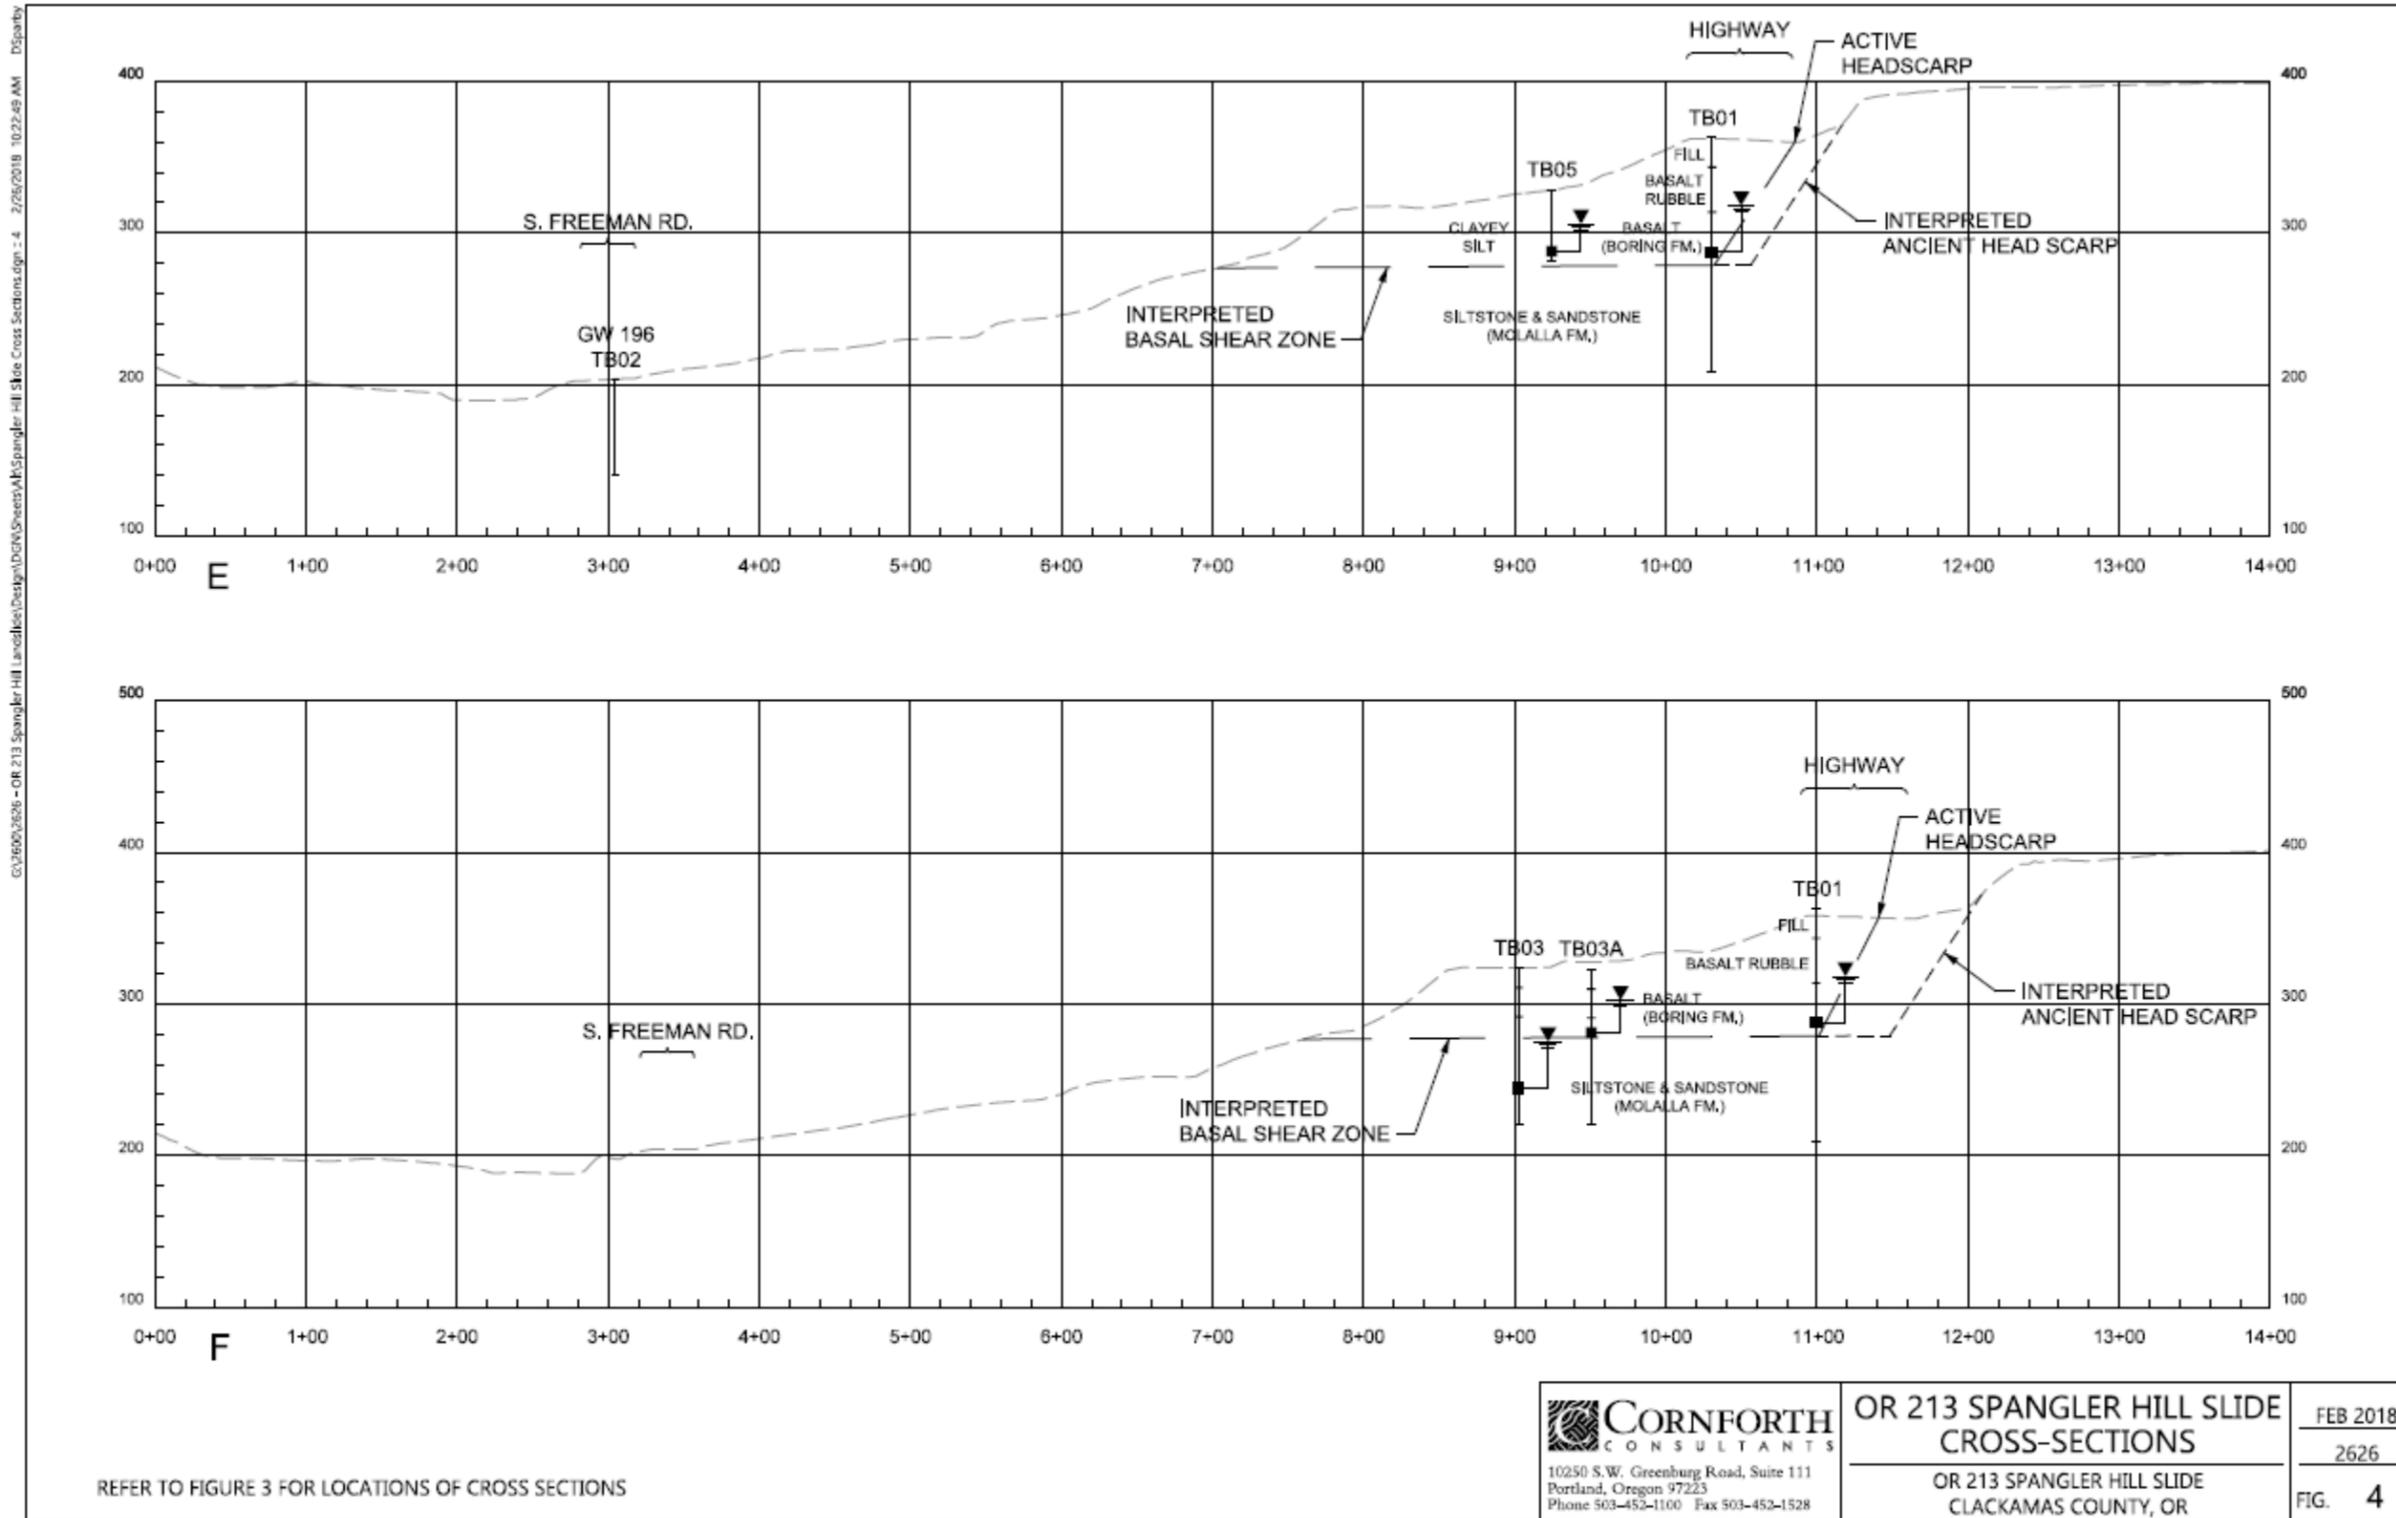
Figure 8: Interpreted Geologic Design Model

Geologic cross sections were developed based on initial exploration results and observed SI displacement profiles.

Traditional terrestrial observation indicated the main head scarp expressed across the road surface as shown in Figure 8.

The developed geologic model was then analyzed for a bi-linear failure surface in standard slope stability software. Based on the geometry and observed soil properties, the above model was verified to have a factor safety of approximately 1.0 under existing conditions.

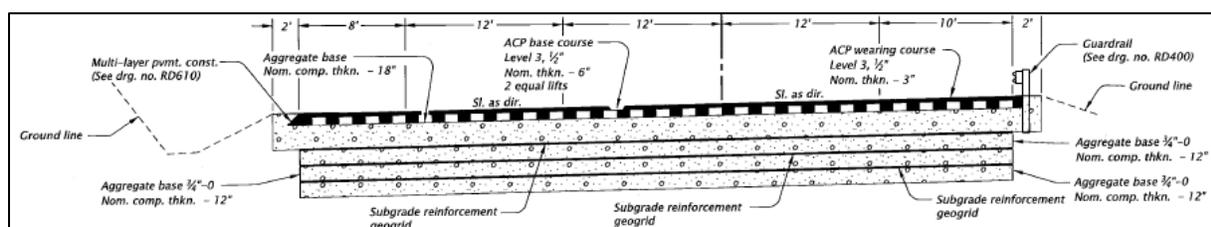
Figure 9: Deep base patch schematic

In late summer to early fall of 2017, a deep base patch repair was completed for the OR213 mainline in order to conduct an emergency paving operation to restore design grade as well as increase the flexibility of the road structure across the main head scarp. Figure 9 below details the design cross section for the deep base repair. The geogrid reinforcement extended 235 feet horizontally, approximately located with the head scarp in the middle along the design alignment.

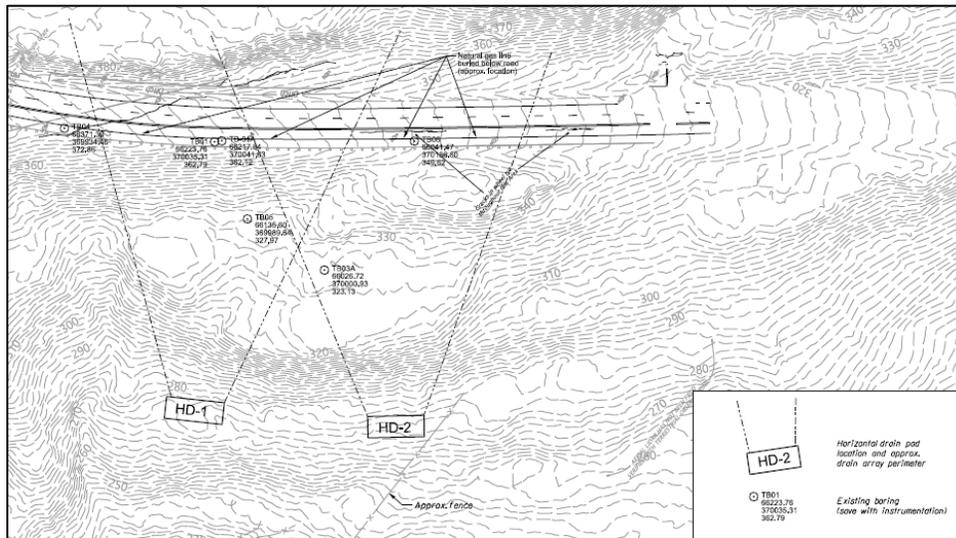
Figure 10: Horizontal drain layout

Figure 10 above displays the negotiated general site layout with north being at the left, showing the staging area in the west, and the drill pads towards the east. Pond 1 was installed per plan (note

5 in northeast corner) while Pond 2 was shifted to the west and south of Pad 2. The access roads to the north and south as well as the drill pads required significant vertical excavation to adequately capture the anticipated drainage. The darker dashed lines in Figure 10 show the proposed path of the drainage pipe excavated and installed in difficult conditions. Initially, the access roads were to be constructed using native fine grained soil matrix from the overburden material once the boulders were removed. Since installation for the access roads started in January 2018, the saturated nature of the fine grained site soils prevented any functional construction. As a result, a contract change order was processed to allow the contractor to bring in pit-run cobbles.

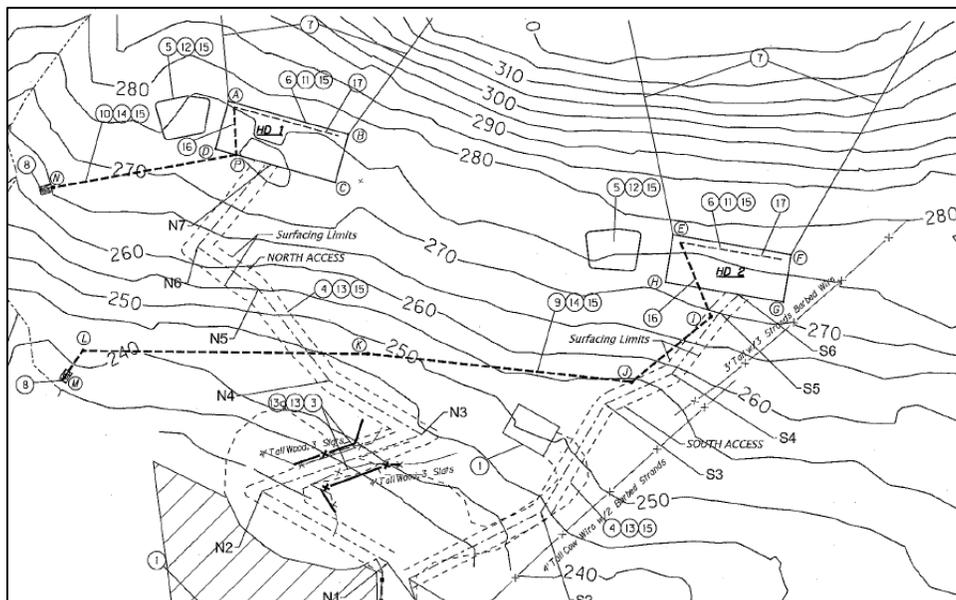
Figure 11: Detail shot of contract plans showing location of drill pads and access roads

The property downslope of the highway is privately owned. In order to reach the optimal drain outlet elevation of 270 feet, the drill pads were forced to be located on the private property. Significant earth work and alteration of the property had to occur in order to get the drill rig into position.

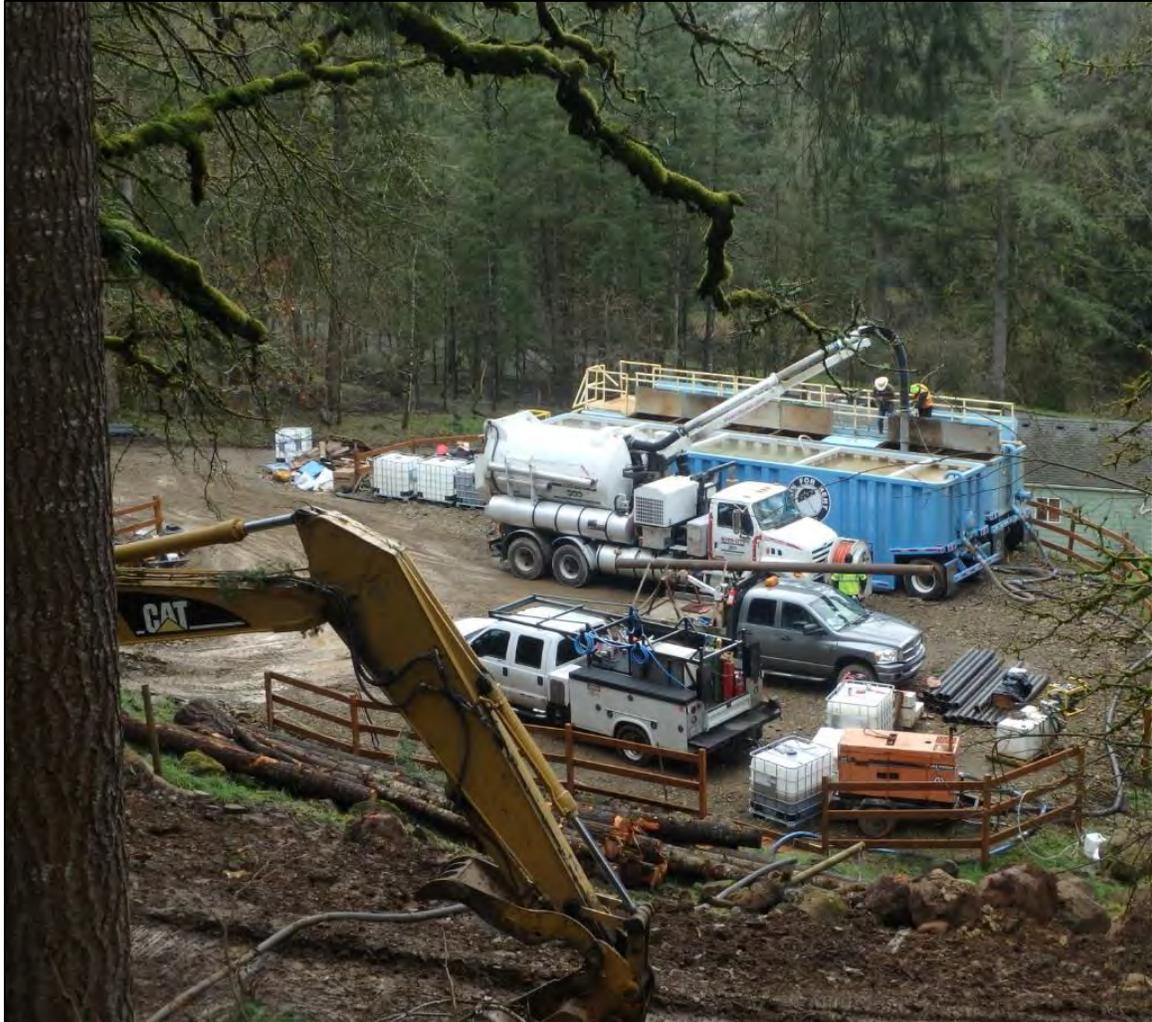
Figure 14: Sediment control solution

Pond 1 was installed partially into the existing slope with the outboard side of the pond supported by a rapidly installed earthen berm constructed of native fine grained soil matrix. Due to the suspect stability of the outboard side of Pond 1, the specified volume of 20,000 gallons was not available. Once drilling for an individual drain reached design length and the steel drill string removed, the newly installed drain flowed at rates above 300 gallons per minute (gpm) of sediment-laden groundwater. After approximately 30 min. the flow rate subsided to approximately 10 gpm and the sediment load decreased. The limited amount of containment available at Pond 1 and the high flows of turbid flow created drainage outfall concern. The project team quickly identified a sediment control plan with settlement tanks and flocculants. With contractor assistance, the project team sized the equipment based on the rapidly fluctuating flow rates and timing. Figure 14 below displays the 20,000 gallon utilized for temporary storage and sediment removal. Ultimately three of the large tanks were needed to capture the flows from Pad 1.

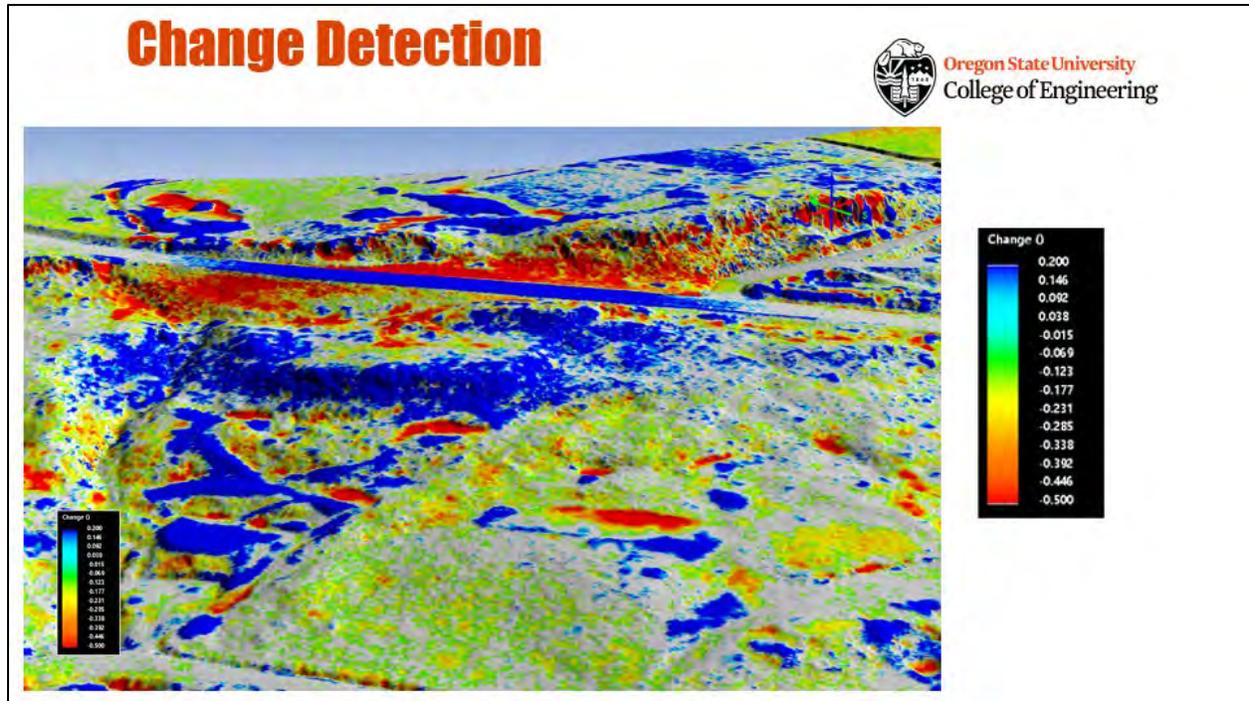
Figure 15: Displacement map based on change detection analysis with UAS LiDAR

The additional analysis was conducted in part to verify assumptions regarding slide movement kinematics, as well as proof of concept for ODOT Geometronics unit for future projects. UAS gathered LiDAR was compared to traditional terrestrial survey techniques for accuracy verification. The collected data were then compared to existing LiDAR data previously acquired by DOGAMI. A change detection analysis was conducted between the two data sets that produced a displacement map of the landslide complex as shown below in Figure 15.

The additional instrumentation and aerial surveys help to prove the efficacy of the horizontal drains. In addition, ODOT and OSU are currently developing an operations and maintenance (O&M) manual to track the long term performance of horizontal drains across the state, with the Spangler slide being one of the case studies. Output flow volume instrumentation is currently being installed at the site utilizing open source software and bespoke hardware.
