70TH HIGHWAY GEOLOGY SYMPOSIUM

“Better Highways Through Applied Geology”

October 21-24, 2019

2019 Proceedings

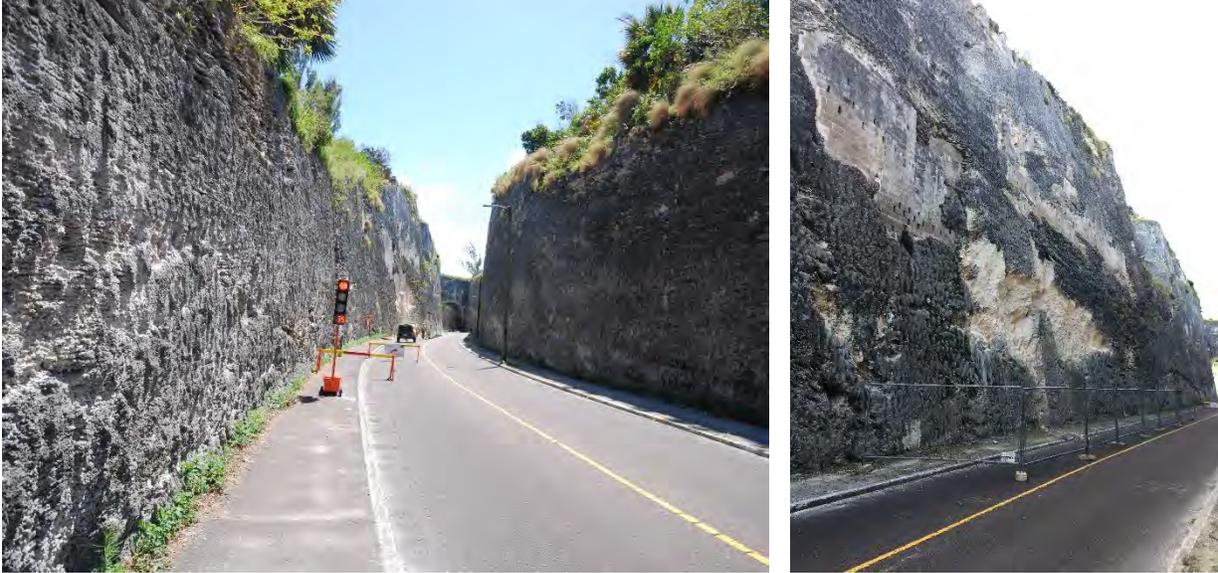
Figure 1 – Black Watch Pass, Bermuda

The Black Watch Pass is located on the north shore of Bermuda in Pembroke Parrish in close vicinity to the ocean. The two-lane roadway runs in north-south direction and was constructed as a box cut with an excavated rock face on both sides of the road (refer to Figure 1). The road cut was constructed in the 1930's and is a major tourist attraction in Bermuda's Pembroke Parrish and site of the major parade.

The rock cut has a length of approximately 300 meters, with sub-vertical (approximately 85 degree) walls that range in height from 3 to 24 meters. Approximately at the midpoint, the Black Watch Pass is crossed by a road that was built on an archway excavated into the rock. Except for a 20-meter long section at the north end of the eastern slope, the walls were excavated without benches. Pedestrian sidewalks are located at the toe of the rock cut with no catchment area or protection between the sidewalk and the rock faces.

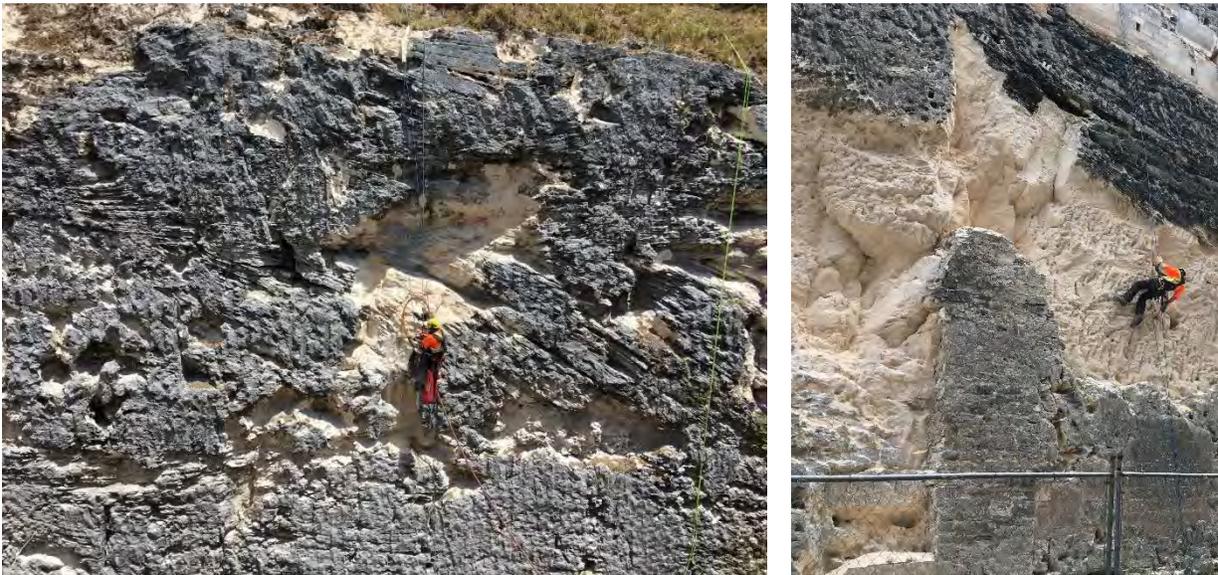
Figure 2 – Cavities Formed by Erosion of Paleosols and Weak Sandstone

The geology of Bermuda consists of Pleistocene epoch aeolianites or sandy limestone with layers of paleosols formed above a volcanic seamount consisting of basaltic rocks. The exposed rock at the project site is defined by many cavities and undermined areas that have formed due to differential weathering and erosion of the paleosols (refer to Figure 2).

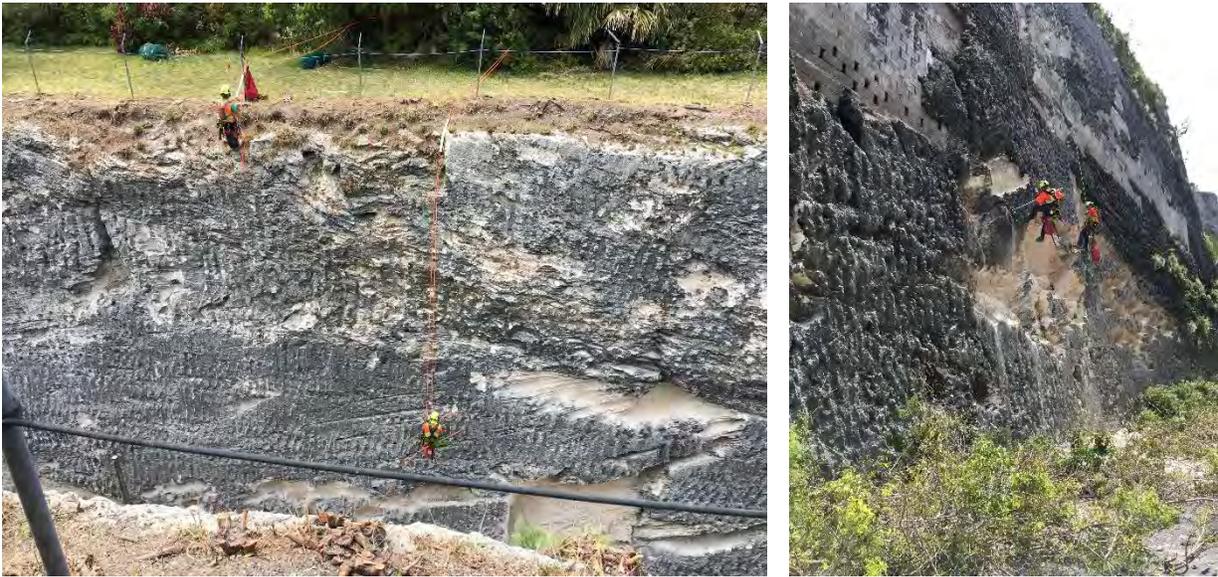
Figure 3 – Manual Scaling and Vegetation Removal

The 2018 slope stabilization project at the Black Watch Pass comprised vegetation removal from the rock faces and slope crests and manual scaling of loose rock and unstable existing masonry block walls, which had been part of stabilization measures carried out in previous stabilization efforts (refer to Figure 3). Further stabilization measures were limited to shotcreting and installation of rock anchors in selected areas.

The scaling was carried out from ropes, using scaling bars, hammers and blow pipes. Challenges included the varying strata of locally extremely weak rock that disintegrated into sand and the excessive vegetation growth along the crest. The weak rock had to be removed while not undermining more competent areas and the still intact existing reinforcement, such as the masonry walls.

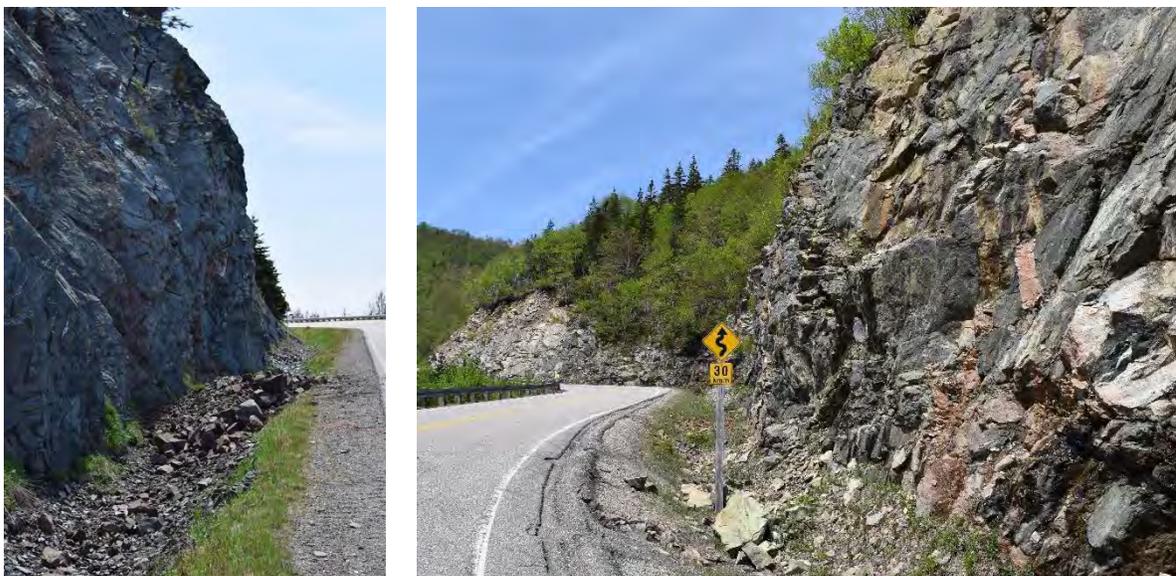
Figure 4 – Cabot Trail, Cape Breton – Typical Slopes

Rock types are highly variable along the trail, but generally consist of high-grade metamorphic rocks (schist and gneiss) intermixed with plutonic rocks. The rocks of the Cape Breton Highlands can be heavily altered, highly fractured, and are exposed to extreme coastal weather patterns and resulting erosion. Typical slope configurations are shown in Figure 4.

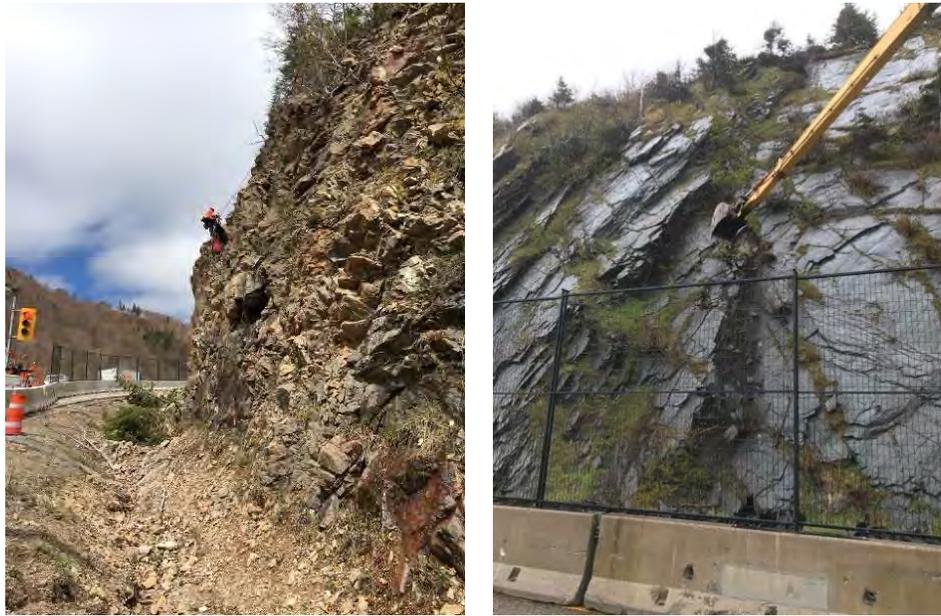
Figure 5 – Manual and Mechanical Scaling

Scaling has been mostly carried out manually by rope access using scaling bars, air bags, and air pressure pipes. Mechanical scaling with long-reach excavators has been completed on some moderately high slopes where conditions enabled reach and allowed for safe and controlled rock removal. Typical scaling set-ups are shown in Figure 5.

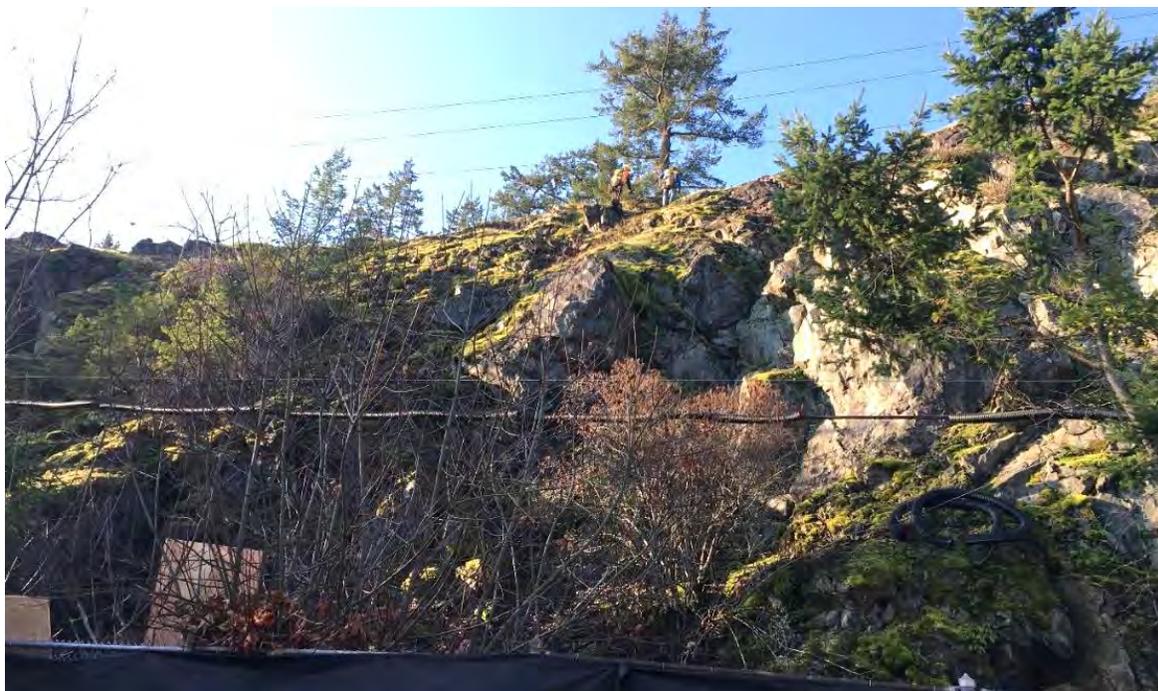
Figure 6 – Colwood Slope, British Columbia

The geology at the site consists of fractured meta-igneous rock. The natural discontinuities in the rock mass were consistent in exposed areas. However, in areas with talus accumulation and dense vegetation growth an extensive network of fractures was observed that was inconsistent with the natural discontinuity sets and appeared to be the result of human impact on the slope.

The slope stabilization program for the site comprised scaling and installation of rock anchors and rockfall protection mesh. Scaling was carried out manually from ropes, and scaling tools were limited to handheld tools, such as scaling bars, pneumatic hammers, and blow pipes.

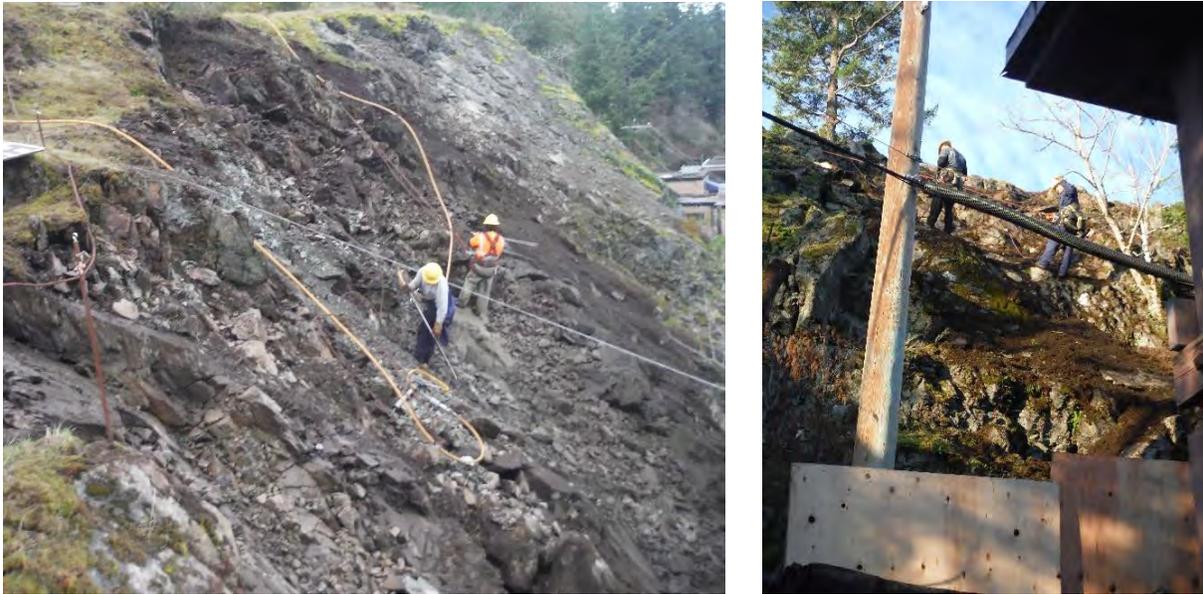
Figure 7 – Manual Scaling and Grubbing in Heavily Fractured Mid-Slope Section

The mid-slope area caused significant scaling efforts in preparation for the subsequent anchor drilling and mesh installation; large amounts of loose rock were removed to prepare stable drilling locations and address safety concerns regarding access to the slope that were raised by the contractor. Further site constraints were the close proximity of the power lines, which had to be deenergized for the work, and other infrastructure and buildings that had to be protected against damages during scaling operations.

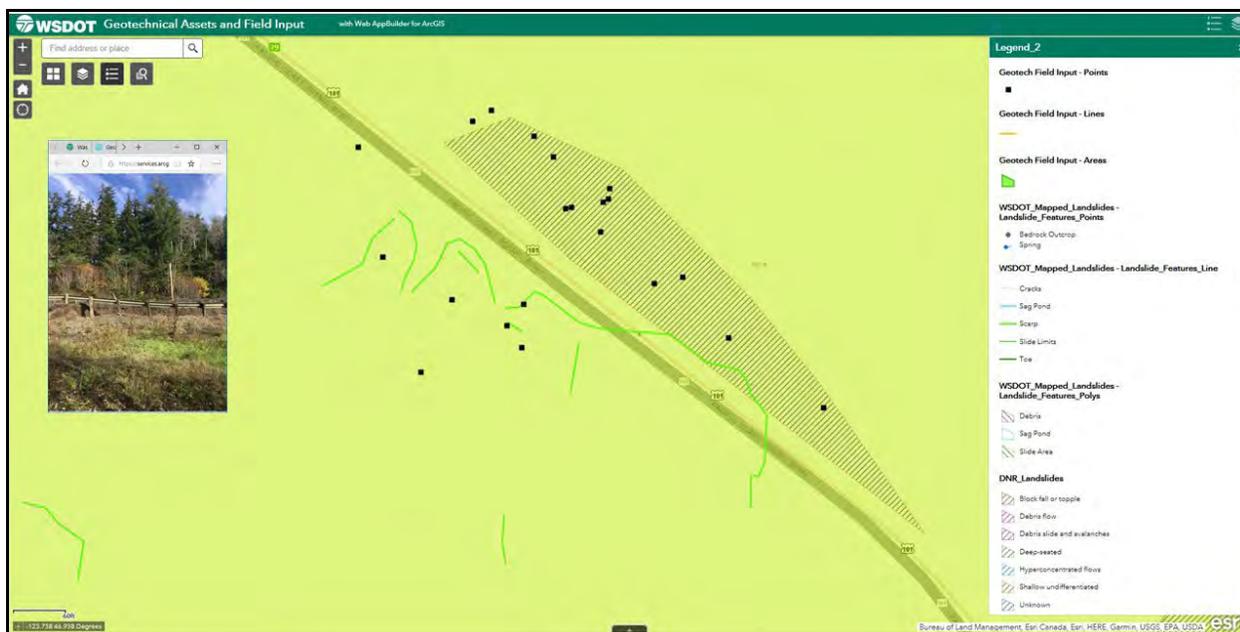
Figure 2: Geotechnical Assets and Field Input Web application showing landslide scarps and points with linked photographs that were mapped with ArcCollector.

Landslide data features (i.e. points, lines, or areas) are collected using either an iPad or a GPS receiver. When using an iPad, mapping is done on top of base layers (i.e. lidar, orthophotos, and topographic maps) or other previously collected GAM data (i.e. USMS data, landslide geomorphology, and constructed geotechnical asset information) (Figure 2). WSDOT internal datasets are only available with a WIFI connection. Photos and notes can be attached to any of the collected features as linked attachments.

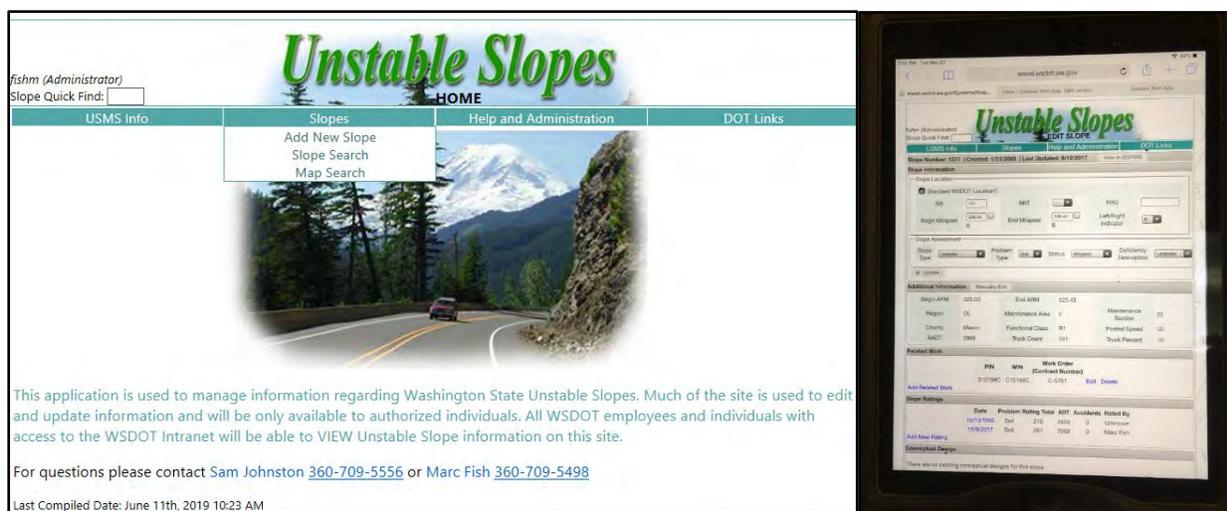
Figure 3: Unstable slopes database accessed through a desktop computer or an iPad.

This data is compiled from within the office and it is entered into a SQL server database through a desktop web browser, or it is collected in the field with an iPad (Figure 3). It includes slope type, status, ratings, photographs, conceptual designs, cost estimates, and benefit-cost analyses. To enter the data while in the field, WIFI with VPN is needed to access the database. A downside to using VPN is that connectivity back to the office is much slower. New slope ratings and photographs are collected for each unstable slope on 1, 3, or 5 year intervals.

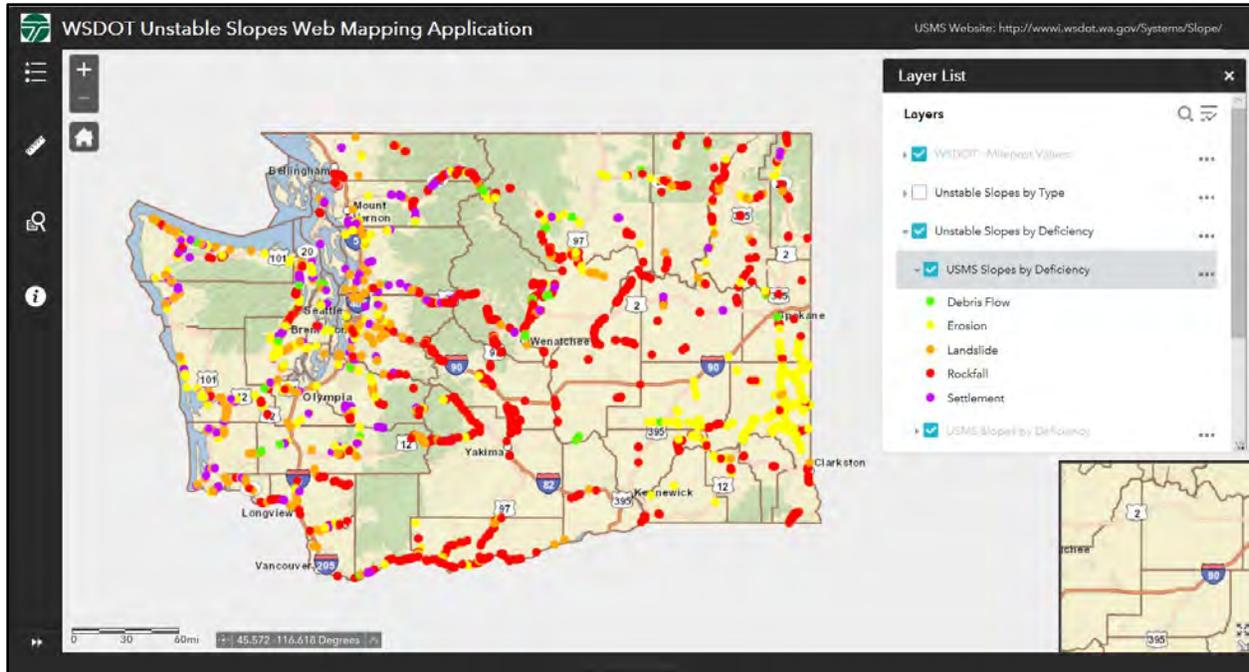
Figure 5: USMS web mapping application showing the types (based on color) of unstable slopes throughout the state.

All of Washington’s approximately 3400 known unstable slopes are displayed on a statewide map. They can be displayed by type, deficiency, status, or rating (Figure 5). As a user “zooms” in, the unstable slope “points” turn into “lines”, and by “clicking” on a “point” or a “line”, data about the unstable slope appears in a pop-up window. At the bottom of the window, a link is provided that takes the user directly to the USMS webpage for that slope. Different base maps can be displayed, and there are book marks that “zoom” the map to each individual county in the state.

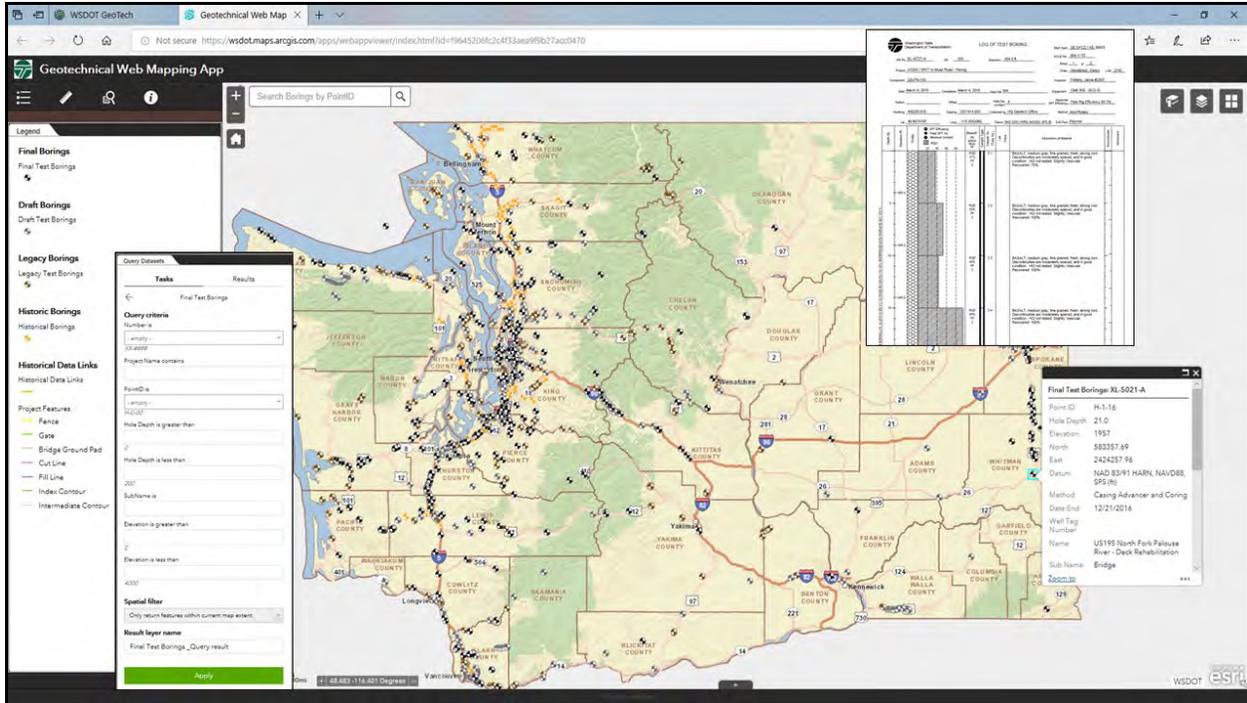
Figure 6: Geotechnical web mapping application showing legend, search function, pop-up window, and linked test boring log.

This web mapping application displays subsurface information and test boring logs (Figure 6). WSDOT has one application that is for public use (external), and another for in-house users (internal). The internal application shows all subsurface data, including draft data, which are not available in the public application. The historical data are composed of pdf version test boring logs that were acquired through the ECM portal (Oracle database), WSDOT's document archive database. The historical test boring locations were mapped by georeferencing historical plan sheets or by locating the stationing and offset along historical project alignments. The legacy boring data are older gINT databases, in a format different from that of the draft and final data, so only the point and project information is viewable in the GIS, with a link to the pdf test boring log.

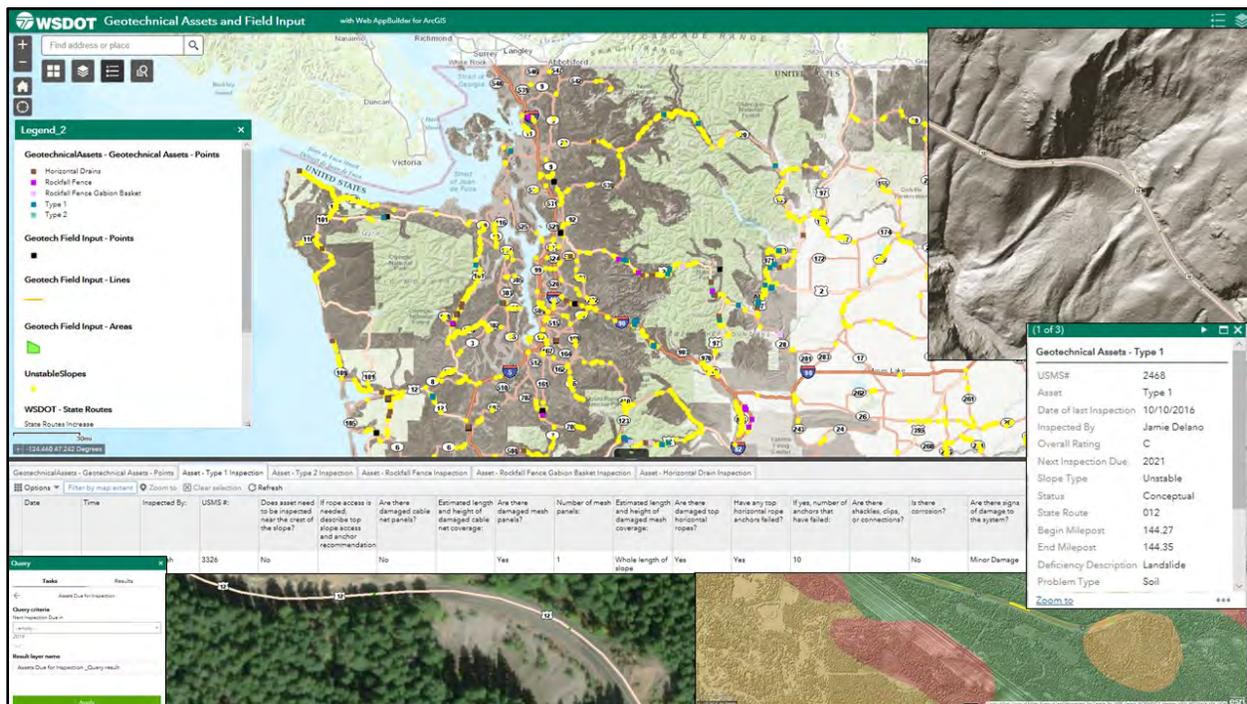
Figure 7: Geotechnical Assets Web Mapping application displaying types and location of the constructed geotechnical assets with the geology, lidar, and orthophoto layers, the legend, a pop-up window, and a search function.

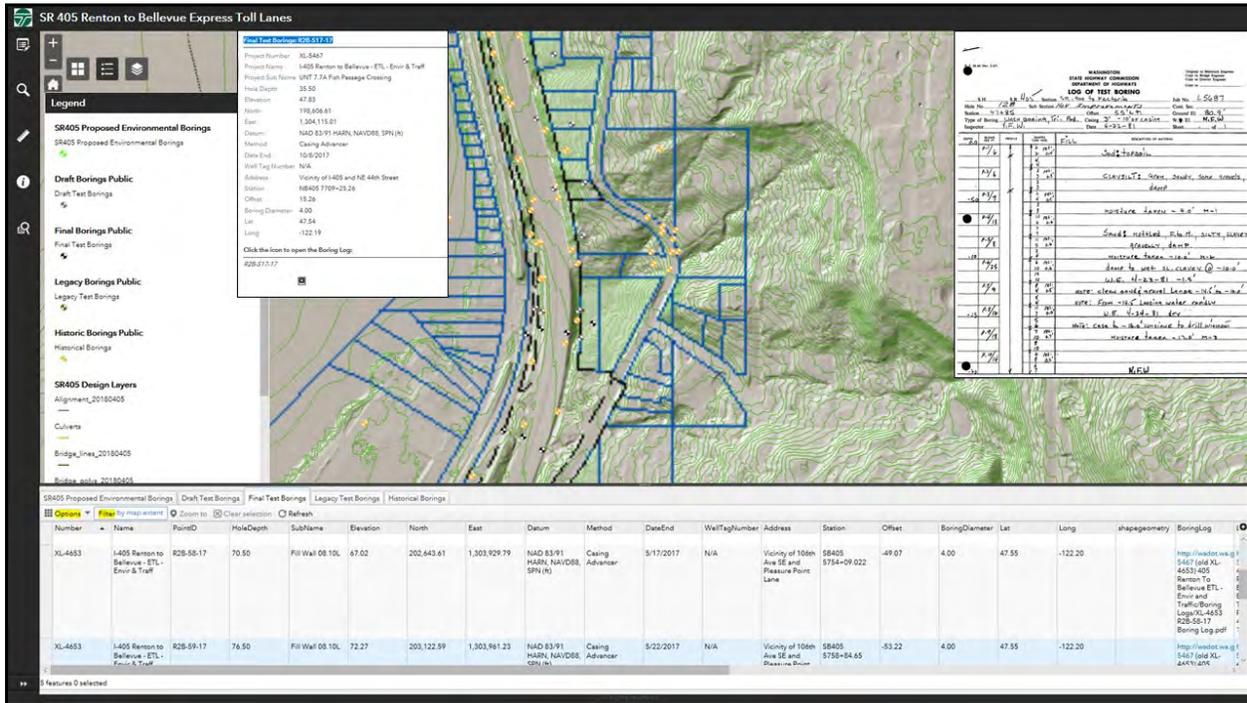
Figure 8: I405 Renton to Bellevue Mega Project. Data layers include parcels, contours, and the historic test boring logs, with the legend, a pop-up window, and the data window.

These applications contain test borings (old and new), lidar, contour intervals, parcels, and specific design layers (Figure 8). This is an internal application, available to all WSDOT staff that are working on a specific project. This web mapping application is updated regularly and is used to make project specific decisions.

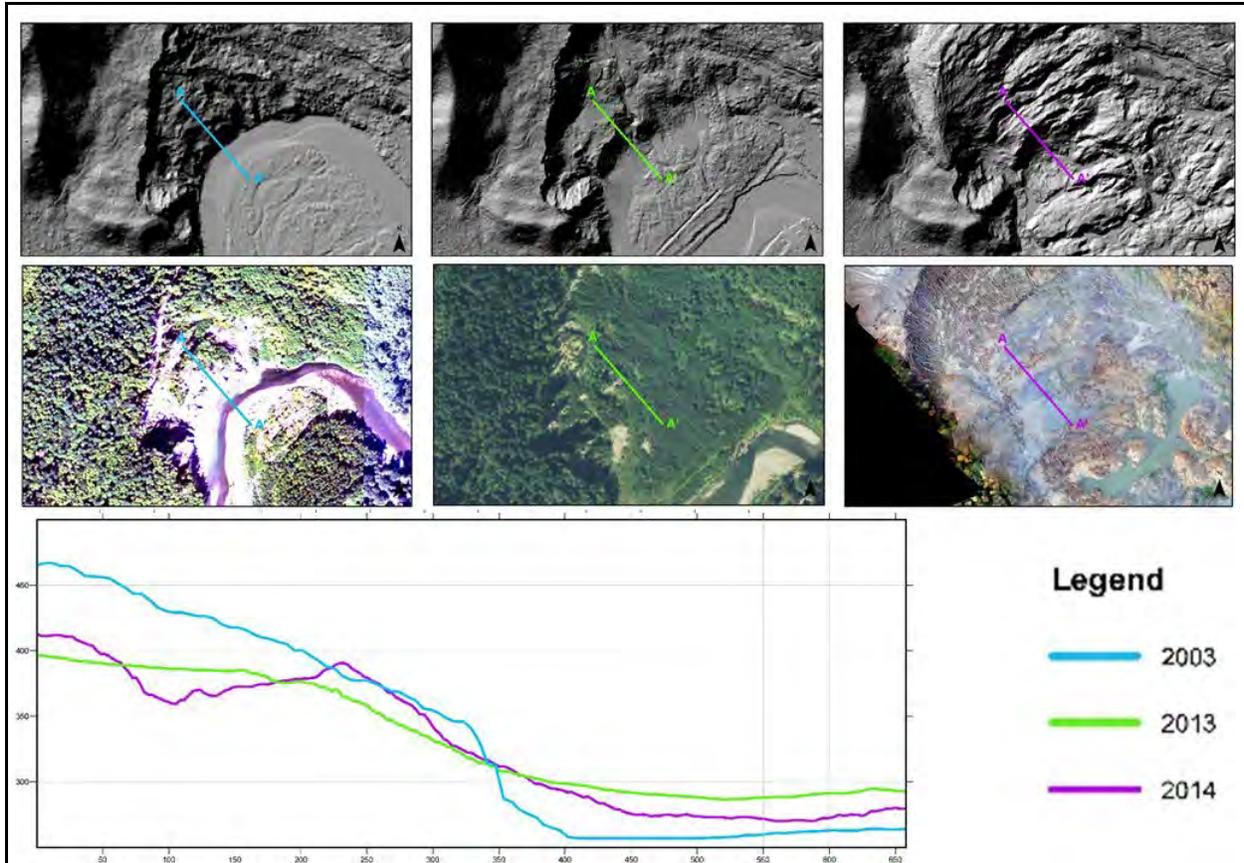
Figure 10: Cross sectional view of a landslide over a 3-year period.

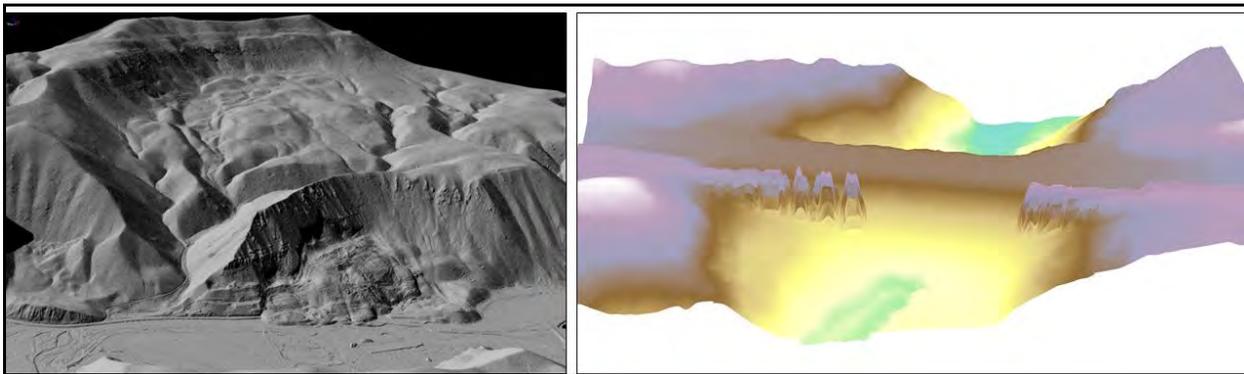
Figure 11: 3D views help to visualize topography at the site of an unstable slope or a project.

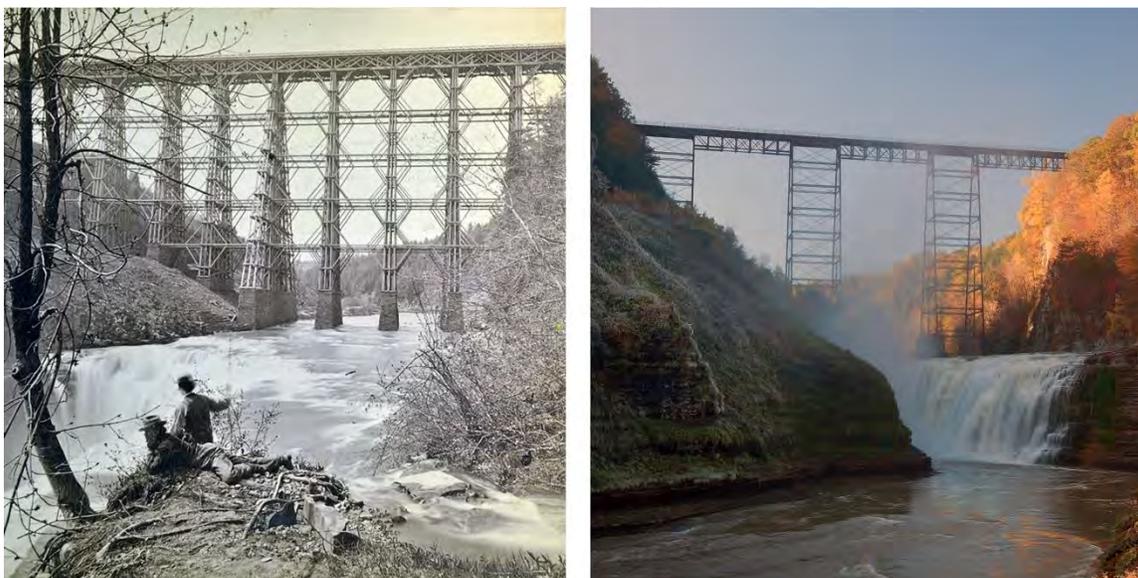
Figure 3 - Views to the south of 1852 (left) and 1903 (right) bridge structures

In 1903, the 1875 bridge superstructure was upgraded to accommodate increased rail traffic loads, requiring replacement of its deck trusses and plate girders, which were supported atop existing wrought iron tower bents. The bridge's tower bents did not require replacement because they were originally designed to support two (2) tracks of rail traffic, and going forward the bridge would remain a single-track structure (Irwin and Johns, 2019). Figure 3 provides views of the original 1852 timber trestle and 1903 wrought iron bridge structures.

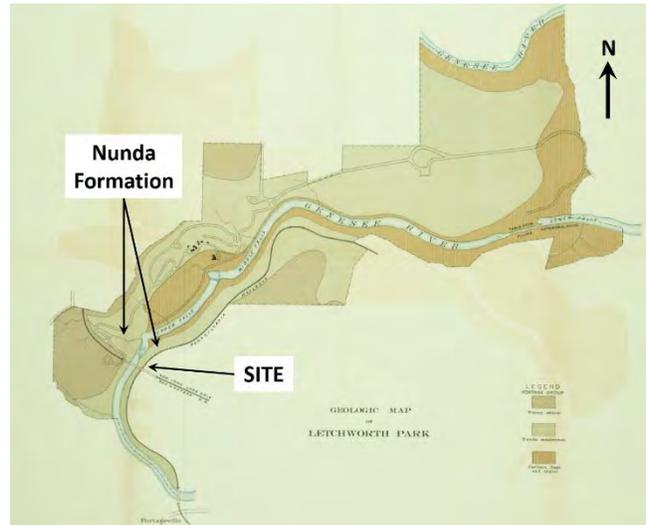
Figure 4 - Site bedrock geologic map (Clarke and Luther, 1908)

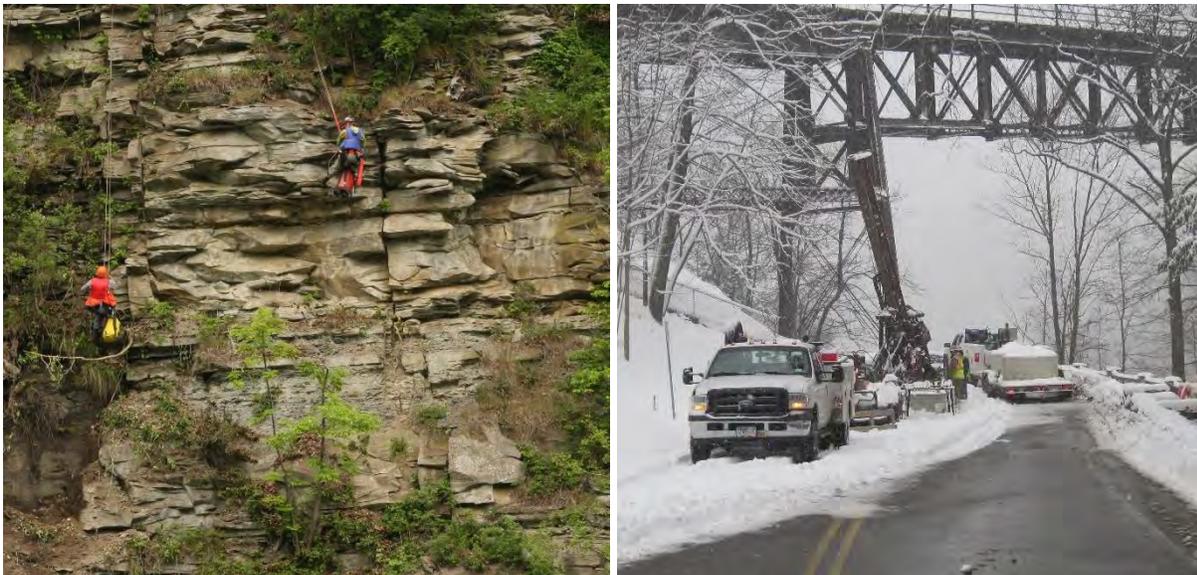
Figure 6 – Geologic mapping using rappelling techniques in spring 2008 (left); and inclined rock core drilling during winter 2011 on west side of gorge (right)

- A geologic field reconnaissance (conducted in 2008), utilizing fixed-line, rappelling techniques, to collect geologic and geotechnical mapping data (e.g., lithographic descriptions and rock mass discontinuity measurements) for exposed river gorge sidewalls within vicinity of the new bridge (Figure 6).
- A subsurface exploration program (conducted in 2011; Figure 6), which included:
 - Four (4) inclined rock coreholes to collect rock core samples
 - Thirteen (13) soil borings along approach embankment alignments
 - Optical / acoustic borehole televiewer (OTV/ATV) surveys to collect rock mass discontinuity measurements (e.g., dip angle and direction)
 - Geotechnical laboratory testing on collected soil and rock samples

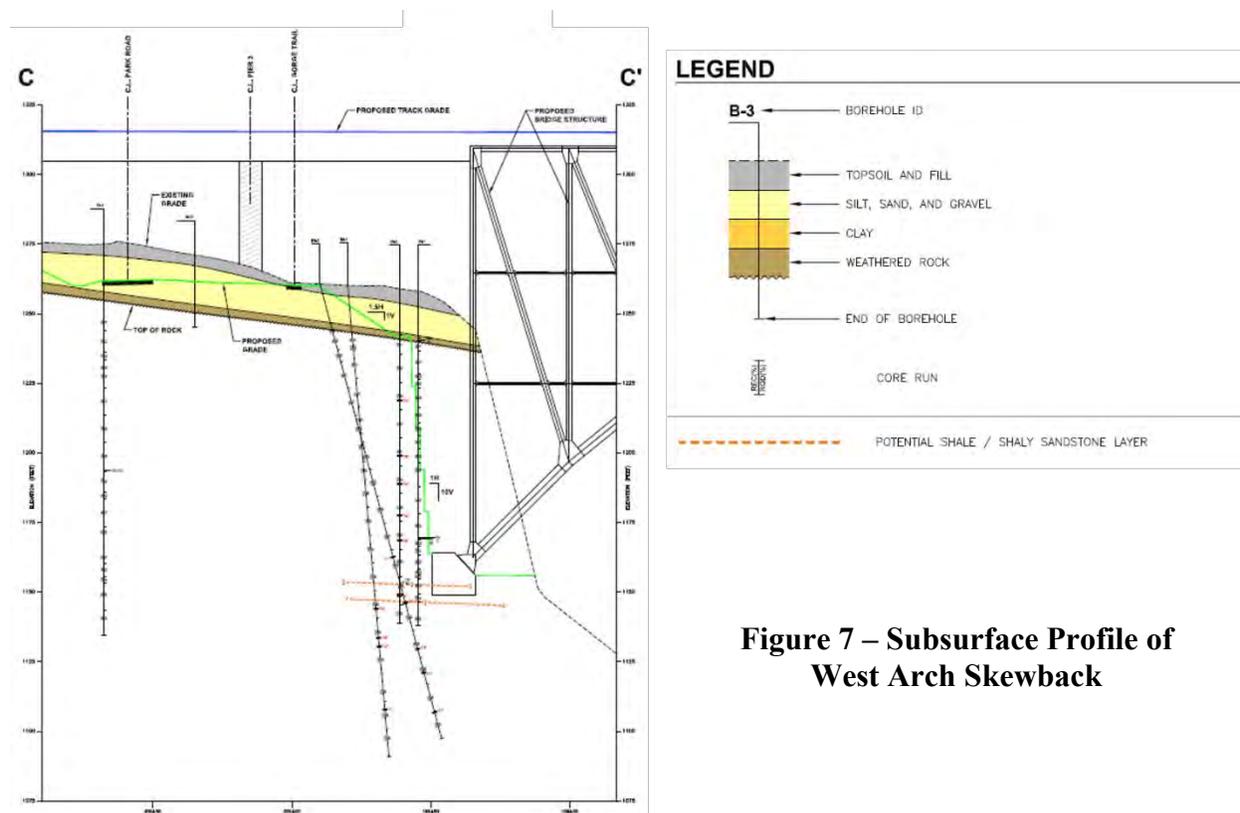
Figure 7 – Subsurface Profile of West Arch Skewback

The surficial geology at the site consists of glacial till and outwash, overlain by colluvium. These sediments overly subhorizontally-bedded, gray, fine-grained sandstone / siltstones with interbedded shale layers, typically 2- to 8-inches thick, which account for about 1% to 3% the “as-drilled” rock mass. Between El. +1145 and +1155, an approximate 6- to 9-foot-thick layer of shale and/or shaly-sandstone lies at / near the bases of the east and west arch skewback foundations (see Figures 7).

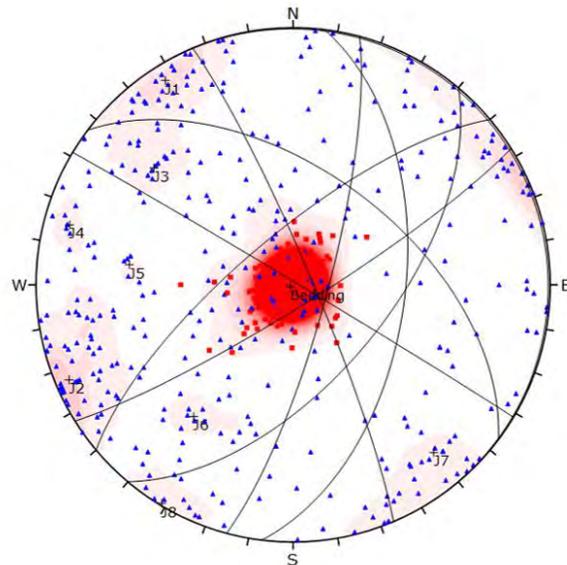
Figure 8 – Equal angle lower hemisphere stereonet showing distribution of bedding (red squares) and joint (blue triangles), with set poles and great circles (901 points, contour interval 0.63%)

Figure 8 presents a representative polar distribution plot for the combined rappelling and OTV/ATV data, including set pole concentrations, and great circles of the eight discontinuity joint sets and bedding plane used in the kinematic stability analyses. The sets include poles representing the three major discontinuities that plot within the 1 percent contour interval, and the poles representing the six minor joint sets that plot within the 0.1 percent contour interval. Table 1 below provides a summary of the nine joint and bedding sets.

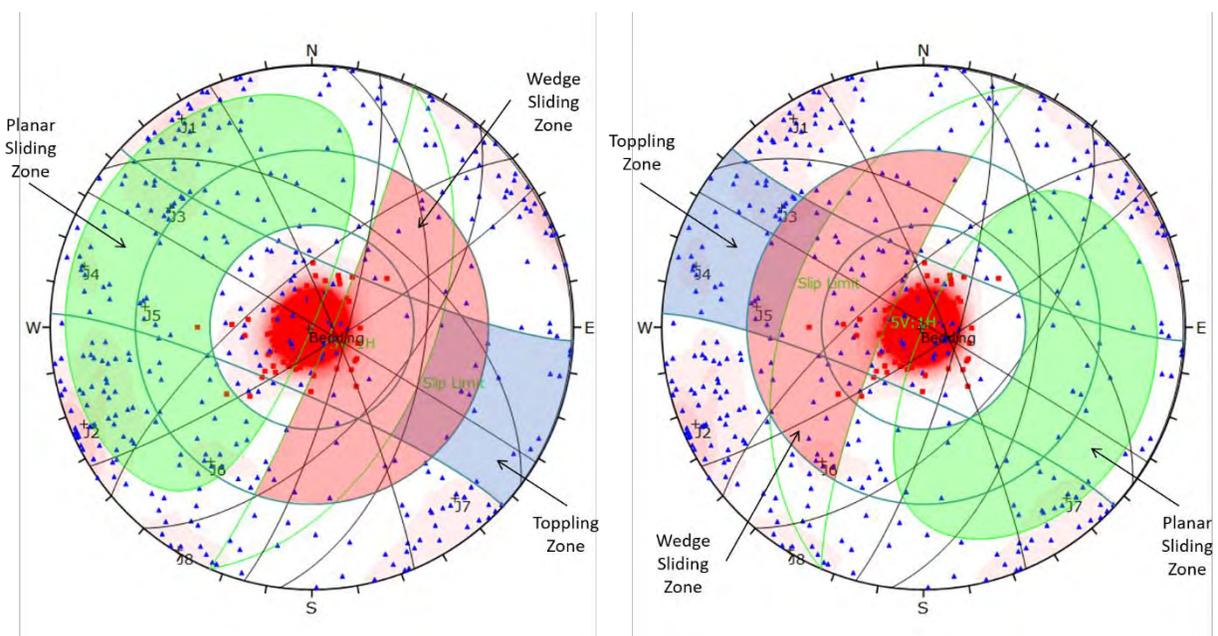
Figure 9 – Kinematics of west slope at 10V:1H (left), and east slope at 5V:1H (right)

For each cut slope, planar sliding daylight envelopes were plotted. The stereonets also include a base friction cone, oriented about the center, and spaced 32.5° from the center. Any pole pertaining to a discontinuity plotting within the daylight envelope but outside of the base friction angle cone is free to slide (the daylight envelope allows for the planar sliding test, i.e., there must be free space for a planar slab to slide into). Poles plotting within the green shaded region represent planes which could be susceptible to planar sliding. See Figure 9 for example stereographic kinematic analyses for the west and east slope excavations.

Each stereonet also contains the slip limit (green great circle) defined as the slope angle minus the friction angle. For toppling failure to occur, the dip of the planes must be steep enough for slip to occur. Each stereonet also has a horizontal cone representing a kinematic bound envelope with limits of 20 degrees on either side of the dip direction of the proposed cut. Poles plotting outside this limit represent discontinuities that are likely aligned too oblique to be able to slide. Any pole plotting outside of the slip limit but within the 20-degree kinematic bounds represents a plane, which could topple kinematically. This zone is represented by the blue shaded region.

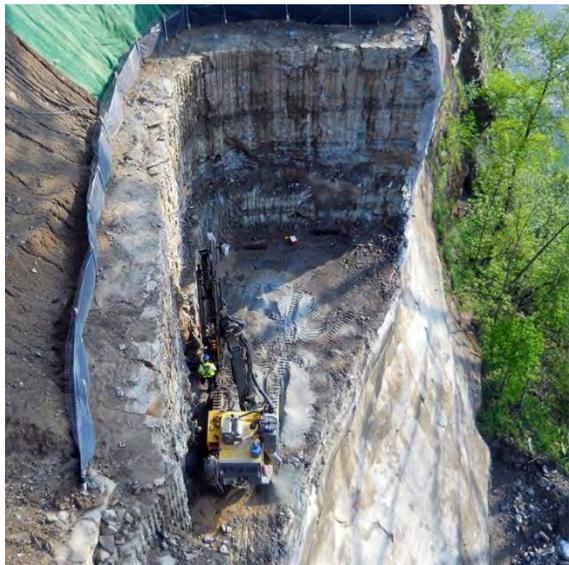
Figure 10 – Narrow, tight conditions for the west slope excavation

Rock excavation activities, using “*close-in*” controlled rock blasting, were conducted from February to December 2016, removing about 15,750 cubic yards of rock. The blast design included unloaded, closely spaced vertical line drilling for perimeter control of each lift (see Figures 10 and 11). Typically, each blasting lift was limited to 15 ft in height. The Contractor was also required to mechanically excavate all rock within 10 ft of the proposed arch skewback foundation bearing surfaces.

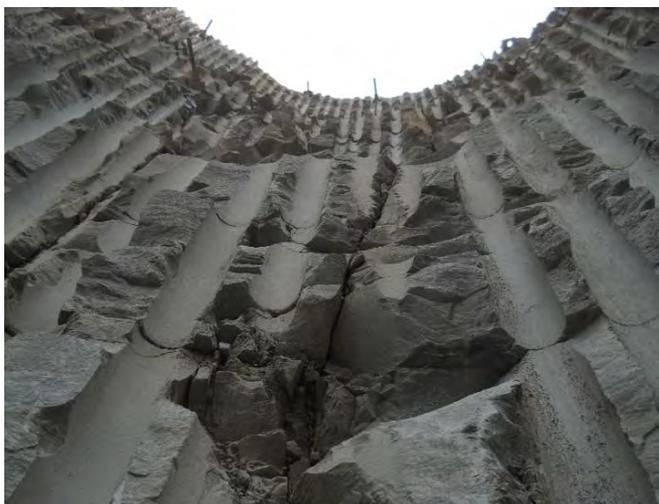
Figure 11 - Line drilling used for perimeter control for each rock excavation lift

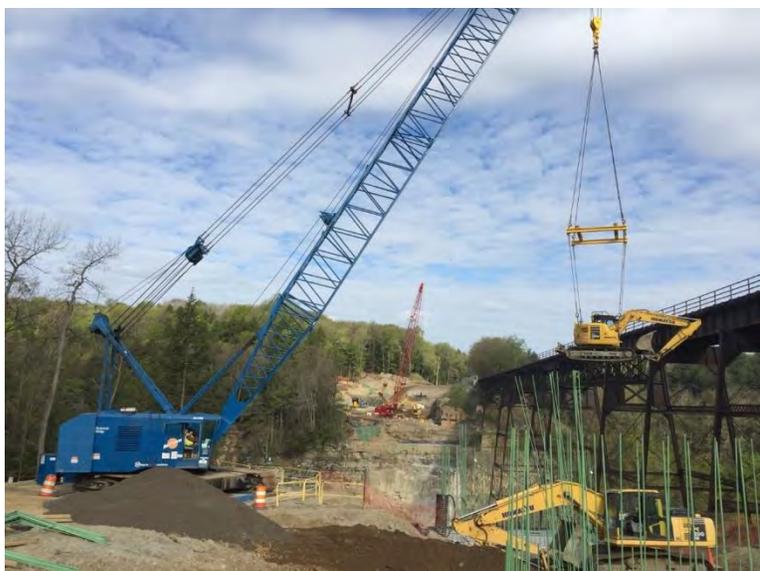
Figure 12 – Access to excavation areas with large cranes

the controlled, close-in blasting, along with anchored rubber-tire blasting mats to contain potential flyrock. In general, two to three blasts were needed for each lift. Excavation equipment consisting of remote-controlled hydraulic blasthole rigs and micro-excavators, along with the workers, explosives and other construction material, and the excavated rock, were lowered into or raised out of each excavation by two 200-ton cranes staged on both sides of the gorge (see Figure 12).

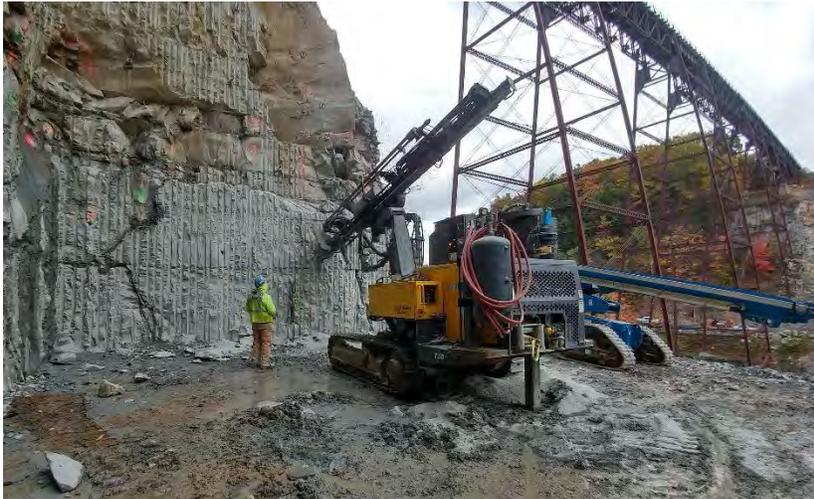
Figure 13 - Drilling rock dowels in the west slope excavation

As each lift was completed, the contractor installed pattern rock dowels (see Figure 13), per the rock slope stabilization design. Dental shotcrete and shotcrete buttresses were installed when each excavation reached full depth. Due to the presence of unsuitable pyritic shale materials at the base of the excavation (verified by rock coring as excavation activities approached foundation levels), the excavations for the arch skewback foundations were

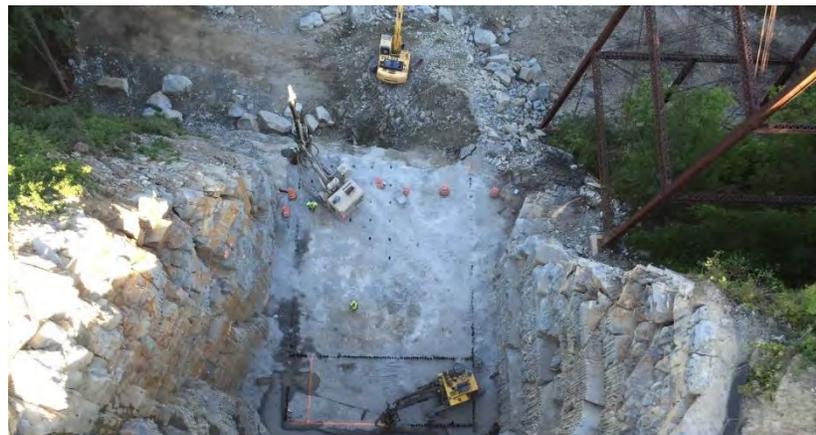
Figure 14 – Line drilling at the bottom of the east slope excavation to over-excavate pyritic shale and replace with concrete

deepened to over-excavate the unsuitable shale materials and replace it with concrete, so that the arch skewback foundations would not bear directly atop such unsuitable pyritic shale materials and thus reduce risks associated with concrete degradation (see Figure 14).

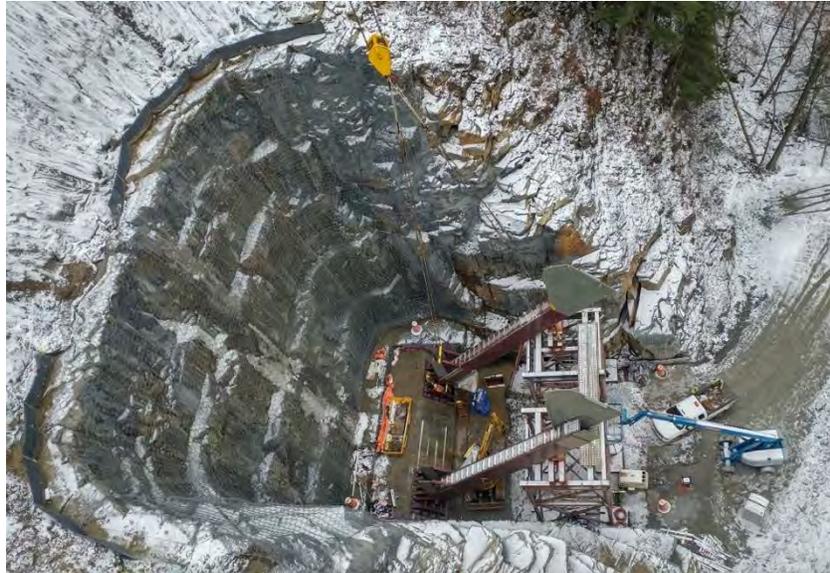
Figure 15 – Completed drape netting and arch skewback bearings under construction in the east slope excavation

Rock blasting and excavation activities were successfully completed without adversely impacting the old High Bridge, and train traffic was not interrupted throughout construction. Following completion of rock excavation activities, a series of rock drains were installed at the toes of each excavation, along with a ring-net drape, attached at the slope crests with wire rope anchors (see Figure 15).

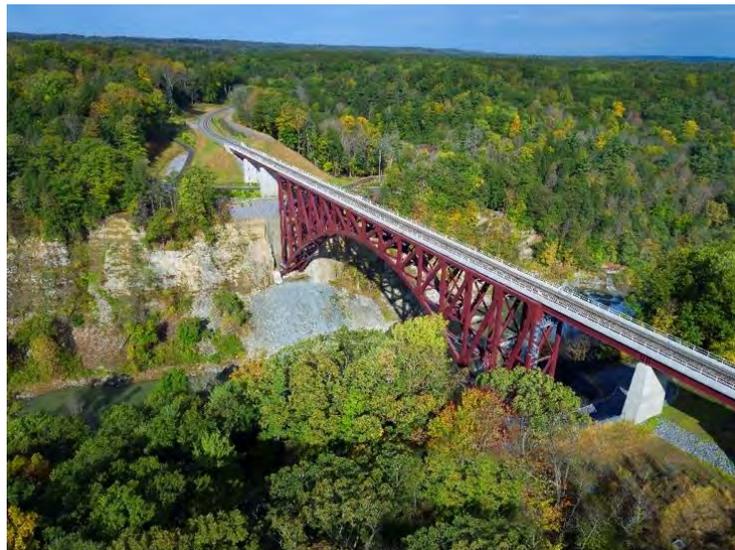
Figure 16 – Completed Genesee Arch Bridge

On December 11, 2017, the new bridge was opened to railway traffic, and AB subsequently started work to demolish the old High Bridge, which was subsequently removed by May 2018. On May 24, 2018, a formal bridge dedication ceremony was held, during which it was officially renamed the Genesee Arch Bridge (Irwin and Johns, 2019; see Figure 16).
