70TH HIGHWAY GEOLOGY SYMPOSIUM

“Better Highways Through Applied Geology”

October 21-24, 2019

2019 Proceedings

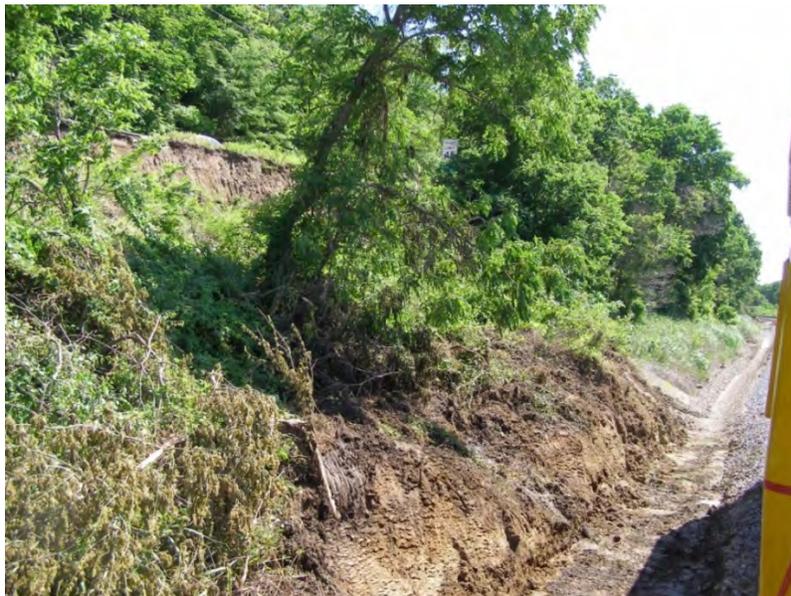
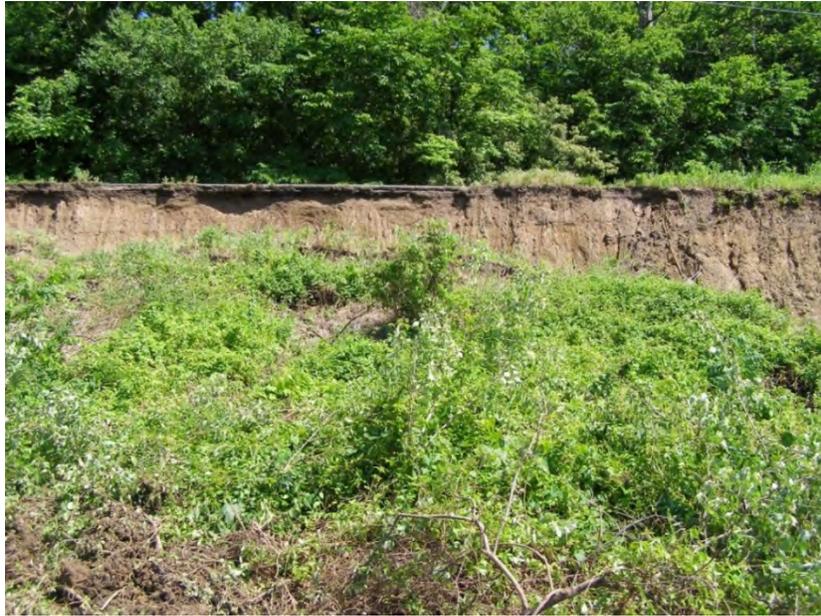
Slope as observed from BNSF

The north (uphill) side of Route T is in a 15 to 20 feet deep vertical cut in loess. Also, at the east end of the study area and along the inside radius of the existing roadway, a significant amount of soil of the bluff has failed and is blocking the roadway. The downhill failure side of Route T has a steep, approximately 1H: 1V slope down to an existing ditch. The BNSF Railroad double tracks are located adjacent to the ditch. The slope failed into the ditch of the railroad during the event and the toe of the slide mass was removed to reopen the railroad. Lateral stress cracks are observed at various locations along the roadway from the centerline to the south edge of the existing pavement indicating instability under nearly all the existing roadway.

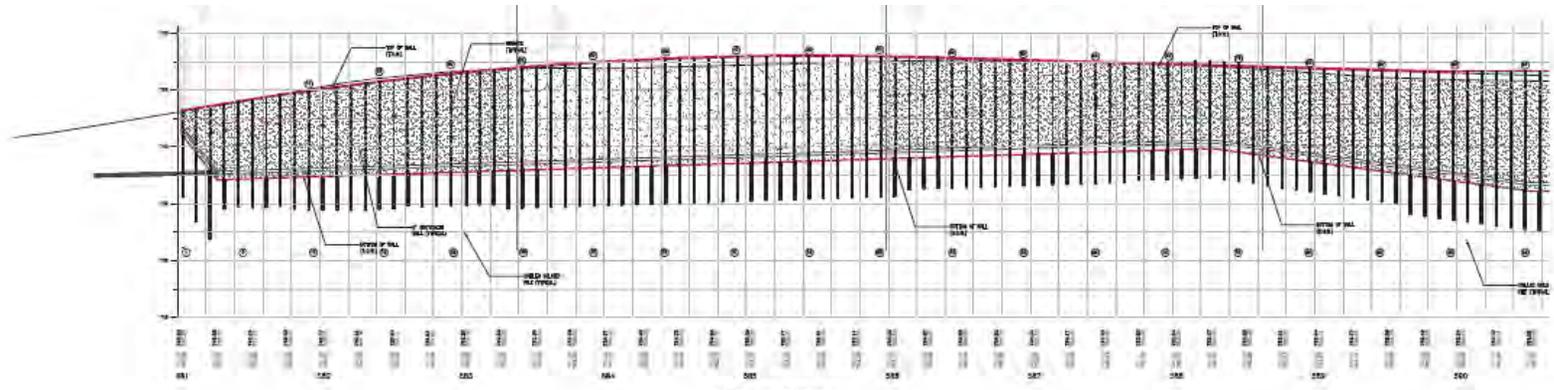
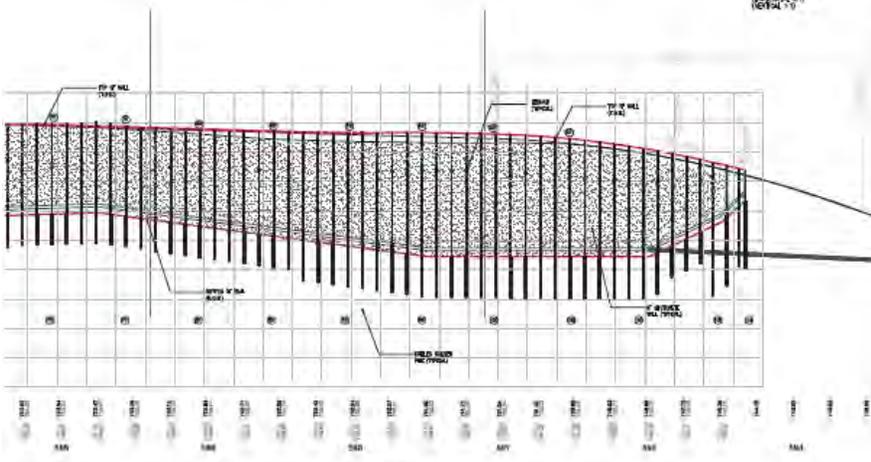
ELEVATION PLAN VIEW
SCALE: 1/4" = 1'-0"
REVERSE SIDE

MoDOT held a series of meetings with the Contractor and his designer to discuss the soldier pile wall alternate and agreed on the requirements for design and construction of the soldier pile wall. After a number of back-and-forth design and plan submittals between the Owner and the Contractor, an approved set of soldier pile wall plans and specifications were finalized in early November 2016. The Contractor had started with site prep and ordering soldier pile and other materials ahead of final approval in order to make up for initial loss of time getting the alternate approved. The final soldier pile wall had a total length of 1165 feet with an exposed height varying from 4 to 21 feet. Soldier piles were spaced at 10-foot centers and consisted of HP 14x102 sections for cantilever heights up to 11 feet and HP 10x42 sections for tieback wall heights from 12 to 21 feet. Single tiebacks consisted of two and three 7-wire strand double corrosion protected tiebacks. Tieback lengths varied from 30 to 40 feet installed at a 20-degree

rake. Tiebacks were required to stay on MoDOT right-of-way that was 46+ feet behind the wall face. All excavation and wall construction operations were required to stay within the narrow bench between the face of wall and property line with the BNSF Railway. A conventional soldier pile wall utilizes timber lagging between soldier piles with a cast-in-place concrete permanent face. The Contractor chose to excavate at the face in 5-foot lifts, install drainage strips, wire mesh and reinforcing bars, and place final shotcrete wall facing with trowel and screed finish before proceeding to the next lower level. Vertical drainage strips were connected to a lateral drainage collector pipe at the base of wall and outleted beyond the wall.

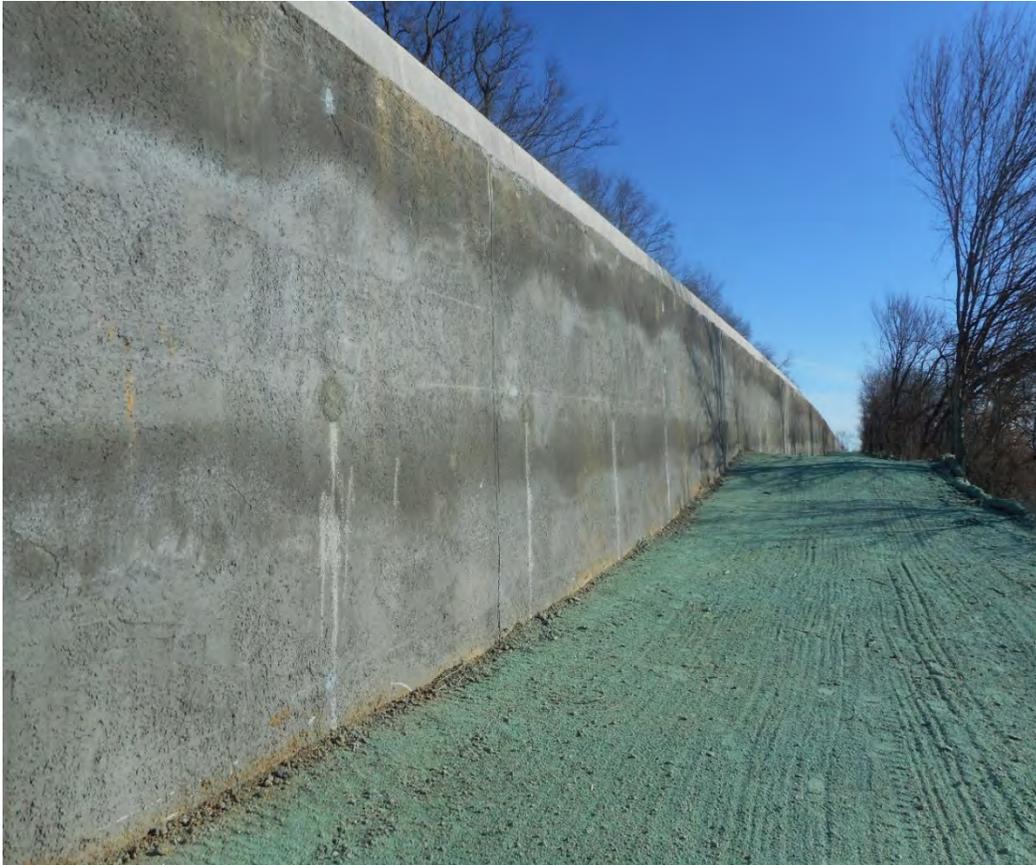
Finished Wall

The wall construction was started in early November 2016 and completed in early January 2017. Wet mix shotcrete was cold-weather protected with blankets and heaters. MoDOT provided the resident engineering and daily construction inspection while HNTB Geotechnical section assisted with shop drawing, wall design, and tieback testing submittal reviews and observation of wall construction. Following final grading and paving, the roadway was opened to traffic on February 14, 2017, some 73 days beyond the contract date.

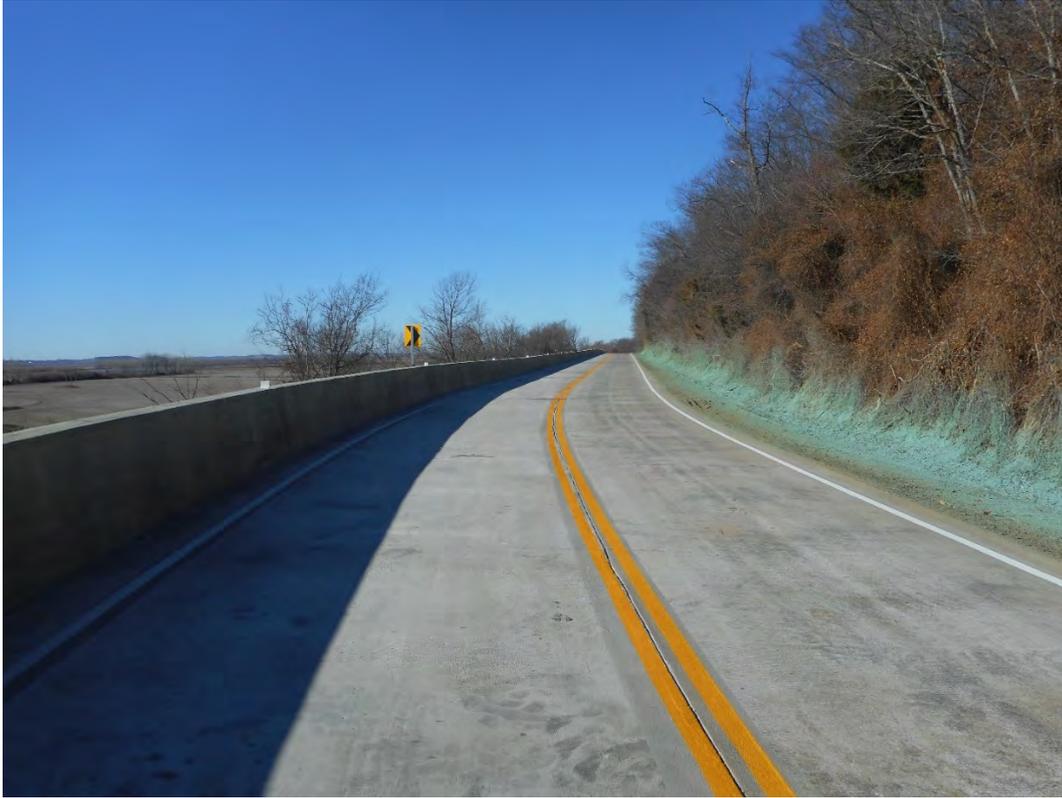
Completed Slide Repair and Reconstructed Roadway

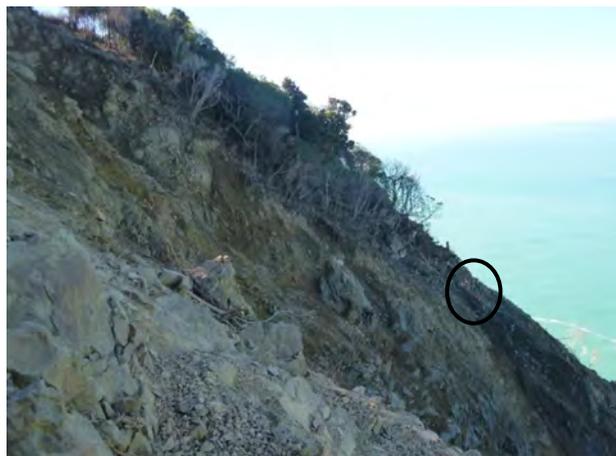
Figure 3 - Rope access technicians (circled) scaling head scarp, Slip 7 north of Ohau Point, Kaikōura, Feb. 2017. Photo: R.Musgrave

Some occupations are unavoidably exposed to hazards that are in the nature of their jobs. The requirements of the role played by rope access workers involved in the Kaikōura reconstruction are such that it could not be performed without exposure to some risk (Fig.3). A lack of New Zealand-based rope access technicians with the relevant experience meant that many in the workforce were contractors from overseas, unfamiliar with New Zealand conditions, or were newly qualified technicians with no prior geotechnical experience.

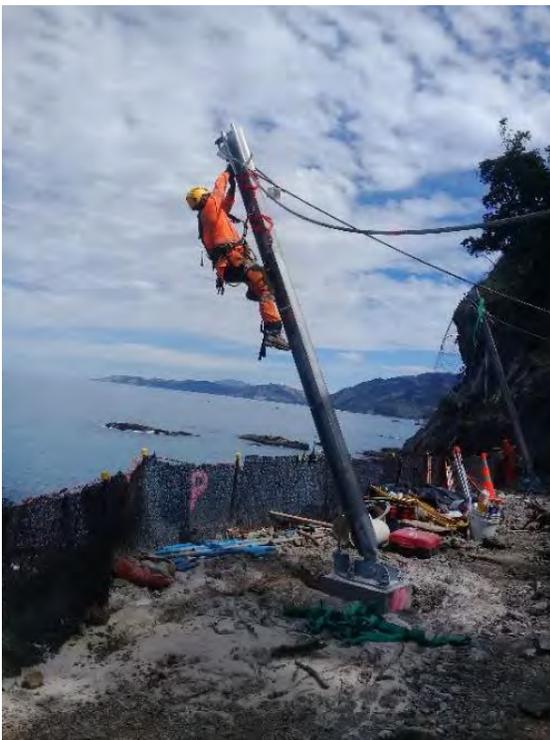
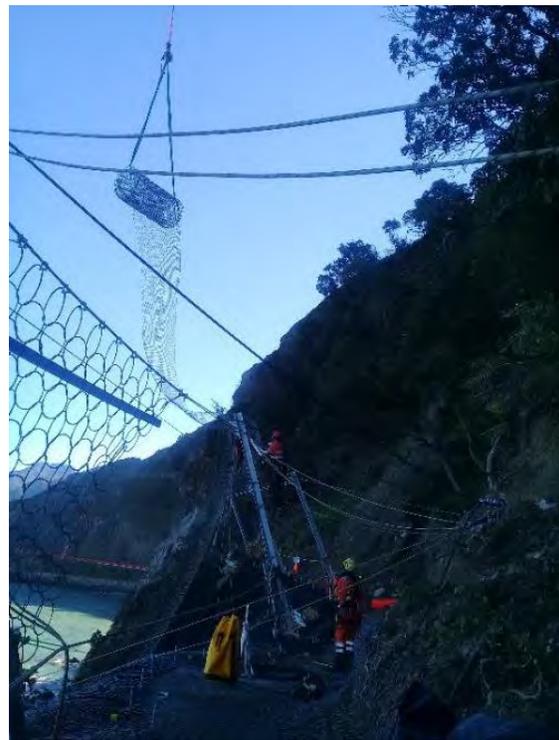
Figure 4 (left) - Construction of shallow landslide barrier, Slip 18 south of Kaikōura, Nov. 2017. Figure 5 (right) - Installing mesh by helicopter sling load, a high-risk activity, Slip 18. Heli-operations were often conducted over an open highway. Photo R. Musgrave

On November 30th 2016 the Inland Kaikōura Road was provisionally opened to civilian convoys. Work then began on SH1 and the MNL, first south and then north of Kaikōura. Construction workers began to remove debris from the toe of the landslides, in order to facilitate access and begin repairs on the road and rail. Initially, the rope access technicians were providing a support role, reducing risk for other workers on the project (as in the response phase), and thus enabling important and urgent work below the earthquake damaged slopes to proceed. Later, the construction of temporary and permanent engineered rock-fall and landslide risk mitigation structures began on the slopes. This specialist activity requires a high degree of skill and experience (Figs. 4 & 5).

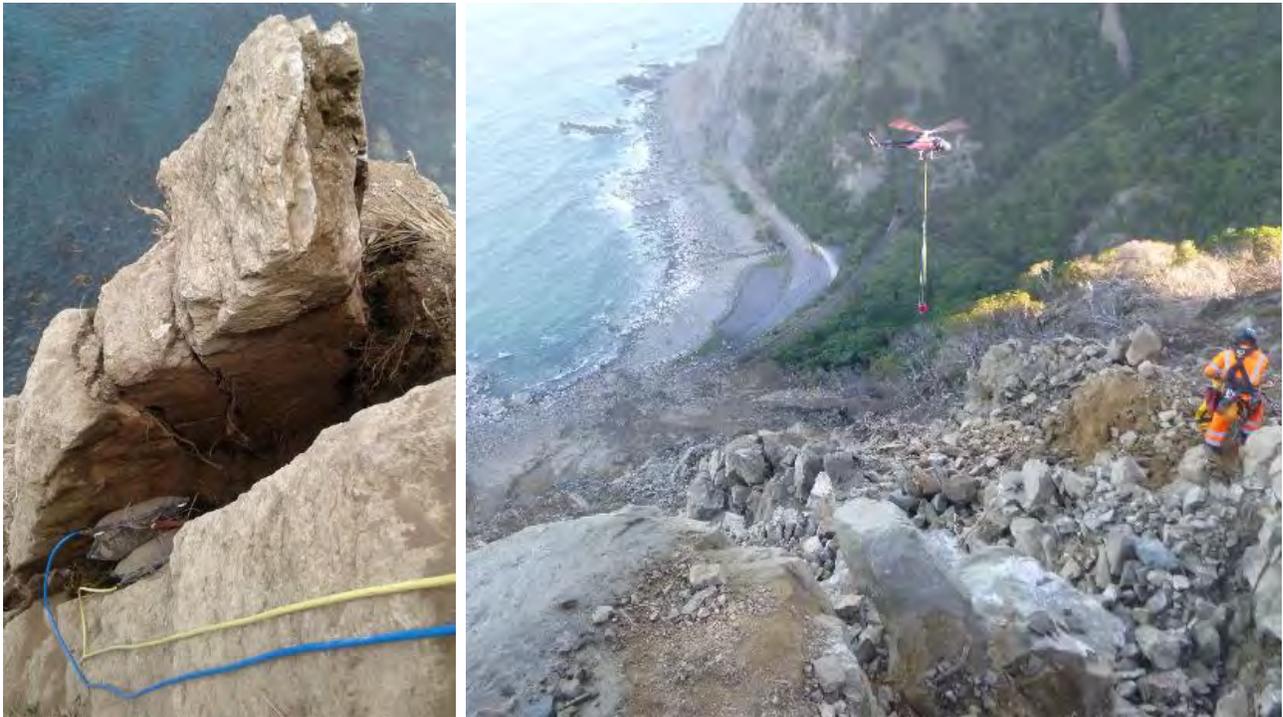
Figure 6 (left) - Air bags used to remove an unstable column of rock while operators retreat to a safer location, Slip 10, south of Kaikōura. Photo R. Musgrave. Figure 7 (right) - Sluicing to remove loose debris below abseiler, Slip 7, north of Ohau Point, Kaikōura. Photo R. Musgrave

Where possible, operators avoided accessing the lower slopes of the landslides, by substituting alternative methods for removal of hazards (Figs. 6 & 7).

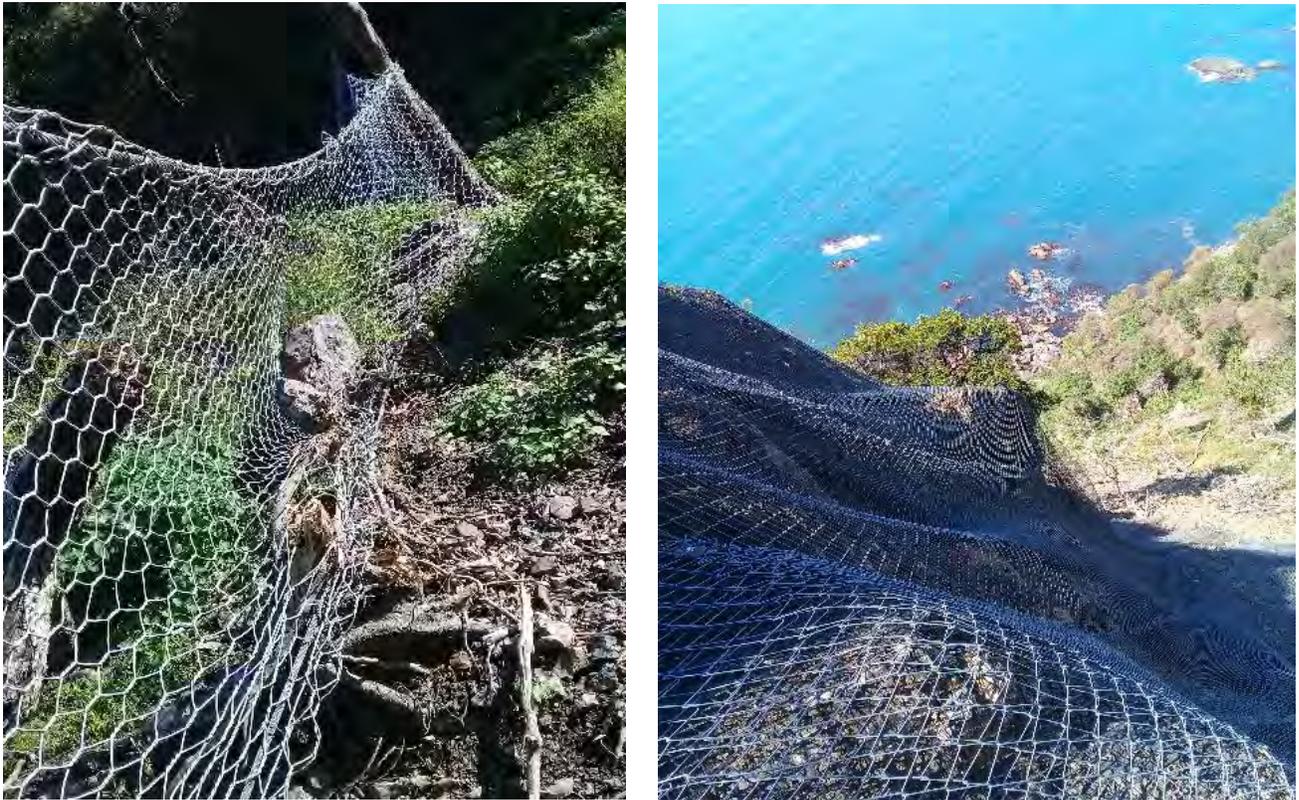
Figure 8 (right): Example of temporary rockfall mesh installed above an occupied worksite, Slips 18 &19, south of Kaikōura. This structure contained a ~100 m³ failure which occurred during rainfall, June 2017. Figure 9 (left): Temporary rockfall catch fence above worksite, Slip 18. This structure was impacted 4 times by rocks ~1m³ during the course of construction of a shallow landslide barrier directly below. Photos: R. Musgrave.

In order to begin the construction of engineered risk-mitigation design structures, it was necessary in some cases to first install temporary structures for the protection of workers required to spend long periods of time below significant rock fall hazard on the lower slopes of landslides (Figs. 8 & 9).

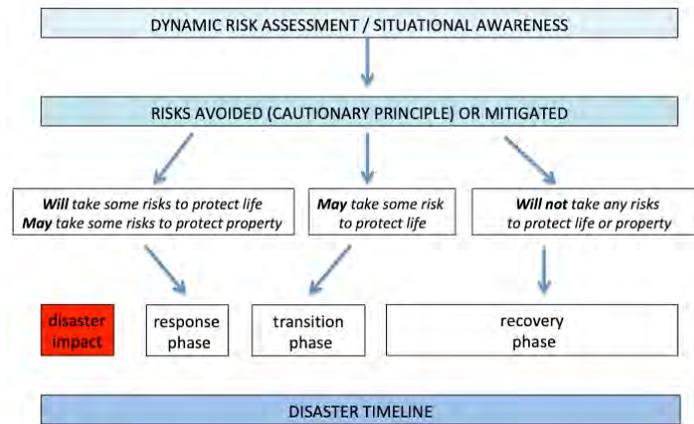
Figure 10 - Suggested decision-making approach for operators during different phases of disaster Practitioners require communication and support from regulators during transition between the phases. Where clear boundaries do not exist, risk levels and accident rates should be trending down. Image adapted from (39).

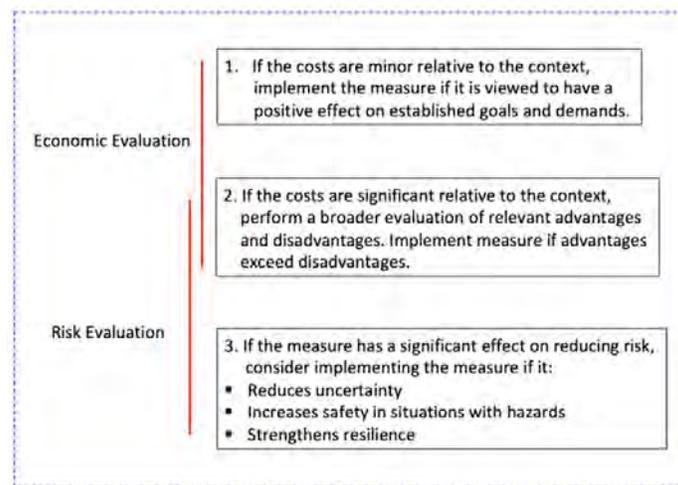
Figure 11 - Suggested decision-making approach for regulators and stakeholders during times of uncertainty. A dynamic approach is recommended, giving weight to either an economic or safety perspective, depending on the context, Image adapted from (37).

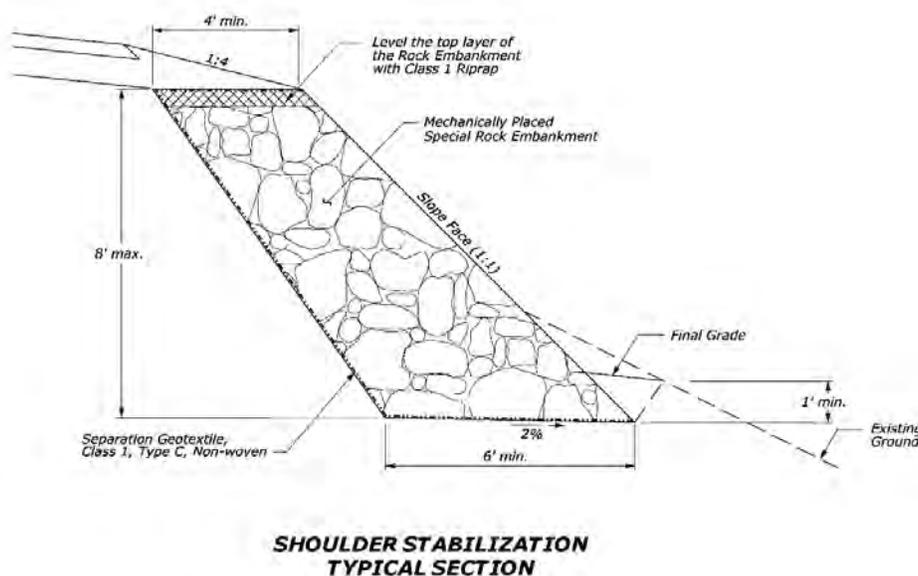
Figure 3 – Typical Shoulder Stabilization Detail by FHWA

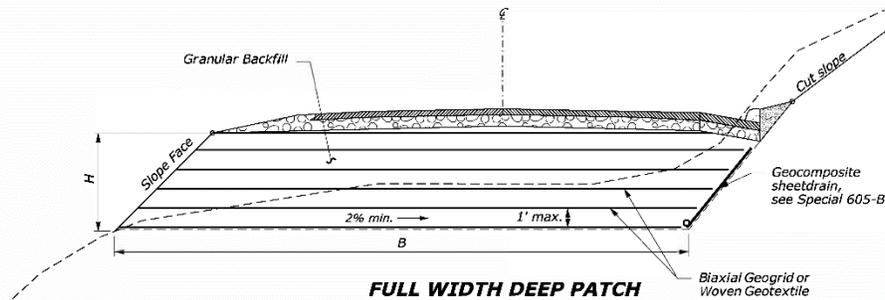
Figure 4 – Typical Deep Patch Detail by FHWA

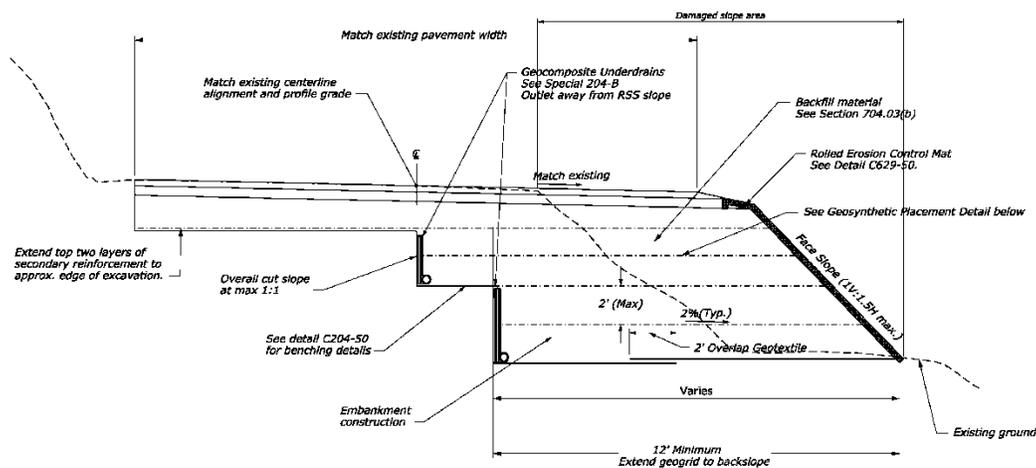
Figure 5 – Typical RSS Detail by FHWA

Where the roadway embankment has been completely lost, a Reinforced Soil Slope (RSS) can be constructed to reestablish the roadway while limiting environmental impacts and import fill. RSS consist of alternating layers of select fill and geosynthetic reinforcement (Berg et al., 2009). Face angles can vary from about 26 degrees to 70 degrees, while vertical reinforcement spacing can vary from 8 inches to 2 feet. The reinforcement spacing depends on the backfill material and the slope angle. Where the slope is constructed steeper than 34 degrees (1V:1.5H), wrapping of the geosynthetic at the face is commonly employed. Relatively shallow slope faces are commonly seeded with native grasses; steeper slopes can employ a hard facing. RSS are taller than the typical deep patch repair and need more detailed analysis, but can still be constructed by a general contractor. A special rock embankment can be included to protect the toe of an RSS. A typical RSS detail is presented in Figure 5.

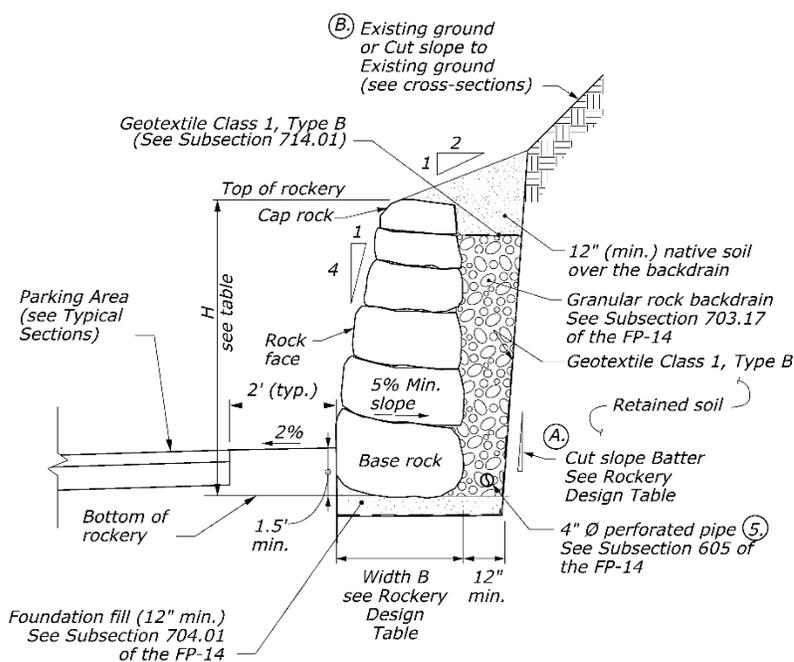
Figure 6 – Typical Rockery Detail by FHWA

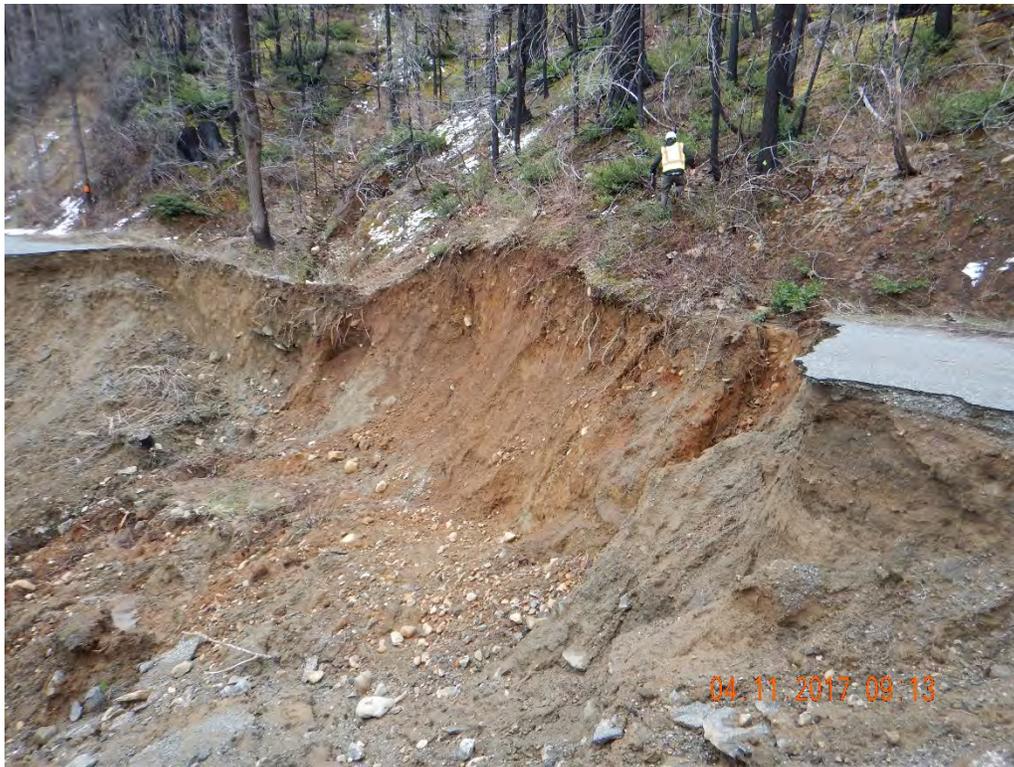
Figure 7 – Embankment Failure at Eleven Pines Road

embankment failures typically extended the full width of the roadway, were 100 to 300 feet wide and 20 to 50 feet deep. The slopes below the failures were relatively steep, with slope ratios between 1V:2H and 1V:1.5H. Based on these factors, RSS and MSE walls were the technically feasible alternatives. Conventional embankments would have required a significantly larger footprint to construct, and no other repair options were appropriate to the situation. RSS were selected due to their lower cost, ease of construction, and use of lower quality backfill compared to MSE walls. Other repair work included standard embankment construction, culvert replacement, drainage improvements such as headwall installation and erosion protection, and pavement reconstruction. The geotechnical engineer performed analyses to correctly size the RSS and assisted other personnel to compile the project plans and specifications.

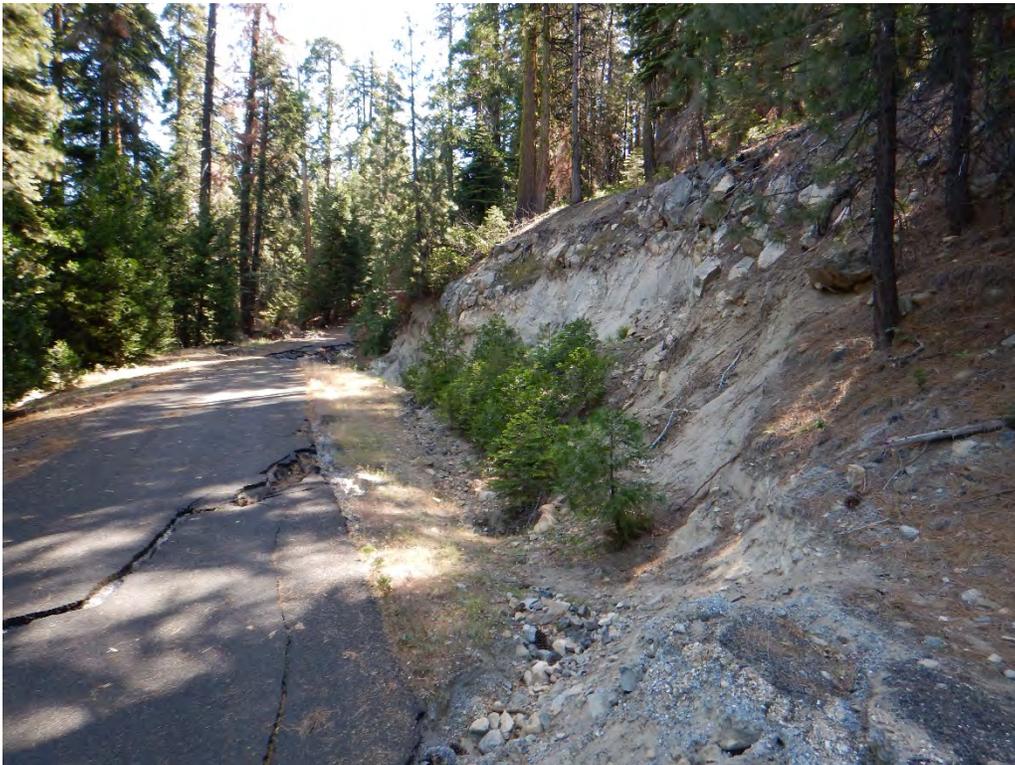
Figure 8 – Embankment Failure on Rattlesnake Road with Bedrock Exposed

Rattlesnake Road (Forest Road 05N14) is located in the Stanislaus National Forest, approximately three miles east of the unincorporated settlement of Camp Connell, California. The road climbs along a variably steep to gentle cross slope, following the course of the Little Rattlesnake Creek. Similar to Eleven Pines Road, heavy precipitation caused embankment failures at several locations along this road. In this case, stable rock was exposed in the slide scarp and the existing slopes were less steep (Figure 8). Therefore, conventional embankment, RSS, and MSE walls are the most

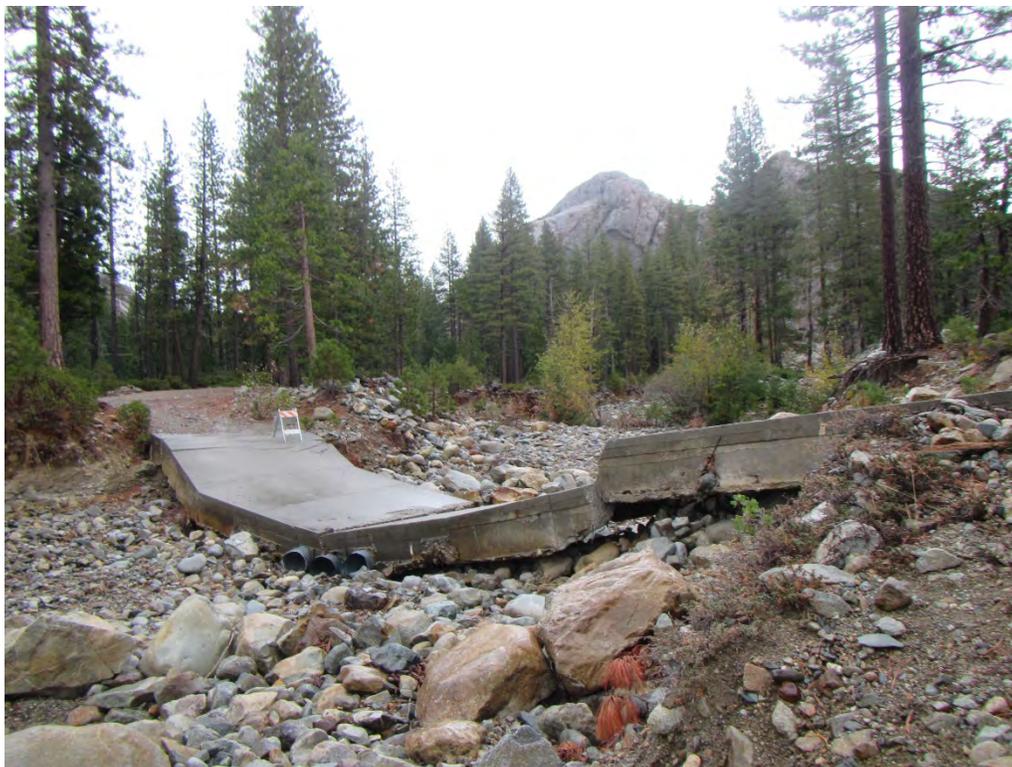
Figure 9 – Damage to Low-Water Crossing on Bowman Lake Road

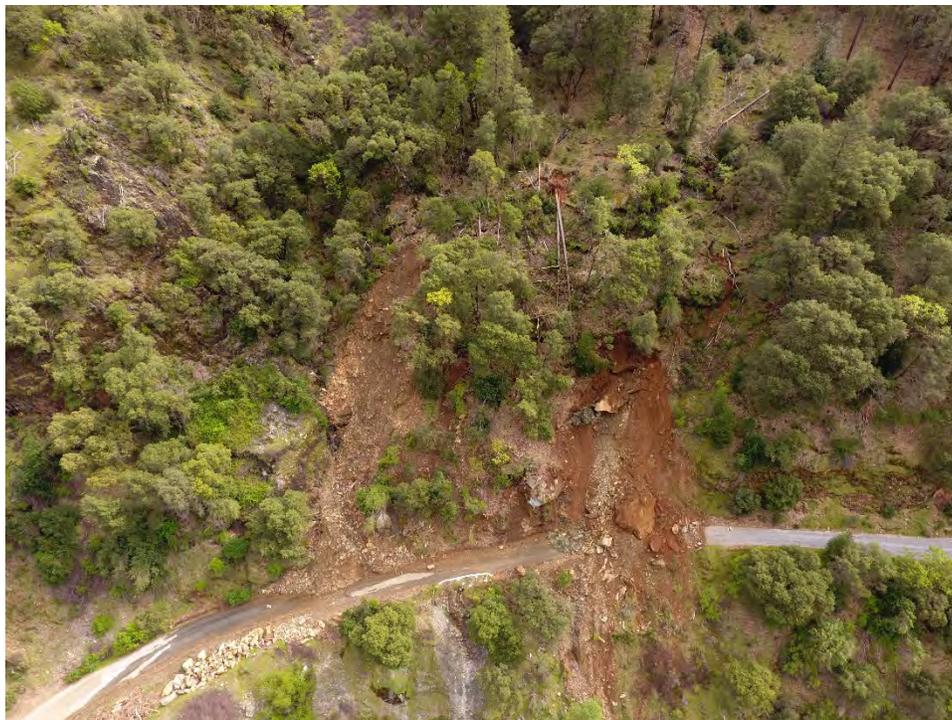
Figure 10 – Slide on Blacksmith Flat Road in 2017.

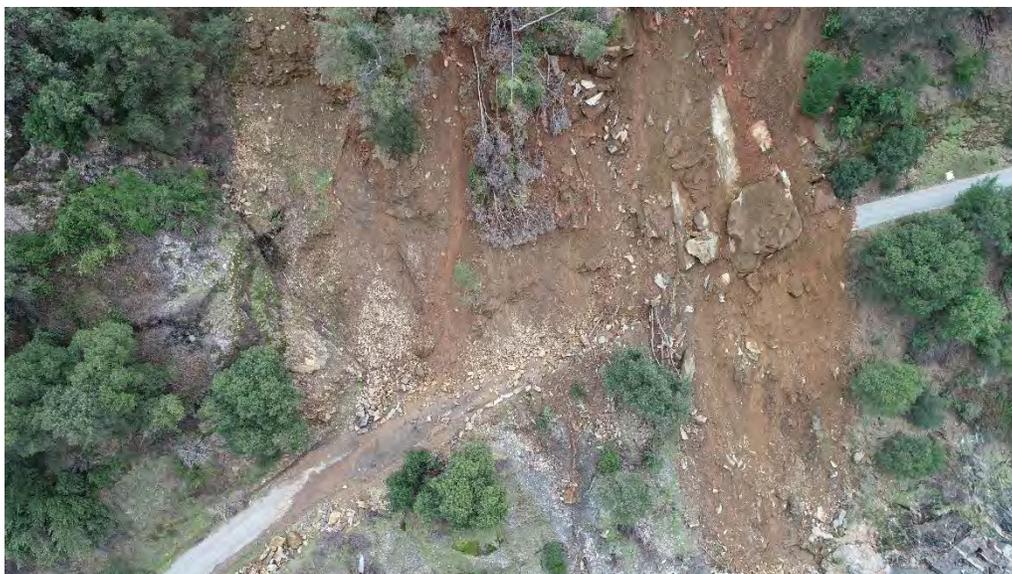
Figure 11 – Slide on Blacksmith Flat Road in 2019.

Raveling of the slope was noted after heavy rains in December, 2018, followed by a large failure of similar size to the original slide in February, 2019 (Figure 11). Repair of this new slide is underway, but is not covered by the ERFO program and not being designed or administered by FHWA. The reactivation of this landslide is indicative of the types of risk involved in emergency repairs.

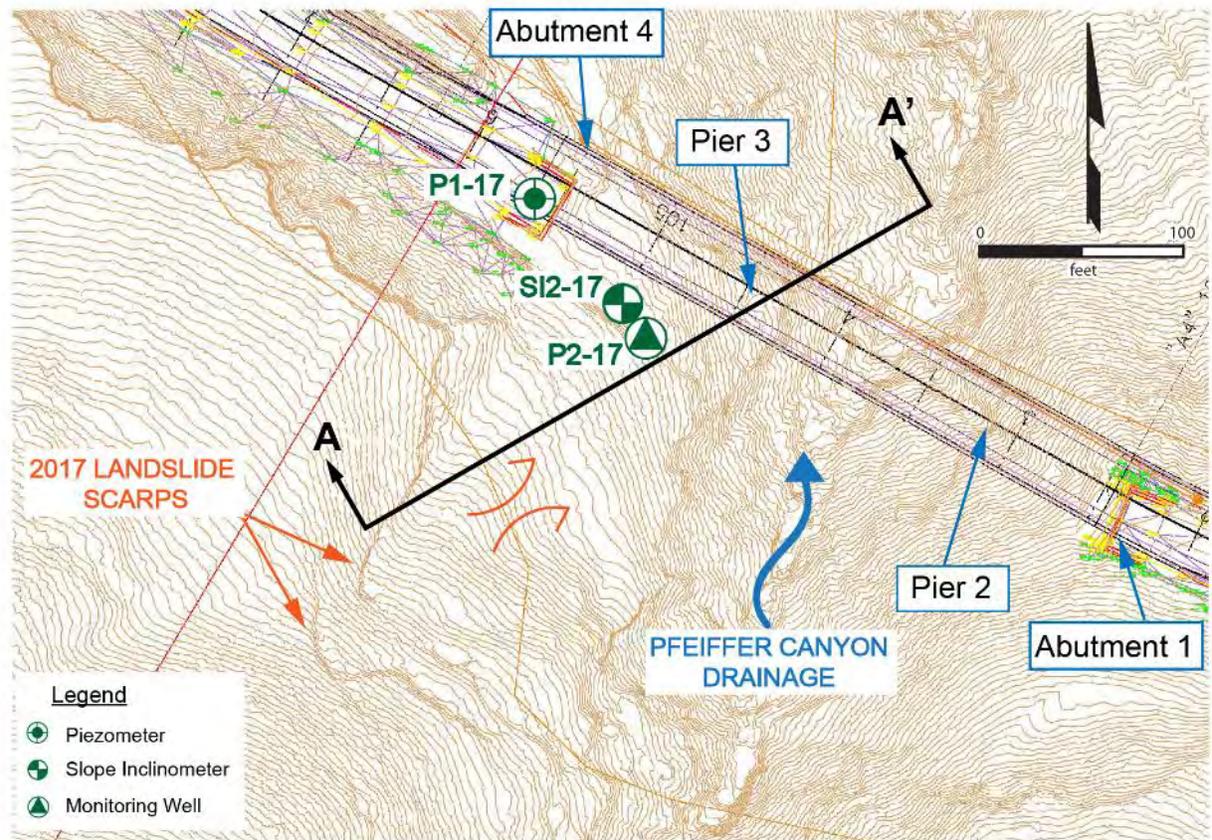
Figure 2: Pfeiffer Canyon Topography

Slope stability analyses were performed to evaluate the probability of failure along cross-section A-A' (see Figure 2), which is oriented along the same azimuth of movement observed in the slope inclinometer data (azimuth = 060) and includes the location of the damaged bridge pier column (Pier 3). The slope stability analyses evaluated potential failure surfaces (i.e., landslide planes) that intersected the 6-foot diameter reinforced concrete pile supporting the pier column, and potential failure surfaces located below the pile. The groundwater surface modeled in the slope stability analysis was based on the highest groundwater elevation measured in piezometer P2-17, approximately 3 weeks after the 2017 landslide.

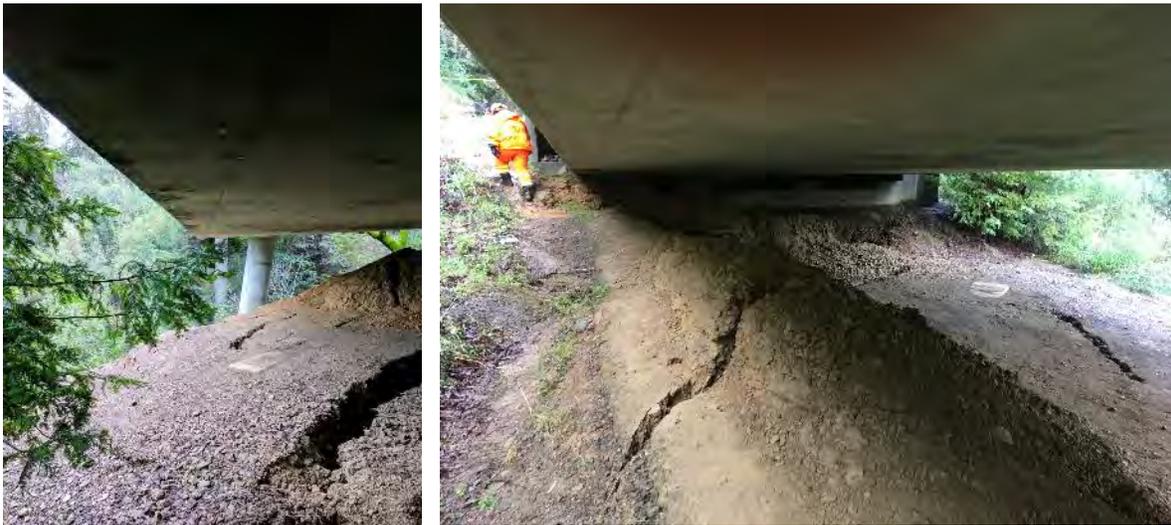
Figure 3: Facing east, displaced Pier 3 in foreground, Pier 2 in background (left); Facing west, lateral scarp of landslide downslope of Abutment 4 (right)

Figure 3 shows photos of the displaced Pier 3 and the lateral scarp of the landslide immediately downslope of Abutment 4. Caltrans engineers considered structurally retrofitting Pier 3 before additional slope displacement and subsequent structural damage to the pier column and bridge deck required permanent closure, and demolition and replacement of the bridge using emergency funding sources. Caltrans contracted with Golden State Bridge (GSB) to demolish and construct

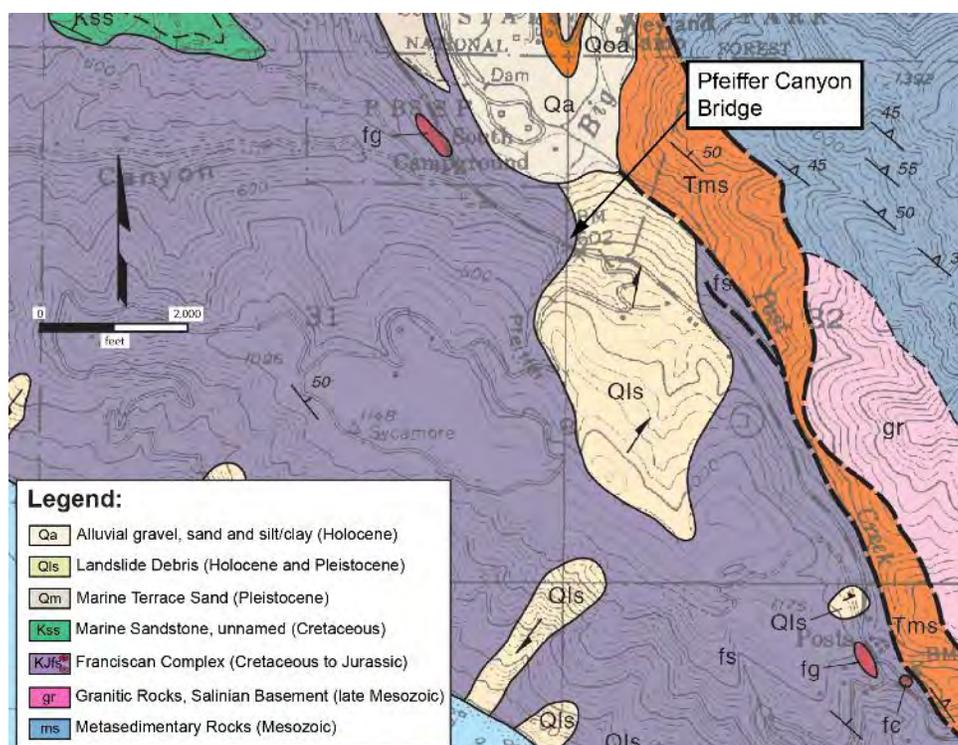
Figure 4: Geologic Map after Dibblee (2007)

The bridge site is located within the Santa Lucia Range of the Coast Ranges geomorphic province. Figure 3 shows the surficial geology at the site as mapped by Dibblee (2007). The site is mapped as late Mesozoic Franciscan Complex (fs), which is described as a *mélange* of pervasively sheared, deep marine sedimentary and volcanic rocks, metamorphosed under conditions of high pressure and low temperature. The composition of the Franciscan Complex represents the subduction of oceanic plates and associated pelagic sediments deposited in a subduction trench during the Jurassic period. This tectonic setting resulted in the accretion of oceanic lithosphere (meta-basalt, fg) and near-source pelagic sediments dragged downwards with the subducting oceanic plate and subjected to high pressure-low temperature metamorphism producing metagraywacke, metasiltstone, chert and shale. The *mélange* is typically characterized as a bimrock (block-in-matrix rock). The sheared matrix of the *mélange* typically weathers to a predominantly clay soil that is prone to landsliding. Dibblee (2007) mapped a relatively large landslide (Qls) immediately east of the bridge site.

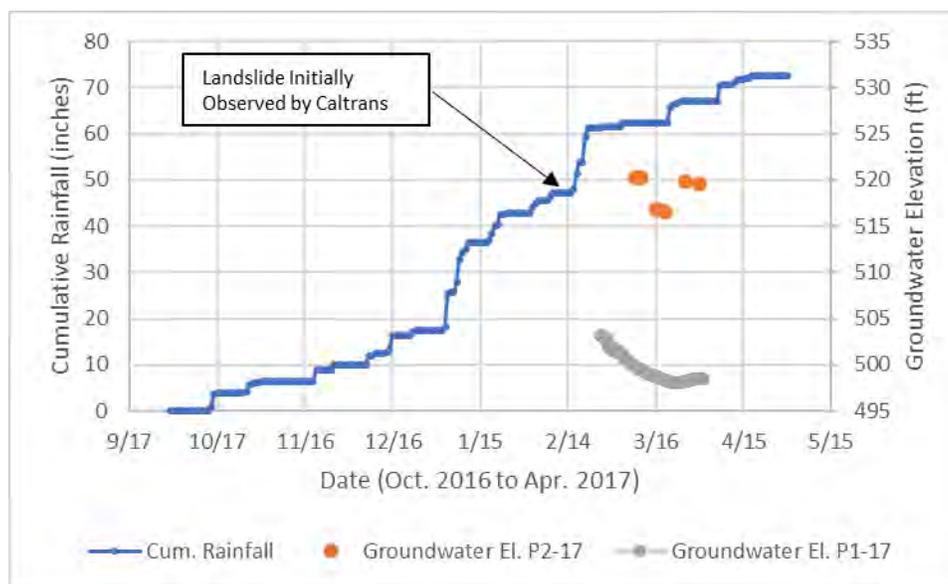
Figure 5: Big Sur Rainfall and Groundwater Data

Landsliding typically occurs in the Franciscan Complex during relatively wet winter months and is predominantly associated with elevated groundwater surfaces. Figure 5 shows Big Sur rainfall data¹ and groundwater data recorded by the piezometer P1-17 and monitoring well P2-17.

Groundwater and seepage conditions within the Franciscan Complex bedrock are typically variable and associated with groundwater flowing along discontinuities, fractures, and relatively impermeable shear planes. The variability of groundwater conditions is illustrated in Figure 5, which shows the groundwater elevations in the monitoring well and piezometer, located approximately 80 feet apart, differed by approximately 17 to 22 feet during March 2017. Slope movement was evident in the slope inclinometer data at depths of approximately 35 and 55 feet, indicating there were multiple slide planes within the landslide mass. Thus, groundwater in P2-17 may have been perched above an interpreted landslide plane at a depth of approximately 55 feet (el. 517.5 feet). The slope inclinometer and groundwater data were used in slope stability analyses, including back-analysis of the 2017 landslide to estimate the shear capacity of the reinforced concrete pile supporting Pier 3.

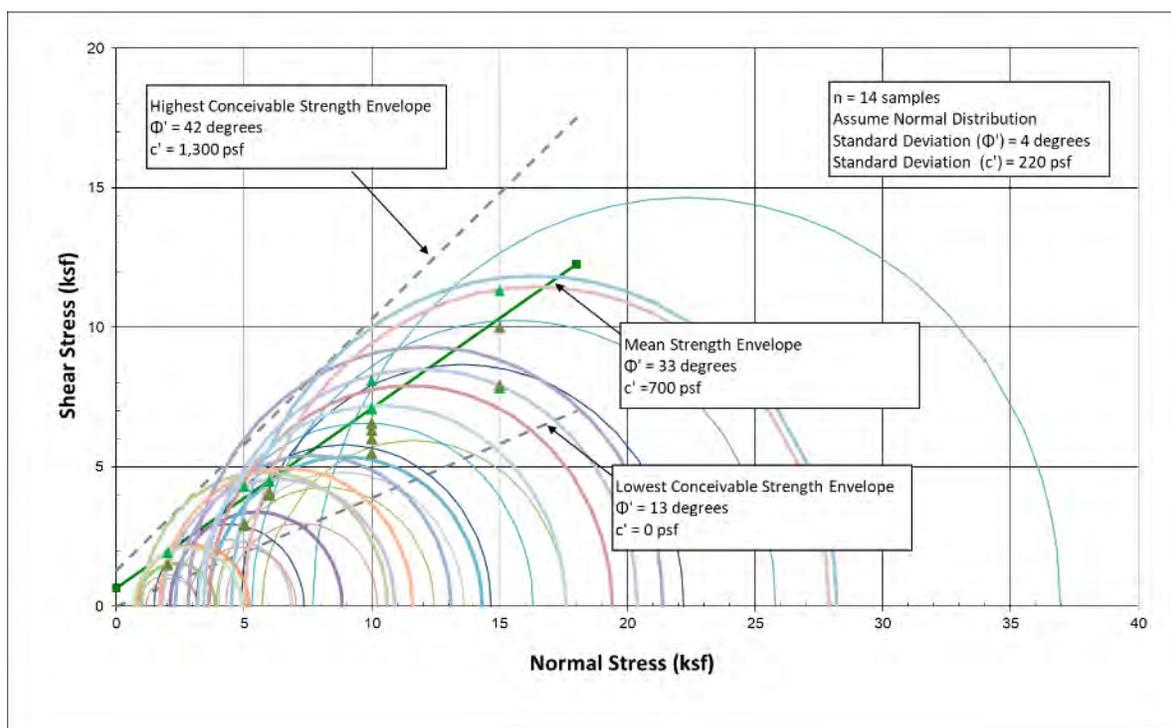
Figure 6: Results of DS and CU Laboratory Tests

Strength parameters for the Franciscan Complex *mélange* were developed on the basis of laboratory test results and statistical analysis of the test results shown in Figure 6. A total of 14 tests for direct shear strength or triaxial compressive strength using consolidated undrained loading were performed on *mélange* samples recovered from borings drilled in the bridge vicinity. Figure 5 shows an estimated mean friction angle of 33 degrees and a mean cohesion of 700 pounds per square foot (psf). Standard deviations of friction angle (4 degrees) and cohesion (220 psf) were estimated assuming a normal distribution for these parameters and using the "three-sigma rule" (Dai and Wang, 1992), which is predicated on the fact that 99.73-percent of all values of a normally distributed parameter fall within three standard deviations above and

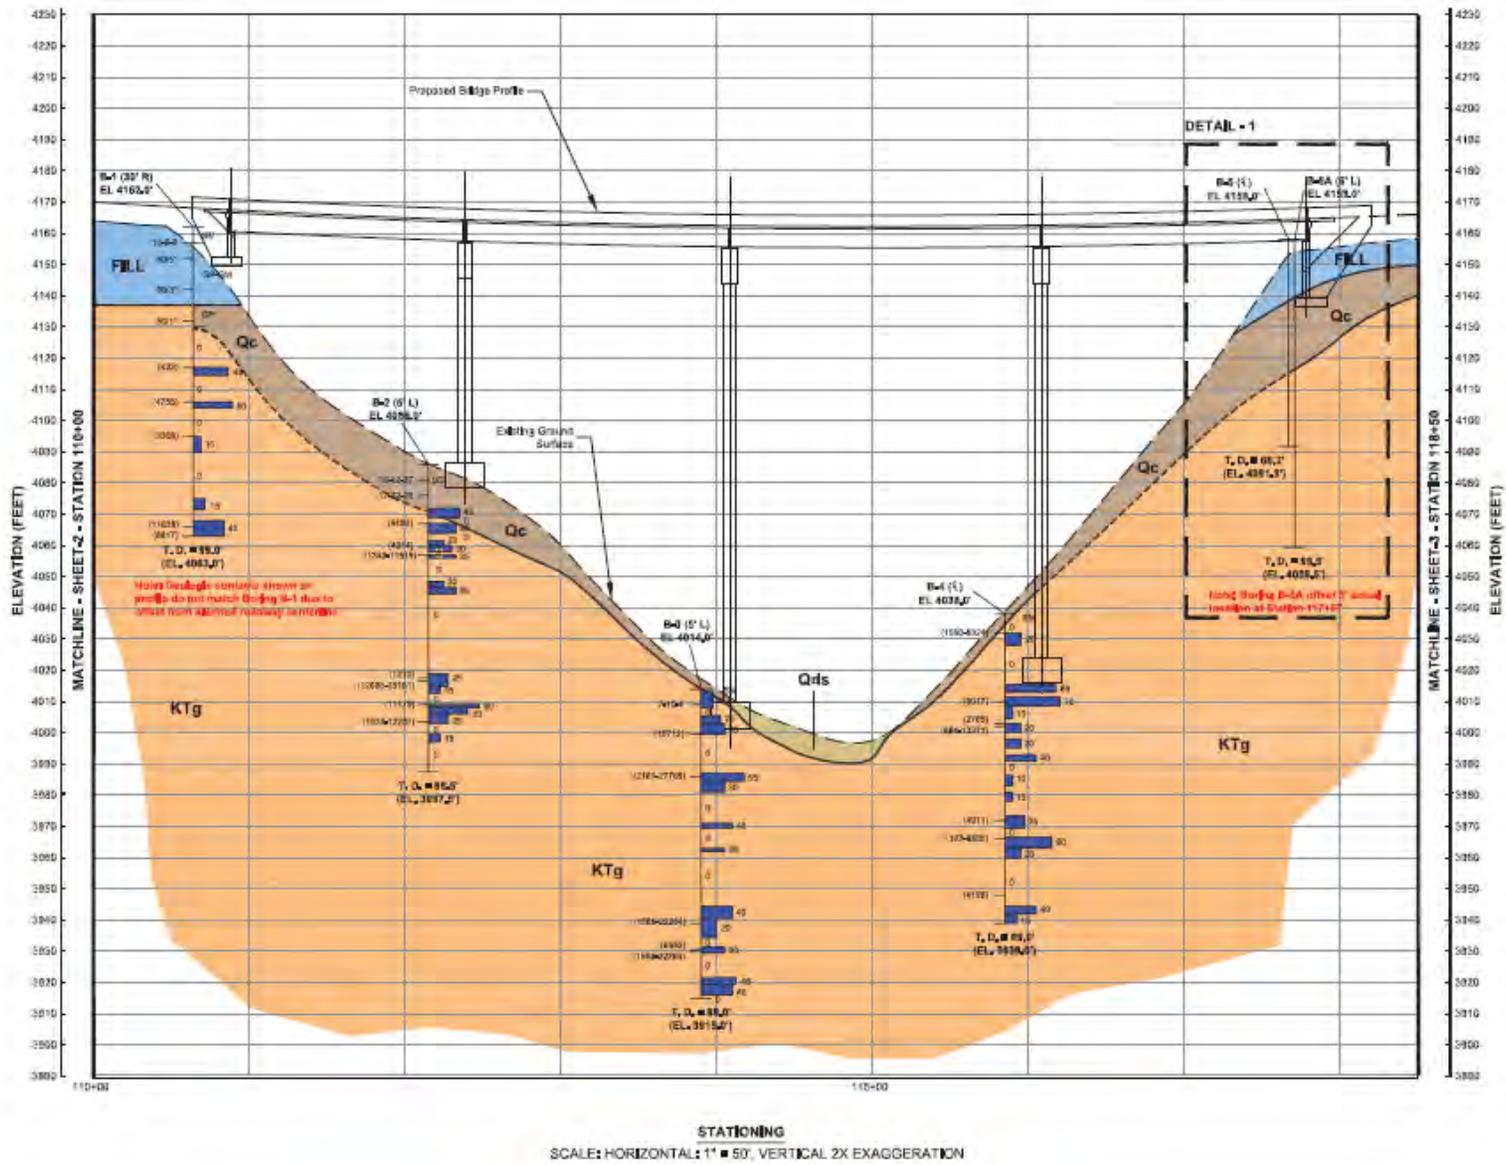
Figure 2 – Geologic Map of Pinto Creek Bridge Area

GEOLOGIC UNITS

- FILL** Silty to clayey sand, gravel & cobbles with occasional boulders at the ground surface, nonplastic with medium plasticity zones & brown to gray.
- Qal** Alluvial Stream Channel Deposits of sand, gravel & cobbles with sand zones, occasional boulders & clay zones, uncemented, nonplastic to low plasticity, light brown.
- Qds** Debris slides of silty sand, gravel & cobbles with considerable boulders up to several feet in diameter, nonplastic & light brown.

note: older debris slides appear weakly cemented.
- Qc** Colluvium of silty to clayey sand & gravel with varying amounts of cobbles & boulders up to 3' in diameter, nonplastic to highly plastic & various shades of brown & gray.
- KTg** Schultze Granite of fine grained to porphyritic texture with quartz-rich bands & alternating very hard & very soft zones. Shear zones, slickensides along fracture surfaces & hydrothermal alteration zones are common throughout the rockmass. The granite typically is various shades of speckled gray to yellowish-brown.
