70TH HIGHWAY GEOLOGY SYMPOSIUM

“Better Highways Through Applied Geology”

October 21-24, 2019

2019 Proceedings

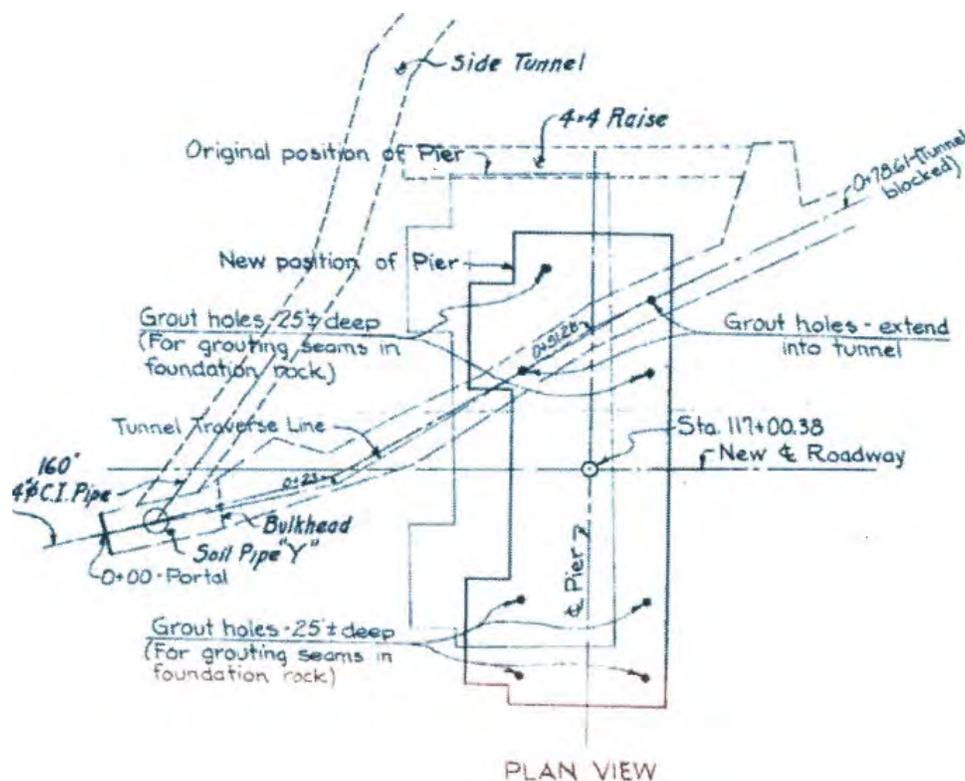
Figure 4 – Mine Adit beneath and near Pier No. 7 of the Existing Pinto Creek Bridge

The area surrounding the Pinto Creek Bridge has a long history of mining activity due to the presence of porphyry copper deposits within the Schultze Granite. A review of the record drawings for the existing bridge shows the presence of an underground mine adit beneath and near Pier No. 7 of the existing bridge, which is in the vicinity of Pier 3 of the new Pinto Creek Bridge, See Figure 4. Portions of the mine adit were grouted during construction of existing bridge, but only those portions in the immediate vicinity of the foundation for Pier No. 7.

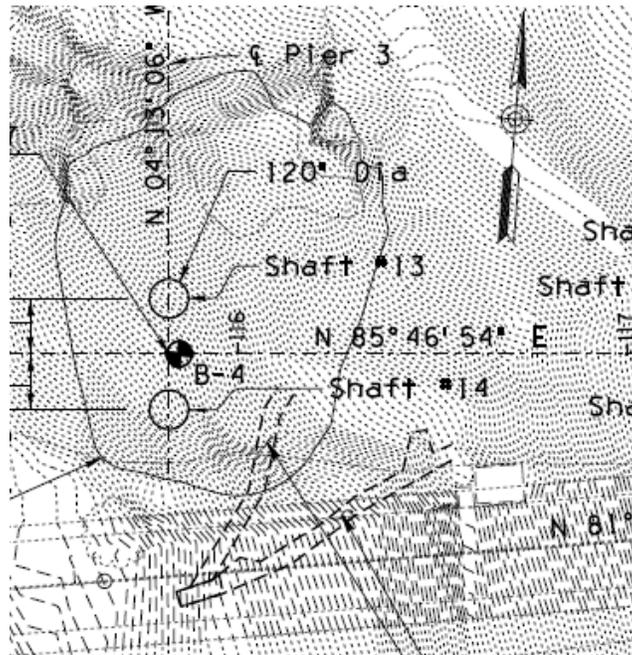
Figure 5 – Mine Adit near Proposed Pier No. 3

A more detailed evaluation of the location of the existing mine adit located near the proposed Pier No. 3 was completed. This was done by overlaying the record drawings on to the project plans, See Figure 5.

Based on the review there is a clear possibility the mine adit is beneath proposed Pier No. 3. Furthermore, the mine adit may have been exposed within the required excavation to construct a spread footing foundation at the proposed Pier No. 3. This would create an unsafe condition during construction that was unacceptable.

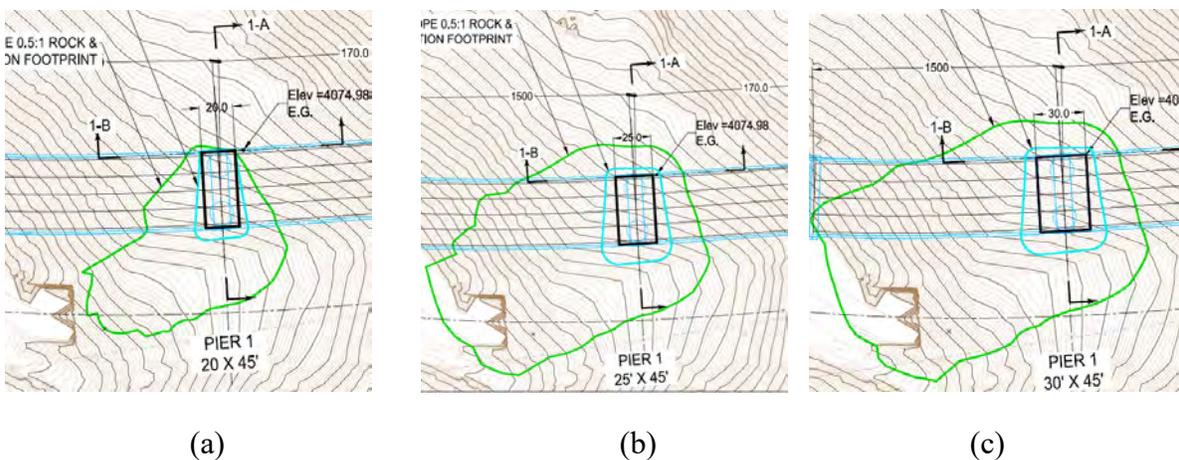
Figure 6 – Potential Limits of Disturbance Pier No. 1

Environmental impacts of using spread footing foundations, a group of small-diameter drilled shafts, or large-diameter drilled shafts was evaluated primarily through identifying the amount of disturbance that would be caused during construction. An evaluation was completed at each bridge pier based on the required footing/pile cap dimensions and bearing elevation. The impacts of these are shown in a Figures 6 through 8 considering temporary slopes of 0.5H:1V in the rock and 1.5H:1V in the colluvium and fill soils.

(a) Large-Diameter Drilled Shaft (b) Small-Diameter Drilled Shaft (c) Spread Footing

The spread footings and small-diameter drilled shafts typically had larger areas of disturbance due to a combination of large footing dimensions and/or lower bearing elevations as is shown in Figures 6 through 8. Alternatives using temporary soil nail shoring with steeper slopes to reduce the impacts were also evaluated.

The impacts of using spread footing foundations, a group of small-diameter drilled shafts, or a pair of large-diameter drilled shafts was evaluated primarily through identifying the amount of disturbance that would be caused during construction similar to the environmental impacts. See Figures 6 through 8 for the areas of disturbance.

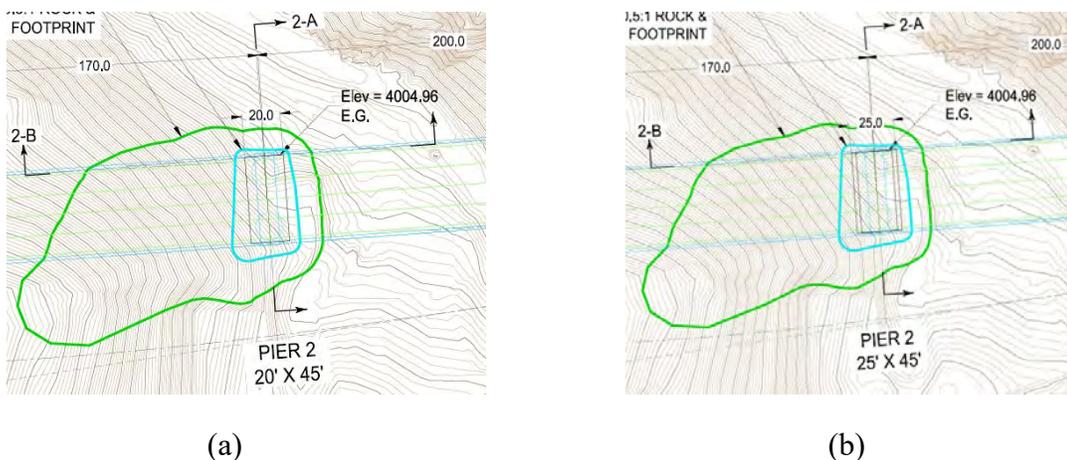
Figure 7 – Potential Limits of Disturbance Pier No. 2

(a) Large-Diameter Drilled Shaft (b) Spread Footing

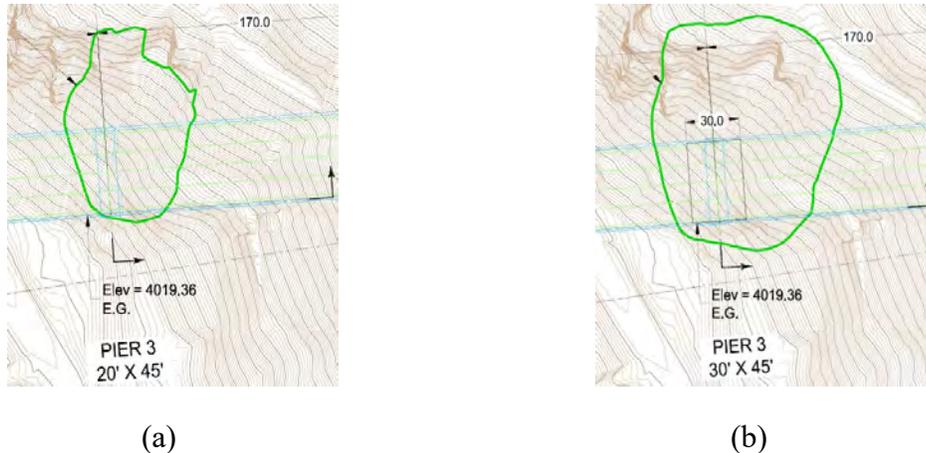
(a) (b)
Figure 8 – Potential Limits of Disturbance Pier No. 3
(a) Large-Diameter Drilled Shaft (b) Spread Footing

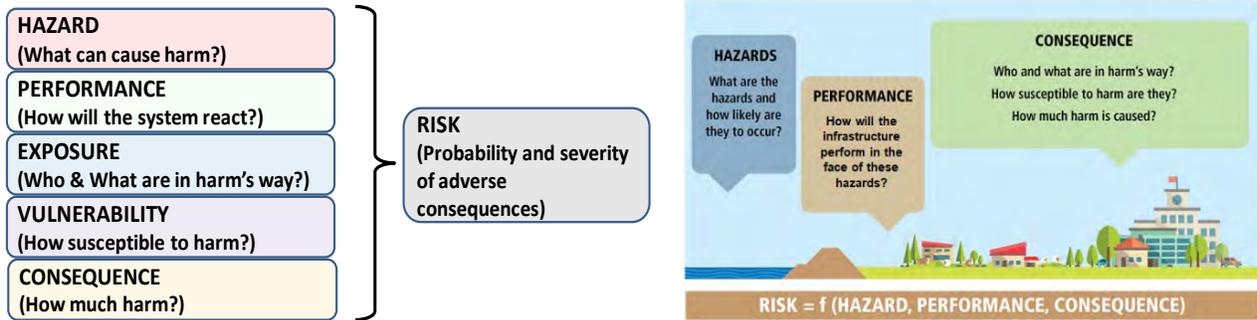
Figure 1 below shows components of risk as understood and applied on USACE Dam and Levee Safety Projects (USACE, 2014). In a quantitative risk assessment, expert elicitation is used to identify potential failure modes and the probability of the failure mode occurring. In a further for a step, event trees are constructed to detail how a failure might progress and capture subjective probability assessments of the

Figure 1. Risk Terminology– Risk is a Function of the Hazard, Performance of the Infrastructure and Consequences of a failure mode

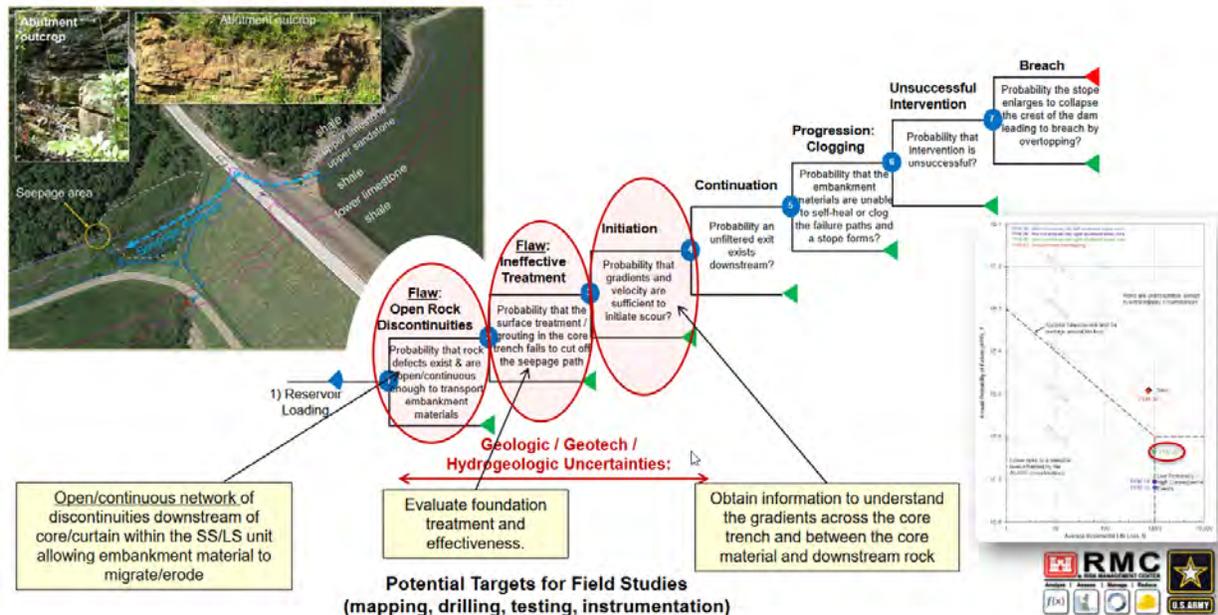
For a fully quantitative risk assessment each potential failure mode (PFM) at a site has an event tree constructed and nodes within that tree are elicited for their probability of occurrence. An example for Internal Erosion failure of a dam or levee is shown in Figure 2 below. The events are laid out in sequence and probabilities of each are estimated at each node with values that must be between 0 and 1.

Figure 2. Internal Erosion event tree for a PFM (Potential Failure Mode) caused by an upstream to downstream path in the rock (Loar, 2017)

The pattern of the failure modes follows the sequence of Flaw → Initiation → Continuation → Progression → Unsuccessful Intervention → Breach occurs. All these nodes must have some probability greater than zero for breach to occur. The nodes are then multiplied to calculate the overall annual probability of failure. One advantage of this approach is that it forces the elicitors to think through the sequence of the problem and to estimate smaller “chunks” of the probabilities, supporting more accurate and consistent estimation. This provides not only a better estimate of the overall subjective

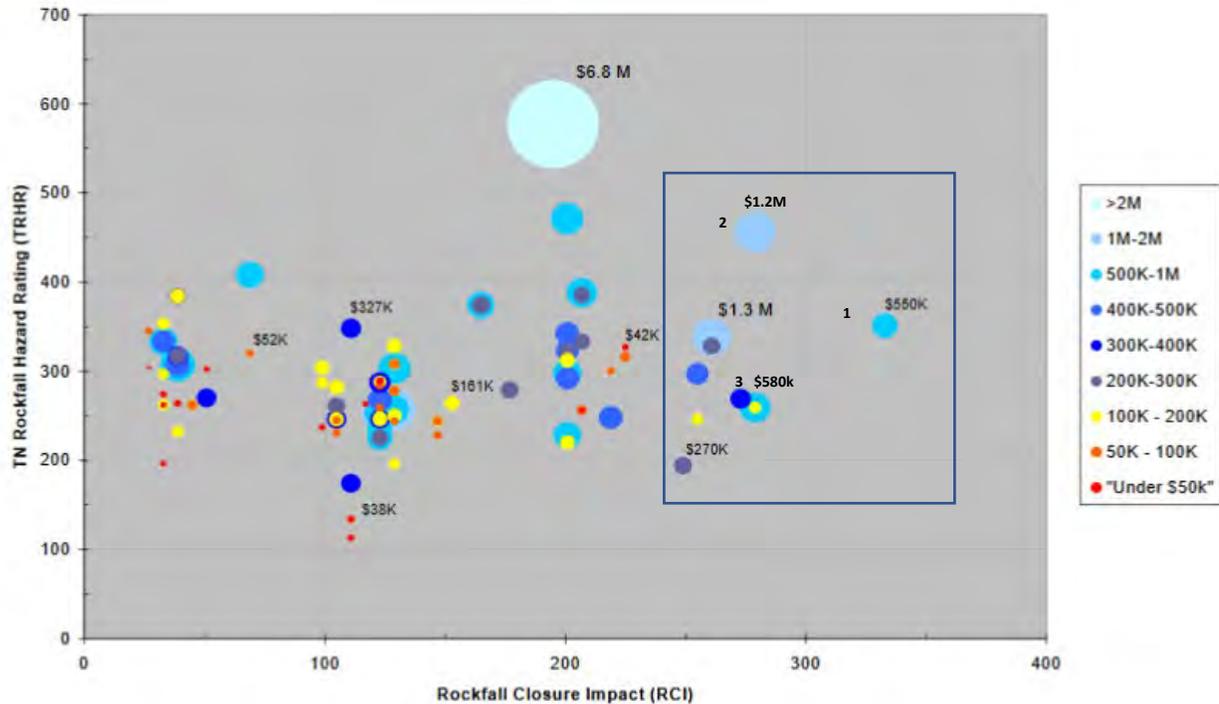
Figure 4. TRHR, RCI and Cost Plot – all the sites contained in the blue box can be repaired for less than the \$6.8M site

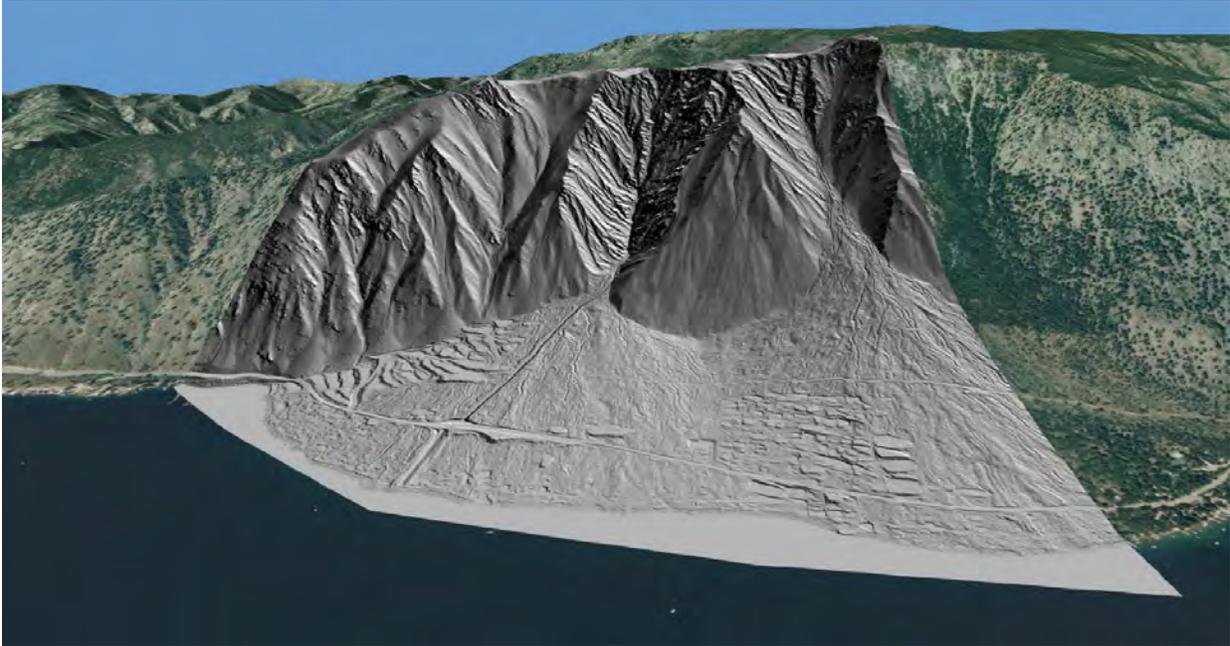
Figure 2 – Slide Ridge LIDAR imagery

Debris flows are discharged down a combined natural and constructed drainage channel with levees (visible in Figure 2) that empties into a containment basin on the west (upstream) side of South Lakeshore Road. This combined channel and containment basin was constructed in 1994 from the apex of the alluvial fan below Slide Ridge to South Lakeshore Road in an attempt to protect the highway, the traveling public and private property downstream. The containment basin drains beneath South Lakeshore Road via a 96-inch corrugated metal pipe culvert, shown in Figure 3, intended to convey runoff and debris flow material downstream to Lake Chelan.

Lake Chelan occupies a 50+ mile long valley of alpine glaciation origin, although advance of the Okanogan lobe of the Cordilleran ice sheet did intrude on the eastern end of the valley which resulted in the formation of two morphometric basins separated at “The Narrows,” shown in Figure 6 by a submerged feature called the “Sill,” shown in Figure 7 (3). Coincident with the “the Narrows” is a coalesced alluvial fan locally referred to as Hollywood and Shrine Beaches. These alluvial fans, in turn, lie below Slide Ridge as shown in Figures 2 and 4.

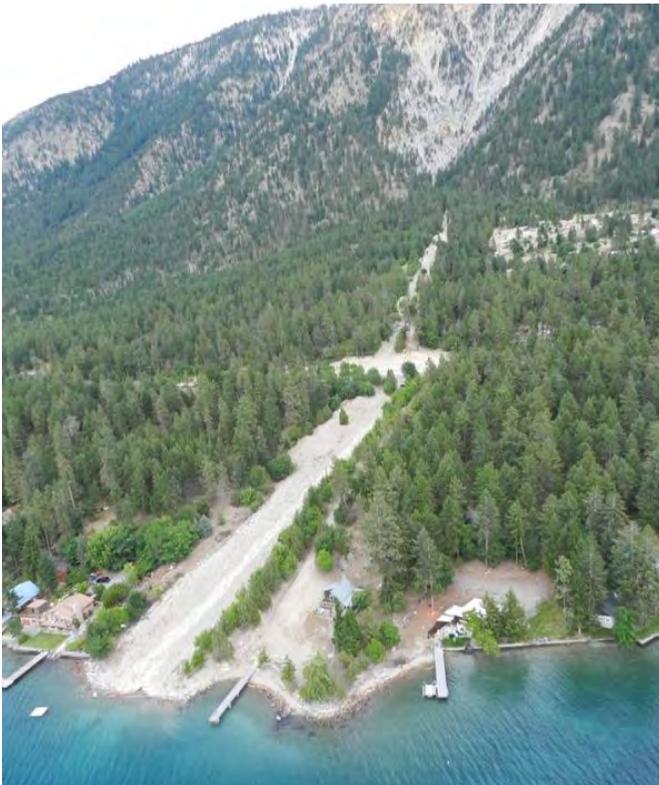
Figure 4 – Project Area

The existing containment basin is capable of holding approximately 4,000 cubic yards of sediment, based on a 2017 survey by Chelan County. During significant debris flow events, the existing culvert is inadequate to convey the material and becomes blocked. The volume of debris has overwhelmed the basin and overtopped the road in the majority of the events over the last 15 years. The maximum height of debris deposited on the roadway was approximately 12 feet in the 2005 event. The relative locations of South Lakeshore Road, the flow channel and the catchment basin are shown in Figure 4. Figure 5 shows the catchment basin and mud caking on a utility pole that indicates the height of debris flow over the roadway from a prior debris flow event.

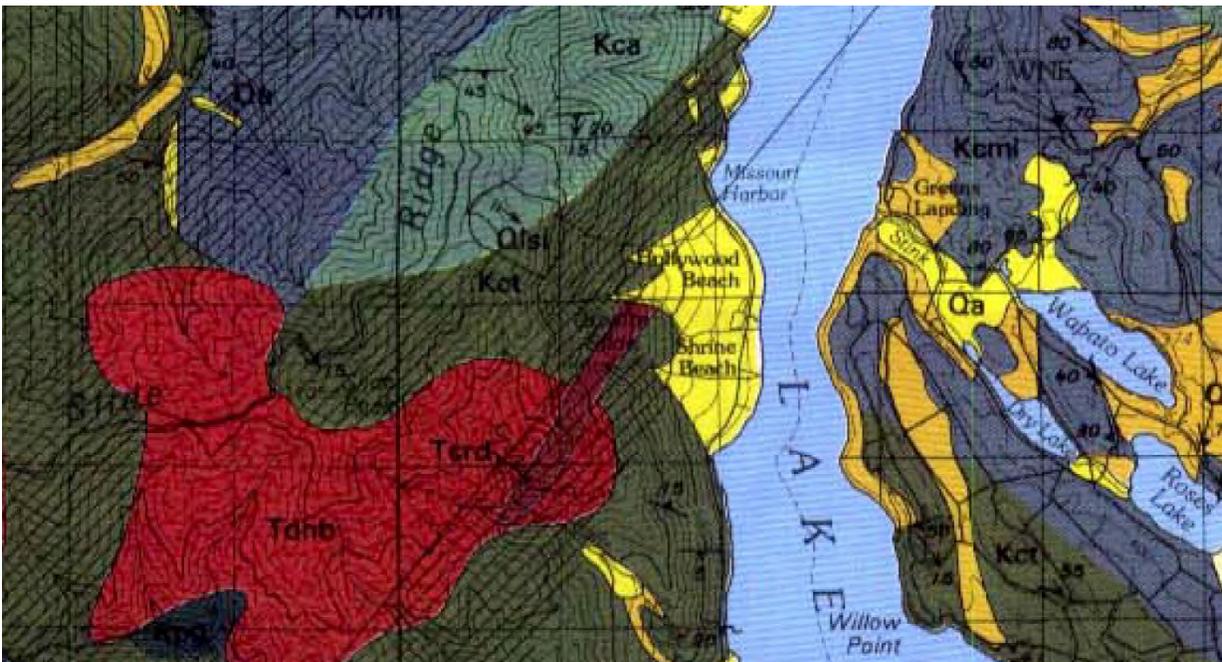
Figure 8 – Site Geology [excerpted from (4)]

Mapping of the geology of the Slide Ridge area is available at the 1:100,000 scale of the Chelan 30' by 60' Quadrangle (4). A cropped and enlarged portion of this geologic map is provided in Figure 8. The alluvial fans of Shrine and Hollywood Beaches are visible at the location of “The Narrows”, with Slide Ridge to the left of the fans. Although difficult to discern, a feature labeled “Granite Slide” is present to the left of Shrine Beach and includes the mapped outcrop of a rhyolite dike denoted “Terd”.

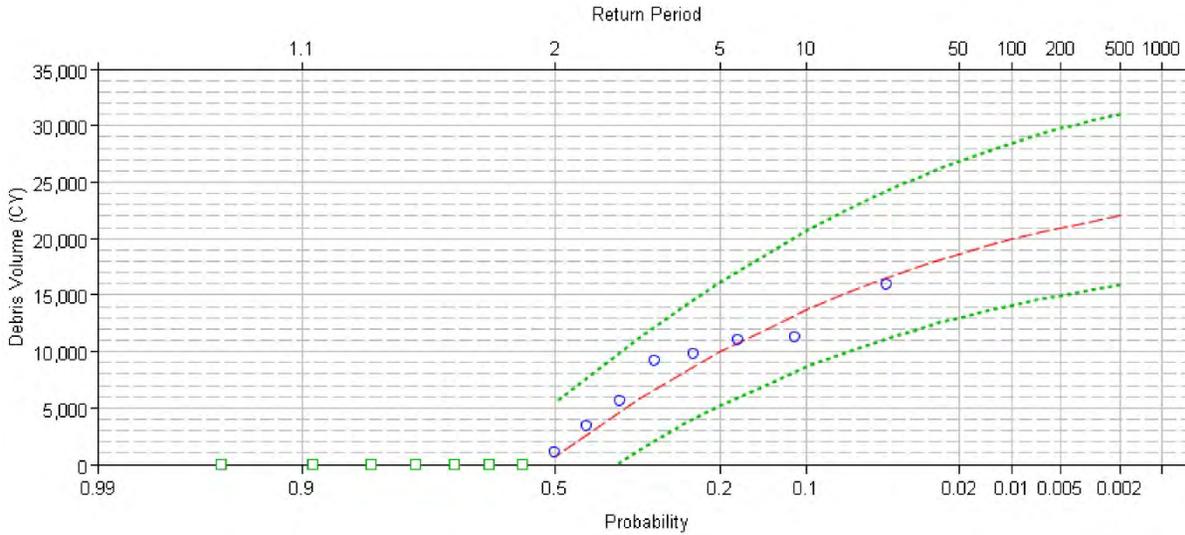
Figure 9 – Frequency Analysis of Debris Volume

The frequency and magnitude of Slide Ridge debris flow events was analyzed by the project team by hand-fitting a log-normal distribution to the total debris flow volumes using the 15-year record of events. The resulting frequency analysis is shown in Figure 9. The analysis estimates a 10,000 cubic yard event to have an approximate 5-year return period, while a 100-year event would mobilize approximately 20,000 to 25,000 cubic yards of debris.

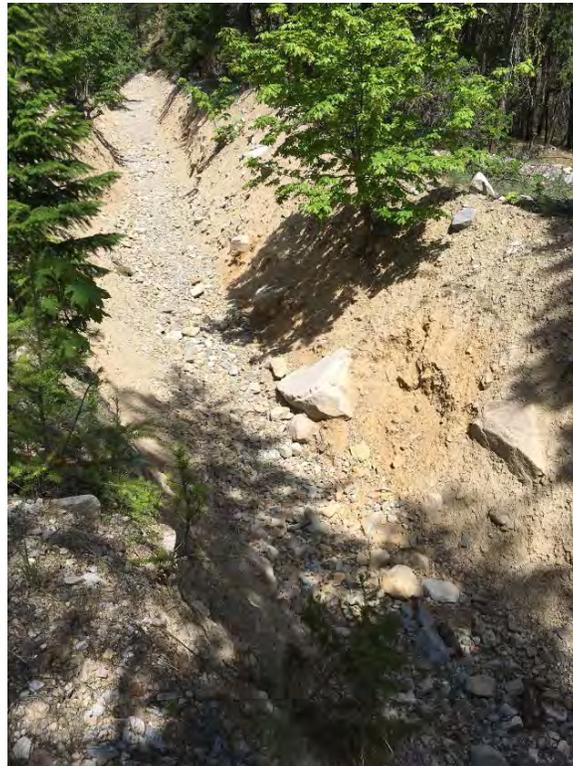
Figure 10 – Large Block Material in Channel Side Slopes

These historic events mobilize up to two- to four-foot boulder-size material based on observations of the debris observed in the catchment basin (Figure 3). However, considerably larger material is visible in the channel side-slopes at locations mid-distance down the alluvial fan as can be seen in the photograph in Figure 10. Some of these blocks are as large as automobiles and are therefore unlikely to be mobilized by debris flows of the sizes recorded over the last 15 years. This suggests that the Slide Ridge basin is capable of producing much larger flows or mass wasting events.

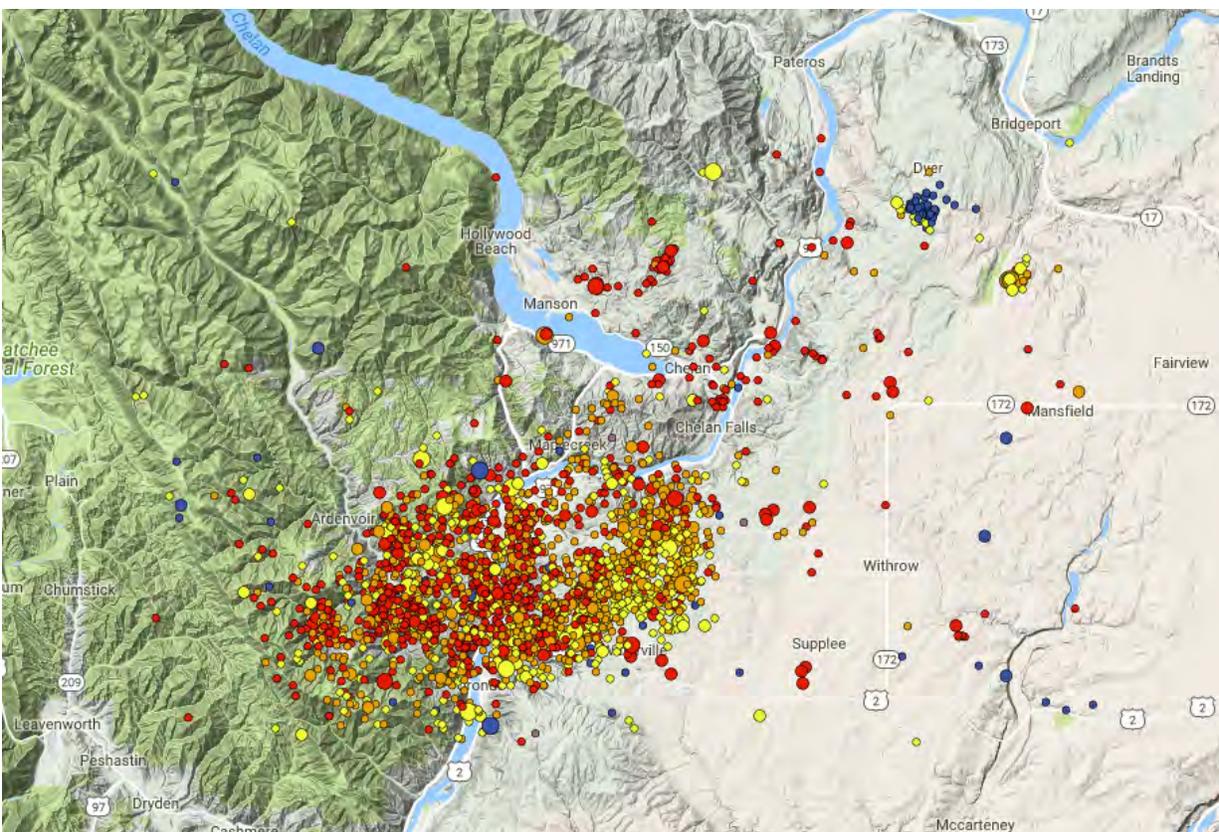
Figure 11 – Micro-earthquake Swarm of the Entiat Cluster (10)

However, the largest historical earthquake observed to date in Washington State, with an estimated magnitude of approximately 6.5 to 7.0, with modified Mercalli intensities up to VIII, occurred on December 14, 1872 in the northern Cascade Mountains (8). Some recent research and thinking suggests that this event may have taken place on a postulated Chelan Seismic Zone (9). Even more recent research by the USGS narrows the potential epicenter for the 1872 event to a zone that coincides with a prolific zone of micro-earthquakes referred to as the Entiat cluster located about 15 miles to the south of the Slide Ridge area (8). The Entiat cluster earthquakes are relatively small, with magnitudes of 3.5 or less, as shown in Figure 11 (10). Figure 11 also provides regional context and proximity to the Hollywood Beach and Slide Ridge area.

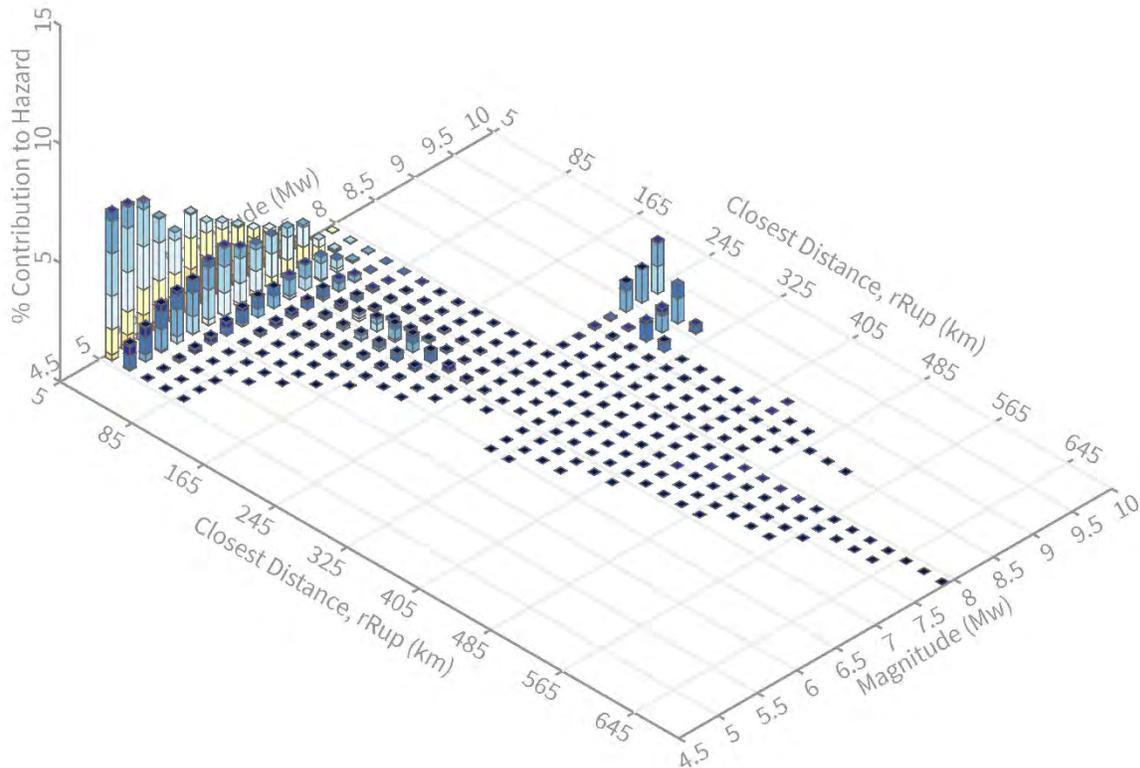
Figure 12 – Deaggregation of Probabilistic Seismic Hazard at Slide Ridge Site (12)

Code-based seismic design criteria for this type of project is available in the AASHTO bridge design guidelines (11). AASHTO, similar to IBC guidelines, follows a probabilistic approach to seismic design. The earthquake hazard at a particular site is assigned according to the proximity of known seismic sources and the strong ground motion potential of each of those sources. The deaggregation of strong motion potential at the project site, following the AASHTO criteria, which is based on a 7 percent probability of exceedance of in 75 years, or an approximate return interval of 975 years, is shown in Figure 12 (12).

In Figure 12 there are two primary sources of earthquake hazard according to the probabilistic model. The first is near source random fault potential represented by the spikes in contribution hazard with relatively small Richter magnitudes at distances less than 50 kilometers from the project site. This proportion of the hazard is associated with the Entiat cluster of micro-earthquake swarms as well as a possibility of small events that could occur in the close vicinity of any particular site according to the general seismicity of the region. The second source is the known fault potential from the Cascadia Subduction Zone (contribution spikes in the Richter magnitude range of 8.5 to 9.5 at a distance of roughly 250 kilometers).

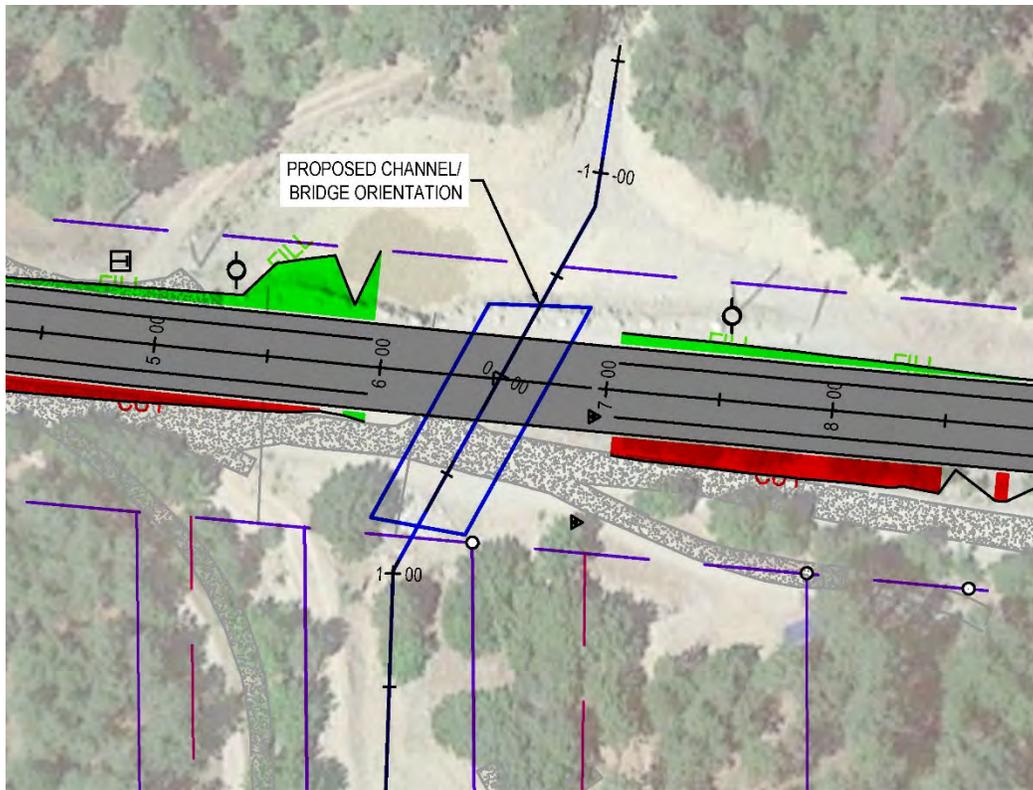
Figure 13 – Roadway and Channel Reconfiguration

The recommended alternative for the culvert replacement is a 108-foot single-span bridge structure founded on spread footing abutments. South Lakeshore Road would remain in its current alignment with traffic during construction routed along the downstream side of the existing roadway where by-pass traffic is currently detoured when a debris flow blocks the main roadway. A channel with 1H:1V sloped banks and a 30-foot bottom width would be constructed beneath the bridge and lined with concrete to maintain the integrity of the slopes and provide scour protection for the shallow spread footings supporting the abutments. Channel regrading and construction would occur upstream and downstream to tie in the existing channel, fill the catchment basin and reconstruct portions of the channel levees. The roadway and channel configurations are shown in Figure 13. The profile (elevation view) of the bridge is shown in Figure 14.

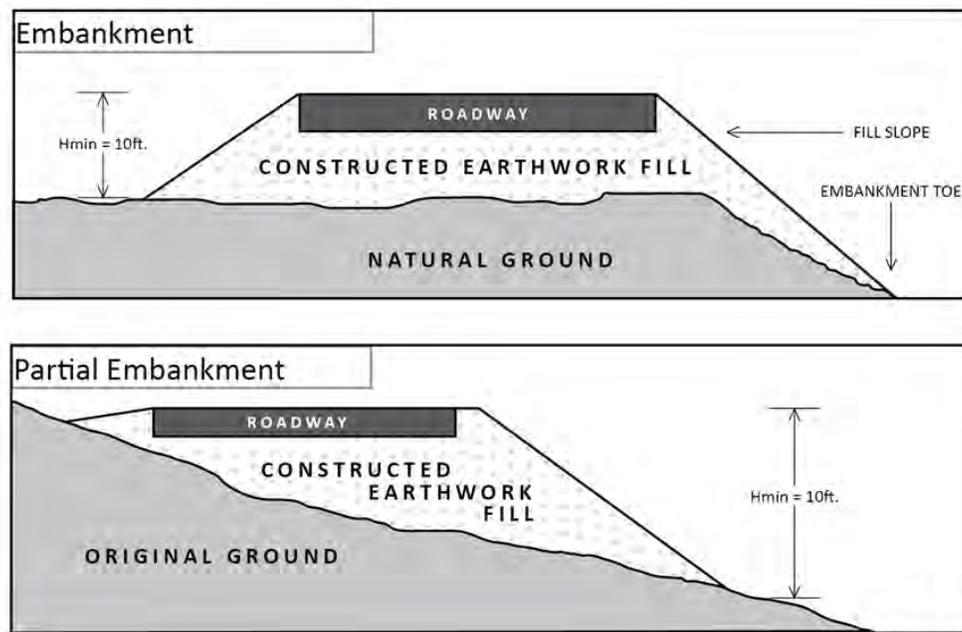
Figure 1 – Embankment Asset Schematics from *TRB Research Report 903* (5).

For a DOT or railway, geotechnical assets are the retaining walls, embankments, cut slopes, and constructed subgrades within the organizations ROW or easement (5, 6). Figures 1 and 2 present schematic examples of embankment and cut slope assets. Like other asset groups within a transportation agency, geotechnical assets are designed, constructed, and maintained by a transportation agency and have an initial and operating value to the agency. In addition to supporting a roadway or railway, geotechnical assets also contribute to the performance of culverts, stormwater drainage systems, and utilities that are often contained within the asset. Geotechnical assets are not unique to transportation organizations and also exist in water storage and conveyance systems, cities and communities, and energy transmission and mineral resource entities.

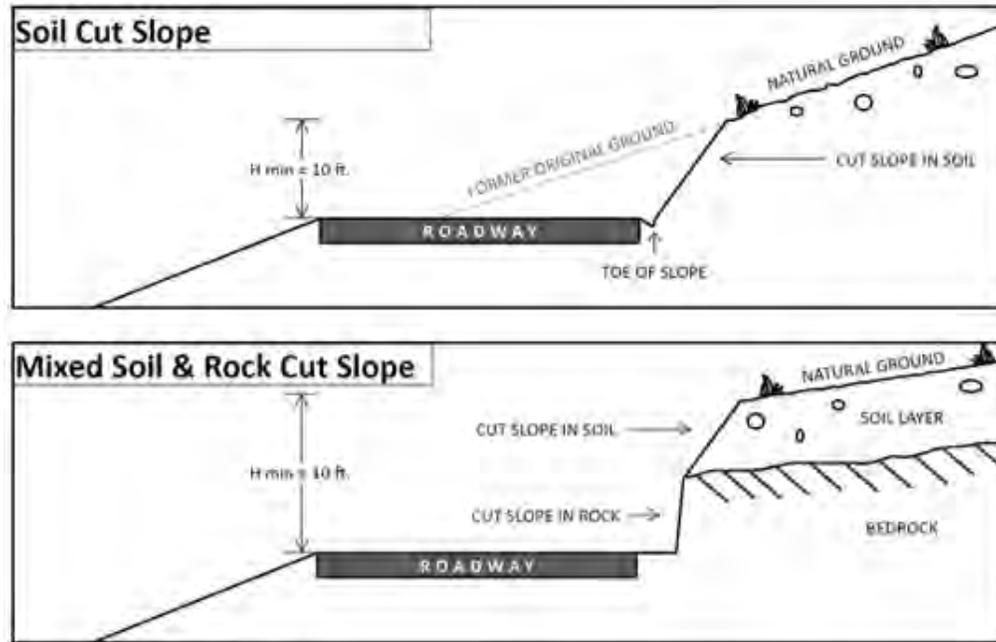
Figure 2 – Slope Asset Schematics from TRB Research Report 903 (5).

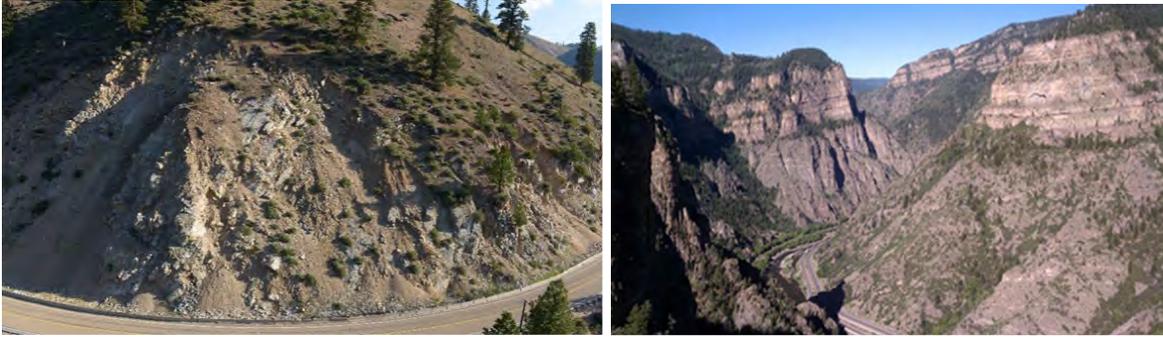
Figure 3 – Distinguishing Assets and Hazards.

Conversely, a geotechnical asset is a constructed and owned earth-based structure. For geotechnical assets, a DOT has control over how they are built, maintained, and managed, in addition to full access rights. This important distinction between owned assets and beyond the ROW hazards is presented in Figure 3, which illustrates the difference between rockfall hazard from a highway cut slope asset and a natural hazard beyond the boundary.

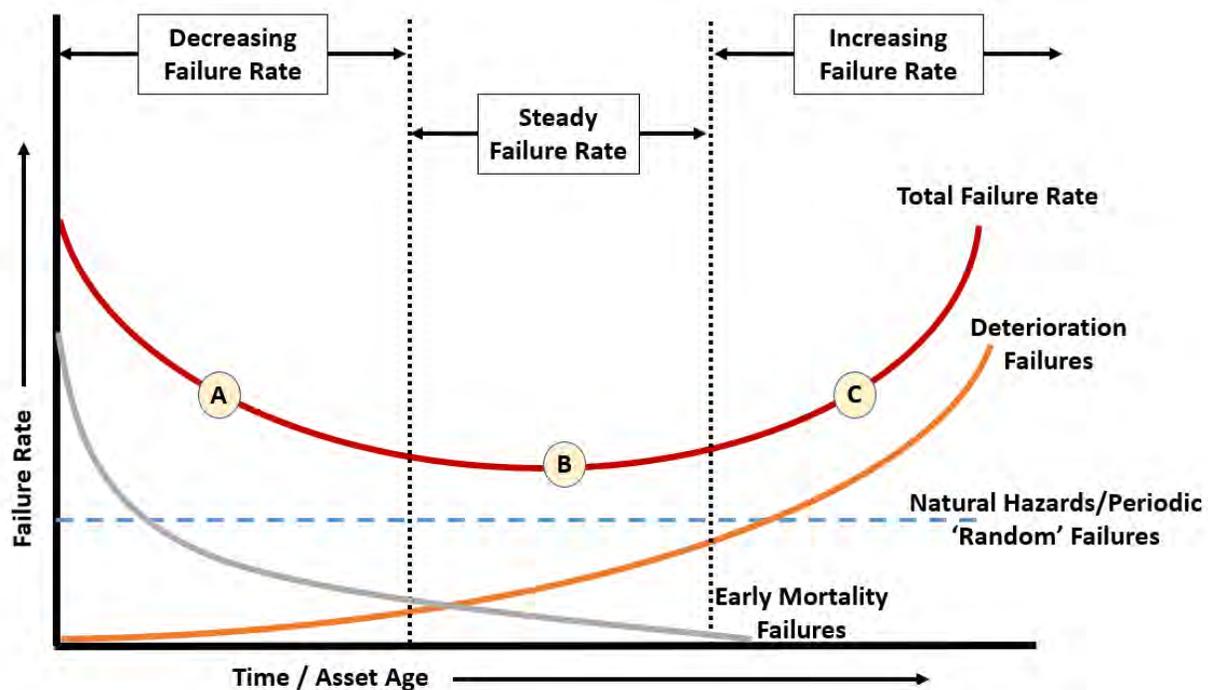
Figure 4 – Bathtub Curve concept applied to geohazards and assets.

These aggregated impacts from event based geohazards and deterioration effects are conceptualized in Figure 4. This figure, commonly termed a ‘bathtub curve,’ illustrates the different types of failure modes that exist for a system or asset and how the sum of those failure modes results in a net or observed failure rate that changes with time. An infrastructure owner with assets at point ‘A’ or ‘B’ on the figure will have the perception that failure impacts are relatively constant or even decreasing because of the benefit of new assets. However, an owner at point ‘C’ will be observing increasing failure rates because of the contribution from an increasing deterioration failure rate.

Either individually or together, geohazards and geotechnical assets generate similar consequences and risk to the performance of a DOT or other infrastructure owner. These consequences are represented as the ‘Total Failure Rate’ curve on Figure 4. All DOTs manage the threats and the resulting performance risks, whether actively through informed processes and programs, or reactively through the default acceptance of the consequences after the event. For an active management program, DOTs have the opportunity to manage geohazards and assets to the lowest possible life-cycle cost to the desired level of risk tolerance, meaning the asset and/or asset contribution to overall value is optimized. Referring back to Figure 4, this means owners have an opportunity to lower the location of the natural hazard failure line and also change the slope and lower the deterioration failure rate. The resulting effect will be a lower total failure rate and the benefits that result from a lower failure rate.

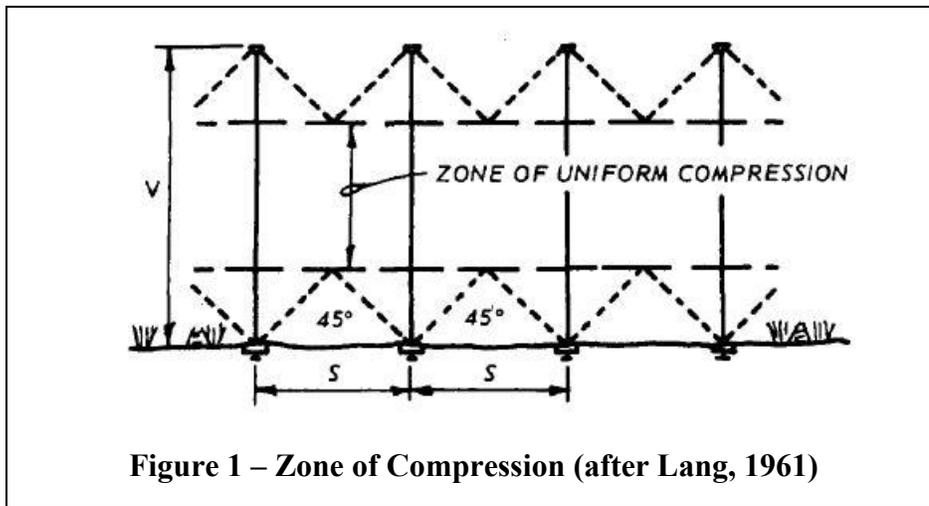
Figure 1 – Zone of Compression (after Lang, 1961)

Ground anchors come in many variations from simple guy wire anchors supporting telephone poles to complex multi-strand tendons tensioned to millions of pounds to tie a dam down during a probable maximum flood event. In 1961 Tom Lang published a treatise on tensioned rock bolting (Lang, 1961) presenting results of extensive testing conducted during the Snowy Mountains Hydroelectric Development construction in New Zealand. The primary application for tensioned rock bolts in that project was to develop a “reinforced rock unit”, which was considered a zone of compression between the rock surface and rock bolt anchor end to hold fractured rock together and mobilize its inherent strength (Figure 1). Concurrently, post-

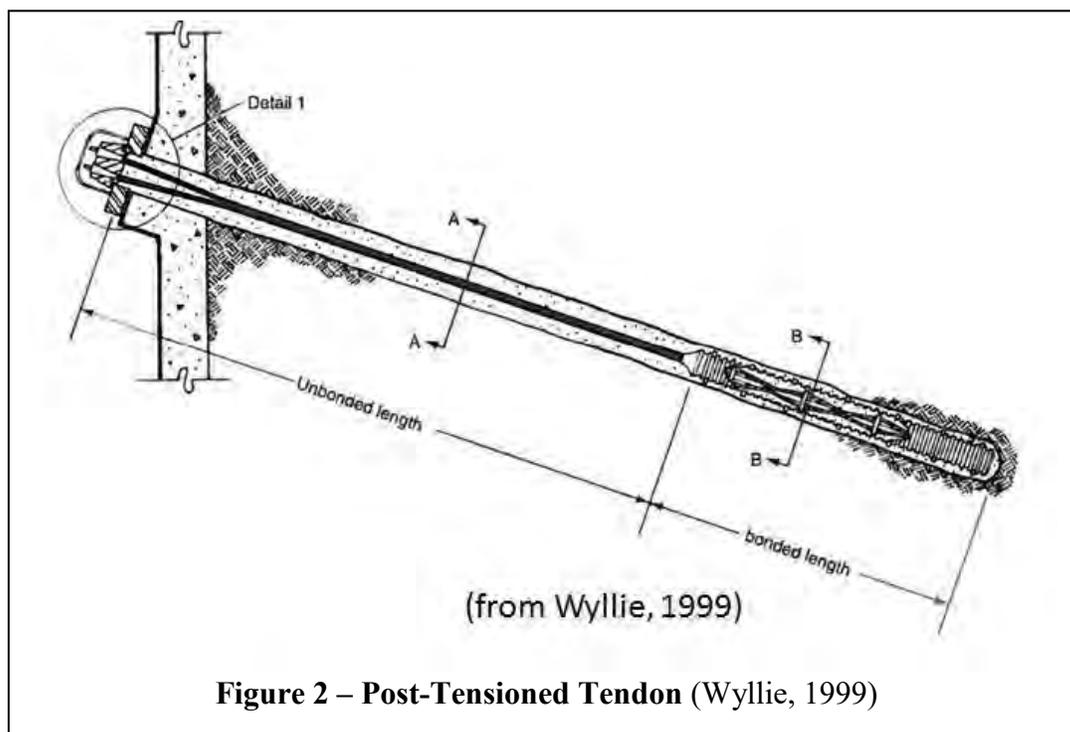
Figure 2 – Post-Tensioned Tendon (Wyllie, 1999)

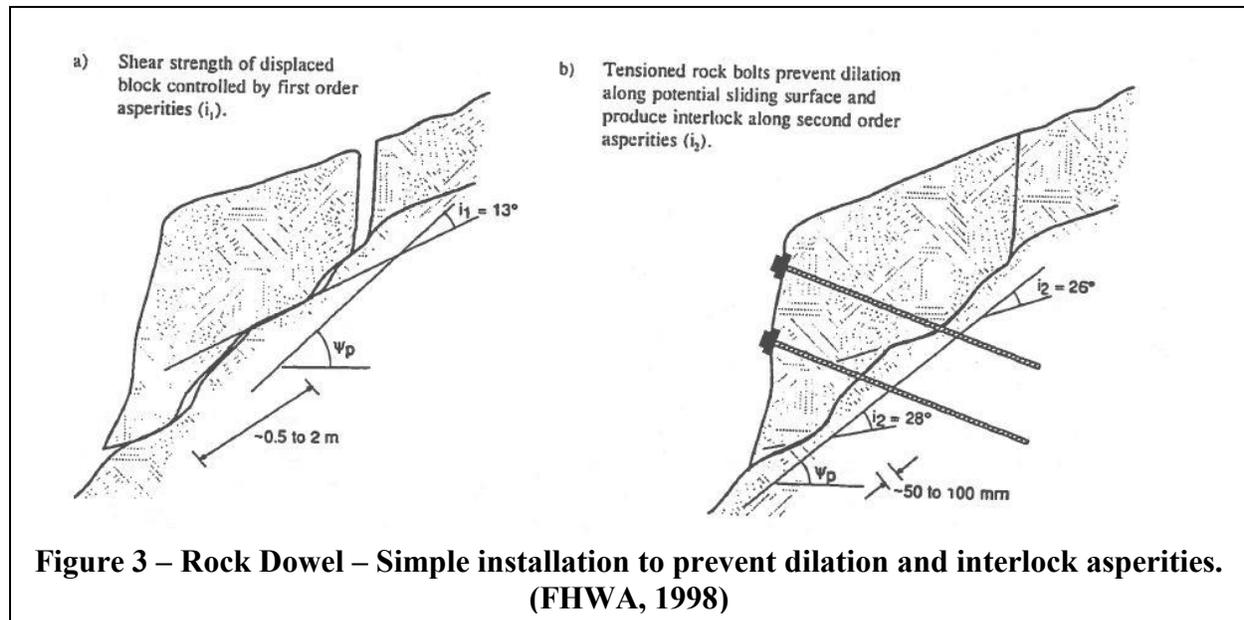
In some jurisdictions, the testing requirements have also been required for less complex anchors, implementing verification test protocols for components of anchors that are not present in simple anchors. This is particularly evident with passive (untensioned) rock bolts often called “rock dowels” that are widely used by the industry. Rock dowels are frequently used to “pin” down unstable rock blocks on slopes and to reinforce the rock mass around underground openings, usually at a substantially reduced installation cost and schedule in comparison to anchors. Other functions of a rock dowel commonly include anchor systems for draped and pinned mesh, post and anchors for flexible rockfall barriers, and many other cases. The function of a grouted rock dowel could be in pure tensile reinforcement to keep two blocks on either side of a planar joint from dilating so it can’t slide over asperities. By holding the two sides together, the asperities interlock and sliding would require shearing intact rock through the asperities; however, a passive dowel element is also free to undergo bending and shear, underscoring the importance of proper dowel installation and orientation with respect to load application (Figure 3).

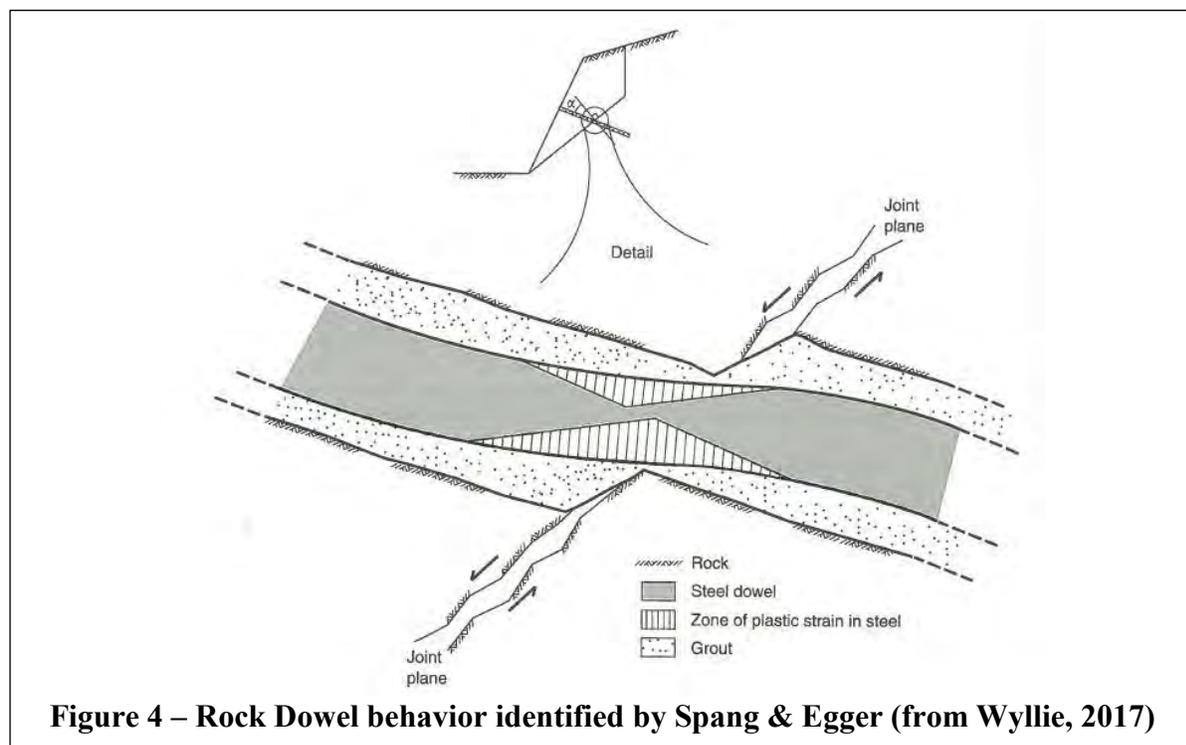
Although dowels can be used for enhanced shear resistance (albeit at a lower allowable shear capacity than for case of tension (ACI Committee 355, 1997), rock dowels are ideally oriented at a non-perpendicular downslope angle to the failure plane surface in order to maximize the available tensile capacity of the bar. Spang and Egger (Spang, 1990) looked at dowel reinforcement as a “nailing” process with rock dowels installed oblique to a planar joint. The analysis considers rock strength, shear, bending, and tensile forces in the dowel (Figure 4) as well as the strength of grout around the bar. In both applications, the principal consideration is

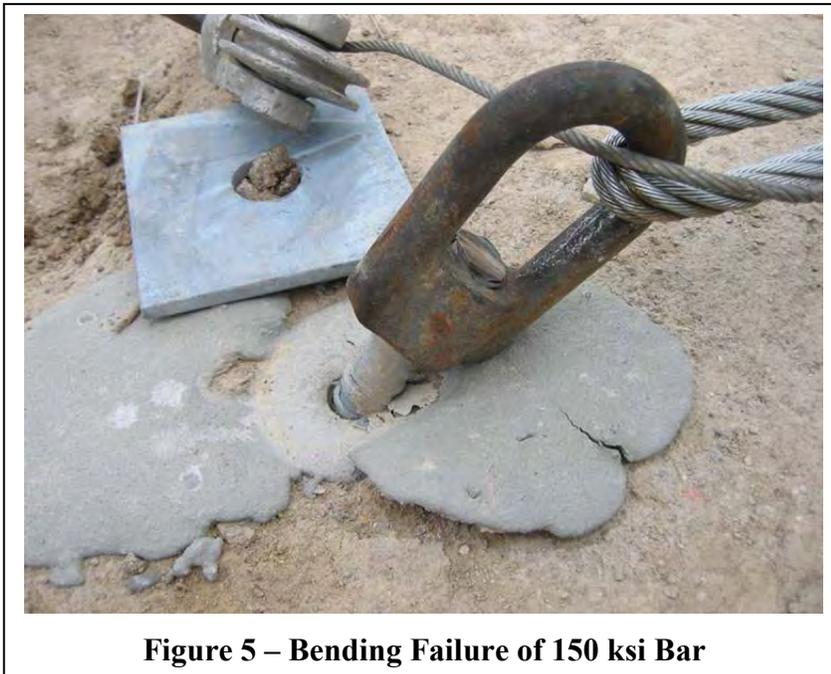
Wire rope anchors are commonly used in our industry to absorb loads that are not aligned with the axis of the anchor itself. Bar anchors are very susceptible bending forces, particularly where high fiber stresses are concentrated at a grouted hole collar. Testing at an Ontario Power development (Wood, 2005) (Ingraham, 2014) saw a 1-inch-diameter 150 ksi bar fail at less than 5-kips load in bending (Figure 5). Wire rope anchors do not suffer the same capacity loss when loading is less than perfectly axial. Most wire mesh drapes, flexible rockfall barriers, and debris

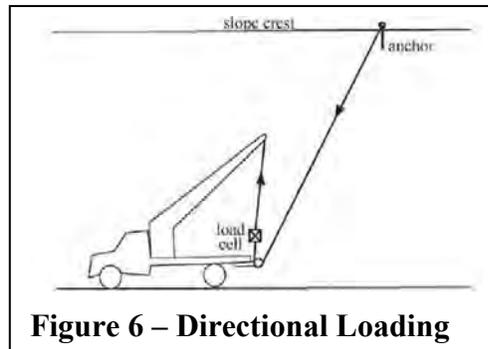
Figure 6 – Directional Loading

Testing of fully grouted wire rope anchors, particularly in the direction of their axial installation can be cumbersome. Muhunthan et. al. suggested different arrangements to facilitate pull-testing wire rope anchors in the direction they will be loaded (Figure 6); however, it is

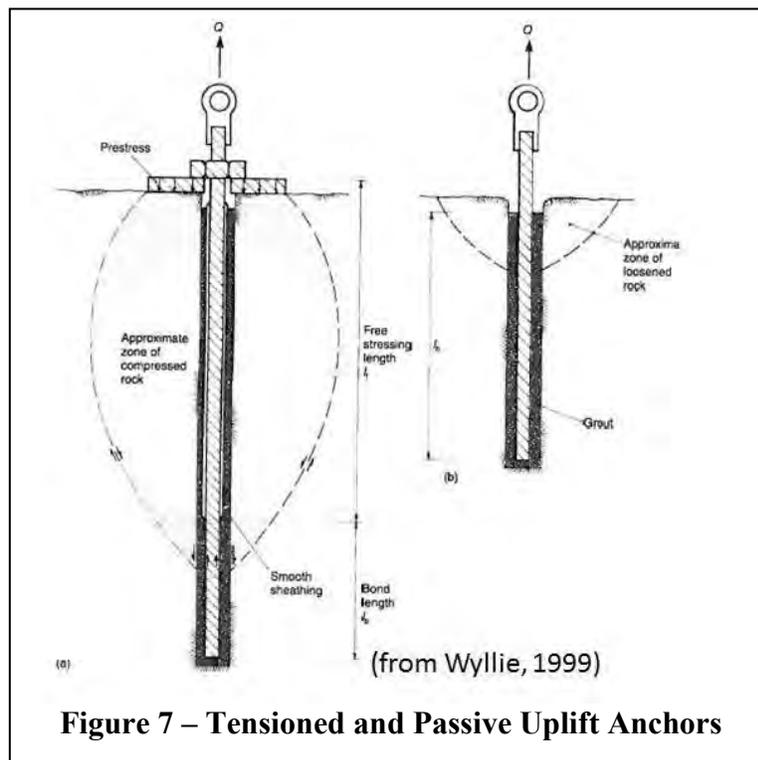
Figure 7 – Tensioned and Passive Uplift Anchors

tensioned (Figure 7, Wyllie, 1999), as was also outlined for complex post-tensioned anchors above for large structural loads. Post tensioned uplift anchors create a zone of compression similar to rock bolt installations to increase the effective diameter of the anchor. Uplift anchors mobilize a cone of rock, the shape of which is dependent upon the properties of the rock
