70TH HIGHWAY GEOLOGY SYMPOSIUM

“Better Highways Through Applied Geology”

October 21-24, 2019

2019 Proceedings

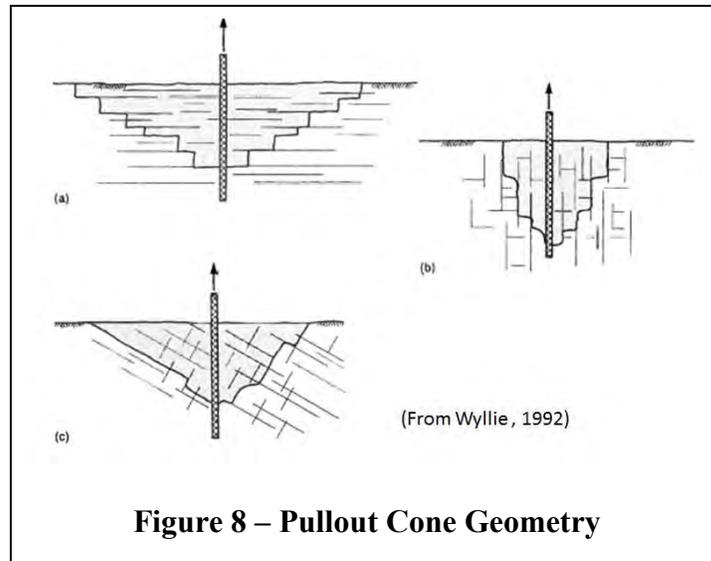
including intact strength and joint orientations within the rock mass (Figure 8). Resistance to pullout is developed by the weight of the rock mass mobilized and the strength of the rock mass around the pullout cone (area of the cone surface). For multiple anchors where the cones overlap, or where the anchor loads come out of a rock slope face and are oblique, the surface area of the coalescing cones is developed using modelling techniques or AutoCAD, and Hoek-Brown strength criteria are applied (Figure 9).

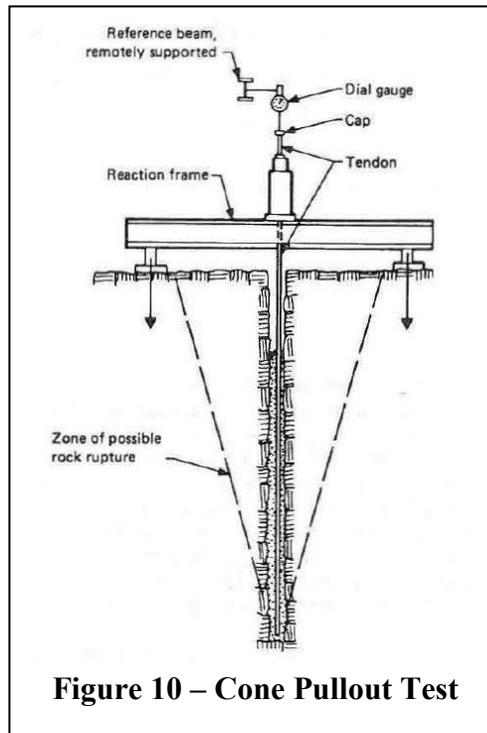
Figure 10 – Cone Pullout Test

Cone pullout testing is by nature sacrificial, complex, requires significant infrastructure, and at a project scale is generally not feasible. On a smaller scale it is invariably expensive and therefore, rare. Figure 10 shows the basic arrangement for a small- scale test, which is complicated by having to span the tested cone with reaction points outside the cone and applying

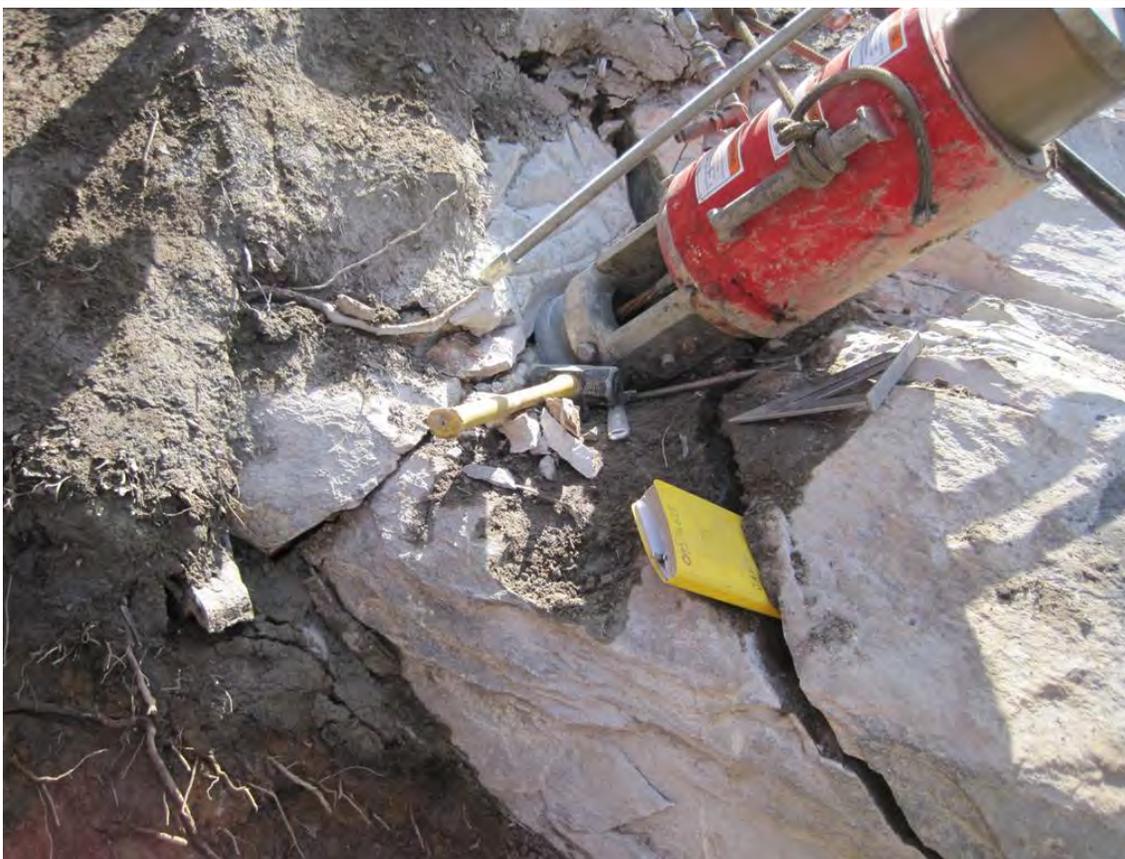
Figure 12 – Rock Broken by Anchor Tensioning

It is important to note that there is also a safety aspect to testing. A lot of energy is stored in a jack chair and anchor head assembly during testing. Tensioning complex anchors to hundreds of thousands of pounds or rock bolts to 50,000 pounds is inherently dangerous and many accidents have occurred when a bar extension fails, or a wire strand fails at the grips and launches out of the jack head assembly. Such dangers are multiplied when the contemplated work is on a rock slope in a high angle situation. Consider also the potential to fail or break the rock block being secured by imparting a large load on the block (Figure 11).

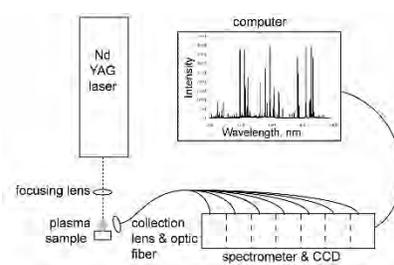
LIBS is a laser ablation technique (Cremers and Radziemski, 2006) in which a high-power laser pulse is focused on the sample (Fig. 1). The pulse energy causes atoms to ablate off the surface and burn in a high-temperature plasma. In the plasma, electrons are excited to higher-energy orbitals and then decay back to lower-energy orbitals as the plasma cools. Photons with wavelengths proportional to the energy difference between the orbitals are emitted from atoms, captured by a lens, and transported through a fiber optic to a spectrometer. The light is diffracted and recorded on a charge-couple device, producing a spectrum with many peaks. The intensity of each peak is proportional to the number of photons generated from a specific orbital transition.

Figure 1 – Schematic Diagram of LIBS System (from McMillan et al., 2012).

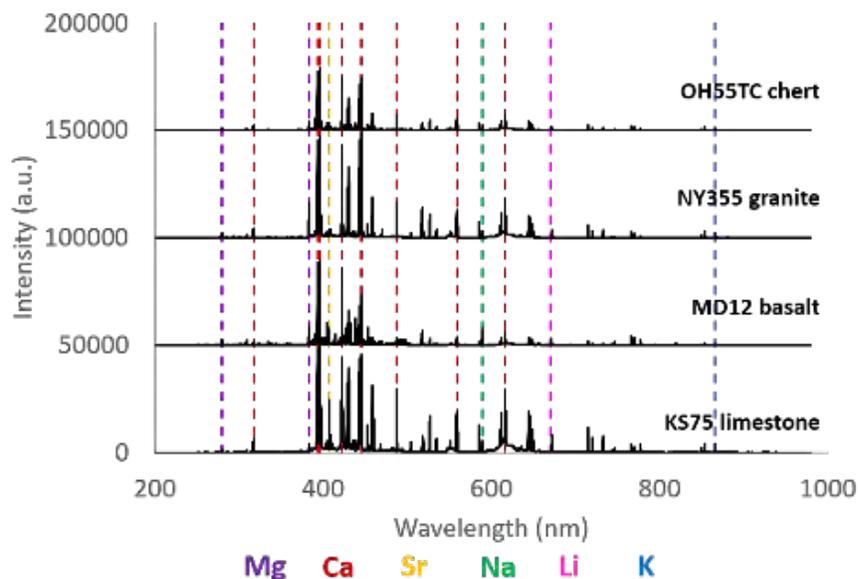
LIBS spectra contain an enormous amount of information on the composition and structure of the analyzed material. Figure 2 shows representative spectra of four different aggregates: limestone, basalt, granite, and chert, with the major peaks labeled. Contained in the spectra are: 1) information on the concentrations of all naturally-occurring elements (Cremers and Radziemski, 2006), 2) information on some isotopic ratios (Russo et al., 2011), and 3) structural information (Serrano et al., 2015). Spectra can be modeled with multivariate statistical analysis to take advantage of this information. A single spectrum can be modeled to yield information on different engineering properties (specific gravity, ASR, AIR, etc.). Each model uses the parts of the spectrum that correlate with the engineering property and treats the rest of the spectrum as insignificant. Thus, LIBS represents an efficient method for highway QA/QC analysis.

Figure 2 – Representative LIBS Spectra with Some Peaks Labeled.

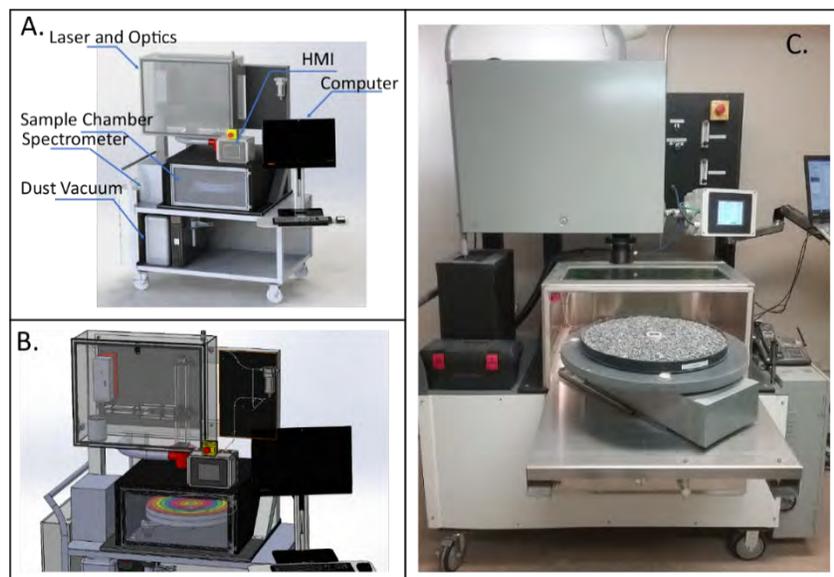
The Sample Laser Targeting (SLT) System is an automated sample delivery-LIBS system designed for analysis of highway aggregate samples. Figure 3A illustrates the design of the instrument. The laser, spectrometer and optical components are housed in separate cabinet boxes (Fig. 3B) that prevent dust contamination from the aggregate samples and heating of the spectrometer, which can cause the data to drift with changing temperature. A dust collection system removes the dust produced during sample ablation. Figure 3C is a photo of the SLT with the sample chamber open and a highway aggregate sample loaded on the circular sample tray. During analysis, the tray table rotates as the laser shoots directly down and light is collected by a lens near the sample. Rotation of the tray table continuously provides fresh sample to the laser,

Figure 3 – Sample Laser Targeting (SLT) System. A. Schematic diagram of the instrument's component parts. B. Schematic diagram of the laser cabinet with transparent faces. C. Photo of the SLT with an aggregate loaded in the sample tray.

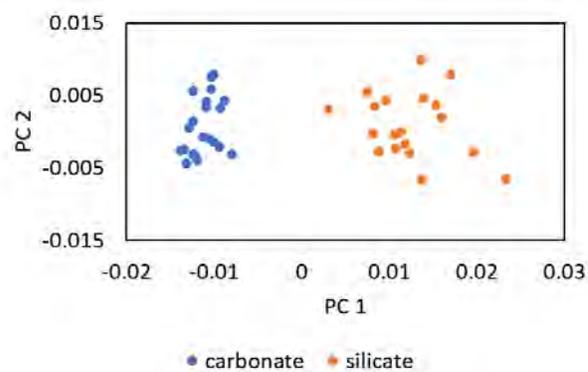
Figure 4 presents a PCA score plot calculated with samples from MDDOT. There are two types of aggregates in this example: carbonates (limestone, dolostone, and marble) and silicates (basalt, granite, serpentinite, gneiss, schist, hornfels, and quartzite). The carbonate and silicate samples plot in two discrete groups with separation along the PC 1 direction. This is an example of how PCA is used to observe groups of samples within a data set and discern which samples are similar in composition to each other.

Figure 4 – Principal Component Analysis (PCA) Score Plot With Carbonate and Silicate Samples Provided by MDDOT.

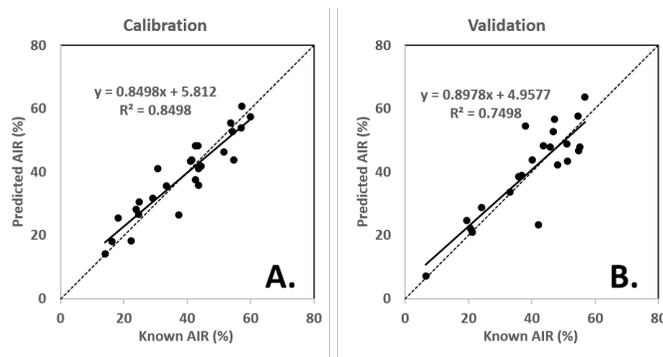
The PLSR model for AIR% calculated with NYSDOT aggregate samples in this study is shown in Figure 5 as an example. The model is calculated using 75% of the samples; the remainder are reserved for model validation. During calculation of the model, the value of the independent variable (AIR% in this case) is calculated for each of the calibration samples. Figure 5A plots these calculated values against the AIR% values measured at NYSDOT compared to the dashed 1:1 line, which indicates a perfect correlation. The model is fairly good, with a slope close to 1 (0.85) and a high correlation coefficient ($r^2 = 0.85$). This indicates a strong model.

In this study, PLSR models are validated using test sets. The 25% of the spectra not used in the calibration are input into the model, and the values of the independent variable are calculated for the test set samples. Because the measured AIR% values are known for these samples, it is possible to evaluate the strength of the model. The measured and predicted AIR% values for the test set samples are plotted in Figure 5B. The slope is high (0.90) and the correlation is fairly strong ($r^2 = 0.75$).

Figure 5 – Partial Least Squares Regression (PLSR) Model for AIR% Using Aggregate Samples Supplied by NYSDOT. A: Calibration. B: Test-set Validation.

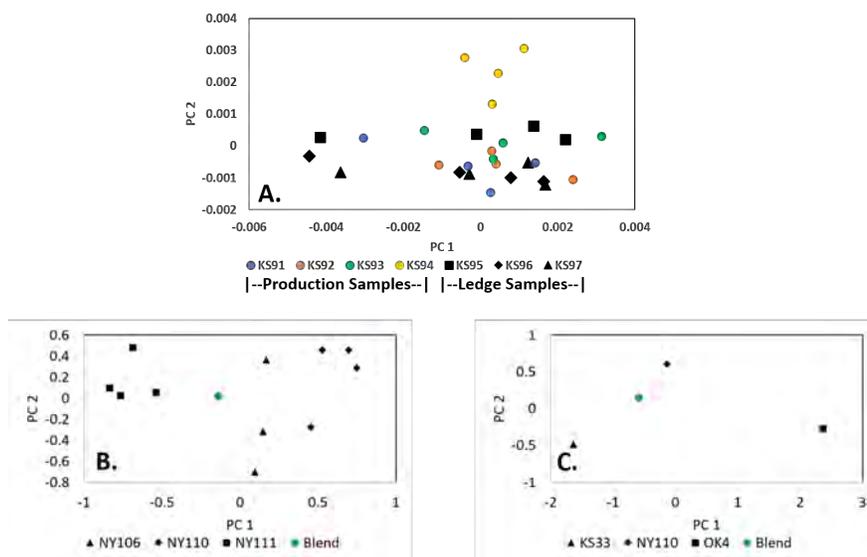
Figure 6A shows a PCA score plot for ledge (black symbols) and production limestone samples (colored circles) from the Bethany Falls Quarry, KS. Each sample was scanned three or four times to capture the inherent heterogeneity of the samples. The approved ledge samples (KS95, KS96, and KS97) define a compositional range that runs along the lower half of the score plot. Production samples KS91, KS92, and KS93 fall within the range of the ledge samples. While one spectrum from KS93 (green) falls slightly to the right of the ledge range, the other three spectra plot well within the range. This one spectrum is interpreted to represent heterogeneity within the KS93 sample. All four samples of KS94 (yellow), however, fall above the range of approved ledge samples. KS94 is interpreted as either a non-approved aggregate or a mixture of an approved aggregate with a non-approved aggregate.

Figure 6 – PCA Score Plots that Compare Ledge and Production Aggregates. A: Ledge and Production Samples from Bethany Falls Quarry, KS. B: Physical Blend of Three New York Limestones. C: Physical Blend of Two Limestones and a Quartz Sandstone.

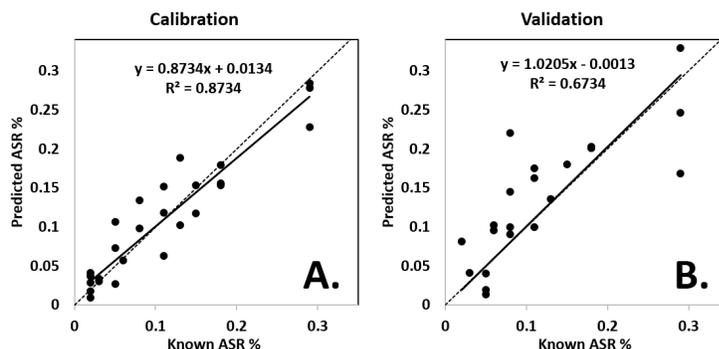
Samples submitted by MDDOT with measured ASR expansion % were modeled using PLSR (Fig. 7). The calibration (Fig. 7A) has a slope of 0.87, close to the ideal 1:1 dashed line. The correlation coefficient indicates a strong correlation between the measured and predicted ASR values. Figure. 7B shows the results of test set validation. The slope is essentially equal to 1; however, the scatter is greater than in the calibration. Aggregates with ASR expansion % greater than 0.20 are considered to be deleterious; there are three such samples in the test set. Two of the three were correctly identified as having ASR expansion % greater than 0.20. Similarly one sample with measured ASR expansion % of 0.08 is predicted at greater than 0.20%. This is a high-quality sample that is classified as deleterious. With the exception of these two samples, all others are correctly classified relative to the 0.20% expansion limit.

Figure 7 – Partial Least Squares Regression (PLSR) Model for ASR Expansion% Using Aggregate Samples Supplied by MDDOT. A: Calibration. B: Test-set Validation.

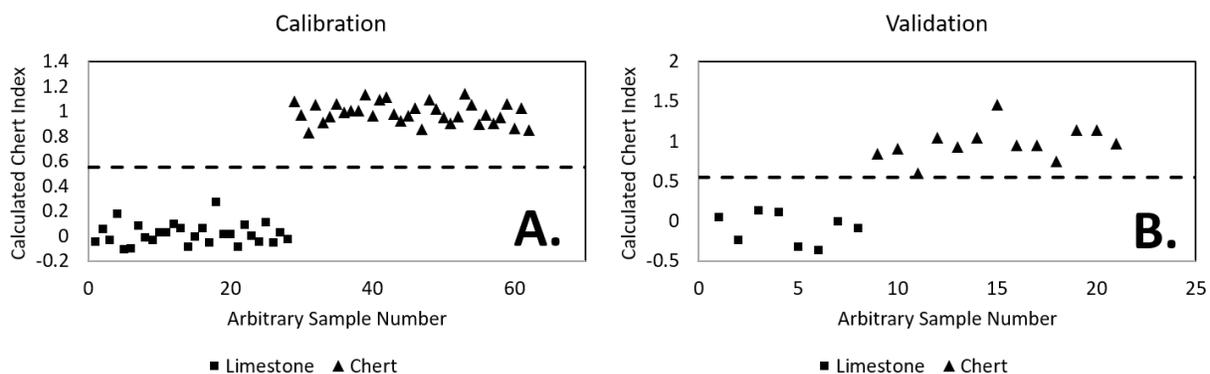
Chert can be a deleterious material, causing ASR cracking of aggregates. OHDOT submitted samples of chert and limestone that were separated from cherty limestones beds. Identification of chert in Ohio aggregates was developed using a PLSR model that classifies an aggregate as chert or as limestone. This PLSR model uses the independent variable “1” for chert samples and “0” for limestone samples. Figure 8A shows the results of model calibration. The independent variable calculated for each calibration sample is plotted against sample number. All limestone samples have low values, clustering around 0, and all chert sample have high values, clustering around 1. The dashed line indicates the VAD (Value of Apparent Distinction), 0.55 in this case. The VAD is used to classify samples as chert (independent variable ≥ 0.55) or limestone (independent variable < 0.55). Test set validation of this model is shown in Fig. 8B. All limestone samples in the test set have Chert Index values $< VAD$, and all chert samples have Chert Index values $> VAD$. This model is 100% successful.

Figure 8 – Partial Least Squares Regression (PLSR) Models for the Presence of Chert and Type of Chert in OHDOT samples. A: Calibration of Chert Model. B. Test-set Validation of Chert Model.

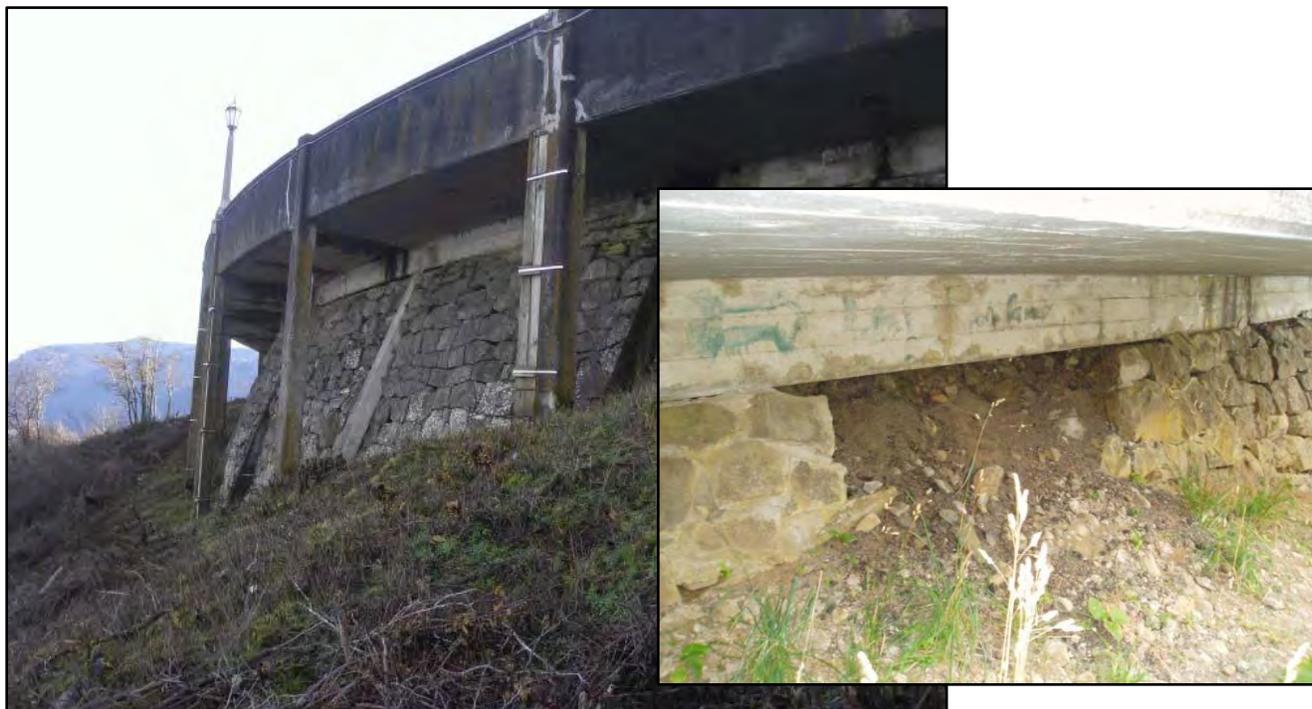
Photos of the viaduct prior to restoration project. Note the additional support at exterior columns in the left photograph on the left and the failed wall section in the photograph on right.

The overall goal of the project was to repair and strengthen the aging viaduct and associated retaining wall while maintaining the appearance and as much of the original structure as possible. The viaduct was in poor condition prior to restoration with cracked and damaged support columns, beams, and deck as well as inadequate foundation support. Portions of the dry-stacked stone retaining wall beneath the viaduct were also in poor condition with failed sections, bulging, settlement areas, and loss of backfill, which in-turn threatened the roadway immediately adjacent to the viaduct.

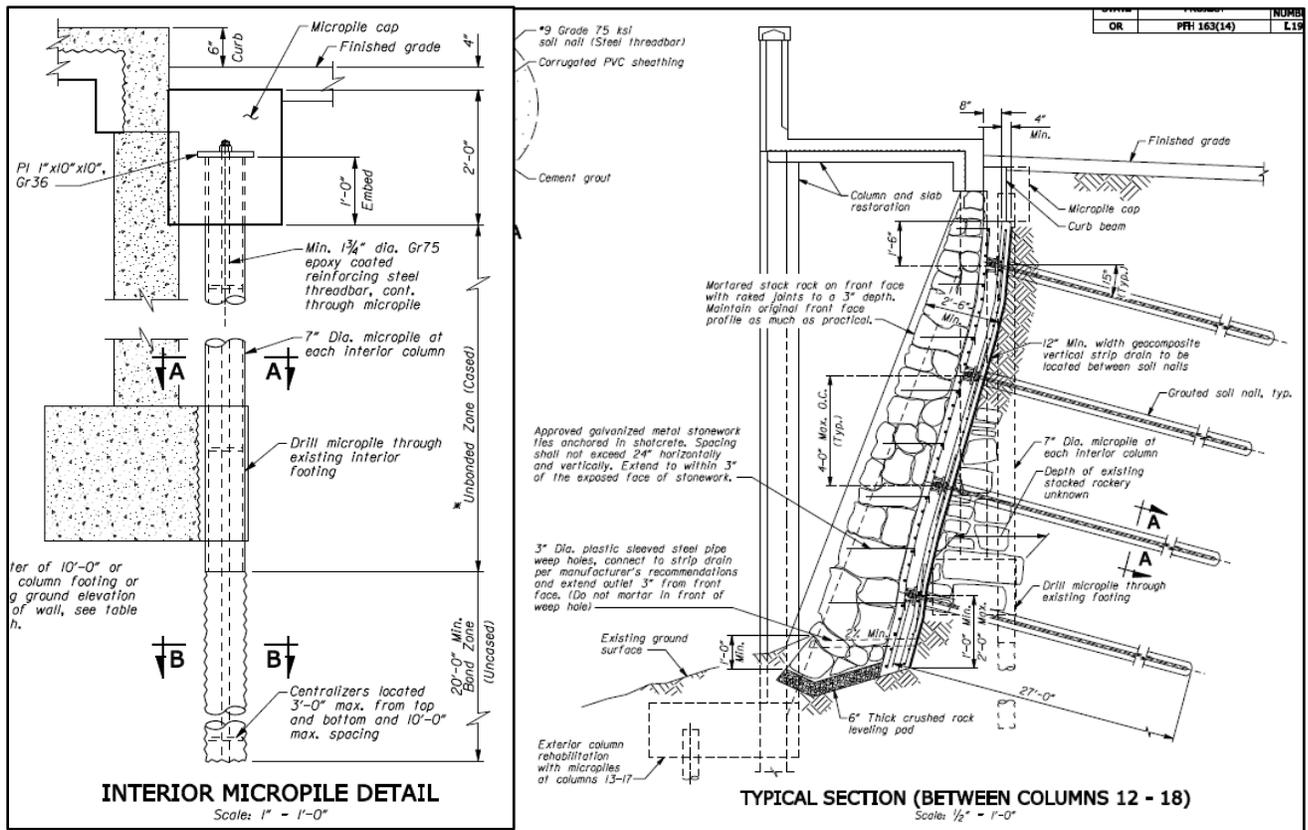
Plan details. Left detail shows interior column micropile support. Right detail shows soil-nail wall stabilization and exterior micropile support.

The final design for the geotechnical elements included providing supplemental foundation support through the use of micropiles at all 29 of the interior column foundations and 15 of the 29 exterior column foundations as shown on the attached figure. The existing dry-stacked stone retaining wall was partially removed using a top down approach and a soil-nail wall was constructed for the full height to provide a durable retaining wall system. The dry-stacked stone that was removed for construction of the soil-nail wall was then replaced as facing to retain the historic appearance and materials as used in the original construction. While the construction was not without challenges, the overall project was considered a great success with positive feedback from the stakeholders and the public.

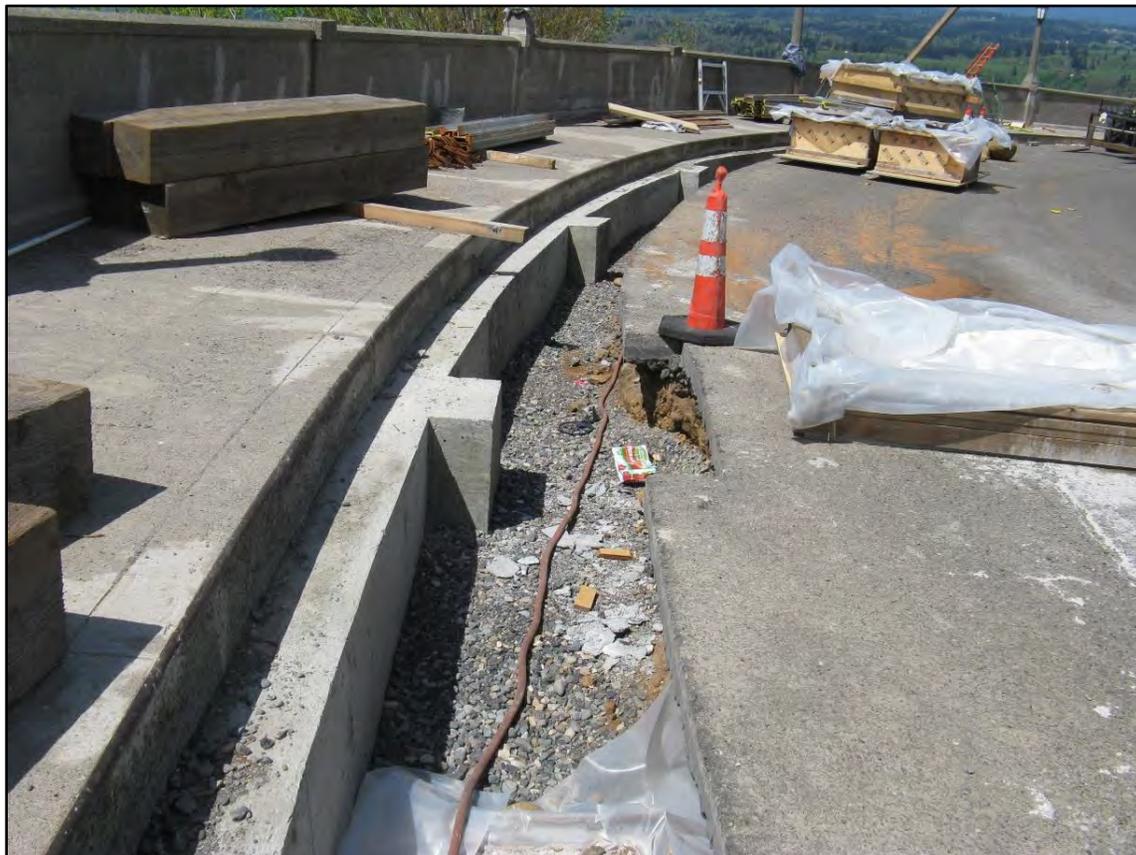
Construction photo showing completed micropiles and micropile cap on the interior side.

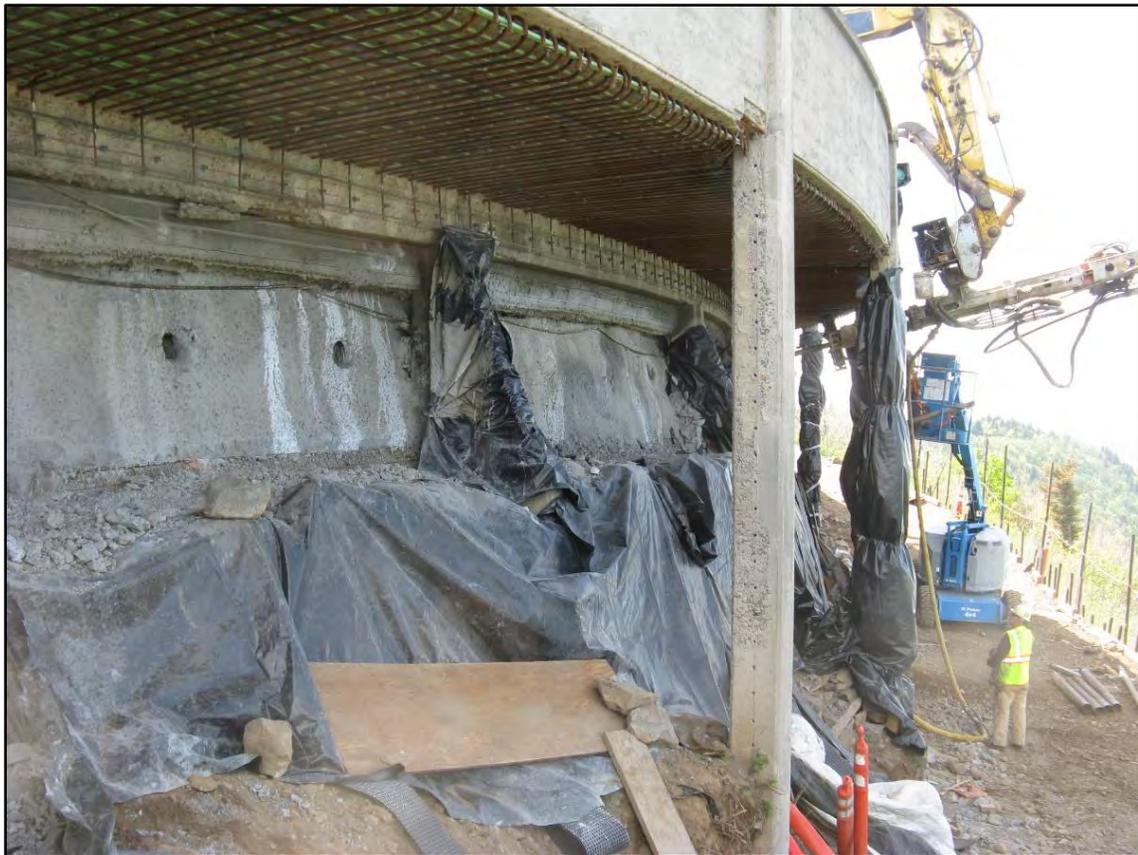
Construction photo showing soil-nail wall construction beneath viaduct on the exterior side.

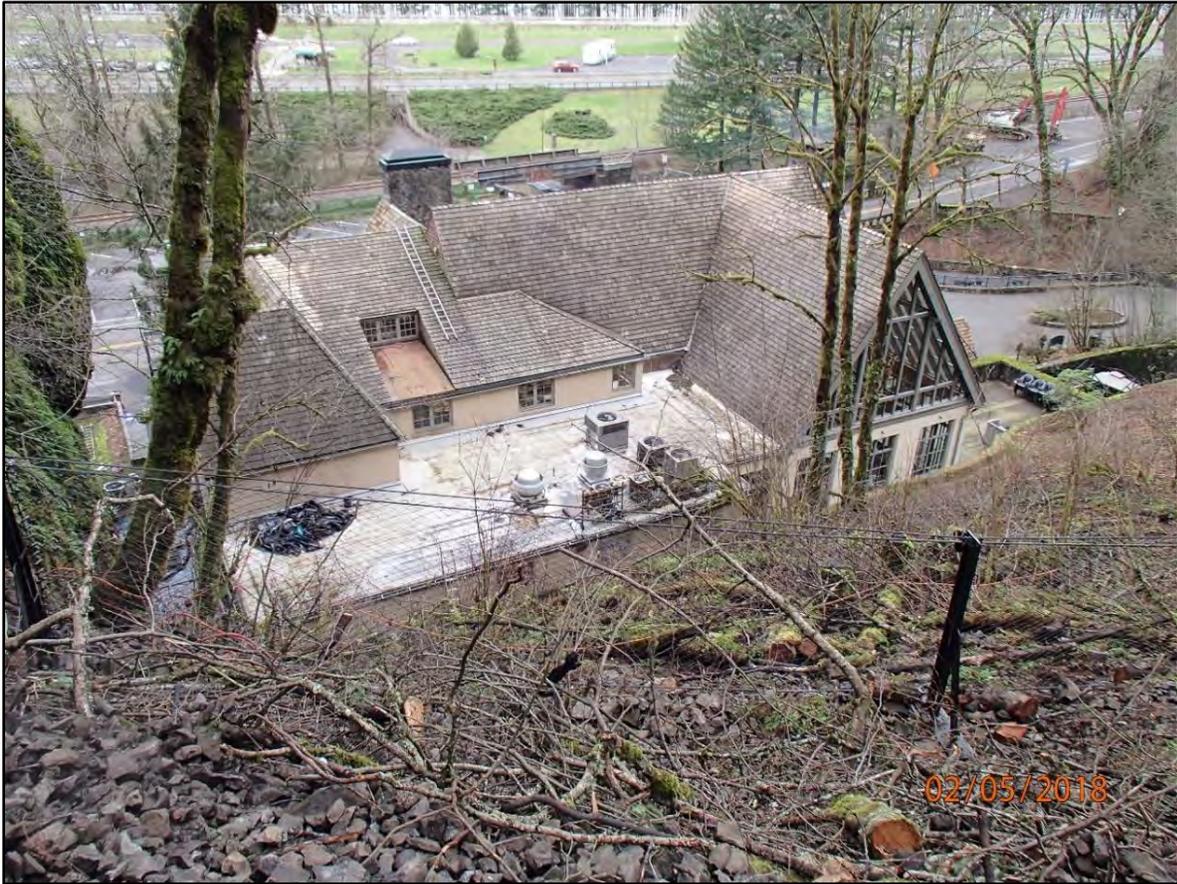
Looking down the rockfall chute where a 10 foot-high flexible rockfall fence was constructed above the historic Multnomah Falls Lodge.

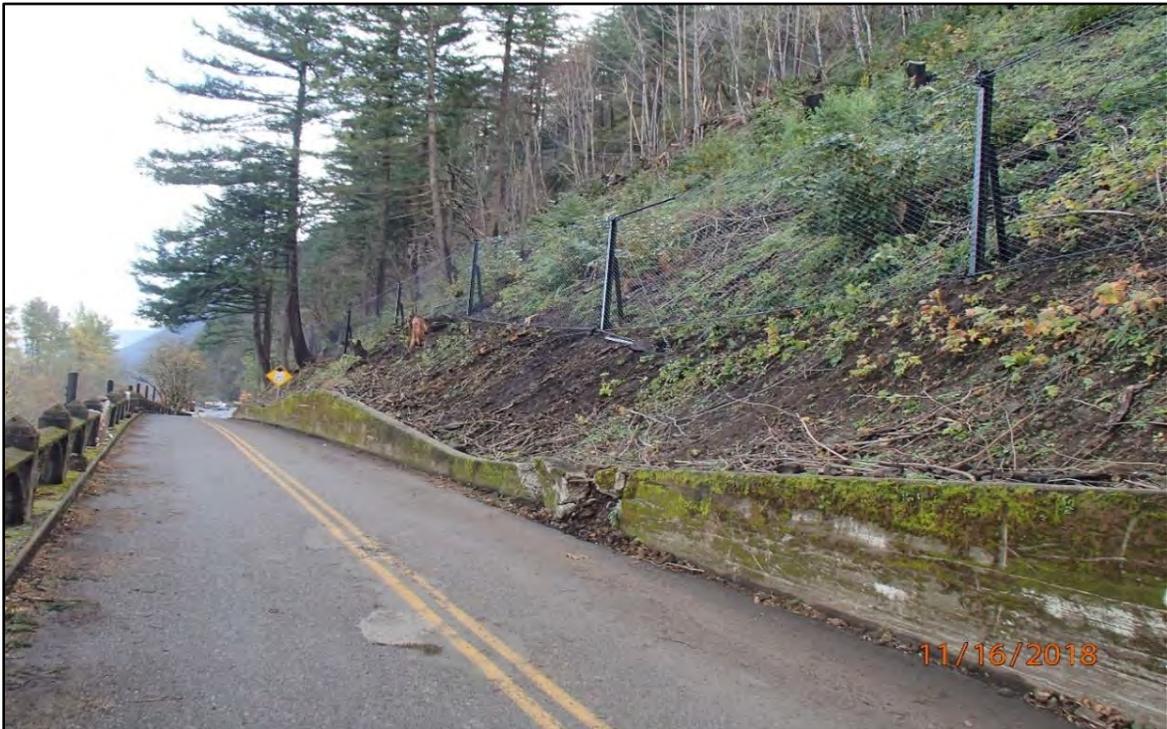
Approximately 3000 linear feet of 10 foot-high flexible rockfall fence along the Historic Columbia River Highway near Multnomah Falls Lodge.

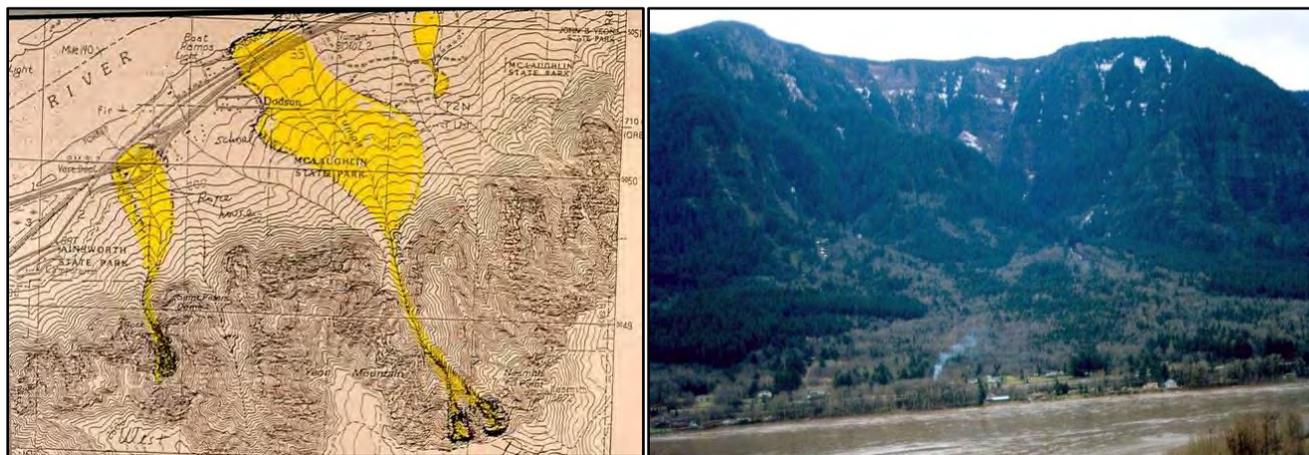
Left: Topographic map with alluvial fan and debris flow channels highlighted in yellow. **Right:** Oblique photograph taken from Washington looking southwest at Dodson alluvial fan complex.

In the middle of the Gorge is a large debris flow/alluvial fan with the hamlet of Dodson on it. This large debris flow and alluvial fan most likely has formed from repeated debris flows over the past 15,000 years building it after the last Missoula Flood flowed through the Gorge. In February 1996, Northwest Oregon and Southwest Washington State received a huge amount of precipitation from a large “Pineapple Express,” or Atmospheric River, from the central Pacific in four days. In the Gorge, we got over 35 inches of precipitation. It caused seven major debris flows on this fan.

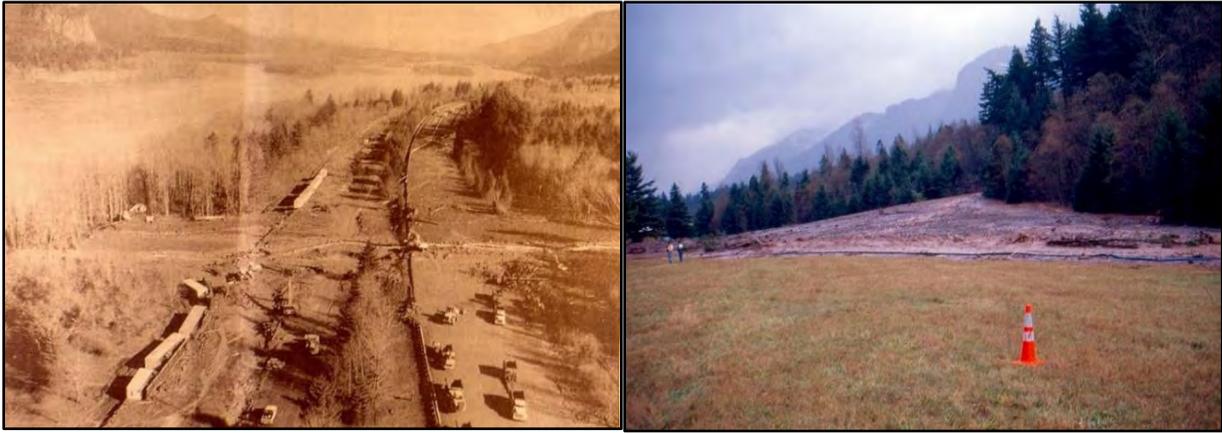
Left: Tumult Creek Debris Flow across I-84 and railroad. **Right:** Royce Debris Flow (west end of fan).

The first one was the Royce Debris Flow which occurred just after noon on the second day of the storm. A house was inundated by at least 4 pulses over the next three days. The debris flow moved about 6.5 miles per hour (mph). This blocked I-84 and the train tracks. Later that same day at 10 PM, another debris flow came from a landslide dammed lake upstream that breached and sent a huge debris flow down the drainage at over 35 mph down Tumult Creek. This debris flow impacted several trucks on I-84 and six cars of a train into the Columbia River. Thankfully, no one was killed. In the intersection near the Royce Debris Flow, where the old highway intersects I-84, another debris flow occurred in 2001 and filled up the whole on-ramp intersection with debris, but did not impact I-84. With the great relief, the presence of colluvium hollows that collect debris during periods of acquiescence between large storm events in the headwaters of several creeks and streams in the Gorge, and the propensity for large tropical storms to impact the NW each year, debris flows continue to be a major geohazard that shapes and impacts the Gorge.

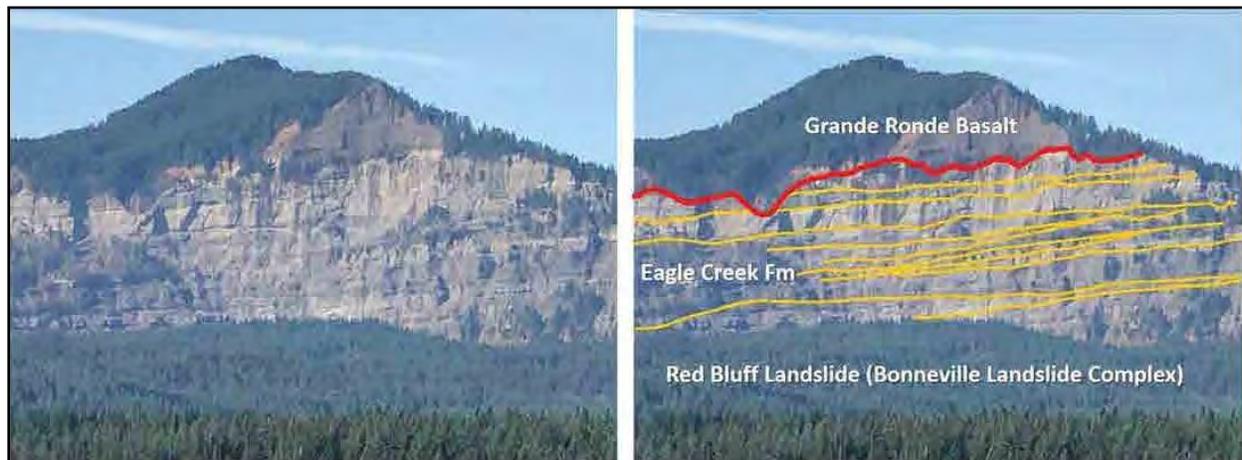
The Bonneville Landslide headscarp with geologic stratigraphy mapped on the right.

The Bonneville Landslide is the most studied landslide in the Pacific Northwest because we built our first dam on the Columbia River buttressed up against it in 1937 – Bonneville Dam. One did not want to have a landslide that might reactivate and cause the dam to fail. This landslide came down from the Washington side and crossed the Columbia River and totally stopped flow for a number of years. It killed the forests upstream (noted by Lewis and Clark when they came through here in 1805). It created a lake all the way to The Dalles, Oregon, over 55 miles upstream. Eventually, the dam broke and a wall of water 50 feet-high flowed down into what is now Portland. It created the Cascades of the Columbia,

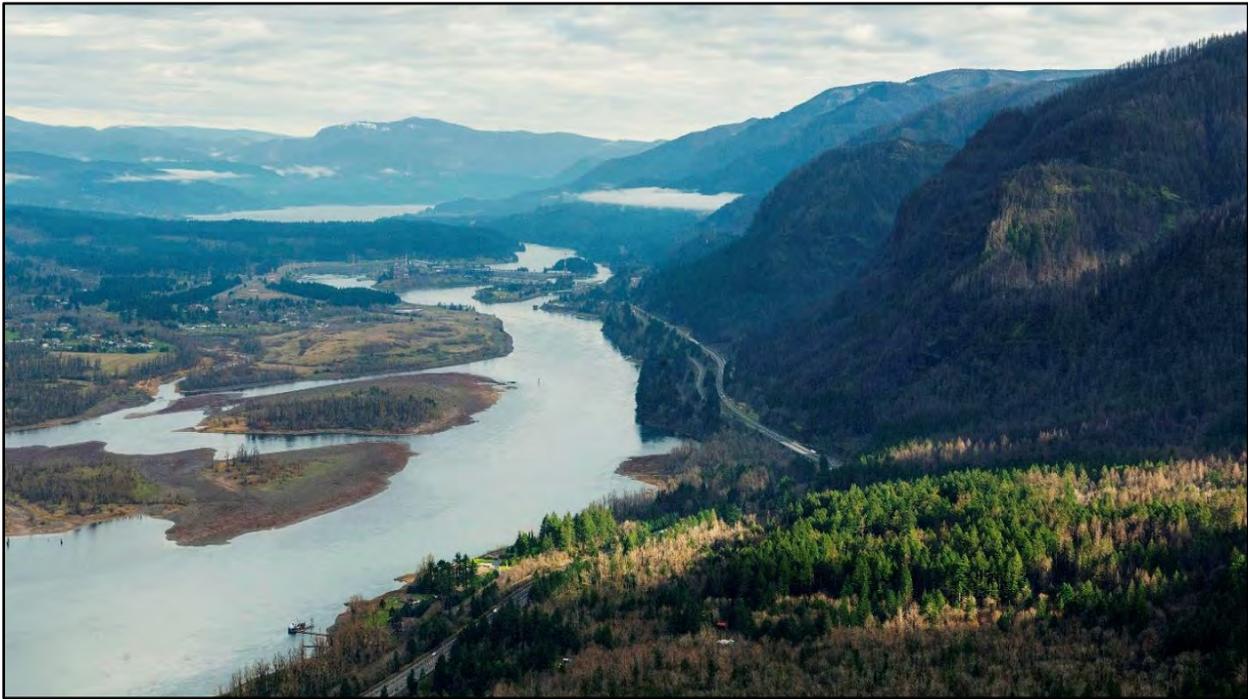
Aerial photograph courtesy of ODOT looking to the northwest from Oregon at the Bonneville Landslide in the left half of the photograph.

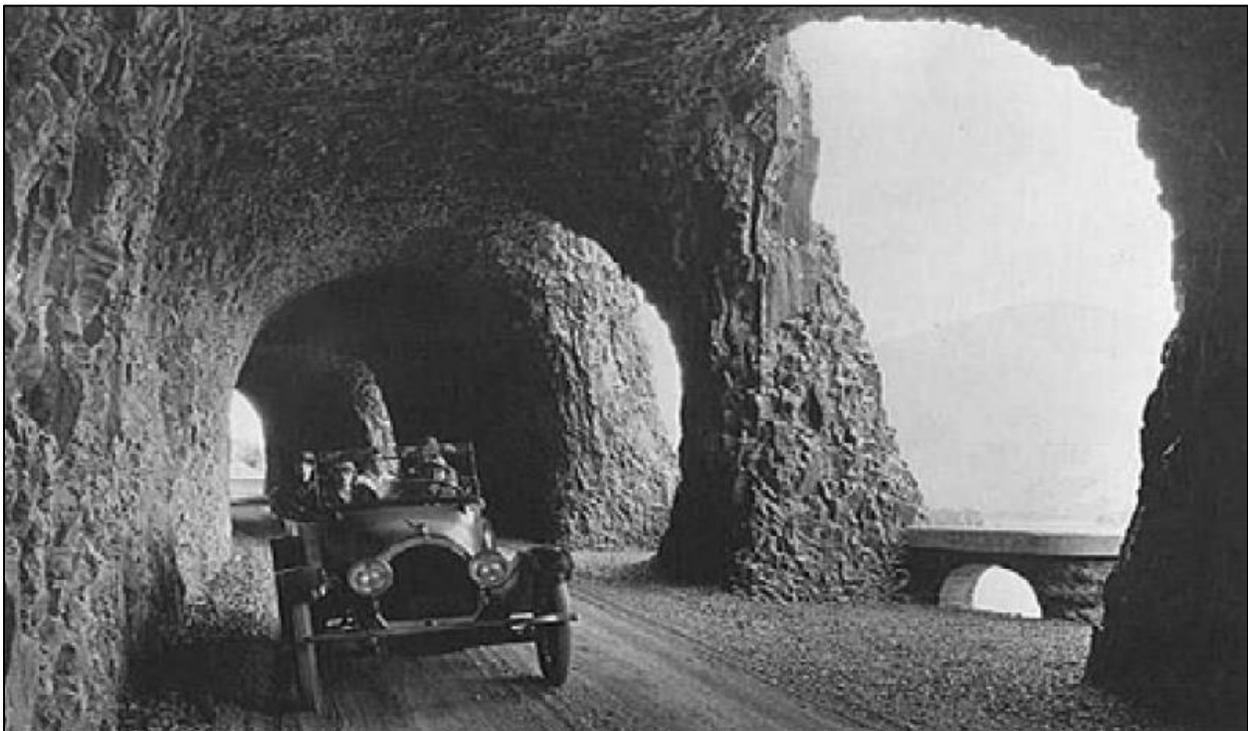
Historic photograph of the Mitchell Point Tunnel with adits. Sources for figures can be found at <https://www.oregon.gov/ODOT/Regions/Documents/HCRH/Trail-Plan-Part-1-Wyeth-Hood-River-HCRH.pdf>

foot tall basalt promontory, but the tunnel was later blasted away during construction of I-84. The tunnel was famous for its adits or windows cut out of the rock to allow light to the driver and provide views of the gorge. We will discuss current design efforts are focusing on a new tunnel with adits similar to the historic tunnel, as well as balancing rockfall mitigation, and scenic area visual, environmental, and cultural concerns throughout these segments.

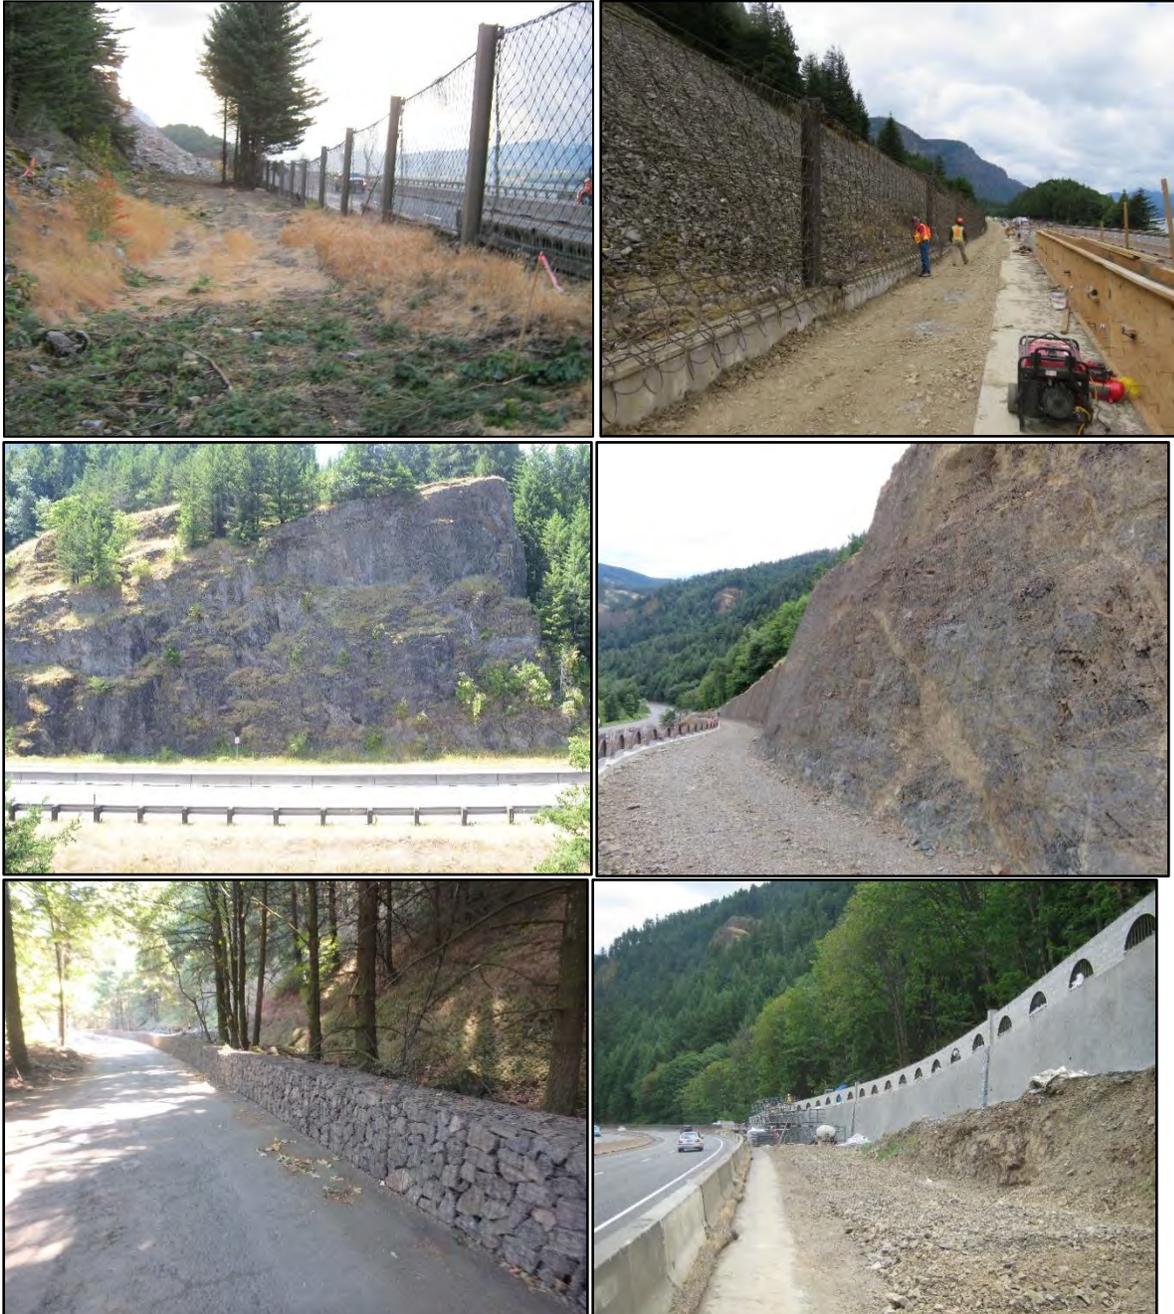
Before and after construction photos from left to right along Wyeth Section from top to bottom.

Rockfall risk reduction designs capable of precluding 99% of impacting rockfalls and 90% of rolling rockfalls from reaching the trail and I-84 were desired (i.e. 90% retention of rolling rocks). This was accomplished using a combination of scaling, rock bolting, gabion basket walls, draped high-tensile strength mesh, mid-slope attenuator fences, and flexible rockfall barriers along the uphill side of the trail depending on site conditions. Context sensitive measures were incorporated into the design to reduce

the visual impacts of the rockfall risk reduction elements. They included the staining of all metal components, rock-faced gabion baskets, and contouring draped mesh sections so it conforms to the slope shape. Over 3,000 linear feet of low-deflection, flexible rockfall fence barrier without upslope tiebacks was constructed. Other challenging geotechnical elements included: over 2,000 linear feet of MSE walls and reinforced soil slopes, a tied-back gravity wall, a 750-foot long viaduct supported on spread footings with micropile and tie-downs, a 400-foot long soldier pile tie-back wall, one micropile supported bridge, and one bridge on conventional spread footings.

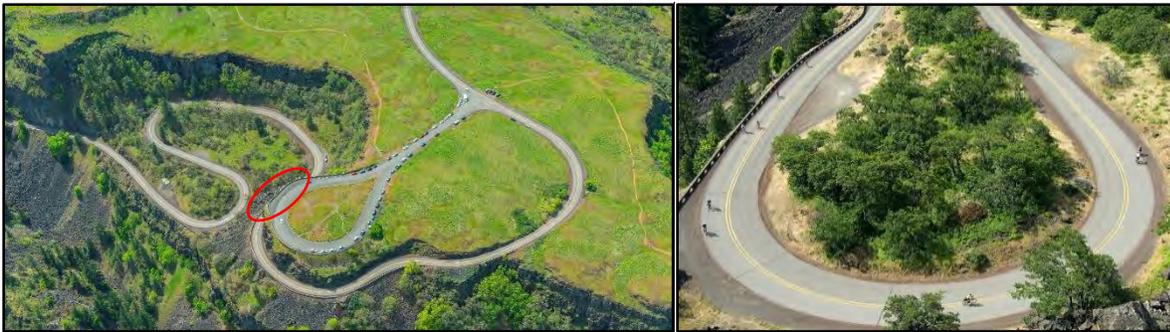
Left: Aerial photograph of Rowena Loops courtesy of ODOT. Red polygon is the location of a risk reduction rockfall project by ODOT. **Right:** Photograph of the lower Rowena Loops taken from the upper viewpoint.

Jamie Schick: The Historic Columbia River Highway (US 30) traverses the Columbia River Gorge along the south side of the Columbia River. Towards the eastern end of the Gorge it passes over the crest of Rowena Bluffs, a broad plateau punctuated with a near vertical 500-foot cliff adjacent to the river. This cliff consists of a series of Miocene-aged Columbia River basalt flows. East of this cliff the highway drops steeply back to the river, passing beneath several steep cliff faces that represent the headscarp of an ancient landslide. This includes a nearly 300-foot-high cliff near mile point 64.7 (red polygon in the picture above).

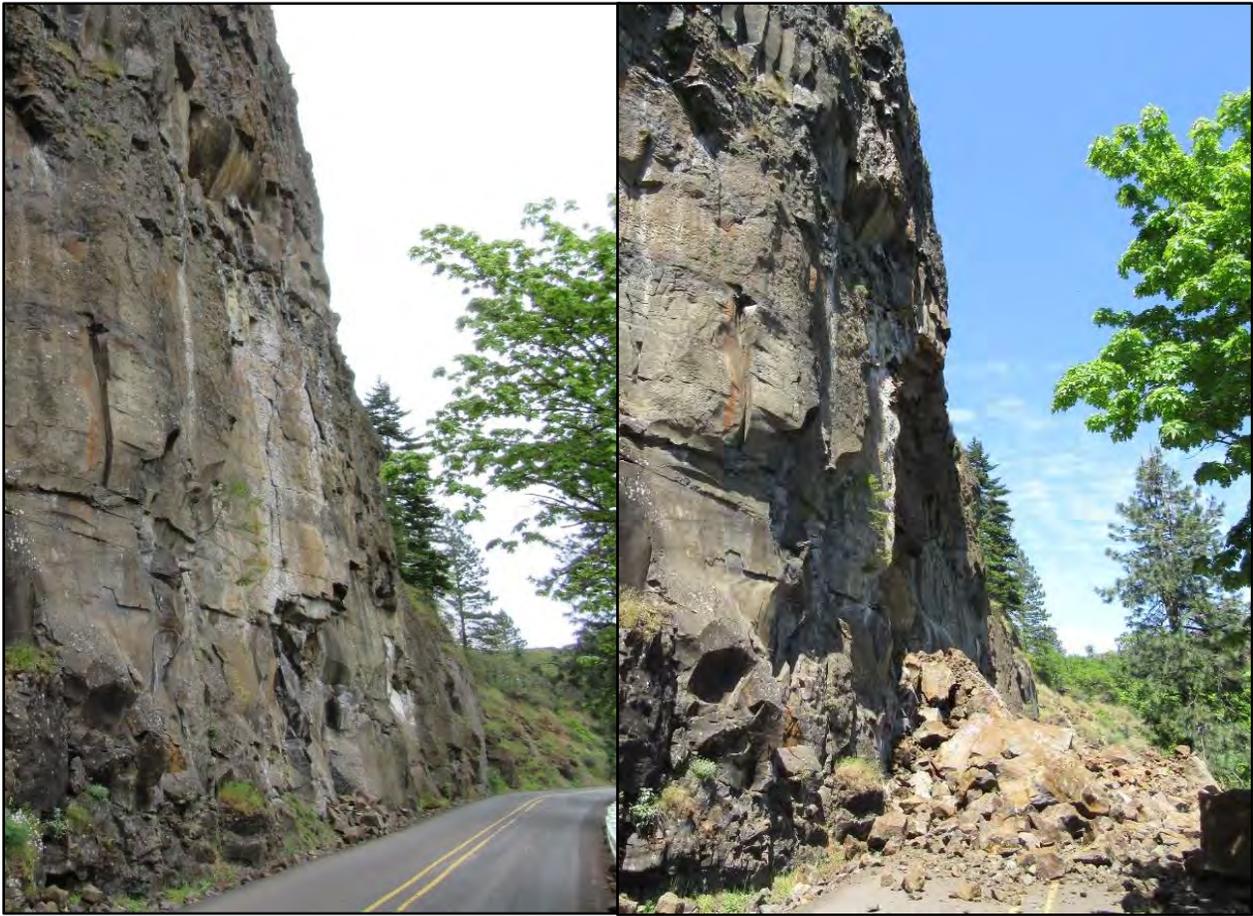
Pre and post rock failure views looking north along the highway.

On May 7, 2017, the lower 75 feet of the cliff failed and fell onto the roadway, burying both lanes for nearly 200 feet with almost 20 feet of debris (figure below). This section of the cliff is dominated by columnar jointing that have developed columns exceeding eight feet in diameter. These columns terminate into a flow contact at approximately 75 feet above road grade. The flow contact includes a five to 15-foot-thick zone of highly weathered, closely fractured vesicular basalt. The failure undermined this flow contact, creating a nearly 10-foot overhang and was at risk of undermining the remainder of the cliff above.
