70TH HIGHWAY GEOLOGY SYMPOSIUM

“Better Highways Through Applied Geology”

October 21-24, 2019

2019 Proceedings

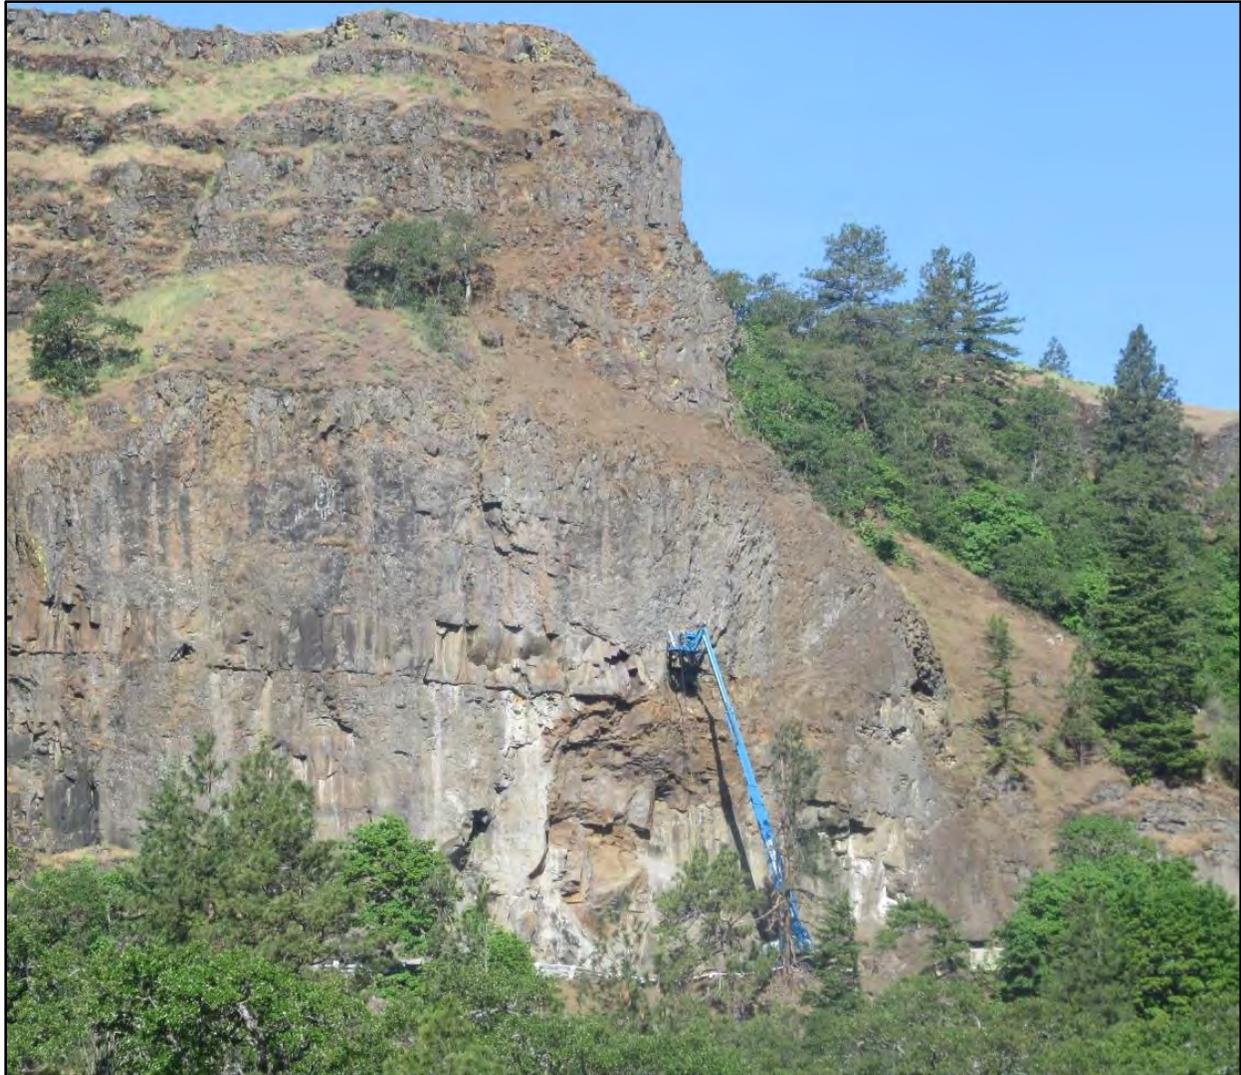
Ongoing installation of rock bolts using 145-ft man-lift.

Initial mitigation response efforts focused on stabilizing the remaining lower columns as well as the columns above the interflow. Approximately 600 linear feet of rock bolts were designed to support this approach and were installed by Rock Supremacy from Bend, Oregon, between approximately May 17th and May 23rd (figure on next page). Rock bolt lengths varied between 10 and 25 feet and were tensioned to 30 kips. Rock bolt heads, nuts and plates were coated with Natina over the galvanization to

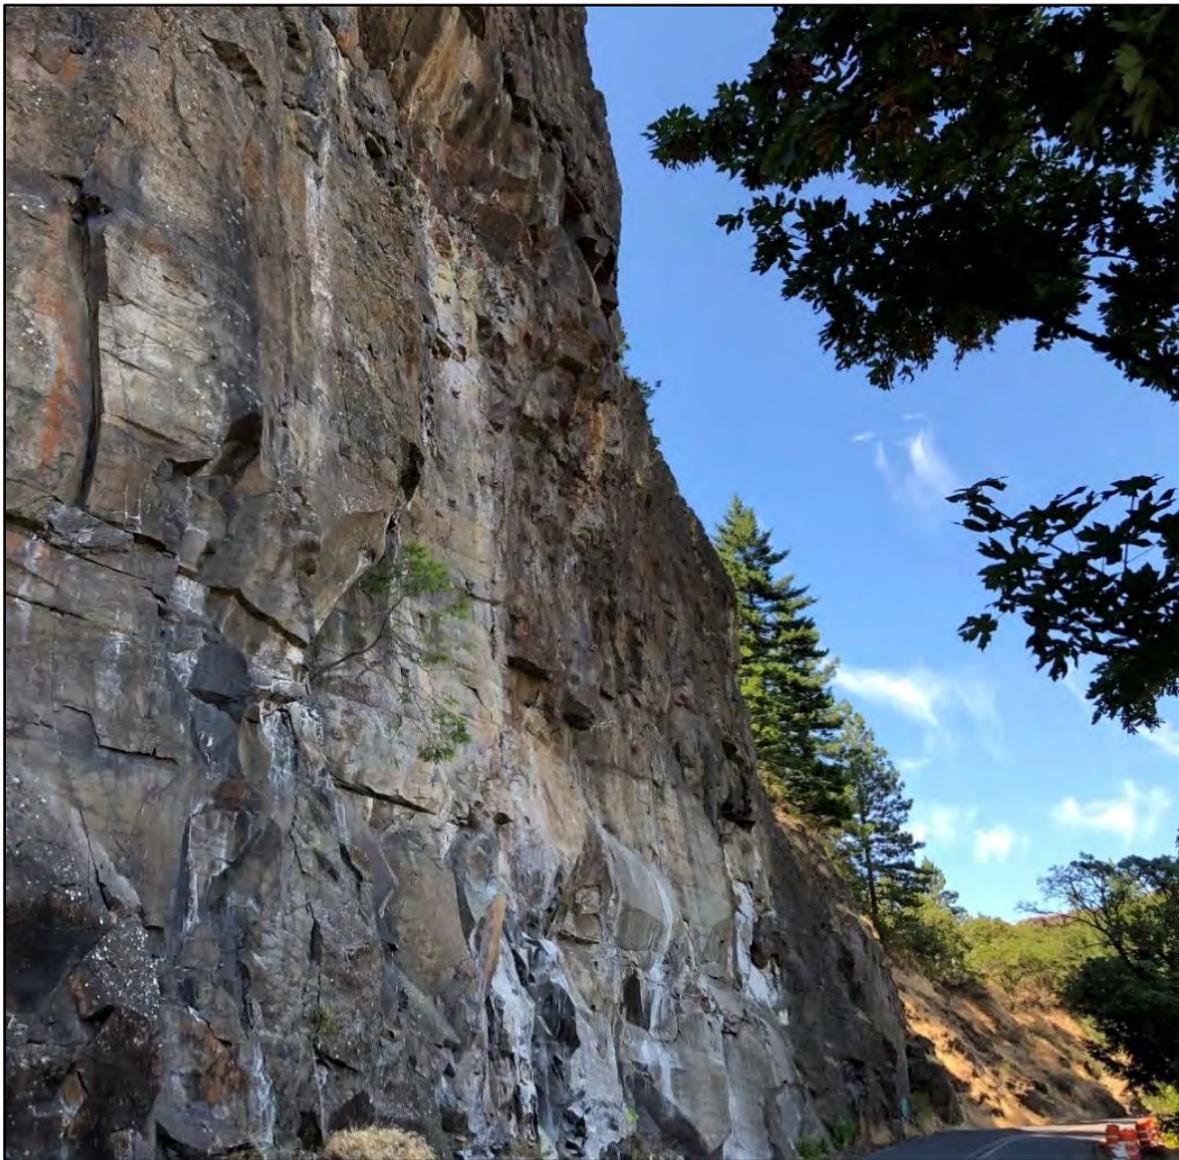
The completed installation of anchored, high tensile strength wire mesh with Natina stain over the galvanization, minimizing its visual impacts.

Final design included an anchored high-tensile strength wire mesh system across the weathered flow top, as well as additional scaling and spot rock bolting. The system was coated with Natina staining over the galvanization to minimize its visual impacts (figure on the next page). Wire mesh anchor nails were designed for a 6.5 foot spacing and extended to 15 feet from the slope face to anchor the system to competent rock. This phase of construction was initiated on January 8, 2018, proceeded without delays, and was completed by Rock Supremacy by early February 2018.
